Stabilization Procedures to Mitigate Edge Rutting for Granular Shoulders – Phase II

Final Report January 2011

Iowa Highway Research Board (IHRB Project TR-591) Iowa Department of Transportation (InTrans 08-319)

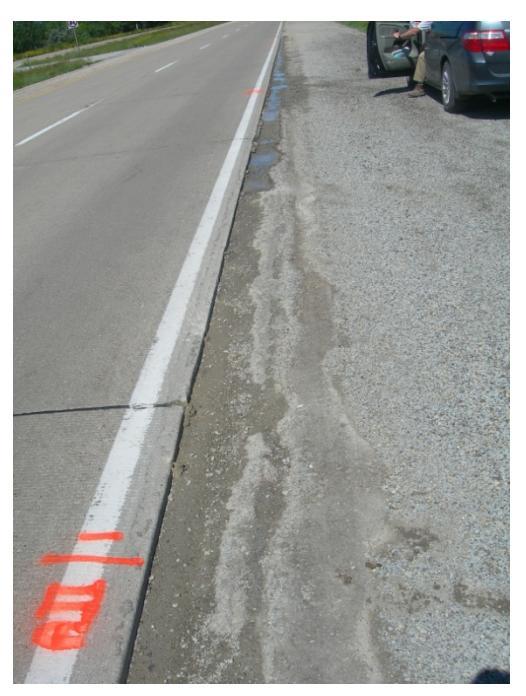
In some locations, the stabilized material was worn off in the edge-rut location, but still intact farther away from the pavement edge, often covered with course aggregate particles. It appeared that the hardpan in the edge rut was losing elevation more slowly than the stabilized material did, while it was being worn away (See Figures 90 and 91).

Figure 90. Looking west from Area II Test Point I milepost 245 June 9, 2010 (approximately same location as in Preconstruction Figure 72)

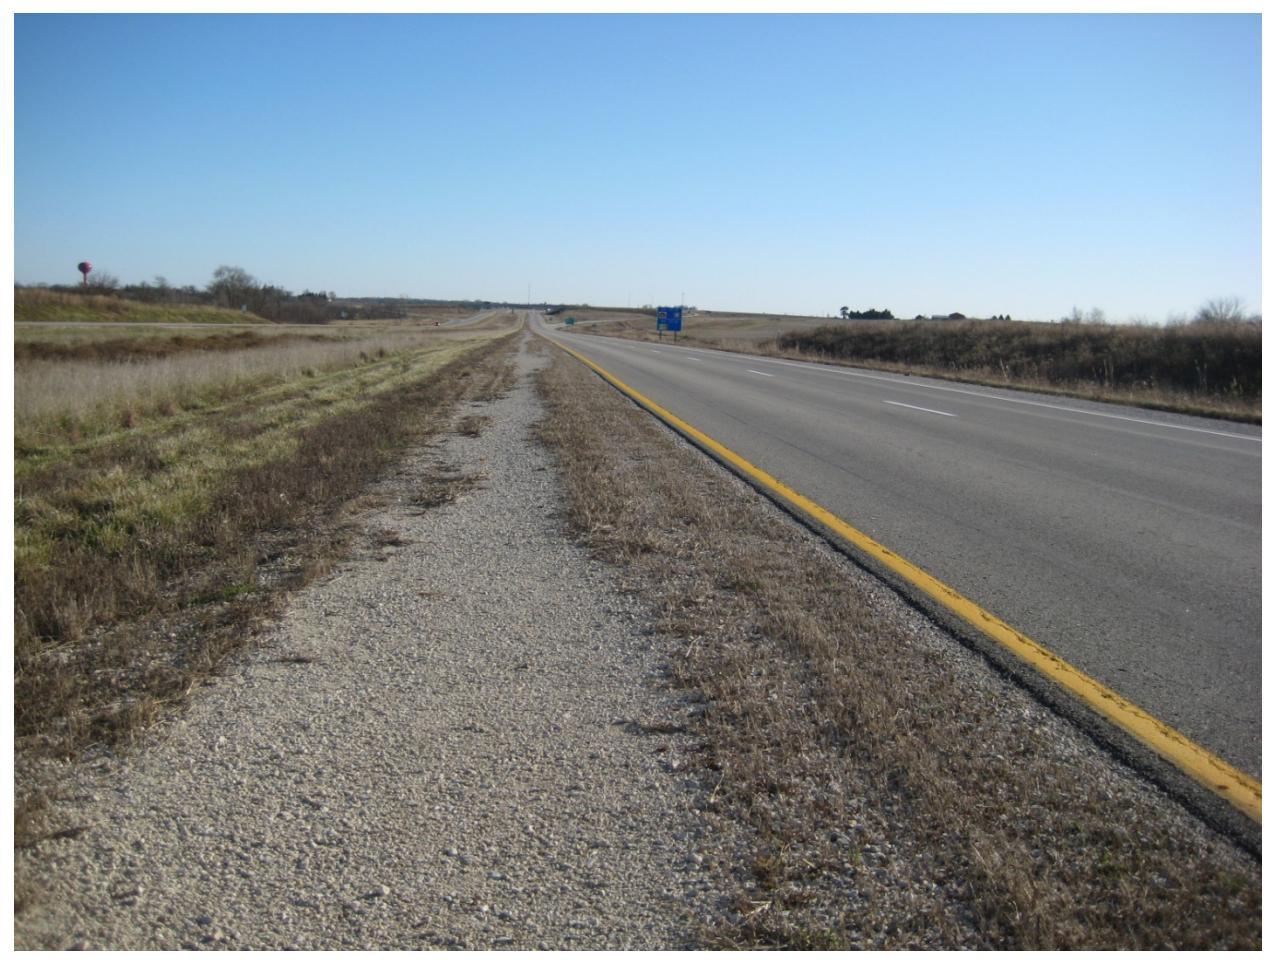
Figure 92. Test sections on November 7, 2009

The control section was 200 ft (61 m) long from mileposts 220.60 to 220.55. It was stable with no heavy rutting observed (See Figure 92). An edge rut was located within 8 in. (200 mm) of the pavement edge with an average depth of about 0.8 in. (20 mm). The elevation profiles showed that the maximum edge rut was about 1.8 in. (45 mm). The CIV values of the shoulder at various points 8 in. (200 mm) from the pavement edge ranged from 13.1 to 15.4 (See Table 31).

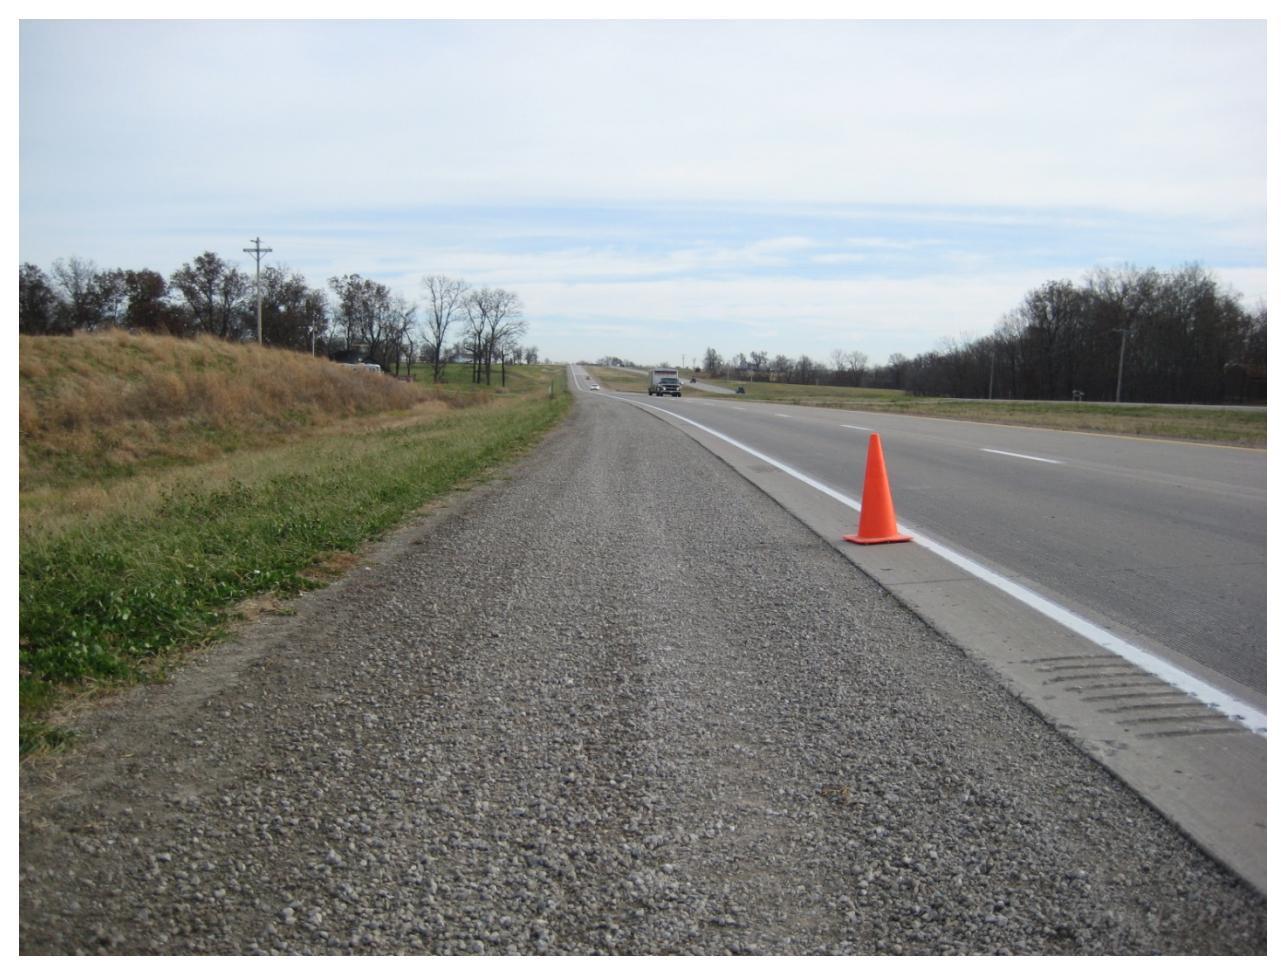
Figure 93. Test sections on November 12, 2009
