# JOINT TRANSPORTATION RESEARCH PROGRAM

## Pack Rust Identification and Mitigation Strategies for Steel Bridges

Patel, C. H., & Bowman, M. D. (2018). *Pack rust identification and mitigation strategies for steel bridges* (Joint Transportation Research Program Publication No. FHWA/IN/JTRP-2018/16). West Lafayette, IN: Purdue University. <https://doi.org/10.5703/1288284316788>

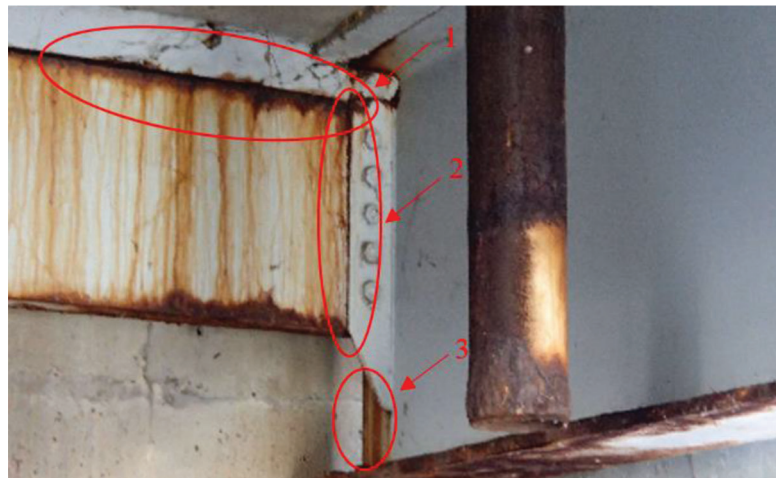
**Figure 4.1** Typical camera angle for photos of end diaphragms.

The overall condition of the end diaphragms in steel bridges of Indiana seems fair. Many of the end diaphragms show surface rusting, and rusting of the top edge. The surface of diaphragms is generally covered by rust bleeding from the top edge, circled as 1 in Figure 4.1.

Figure 4.1 is the most common camera position from which the photos are taken. From this position, the crevice between the connections (location 2 in Figure 4.1) is not visible, and hence minor pack rust cannot be detected. There is a high possibility of pack rust in the crevice at the back of the diaphragms from the water and salt seeping down the deck joint but only rust bleeding can be seen, as shown in location 3 in Figure 4.1.

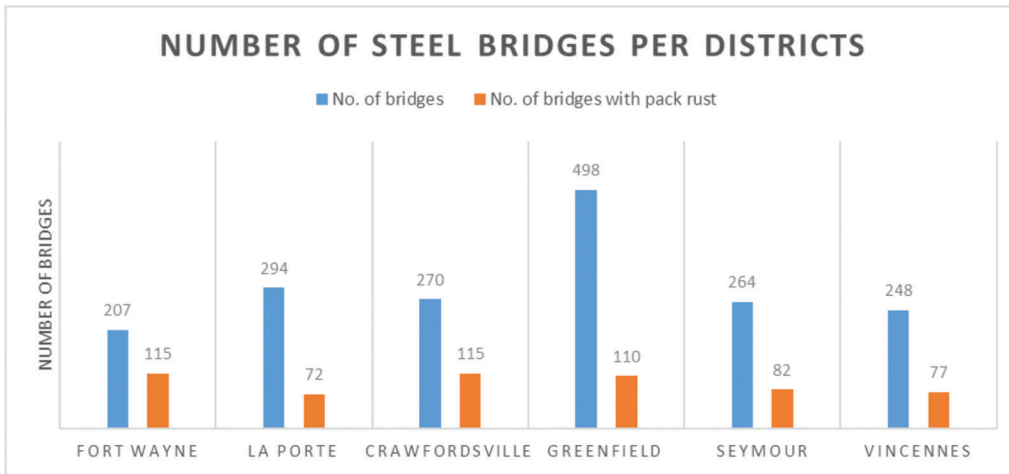
**Figure 4.19** Total number of bridges and bridges with pack rust in different districts.

close; moreover, the number of bridges with pack rust is fairly close for the LaPorte, Seymour, and Vincennes Districts (refer to Figure 4.19). It is also essential to compare the percentage of bridges in a district that have pack rust. Comparing the percentage of bridges having pack rust in Figure 4.20, Fort Wayne has the highest percentage, with more than half of the bridges having some form of pack rust. On the other hand, 22% of bridges in Greenfield have pack rust, which is least among all the districts in Indiana.

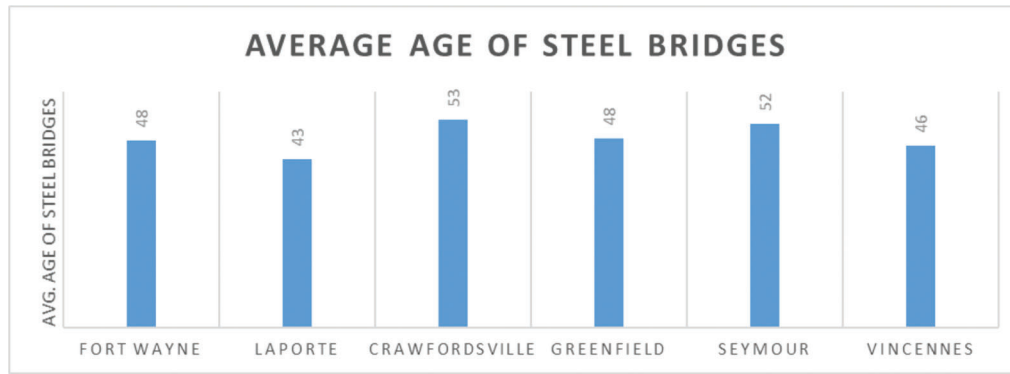
Figure 4.21 Average age of steel bridges in each district.

Figure 4.21 shows average age of the steel bridges in each district. The relative age of bridges in each district does not differ by much from the average of steel bridges in Indiana, which is 48 years. The average age of the steel bridges is highest in Crawfordsville district but, the pack rust percentage is not highest. The average age of bridges in Seymour is higher than average of bridges in Fort Wayne by 4 years but, the pack rust percentage in Fort Wayne is almost twice of that in Seymour. No distinct correlation seems to exist between average ages of the steel bridges and pack rust percentage, because

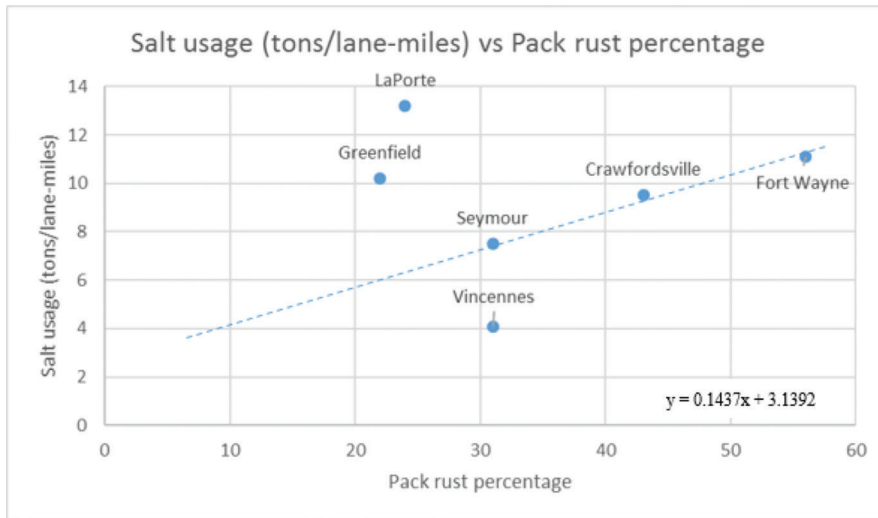
Figure 4.22 District wise breakdown of the salt usage (tons/lane-miles) vs pack rust percentage.

Figure 4.22 shows district wise breakdown of salt usage in tons/lane-miles vs pack rust percentage. Except for LaPorte and Greenfield other four districts should show some correlation between salt usages (tons/lane-miles) and pack rust percentage. The districts Fort Wayne, Crawfordsville and Seymour seems to follow a trend of decreasing pack rust percentage with decreasing salt usage (tons/lane-miles). Vincennes does not seem to follow the same trend and experiences higher pack rust percentage than expected. Based on the best-fit line using data points of Fort Wayne, Crawfordsville and Seymour, Vincennes is expected to show a pack rust percentage near about 10%.

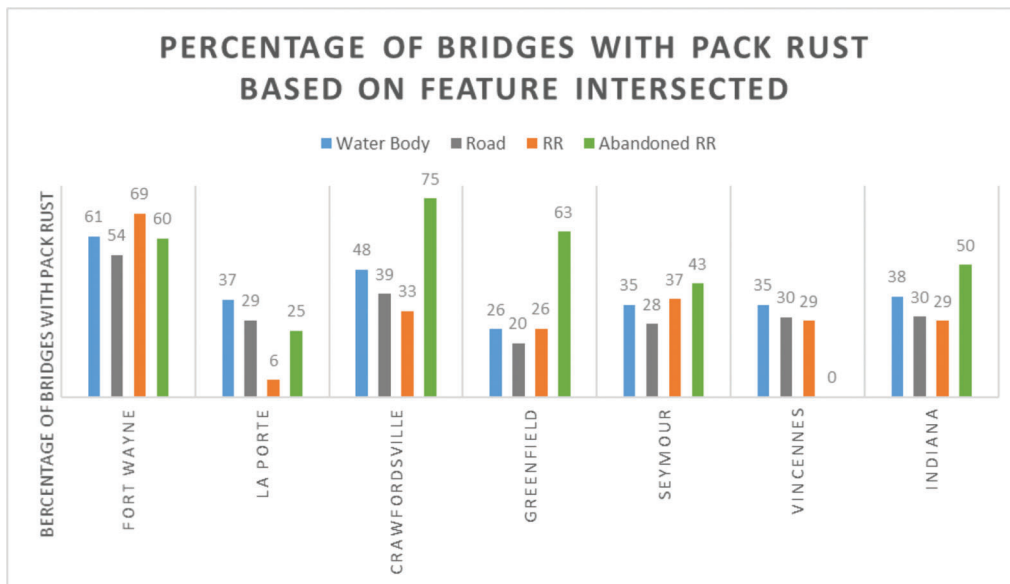
Figure 4.23 Percentage of bridges with pack rust based on features intersected.

In Figure 4.23, the percentage of the bridges with pack rust that intersect abandoned railroads stand out very prominently for the Crawfordsville and Greenfield Districts, but the number of bridges is a small number totaling to 22 bridges out of 44 bridges in Indiana. The number of bridges that have pack rust and the total number of bridges that intersects specific feature is presented in Table A.2 in the Appendix.

From the percentage perspective, abandoned railroad appear to be the most concerning feature intersected for its high percentage values in four districts, but the overall number of bridges are small. In general, the trends in individual districts are not distinctly clear and consistent. The percentages are highest for the bridges that intersect water bodies (after abandoned railroads) except for Fort Wayne, where the highest percentage is observed for railroads. The percentage of pack rust in

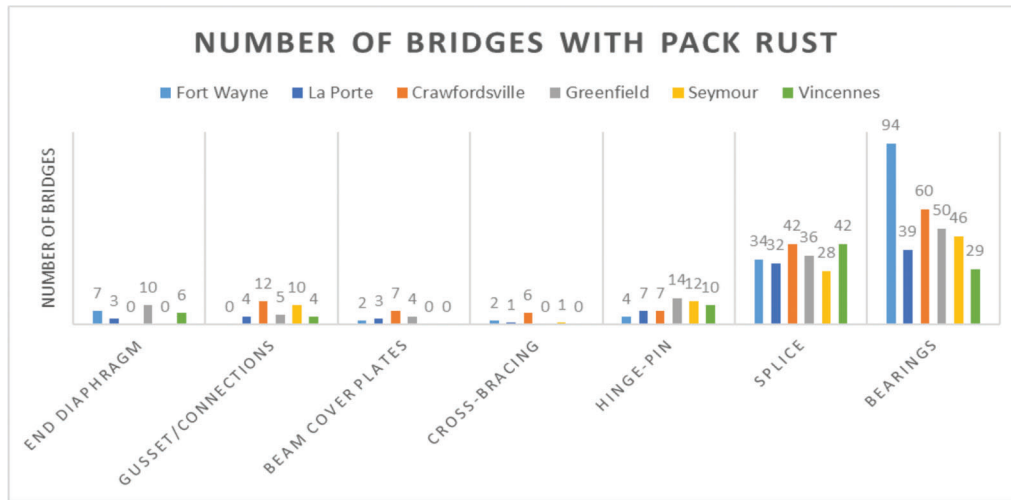
Figure 4.24 Number of bridges with pack rust in bridge members.

Figure 4.24 illustrates the breakdown of the number of bridges with pack rust in a particular member of a bridge in each district. From these data, it is observed that the number of bridges that have pack rust in splice details and bearings is large. Pack rust in the other members does not seem to be as common. The number of bridges in LaPorte that have pack rust in bearings is less than half of that in Fort Wayne. As noted before, it is believed that this is because LaPorte has a dedicated maintenance crew that annually pressure washes the bearings from all the dirt and salts using water jets.

The number of bridges that have pack rust in a specific member of a bridge does not give an overall picture of how frequently pack rust occurs. Looking at the percentage of occurrence is important. Numbers for the end diaphragm and cross bracings are less in Figure 4.24, and so are the percentage of bridges that have pack rust. A number of bridges were observed with general corrosion problem in end diaphragms, but it is difficult to identify if pack rust exists between the diaphragm and the connection plate, so only few bridges were identified to have pack rust in diaphragms from images and it is likely that many bridges with pack rust in end diaphragms went unidentified.

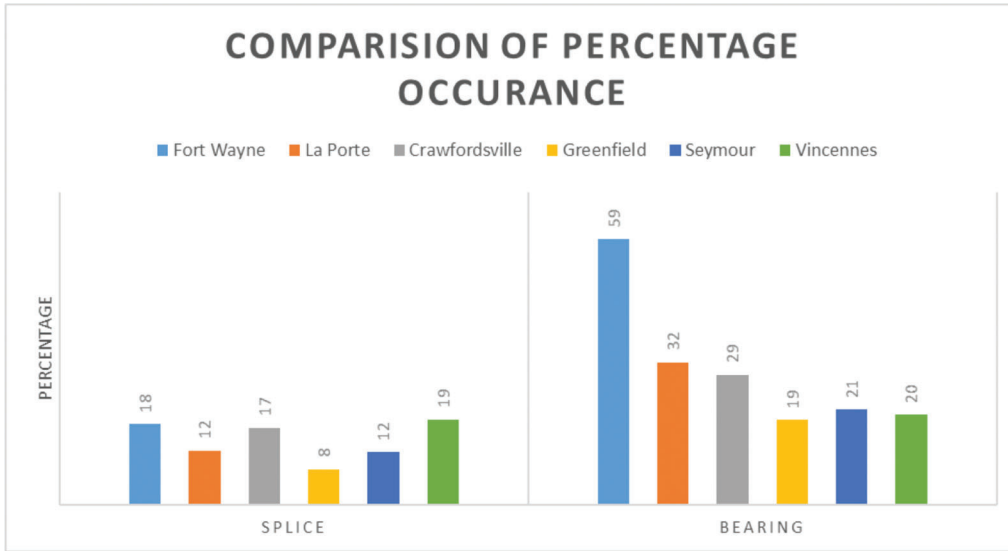
**Figure 4.25** Percentage of pack rust occurrence in splices and bearings for each district.

The total number of bridges with pack rust in splices and bearings stands out from the rest of the details. Figure 4.25 shows the distribution of the pack rust percentage for the splices and bearings for each district.

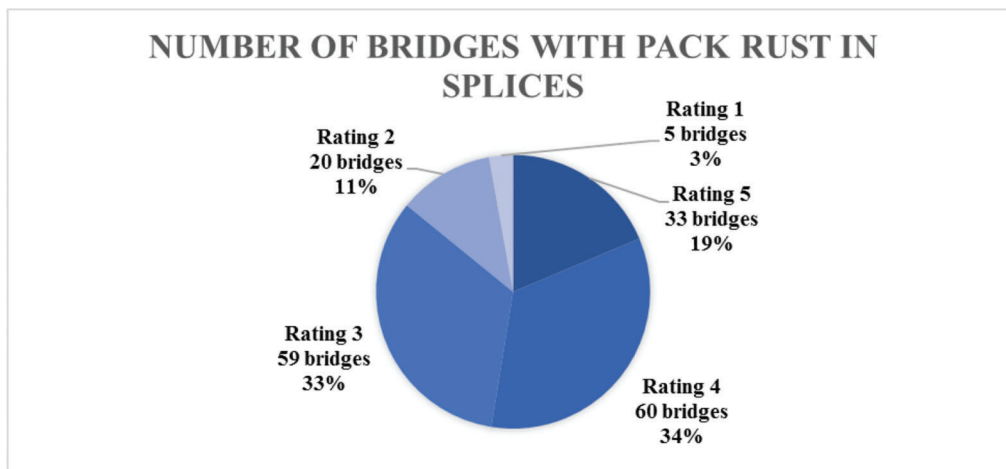
Figure 4.26 Number of bridges with pack rust in splices classified by pack rust rating.

The ratings were given to the splice details for which the images (a total of 177 bridges) were available in the inspection reports. There were 37 bridges where pack rust in the splices was mentioned in the inspection reports, but the images of the splice with pack rust were absent. Figure 4.26 shows the number of bridges that have pack rust in splices together with their corresponding ratings. It is observed that majority of the bridges have a rating of 3 and 4. Rating 5 is given when rust bleeding is observed but, these cases are generally not reported or given a serious concern. It is therefore likely that there could be more bridges with splices of rating 5 that were not recorded and are unaccounted in this study.

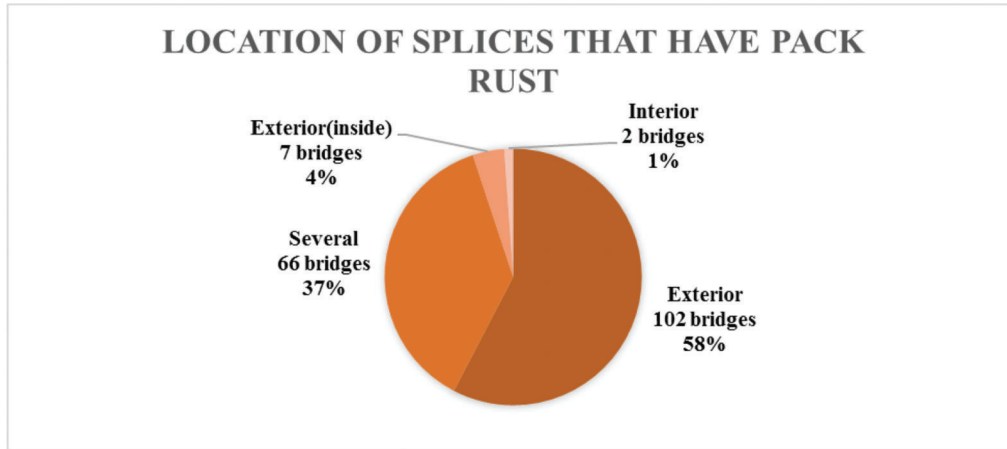
**Figure 4.27** Location of splice connections that have pack rust.

**4.3.4.2 Location of splices that have pack rust.** The section illustrates which splices are most affected by pack rust. Figure 4.27 shows that the splices that are located on the exterior beams have the highest probability for formation of pack rust in the exterior face of the splice. There are 66 bridges that have pack rust in splices which are on both the exterior beams and interior beams. Only 2 bridge were observed to have pack rust in splices located in interior beams only, with no pack rust observed in exterior splices. About 7 bridges were observed to have pack rust on the inside face of splices on the exterior beams. An example for this can be seen in Figure c and Figure d in Table 4.3. It should be noted that there is a possibility that pack rust is present on the exterior face also, but no images were present in the reports.

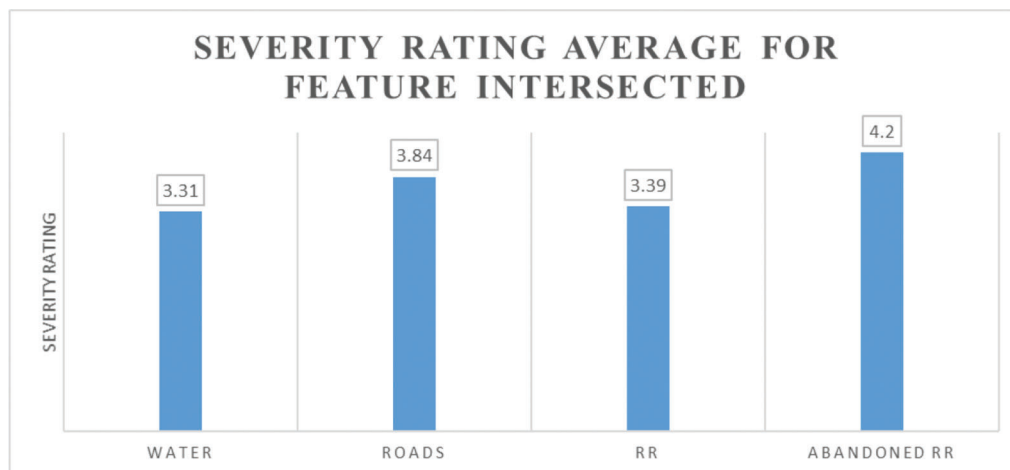
**Figure 4.29** Average severity rating for the intersecting feature.

The average rating for the bridges which intersect a particular feature is shown in Figure 4.29. The condition of the splices in the bridges over abandoned bridges is better than all the other three features. The severity rating of splices over water bodies is least among all other features intersected. The average rating for the bridges intersecting roads and railroads does not differ by a large value from the average rating of the bridges intersecting the water bodies.

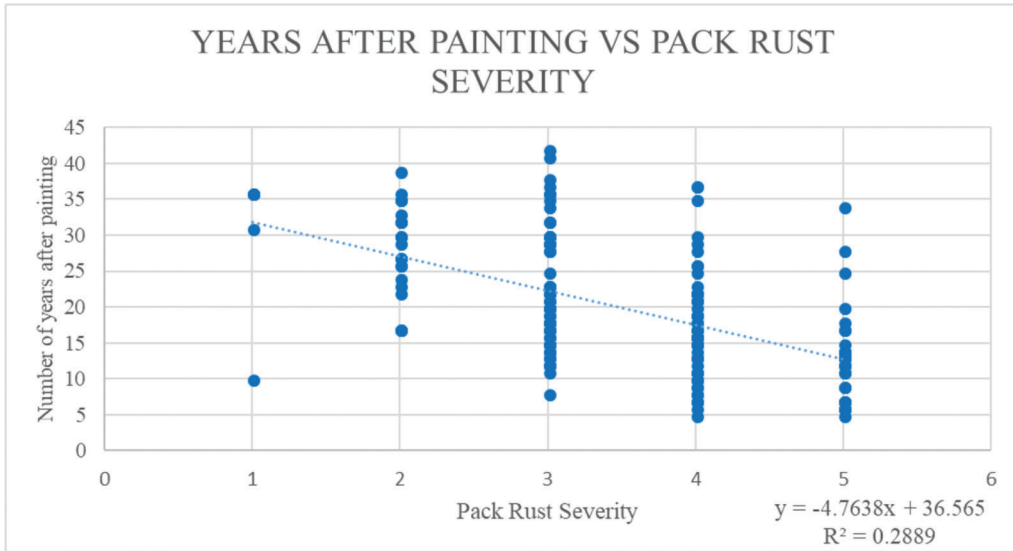
Figure 4.30 Relation between years after painting and pack rust severity in splices.

**4.3.4.4 The relationship between the number of years after painting and pack rust severity in splices.** A correlation between the pack rust severity in splices in the observed year and the number of years after the bridge is painted plotted in Figure 4.30. This is done to

estimate how long it will take for the pack rust in splices to go from minor pack rust to very severe pack rust. The number of years is counted from the year the bridge was most recently painted to the year when splices were observed to exhibit pack rust, and ratings were given. If it is observed that the pack rust was already present in the most recent painting job, then the number of years is counted from the previous painting job.

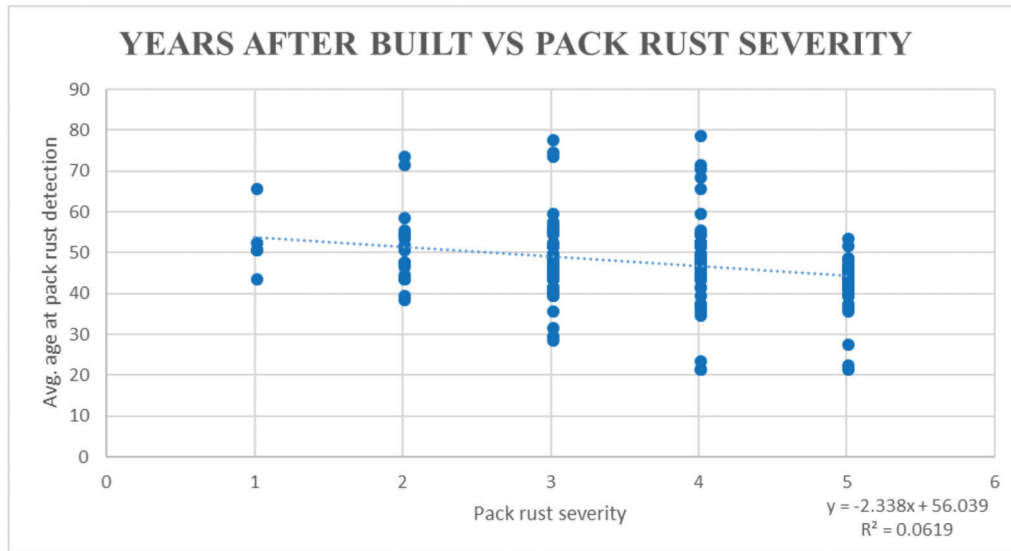
Figure 4.32 Relation between years after built and pack rust severity in splices.

**4.3.4.5 The relationship between years after built and pack rust severity in splices.** Figure 4.32 plots the data for the severity rating of the pack rust in splices and the age of the bridge at pack rust detection. The best fit line starts from 45 years for minor pack rust to 53 years for severe pack rust. The newest bridge which has pack rust in splices has an age of 21 years. The oldest bridge with pack rust has an age of 79 years but has a moderate to minor pack rust.

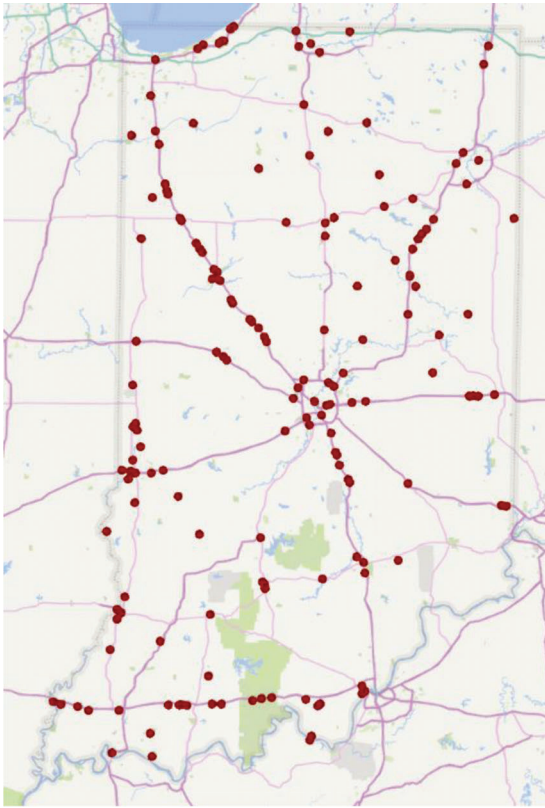
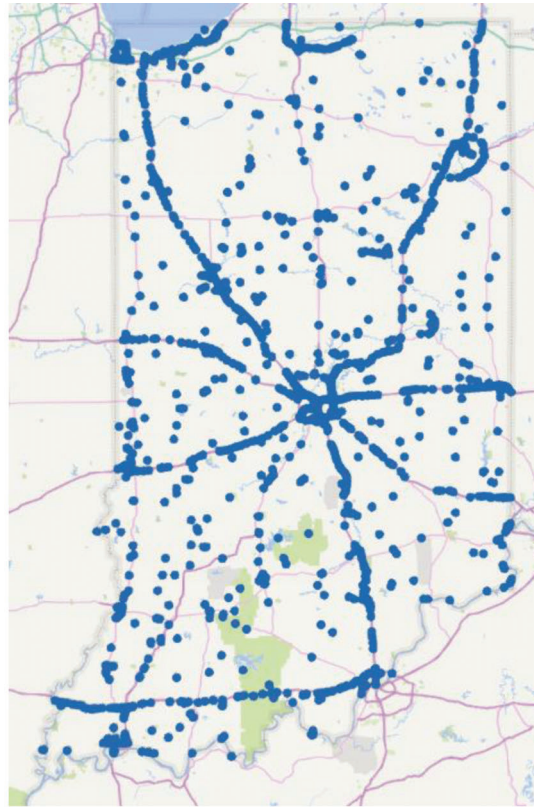
**Figure 4.33** Location of all state owned steel bridges and bridges with pack rust in splice connection.

**4.3.4.7 Location of bridges that have pack rust in splices.** The location of bridges that have pack rust in splices was marked on a map to find if any pattern for pack rust severity and location exists. Figure 4.33 locates all the steel bridges in Indiana with pack rust (of any rating) in splices whose images are available. Figure 4.33 (b) shows location of all the state owned steel bridges in Indiana. This study was conducted particularly for the state owned steel bridges. Figure A.2 shows location of all steel bridges in Indiana. Almost all bridges that are identified to have pack rust in splice connections are on interstates and other NHS routes. These routes represents highest priority/traffic routes for snow removal. There are some stretches of highways where there are no steel bridges that were identified to have pack rust in splice connection. There would be number of steel bridges which are not state owned and have pack rust in splice connection which are not covered in this study. The distribution of bridges that have pack rust in splices based on the rating value is presented in the Appendix Figure A.1.

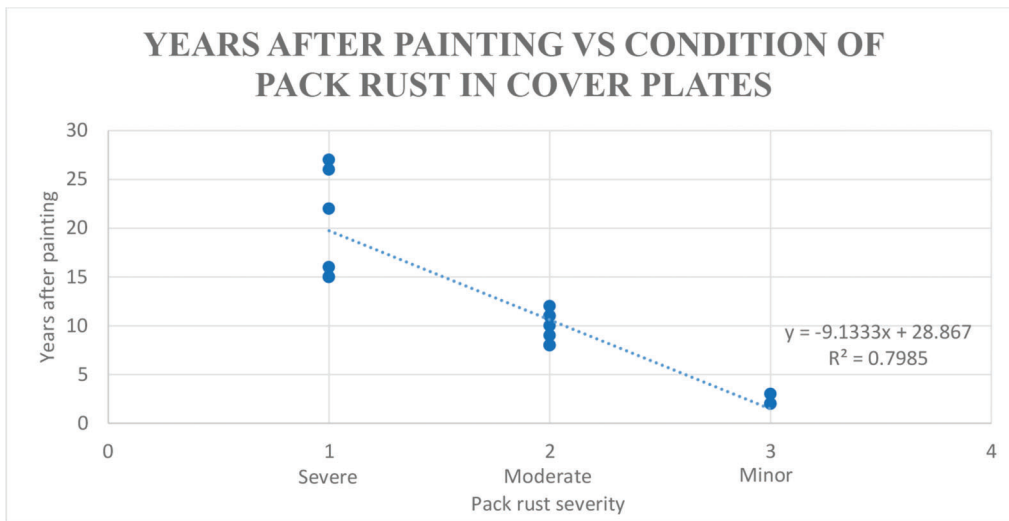
**Figure 4.34** Number of years after painting and the condition of pack rust in cover plates.

**4.3.5.1 The relationship between the number of years after painting and pack rust severity in cover plates.** Ratings from 1 to 3 were given to the cover plates with pack rust, 1 being severe pack rust where there exist major weld failures and bending of cover plates, rating of 2 where welds have cracked significantly and a rating

of 3 where pack rust have just started to form, and rust bleeding is observed. The pack rust ratings were plotted against the number of years after painting the bridge to the year when pack rust was observed. It should be noted that painting here refers to either the initial coating or after one or two repainting; the majority of cases are after repainting. Figure 4.34 illustrates a best-fit line that provides the probable condition of pack rust in cover plates after a certain number of years of painting the bridge. If the bridge was painted 10 years ago it does not mean that the cover plates will have moderate pack rust, but rather that there is only 12% chance for the pack rust to occur in cover plates in Crawfordsville district (refer to section 4.3.3). The time range for severe pack rust to develop is from 15 years to 27 years while the time range for the minor and moderate pack rust is not that wide. The correlation in the data is very good with  $R^2$  of about 80% compared to that for the splices which is less than 30%.
