Monitoring of Bridge Abutment Walls at SR 33 Over East State St. (Athens, OH)

Teruhisa Masada
ORITE, Ohio University

Final Report
FHWA/OH-2007/02
March 2007

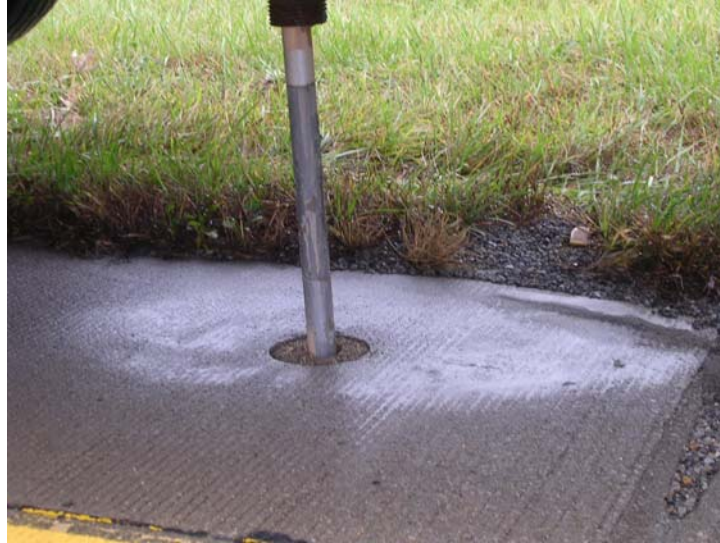
Figure 3.3: CPT Probe Pushed into Ground at Hole #2

- [Notes]
- Hit a large boulder at 9.7' (3.0 m).
 - Managed to reach a depth of 11.5' or 3.5 m (end of penetration).
 - Soil overall dry in this hole.

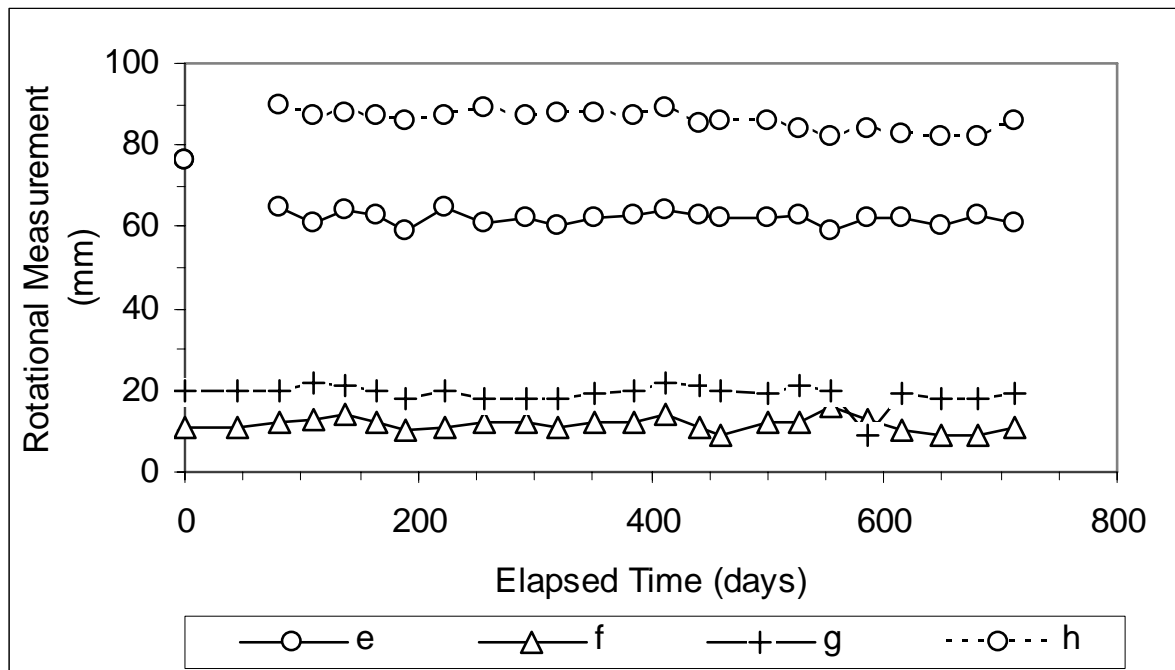
Figure 3.25: Changes in Rotational Measurements (North Side)

According to Table 3.4 and Figure 3.25, there might have been some rotational movements on Wall Panels S1, S5, N1, and N5. Table 3.5 and Figure 3.26 show that the joint openings changed very little between July 2005 and April 2006.
