REPORT NOS. DOT-TSC-NHTSA-79-47

ULTRASONIC INSPECTION OF TEN RETREADED TIRES  
AND THIRTY-TWO CASINGS

Stephen Bobo

FINAL REPORT

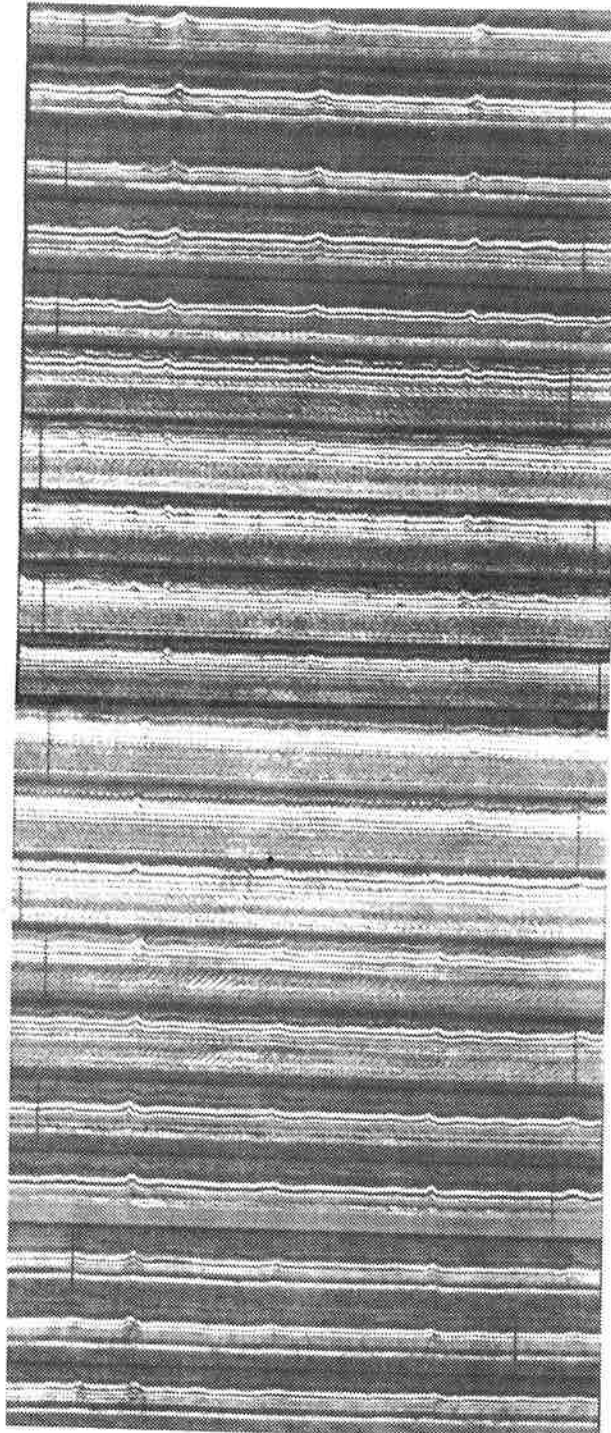
FIGURE 3-2. HIGH QUALITY DATA PRINTOUT

Degree of clarity and focus of traces, black and white detail and gray shades (good quality - Figure 3-2; poor quality, Figure 3-3).
