# **DEVELOPMENT OF THE MIDWEST GUARDRAIL SYSTEM (MGS) W-BEAM TO THRIE BEAM TRANSITION ELEMENT**

## **MIDWEST ROADSIDE SAFETY FACILITY**

MwRSF Research Report No. TRP-03-167-07

November 26, 2007

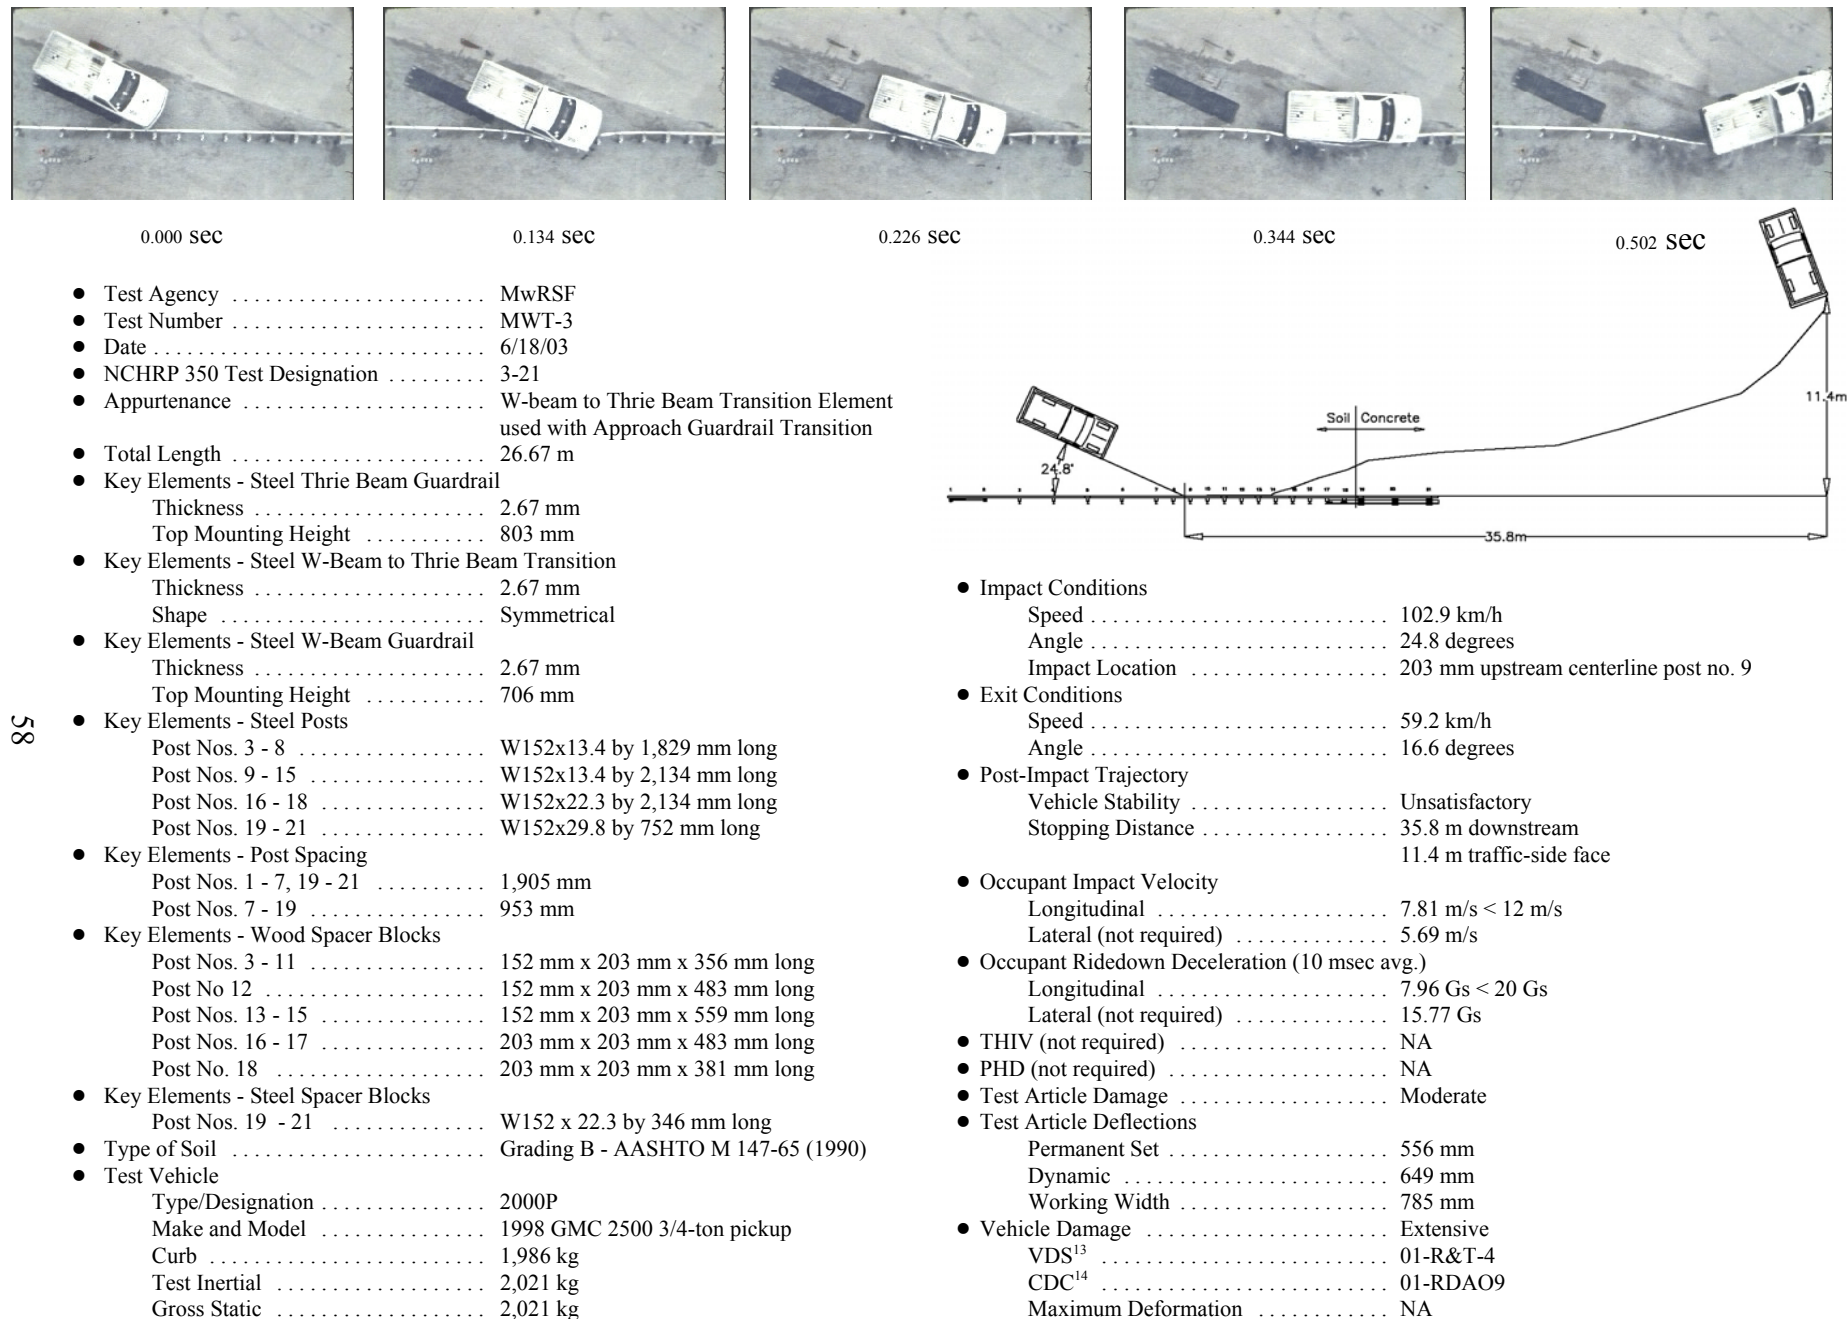
Figure 31. Summary of Test Results and Sequential Photographs, Test MWT-3

The 2,021-kg (4,456-lb) pickup truck impacted the guardrail system (Design No. 1) upstream from the W-beam to thrie beam transition element at a speed of 102.9 km/h (63.9 mph) and at an angle of 24.8 degrees. A summary of the test results and sequential photographs are shown in Figure 31. The summary of the test results and sequential photographs in English units are shown in Appendix B. Additional sequential photographs are shown in Figures 32 through 34. Documentary photographs are shown in Figures 35 and 36.

The analysis of the test results for test no. MWT-3 showed that the W-beam to thrie beam transition element, used in conjunction with an approach guardrail transition system, did not meet safety performance criteria established in NCHRP Report No. 350. The system adequately contained

but did not safely redirect the vehicle, since the vehicle rolled over after collision with the barrier. There were no detached elements nor fragments which showed potential for penetrating the occupant compartment nor presented undue hazard to other traffic. Deformations of, or intrusion into, the occupant compartment that could have caused serious injury did occur with the crushing of the roof. The test vehicle did not penetrate nor ride over the barrier system; however, the vehicle did not remain upright after the collision. Vehicle roll, pitch, and yaw angular displacements were noted. After collision, the vehicle's trajectory revealed minimum intrusion into adjacent traffic lanes. Therefore, test no. MWT-3 conducted on the W-beam to thrie beam transition element used in conjunction with an approach guardrail transition system was determined to be unacceptable according to the TL-3 safety performance criteria found in NCHRP Report No. 350 due to vehicle rollover.

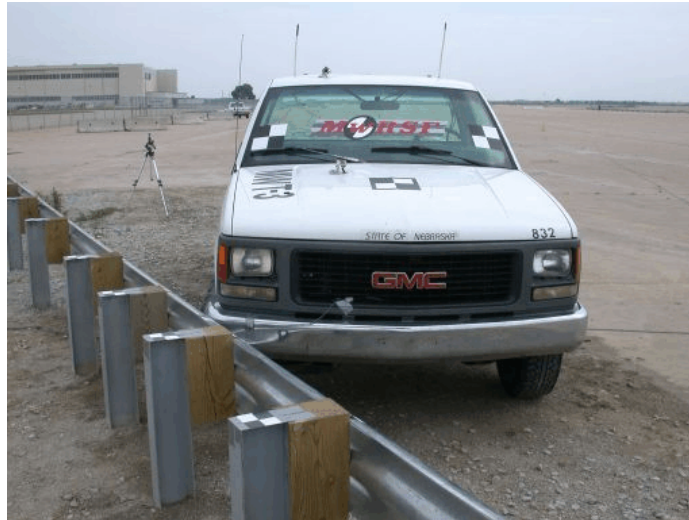
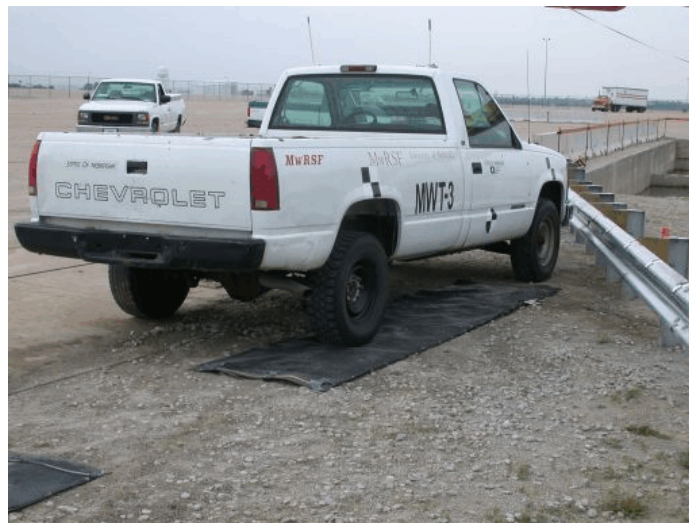
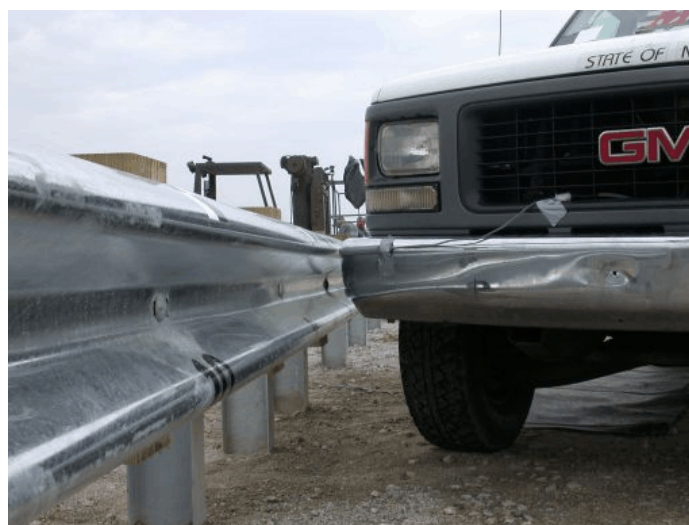
Figure 37. Impact Location, Test MWT-3

Initial vehicle impact was to occur between post nos. 8 and 9, or 330 mm (13 in.) upstream from the centerline of post no. 9, as shown in Figure 37. Actual vehicle impact occurred 203 mm (8 in.) upstream from the centerline of post no. 9. At 0.010 sec after impact, the right-front corner of the vehicle was located at post no. 9 and began to crush inward. At 0.022 sec, the rail deformed at post nos. 8, 9, and 10. At this same time, the soil around post no. 9 began to fail, and the right-front corner of the hood protruded over the rail. At 0.050 sec, the right-front corner of the hood was positioned over post no. 10, rail deflection continued downstream to post no. 11, and large amounts of soil damage were evident. At 0.093 sec, the right-side door became ajar at the top, and the right-front corner of the hood, which was crushed inward to the centerline of the truck with bumper completely under the hood, was positioned over post no. 11. At this same time, post no. 9 rotated clockwise slightly, and post nos. 12 and 13 began to deflect. At 0.097 sec, the body of the truck began to redirect while the truck continued along its same direction and encountered positive roll toward the system. At 0.145 sec, post no. 10 rotated clockwise. At this same time, the left-front edge of the hood separated from the quarter panel, and the front edge of the right-side door crushed into the rail. At

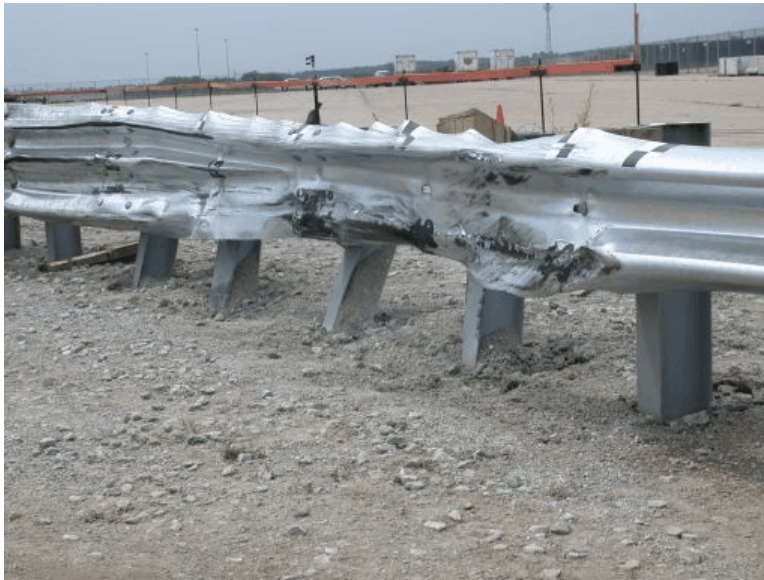
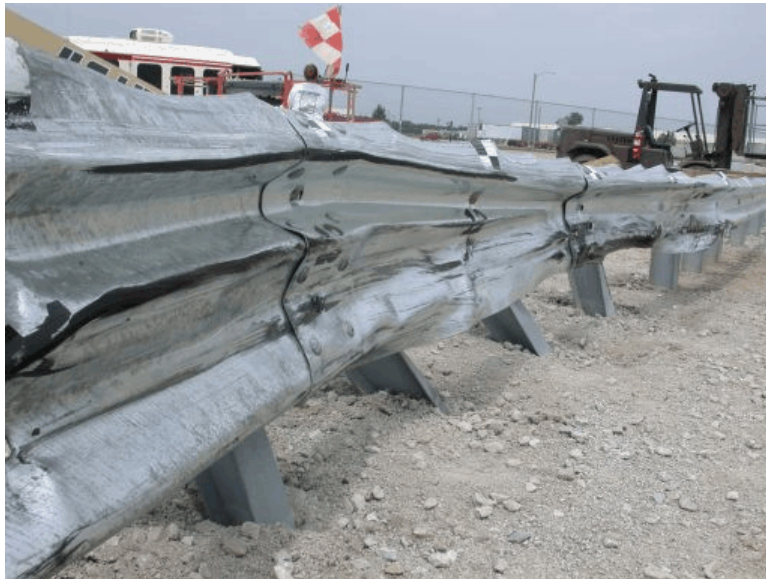
Figure 40. System Damage, Test MWT-3

Damage to the barrier was moderate, as shown in Figures 39 through 45. Barrier damage consisted of deformed guardrail and posts, contact marks on a guardrail section, and fractured wooden spacer blockouts. The length of vehicle contact along the approach guardrail system was approximately 5.7 m (18.75 ft), which spanned from 203 mm (8 in.) upstream from the centerline of post no. 9 through 203 mm (8 in.) upstream from the centerline of post no. 15.

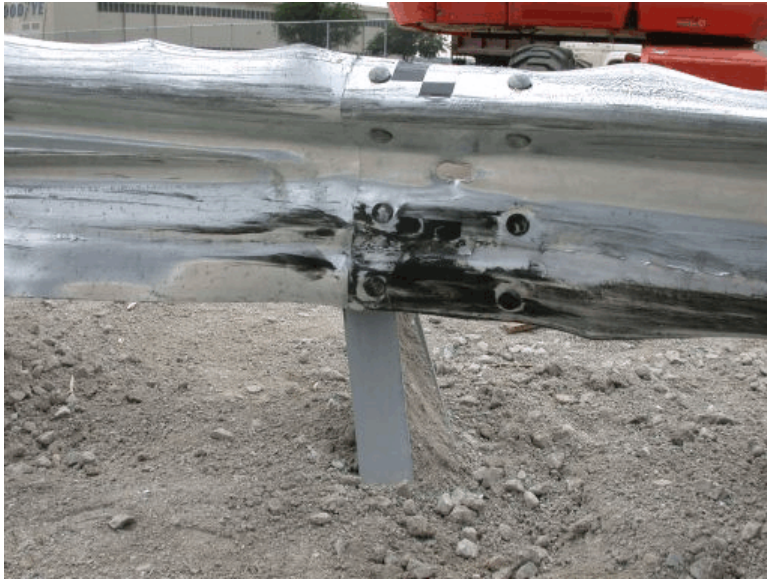
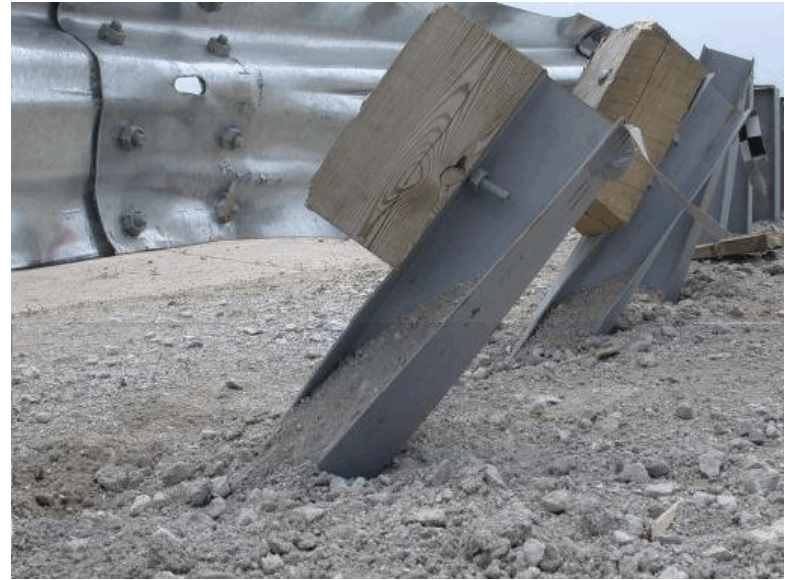
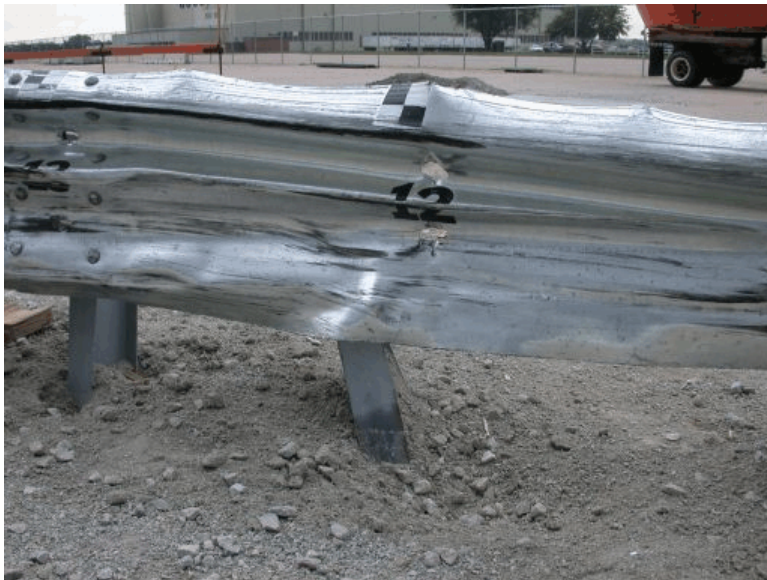
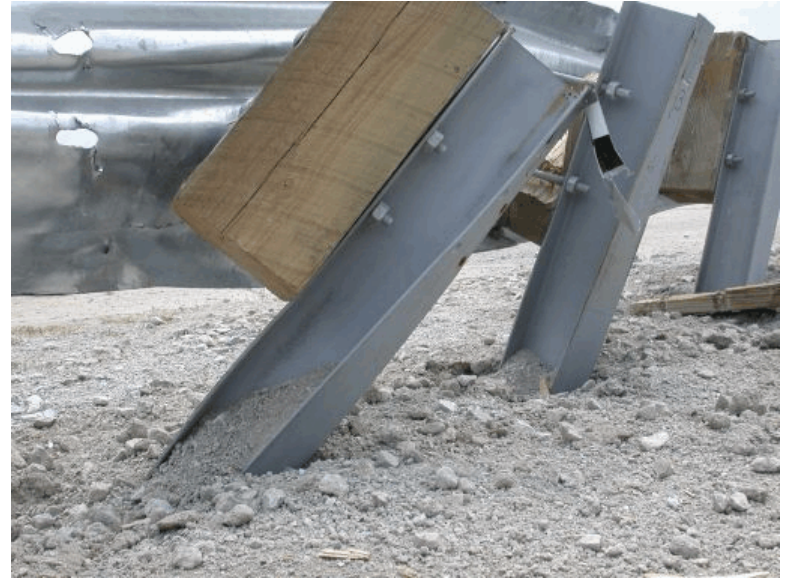
Figure 43. Post Nos. 11 and 12 Damage, Test MWT-3

The permanent set of the barrier system is shown in Figure 39. The maximum lateral permanent set rail and post deflections were 389 mm (15.3 in.) at the centerline of post no. 12 and 556 mm (21.9 in.) at the centerline of post no. 11, respectively, as measured in the field. The maximum lateral dynamic rail and post deflections were 620 mm (24.4 in.) at the centerline of post no. 12 and 649 mm (25.5 in.) at the centerline of post no. 11, respectively, as determined from the high-speed film analysis. The working width of the system was found to be 785 mm (30.9 in.).

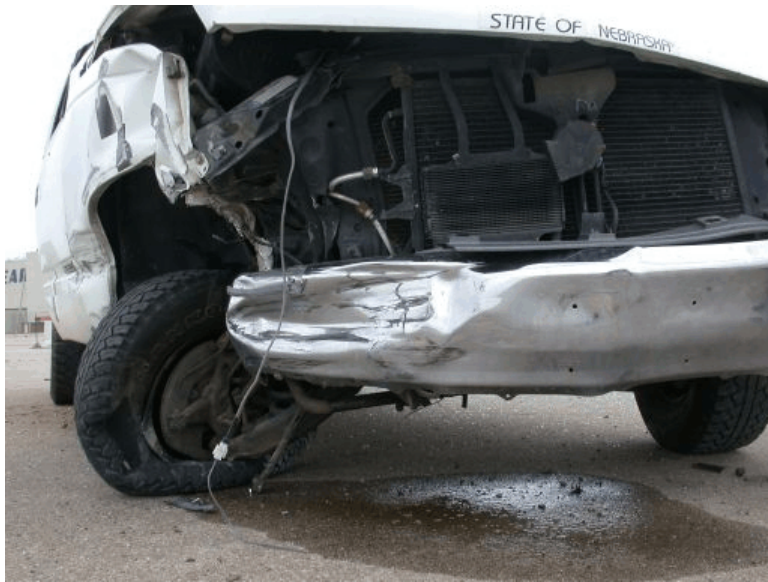
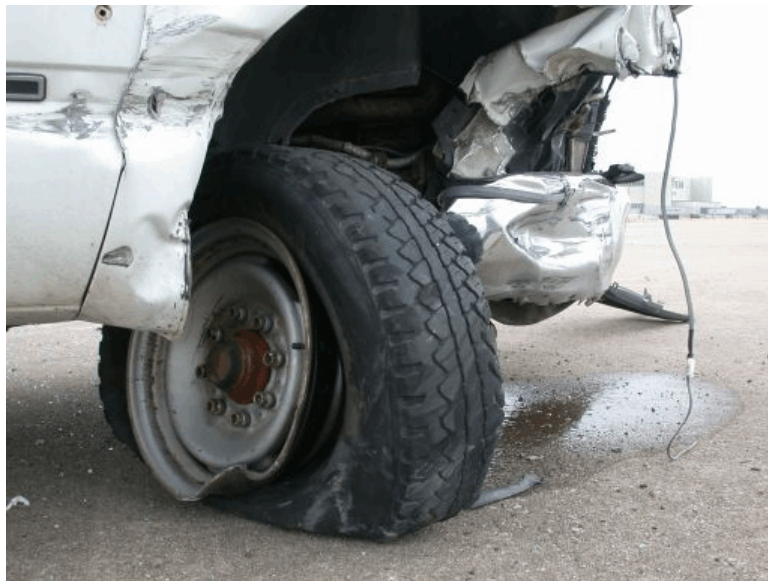
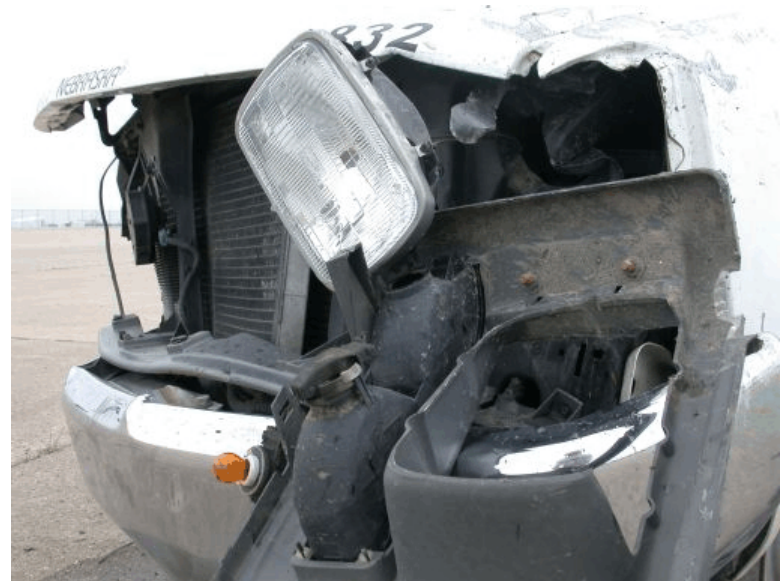
Figure 47. Vehicle Damage, Test MWT-3

The damage to the frame was minimal and focused mainly around the bumper bracket and frame horns. Deformations to the vehicle's body were evident on the right side in the shape of the guardrail. Left-side damage was limited to light scraping and box deformations due to rollover. The windshield was shattered but remained intact due to the safety layer, as shown in Figure 48. All other window glass shattered and was removed from the system.

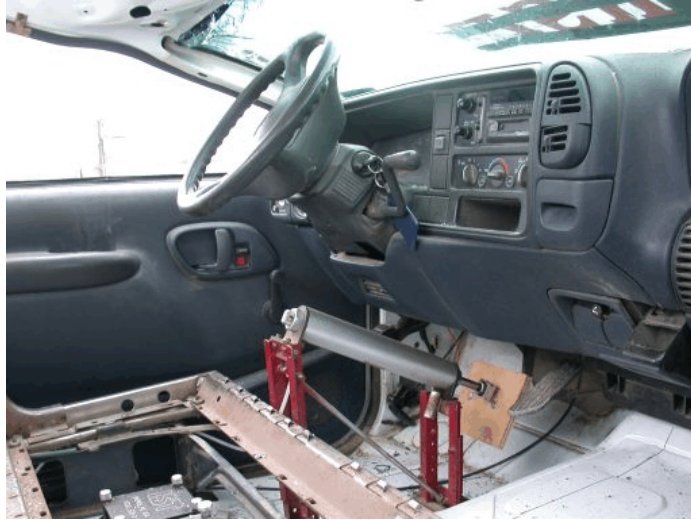
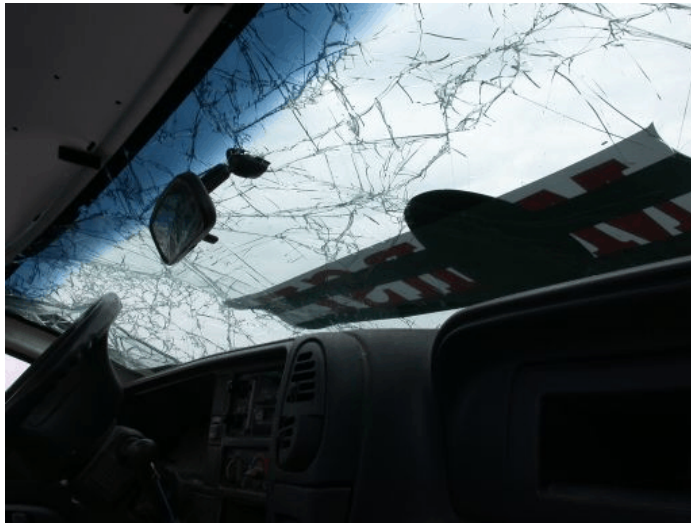
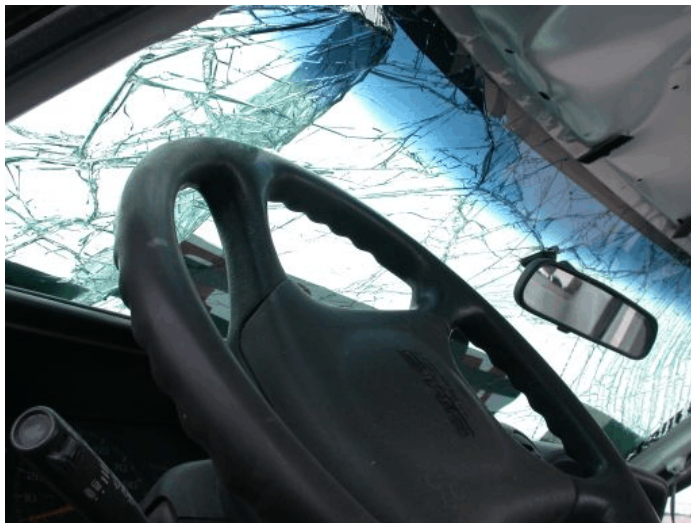
Figure 49. Occupant Compartment and Windshield Damage, Test MWT-3

Exterior and interior damage to the vehicle was extensive, as shown in Figures 46 through 49. Occupant compartment deformations to the roof were severe due to vehicle rollover. However, the floorboard and firewall deformations were minimal. Complete occupant compartment deformations and the corresponding locations are provided in Appendix C.

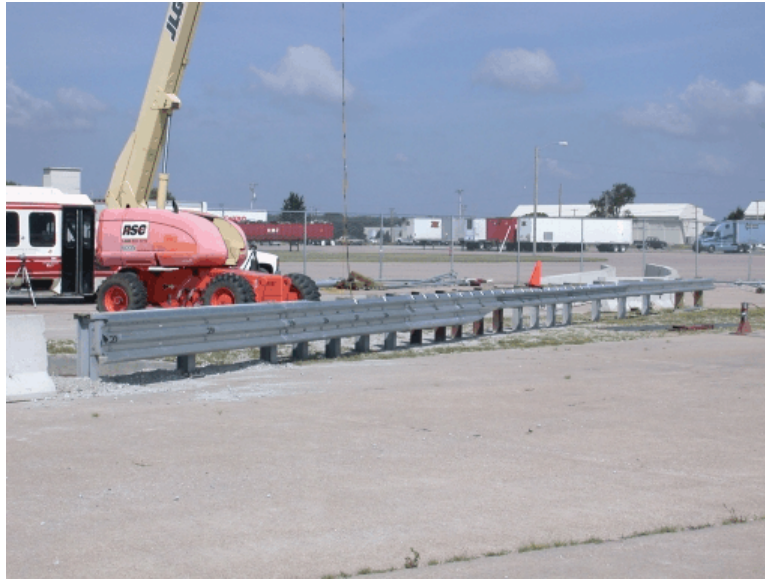
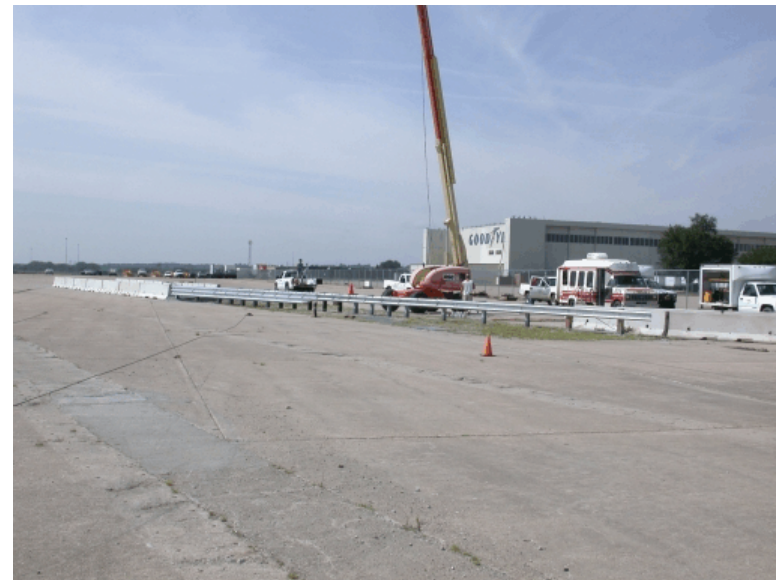
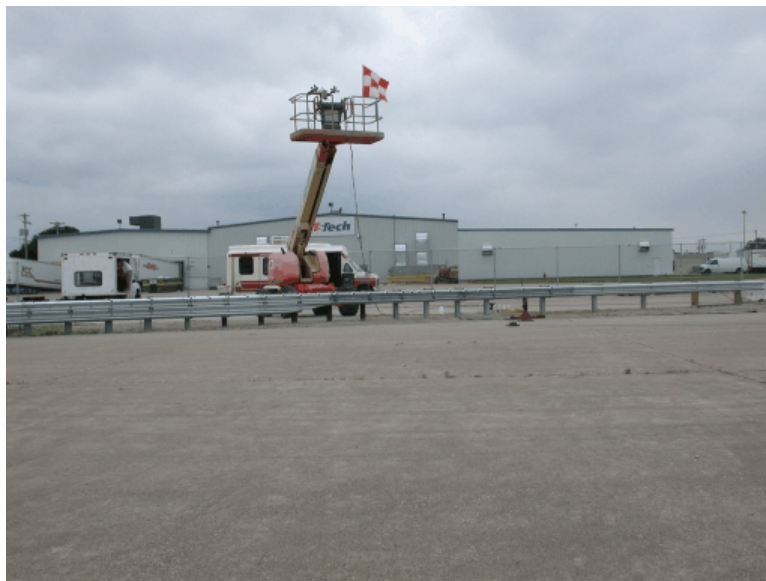
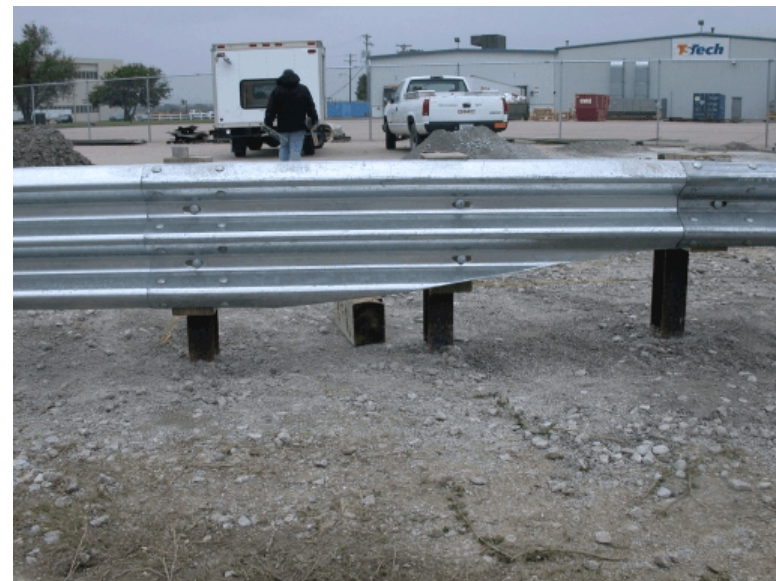
Figure 61. System and Transition Element (Design No. 2)

Additionally, the only asymmetrical W-beam to thrie beam transition element available was a segment fabricated by cutting a triangular piece from the bottom of a standard 2.67-mm (12-gauge) thick thrie beam rail. A 3.43-mm (10-gauge) thick flat plate was welded along a portion of the cut region to reduce the risk of the exposed edge slicing through the sheet metal on an impacting vehicle, as shown in Figure 61. Although, this element clearly included some undesirable stress concentrations, it was the only readily available alternative.

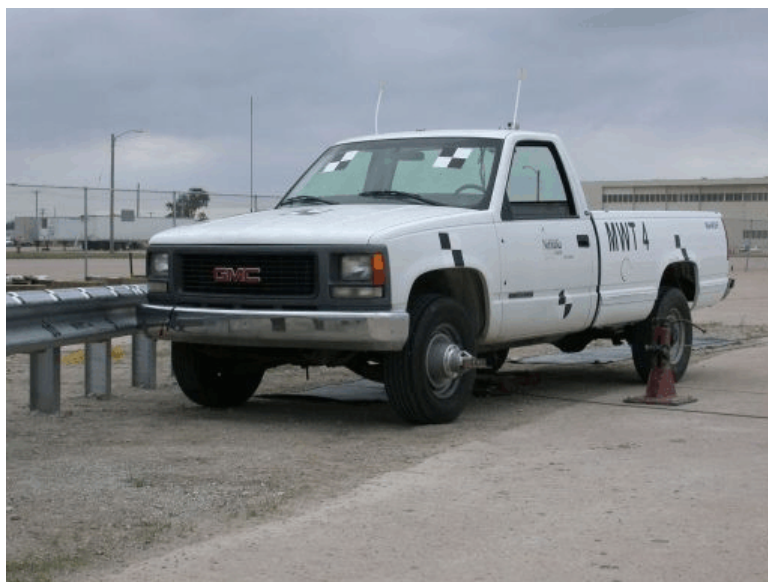
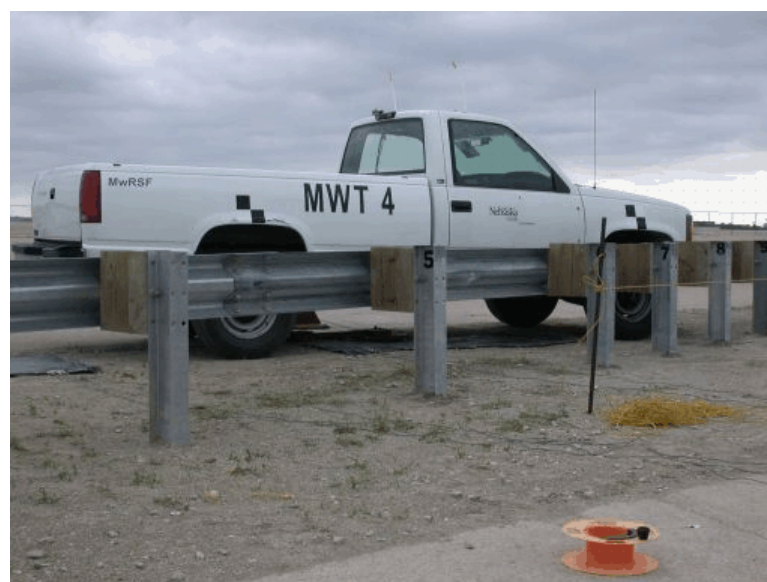
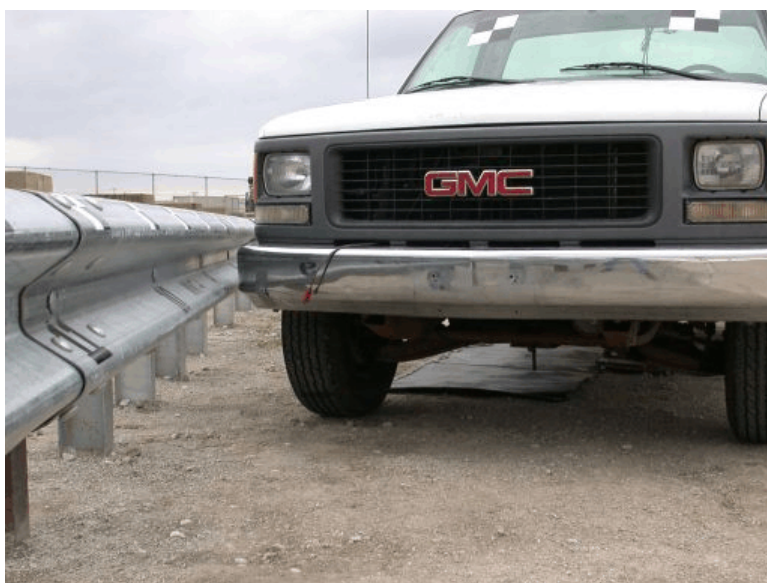
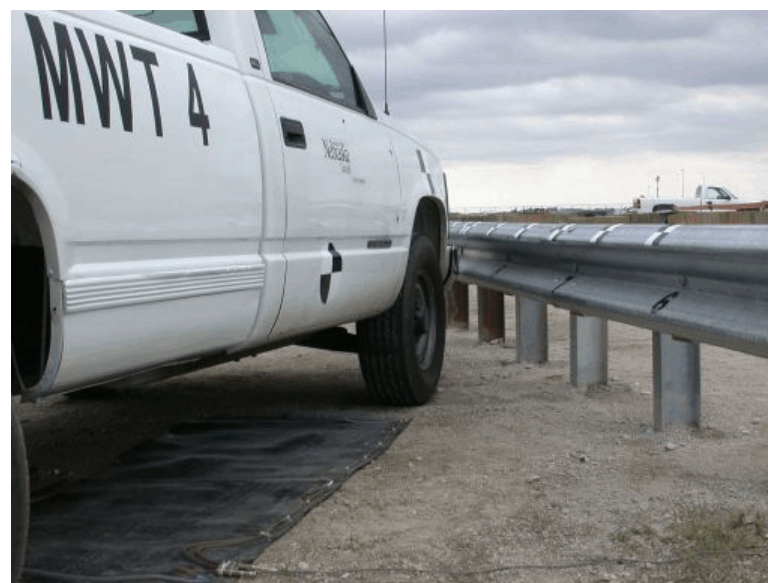
Figure 68. Impact Location, Test MWT-4

Initial vehicle impact was to occur between post nos. 8 and 9, or 330 mm (13 in.) upstream from the centerline of post no. 9, as shown in Figure 68. Actual vehicle impact occurred 229 mm (9 in.) upstream from the centerline of post no. 9. At 0.010 sec after impact, the right-front corner of the truck began to crush inward. At this same time, the bumper buckled at its midpoint, and the right-front quarter panel buckled outward. At 0.020 sec, the right-front corner of the truck protruded over the rail. At 0.040 sec, post nos. 5 through 9 deflected and rotated as the right-front corner of the truck continued to deform. At 0.086 sec, post no. 10 separated from the rail. At 0.100 sec, the truck began to redirect, and the right-front corner of the truck, up through the wheel well, extended over the rail. At this same time, post no. 11 disengaged from the rail, and the right-front tire contacted the post. At 0.188 sec, post nos. 11 and 12 continued to rotate and pull away from the rail as the truck yawed. By 0.196 sec, the rail had fractured and the downstream end of the fracture was located near the right-front corner of the truck. At 0.254 sec, the truck twisted and the front of the truck pitched downward with the rear end rising into the air. At 0.292 sec, the truck bowed along

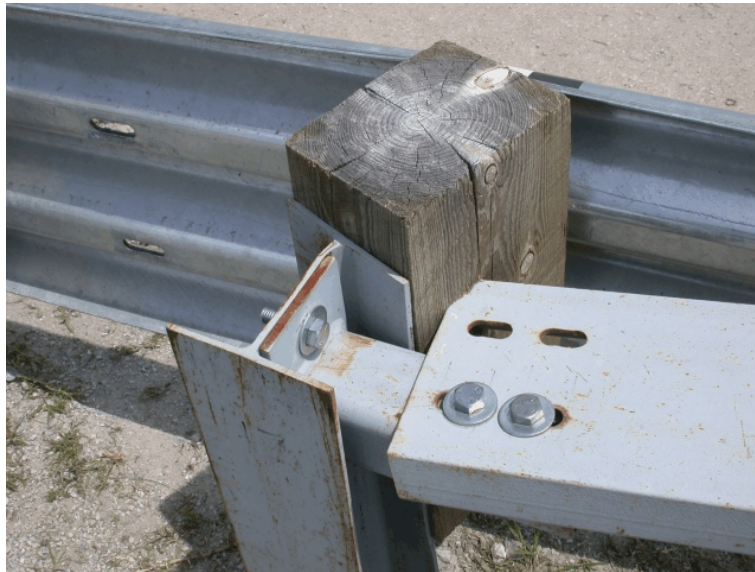
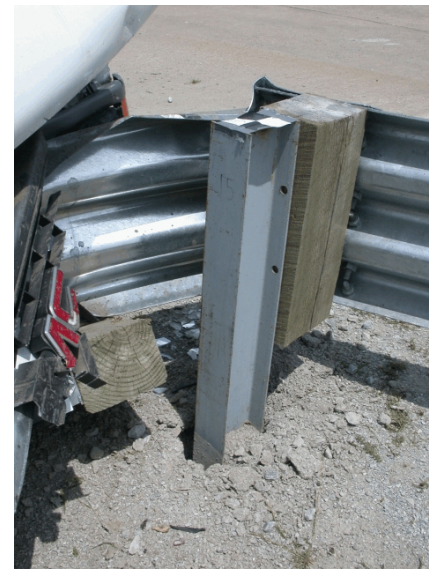
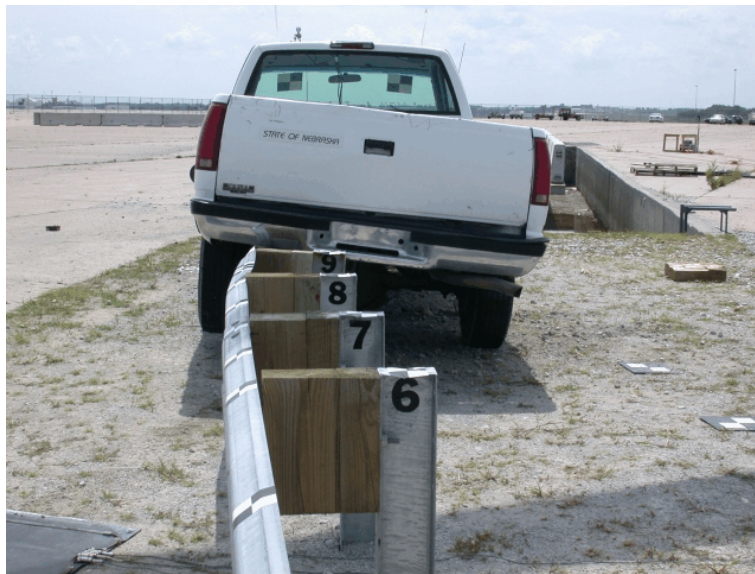
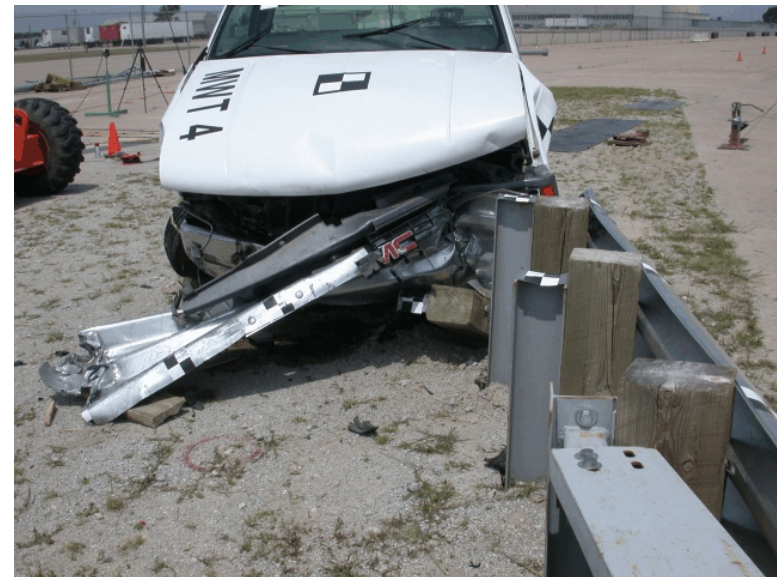
Figure 71. System Damage, Test No. MWT-4

Barrier damage was extensive as shown in Figures 70 through 76. Barrier damage consisted of deformed guardrail and posts, ruptured guardrail, fractured blockouts, and contact marks on a guardrail section. The length of vehicle contact along the approach guardrail system was approximately 5.9 m (19.5 ft), which spanned from 229 mm (9 in.) upstream from the centerline of post no. 9 through the centerline of post no. 15.

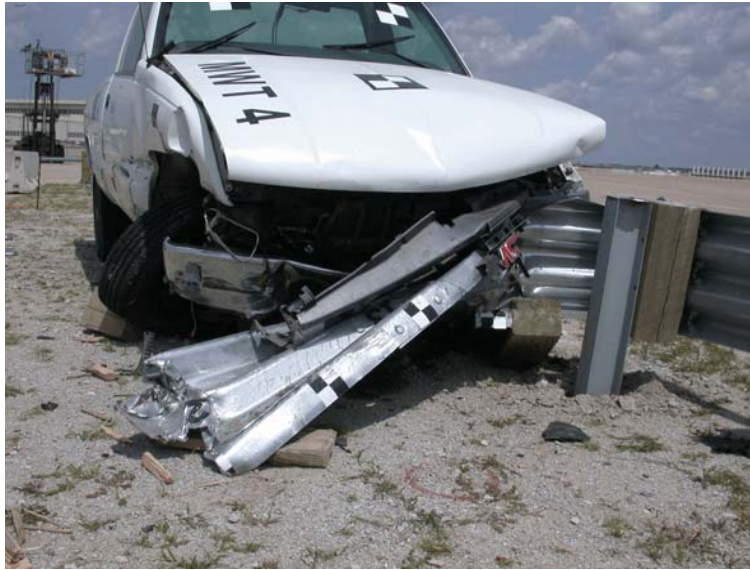
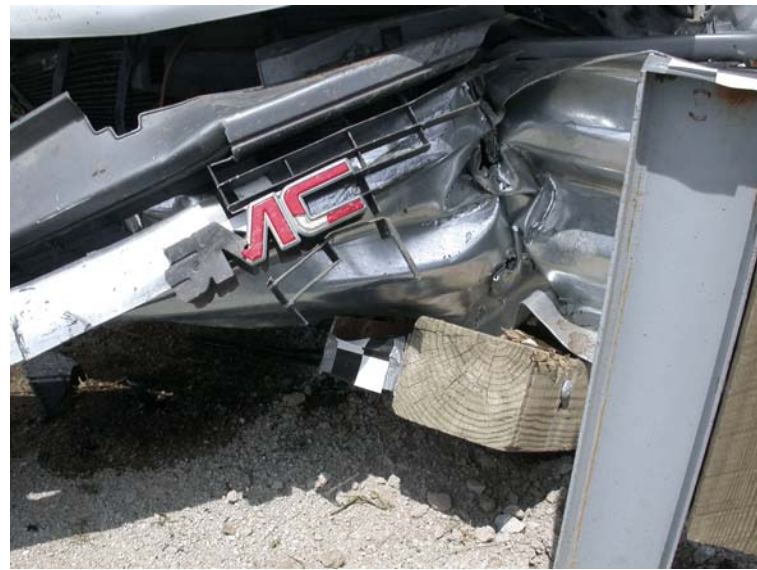
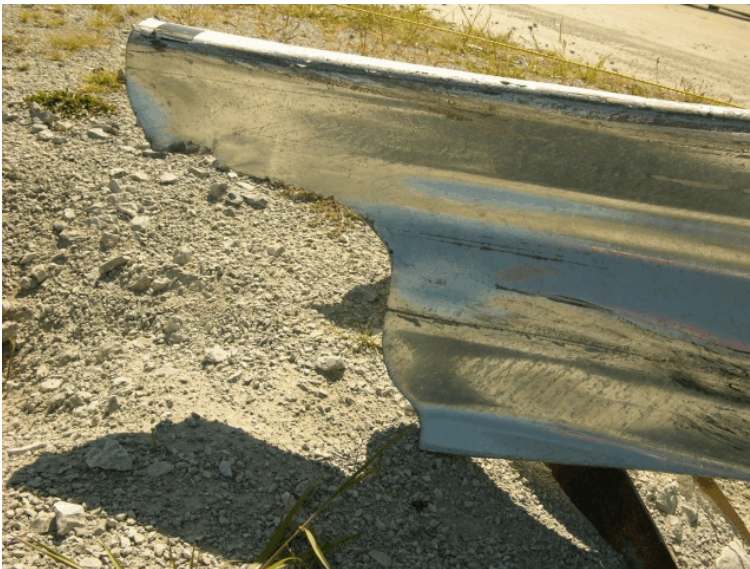
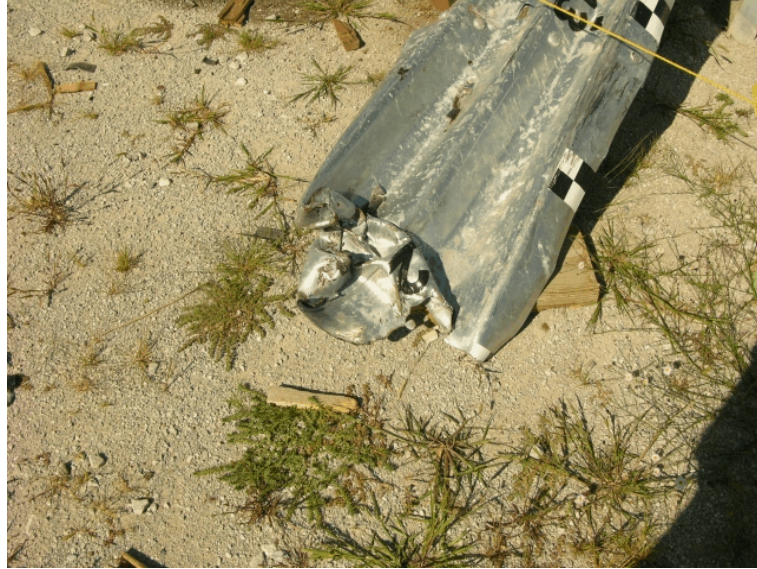
Figure 72. Rail Rupture Damage, Test MWT-4

through the cross section, beginning at the bottom of the W-beam to the beam transition element 476 mm (18.75 in.) downstream of the centerline of post no. 11, propagating up vertically 267 mm (10.5 in.), then horizontally 305 mm (12 in.), and then vertically once again ending at the top of the W-beam rail at the centerline of post no. 12 as shown in Figure 72. The W-beam was pulled off of post nos. 6, 10, and 13. The W-beam guardrail sustained significant yielding around the post bolt slots at post nos. 3 through 5 and 7 through 12, and the post bolt slot at post no. 8 also sustained small tears. The thrie beam guardrail sustained significant yielding around the post bolt slots at post nos. 14 through 18. No significant guardrail damage occurred downstream of post no. 16.

As the truck progressed into the guardrail during test no. MWT-4, vehicle redirection continued until the front bumper contacted the point of the flat plate extension on the bottom of the transition element. The start of the weldment proved to be a stress concentrator that produced a tear in the W-beam to thrie beam transition section. The tear quickly propagated through the entire segment and ruptured the rail system. Thereafter, all redirection stopped, and the test vehicle moved forward into the end of the stiff transition section where it was brought to an abrupt stop. Although the performance of the guardrail system initially looked promising and the rapid roll velocity associated with test no. MWT-3 was eliminated, the premature failure of the only available transition piece caused this test to be unsuccessful.

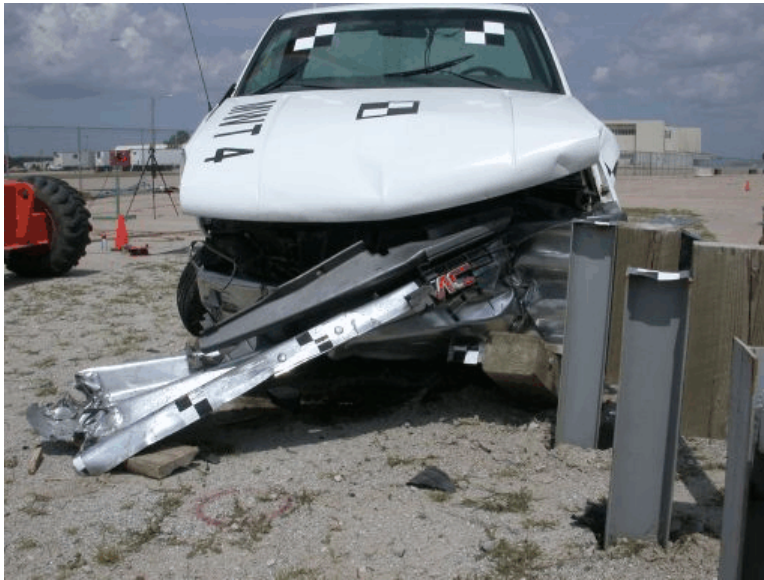
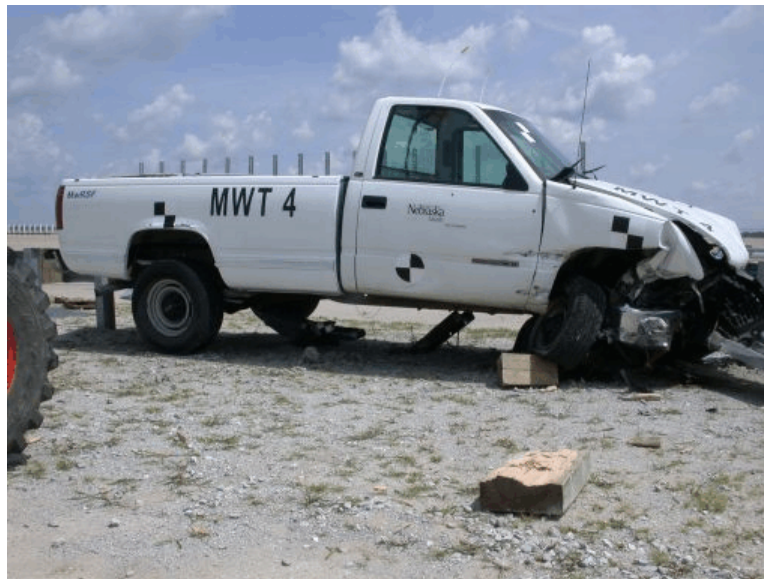
Figure 77. Vehicle Damage, Test MWT-4

Exterior vehicle damage was moderate, as shown in Figures 77 and 80. Extensive occupant compartment deformations occurred with the penetration of the center of the floorboard, as shown in Figure 80. The drive shaft U-joint penetrated through and caused a 178-mm (7-in.) slice in the floorboard. A 64-mm (2.5-in.) dent was also found in the floorboard. Complete occupant compartment deformations and the corresponding locations are provided in Appendix C.

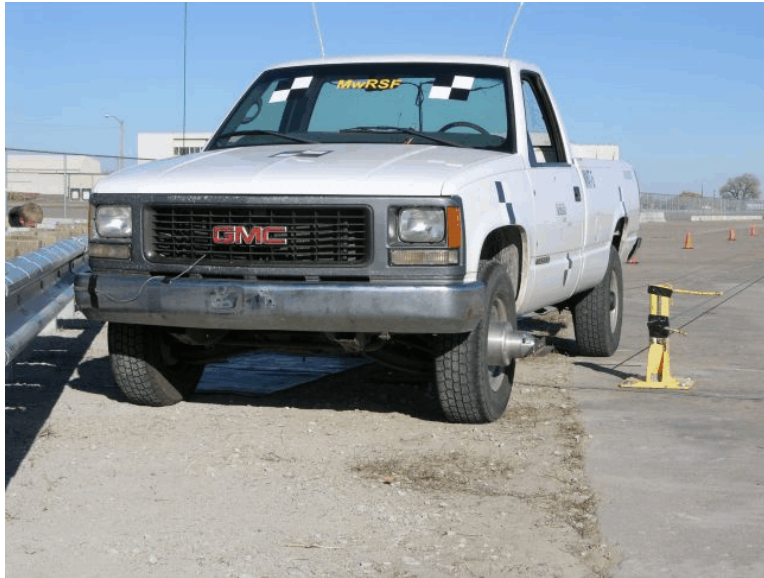
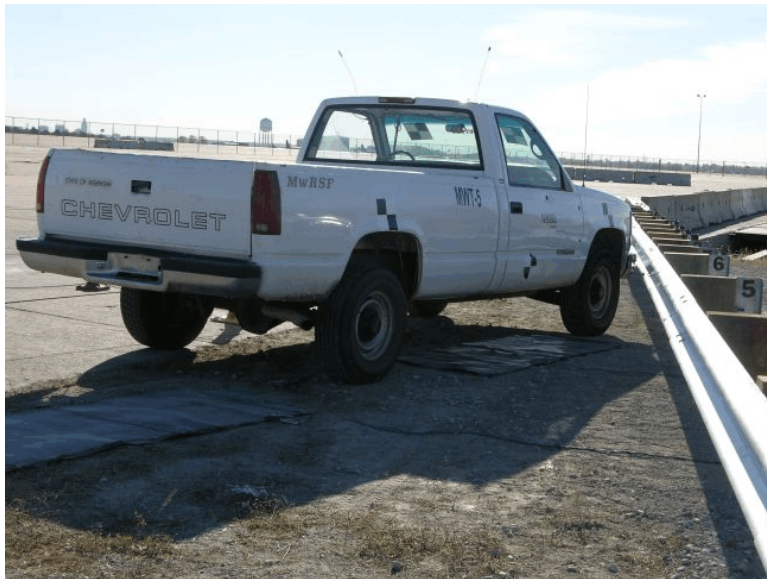
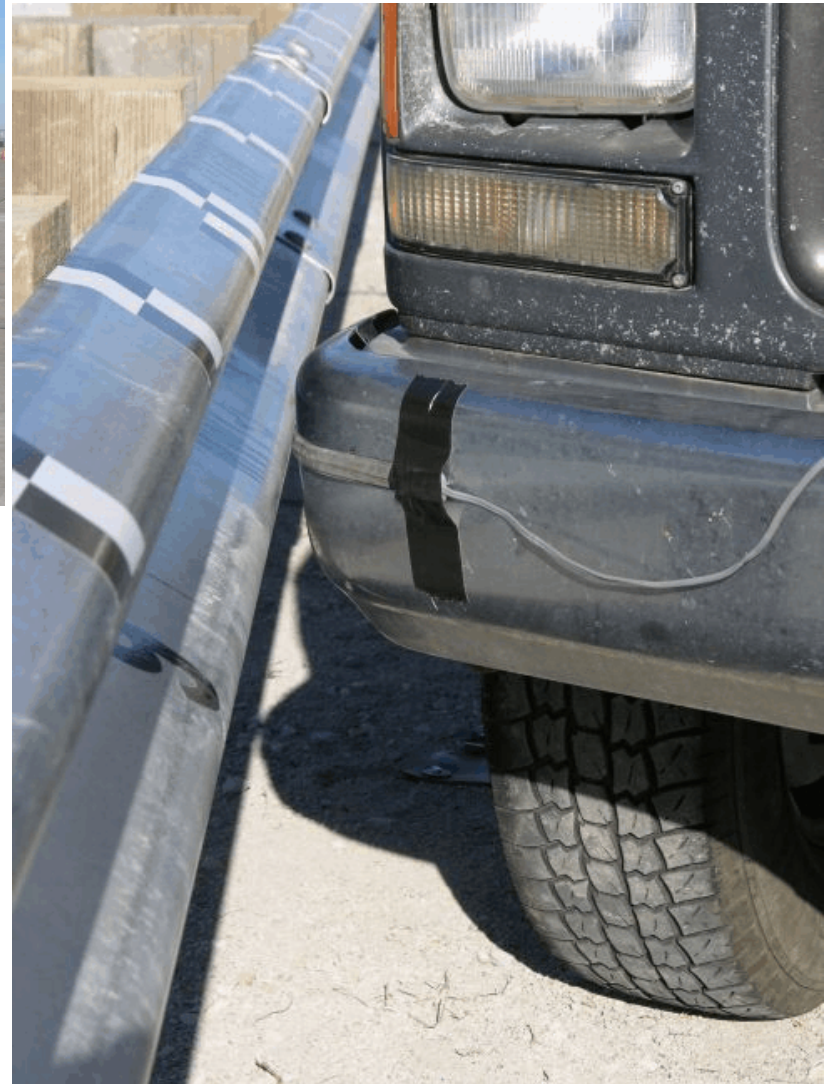
Figure 103. Impact Location, Test MWT-5

Initial vehicle impact was to occur between post nos. 8 and 9, or 330 mm (13 in.) upstream of the centerline of post no. 9, as shown in Figure 101. Actual vehicle impact occurred at the targeted impact location. At 0.016 sec after impact, the pickup bumper and the right-front quarter panel crushed inward towards the engine compartment. At 0.042 sec, post nos. 9 through 11 rotated backwards slightly, and the right-front right quarter panel crushed inward under the hood. At 0.066 sec, post nos. 11 through 13 rotated backward, and the guardrail flattened around the right-front quarter panel of the truck. At this same time, the hood protruded over the rail. At 0.082 sec, the rail buckled at post no. 12, and post nos. 10 and 11 continued to rotate backwards. At 0.096 sec, post nos. 10 and 11 deflected downstream, while post nos. 12 through 14 deflected upstream and rotated backwards. At this same time, the rail continued to flatten around the front of the vehicle. At 0.124 sec, the blockout at post no. 11 disengaged from the system and traveled downstream. By this time, the front bumper was located at post no. 12, and the right-front side of the vehicle continued to crush inwards. At 0.174 sec, the blockout at post no. 12 disengaged from the system and fell to the ground. At this same time, post no. 13 rotated backwards, and a buckle in the rail appeared at post
