# **DEVELOPMENT OF THE MIDWEST GUARDRAIL SYSTEM (MGS) W-BEAM TO THRIE BEAM TRANSITION ELEMENT**

## **MIDWEST ROADSIDE SAFETY FACILITY**

MwRSF Research Report No. TRP-03-167-07

November 26, 2007

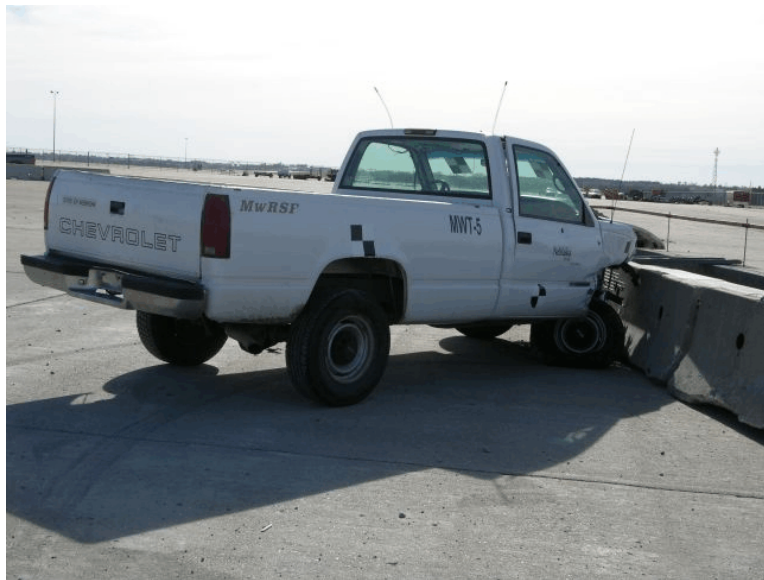
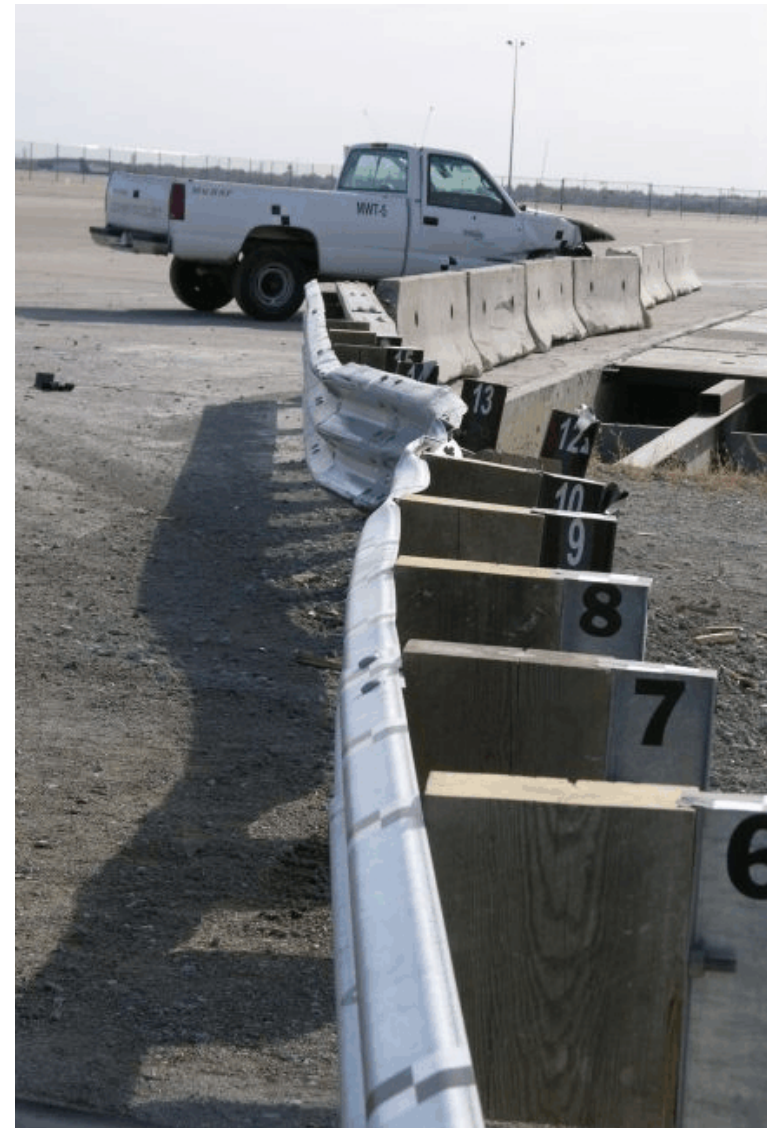
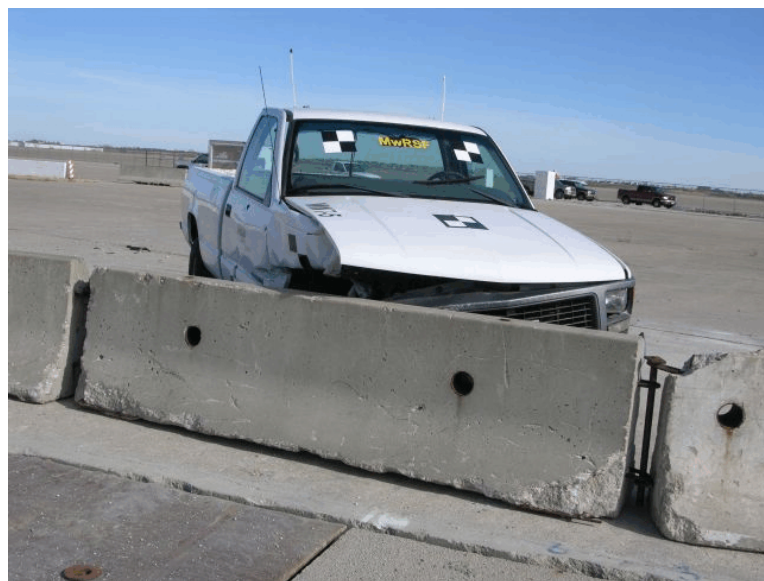
Figure 104. Vehicle Final Position and Trajectory Marks, Test MWT-5

- Speed ..... 37.7 km/h
  - Angle ..... 23.9 degrees
- Post-Impact Trajectory
  - Vehicle Stability ..... Satisfactory
  - Stopping Distance ..... 23.9 m downstream, 2.8 m behind traffic-side face

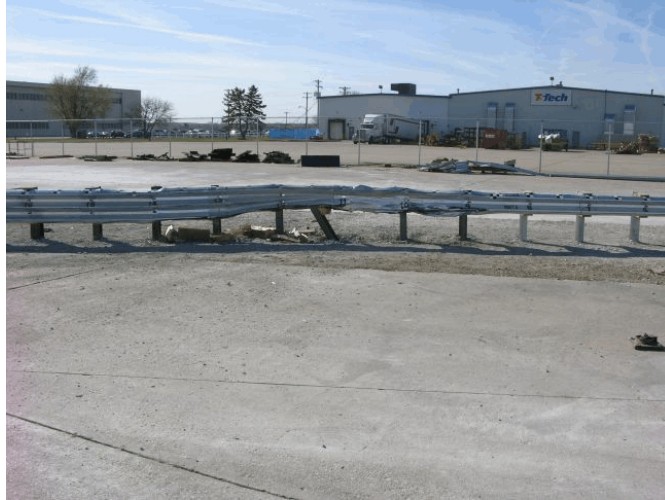
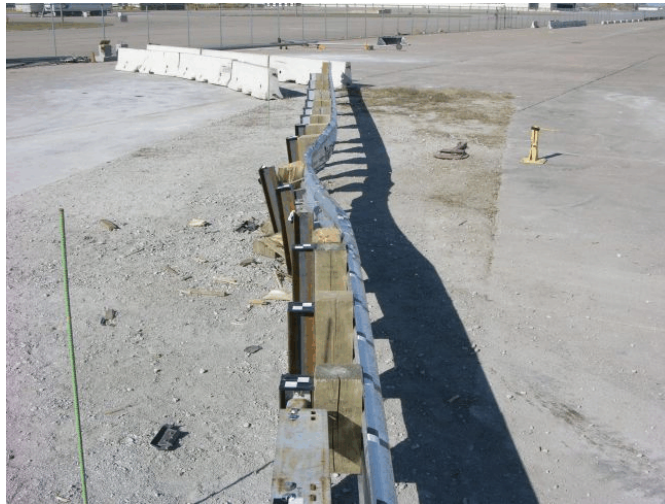
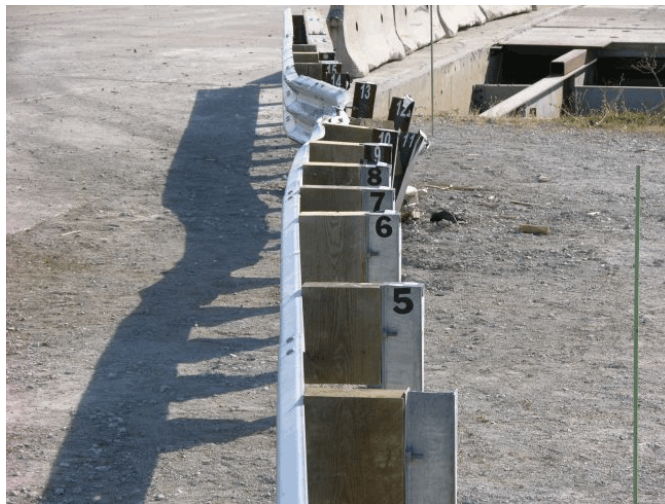
Figure 105. System Damage, Test MWT-5

System damage was moderate as shown in Figures 105 through 112. System damage consisted mostly of deformed guardrail and posts, soil damage, fractured wooden spacer blockouts, and contact marks on a guardrail section. The length of vehicle contact along the approach guardrail

Contact marks on the lower corrugation of the rail began 330 mm (13 in.) upstream of post no. 9 and continued through 762 mm (30 in.) downstream of post no. 14. Slight buckling of the rail was visible between post nos. 8 and 9. Flattening of the rail was found between post nos. 9 and 10. Slight rail buckling also occurred at the rail splice at post no. 13. The rail between post nos. 10 and 13 was deformed upward from vehicle contact. The rail was also deformed at the guardrail to post bolt at post no. 14, but the bolt did not pull through the rail. Slight deformation was visible at the rail splice at post no. 15. Guardrail to post bolt pullout occurred at post no. 11.

Minor soil gaps were visible around post nos. 1, 2, and 8 through 14. Post nos. 3 through 8 rotated slightly downstream. Post nos. 9 and 10 rotated backward. Post no. 11 rotated backward and downstream to approximately 60 degrees. Post nos. 12 through 14 also deflected downstream and backward, but to a lesser extent than post no. 11. Post nos. 15 through 21 were not visibly damaged. The wooden blockouts at post nos. 10 and 14 were fractured but remained attached to the post and rails. The wooden blockouts at post nos. 11 through 13 fractured and disengaged from the system.

The permanent set of the barrier system is shown in Figures 105 and 106. The maximum lateral permanent set rail and post deflections were 375 mm (14.75 in.) at the centerline of post no. 11 and 318 mm (12.5 in.) at the centerline of post no. 12, respectively, as measured in the field. The maximum lateral dynamic rail and post deflections were 605 mm (23.8 in.) at the midspan between post nos. 11 and 12 and 557 mm (21.9 in.) at the centerline of post no. 11, respectively, as determined from high-speed video analysis. The working width of the system was found to be 1,021 mm (40.2 in.).

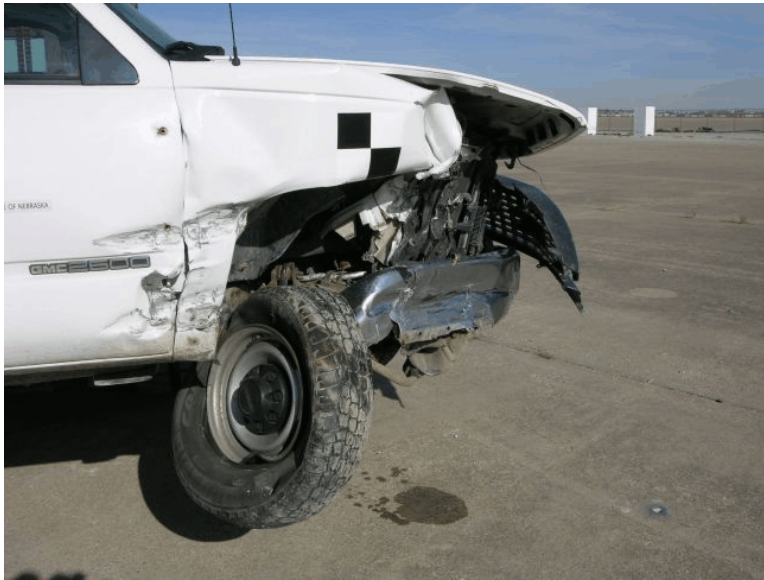
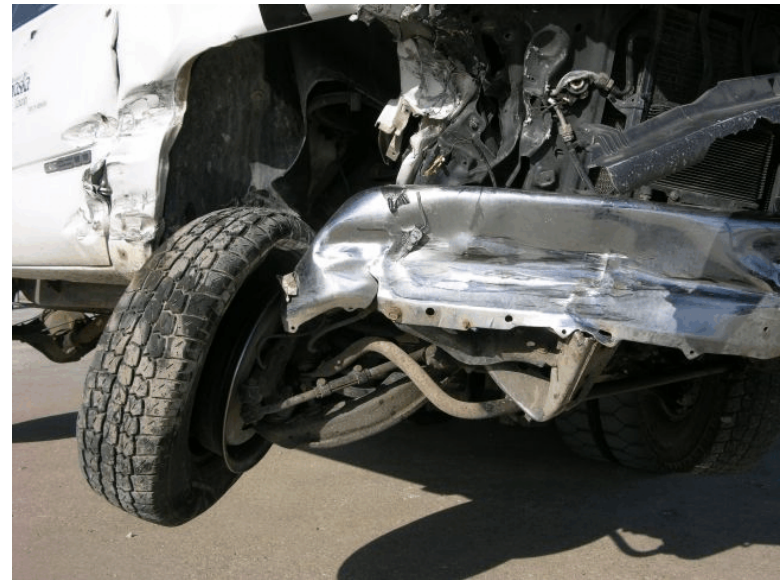
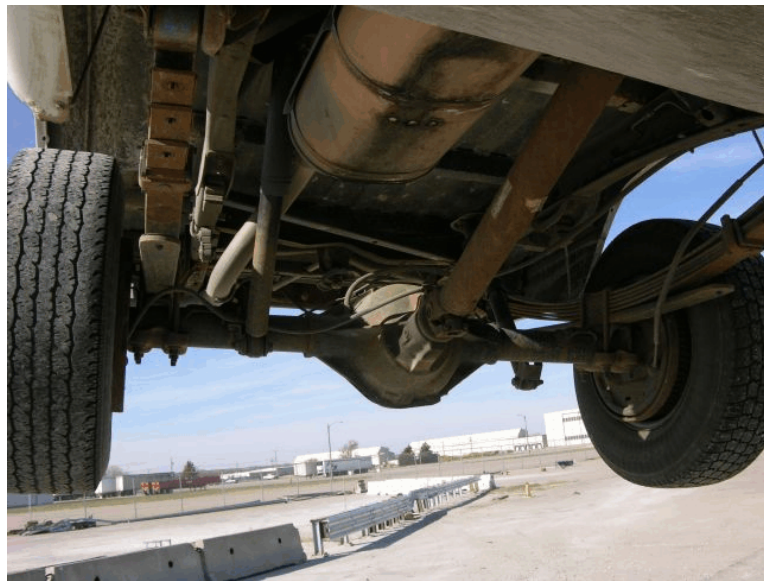
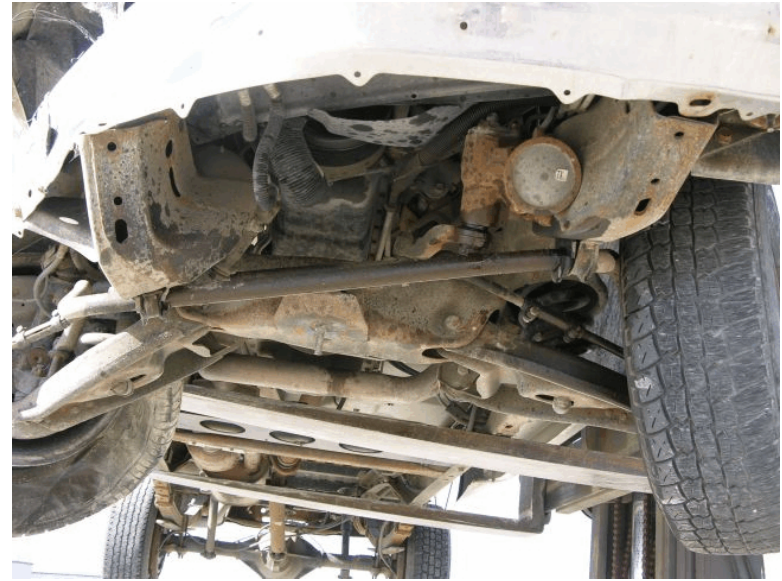
Figure 113. Vehicle Damage, Test MWT-5

Exterior vehicle damage was minimal, as shown in Figures 113 through 115. Occupant compartment deformations to the right side and center of the floorboard were judged insufficient to cause serious injury to the vehicle occupants, as shown in Figure 115. Maximum longitudinal deflections of 13 mm (0.5 in.) were located near the left-front side of the right-side floorboard. Maximum lateral deflections of 44 mm (1.75 in.) were located near the front center of the floorboard. Maximum vertical deflections of 32 mm (1.25 in.) were located at the front of the floorboard. Complete occupant compartment deformations and the corresponding locations are provided in Appendix C.

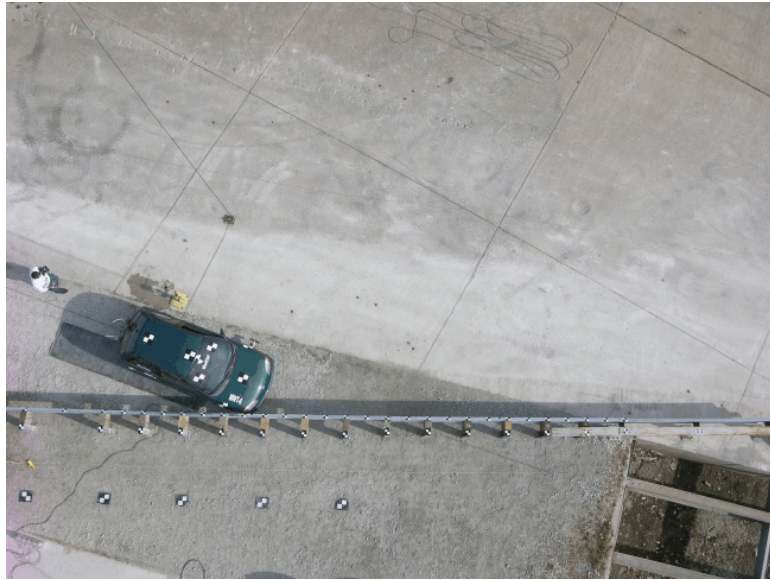
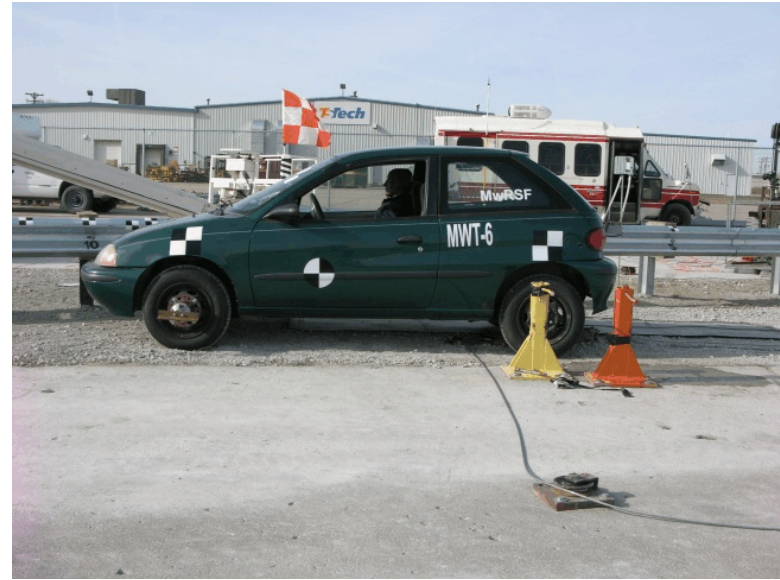
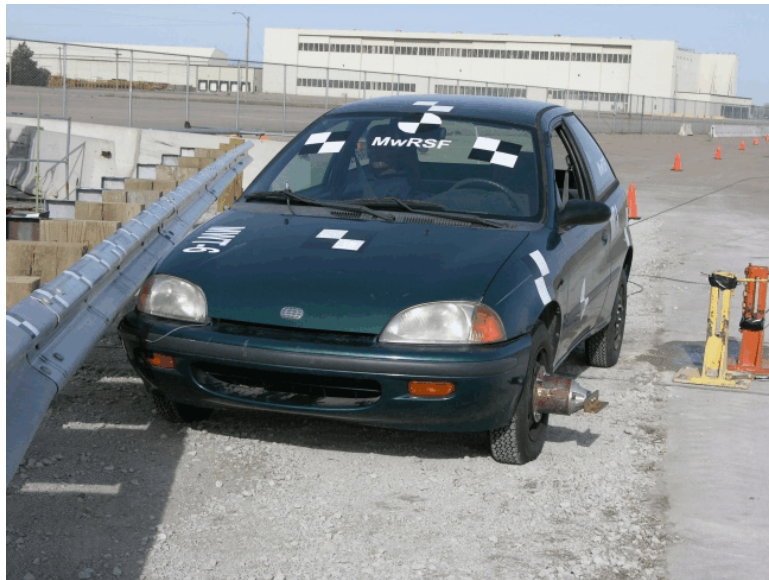
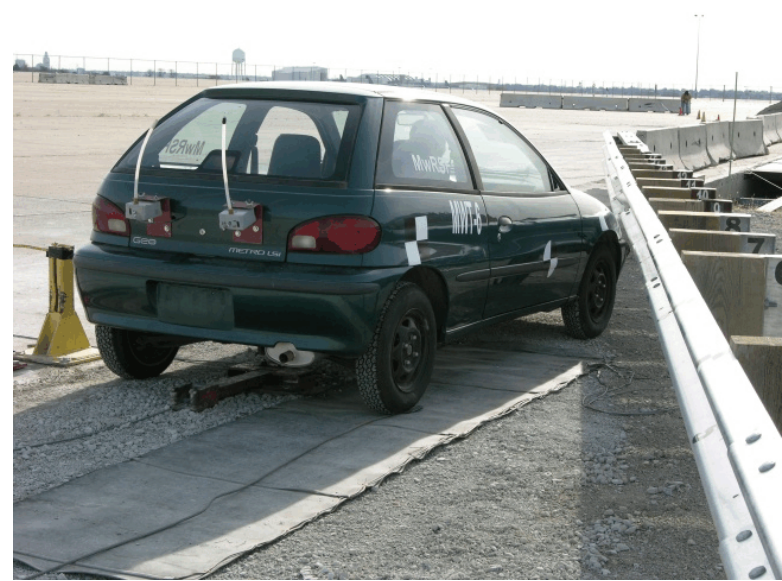
Figure 121. Impact Location, Test MWT-6

Initial vehicle impact was to occur between post nos. 9 and 10, or 318 mm (12.5 in.) upstream of the centerline of post no. 10, as shown in Figure 121. Actual vehicle impact occurred 235 mm (9.25 in.) upstream from the centerline of post no. 10. At 0.024 sec after impact, the right-front corner of the vehicle was located at the midspan between post nos. 10 and 11. At this same time, post nos. 10 and 11 deflected away from the vehicle. At 0.052 sec, the blockout at post no. 11 fractured, and the rail continued to deflect. At this same time, the front of the vehicle pitched downward. At 0.066 sec, the right-front corner of the vehicle was located at post no. 12. At this same time, the system continued to deflect through post no. 13. At 0.084 sec, the right-side window fractured, and the right-front tire protruded under the rail. At 0.116 sec, the right-front tire was located at post no. 13. At 0.128 sec, the right side of the hood was pushed back toward the windshield, and the system reached its maximum deflection. At 0.160 sec, the front of the vehicle was located at post no. 14. At this same time, the vehicle redirected toward parallel, and the right-front tire was no longer protruding under the rail. At 0.188 sec, the right-rear side of the vehicle

The permanent set of the barrier is shown in Figure 121. The maximum lateral permanent set rail and post deflections were 314 mm (12.375 in.) at the centerline of post no. 11 and 298 mm (11.75 in.) at post no. 12, respectively, as measured in the field. The maximum lateral dynamic rail and post deflections were 314.3 mm (12.375 in.) at the midspan between post nos. 11 and 23 and 307 mm (12.1 in.) at post no. 12, respectively, as determined from high-speed digital video analysis. The working width of the system was found to be 847 mm (33.3 in.).

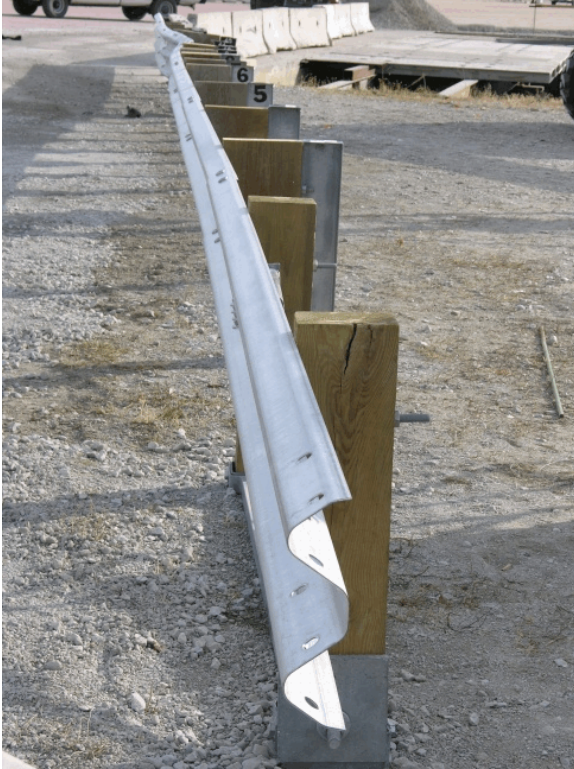
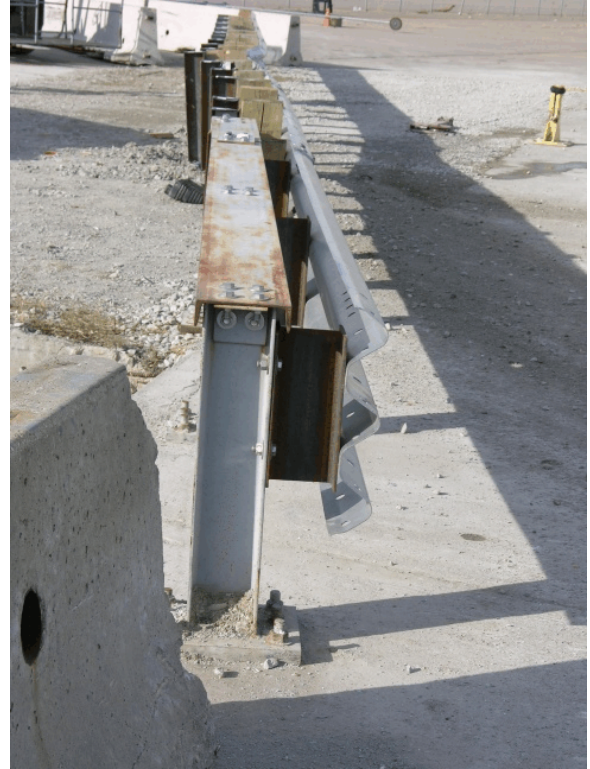
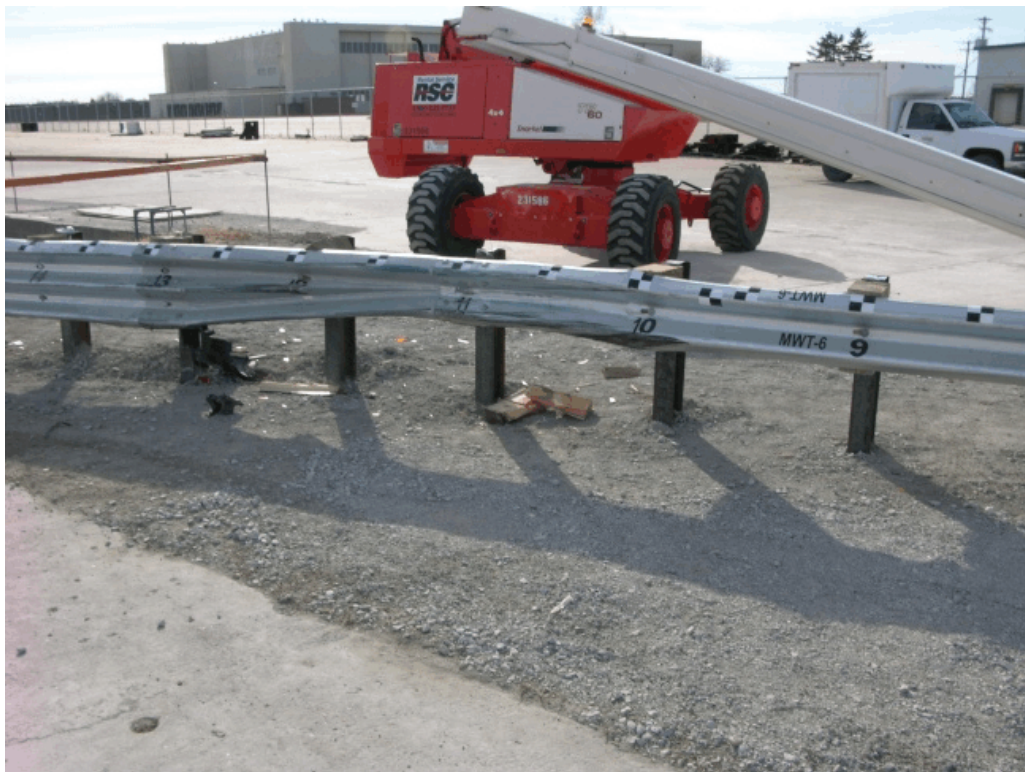
Figure 123. System Damage, Test MWT-6

Barrier damage was minimal, as shown in Figures 121 through 126. Barrier damage consisted of deformed guardrail and posts, damaged blockouts, and contact marks on a guardrail section. The length of vehicle contact along the approach guardrail system was approximately 4.5 m (14.8 ft), which spanned from 235 mm (9.25 in.) upstream from the centerline of post no. 10 through the midspan between post nos. 14 and 15.
