Performance of Modified Class D HMA Pavements in Washington State

WA-RD 711.1

December 2008

Special Report

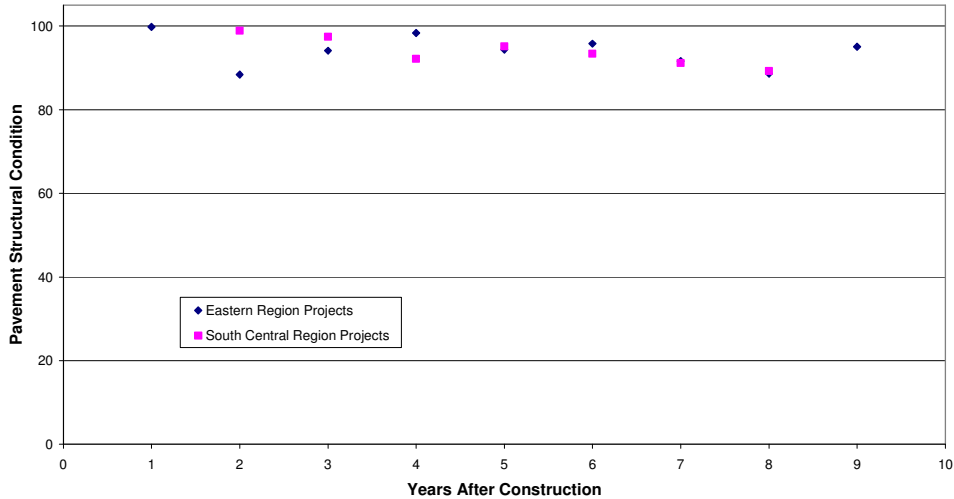
Figure 2. Average PSC of Modified Class D HMA for each year after construction in Eastern and South Central Region.

Figure 2 displays the average PSC for each year after construction for Modified Class D HMA projects in Eastern and South Central Regions. The Eastern Region data is from ten projects consisting of 255 lane miles of Modified Class D HMA placed from 1993 through 2005. A total of 137 lane miles in nine projects placed from 1993 through 1997 make up the South Central Region data.

The figure shows an average PSC of over 80 after eight years indicating good structural performance of the Modified Class D HMA used in both Eastern and South Central Region. The low value in the second year for the Eastern Region data is due to the early failure of one project, contract 6708, which is discussed later. These results are project averages and the actual distress can vary considerably within a project requiring repair or rehabilitation even though the average PSC is still good.

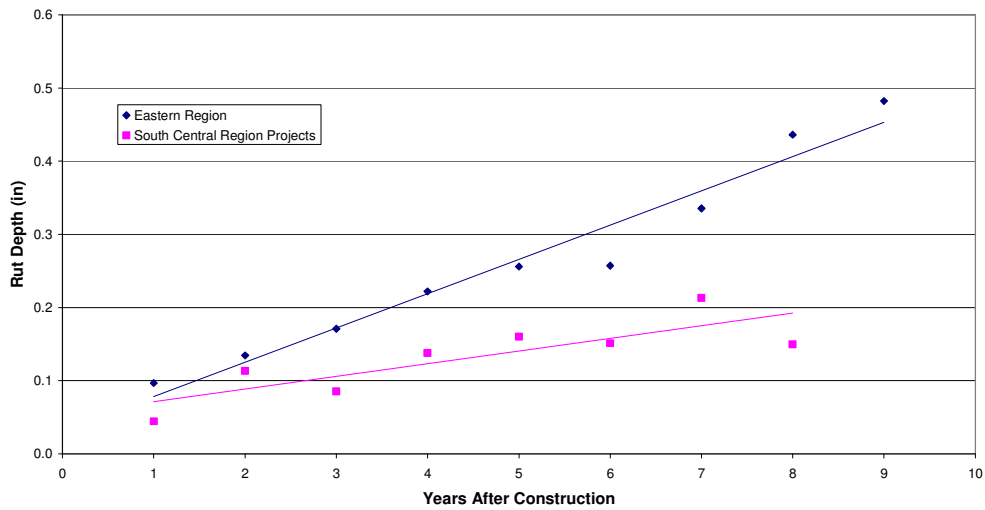
Figure 3. Average rut depth for Modified Class D HMA in Eastern and South Central Regions.

Figure 3 shows a divergence in rutting performance between the two Regions. The trend line predicts that the average rutting in Eastern Region will reach 0.4 inches in about 8 years and about 16 years for South Central Region. The cause of the difference in rutting performance between the two Regions is unclear, however Eastern Region does experience a higher use of studded tires which may contribute to the rutting in that Region.

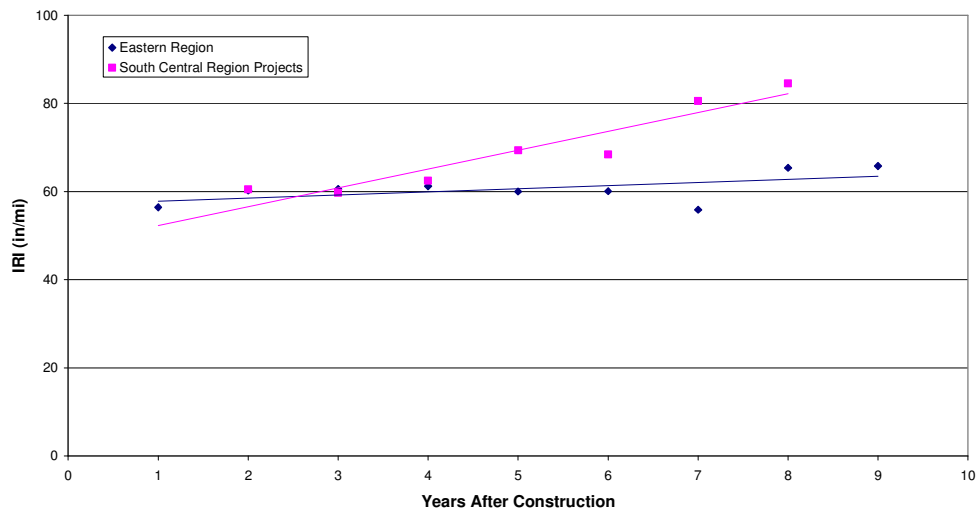
Figure 4. Average IRI for Modified Class D HMA in Eastern and South Central Regions.

Figure 4 shows that Modified Class D HMA projects performed well with respect to ride in both Regions. The trend of the IRI indicates that it will not reach 220 in/mi, the level at which rehabilitation is due, until long after Modified Class D HMA pavements have reached the PSC or rutting thresholds for rehabilitation. IRI is therefore not a factor leading to rehabilitation of Modified Class D HMA pavements and further evaluation of the performance of Modified Class D HMA in this report will be limited to PSC and rutting.

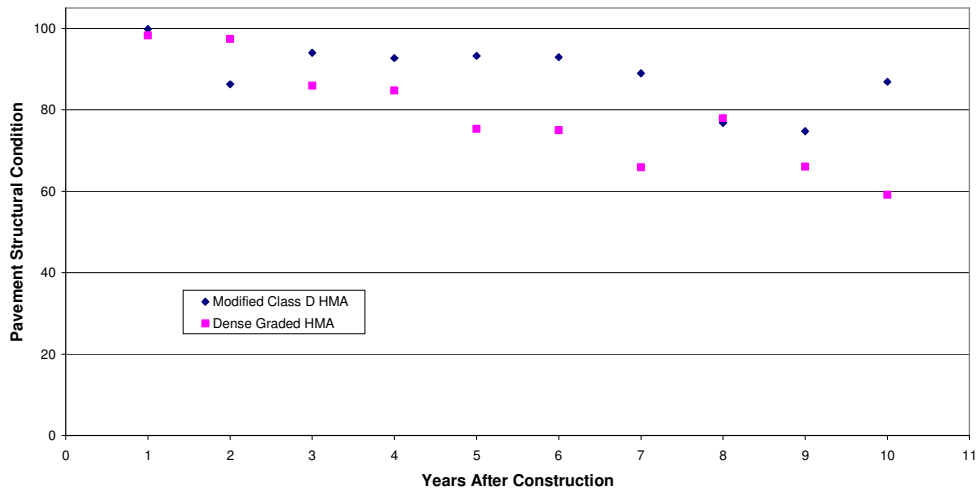
Figure 5. Comparison of average PSC each year after construction on Interstate 90.

Structural performance of both Modified Class D HMA and dense graded mixes on Interstate 90 is shown in the plot of average PSC versus project age in Figure 5. The Figure illustrates that the PSC of Modified Class D HMA was consistently higher than dense graded mixes meaning that Modified Class D HMA exhibits less cracking and patching than dense graded mixes. As discussed earlier the failure modes of Modified Class D HMA (raveling, rutting, flushing and stripping) do not show up in the PSC score so this does not necessarily indicate superior performance of Modified Class D HMA.

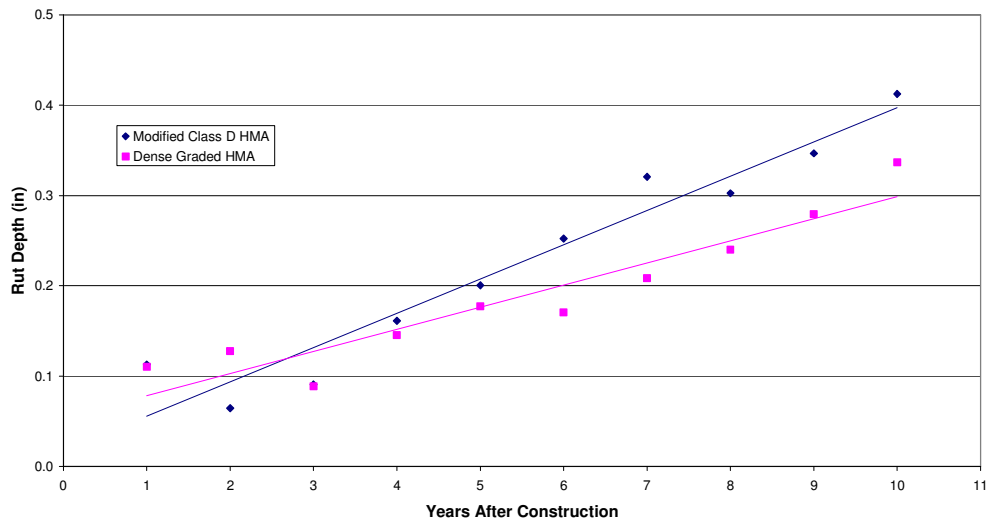
Figure 6. Comparison of average rut depth each year after construction on Interstate 90.

The rutting performance of dense graded pavement on Interstate 90 is somewhat better than Modified Class D HMA (Figure 6). This is not surprising given Modified Class D HMA tendency to ravel in the wheel paths. Neither mix type has performed well at preventing rutting on Interstate 90. The trend lines show average rut depth of Modified Class D HMA exceeding 0.4 inches after about 10 years and dense graded mixes exceed 0.4 inches at about 12 years. The

short time needed for ruts to reach 0.4 inches may lead the pavement to require rehabilitation even though the pavement still has structural life.

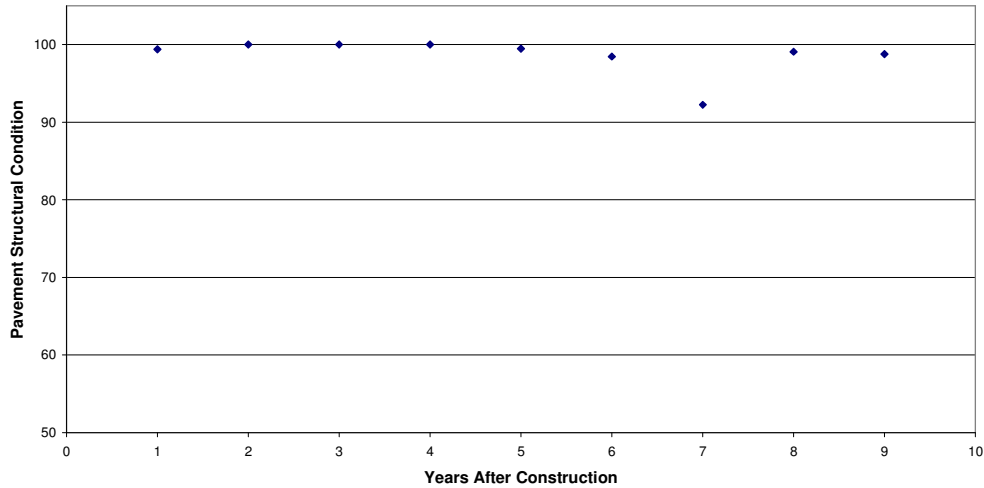
Figure 11. PSC each year after construction for Modified Class D HMA on Interstate 5.

The PSC for this section was near 100 nine years after construction indicating the pavement was in good condition structurally. The dip that occurred at age seven is due to longitudinal cracking recorded on the 1999 pavement condition survey. The 1999 survey data also showed

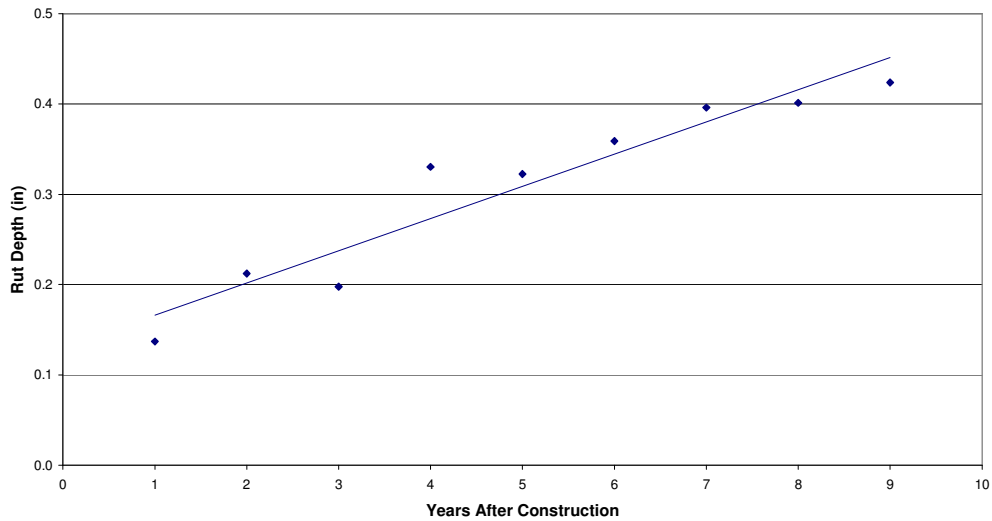
Figure 12. Rut depth each year after construction for Modified Class D HMA on Interstate 5.

Figure 12 illustrates the poor rutting performance of the one Modified Class D HMA on Interstate 5. By 2001, seven years after placement, the ruts reached the 0.4 inch average depth at which WSDOT considers pavement due for rehabilitation. Subsequent pavement condition surveys recorded rut depths up to 0.55 inches. With only one project it is difficult to say that Modified Class D HMA is inappropriate for overlays in western Washington, however, its performance on this project on Interstate 5 was less than desirable.
