Revisiting Aloha Airline Flight 243: Corrosion Engineer's Stand point

Mr Nauman Hashmi

School of chemical and materials engineering, National University of
Science and technology, Islamabad, Pakistan

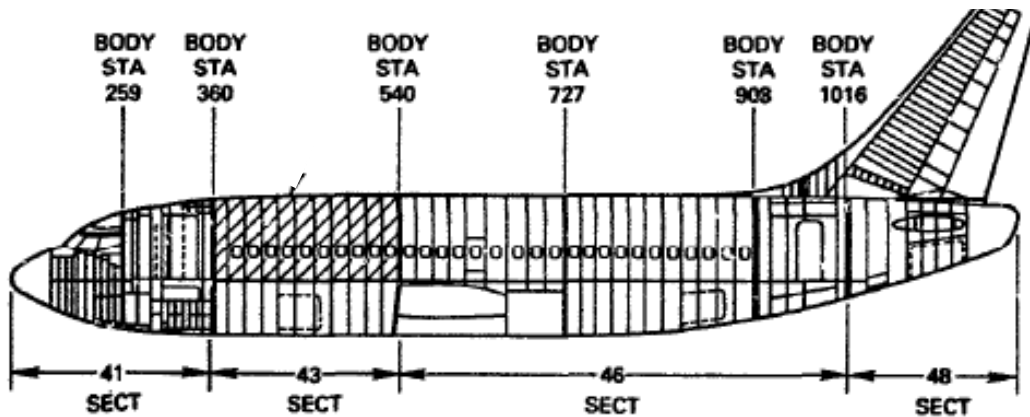
Figure 7: Section wise distribution of Boeing 737 Fuselage (Source: **(National Transportation Safety Board, 1989, p. 6)**)

13. According to (National Transportation Safety Board, 1989, p. 13), the fuselage structure of Boeing 737 comprises of four sections. The section 41, 43 and 46 formulates the most of pressurized area. These sections are joined with section 48 by butt joints forming the complete fuselage. The section wise distribution of the Boeing 737 structure is illustrated below.

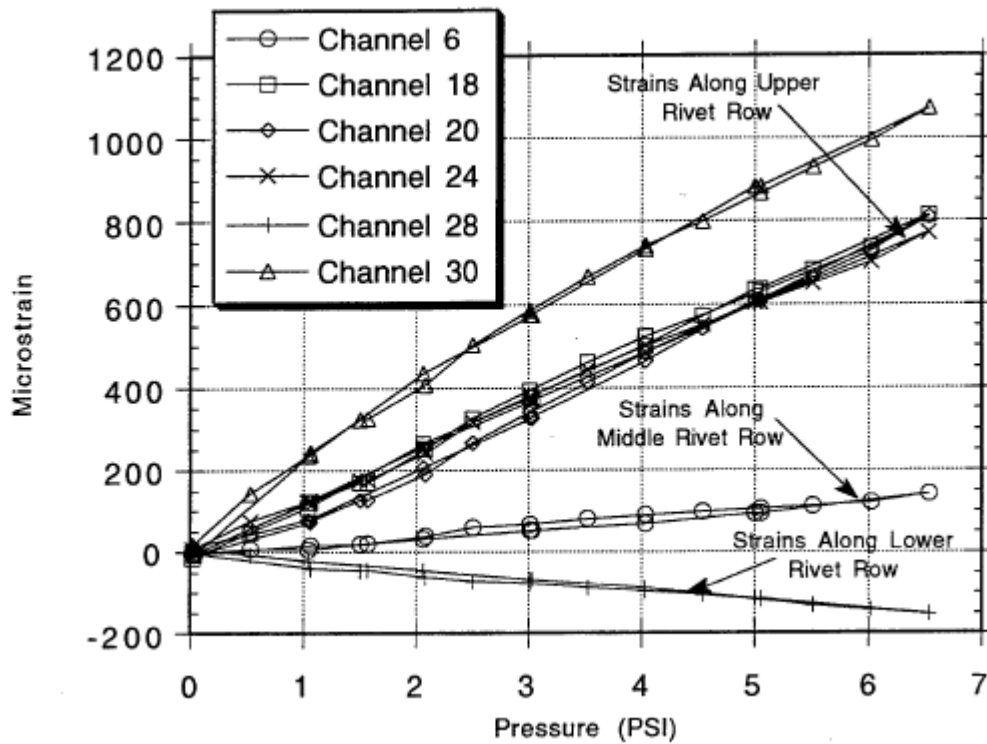
Figure 20: Strain rate of row of rivets on lap joint (Source: (D.Y.Jeong, 1995))

40. According to the experiments conducted by (D.Y.Jeong, 1995, p. 30), the highest strain rate was experienced by top row of rivets. The graphical presentations of his results are illustrated below in the figure.

41. This independent data indicates that Boeing's claims of vulnerable area are correct and the top most row of rivets is the susceptible one in case of fatigue cracking. According to (R.J.H.Wanhill, 1999, p. 19), there is no primary association between corrosion and fatigue. Severe corrosion did not result in multiple site damage (MSD). However (Craig L. Brooks, 1998, pp. 14-12) suggests that the corrosion has propounding effect on structural life. It can degrade the structural capabilities. His experimental result also indicates the reduction in critical length of the crack under aging effects. The graphical representations of his observations are illustrated below.

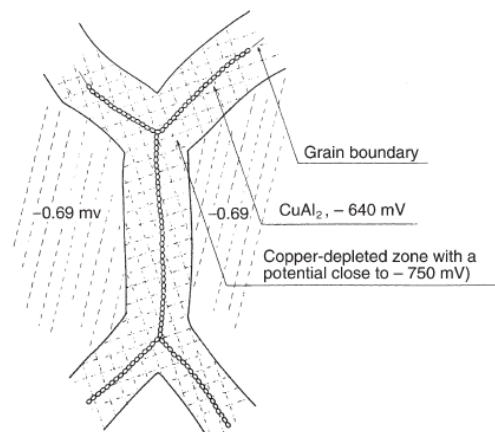
Figure 24: Precipitation of a cathodic phase on grain boundaries (Source: (Vargel, 2004, p. 125))

density (number of pits/area), rate of deepening and probability of pitting. The rate of deepening is more important than the density. As the deepening pit would determine the service life of the structure. As per (Vargel, 2004, pp. 123-127), the corrosion propagates either by intergranular means or by transgranular means. The transgranular corrosion starts from a pit. There is not relationship between intercrystalline corrosion and corrosion pit diameter. The intercrystalline corrosion can also propagate from minute and superficial pits. In case of Aloha airline flight 243, the fuselage is composed of Aluminum alloy 2024. In case of aluminum alloy 2024, the hardening phase Al_2Cu hardening phase would have a potential of 640 mv. This phase would have copper atoms in vicinity, the copper depleted zone would have a potential of 750 mv which is anodic to grain boundaries. The pictorial illustration of the phase distribution is illustrated below.
