Detection of Voids in Prestressed Concrete Bridges using Thermal Imaging and Ground-Penetrating Radar

WA-RD 717.1

December 2008

**DETECTION OF VOIDS IN PRESTRESSED CONCRETE BRIDGES USING
THERMAL IMAGING AND GROUND-PENETRATING RADAR**

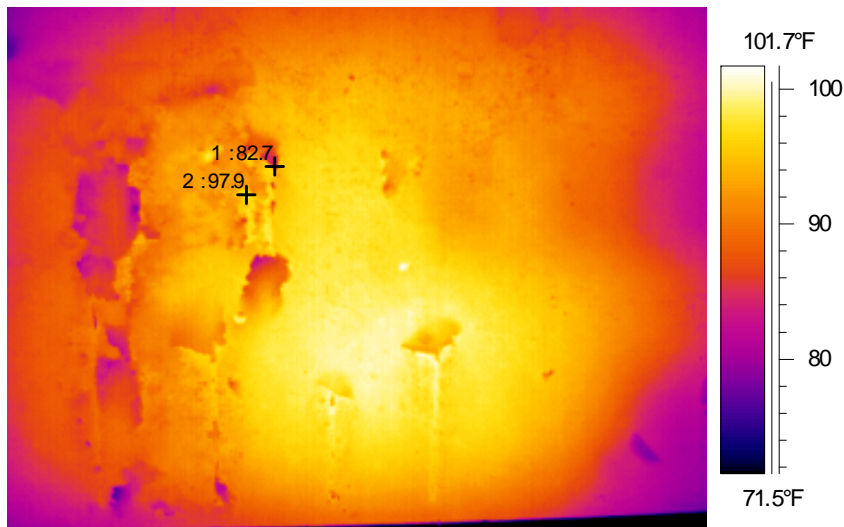
Figure 26 –Thermal image and photo of Heating Location # 5

Figure 26 shows both a photo and thermal image of Heating Location # 5. This figure is helpful because one can see exactly how each area in the photo appears in the thermal image. An example is the steel reinforcement. It is seen exposed in the photo, and then as a warmer line in the image, designated by circled area 1 in the figure. Most of the longitudinal rebar can be traced in a similar manner.

Circled area 2 in Figure 26 shows an interesting irregularity. The area doesn't display anything significant in the photo except a small amount of discoloration, but the thermal image demonstrates inconsistencies in the material in the form of great temperature differences. The thermal imaging software showed an approximate 5 °F difference between areas within the circle. This may be due to delamination, poorly consolidated concrete, or another irregularity, but there is no way to be certain of the specific cause until further tests are completed (either "sounding" with a hammer, or chipping out the loose concrete). This does, however, reveal that there may be a problem at this location. There are also a few other areas in the figure that exhibit similar temperature anomalies.

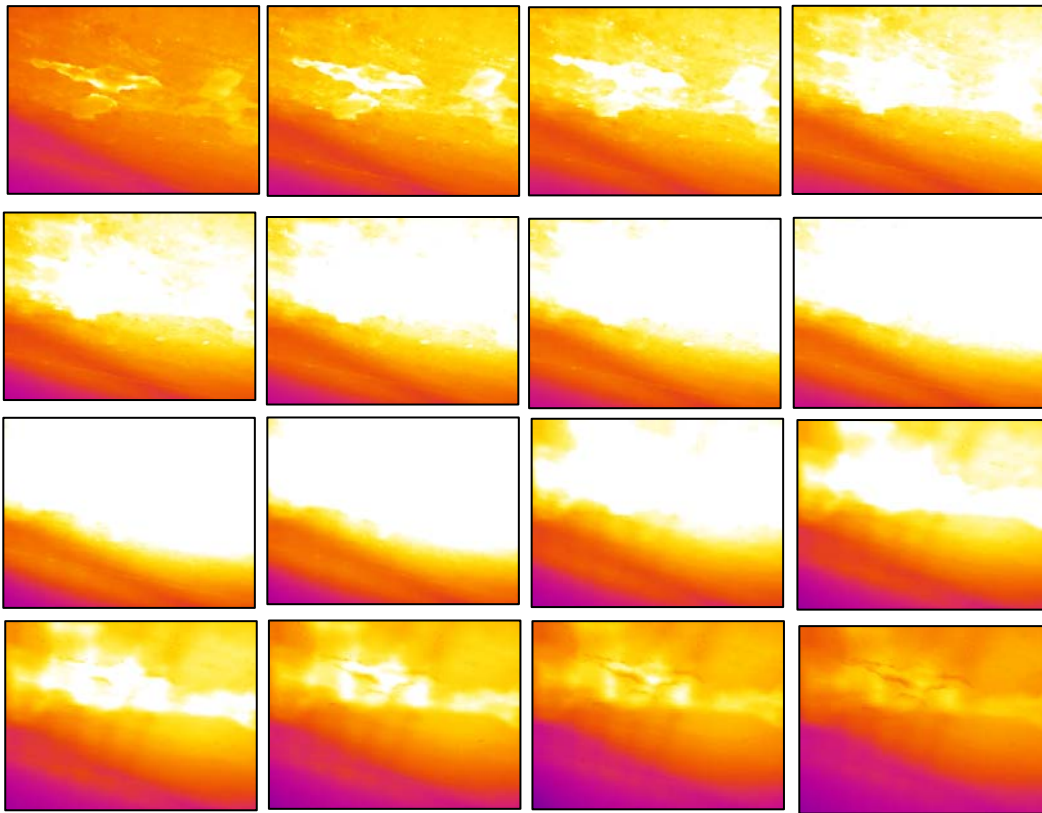
Figure 37 – Thermal image progression at Heating Location # 1

The thermal images in Figure 36 were taken in order to help locate areas that, with further heat input, might reveal subsurface flaws. The circled region shows what looks like a flaw, so the heater was moved so that its center was directly underneath this region, and then heating commenced again. From here, thermal images were taken every two minutes. Figure 37 shows a typical image progression during heating, or what one would see from the camera display. Figure 38 shows a single image from the progression.

Heating Location # 1 was a very important inspection because, after heating was stopped, the surface was examined with a rock hammer. Tapping confirmed what was seen in the thermal images. A WSDOT inspector tapped part of the surface that had no apparent flaws (either visually or thermally) and then tapped at suspected flaw locations. Sound differences were easily discernable between the two locations, and then the pick end of the hammer was used to remove surface concrete and excavate the flaw. Delamination and poorly consolidated concrete (small air voids) were discovered. Figure 39 shows a thermal image of a WSDOT employee excavating the delaminated concrete at the flaw location shortly after thermal imaging inspection. This was the first inspection location where flaws discovered thermally were confirmed using physical means (tapping and excavation).

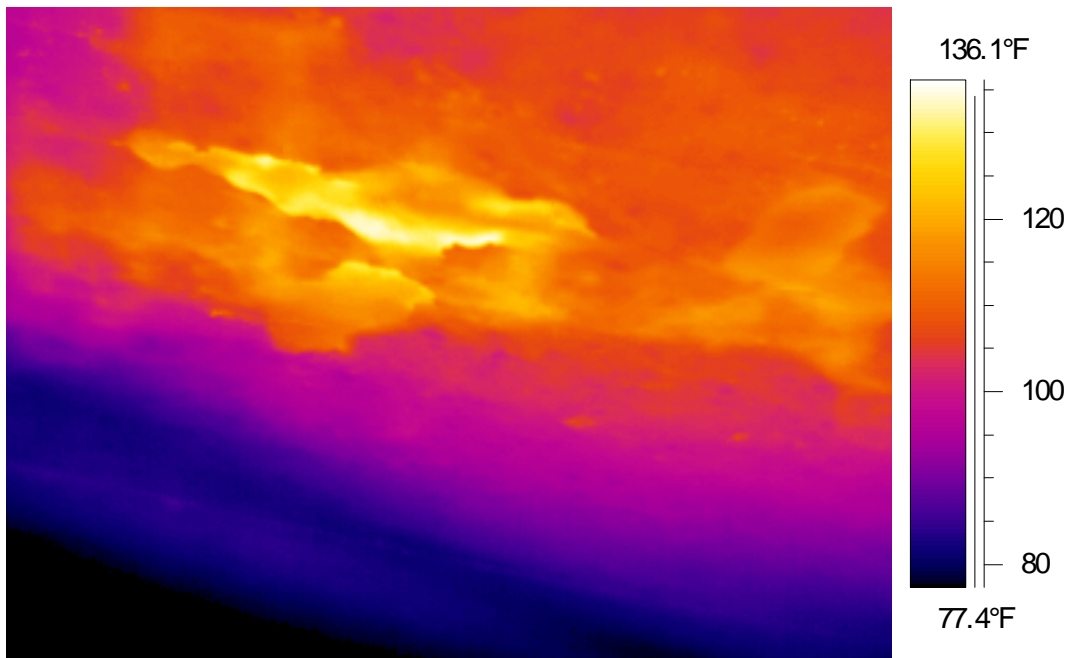
Figure 38 – Thermal image of Heating Location # 1 at middle of time interval

Field Inspection 2, conducted at an I-5 overpass (Bridge 5/537E-N) in Seattle, WA, was very successful because what was detected with thermal imaging was confirmed by “tapping” and excavation of the heated surface (at Heating Location # 1). The thermal images (Figures 36 and 38) suggested some sort of flaw (hypothesized as delamination), which was then verified by a WSDOT employee using a rock hammer to excavate the flaw. These inspections also confirmed that flaws can be visible in thermal images after only about 10 minutes of heat input (such as at Heating Location # 1).

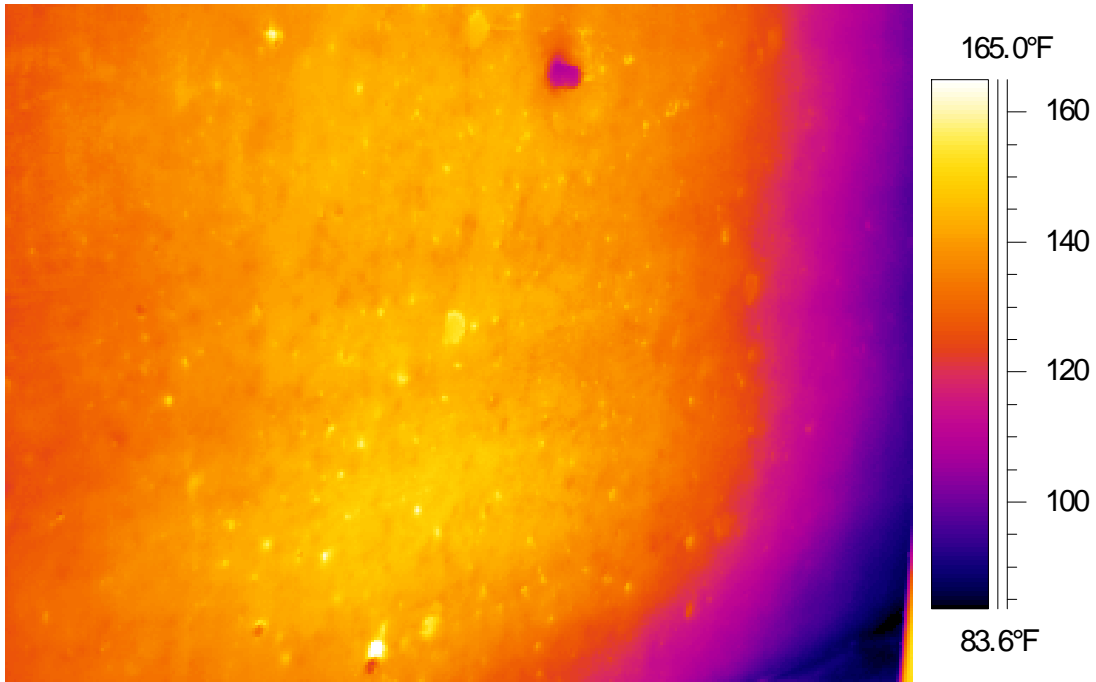
Figure 42 – Thermal image of Heating Location # 1 (30 minutes after heating began)

Figure 42 shows a thermal image of Heating Location # 1 taken approximately 30 minutes after heating commenced. This image illustrates the state of the concrete surface and its characteristics. A few hot and cool spots can be seen, but this image primarily reveals surface characteristics of the concrete.

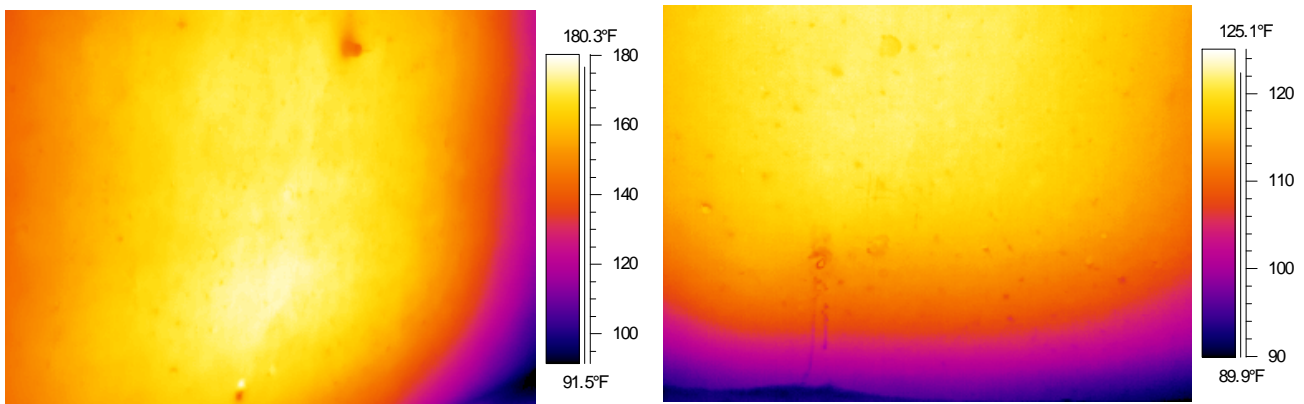
Figure 43 –Thermal images of Heating Location # 1:
a) after 2:55 (hh:mm) of heating (left)
b) 0:45 (hh:mm) after heating stopped (right)

The next two thermal images, shown in Figure 43, do not reveal anything regarding materials embedded in the concrete box girder web. The first image on the left was taken after 2:55 (hh:mm) of heating. The second image on the right was taken after the camera was moved directly in front of the heated surface, about 0:45 (hh:mm) after heating ended. None of the PT-ducts are visible in any of the thermal images, which indicates a couple of different things. First, three hours of heat input may not be enough to provide thermal images showing PT-ducts embedded in 30 cm (12 in.) thick concrete. Second, it is likely that the inspection setup was not

ideal for detecting the ducts. Inspection Method 2 involves taking thermal images from the same side as the heat input, and specimen inspections conducted in the lab indicated that Method 2 does not yield images showing inner-surface characteristics. Also, due to the confined area inside the box girder, the camera could not be placed as far from the heated surface as desired. Thus the camera lens could not capture the entire heated surface area. Unfortunately, since access to the opposite face of the box girder web was not available, Inspection Method 2 was the only option available.

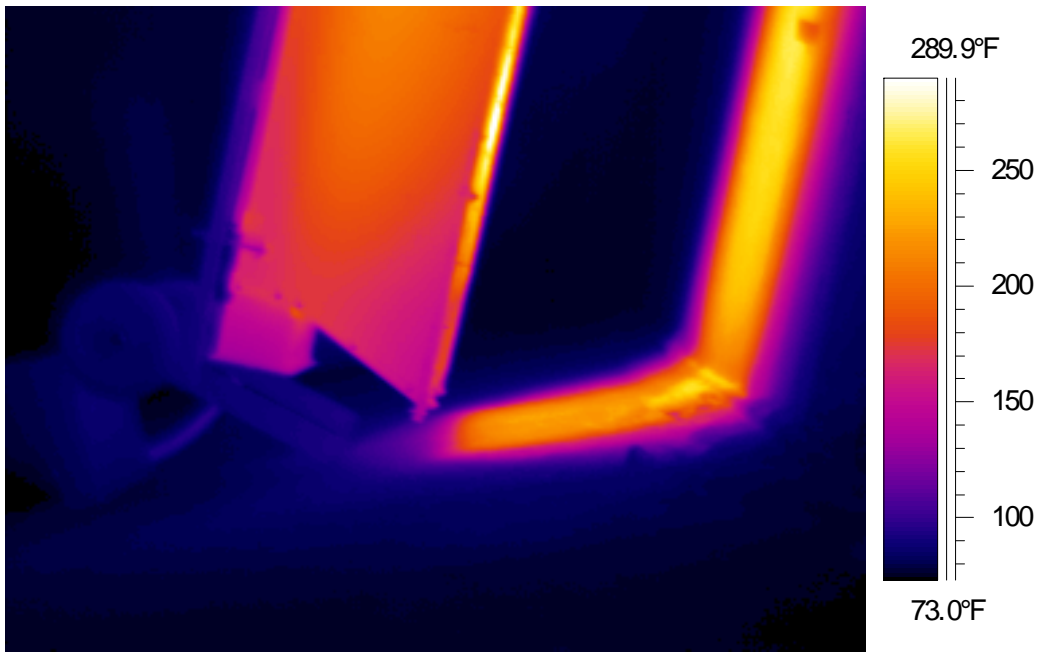
Figure 44 – Thermal image of Heating Location # 2 showing heater setup

The heater was not elevated, so both the box girder wall and floor were heated, as shown in Figure 44. Thermal images were obtained both during heating and for 40 minutes after heating ended.

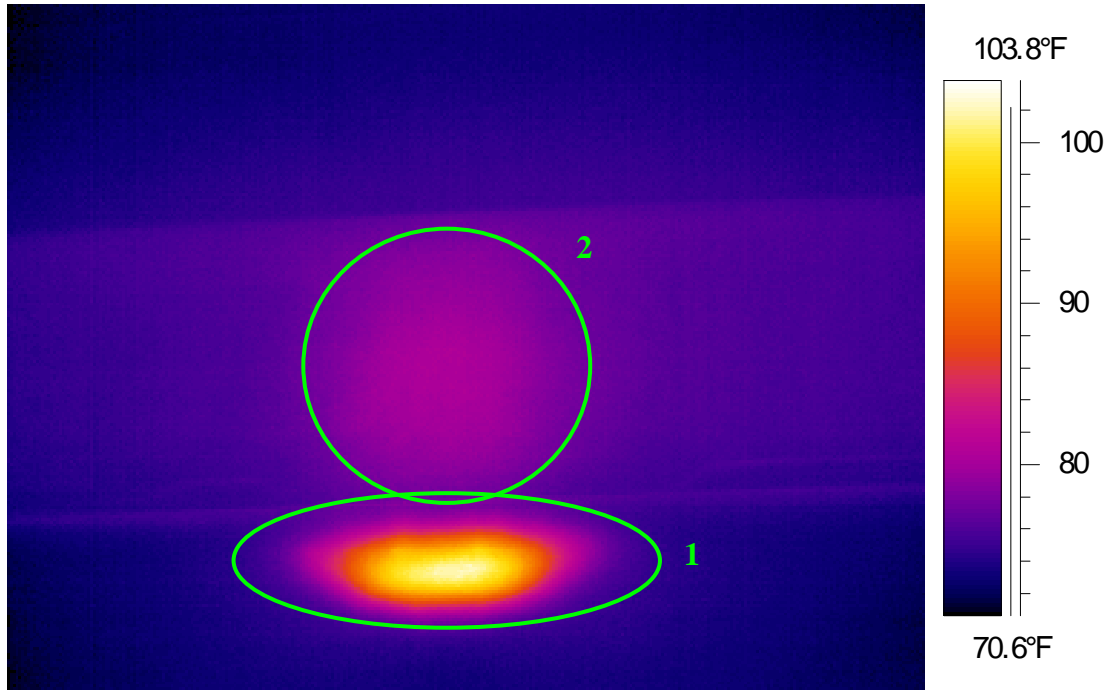
Figure 45 – Thermal image of Heating Location # 2 taken of the unheated surface

The inspection setup for this location allowed for two kinds of thermal images to be obtained. The first kind of image was of the unheated surface, taken from ground level outside the box girder (Method 1). Due to the large distance from the camera to the surface, images had less detail and a large viewing window. Figure 45 shows one such image taken about three hours after heating began. From the image, one can see that the heated surface (wall) was not as warm as the floor of the box girder. This is due to the fact that the wall is thicker than the floor (12 in. versus 8 in.), and it takes longer for heat to propagate through thicker concrete. After only three hours of heat input, there were no PT-ducts or flaws visible in the thermal image. In Figure 45, circled area 1 shows the floor, while circled area 2 shows the wall of the box girder. Thermal

images taken of the unheated surface after five hours of heating did not reveal the PT-ducts in the box girder wall.

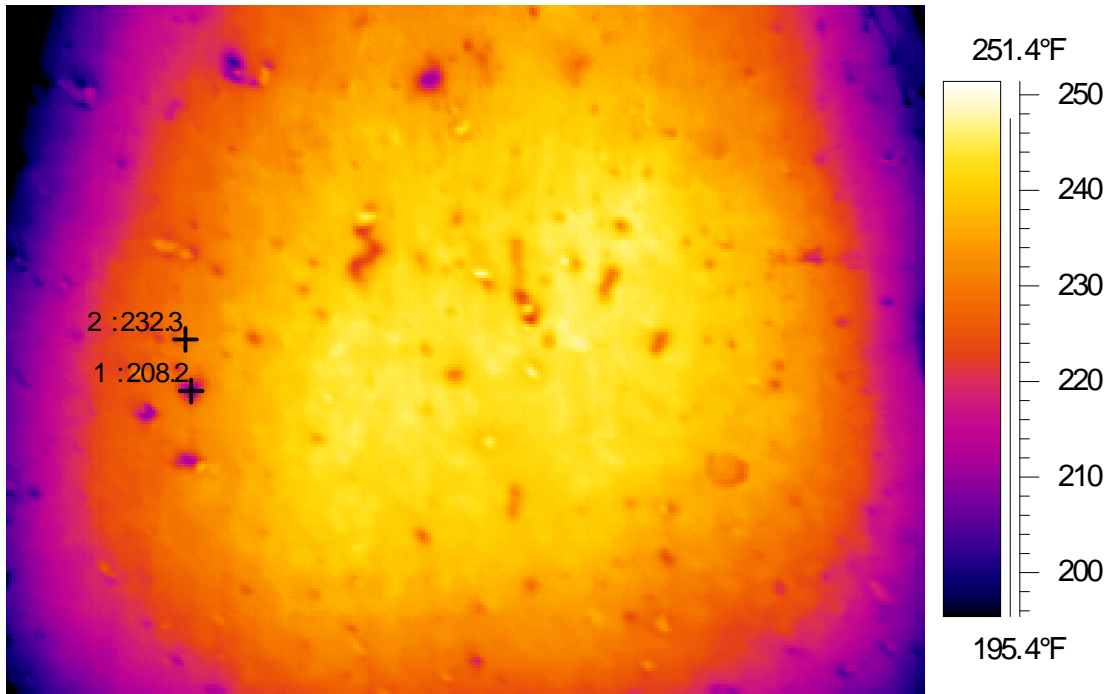
Figure 46 – Thermal image of Heating Location # 2 taken of the heated surface

Images of the heated surface were also obtained from inside the box girder after heating ended. Figure 46 displays one such image where surface characteristics are visible. However, as with Figures 44 and 45, the image does not show any PT-ducts. The flaws shown are mostly surface irregularities and small surface voids. Points 1 and 2 in Figure 46 show a temperature difference of approximately 24 °F in a span of only a few inches.
