# **DEVELOPMENT AND EVALUATION OF THE MIDWEST GUARDRAIL SYSTEM (MGS) PLACED ADJACENT TO A 2:1 FILL SLOPE**

## **MIDWEST ROADSIDE SAFETY FACILITY**

MwRSF Research Report No. TRP-03-185-10

February 24, 2010

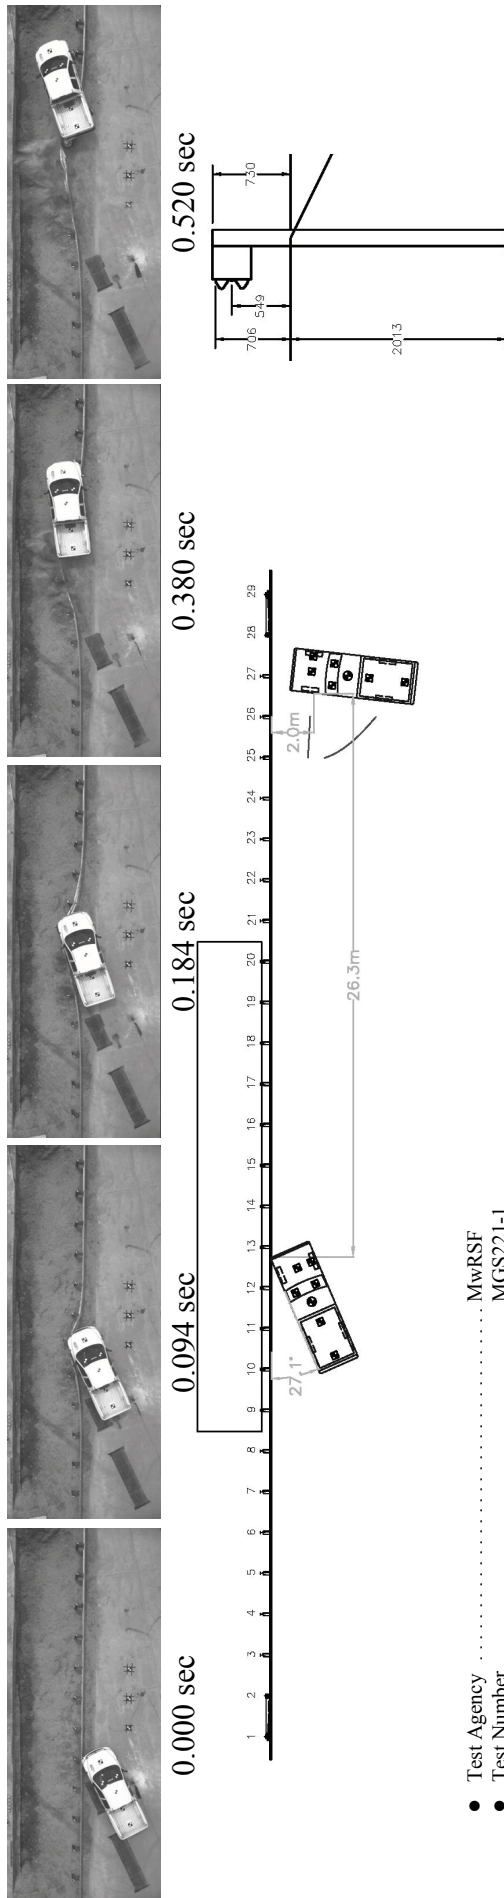
Figure 24. Summary of Test Results and Sequential Photographs, Test No. MGS221-1

The analysis of the test results for test no. MGS221-1 showed that the MGS, with a 706-mm (27¾-in.) top mounting height and installed adjacent to a 2:1 fill slope, did not adequately contain nor redirect the 2270P vehicle as the vehicle overrode the top of the system and subsequently landed behind the system. There were no detached elements nor fragments which showed potential for penetrating the occupant compartment nor presented undue hazard to other traffic. Deformations of, or intrusion into, the occupant compartment that could have caused serious injury did not occur. The test vehicle overrode and penetrated the guardrail system. It did remain upright during and after the collision. Vehicle roll, pitch, and yaw angular displacements were noted, but they were deemed acceptable because they did not adversely influence occupant risk safety criteria nor cause rollover. Therefore, test no. MGS221-1 conducted on the MGS installed adjacent to a 2:1 fill slope was determined to be unacceptable according to the TL-3 safety performance criteria found in MASH.

The vehicle override was attributed to the slow release of post no. 15 from the guardrail, thus causing the W-beam to be pulled downward. In addition, the vehicle override was also attributed to the failure of the vehicle's front suspension shortly after impact, thus preventing the guardrail from capturing the pickup truck's left-front tire.

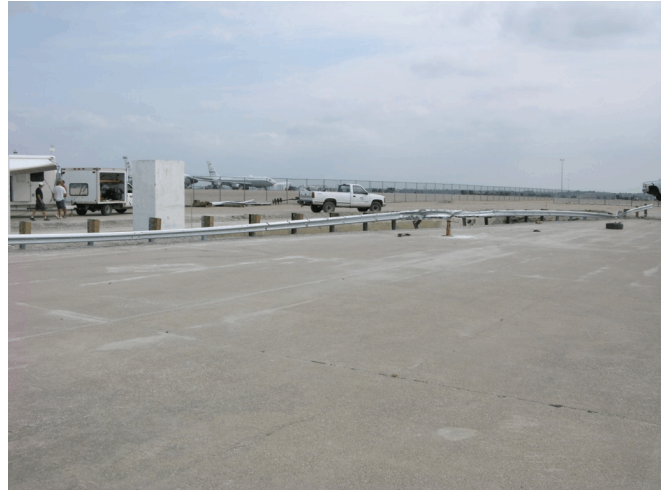
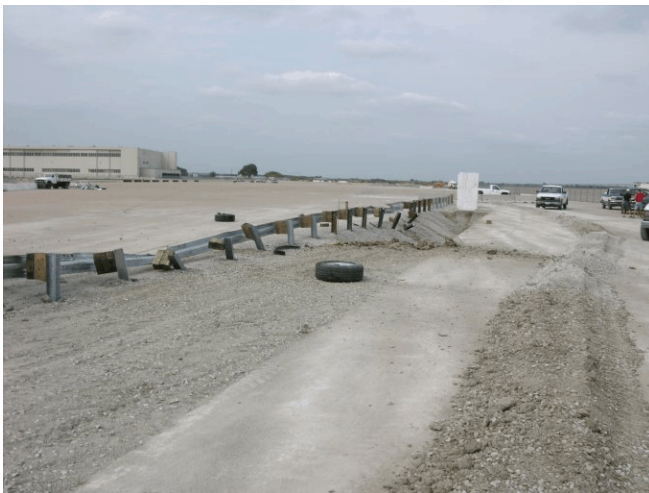
Figure 33. System Damage, Test No. MGS221-1

Damage to the barrier was moderate, as shown in Figures 33 through 41. Barrier damage consisted of deformed guardrail posts, disengaged wooden blockouts, contact marks on a guardrail section and posts, and deformed and fractured W-beam rail. The length of the vehicle contact along the MGS system was approximately 8.8 m (29 ft - 1½ in.), which spanned from 305 mm (12 in.) upstream from the centerline of post no. 13 through the midspan between post nos. 17 and 18.

The permanent set of the barrier system is shown in Figure 33. The maximum lateral permanent set rail and post deflections were 810 mm (31 $\frac{7}{8}$  in.) at the centerline of post no. 16 and 1,086 mm (42 $\frac{3}{4}$  in.) at post no. 15, respectively, as measured in the field. The maximum lateral dynamic rail and post deflections were 955 mm (37.6 in.) at the centerline of post no. 15 and 1,126 mm (44.3 in.) at post no. 15, respectively, as determined from high-speed digital video analysis.

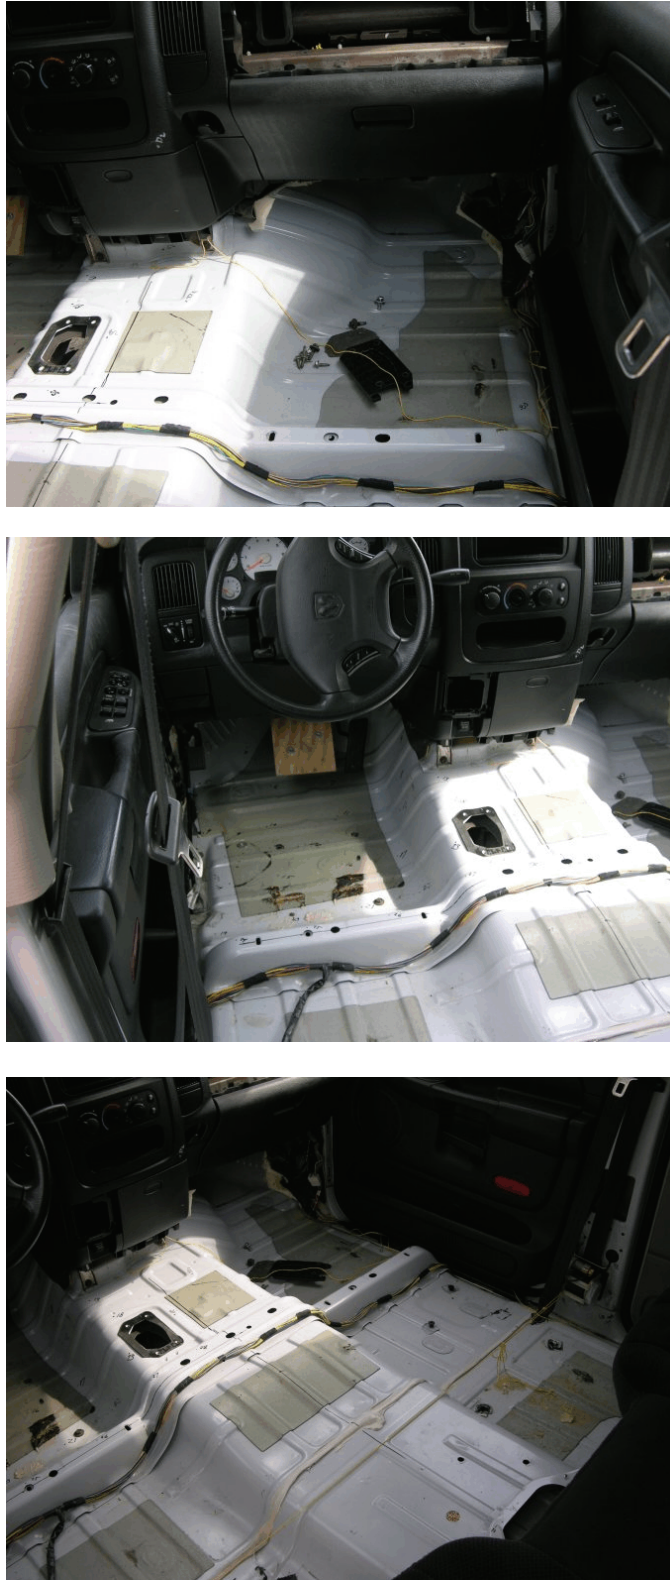
Figure 45. Occupant Compartment Damage, Test No. MGS221-1

Exterior vehicle damage was moderate, as shown in Figures 42 through 44. Occupant compartment deformations to the left side and center of the floor pan were judged insufficient to cause serious injury to the vehicle occupants, as shown in Figure 45. Maximum longitudinal deflections of 6 mm ( $\frac{1}{4}$  in.) were located throughout the left-side floor pan. Maximum lateral deflections of 13 mm ( $\frac{1}{2}$  in.) were located at the rear-center of the left-side floor pan. Maximum vertical deflections of 13 mm ( $\frac{1}{2}$  in.) were located on the floor pan near the left-side door. Complete occupant compartment deformations and the corresponding locations are provided in Appendix E.

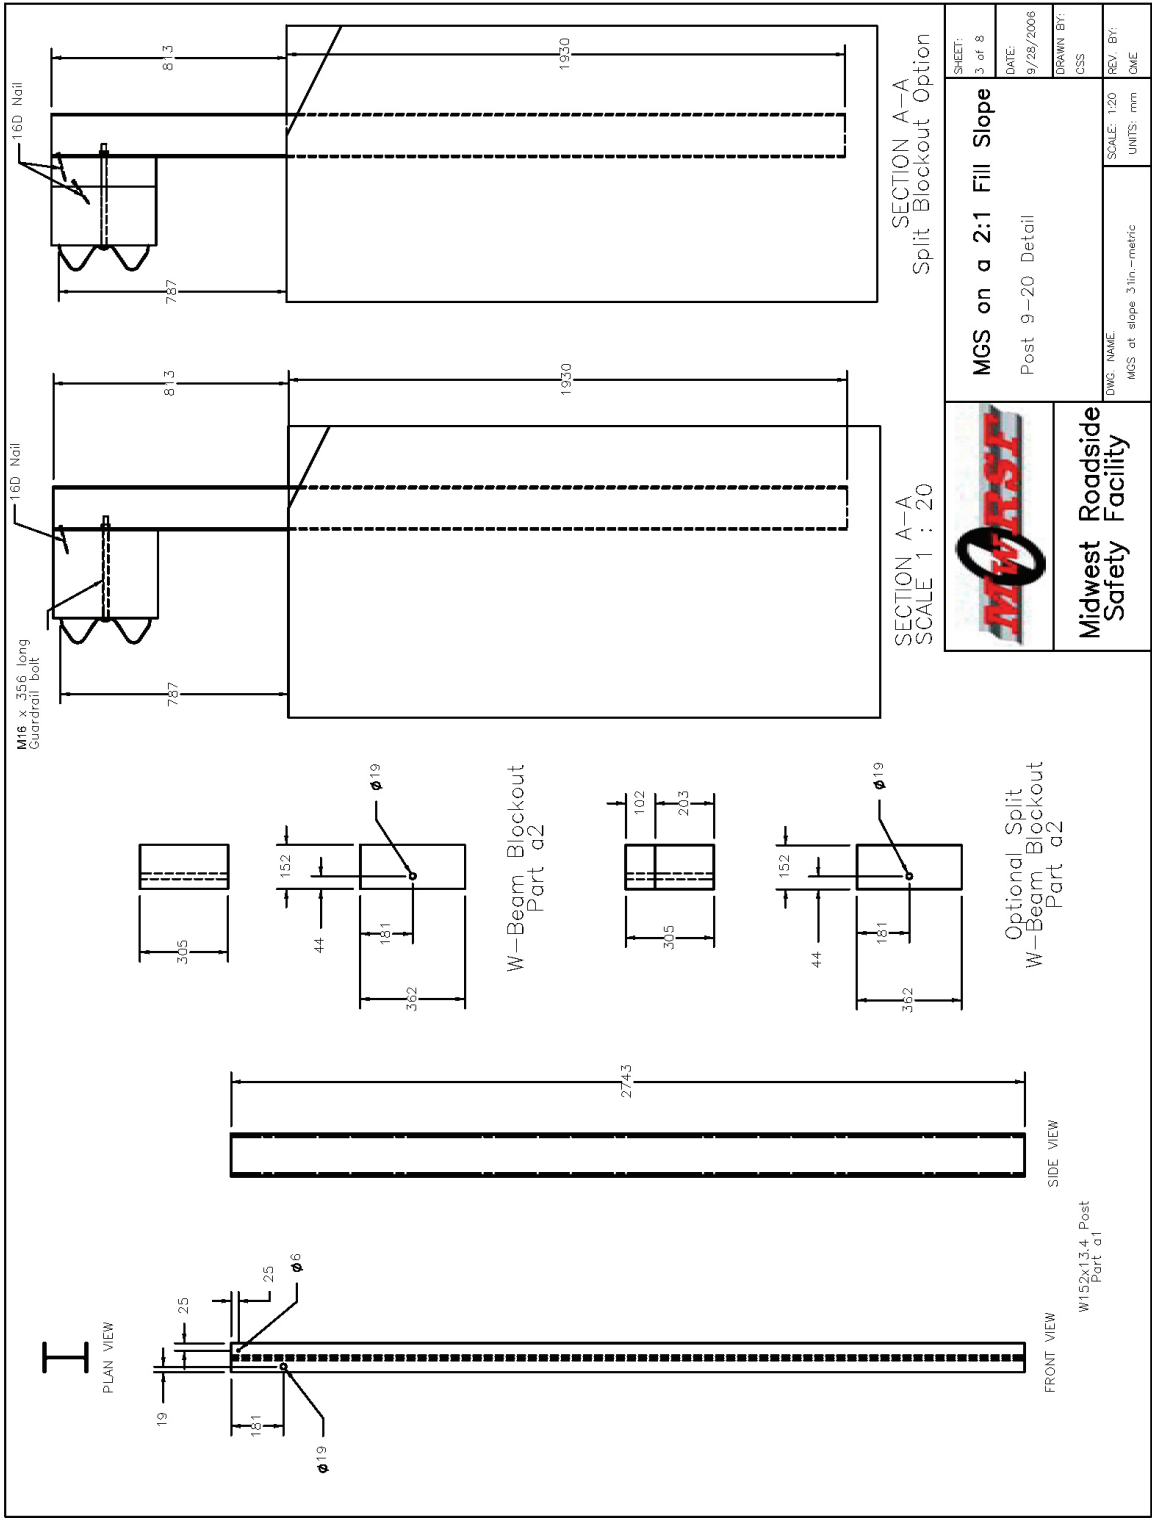
Figure 46. MGS Installed Adjacent to a 2:1 Fill Slope System Modifications, Test No. MGS221-2

Following the unsuccessful performance of the 706-mm (27<sup>3</sup>/<sub>4</sub> in.) high, MGS installed adjacent to a steep slope, it was believed that raising the rail height to 787 mm (31 in.) would allow for improved engagement between the barrier system and the vehicle. Therefore, the second design of the MGS installed adjacent to a 2:1 fill slope system was identical to the system in test no. MGS221-1 except for the guardrail's top mounting height. The first installation's height was set at the design's anticipated minimum height tolerance of 706 mm (27<sup>3</sup>/<sub>4</sub> in.). For the second installation, the top W-beam guardrail height was raised to 787 mm (31 in.) with a 632-mm (24<sup>7</sup>/<sub>8</sub>-in.) center mounting height. Additionally, post nos. 1 through 29 were still spaced 1,905 mm (75 in.) on center but were embedded to a depth of 1,930 mm (76 in.), as shown in Figures 46 and 47.

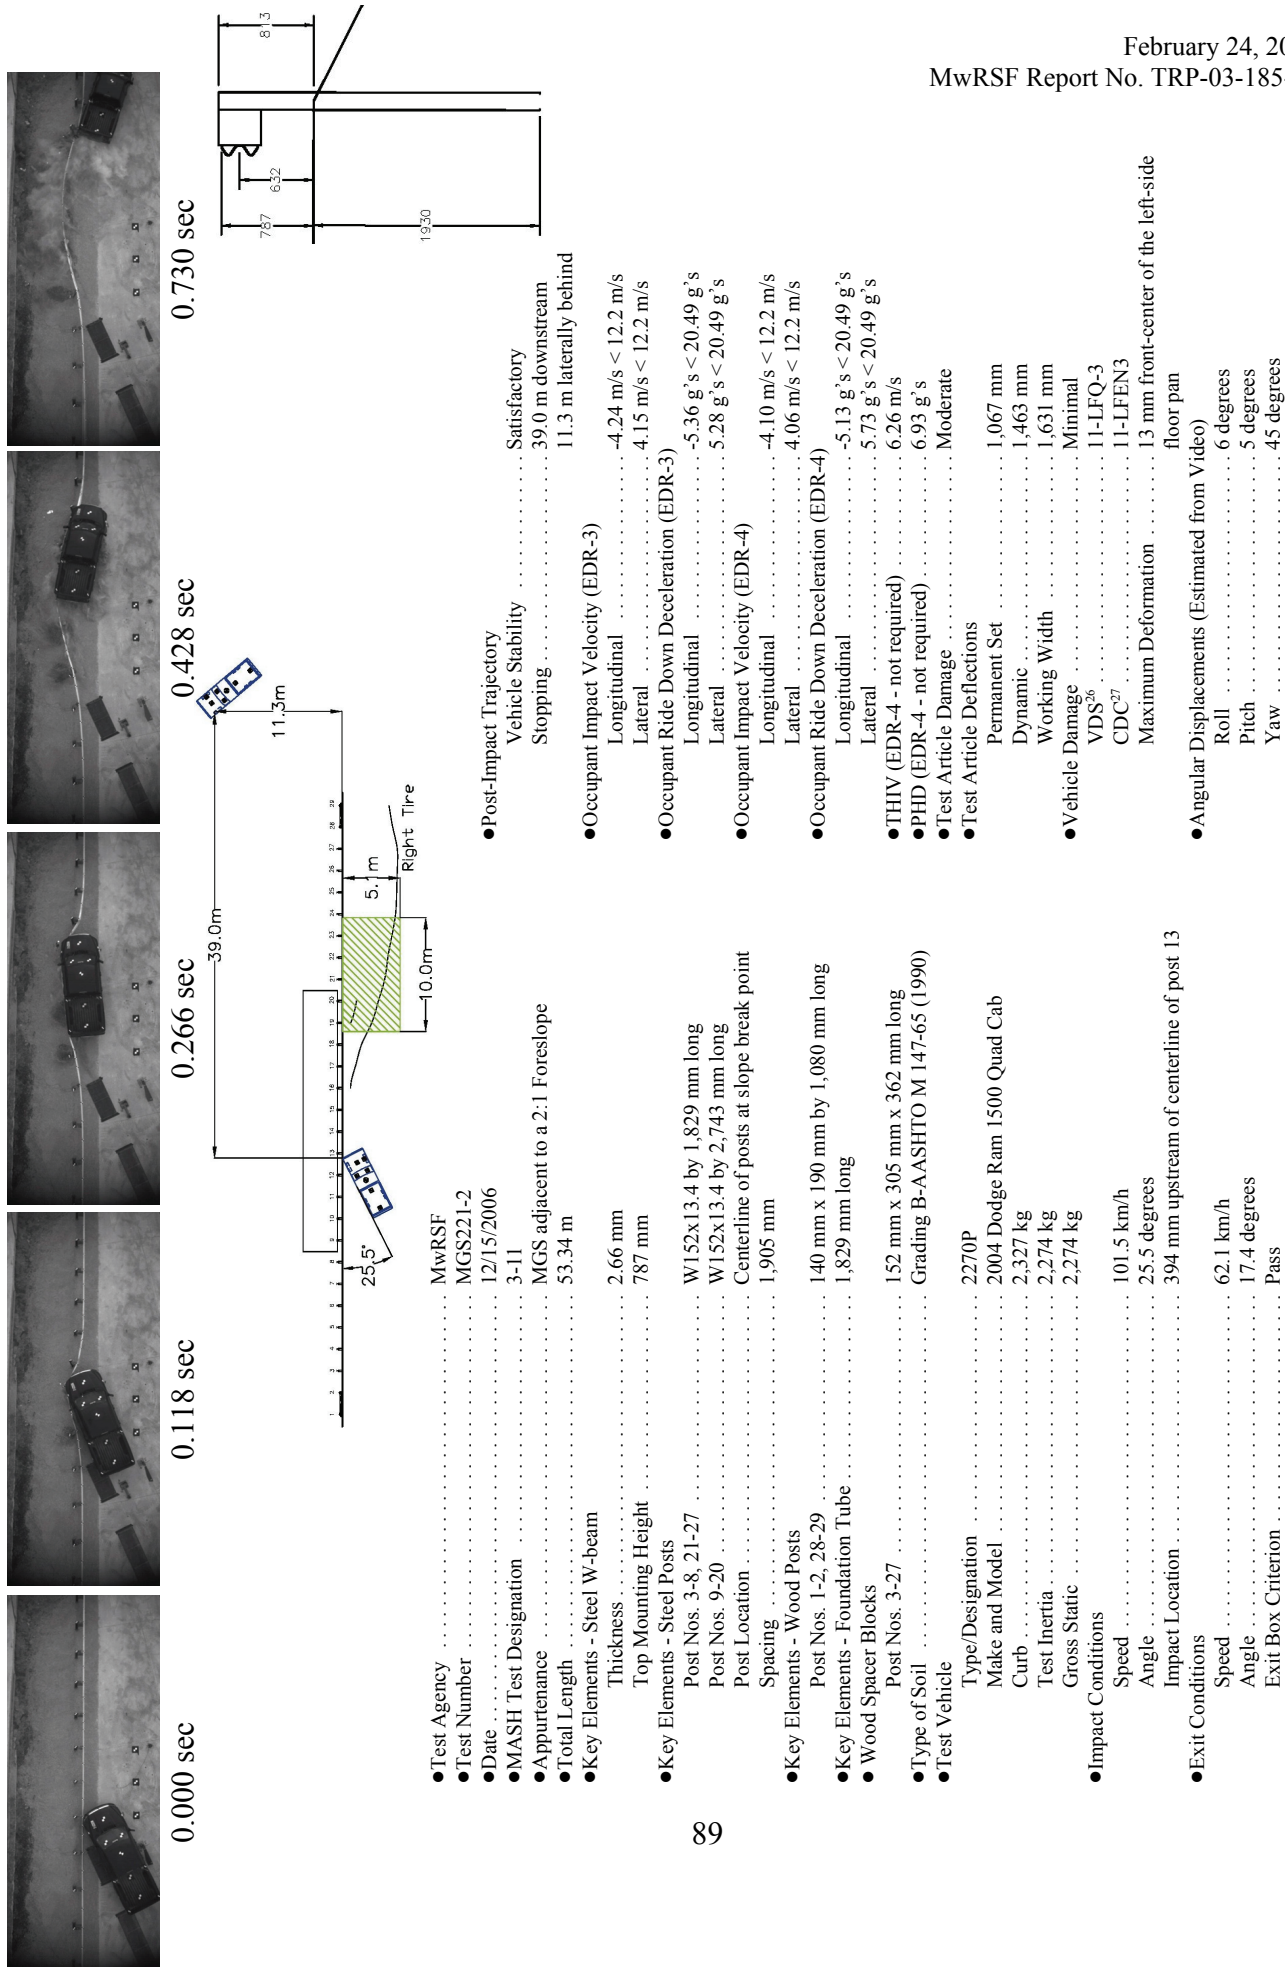
Figure 50. Summary of Test Results and Sequential Photographs, Test No. MGS221-2

The 2,274-kg (5,013-lb) pickup truck impacted the MGS, with a 787-mm (31-in.) top mounting height, installed adjacent to a 2:1 fill slope system at a speed of 101.5 km/h (63.1 mph) and at an angle of 25.5 degrees. A summary of the test results and sequential photographs are shown in Figure 50. A summary of the test results and sequential photographs in English units are shown in Appendix D. Additional sequential photographs are shown in Figures 51 through 54. Documentary photographs of the crash test are shown in Figure 55.

wheel disengaged from the vehicle. At 0.428 sec, the left-front corner of the vehicle was located at post no. 18 as the vehicle continued to redirect out of the system. At 0.552 sec, the left-front corner of the vehicle was no longer in contact with the rail. At 0.726 sec, the vehicle exited the guardrail at a trajectory angle of 17.4 degrees and a resultant velocity of 62.1 km/h (38.6 mph). The vehicle continued to travel downstream away from the system until it was redirected behind the end of the system. The vehicle came to rest 39.0 m (127 ft - 11½ in.) downstream from impact and 11.3 m (37 ft) laterally behind the traffic-side face of the rail. The trajectory and final position of the vehicle are shown in Figures 50 and 57.

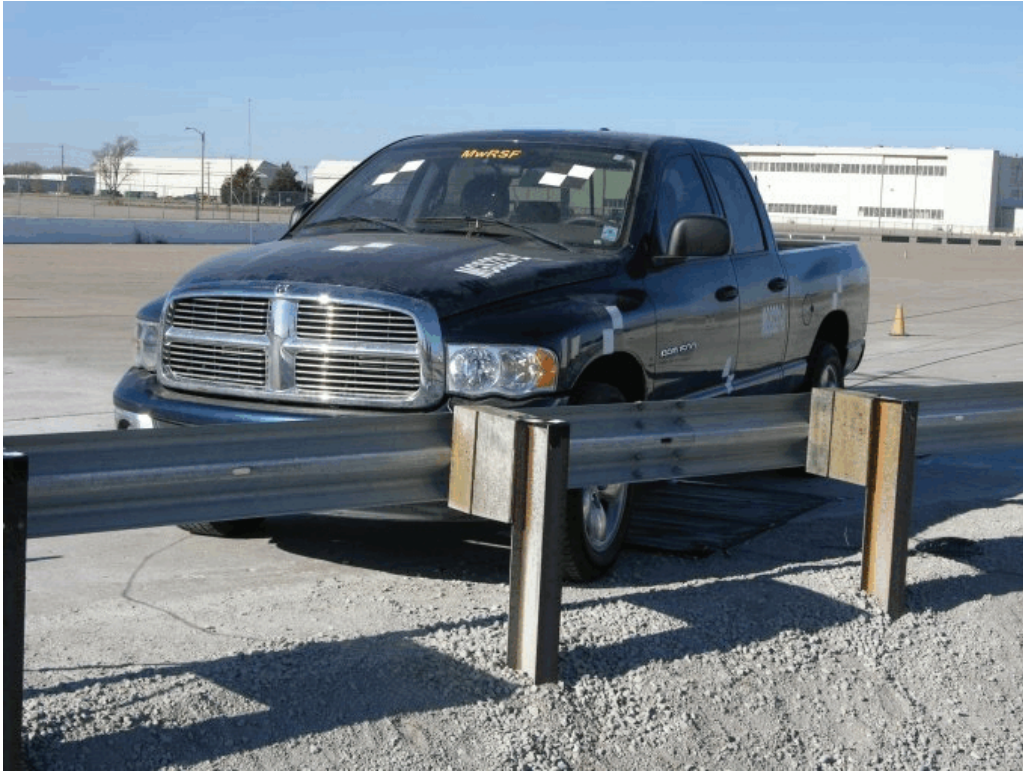
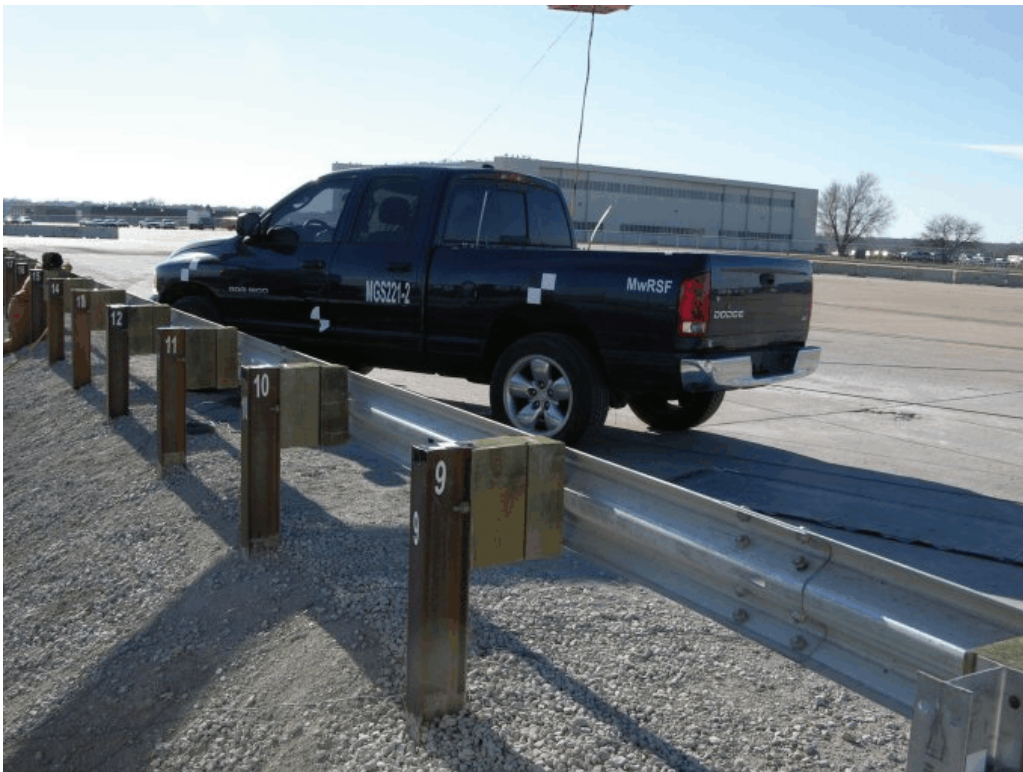
Figure 56. Impact Location, Test No. MGS221-2

Initial vehicle impact was to occur 476 mm (18¾ in.) upstream from the centerline of post no. 13, as shown in Figure 56. Actual vehicle impact occurred 394 mm (15½ in.) upstream from the centerline of post no. 13. At 0.014 sec after impact, post no. 13 deflected. At 0.022 sec, post no. 12 twisted downstream, and the left-front corner of the vehicle crushed inward toward the engine compartment. At this same time, post no. 14 deflected. At 0.030 sec, the soil heaved behind post no. 13. At 0.044 sec, post nos. 14 through 19 twisted downstream. At 0.050 sec, the rail buckled upstream of post no. 5, and the soil heaved behind post no. 14. At 0.076 sec, the left-front tire protruded past the slope break point, and post no. 15 deflected. At this same time, the rail buckled downstream of post no. 15. At 0.084 sec, the left corner of the front bumper was located at post no. 14. At this same time, the left-front corner of the vehicle crushed inward, and the left-side headlight fractured. At 0.090 sec, the rail released from post no. 14 as the post deflected. At this same time, the soil heaved behind post no. 15. At 0.112 sec, the rail buckled at post no. 16. At 0.126 sec, the vehicle began to redirect. At 0.150 sec, the rail released from post no. 15 as the vehicle traversed over it. At this same time, the left-front wheel deformed due to contact with post no. 14. At 0.166 sec, the rail released from post nos. 10 and 11. At 0.208 sec, the deformed left-front wheel contacted post no. 15. At 0.220 sec, the entire left side of the vehicle was in contact with the rail, and both left-side tires protruded past the slope break point. At 0.236 sec, the rail released from post no. 16. At 0.266 sec, post no. 17 deflected. At 0.298 sec, the left-front tire contacted post no. 16. At 0.306 sec, the vehicle became parallel to the system with a resultant velocity of 68.1 km/h (42.3 mph). At 0.322 sec, the left-front corner of the vehicle contacted post no. 17 as the vehicle redirected away from the system. At this same time, the left-rear tire was airborne above the slope. At 0.330 sec, the left-front

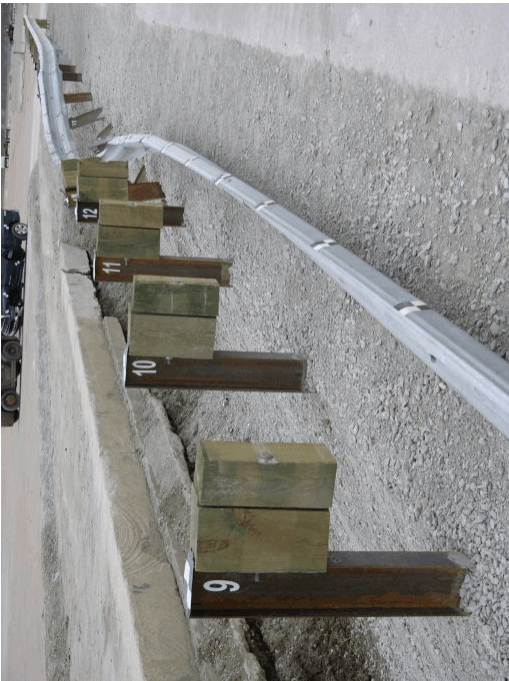
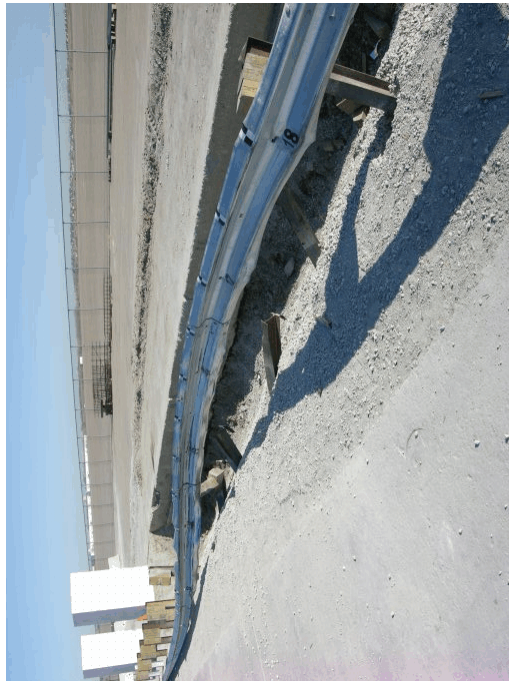
Figure 58. System Damage, Test No. MGS221-2

Damage to the barrier was moderate, as shown in Figures 58 through 64. Barrier damage consisted of deformed W-beam and guardrail posts, disengaged wooden blockouts, and contact marks on a guardrail section and posts. The length of the vehicle contact along the MGS system was approximately 12.42 m (40 ft - 9 in.), which spanned from 394 mm (15½ in.) upstream of the centerline of post no. 13 through 597 mm (23½ in.) downstream from the centerline of post no. 19.

The permanent set of the barrier system is shown in Figure 58. The maximum lateral permanent set rail and post deflections were 1,067 mm (42 in.) at the midspan between post nos. 15 and 16 and 864 mm (34 in.) at post no. 14, respectively, as measured in the field. The maximum lateral dynamic rail and post deflections were 1,463 mm (57.6 in.) at the centerline of post no. 15 and 805 mm (31.7 in.) at post no. 14, respectively, as determined from high-speed digital video analysis. The working width of the system was found to be 1,631 mm (64.2 in.).
