EVALUATION OF CRITICAL FLARE RATES FOR THE MIDWEST GUARDRAIL SYSTEM (MGS)

MIDWEST ROADSIDE SAFETY FACILITY

MwRSF Research Report No. TRP-03-191-08

July 15, 2008

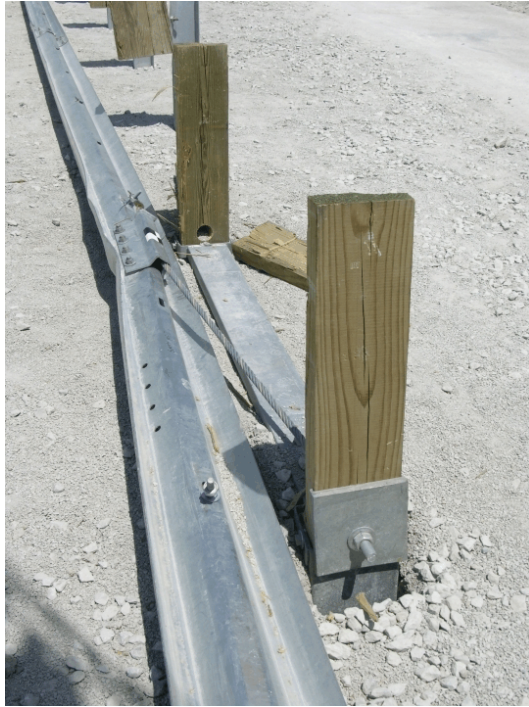
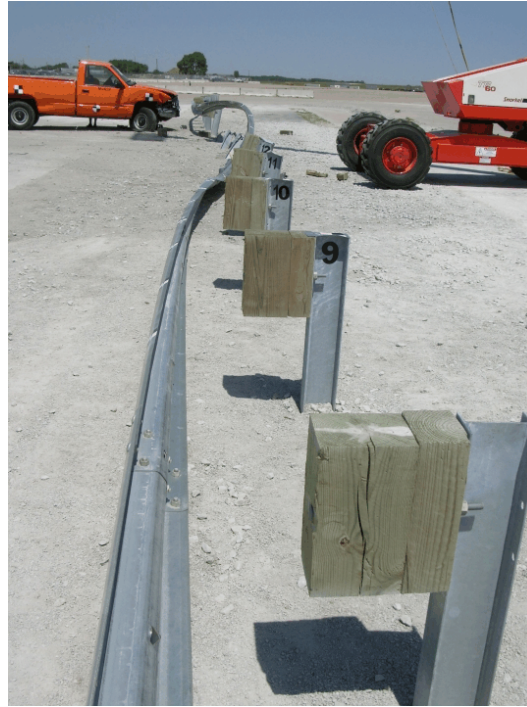
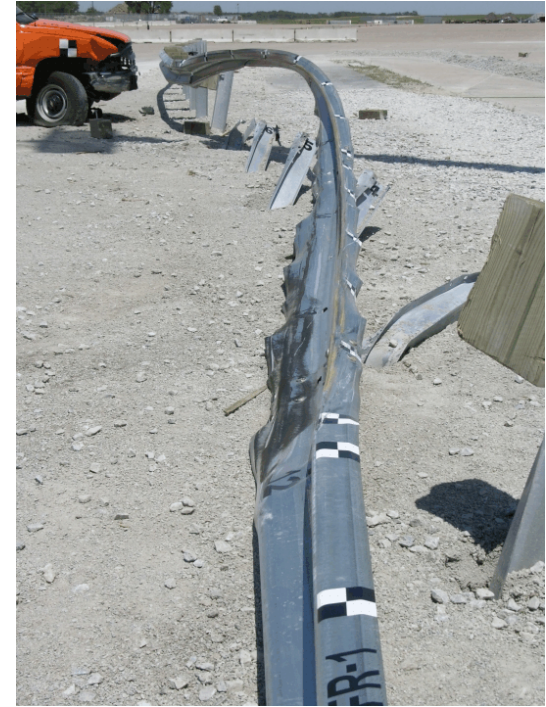
Figure 39. System Damage, Test FR-1

Barrier damage was moderate, as shown in Figures 39 through 44. Barrier damaged consisted of deformed guardrail posts, deformed W-beam rail, deformed and disengaged blockouts, and contact marks on a guardrail section. The length of vehicle contact along the system was approximately 11.4 m (37 ft - 6 in.), which spanned from the centerline of post no. 12 through the centerline of post no. 18.

The permanent set of the barrier system is shown in Figure 39. The maximum lateral permanent set rail and post deflections were 1,140 mm (44.875 in.) at the midspan between post nos. 15 and 16 and 813 mm (32 in.) at the centerline of post no. 13, respectively, as measured in the field. The maximum lateral dynamic rail and post deflections were 1,684 mm (66.3 in.) at the centerline of post no. 15 and 853 mm (33.6 in.) at the centerline of post no. 13, respectively, as determined from high-speed video analysis. The working width of the system was found to be 1,794 mm (70.6 in.).

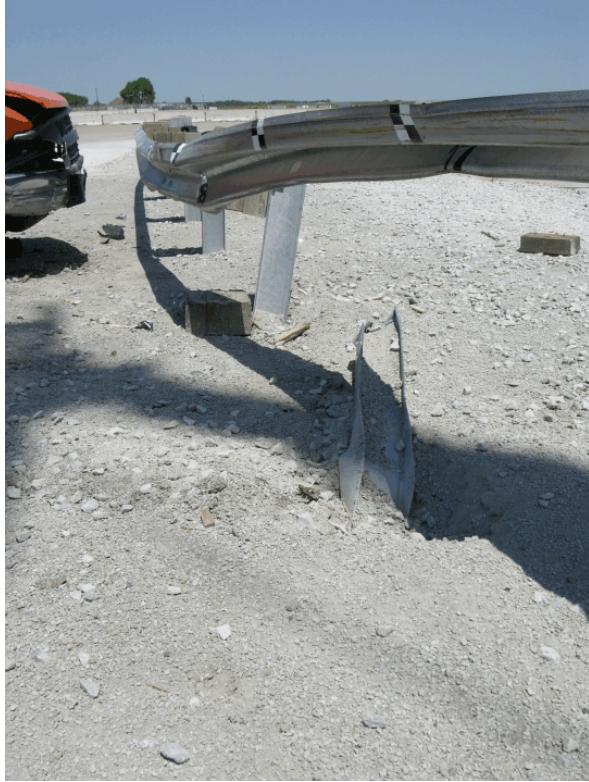
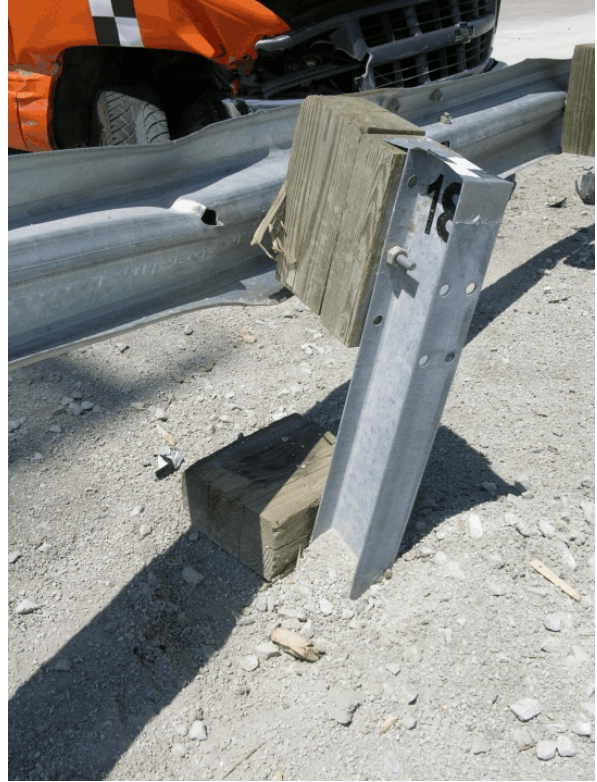
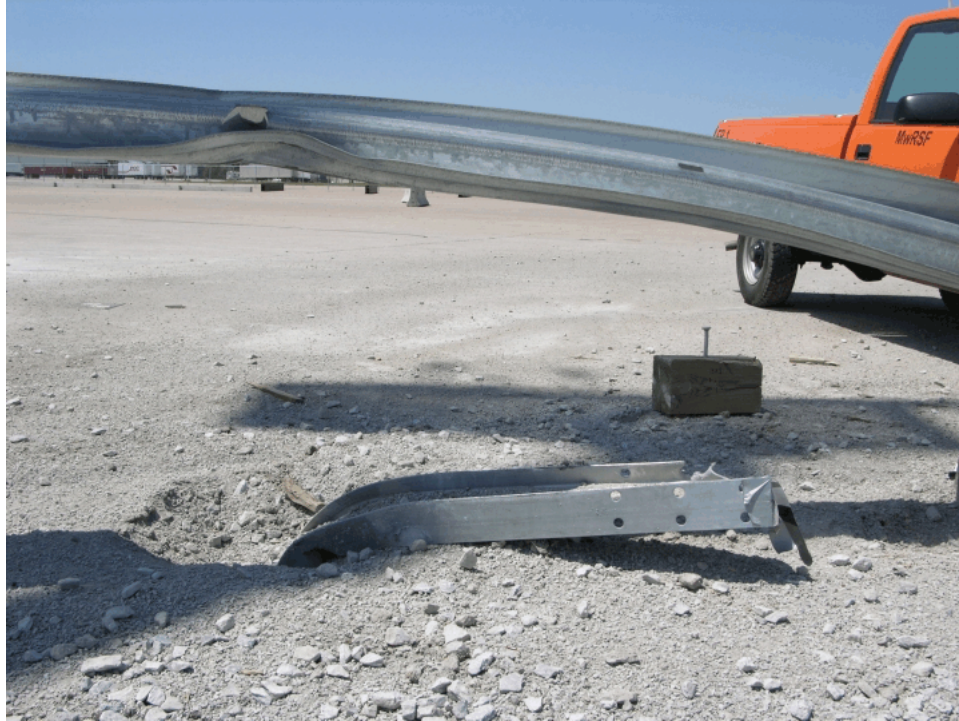
Figure 44. Post Nos. 17 and 18 Damage, Test FR-1

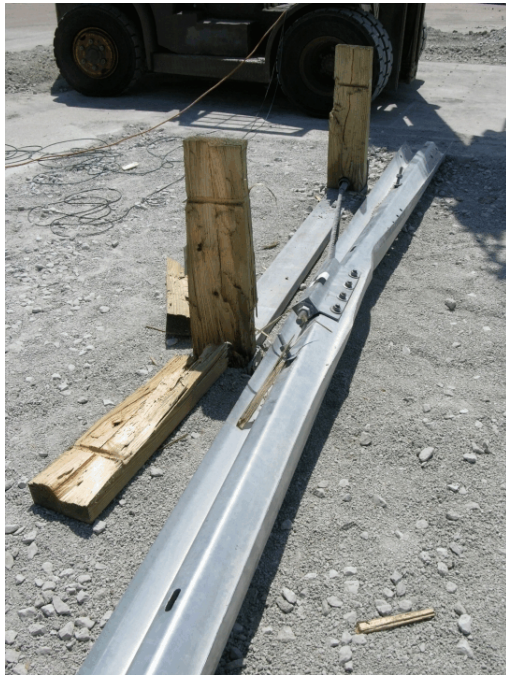
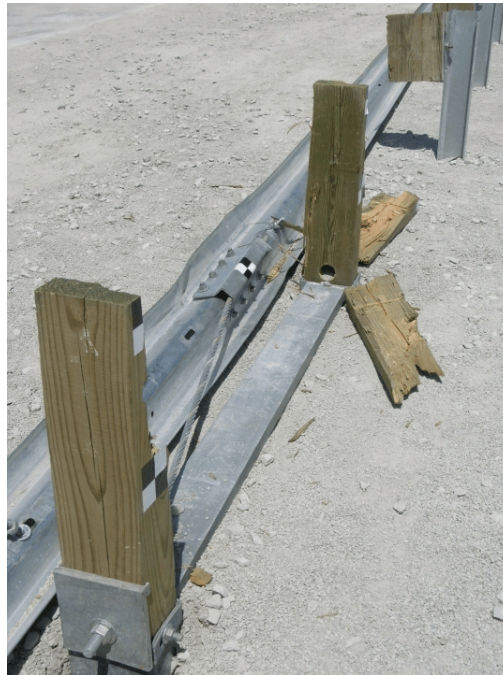
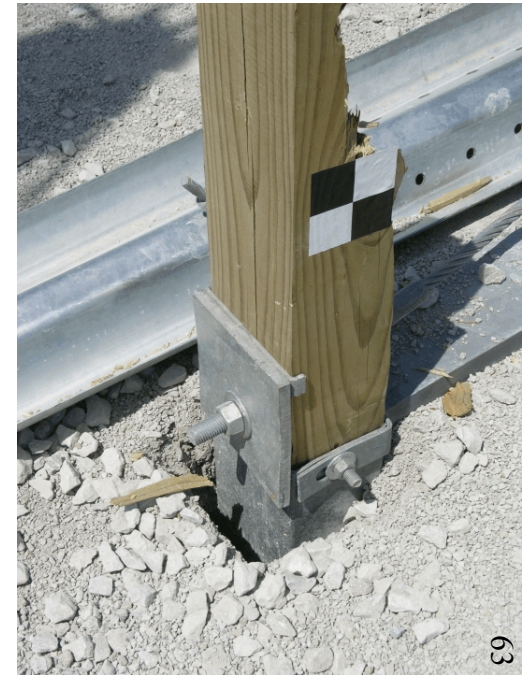
Figure 45. Upstream Anchorage Damage, Test FR-1

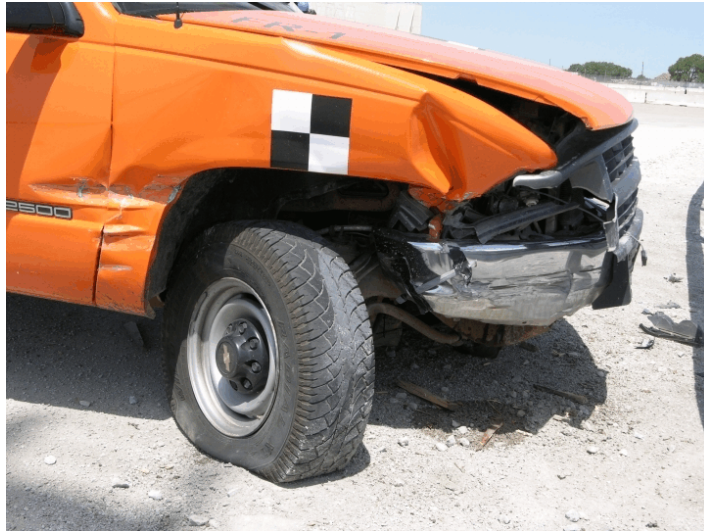
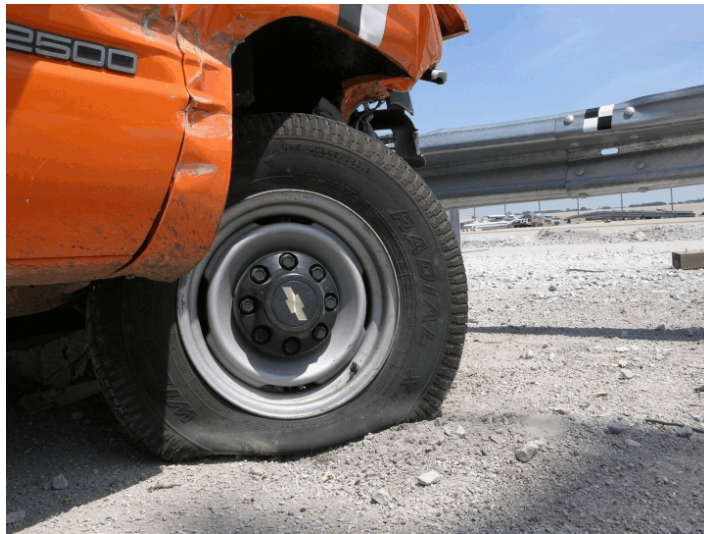
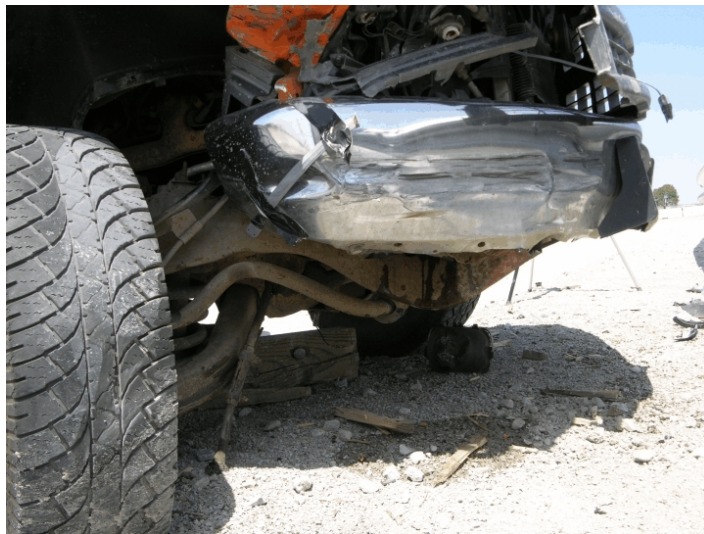
Exterior vehicle damage was moderate, as shown in Figures 46 through 49. Occupant compartment deformations to the right side and center of the floorboard were judged insufficient to cause serious injury to the vehicle occupants. Maximum longitudinal deflections of 6 mm (0.25 in.) were located near the front and left sides of the right-side floorpan. Maximum lateral deflections of 13 mm (0.5 in.) were located near the center of the right-side floorpan. Maximum vertical deflections of 19 mm (0.75 in.) were located near the right side of the right-side floorpan. Complete occupant compartment deformations and the corresponding locations are provided in Appendix C.

Figure 47. Vehicle Damage, Test FR-1

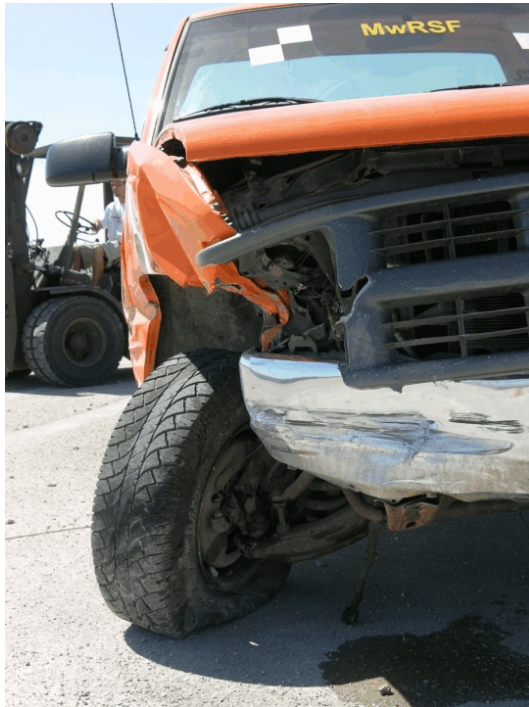
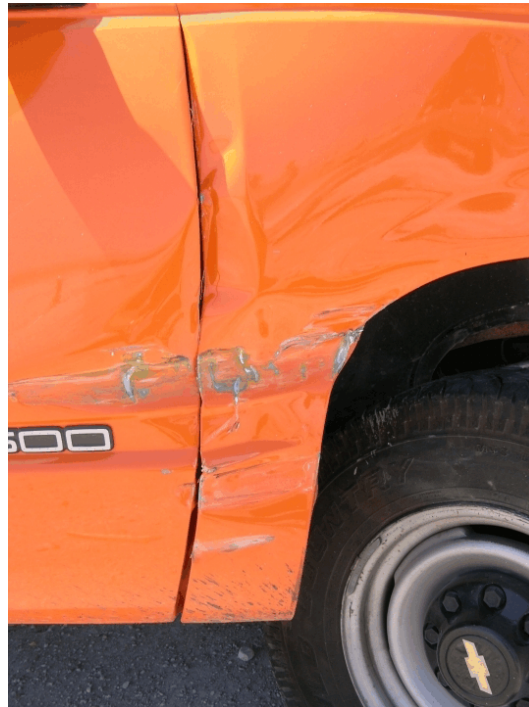
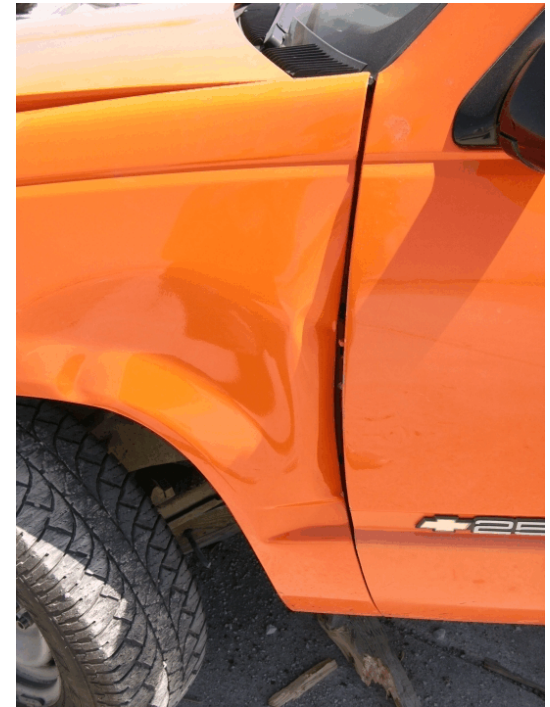
Figure 48. Vehicle Damage, Test FR-1

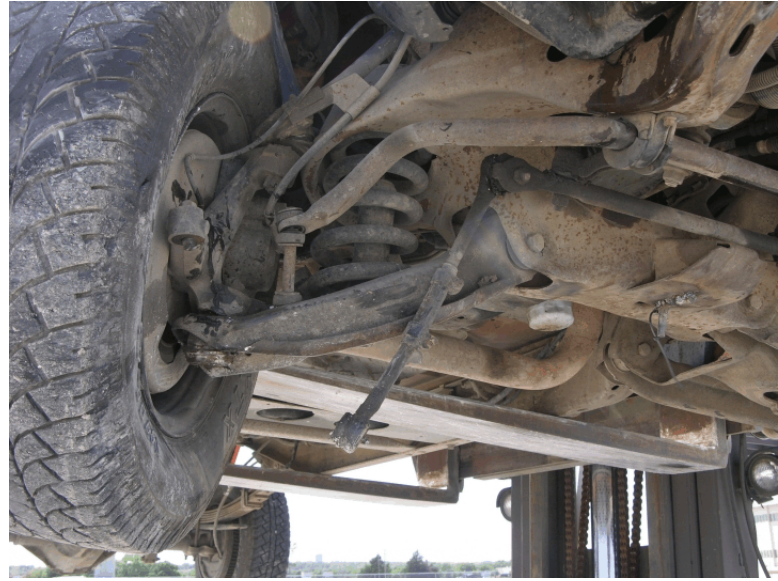
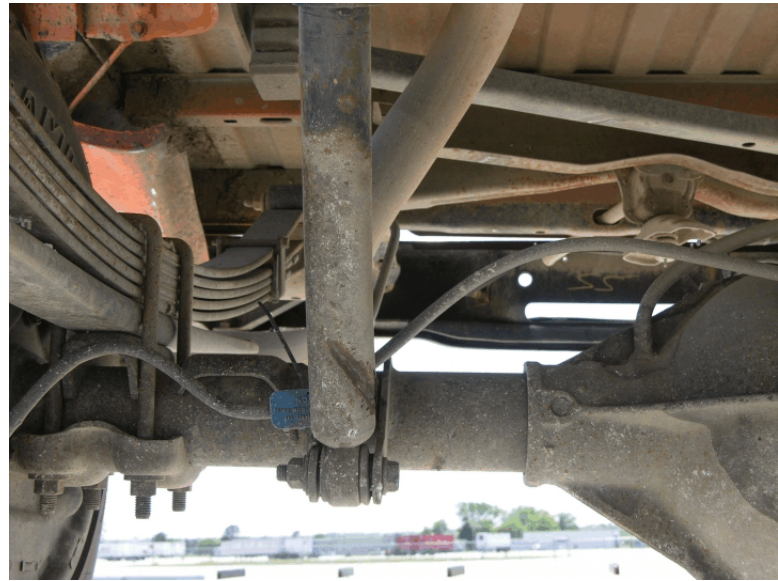
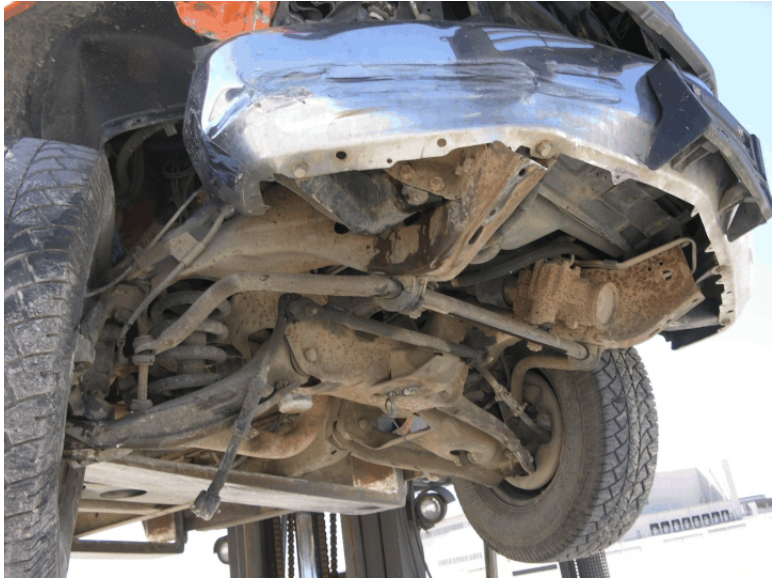
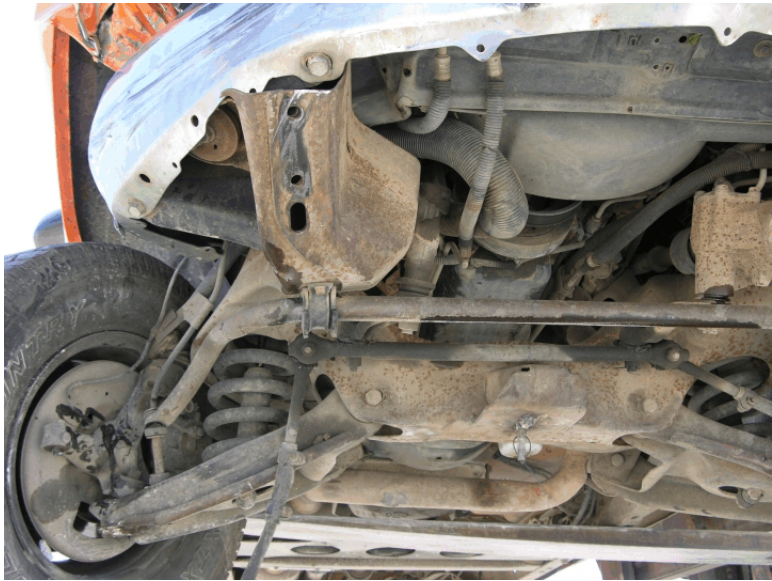
Figure 49. Vehicle Undercarriage Damage, Test FR-1

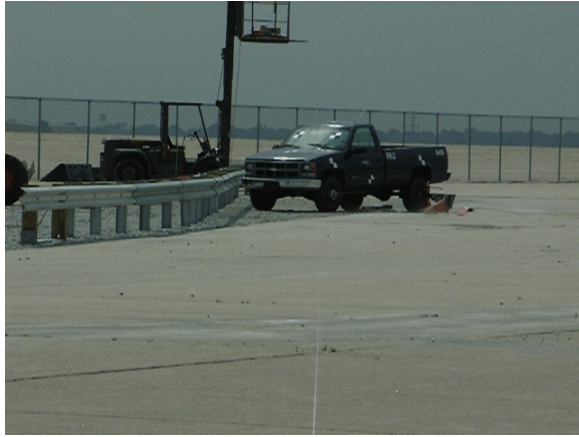
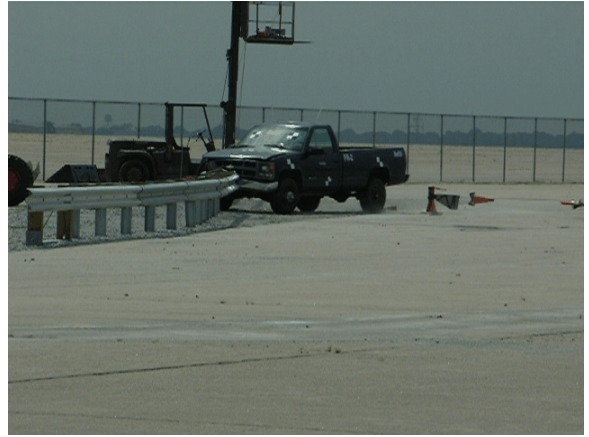
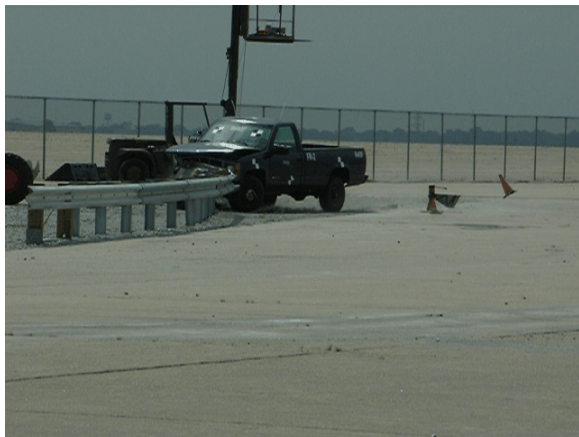
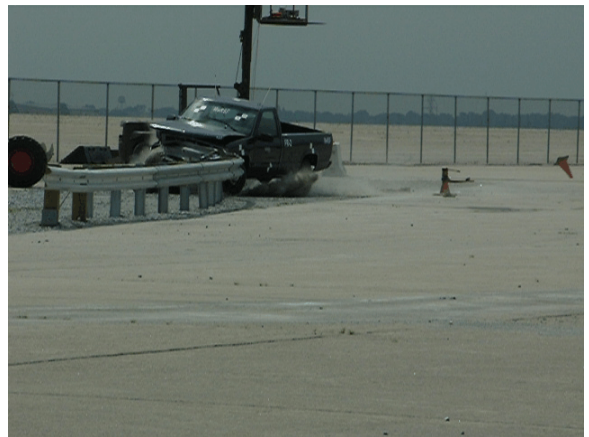
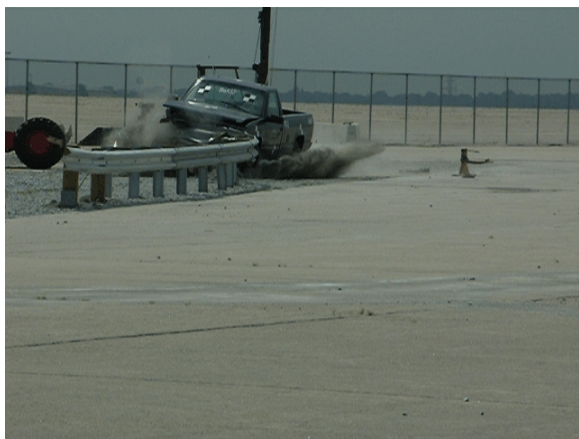
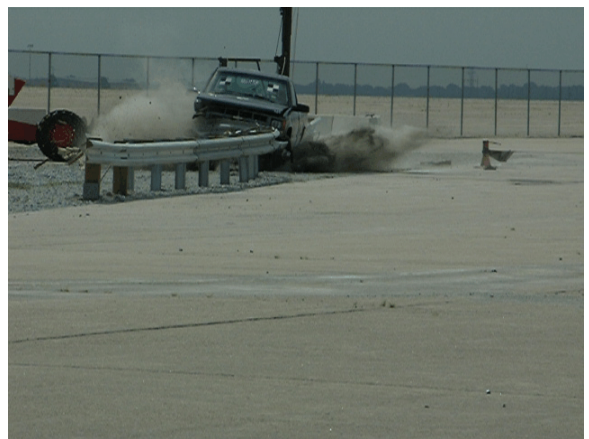
Figure 57. Documentary Photographs, Test FR-2

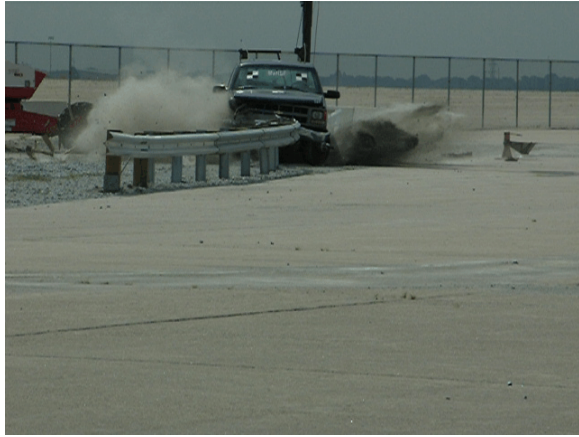
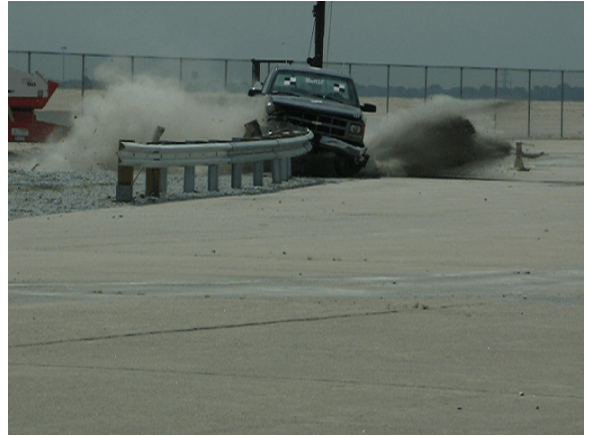
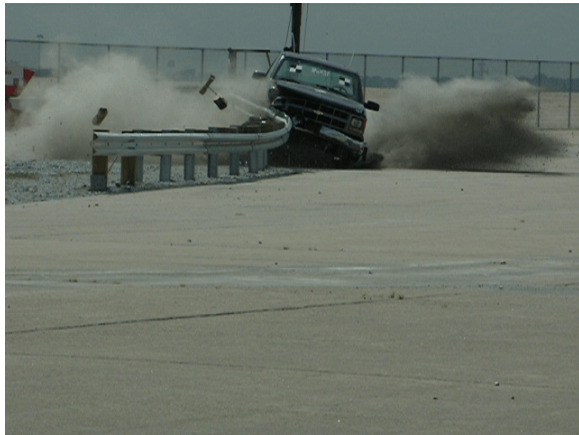
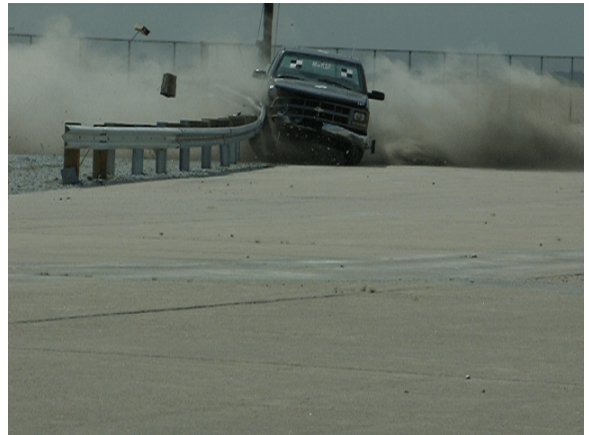
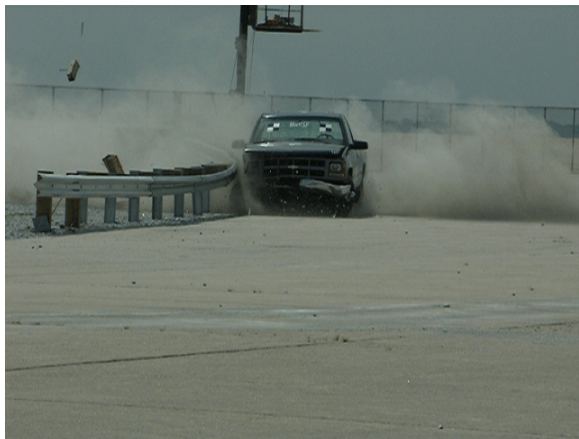
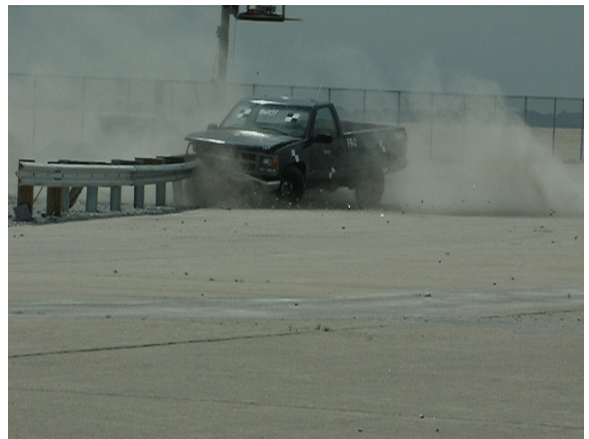
Figure 58. Documentary Photographs, Test FR-2

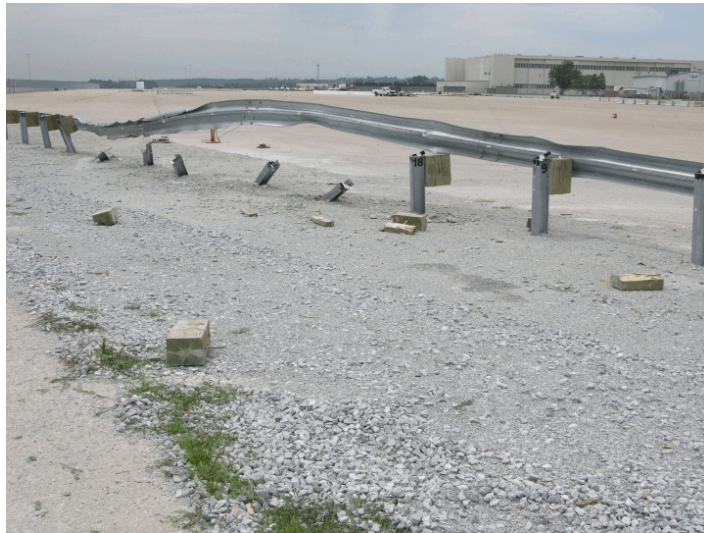
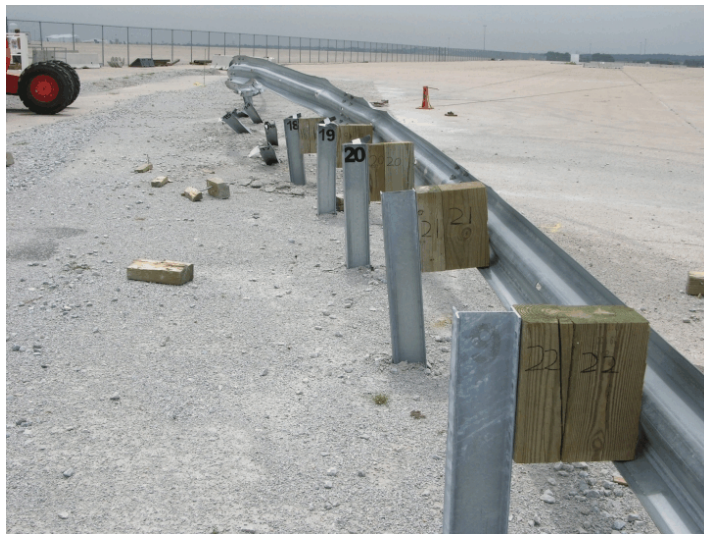
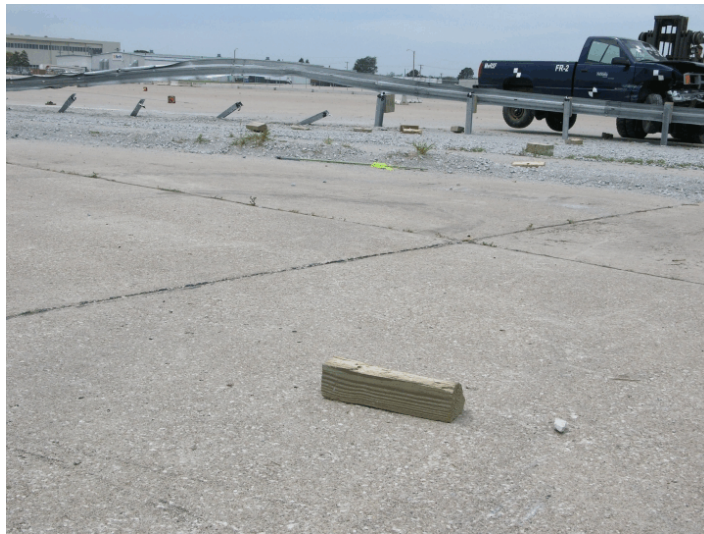
Figure 61. System Damage, Test FR-2

Damage to the barrier system was moderate, as shown in Figures 61 through 69. Barrier damage consisted of deformed guardrail posts, deformed W-beam rail, deformed and disengaged blockouts, and contact marks on a guardrail section. The length of vehicle contact along the system was approximately 16.3 m (53 ft - 6.75 in.), which spanned from 451 mm (17.75 in.) upstream from the centerline of post no. 12 through 635 mm (25 in.) downstream from the centerline of post no. 20.

The permanent set of the barrier system is shown in Figures 61 and 62. The maximum lateral permanent set rail and post deflections were 1,156 mm (45.5 in.) at the midspan between post nos.

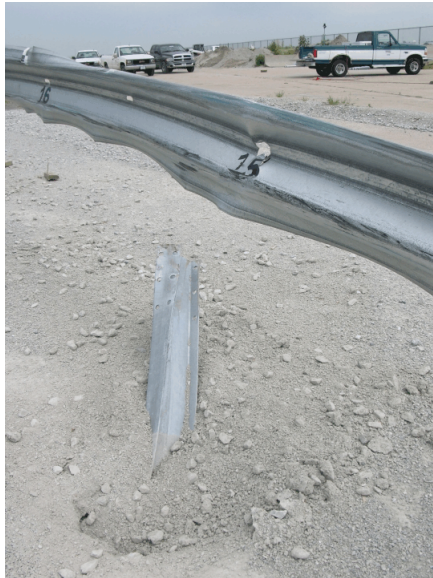
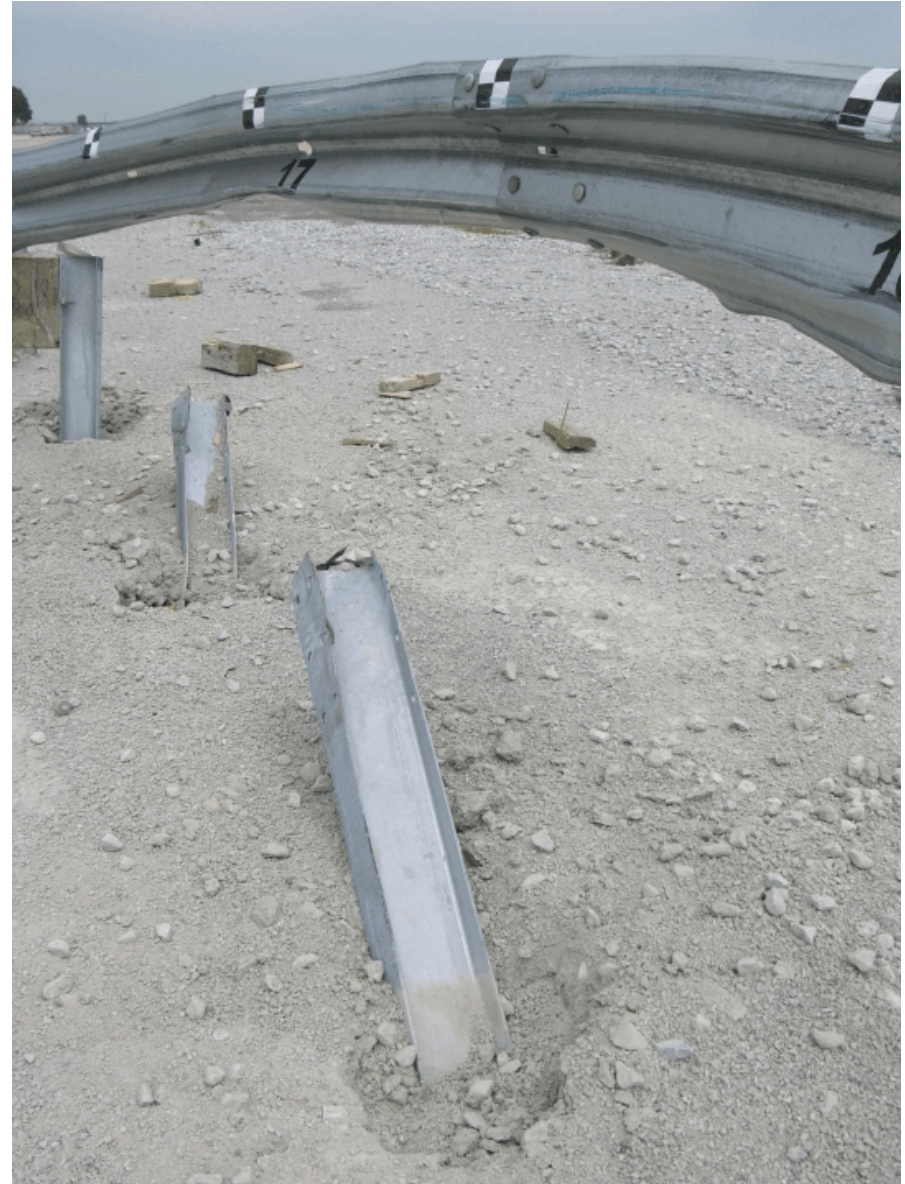
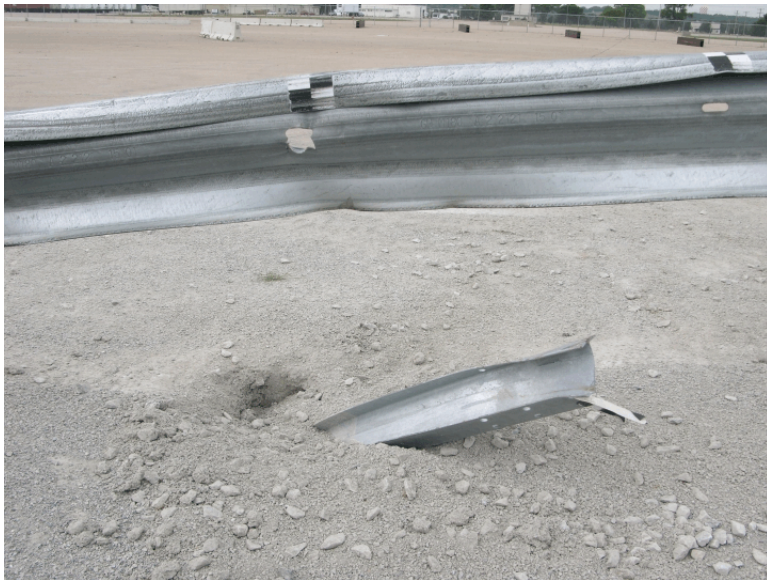
Figure 67. Post Nos. 15 and 16 Damage, Test FR-2

Initial impact was to occur between post nos. 11 and 12, or 5.24 m (17 ft - 2.25 in.) upstream from the centerline of the splice between post nos. 14 and 15, as shown in Figure 59. Actual vehicle impact occurred 5.21 m (17 ft - 1 in.) upstream from the centerline of the splice between post nos. 14 and 15. Immediately following impact, the front bumper and the rail deformed. At 0.010 sec, post no. 12 deflected backward. At 0.018 sec, post no. 13 deflected, and a gap formed between the vehicle's hood and body. At 0.042 sec, post nos. 3 through 11 twisted clockwise towards impact, and post no. 14 deflected slightly. At 0.078 sec, the vehicle contacted the blockout and traffic-side flange of post no. 13. At 0.086 sec, cracks propagated throughout the blockout at post no. 13. At 0.100 sec, the blockout at post no. 13 disengaged from the system. At 0.122 sec, post no. 14 twisted counter-clockwise, and post no. 13 contacted the ground. At 0.132 sec, post no. 16 deflected backwards. At 0.150 sec, the vehicle contacted the blockout on post no. 14, and the vehicle's right-front tire protruded under the rail. At 0.182 sec, post no. 17 deflected backwards, and the hood rose slightly. At 0.216 sec, the blockout at post no. 15 disengaged from the rail. At 0.242 sec, the vehicle

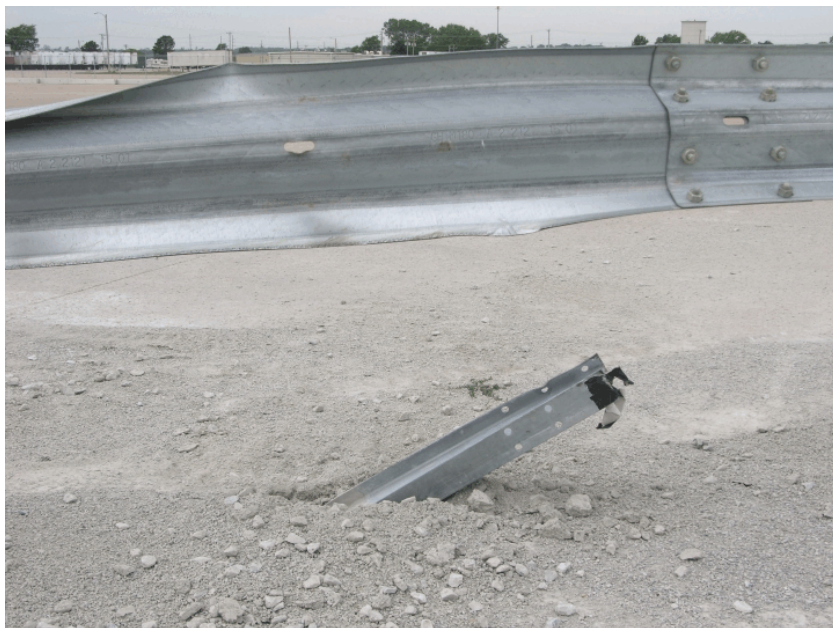
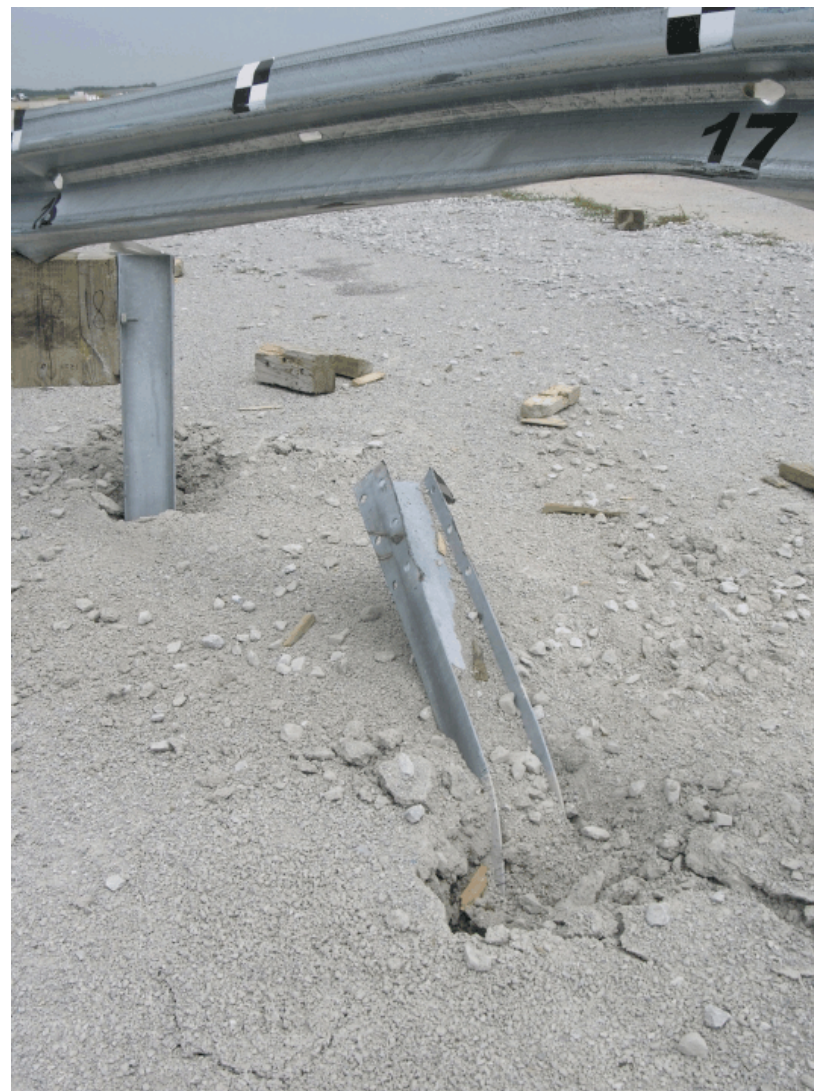
Figure 68. Post No. 17 Damage, Test FR-2

contacted the traffic-side flange of post no. 15. At 0.262 sec, the blockout at post no. 16 disengaged from the system, and the right-rear tire became airborne. At 0.286 sec, post no. 17 twisted counter-clockwise toward the vehicle as the rear of the vehicle pitched downward. At 0.302 sec, the right-rear corner of the vehicle contacted the guardrail. At 0.364 sec, the vehicle contacted the upstream edge of the traffic-side flange of post no. 16. At 0.392 sec, the rail disengaged from the blockout at post no. 17 and twisted. At 0.478 sec, the vehicle became parallel to the system with a resultant velocity of 41.4 km/h (25.7 mph). At this same time, the vehicle contacted post no. 17. At 0.490 sec, the right-rear corner of the vehicle rode on top of the guardrail section. At 0.562 sec, post nos. 8 through 10 ceased twisting as the rail rebounded. At 0.960 sec, the vehicle yawed while in contact with post no. 18. At 1.360 sec, the vehicle exited the system with a resultant velocity of 23.2 km/h (14.4 mph) and at an angle of 8.7 degrees relative to the tangent section. At 2.410 sec, the vehicle came to rest in contact with the “knee joint” between the flare and the tangent guardrail sections. The vehicle came to rest 16.9 m (55 ft - 4 in.) downstream from impact and 2.5 m (8 ft - 2 in.) laterally away from the traffic-side face of the tangent rail. The trajectory and final position of the pickup truck are shown in Figure 60.

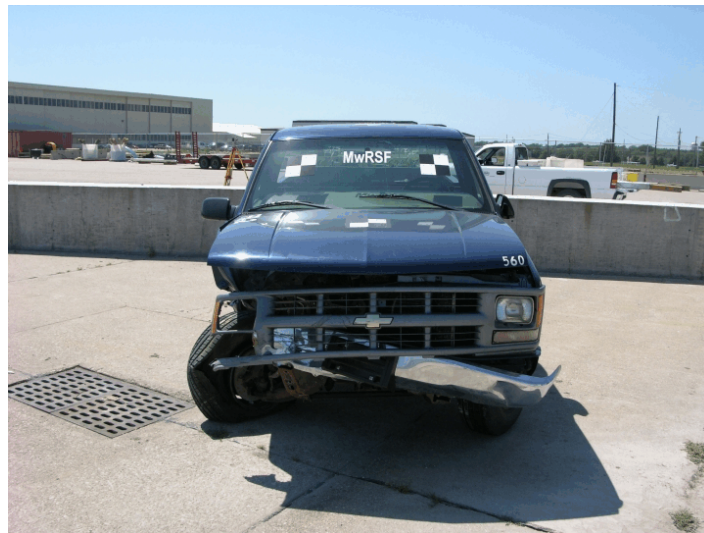
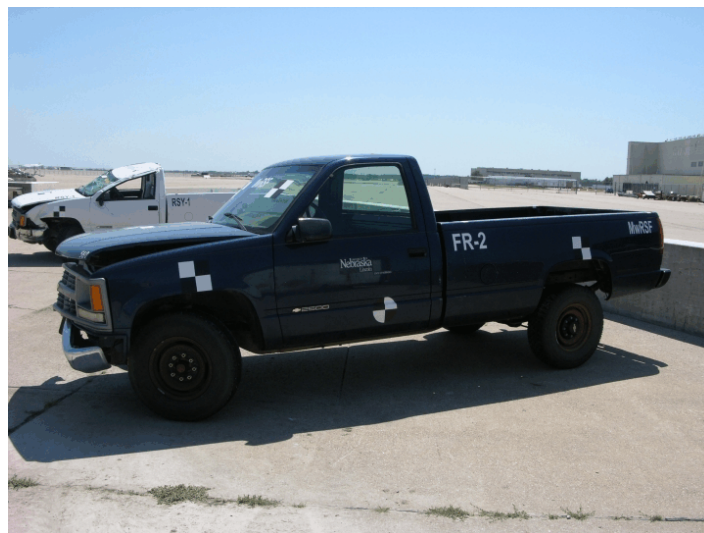
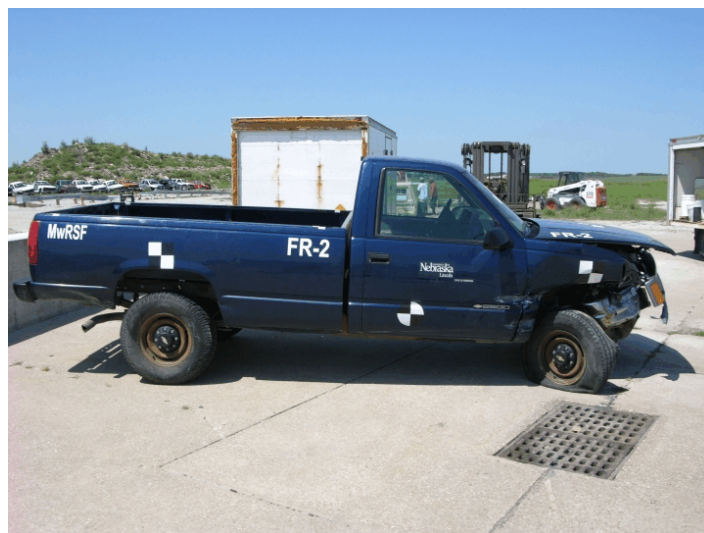
Figure 71. Vehicle Damage, Test FR-2

Exterior vehicle damage was moderate, as shown in Figures 71 through 74. Occupant compartment deformations to the right side and center of the floorboard were judged insufficient to cause serious injury to the vehicle occupants. Maximum longitudinal deflections of 6 mm (0.25 in.) were located along the left side of the right-side floorpan. Maximum lateral deflections of 13 mm (0.5 in.) were located near the left-front corner of the right-side floorpan. Maximum vertical deflections of 6 mm (0.25 in.) were located near the center of the right-side floorpan. Complete occupant compartment deformations and the corresponding locations are provided in Appendix F.

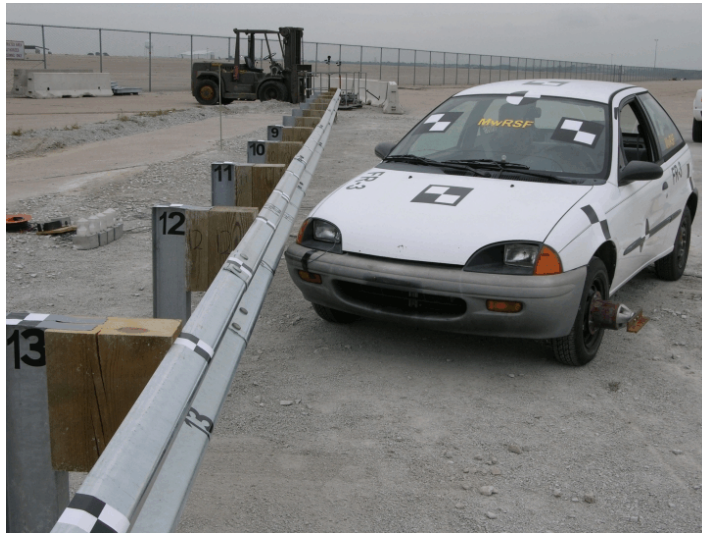
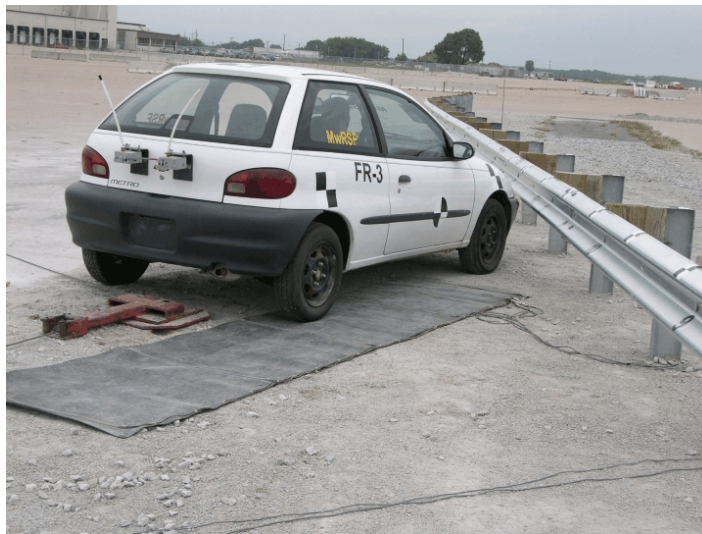
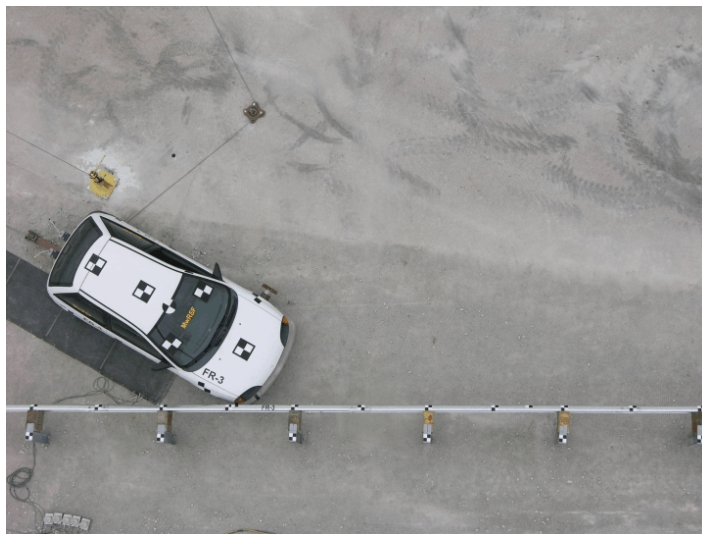
Figure 81. Impact Location, Test FR-3

Initial impact was to occur between post nos. 11 and 12, or 1.80 m (5 ft - 10.8125 in.) upstream from the centerline of the splice between post nos. 12 and 13, as shown in Figure 81. Actual vehicle impact occurred 1.80 m (5 ft - 10.9375 in.) upstream from the centerline of the splice between post nos. 12 and 13. Immediately following impact, the front quarter panel deformed and crushed inward toward the engine compartment. At 0.010 sec, the right-front corner of the bumper protruded under the rail, deforming the rail upward. At 0.016 sec, the right-front corner of the bumper contacted the bottom edge of the blockout at post no. 12. At 0.020 sec, post nos. 11 and 12 rotated backward and the rail deformed around the vehicle. At 0.024 sec, post no. 12 twisted clockwise, and the right-front corner of the vehicle's bumper contacted the traffic-side face of post no. 12. At 0.034 sec, the vehicle's hood deformed upward, and post no. 13 deflected. At 0.044 sec, the hood deformed toward the windshield, the right-front tire contacted the upstream edge of the traffic-side face of post no. 12, and the blockout at post no. 12 twisted. At 0.068 sec, the blockout at post no. 12 split vertically. At this same time, the right-front tire was located at the splice between

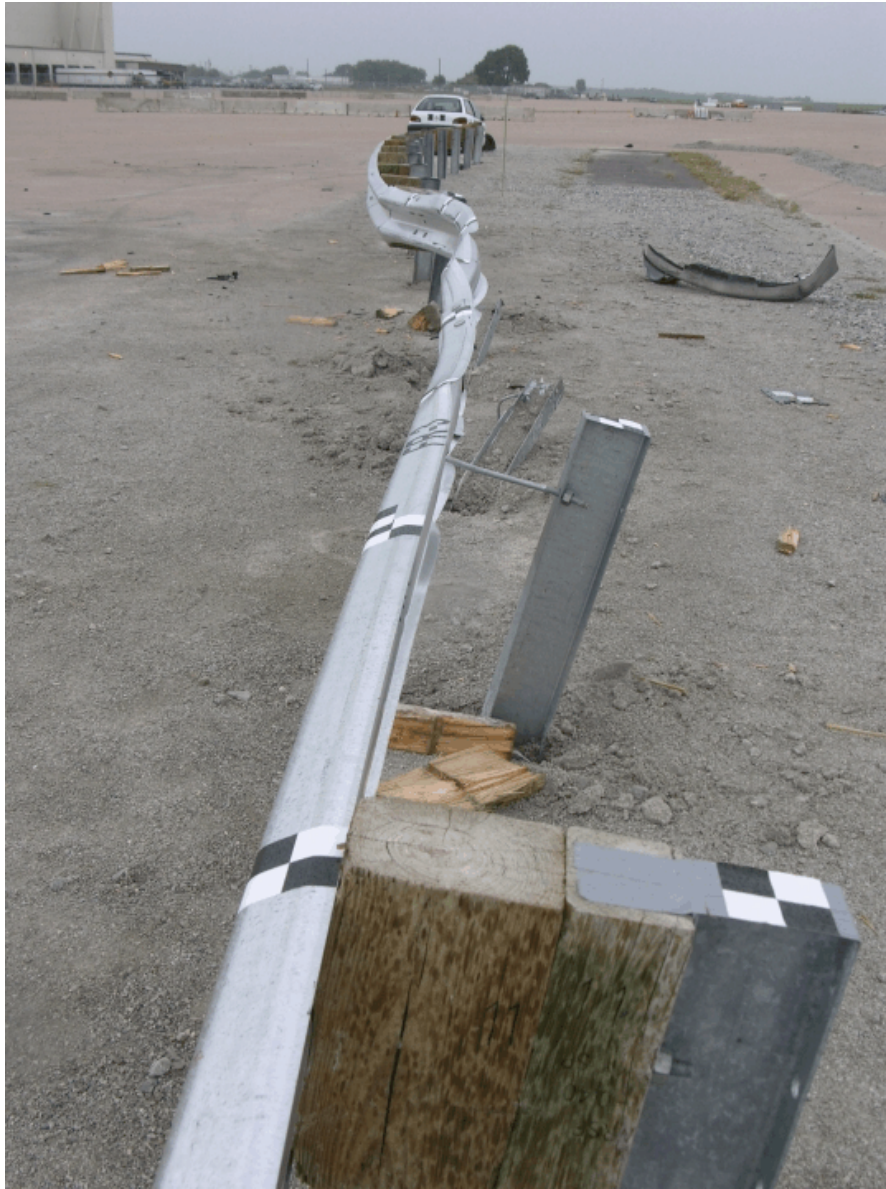
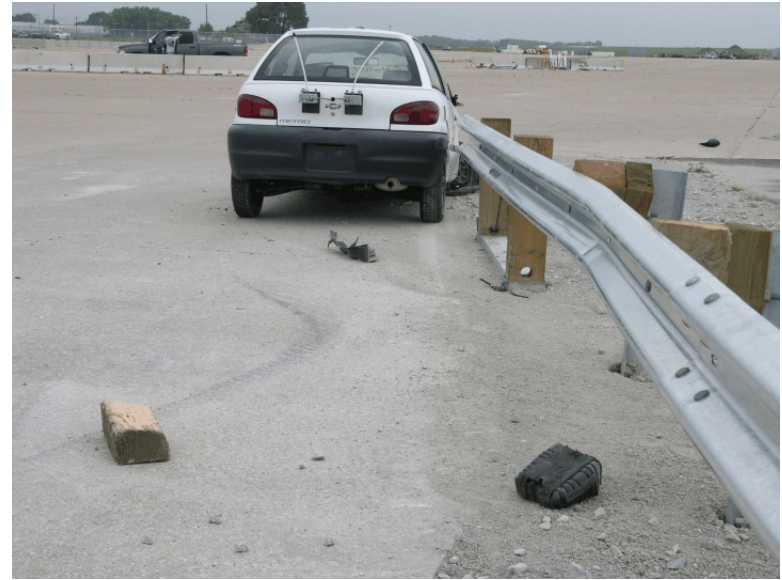
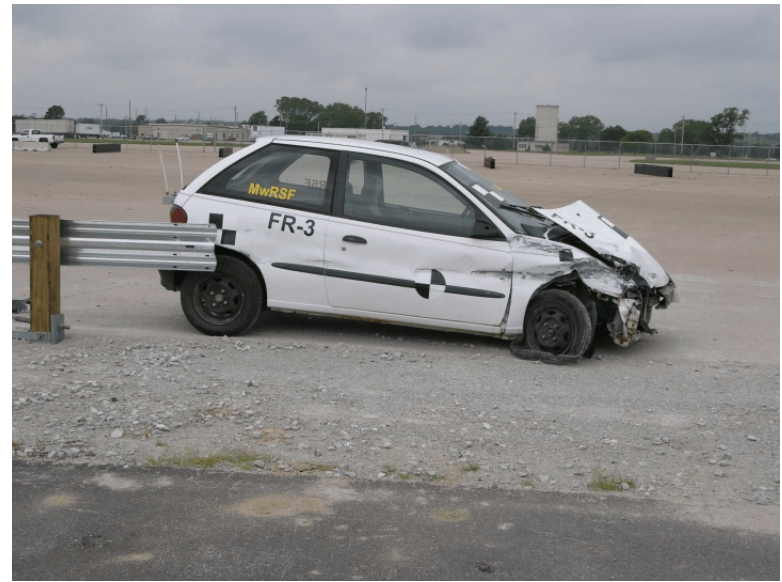
Figure 82. Vehicle Trajectory and Final Position, Test FR-3

of 40.8 km/h (25.3 mph). At 0.664 sec, the vehicle yawed toward the system. At 2.106 sec, the vehicle recontacted the barrier near post no. 26. At 2.188 sec, the right-front tire snagged on post no. 26. The vehicle came to rest 34.4 m (112 ft - 11 in.) downstream from impact and 2.4 m (8 ft - 9 in.) laterally away from the traffic-side face of the rail at impact. The trajectory and final position of the small car are shown in Figures 75 and 82.

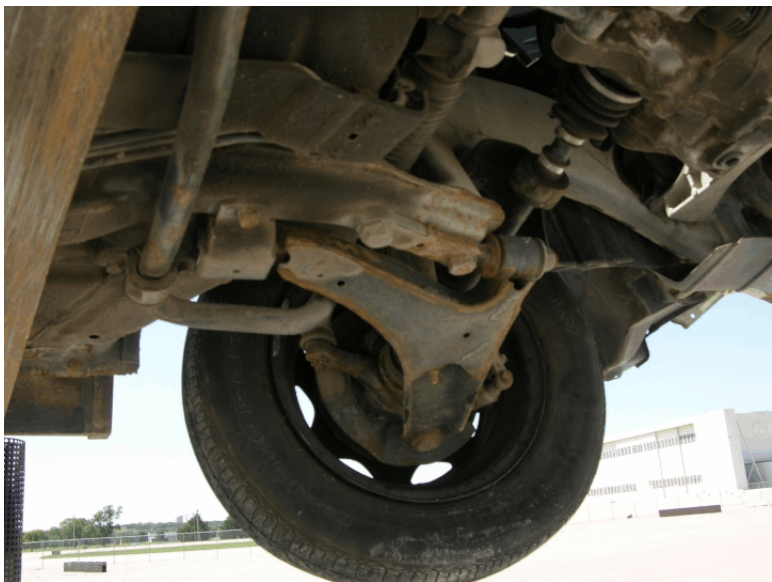
Figure 95. Suspension Damage, Test FR-3

Exterior vehicle damage was moderate, as shown in Figures 91 through 96. Occupant compartment deformations to the right side and center of the floorboard were judged insufficient to cause serious injury to the vehicle occupants. Complete occupant compartment deformations and the corresponding locations are provided in Appendix H.
