EVALUATION OF CRITICAL FLARE RATES FOR THE MIDWEST GUARDRAIL SYSTEM (MGS)

MIDWEST ROADSIDE SAFETY FACILITY

MwRSF Research Report No. TRP-03-191-08

July 15, 2008

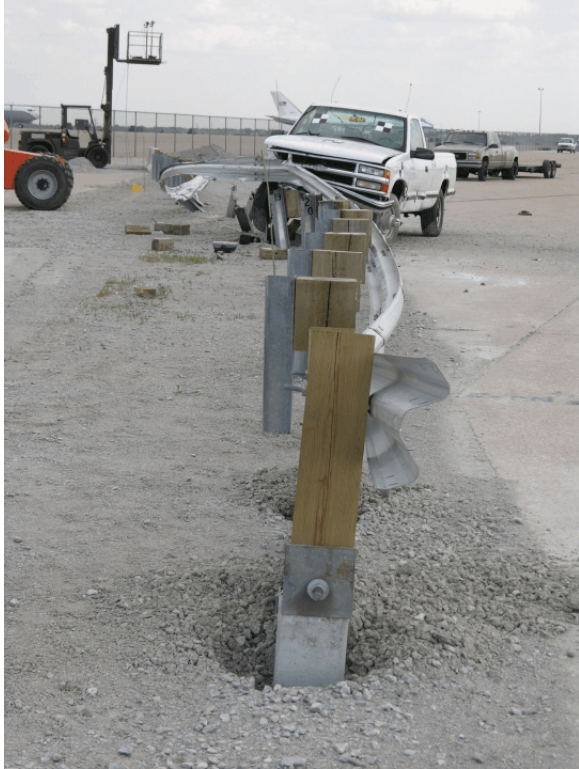
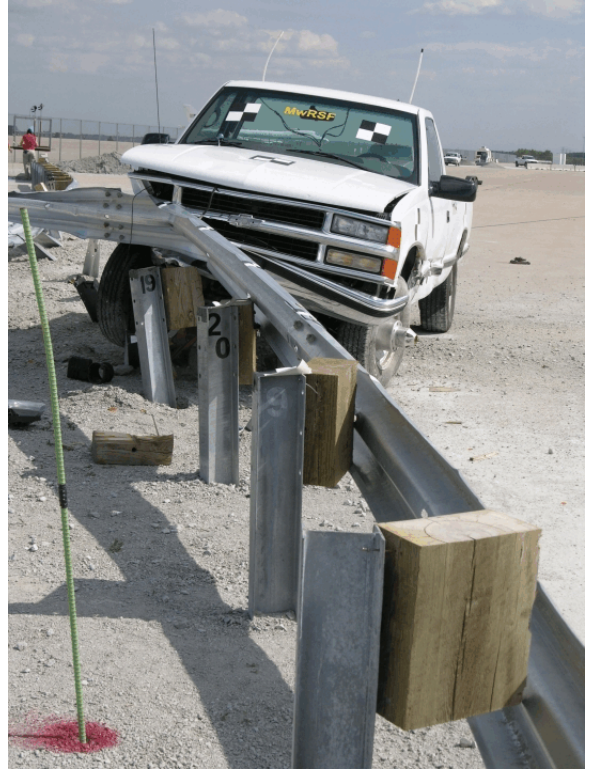
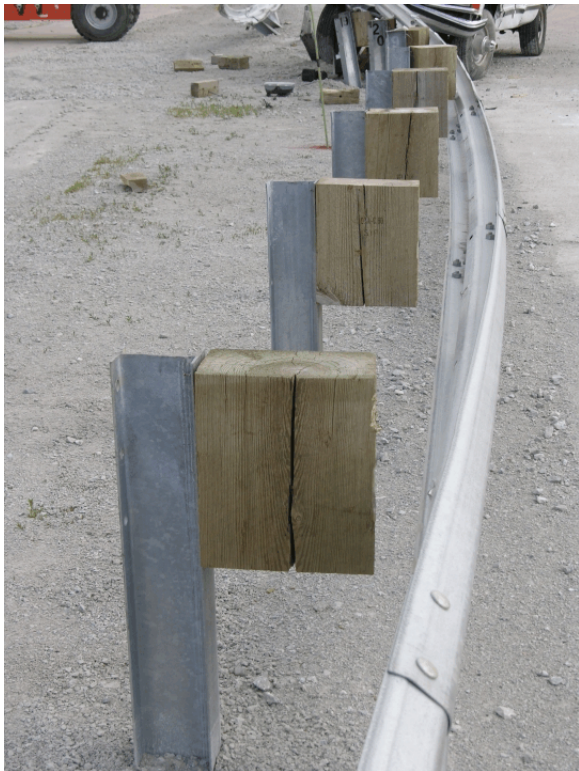
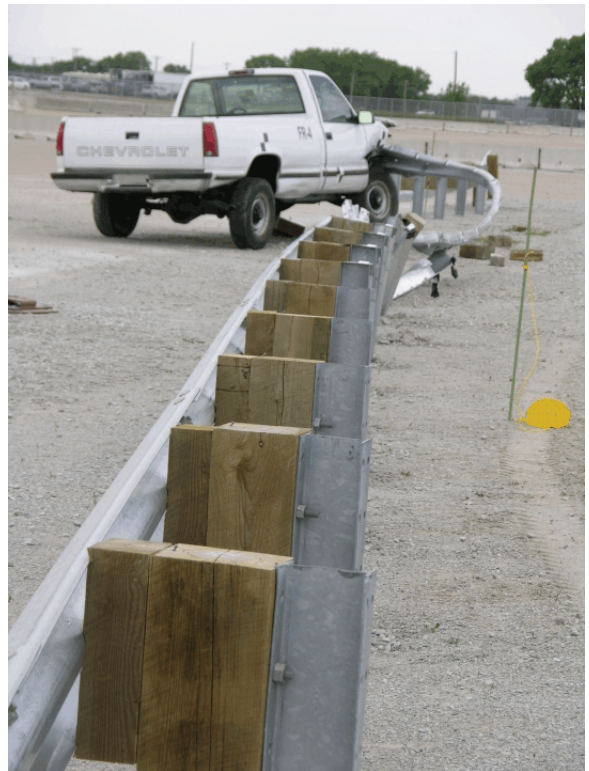
Figure 109. System Damage, Test FR-4

The permanent set of the barrier system is shown in Figure 109. The maximum lateral permanent set rail and post deflections were 1,753 mm (69 in.) at the midspan between post nos. 16 and 17 and 737 mm (29 in.) at the centerline of post no. 14, respectively, as measured in the field. The maximum lateral dynamic rail and post deflections were 1,919 mm (75.6 in.) at the centerline of post no. 16 and 834 mm (32.8 in.) at the centerline of post no. 14, respectively, as determined from high-speed digital video analysis. The working width of the system was found to be 2,475 mm (97.4 in.).

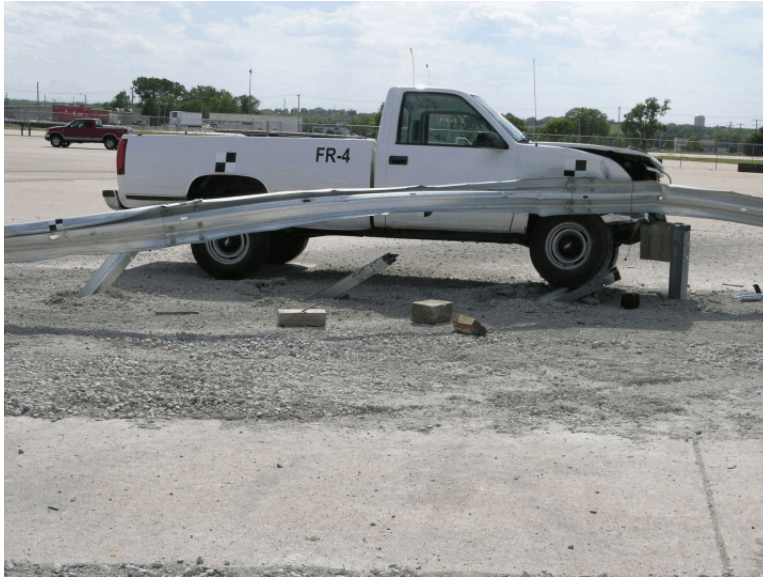
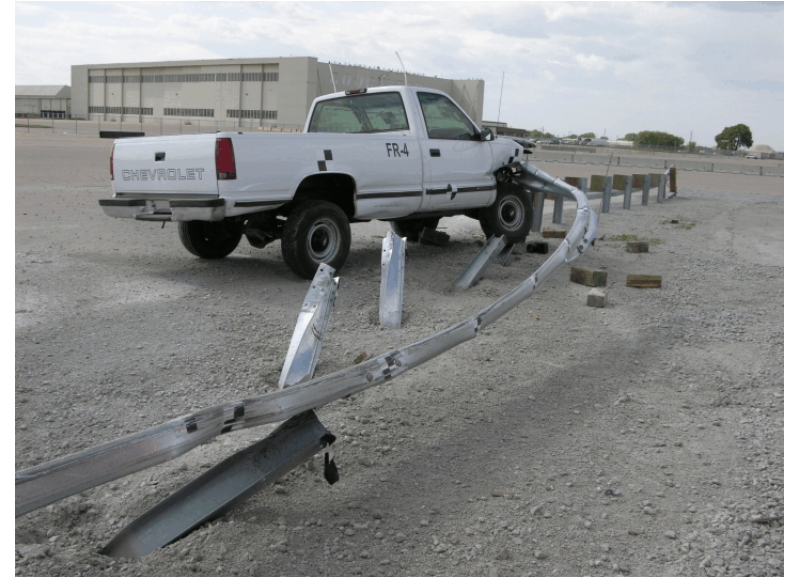
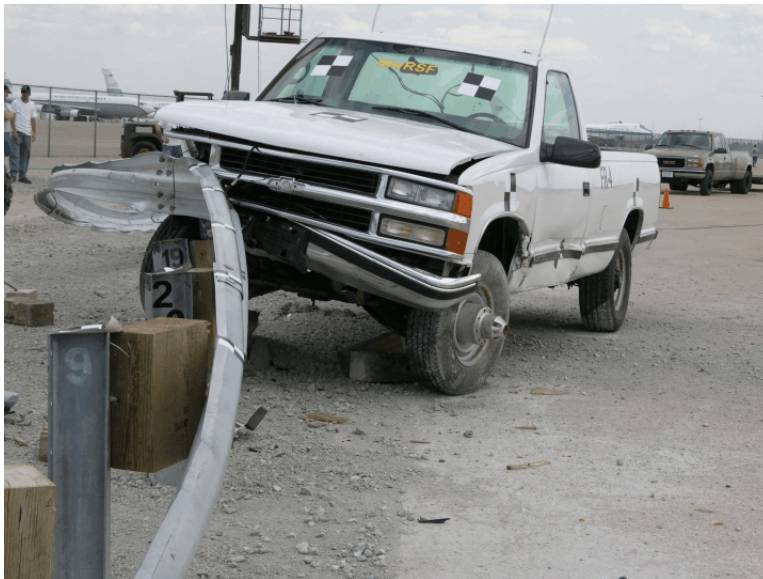
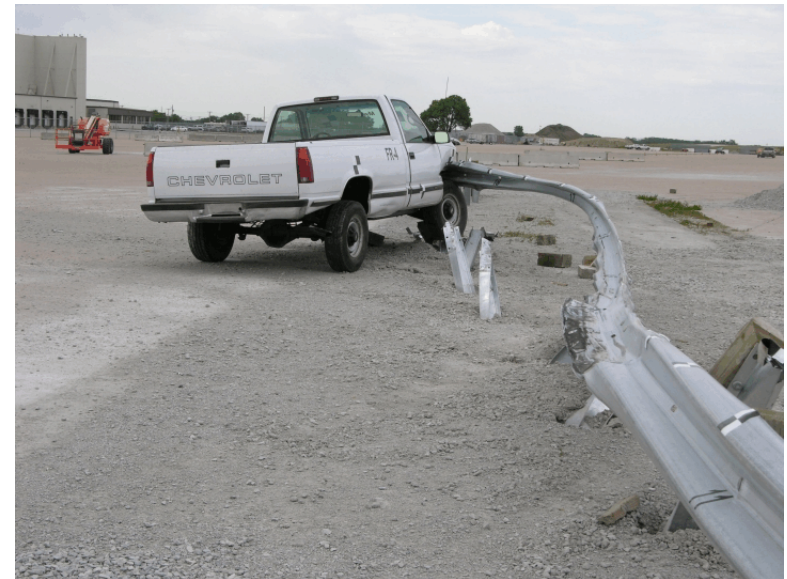
Figure 110. System Damage, Test FR-4

Barrier damage was moderate, as shown in Figures 109 through 119. Barrier damage consisted of deformed guardrail posts, deformed and disengaged blockouts, deformed W-beam guardrail, and contact marks on a guardrail section. The length of vehicle contact along the system was approximately 11.8 m (38 ft - 10 in.), which spanned from the centerline of post no. 12 through 406 mm (16 in.) downstream from the centerline of post no. 18.

Contact marks were found along the length of vehicle contact with the system, which spanned from post nos. 12 through 19. The W-beam rail was deformed and flattened between post nos. 13 and 19. The guardrail buckled at post nos. 11, 13, 17, 19, 20, and between post nos. 19 and 22. The guardrail was deformed upward between post nos. 14 and 17, and reached a maximum height of 775 mm (30.5 in.) above the ground at post no. 17. Minor yielding occurred around the post bolt slots at post nos. 12 through 27. The W-beam was pulled off of post nos. 6 and 12 through 28. No significant damage occurred upstream of post no. 11.

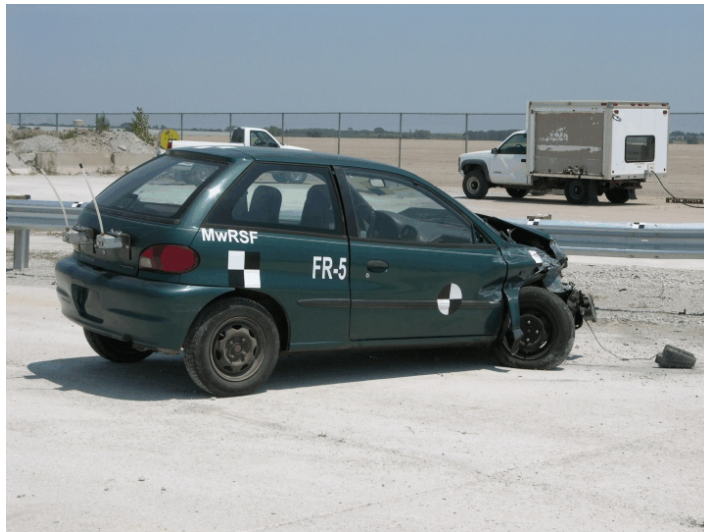
Figure 141. Vehicle Damage, Test FR-5

Exterior vehicle damage was moderate, as shown in Figures 141 through 145. Occupant compartment deformations to the right side and center of the floorboard were judged insufficient to cause serious injury to the vehicle occupants. The occupant compartment deformation is shown in Figure 145. Complete occupant compartment deformations and the corresponding locations are provided in Appendix M.

Damage was concentrated on the right-front corner of the vehicle. The right-front quarter panel, bumper, and radiator were deformed and crushed inward toward the engine compartment. Significant sheet metal tears occurred to the right-front corner of the hood, the right-front quarter panel, and the right door panel. The right-side door could not be opened. The front of the hood was crushed, deformed, and shifted to the right side, causing the right-side hood clips to fracture. Dents and scratches occurred to the entire right side of the vehicle and the exhaust system. The bumper cover disengaged from the vehicle. The right-side headlight was fractured and removed from the housing. The right-front tire was twisted at the wheel attachment and deformed into the wheel well. The right-side lower control arm and steering arm were fractured. The right-side sway bar was bent at the connection to the wheel. The lower-right corner of the windshield encountered “spider-web” cracking due to hood contact. The left side, rear, roof, and all window glass except the windshield remained undamaged.
