# **EVALUATION OF A MODIFIED THREE CABLE GUARDRAIL ADJACENT TO STEEP SLOPE**

## **MIDWEST ROADSIDE SAFETY FACILITY**

MwRSF Research Report No. TRP-03-192-08

March 4, 2008

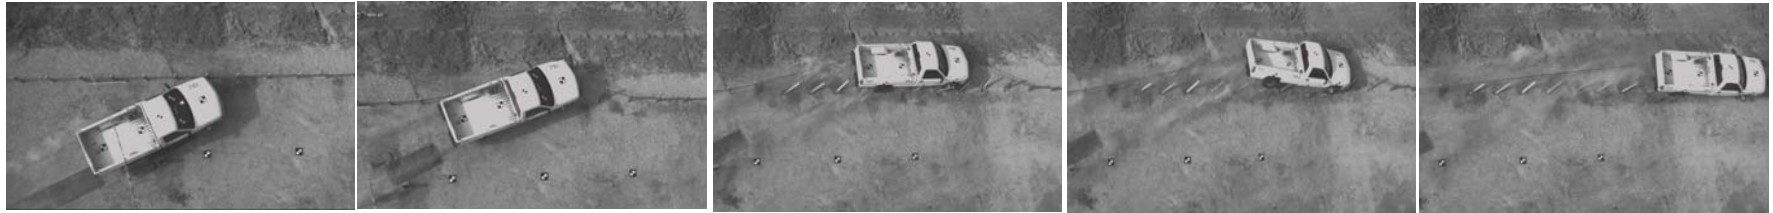
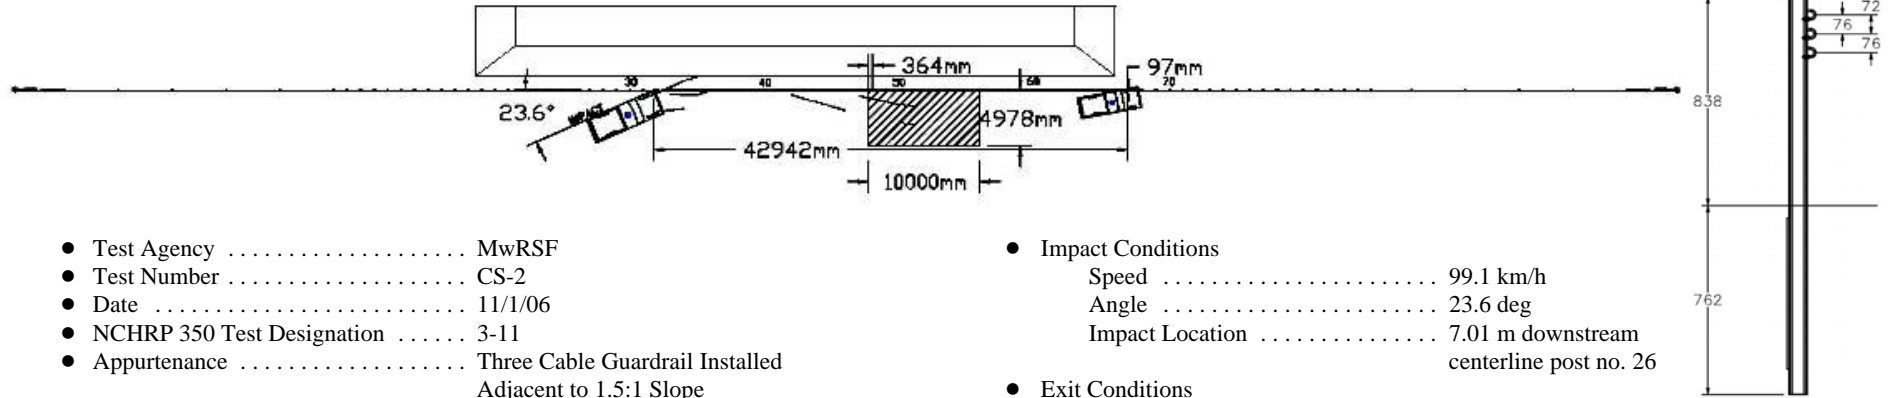
Figure 23. Summary of Test Results and Sequential Photographs, Test CS-2

The 2,032-kg (4,481-lb) pickup truck impacted the three cable guardrail system at a speed of 99.1 km/h (61.6 mph) and at an angle of 23.6 degrees. A summary of the test results and the sequential photographs are shown in Figure 23. The summary of the test results and sequential photographs in English units are shown in Appendix B. Additional sequential photographs are shown in Figures 24 through 26. Documentary photographs of the crash test are shown in Figure 27.

The analysis of the test results for test no. CS-2 showed that the three cable barrier system with quarter-post spacing and located 1,219 mm (4 ft) in front of a 1.5:1 slope impacted with the 2000P vehicle adequately contained and redirected the vehicle with controlled lateral displacements of the barrier system. There were no detached elements nor fragments which showed potential for penetrating the occupant compartment nor presented undue hazard to other traffic. Deformations of, or intrusion into, the occupant compartment that could have been caused serious injury did not occur. The vehicle did not penetrate nor ride over the barrier and remained upright during and after the impact. The vehicle's post impact trajectory revealed no intrusion into adjacent traffic lanes. The vehicle's exit angle was 16.3 degrees, as determined by high-speed film analysis, which was slightly higher than the preferable exit angle of 14.2 degrees. The longitudinal occupant impact velocity and ridedown deceleration were within the required limitations. Therefore, test no. CS-2 was determined to be acceptable according to the TL-3 safety performance criteria found in NCHRP Report No. 350.
