## **EVALUATION OF RIGID HAZARDS PLACED IN THE ZONE OF INTRUSION**

### **MIDWEST ROADSIDE SAFETY FACILITY**

MwRSF Research Report No. TRP-03-151-08

January 3, 2008

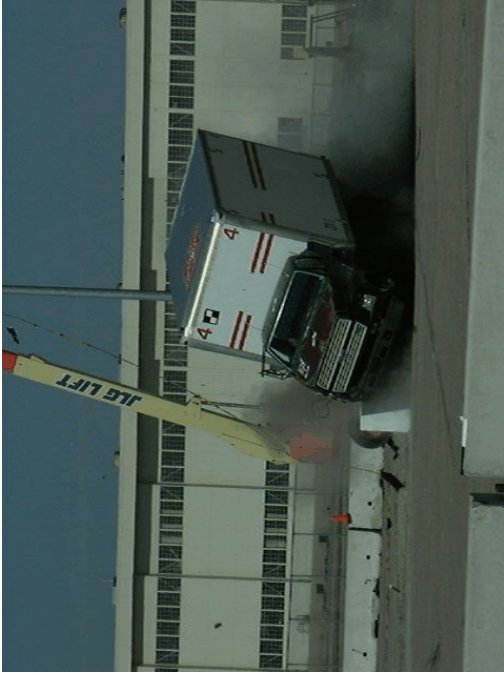
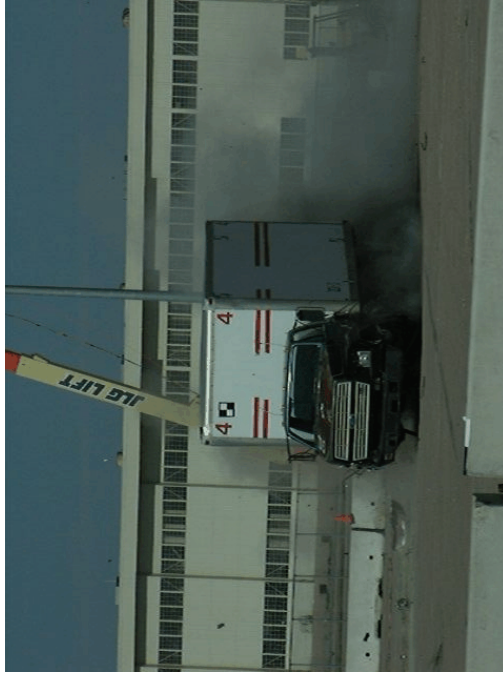
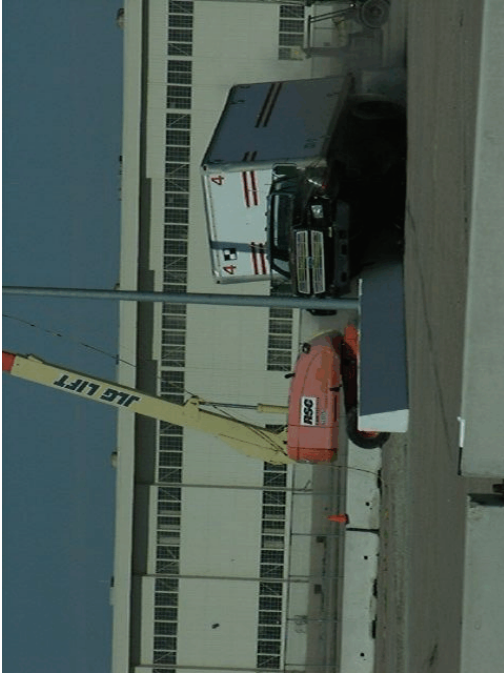
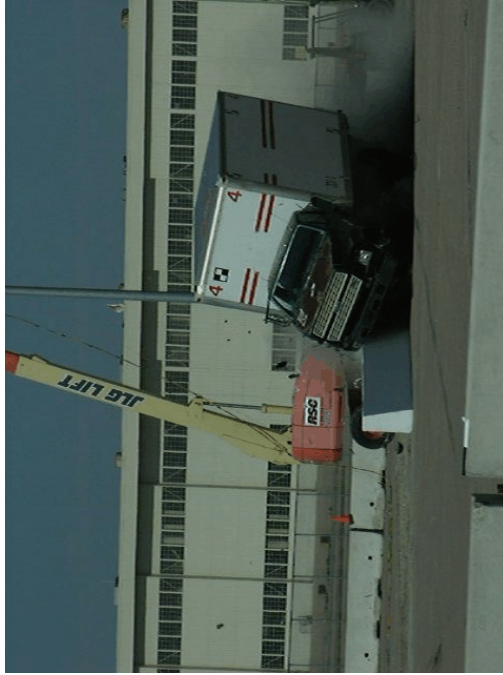
Figure 68. Documentary Photographs, Test No. ZOI-3

An 8,000-kg (17,637-lbs) single-unit truck impacted the single-slope concrete barrier with a luminaire pole placed behind the barrier and mounted to the lower concrete surface at a speed of 80.8 km/h (50.2 mph) and at an angle of 16.4 degrees. A summary of the test results and sequential photographs are shown in Figure 63. The summary of the test results and sequential photographs in English units are shown in Appendix D. Additional sequential photographs are shown in Figure 64 through 67. Documentary photographs of the crash test are shown in Figures 68 and 69.

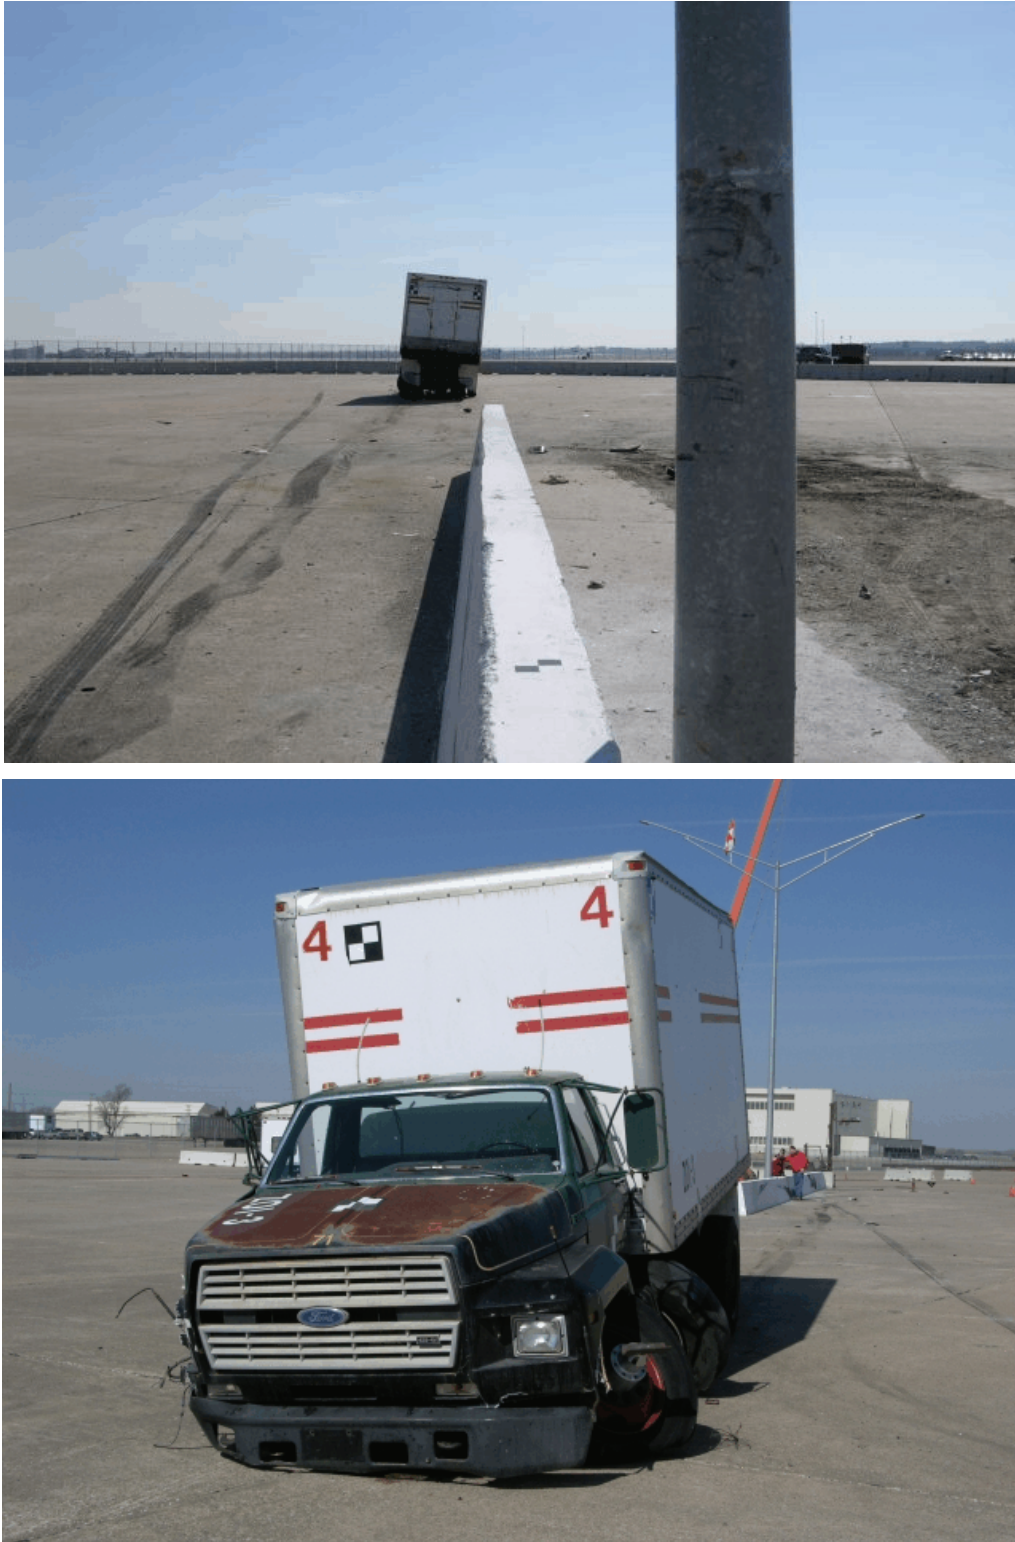
Figure 70. Impact Location, Test No. ZOI-3

Initial vehicle impact was to occur 16.61 m (54 ft - 6 in.) upstream of the centerline of the luminaire pole, as shown in Figure 70. Actual vehicle impact occurred 178 mm (7 in.) downstream of the targeted impact. At 0.042 sec after impact, the right-front corner of vehicle crushed inward. At 0.052 sec, the vehicle began to redirect with the right-front corner protruding over the top of the system. At 0.082 sec, the front end of vehicle pitched upward. At 0.130 sec, the box rolled toward the system. At this same time, the box and cab twisted. At 0.180 sec, the right-front corner of the box protruded over the top of the system, and the front of the box lifted upward. At 0.192 sec, the right side of the cab protruded over the top of the system. At 0.210 sec, the front of the box pitched upward. At 0.292 sec, the box rolled toward the system again. At 0.360 sec, the cab rolled toward the system. At this same time, the left side of the vehicle rose into the air. At 0.400 sec, the left-rear tire became airborne. At 0.510 sec, the box reached its maximum intrusion of 906 mm (35.6875 in.) over the system. At 0.582 sec, the vehicle slid along the top of the barrier. At 0.732 sec, the left side of the vehicle descended toward the ground. At 0.858 sec, the pole moved due to vehicle impact but
