BARRIERS IN CONSTRUCTION ZONES

VOLUME 4

Report No.
FHWA/RD-86/095

1. Report No. FHWA/RD-86/095		2. Government Accession No.		3. Recipient's Catalog No.	
4. Title and Subtitle BARRIERS IN CONSTRUCTION ZONES - THE RESPONSE OF ATYPICAL VEHICLES DURING COLLISIONS WITH CONCRETE MEDIAN BARRIERS VOLUME 4				5. Report Date April 1985

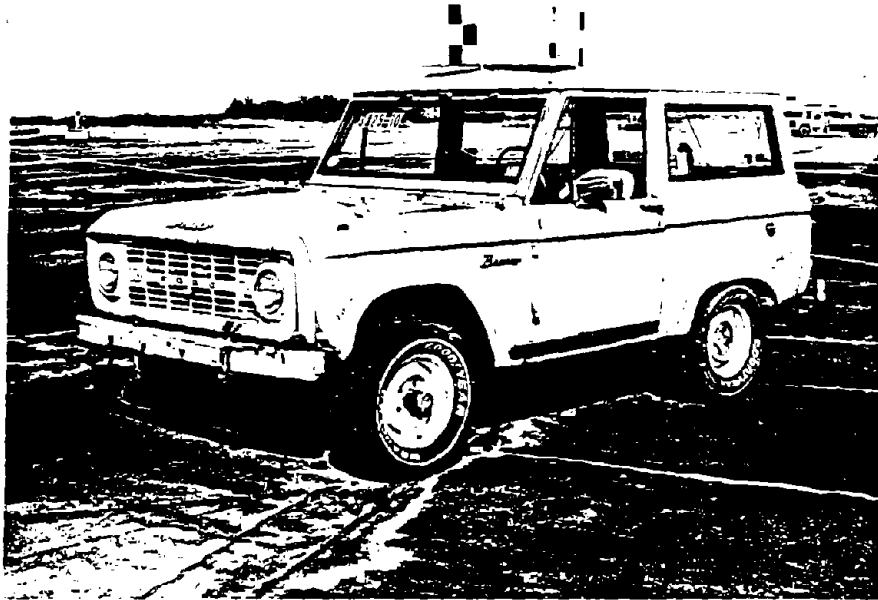
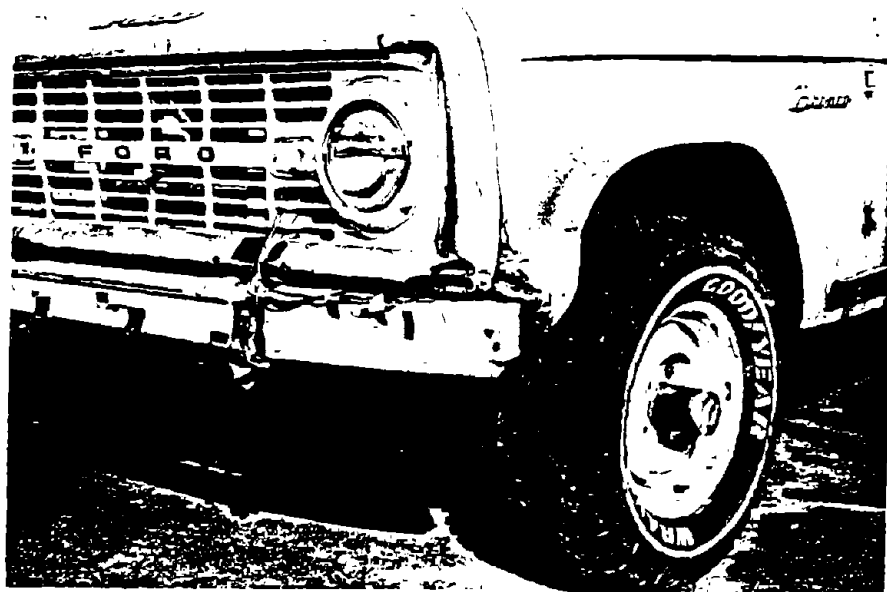
Figure 7. Vehicle after test 3825-10.

As shown in figure 7, the vehicle sustained slight damage to the left front quarter. The left end of the bumper was bent back slightly.

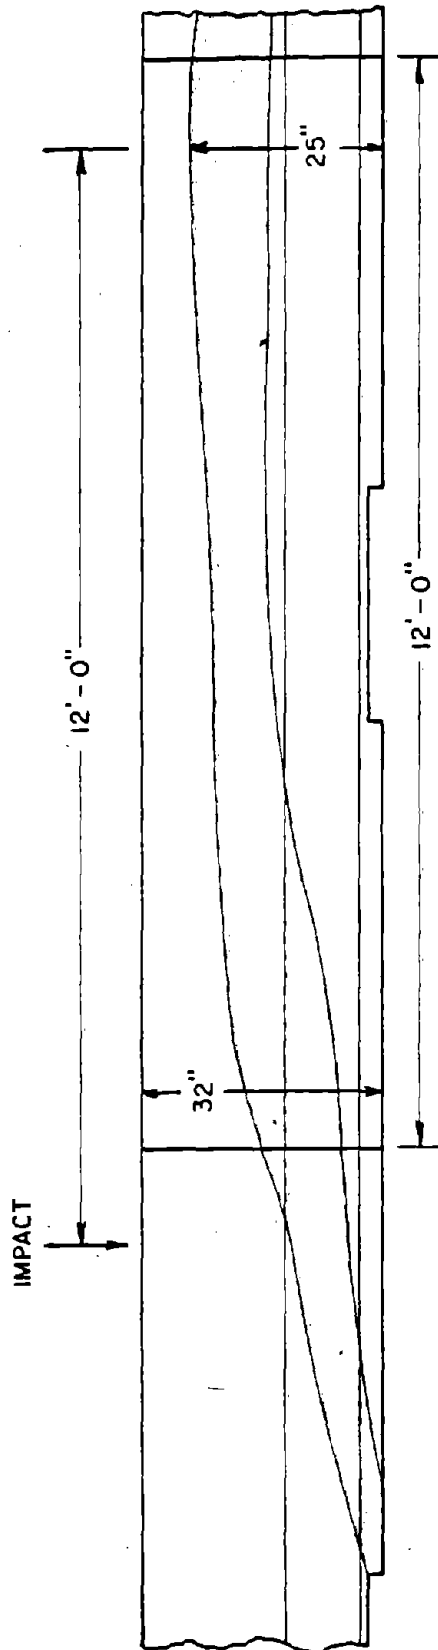
Figure 9. Tire path for test 3825-10.

The barrier received minor cosmetic damage to segments 3 and 4 as shown in figure 8. The tire path of the initial impact is plotted in figure 9. There were also tire marks on segments 9 and 10 where the vehicle impacted the barrier a second time. The top of the barrier moved 0.05 ft (0.02 m) during the test but retained a set of only 0.02 ft (0.01 m).

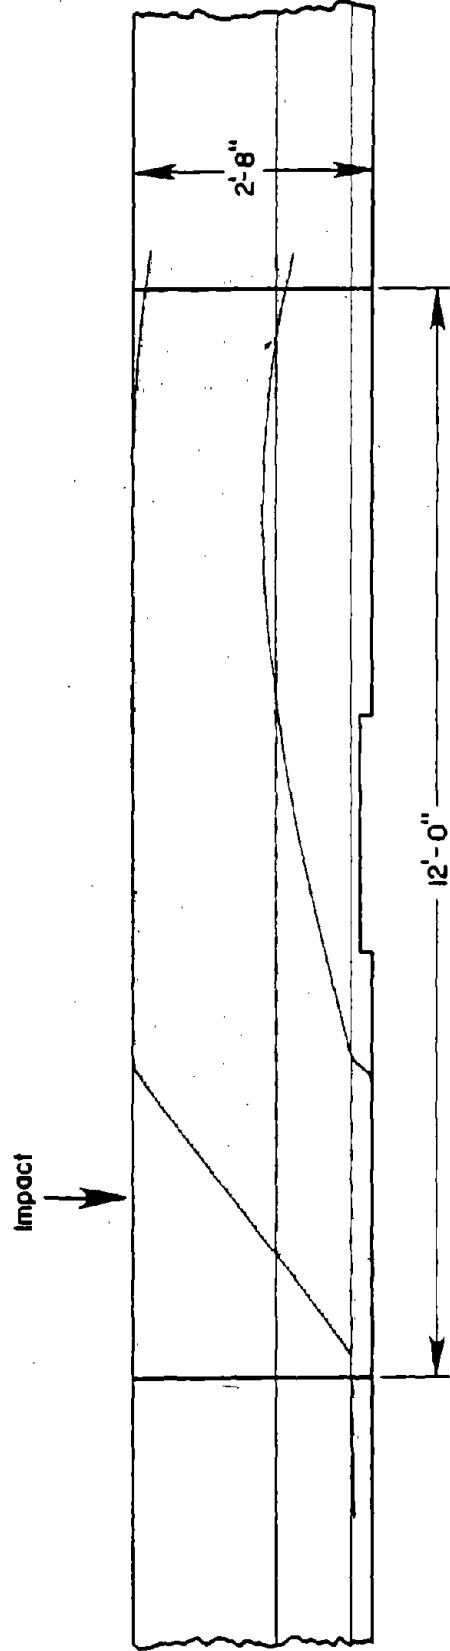
Figure 17. Tire path for test 3825-11.

The vehicle impacted the barrier approximately 2.0 ft (0.6 m) downstream of the joint between segments 3 and 4. The tire path on the barrier face is shown in figure 17. The top of the path reached the top of the barrier approximately 2.0 ft (0.6 m) downstream of the impact point. Tire marks extended to the upper edge of the barrier for a distance of about 7.0 ft (2.1 m) and the bottom of the tire marks formed a curved path as shown in figures 17 and 18. Total length of contact was approximately 13.8 ft (4.2 m). The vehicle was redirected and exited the barrier at 0.286 sec with exit angle of 1.2 degrees. The speed of the vehicle at loss of contact was 52.0 mph (83.7 kph).

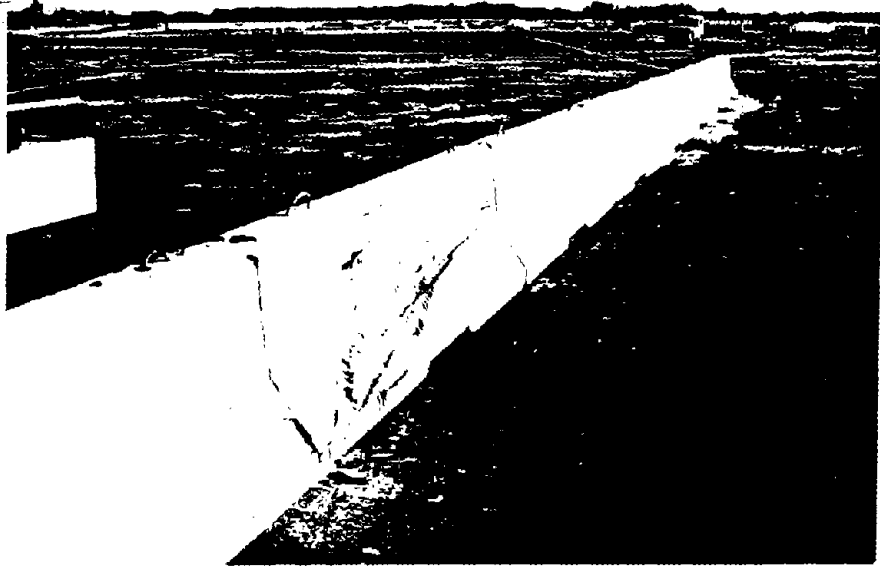
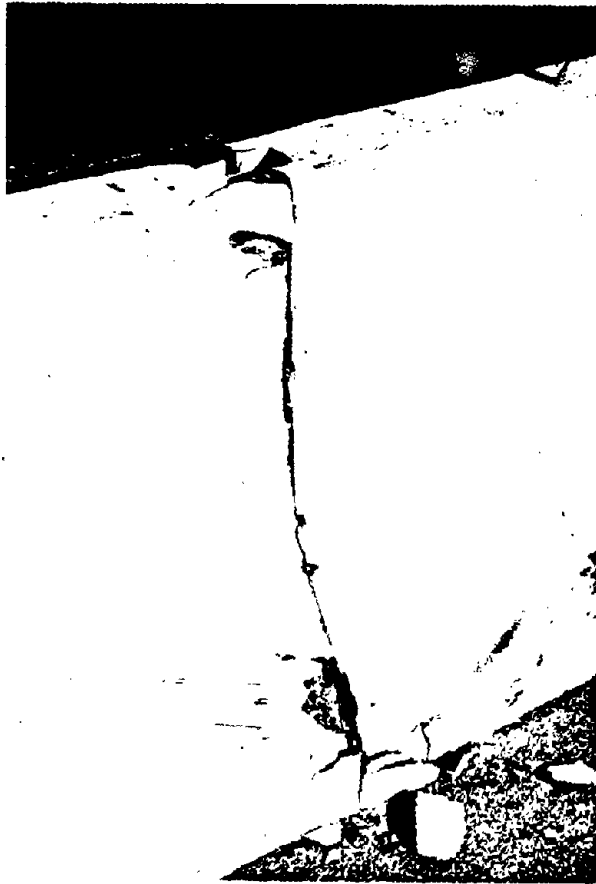
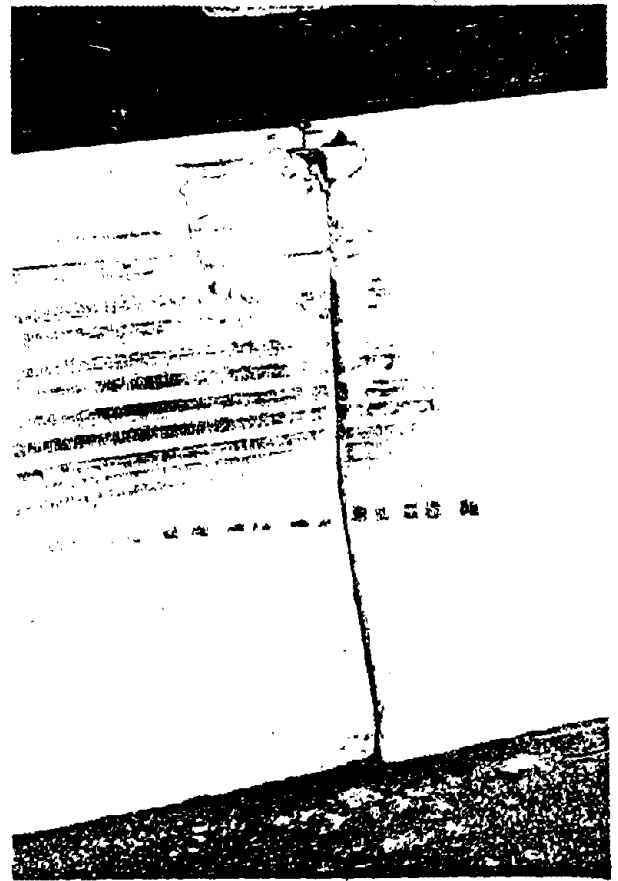
Figure 18. Barrier after test 3825-11.

The barrier received damage to segment 4 as shown in figure 18. The upper corners of joints 3-4 and 4-5 were cracked and broken. The top of the barrier moved 0.11 ft (0.03 m) during the test but returned to its original position afterwards.

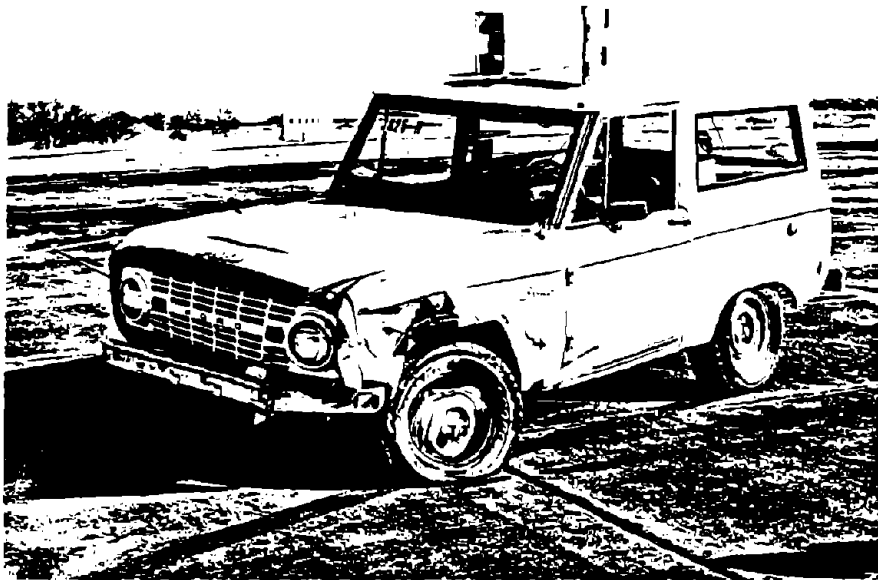
Figure 19 . Vehicle after test 3825-11.

As shown in figure 19, the vehicle sustained minimal damage to the left front quarter. The left front tire was deflated and the rim bent. The left corner of the rear bumper was also pulled back.

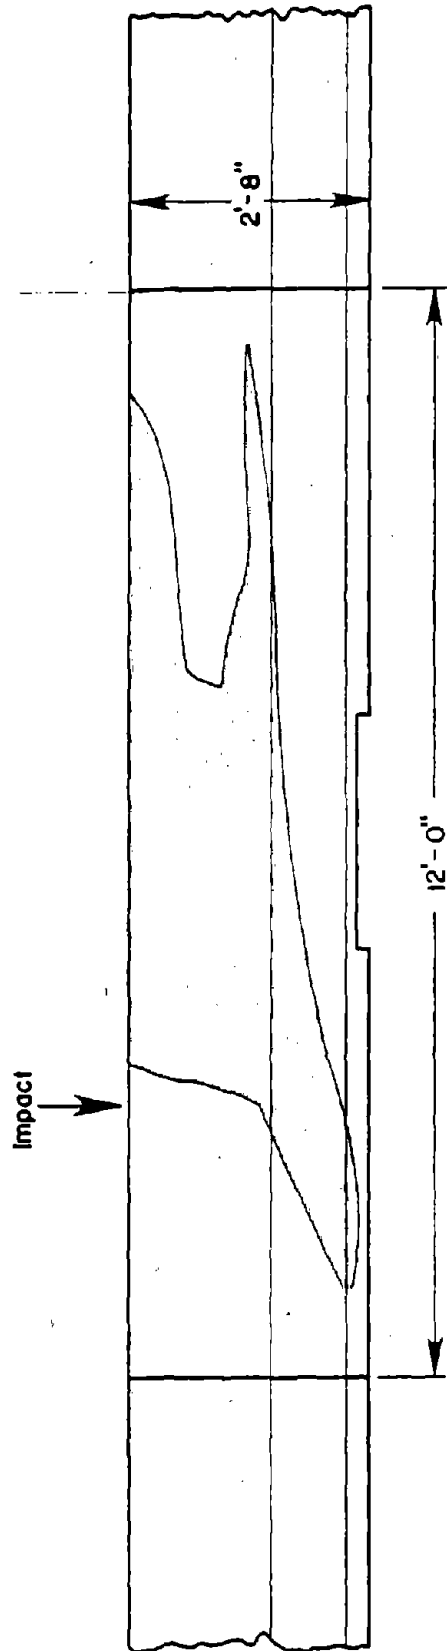
Figure 27. Tire path for test 3825-12.

The vehicle impacted the barrier approximately 3.0 ft (0.9 m) downstream of the joint between segments 3 and 4. The tire path on the barrier face is shown in figure 27. The top of the path reached the top of the barrier approximately 0.5 ft (0.2 m) downstream of the impact point. Tire marks extended to the upper edge of the barrier for a distance of about 7.5 ft (2.3 m) before fading out as shown in figures 27 and 28. Total length of contact was approximately 10.5 ft (3.2 m). The vehicle was redirected and exited the barrier at 0.284 sec with exit angle of 2.0 degrees. The speed of the vehicle at loss of contact was 54.0 mph (86.9 kph).

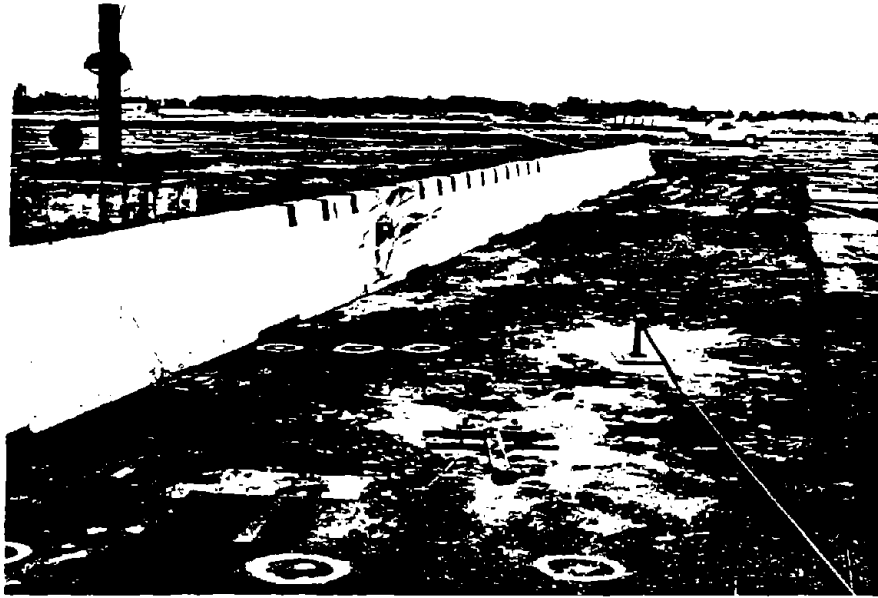
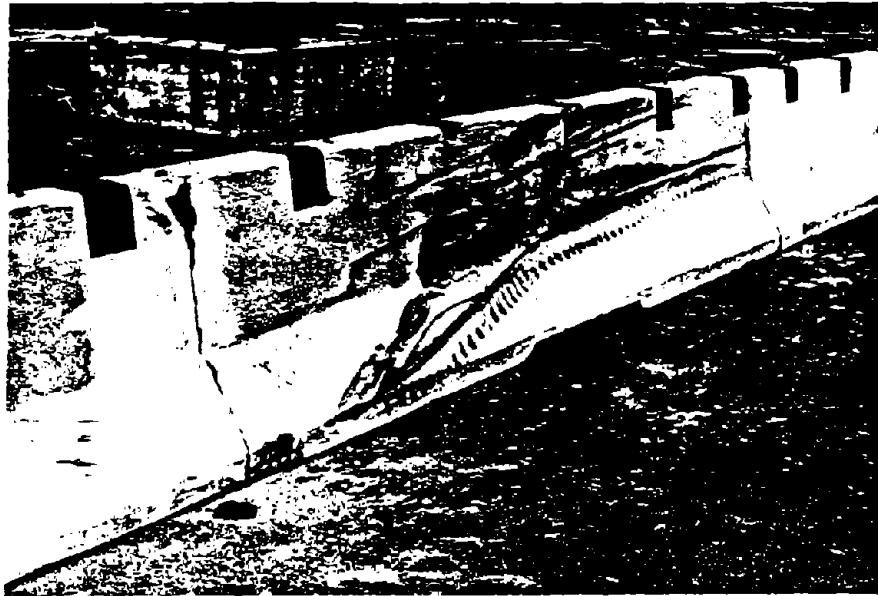
Figure 28. Barrier after test 3825-12.

The barrier received damage to segments 3 and 4 with minimal cracking at joints 3-4 and 4-5. Damage to the barrier is shown in figure 28. The barrier showed no measurable movement during the test.

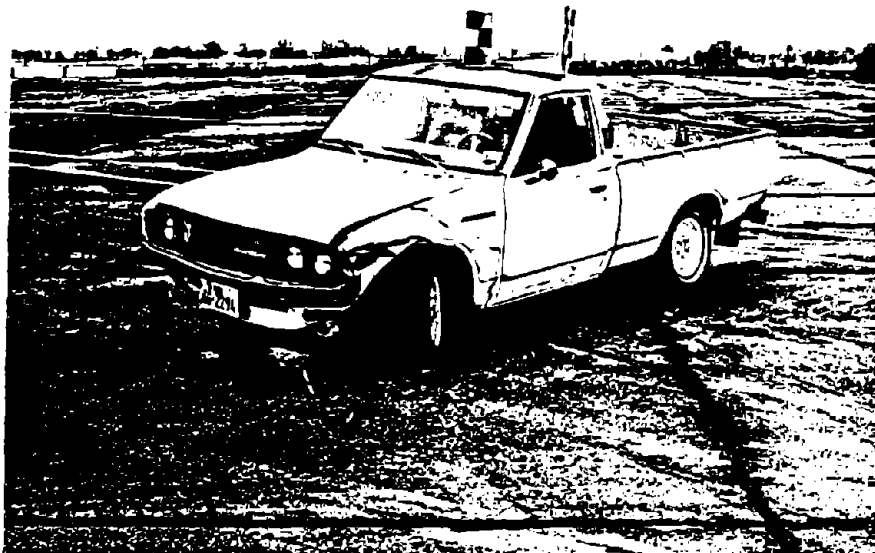
Figure 29. Vehicle after test 3825-12.

As shown in figure 29, the vehicle sustained minimal damage to the left front quarter. The left front tire was deflated and the rim bent slightly.

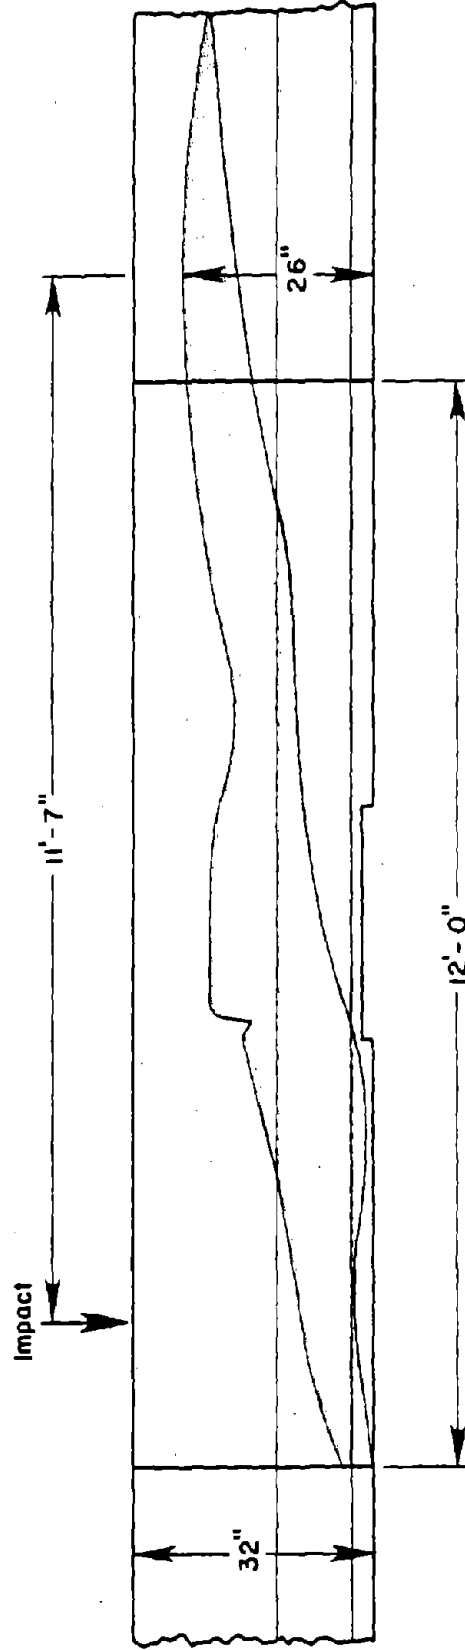
Figure 37. Tire path for test 3825-13.

The vehicle impacted the barrier approximately 2.0 ft (0.6 m) downstream of the joint between segments 3 and 4. The tire path on the barrier face is shown in figure 37. The top of the path reached a maximum height of 2.2 ft (0.7 m) approximately 11.6 ft (3.5 m) downstream of the impact point. Total length of contact was approximately 16.8 ft (5.1 m). The vehicle was redirected and exited the barrier at 0.363 sec with exit angle of 4.0 degrees. The speed of the vehicle at loss of contact was 50.6 mph (81.3 kph).

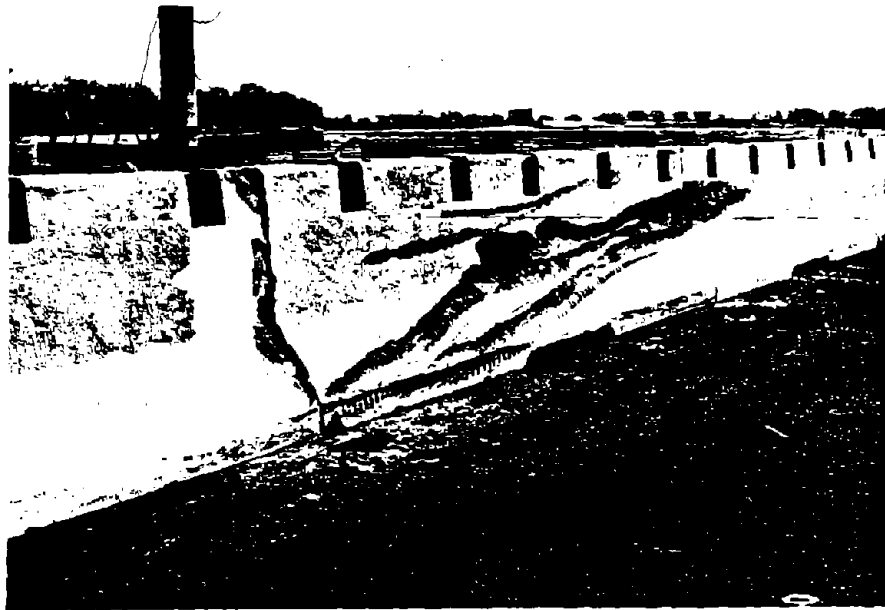
Figure 38. Barrier after test 3825-13.

The barrier received damage to segments 3 through 5 as shown in figure 38. The upper corners of joints 3-4 and 4-5 were cracked and broken. The top of the barrier moved 0.11 ft (0.03 m) during the test but returned to its original position afterwards.

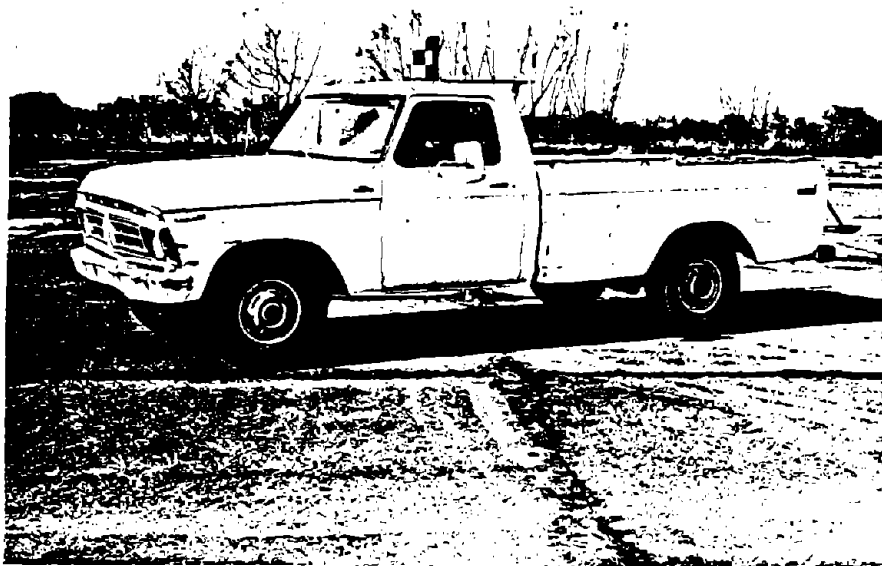
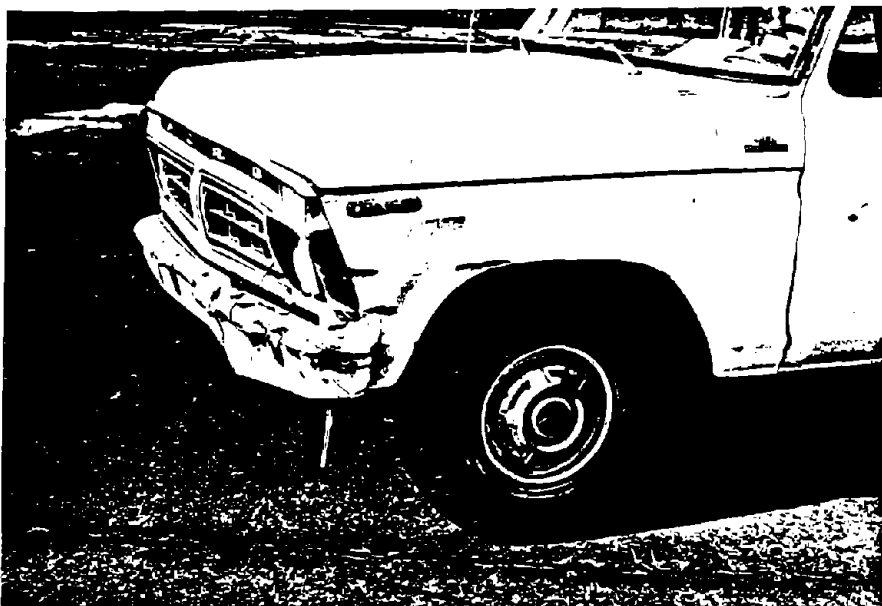
Figure 39. Vehicle after test 3825-13.

As shown in figure 39, the vehicle sustained minimal damage to the left front quarter. The left front corner of the bumper was pushed back.

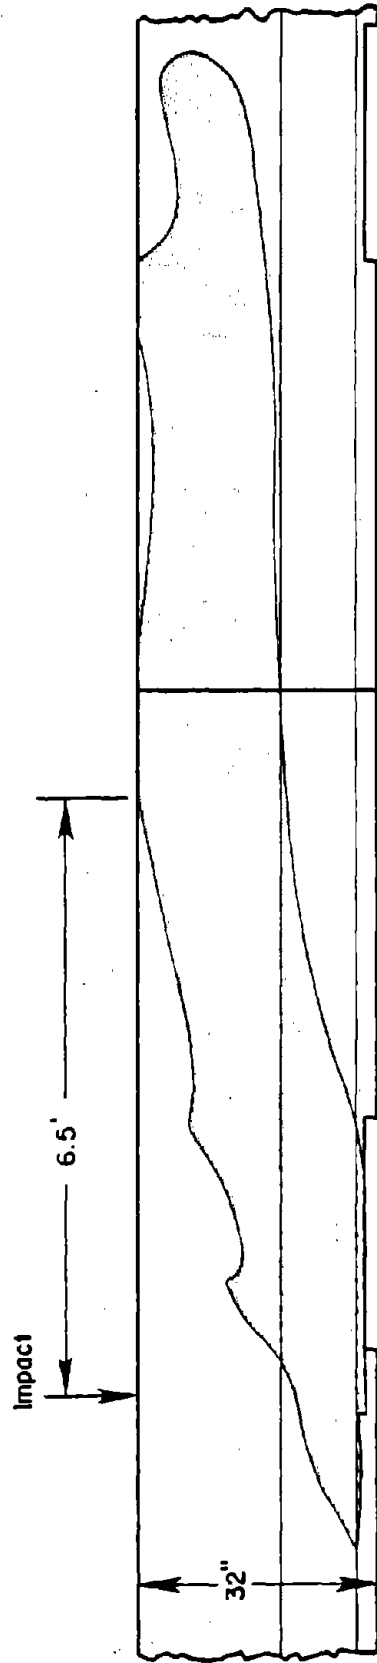
Figure 47. Tire path for test 3825-14.

The vehicle impacted the barrier approximately 4.0 ft (1.2 m) downstream of the joint between segments 3 and 4. The tire path on the barrier face is shown in figure 47. The top of the path reached the top of the barrier approximately 6.5 ft (2.0 m) downstream of the impact point. Tire marks extended to or near the upper edge of the barrier for a distance of about 6.0 ft (1.8 m) as shown in figures 47 and 48. Total length of contact was approximately 17.0 ft (5.2 m). The vehicle was redirected and exited the barrier at 0.418 sec with exit angle of 4.0 degrees. The speed of the vehicle at loss of contact was 46.8 mph (75.3 kph).

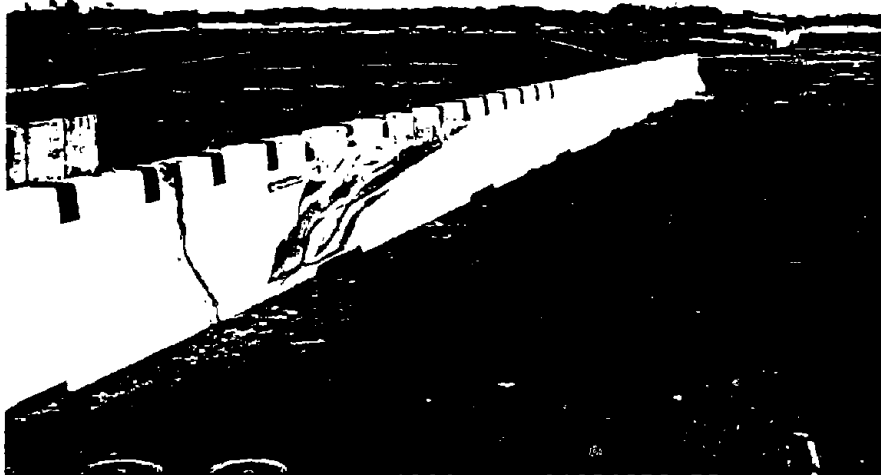
Figure 48. Barrier after test 3825-14.

The barrier received damage to segments 3 through 5 as shown in figure 48. The upper corners of joints 3-4 and 4-5 were cracked and broken. The top of the barrier moved 0.12 ft (0.04 m) during the test but returned to its original position afterwards.

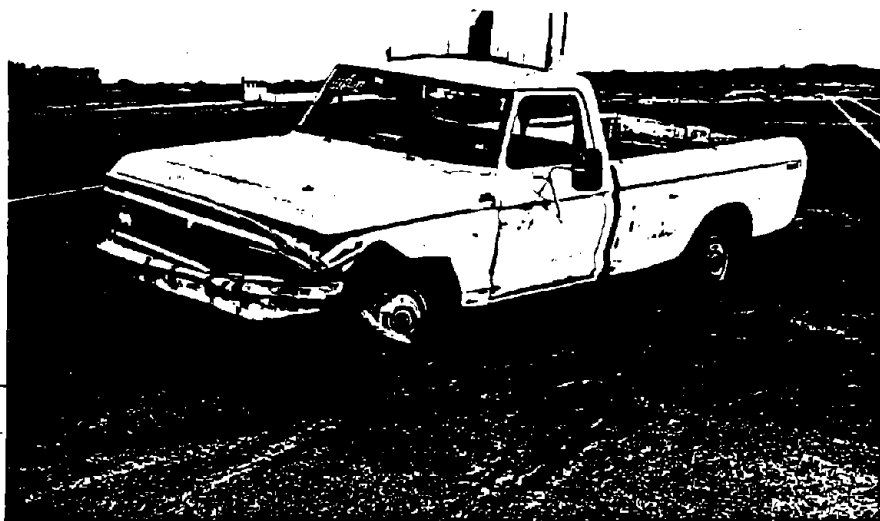
Figure 49. Vehicle after test 3825-14.

As shown in figure 49, the vehicle sustained damage to the left side. The left front and left rear tires were deflated and the rims bent.

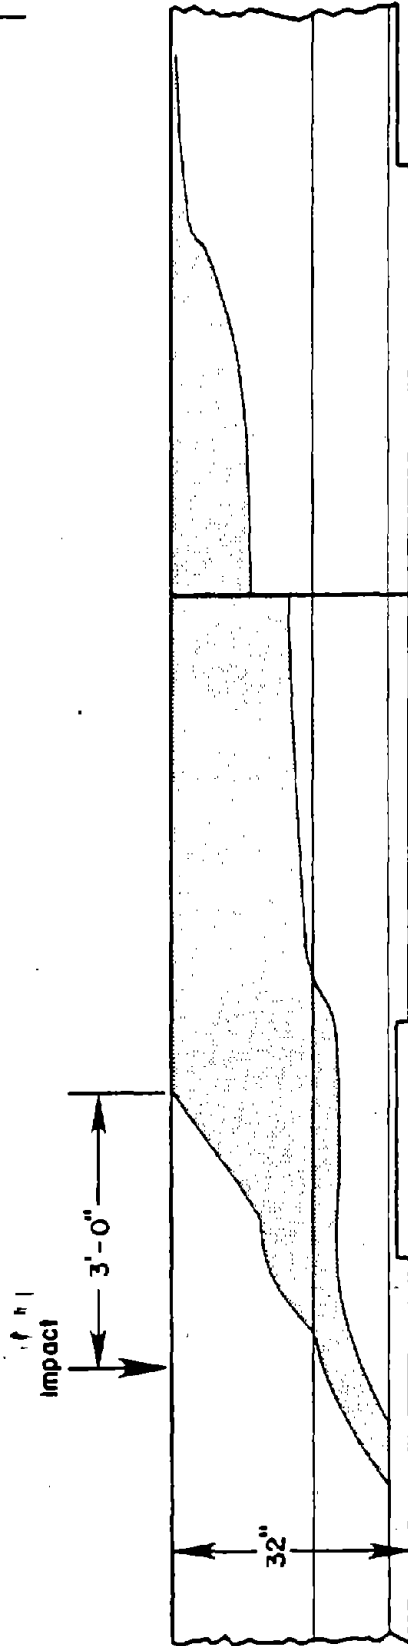
Figure 57. Tire path for test 3825-15.

The tire path on the barrier face is shown in figure 57. The top of the path reached the top of the barrier approximately 3.0 ft (0.9 m) downstream of the impact point. Tire marks extended to the upper edge of the barrier for a distance of over 12.0 ft (3.7 m). Total length of contact was approximately 16.0 ft (4.9 m).

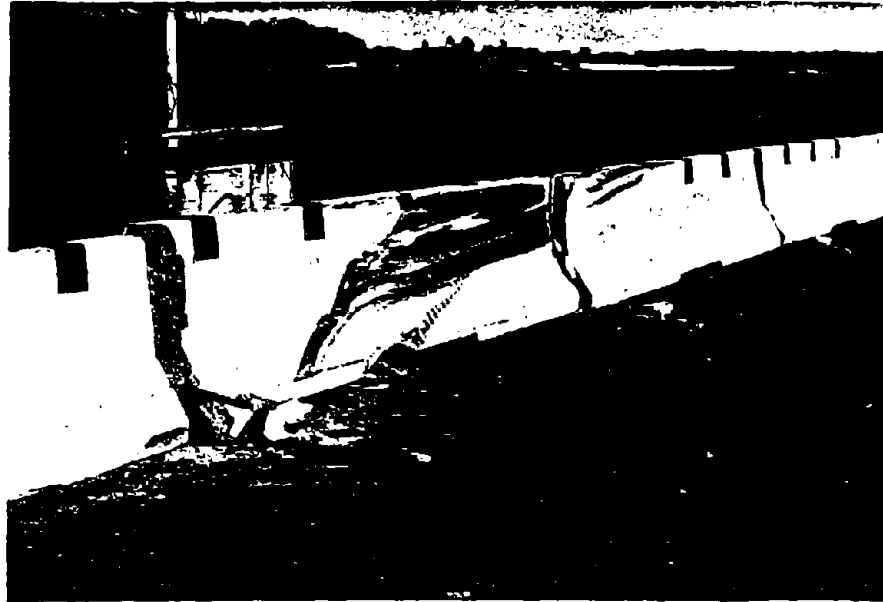
Joint between
segments 3 and 4.

Segment 4 had tilted back during impact causing the concrete at the joints on each end to break off, exposing the channel in the T-lock as shown in figure 58. The segment came to rest on some of these pieces of concrete elevating it approximately 2 in (5.1 cm). The T-lock was also exposed at joint 5-6. The top of the barrier (segment 4) moved 0.63 ft (0.19 m) during impact and retained a permanent deflection of 0.08 ft (0.02 m).

Figure 58. Barrier after test 3825-15.

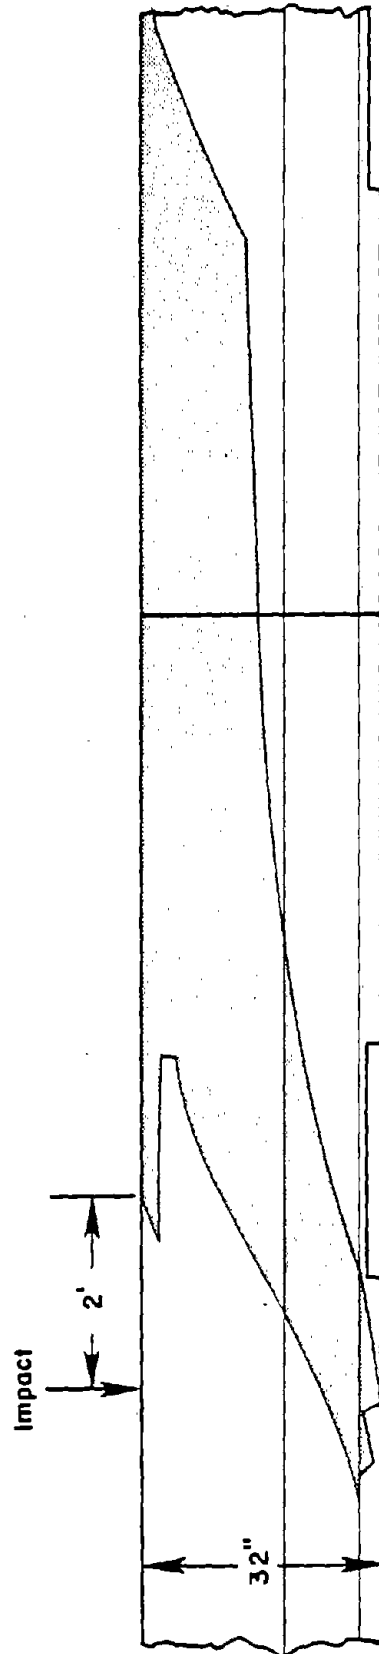
The vehicle impacted the barrier approximately 3.0 ft (0.9 m) downstream of the joint between segments 3 and 4. The tire path on the barrier face is shown in figure 68. The top of the path reached the top of the barrier approximately 2.0 ft (0.6 m) downstream of the impact point. Tire marks extended to the upper edge of the barrier for a distance of over 14.0 ft (4.3 m) and the bottom of the tire marks formed a curved path as shown in figures 68 and 69. Total length of contact was approximately 18.0 ft (5.5 m). The vehicle was redirected and exited the barrier at 0.405 sec with exit angle of 0.5 degrees toward the barrier. The speed of the vehicle at loss of contact was 51.7 mph (83.2 kph).

Figure 68. Tire path for test 3825-16.

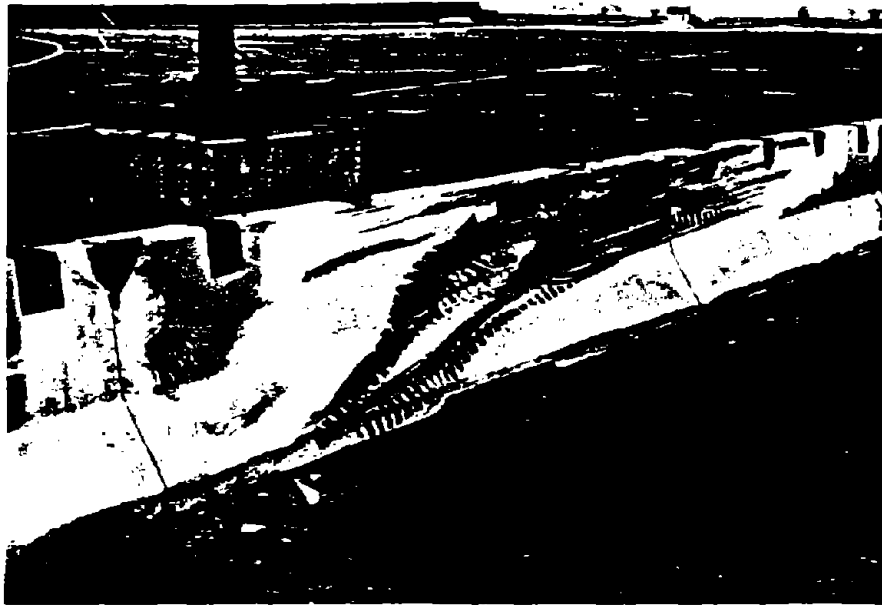
The barrier received damage to segment 4 as shown in figure 69. Joints 3-4 and 4-5 were chipped and broken. The top of the barrier moved 0.14 ft (0.04 m) during the test and retained a permanent set of 0.03 ft (0.01 m).

Figure 69. Barrier after test 3825-16.

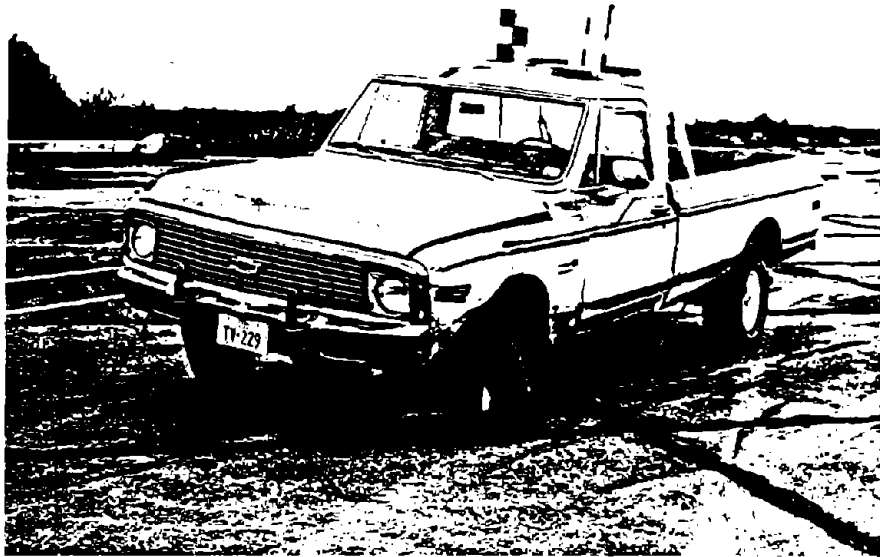
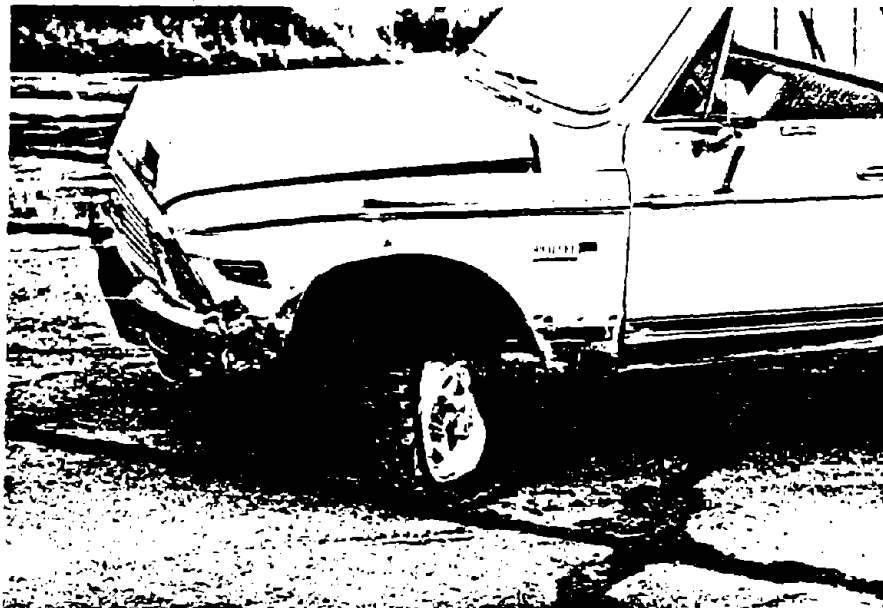
As shown in figure 70, the vehicle sustained damage to the left front quarter. The left front tire was deflated and the rim bent. The front axle and wheel assembly were also damaged.

Figure 70. Vehicle after test 3825-16.

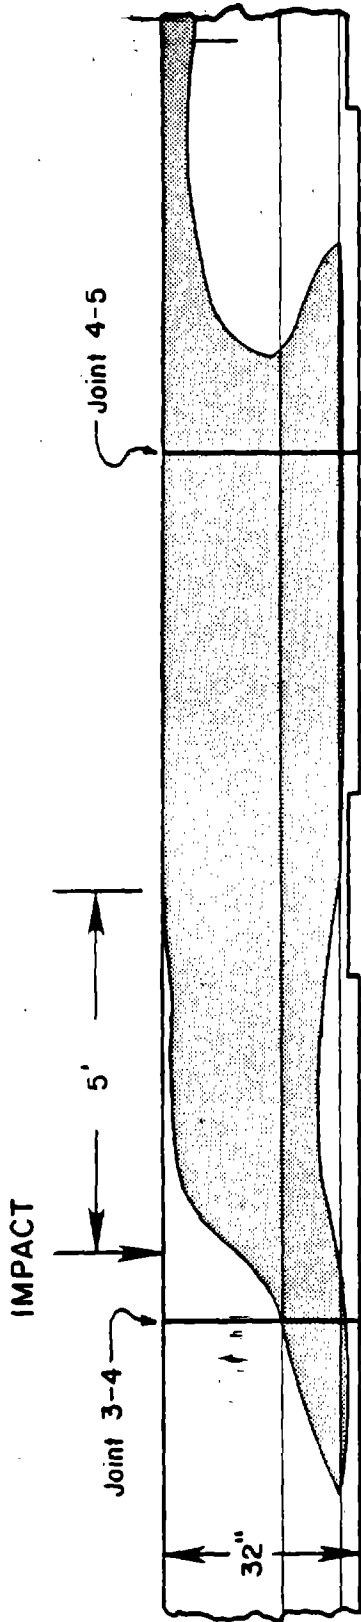
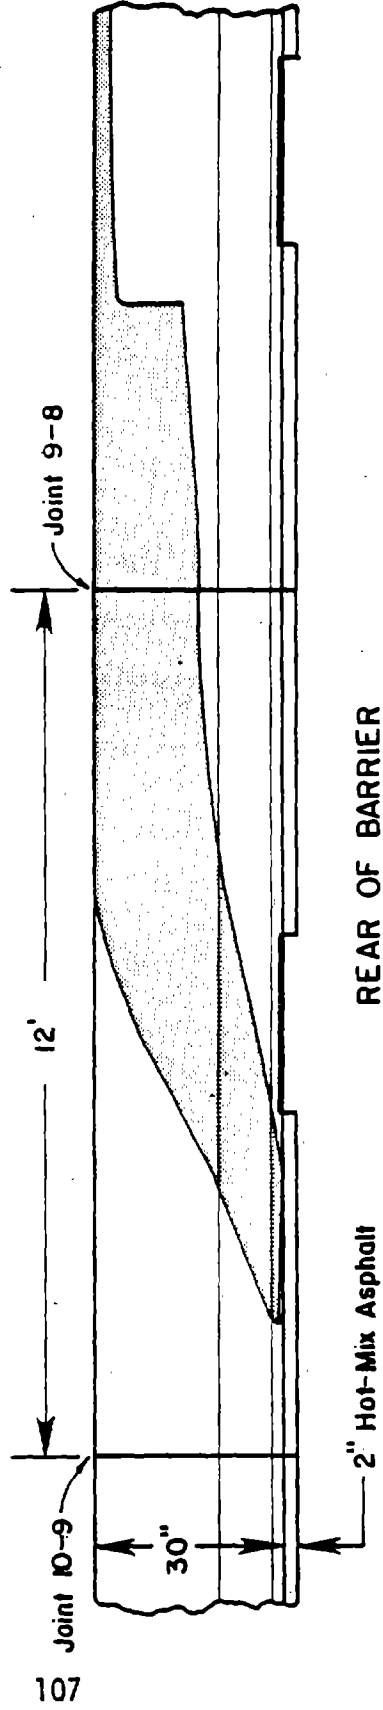
Figure 80. Tire path for test 3825-17.

The vehicle impacted the barrier approximately 1.0 ft (0.3 m) downstream of the joint between segments 3 and 4. The tire path on the barrier face is shown in figure 80. The top of the path reached the top of the barrier approximately 5.0 ft (1.5 m) downstream of the impact point. Tire marks extended to the upper edge of the barrier for a distance of over 60.0 ft (18.3 m) as shown in figure 81. Marks were also made on the rear of the barrier. Total length of contact was approximately 86.0 ft (26.2 m). The vehicle was redirected; however, it rolled onto the barrier and slid off the end at about 1.224 sec. Maximum roll was approximately 94 degrees. The speed of the vehicle at 1.000 sec (end of data processing) was 54.1 mph (87.0 kph).

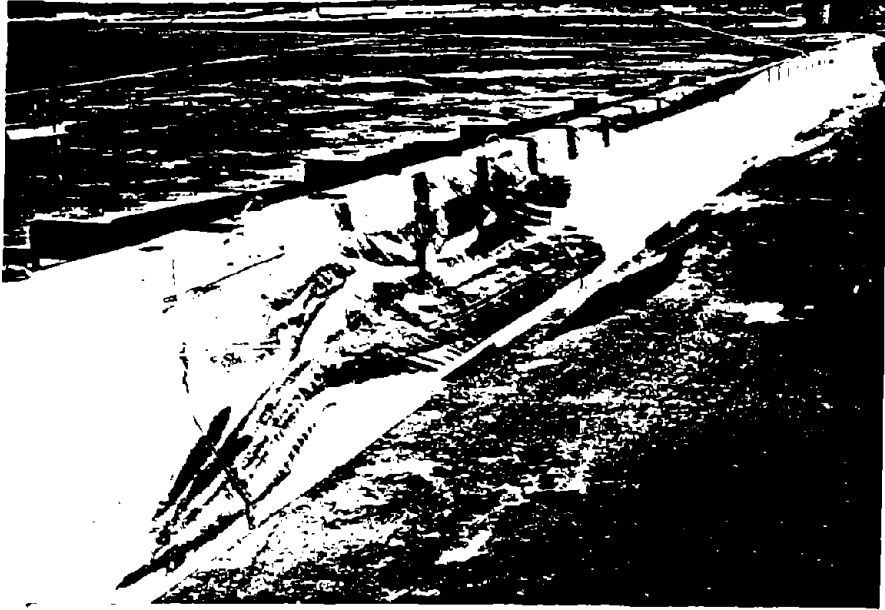
Figure 81. Barrier after test 3825-17.

The barrier received damage extending from the downstream end of segment 3 to the downstream end of the barrier (approximately 86.0 ft (26.2 m)). Joints 3-4, 4-5, 5-6 and 6-7 were chipped and cracked. Damage to the front of barrier is shown in figure 81. The top rear of segment 6 and the steel framework were scraped. Tire marks started on the top rear of segment 7, moved along the rear of segment 8 and ended near the ground 1.8 ft (0.6 m) upstream of joint 9-10. The rear of segment 10 was scraped. The barrier showed no measurable sign of movement.

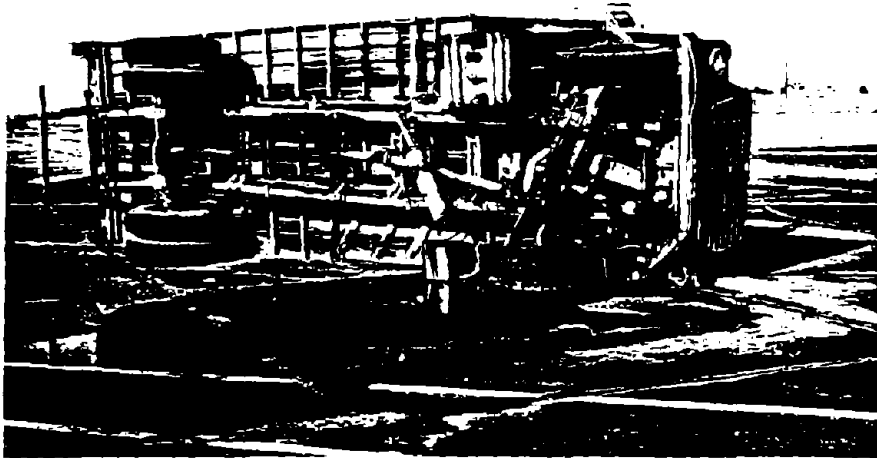
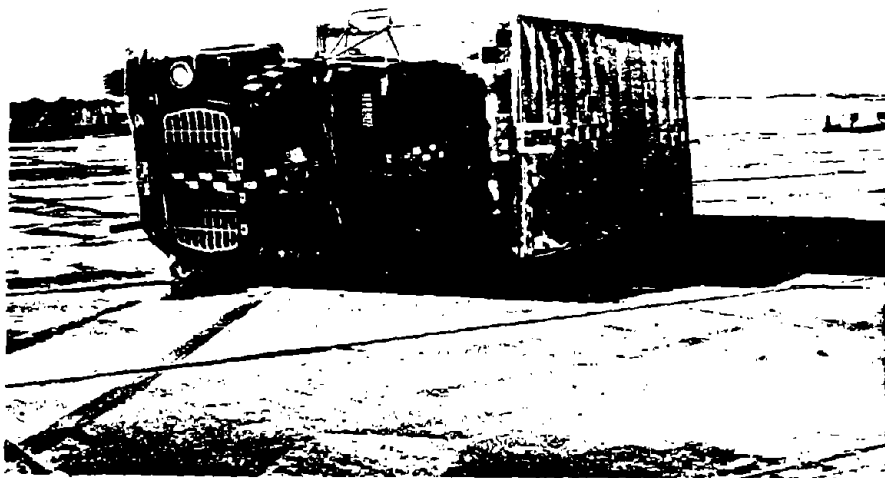
Figure 82. Vehicle after test 3825-17.

The vehicle was severely damaged. The U-bolts attaching the axle to the frame were broken and the frame was bent. The motor mounts, springs

and shackles were severely damaged. The vehicle is shown in figures 82 and 83.

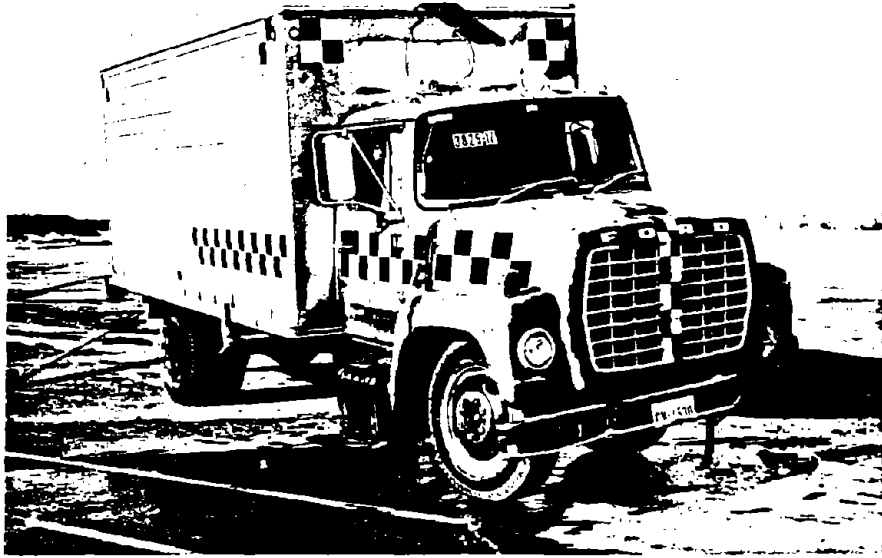
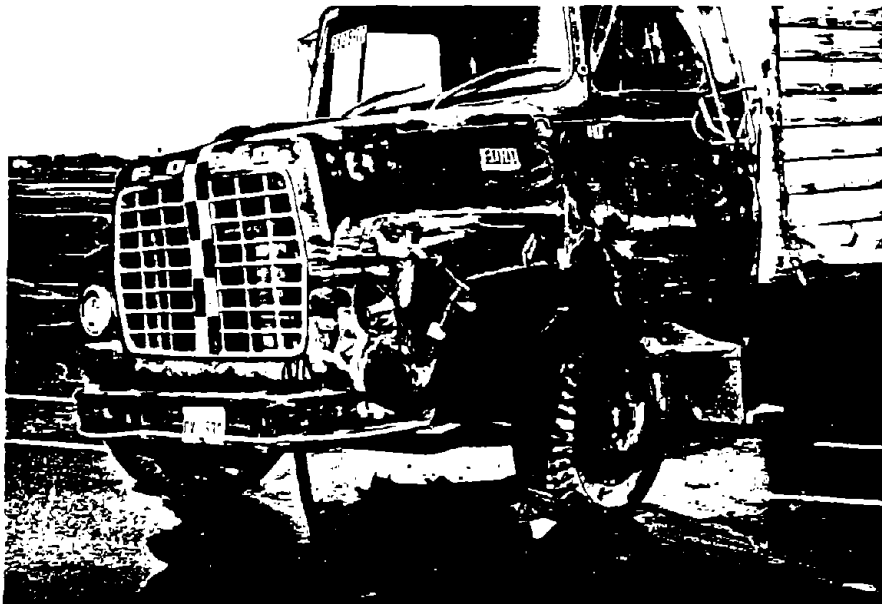
Figure 83. Vehicle after being uprighted
(After test 3825-17)

The barrier redirected the vehicle and detached elements did not penetrate the occupant compartment. However, the vehicle rolled onto the barrier and subsequently slid off the end of the barrier and came to rest on its left side. Vehicle change in speed at 1.000 sec after impact was 6.0 mph (9.7 kph).

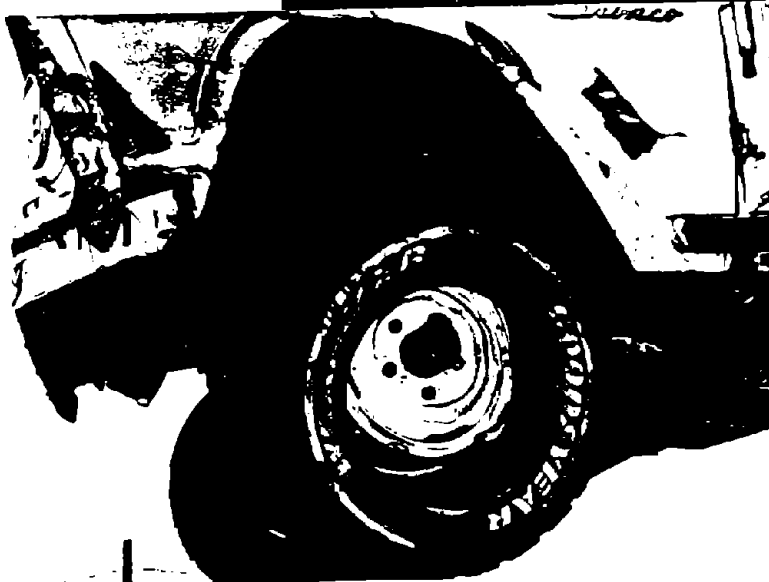
Figure 104. Damage to 1966 Ford Bronco suspension in test 3825-11.

There was significant damage to the suspension of the vehicle on this test, as documented in figure 104. The left front control arm was bent out of line approximately 6 in (15 cm). This appears to be a column-buckling type failure due to the longitudinal loading from impact. This buckling allowed a rearward displacement of the left side of the solid axle of approximately 2 in (5 cm). There was no apparent damage to the frame. The left front wheel rim was damaged sufficiently to cause an air-out of the tire. The suspension damage was probably not severe enough to prevent a driver from regaining control after redirection.
