BARRIERS IN CONSTRUCTION ZONES

VOLUME 4

Report No.
FHWA/RD-86/095

1. Report No. FHWA/RD-86/095		2. Government Accession No.		3. Recipient's Catalog No.	
4. Title and Subtitle BARRIERS IN CONSTRUCTION ZONES - THE RESPONSE OF ATYPICAL VEHICLES DURING COLLISIONS WITH CONCRETE MEDIAN BARRIERS VOLUME 4				5. Report Date April 1985

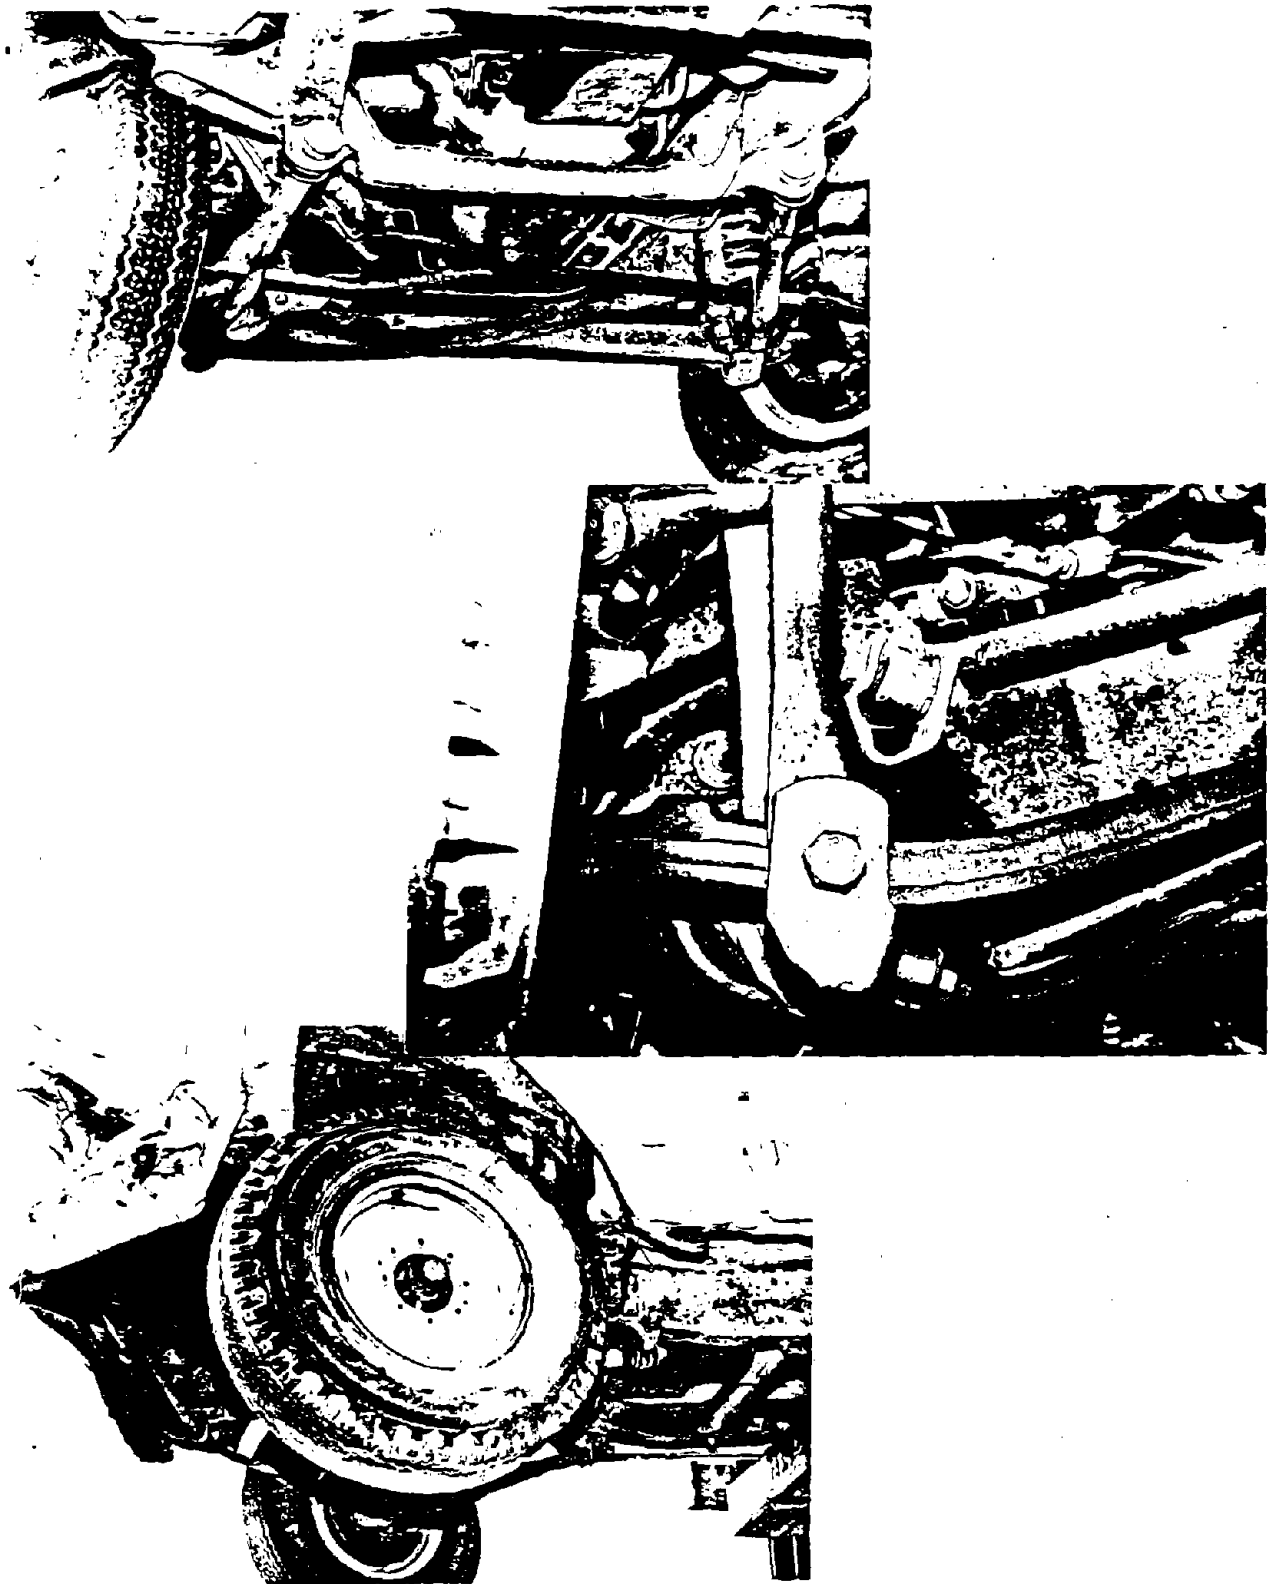
Figure 106. Damage to 1974 Ford F250 pickup suspension in test 3825-14.

1974 Ford F250 Pickup 60 mph 15-degree angle
There was significant damage to the suspension of the vehicle on this test, as documented in figure 106. The left side I-beam was severely bent rearward outside of the control arm attachment, and bowed downward inboard of the control arm. The maximum deviation from the original relatively straight shape was about 6 in (15 cm). The rearward force of impact caused the outward bend, while the sideward force caused the column buckling type failure (bowing). The control arm was relatively undamaged, showing only a slight compression deformation. The split ring detached on both front wheels allowing both tires to deflate. The deformation in the I-beam allowed the left front wheel to move rearward sufficiently to heavily contact the wheel well. This damage was probably sufficient to cause driver control problems after redirection.

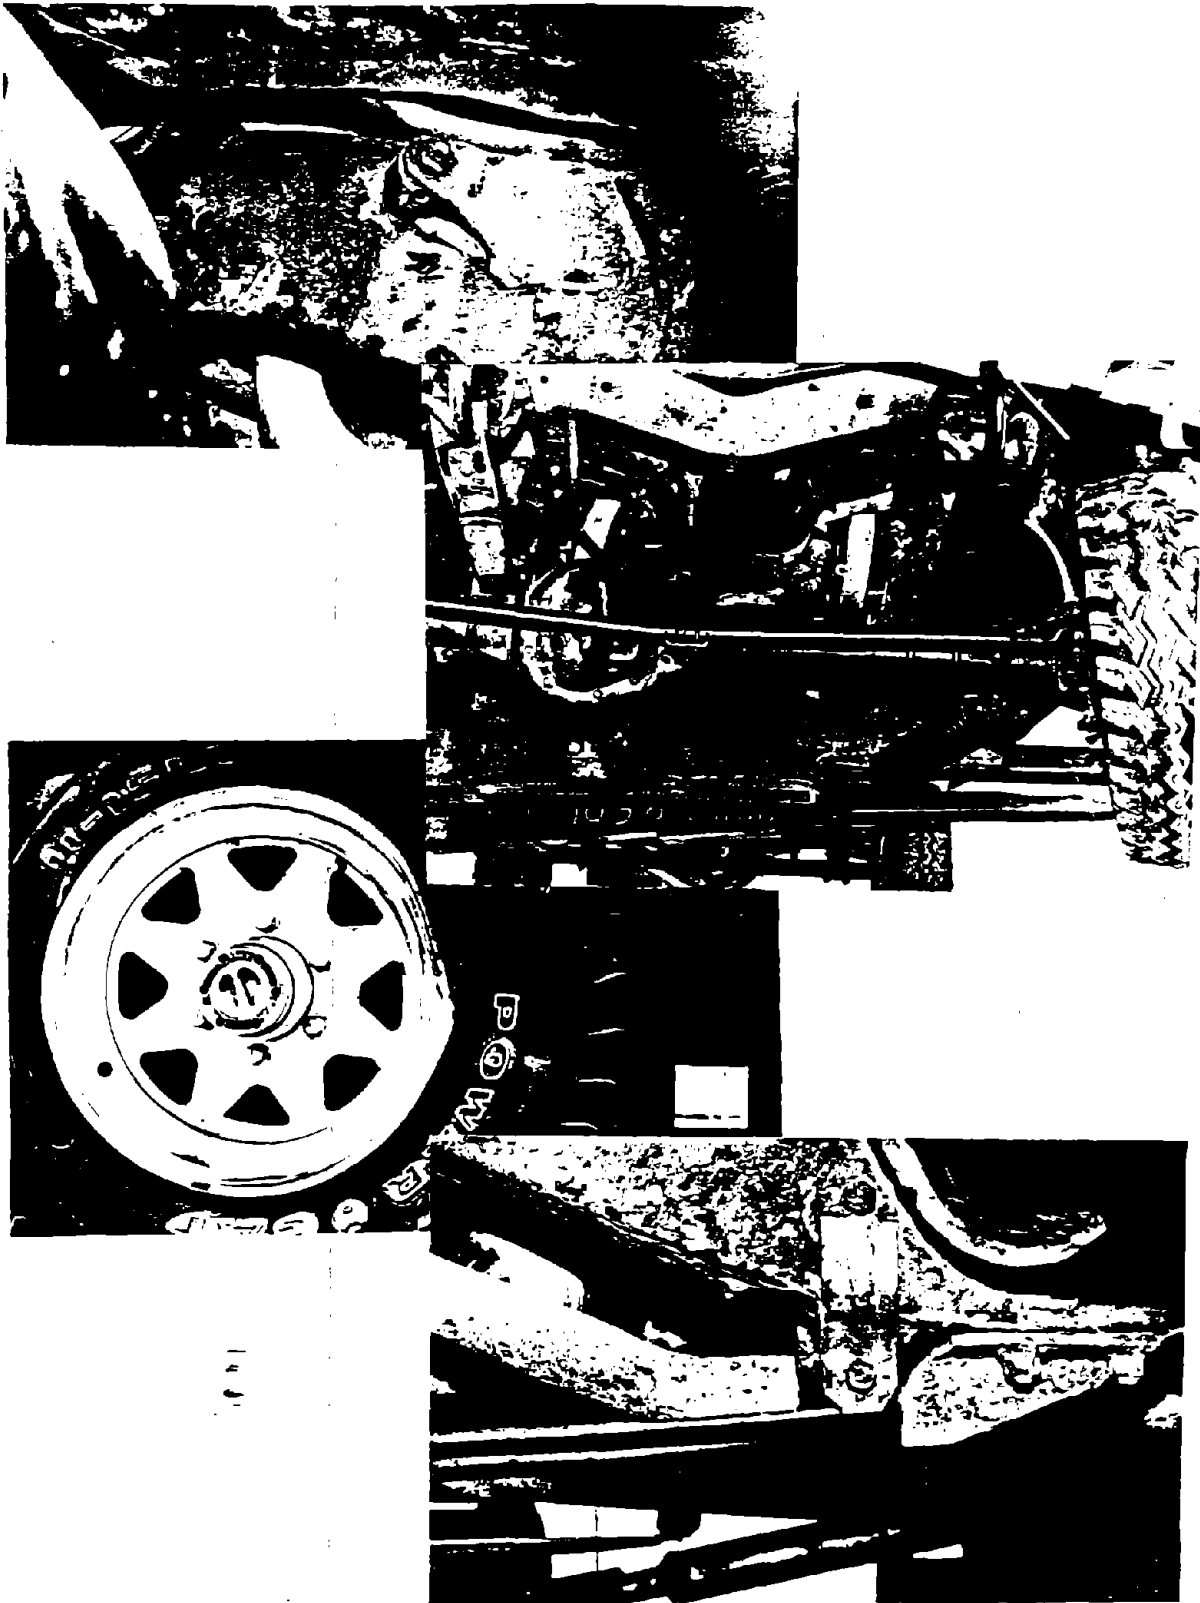
Figure 108. Damage to 1972 Chevrolet 4WD pickup suspension in test 3825-16.

There was significant damage to the suspension of the vehicle on this test, as documented in figure 108. The front of the left spring attaches to the frame through a shackle. This shackle was bent sideways toward the center of the vehicle by approximately 3/4 in (2 cm). The frame arch above the axle on the left front was buckled, with the front spring attachment approximately 2 in (5 cm) lower than originally. The combination of these two deformations caused the left front leaf spring leafs to separate horizontally and twist relative to their original position. The shock/booster spring failed at the upper eyelet connection to the shaft. The left front wheel was severely deformed and bent out of plane due to contact with the barrier. The tire side wall was cut and resulted in an air-out. The suspension damage was probably not severe enough to prevent a driver from regaining control after redirection.

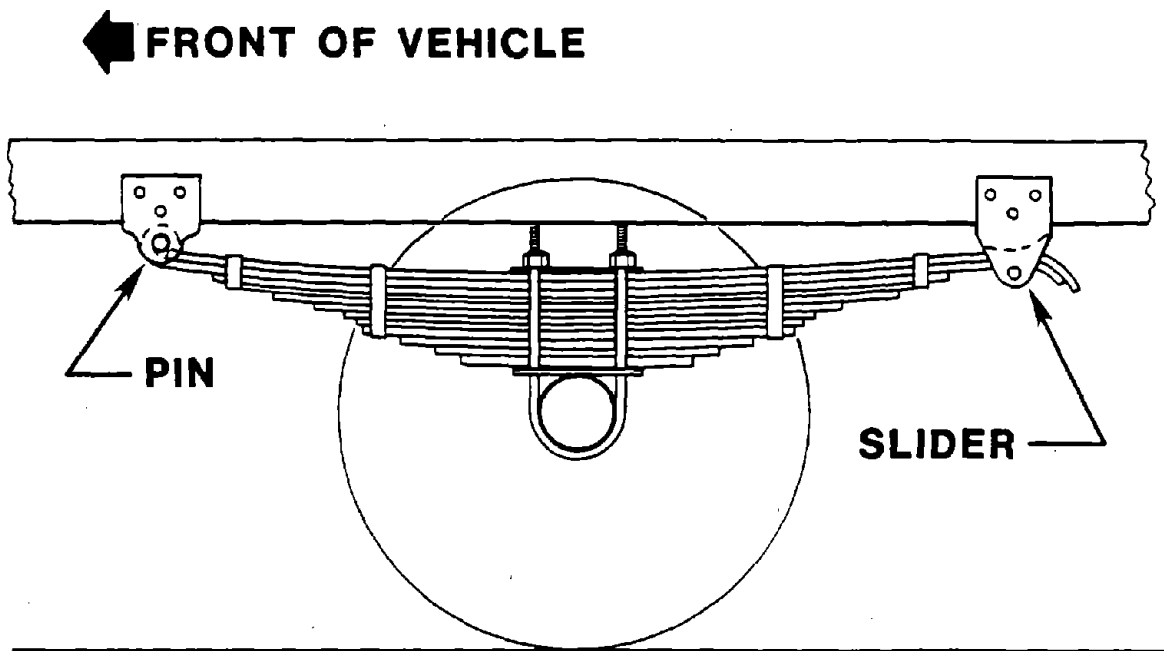
Figure 112. Leaf spring system (1): pin support at front with slider to rear.

During the course of testing a number of school buses during the 1970's and 80's, primarily pre-1970 buses, researchers at Southwest Research Institute noted some major differences in the way the front suspensions of different bus makes were constructed. Figures 112, 113 and 114 show three ways leaf springs carrying the front or steering axle were attached to the frame. Figure 112 shows a common system of having a pin support at the front with slider to the rear. Figure 113 shows the reverse of 112, i.e. slider to the front, pin support at the rear. Figure 114 is somewhat similar to 112 except that it has a shackle to the rear in place of the slider.

1. Pin Forward, Slider to Rear.
Section A. Torsion, Moment and Tension
Section B. Moment and Torsion
2. Slider Forward, Pin to Rear
Section A. Moment and Torsion
Section B. Torsion, Moment and Compression
3. Pin Forward, Shackle to Rear
Section A. Torsion, Moment and Tension
Section B. Moment and Torsion

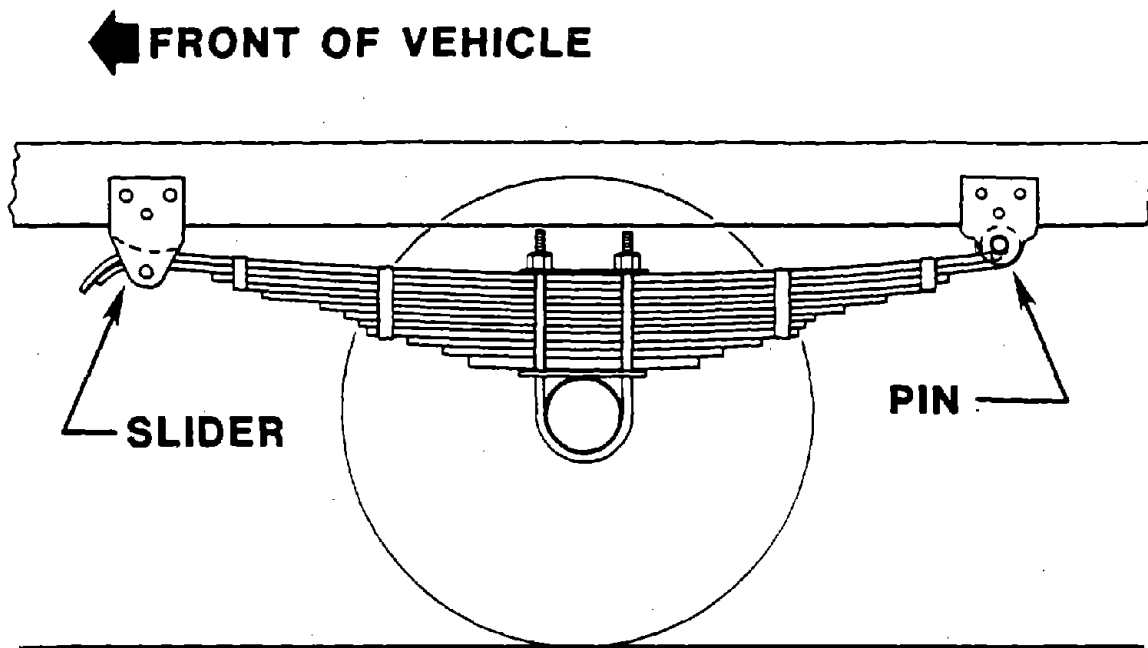
Figure 113. Leaf spring system (2): slider at front with pin support to rear.

Comparison of these three cases indicate 1 and 3 are quite similar but both of these have a major difference from 2. In Case 2, a critical spring section (Section B) is placed in compression while in Cases 1 and 3 the critical section (Section A) is placed in tension. Considering the relatively small cross section, there is no doubt the compression situation is the most critical. A local buckling situation will be produced if the rearward force F_x' becomes large enough. This type of

Although there are many ways front suspensions can fail when subjected to the intense loads typical during impacts with CMB's, it does appear the slider to the front case, as shown in figure 113, is more sensitive to these loads, from the view point of structural geometry, than are Cases 1 and 3, which move the pin to the front. It is this simple - a leaf spring, when subjected to loads along its longitudinal axis can support more tensile load than it can compressive load.

During the course of this contract examples of this slider forward condition were sought for straight trucks. None were found. The only examples of this found to date have been in pre-1970 school buses. The writers feel strongly that this suspension configuration should be discouraged.

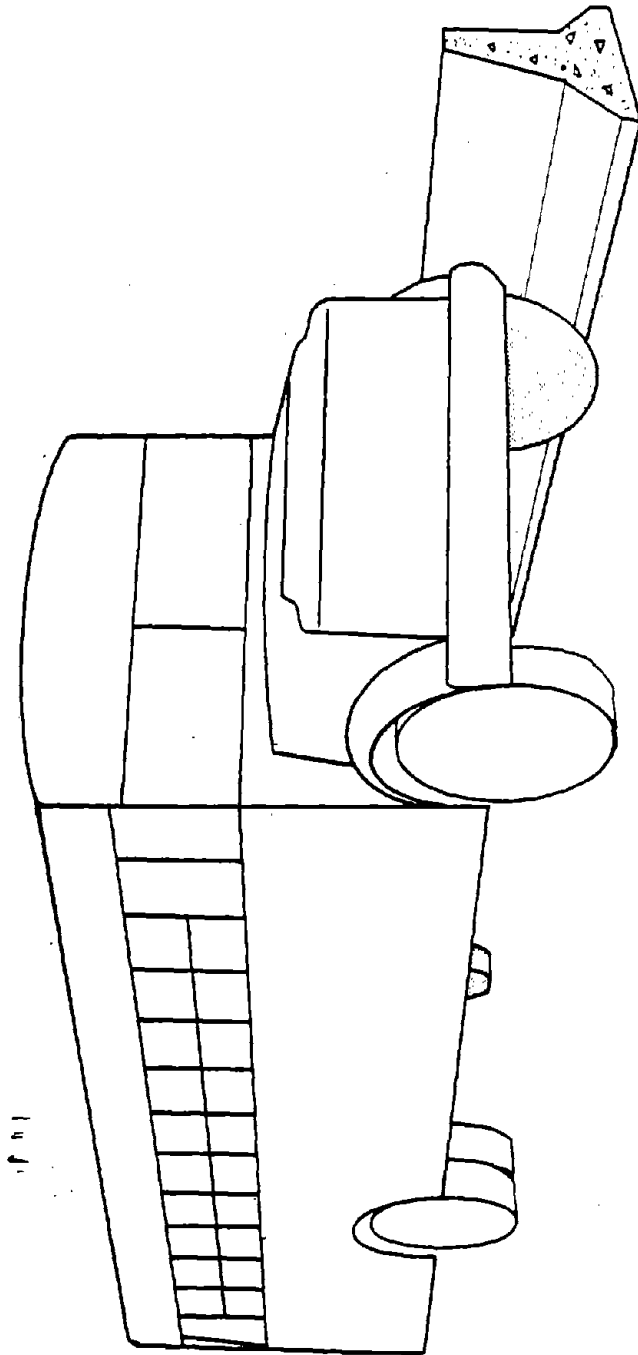
Figure 115. Impact on left front wheel.

Crash tests of buses into concrete median barriers (CMB's) as shown in figure 115 can produce loads on the impacting front wheel that will cause structural damage to both wheel and suspension. In some cases the front axle may be knocked completely out from under the bus. The main loads produced by this kind of an impact are shown in figure 116.

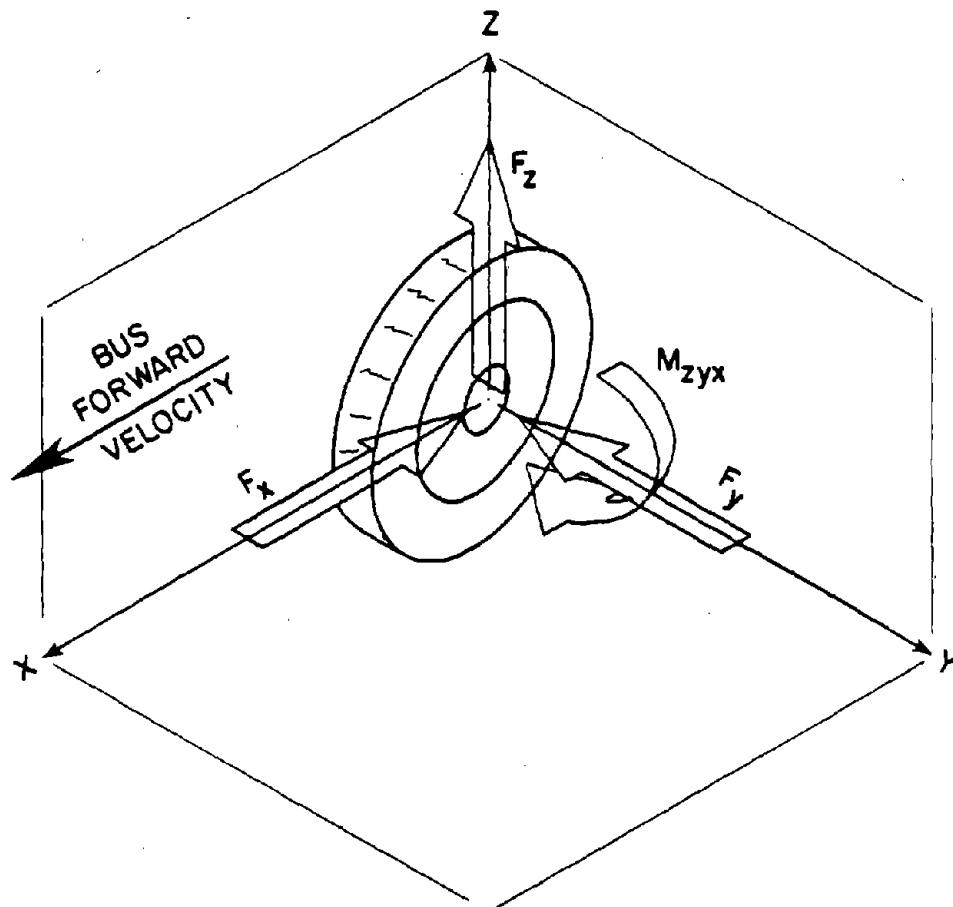
Figure 116. Main loads on the left front wheel impacting a CMB.

M_{zyx} is a moment about the x axis in the zy plane tending to make the wheel in contact with a CMB tuck under. Using the right hand rule this would be a negative rotation about the x axis. The freedom of the vehicle wheel to roll and the steering degree of freedom would preclude development of major moments about the y and z axes respectively.

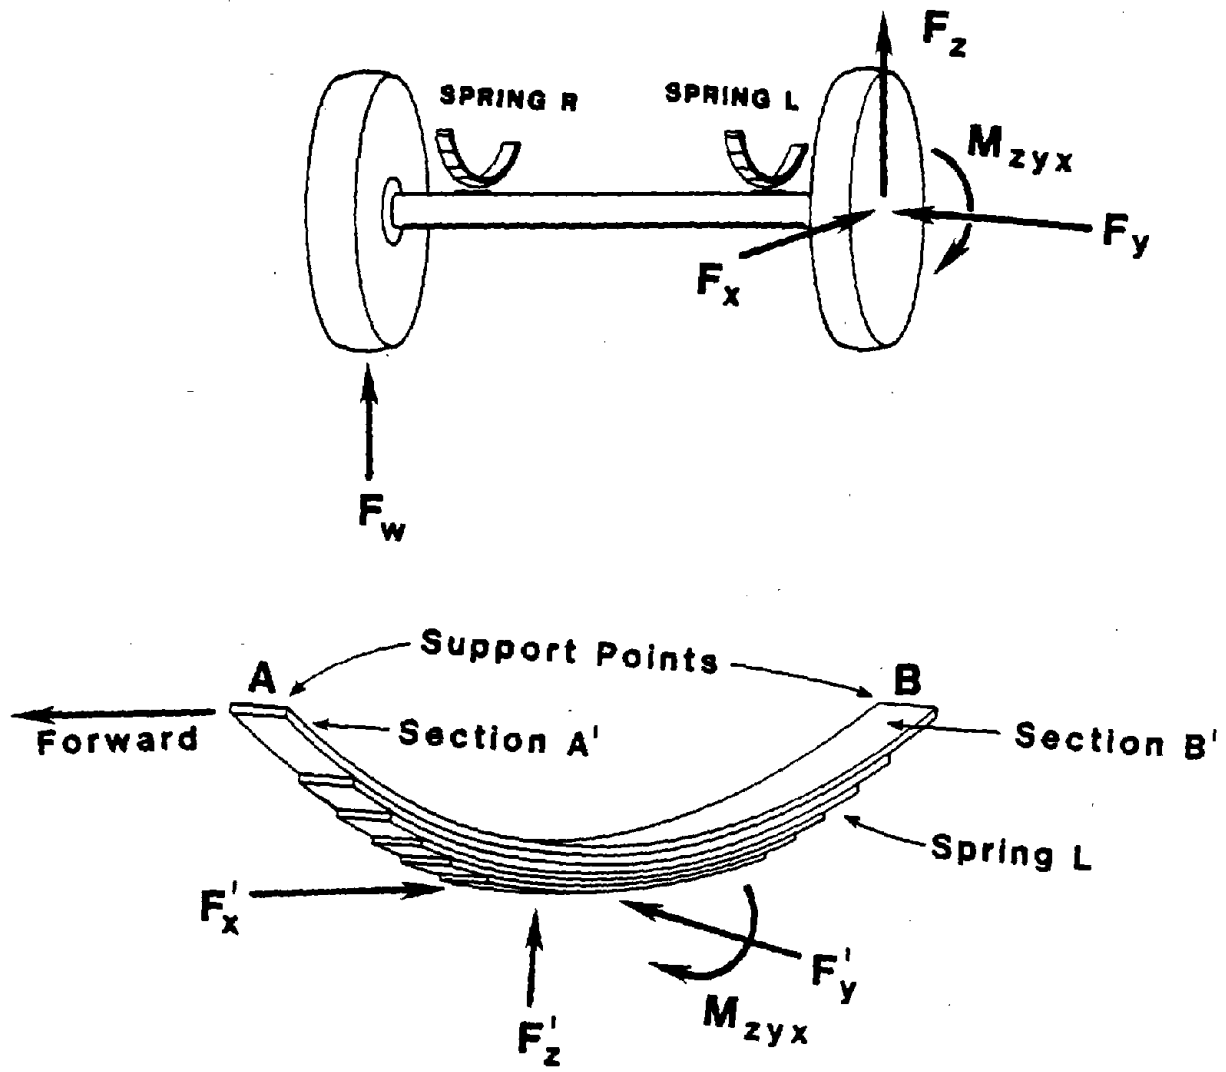
Figure 117. Forces transmitted to the impact side front leaf spring.

The major forces and moment acting on the left spring (Spring L of figure 117) are transmitted from the wheels through the axle to the spring. These forces and moment are in directions the same as those specified on the wheel and are caused primarily by the forces on the wheel. Figure 117 shows how these forces would be transmitted through the axle to the leaf springs.

failure is illustrated by figure 118. Another disadvantage of Case 2 is that Case 2—(slider forward) is the only one which can produce disengagement of the spring from the forward support if the spring bends in compression due to the force, F_x' (figure 117). It may be equally important to consider what happens if the bolts holding a pin bracket to the frame are sheared. Such an occurrence is shown in figure 119. In this case, if the pin bracket is forward, some support of the spring and axle is still available from the rear slider or shackle (See figure 120). This may be enough to hold the axle under the vehicle following a collision. In contrast, if the pin bracket is to the rear its failure allows the spring to move rearward and disengage from the front axle. Neglecting support from steering linkage, the axle is then completely unsupported on one side. This can lead to a progressive failure of supports on the other end of the axle and complete loss of the steering axle. This situation may make a roll more likely.
