# **DOWNSTREAM ANCHORING REQUIREMENTS FOR THE MIDWEST GUARDRAIL SYSTEM**

## **WISCONSIN DEPARTMENT OF TRANSPORTATION**

MwRSF Research Report No. TRP-03-279-13

October 28, 2013

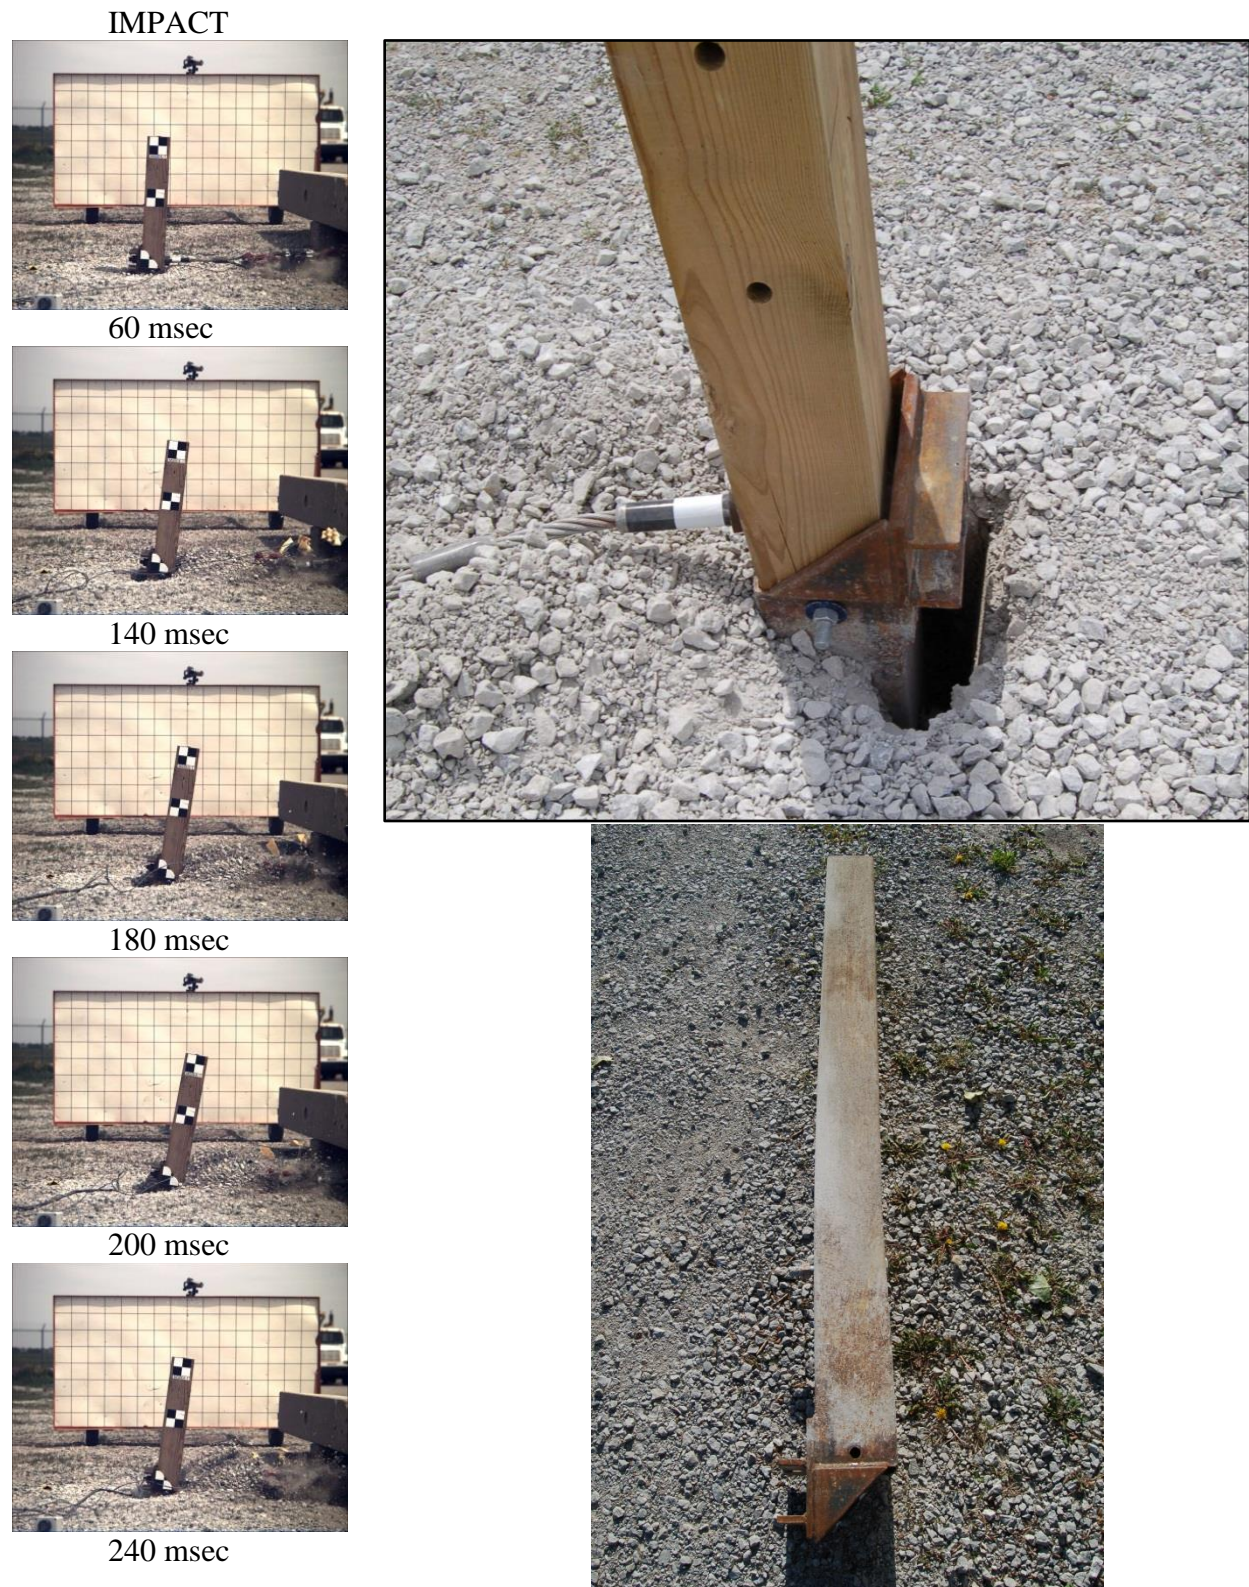
Figure 37. Time-Sequential and Post-Impact Photographs, Test No. MGSEA-1

Time-sequential and post-test photographs of test no. MGSEA-1 are shown in Figure 37. During test no. MGSEA-1, the anchor foundation tube was pulled by the cable attached to the bogie vehicle, which was traveling at an initial speed of 16.1 mph (26.0 km/h) when the cable started to be tensioned. As a consequence of the pull force, the foundation tube rotated through the ground over a maximum dynamic displacement of 6.5 in. (165 mm). The final permanent

set deflection was 4.2 in. (107 mm), as measured using the string potentiometer attached to the back of the tube at ground line. The steel foundation tube bent slightly, thus initiating a plastic hinge at about 8½ in. (216 mm) from its top edge.

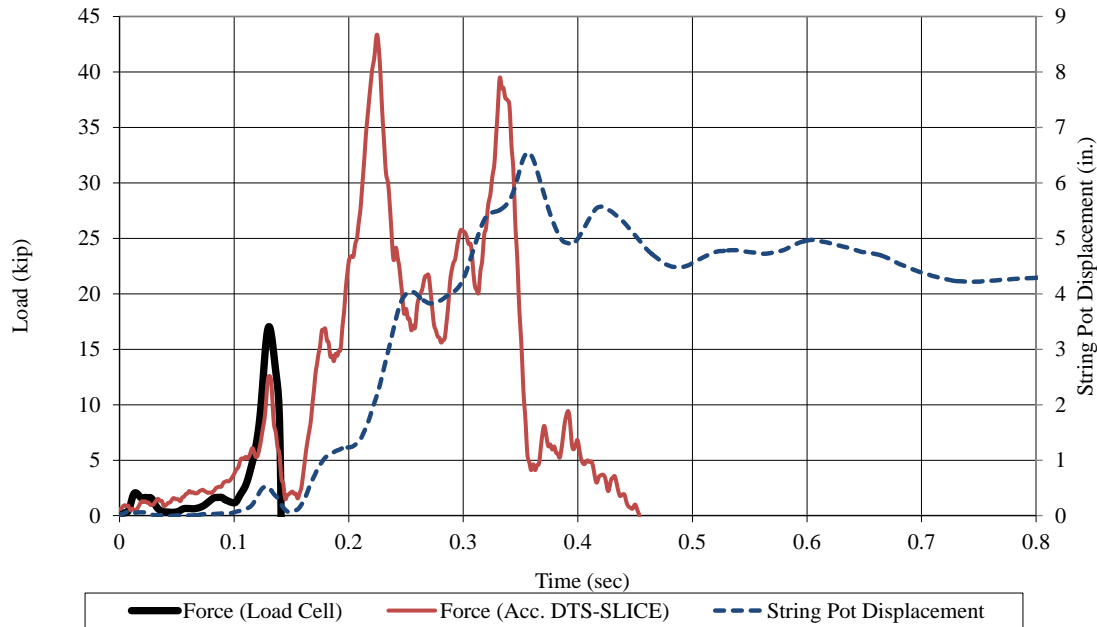
Figure 38. Forces vs. Time and Displacement vs. Time, Test No. MGSEA-1

The load cell cable connector became disconnected almost immediately after the pull cable was tensioned. Thus, the force was obtained using acceleration data from the bogie vehicle. Although the acceleration measured at the bogie center of mass may include damping effects due to the extension of the pull cable and a time shift, it still provides useful information related to load resistance of the foundation tube embedded into the soil. The maximum peak load was 43.4 kips (193 kN), as obtained from DTS-SLICE accelerometer data.

The force measured by the accelerometer mounted on the bogie, DTS-SLICE, indicated that the maximum force encountered by the BCT anchor cable was approximately 43.4 kip (193

kN), leading to a maximum displacement of the soil tube of approximately 6.5 in. (165 mm) as measured by the string pot. However, real-world soil strengths may be lower than provided by the coarse, compacted crushed limestone recommended by MASH and used for this bogie testing effort. Larger deflections of soil tubes may occur when anchor loads approach the failure limits of a guardrail system's end anchorage.

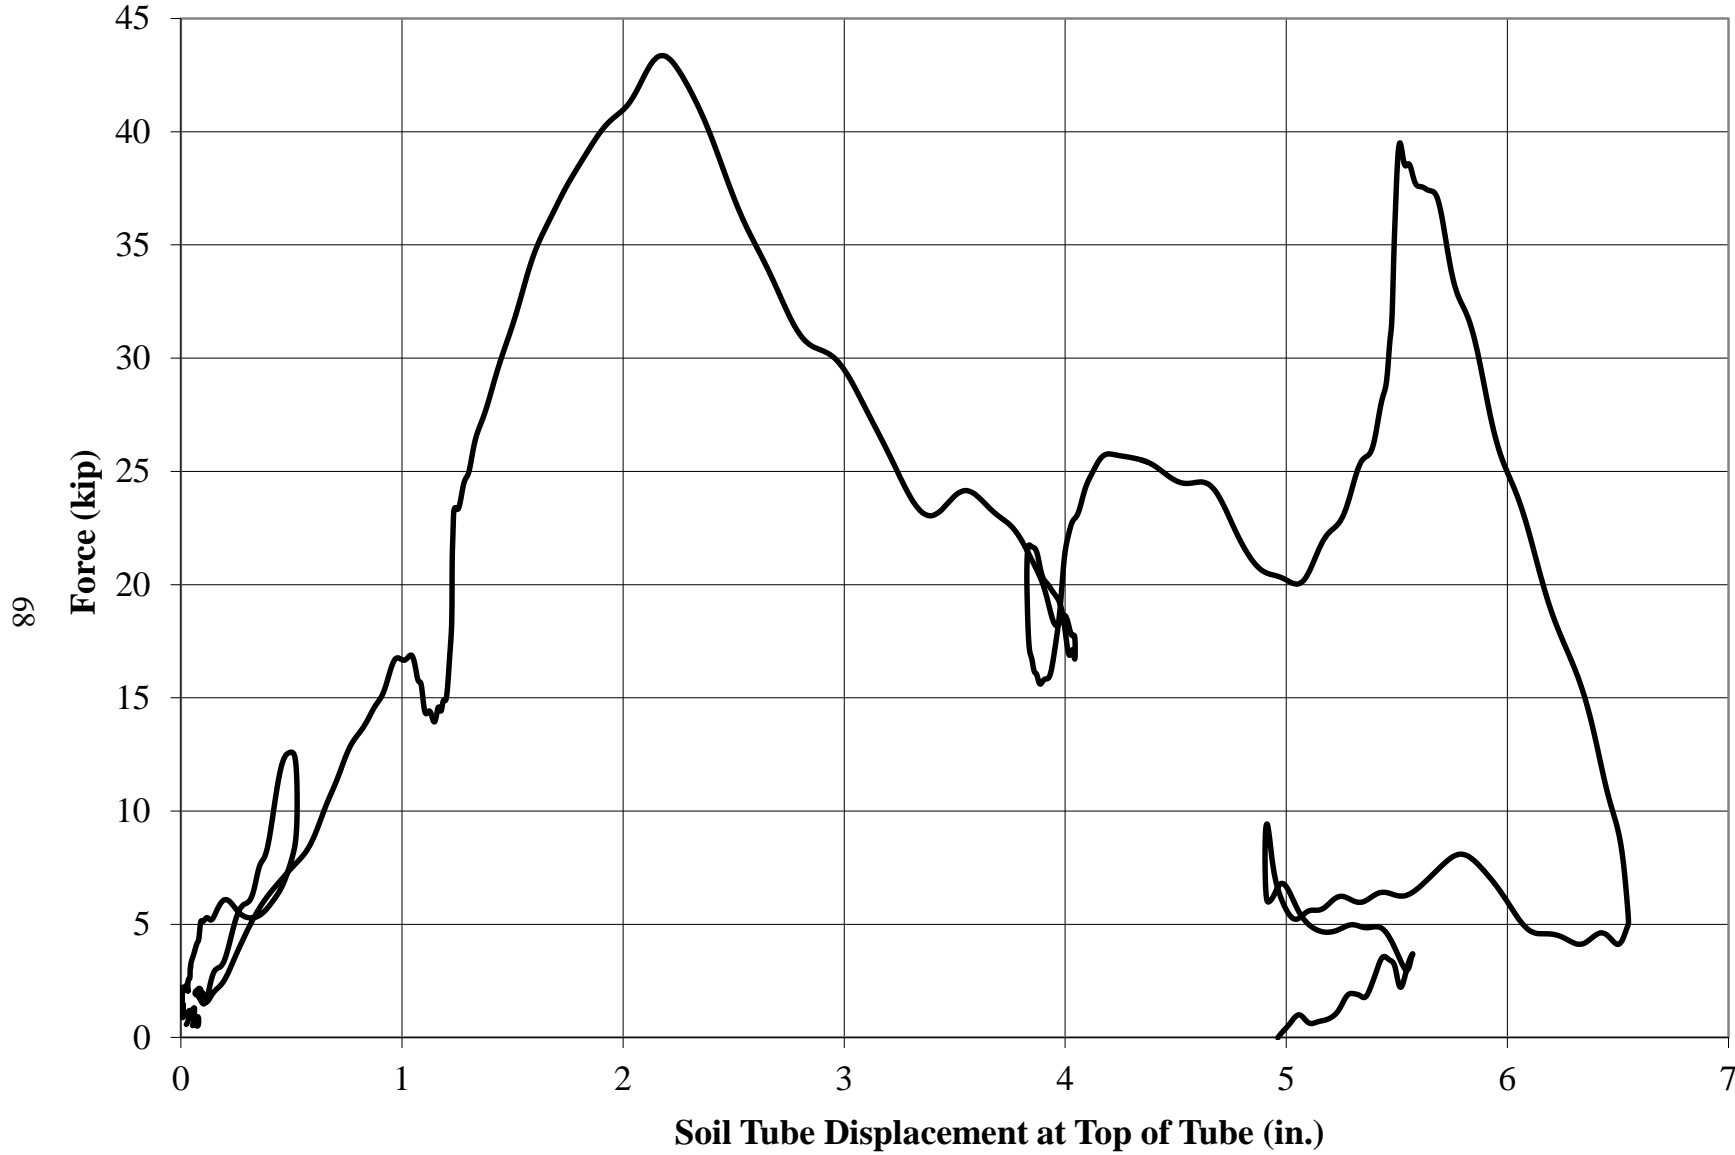
Figure 39. Bogie Force vs. Soil Tube Displacement Measured by String Pot, Test No. MGSEA-1

The force versus deflection curve of the soil foundation tube in test nos. MGSEA-1 is shown in Figure 39. An initial tension pulse caused the force on the foundation tube to ramp up to 13 kip (58 kN), and the deflection increased approximately proportional to the load to a maximum of 0.5 in. (13 mm), after which point the force and deflection dropped to nearly zero. This indicated the foundation tube and soil interaction was initially linearly elastic. The largest force impulse, experienced at approximately 2 in. (51 mm) of deflection, was required to overcome inertia and move the soil and foundation tube. A relatively steady force was recorded between 3 and 5 in. (76 and 127 mm) of displacement before the final force spike and maximum deflection were reached.

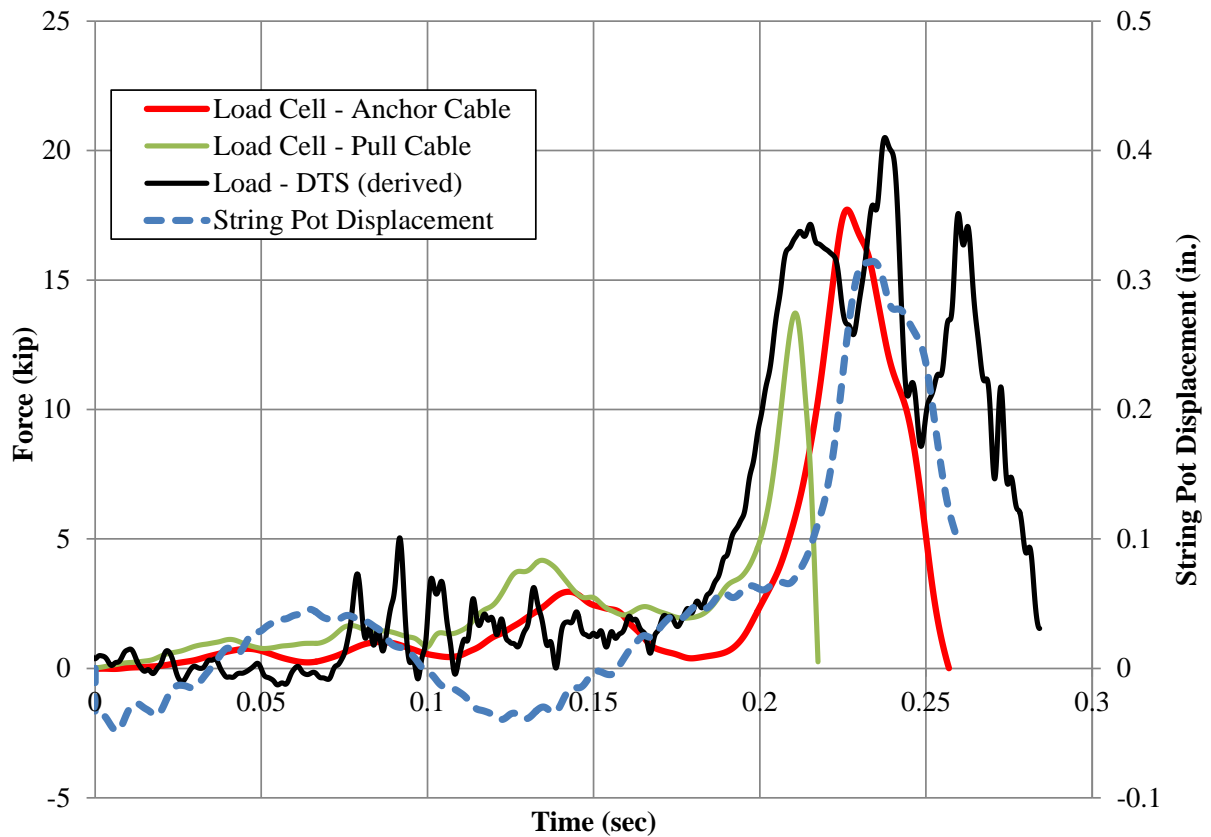
Figure 53. Forces vs. Time and Displacement vs. Time, Test No. DSAP-1

During test no. DSAP-1, the nylon strap used in the connection joint between the pull cable and upstream end of the guardrail ruptured. As a consequence, the anchorage was only partially loaded, and no damage occurred to the wood posts or the post-to-rail connection.

The force versus time curve and deflection versus time curve for test no. DSAP-1 are shown in Figure 53. The load measured by the two compressive load cells in test no. DSAP-1 were discarded, because it was determined that the washer-type load cell is extremely sensitive to small misalignments. The results from all transducers used during the test are provided in Appendix C. The maximum force measured by the tension load cell attached to the anchor cable was approximately 18 kip (80 kN) at approximately 0.13 sec after the start of the pull event. The maximum displacement, as measured by the string potentiometer connected to the top of the foundation tube of the end post, was approximately 0.31 in. (8 mm) and occurred in concomitance to the peak force in the anchor cable. Time-sequential and post-impact photographs are shown in Figures 54 and 55, respectively. Due to the uncertainty associated with the start time in the string pot and load cells, the start time used for the load cell, anchor cable, and string pot data should be considered approximate. Therefore, force versus displacement and energy versus displacement curves were not plotted.

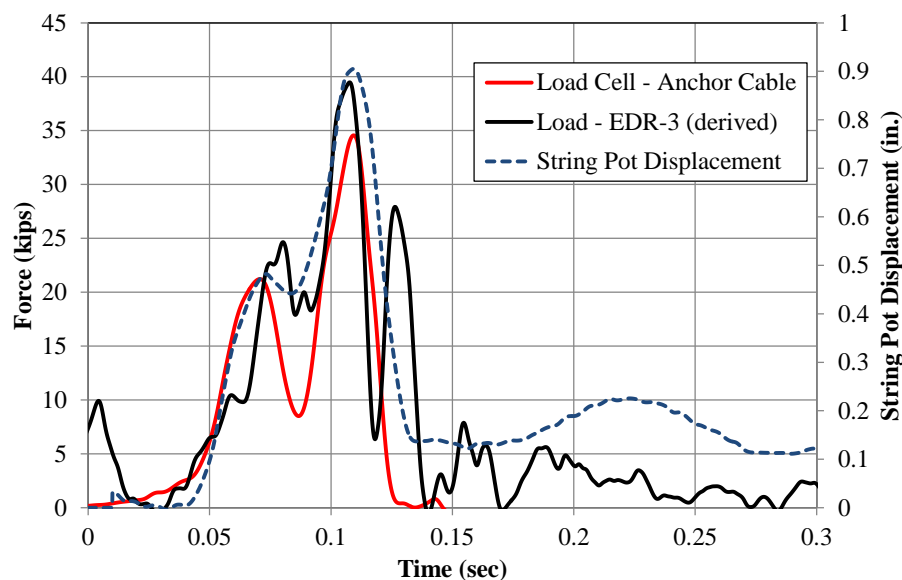
Figure 56. Force vs. Time and Displacement vs. Time, Test No. DSAP-2

The force versus time and the deflection versus time curves for test no. DSAP-2 were processed from transducer data. Event start times for the load cells, accelerometer, and string pot data were approximated, and the processed data are shown in Figure 56. Technical difficulties with the pull cable load cell rendered pull cable tension data unusable. The results from all transducers used during the test are provided in Appendix C. As illustrated in the force versus time curve, two peak forces of about 21 kip (93 kN) and 35 kip (156 kN) occurred at around 0.06 sec and 0.10 sec, respectively. Two local maximum displacements of about 0.5 in. (13 mm) and 0.9 in. (23 mm) were measured by the string potentiometer connected to the base of the end post. These two local peak displacements occurred at nearly the same time as two local force peaks. Time-sequential photographs are shown in Figures 56 and 57. Post-impact photographs are shown in Figure 58.

The maximum load sustained by the end anchorage was between 35 and 40 kip (156 and 178 kN). A reasonable limit for estimating the capacity of an end anchorage would thus be 35 kip (156 kN). The anchor cable load versus downstream foundation tube displacement is shown in Figure 60. The loading curve of the anchor was linear through 0.40 in. (10 mm). The maximum load of 35 kip (156 kN) occurred at nearly the same time as the maximum deflection of 0.90 in. (23 mm). The anchor rebounded 0.75 in. (19 mm) in the soil, with a maximum permanent set deflection of 0.15 in. (4 mm). It should be noted that the rebound force curve was not relevant, because the anchor cable load cell disengaged from the soil foundation tube after the BCT post fractured and the bearing plate was released.

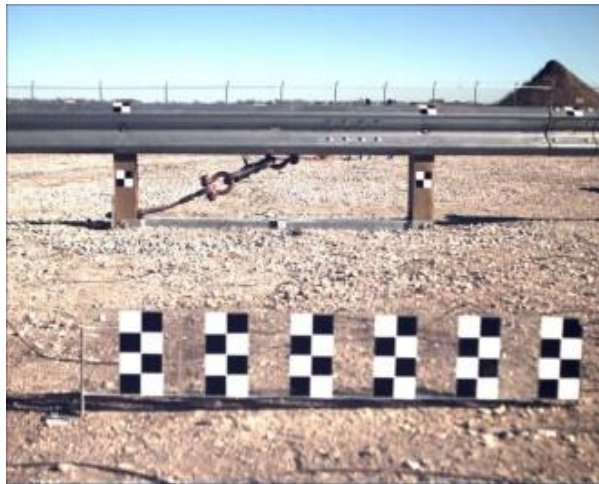
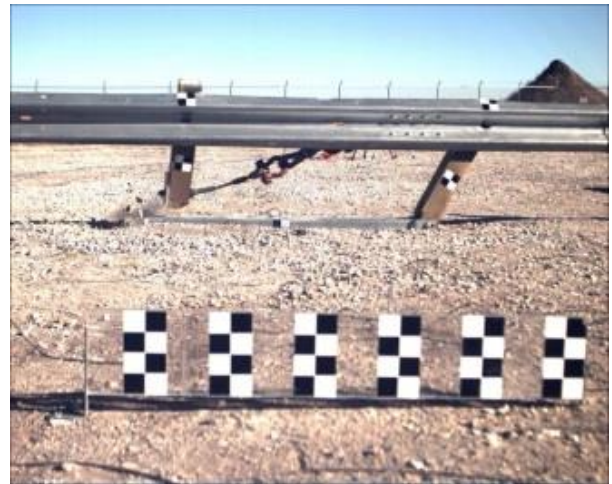
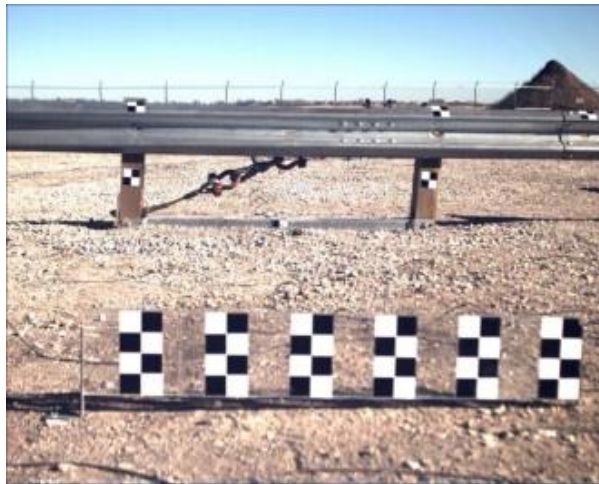
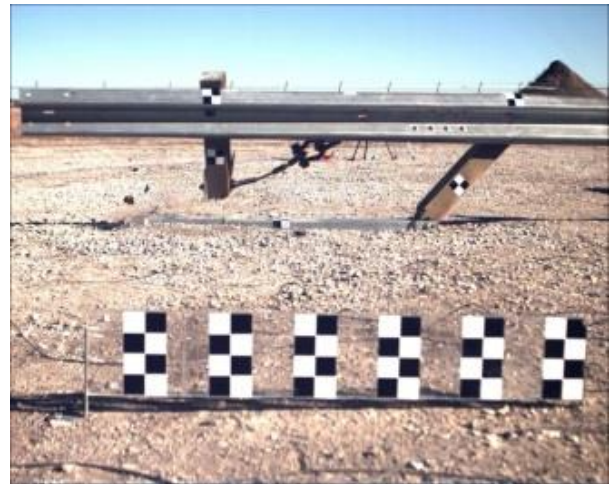
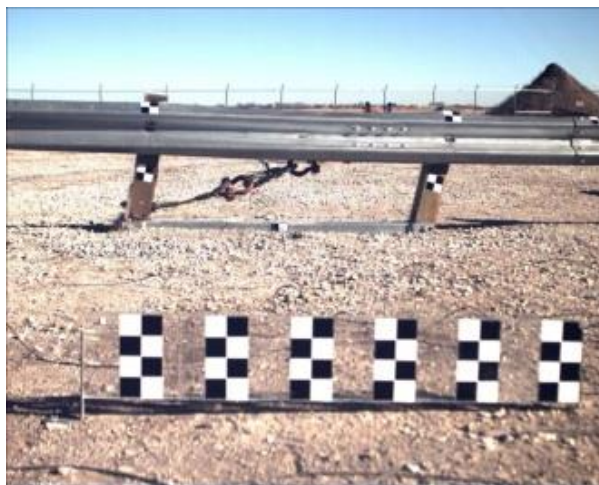
Test no. DSAP-2 was conducted as a repeat of test no. DSAP-1; since, the nylon strap that was used to connect the pull cable to the anchor cable ruptured during the first test. As the pull cable started to be tensioned in test no. DSAP-2, the rail was pulled upstream, causing the two wood BCT posts to deflect upstream. The pull force was almost immediately transferred to the two foundation tubes, which rotated through the soil. When the cable anchor was tensioned, a downward vertical force component was applied to the rail. This force deformed the upper side of the rail slot at the connection with each of the two BCT posts due to the contact with the post bolt. The end BCT post fractured at the ground line first, followed immediately after by the other BCT post. After the fracture of the two BCT wood posts, the W6x8.5 (W152x12.6) steel

For test no. DSAP-2, several important observations were made. The increased tension in the anchor cable caused the farthest downstream anchor post to fracture first. The post was pulled upward and upstream by the releasing anchor cable, but it remained attached to the rail following fracture until it had rotated nearly 90 degrees. The second post from the downstream end also fractured at nearly the same time, but the post largely rotated around the BCT hole toward the ground level, and the post released away from the rail during fracture. Neither post was split due to the BCT loading through the post bolts.

The upward motion of the downstream BCT post after fracture was likely the result of the angle of the anchor cable between its attachment point on the W-beam and the BCT post. As the anchor cable tension increased, the angle of the cable resulted in a vertical force and a shear load applied longitudinally to the post. The lifting load from the cable pulling on the post was clearly visible at 0.120 sec into test no. DSAP-2, as shown in Figures 57 and 58.

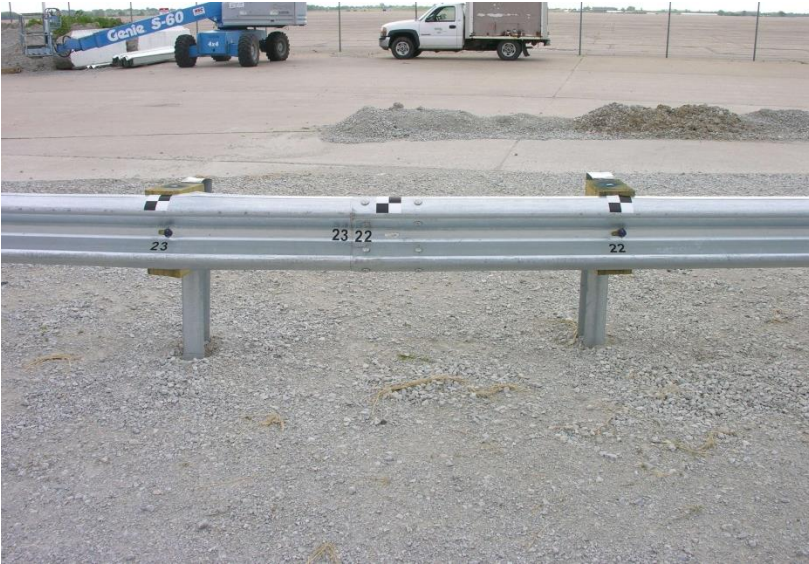
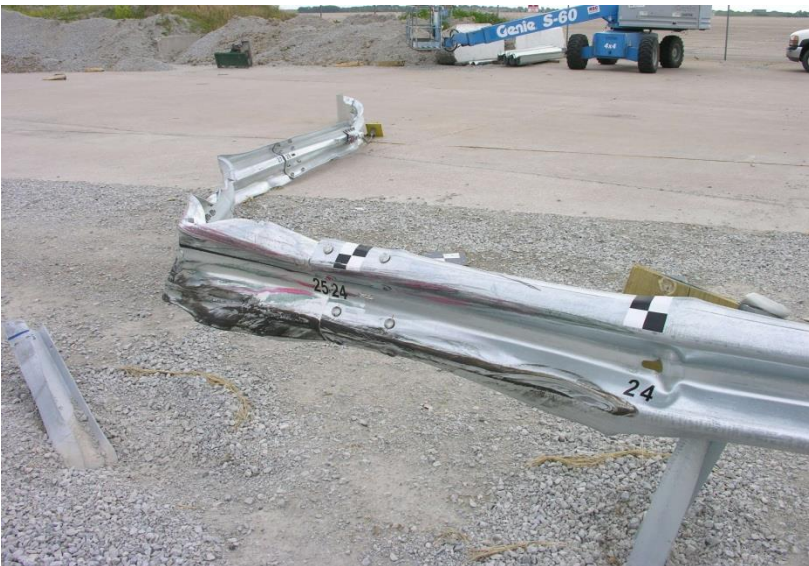
Figure 138. Details of Rail Damage, Test No. WIDA-1

The rail buckled at post no. 25, post no. 27, and 27¼ in. (692 mm) downstream of post no. 28, as shown in Figure 138. Kinks in the top and/or bottom corrugations of the rail were found between post nos. 22 and 29, as shown in Figure 136. Flattening and folding of the bottom corrugation of the W-beam rail occurred between post nos. 24 and 29. The bottom corrugation was folded upward at two main locations downstream of the initial impact point. The first location where the rail folded started at 6 in. (152 mm) from post no. 24, and extended downstream for 40¼ in. (1,022 mm), while the second location started 23 in. (584 mm) downstream of post no. 27 and ended 7 in. (178 mm) downstream of post no. 29. The bottom corrugation of the rail was also flattened at two locations. The first flattened segment started 6 in.

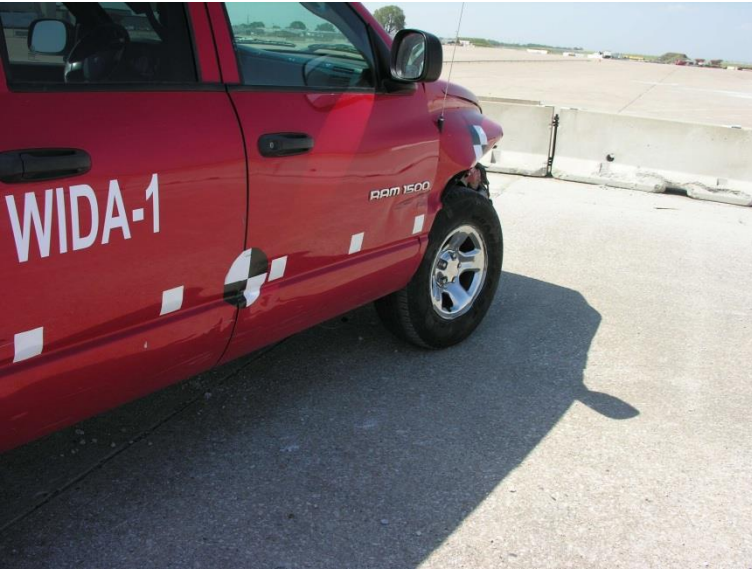
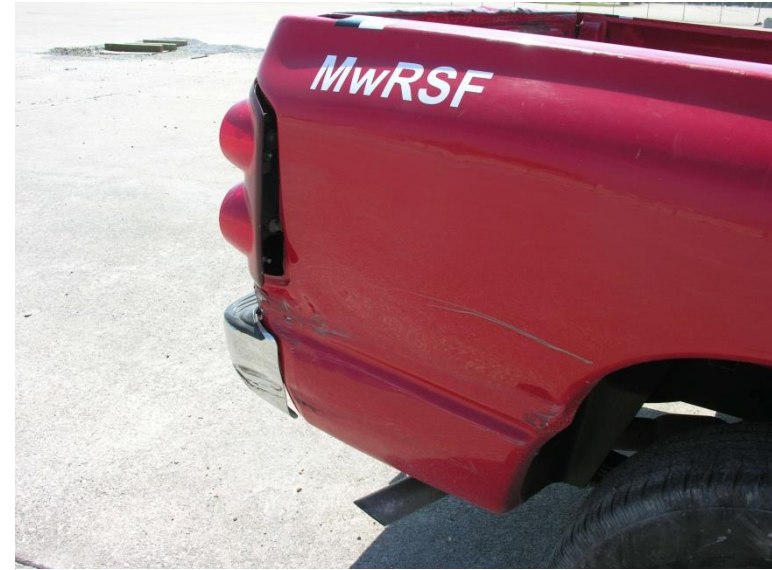
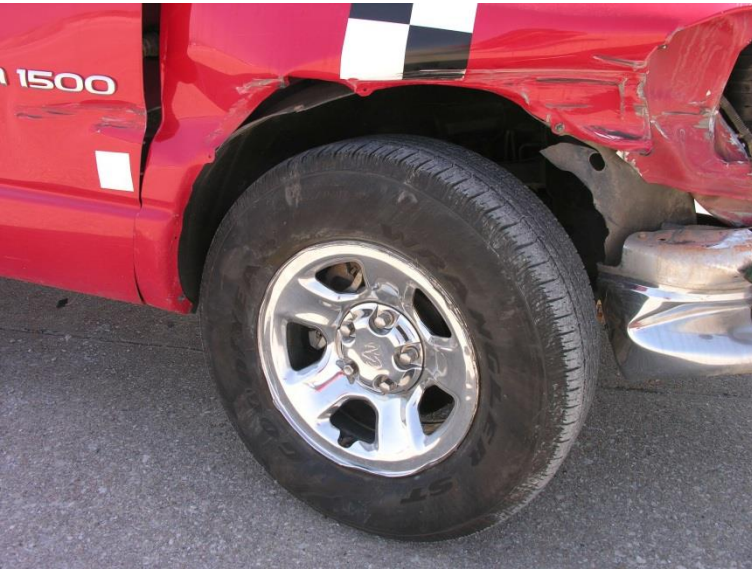
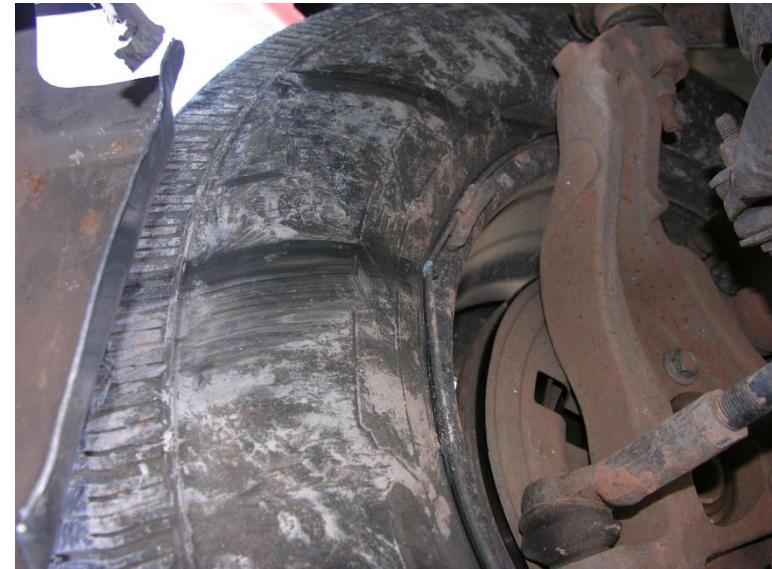
Figure 143. Vehicle Damage, Test No. WIDA-1

The damage to the vehicle was moderate, as shown in Figures 142 through 144. The maximum occupant compartment deformations are listed in Table 13 along with the deformation limits established in MASH for various areas of the occupant compartment. Note that none of the MASH established deformation limits were violated. Complete occupant compartment and vehicle deformations and the corresponding locations are provided in Appendix H.

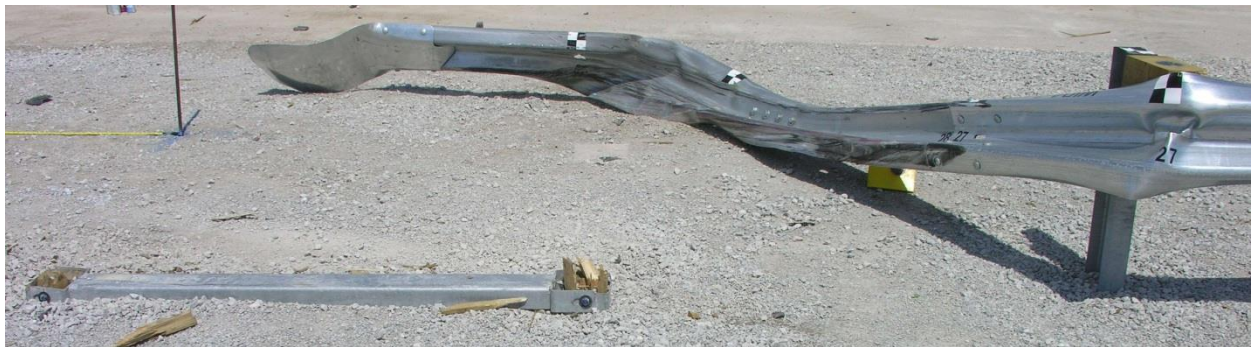
Figure 152. System Damage, Test No. WIDA-2

Damage to the barrier was extensive, as shown in Figures 152 through 156. Barrier damage consisted of deformed W-beam rail and guardrail posts, disengaged rail and wood blockouts, contact marks on posts and guardrail, and fractured end anchorage BCT posts. The length of vehicle contact along the barrier, which spanned from the actual impact point, was approximately 12 ft – 5 in. (3.8 m), at 4 in. (102 mm) upstream from the midspan between post nos. 27 and 28, to 5 in. (127 mm) upstream from the end of the guardrail.

Kinks in the top corrugation of the rail were found between post nos. 28 and 29, as shown in Figures 152 through 156. Flattening of the bottom corrugation of rail started at 4 in. (102 mm) upstream from post no. 28 and extended through 6 in. (152 mm) upstream from post no. 29. The bolt pulled through the W-beam rail slots at the post connections between post nos. 27 and 29, as shown in Figure 153. The W-beam rail buckled at post no. 27, and plastic deformation occurred on the top side of the W-beam rail slot at post nos. 27 through 29, as shown in Figure 154. The upper-front corner of the wood blockout at post no. 27 was fractured off and a  $\frac{3}{8}$ -in (10-mm) gap formed between the blockout and the front flange of the post. A  $\frac{1}{2}$ -in. (13-mm) soil gap formed

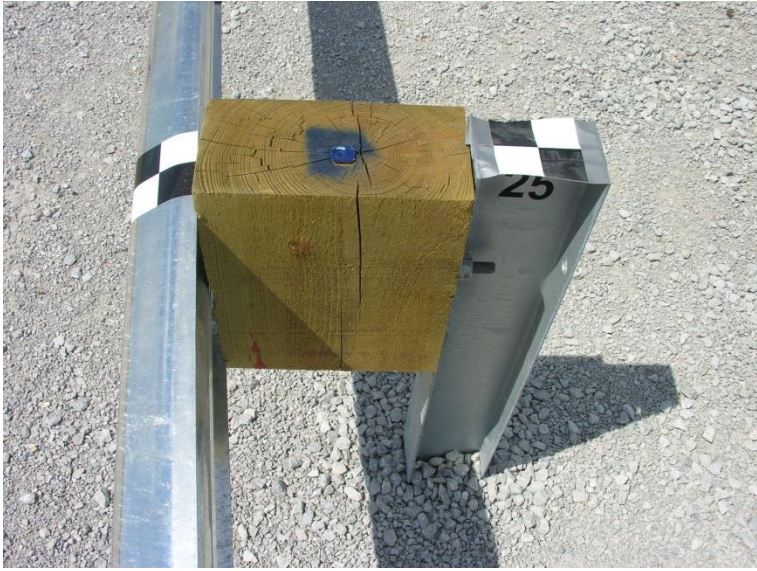
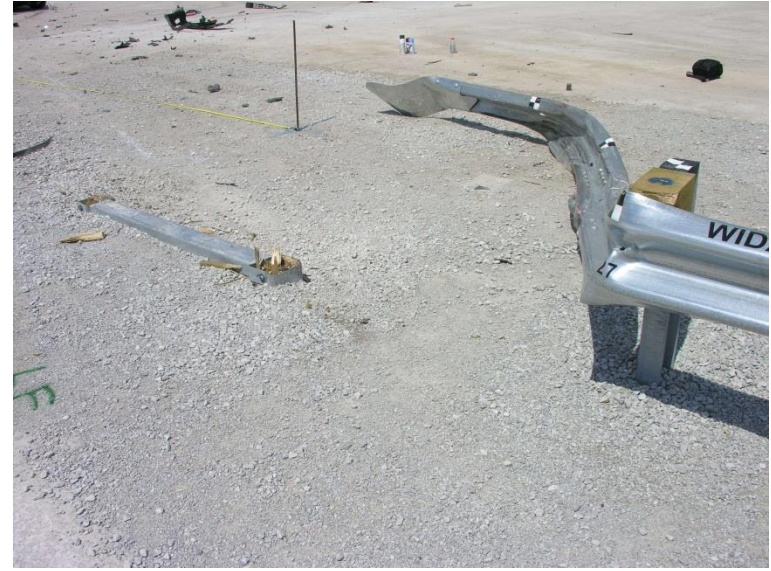
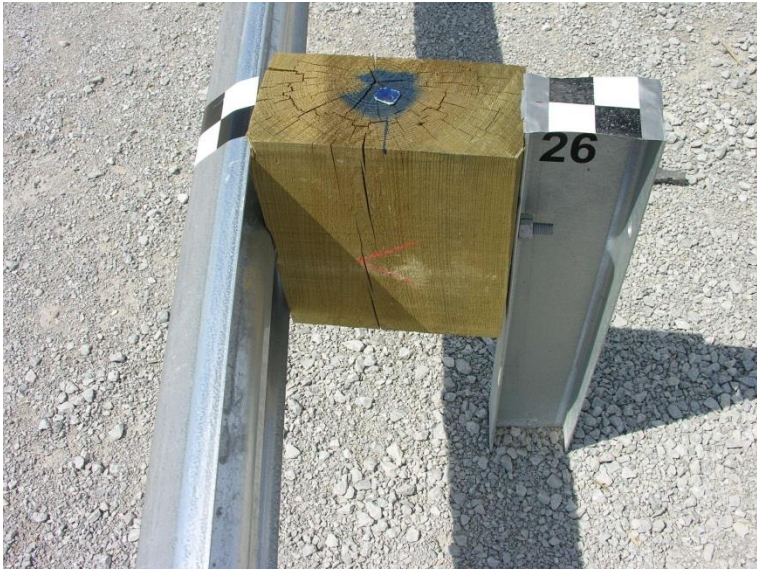
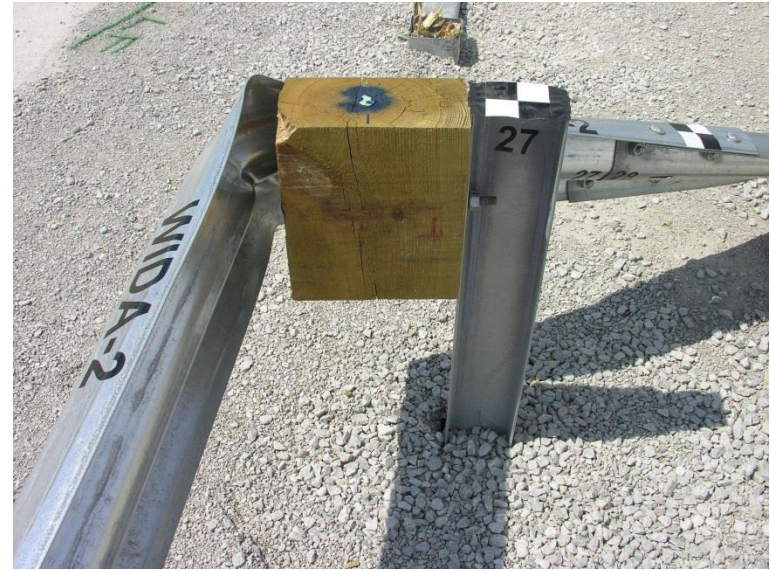
Figure 155. System Damage at Post Nos. 25 through 29, Test No. WIDA-2

in front of post no. 27, as shown in Figure 155. Post no. 28 fractured into three pieces beginning at the bolt connection to the rail through the ground line. Post no. 29 fractured at the ground line.

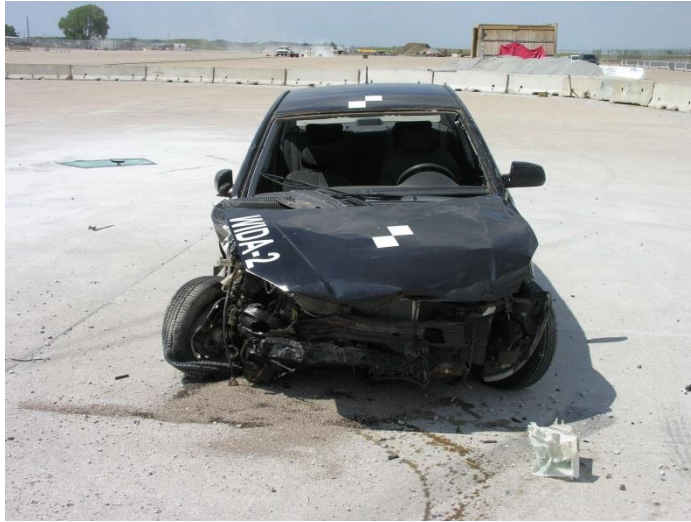
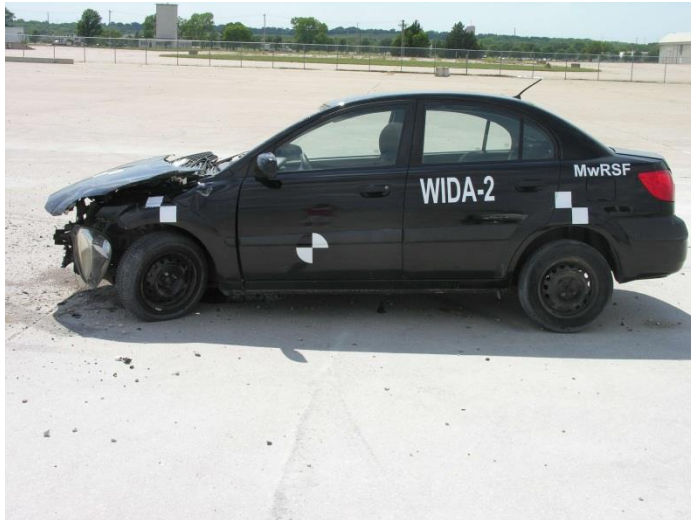
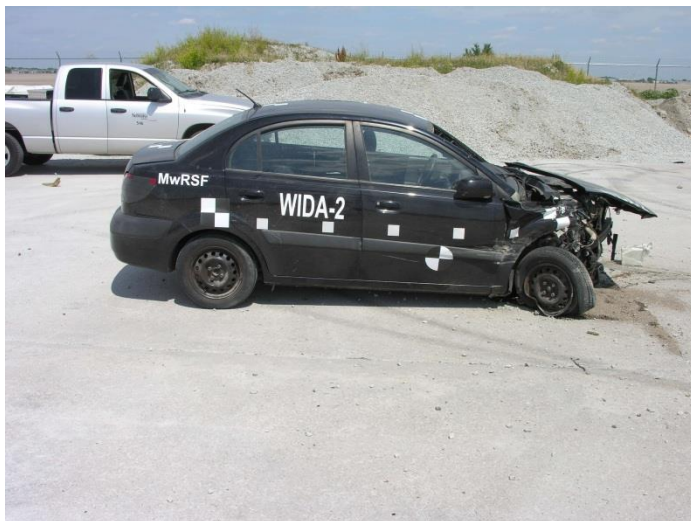
Figure 157. Vehicle Damage, Test No. WIDA-2

The damage to the vehicle was extensive, as shown in Figures 157 through 161. The maximum occupant compartment deformations are listed in Table 17 along with the deformation limits established in MASH for various areas of the occupant compartment. Note that none of the MASH established deformation limits were violated. Complete occupant compartment and vehicle deformations and the corresponding locations are provided in Appendix H.

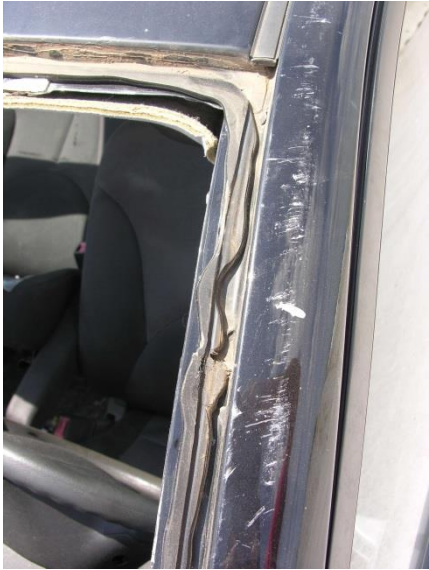
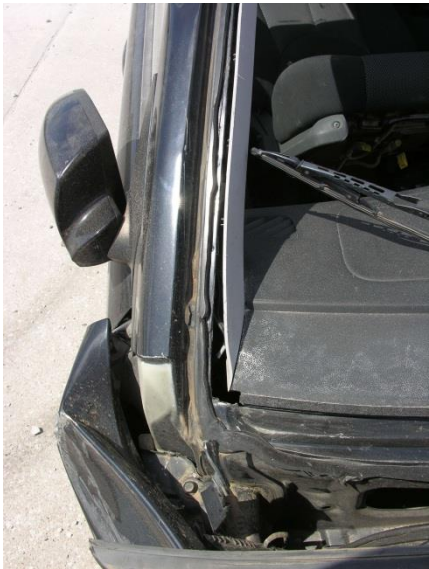
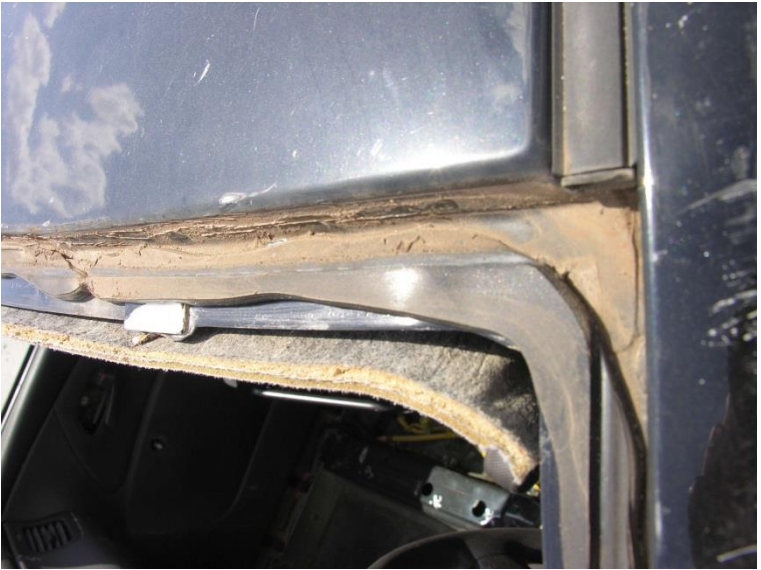
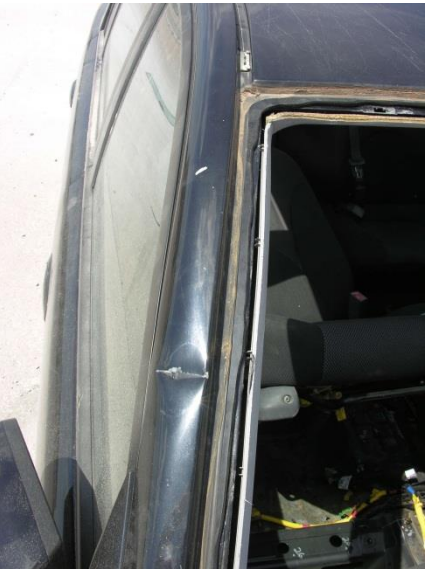
Figure 159. Vehicle Damage - Windshield Glue Strip, Test No. WIDA-2

The windshield, which separated from the vehicle in the early stage of the crash test, was located downstream from the vehicle and encountered spider-web cracks. The windshield sealing tape running around the vehicle frame had several irregularities, which indicated that a post-factory windshield installation was made with poor quality. In particular, the presence of dirt surrounding the sealing tape connection with the upper part of the windshield indicated that the glue did not adhere properly. The roof and remaining window glass remained undamaged. A dent was located at the center of the right A-pillar. Traces of yellow paint used to identify the bearing plate in the high-speed videos were found on the front bumper supporting rail, the engine alternator, the lower-right corner of the right-front suspension, and the right-front quarter panel, as shown in Figures 161 and 162.

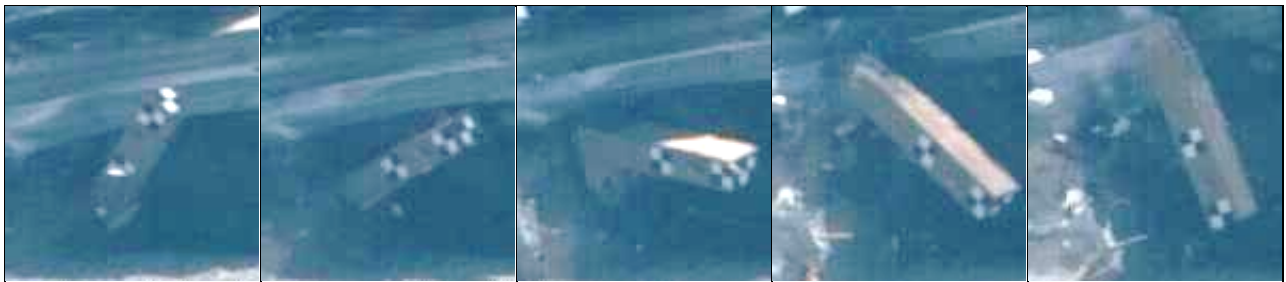
Figure 163. Spinning of Downstream Anchor End Post, Test No. WIDA-2

Inspection of video, barrier damage, and vehicle damage indicated that the impacting tire slid under the anchor cable. This evidence was provided by the sudden rotation of the end wood post after it fractured at its base as a consequence of a direct impact with the vehicle's front

bumper. Although the end post was already tilted more than 45 degrees with respect to its initial vertical configuration, it abruptly began to rotate as a consequence of a pull force applied by the bearing plate, which was still in contact with the fractured post base. The sequence of this rotation event is shown in Figure 163. The sudden tensioning of the anchor cable indicated that the right-front tire wedged under the cable. Further, the wedging under the cable anchor may have been facilitated by a preexisting outward tilt angle of the wheel after it snagged on the previous BCT wood post. In fact, a post-impact investigation showed a large deformation of the external side of the right-front rim, thus indicating considerable snag occurred on the wood post immediately upstream from the end post. This first snag event may have been the cause for the disengagement of the lower suspension arm from the vehicle frame. As a consequence of the damage to the corresponding suspension, the right-front wheel may have been deformed toward the barrier prior to impact with the second BCT post and anchor cable.

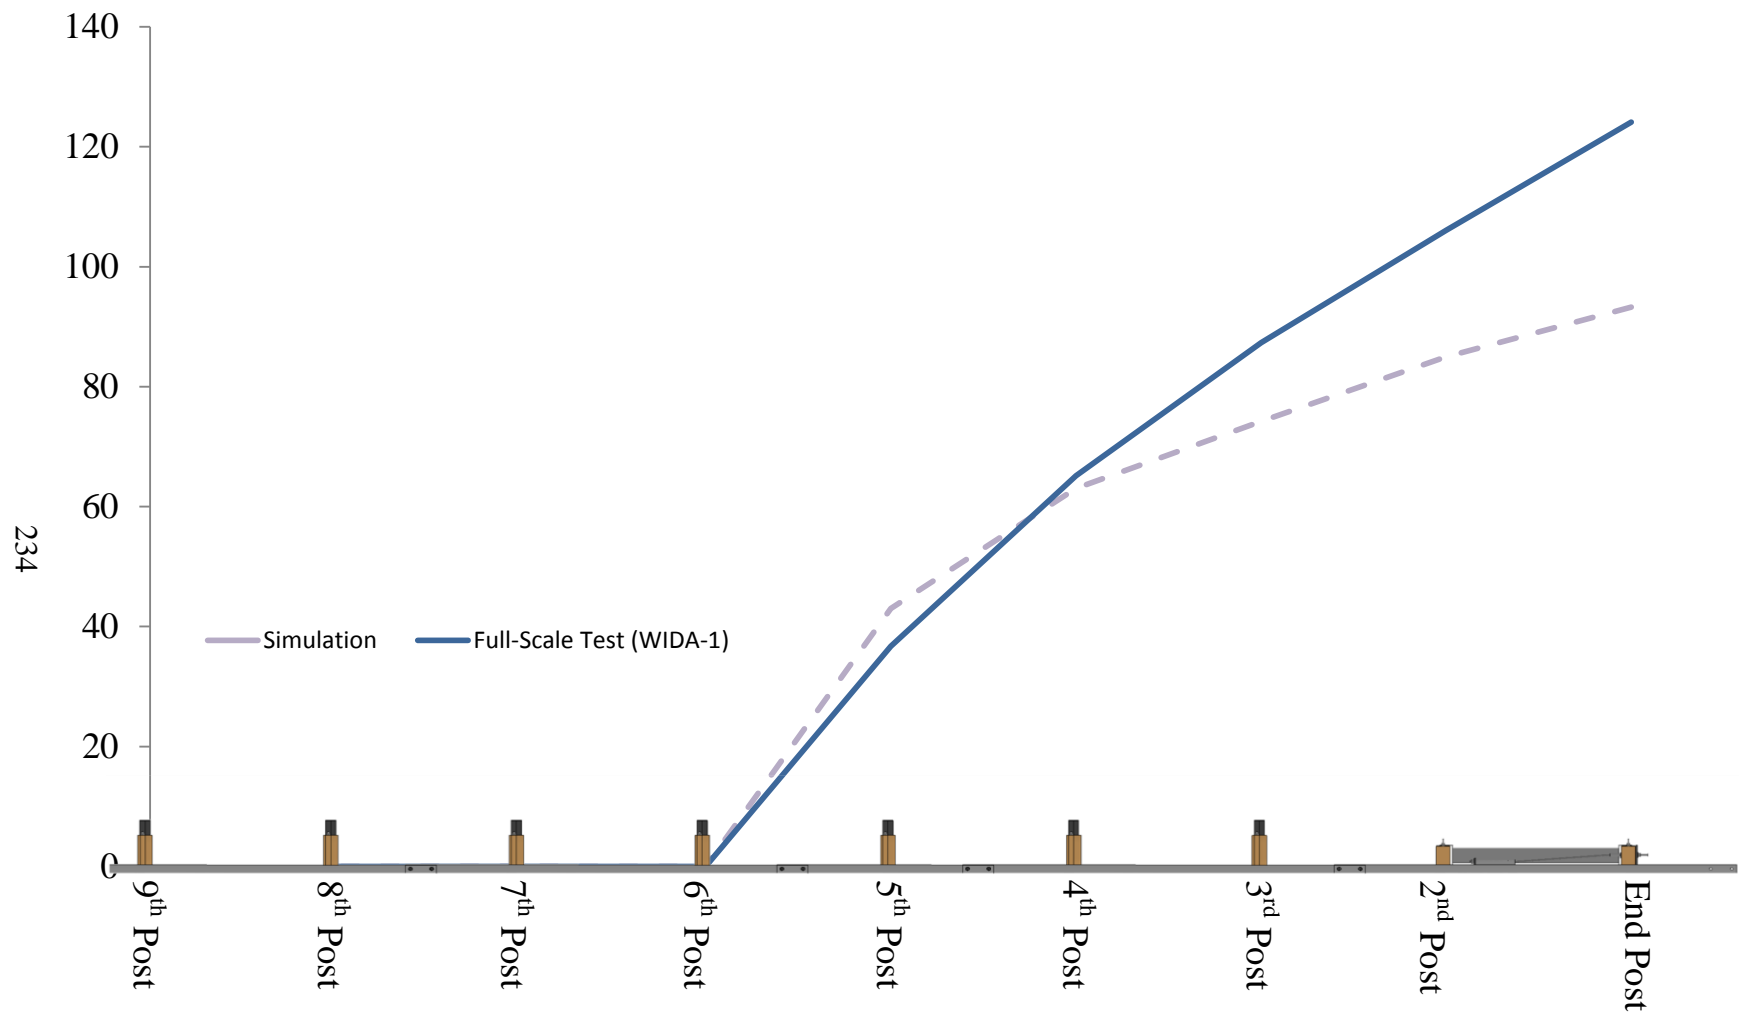
Figure 166. Predicted and Actual Maximum Penetration of 2270P in Test No. WIDA-1

The comparison between simulated and actual vehicle kinematics during full-scale vehicle crash test no. WIDA-1 indicated that the numerical model can reasonably replicate an impact in close proximity to the tested, non-proprietary, MGS downstream anchorage system with the 2270P pickup truck. A comparison of the simulated and actual kinematics during test no. WIDA 1 is shown in Figures 164 and 165. A comparison of simulated and actual maximum penetration of the pickup truck at each post location is shown in Figure 166.
