*Midwest States' Regional Pooled Fund Research Program  
Fiscal Year 2001-2002 (Year 12)  
Research Project Number SPR-3 (017)  
NDOR Sponsoring Agency Code RFPF-02-02*

## **Phase III Development of a Short-Radius Guardrail for Intersecting Roadways**

MwRSF Research Report No. TRP-03-183-07

December 6, 2007

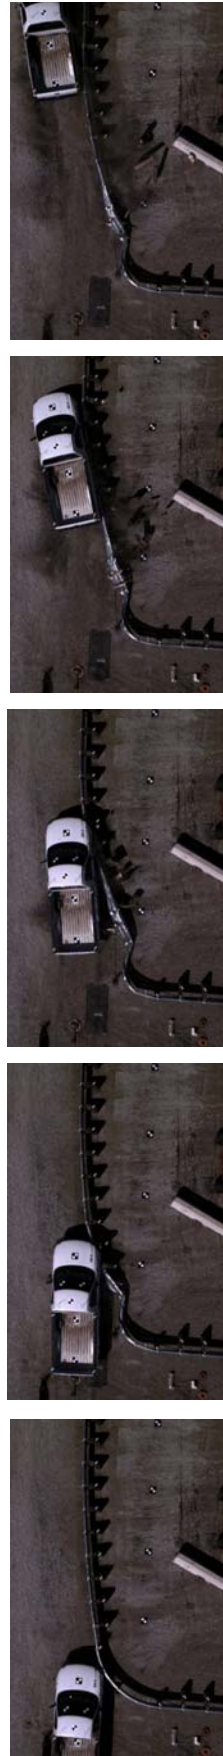
Figure 41. Summary of Test Results and Sequential Photographs, Test SR-5

The analysis of the test results for test SR-5, showed that the short-radius guardrail system

adequately contained and redirected the 2000P vehicle with controlled lateral displacements of the barrier system. There were no detached elements nor fragments which showed show potential for penetrating the occupant compartment nor presented undue hazard to other traffic. Deformations of, or intrusion into, the occupant compartment that could have caused serious injury did not occur. The test vehicle did not penetrate nor ride over the guardrail system and remained upright during and after the collision. Vehicle roll, pitch, and yaw angular displacements were noted, but they were determined acceptable because they did not adversely influence occupant risk safety criteria nor cause rollover. After collision, the vehicle's trajectory did not intrude into adjacent traffic lanes. Therefore, test no. SR-5 conducted on the short-radius guardrail system was determined to be acceptable according to the TL-3 safety performance criteria found in NCHRP Report No. 350.

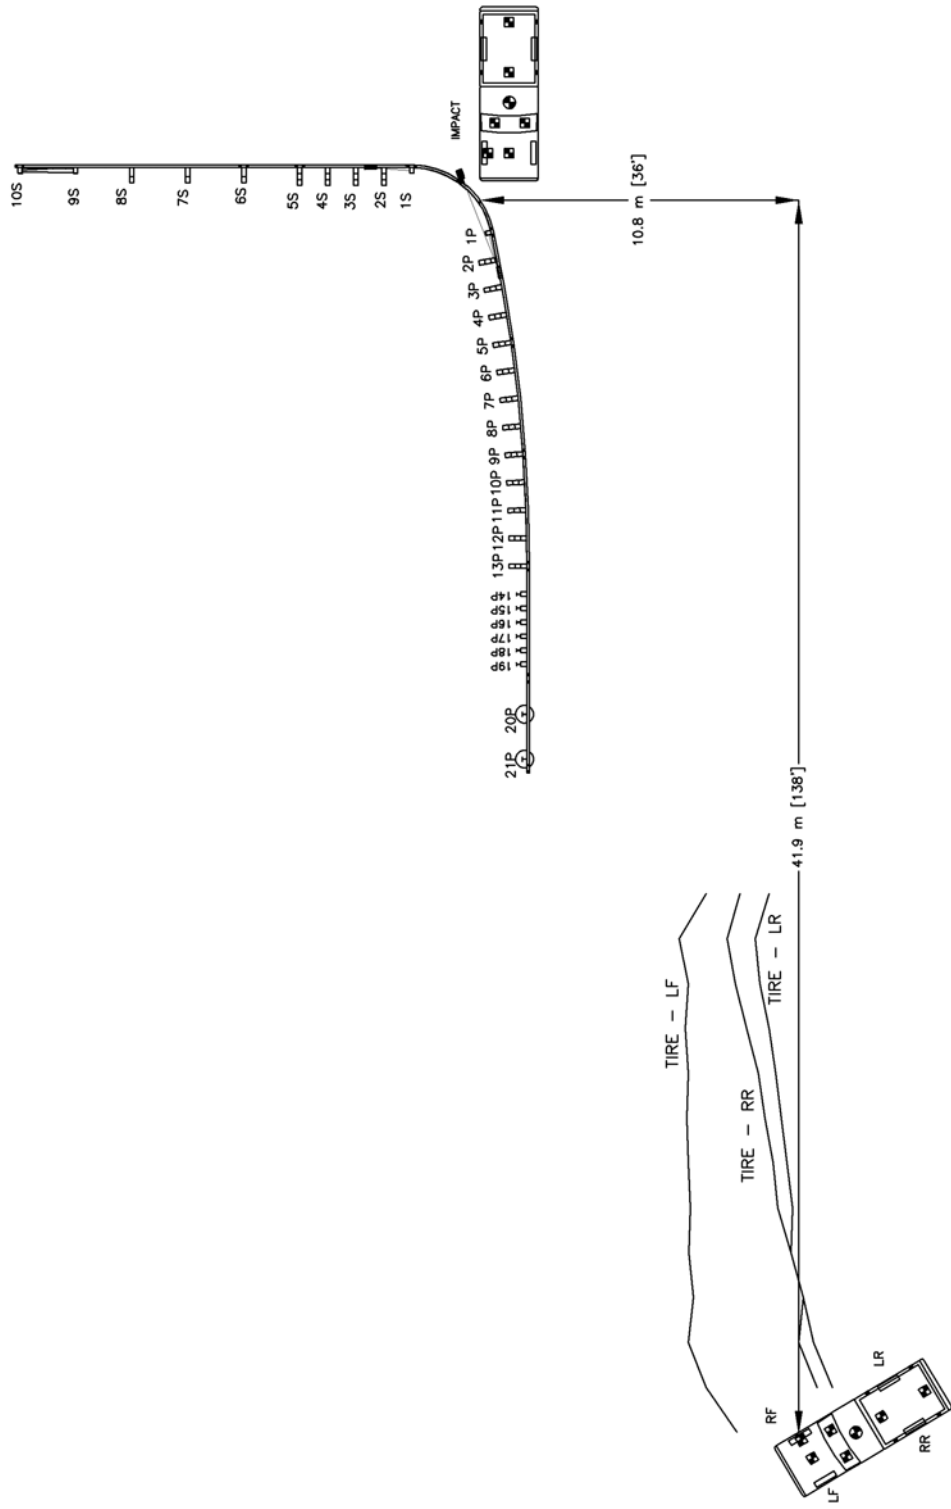
Figure 42. Vehicle Trajectory and Final Position, Test SR-5

quarter panel, and the right-front corner of the bumper continued to deform as the rail continued to flatten. At 0.182 sec, the pickup truck contacted post no. 4P which rotated slightly backward in the soil. At 0.190 sec, a gap between the right-front corner of the hood and the quarter panel formed, and the pickup truck rolled slightly counter-clockwise away from the system. At 0.216 sec, the top of the right-side door separated from the frame and bent outward at the door trim. At 0.276 sec, vehicle continued to be redirected, and the front bumper was located at post no. 7P. At 0.468 sec, the pickup truck exited the system with a resultant velocity of 85.4 km/h (53.1 mph) and at an angle of 12.6 degrees. The pickup truck came to rest 41.9 m (137 ft - 6 in.) downstream from impact and 10.8 m (35 ft - 6 in.) laterally away from the primary side, as shown in Figure 42. It should be noted that the secondary anchor remained in place throughout the vehicle contact and successfully developed upstream tension necessary to redirect the vehicle. The trajectory and final position of the pickup truck are shown in Figure 50.

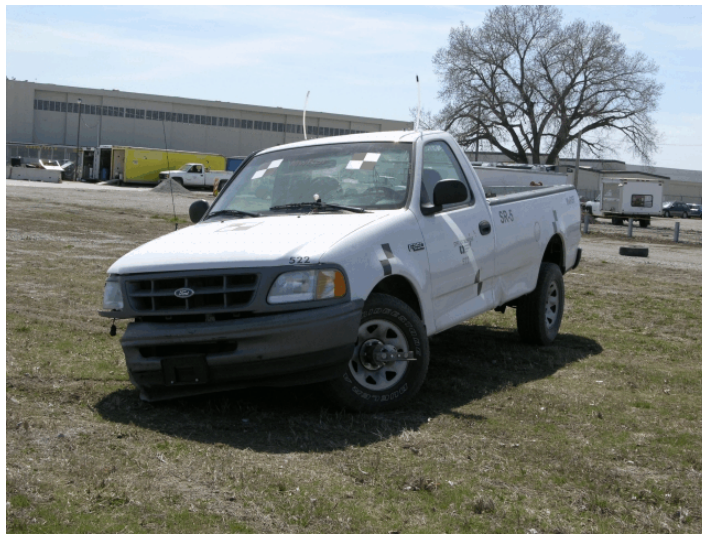
Figure 62. Vehicle Damage, Test SR-5

Exterior vehicle damage was minimal, as shown in Figures 62 through 64. Occupant compartment deformations to the right side and center of the floorboard were judged insufficient to cause serious injury to the vehicle occupants. Maximum longitudinal deflections of 13 mm (0.5 in.) were located near the left side of the right-side floorboard. Maximum lateral deflections of 25 mm (1 in.) were located near the right-front corner of the right-side floor pan. Maximum vertical deflections of 38 mm (1.5 in.) were located near the center of the right-side floorboard. Complete occupant compartment deformations and the corresponding locations are provided in Appendix C.

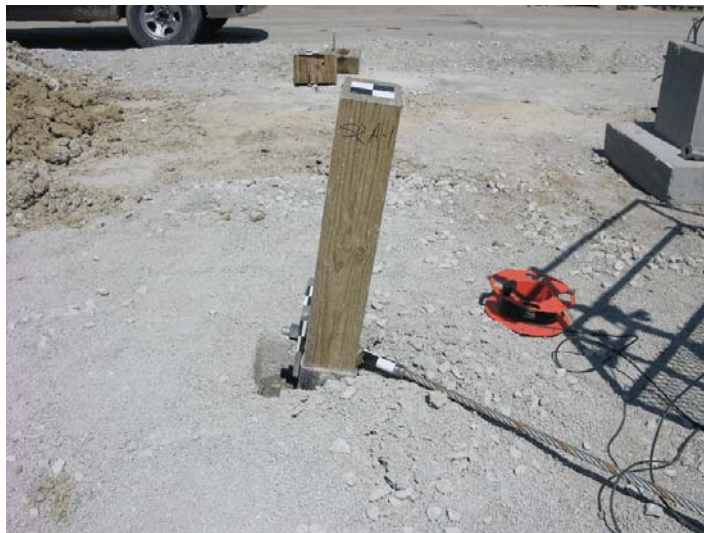
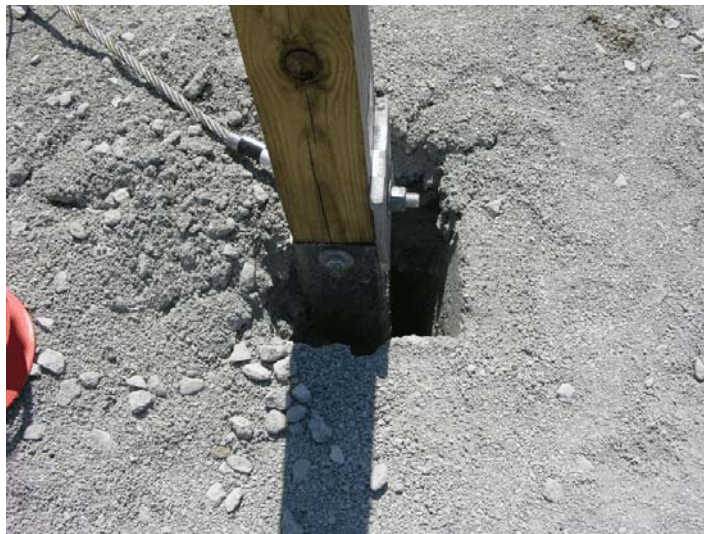
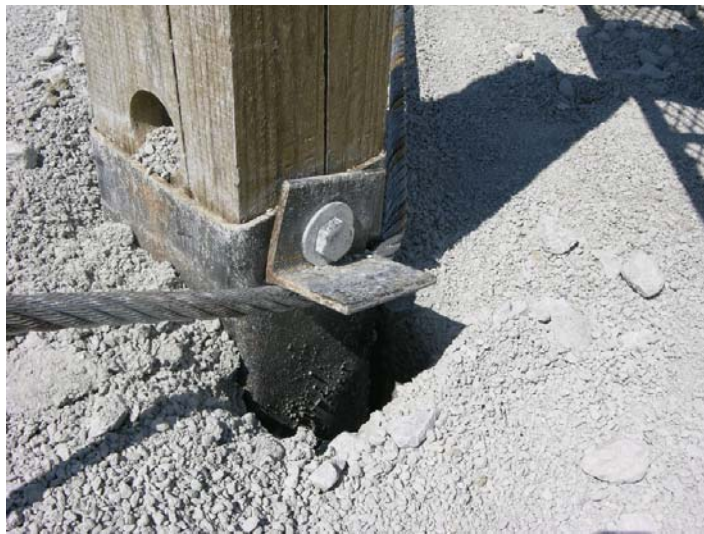
Figure 66. Bogie Test Results, Test No. SRA-1

The 2,082-kg (4,589-lb) bogie, attached to the cable, was pulled away from the installed posts to determine the maximum load the system could withstand and the amount of deformation imparted to the cable anchor bracket at the bottom of the primary-side post. The bogie speed was 34.66 km/h (21.54 mph). The posts experienced moderate movement in the soil as shown in Figure 66. In addition, the cable anchor bracket did not experience any deformations. The maximum load was found to be approximately 35 kips as shown in the load curve in Figure 67. Previous experience and testing of guardrail cable anchorages has demonstrated that the loads found for the new SR anchorage were consistent with past guardrail anchorage loads in the 35 kip range. This suggested that the revised short-radius anchorage would be sufficient for redirective impacts on the primary side of the system. Test results are shown in Table 2.

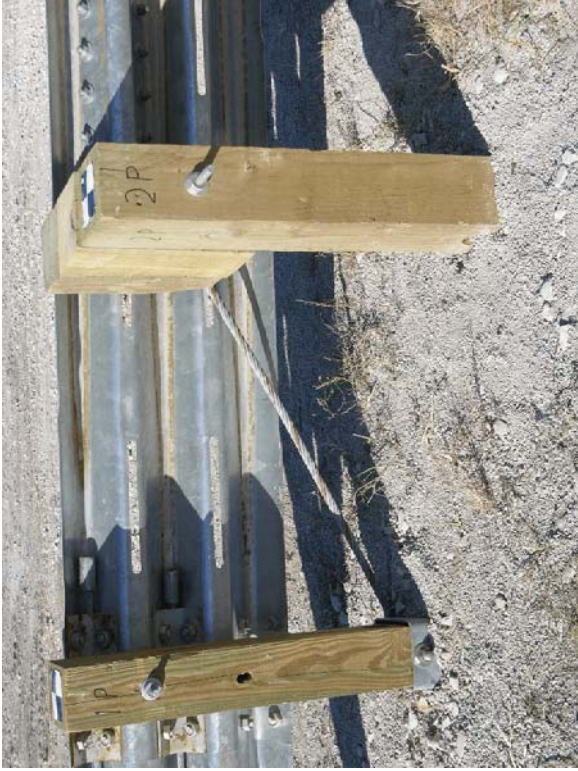
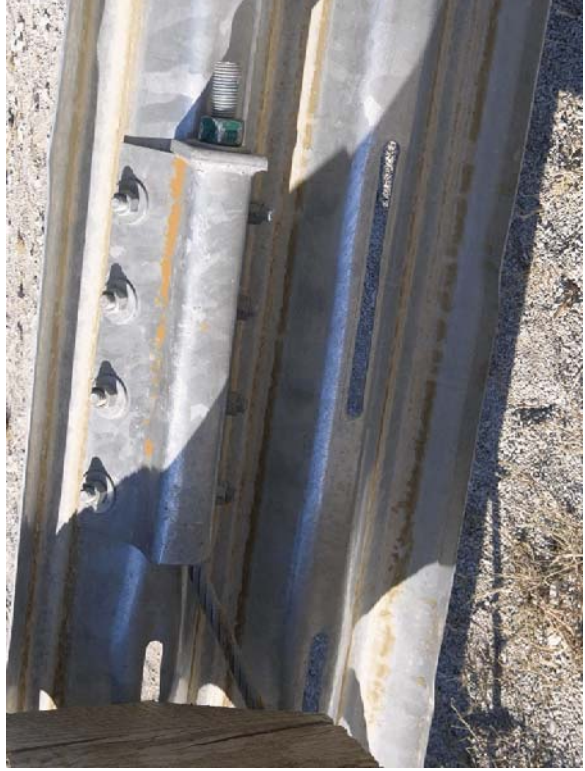
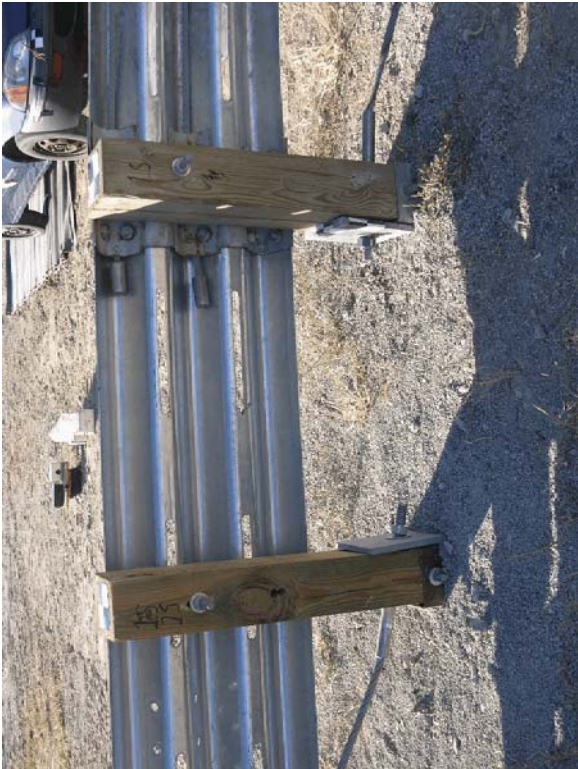
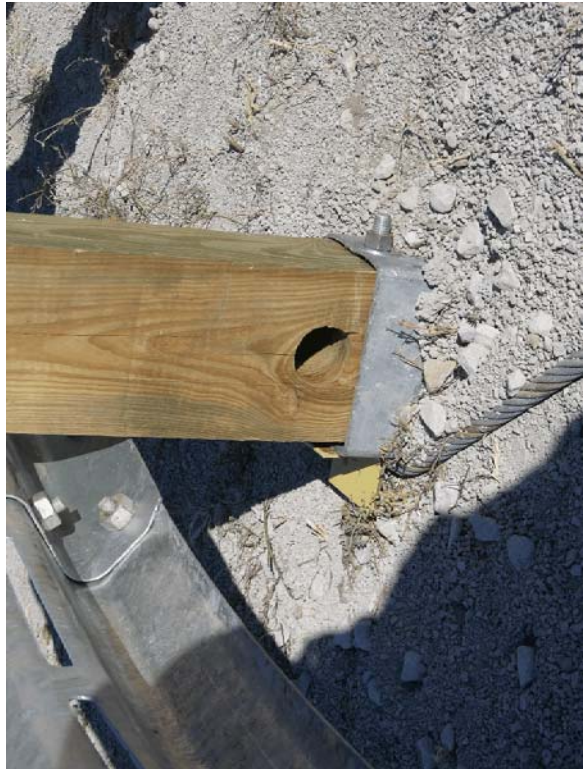
Figure 77. System Modifications, Test SR-6

The modified short-radius guardrail system was identical to the previous system except for the method used to develop the tensile strength of the three beam guardrail downstream from the nose section. The cable anchor assembly on the primary side was lengthened and oriented differently within the system thereby removing the cable release mechanism from the traffic side of the system. The cable came around the traffic face of the first post on the primary side and then terminated in the first post on the secondary side, as shown in Figures 68 through 72. The existing anchorage on the secondary side was located at post no. 2S. This change shifted the location of the anchorage one post downstream on the secondary side. A cable bracket was located at the ground line of post no. 1 on the primary side which held the cable down and developed the necessary tensile strength, as shown in Figures 71 and 74. Photographs of the modified system are shown in Figures 76 and 77.

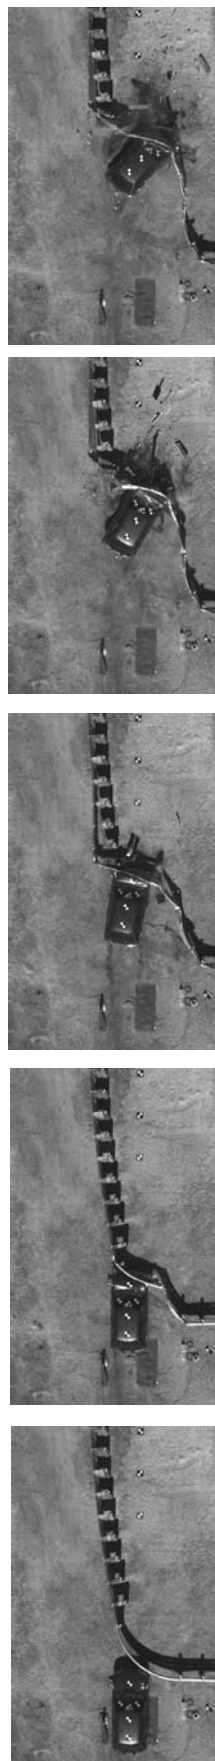
Figure 78. Summary of Test Results and Sequential Photographs, Test SR-6

impacted with the 820C vehicle adequately contained the vehicle and brought the vehicle to a stop. Detached elements and fragments did not penetrate nor presented undue hazard to other traffic but showed potential for penetrating the occupant compartment. Deformations of, or intrusion into, the occupant compartment that could have caused serious injury did occur due to the penetration of the hood through the windshield which was crushed inward greater than 76 mm (3 in.). The test vehicle remained upright during and after the collision. Vehicle roll, pitch, and yaw angular displacements were noted, but they were determined acceptable because they did not adversely influence occupant risk safety criteria nor cause rollover. After collision, the vehicle's trajectory did not intrude into adjacent traffic lanes. The longitudinal occupant ridedown decelerations were not within the maximum limits provided in NCHRP Report No. 350. Therefore, test no. SR-6 conducted on the short-radius guardrail system was determined to be unacceptable according to the TL-3 safety performance criteria found in NCHRP Report No. 350 due to the excessive longitudinal occupant ridedown deceleration and excessive windshield crush and penetration.
