Phase IV Development of a Short-Radius Guardrail for Intersecting Roadways

MwRSF Research Report No. TRP-03-199-08

February 29, 2008

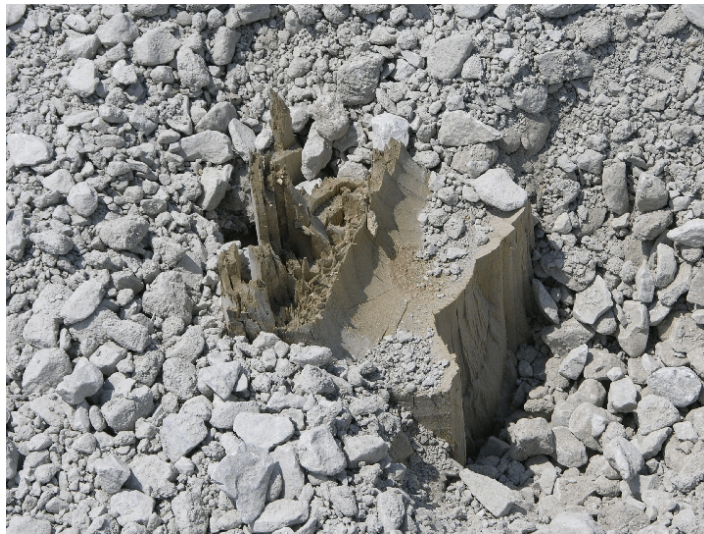
Figure 52. Post Nos. 3S through 5S Damage, Test SR-7

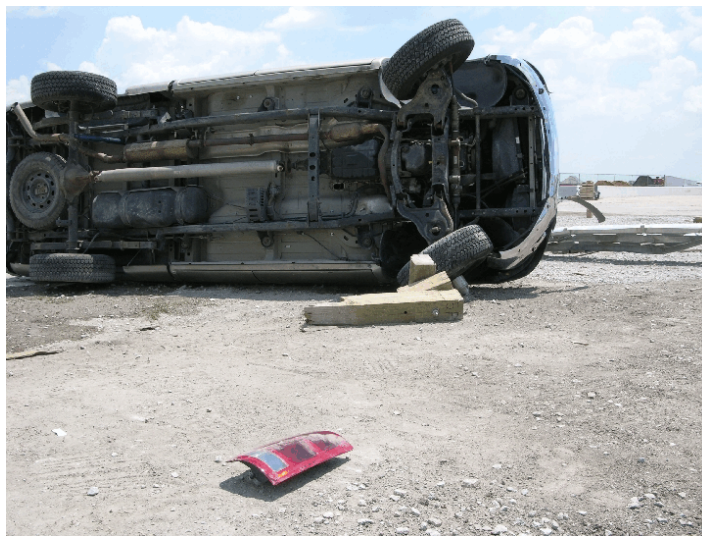
Exterior vehicle damage was moderate, as shown in Figures 59 through 62. Occupant compartment deformations to the right side and center of the floorboard were judged insufficient to cause serious injury to the vehicle occupants. A maximum longitudinal deflection of 13 mm (0.5 in.) was located in the right-front corner of the right-side floor pan. A maximum lateral deflection of 13 mm (0.5 in.) was located at the center of the right side of the right-side floor pan. Maximum vertical deflections of 6 mm (0.25 in.) were located throughout the right-side floor pan. Complete occupant compartment deformations and the corresponding locations are provided in Appendix C.

Figure 59. Vehicle Damage, Test SR-7

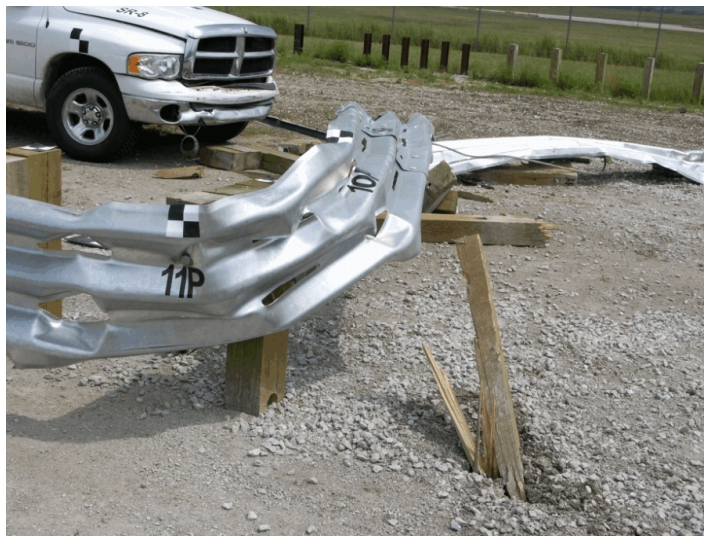
Figure 86. System Damage, Test SR-8

Barrier damage was extensive, as shown in Figures 85 through 93. Damage consisted mostly of flattened, deformed and torn guardrail, fractured posts, blockouts, and bolts, and deformed cable anchor hardware. System damage occurred between post nos. 8S and post no. 11P. The maximum permanent set of the guardrail was 6,518 mm (21 ft - 4.5 in.) from the primary side and 8,448 mm (27 ft - 9 in.) from the secondary side, measured to the center of the nose.

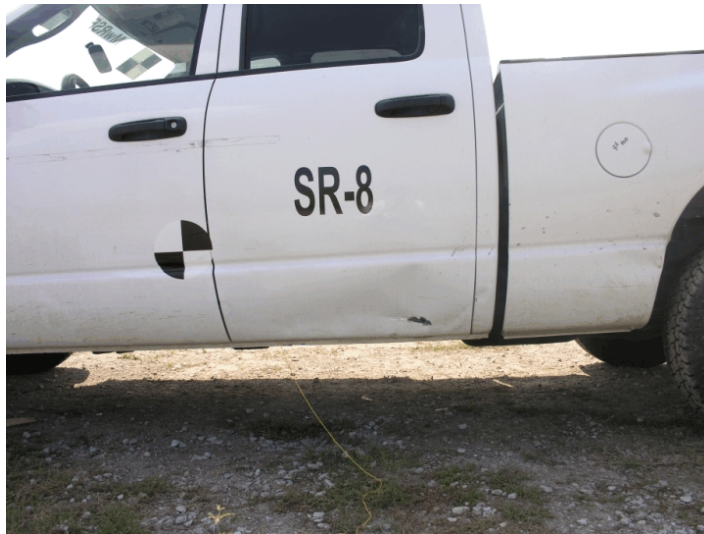
Figure 95. Vehicle Damage, Test SR-8

Exterior vehicle damage was minimal, as shown in Figures 94 through 96. Occupant compartment deformations to the right side and front of the floorboard were deemed insufficient to cause injury to the vehicle occupants. Maximum longitudinal displacements of 6 mm (0.25 in.) occurred throughout the right side of the floorboard. Maximum lateral displacements of 19 mm (0.75 in.) occurred at the left-front corner of the right-side floorboard. Maximum vertical displacements of 6 mm (0.25 in.) were located throughout the right-side floorpan. Complete occupant compartment deformations and the corresponding locations are provided in Appendix G.
