Premature Failure of Concrete Patching: Reasons and Resolutions

Final Report VTRC 19-R14

**PREMATURE FAILURE OF CONCRETE PATCHING:
REASONS AND RESOLUTIONS**

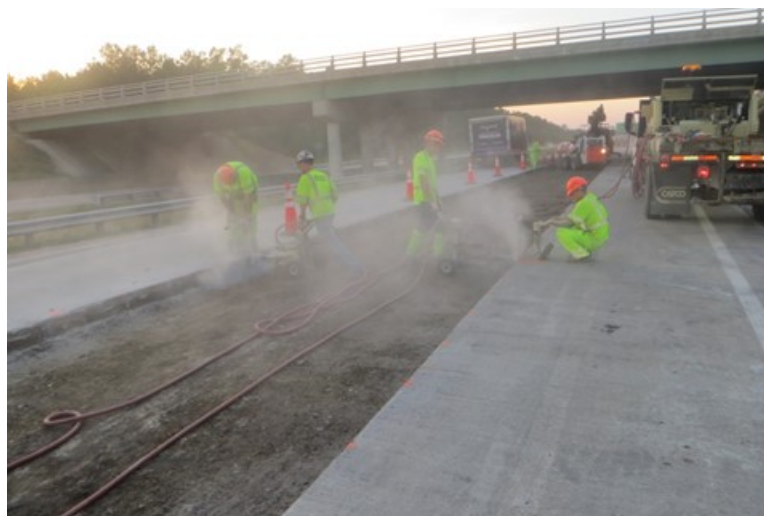
Figure 13. Longer of Two Patches on SR 288 Constructed on 6/10/14

On the second night, June 10, only two patches were placed. The first (Batch 1B) was 381 ft 10 in long, and the second (Batch 2B) was 8 ft 8 in long. Figure 13 shows work being done on the longer patch. The first patch (Batch 1B) was under the overpass and did not appear to be in distress, but it was placed so that better quality exposed concrete to maintain the clearance would be present when the rest of the patch areas would be overlaid with asphalt. Core samples from the placement on the second night were taken from only the second smaller patch since the purpose of the first large patch was mainly to maintain the clearance under the bridge deck rather than to correct the damaged concrete pavement. Three cores each were taken on the north and south sides of the second, shorter patch at varying distances in the transverse and longitudinal directions.

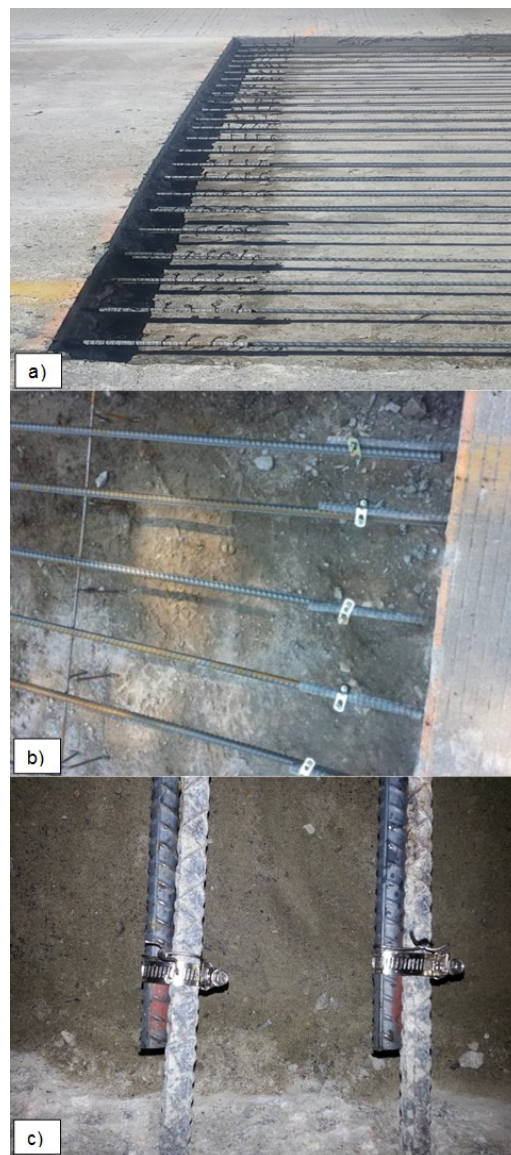
These trial installations (two locations) on SR 288 were done successfully and did not raise any concern. So experimental installations of all three splicing techniques were done as part of the I-85 patching project. The new splice connections on I-85 are shown in Figure 22 and included six tie wires (Figure 22a), U-bolts (Figure 22b), and hose clamps (Figure 22c). The contractor did not have a problem installing the new connections, although some required more time and material than others. For example, six tie wires required more time and materials

Figure 22. Splicing of Steel in Patches on I-85: a) 6 tie wires; b) 1 U-bolt; c) 1 of 2 hose clamps
