Field Analysis of Wood Guardrail Post Decay

WA-RD 890.1

December 2018

WSDOT Research Report

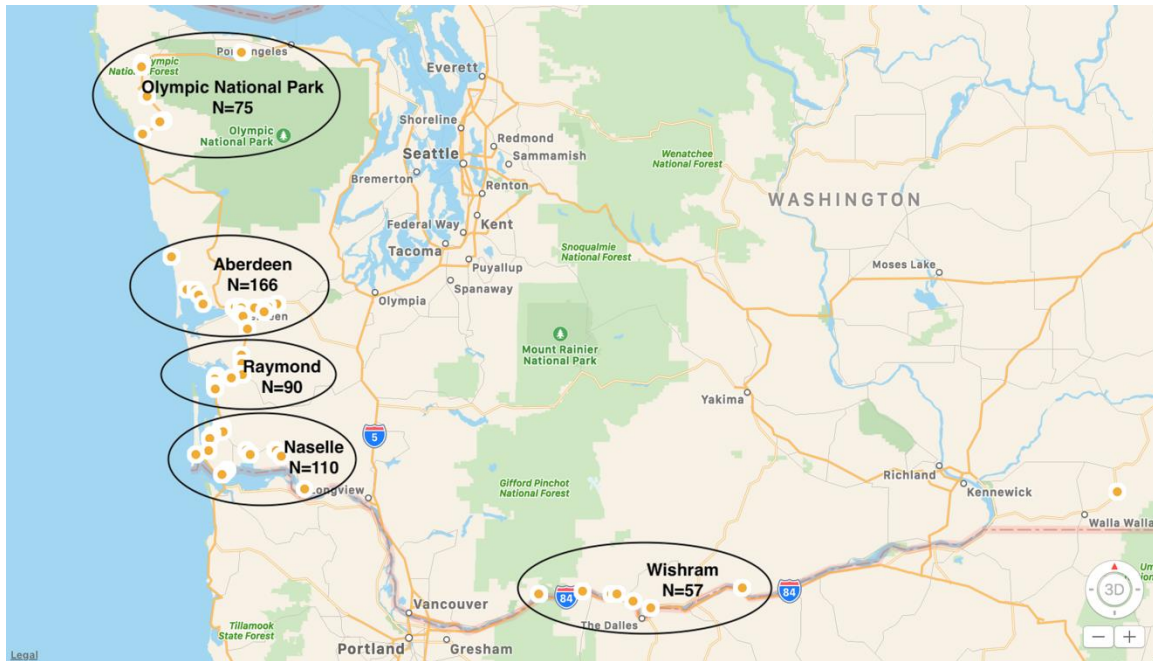
Figure 2. Timber post inspection regions

Five geographic regions were targeted for field inspection based on WSDOT's recommendations and a Scheffer Decay Hazard Index map, shown in Figure 2. Four of the regions are located on the western coast of Washington, which is the wettest part of the state based on annual precipitation data. One region, Wishram, was used as a baseline measurement for comparison and was assumed to be similar to the rest of the state east of

the Cascade mountain range, where annual precipitation is much lower. Figure 2 also shows the number of field inspections that were conducted in each region.

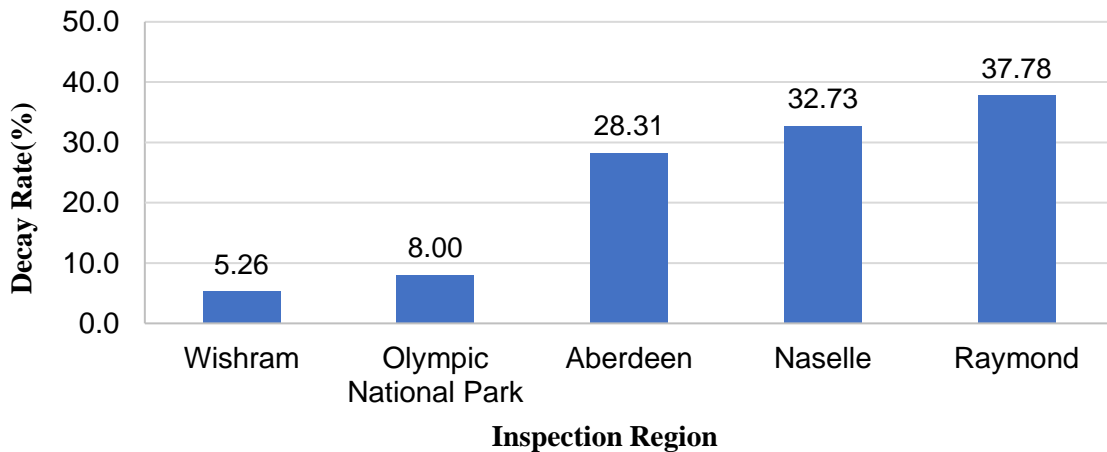
Figure 10. Decay rate for inspection regions

The decay rate of the inspected posts can be further classified by inspection region (shown in Figure 2), presented in Table 3. The Raymond and Naselle regions had the highest decay rates of approximately 38% and 33%, respectively. The Olympic National Park and Wishram regions had the lowest decay rates of approximately 8% and 5%, respectively. Scheffer climate index was used to quantify the environmental conditions

in each region and was calculated as the average climate index for the posts located in that region. Figure 10 presents the decay rate for each region and Figure 11 shows the decay rate for each region versus climate index.

As shown by Table 3 and Figure 10, the highest timber decay risk location in the sample was found to be in Raymond, with a decay rate of approximately 38%. The inspection regions of Aberdeen and Naselle had the next highest decay rates of approximately 30%. Additionally, Figure 11 and 12, demonstrate that Scheffer climate index is likely a good predictor of high decay rates. For posts in regions with climate index less than 40, virtually no cases of decay were found during field evaluations.

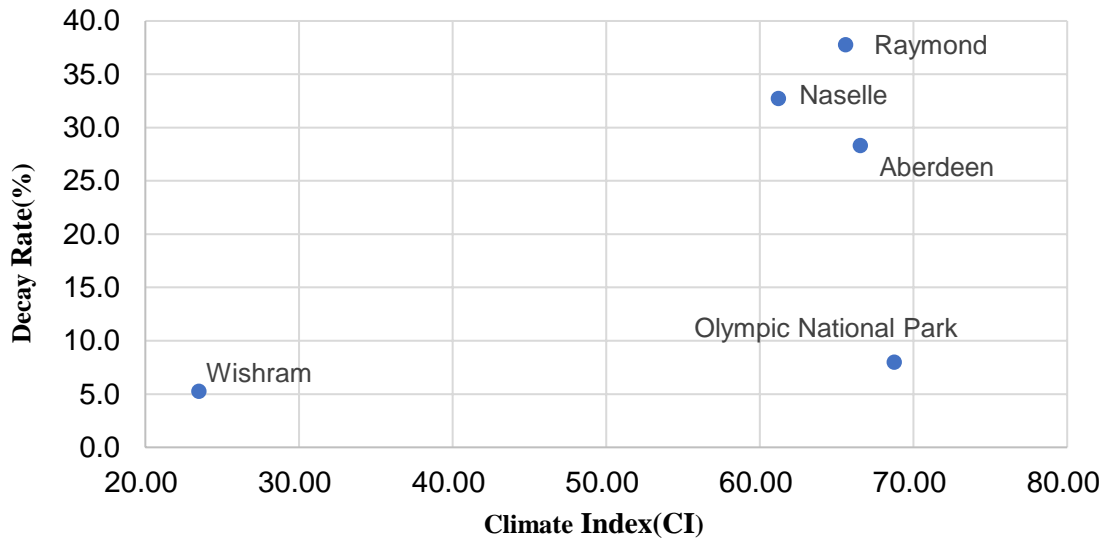
Figure 11. Decay rate versus climate index for inspection regions

Figure 11 clearly shows that the regions with higher climate index (CI) had significantly higher rates of decay. To understand more about the relationship between the climate index and wood post decay, the individual posts SWT velocity at the ground level (GL) were plotted versus the climate index of their location, shown in Figure 12. Based on the SWT Equation 1, a wave velocity for sound Hemlock was calculated to be approximately 38 in./ μ s, using the AWC/ANSI *National Design Specification* value for density and modulus (AWC 2015). For values of CI less than 40 only a handful of posts fell below the sound wood velocity of 38 in./ μ s, whereas for values of CI above 60 approximately 40% of the posts had velocities below 38 in./ μ s.

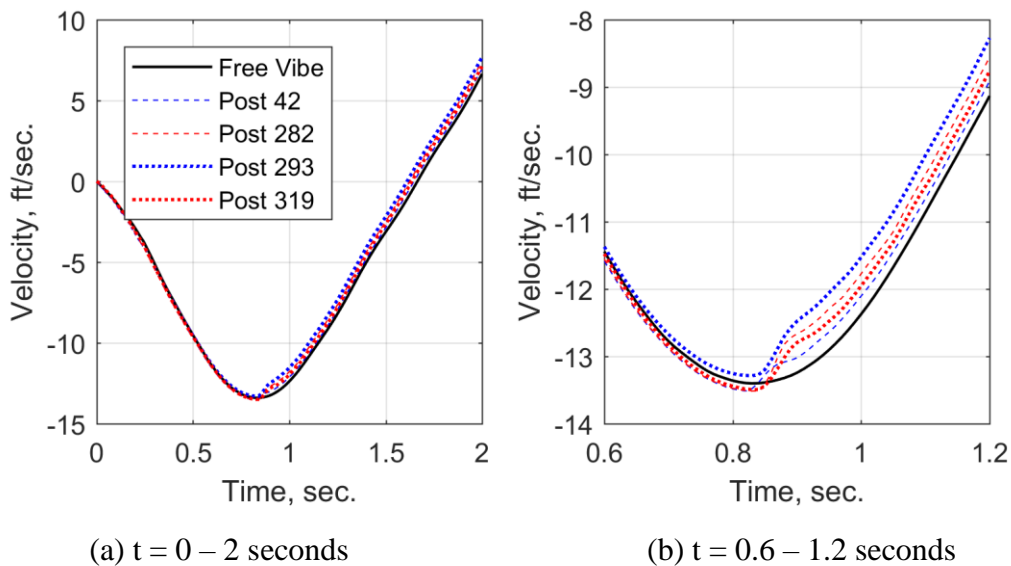
Figure 13. Pendulum velocity for posts with SWT velocities at the ground level between 0 and 20 in/ μ s

Figure 13 and 14 show the velocity response of the severely decayed and sound posts, respectively. It can be seen in Figure 13b that the average change in velocity immediately following impact was approximately 0.75 fps for the severely decayed posts. For the posts without noticeable decay, the average change in velocity immediately following impact was approximately 2.25 fps, or 3 times more than the severely decayed posts. This difference in the change in velocity shows that the decayed posts had less fracture energy than the sound posts.

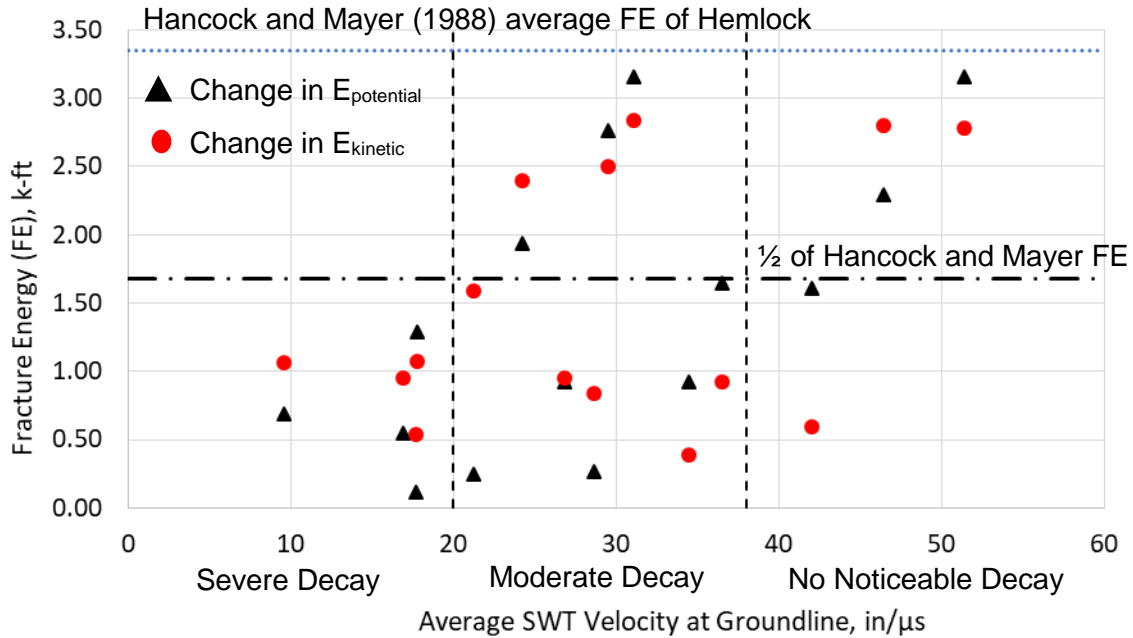
Figure 17. SWT velocity at ground level versus fracture energy

Lastly, Figure 17 presents the calculated fracture energies of the 15 posts using both methods. It can be seen that there is a substantial difference in calculated fracture energy between the two methodologies for an individual post, though the same trends exist. The fracture energy of new, stress-graded Hemlock posts, as tested by Hancock and Mayer (1988), is shown in Figure 17 to be 3.35 k-ft. None of the 15 posts achieved this fracture energy. There could be several reasons for this, but the most likely one is the age of the posts (>20 years in service) since the sound posts were not far below the Hancock and Mayer (1988) test data. None of the posts having severe decay, or SWT velocities at the ground level less than 20 in./ μ s, were able to attain half the fracture energy of the new sound posts from Hancock and Mayer (1988). Only half of the moderately decayed posts had fracture energy greater than half of the Hancock and Mayer (1988) tests. Interestingly, two of the moderately decayed posts had approximately the same fracture energy as two of the posts with no noticeable decay.

The impact testing results present a different conclusion on the effect of wood decay than previously conducted static bending tests, where even severe decay did not cause posts to lose their flexural capacity (Olszko and Bender 2015). In this case, the fracture energy of decayed posts was significantly less than that of sound posts. Table 5 presents the impact testing results for each post, including field and laboratory SWT velocity at the ground level, impact velocity, final velocity, peak negative pendulum displacement, and fracture energy calculated with both methods.
