TWO APPROACH GUARDRAIL TRANSITIONS FOR

CONCRETE SAFETY SHAPE BARRIERS

MIDWEST ROADSIDE SAFETY FACILITY

MwRSF Research Report No. TRP-03-69-98

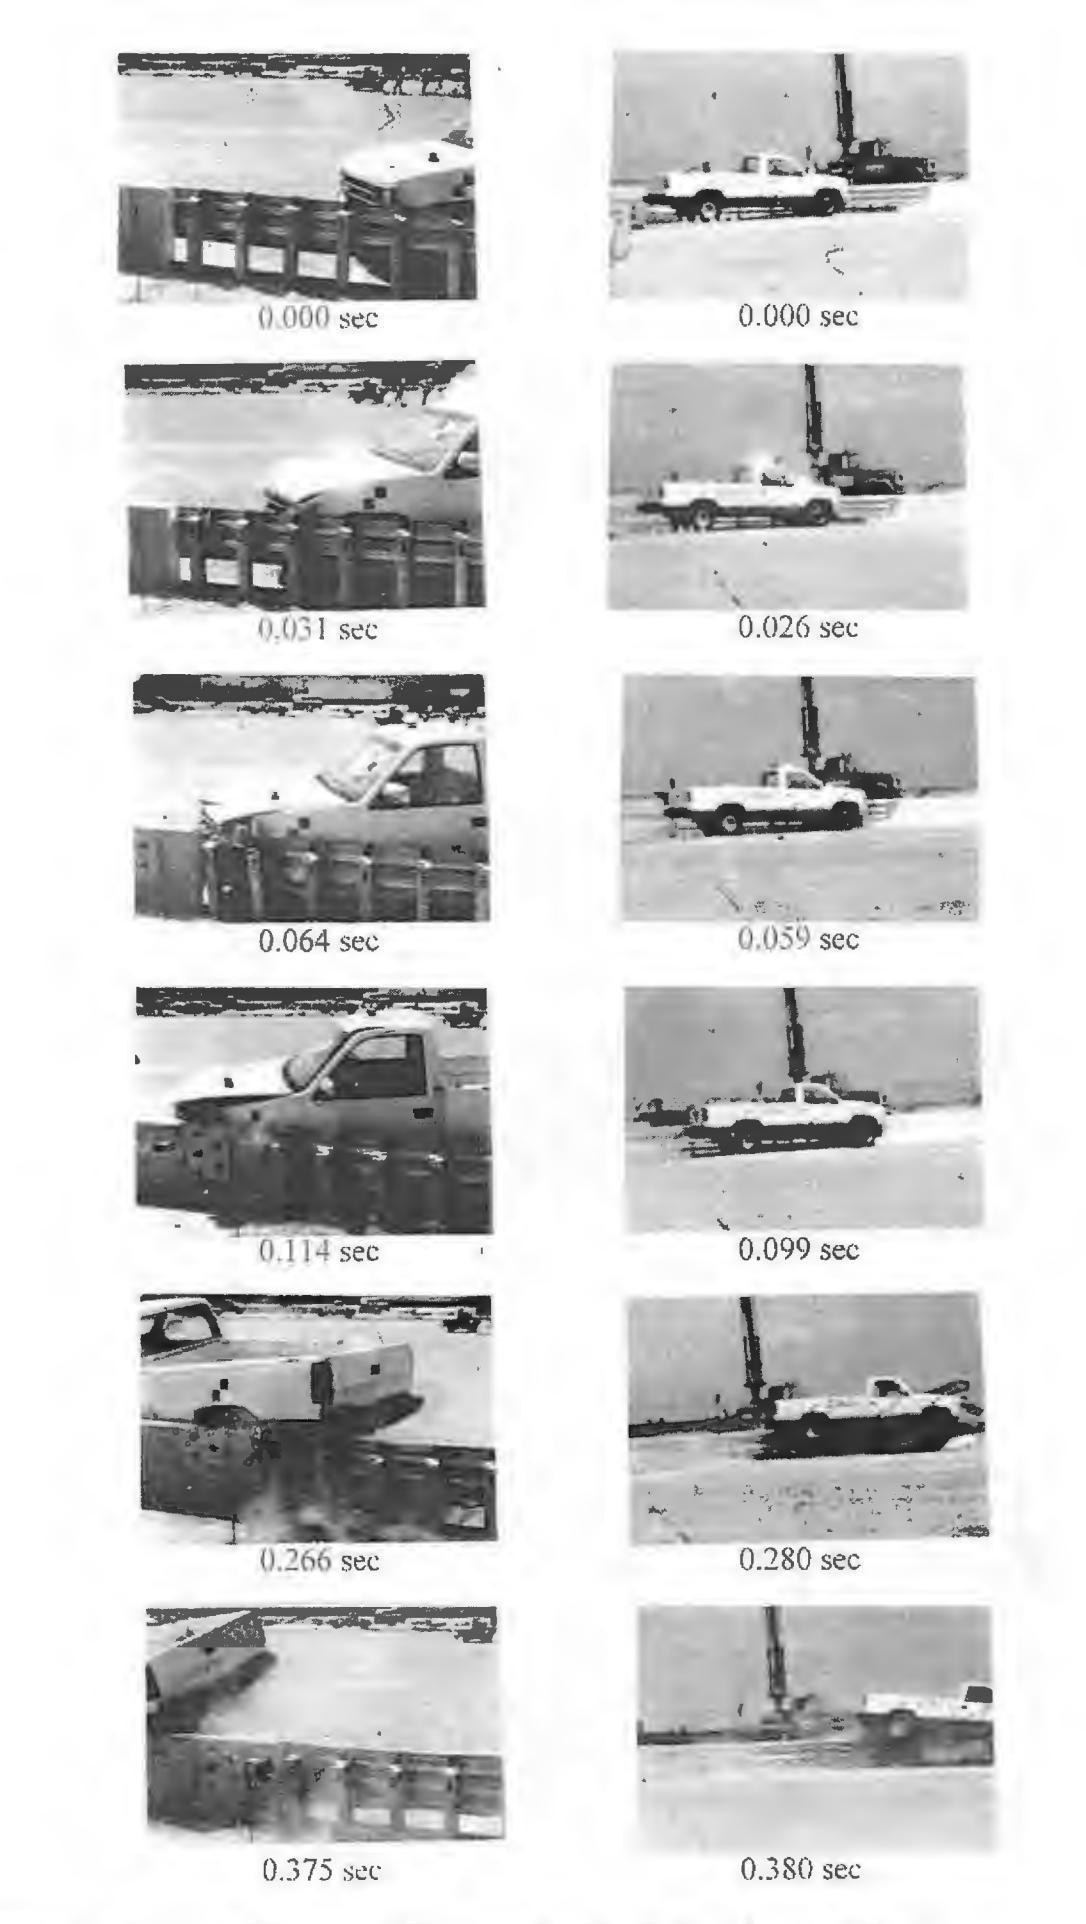
Figure 28. Additional Sequential Photographs, Test ITNJ-1 (Design No. 1)

The 1,994-kg pickup truck impacted the approach guardrail transition (Design No. 1) at a speed of 99.9 km/hr and an angle of 25.0 degrees. A summary of the test results and the sequential photographs are shown in Figure 27. Additional sequential photographs are shown in Figure 28.

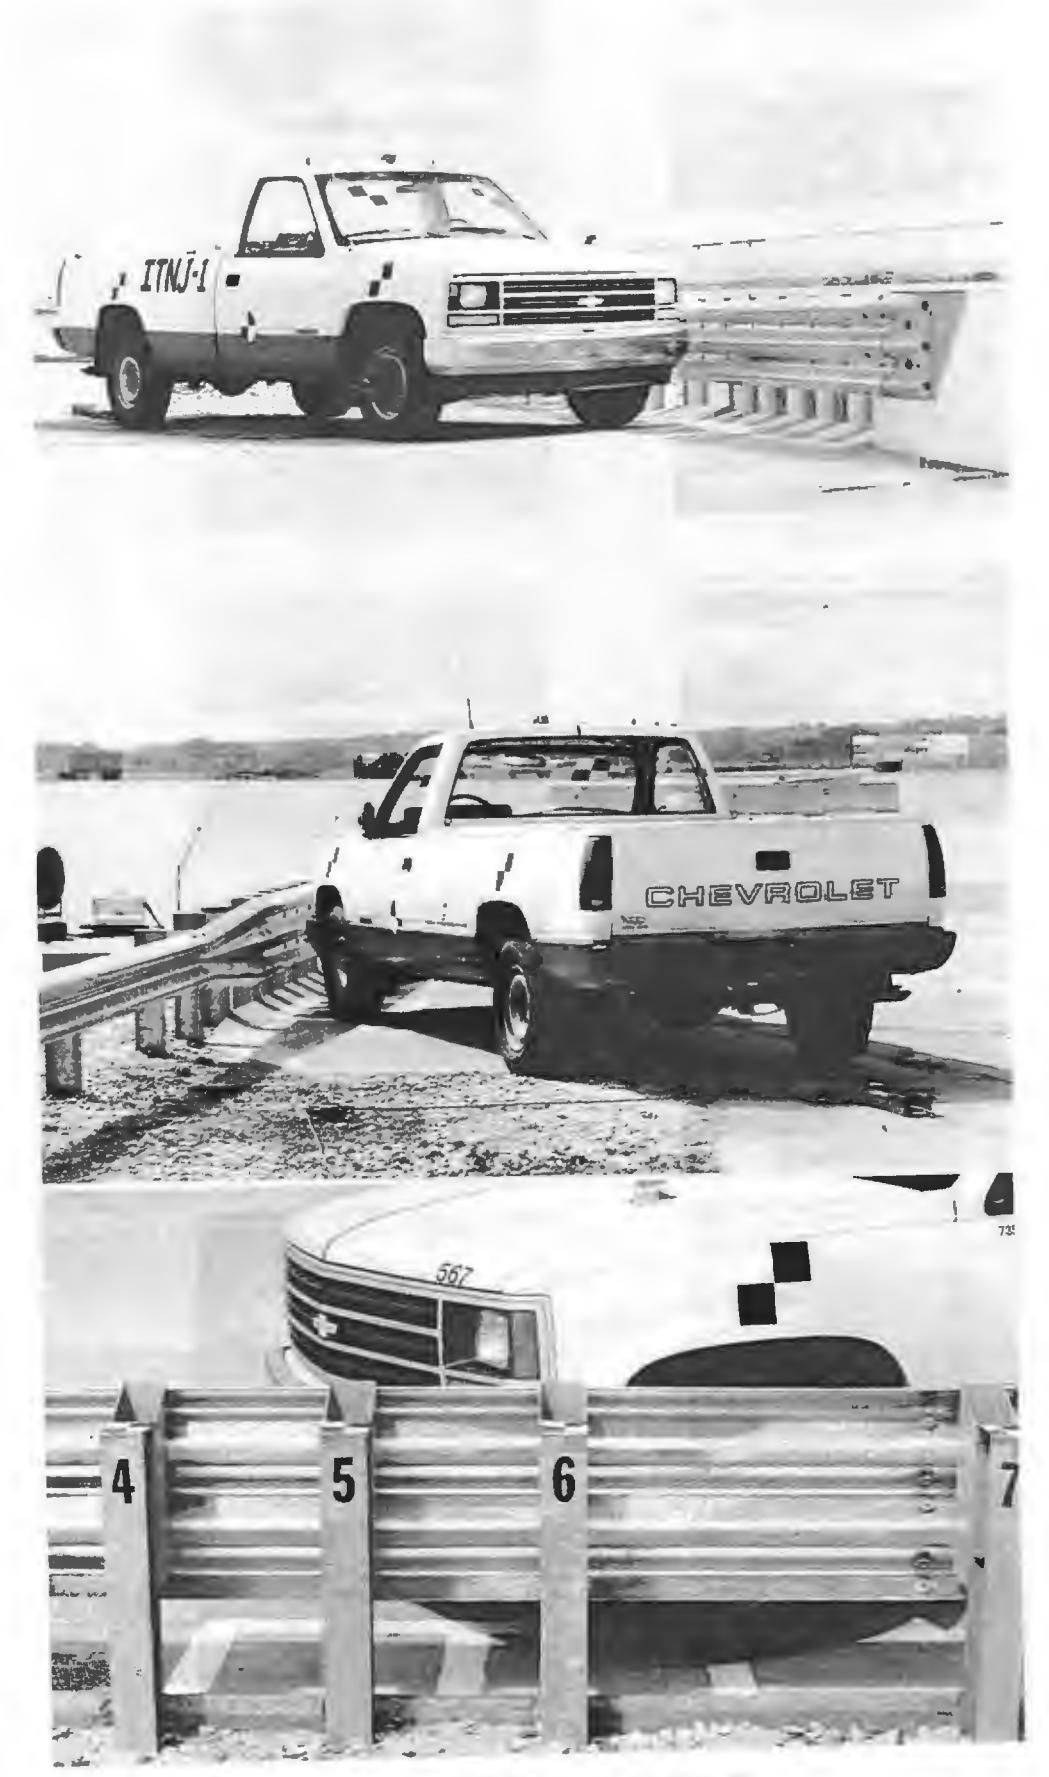
Figure 29. Impact Location, Test ITNJ-1 (Design No. 1)

Initial impact occurred at the midspan between post nos. 5 and 6 or 2,435-mm upstream from the end of the concrete barrier, as shown in Figure 29. Large lateral dynamic and permanent set barrier deflections occurred, as shown in Figures 27 and 30. This was evidenced by the sharp crease formed in the thrie beam rail at the end of the concrete barrier. During vehicle redirection, the pickup truck's left-front quarter panel extended over the thrie beam, contacting the top corner of the spacer blocks as well as the top edge of the concrete end section. This contact caused moderate tearing of the sheet metal and downward forces applied to the left-front corner of the vehicle. At 0.183 sec after impact, the vehicle became parallel to the barrier with a velocity of 65.2 km/hr. During vehicle tailslap with the barrier, the rear-end of the vehicle pitched upward moderately, allowing the left-rear corner of the bumper to mount the top of the thrie beam and contact the spacer blocks. At 0.422 sec after impact, the vehicle exited the barrier at an angle of 16.2 degrees and a speed of 64.7 km/hr. Subsequently, the left-front wheel assembly contacted the ground with significant vehicular motions, including counter-clockwise vehicle roll, downward pitching, and clockwise yawing. These angular motions caused the pickup truck to roll over 2¹/₂ times. The vehicle's post-impact trajectory is shown in Figure 27. The vehicle came to rest 38.71 m downstream from impact and 15.85 m away from the traffic-side face of the barrier.

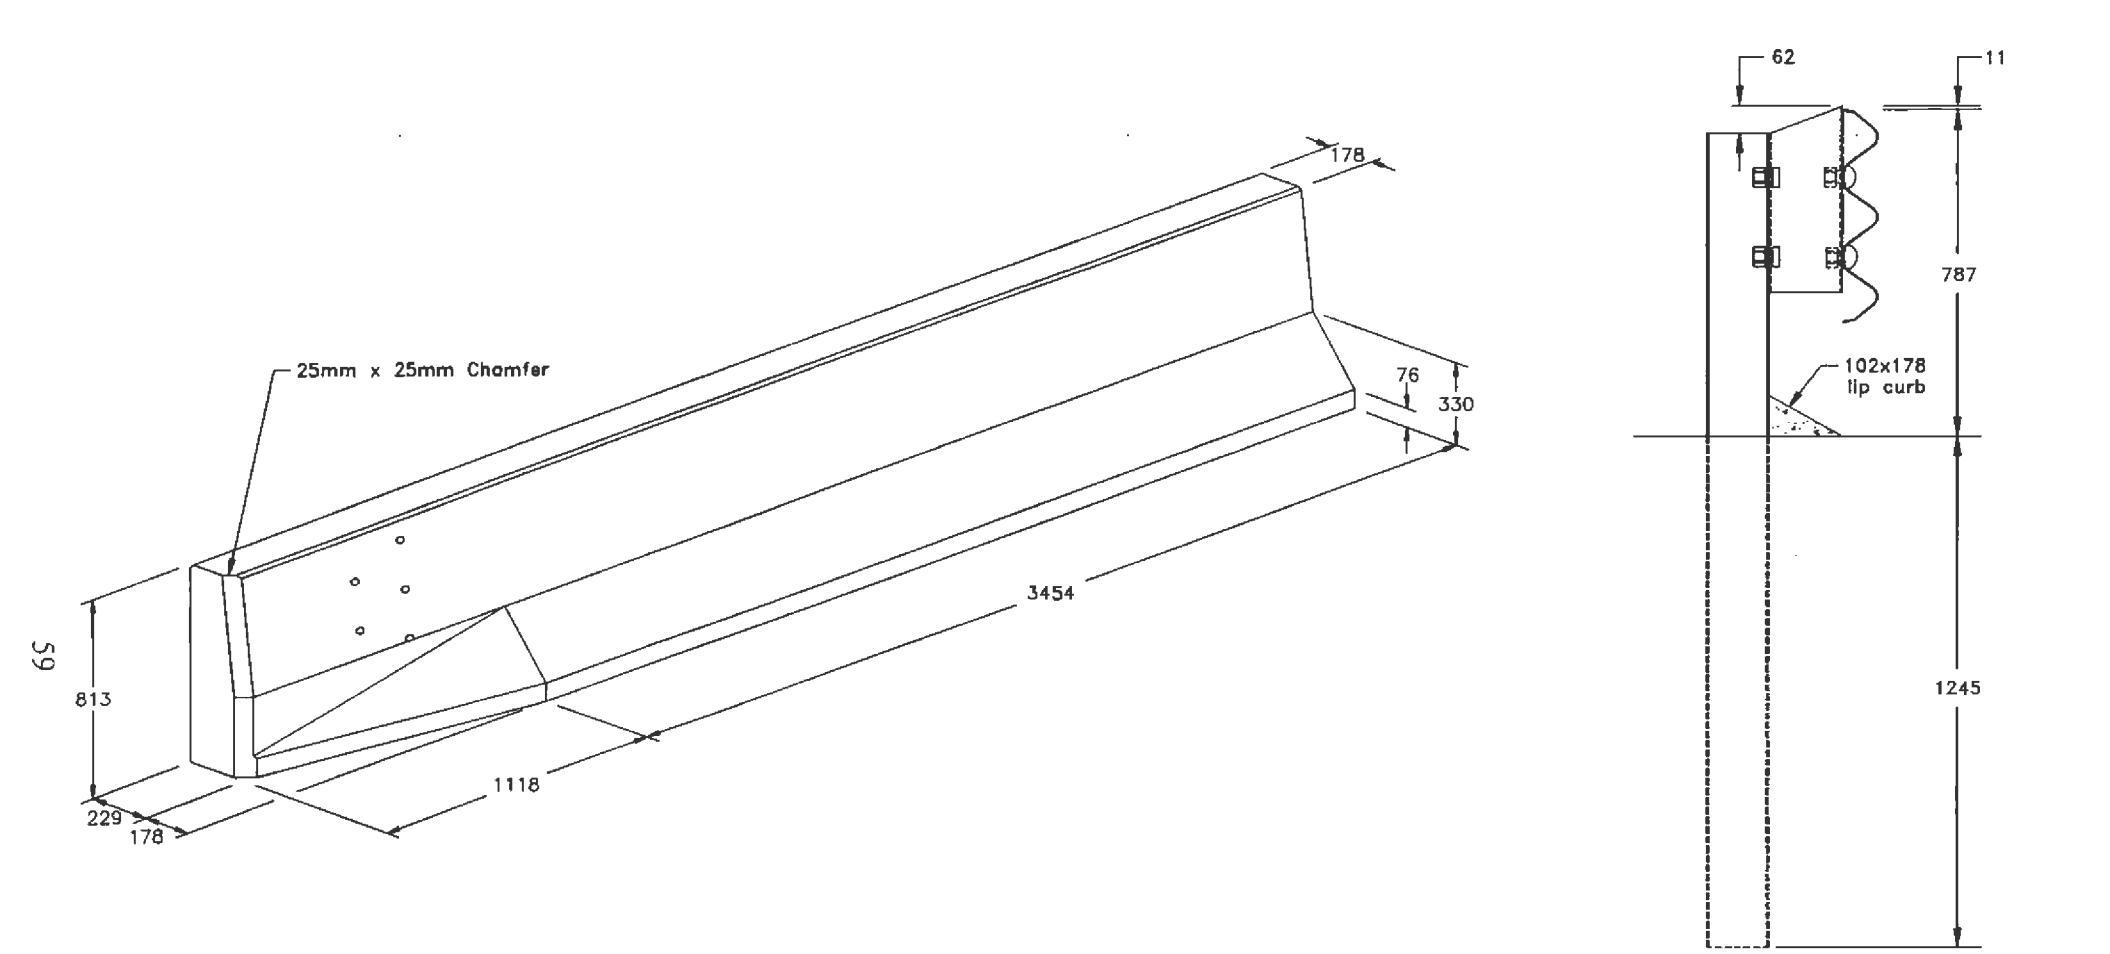
Figure 36. Barrier and Post Modifications, Design No. 2

Following the unsuccessful crash test of Design No. 1, it was necessary to determine the cause of the poor barrier performance and subsequent vehicle rollover so that design modifications could be made to the system. A careful examination of the damaged barrier system and an analysis of the test results revealed that the dynamic and permanent set barrier deflections were greater than those predicted. It is believed that these excessive barrier deflections occurred due to post-soil forces being significantly lower than expected. These lower post-soil forces may be attributed to the use of a relatively poorly-graded, coarse crushed limestone material meeting NCHRP Report 350 specifications.

As a result of the extensive vehicle penetration into the barrier system, the pickup truck was redirected out of the barrier system at a higher than normal exit angle. Significant roll, pitch, and yaw angular motions were also produced, resulting in vehicle rollover. In addition, the increased vehicle penetration and minor pocketing led to higher than expected impact forces being applied to the concrete end section, resulting in cracking of the safety shape barrier.

modifications were made to the approach guardrail transition system. The embedment depth of post nos. 1 through 7 were increased by 152 mm, resulting in a total embedment depth of 1,245 mm. The relatively poorly-graded aggregate material used in Design No. 1 was replaced with a crushed limestone material more consistent with the AASHTO specification. In addition, a 25-mm chamfer was placed on the front vertical edge of the concrete safety shape's upstream end. These modifications, incorporated in Design No. 2, are shown in Figure 36.

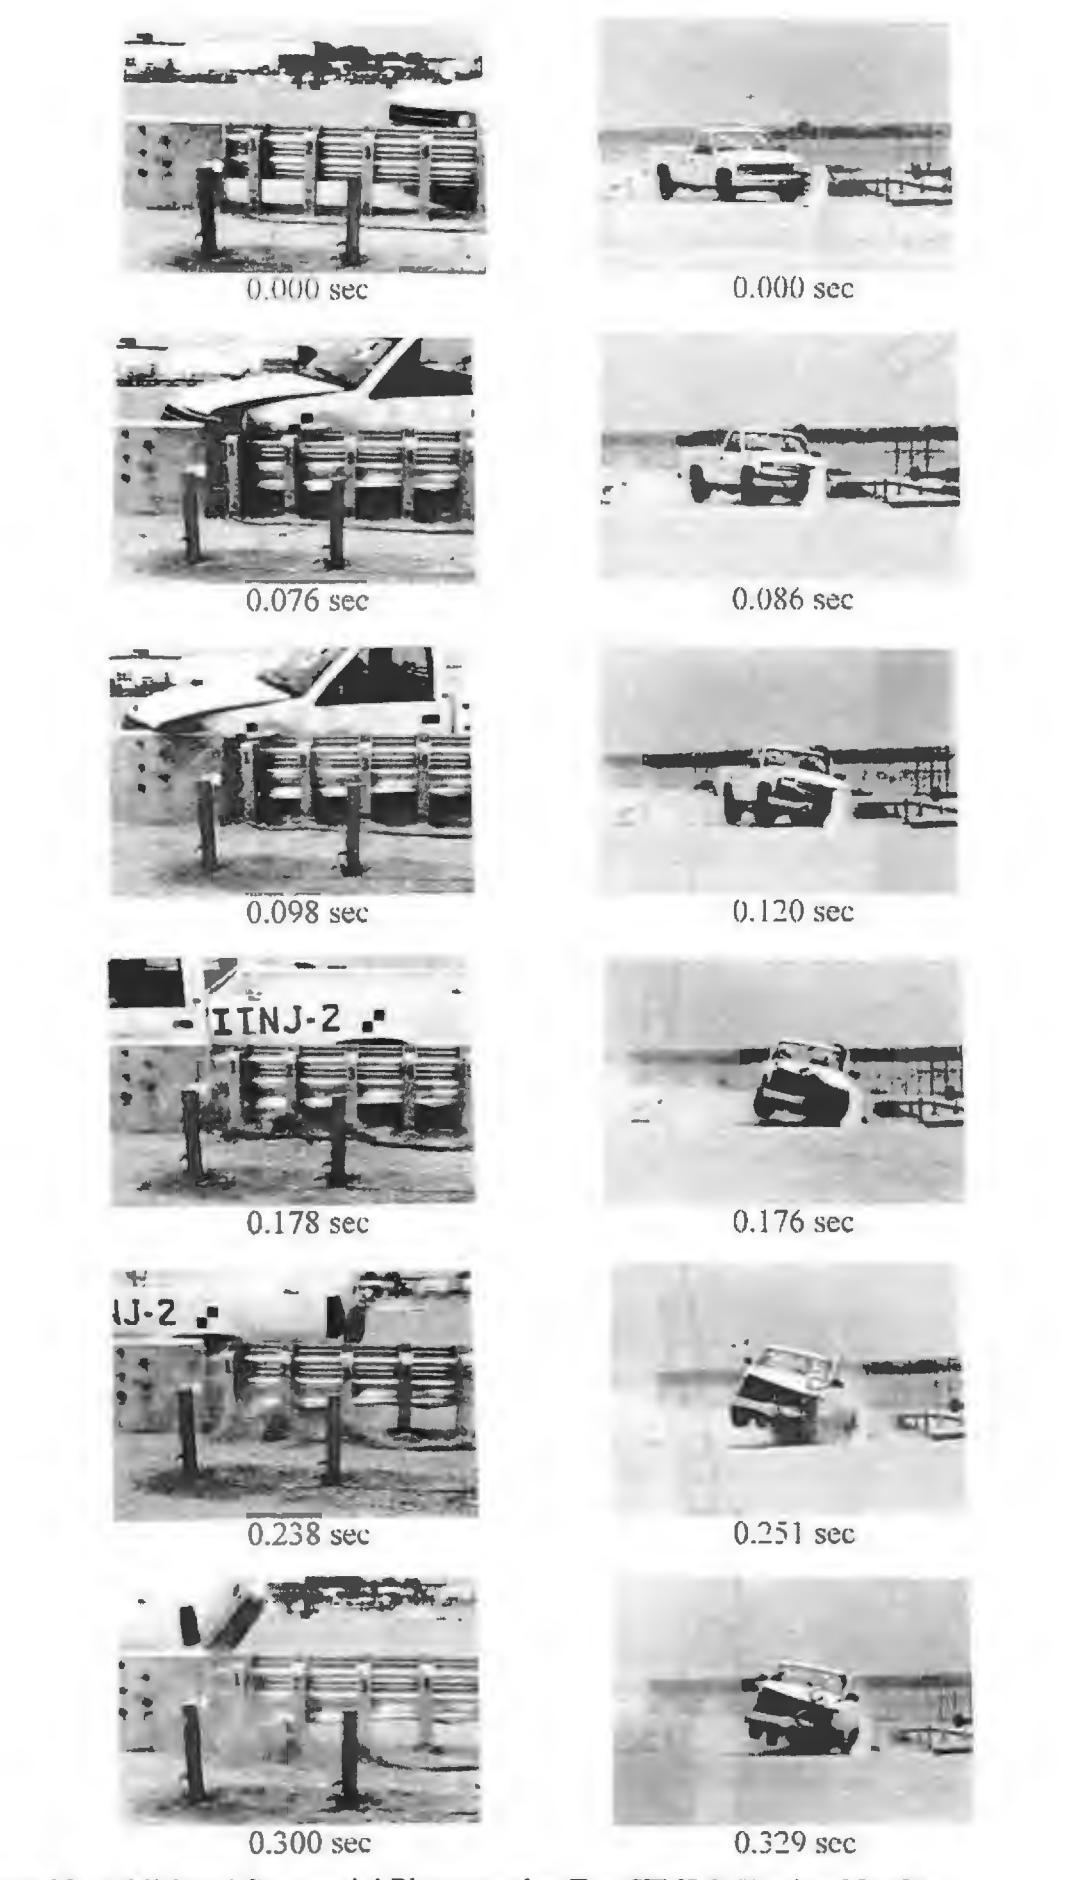
Figure 38. Additional Sequential Photographs, Test ITNJ-2 (Design No. 2)

The 1,977-kg pickup truck impacted the approach guardrail transition (Design No. 2) at a speed of 101.6 km/hr and an angle of 25.7 degrees. A summary of the test results and the sequential photographs are shown in Figure 37. Additional sequential photographs are shown in Figure 38. Documentary photographs of the crash test are shown in Figures 39 and 40.

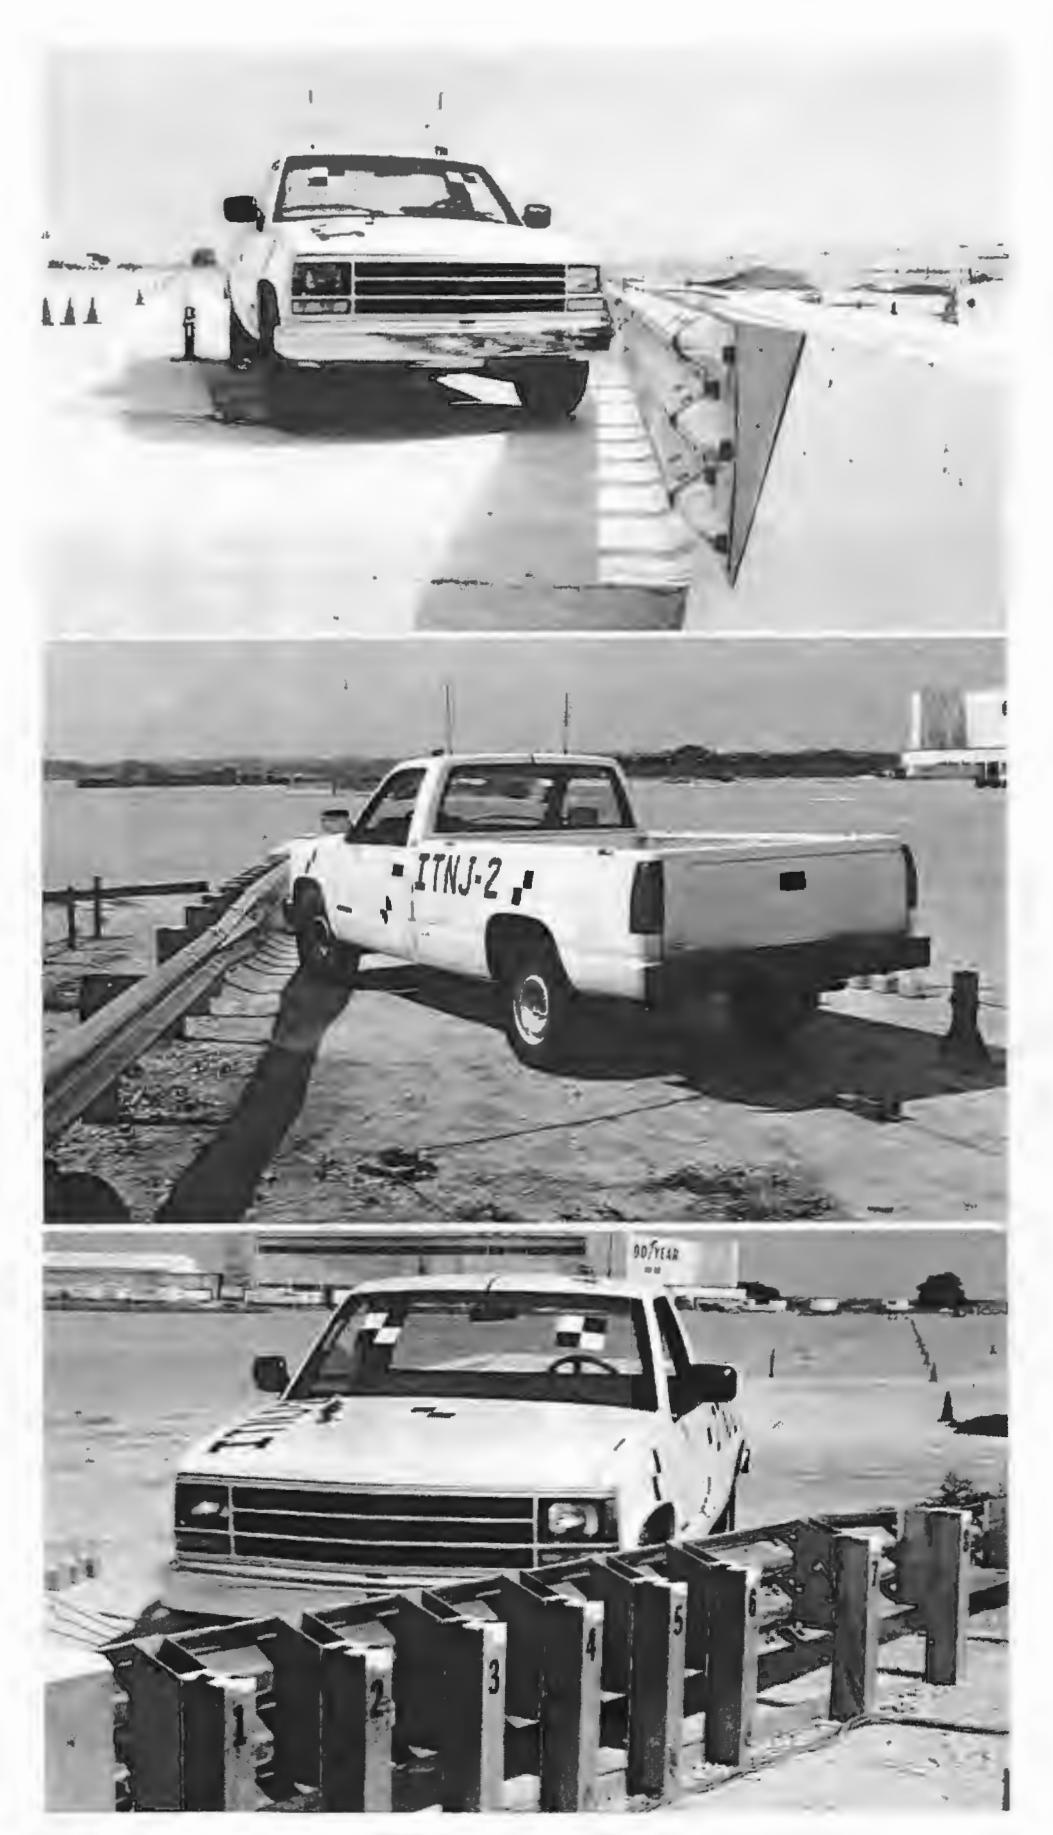
Figure 41. Impact Location, Test ITNJ-2 (Design No. 2)

Initial impact occurred at the midspan between post nos. 5 and 6 or 2,435-mm upstream from the end of the concrete barrier, as shown in Figure 41. Moderate lateral dynamic and permanent set barrier deflections were encountered, as shown in Figures 37 and 42. During vehicle redirection, the pickup truck's left-front quarter panel extended over the thrie beam, contacting the top corner of the spacer blocks as well as the top edge of the concrete end section. This contact caused moderate tearing of the sheet metal and downward forces applied to the left-front corner of the vehicle. At 0.183 sec after impact, the vehicle became parallel to the barrier with a velocity of 71.1 km/hr. During vehicle tail-slap with the barrier, the rear-end of the vehicle pitched upward slightly; however, the left-rear corner of the bumper did not mount the top of the thrie beam nor contact the spacer blocks. Subsequently, the vehicle began to roll counter-clockwise toward the barrier with the right-side wheels becoming airborne. At 0.329 sec after impact, the vehicle exited the barrier at an angle of 6.9 degrees and a speed of 70.8 km/hr. As the vehicle exited the barrier, the left-front wheel assembly contacted the ground but with minor counter-clockwise vehicle roll, resulting in a smooth and stable vehicle redirection. The vehicle's post-impact trajectory is shown in Figure 37. The vehicle came to rest 76.8 m downstream and 11.2 m behind the barrier.

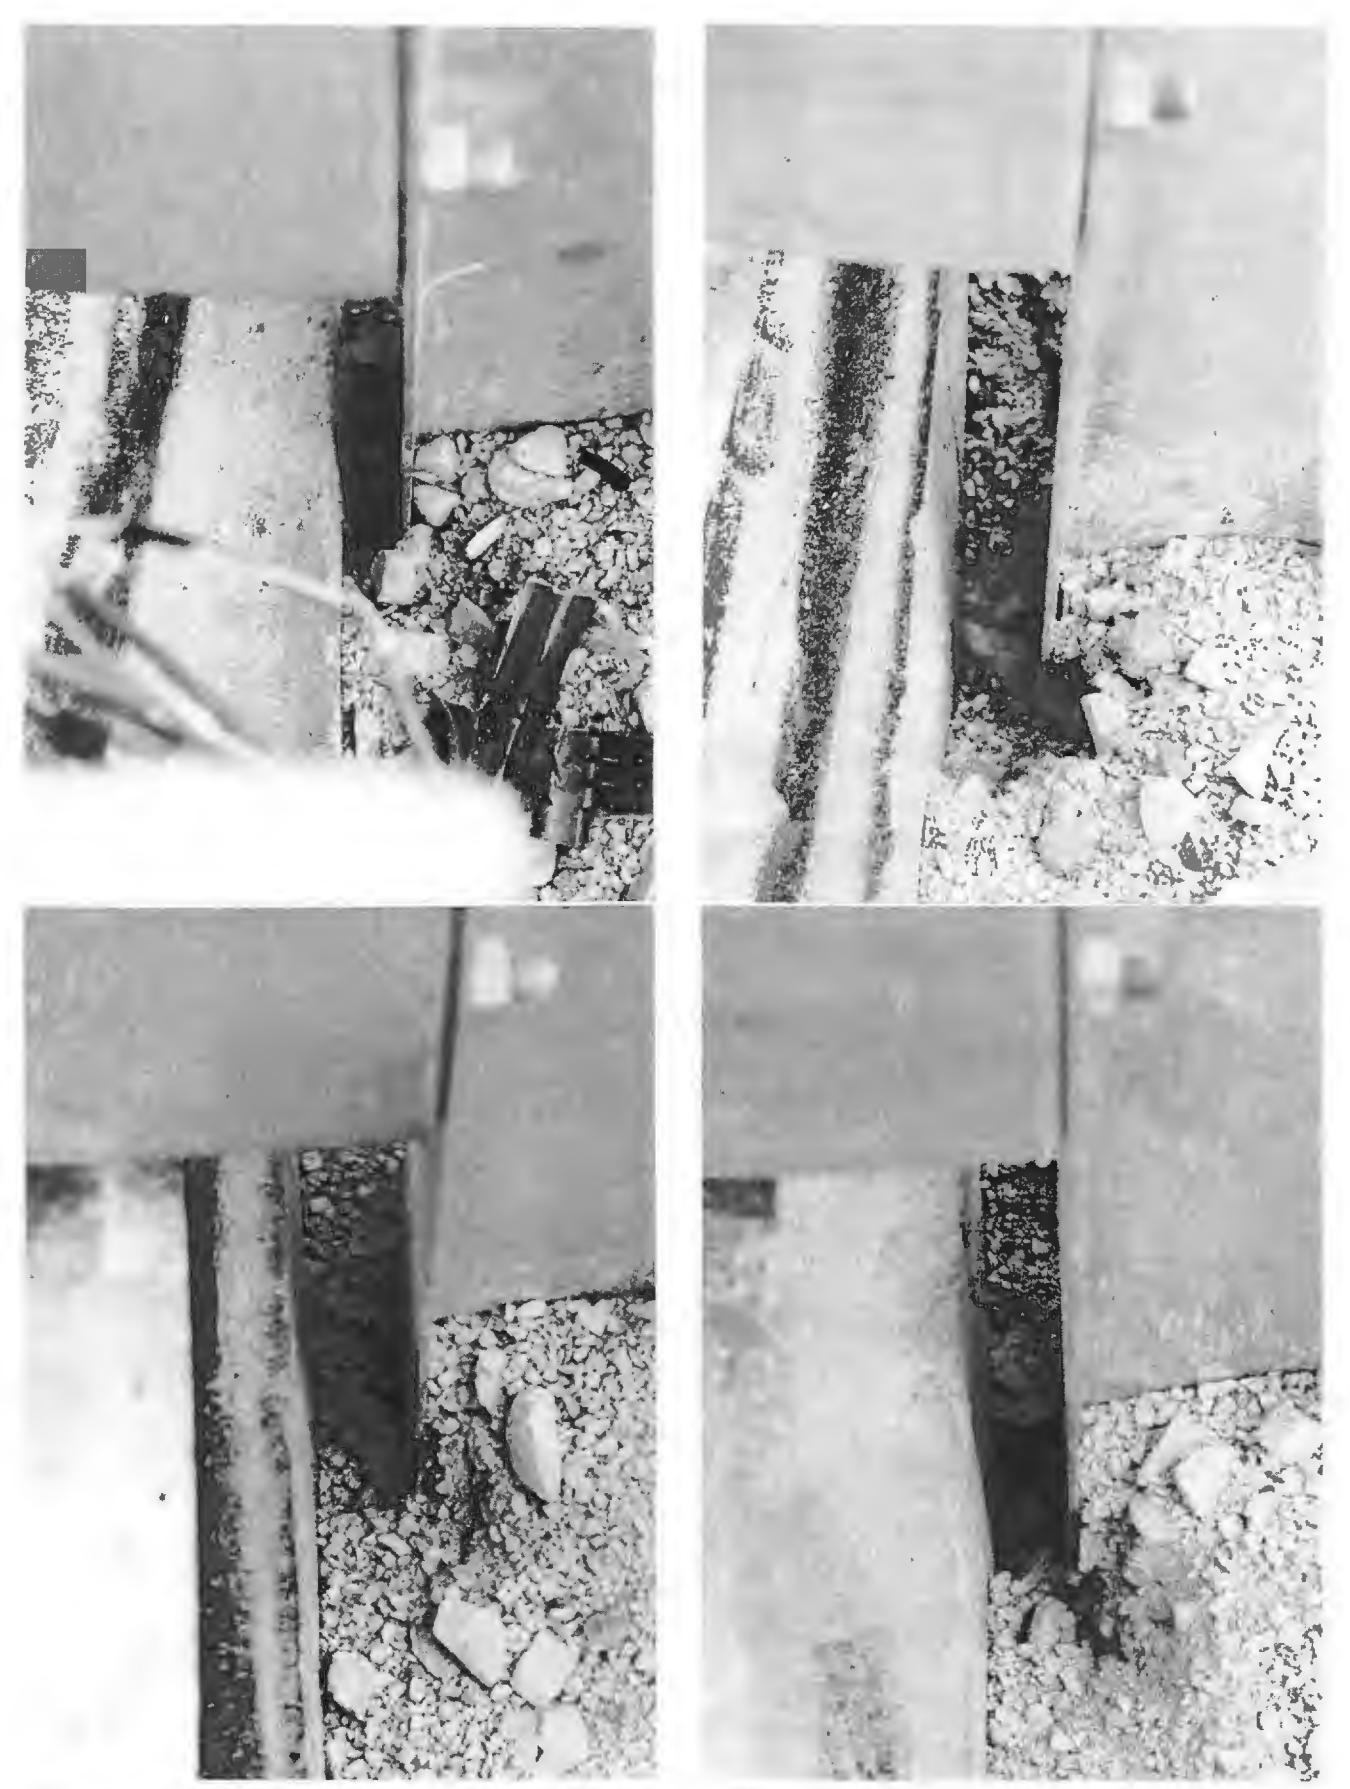
Figure 44. Final Post Positions, Test ITNJ-2 (Design No. 2)

Damage to the barrier was moderate, as shown in Figures 42 through 45. Barrier damage consisted mostly of deformed thrie beam and tire marks on the lower upstream face of the concrete end section. No cracking was observed in the concrete end section. The permanent set of the guardrail and posts is shown in Figures 42 and 44 through 45. The maximum lateral permanent set deflection was approximately 92 mm at post no. 2 and the midspan between post nos. 2 and 3, as measured in the field. The maximum lateral dynamic deflection was 133 mm at post no. 3, as determined from the high-speed film analysis. It is noted that some dynamic deflection measurements were not available for viewing from the overhead camera due to the vehicle extending over the barrier.

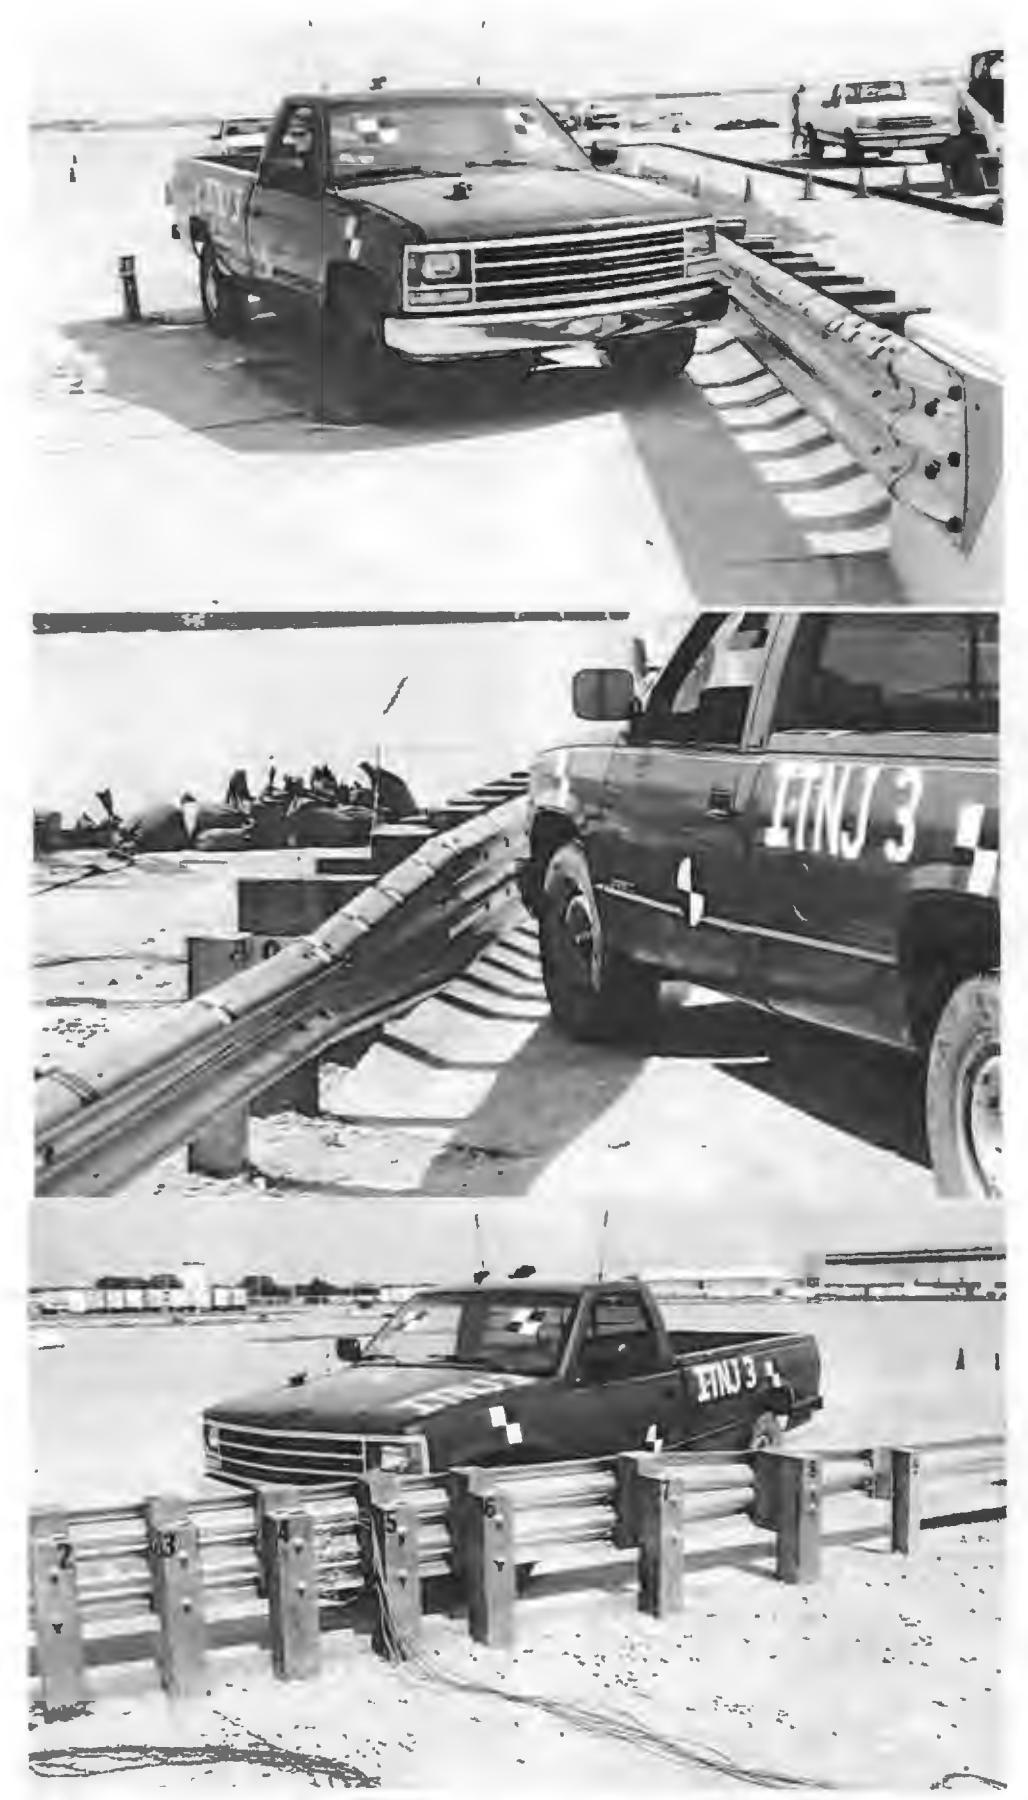
Figure 55. Impact Location, Test ITNJ-3 (Design No. 3)

Initial impact occurred at the midspan between post nos. 5 and 6 or 2,435-mm upstream from the end of the concrete barrier, as shown in Figure 55. Large lateral dynamic and permanent set barrier deflections occurred, as shown in Figures 51 and 56. This was evidenced by the crease formed in the thrie beam rail near post no. 3. During vehicle redirection, the pickup truck's left-front quarter panel extended over the thrie beam, contacting the top corner of the spacer blocks as well as the top edge of the concrete end section. This contact caused moderate tearing of the sheet metal and downward forces applied to the left-front corner of the vehicle. At 0.208 sec after impact, the vehicle became parallel to the barrier with a velocity of 63.1 km/hr. During vehicle tail-slap with the barrier, the rear-end of the vehicle pitched upward moderately, allowing the left-rear corner of the bumper to mount the top of the thrie beam and contact the several spacer blocks and concrete end section. At 0.401 sec after impact, the vehicle exited the barrier at an angle of 13.1 degrees and a speed of 61.7 km/hr. Subsequently, the left-front wheel assembly contacted the ground with significant vehicular motions, including counter-clockwise vehicle roll, downward pitching, and clockwise yawing. These angular motions caused the pickup truck to roll over 3 times. The vehicle's post-impact trajectory is shown in Figure 51. The vehicle came to rest 44.2 m downstream from

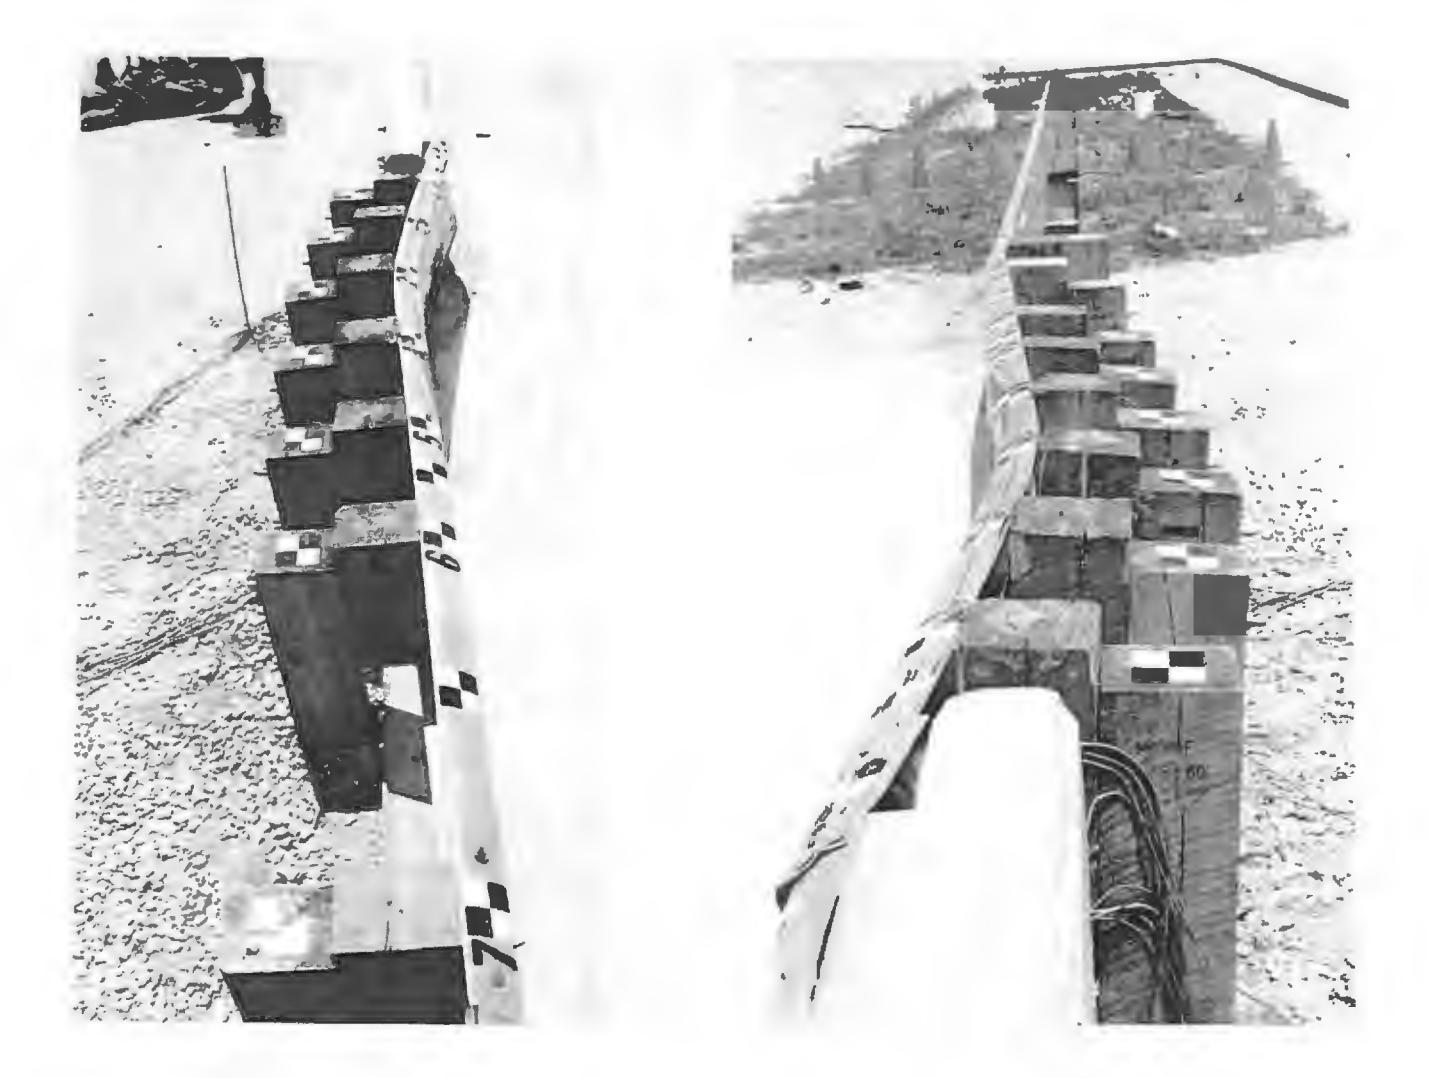
Figure 56. Barrier Damage, Test ITNJ-3 (Design No. 3)

Damage to the barrier was moderate, as shown in Figures 56 through 59. Barrier damage consisted mostly of deformed thrie beam, tire marks on the lower upstream face of the concrete end section, and cracking in the concrete end section. Concrete cracking and minor spalling was observed on the upstream end of the concrete end section. The permanent set of the guardrail and posts is shown in Figures 51 and 56 through 59. The maximum lateral permanent set deflection was approximately 171 mm at post no. 3, as measured in the field. The maximum lateral dynamic deflection was 264 mm at post no. 3, as determined from the high-speed film analysis.

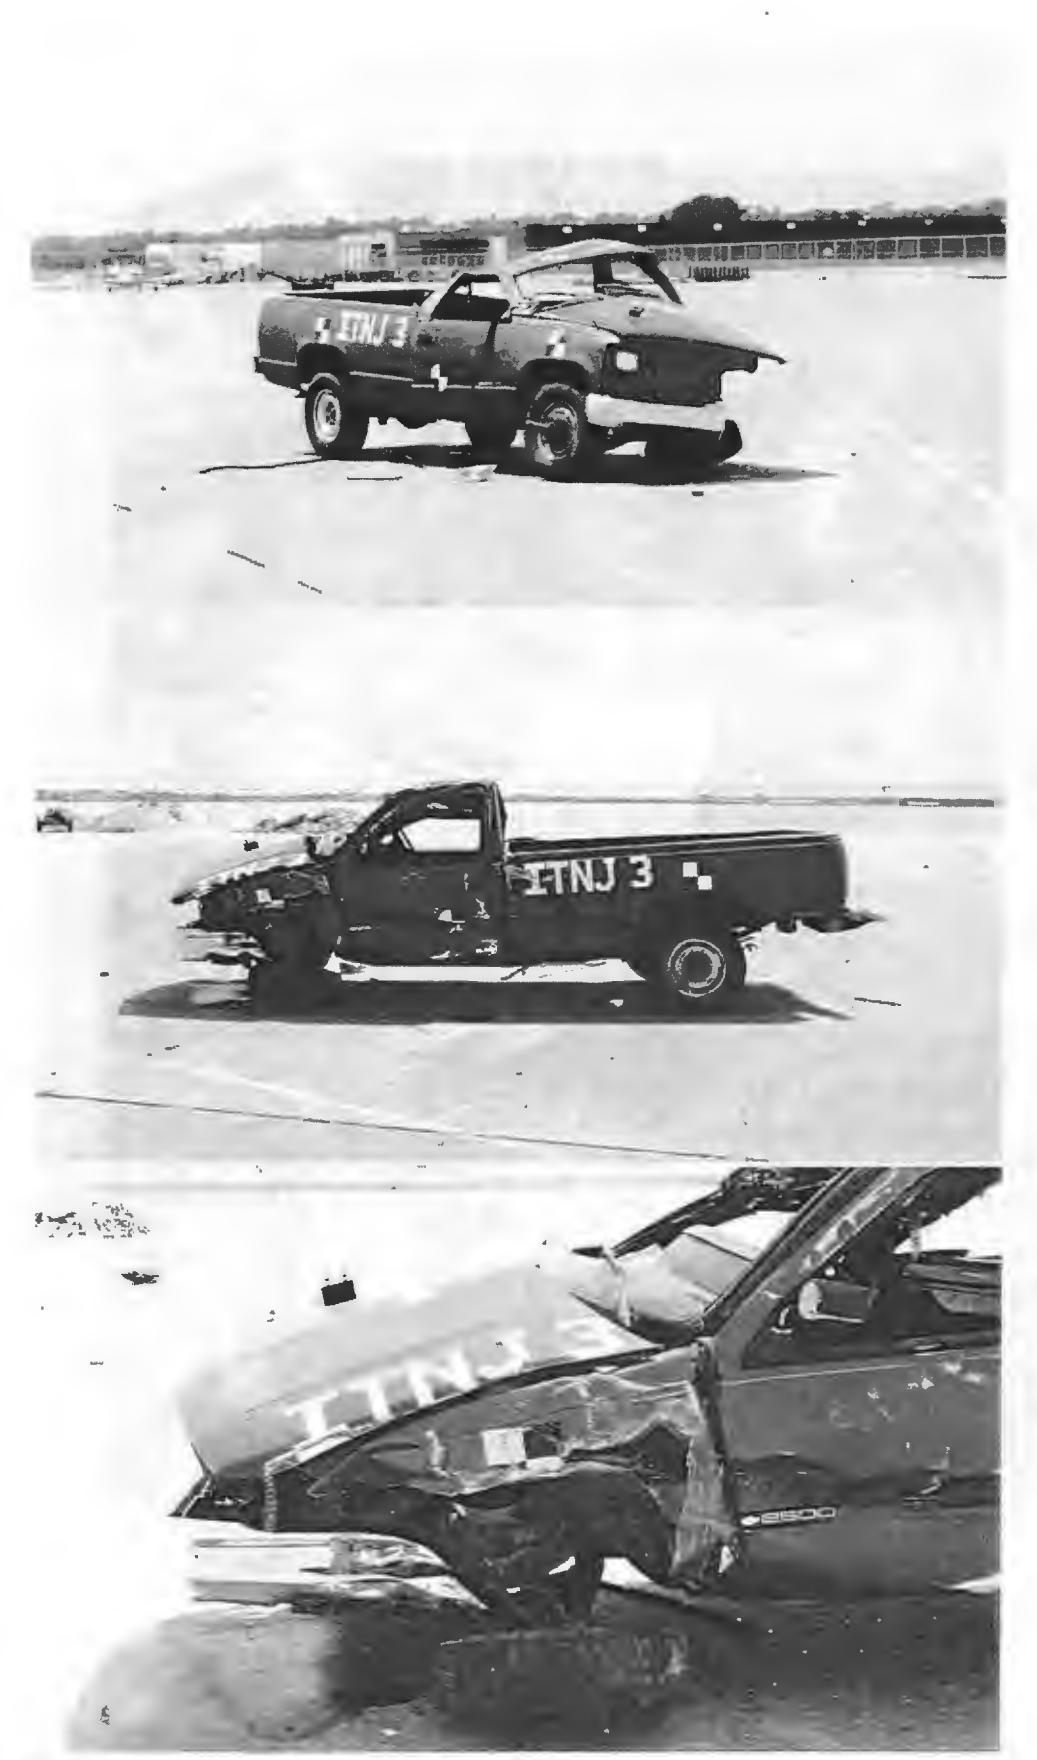
Figure 60. Vehicle Damage, Test ITNJ-3 (Design No. 3)

Exterior and interior vehicle damage was extensive and occurred to several body locations, as shown in Figures 60 and 61. The left-front quarter panel was crushed inward, and the left-side of the front bumper was also bent back toward the engine compartment. The engine hood, roof, truck cab, and window glass were severely crushed during the vehicle rollovers. The floorboard of the occupant compartment also contained significant plastic deformations due to the severe impact with the barrier as well as from vehicle rollover.

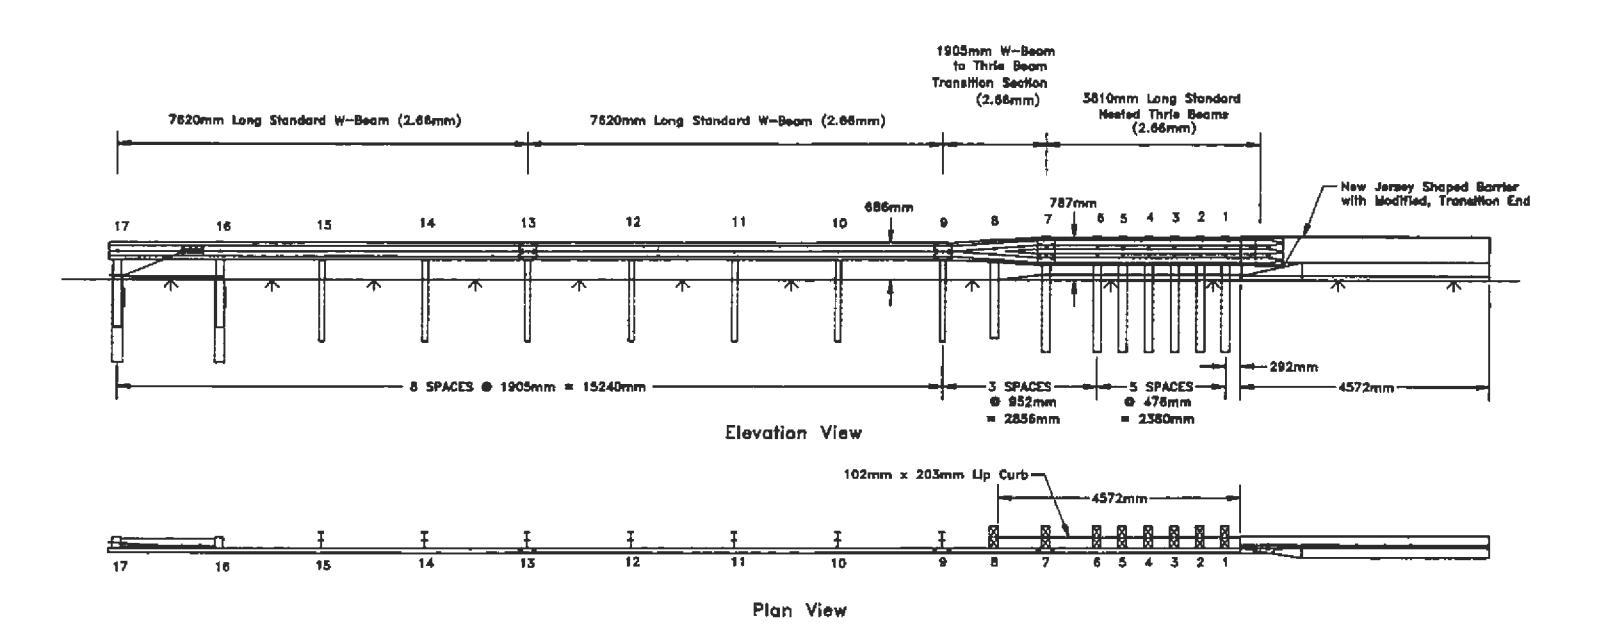
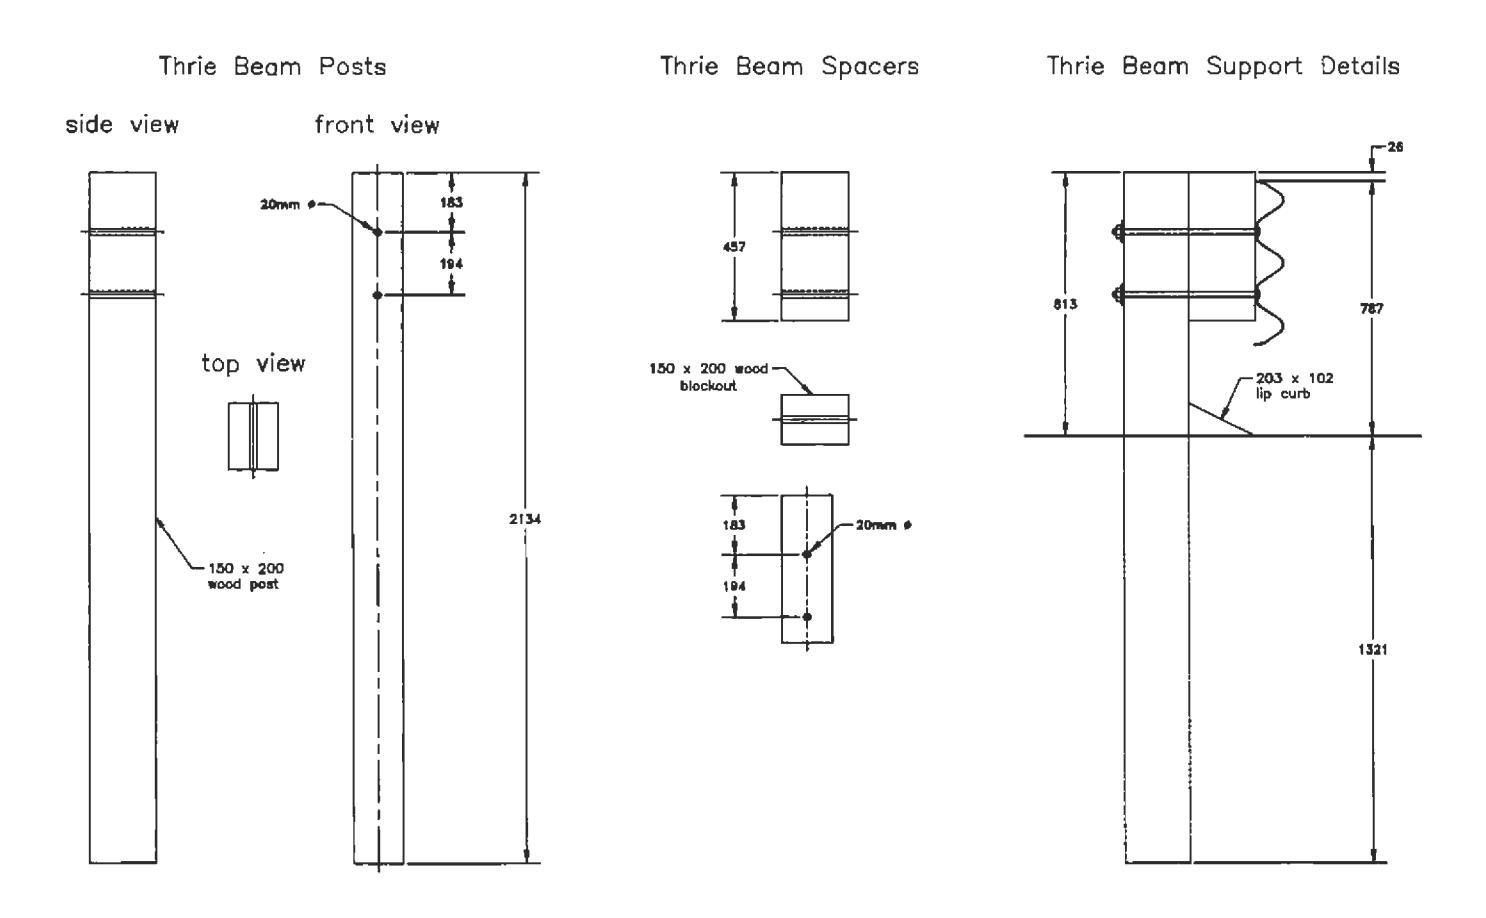
Figure 62. Barrier and Post Modifications, Design No. 4

Following the unsuccessful crash test of Design No. 3, it was necessary to determine the cause of the poor barrier performance and subsequent vehicle rollover so that design modifications could be made to the system. A careful examination of the damaged barrier system and an analysis of the test results revealed that the dynamic and permanent set barrier deflections were greater than those predicted. It is believed that these excessive barrier deflections occurred due to post-soil forces lower than expected.

As a result of the extensive vehicle penetration into the barrier system, the pickup truck was redirected out of the barrier system at a higher than normal exit angle. During, vehicle redirection, the left-corner of the rear bumper mounted the top of the thrie beam, contacting several spacer blocks and the concrete end section. These two conditions led to significant roll, pitch, and yaw angular motions, resulting in vehicle rollover. Once again, the increased vehicle penetration and minor pocketing led to higher than expected impact forces being applied to the concrete end section, resulting in cracking of the safety shape barrier.

After this investigation, it was believed that the safety performance of the approach guardrail transition (Design No. 3) could be significantly improved with a reduction in dynamic and permanent set barrier deflections. One major modification was implemented for stiffening the approach guardrail transition. The embedment depth of post nos. 1 through 7 were increased by 229 mm, resulting in a total embedment depth of 1,321 mm. In addition, the top height of the wood posts were placed flush with the wood spacer blocks, thus requiring the use of 2,134-mm long posts. Also, the well-graded aggregate material used in Design No. 3, with a reduced amount of material in the middle sieve sizes, was replaced with the well-graded crushed limestone material used in Design No.

2. These modifications, incorporated in Design No. 4, are shown in Figures 62 and 63.
