TWO APPROACH GUARDRAIL TRANSITIONS FOR

CONCRETE SAFETY SHAPE BARRIERS

MIDWEST ROADSIDE SAFETY FACILITY

MwRSF Research Report No. TRP-03-69-98

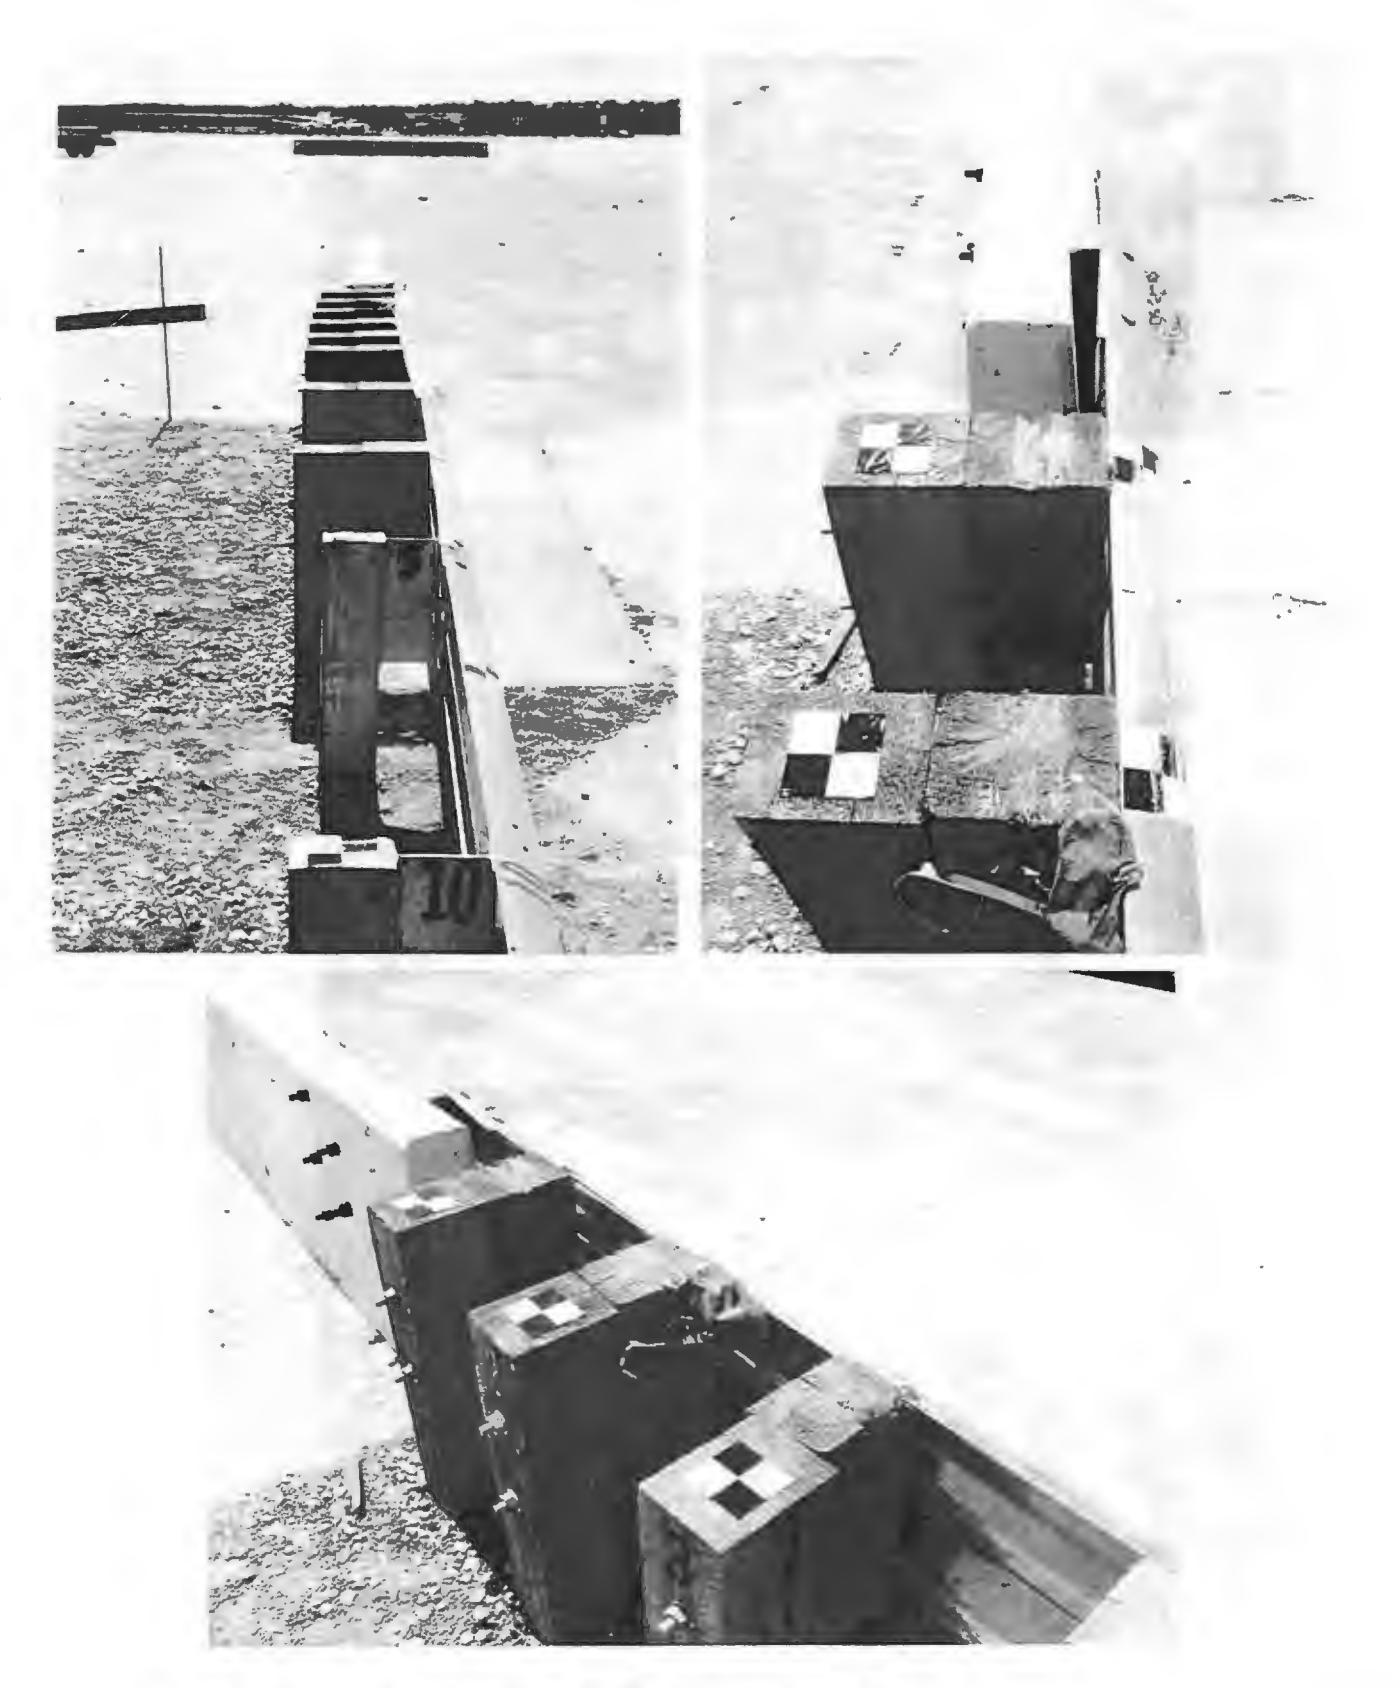
Figure 69. Barrier Damage, Test ITNJ-4 (Design No. 4)

Damage to the barrier was moderate, as shown in Figures 69 and 70. Barrier damage consisted mostly of deformed thrie beam and tire marks on the lower upstream face of the concrete end section. No cracking was observed in the concrete end section. The permanent set of the guardrail and posts is shown in Figures 69 and 70. The maximum lateral permanent set deflection was approximately 32 mm at post no. 4 through the midspan between post nos. 2 and 3, as measured in the field. The maximum lateral dynamic deflection was 99 mm at post no. 3, as determined from the high-speed film analysis. It is noted that some dynamic deflection measurements were not available for viewing from the overhead camera due to the vehicle extending over the barrier.

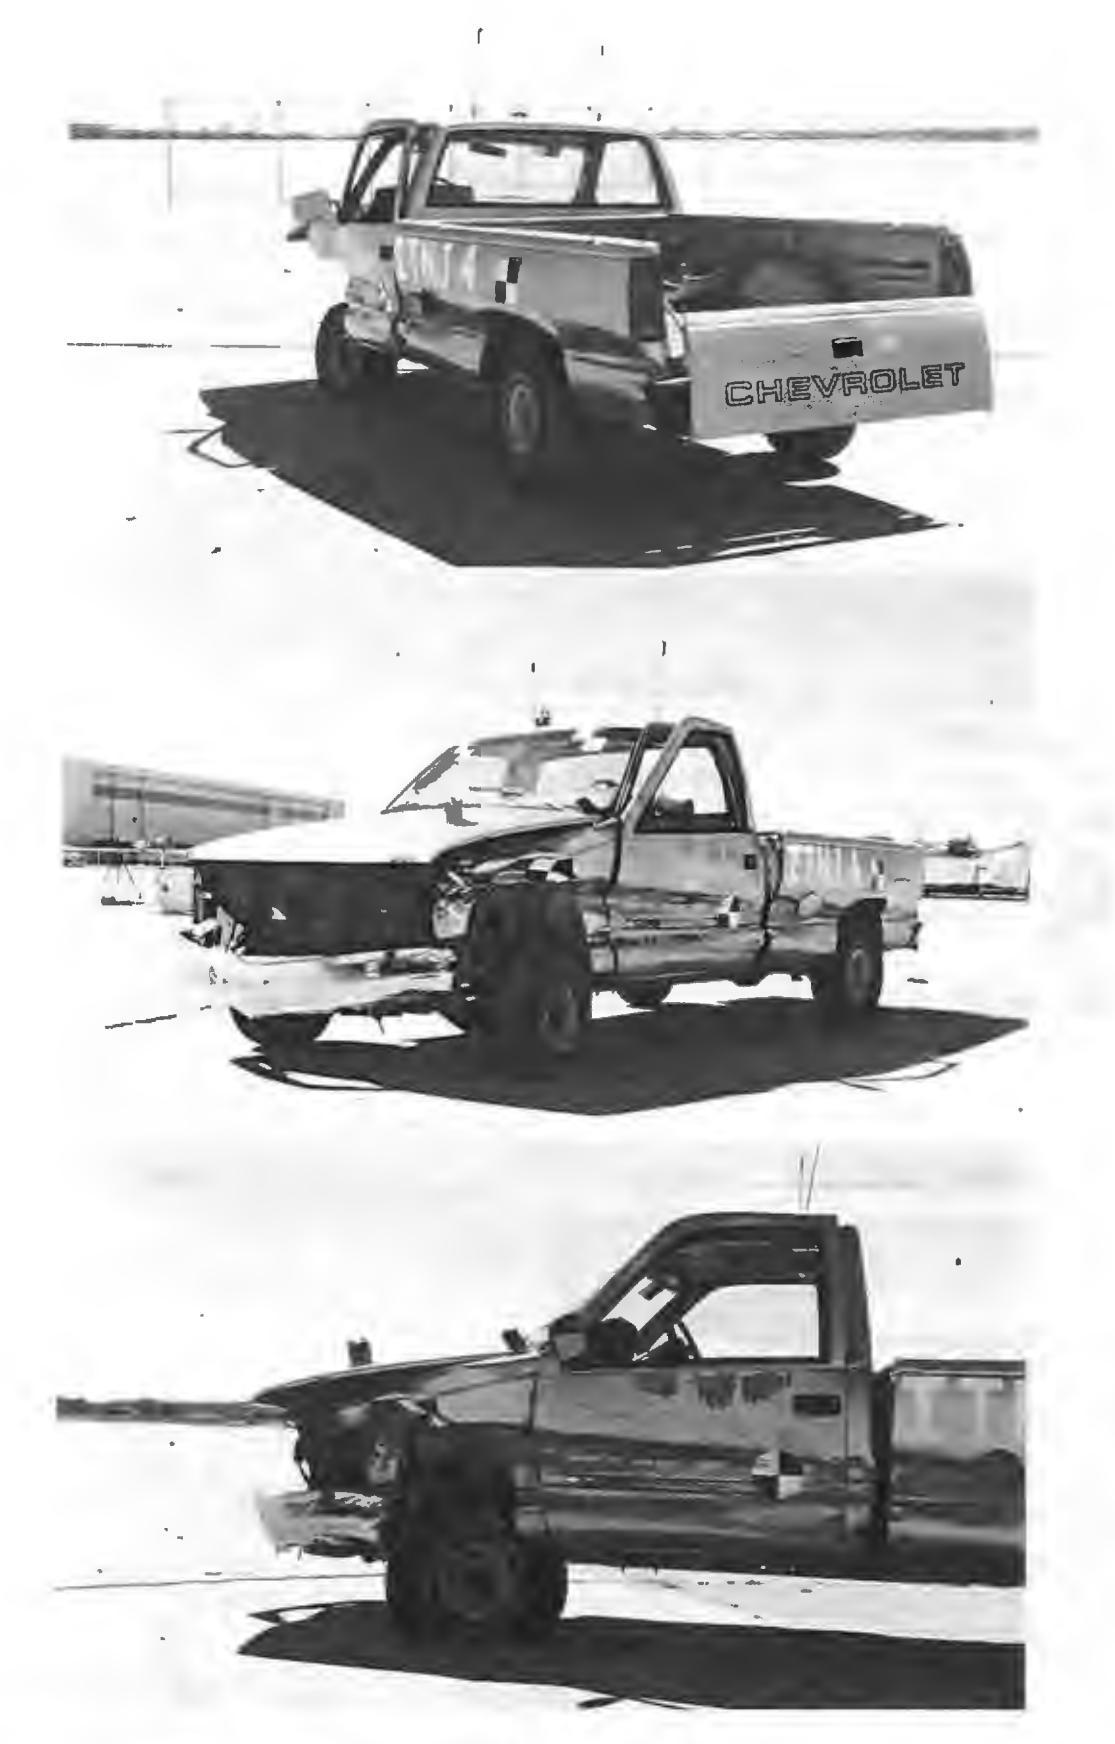
Figure 71. Vehicle Damage, Test ITNJ-4 (Design No. 4)

Vehicle damage was moderate, as shown in Figure 71. The left-front quarter panel was crushed inward, and the left-side of the front bumper was also bent back toward the engine compartment. The left-front wheel assembly was deformed and pushed backward into the firewall. Longitudinal deformations, due to vehicle-rail interlock, were observed along the entire left-side of the vehicle. Maximum occupant compartment deformations to the floorboard and/or firewall in the lateral, longitudinal, and vertical directions were 114 mm, 89 mm, and 133 mm, respectively, as shown in Figure 72.
