ALASKA DEPARTMENT OF TRANSPORTATION

The Effects of a Winter Ice Jam Event On Bioengineered Bank Stabilization Along The Kenai River

Prepared by: Kenneth F. Karle, P.E.
Hydraulic Mapping and Modeling

Date
October 2007

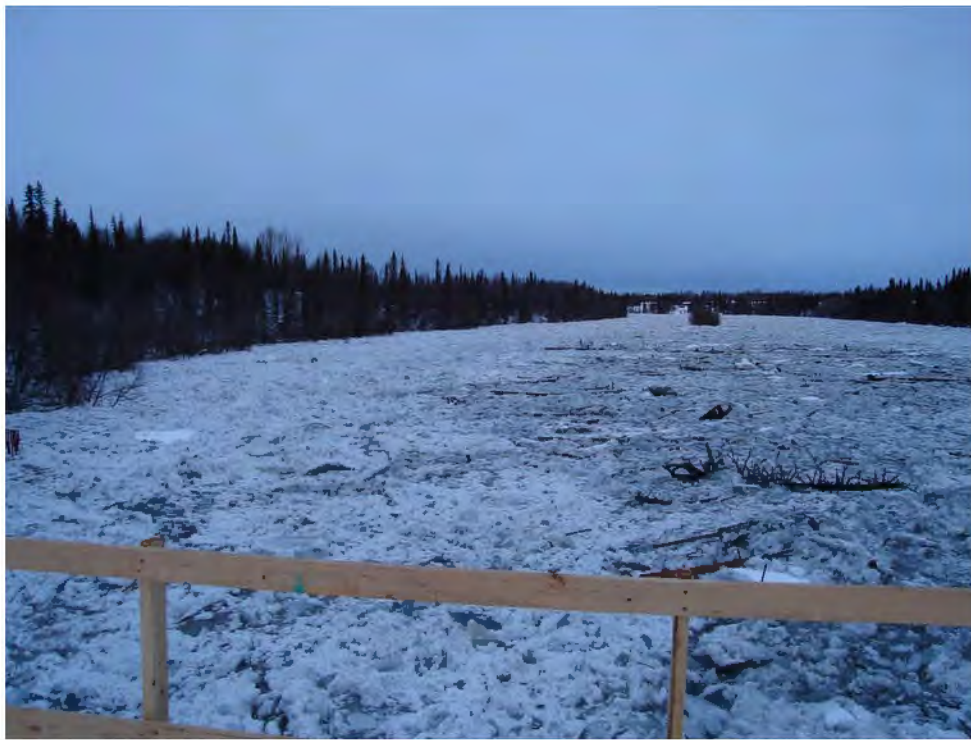
The lake began releasing around January 16. The Kenai River at Skilak Lake rose about 3.8 feet beginning on January 18, and experienced a broad crest below Skilak Lake on January 27 (Kenai Borough, 2007). The rise in water levels caused the existing ice cover on the Kenai River to break up and form a series of ice jams that moved downstream over a period of several days, causing localized flooding in the Soldotna vicinity. Ice jams were noted upstream of the Sterling Highway Bridge near the confluence of Soldotna Creek; that ice moved downstream and jammed at the Sterling Highway Bridge by January 29. The bridge jam broke loose and moved downstream early January 30, allowing the water level at the bridge to decrease from 20 feet to 11.20 feet, which is just under flood stage. Ice was jammed at Centennial Park on the morning of January 30, but open channels allowed water to flow through and not back up behind the jam (Peninsula Clarion, 2007). By the afternoon of January 30, the Centennial Park jam cleared and reformed downstream near Slikok Creek, two miles below the Sterling Highway Bridge; this jam was over a mile in length (DHS, 2007). See Figure 2.

Figure 2. Ice jam on the Kenai River January 28, 2007. ADOT&PF photo.

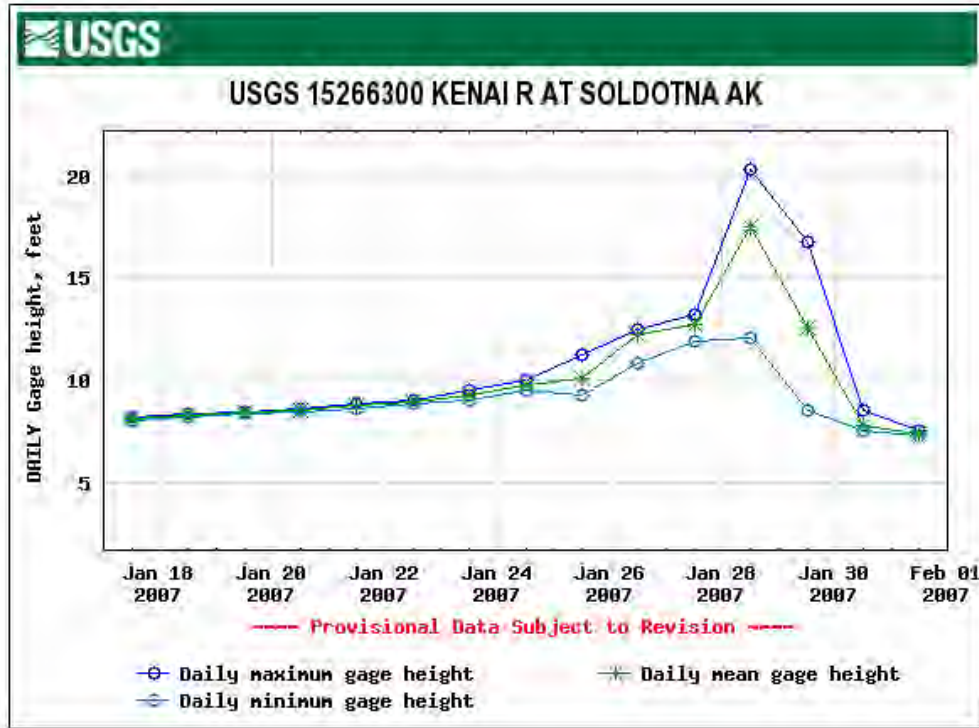
A USGS gaging station is located adjacent to the Sterling Highway Bridge, just upstream of the large ice jam location. The hydrograph at that station for a 14-day period surrounding the event is found in Figure 3. The flood peaked at 20.26 feet. The generally accepted elevation of ordinary high water in this reach is 9.1 feet.

Figure 3. USGS hydrograph for the January 2007 flood and ice jam event.
