GEORGIA DOT RESEARCH PROJECT 16-26

FINAL REPORT

**CRASH TESTS ON GUARDRAIL SYSTEMS
EMBEDDED IN ASPHALT VEGETATION
BARRIERS IN ACCORDANCE WITH GDOT
DESIGN SPECIFICATIONS**

GDOT Research Project No. 16-26

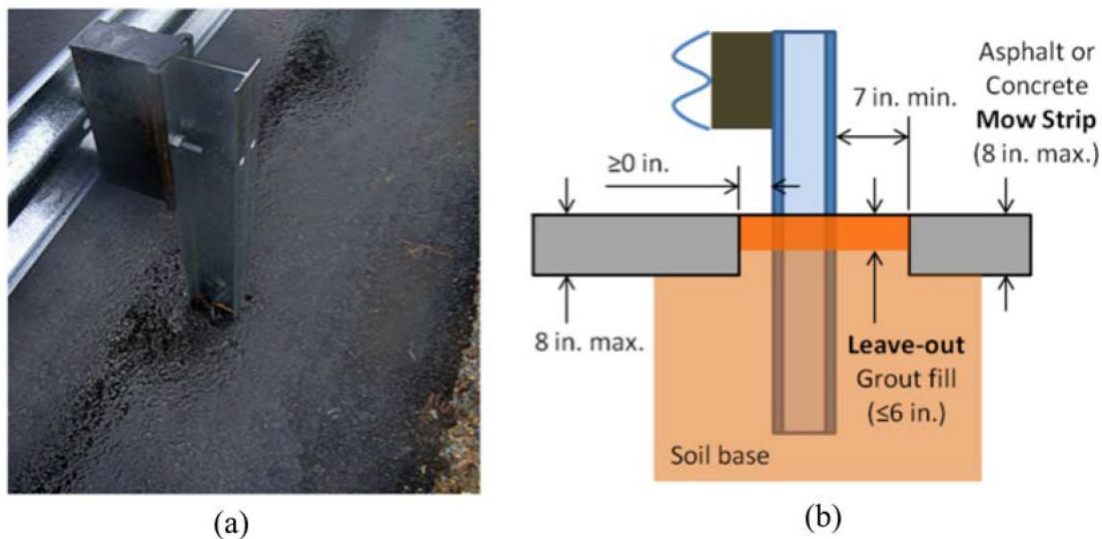
FIGURE 1 Guardrail Installations: (a) Typical Installation in Georgia; (b) Installation Incorporating Grout Leave-outs as Recommended in the *Roadside Design Guide* [3]

Prior to March 2017, the preferred procedure for steel guardrail installation in the state of Georgia [1,2] employed a post-installation machine, which is typically hydraulic, to drive the posts through a layer of asphalt (i.e., a “mow strip”) placed to retard vegetation growth around the system (Figure 1a). This procedure was outlined in Georgia Department of Transportation (GDOT) Standard Detail S-4-2002 (referred to hereafter as GDOT S-4-2002). However, to avoid undesirable restraint at the ground line, the Fourth Edition of the AASHTO *Roadside Design Guide* [3] recommends a post installed incorporating grout leave-outs (LOs) (Figure 1b). This recommendation is based on research performed by the Texas Transportation Institute (TTI) [4,5].

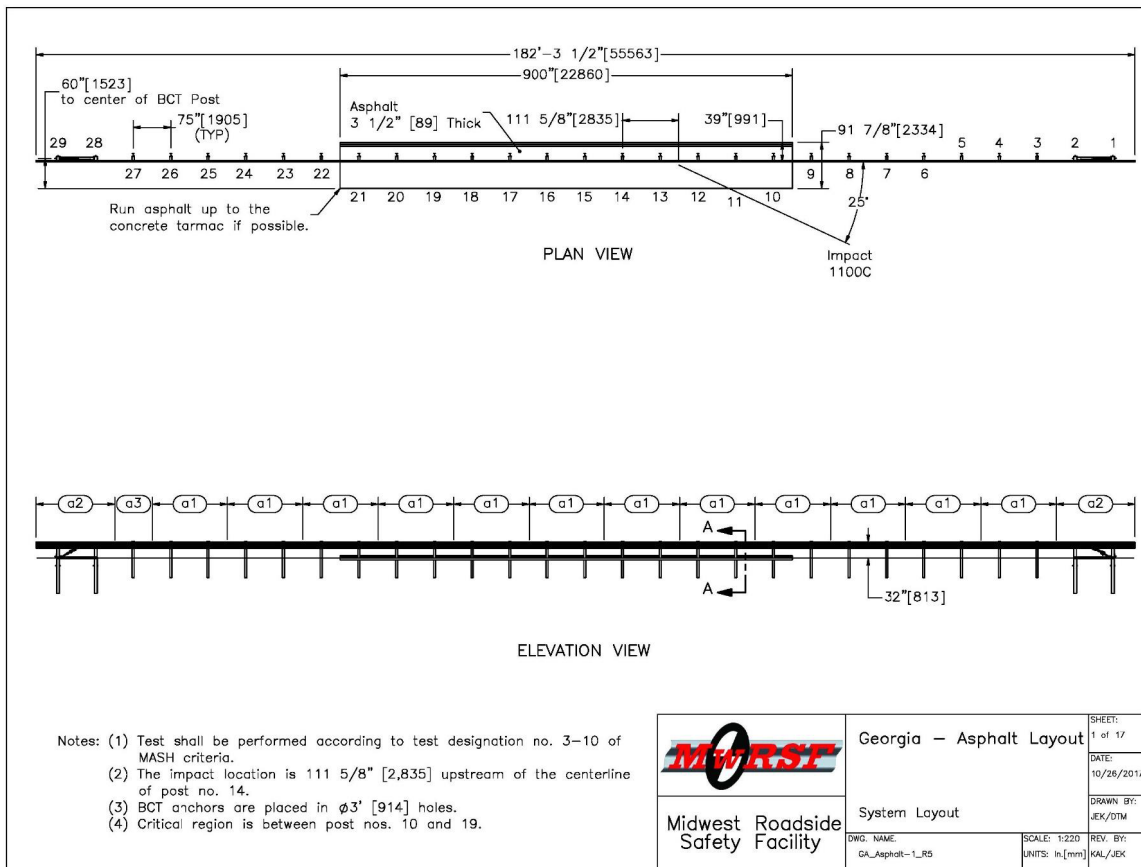
FIGURE 2 Test Installation Layout for MASH Test 3-10

A test installation site approximately 182 ft in length was constructed at the MwRSF proving grounds beginning in December 2016, with completion in February 2017. The general layout for the test installation is shown in Figure 2.

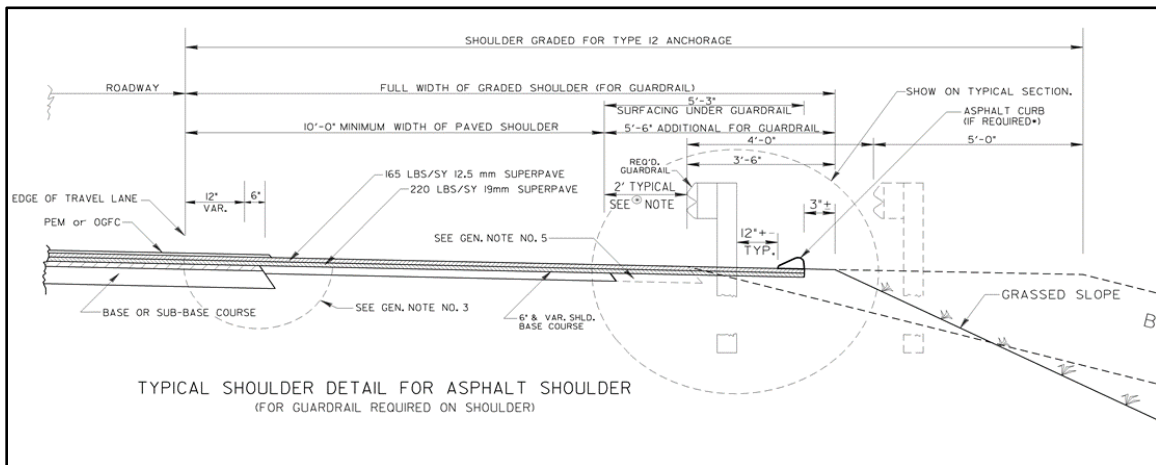
FIGURE 3 GDOT Drawing Detail S-4-2002 [2]

A detailed description of the test bed construction is given in Chapter 3 of the MwRSF report found in the Appendix. In general, the installation of the test site appeared to adhere to the material specifications and dimensions found in GDOT S-4-2002. One variation was noted in that the GDOT detail indicates a graded slope located approximately 42 in. behind the face of the guardrail, as shown in Figure 3. As can be seen in Figure 4, the area behind the post in the test installation was graded horizontal, with an additional pad/test bed located behind the test bed.

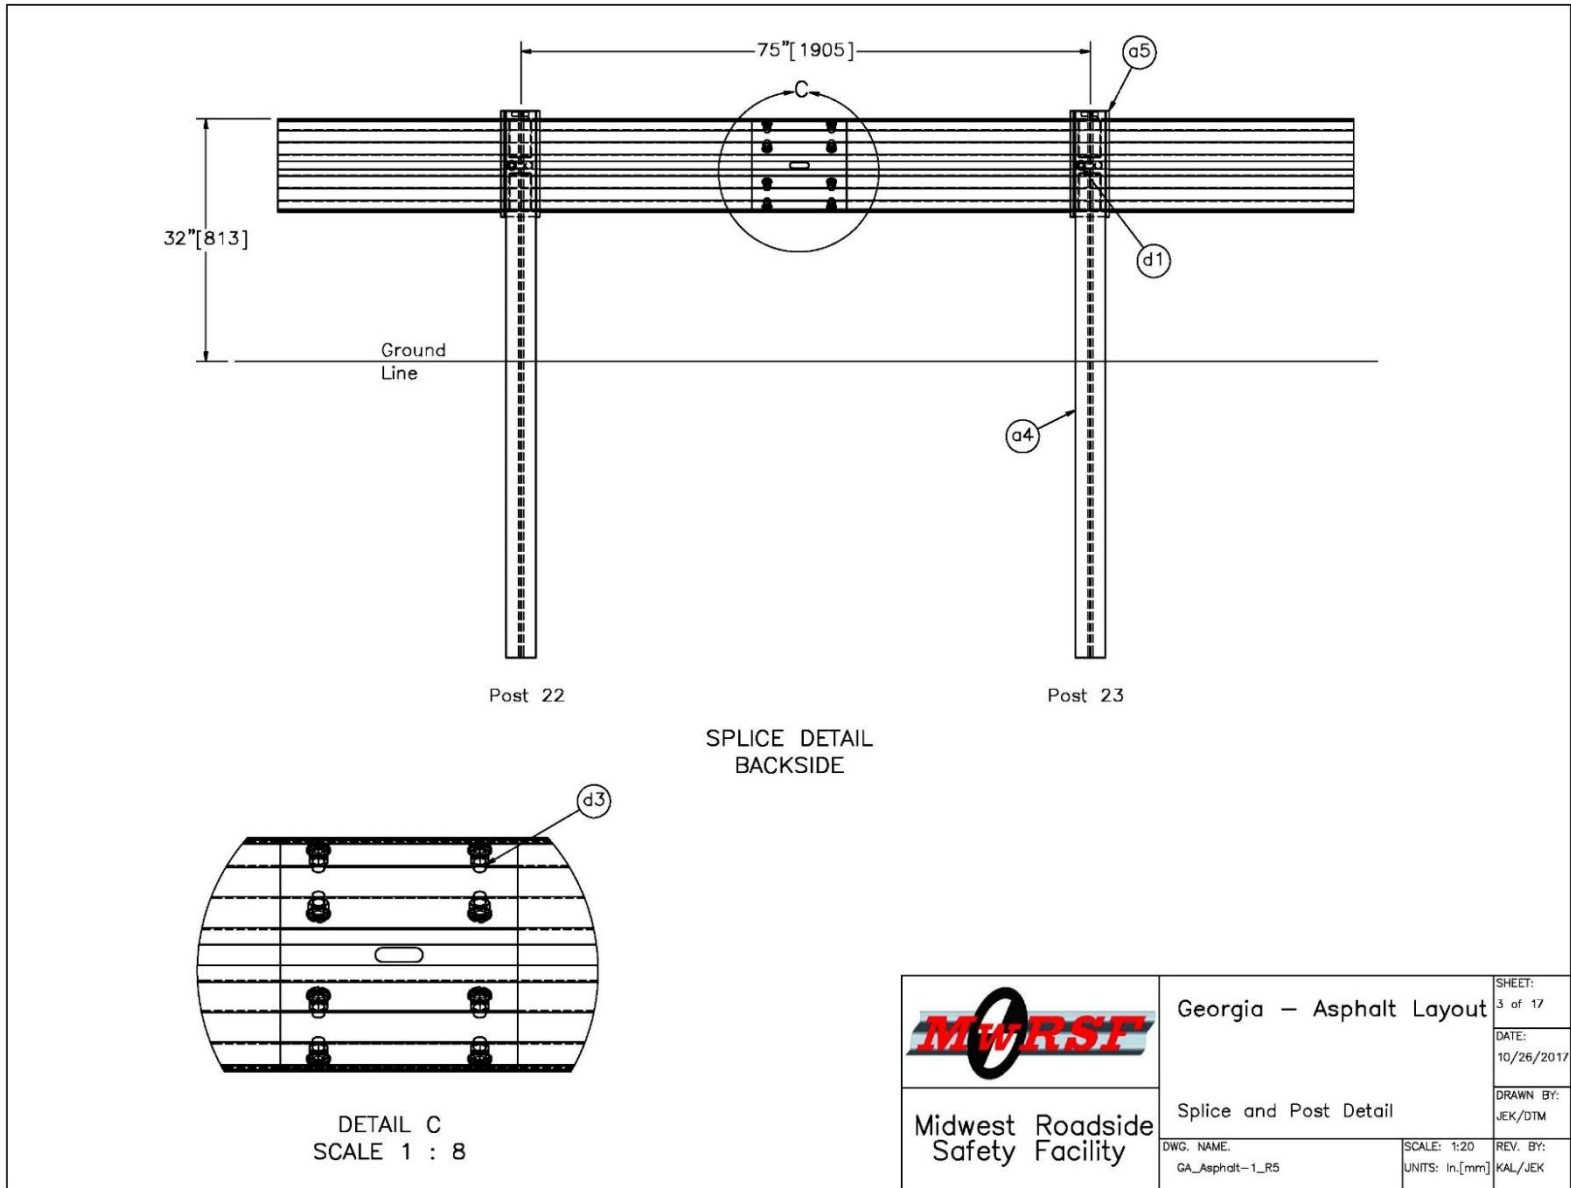
Figure 3. Splice Detail, Test No. GAA-1

Standard 12-gauge (2.7-mm) thick W-beam rail segments were supported by 72-in. (1,829-mm) long, W6x8.5 (W152x12.6) steel posts. The W-beam rail was mounted with a top-rail height of 32 in. (813 mm). Rail splices were located at midspans between posts, as shown in Figure 3. The lap splice connections between the rail sections were configured to reduce the potential for vehicle snag at the splice during impact. The posts were spaced at 75 in. (1,905 mm) on center. Holes 36 in. (914 mm) wide were cored and filled with densely-compacted, coarse crush limestone strong soil at post locations before asphalt was laid, as recommended by MASH 2016 [1]. Post nos. 10 through 21 were driven through the approximately 3½-in. (89-mm) thick asphalt mow strip to an embedment depth of 39 in. (991 mm). A Mondo Polymer MGS14SH [2] blockout was used to offset the rail away from the front face of each steel post.

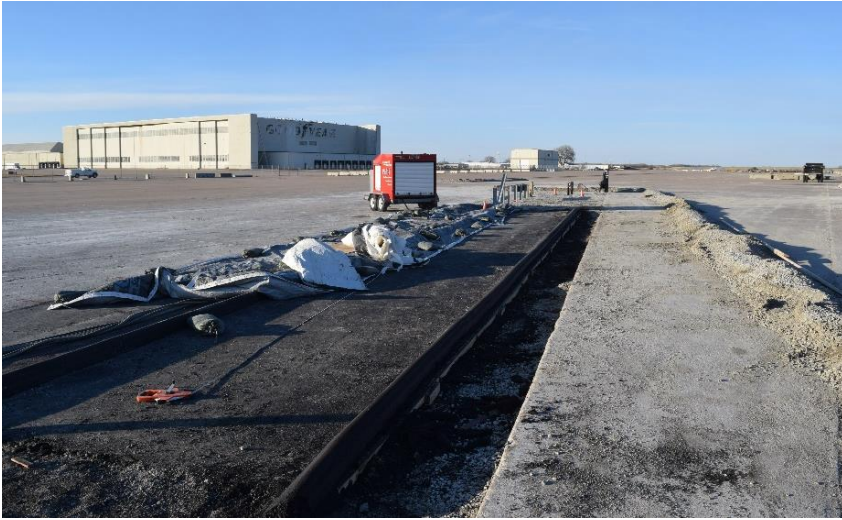
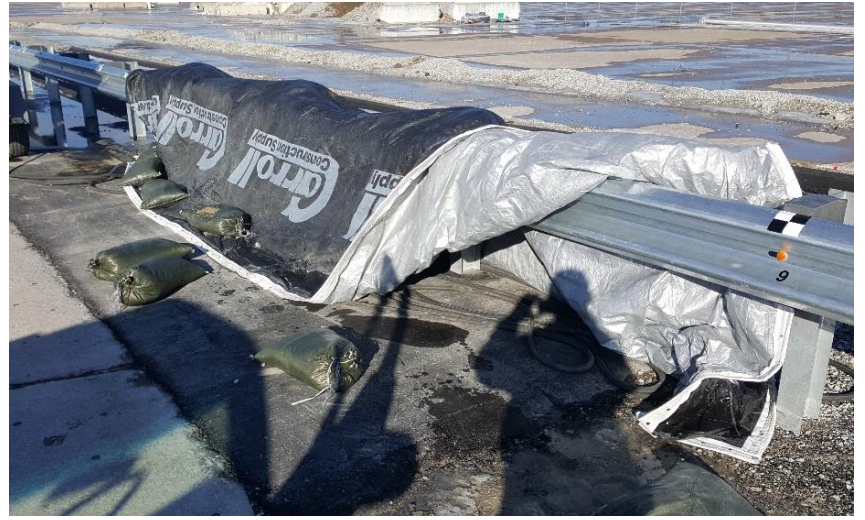
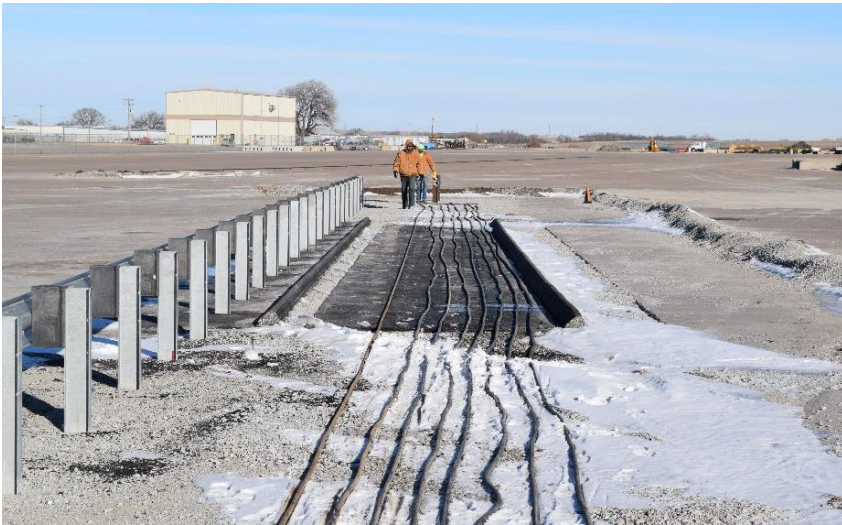
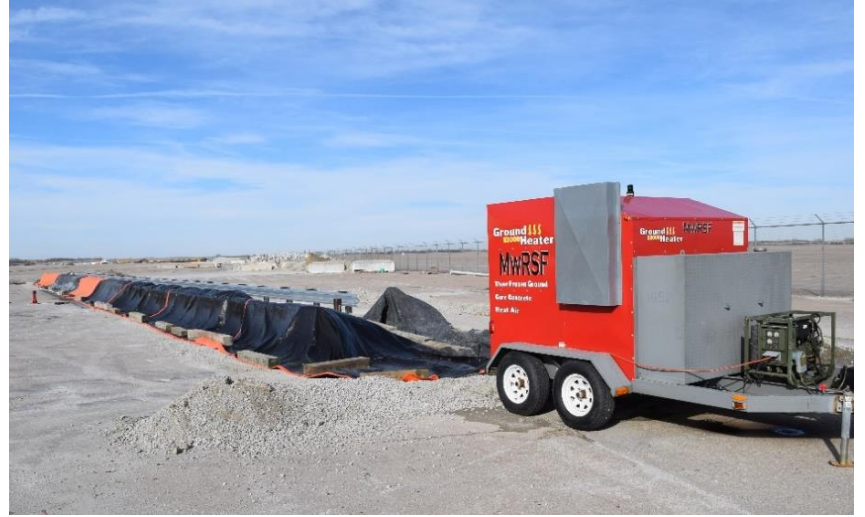
Figure 19. Test Construction – Soil and Asphalt Heating, Test No. GAA-1

A heating system was used to ensure that the soil was not frozen during construction and before the full-scale crash test was conducted, as seen in Figure 19. The heating system is capable of thawing 18 in. (457 mm) of soil over a 12-hour period. Holes were drilled through the asphalt and into the frozen soil. Soil temperature was taken at a depth of 3 ft (914 mm) using an infrared thermometer probe. Prior to conducting the crash test, the soil temperature at bottom of the holes was approximately 60 degrees.

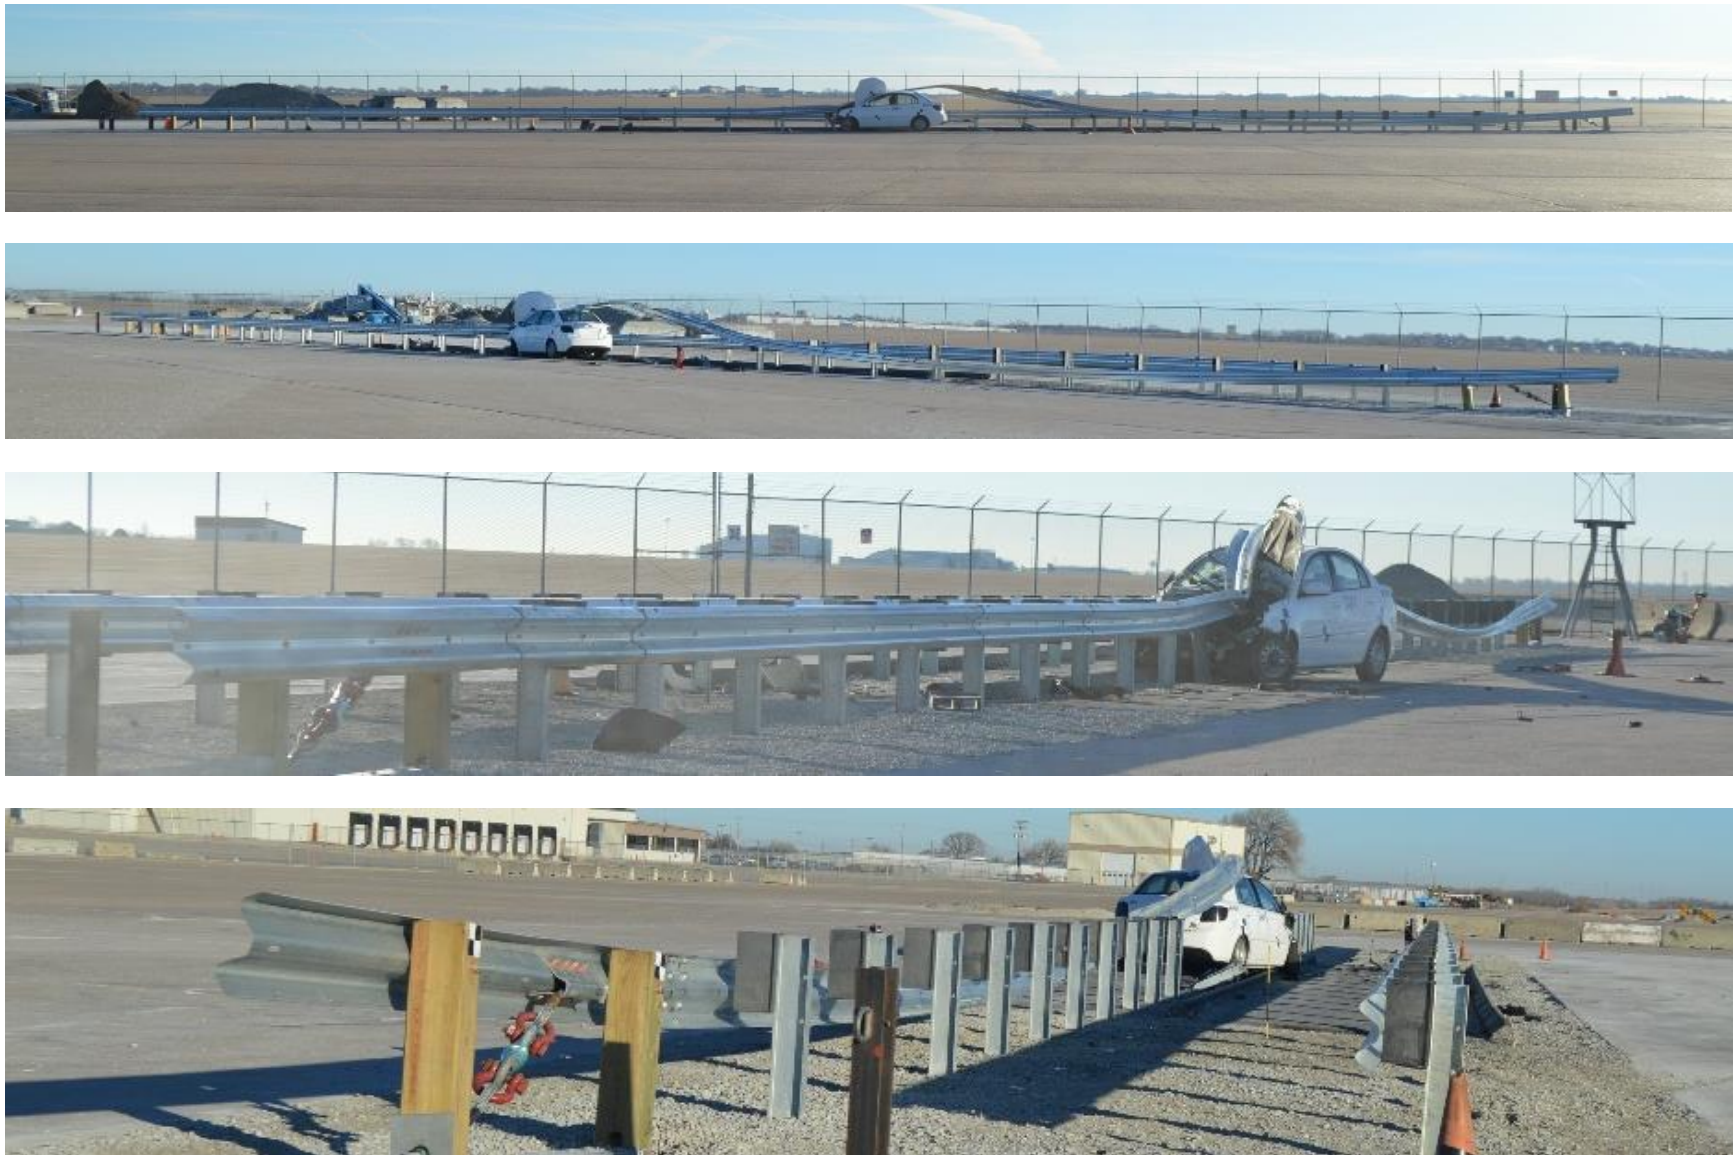
Figure 37. System Damage, Test No. GAA-1

Damage to the barrier was extensive, as shown in Figures 37 through 44. Barrier damage consisted of rail deformation, contact marks on the front face of the guardrail, guardrail disengagement from posts, deformed steel posts, and asphalt gouging. The length of vehicle contact along the barrier was approximately 27 ft – 7⁵/₈ in. (8.4 m), which spanned from 38³/₈ in. (975 mm) downstream from the centerline of post no. 12 through 5 in. (127 mm) upstream from the centerline of post no. 17. The maximum vehicle pocketing angle was 20 degrees.

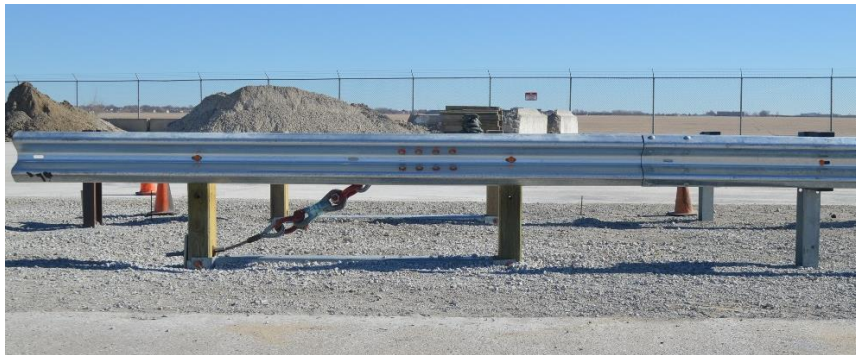
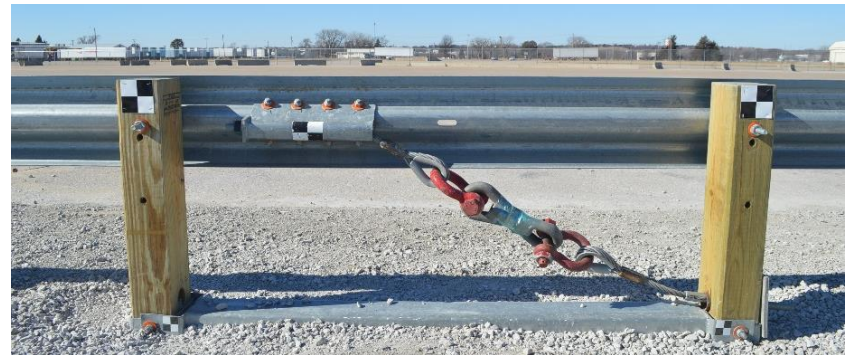
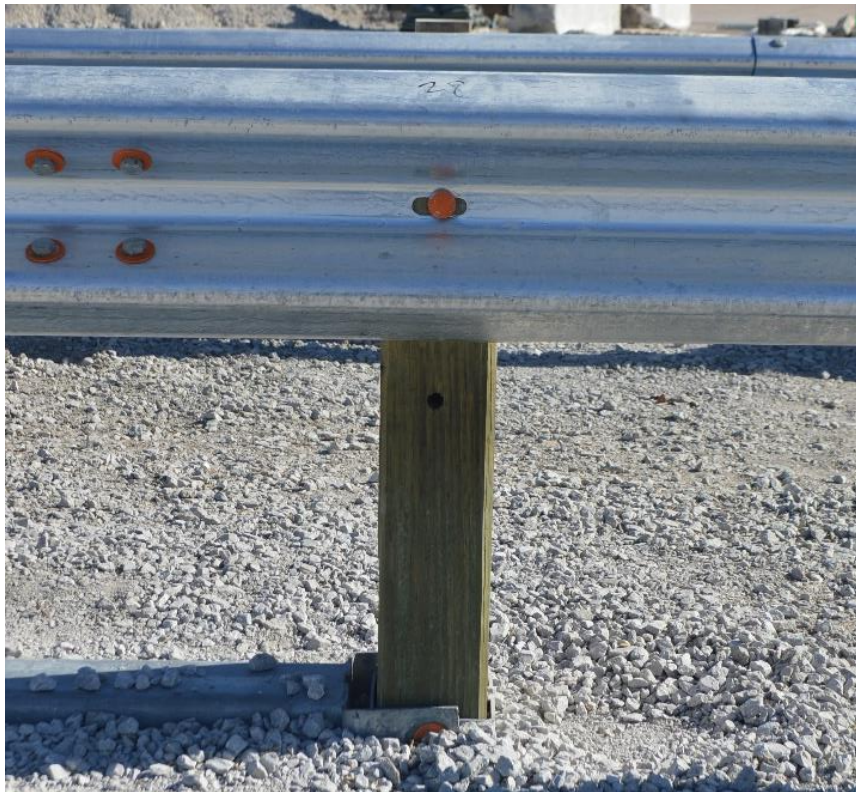
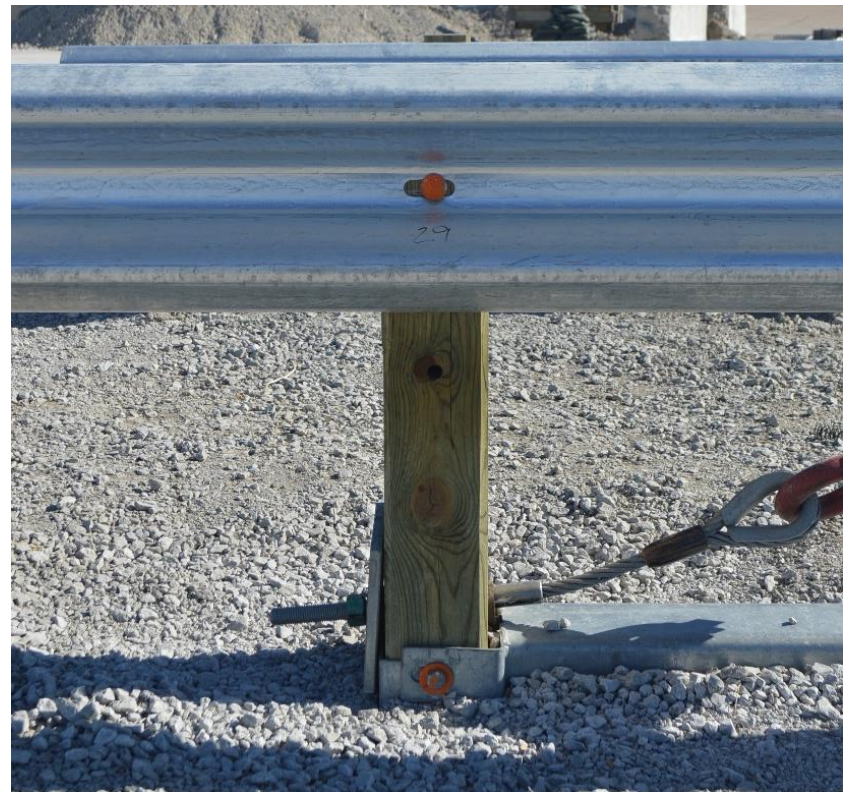
Figure 45. Downstream End Anchorage Movement, Test No. GAA-1

heave on the downstream side. Post nos. 13, 14, 15, and 17 also had minor gaps in the asphalt. For the downstream BCT wood posts and foundation tubes, no longitudinal movement or damage was observed, as documented in Figure 45. More specifically, the wood posts were not cracked or split at the post bolt locations, as depicted in Figure 46.

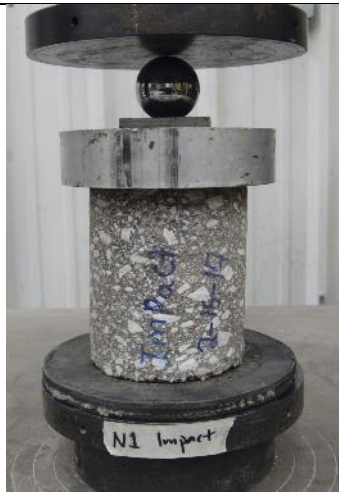
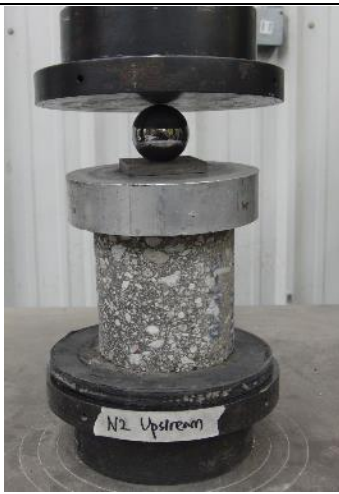
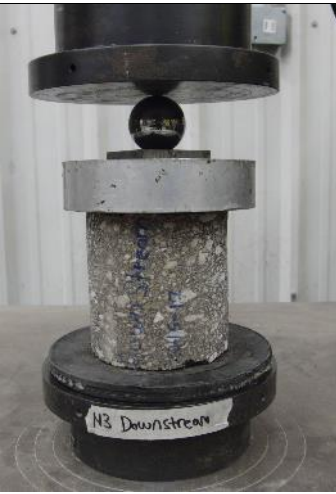
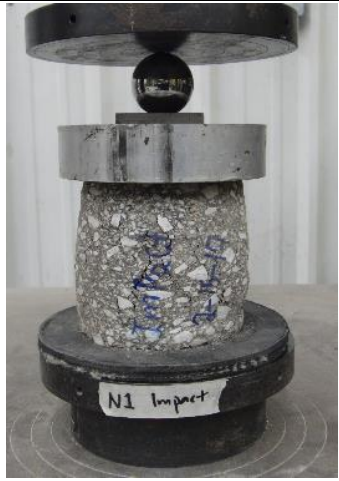
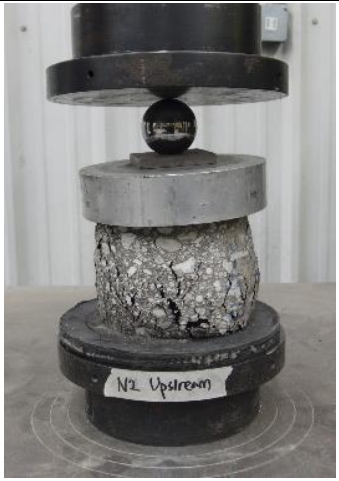
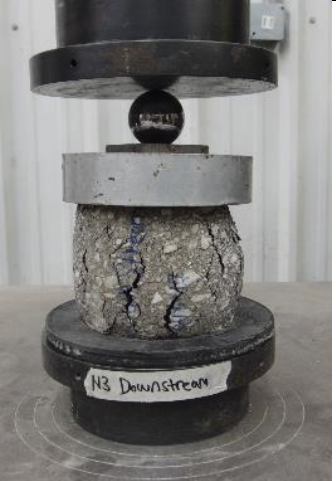
Table 1. MwRSF Specimen Test Sheet

Three specimens cored from asphalt mow strip at MwRSF test site were tested on 2/21/2017. To determine a representative strength, each specimen was taken from different location: (1) near the impact point of crash vehicle, (2) upstream section, and (3) downstream section. Table 1 includes compression test results and other test information including specimen dimension, test condition, and photographs taken during the test. All specimens showed a similar failure mode represented by lateral expansion and vertical cracks. The average compressive strength from the 3 cores was approximately 400 psi.

Actual diameter	3.70 in.	3.70 in.	3.70 in.
Thickness (Height)	4.25 in.	3.75 in.	3.80 in.
Test temperature	70 °F	71 °F	67 °F
Age of specimen	76 days (curing time from asphalt placement)		
Compressive strength	371.0 psi	396.5 psi	430.6 psi
	Average compressive strength = 399.4 psi

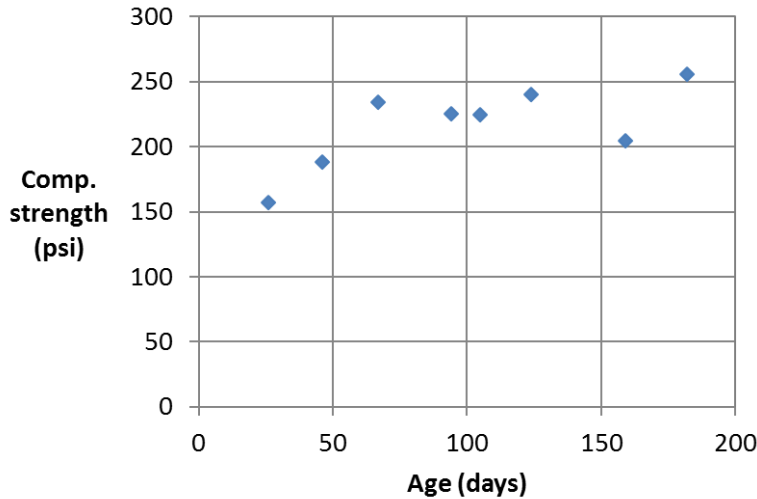
Figure 1. Average Compressive Strength Versus Age (specimens from Georgia Tech static test site)

In the Phase 1 GDOT research project involving static tests of guardrail posts driven through an asphalt layer, a total of 35 compression tests were performed to investigate the effect of aging/curing on asphalt strength (from 11/12/2014 to 4/17/2015). Figure 1 shows the trend of asphalt strength gain over time.

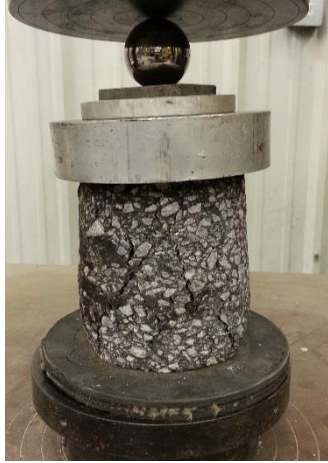
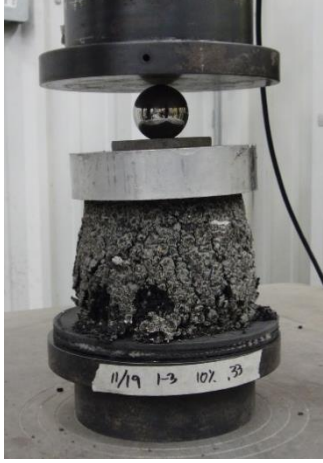
Table 2. Georgia Tech Specimen Test Summary Sheet

Table 2 shows a summary of all specimen test information performed at Georgia Tech. Vertical cracks and horizontal expansion was similarly observed in most of the tested specimens. The average compressive strength values were approximately 240 psi.

No. of tested specimen	9	10
Test temperature	68 °F	66 ~ 71 °F (average: 68.2)
Age of specimen	124 days	11 ~ 14 days (average: 12.9)
Average compressive strength	240.5 psi (60.2% of MwRSF)	239.3 psi (59.9% of MwRSF)

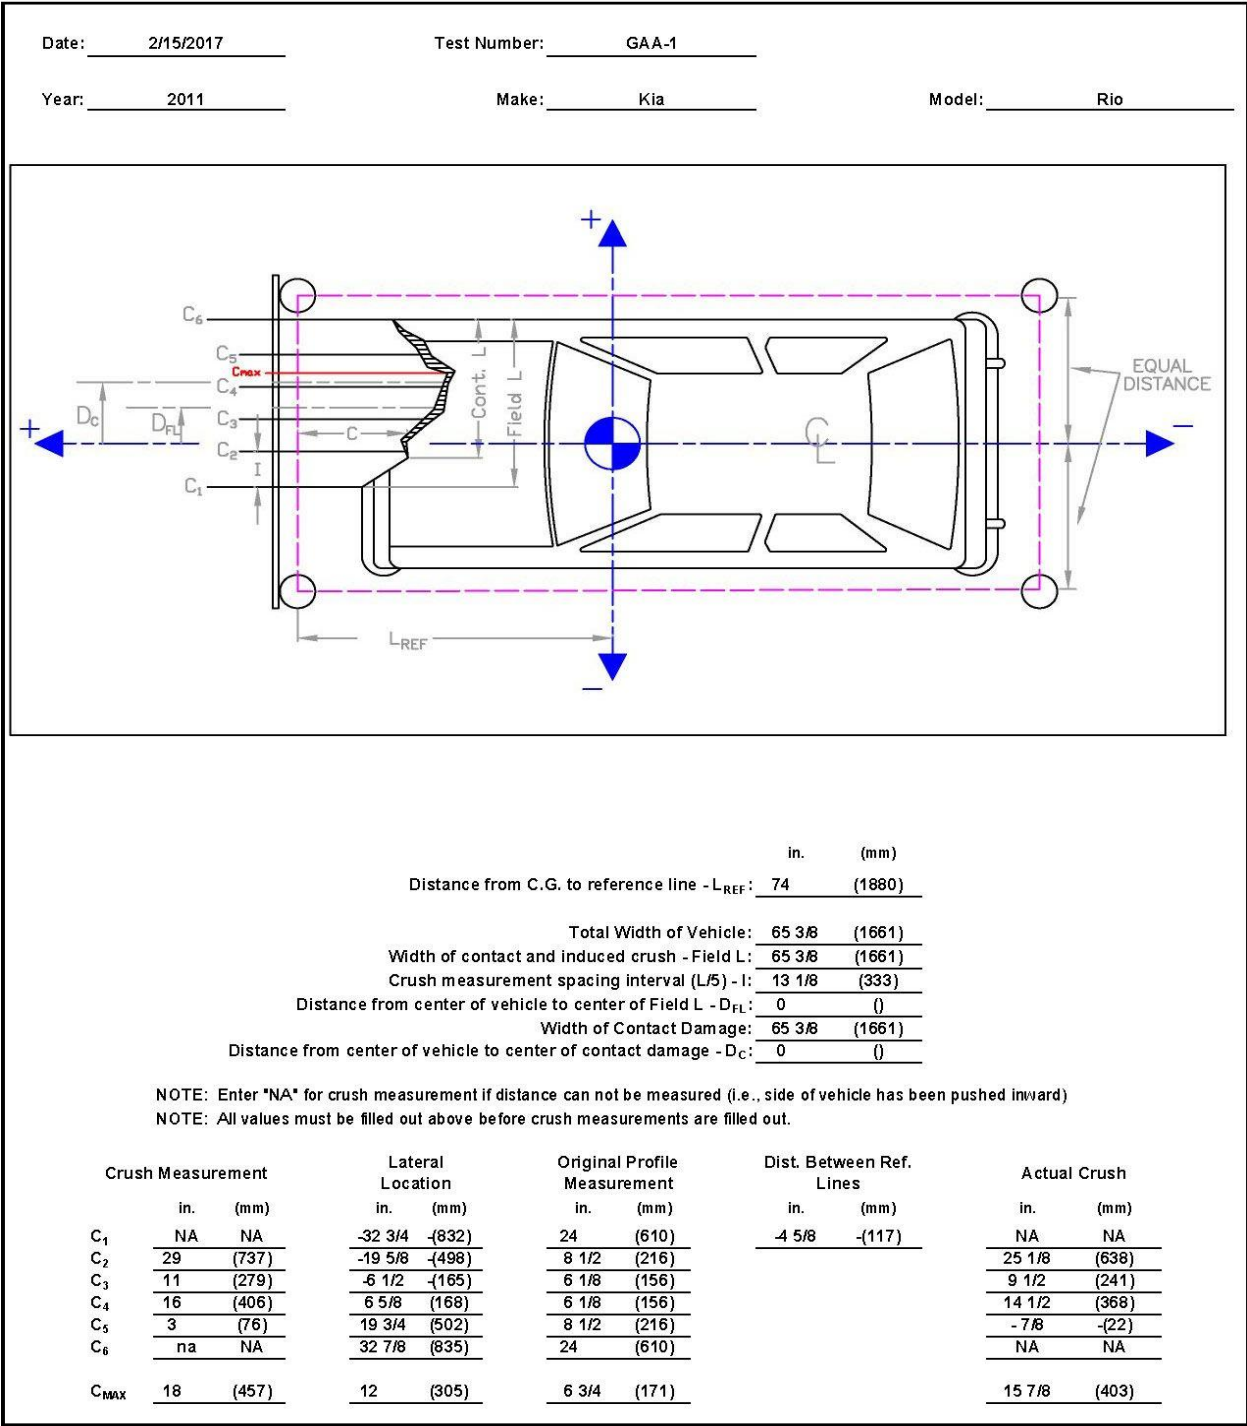
Figure F-3. Exterior Vehicle Crush (NASS) - Front, Test No. GAA-1

- Vehicle Damage Extensive
 - VDS [10] 1-FR-7
 - CDC [11] 01-FDAW-9
 - Maximum Interior Deformation 5½ in. (130 mm)

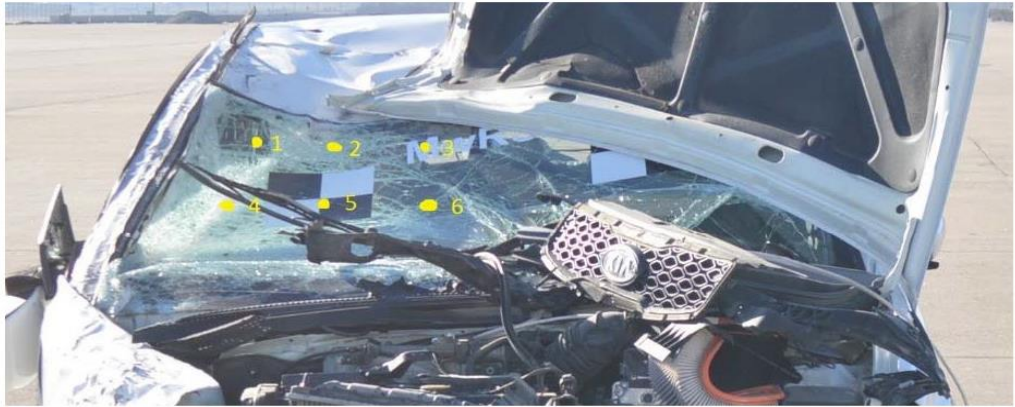
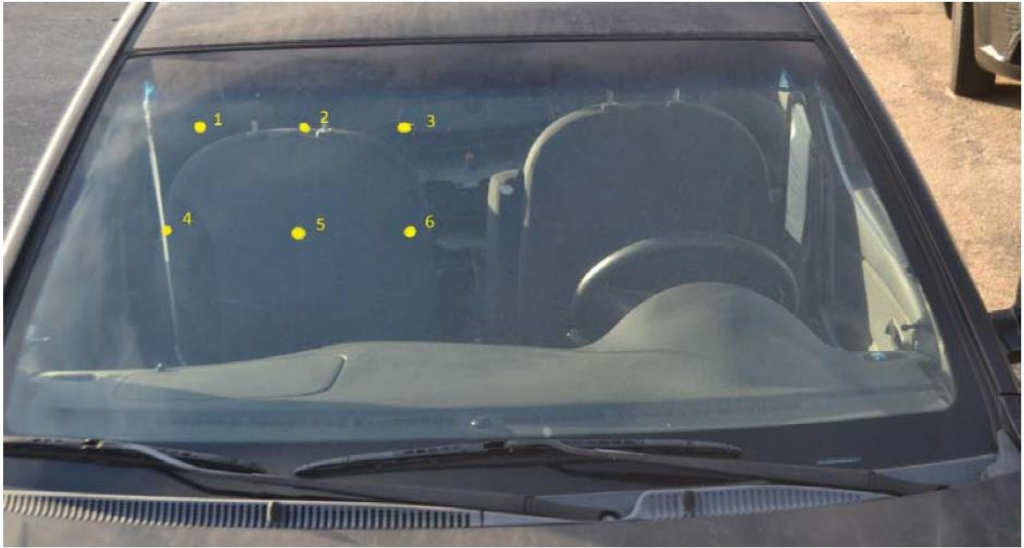
Figure F-5. Windshield Crush, Test No. GAA-1

Point	Vertical on Left Side A-pillar (from top corner) (in.)	Lateral from Left Side A-pillar (from top corner) (in.)	Reference Vehicle (in)	Test No. GAA-1 (in.)	Crush (in.)
1	6	8	5.375	10	4 5/8
2	6	12.5	5	12	7
3	6	19	4.875	12	7 1/8
4	15	7	5 1/4	8.25	3
5	15	12	5	8 1/2	3 1/2
6	15	18.5	4 3/4	10 3/4	6
