RESEARCH REPORT 1857-1

BRIDGES WITH PREMATURE CONCRETE
DETERIORATION: FIELD OBSERVATIONS
AND LARGE-SCALE TESTING

A. Boenig, L. Fúnez, R. E. Klingner, and T. J. Fowler

*STRUCTURAL ASSESSMENT OF IN-SERVICE BRIDGES
WITH PREMATURE CONCRETE DETERIORATION*

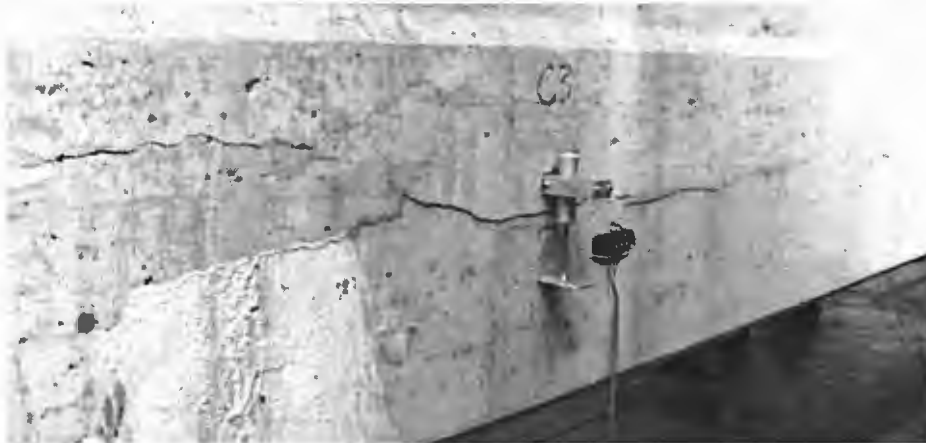
Because a longitudinal crack 5.5 in. (0.14 m) from the bottom was not obvious along the entire length of BG4, for the BG4F test, a single linear potentiometer was placed at the location of C3 in Figure 3.14. Additional linear potentiometers were attached on the east and west faces, 293 in. (7.44 m) from the south end, to measure possible growth of the crack 12 in. (0.31 m) from the bottom (Figure 3.15).

Figure 3.15 Linear potentiometer on west face of BG4F to monitor change in width of pre-existing crack

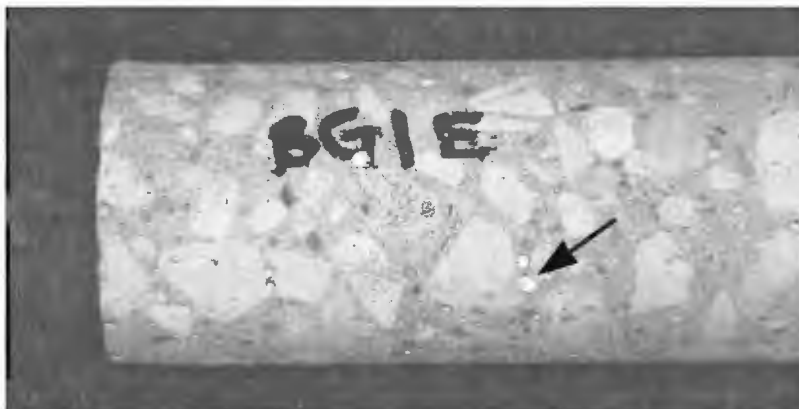
A white, soap-like substance was evident in the voids of the cores (Figure 3.29).

Figure 3.29 White, soap-like substance in voids of core from end-block of BG1

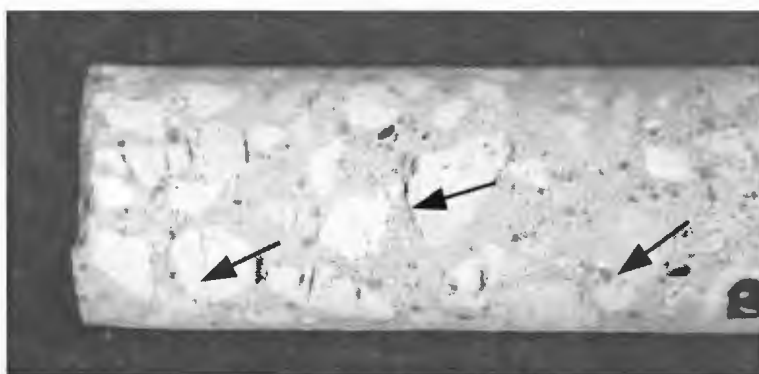
Placement of transverse reinforcement in BG2 was inconsistent, and the concrete was in such poor condition that many of the cores taken from the end-blocks crumbled inside the barrel of the core drill. Only two intact, steel-free cores were obtained from the end (BG2E-1 and BG2E-2), and two from the webs (BG2W-1 and BG2W-2). Cracked aggregate, a white, soap-like substance filling the voids, and separations between the aggregate and cement matrix were noted in these cores (Figure 3.30). The cores were tested for modulus of elasticity according to ASTM C469, and then loaded to failure to obtain data on compressive strength.

Figure 3.30 Cracked aggregate, separation between aggregate and cement matrix, and white substance in voids of core from end-block of BG2

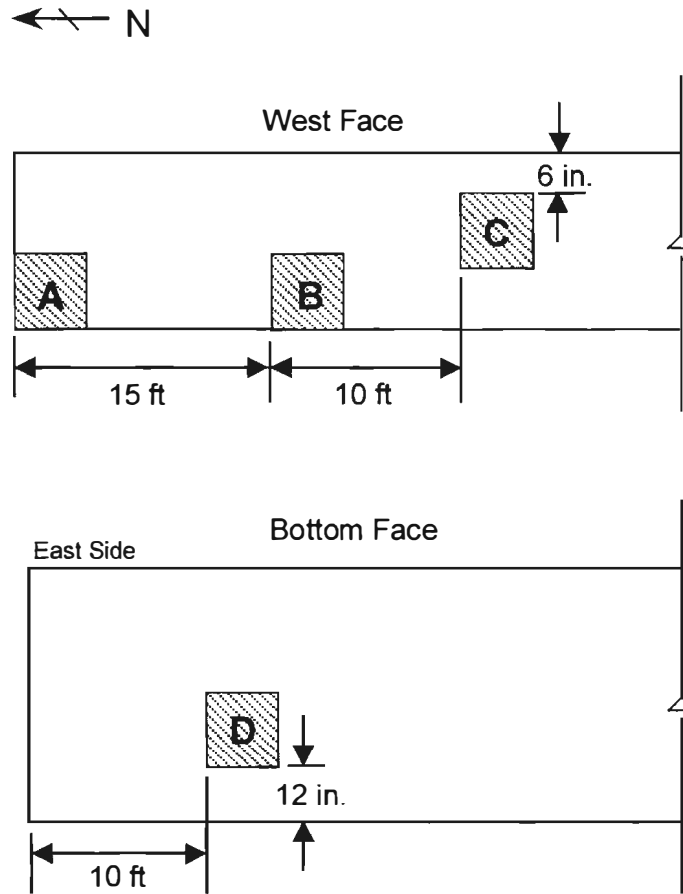
Visible cracks in representative 12 in. (0.30 m) squares on BG1, BG3 and BG4 were measured and sketched (Appendix C). Square A, at the northern bottom corner of the west face; Square B, 15 ft (4.6 m) from the north end on the west face; Square C, 25 ft (7.6 m) from the north end on the west face; and Square D, 10 ft (3.0 m) from the north end on the bottom face, are shown in Figure 3.32.

Figure 3.32 Locations of representative squares on box girders monitored for crack growth

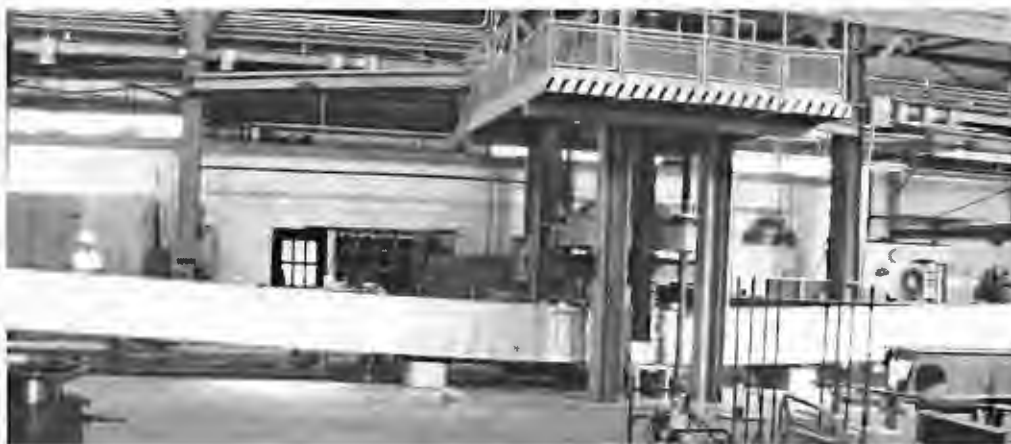
Figure 4.8 BG2F under 110 kips (490 kN)

Figure 4.8 shows BG2F at a load of 110 kips (490 kN). Cracking, first heard at 113 kips (503 kN), was heard consistently as concrete at midspan crushed and spalled off the top and sides. At 115.7 kips (515 kN) the load was reduced slightly to lower the supports intended to catch the girder after failure. Loading then resumed until failure at 116.3 kips (517 kN), at which point flexural cracks had spread 13 ft (4.0 m) from midspan.

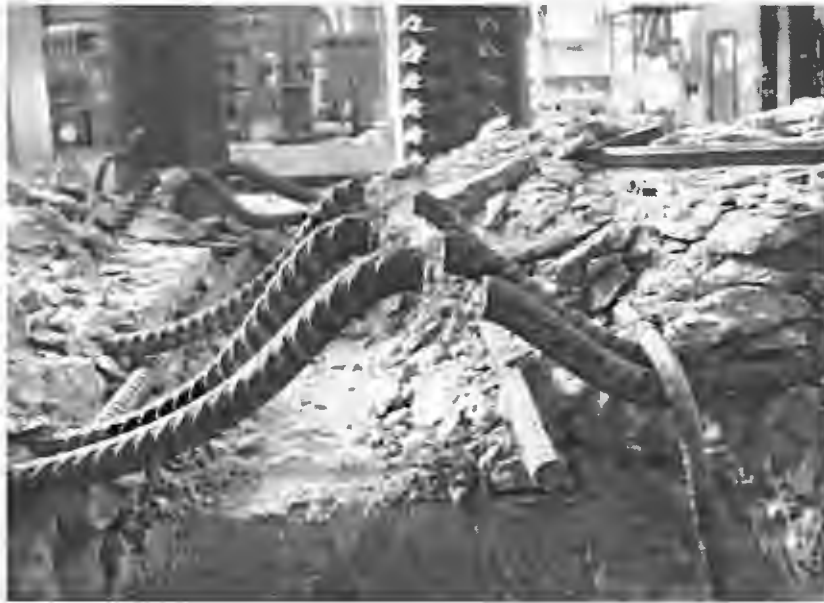
Figure 4.14 Fractured top reinforcement in BG4F

The failure was at midspan. Concrete in the flanges and webs was completely crushed. Four of the six top reinforcing bars fractured after they buckled (Figure 4.14).

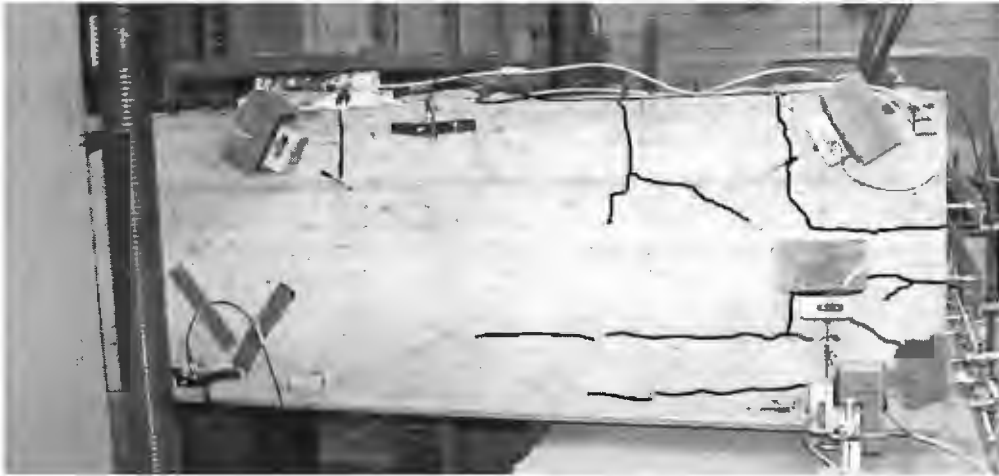
Figure 4.18 Pre-existing cracks on the east face of BG1S

The pre-existing cracks on the east and west faces of BG1S are shown in Figures 4.18 and 4.19.

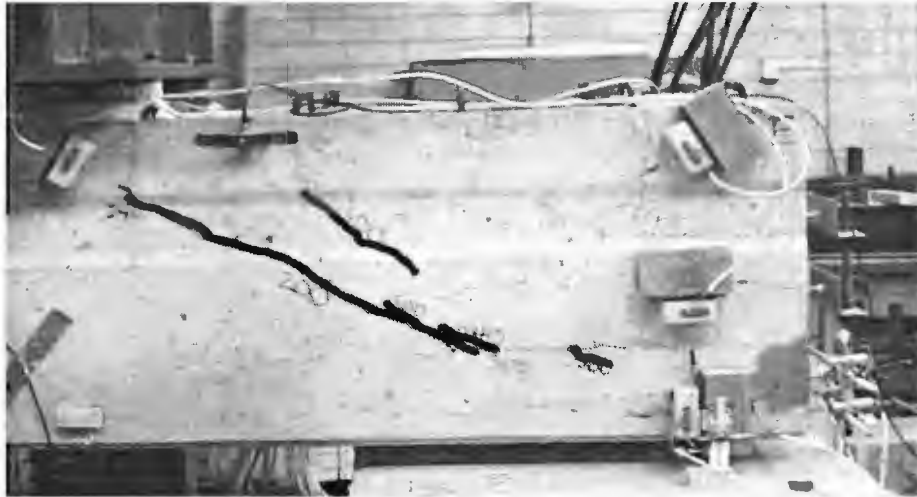
Figure 4.20 Shear-induced cracks on the east face of BG1S under a load of 300 kips (1330 kN)

BG1S was tested on February 2, 2000. The first shear crack was visible at 160 kips (712 kN) on the west side, and at 200 kips (890 kN) on the east side. New cracks were concentrated primarily in the region directly in line between the first loading point and the bearing pad. Figures 4.20 and 4.21 show the development of cracks at 300 kips (1330 kN) on the east and west faces.

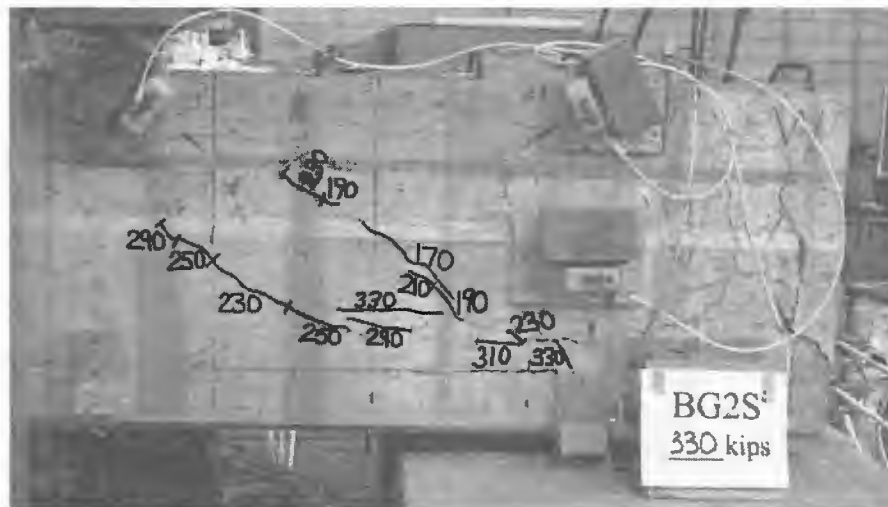
Figure 4.31 Shear-induced cracks on the west face of BG2S under a load of 330 kips (1470 kN)

BG2S was tested on November 30, 1999. Shear cracks first appeared at 170 kips (756 kN) on the west side, and at 210 kips (934 kN) on the east side. Figures 4.30 and 4.31 show the development of cracks at 330 kips (1470 kN) on the east and west sides.

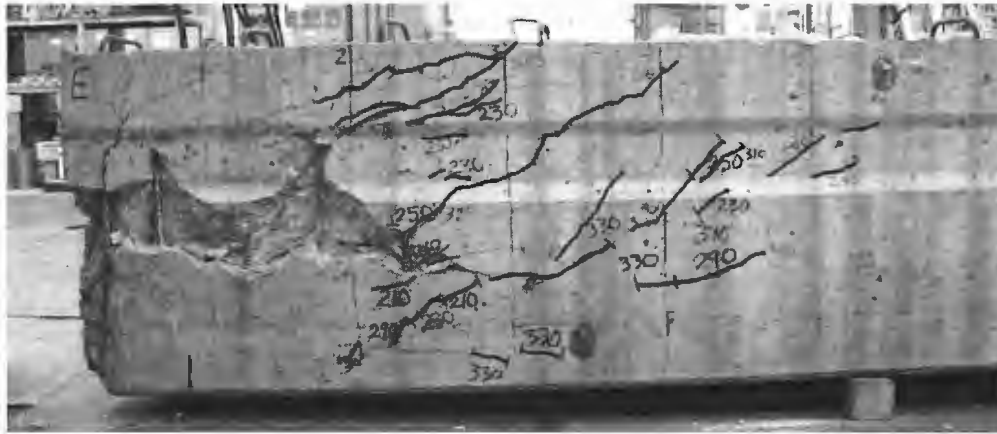
Figure 4.32 Failure of the east face of BG2S at 358 kips (1590 kN)

The transverse loading girders were replaced and the test resumed on December 16, 1999. Since the predicted load had been reached, load was applied continuously until failure. Shear cracks continued to extend and widen. On the east side the two most prominent cracks were 1/4 to 3/8 in. (6.35 to 9.53 mm) wide. A strip of cover concrete 33 in. (0.84 m) long and from 2 to 10 in. (0.05 to 0.25 m) wide broke off the east side, exposing the transverse reinforcement (Figure 4.32). A horizontal crack 9 in. (0.23 m) from the bottom, continuing from where the cover had spalled, appeared right before failure and extended northward to under the second loading point. On the west side, the final damage was significantly less dramatic; the web was still intact. The maximum load reached during the final continuous loading was 358 kips (1590 kN).

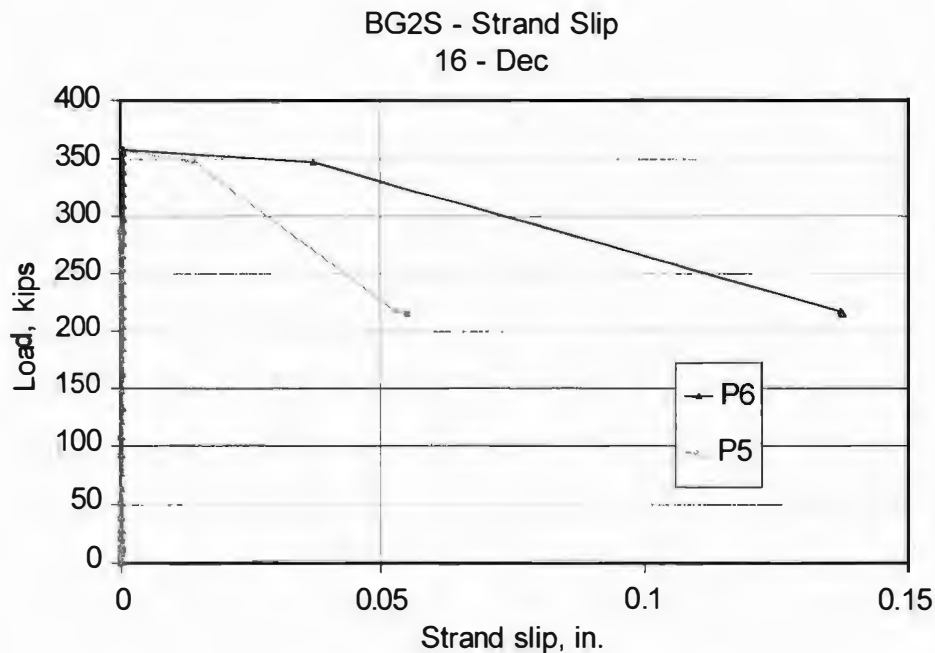
Figure 4.35 Strand slip of BG2S

Two linear potentiometers on the strands of BG2S showed significant displacement (Figure 4.35). P5 slipped 0.055 in. (1.4 mm), and P6 slipped 0.14 in. (3.6 mm).

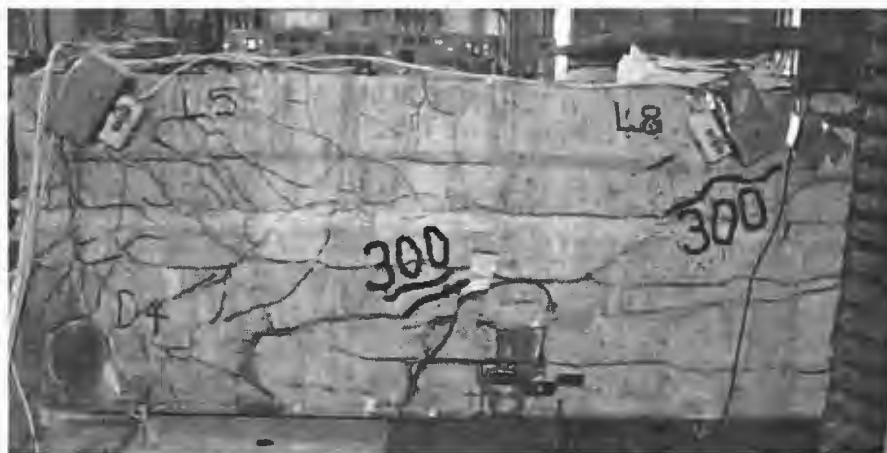
Figure 4.41 Shear-induced cracks on the east face of BG4S under a load of 300 kips (1330 kN)

BG4S was tested on March 24, 2000. The first new visible cracks were seen at 260 kips (1160 kN) on the west side. At 300 kips (1330 kN) water began seeping out of pre-existing cracks and new shear-induced cracks in the webs. As in BG2S, shear cracks were not limited to the area directly between the first loading point and the bearing pad, but spread in a wider band. Figures 4.41 and 4.42 show the new shear-induced cracks after a load of 300 kips (1330 kN) was reached.

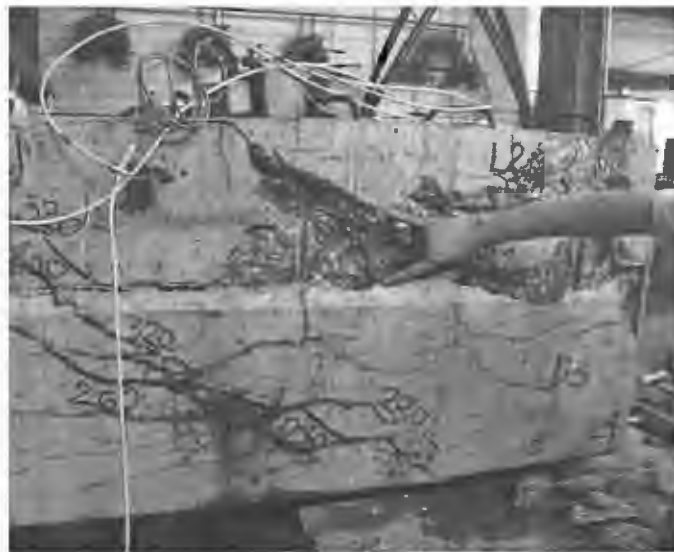
Figure 4.43 Failure of the west face of BG4S at 361 kips (1610 kN)

AE sensors were removed after a load of 340 kips (1510 kN) was attained. At 360 kips (1600 kN) a loud pop was heard and the load started to drop. On the west face the concrete cover spalled off the reinforcement in an area 36 in. (0.91 m) long, and the web blew open at failure (Figure 4.43). The bottom boundary of this failed area coincided with the pre-existing crack 17 in. (0.43 m) from the bottom of the girder. An area of cover concrete approximately 30 x 7 in. (0.76 x 0.18 m) blew off the east web at failure (Figure 4.44). The south three stirrups on the west side and the south two stirrups on the east side had corroded. Pre-existing cracks on the top of the girder, directly south of the first loading point, opened and the top flange crushed in that location.

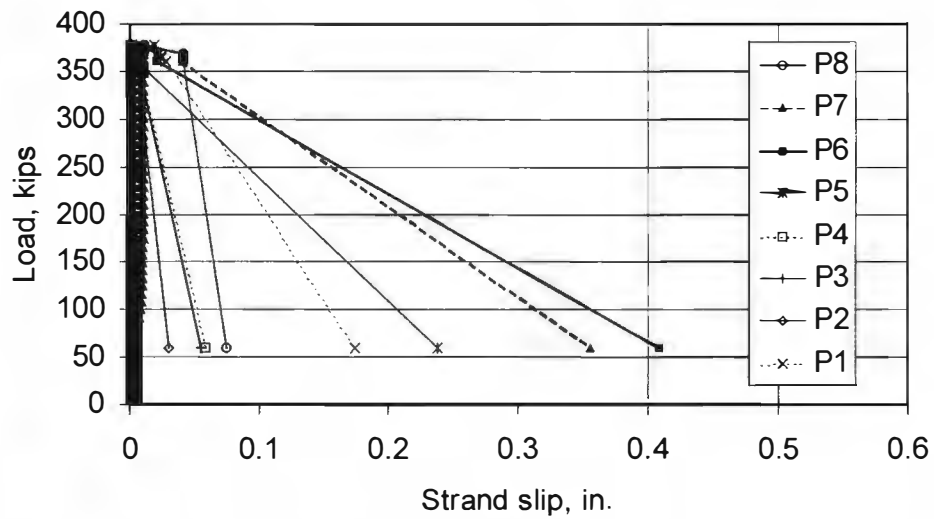
Figure 4.47 Strand slip of BG4S

As seen in Figure 4.47, all monitored strands slipped. The largest slips recorded were 0.24 in. (6.1 mm), 0.36 in. (9.1 mm), and 0.41 in. (10 mm), from P5, P6, and P7 respectively.

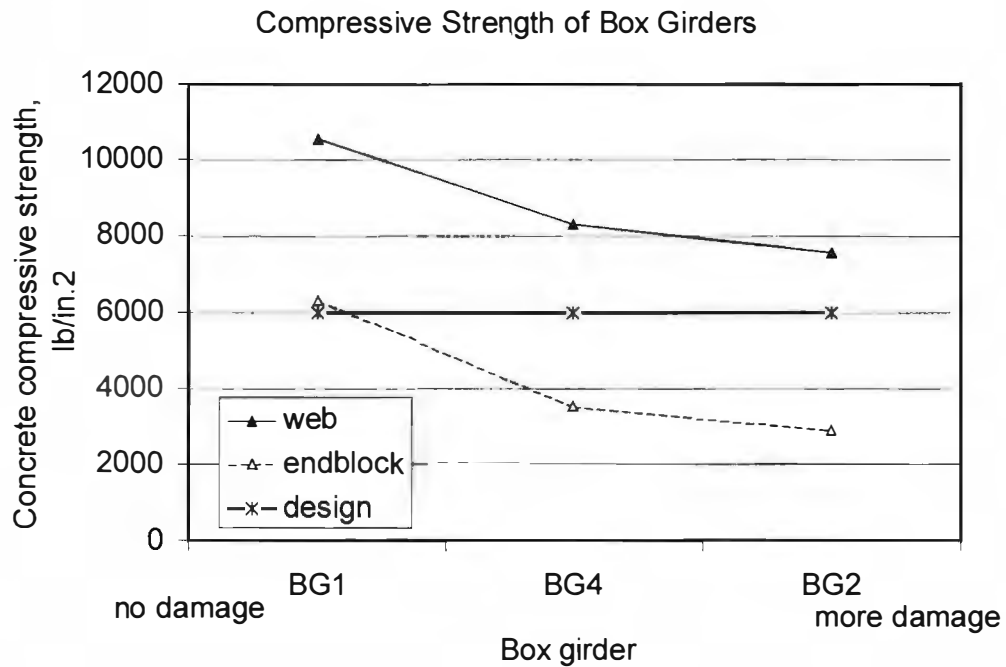
Figure 5.4 Concrete compressive strength of cores from box girders

The compressive strength and modulus of elasticity of concrete cores taken from the box girders are shown in Table 5.1. For girders BG1, BG2, and BG4 respectively, compressive strength of cores from the end-blocks, where damage was more pronounced, was 60%, 38%, and 42% of the compressive strength of cores from the webs, where damage was less pronounced. Thus the local effect of deterioration is obvious. Results from core tests show that internal damage in the end-blocks of BG1, though superficially undetectable, made those end-blocks significantly weaker than the webs.

As would be expected, concrete compressive strength and modulus of elasticity vary inversely with the degree of deterioration (Figures 5.4 and 5.5). BG1, with the least deterioration, had the highest compressive strength and modulus; BG2, with the most deterioration, had the lowest compressive strength and modulus.

The specified compressive strength of the girders was 6000 lb/in.² (41.4 MPa). Cores from the end-blocks of BG2 and BG4 have already deteriorated to the point that their compressive strength is below that value, and compressive strengths of cores from the end-block of BG1 are only 5% above it (Figure 5.4).

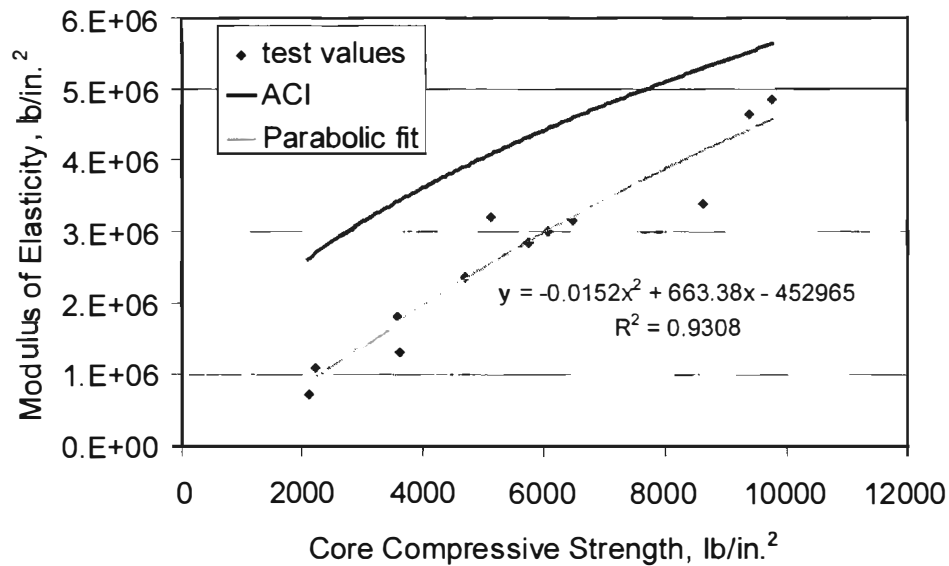
Figure 5.6 Modulus of elasticity versus concrete compressive strength of cores from box girders

In Figure 5.6 is shown the relationship between modulus of elasticity and compressive strength of cores from box girders. A parabolic curve fit to the test values, and the ACI 318-99 equation for modulus of elasticity, $E_c = 57,000(f_c)^{0.5}$ (US customary units), are also plotted.

According to the ACI 318-99 Commentary, Section R8.5.1, “measured values range typically from 120 to 80 percent of the specified value.” The parabolic curve fit to measured values from the box girder cores ranges from 81 to 33 percent of the specified value. The premature damage seems to not only reduce the compressive strength of cores, but also disproportionately reduce the modulus of elasticity relative to that compressive strength.

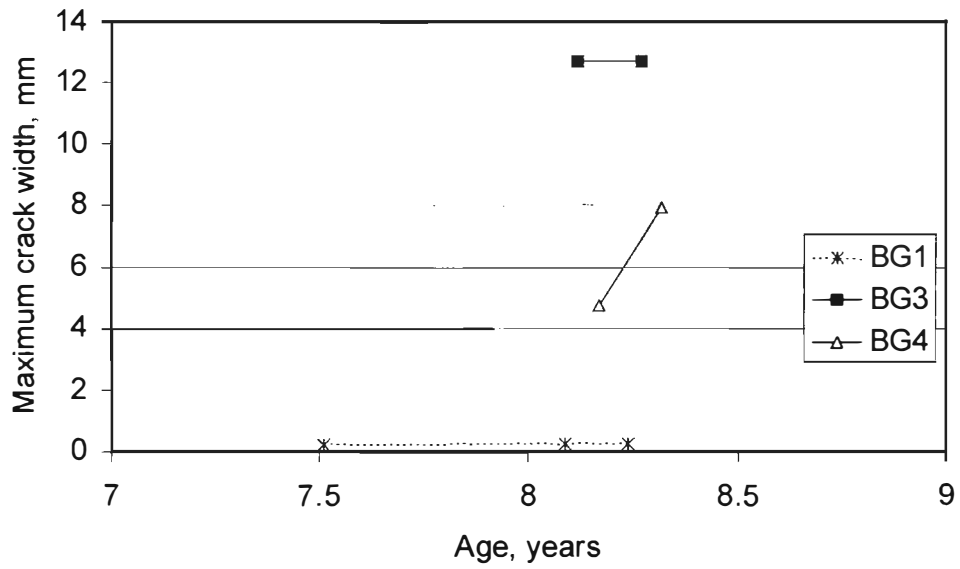
Figure 5.7 Maximum crack width versus age for box girders

The maximum crack widths of the girders monitored are displayed in Figure 5.7, in terms of the age of the girders. The effect of a more severe environment (exposure to water) is evident. BG4 (wetted) showed a drastic increase over time in maximum crack width. BG3 is considered to have severe inherent problems because of its constant, large maximum crack width.

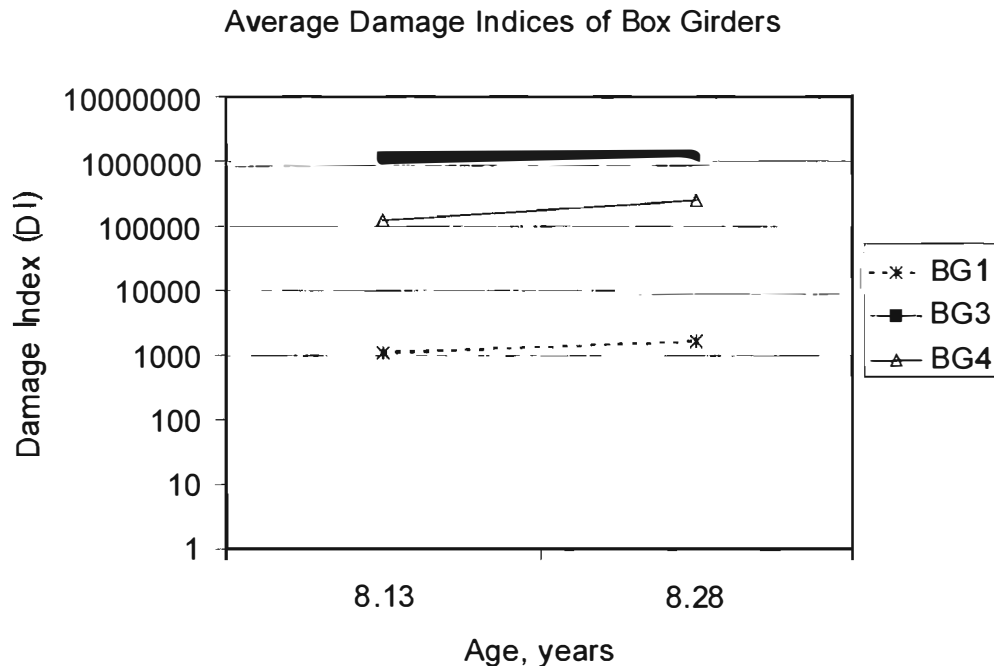
Figure 5.9 Average damage indices versus age for box girders

Plots of damage index versus age for the representative squares, and of the average damage index for the box girders, are shown in Figures 5.8 and 5.9. Ages were determined by averaging the ages of the three box girders monitored based on their casting dates.

High damage indices correlate well with high levels of visually observed damage. All three girders monitored showed an increase in damage index over time. The slopes of the lines suggest that the damage index is increasing by 3500 per year for BG1, 815,100 per year for BG3 and 839,200 per year for BG4. The percentage increases in damage index for the representative squares and box girders from 8.13 years to 8.28 years are shown in Table 5.2.

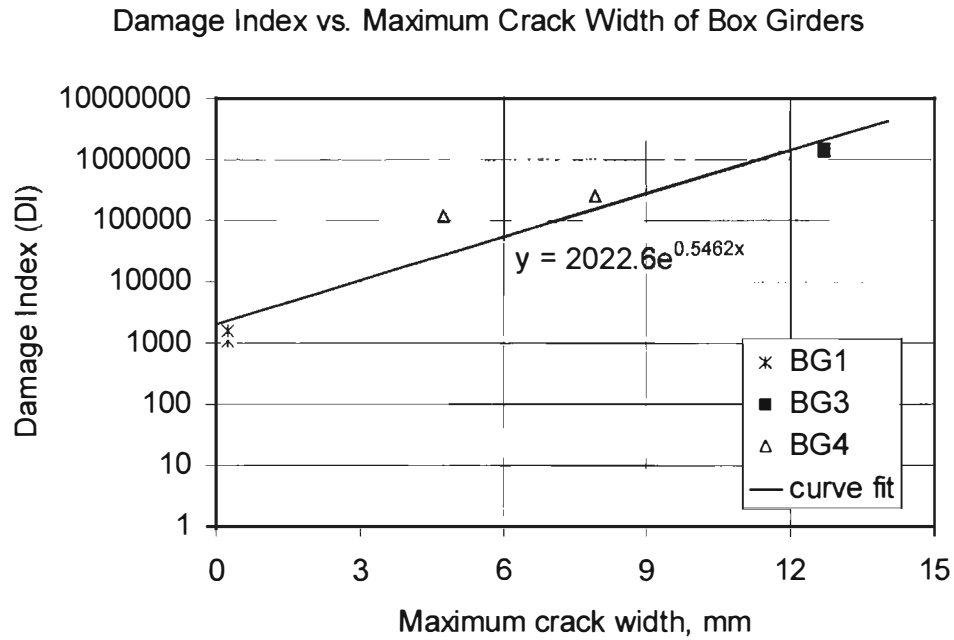
Figure 5.10 Damage index versus maximum crack width of box girders

A correlation is seen between maximum crack width and damage index (Figure 5.10). The best-fit curve shows that damage index increases exponentially as maximum crack width increases.

The first method should be used as a preliminary assessment tool. For example, the latest maximum crack width measured on the US-90 structure is 0.13 in. (3.4 mm). Using Figure 5.10, this corresponds to a damage index of 13,097 (US customary units). Using Figure 5.11, the compressive strength is estimated as 5170 lb/in.². If this is below the specified compressive strength, ACI Equation 11-2 should be used to estimate the reduced shear capacity of end regions of affected girders. If the shear capacity estimated in this way fell significantly below that used for design, compressive strengths could be verified by core tests.

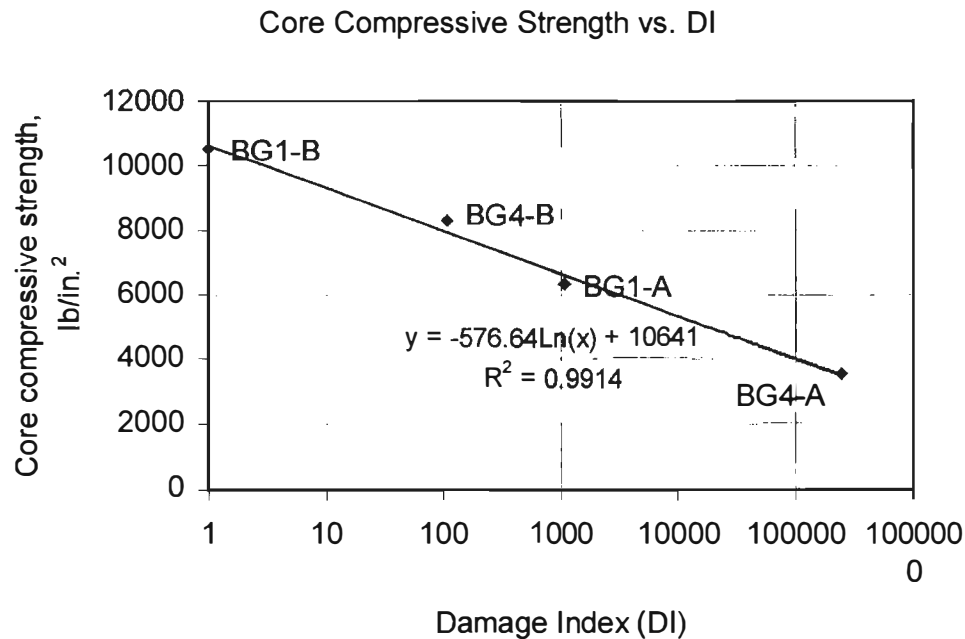
Figure 5.11 Concrete compressive strength of cores from box girders versus damage index

As would be expected, cores taken from areas with greater Damage Indices have lower compressive strengths. Figure 5.11 shows this relationship; a logarithmic fit to the data is also plotted. The points plotted are from cores of BG1 (representing girders with slight inherent problems and mild exposure) and BG4 (representing girders with severe inherent problems and severe exposure). The damage indices used are those that correspond most closely to the test date of the core in question. The damage index from Square A was used to represent end-block damage, and the damage index from Square B was used to represent web damage, since those locations corresponded most closely to the areas from which cores were taken.

- 5) Reductions in compressive strength are very strongly correlated to damage indices (Figure 5.11).
- 6) Reductions in compressive strength can be correlated to reductions in structural capacity, using strut-and-tie models. Structural capacity of prestressed girders can be governed by the tensile capacity of prestressing strand and by the bond of that strand to the surrounding concrete. It can also be governed by the compressive strength of the compression diagonals and compression chords comprising the strut-and-tie model. Gross strand slip, while not observed in these tests, is another possible failure mechanism. It is being investigated in a separate part of this overall study.

- 3) To predict capacity of a field girder with premature concrete deterioration, two methods are recommended:
 - Determine a damage index. Use that damage index with Figure 5.11 to estimate the compressive strength of the deteriorated concrete. Use that compressive strength with ACI Equation 11-2 to estimate the remaining shear strength.

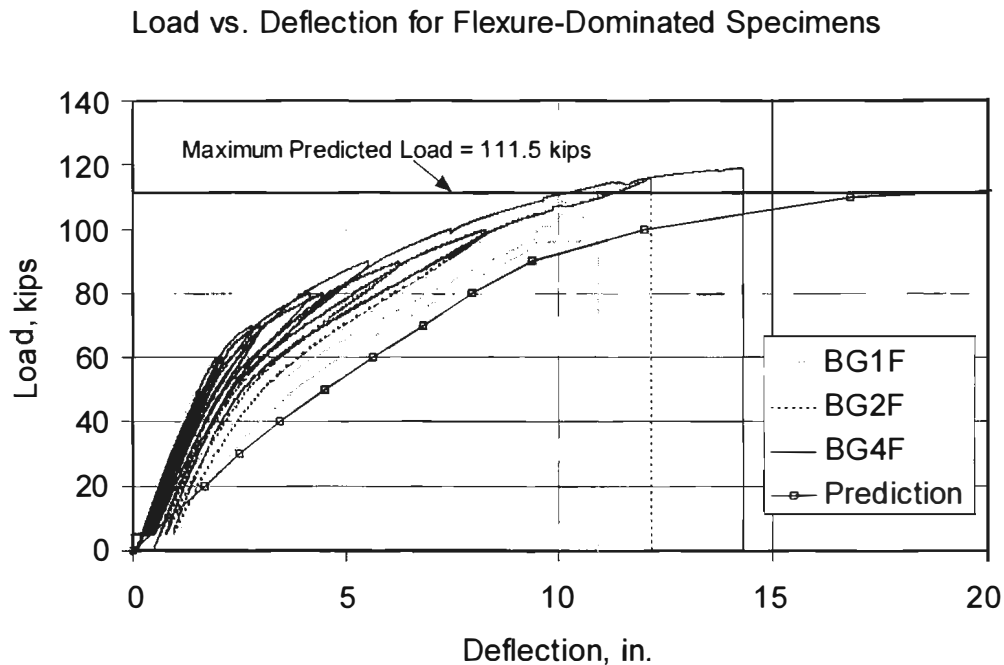
Figure 5.12 Load-deflection curves and predicted behavior for flexure-dominated specimens

Figure 5.12 shows the load-deflection curves for the flexure-dominated specimens as well as the predicted response and maximum load expected according to ACI 318-99.

The ultimate capacity of the three flexure-dominated specimens varied by only 2.7 kips (12 kN), or 2% of the lowest capacity, while the final deflection varied by 3.44 inches (87 mm), or 32% of the lowest deflection. Actual deflection of BG1 may have been greater than recorded; due to the limitation of the deflection-measuring instrument; the actual variation in final deflection may be less than 32%. The similar capacity of the three specimens may be explained by their comparable damage in the critical flexural area.

All three specimens carried more than the predicted maximum load of 111.5 kips (496 kN). The ratios of tested to calculated flexural strength were 1.06, 1.04, and 1.07 for BG1F, BG2F and BG4F respectively. These values are at least as high as the value of 1.03 found by Mattock (1961) for prestressed beams with well-bonded tendons tested in simple bending. Therefore it appears that the minimal pre-existing damage in the critical flexural area of these beams did not reduce their flexural capacity.

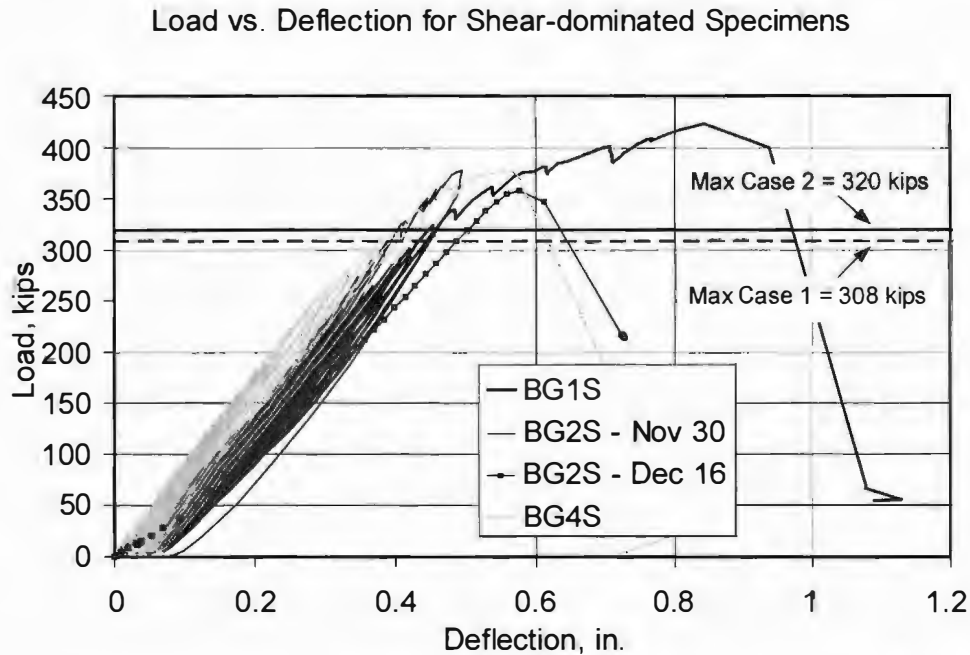
Figure 5.14 Load-deflection curves and predicted maximum loads for shear-dominated specimens

Figure 5.14 shows the load-deflection curves for the shear-dominated specimens as well as the maximum expected load calculated according to ACI 318-99, assuming a specified concrete compressive strength of 6,000 lb/in.² (41.4 MPa).

BG2S and BG4S had ultimate capacities of 377.1 kips (1680 kN) and 377.8 kips (1681 kN) respectively, while BG1S had an ultimate capacity of 422.6 kips (1880 kN). BG2S and BG4S had final deflections of 0.73 in. (19 mm) and 0.88 in. (22 mm) respectively; BG1S had a final deflection of 1.13 in. (29 mm). Thus the less damaged girder, BG1S, carried 12% more load and deflected 40% more than the severely damaged girders, BG2S and BG4S.

The ratios of tested to calculated ultimate strength were 1.32, 1.18, and 1.18 for BG1S, BG2S, and BG4S respectively. Though these ratios exceed 1.0, they fall below the average ratio of 1.368 found by Hognestad et al. (1967) - even for BG1S, which had the least damage. The more-damaged specimens are almost 14% below the average expected for specimens with normal concrete.

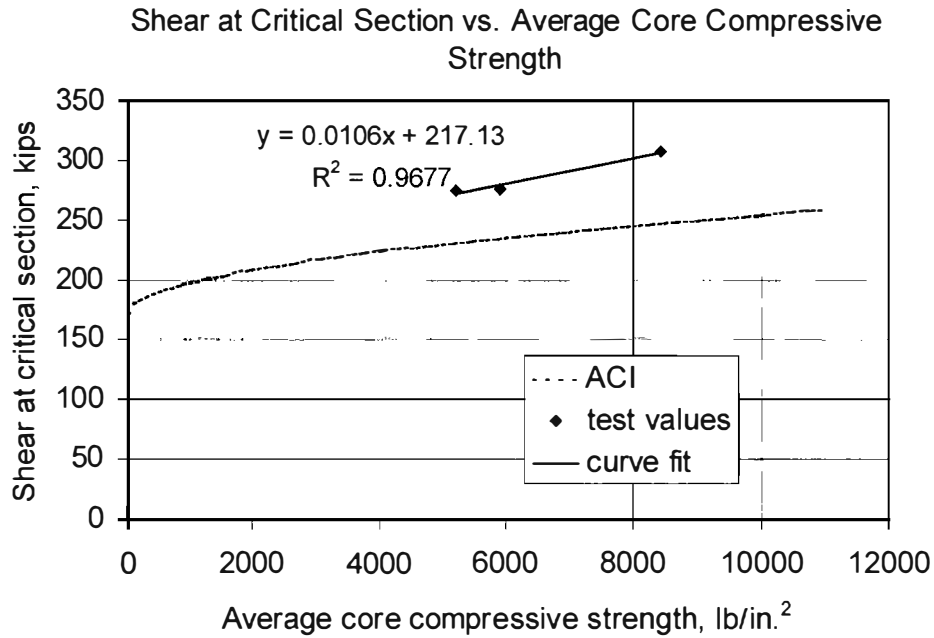
Figure 5.15 Shear strength versus average core compressive strength

Figure 5.15 shows the relationship between shear at the critical section at failure and the compressive strength of concrete cores. Also plotted in that figure are the best straight-line fit to the test data, and ACI Equation 11-2 for nominal shear strength (V_c plus V_s) of prestressed-concrete beams. The shear at the critical section at failure is the end reaction minus the self-weight between the support and the end of the void. An average core strength was used because cores were not taken from the critical shear area. The amount of pre-existing damage in the critical shear area was less than the amount seen in the end-blocks, but more than that seen in the webs.

From the limited data available, it appears that ACI Equation 11-2 can safely be used to predict shear strength, based on the compressive strength of concrete cores from the critical region. Because damage reduces not only compressive strength, but also bond strength, as strand slip in BG2S and BG4S and the crumbled concrete in ends of BG2 imply, capacities for specimens with very low compressive strengths might drop below the ACI curve. At very low strengths, the concrete is no longer a solid matrix holding the shear reinforcement and prestressed strand in formation. Table 5.4 shows the maximum strand slip recorded during the shear-dominated tests.

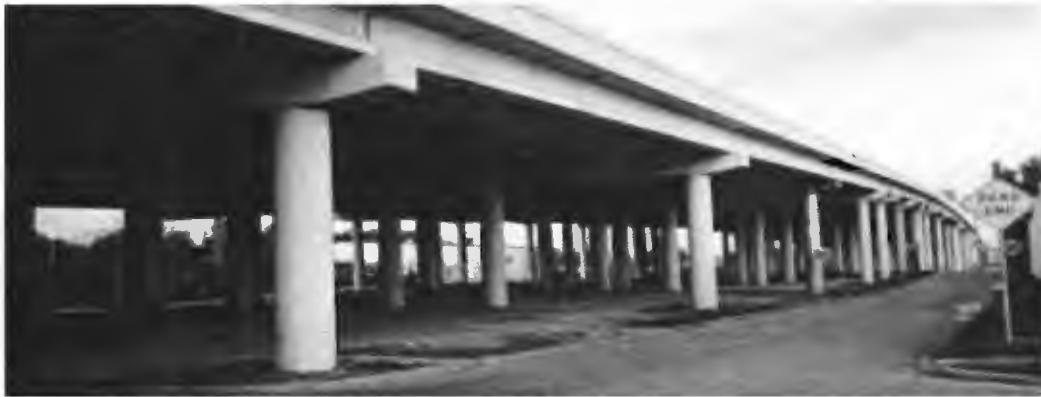
Figure 6.1 I-10 at AT & SF RR

The first structure inspected (Figure 6.1) is in Beaumont, TX on I-10 crossing the Atchison Topeka and Santa Fe railway lines (I-10 eastbound, take 7th Street exit). The affected elements are standard AASHTO Type C prestressed girders, fabricated in 1987.

In November of 1998, two of the exterior girders near the northwest abutment were replaced, and the original girders were sent to The University of Texas for testing.

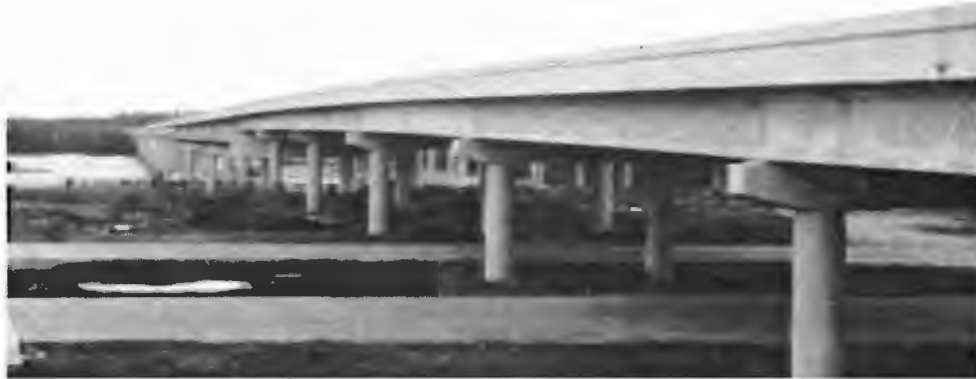
Figure 6.2 US-90 at San Jacinto River

The US Highway 90 structure crossing the San Jacinto River (Figure 6.2) is approximately 25 miles northeast of Houston (US-90 eastbound, exit before San Jacinto River). The affected elements are Type 54 prestressed girders, cast in 1986.

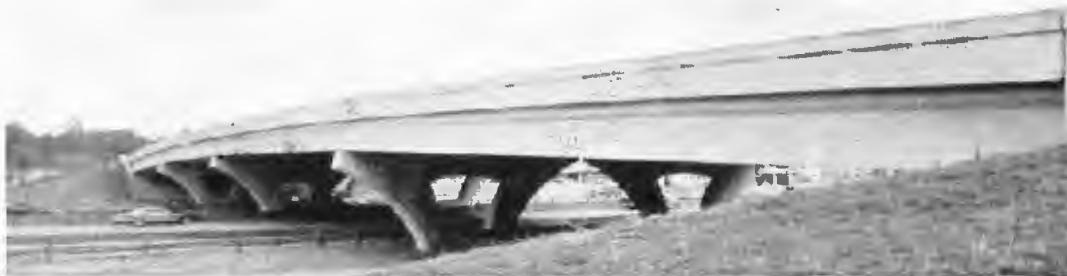
Figure 6.3 Robinson Road at I-45

The Robinson Road overpass of I-45 (Figure 6.3) is located north of Houston in the Woodlands (I-45 northbound, exit before Woodlands Parkway). The affected elements are Type IV prestressed girders, fabricated in 1987.

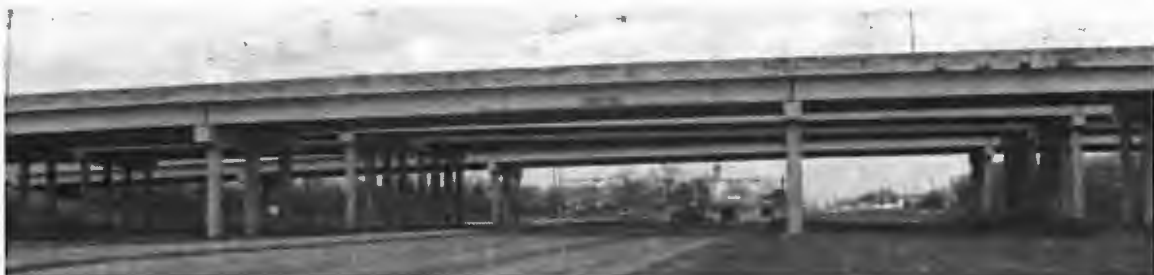
Figure 6.4 Beltway 8 at State Highway 3

Beltway 8 over State Highway 3 (Figure 6.4) is approximately 15 miles southeast of downtown Houston. The affected elements are Type IV prestressed girders over the northbound lanes of State Highway 3, fabricated in 1987.

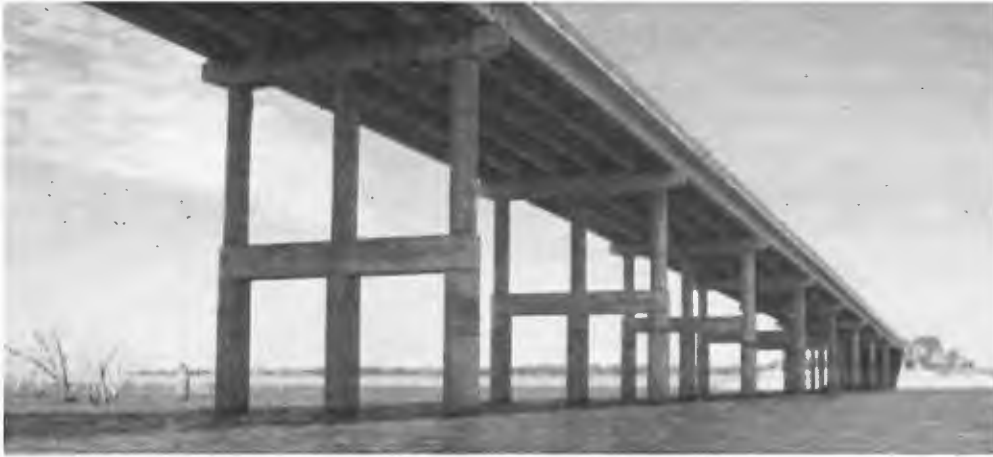
Figure 6.5 FM 1979 at Lake Ivie

FM 1979 crosses Lake Ivie (Figure 6.5) near San Angelo, TX. The bent caps and columns, built in 1989, are affected.

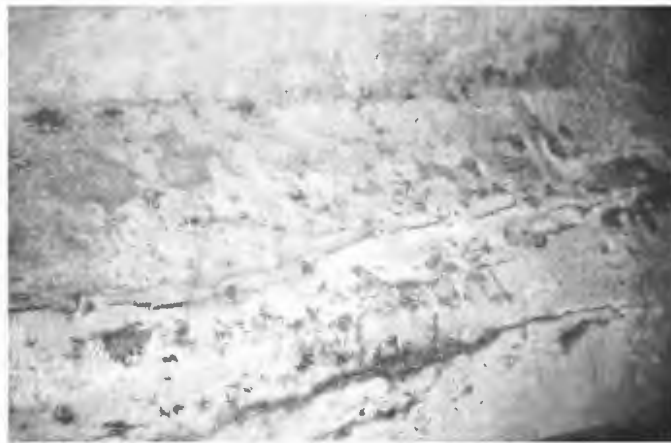
Two types of repair materials were observed in some of the cracks. One was hard and gray, and appeared to be applied to the surface only. According to TxDOT, it was a paste-type epoxy¹. The other type, less common than the first, was clear, yellow, and more pliable. It was probably an elastometric sealant, injected through ports that are apparent on the face of the girder (Figure 7.3).

Figure 7.3 Injected sealant on I-10 structure

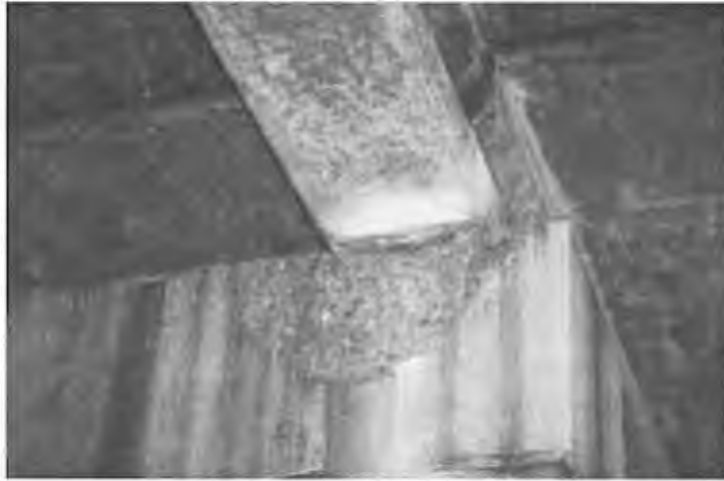
At one bearing point, the bearing pad had slipped out, causing the girder to rest directly on the concrete support. This had caused a portion of the support to spall off (Figure 7.4).

Figure 7.4 Missing bearing pad at I-10 structure

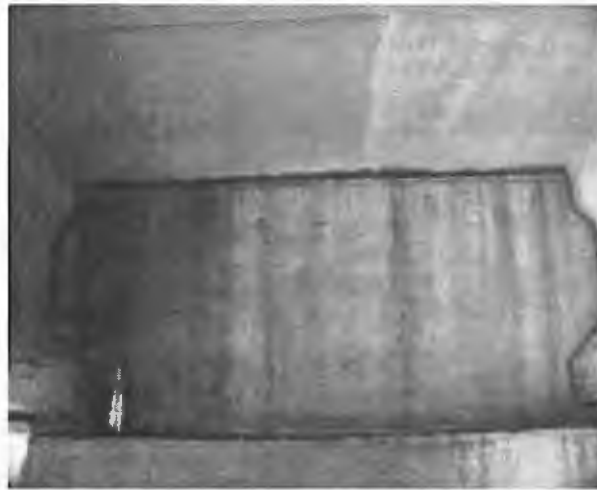
On October 22, 1999, the role of water in accelerating damage was more evident. In Figure 7.5, the west abutment between SW Girder 2 and SW Girder 3 is shown. Note the staining that indicates more water on SW Girder 2 than on SW Girder 3. In Figures 7.6 and 7.7, respectively, damage to SW Girder 2 is seen to be heavier than to SW Girder 3.

Figure 7.5 View of west abutment between SW Girder 2 (left) and SW Girder 3 (right)

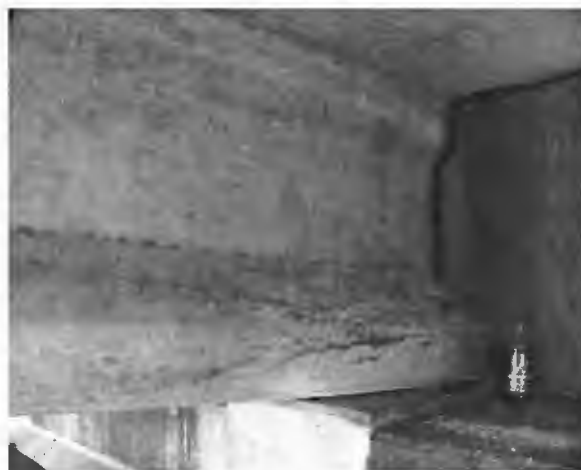
Figure 7.6 View of greater damage to SW Girder 2

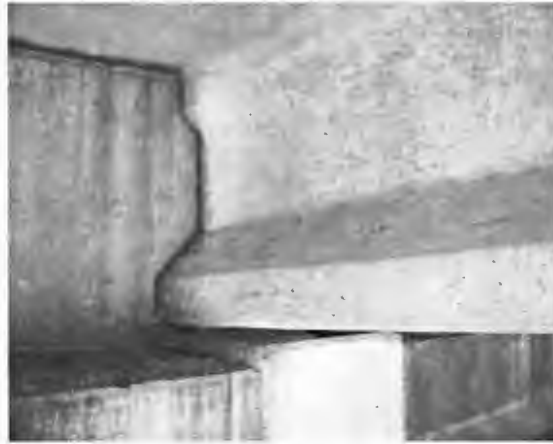
Figure 7.7 View of lesser damage to SW Girder 3

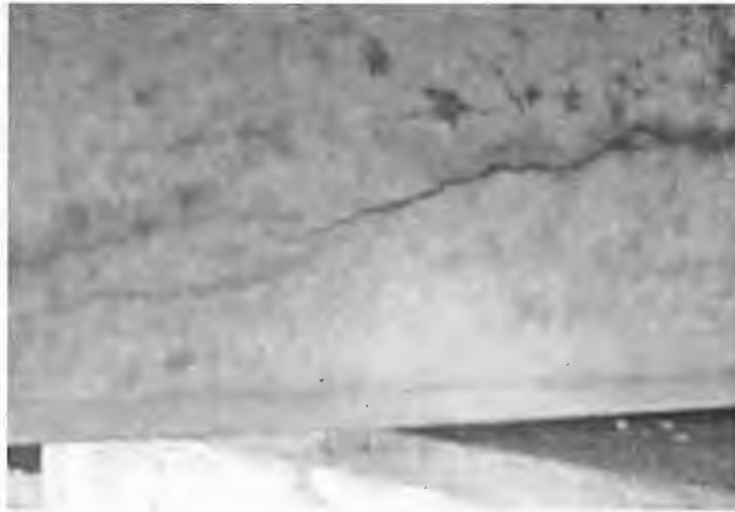
TxDOT personnel had filled some cracks with some type of repair material, and had also monitored their length in September 1998. The markings they left suggested that while the cracks had not grown much, new cracks had formed slightly above and below the old ones. These new cracks extended several inches past the ends of the old ones (Figure 7.9).

Figure 7.9 New cracks extending past the end of the old crack

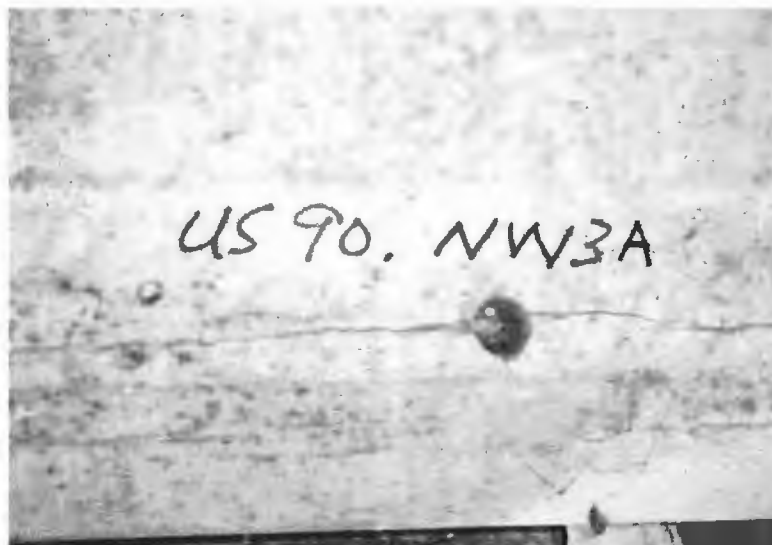
Cores had been taken from other girders in the span (Figure 7.10). Some core holes had been filled with grout; others were left unfilled. In one of the holes, a strand had also been cut and was exposed. The anchor bolts for the coring machine seemed to have been set into existing cracks, making them wider.

Figure 7.10 Core removed from US-90 girder

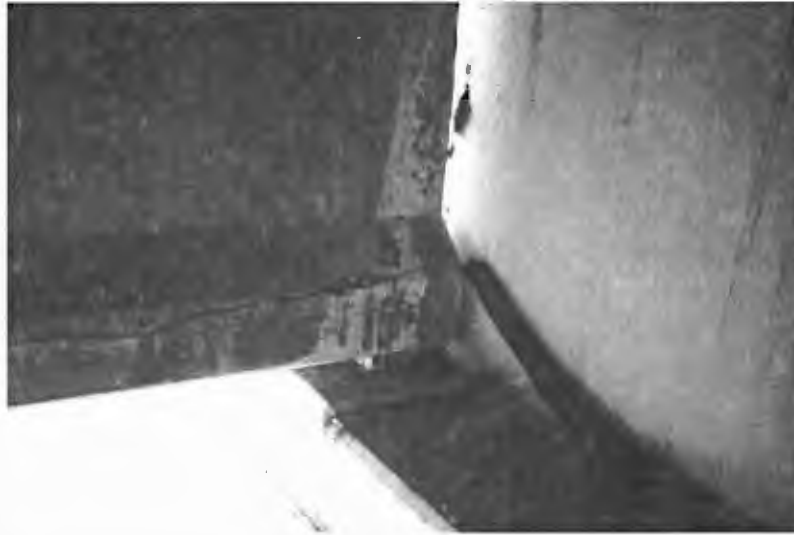
More severe damage was present on girders below where a section of the rubber seal, normally compressed between two spans of slab, had fallen out (Figure 7.11).

Figure 7.11 Rubber seal dropped from joint above at west abutment of US-90 structure

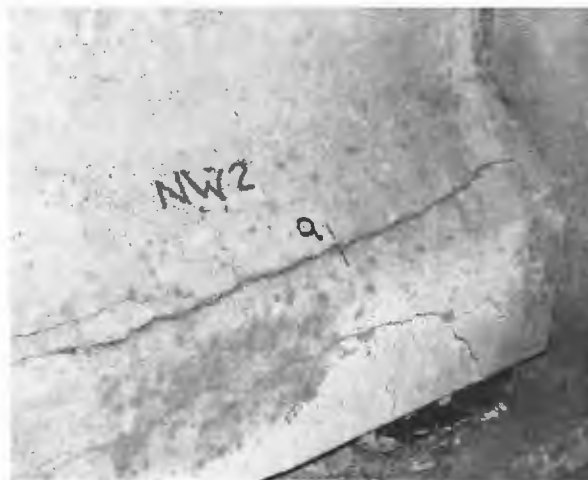
On October 22, 1999, cracking on the outside of the NW Girder 1 appeared markedly more severe than on previous trips, probably because the paint there had begun to peel, exposing the cracking beneath. At the north side of NW Girder 2, Point “a” was marked (Figure 7.12). The crack at that location was more than 1/4 in. (6.4 mm) wide.

Figure 7.12 Point “a” on NW Girder 2 of US-90 structure

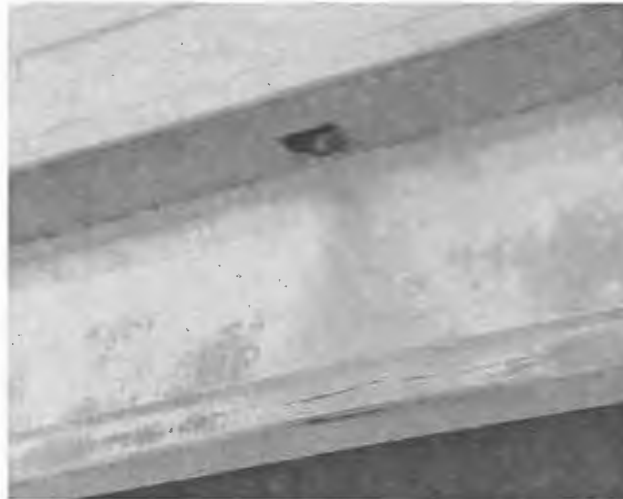
The apparent role of exposure to water was more evident than before. In examining overall damage on the northwest portion of the bridge, horizontal cracks were clearly visible on Face 5 of the northwest girders, directly below each drain scupper (Figure 7.13).

Figure 7.13 Cracking on Face 5 of exterior girder under drain scupper
