RESEARCH REPORT 1857-1

BRIDGES WITH PREMATURE CONCRETE
DETERIORATION: FIELD OBSERVATIONS
AND LARGE-SCALE TESTING

A. Boenig, L. Fúnez, R. E. Klingner, and T. J. Fowler

*STRUCTURAL ASSESSMENT OF IN-SERVICE BRIDGES
WITH PREMATURE CONCRETE DETERIORATION*

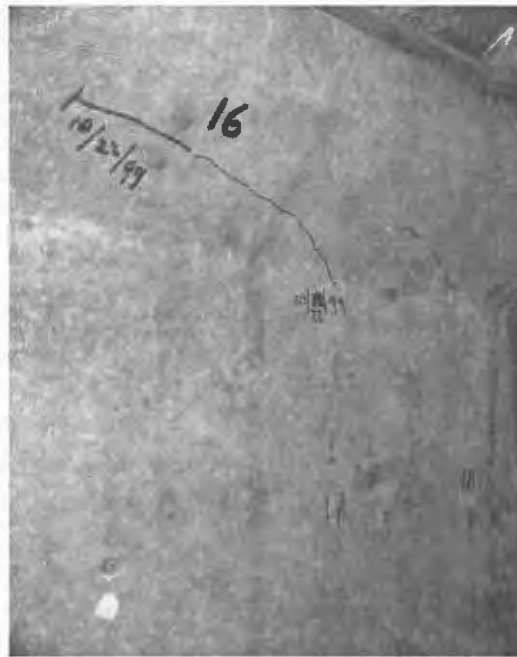
On October 22, 1999, cracks on Face 6 of NW Girder 3 had not propagated since the last visit. On the north face of NW Girder 3, previously identified cracks on Face 2 had continued to propagate (Figure 7.15). Lettered Points "a" through "f" were marked and measured with the crack comparator.

Figure 7.15 Extension of crack on Face 2 of NW Girder 3 at Robinson Road structure

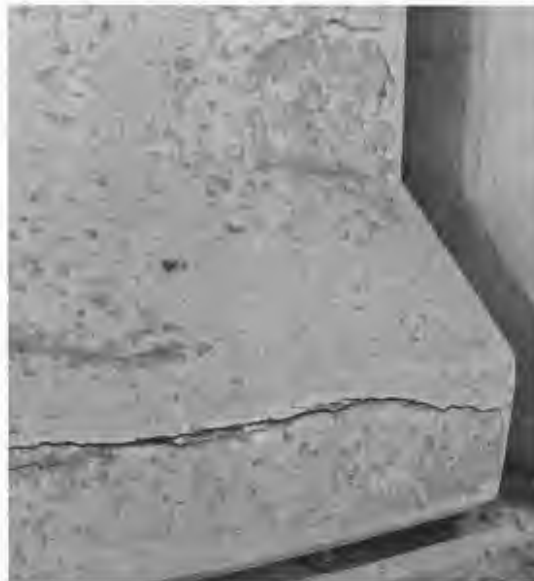
On June 4, 1999, Location 1 and Location 2 were chosen for closer study. At Location 1 large cracks were noticed on Face 5 of the southernmost girder, as well as minor cracking in the web and top flange. The paint was peeling excessively, and remaining paint seemed to obscure some minor cracks (Figure 7.17). At Location 1, the contrast between damaged and undamaged girders is quite striking (Figure 7.18).

Figure 7.17 Typical cracks on bottom flange of Beltway 8 girders

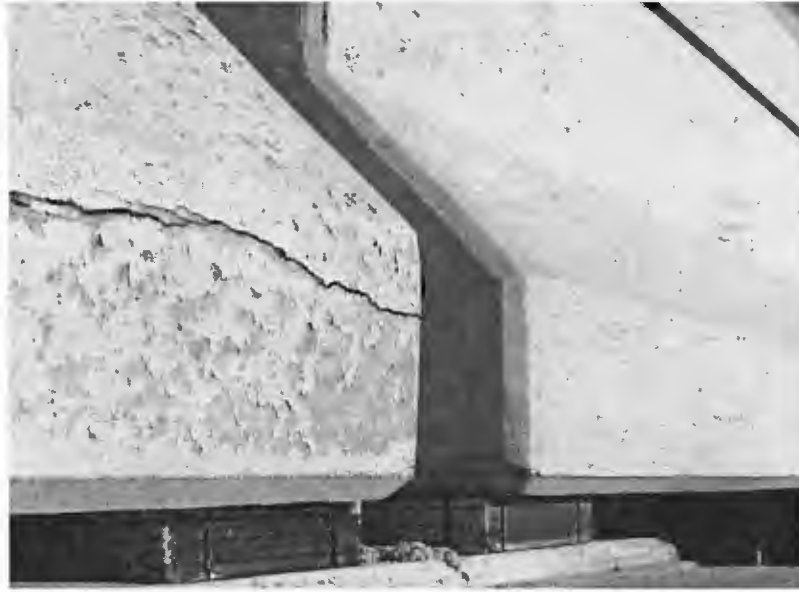
Figure 7.18 Contrast between damaged and undamaged girders at Location 1

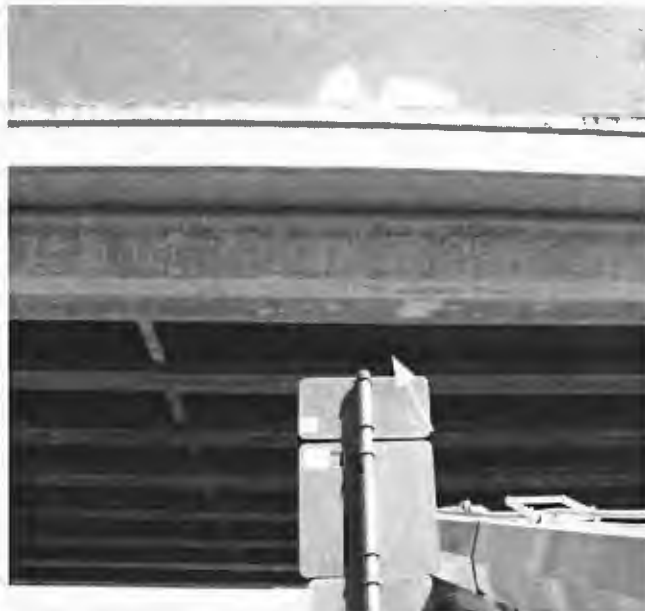
Cracks were mapped, and two Demec points were placed on the bottom flange of the east end of the girder: Point 1 on Face 5, and Point 2 on Face 4. At Location 2, cracks approximately 0.06 in. (1.5 mm) wide and 5 to 10 ft (1.5 to 3.0 m) long were noted directly on either side of the midspan diaphragm (Figure 7.19). Three additional Demec points were placed to the west of this diaphragm on the exterior of the north girder: Points 3 and 5 on Face 4, and Point 4 on Face 5.

Figure 7.19 Cracks on Face 5 of exterior girder at Location 2

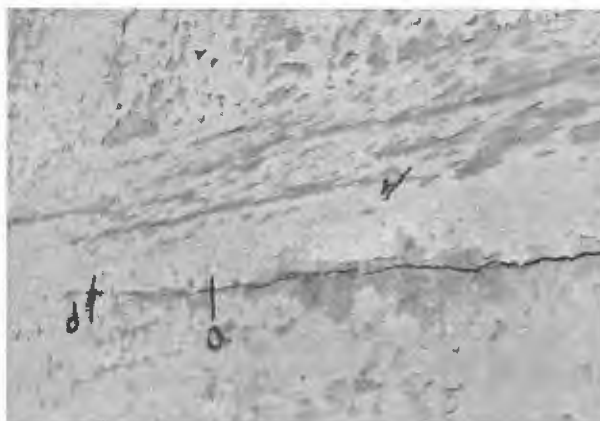
Figure 7.20 Marked points at Location 1

Cracks at Location 1 were about 1/8 in. (3.2 mm) wide. On the bottom flange, cracks were as wide as 1/4 in. (6.4 mm). The Demec discs had fallen off at Points 1 and 4. At Location 2, Points “e” through “i” on the bottom and sides of the bottom flange were marked and measured. Points “e” and “f” correspond to Points 4 and 5 respectively (Figures 7.21). Cracks at Locations 3 and 4 looked very similar to those at Location 1.

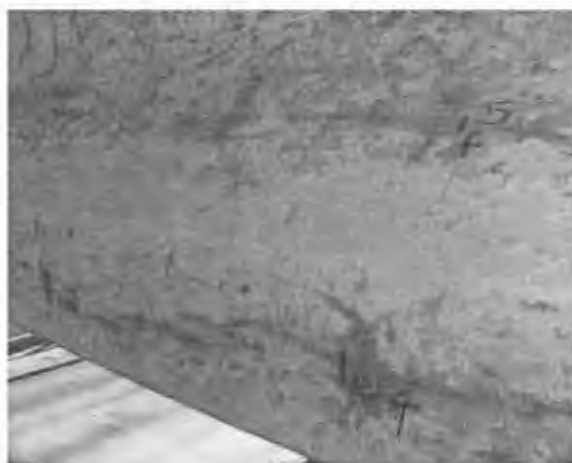
Figure 7.21 Marked points on Faces 4 and 5 at Location 2

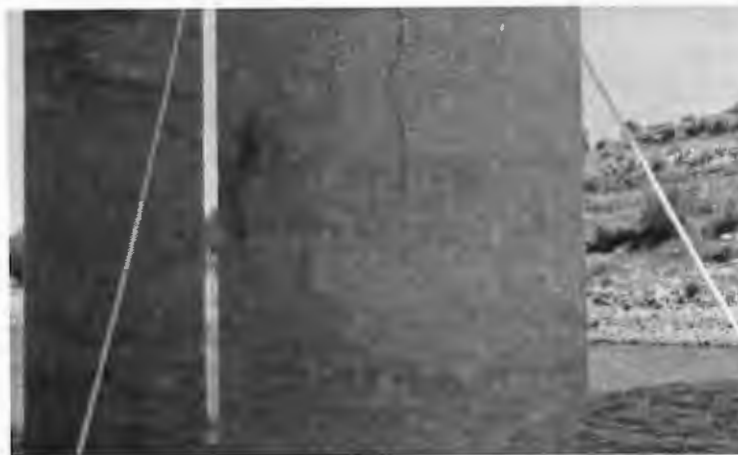
On September 29, 1999, cracks could be seen at each bent. Damage was concentrated at bents with expansion joints, probably because of greater exposure to rain of bent caps and girders in those locations. Bents 5, 9, 10 and 11 were visually assessed. Bent 10 showed clearly visible cracks, about 1/8 in. (3 mm) wide, over the entire height of the lower columns. The cracks appeared to coincide with the locations of

the longitudinal reinforcement in the lower columns. Bents 9 and 11 show similar cracks, about 1/16 in. (2 mm) wide. Examples of these cracks are shown in Figure 7.24. Bent 5 shows similar vertical cracks, about 1/16 in. (2 mm) wide. It also showed clearly visible horizontal cracks, about 1/32 in. (1 mm) wide, apparently in line with the locations of the transverse reinforcement in the lower columns. This cracking is shown in Figure 7.25.

Figure 7.24 Vertical cracking typical of Bents 9, 10 and 11 of FM 1979 structure (Bent 10)

An underwater investigation revealed that the vertical cracks go all the way to the mud line. At Bent 10 the cracks are 1/8 in. (3 mm) wide and at Bent 5, 1/16 in. (2 mm) wide down to the mud line.

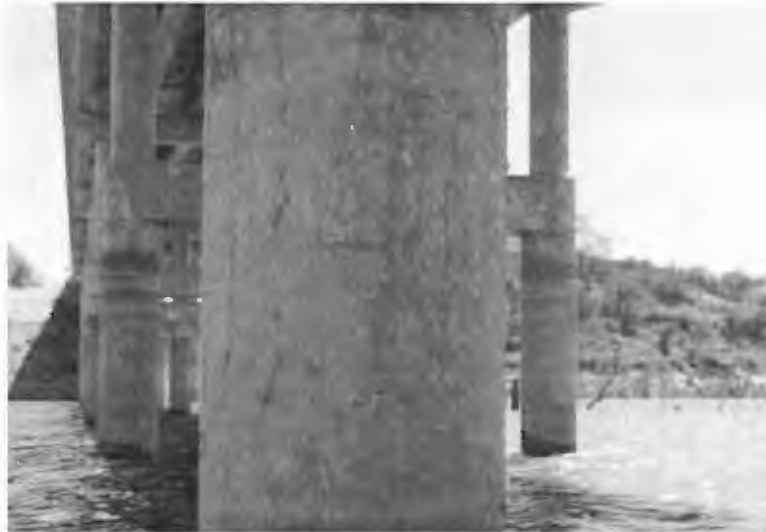
Figure 7.25 Horizontal and vertical cracking in Bent 5 of FM 1979 structure

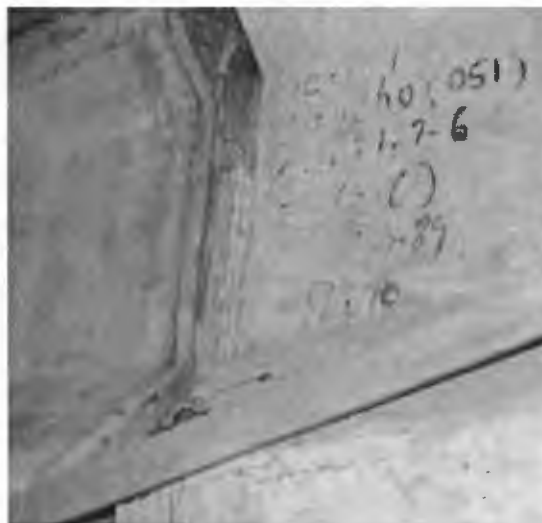
Observations on the west side of the structure revealed damage on the bent caps, upper columns and tie beams in those same bents. At Bent 5, the girder ends showed horizontal cracking on their bottom flanges, and map cracking on their webs (Figures 7.26 and 7.27). The bent cap showed extensive map cracking, with a typical width of 1/16 in. (2 mm), on the top, sides and ends (Figure 7.28). On the sides of the bent cap, some diagonal cracks propagated outward from the top of the upper column (Figure 7.29).

Figure 7.26 Horizontal cracking on bottom flanges of outside girder ends (Bent 5)

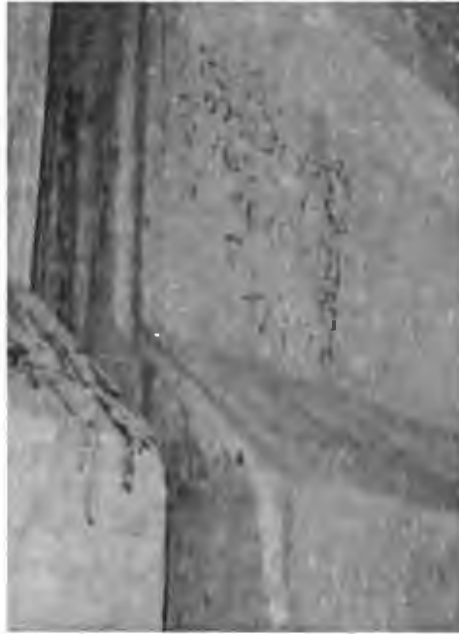
Figure 7.27 Horizontal cracking at bottom flanges of inside girder ends (Bent 5)

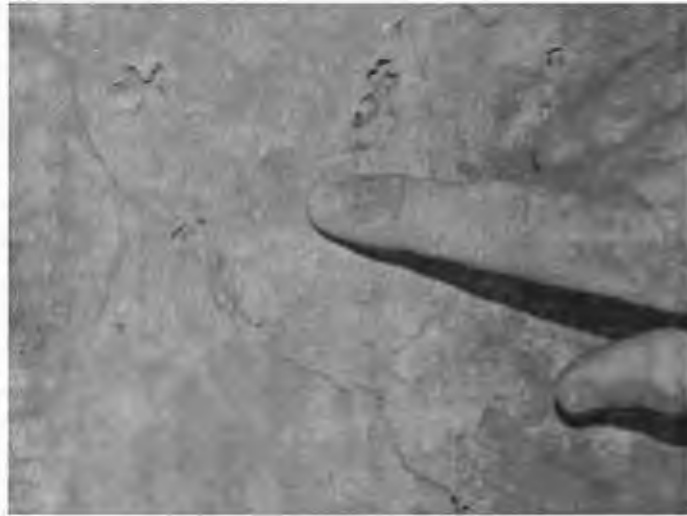
Figure 7.29 Map cracking on side of bent cap (Bent 5)

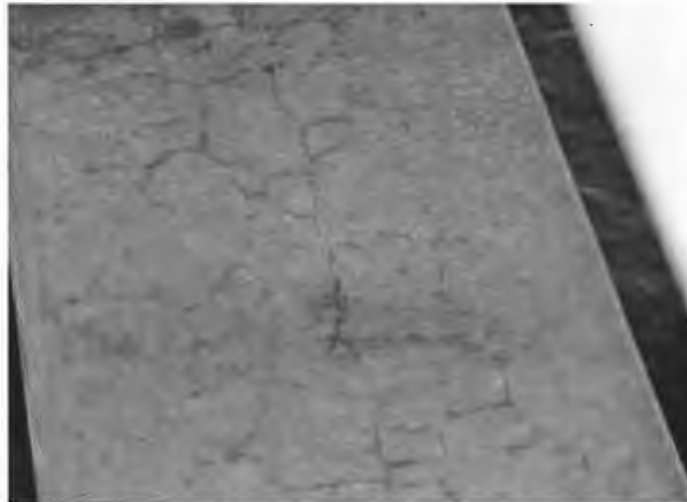
At Bent 5, map cracking was clearly visible on the upper columns, and on the upper surfaces of the tie beams (Figure 7.30). The vertical cracks on the lower columns extended upward to the upper surface of the tie beam (Figure 7.31).

Figure 7.30 Map cracking on upper surface of tie beam (Bent 5)

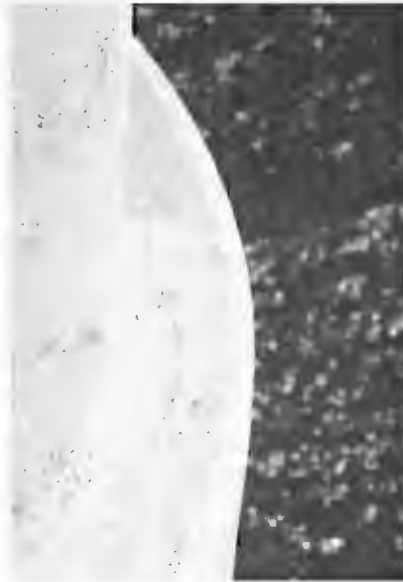
Figure 7.31 Propagation of vertical cracks in lower column to top of tie beam (Bent 5)

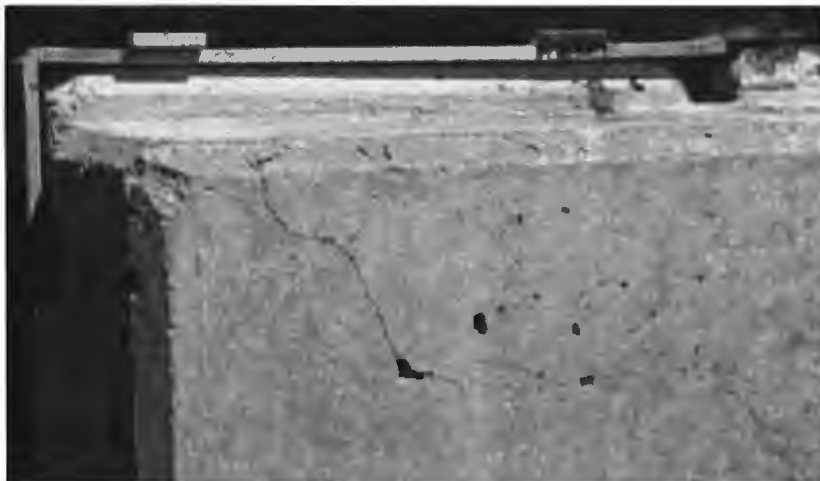
At Bent 9, similar damage was evident to the bent caps (Figure 7.32) and girder ends (Figure 7.33).

Figure 7.32 Map cracking at ends of bent cap (Bent 9)

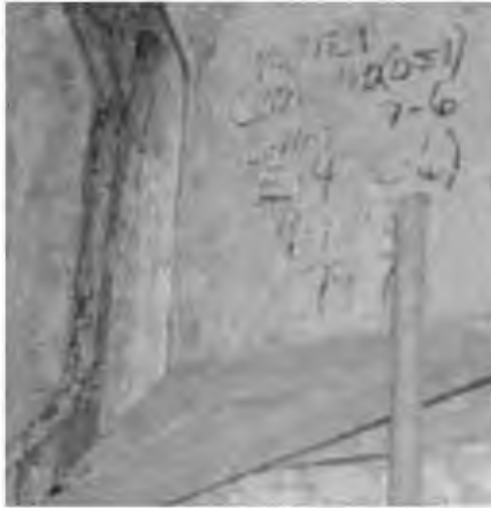
Figure 7.33 Horizontal and map cracking at girder ends (Bent 9)

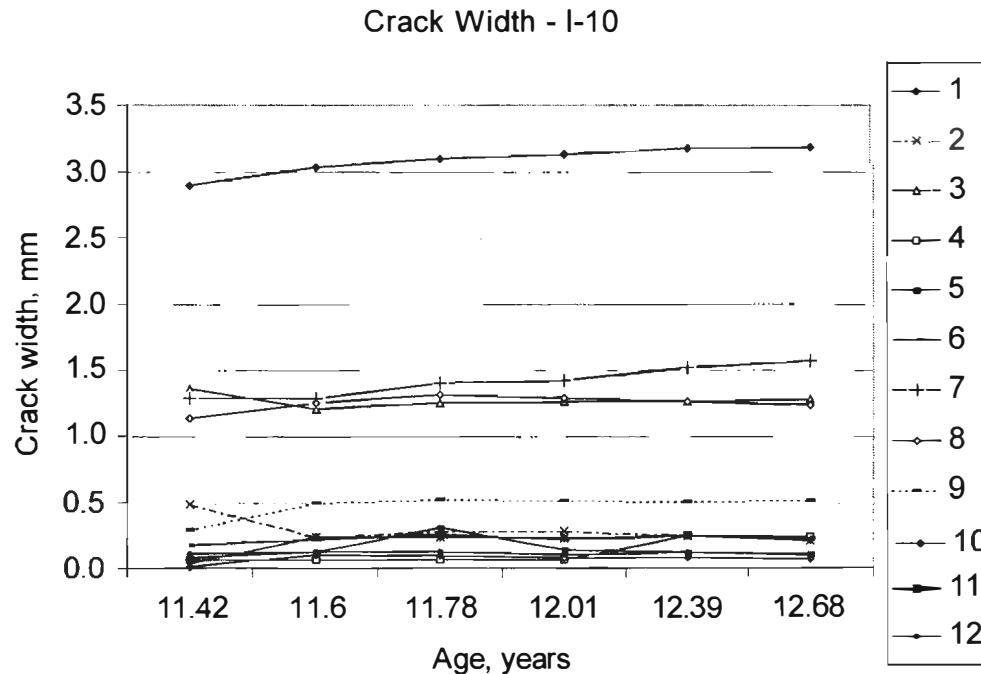
Figure 8.1 Crack width versus age of beam for I-10 structure

On the I-10 structure, cracks at Points 1, 3, 7 and 8 were significantly wider than others, and were all within 65 in. (1.65 m) of the ends of the girders. Cracks at Points 1 and 7, which consistently grew in width, were within 36 in. (0.91 m) of the ends. On the US-90 structure, cracks at Points 1, 3, 7, and 12 were significantly wider than others, and were all within 53 in. (1.35 m) of the ends of the girders. Only Point 1 consistently grew in width; it was 24 in. (0.61 m) from the ends. No significant crack growth was observed on the Robinson Road structure. Conclusions regarding the Beltway 8 structure cannot be made at this time.

All documented points where cracks grew significantly were near the ends of the girders, where they were subjected to a more extreme exposure.

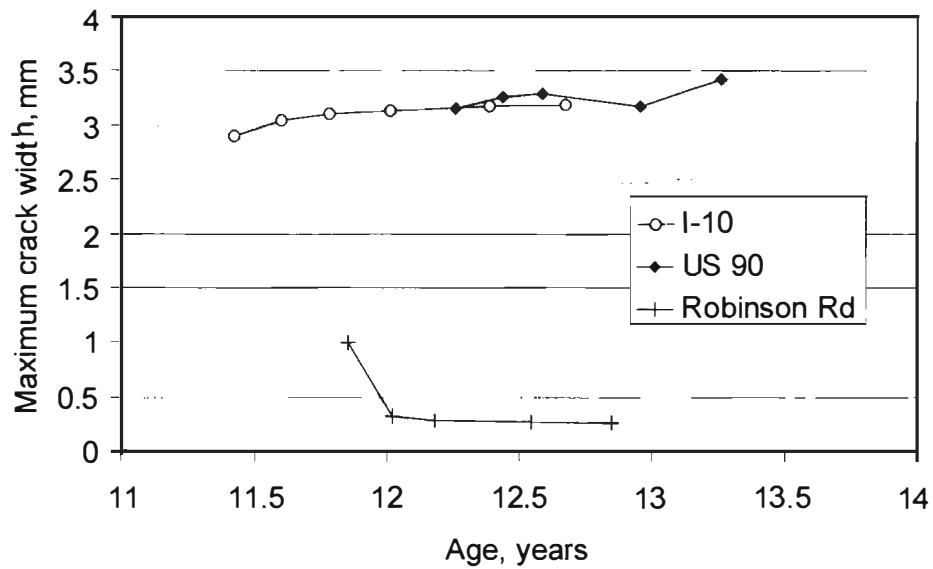
Figure 8.7 Maximum crack width of field girders

Effect of exposure on level of damage and rate of deterioration is evident. For a common age of 12.5 years, structures with severe exposure had maximum crack widths 13 times greater than structures with mild exposure. In structures with severe exposure, maximum crack widths continued to increase; in the structure with mild exposure, maximum crack widths were relatively stable.

For the age of structures monitored, some cracks stop growing, while others continue to grow. Looking at one crack could lead one to conclude that the damage has stopped progressing. Looking at a different crack, however, could lead one to conclude that the damage is progressing rapidly. Visual inspection shows that most cracks that stopped growing are adjacent to a new crack that is growing. The rate of change in width of individual cracks may indicate that the rate of damage is increasing or decreasing. The plot of maximum crack width, however, along with visual inspection, confirms that overall damage is progressing.

- 1) Crack widths in field structures and laboratory specimens should be monitored further, to document their trends over a longer time. Representative squares, similar to those of the laboratory specimens, should be used on the field girders to calculate and compare damage indices. Those damage indices should be used to determine the relationship between maximum crack width and damage index for field girders. Curves like those of Figure 5.10 could be used for preliminary diagnostic purposes; structure-specific curves should be developed as needed.

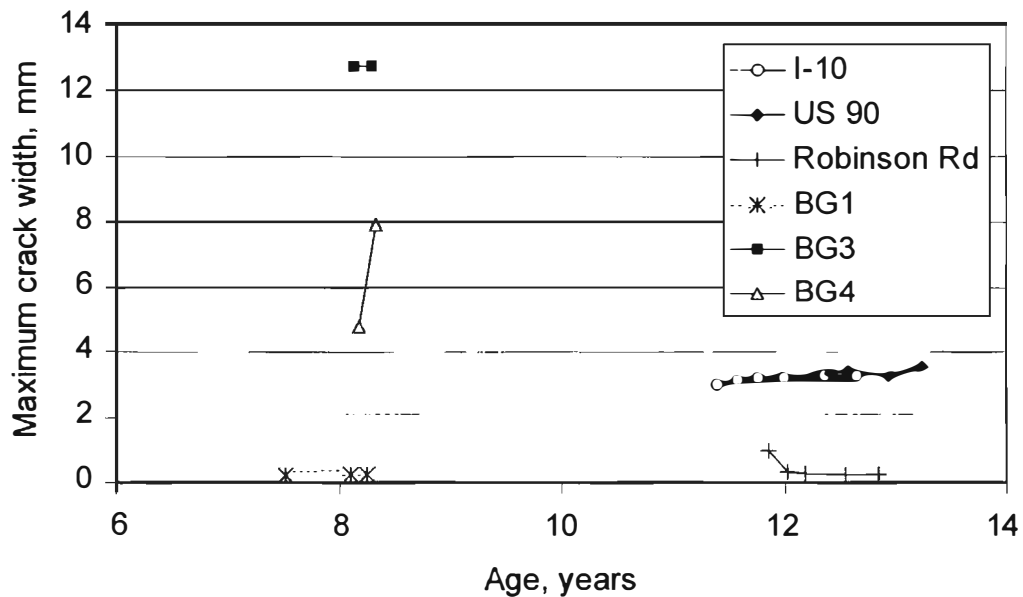
Figure 8.8 Maximum crack width of box and field girders

This shows similar trends in the structures with mild exposure and low inherent problems (BG1 and Robinson Road). Though the field girders with severe exposure show an increase in maximum crack width, they have lower maximum widths than the younger box girders studied in the laboratory. This

might be explained by lower inherent problems. No structure or girder showed as drastic an increase in maximum crack width as BG4 (wetted). This is consistent with its severity of exposure. Although some field girders may have been located in areas with rainfall as severe as the wetting exposure of BG4, field girders would not generally have as severe exposure, because they would be protected to some degree by overlying slabs.
