ASSESSMENT OF JAHN PERMEABLE MORTAR SYSTEM IN A HISTORIC BRIDGE ABUTMENT APPLICATION

Ian Anderson, Research Engineer
Vermont Agency of Transportation
Research Section

January 2019

Final Report 2019-01

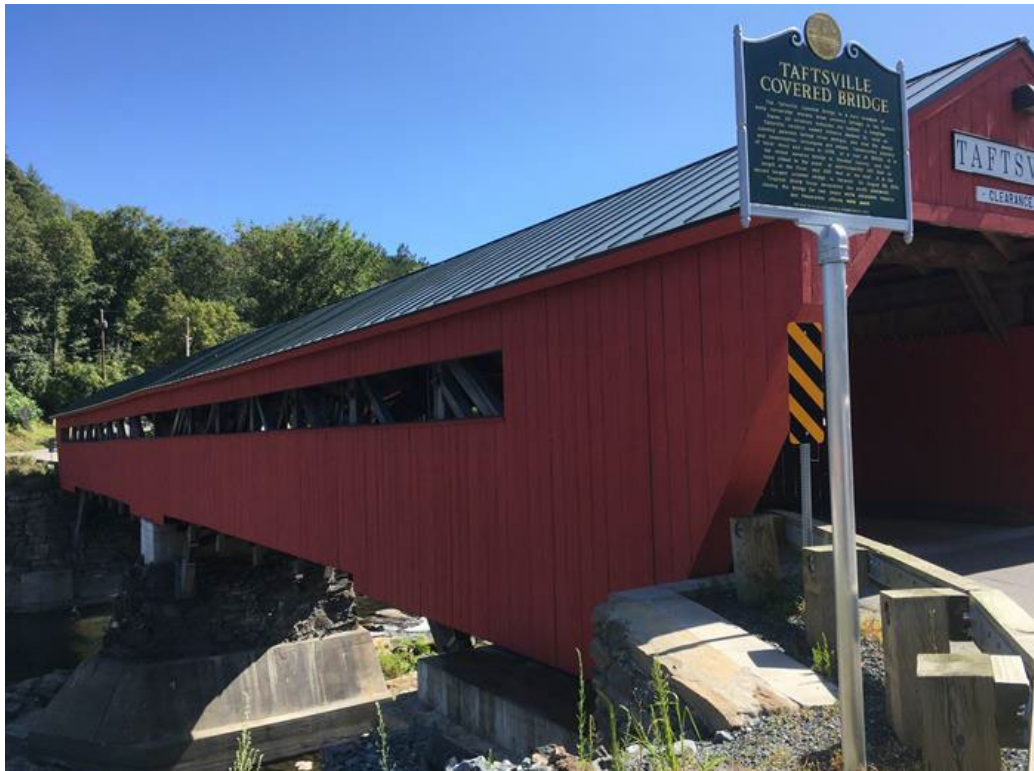
Figure 3: Taftsville covered Bridge after repair in 2012

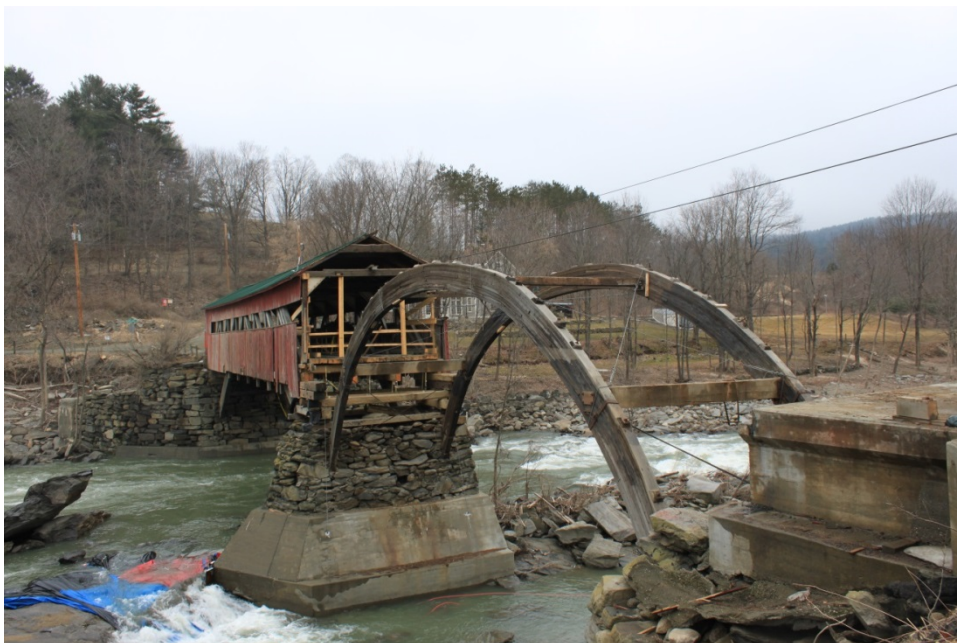
Figure 10: Western span dismantled leaving only the arches

According to McFarland Johnson, the engineering firm hired to design and specify the rehabilitation work for the covered bridge, the dry-laid stone abutments and pier have flaws and weaknesses. The pier comprises of dry-laid stone down to the riverbed. The pier and abutments have a concrete skirt encasing the stone pier placed after the original construction, which can be seen in Figure 10.
