A HYDRAULIC EVALUATION OF FISH PASSAGE THROUGH
ROADWAY CULVERTS IN ALASKA: DATA REPORT

Paula M. Wellen and Douglas L. Kane

Institute of Water Resources/Engineering Experiment Station
University of Alaska-Fairbanks
Fairbanks, AK 99701

May 1985

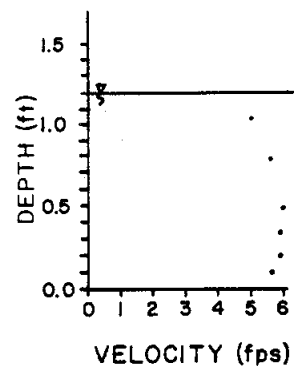
A-001
19 MAY 1982
CULVERT EXIT

The discharge at this unnamed creek was 22.1 cfs on May 19, 1982. A single 6 ft diameter corrugated metal pipe culvert contained the flow from the 6.3 sq mi watershed. A 4 ft diameter overflow culvert was nearby but contained no flow. The main culvert barrel did not have a constant slope: the water depth in the barrel decreased for the first 20 ft where the slope was steeper. At this point a hydraulic jump occurred and the water depth increased. The culvert barrel was clean. The stream bed was brushy with grass on the bottom; the estimated bedload size was medium gravel. The flat slope and pools downstream were due to beaver activity. These pools provided rest areas for fishes; there were also some rest areas at high water at the upstream end of the culvert. The velocity profiles at this site were taken with an electromagnetic flowmeter.

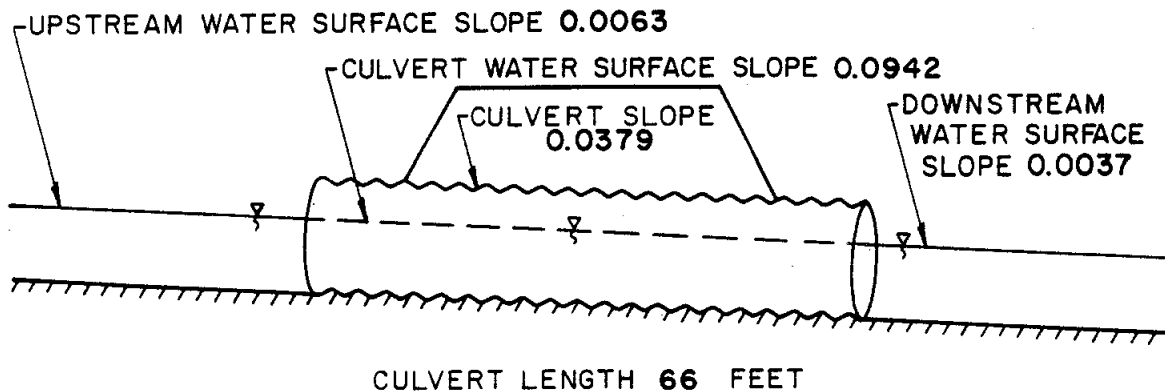
This unnamed creek was visited on May 20, 1982. The 35.8 cfs discharge was totally contained by a 6 ft square wooden culvert. The water surface profile for this installation is shown in the diagram. The inlet and outlet water depths were 1.45 and 0.50 ft, respectively. A 50 ft diameter pool was noted at the culvert outlet. A velocity profile was not measured at the culvert exit due to high water velocities from the steep culvert slope at the outlet. The downstream end of the culvert barrel appeared to be broken, causing the steeper outlet slope. The bed material was small gravel and the stream banks were sandy; roots and branches lined the stream banks. A USGS crest stage indicator was located at this site. For the period of record, the high water level was 2.3 ft above the present water level; in 1968 the high water mark was 0.9 ft above the present water level. The watershed area was 11.0 sq mi.

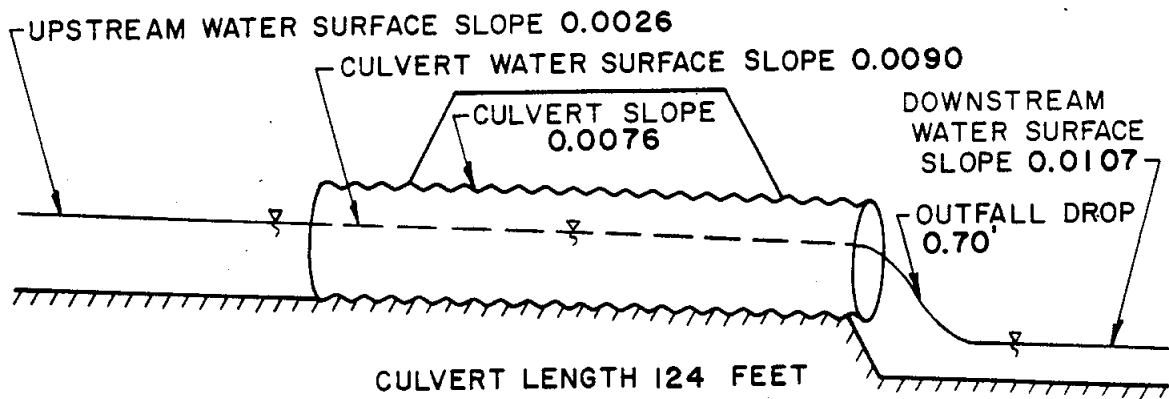
Three culverts were observed at the Steele Creek site along Chena Hot Springs Road on August 16, 1982. The main culvert (pictured) contained all of the flow (1.6 cfs). The water surface profile for this culvert and the stream appear in the diagram. A smaller overflow culvert (about 4 ft in diameter, crown slope 0.0054) was dry but erosion marks were visible at the outlet. A third culvert was completely buried at the outlet, and the inlet was only partially visible. The bedload was estimated as silt, sand, and very fine gravel. The first part of the main culvert barrel contained some drift, but the last part was clean. There was a quiet pool at the main culvert entrance, but none at the exit. The water depth at the culvert inlet was 0.70 ft and at the outlet was 0.30 ft. The watershed area was 10.60 sq mi.

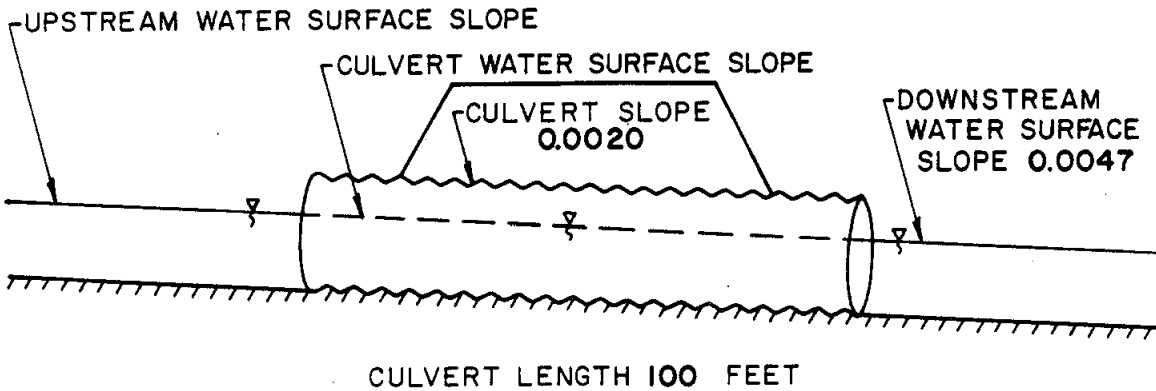
Woodchopper Creek was first observed on May 26, 1982. The discharge was 74.4 cfs from a watershed area of 13.4 sq mi. The water depths at the inlet and outlet of the culvert were 2.80 and 3.15 ft, respectively. The bedload was fine sand and silt; no sediment was observed in the culvert. There was a small pool just downstream of the culvert outlet. The brush and vegetation was too thick to obtain a slope measurement upstream of the culvert, other slopes are shown in the diagram.

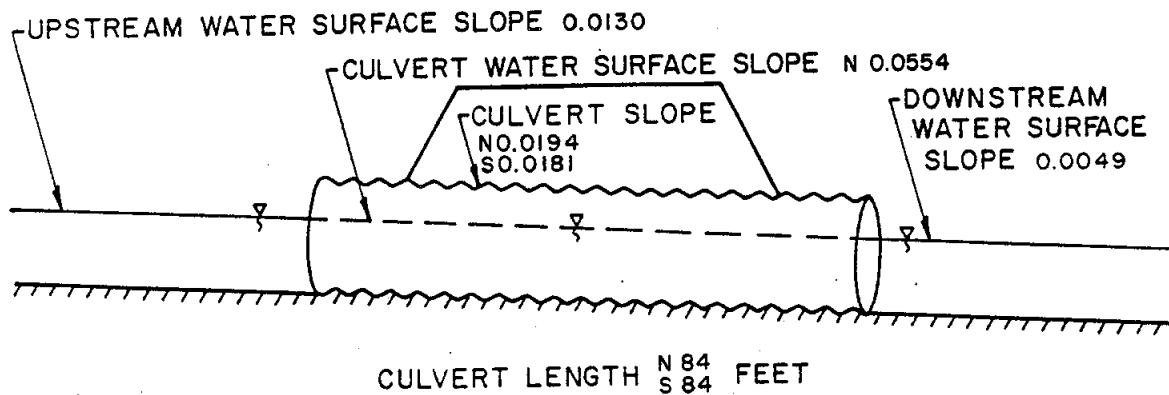
Two identical culverts contained the 50.2 cfs discharge in this creek on May 10, 1983. Ice was noted in both culverts, filling about 2/3 of each barrel. Anchor ice was present in the stream channel and the discharge measurement was taken on top of the ice. A velocity profile measurement was taken at the outlet of the north culvert. Here the ice was 5.62 ft thick and the water depth on top of the ice was 1.10 ft. The watershed area was 36.2 sq mi. The water surface profile for this stream is shown in the diagram.

Fort Hamlin Hills Creek was also visited on May 26, 1982. Flow conditions appeared similar to those described above except less ice was noted. A 60 by 50 ft pool was situated downstream of the culvert installation while upstream of the north culvert was a 15 ft diameter pool.

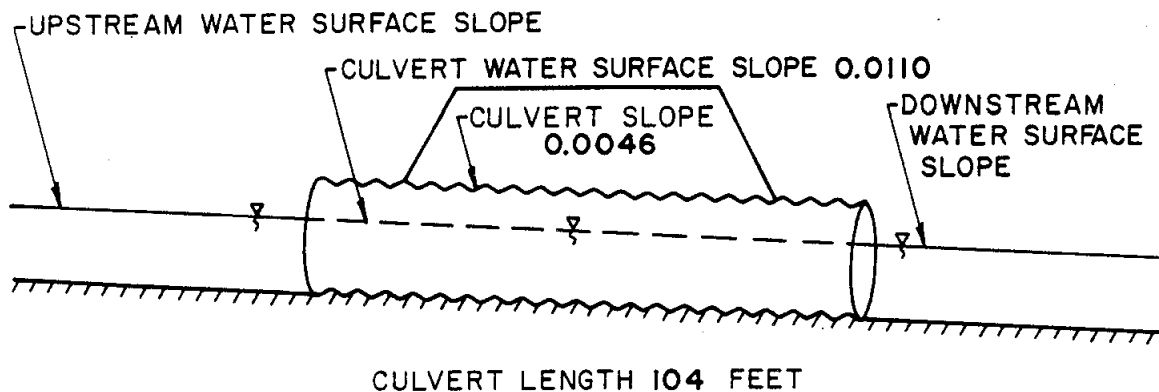
This site was first visited on May 26, 1982. No discharge measurement was made due to the aufeis up and downstream of the culvert. Upstream, the channel was full of ice causing the water to flow through the trees; downstream the channel was filled with debris and ice. Some ice was also noted inside the culvert. No slope measurements were made above and below the culvert due to the lack of a defined channel. The watershed area was 4.3 sq mi.

Fed Creek was again observed on July 23, 1982. Culvert inlet and outlet depths were measured: the water depth was 0.30 ft at the entrance and 0.55 ft at the exit. The barrel contained small rocks and silt.

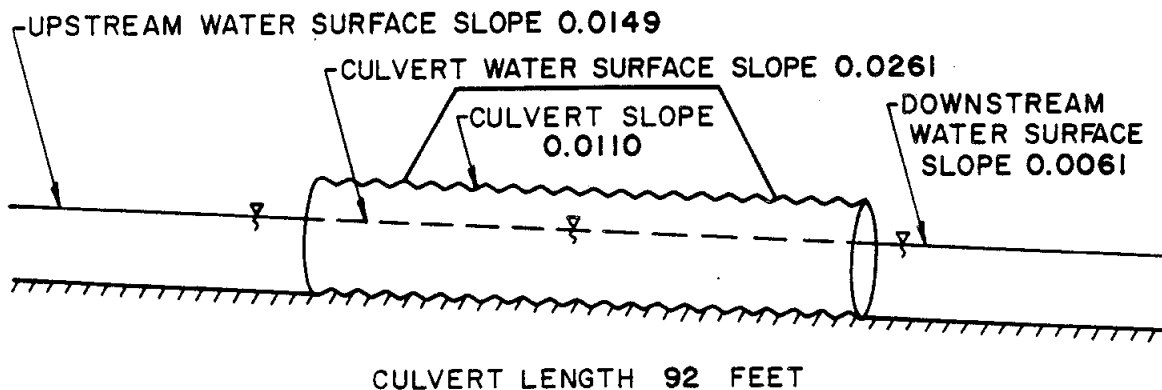
The culvert and stream at this location were measured on May 28, 1982 and the surveyed slopes are presented in the diagram. The discharge (55.9 cfs) was measured in the culvert entrance. Due to high discharge, channels were undefined both up and downstream of the culvert. A large shallow pool (70 by 20 ft) just upstream of the culvert may also have been a result of the high flows. There was no drift in the culvert although ice was observed in the barrel frozen to the sides about three feet up. The velocity at the culvert outlet appeared to be greater than at the inlet. The total depth at the inlet was 2.00 ft. A velocity profile was attempted at the culvert outlet but the combined water depth and velocity was too great. The watershed area was 4.0 sq mi.

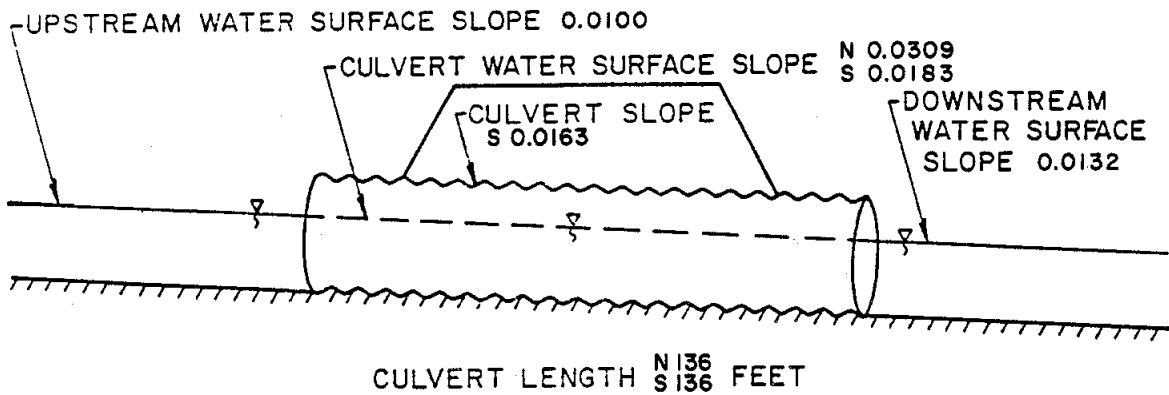
Olson Lake Creek was visited on May 27, 1982, when the flow was 63.8 cfs. Two culverts carried the flow, a circular overflow culvert to the north and an arch culvert to the south. The water surface profiles of the culverts and stream are shown in the diagram. The north culvert was completely submerged on the upstream side. This culvert was not flowing full however, and the outlet depth of flow was near 2 ft. The south culvert had an outlet water depth of 0.70 ft and the velocity profile recorded here was with an electromagnetic flow meter. The bedload size was small gravel and there was some gravel in the south culvert invert. The watershed area was 4.4 sq mi.

On July 23, 1982, the inlet and outlet water depths were recorded for Olson Lake Creek. They were 1.80 and 0.75 ft, respectively, for the north culvert. The south culvert was dry.

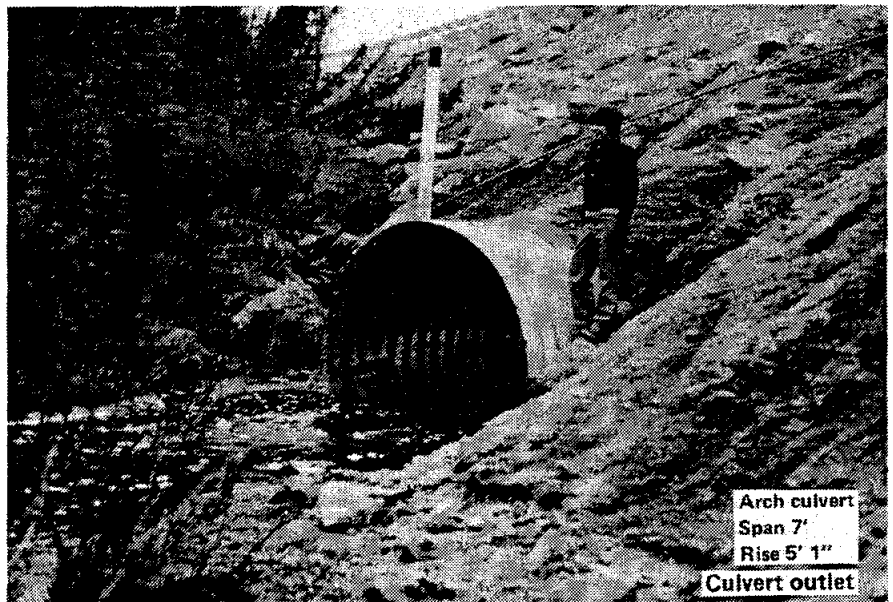
Arch culvert
Span 7'
Rise 5' 1"
Culvert outlet

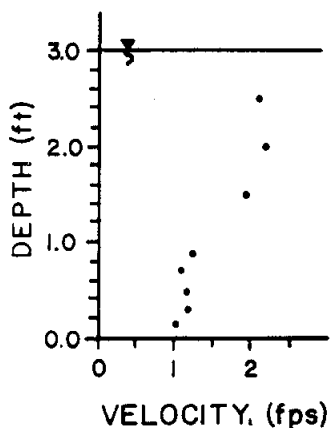
B-006
27 MAY 1982
CULVERT ENTRANCE

This creek was first observed on May 27, 1982. The surveying results are shown in the diagram. The total water depth at the culvert inlet was 3.00 ft. No discharge measurement was obtained due to the depth of flow. Snow and ice were observed in the stream channel. A velocity profile was taken at the culvert entrance with an electromagnetic flowmeter. The watershed area was 7.0 sq mi.

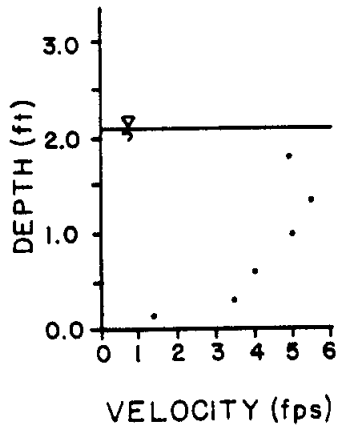
B-008
 27 MAY 1982
 AT DISCHARGE
 MEASUREMENT

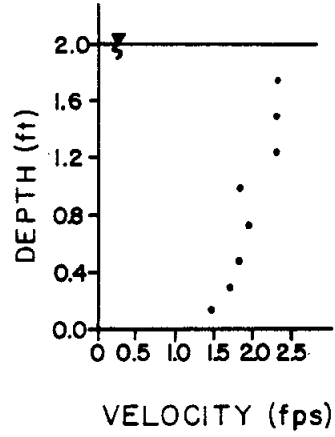
B-008
 27 MAY 1982
 N. CULVERT EXIT

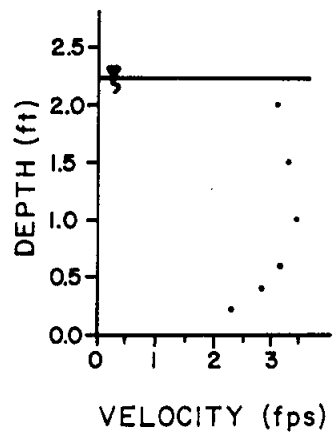
B-009
27 MAY 1982
SOUTH
CULVERT EXIT

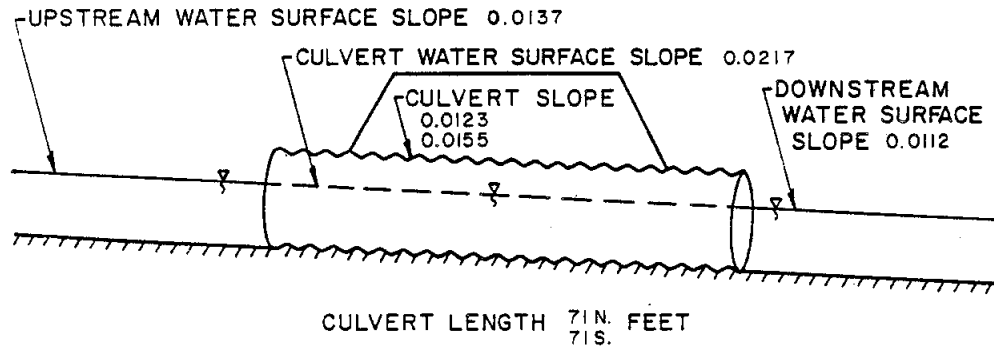
B-012
11 JUNE 1982
NORTH CULVERT EXIT

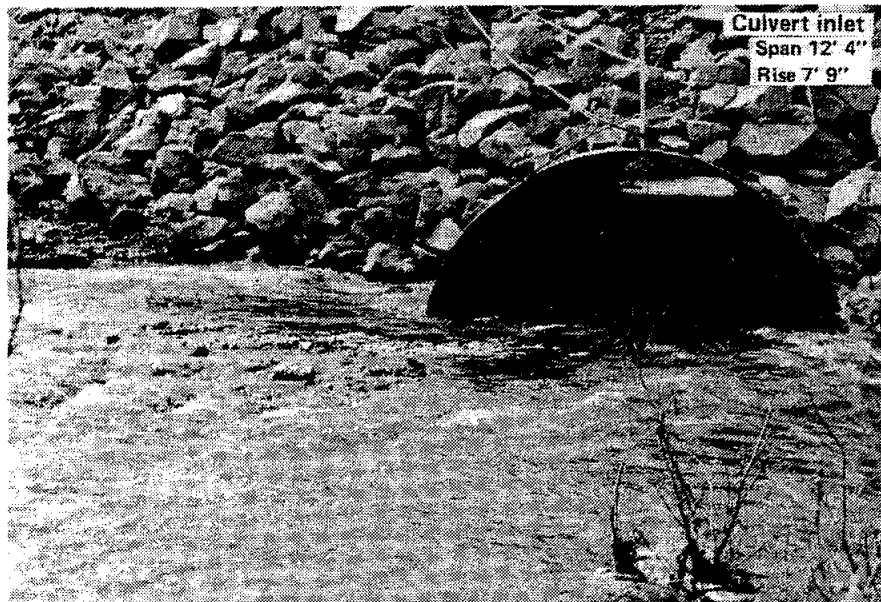
Culvert outlet

Rosie Creek was observed on June 8, 1982. The discharge at that time was 88.0 cfs, and the total water depth at the culvert outlet was 1.80 ft. The bed material was gravel up to 4 in in diameter. Small pools at both ends of the culvert were due to the barrel being misaligned with the streamflow. This also caused some erosion problems along the banks near the culvert. The watershed area was 17.7 sq mi. The water surface profiles for the stream and culvert appear in the diagram.

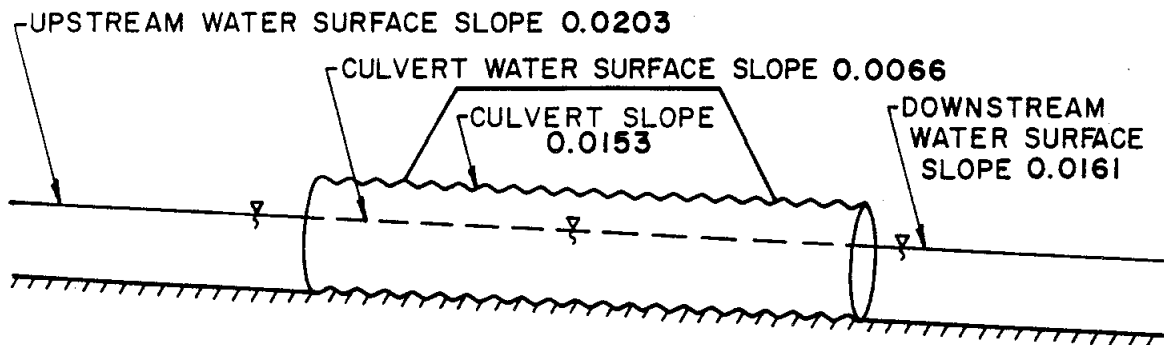
B-033
9 JUNE 1982
CULVERT EXIT

Linda Creek was first observed on June 9, 1982. The discharge through the culvert was 40.6 cfs. The surveyed slopes for this date appear in the diagram. The estimated bedload size was 4 to 6 in in diameter. A layer of cobbles and gravel was found throughout the barrel; the deposit was about 3 ft thick at the culvert outlet. No pools were observed. The water depths at the entrance to and exit from the culvert were 0.90 ft and 1.10 ft, respectively. The velocity profile was obtained with an electromagnetic flowmeter. The watershed area was 9.2 sq mi.

CULVERT LENGTH 118 FEET

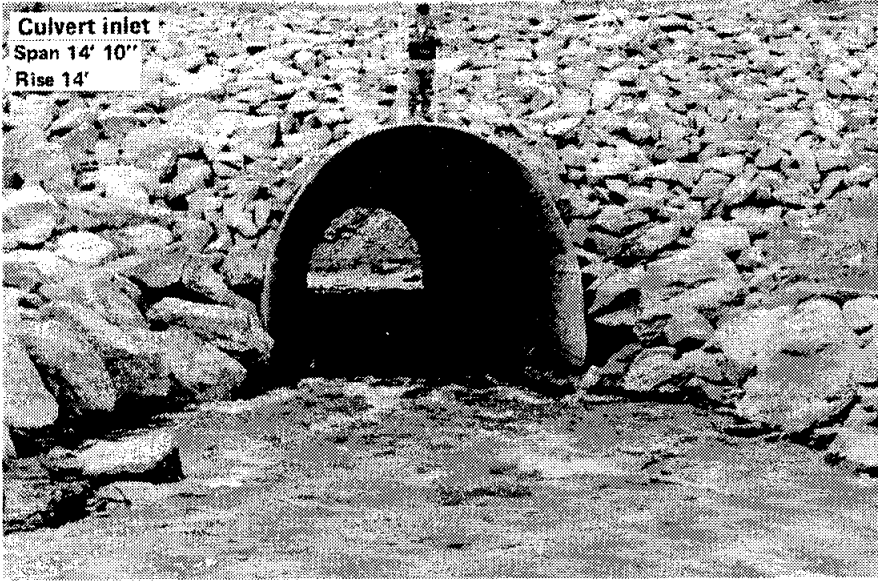
Culvert inlet
Span 14' 10"
Rise 14'

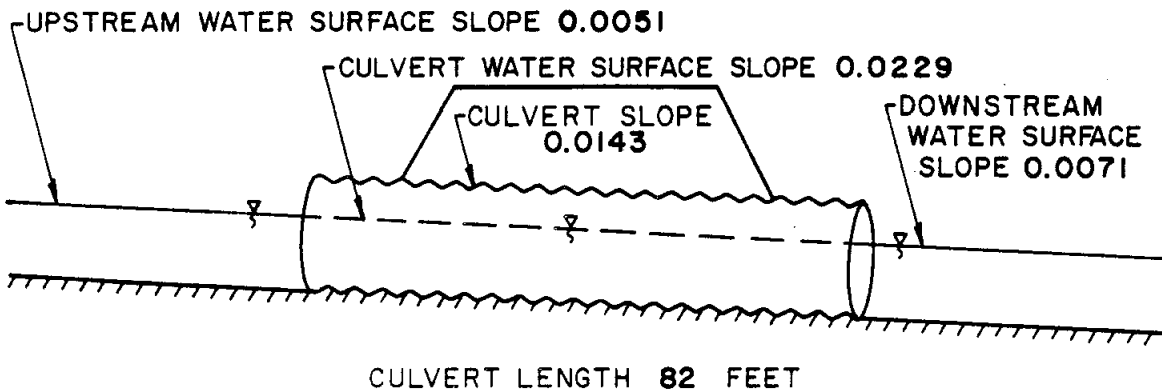
B-034
9 JUNE 1982
CULVERT ENTRANCE

This creek was observed on June 9, 1982. The total streamflow on this date was 25.3 cfs and the watershed area was 6.1 sq mi. The surveyed stream profile appears in the diagram. Sukapak Creek was flowing bank full. The water depth at the culvert inlet was 1.50 ft; at the culvert outlet the water depth was 0.90 ft. The bed material was silt. Some riprap was in the culvert entrance, otherwise the barrel was clean. No pool was noted downstream; at the culvert entrance a pool existed due to thermal degradation of the permafrost in this area.

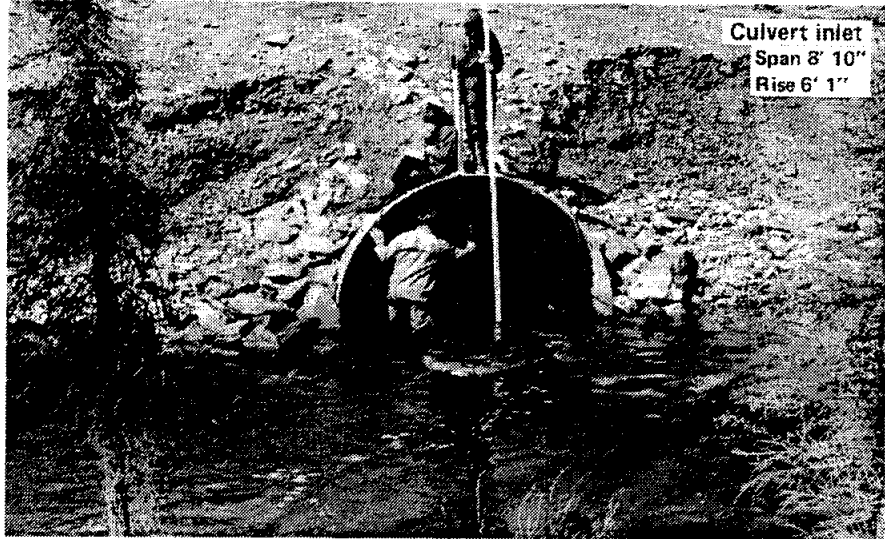
Culvert inlet
Span 8' 10"
Rise 6' 1"

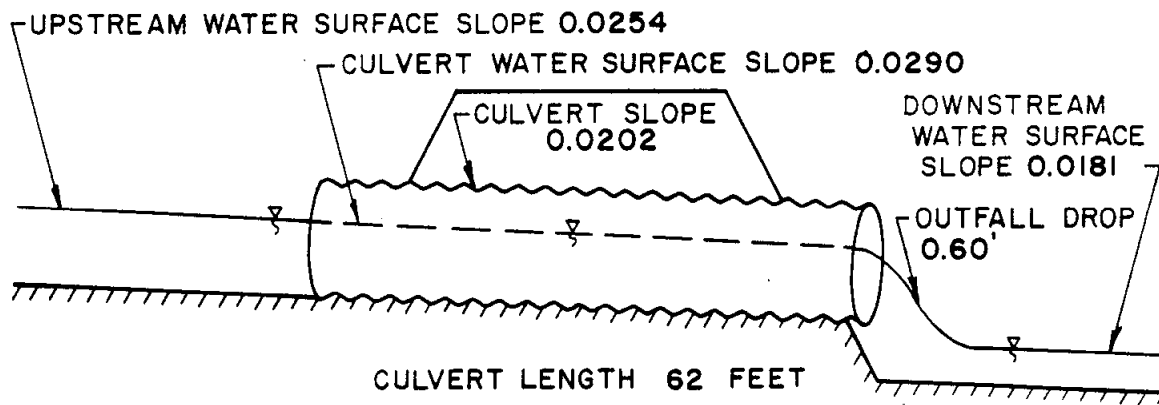
B-036
 19 JULY 1982
 CULVERT EXIT

Measurements at Brockman Creek were made on July 19, 1982. The streamflow was 10.4 cfs. The discharge measurement was poor due to the rocky shallow stream channel. The culvert inlet water depth was 0.70 ft, while the outlet water depth was 0.55 ft. The culvert barrel was clean except for some 5 to 6 in diameter rocks. At the culvert outlet a 20 ft diameter pool was noted. The stream channel at this location was rerouted when the culvert was installed. Upstream the channel was quite braided; downstream a man-made channel was cut. About 100 ft north of the main culvert was a small dry channel with no culvert installed. About 300 ft north of the main stream channel was a large dry overflow culvert and stream channel. The watershed area was 19.5 sq mi.

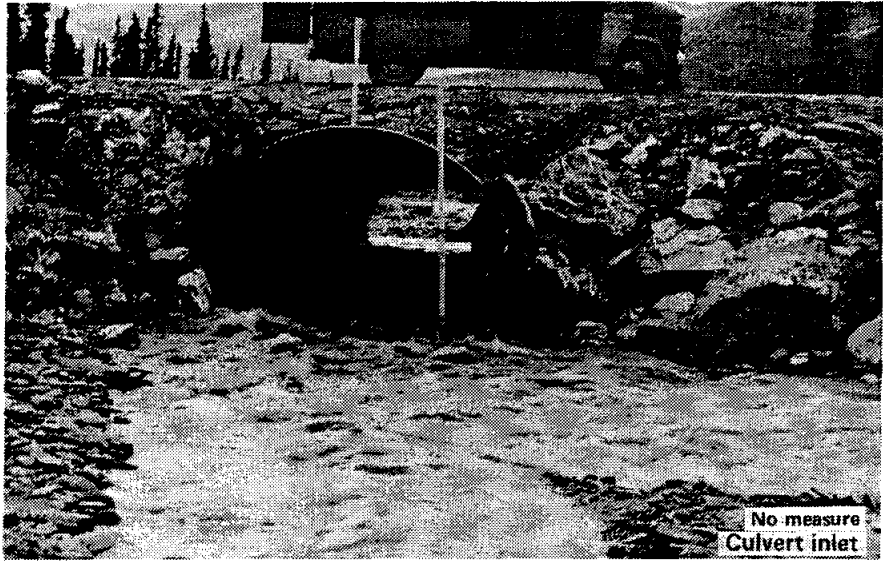
No measure
Culvert inlet

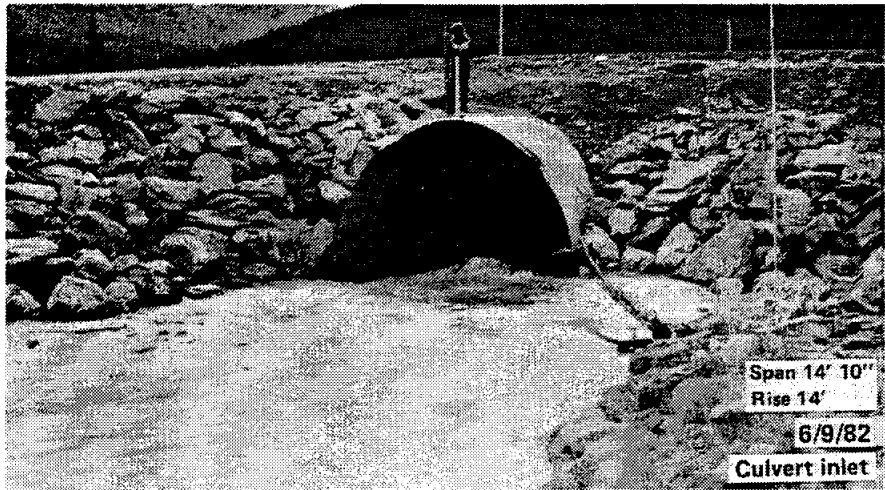
Span 14' 10"
Rise 14'
6/9/82
Culvert inlet

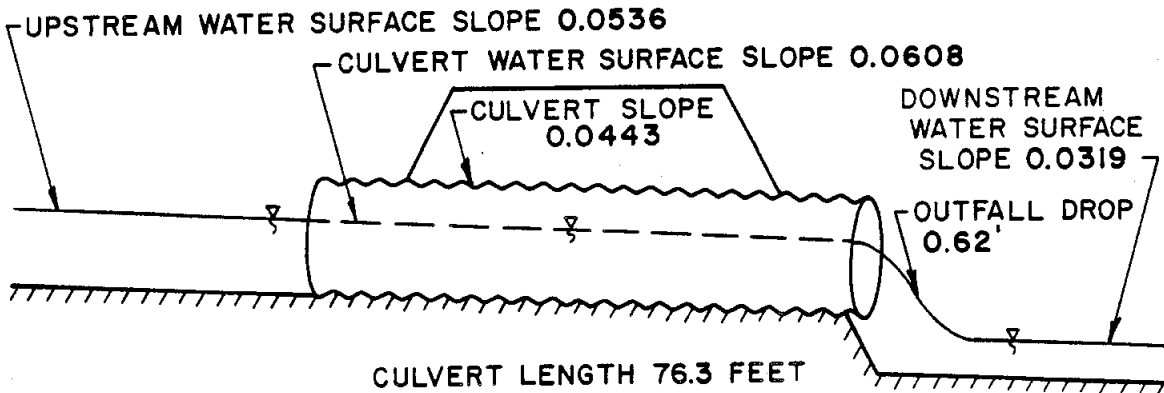
B-048
20 JULY 1982
CULVERT EXIT

Trevor Creek was first observed on June 10, 1982. The discharge (87.2 cfs) was mostly contained by the main culvert with a small amount of flow through the overflow culvert (68 ft long, 60 in in diameter). The water surface profiles for the creek and main culvert are presented in the diagram. A small turbulent pool at the culvert exit was noted with some backwater eddies. The water velocity was too high through the culvert to obtain a velocity profile. The bed material was composed of rocks up to 6 in in diameter; the culvert barrel was clean.

Two velocity profiles were obtained on July 20, 1982 at a lower flow. The outlet water depth at this time was 0.85 ft and the inlet water depth was 0.80 ft.

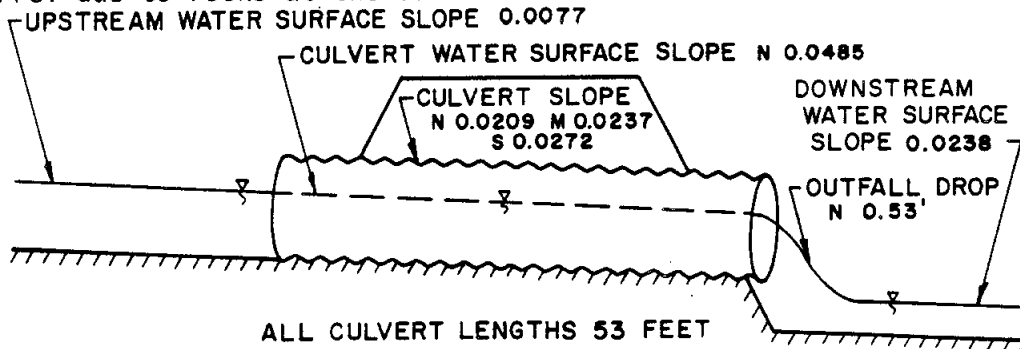
B-050
10 JUNE 1982
CULVERT EXIT

Three culverts (north, middle and south) contained the discharge at this Dalton Highway stream crossing. The flow measured 213.6 cfs on June 10, 1982. The middle culvert carried the most flow and the least flow was through the south culvert. The water depth at the north culvert outlet was 0.95 ft. All three culverts were perched: the water surface drop out of the north culvert was 0.53 ft; the drop was less in the south culvert and more in the middle culvert. Water surface profiles for the culverts and stream are shown in the diagram. The north and middle barrels were clean while the south culvert contained large rocks. Erosion was noted around the culvert inlets. Eddies between the culverts at the downstream end served as rest areas for fishes. The estimated bedload size was rocks up to 2 ft in diameter. The watershed area was 32.3 sq mi. Upstream of the culvert installation was a USGS gaging station

Culvert inlet and outlet depths were measured on July 22, 1982. The inlet depths were: north, 1.20 ft; middle, 1.50 ft; south, 0.30 ft. The outlet depths were: north, 1.00 ft; middle, 1.20 ft; south, 0.50 ft. The south culvert inlet depth was measured 5 ft inside the barrel due to rocks at the culvert entrance.

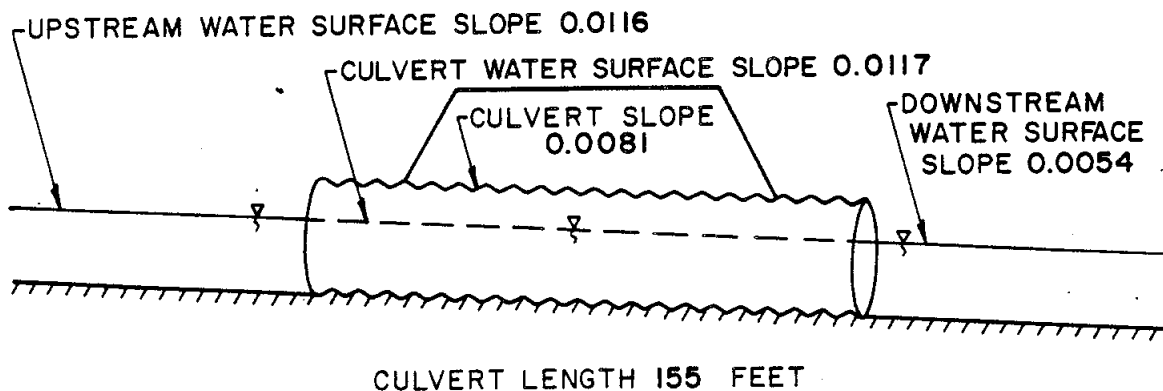
B-055
 21 JULY 1982
 10' DOWNSTREAM
 FROM CULVERT EXIT

Observations were made at Dan Creek on July 21, 1982. A discharge of 8.2 cfs was contained by one large arch culvert. The water surface profiles for the creek and culvert appear in the diagram. The water depth at the culvert inlet was 2.00 ft. The water depth was 1.20 ft at the culvert outlet. The bedload size was difficult to measure. Some 2 ft diameter rocks were in the stream channel; smaller rocks (predominantly 3 to 4 in in diameter) were also noted. The culvert barrel was clean except for some rocks (1 to 2 ft in diameter) at the inlet. Pools (30 by 30 ft) were observed at each end of the culvert. The slope of the culvert increased through the barrel. Small fry and large grayling were noted inside the culvert. The watershed area was 34.4 sq mi.

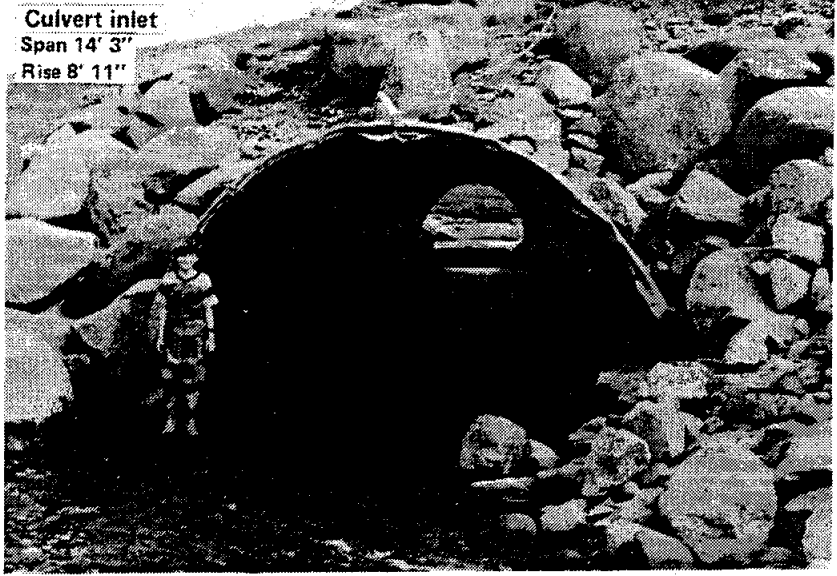
Culvert inlet
 Span 14' 3"
 Rise 8' 11"

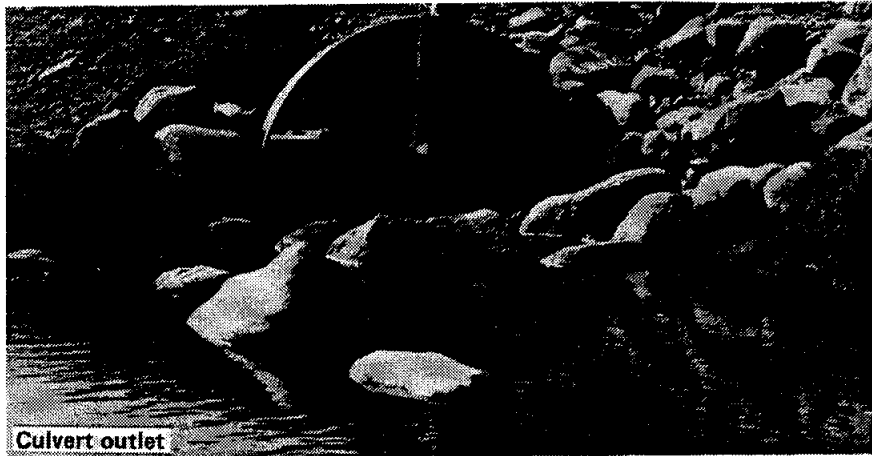
B-055
 21 JULY 1982
 100' DOWNSTREAM
 FROM CULVERT EXIT

Culvert outlet

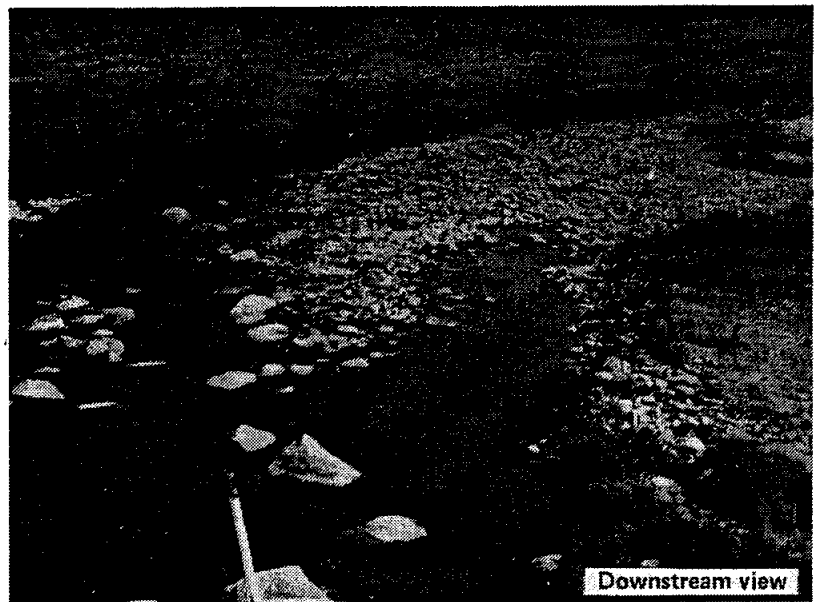
Downstream view

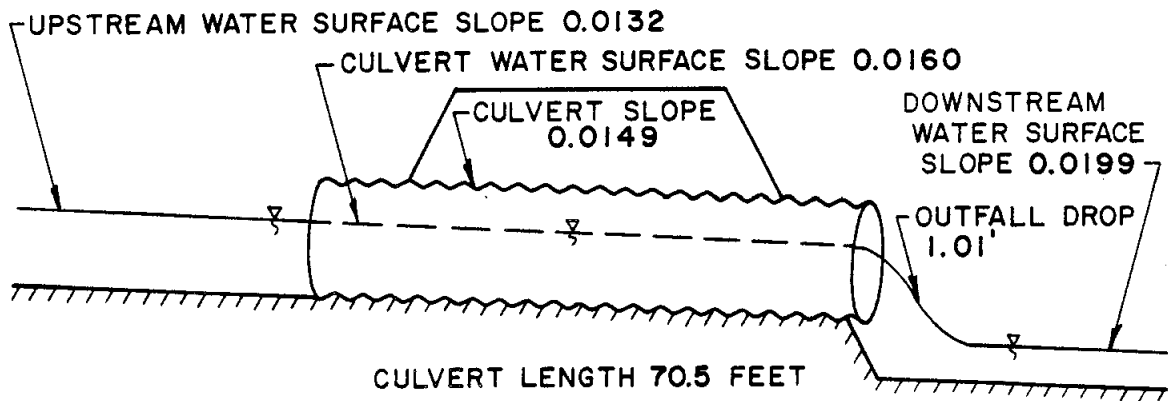
Measurements were made at this stream site on June 21, 1982. Due to rocks in the streambed, a poor discharge measurement was obtained; the streamflow was 21.9 cfs. A 25 ft diameter pool was downstream of the culvert. The downstream end of the culvert appeared to be damaged, causing perched conditions at the outlet. The water surface profile for this culvert and stream is shown in the diagram. The downstream embankment also had erosion problems. Although there were no erosion problems at the upstream end of the culvert, the barrel was not directly aligned with the streamflow. This caused the greatest water velocities at the culvert entrance. The watershed area was 2.7 sq mi.

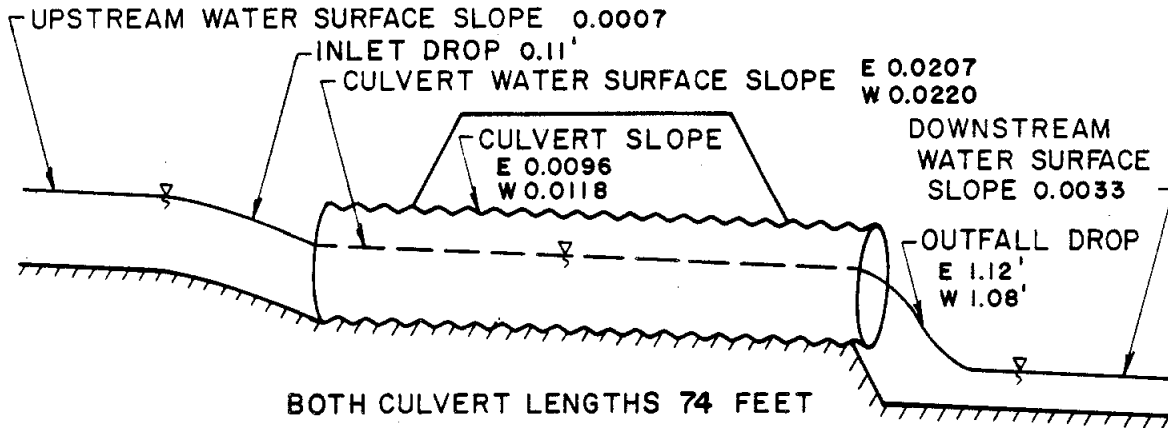
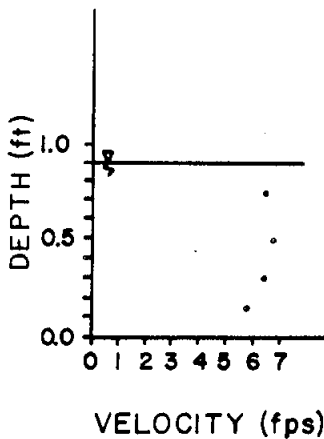
D-003
 22 JUNE 1982
 WEST CULVERT EXIT

The stream crossing at 18.5 mile Denali Highway was inspected on June 22, 1982. Two identical corrugated metal pipes carried a combined flow of 33.6 cfs. A large pool with relatively low velocities was observed upstream of the culverts. The water surface profiles for the culverts and creek are shown in the diagram. The water depth at the outlet to the west culvert was 0.90 ft. A small pool was observed at the downstream end of the culverts. No drift was observed in either barrel. The estimated bed material size was 1 to 3 in in diameter. The watershed area was 8.8 sq mi.

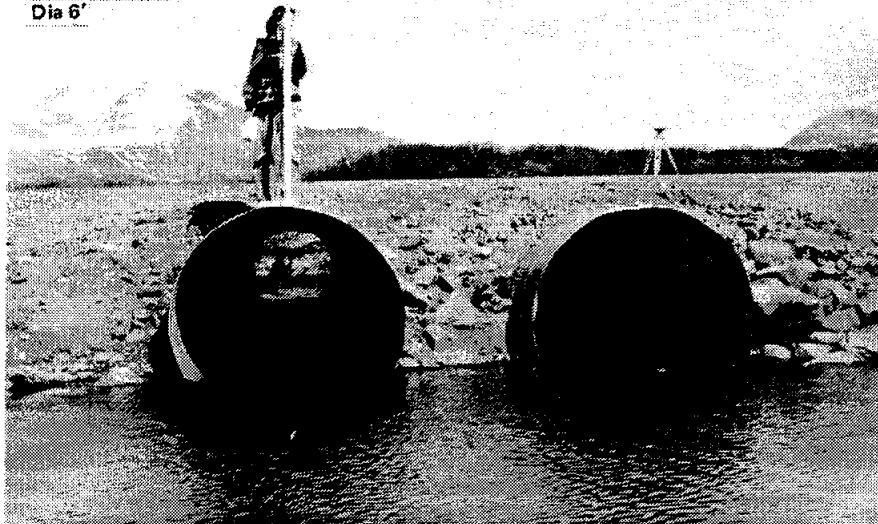
Culvert outlet

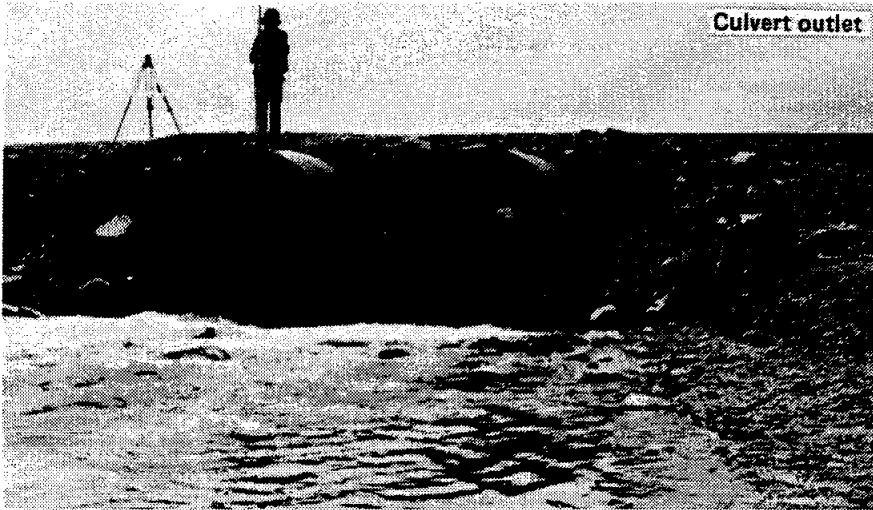
Downstream view

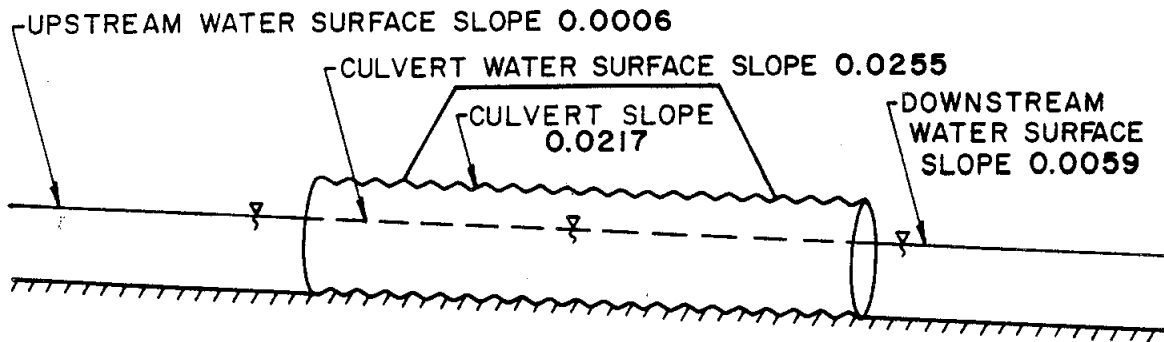
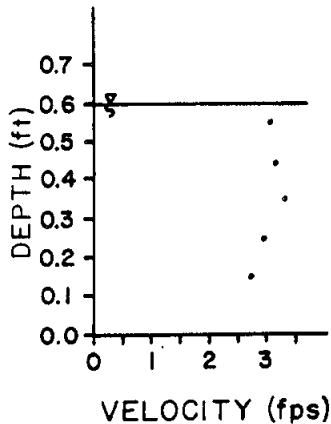
D-006
22 JUNE 1982
CULVERT EXIT

The Osar Creek Tributary was visited on June 22, 1982. A single 5 ft diameter culvert carried the discharge of 5.4 cfs. The minimum depth of flow in the culvert was 0.50 ft, while the total depth at the outlet was 0.60 ft. The surveyed slopes for this installation are presented in the diagram. Most of the water surface drop in the culvert occurred in the upper half of the culvert. There was a 30 ft diameter pool at the downstream end of the culvert; no pool was observed at the upstream end. Fish were sighted in the downstream pool. The culvert barrel was clean. The estimated bed material size ranged from fine sand (upstream of the culvert) to small gravel (downstream of the culvert). The watershed area was 8.2 sq mi.

CULVERT LENGTH 77.3 FEET

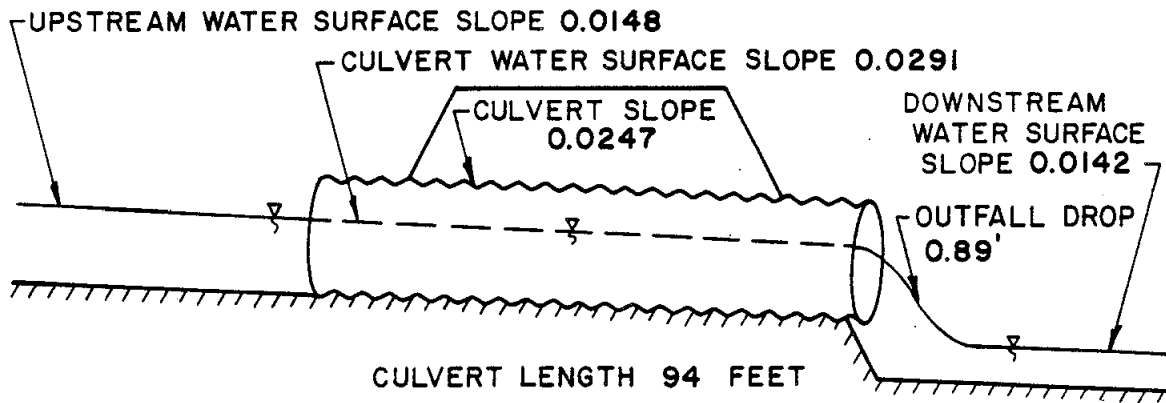
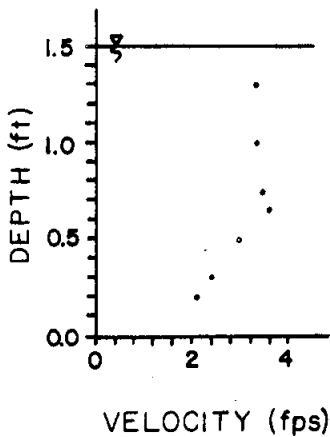
D-007
22 JUNE 1982
CULVERT ENTRANCE

Measurements were taken at Osar Creek on June 22, 1982. The flow was gaged at 26.6 cfs. The water surface profiles appears in the diagram. In a 30 ft diameter pool at the culvert outlet fish were noted. The culvert barrel contained no drift. Velocity profiles were taken at both the culvert entrance and exit; the total water depths were 1.50 and 1.10 ft, respectively. A high water mark was surveyed 1.24 ft above the present water surface level 50 ft upstream of the culvert. The watershed area was 9.1 sq mi.

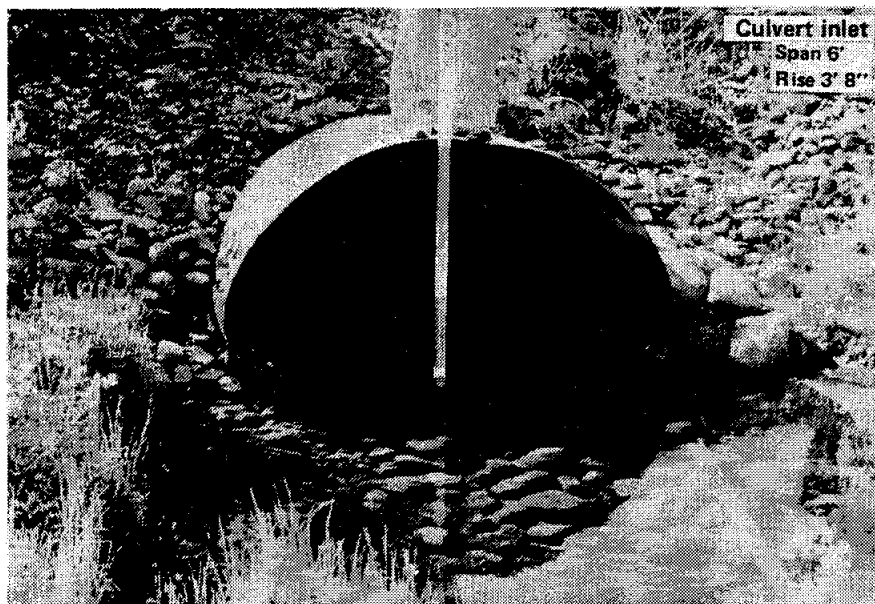
Measurements were taken at this unnamed creek site along the Denali Highway on June 23, 1982. Fine material consisting of silt and sand was the estimated bedload size. The depth of flow at the culvert inlet was 0.50 ft, and at the outlet was 0.40 ft. The barrel was clean, no drift was observed. Fish passage may be a problem when the flow declines and the water depths in the culvert decrease. No slope measurements were surveyed. The watershed boundaries were insufficiently defined so no area measurement was obtainable.

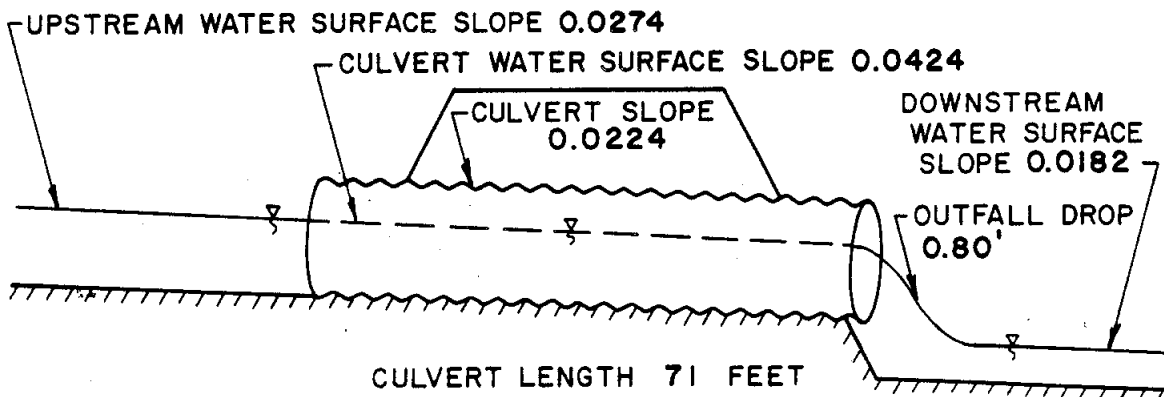
Measurements were taken at this unnamed creek along Denali Highway on June 23, 1982. A single culvert contained the 3.0 cfs flow, but the culvert size was not uniform. The diameter was 3.0 ft at the inlet and for the first 20 ft; the remainder of the culvert was 4.0 ft in diameter. Posts inside the culvert braced the crown and kept the culvert from deforming. The outlet of the culvert was broken (water depth 0.35 ft) and there was a 20 ft diameter scour pool noted at the culvert exit. Estimated bedload size was fine material and the culvert barrel was clean. The surveyed slopes for this site are shown in the diagram. The slope upstream of the culvert included a 1.54 ft drop 89 ft above the inlet. Grayling (up to 9 in long) were noted above and below the culvert, and above the upstream drop. The watershed area was 7.0 sq mi.

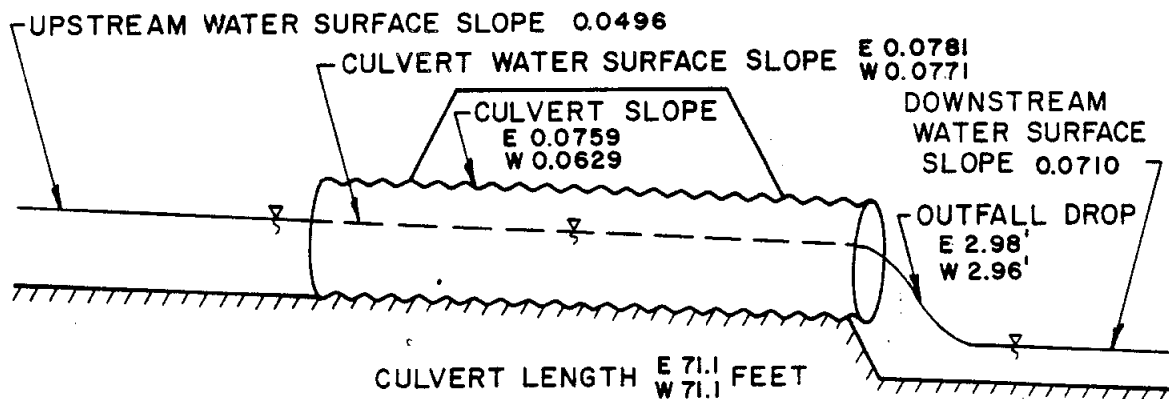
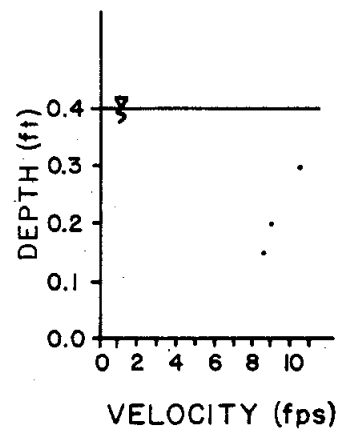
D-014
23 JUNE 1982
CULVERT EXIT

A double barrel culvert installation contained the flow at this stream site. Observations were made on June 23, 1982. Both barrels were clean, although 3 to 4 in diameter gravel was noted passing through the culverts. The stream channel was fairly shallow with large rocks in it, so no streamflow measurement was obtained. Downstream of the culvert was one main stream channel, while the stream was braided above the culvert. The surveyed slopes appear in the diagram. The upstream slope was measured along the west channel. Much of the downstream water surface drop occurred within 20 ft of the culvert exit. The outlet water depth was 0.40 ft. The watershed area was 6.2 sq mi. A high water mark was observed 1.40 ft above the existing water surface 50 ft downstream of the culverts on the east bank.

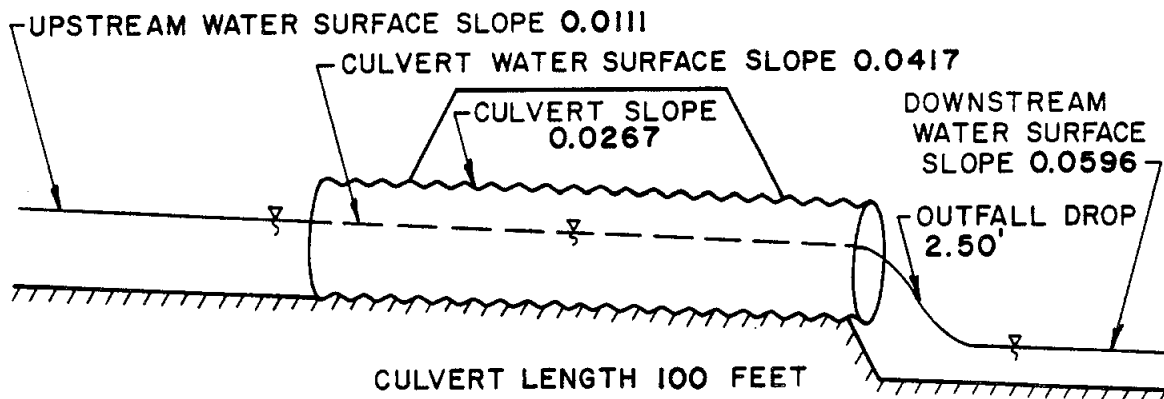
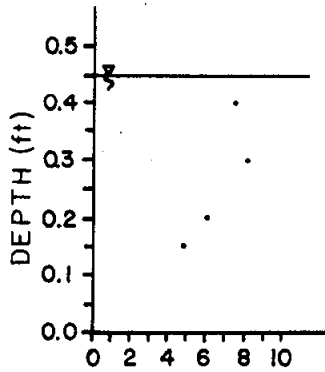
D-015
23 JUNE 1982
CULVERT EXIT

The creek at mile 89.9 on the Denali Highway was observed on June 23, 1982. The inlet and outlet depths were 2.00 and 0.45 ft, respectively. Pools were noted at both ends of the culvert: downstream was a smaller pool 12 ft in diameter and upstream was a larger 75 ft diameter pool. A high water mark was noted 1.42 ft above the existing water surface 104 ft upstream of the culvert. The bedload ranged from small to very large rocks. The water surface profile for the creek and culvert are shown in the diagram. The culvert slope changed substantially over the length of the culvert. Most of the drop through the culvert took place in a culvert section 30 to 40 ft from the culvert exit. Icing was a problem at this culvert, diverting some of the discharge to an overflow culvert to the east. The watershed area was 3.1 sq mi.

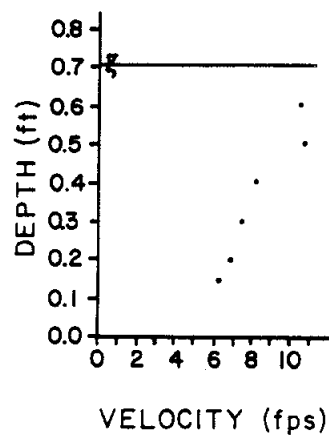
D-017
23 JUNE 1982
CULVERT EXIT

Two culverts were located at this unnamed creek crossing along the Denali Highway. The slopes measured at this site are shown in the diagram. The majority of the measured flow (9.8 cfs on June 23, 1982) passed under the highway through the smaller eastern culvert. The measured water depths at the inlet and outlet of the west culvert were 0.15 and 0.20 ft, respectively. For the east culvert the inlet water depth was 1.15 ft and the outlet water depth was 0.71 ft. Both culverts were perched at the outlet. Two small interconnected pools (each about 20 ft in diameter) were noted at the downstream end of the culverts.

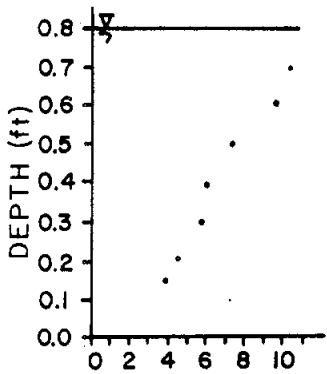
D-018
24 JUNE 1982
CULVERT EXIT

On June 24, 1982, measurements were made at Stixkwan Creek along the Denali Highway. The surveyed water surface profile is shown in the diagram. The single culvert had a middle section 10 ft in diameter. Extensions on both ends of the culvert resulted in nonuniform dimensions at the culvert entrance and exit. The span and rise at the inlet was 9.6 and 10.0 ft, respectively, while the span and rise at the outlet was 10.6 and 11.0 ft, respectively. The water depth at the inlet was 1.10 ft and the water depth at the outlet was 0.80 ft. The discharge measurement (14.6 cfs) was poor due to rocks in the stream channel. The bedload size ranged from 2 to 12 in in diameter and the barrel was clean, however, this stream carried considerable suspended sediments. Pools were present both upstream and downstream of the culvert: downstream was a 25 ft diameter pool while upstream was a long pool 100 by 20 ft. Grayling were noted in the upstream pool. The upstream slope included several drops; the downstream slope measurement was more uniform and representative of the stream gradient. The watershed area was 8.6 sq mi.
