A HYDRAULIC EVALUATION OF FISH PASSAGE THROUGH
ROADWAY CULVERTS IN ALASKA: DATA REPORT

Paula M. Wellen and Douglas L. Kane

Institute of Water Resources/Engineering Experiment Station
University of Alaska-Fairbanks
Fairbanks, AK 99701

May 1985

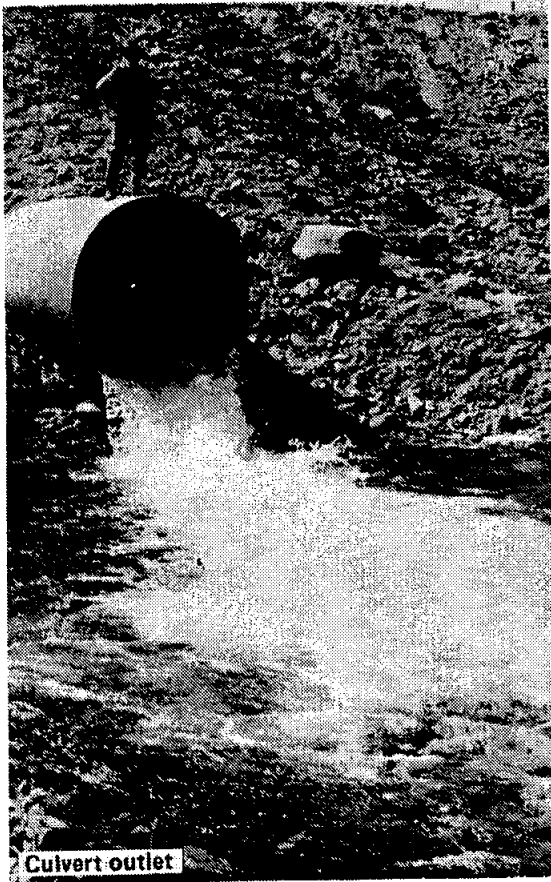
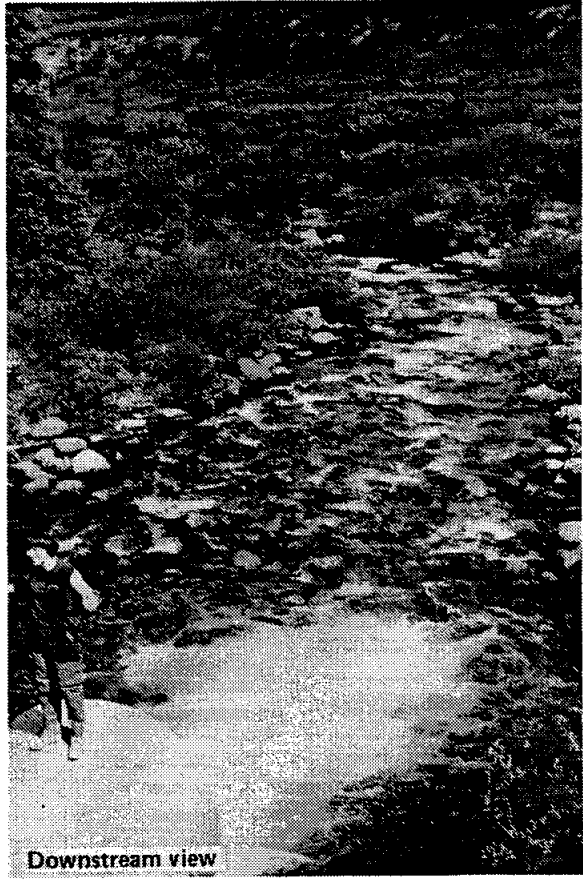
Lily Creek was observed on June 24, 1982. The inlet and outlet water depths were 1.60 and 0.95 ft, respectively. At the culvert outlet was a 25 ft diameter scour pool and the barrel was perched. A 3 ft diameter overflow culvert was dry. The bedload consisted of fine to small gravel upstream of the culvert and up to 6 in diameter gravel downstream. The culvert contained no drift although some ice remained inside the barrel. The surveyed slopes are shown in the diagram. The upstream slope was less than the downstream slope, and about 100 ft of the stream channel above the culvert was braided. The watershed area was 5.8 sq mi.

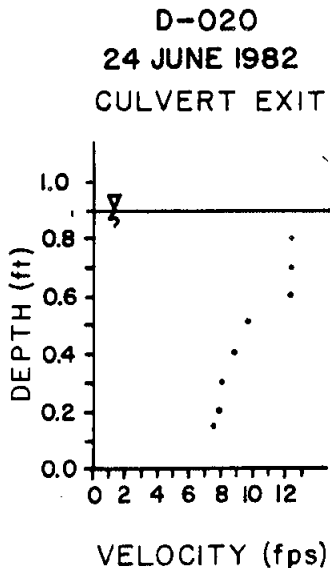
A single perched culvert contained the discharge from this high gradient stream on June 24, 1982. A discharge measurement was not obtained due to the rocky, shallow stream channel. The drop at the culvert outlet was 0.94 ft, and the water depth was 0.90 ft. The survey results are shown in the diagram. Within 15 ft of the culvert outlet, a 1.62 ft drop occurred. There was a very small turbulent scour pool at the culvert exit. The estimated bedload size was very large cobbles. The culvert was clean, although the barrel was about half full of ice; the ice was no obstruction to the flow. Ice was also present upstream of the culvert and had damaged the entrance. The water depth at the culvert inlet was 1.35 ft. The watershed area was 1.75 sq mi.

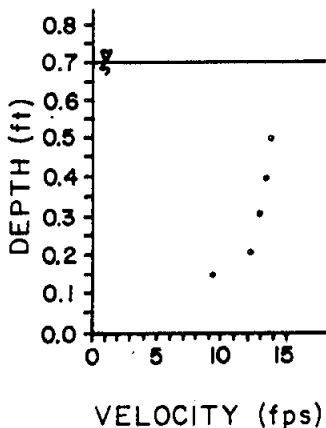
D-021
23 JUNE 1982
CULVERT EXIT

The unnamed stream at this location was observed on June 23, 1982. The water depths at the culvert inlet and outlet were 1.00 and 0.70 ft, respectively. The estimated bedload size was large cobbles; the culvert barrel was clean. Because of the large cobbles and shallow water depths, no streamflow measurement was taken. The water surface dropped 3.59 ft within 10 ft of the culvert exit. The watershed area was 2.65 sq mi.

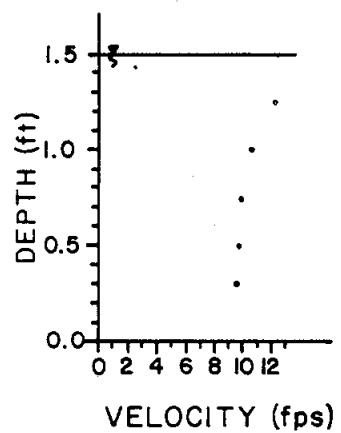
D-022
24 JUNE 1982
CULVERT EXIT

Measurements at Edmonds Creek were taken on June 24, 1982. No flow measurement was obtained due to the large cobbles in the streambed and relatively shallow water depth. The results of the surveying are shown in the diagram. The culvert barrel was clean, but slightly broken at the downstream end. The channel below the culvert contained debris and was ill defined; a new channel was in the process of being cut. The estimated bed-load size was large cobbles. Culvert inlet and outlet water depths were 1.80 and 1.50 ft, respectively. A high water mark was surveyed 1.24 ft above the existing water surface 30 ft upstream from the culvert. The watershed area was 7.5 sq mi.

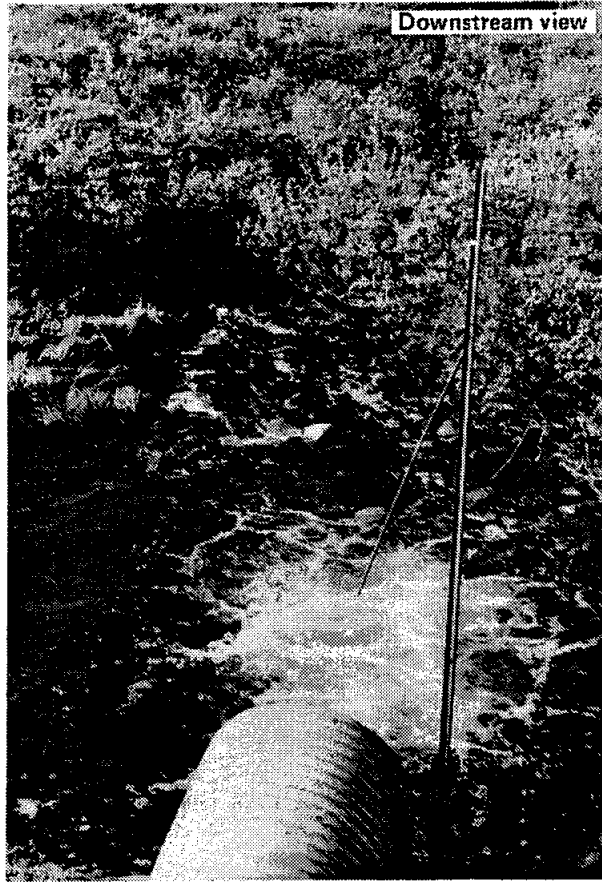
D-023
24 JUNE 1982
CULVERT EXIT

Measurements were taken on this unnamed creek on June 24, 1982. The water depth at the culvert exit was 0.75 ft and the water surface drop was 0.93 ft out of the culvert to the downstream pool. The downstream pool was about 10 ft in diameter, and the upstream pool was 100 by 150 ft. Above the upstream pool was a beaver dam and pond. In view of the flat water surface slope no upstream slope measurement was taken. The other slope measurements appear in the diagram. The culvert barrel was clean except for some debris tangled in the thaw pipe; the estimated bedload size was very fine material to small gravel. Small 3 inch fish (grayling?) were observed in the upstream pool. The watershed area was 1.35 sq mi.

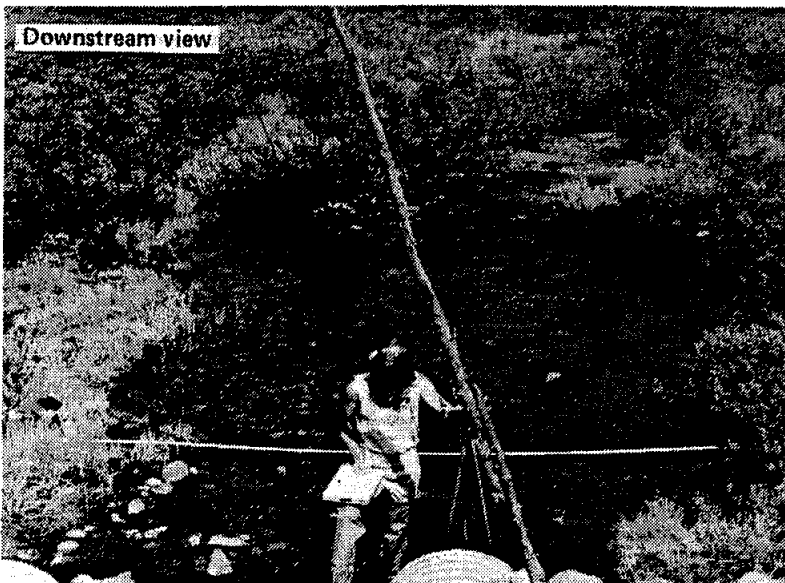
D-024
 25 JUNE 1982
 CULVERT EXIT

The flow was 4.0 cfs at this unnamed creek on June 25, 1982. The water surface profile for the creek and culvert is shown in the diagram. The water depth at the culvert outlet was 0.80 ft. The estimated bedload was fine material, and the culvert barrel was clean. Pools were observed at both ends of the culvert: upstream was a pool about 15 ft long; downstream was a shallow pool 15 ft in diameter. Four inch grayling (?) were observed in the upstream pool. The culvert barrel was broken and pushed upwards at the entrance. The watershed boundaries were insufficiently defined to obtain an accurate area measurement.

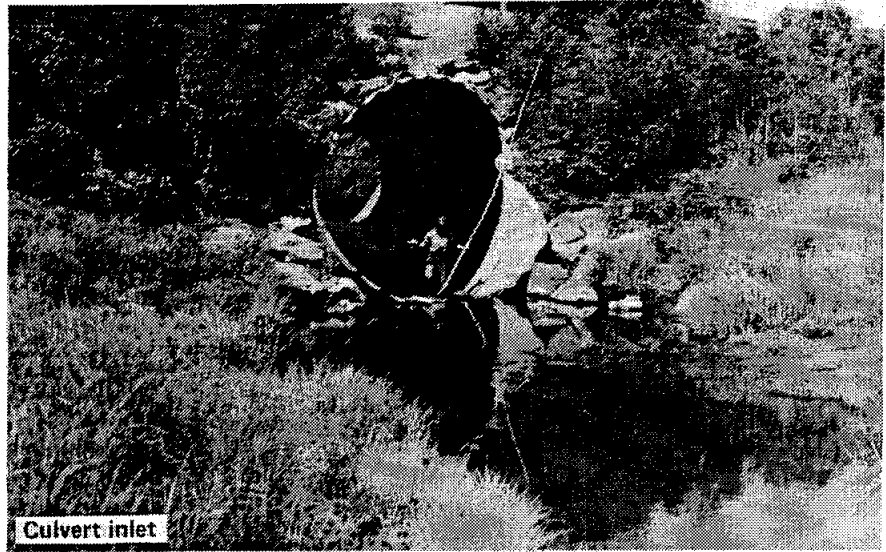
Culvert inlet

Observations were first made at Dome Creek on June 30, 1982. The discharge through the culvert at this time was 3.8 cfs. The surveyed slopes for the stream and culvert are shown in the diagram. Upstream of the culvert was a pool 10 ft wide and 20 ft long. The barrel was bent upwards at the entrance so the water depth just outside of the barrel was 1.40 ft and the water depth just inside of the culvert was 0.35 ft. The barrel was clean except for some large pieces of riprap in the first 15 ft of the culvert. The culvert outlet was perched and the water depth was 0.50 ft. No pool was observed downstream. The bedload size was estimated as fine sand and silt. A 2 ft diameter overflow culvert located 400 ft to the north was dry. The watershed area was 11.2 sq mi.

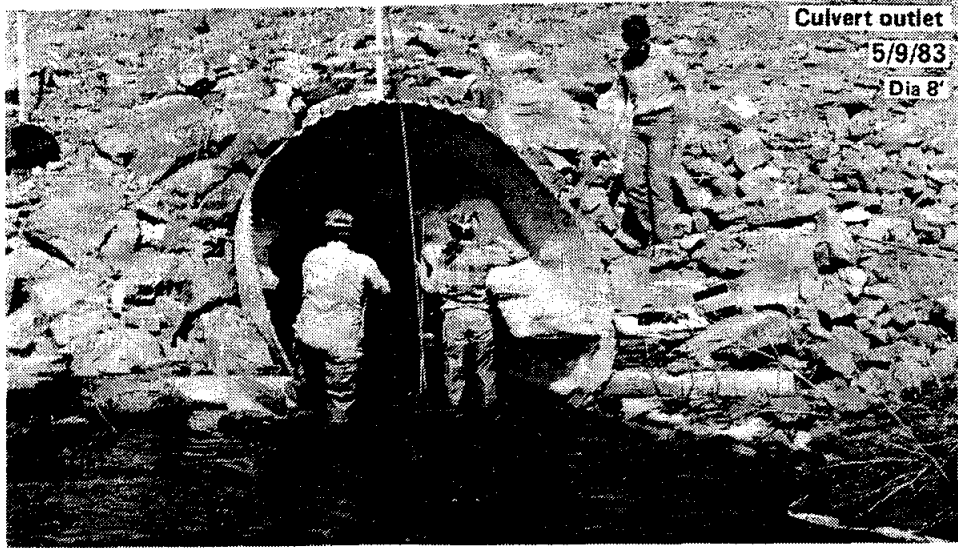
Culvert outlet

A higher flow was observed the following year at Cushman Creek on May 9, although no discharge measurement was taken. Pictures show the icing conditions at this location on May 9 and May 26, 1983. The flow receded to 2.8 cfs by May 26. The inlet depth was 0.40 ft and the outlet depth was 0.45 ft.

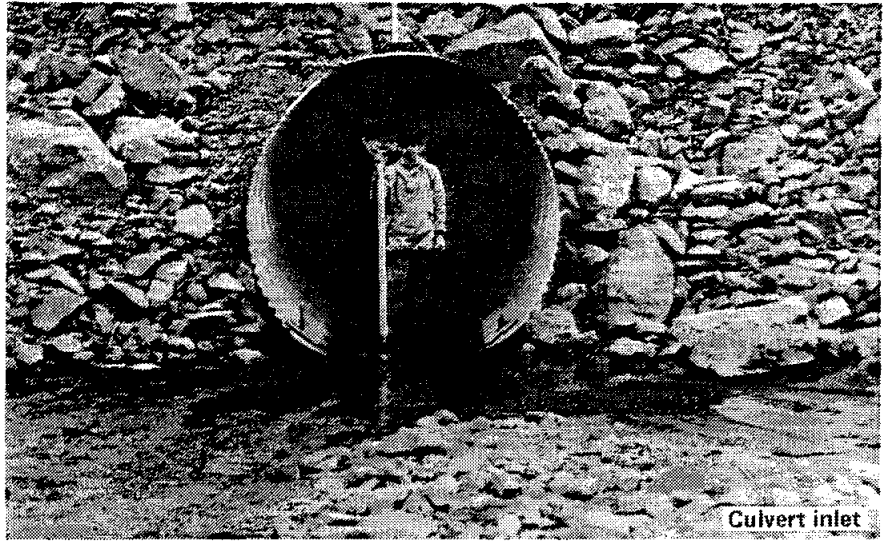
Culvert inlet

Measurements were first taken at Globe Creek on July 1, 1982. The observed discharge was 1.5 cfs and the surveyed slopes are shown in the diagram. The estimated bedload was sand and silt. The culvert barrel contained some small gravel (1 to 2 in in diameter) and rocks (up to 4 in in diameter). Some small breaks in the culvert slope occurred where barrel sections were joined together. The water depth at the culvert outlet was 0.35 ft. The stream made a 90° bend at the culvert exit. The watershed area was 13.6 sq mi.

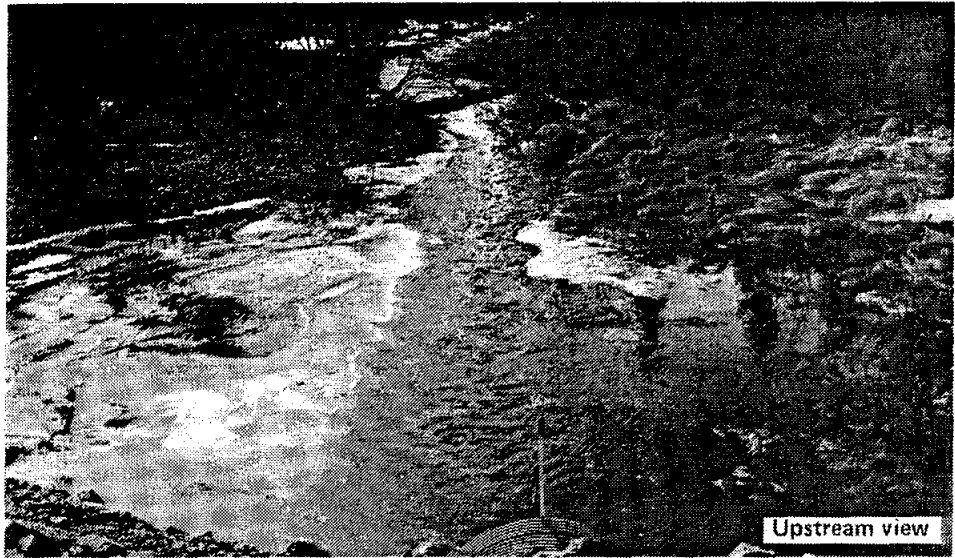
Upstream view

Measurements were taken a second time at Globe Creek on May 9, 1983. The measured flow was 15.6 cfs. The survey results of the water surface profile are shown in the diagram. Ice in the culvert acted like a weir: there was a large pool at the culvert inlet and an ice spillway at the culvert outlet. After exiting from the culvert, the water flowed at a 90° angle from the culvert.

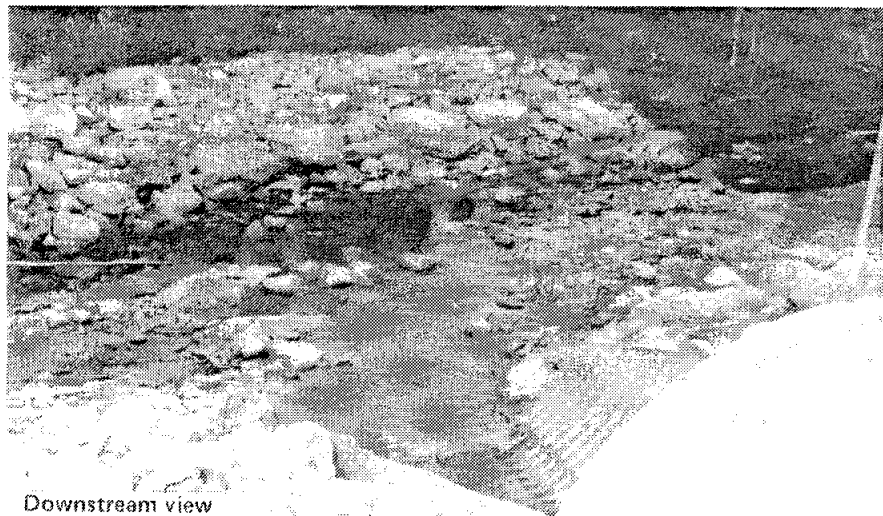
E-004
1 JULY 1982
CULVERT EXIT

This creek was visited on July 1, 1982 and the total flow was 0.6 cfs. The water depths at the entrance and exit of the main (south) culvert were 0.30 and 0.25 ft, respectively. At this flow, no pools were observed. The culvert barrel was mostly clean although a few rocks up to 9 in in diameter were in the barrel. The stream made a 90° bend upon exiting from the culvert; riprap was placed to induce this bend. The water surface profiles for the creek and main (south) culvert are shown in the diagram. There was a beaver dam 148 ft upstream from the culvert that produced a 2.8 ft water surface drop. The upstream slope was measured below this drop. At this flow, there was no well defined channel downstream of the culvert. The creek flowed through the trees, blocking possible fish passage. An overflow culvert to the north also contained some flow. The measured slopes for this culvert were: culvert crown, 0.0039; culvert water, 0.0053; and the drop at the outlet was 2.21 ft. The watershed area was 28.0 sq mi.

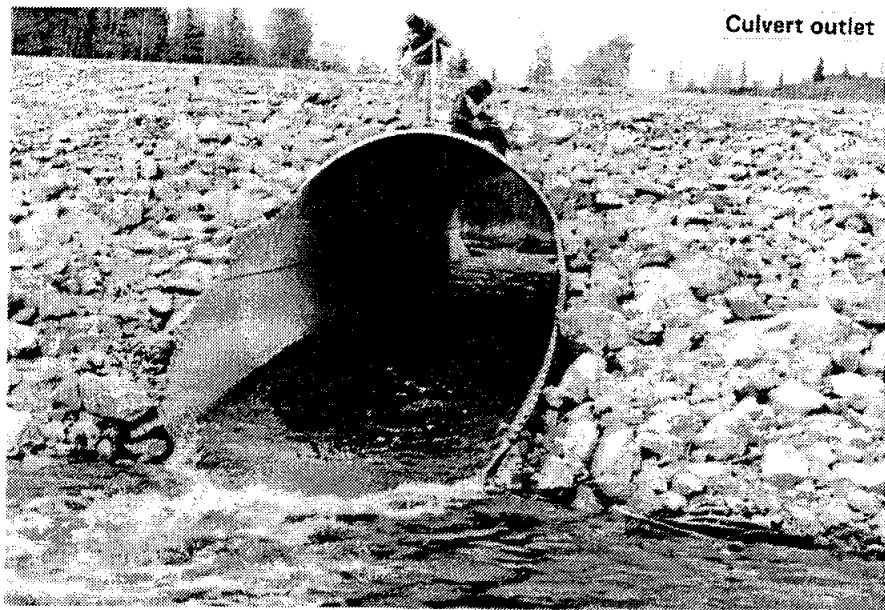
Culvert outlet

Higher flow conditions were encountered at this site on June 3, 1982. The depth of flow in the main culvert was about 2.5 ft. The overflow culvert (7 ft diameter by 182 ft long) had an outlet water depth of 2.6 ft. High flow conditions were due to a recent rainfall event.

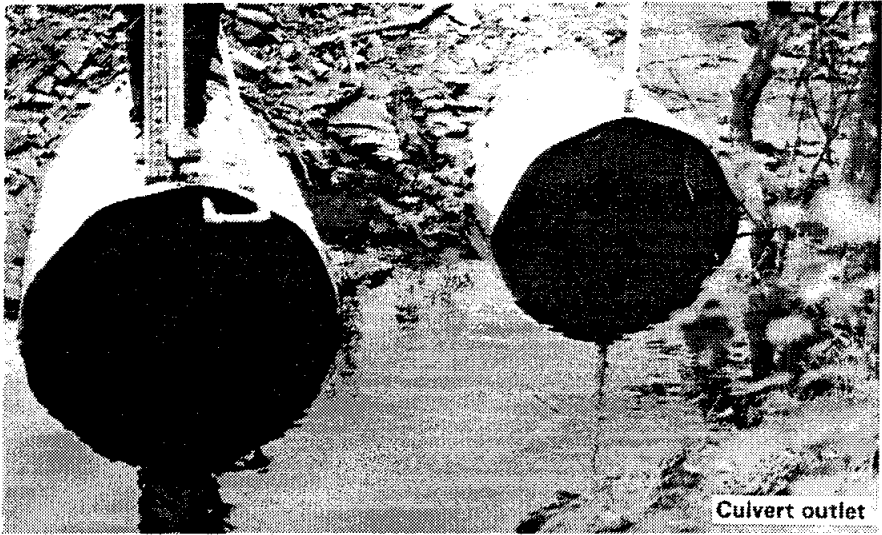
Culvert outlet

This unnamed creek was observed on July 1, 1982. The measured discharge was 0.65 cfs and was contained by two identical culverts. Inlet depths for the north and south culverts were 0.25 and 0.10 ft, respectively. The outlet depth was 1.00 ft for both culverts. Culvert slopes were measured (see diagram), however, there was too much vegetation to obtain the up and downstream slopes. The bedload was silt; thick deposits of fine grained material were observed at the culvert entrances.

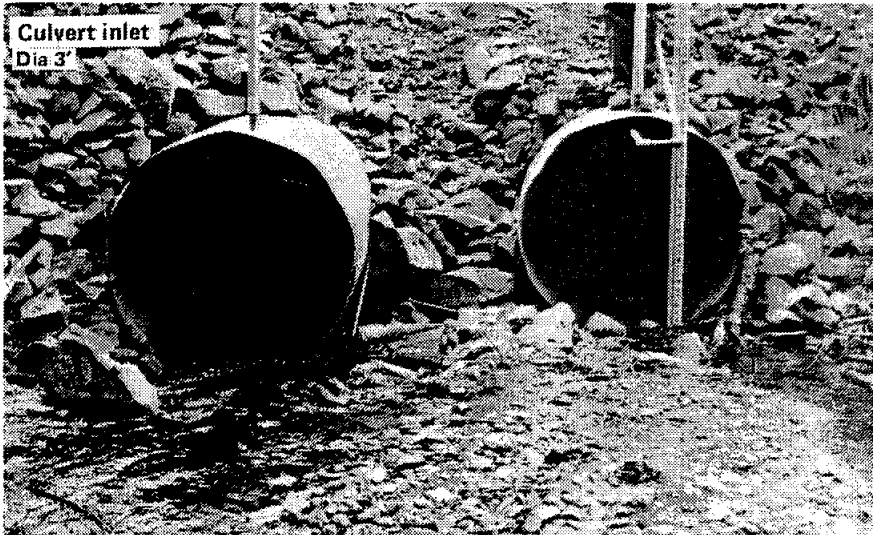
Culvert inlet
Dia 3'

High flows were observed during a visit to this site on June 2, 1982: one of the culverts was 3/4 full of silt and the other culvert was flowing almost full. The watershed area was 4.0 sq mi.

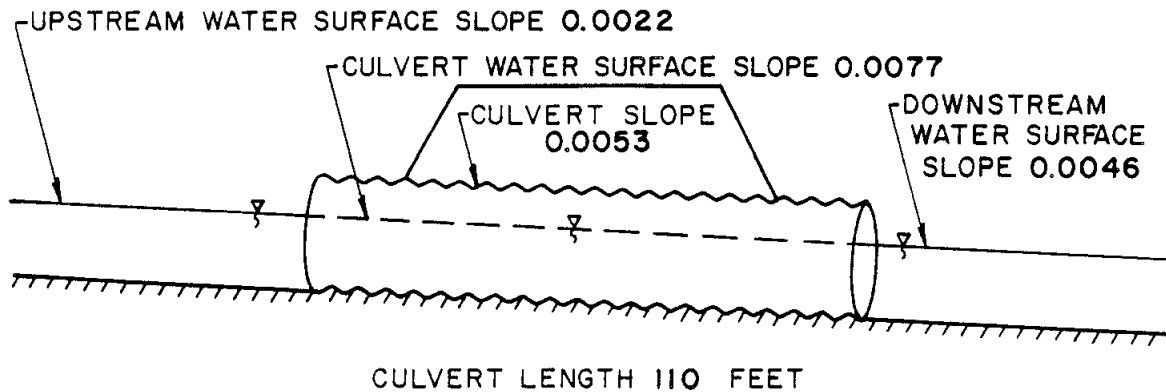
E-007
3 JUNE 1982
CULVERT ENTRANCE

Bridge Creek was observed on June 3, 1982. The measured flow was 56.8 cfs from a watershed area of 8.2 sq mi. This was a relatively high flow due to a recent precipitation event. The water surface profiles for this creek and culvert are shown in the diagram. The depth of flow at the culvert entrance was 2.20 ft and at the culvert exit was 2.80 ft. The outlet water velocities were lower than the inlet water velocities. No drift was noted in the culvert barrel. A 30 by 50 ft pool was located at the culvert exit; the stream left this pool at a 90° angle from the flow through the culvert. Upstream of the culvert was a small pool that only existed at higher flows. The velocity profile at the culvert entrance was taken with an electromagnetic flowmeter.

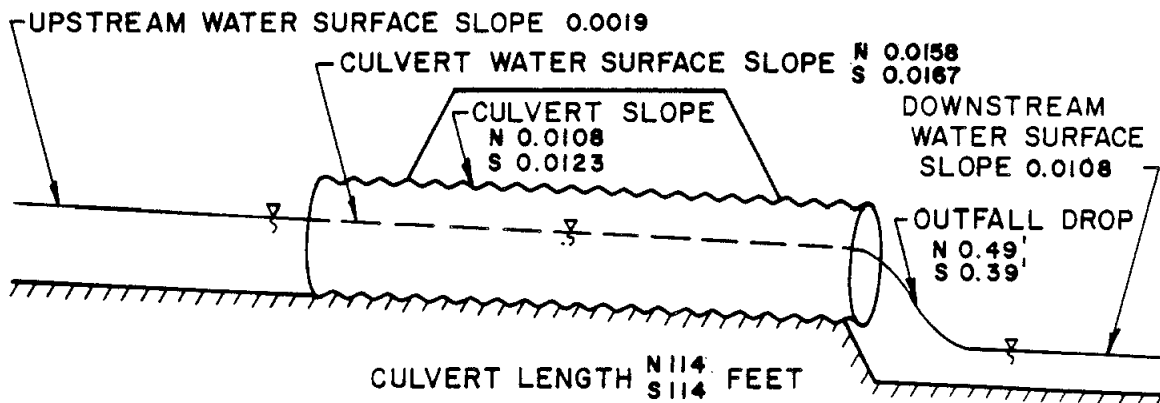
E-008A
1 JULY 1982
SOUTH CULVERT EXIT

The flow in Livengood Creek Slough was 30.7 cfs on July 1, 1982. Two identical circular culverts contained the flow; an overflow culvert was dry. The surveyed profiles for the culverts and stream are shown in the diagram. A high water mark was surveyed on the north bank above the inlet, 4.59 ft above the water surface. Both main culvert barrels were clean. The estimated bedload was silt and fine grained material. A 25 ft diameter pool was located just downstream of the culverts; no pool was noted upstream. The culverts were perched at the downstream end, and the water depth at the outlet of the south culvert was 0.65 ft. The watershed boundaries were insufficiently defined, therefore, no watershed area was obtained.

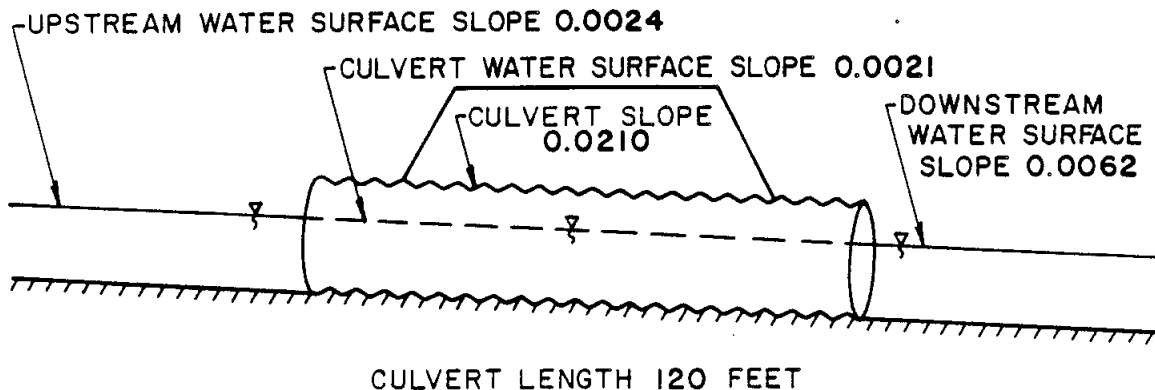
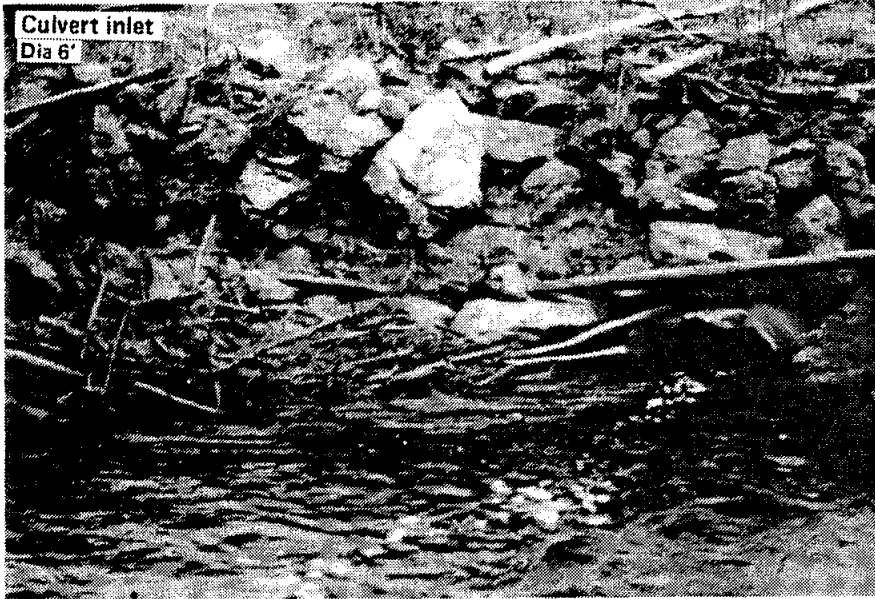
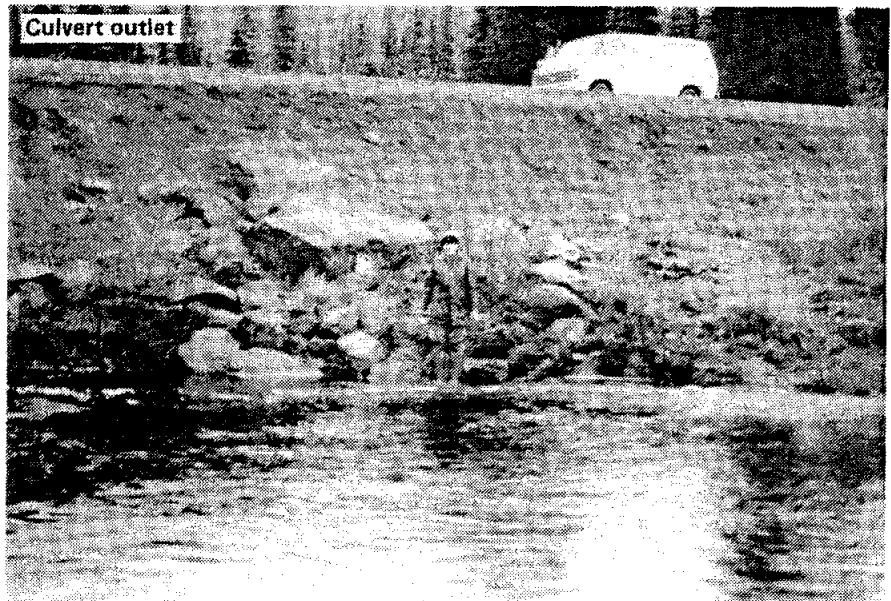
The flow in Lost Creek (58.5 cfs) was contained by two culverts when visited on June 2, 1982. The south culvert was blocked at the inlet. The north culvert contained debris and the inlet was damaged; the outlet was totally submerged. The water depth at the north culvert inlet was 4.5 ft; the water velocity was not inordinately high. Slopes for the north culvert are shown in the diagram. Four overflow culverts were dry or contained standing water. Mud and organic matter on trees 6 ft above the present water surface indicated higher water levels. Large gravel was observed in the streambed. A 50 by 30 ft pool was located at the culvert outlet and a beaver dam was situated 105 ft downstream of the highway. The drop through the beaver dam was 0.80 ft and was included in the downstream slope measurement. The watershed area was 54.9 sq mi.

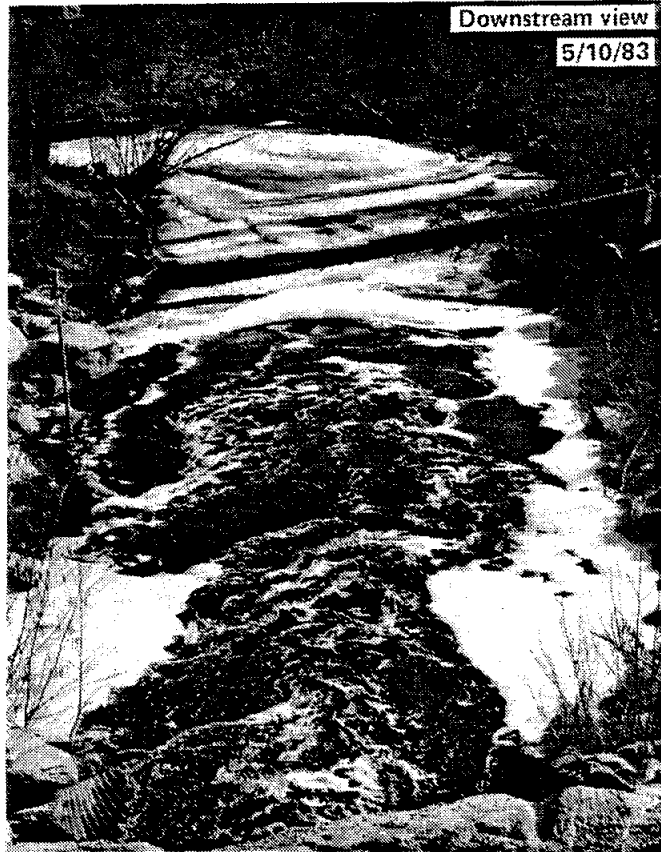
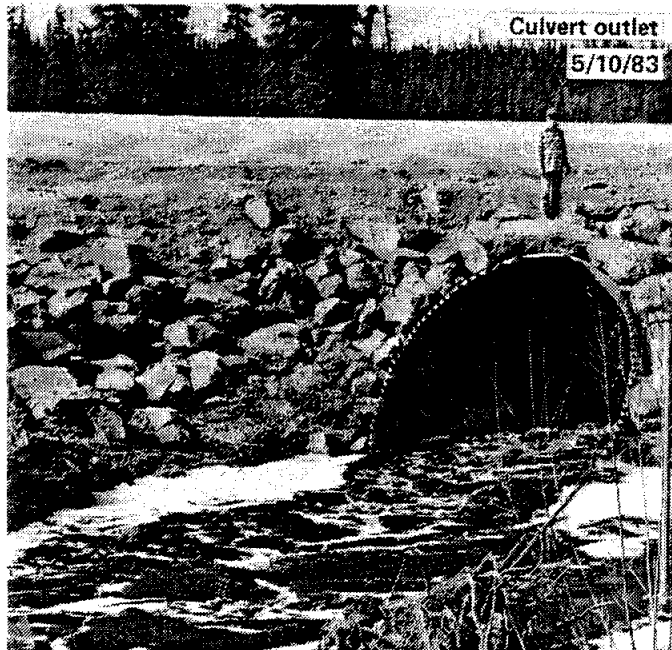
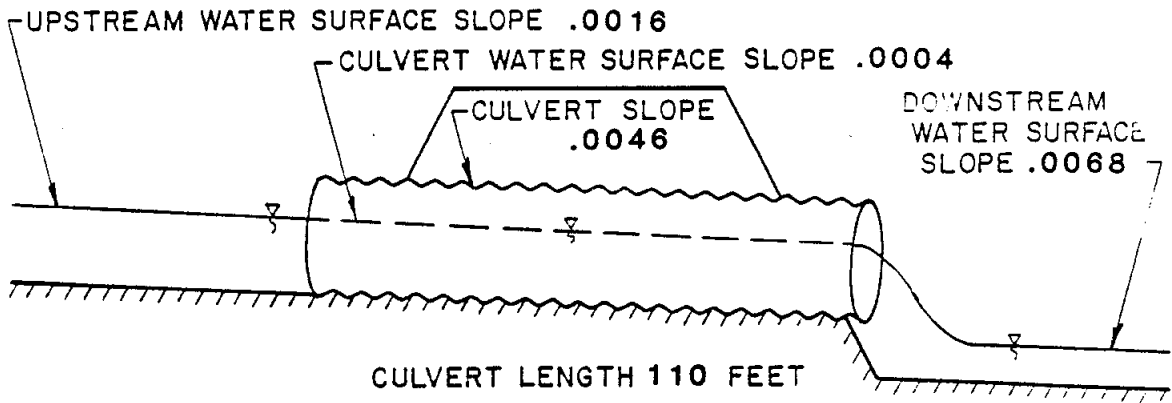
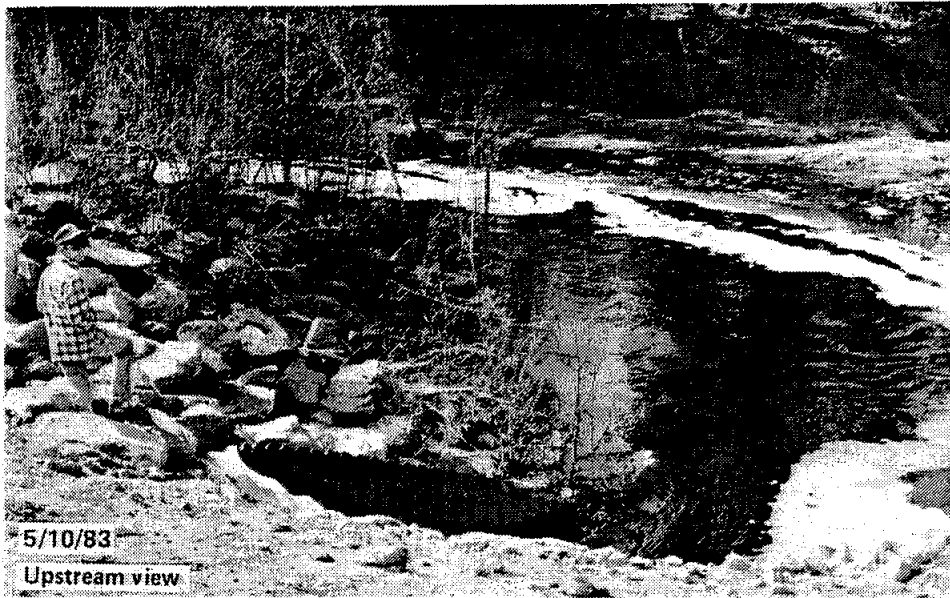
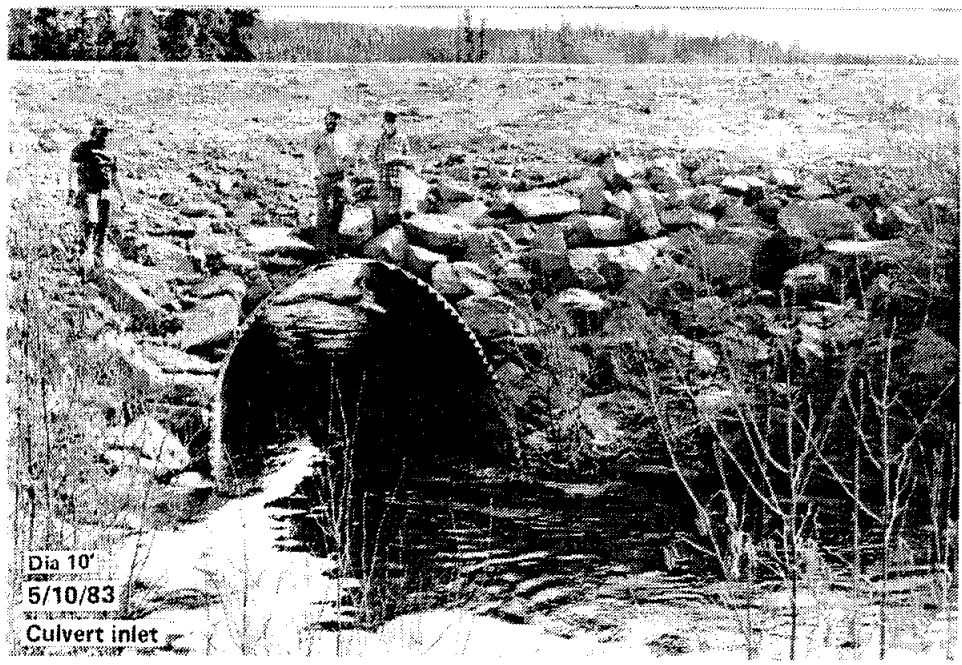
Considerable anchor ice was in the streambed at this time, which may have accounted for the unusually high water surface slope through the culvert. The photos on the following pages were taken on May 10, 1983.

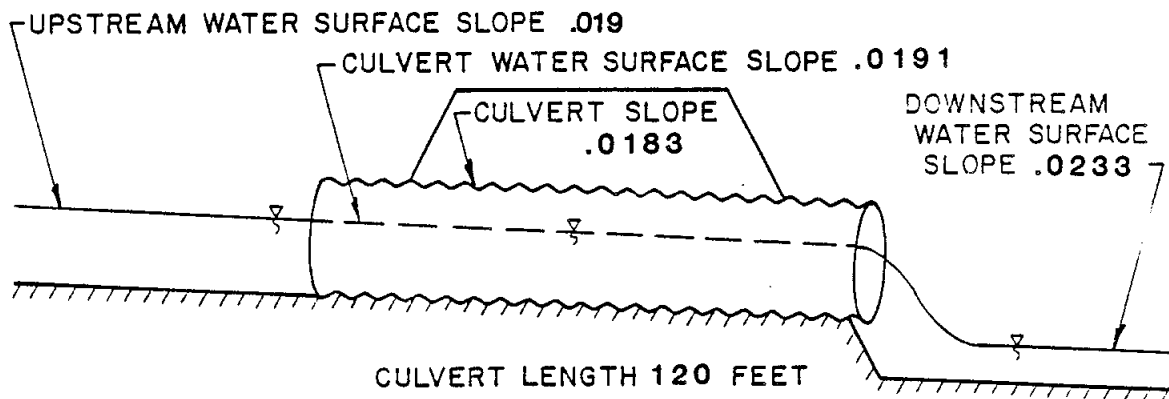
Culvert inlet

A single corrugated metal pipe culvert contained the flow (34.9 cfs) from this creek on June 2, 1982. Slopes were measured on this date and are shown on the diagram. The total water depth at the culvert inlet was 2.10 ft. The bed material was rocks up to large cobbles; a very small amount of sediment was deposited at the barrel entrance. There was a large amount of suspended sediment in the stream. A small pool, 30 by 10 ft, was noted at the downstream end of the culvert. This pool was due mainly to the culvert not being aligned with the streamflow; the stream left the pool 90° from the direction of flow through the culvert. The culvert slope was not uniform throughout the length of the barrel; the slope decreased toward the downstream end. This resulted in lower outlet velocities. The watershed area was 4.0 sq mi.

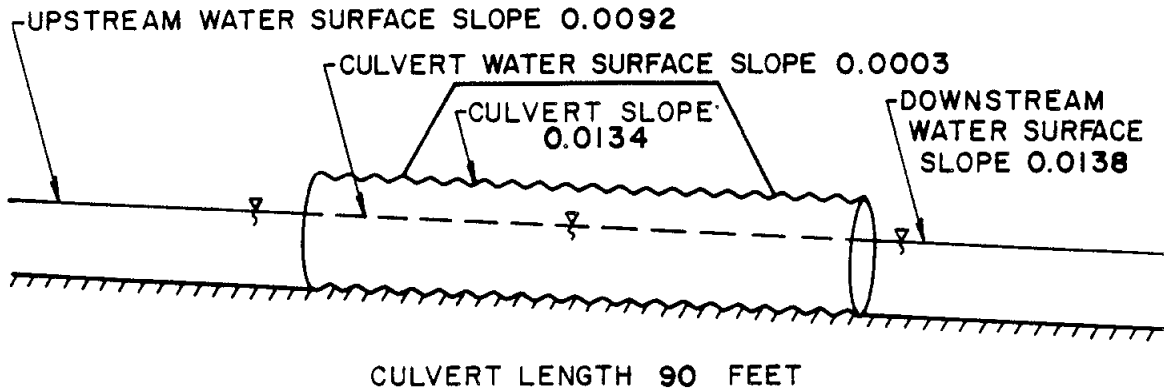
E-012
3 JUNE 1982
CULVERT ENTRANCE

The flow in Hot Cat Creek was 42.9 cfs on June 3, 1982. This flow was higher than normal due to a rainfall event; the water surface profile is presented in the diagram. The culvert inlet depth at this discharge was 3.10 ft, while the outlet depth was about 5 ft. A back-water pool downstream of the culvert was 25 ft long by 10 ft wide. The culvert barrel was clean, although fine sediment was being transported at this flow. Downstream of the culvert, the water had topped the channel banks and flowed through trees and bushes. The watershed area above the culvert was 11.0 sq mi.

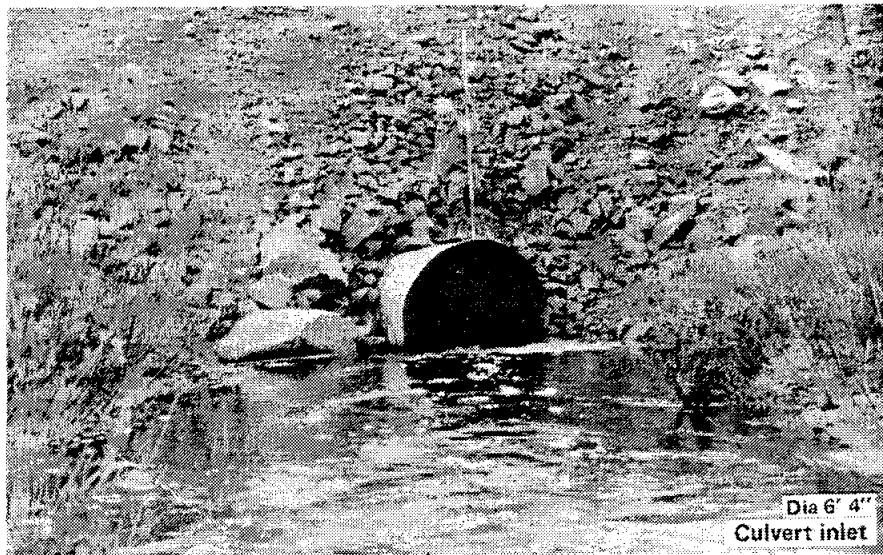
Dia 6' 4"
Culvert inlet

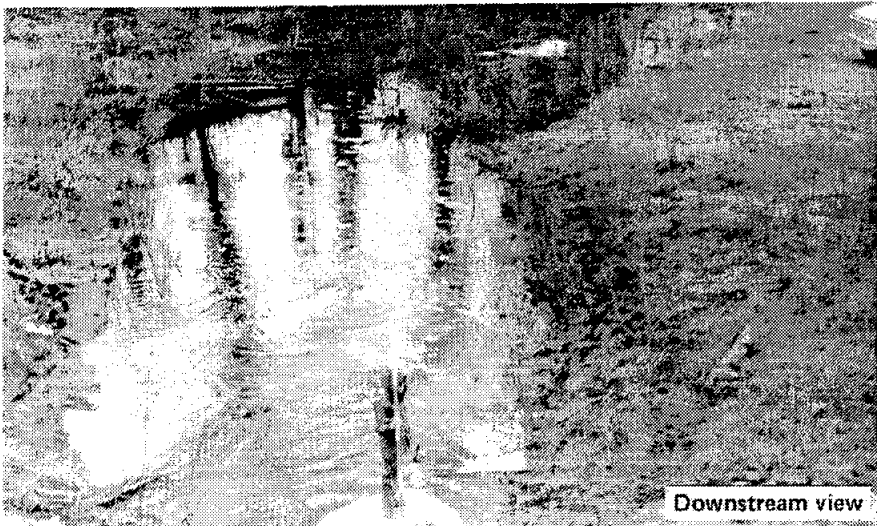
Downstream view

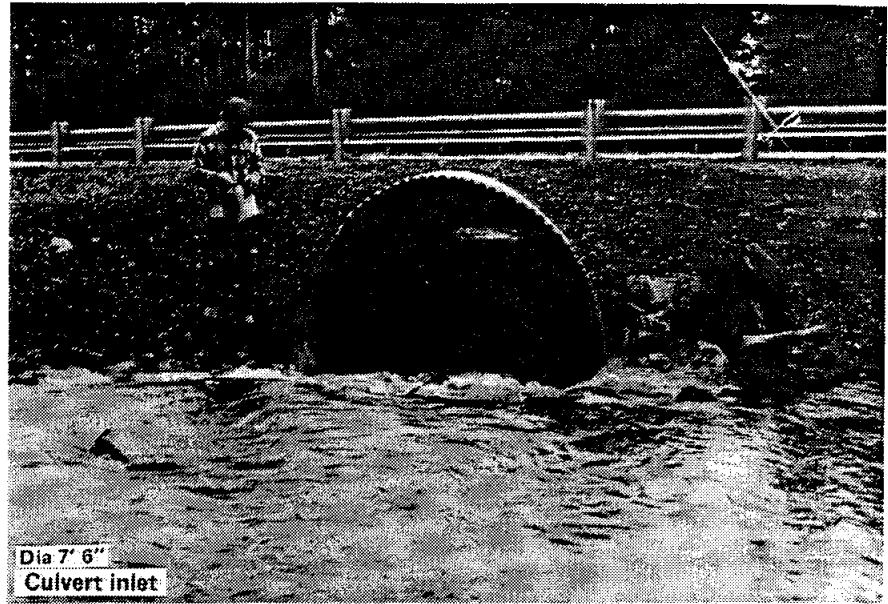
Dia 7' 6"
Culvert inlet

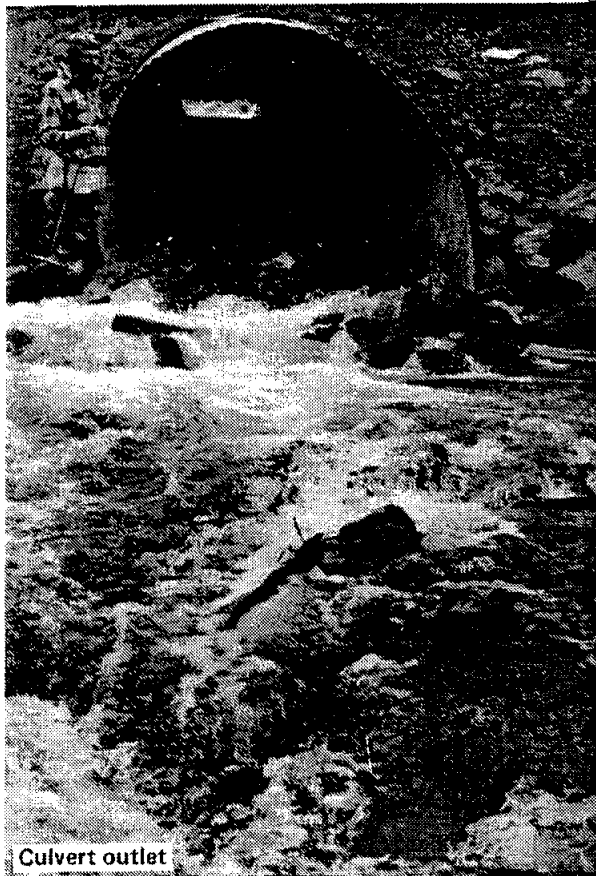
Culvert outlet

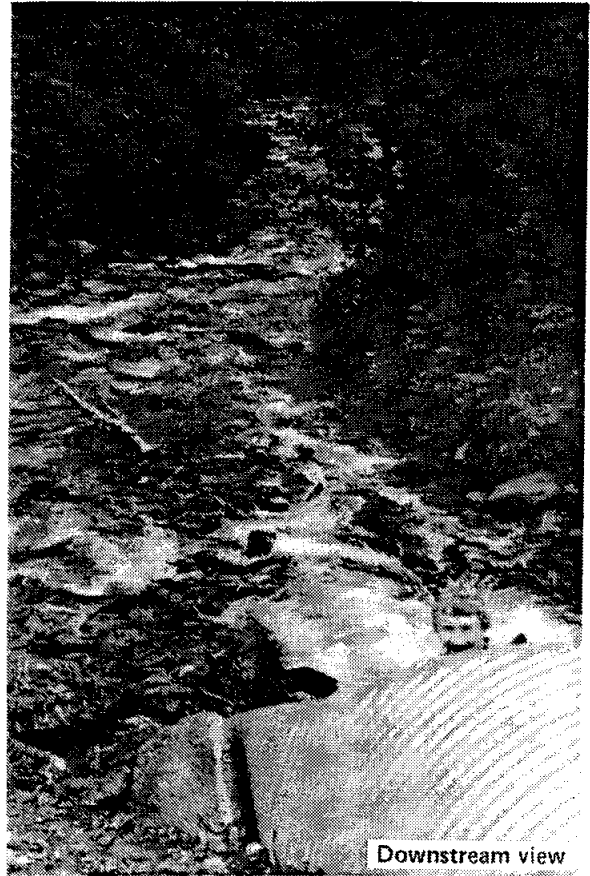
Downstream view

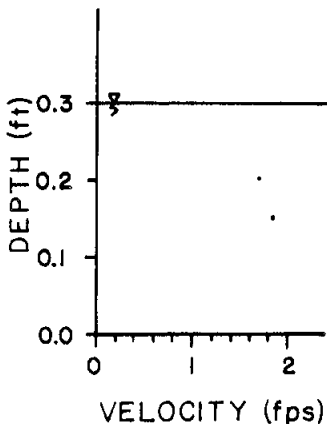
P-002
6 JULY 1982
CULVERT ENTRANCE

A single 10 ft diameter culvert carried all of the 1.2 cfs observed on July 6, 1982 at this site. The water surface profile surveyed on this date appears in the diagram. A slope stability problem blocked the entrance to the overflow culvert and caused the upstream channel banks to slump. The culvert barrel was bent upwards at the entrance, creating a small pond at the inlet. At the culvert entrance the water depth was 1.10 ft just outside of the culvert and 0.30 ft just inside. Due to changes in the culvert slope, the water depth increased from 0.30 to 2.5 ft inside the culvert. There was a large amount of silt and mud debris in the culvert with some larger rocks up to 8 in in diameter. At the exit, the water depths were 0.35 and 0.95 ft just inside and outside of the culvert, respectively. At this discharge the culvert was slightly perched. There was a large scour pool at the exit about 20 by 50 ft. A high water mark was surveyed 15 ft downstream of the outlet at 1.80 ft above the present water surface. The watershed boundaries were insufficiently defined to determine the watershed area.

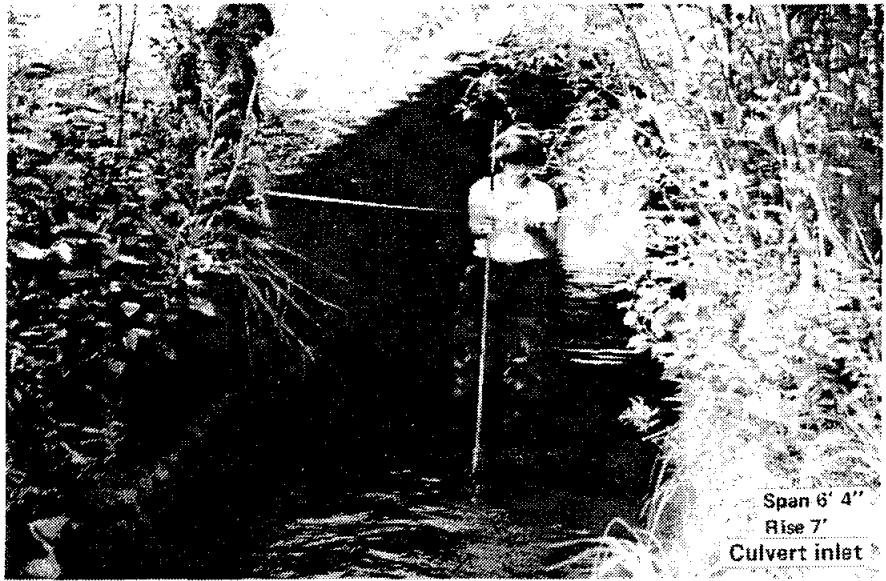
Span 6' 4"
Rise 7'
Culvert inlet

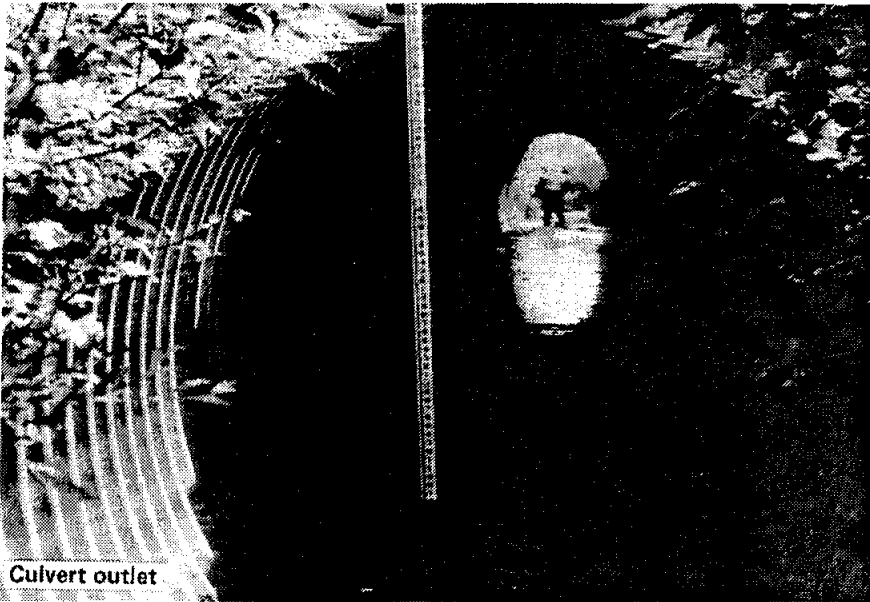
Culvert outlet

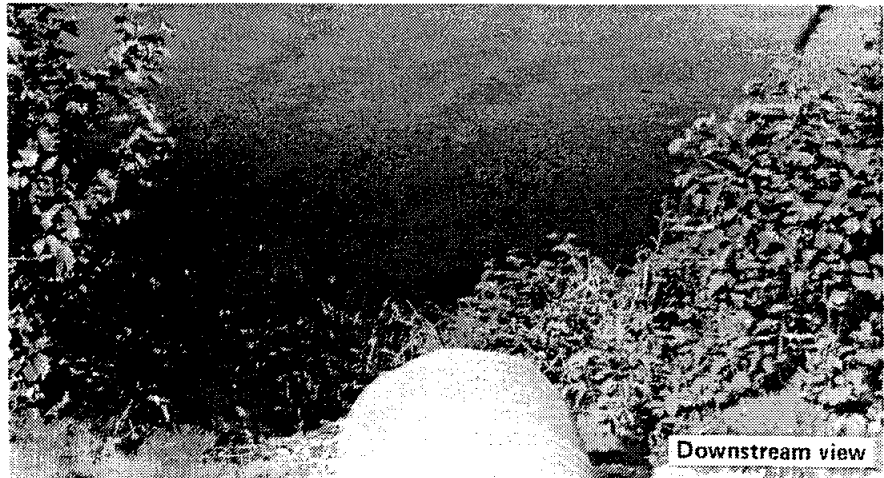
Downstream view

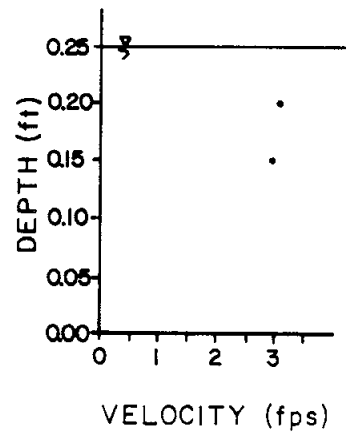
P-014
8 JULY 1982
CULVERT EXIT

Little Panguingue was visited on July 8, 1982 when the discharge was 1.5 cfs. Large cakes of mud were noted in the culvert 3 ft above the culvert invert, indicating higher flows had occurred. The crest-stage indicator gave a high water mark reading of 2.85 ft. The estimated bed-load size was 3 to 4 in in diameter; the barrel was mostly clean except for a few rocks of this size. The water depth at the culvert outlet was 0.25 ft. A large scour pool 25 ft in diameter was at the culvert exit. The watershed area was 4.1 sq mi.

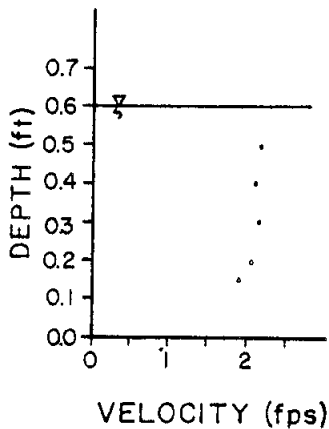
P-015
8 JULY 1982
CULVERT EXIT

This unnamed creek site along the Parks Highway was observed on July 8, 1982 when the flow was 2.44 cfs. The surveyed slopes for the culvert and creek are shown in the diagram. The creek emptied into the Nenana River 97 ft below the culvert exit. The watershed area was 2.6 sq mi. The bedload size was estimated to be fine sands and silts, and the barrel was clean. A high water mark was surveyed at 0.49 ft above the present water surface (on the south bank downstream of the culvert). Inlet and outlet water depths were 1.10 and 0.60 ft, respectively.

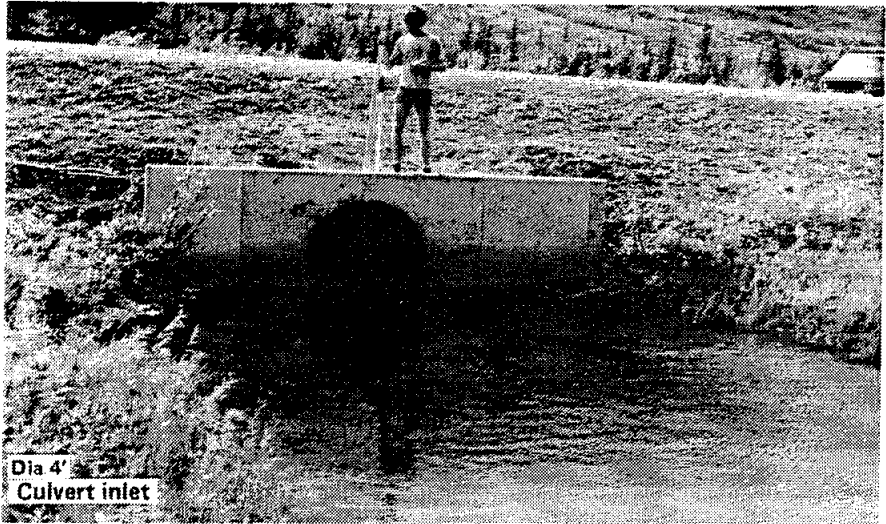
Dia 4'
Culvert inlet

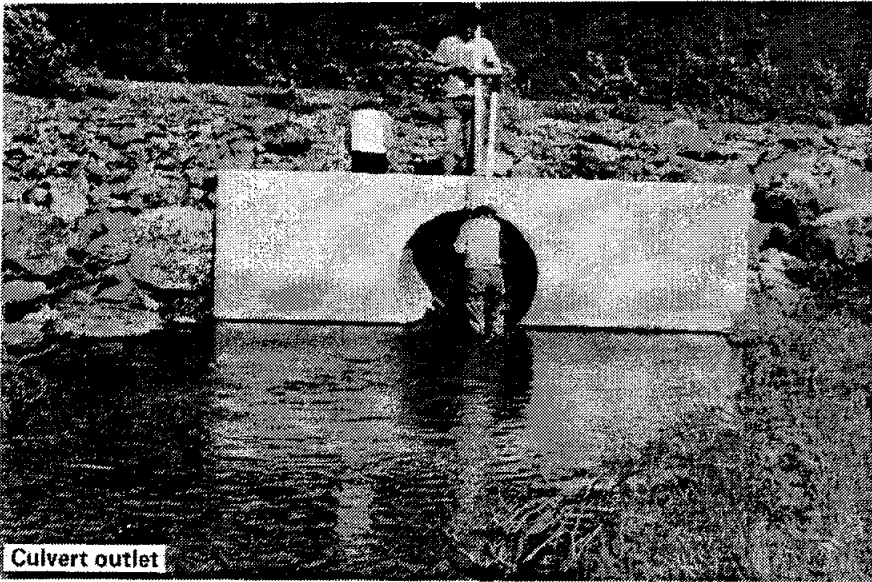
Culvert outlet

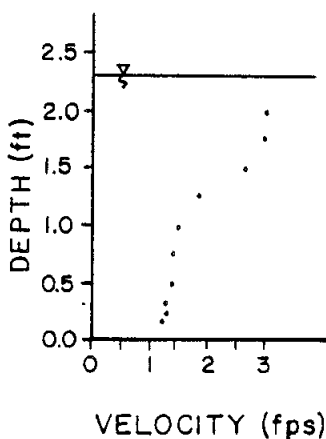
P-016
8 JULY 1982
NORTH CULVERT EXIT

Two identical perched culverts contained the flow from the 6.9 sq mi Slime Creek watershed. The discharge was 58.1 cfs on July 8, 1982. The slopes for the two culverts and the creek are presented in the diagram. Both barrels were clean. A 30 ft diameter scour pool below the culverts, a smaller 15 ft diameter pool above the culverts, and calm water between the culvert inlets provided potential rest areas for fishes. The crest stage indicator at this site was washed out. The outlet depths were 0.80 and 1.30 ft for the north and south culverts, respectively. The inlet depth for the north culvert was 2.30 ft.

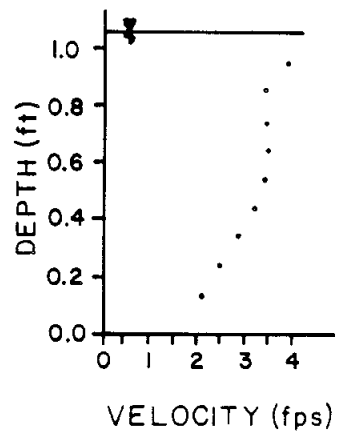
P-016
 5 AUG 1983
 25' UPSTREAM FROM
 NORTH
 CULVERT ENTRANCE

Slime Creek was visited again on August 5, 1983. Velocity profiles were obtained at the culvert inlet and 25 ft upstream of the inlet. This velocity data appears in Section III.

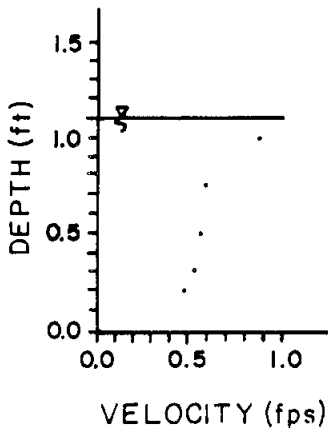
R-001
17 AUG 1982
NO. 3
CULVERT ENTRANCE

This creek, a drainage channel of the Chena Flood Project, was observed on August 17, 1982. Five culverts, numbered 1 to 5, north to south, contained the flow. The surveyed slopes are shown in the diagram. The five crown slopes were averaged: -0.0016 , -0.0009 , 0.0002 , 0.0003 , and -0.0028 (north to south). The bed material was sand and silt, and drift was observed in all five barrels. A velocity profile was measured at the inlet of the middle culvert. The watershed boundaries were insufficiently defined so the area was not determined.
