A HYDRAULIC EVALUATION OF FISH PASSAGE THROUGH
ROADWAY CULVERTS IN ALASKA: DATA REPORT

Paula M. Wellen and Douglas L. Kane

Institute of Water Resources/Engineering Experiment Station
University of Alaska-Fairbanks
Fairbanks, AK 99701

May 1985

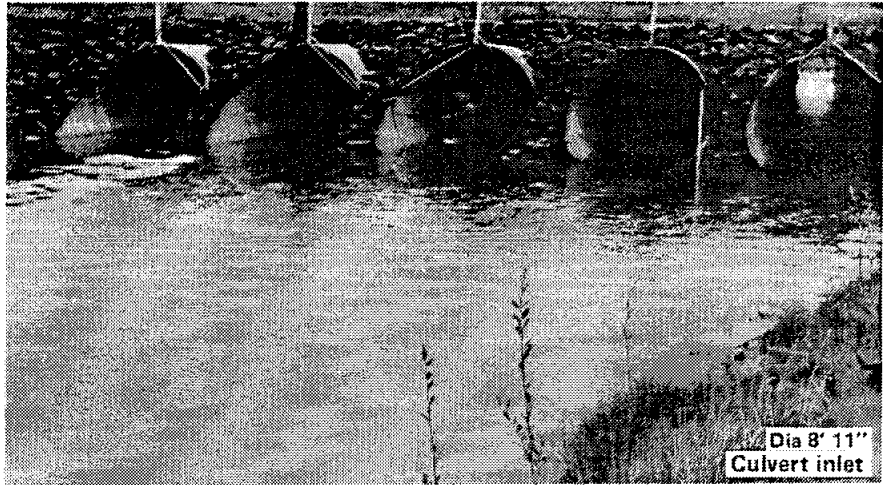
Dia 8' 11"
Culvert inlet

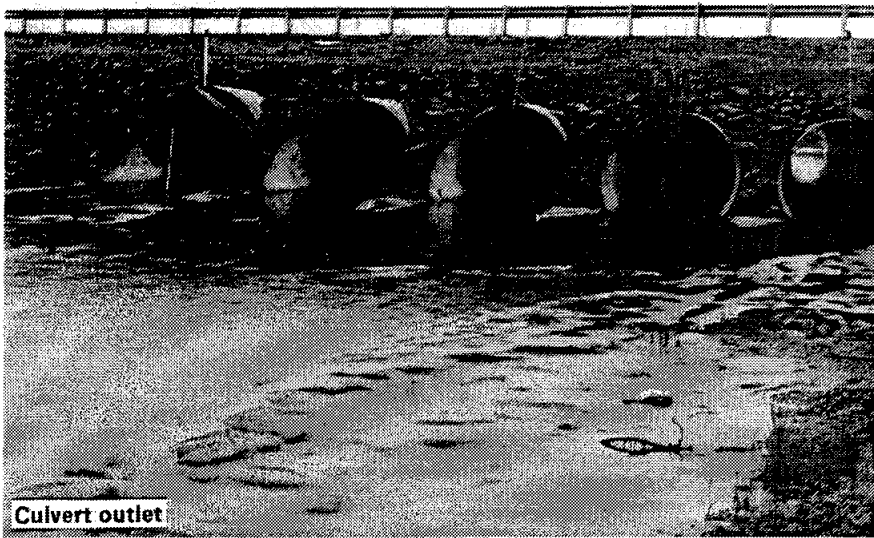
Culvert outlet

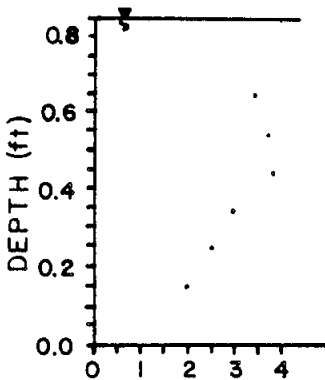
R-004
18 AUG 1982
NORTH
CULVERT ENTRANCE

Two culverts accommodated the 10.5 cfs flow observed at this site on August 18, 1982. The north culvert carried 8.3 cfs; inlet and outlet water depths for the north culvert were 0.85 and 2.40 ft, respectively. The south culvert had lower velocities and contained 2.2 cfs; inlet and outlet depths for the south culvert were 1.95 and 2.10 ft, respectively. The south barrel contained some fine silt; the north barrel had up to 4 in diameter rocks at the entrance. The water surface profiles for both culverts and the slough appear in the diagram. The small slopes observed at this site were the result of large ponds both upstream and downstream of the culvert installation. Small fishes (up to 4 in long) were observed in these ponds on both sides of the highway. The watershed boundaries were insufficiently defined, so no watershed area was determined.

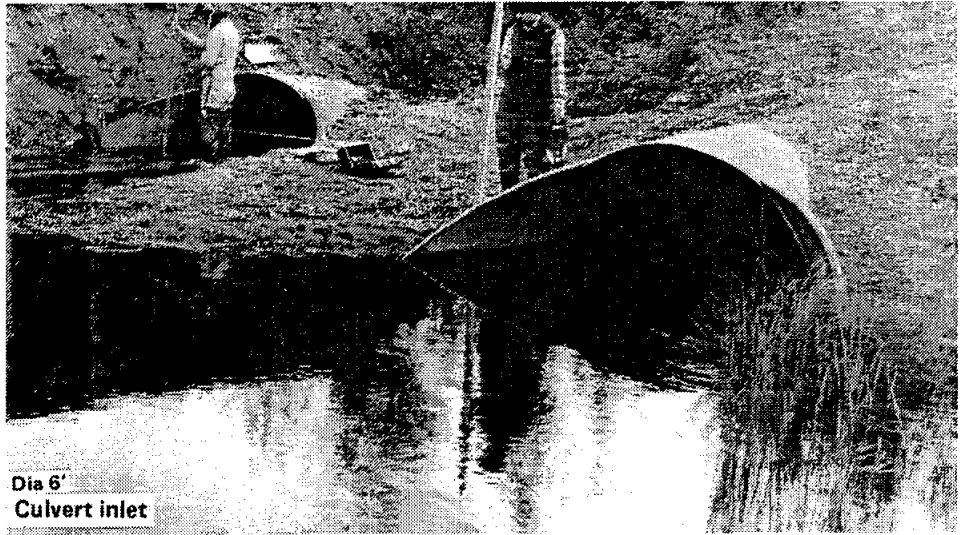
Dia 6'
Culvert inlet

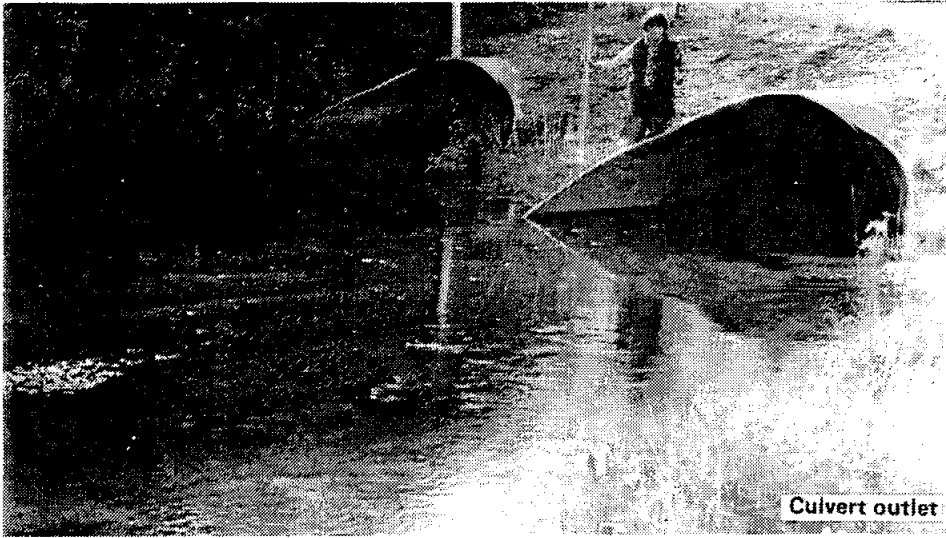
Culvert outlet

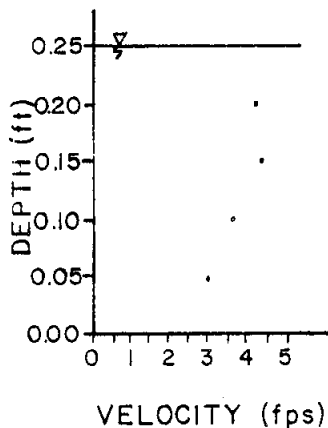
R-009
3 AUG 1982
CULVERT EXIT

This unnamed creek along the Richardson Highway was observed on August 3, 1982. The discharge was 1.7 cfs and the surveyed slopes are shown in the diagram. A water surface drop at the culvert inlet measured 0.68 ft. The culvert barrel was clean; no drift was observed. The total water depth at the culvert outlet was 0.25 ft, and the drop out of the culvert was 0.12 ft. Large pieces of riprap were noted in the channel at the culvert outlet. These pieces of riprap provided the only resting areas for fishes as no pools were observed upstream or downstream of the culvert. The bedload size was estimated at 4 in in diameter. The watershed area was 3.3 sq mi.

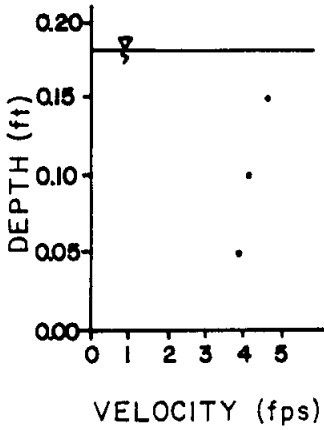
R-010
 3 AUG 1982
 CULVERT EXIT

A rectangular wooden culvert contained the 3.1 cfs discharge at this unnamed creek on August 3, 1982. The water depth at the culvert inlet was 0.13 ft; the water depth at the culvert outlet was 0.18 ft. A beaver pond was located upstream and south of the culvert. The upstream slope was measured along another channel upstream and to the north of the culvert. The surveyed slopes for this site appear in the diagram. Two 7 inch grayling were observed above the culvert installation. A 10 ft diameter scour pool was noted below the culvert outlet. The barrel was clean from sediments and drift but there was a dam of branches and twigs at the culvert entrance causing a measurable water surface drop. The watershed boundaries were insufficiently defined to obtain a watershed area.

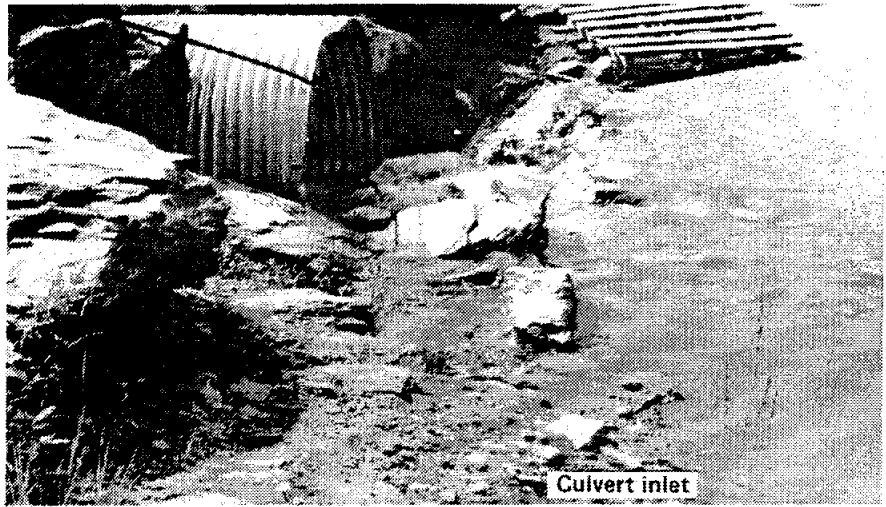
Culvert inlet

The surveyed water surface profiles for Boston Creek appear in the diagram, below. Significant drops into and out of the culvert were observed, due to large pieces of riprap at both ends of the culvert. A 25 ft diameter pool upstream of the culvert was silt laden and contained minnows. A deep 25 ft diameter scour pool downstream of the culvert was rocky and contained large pieces of riprap. Other than some large pieces of riprap in the culvert, the barrel was clean. Bed material was silt upstream of the culvert and 5 in diameter (maximum) material downstream of the culvert. Total depth at the culvert outlet was 1.10 ft. The watershed area was 7.1 sq mi. The observed flow on August 10, 1982 was 4.5 cfs.

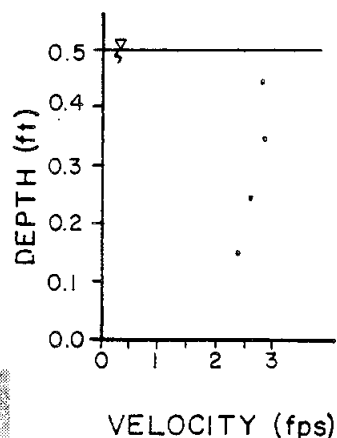
S-007
9 AUG 1982
CULVERT ENTRANCE

The creek crossed the Old Steese Highway about 3/4 mi upstream from the New Steese Highway crossing. The culvert at the Old Steese Highway was in poor condition; the first section at the inlet was broken and pushed up. This caused high inlet velocities and was a potential problem for fish passage.

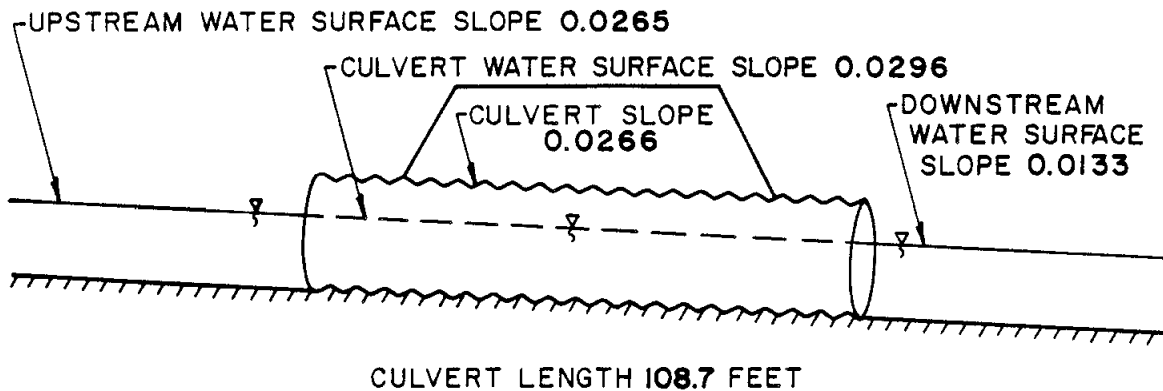
The measured discharge at Grouse Creek was 2.3 cfs on July 9, 1982. The surveyed slopes for the culvert and creek are shown in the diagram. The culvert slope flattened out for the last 1/3 of the barrel. This resulted in a thick deposit of sand size material in the last part of the culvert, and low outlet water velocities. No drift was observed in the first part of the culvert. The total depth at the culvert inlet was 0.50 ft. The watershed area was 8.0 sq mi. No pools or rest areas for fishes at the inlet or outlet were observed.

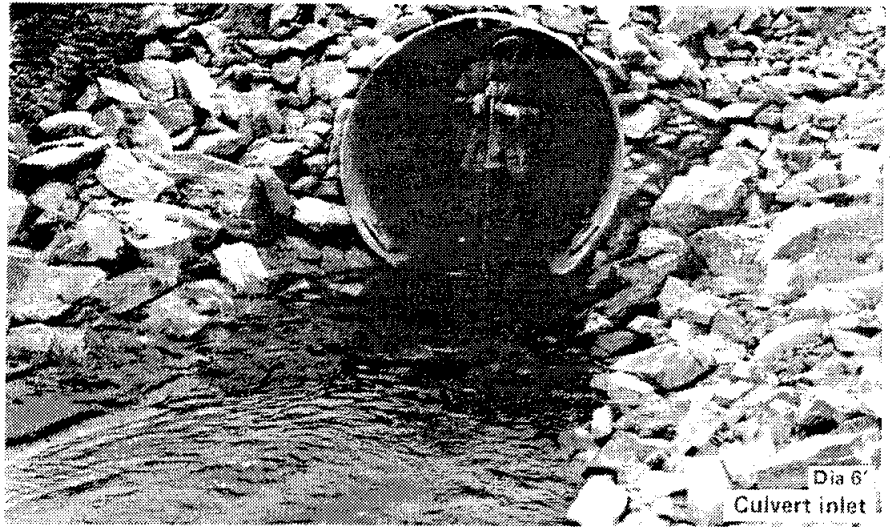
Dia 6'
Culvert inlet

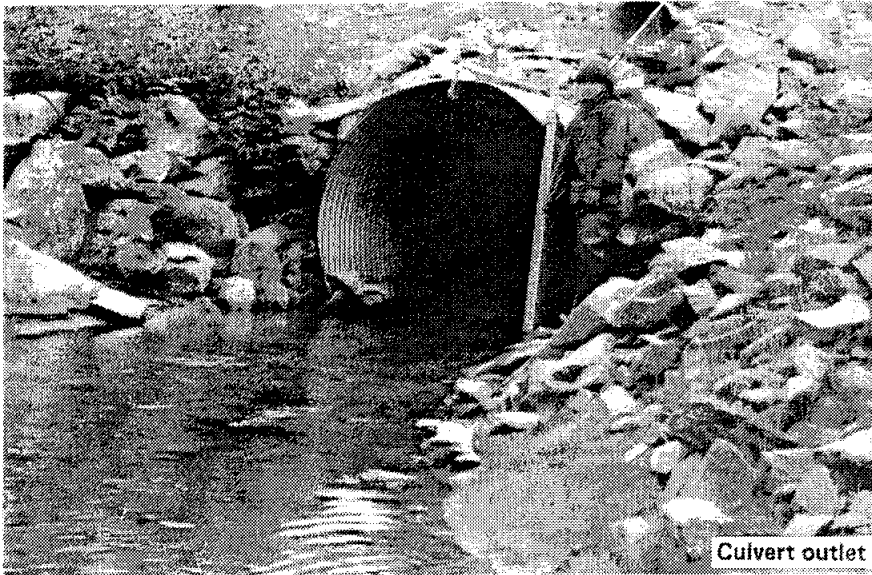
Culvert outlet

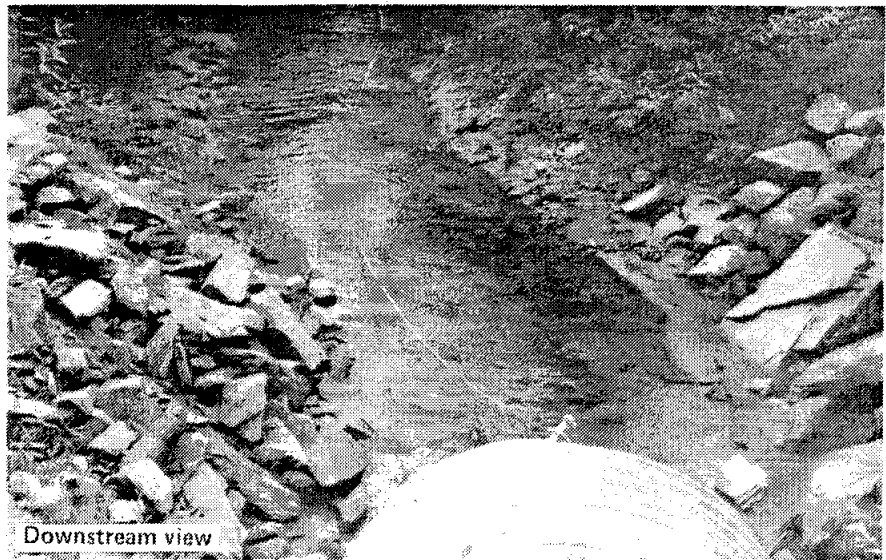
Downstream view

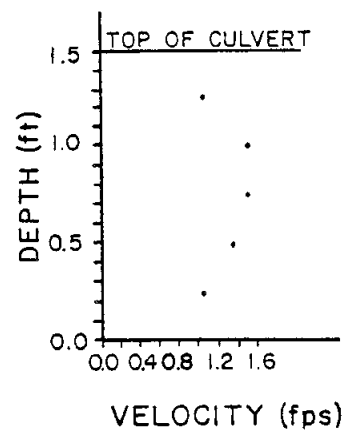
S-011
 27 AUG 1983
 CULVERT EXIT

US Creek was observed on July 27, 1983; the measured discharge was 7.67 cfs. A single 18 in diameter culvert (flowing full and totally submerged at both ends) contained the flow. A 6 ft diameter culvert above the smaller culvert was dry. The surveyed water surface profile for this installation is shown in the diagram. A pool, 50 by 25 ft was noted at the culvert outlets; numerous grayling (up to 12 in long) were sighted in this pool. The outlet channel was man-made and the culverts were not aligned with the new channel. A large pool was excavated at the upstream end of the culverts, but the water level was low. A large water surface drop was noted from the natural upstream channel to the culvert entrance where the pool had been excavated. The watershed area was 5.01 sq mi.

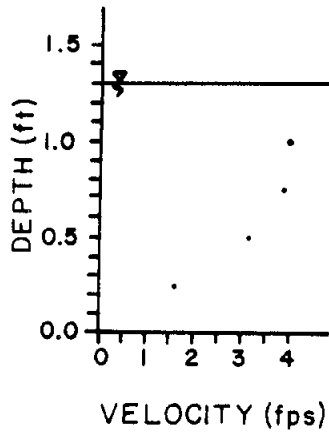
S-029
 2 SEP 1983
 CULVERT ENTRANCE

The culvert and stream at this location were measured on September 2, 1983. The discharge on this date was 24.4 cfs; the water surface profile is shown in the diagram. A 3 ft diameter overflow culvert was nearby but contained no flow. There was drift in the last 10 ft of the culvert near the outlet. The bed material was rocks up to large cobbles (3 to 10" in diameter). The channel upstream was not the natural one and there was a drop in the culvert just below the entrance. The outlet depth was 1.4 ft and the watershed area was 3.6 sq miles.

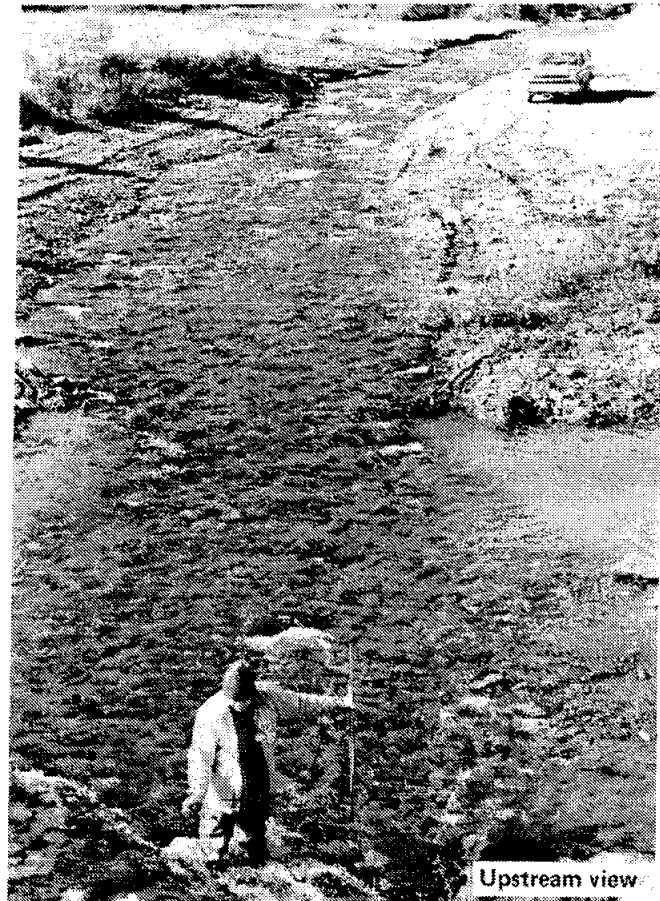
Upstream view

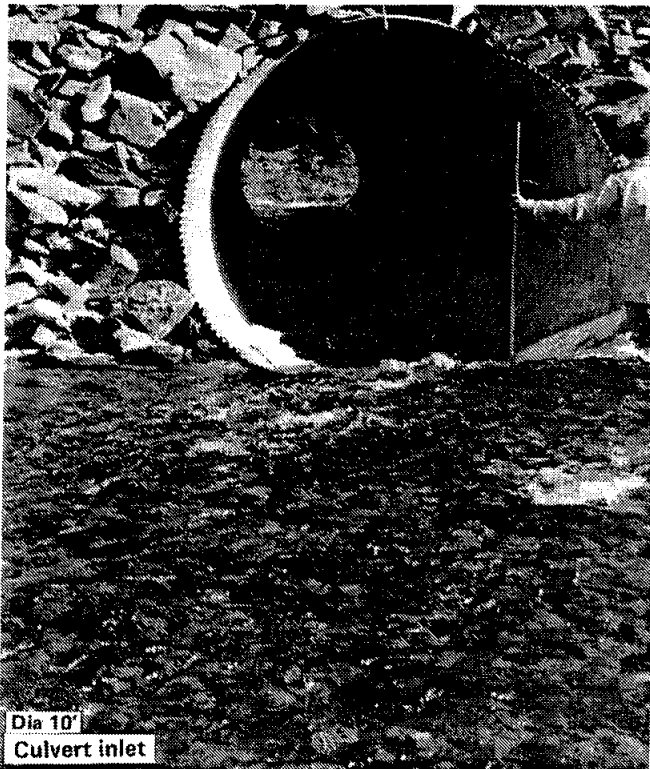
Dia 10'
 Culvert inlet

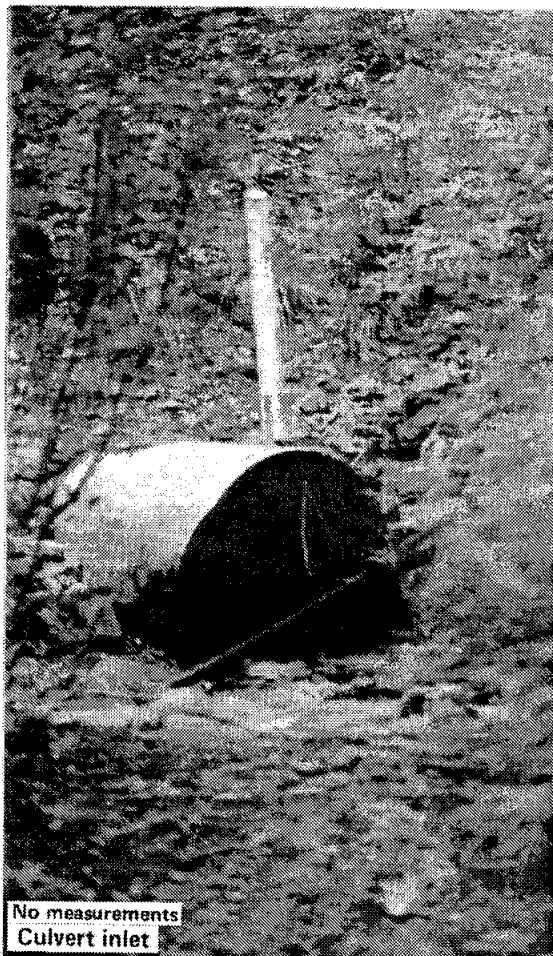
The Stack Pup Creek site was observed on August 23, 1983. The perched culvert (4 ft drop) had created a 10 ft diameter scour pool at the outlet. The creek appeared to be a small, high gradient headwater stream. No slopes were surveyed. The bed material was rocks up to 1 ft in diameter. The stream water was colored with tannic acid. The watershed area was 3.0 sq mi.

No measurements
Culvert inlet

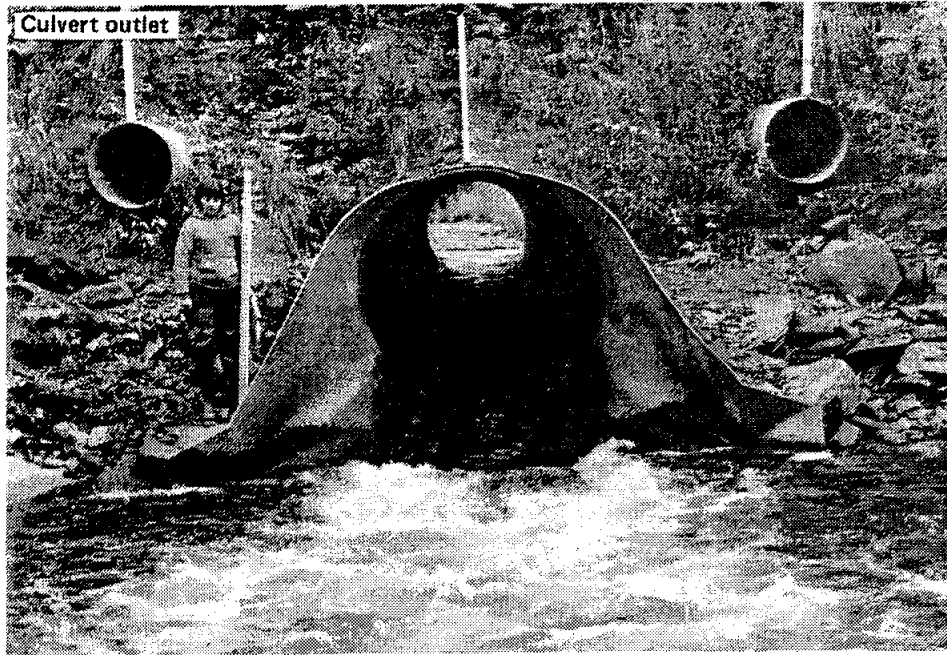
Measurements were made at Bedrock Creek on August 23, 1983. The discharge (16.6 cfs) was contained by one 6 ft diameter culvert while two smaller overflow culverts were dry. The water surface profiles for the culvert and creek are shown in the diagram. The larger culvert had aprons at both ends of the barrel. The water depth at the culvert inlet was 1.00 ft, at the culvert outlet it was 0.75 ft, and at the lip of the downstream apron it was 0.30 ft. The aprons greatly increased the water velocity, especially at the culvert outlet. A pool 30 ft in diameter was noted downstream of the culvert, and the barrel was clean. The stream had migrated to the north after the culvert was emplaced; the stream was not aligned at the culvert entrance. The watershed area was 10.1 sq mi.

Culvert outlet

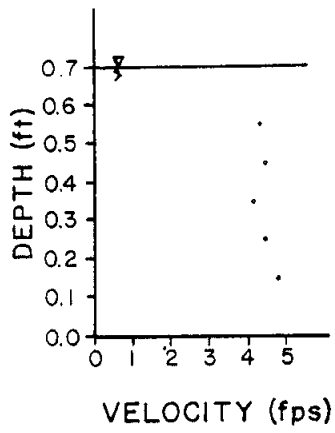
S-036
 23 AUG 1983
 10' DOWNSTREAM FROM
 CULVERT EXIT

This location was visited on August 23, 1983, and the measured discharge was 4.8 cfs. The surveyed slopes appear in the diagram. Large cobbles in the streambed resulted in a poor discharge measurement. Sawpit Creek was a high gradient clear head-water stream. No pools or other rest areas for fishes were observed. The culvert barrel was clean except for a very small amount of drift at the entrance. The inlet and outlet water depths were 0.50 and 0.40 ft, respectively. The watershed area was 5.2 sq mi.

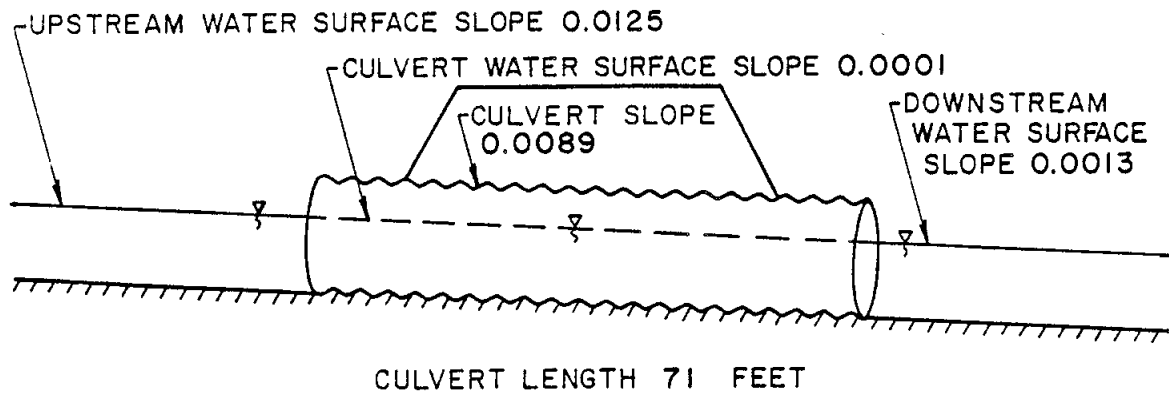
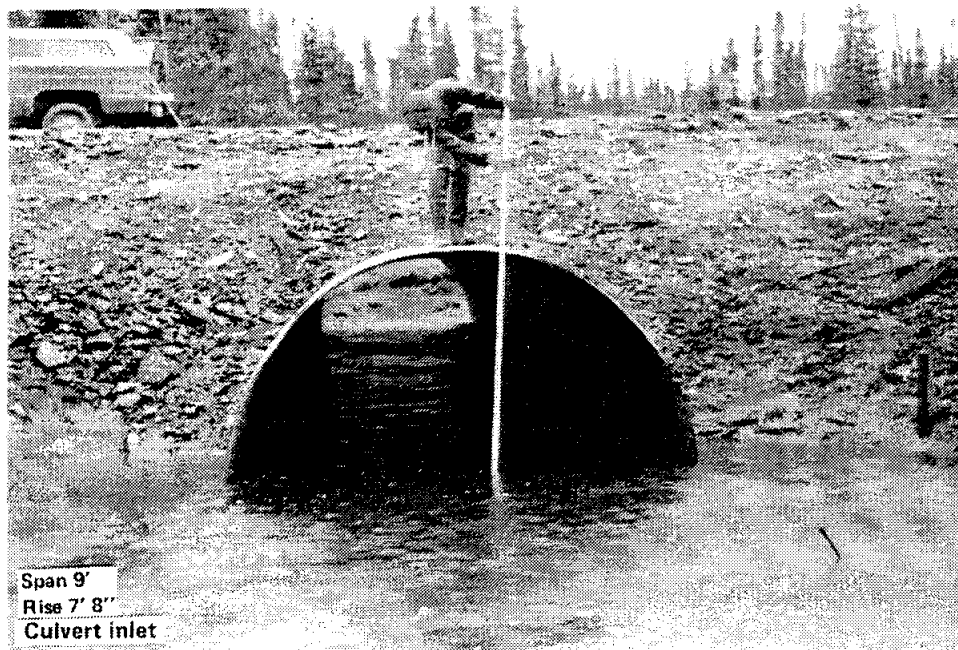
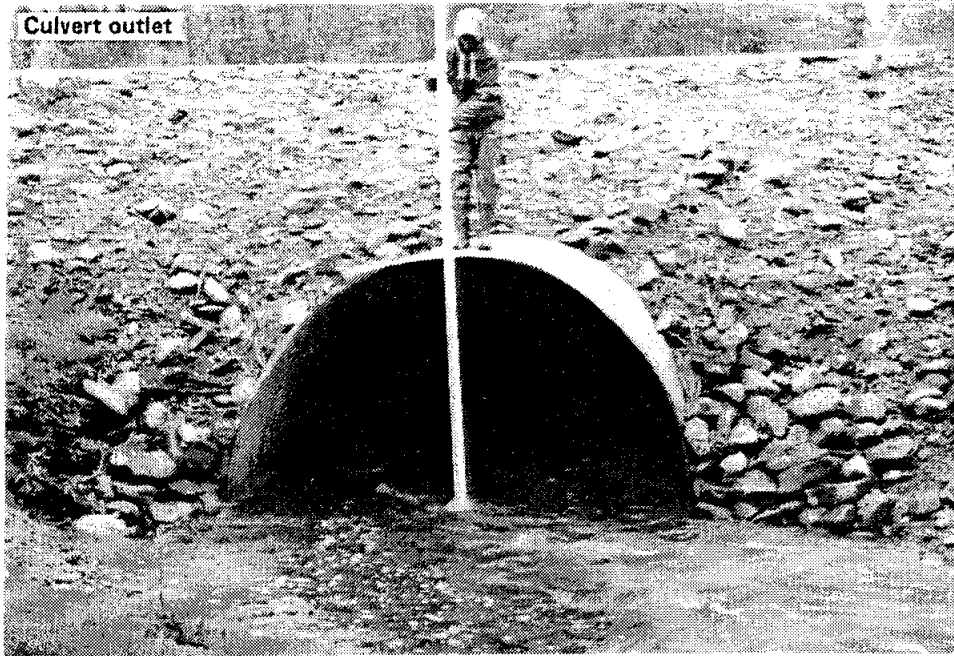
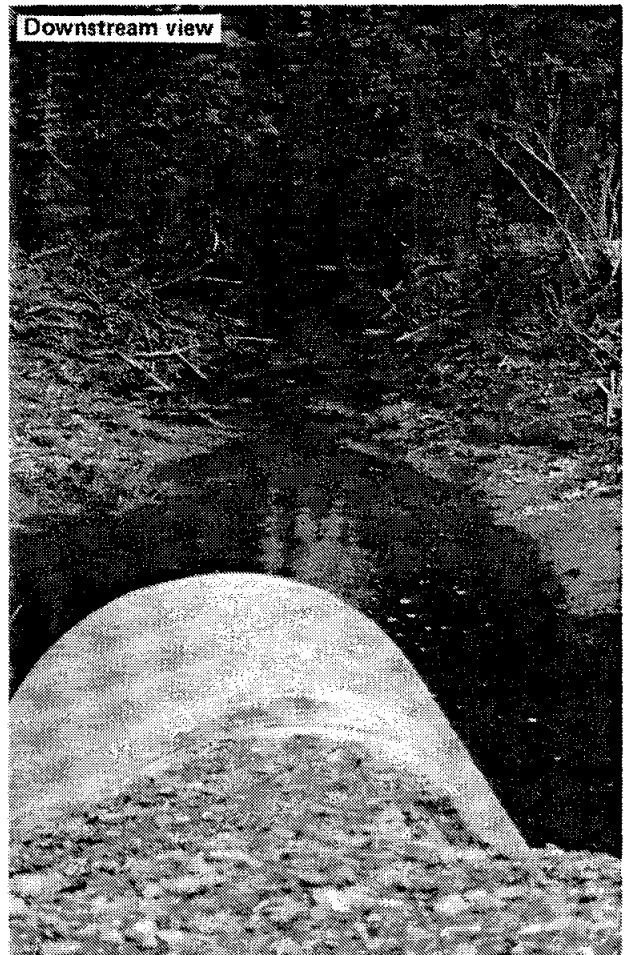
Map: Circle C-1, T9N, R16E, Sec. 7

This stream site was measured on August 22, 1983 when the discharge was 13.3 cfs. The culvert inlet and outlet water depths were 2.6 and 3.1 ft, respectively. These depths were measured on top of 2 to 3 ft of gravel, placed in the culvert at the time of construction to aid in fish passage. The surveyed water surface profile for the stream and culvert is shown in the diagram. The stream carried a high suspended sediment load and was stained with tannic acid. The watershed area was 16.3 sq mi.

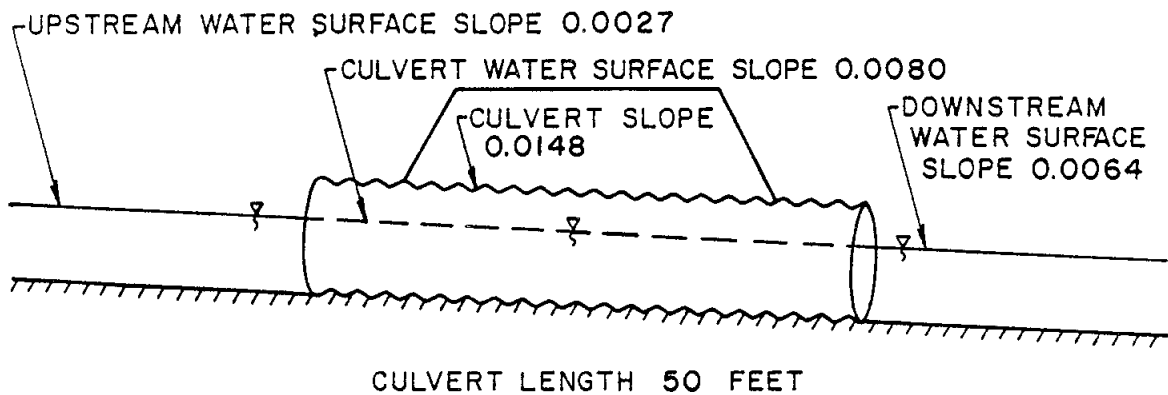
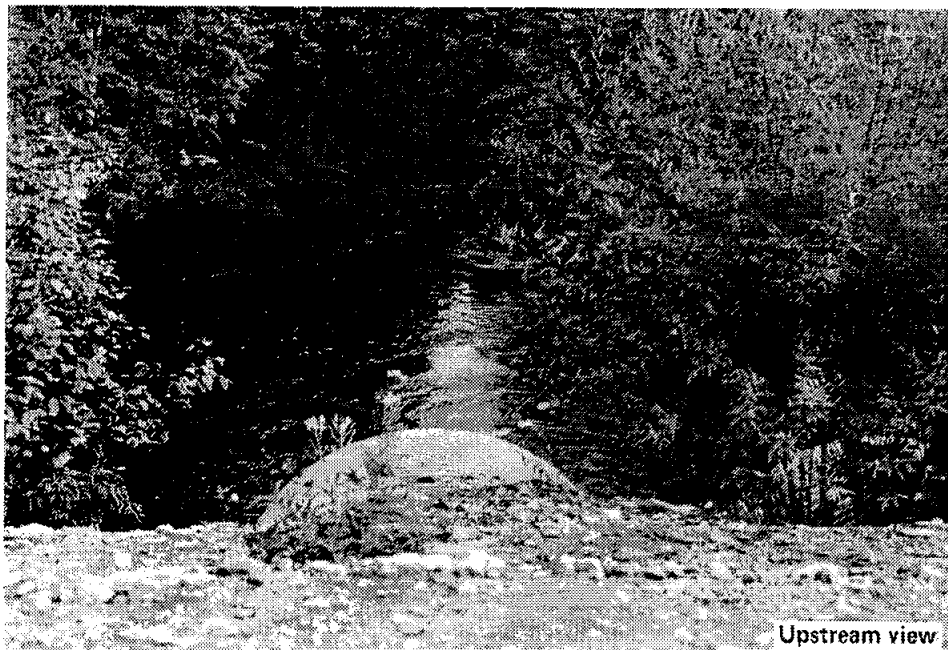
Site No. S-040 Crazy Creek

Crazy Creek was visited on August 20, 1983. A double culvert installation contained the observed 15.9 cfs discharge. The water surface profiles for the culverts and creek are presented in the diagram. The inlet water depths for the north and south culverts were 2.00 and 1.30 ft, respectively. The outlet water depths were 0.80 and 0.95 ft, respectively. There was a 30 by 30 ft pool downstream of the culverts and deep calm water upstream of the culverts. Very little drift was observed in the culvert barrels. The watershed area was 20.7 sq mi.
