CRASH TESTING OF MISSOURI'S W-BEAM TO THRIE-BEAM TRANSITION ELEMENT

MIDWEST ROADSIDE SAFETY FACILITY

MwRSF Research Report No. TRP-03-94-00

September 12, 2000

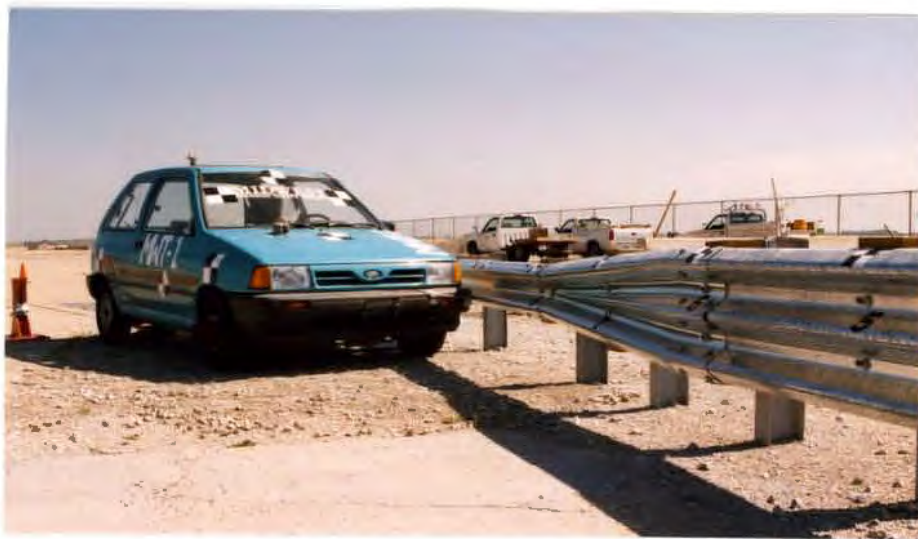
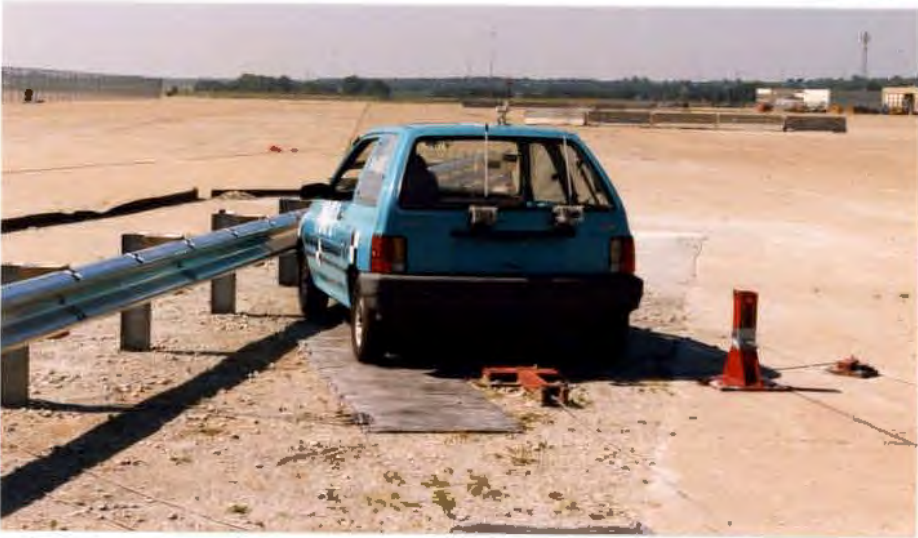
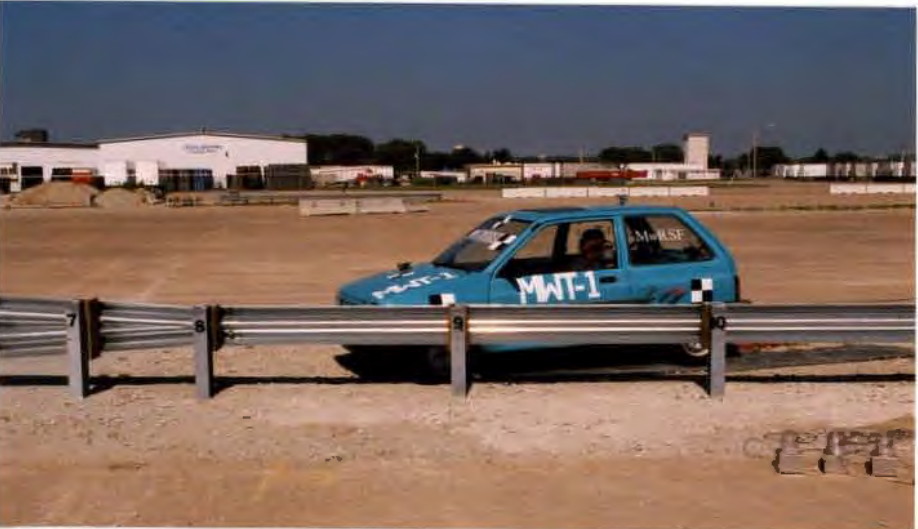
Figure 26. Impact Location, Test MWT-1

Initial impact occurred between post nos. 8 and 9 or 1,219-mm upstream from the center of post no. 8, as shown in Figure 26. At 0.040 sec after impact, the left-front corner of the vehicle was at post no. 8, and the hood began to bulge upward and separate from the fenders. At 0.052 sec, the left-front tire only rubbed across the face of post no. 8. At this same time, the left-front fender crushed inward toward the engine compartment, and the top of the left-side door separated from the top of the vehicle. At 0.081 sec, the left-front corner of the vehicle was at post no. 7. At 0.098 sec, the left-front tire wedged under the W-beam to thrie beam transition section, and the tire impacted the bottom of the wooden blockout at post no. 7 and snagged on post no. 7. At this same time, the left-side window shattered. At 0.113 sec, the left-front corner of the vehicle was at post no. 6. At 0.126 sec, the deformed left-front tire, still wedged under the rail, was at the midpoint between post nos. 6 and 7. At this same time, the front of the vehicle was downstream from post no. 6 and with the dummy's head protruding out of the left-door's shattered window. At 0.149 sec, the left rear of the vehicle contacted the guardrail with the rear bumper slightly upstream of post no. 8. At this same time, the shattered glass from the left-side door was flying away from the vehicle. At 0.150 sec, the

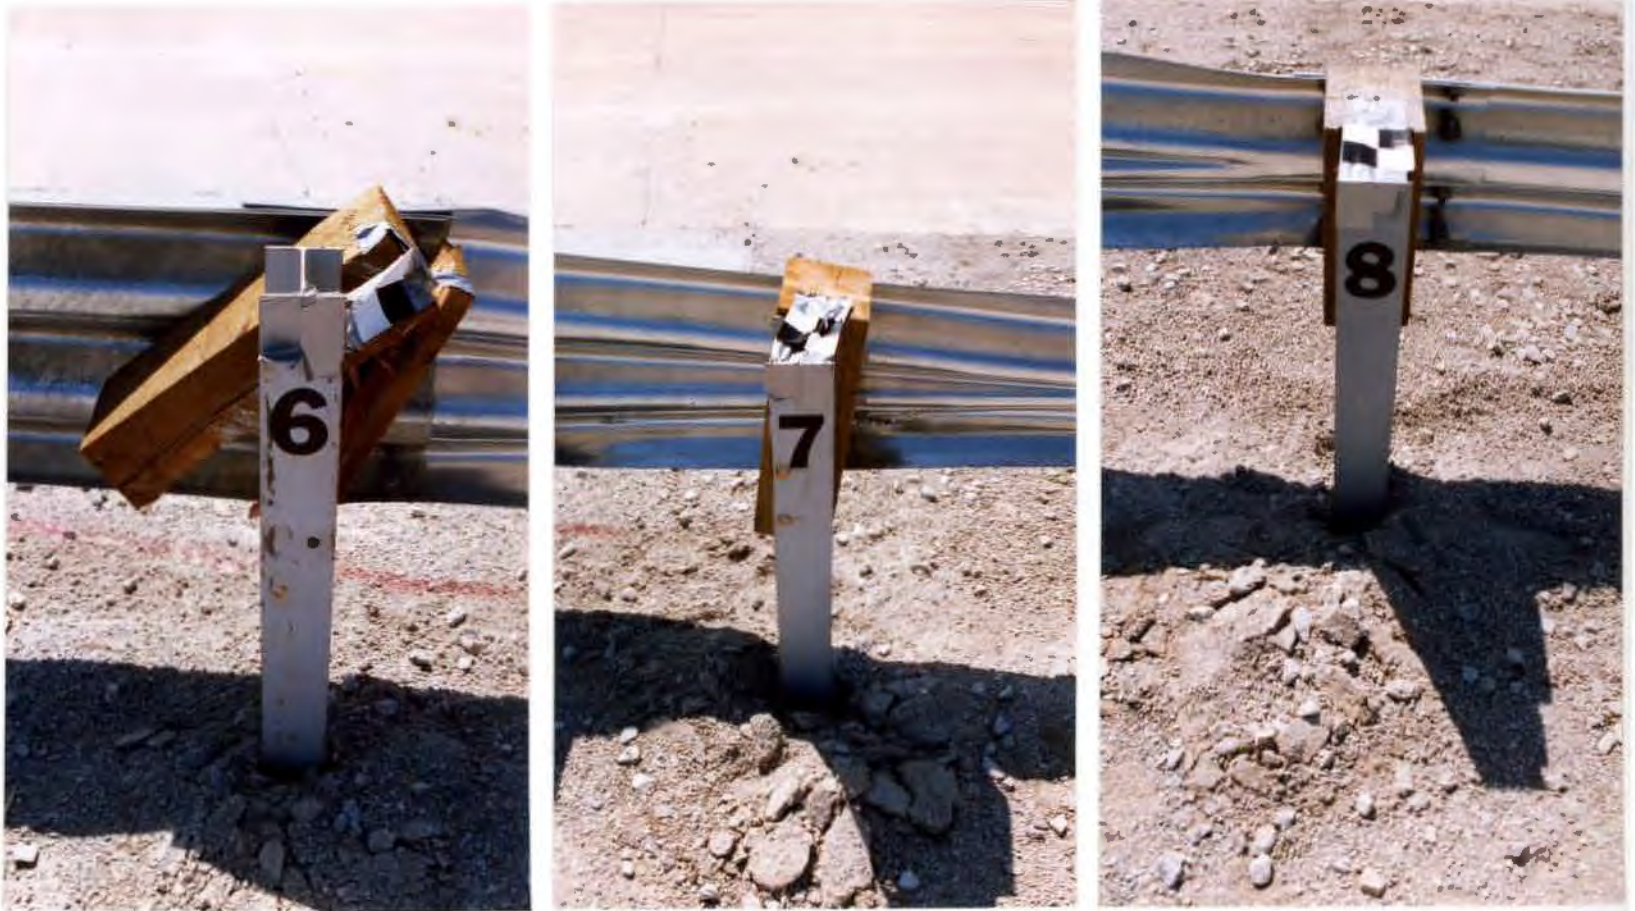
Figure 32. Permanent Set Deflections, Test MWT-1

The permanent set of the guardrail and posts is shown in Figure 32. The maximum lateral permanent set rail and post deflections were approximately 108 mm at the center line of post no. 8 and 114 mm at post no. 8, respectively, as measured in the field. The maximum lateral dynamic rail and post deflections were 220 mm at the centerline of post nos. 7 and 8, as determined from the high-speed film analysis.

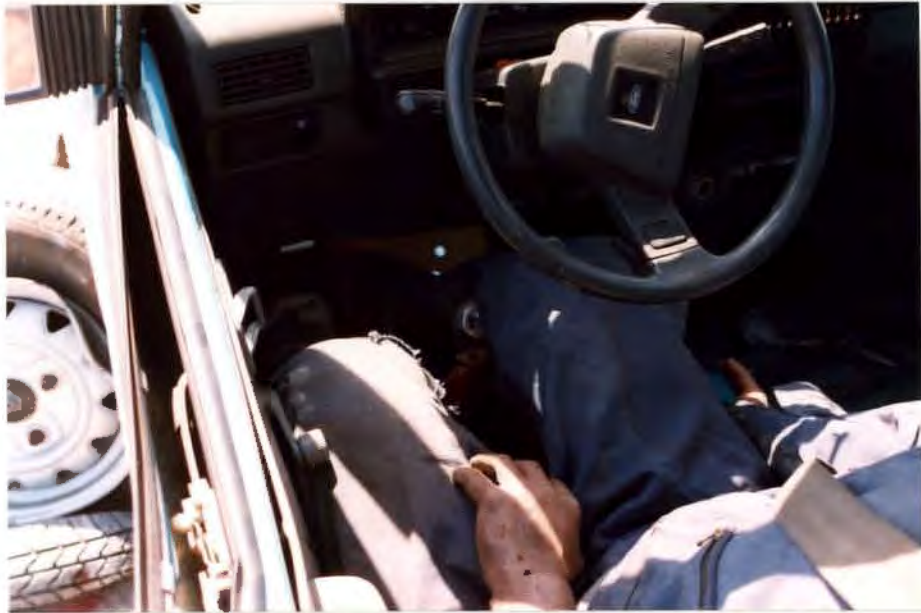
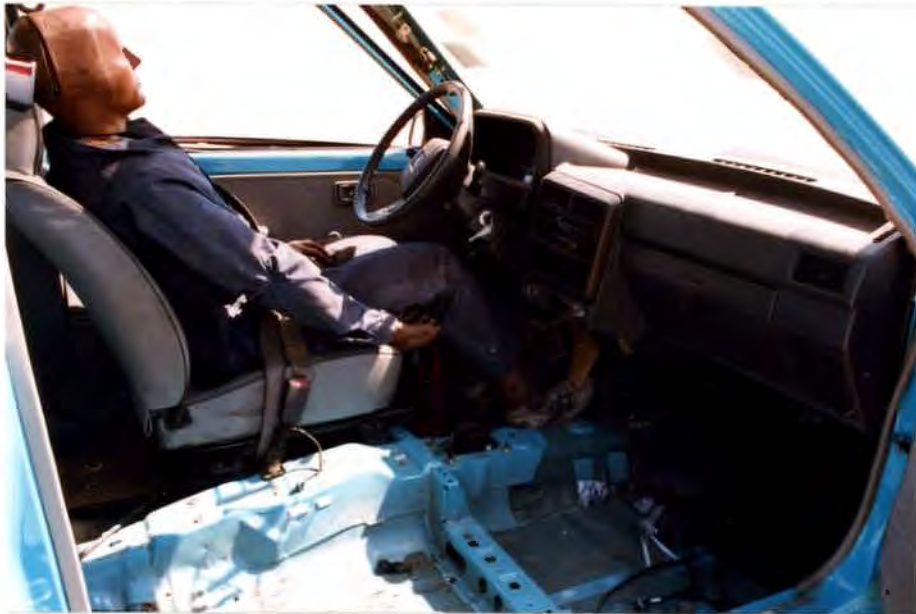
Figure 35. Occupant Compartment Deformations, Test MWT-1

Exterior and interior vehicle damage was moderate, as shown in Figures 33 through 35. Most of the vehicle damage occurred near the left-front corner of the vehicle, as shown in Figure 34. The left-front corner was crushed inward toward the engine. The major left-front wheel components, such as the lower A-frame, the tie rod end, the brake line, and the shock attachment, disengaged. Major damage occurred to the left-front tire rim, and the tire was slashed. The vehicle's left side encountered contact marks and deformations due to the vehicle/rail interlock. The engine hood was shifted to the right, and the grill disengaged from the front mounts. The plastic, front-bumper cover

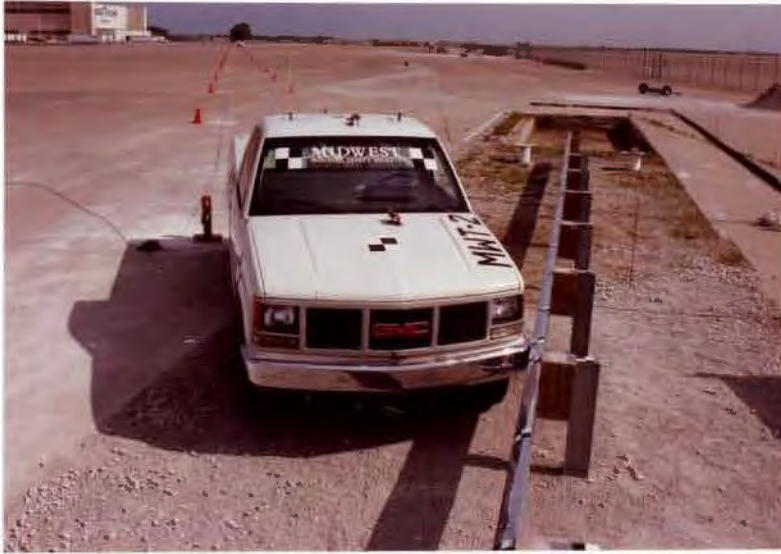
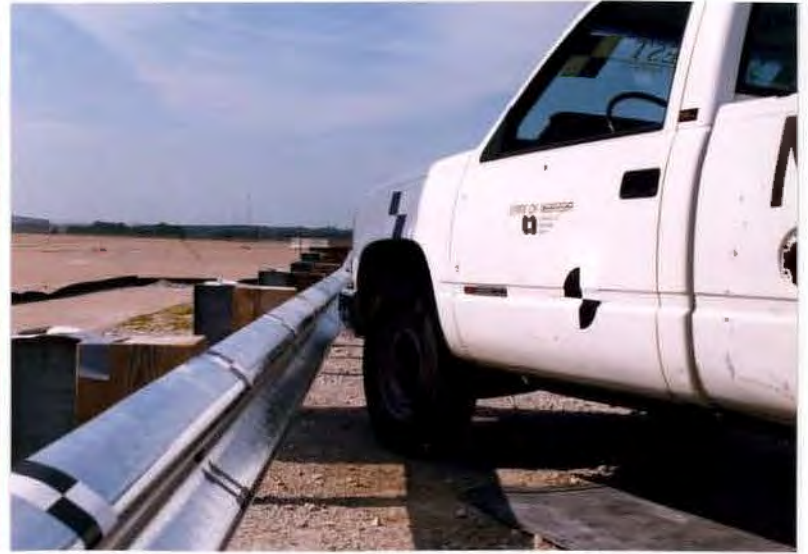
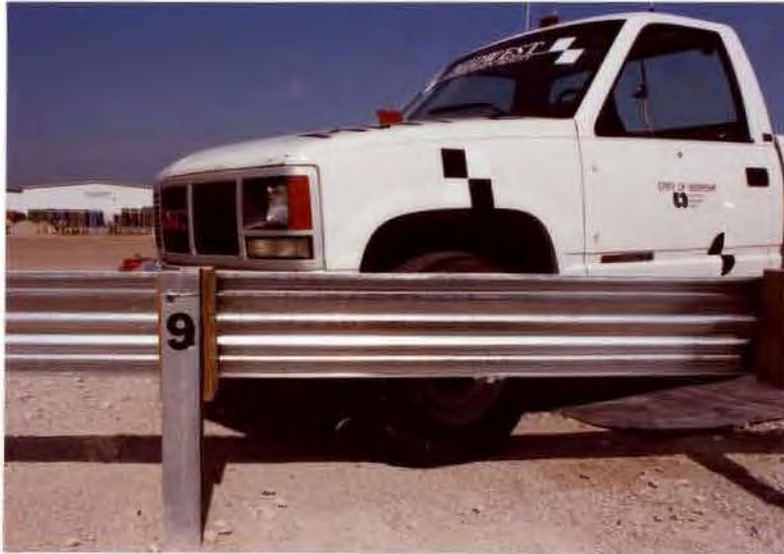
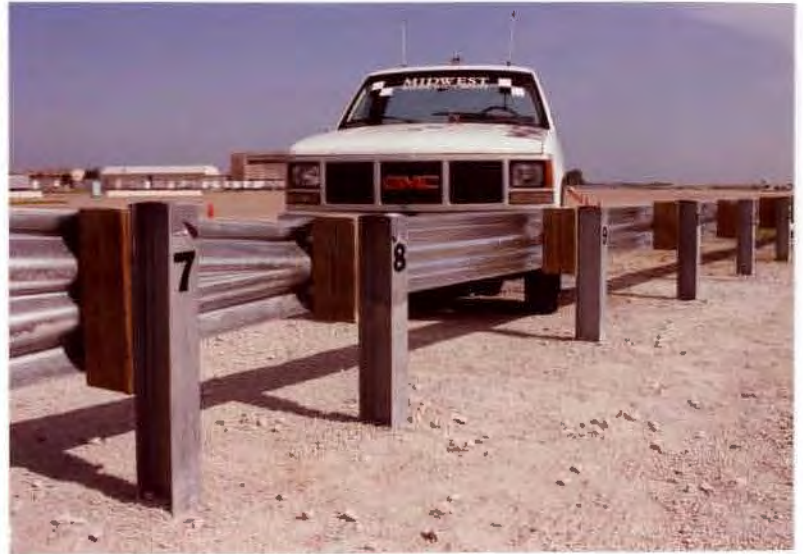
Figure 42. Impact Location, Test MWT-2

Initial impact occurred between post nos. 9 and 10 or 330-mm upstream from the center of post no. 9, as shown in Figure 42. At 0.040 sec after impact, the left-front corner of the vehicle was at the midspan between post nos. 8 and 9. At this same time, post no. 9 was observed to be pushed backward and away from its original position. At 0.056 sec, post no. 8 began to twist CCW, and the left-front side of the bumper and lower fender crushed inward. At this same time, the left-front corner of the engine hood and upper edge of the fender became separated. At 0.080 sec, the left-front corner of the vehicle was at post no. 8, and the left-front tire had turned sideways. At this same time, post no. 7 had not moved, although significant twist about its longitudinal axis was observed in the rail between post nos. 7 and 8. At 0.094 sec, post no. 7 began to deflect backward and twist about its vertical axis. At 0.102 sec, the deformed left-front tire snagged on the bottom of post no. 8 which had deflected, causing the tire to turn sharply to the left. However, the tire was not captured under the rail. At 0.113 sec, post no. 6 began to deflect away from its original position. At 0.117 sec, the rail upstream of post no. 6 kinked across the full depth. At 0.124 sec, significant vehicle pocketing in the rail upstream of post no. 7 was observed. At this same time, post no. 7 was

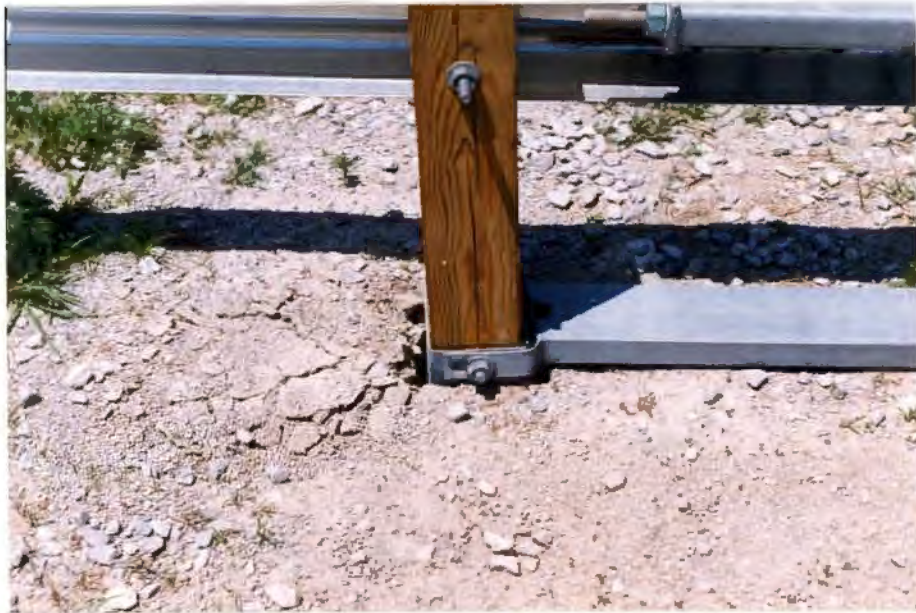
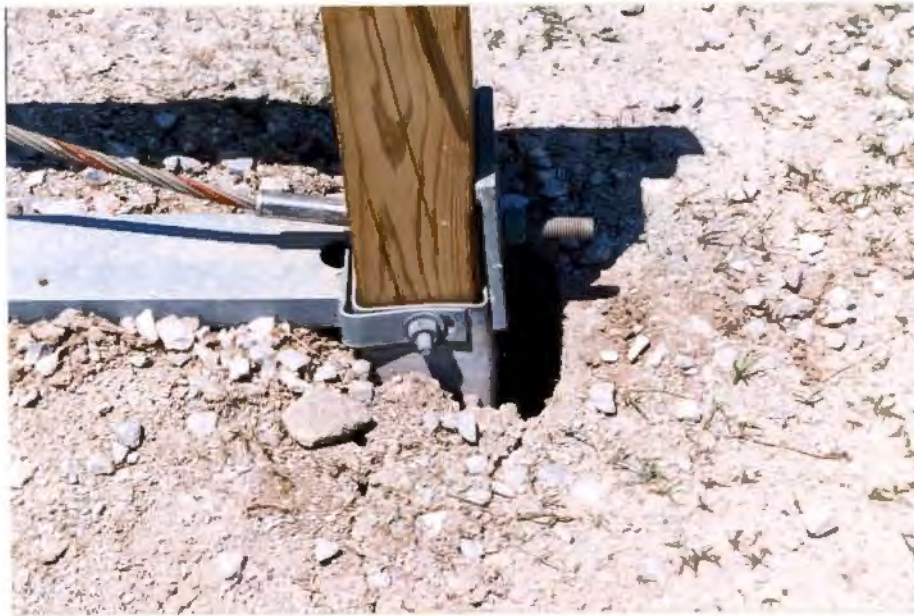
Figure 50. Permanent Set Deflections, Test MWT-2

The permanent set of the guardrail and posts is shown in Figures 47 through 49. The cable anchorage system encountered slight permanent deformation due to the tensile loads transmitted through the guardrail, as shown in Figure 50. The maximum lateral dynamic rail and post deflections were 806 mm at the centerline of post nos. 4 through 6 and 806 mm at post no. 6, respectively, as determined from the high-speed film analysis.
