**CORROSION PERFORMANCE OF EPOXY-COATED
REINFORCEMENT–MACROCELL TESTS**

Research Report No. 1265-3

STRUCTURAL INTEGRITY OF EPOXY-COATED BARS

Texas Department of Transportation

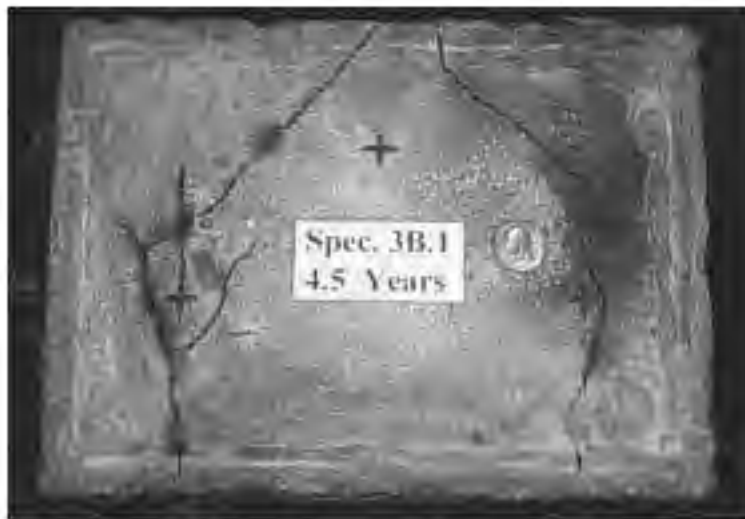
All specimens with uncoated bars underwent extensive deterioration after 4.5 years of exposure, including concrete cracking, rust staining, and surface scaling, as shown in Figures 2.7 and 2.8. The first outward signs of corrosion became apparent after about 100 days of exposure. The large bar specimens, in particular, showed minor brown spots on the concrete surface around the protruding ends of top bars. After about 170 days of exposure, larger brown stains were apparent at the same locations. Rust staining on the top concrete surfaces was visible after about 200 days of exposure. The small bar specimens

showed staining on the top concrete surfaces after about 330 days of exposure. Rust stains were of different sizes and colors (light to dark brown, reddish and orange brown) and generally formed along cracks on the top surface. Their appearance constantly changed during exposure. At different periods during the third and fourth years, fine orange brown rust powder exuded on the surface, especially on cracks. The top surface of all control specimens had an overall yellowish appearance, probably due to contamination by dissolved rust products in the solution.

Figure 2.7 Surface condition of specimen with uncoated bar.

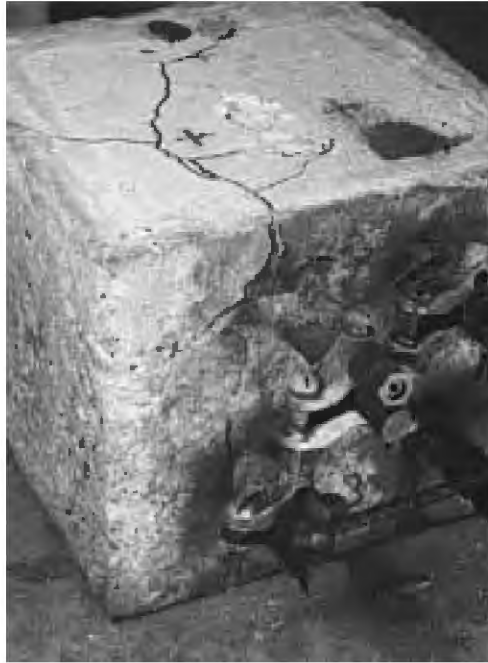
In all cases, cracks propagated on the front face above the protruding bar legs. In specimen 3A1 (13-mm bar with parallel ribs) horizontal cracking developed on the front face between the 2 bar legs, which is a symptom of concrete delamination. In specimen 3A8 (13-mm bar with cross ribs), the crack above the left bar leg propagated on the front face all the way down to the bottom of the specimen and was visible at the bottom surface, along the left cathodic bar (Figure 2.8). Horizontal cracks appeared on the two lateral surfaces of specimen 3B1 (25-mm bar with parallel ribs) at a section slightly below the top bar location. The maximum crack width was 1.0 mm in specimens with 13-mm bars and 1.25 mm in specimens with 25-mm bars.

Figure 2.8 Surface condition of specimen with uncoated bar.

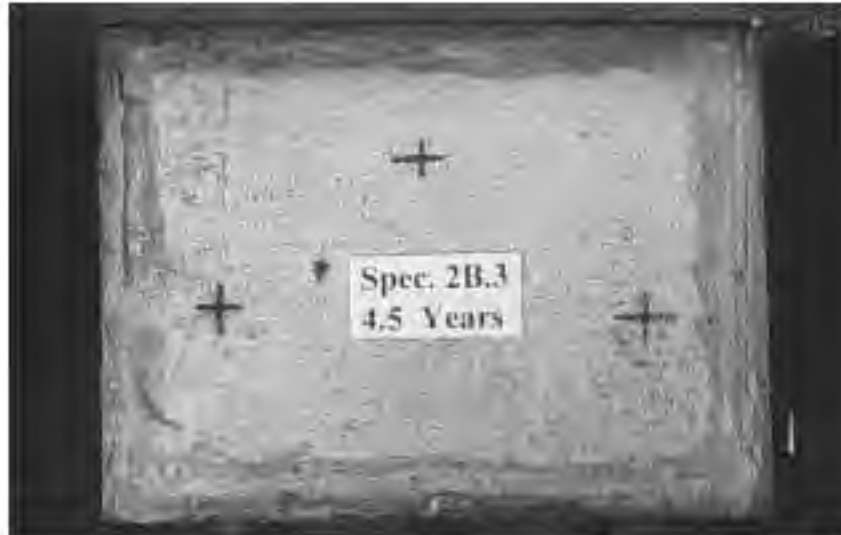
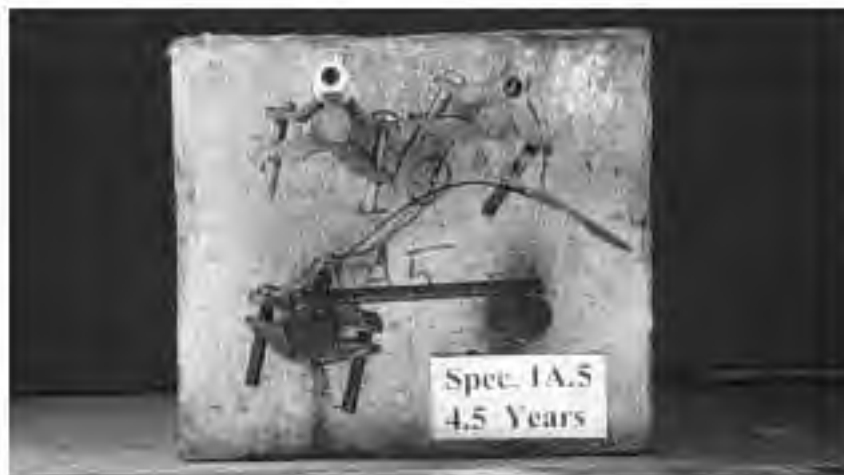
Figure 2.9 Surface condition of specimens with coated bars.

Unlike specimens with uncoated bars, specimens with coated bars maintained very good surface conditions after 4.5 years (Figure 2.9). Some specimens cracked but widths were narrower than in control specimens. Twenty percent of specimens with 13-mm bars and 80% of specimens with 25-mm bars developed cracking. In the first two years of exposure, none of the epoxy-coated bar specimens showed surface staining or cracking beyond the plastic settlement and shrinkage cracks detected at the beginning of the test. These initial cracks are described in Appendix A.

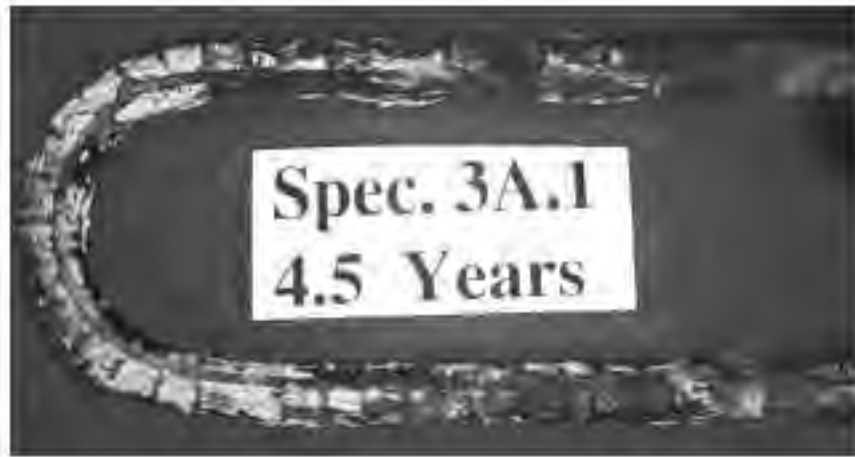
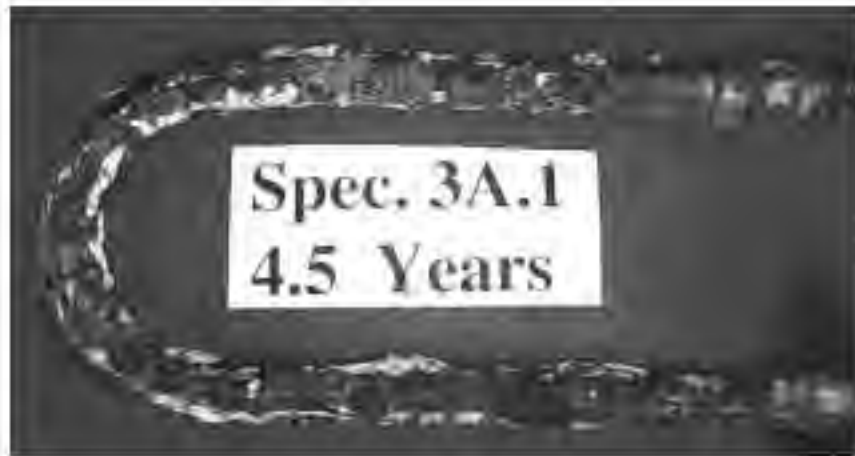
Figure 2.15 Uncoated bars after autopsy.

The uncoated bars showed relatively high levels of corrosion with discernible extensive degradation and localized loss in section, especially after 4.5 years. Figure 2.15 shows the top and bottom sides of one uncoated bar after removal. Immediately after opening the specimens, corroded metal had a black or dark appearance with randomly distributed areas of reddish-brown rust and several smaller areas of dark-green and bluish-green rust. After being exposed to oxygen, all dark- and bluish-green areas changed to bright orange-brown or yellowish-brown rust.

The accumulation and build-up of rust products was evident in the most corroded areas. Corrosion was concentrated mostly at the straight portions of the bar, exhibiting appreciable loss of metal and pitting (Figure 2.16). On bent areas, a relatively clean, non-corroded metallic surface was visible over most of the top half of the bar and over a portion of the bottom side. After 1 and 2 years, more pitting corrosion occurred on the top side than the bottom side of the bar. However, corrosion spread more on the bottom side than on the top side of the bars after 4.5 years. Larger bars were more severely attacked than the smaller bars.

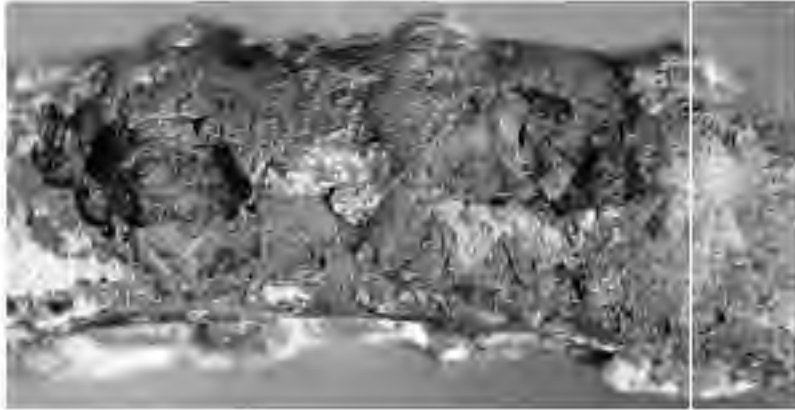
(a) Severe pitting on 25-mm (#8) uncoated bar after 2 years of exposure.

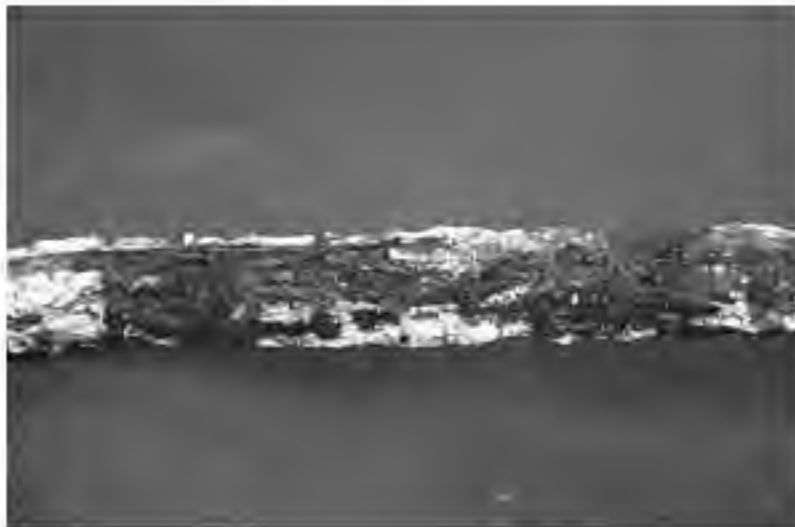
Pitting corrosion worsened after 4.5 years of exposure. Several large pits, ranging from 0.5 to 2.0 mm deep, developed on the straight legs of both 13-mm bars [(Figure 2.16(b)], outside of the bent portion on a 13-mm bar with cross ribs, and on the right side of the bent portion in a 25-mm bar with parallel ribs. A large, deep pit on the top side of a 13-mm bar with parallel ribs caused a significant reduction in bar area at that location.

(b) Severe metal loss and pitting at straight leg of 13-mm (#4) uncoated bar after 4.5 years of exposure.

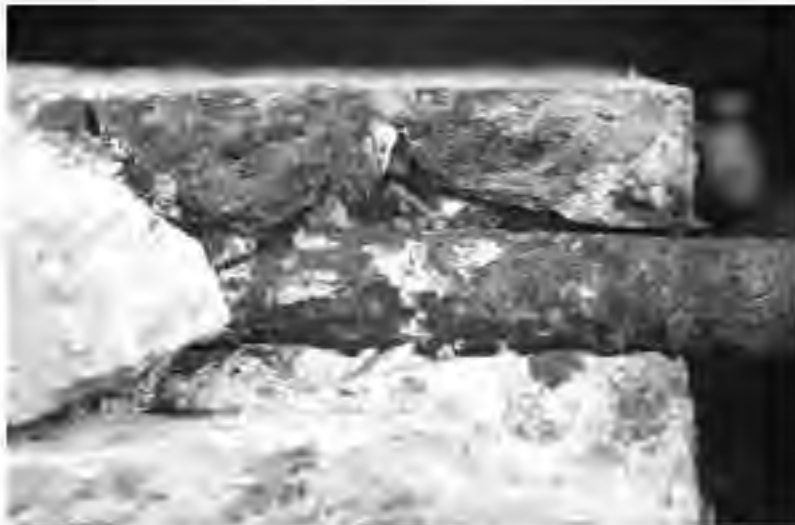
(c) Pitting at straight leg of 25-mm (#8) uncoated bar after 4.5 years of exposure.

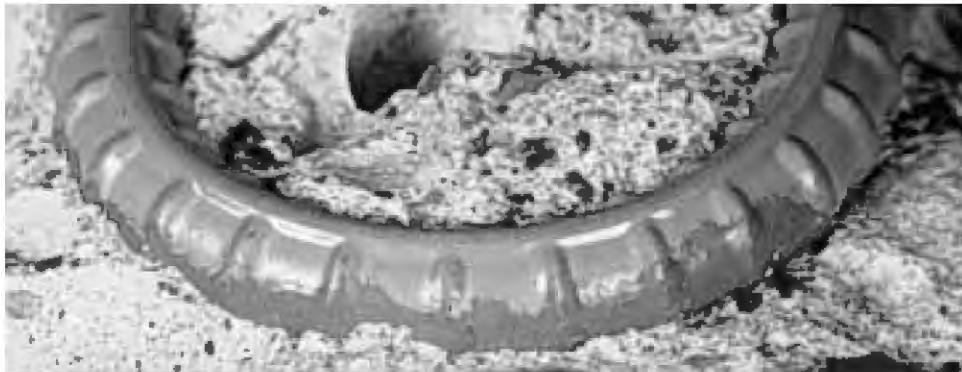
(a) Specimen 1A.4

After one year of exposure, the small coated bars showed either no apparent corrosion or minor surface corrosion on the introduced damage and other defective areas of coating (inside and outside of bend). Figure 2.17 shows two examples of the 13-mm (#4) bars exposed for one year. At the damaged locations, steel was only discolored or had suffered minor (shallow) loss of metal.

Figure 2.17 Examples of 13-mm (#4) coated bar specimens autopsied after one year of exposure.

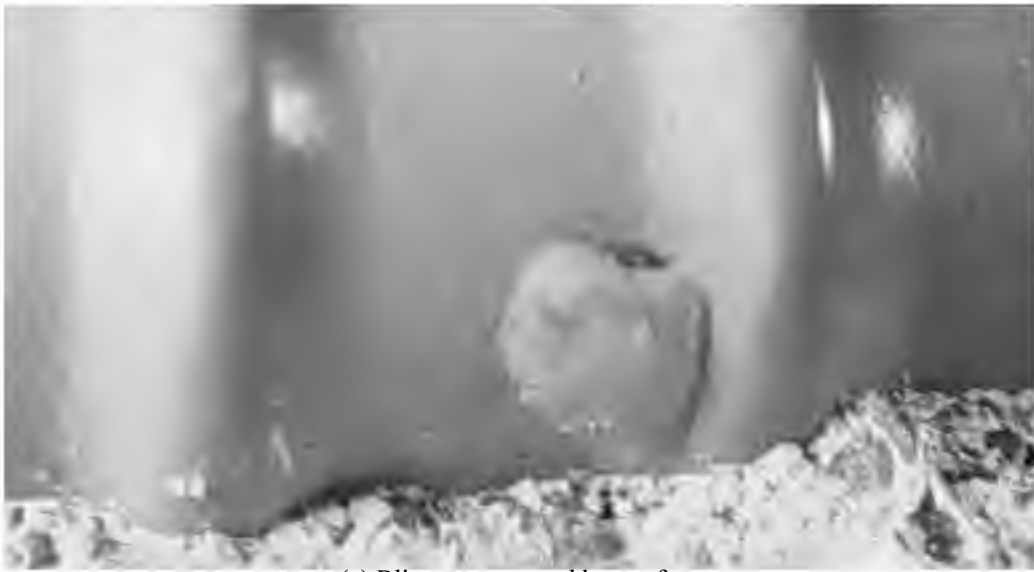
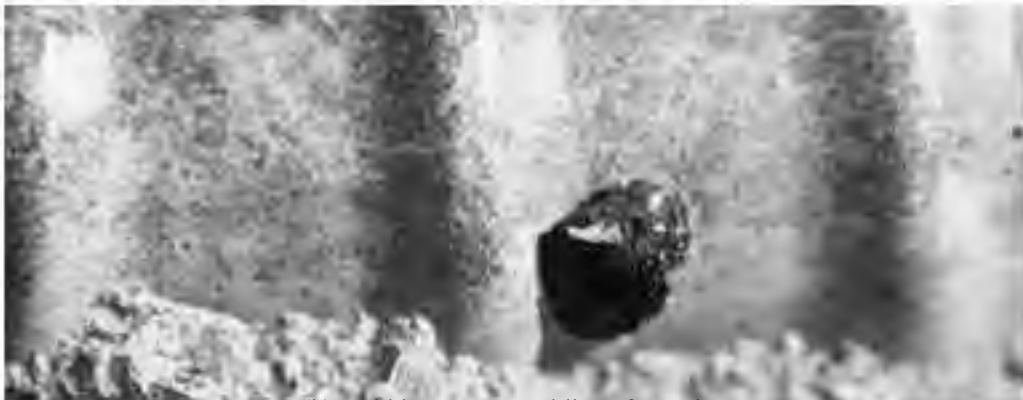
The large bars showed relatively more corrosion activity; however, metal loss was minor as shown in Figure 2.18. Rust spotting at some patched areas was visible. On the majority of the large bars, many variable size blisters distributed on the coated surface were noted. The blisters formed at spots facing air voids in concrete as shown in Figure 2.19. Based on appearance, the worst bars, from both series, were those with exposed damaged areas slightly exceeding 2% of the bar surface area.

Figure 2.19 Coating blistering at voids in concrete.

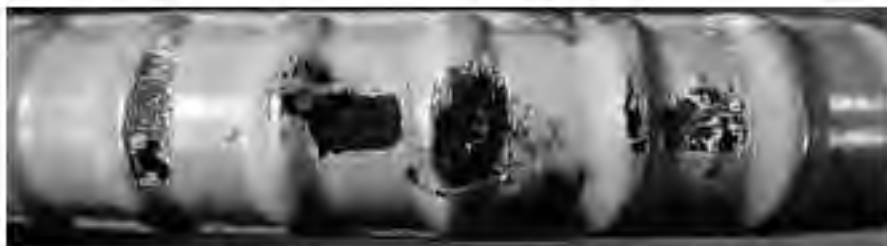
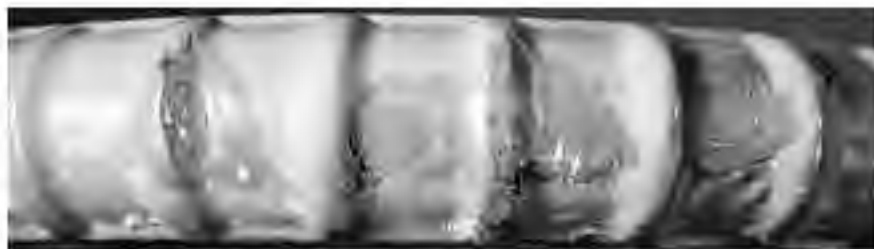
More corrosion activity was visible after two years than after one year. After two years, it was clear that pitting corrosion was occurring on the exposed areas of some specimens. Rust spotting at some patched areas was also observed, particularly on the larger size bars. These observations are illustrated in Figure 2.20. Again, blisters of variable sizes formed on the coated bar surface at locations facing voids in concrete. These voids were more concentrated on the underside of the bar as shown in Figure 2.21. The blisters were also much more apparent after two years than after one year for the corresponding specimens indicating further breakdown of the coating with longer exposure. Figure 2.21 shows a bar with many blisters formed on the bottom side.

(a) Pitting corrosion on specimen 3B.3

(b) Rust spotting on specimen 1B.2

Figure 2.20 *Examples of 25-mm (#8) coated bar specimens after two years of exposure.*

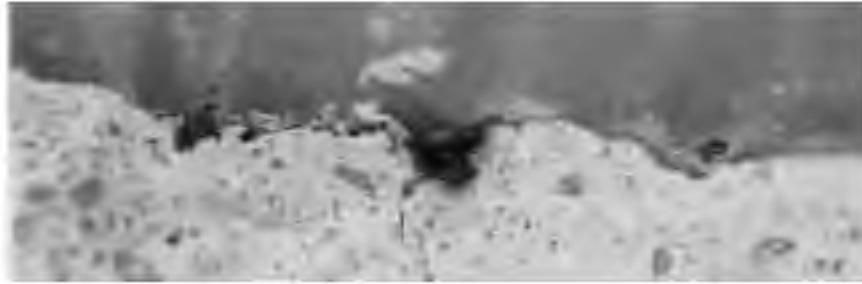
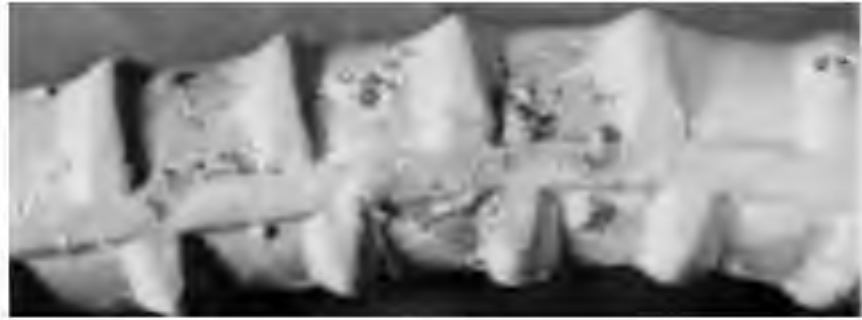
(a) Specimen 3B.7

(b) Specimen 2B.5

Figure 2.21 *Blister formation at bottom side of coated bars after two years of exposure.*

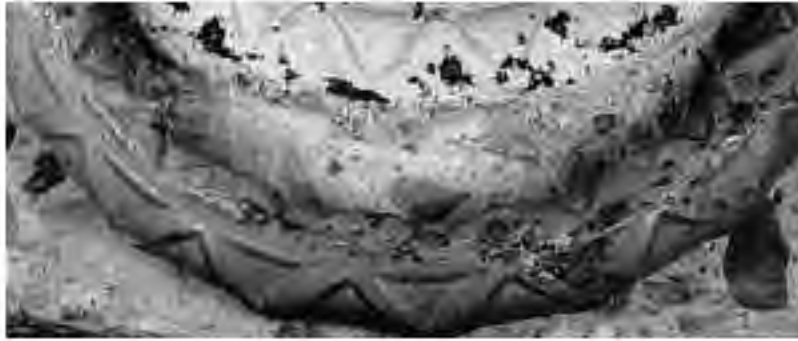
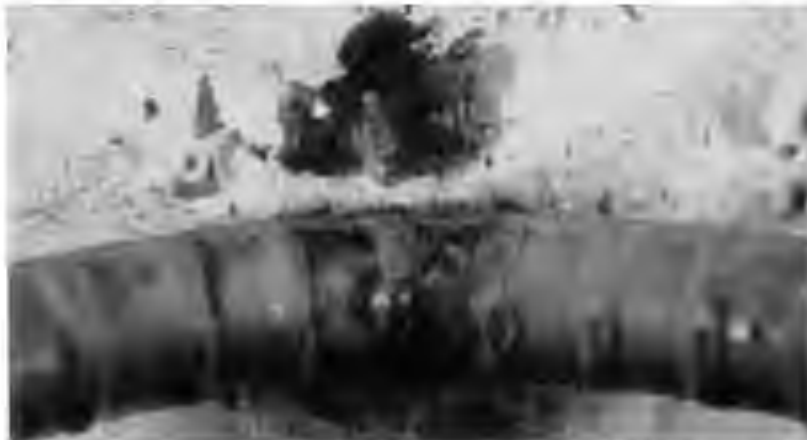
(a) Specimen 3B.10 (bottom side facing up)

(b) Specimen 2B.5 (inside of bend facing up)

Figure 2.22 *Rust spotting on bottom sides of coated bars coincident with voids in concrete.*

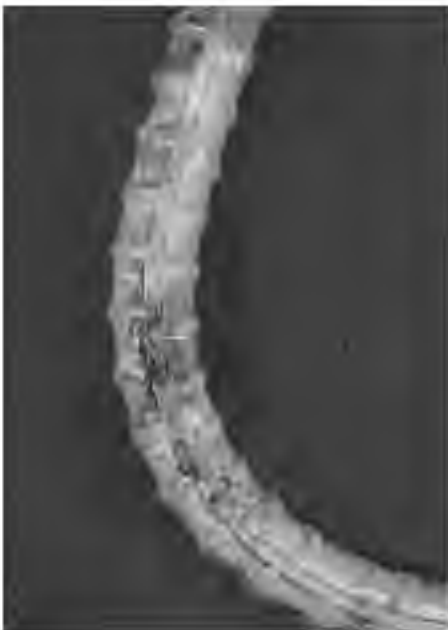
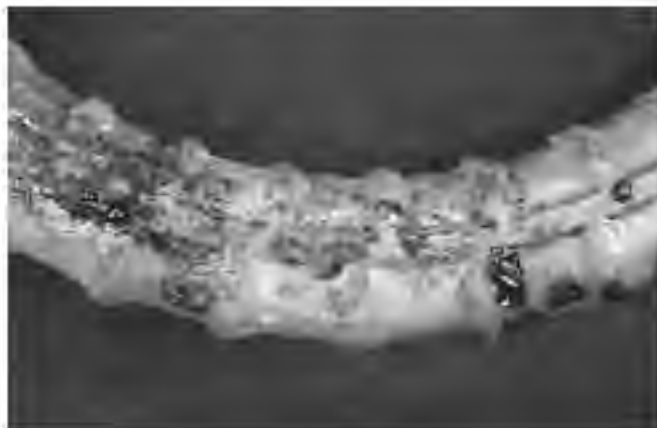
As expected, corrosion of coated bars progressed with time. Corrosion was more extensive after 4.5 years, especially in larger bars. Rust staining, coating blistering, and corrosion of exposed areas were noted (Figure 2.23). The color of rust stains ranged from dark to light brown, and their appearance varied from dense to tenuous. Blisters of different sizes formed but small ones were prevalent. In some bars, a few small stain lines with dull appearance (indicating coating distress or cracking) were detected next to longitudinal lugs. Corrosion did not always occur at the damaged, exposed areas of smaller bars. In contrast, all exposed areas of larger bars corroded severely. Rust at damaged spots on the outside of the bend was uniformly dark. Traces of bright or dull reddish-brown rust were found inside the darkly rusted damaged areas. At some of the damaged spots, metal depletion was evident. Traces of acidic (pH = 3) brown solution were observed on several damaged areas. In contrast, generally minor corrosion was observed on patched areas. Patched areas were frequently discolored, had medium-sized to small dark-brown or reddish-brown rust spotting, and tiny blisters (See Figure 2.29 later in Chapter). Fine reddish-brown rust products (in small amounts) were deposited at several patched spots.

(a) Rust staining and blistering on epoxy-coated bar.

(b) Rust staining and exudation of brown liquid on epoxy-coated bar.

Figure 2.23 *Corrosion of epoxy-coated bars after 4.5 years of exposure.*

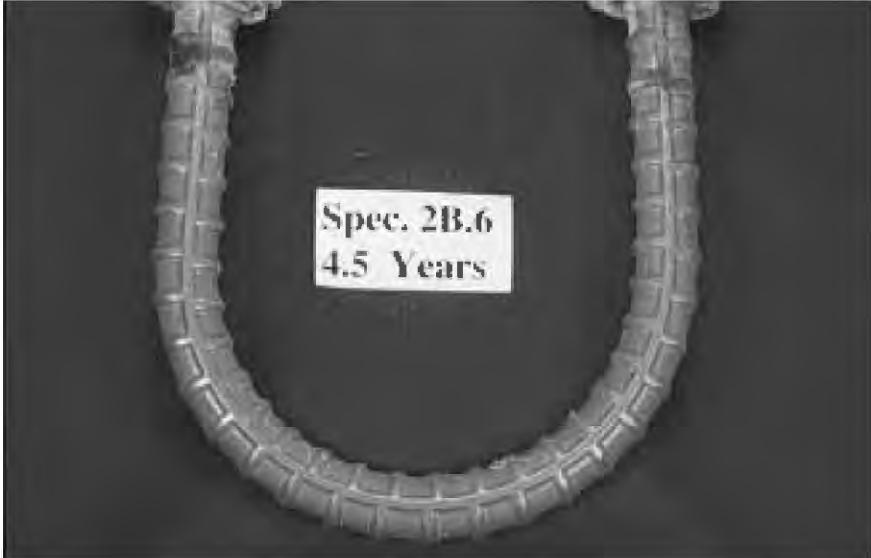
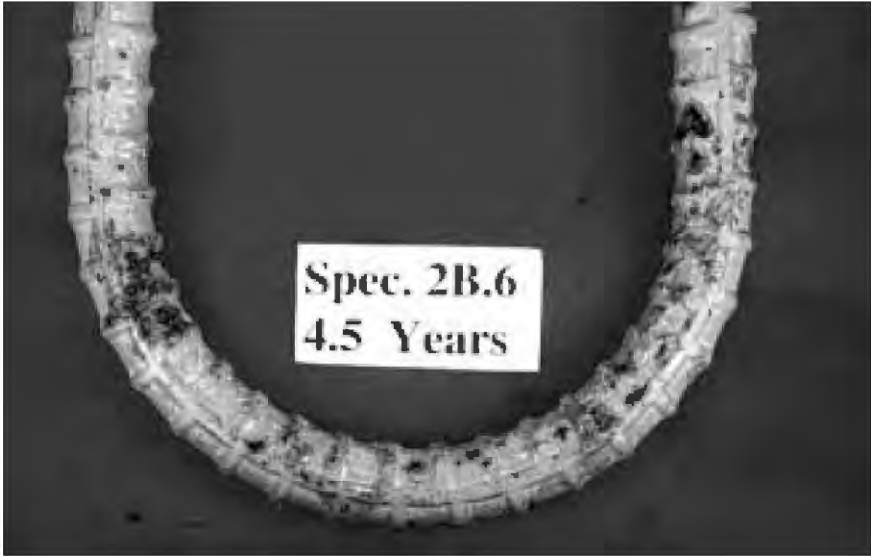
Except for bar 3B.5 (25-mm bar with damage greater than 2%), all bars experienced more rust staining or spotting and blistering on the bottom surface than on the top (Figure 2.24). In most cases, more corrosion developed on the bent area than on the straight portions. Blistering and rust staining tended to concentrate next to the longitudinal lugs. Most damaged areas on the inside of the bend (produced by the mandrel during fabrication) did not show much corrosion, only superficial rusting. There was almost always a void in the concrete where a blister formed. However, corrosion did not occur at all voids. As with 1-year and 2-year specimens, smaller bars corroded less than large bars.

Figure 2.24 Appearance of top and bottom sides of epoxy-coated bars.

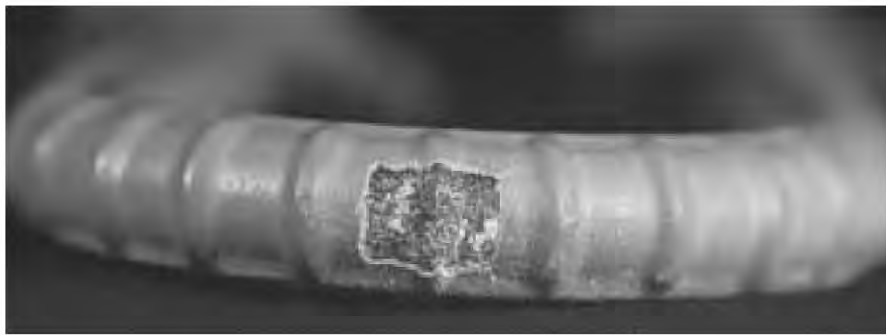
In group A (smaller bars), bar 1A.5 (damage > 2%) experienced the most corrosion, followed by bars 2A.6 (cracks with damage < 1%), and 1A.10 (damage > 6x6mm). There were traces of dark rust along coating cracks of bar 2A.6. The coating condition on remaining bars was good with few rust stains and blisters. The bars with the best appearance were 3A.3 (damage > 6x6 mm) and 3A.7 (damage < 2%). It was a significant contrast to find that the exposed steel areas at damaged spots in specimens 3A.3 and 3A.7 were completely free of corrosion after 4.5 years of exposure and displayed a shiny, bright surface (Figures 2.25 and 2.26). No voids were visible in the concrete adjacent to the exposed areas. The overall condition of bars 3A.3 and 3A.7 away from the damaged areas was good, with only a few blisters and small brown stains.

Figure 2.25 Clean, uncorroded damaged area after 4.5 years of exposure (Bar 3A.3).

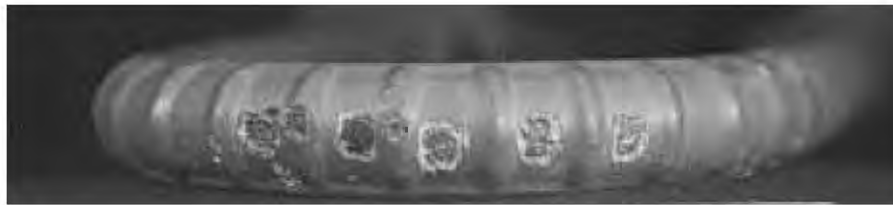
Figure 2.26 Clean, uncorroded damaged areas after 4.5 years of exposure.

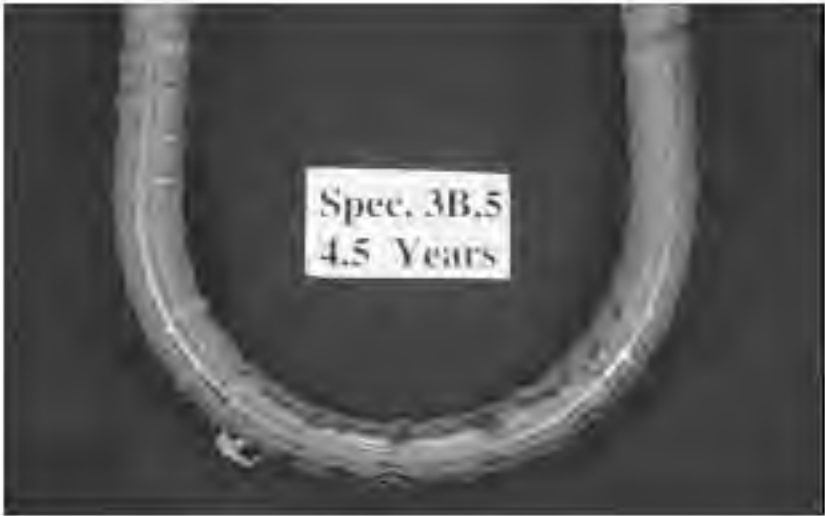
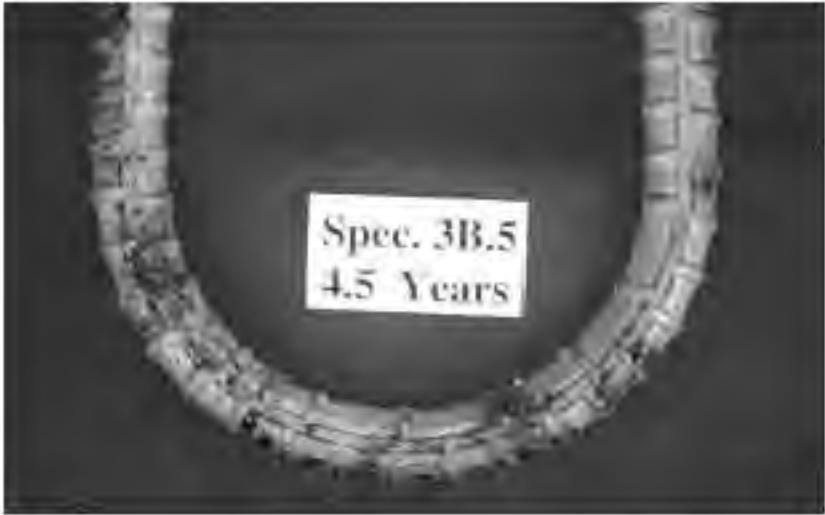
In group B (larger bars), bars 2B.3 (damage > 6x6 mm), 3B.5 (damage > 2%), and 1B.7 (damage < 2%) exhibited the highest corrosion. Dark, dense stains formed on the top portion of bar 3B.5 [Figure 2.27(a)]. Diluted, dark and brownish stains appeared at the bottom side around the bent zone and on one bar leg [Figure 2.27(b)]. Damaged areas at the outside of the bend had a dark rust accumulation (Figure 2.28). For comparison, Figure 2.29 shows the appearance of patched areas at the outside of the bend on box 3B.4.

Figure 2.27 Bar 3B.5 after 4.5 years of exposure.

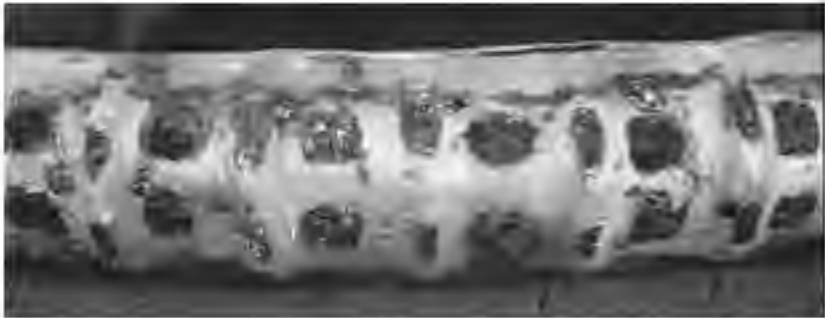
Figure 2.28 Corrosion of damaged areas at outside bend on bar 3B.5.

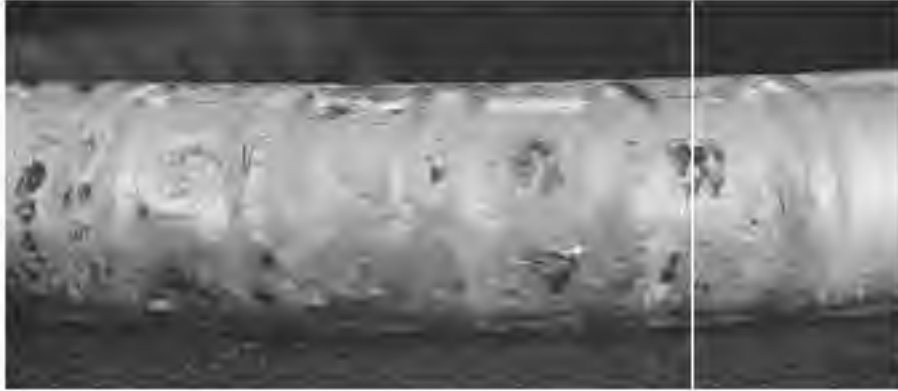
Figure 2.29 Corrosion of patched areas at outside bend on bar 3B.4.

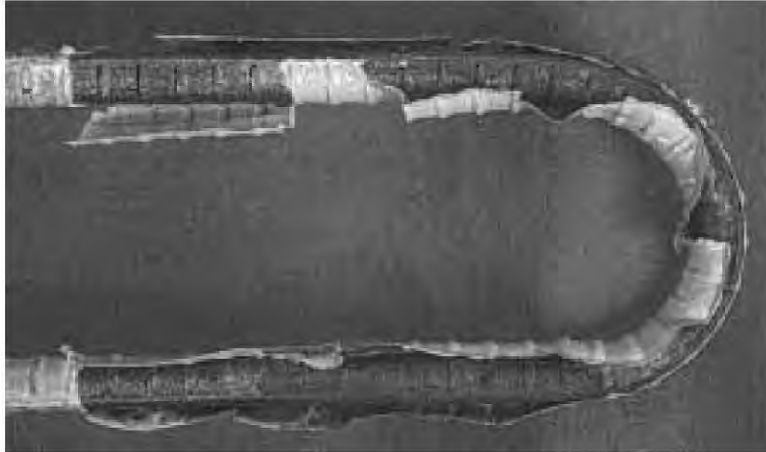
Scraping the coating after two years was easier than after one year and resulted in larger chipped off pieces. The extent of coating debonding after 4.5 years was slightly greater than after 2 years. Extensive adhesion loss was observed more frequently on large bars than on small bars. Four small bars developed complete coating debonding throughout their whole length (bent and straight zones). At the remaining

small bars, debonded areas included the bent zone and an adjacent portion of the straight bar legs. Coating adhesion was preserved in the portion of straight bar legs closer to the protruding ends, away from the bent zone (a 4- to 7.5-cm stretch extending from the front face). In contrast, all large bars experienced complete loss of adhesion throughout their length. Only in bar 1B.7, a short piece of coating (about 2.5 cm long) adjacent to the protruding end of one leg remained adhered to the steel substrate.

Figure 2.34 Coating debonding on 13-mm (#4) bar.

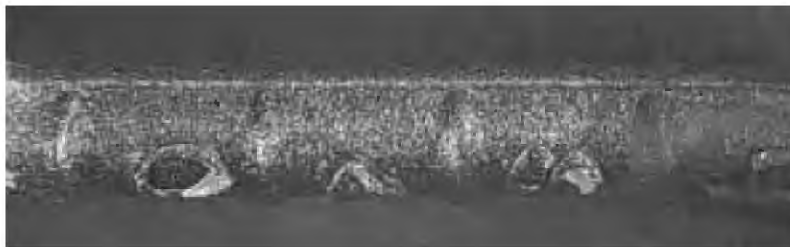
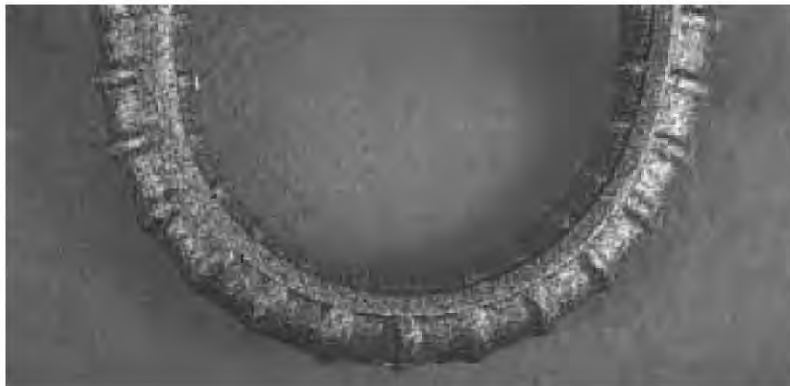
The designation of “non-corroded” is possibly a misnomer because corrosion may be in an initial stage. The steel surface showed a very unique characteristic: A sort of a mottled, glittery or twinkling appearance with a golden-brown or similar brownish color. An example of such a surface is illustrated in Figure 2.35. The condition of such steel surfaces was very good, with no discernible pitting or metal attack. The term “non-corroded” was used to describe the good condition of the steel. The loss of coating adhesion, though, may indicate that corrosion may already be in early stages. Mottled surfaces were found mainly in the less corroded small bars and occurred more often at straight bar legs than at bent zones. Debonded areas with mottled surfaces underneath were suspected to have undergone cathodic disbondment, as will be explained later.

Figure 2.35 Mottled, glittery surface with golden-brown (or similar brownish) appearance under the coating.

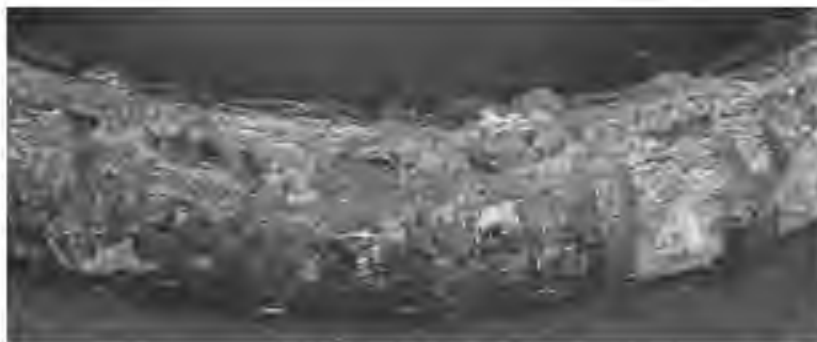
The appearance of corroded surfaces varied from bar to bar. In most cases, a uniformly black or dark rusted surface developed. The degree of darkness varied from specimen to specimen and it also changed with time for the same specimen. In several bars, the corroded surface looked darker one or two days after the coating was removed. Depending on the length of exposure and severity of corrosion, shallow pitting and metal depletion, rust volume increase, and blistering may have developed in varying degrees (Figure 2.36). In many specimens, spots of whitish matter with pasty consistency, sometimes combined

Figure 2.36 Shallow pitting and accumulation of rust products on steel surface under the coating (outside bend).

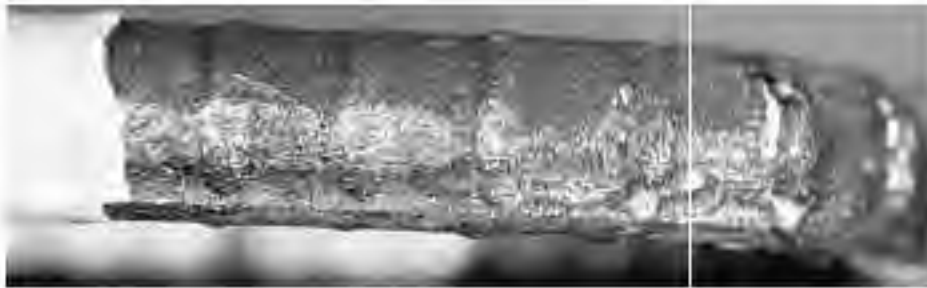
After two years, specimens showed moderate underfilm activity and pitting. There was a clear distinction between the appearance of the top and bottom sides of the bar. The top side was black, and sometimes moist, while the bottom side was dull with sporadic rust spotting as shown in Figure 2.38. Even the patched large bars showed surface darkening with minor metal loss or slight pitting as shown in Figure 2.39. Whitish and orange residue was occasionally observed in some pockets forming alongside the bottom continuous rib as shown in Figure 2.40. The blisters were often full of corrosion products and some had an acidic (pH 2 to 4) trapped solution. Figure 2.41 shows a close up of the solution detected underneath the coating.

Figure 2.38 Thin black layer on top side of steel surface.

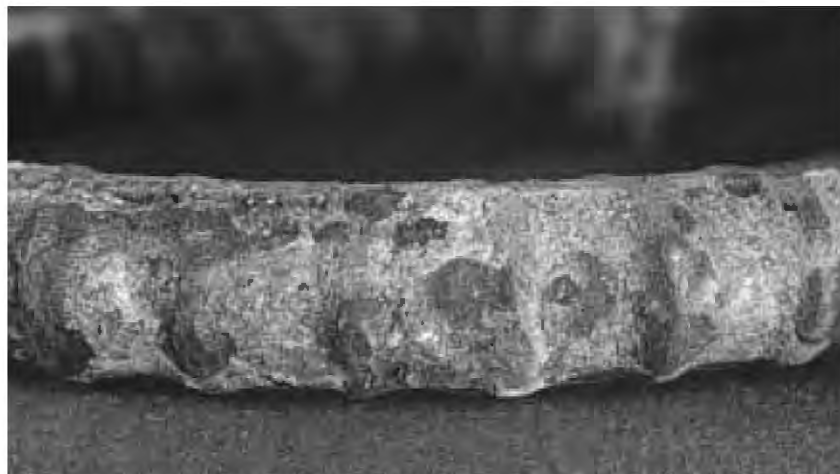
Areas with rust deposits or pockets of varying size, shape, appearance, color, and amount were usually present along the bar surface above the uniform black rusted surface (Figures 2.42 and 2.43). The size of such rust spots ranged from very large, occupying large areas of the bar surface, to small flecks. Appearance of rust spots was dependent on rust concentration, varying from a light film of rust, similar to a stain, to thicker layers of rust deposits. Rust layers at some spots were bulky enough to cause a bulge in the coating, but in most instances, rust amounts in such areas were light. At the time of autopsy, whitish products were the most prevalent. After a few days of being exposed to air, more commonly found colors were light-brown, reddish-brown, orange-brown, and yellowish-brown. Many of the larger and medium-sized rust stains often had shapes with clearly delineated boundaries, giving the appearance of traces or remains of a solution (Figure 2.43). Several rust spots or stains appeared to be wet. In one case (bar 3B.5), a silver-colored stain was detected (top side of bar between bent zone and right straight leg) immediately after removing the coating. One hour later its color changed to whitish, and 2 days later changed to dull-brown and orange-brown. At the bottom side of bar 1A.5, a whitish substance found alongside a longitudinal lug (bent zone and straight right leg) turned yellowish-brown a few hours after coating removal. Such matter was deposited along a strip, giving the appearance of a solution trace (Figure 2.44).

Figure 2.42 Various rust products above uniformly black corroded surface under the coating.

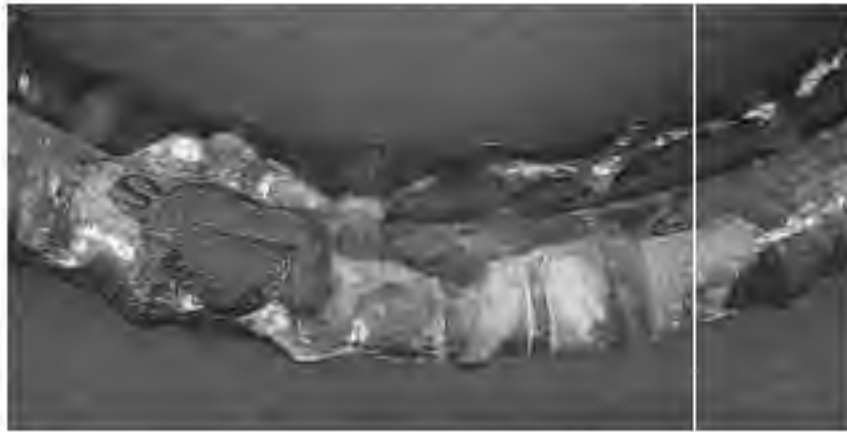
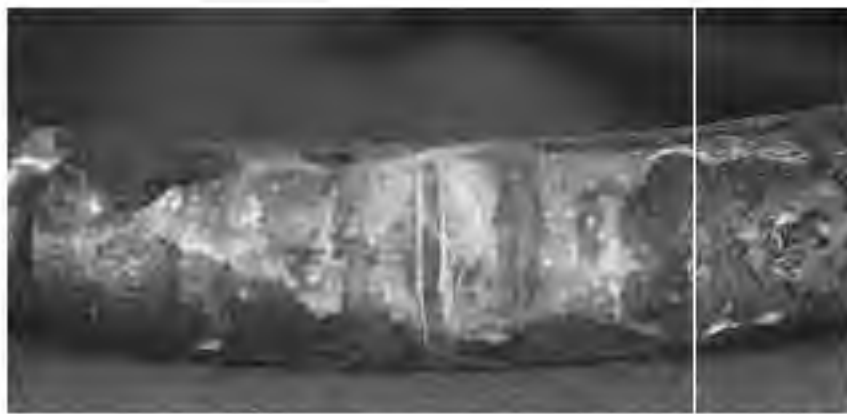
Figure 2.43 Rust products or stains with clearly delineated boundaries, with the appearance of solution trace.

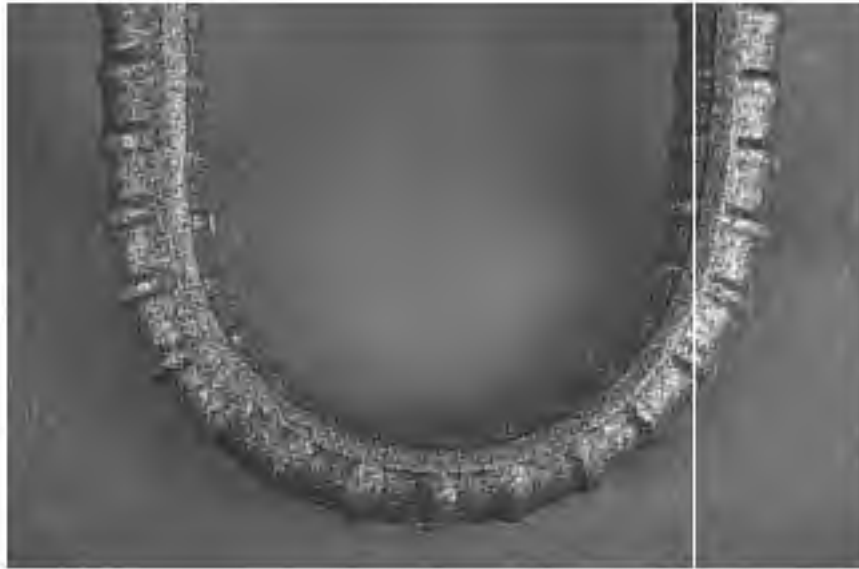
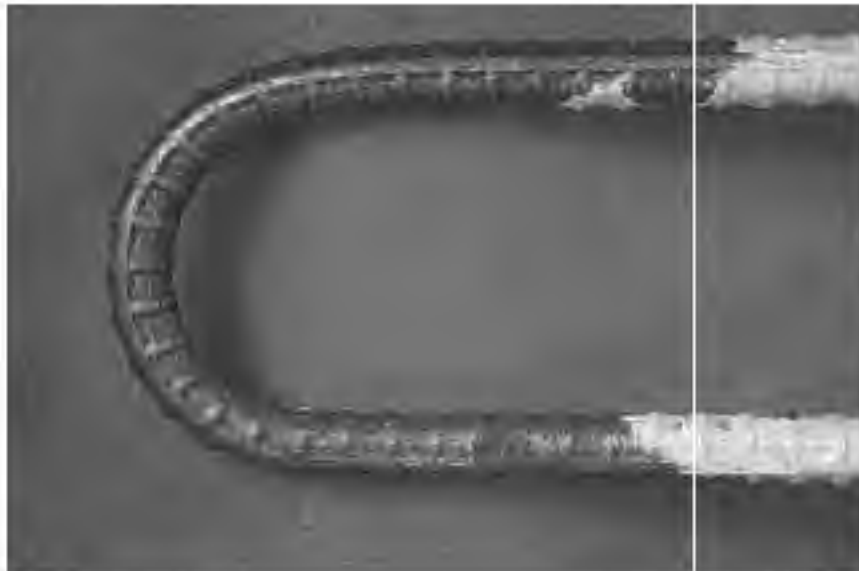
Among smaller bars, specimen 1A.5 (damage > 2%) suffered the worst corrosion (Figure 2.45), followed by bars 2A.6 (cracks with damage < 1%) and 1A.10 (damage > 6x6 mm). The bar with best condition was, amazingly, 3A.3 (damage > 6x6 mm) (Figure 2.46), followed by bar 3A.7 (damage < 2%). Among larger bars, specimen 3B.5 (damage > 2%) suffered the worst corrosion (Figure 2.47), followed closely by bar 3B.4 (damage > 2%, patched). The extent and severity of corrosion was similar for the remaining bars. Interestingly, in bars with damage greater than 6x6 mm, corrosion spread much more on the repaired bar (3B.2) than on the unrepaired bar (2B.3).

Figure 2.46 Steel surface condition beneath the coating of bar 3A.3.

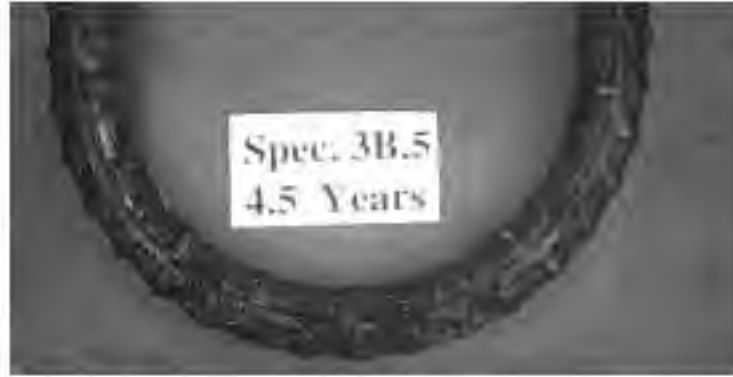
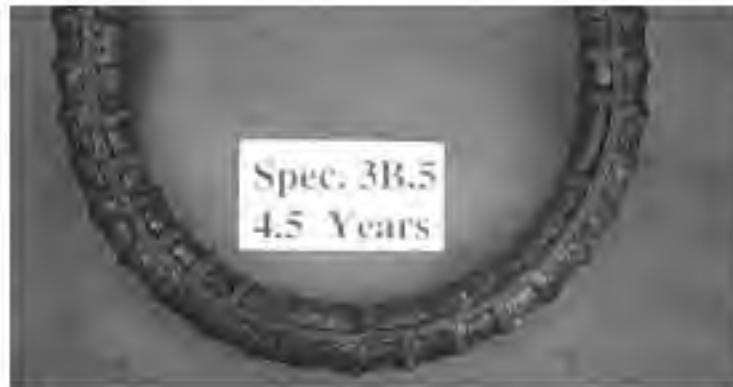
Figure 2.47 Steel surface condition under the coating of bar 3B.5.

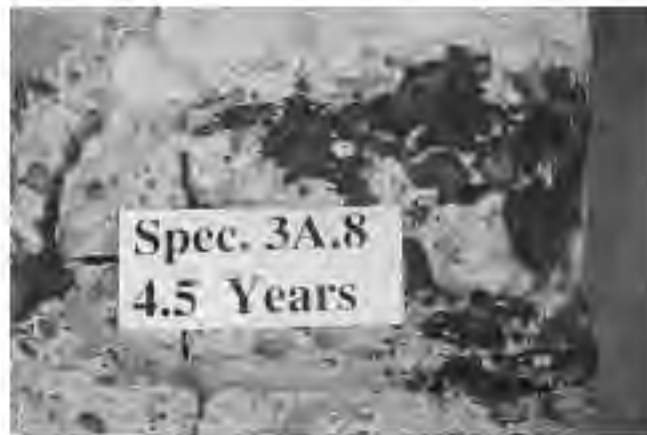
Concrete surrounding the top bar (above and below the bar) was extensively rust stained (Figure 2.48). Rust stains were very large, mostly black or dark and reddish-brown colored. Sometimes, reddish-brown stains had a black rim. Other observed stains were bluish, bright orange, brownish, yellowish-brown, and whitish. In specimen 3B.1, a few dark-greenish spots were observed immediately after autopsy, and hours later turned bluish or dark. In specimens with small bars, concrete around straight bar legs experienced more rust staining than concrete around the bend zone. Black and reddish-brown rust usually accumulated and hardened in concrete above straight bar legs. Staining distribution seemed more uniform in concrete around large bars. Rust staining was more extensive in concrete above smaller bars, especially in the portion closer to the front face of the specimen, where stains penetrated the concrete far beyond the bar location at either side or both sides of bar legs (Figure 2.48). Rust staining was more extensive in concrete below large bars. In general, rust stains penetrated the concrete far beyond the bar location along different portions of the bar. Stains penetrated cracks and expanded towards the top concrete surface (Figure 2.49). Rust staining was mostly reddish-brown and orange-brown at areas closer

Figure 2.48 *Rust staining on surrounding concrete under uncoated bar 3A.8.*

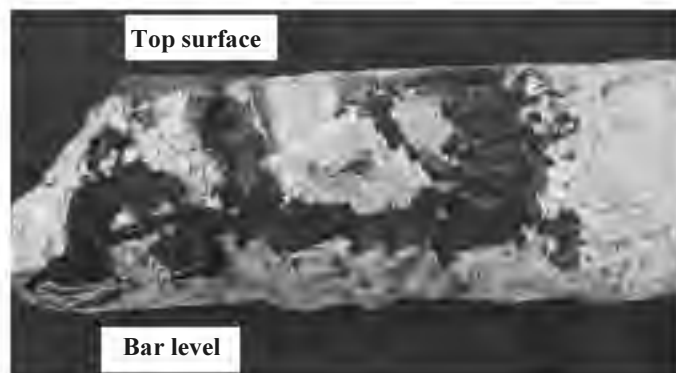
Figure 2.49 *Rust products penetrated through cracks and rose to the upper surface in specimens with uncoated bars.*

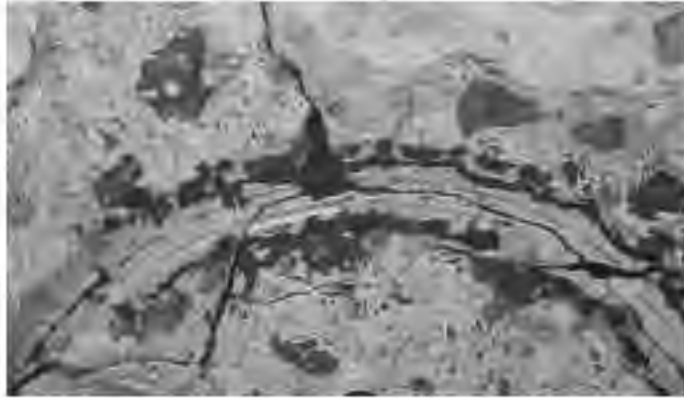
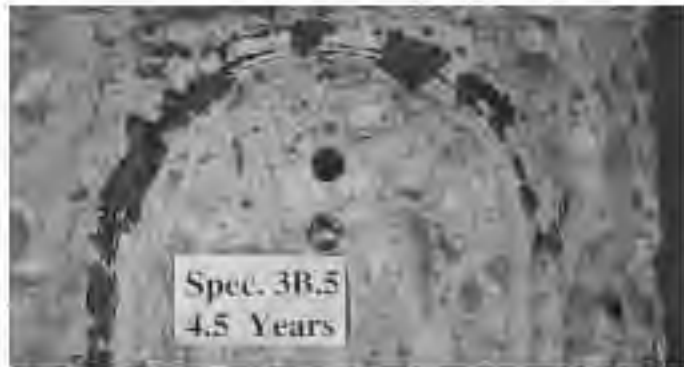
Figure 2.50 Bar trace in concrete of specimens 3B.5.

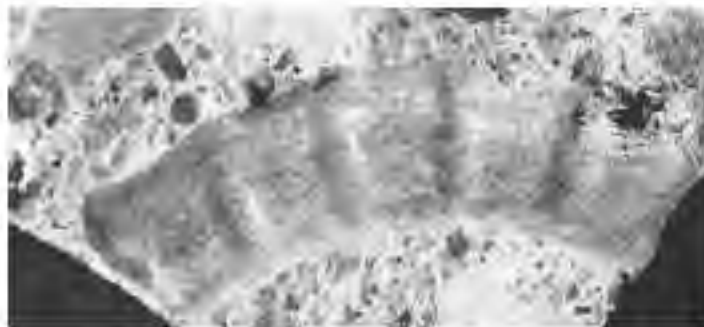
The bar trace in concrete above epoxy-coated bars consisted of a smooth, shiny, glossy surface with a grayish-like appearance, the rib imprints were clearly defined, and there were few voids (Figure 2.51). The bar trace in concrete below epoxy-coated bars had a whitish-like appearance, looked more dusty and porous with presence of laitance, and had much more voids of different size (Figure 2.52). Sometimes white deposits, probably salt, accumulated on the underside bar trace as shown in Figure 2.53. Chemical adhesion to concrete was lost, as evidenced by the ease with which the bar was removed from the concrete and lack of concrete adhering to the bar. Only a film of white dust from the concrete paste adhered to the bottom of the bars.

Figure 2.51 Bar trace on top of coated bar in concrete.

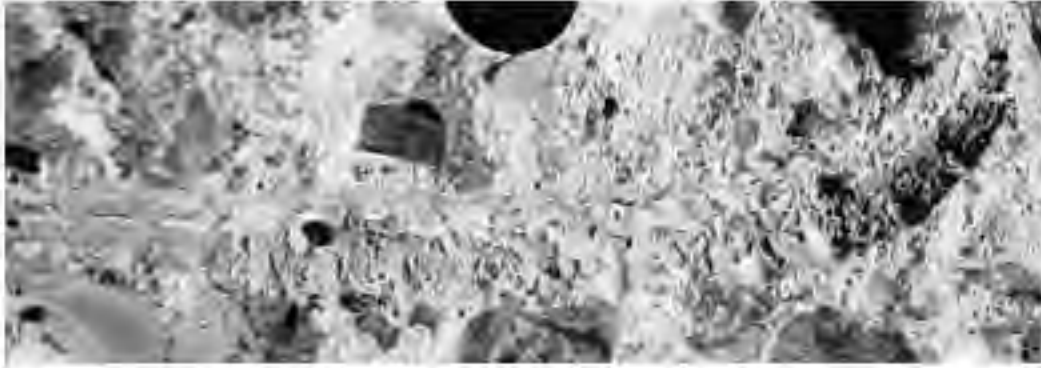
Figure 2.52 Bar trace on bottom of coated bar in concrete.

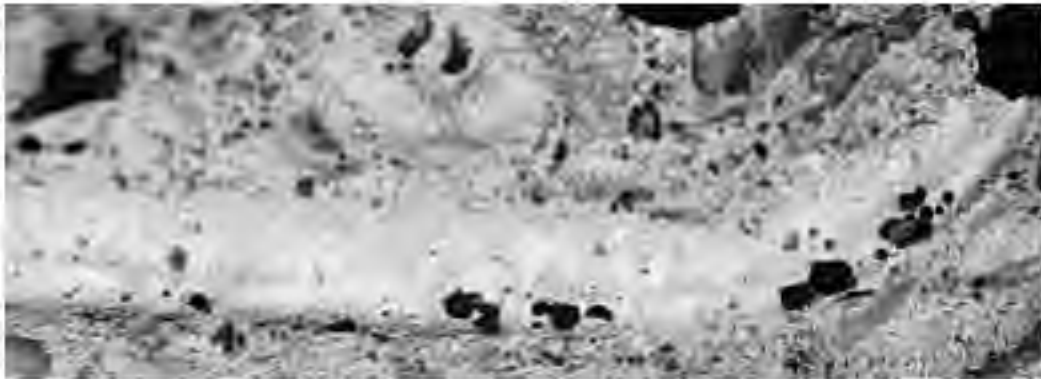
Figure 2.53 White deposits accumulated under coated bar.

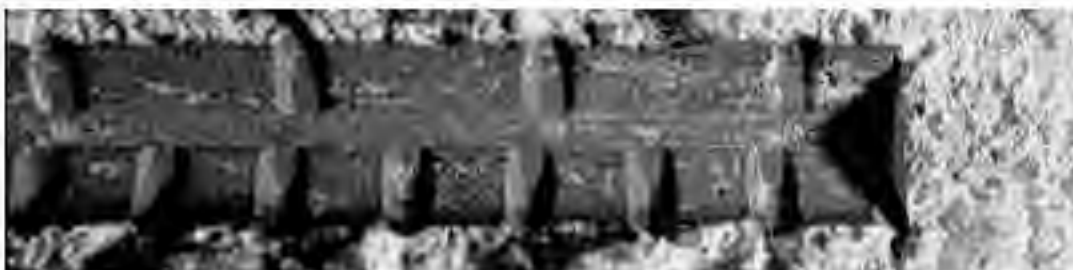
The trace of uncorroded bars in concrete had a grayish-like appearance, with a darker gray within 1.0 to 2.0 cm from the front face. This appearance was probably the result of the alkalinity produced by cathodic activity at the steel surface. Concrete at the top side of the bar was smoother with few concrete voids. Concrete on the bottom of the bars was more porous with many more voids. Figure 2.54 shows the cathodic bar imprint in concrete.

Figure 2.54 Cathodic bar trace in concrete

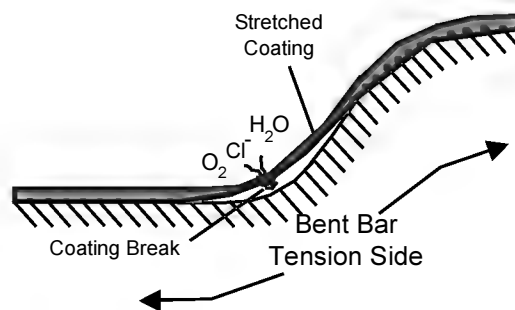
There are indications that coating bond strength to steel is weakened by fabrication. Bending coated bars causes stretching of the coating at the rib bases (rib-bar intersections) on the outer surface of bend. The regions at the rib bases of the test bars seemed slightly discolored which indicated thinning of the coating and a tendency for debonding. A study has demonstrated that coating films are consistently thinner at deformation edges than in the areas between the deformations.³⁶ The difference in coating thickness averaged about 23 μm (0.9 mils) for straight bars, and about 55 μm (2.2 mils) for bent bars.

The initiation of corrosion activity in thin film regions is a consequence of holidays. This is a common observation in corrosion studies.³⁶ A thin film spot is a point of weakness where holiday formation is most likely to occur. The indicators to debonding are the micro-tears in the coating and the more noticeable cracking. Cracks in the coating on specimens from groups A.6 and B.6 were produced during fabrication. Even if the film remained unbroken, it probably allowed oxygen and water to cross the film. With debonding, the condition became worse; moisture and oxygen were retained beneath the coating and corrosion was more likely to initiate. Fabricated bars became more vulnerable and susceptible to corrosion at the bent zones. Figure 3.18 illustrates stretching and debonding in the rib base region on the outside of bend.

Figure 3.18 Coating thinning and debonding at rib/bar interface.
