**CORROSION PERFORMANCE OF EPOXY-COATED
REINFORCEMENT–MACROCELL TESTS**

Research Report No. 1265-3

STRUCTURAL INTEGRITY OF EPOXY-COATED BARS

Texas Department of Transportation

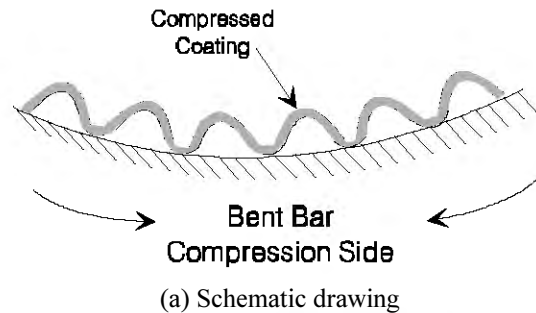
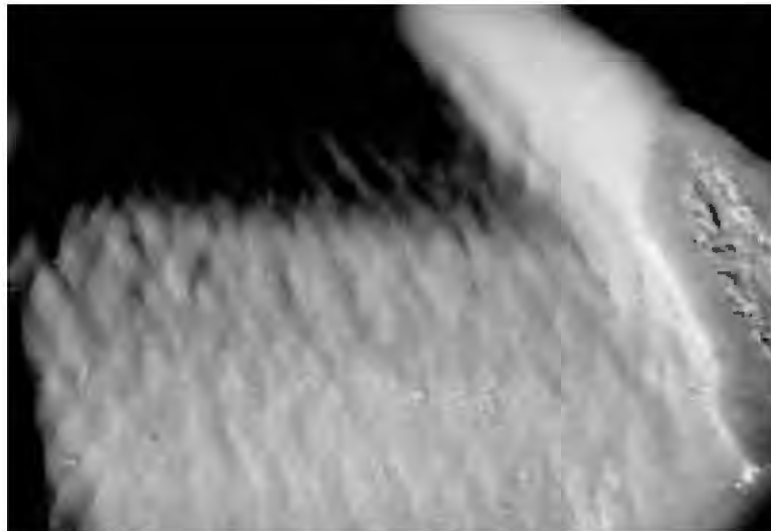
Damage on the inside of bend is usually neglected mainly because the region is compressed instead of stretched. However, coating debonding may still occur. Bending a coated bar generates high shear stresses at the steel/coating interface on both sides of the bend. The stresses may break the adhesion creating paths for oxygen and water migration to the debonded region. Figure 3.19 shows the microscopic ripples that form on a compressed coated surface. Localized compressive residual stresses at the metal surface have been recognized as a factor to initiate corrosion at the inside of bends.³⁷ Such a phenomenon explains why sheet steel often rusts first at bent edges.

(b) Inside of bend

Figure 3.19 Compressed coating surface.

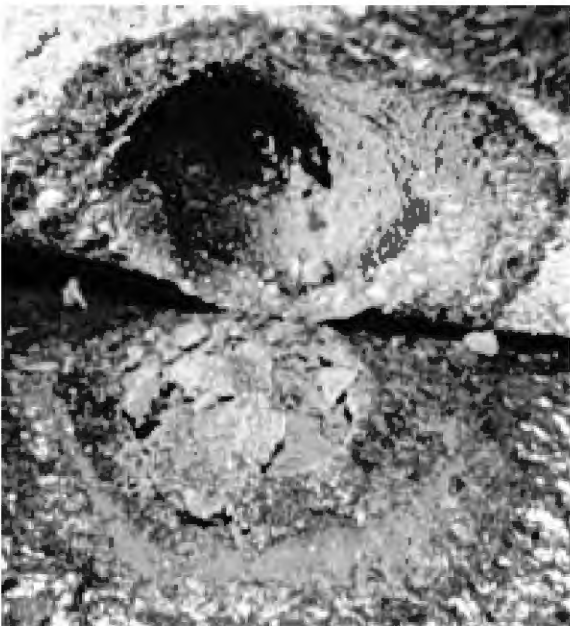
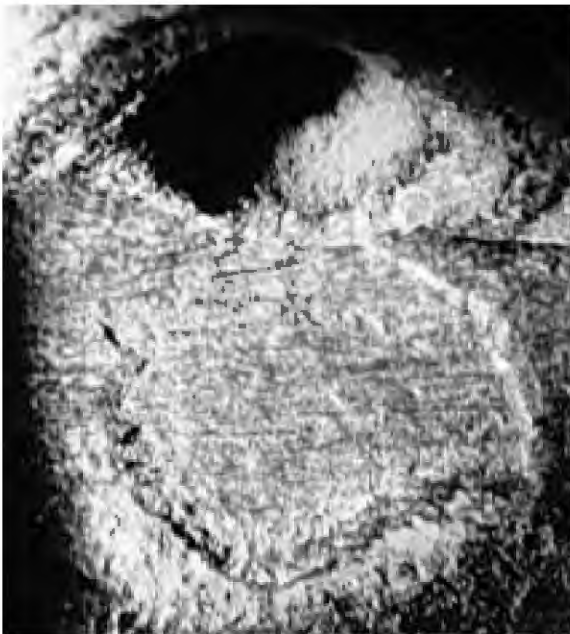
In bars examined after 2 years, blisters spread on the coating surface and indicated pitting corrosion. The pits were generally very slight (shallow depth) covered with black and brown brittle corrosion products. Figure 3.23 shows a blister under microscopic examination. At some locations, the buildup of corrosion products breached the epoxy film. At other locations, the blisters were soft and full of liquid. Blisters had varying sizes and small blisters (up to 5 mm) were more abundant than large blisters (greater than 5 mm). A concrete void was always present adjacent to a blister in the coating (Figure 3.24). Concrete voids provided an ideal environment for the formation of blisters, because chlorides, water and oxygen could

be stored in those voids. Consequently, corrosion was particularly intense at bar locations facing concrete voids where corrosion products accumulated and increased in volume under the coating, eventually bulging or blistering the coating. The greater quantity of concrete voids at the lower half of the bar surfaces explains the prevalence of more blisters at those regions.

(a) Blister on Coating Surface

(b) Corrosion product buildup in blister

(c) Pitting Inside Blister

Figure 3.23 Blister under microscopic examination.

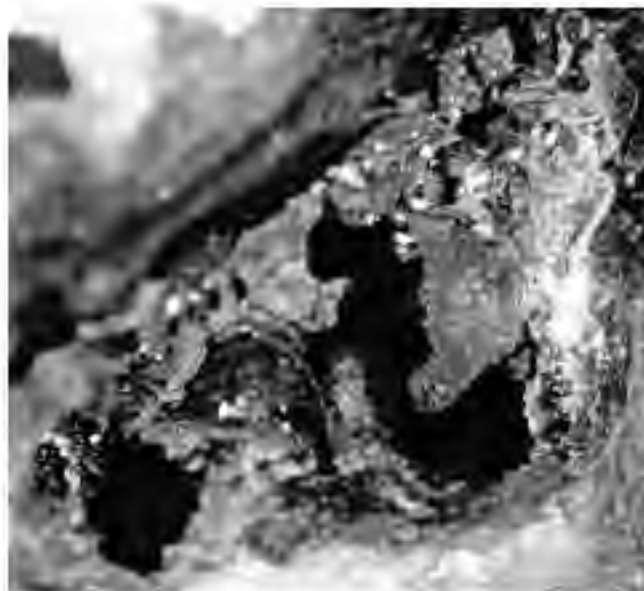
During concrete consolidation and setting, water migrates towards the top concrete surface. Some of the bleed water is trapped under the horizontal epoxy-coated bars. As fresh concrete settles, small gaps are formed under the coated bar. Gap formation is enhanced by lack of interlock and cohesion between cement mortar and coated bar surface. Free water may then accumulate in that zone underlying the bar. When water eventually evaporates, it leaves voids or air pockets adjacent to bar surface. These voids will not be filled during hydration similar to the voids forming around the aggregates due to bleeding and inefficient packing of the cement mortar. As a result, a weak porous zone, with possible interconnected cavities, forms underneath the bar. This zone is characterized by a dull, light gray appearance as shown in Figure 3.25.

Figure 3.25 Concrete below coated bar.

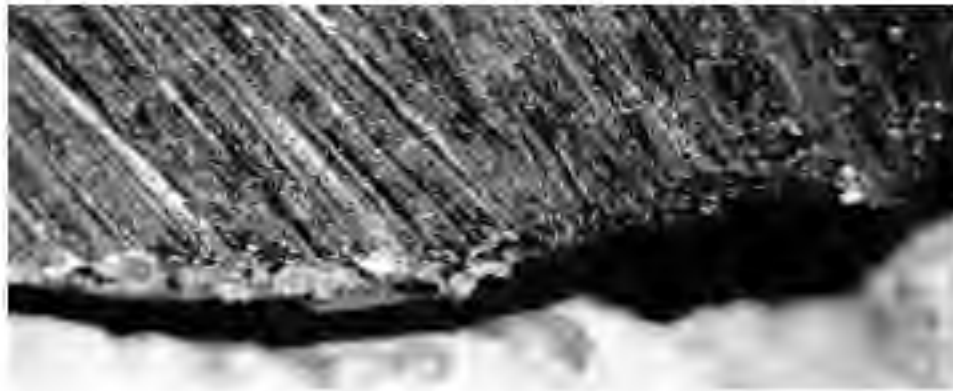
Based on observations from the opened macrocell specimens, initial efforts were made in this study to investigate the possibility of gap formation beneath the coated bars. One concrete prism of similar dimensions to the macrocell specimens was cast with an individual coated bent bar typical of those bars used in series B. Concrete was vibrated as in a normal casting procedure. The prism was sawcut after few days in a plane perpendicular to the bar axis. The condition of concrete above and below the bar was microscopically inspected. Although concrete was compacted well above the bar, a gap was found underneath the bar. A view of the gap is shown in Figure 3.26.

Figure 3.26 Gap formation below coated bar.

The zone under the bar may trap relatively large amounts of harmful substances very close to the bar surface. Moisture, oxygen, and chlorides are the specific agents necessary for corrosion. With time, these agents penetrate to the metal surface mainly through damaged spots, coating defects, and holidays. Salt solution may also accumulate under the bar and beneath the coating bridging between concrete and the corroded sites. Corrosion commences and progresses causing widespread undercutting.

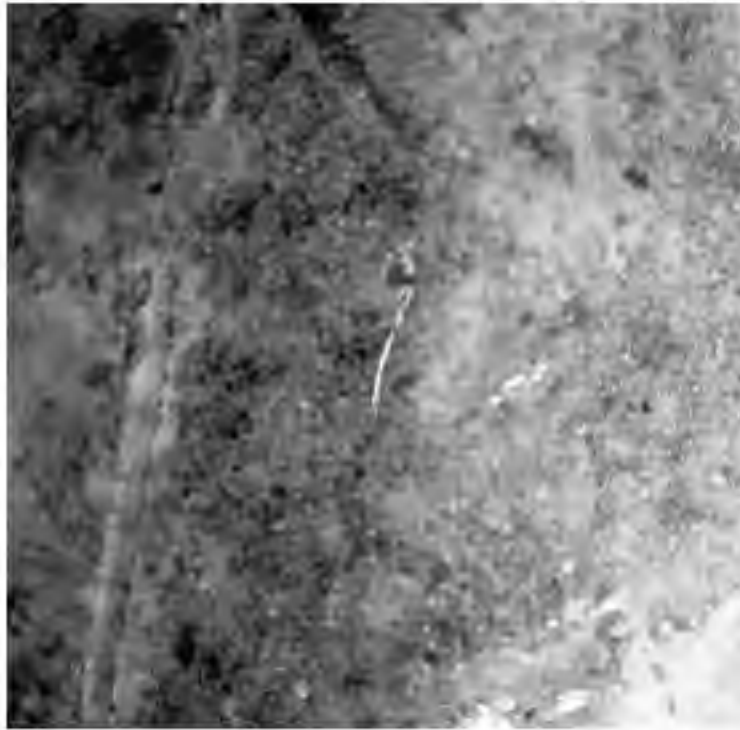
In contrast, concrete resting on top of the coated bar will be more dense and closely-packed than that below the bar. Concrete consolidates as it builds up on top of the bar. The smoothness of the coated surface facilitates displacement of concrete to the sides of the bar. With vibration, more cement paste concentrates at the bar/concrete interface. As a result, the condensed fine mortar on top of the bar will generally have a smooth and continuous interface layer. This layer appears glossy and relatively dark gray when cover is removed as shown in Figure 3.27.

Figure 3.27 Concrete above coated bar.

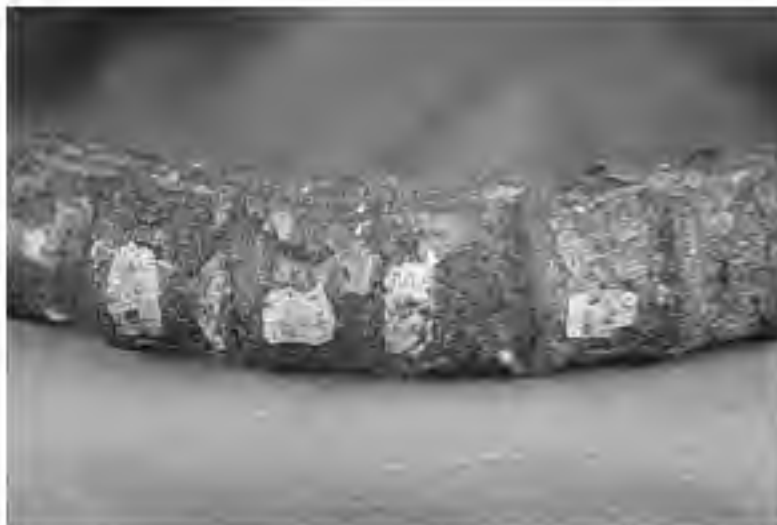
(a) Patched bar 3B.2, outside bend.

Bars with damaged spots greater than 2% of the bar surface suffered the worst corrosion among coated specimens. With the remarkable exception of bar 3A.3, bars with damaged spots greater than 6x6 mm experienced similar levels of corrosion after 4.5 years of exposure. In comparison, bars with patched damage experienced lower amounts of current, with the exception of bar 3A.4 (spots > 6x6 mm, patched), that exhibited higher corrosion currents than the respective unpatched bar 3A.3. Despite displaying slightly lower currents, the steel surface of most bars with patched coating showed levels of corrosion similar to bars with exposed, damaged areas (Figure 3.36). Corrosion products built up at exposed sites while only a very light rusting developed at patched areas. However, corrosion spread on the steel surface

far beyond patched areas and was not dissimilar from the corrosion observed at bar surfaces beyond exposed areas. These observations were in good agreement with measured macrocell currents.

In general, corrosion in bars with exposed areas tended to be slightly more severe and corrosion in bars with repaired areas tended to be more widespread. Patching damaged areas on the outside of the bend only was not sufficient. Corrosion also propagated from mandrel indentations at the inside of the bend and at the outside of one straight leg (at point of support for bending operation). The only case where a bar with patched coating presented a substantially improved steel surface condition relative to a bar with exposed areas after 4.5 years was provided by the small bars with parallel ribs and damaged spots greater than 2% of the bar surface.

Figure 3.36 Comparative steel corrosion under the coating at outside bend of bars with damaged coating, with and without repair.

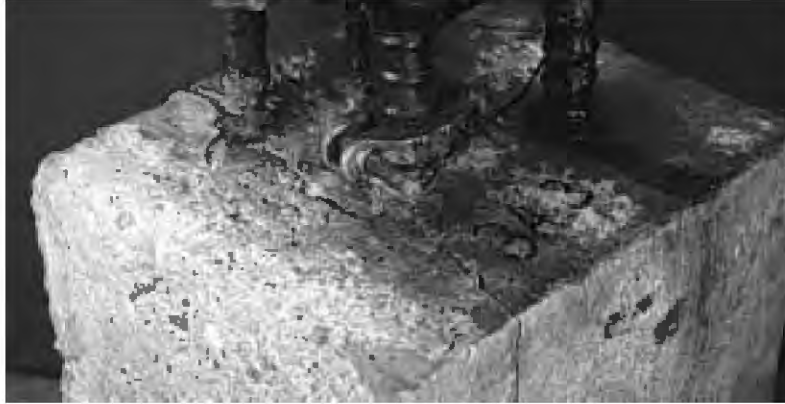
The effect of disruptive forces by expansive hydrated crystals was visible in the lateral surfaces of the specimens in the form of concrete scaling. At scaled areas, the hardened cement paste and embedded fine aggregate particles were removed, leaving behind protruding coarse aggregate particles (Figure 3.37). Large deposits of salt crystals were visible at scaled surfaces. The lateral surfaces with more extensively scaling were near the concrete cracks on the top surface, reinforcing the notion that cracks facilitated percolation of salts towards the inside. Both processes of salt weathering and corrosion-induced cracks interacted with each other to further propagate deterioration. Specimens with coated bars also experienced concrete scaling on their lateral surfaces, but the scaling was much less extensive and not severe. Undoubtedly, the lack of extensive concrete cracking greatly reduced the amount of salt weathering in specimens with coated bars.

Figure 3.37 Severe concrete scaling on specimen 3A.8 with uncoated bars.

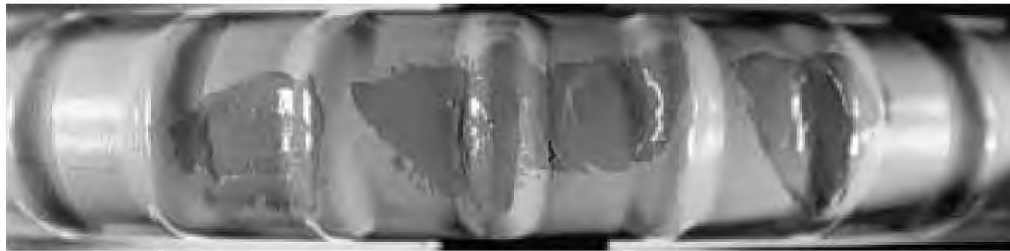
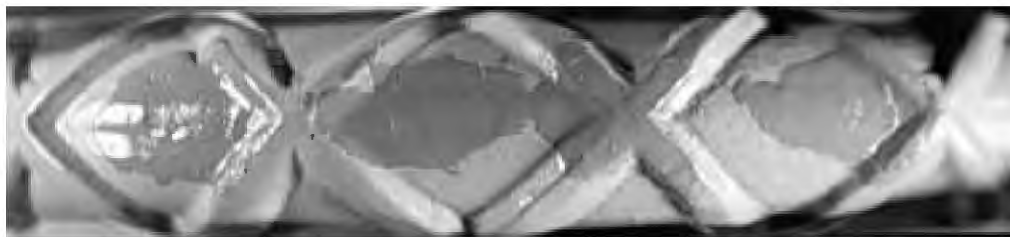
Only the introduced damaged areas on bar specimens in groups A.2, A.9, B.2, and B.9 were patched. A two-part liquid epoxy, especially formulated for coating repair, was applied by brush. The exposed steel areas were not given any special treatment before patching. Figure A.13 shows examples of patched damaged areas on two test bars.

Figure A.13 Examples of patched coating damage.

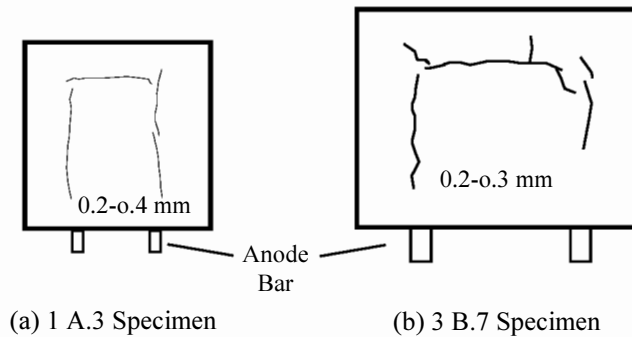
The macrocell specimens were visually inspected at the beginning of the test and periodically thereafter. Any initial cracks detected on the top concrete surfaces (suspected to be due to plastic settlement), such as those shown in Figure A.18, were documented before testing. Specimens that exhibited such cracking were the following:

Figure A.18 Examples of initial cracks detected on top surfaces of macrocell specimens.

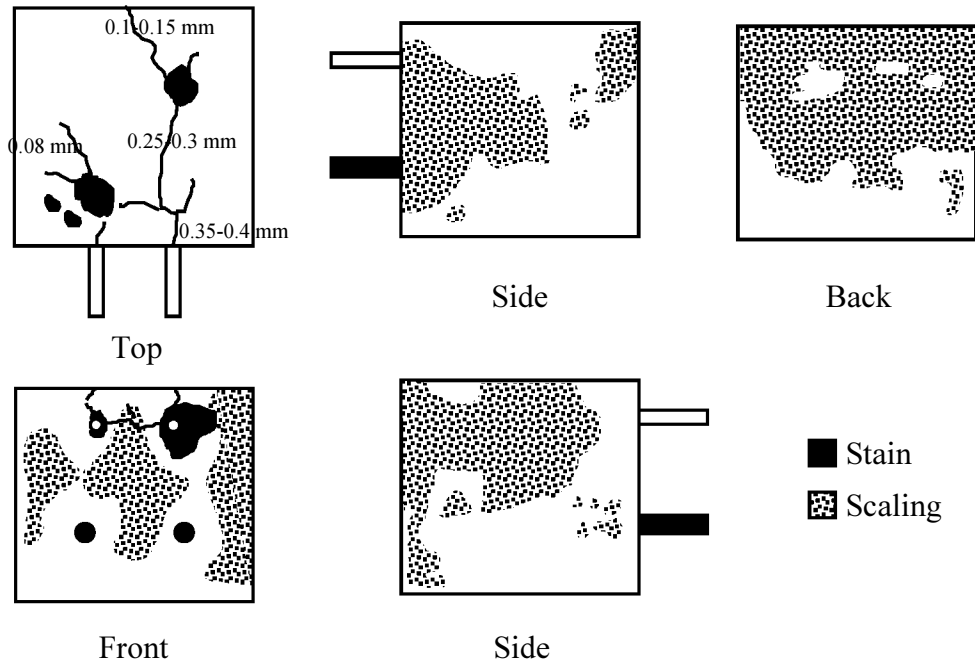
(a) 3A.1 Specimen

Figure A.23 Cracks and stains on macrocell specimens 3A1, 3A.4, and 2A.6 inspected after 4.5 years of exposure.

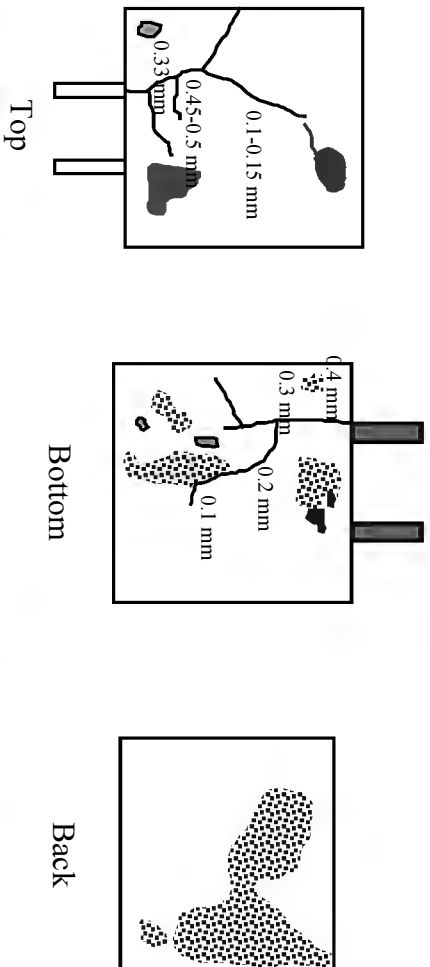
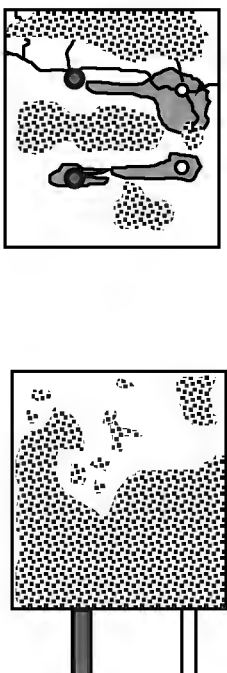
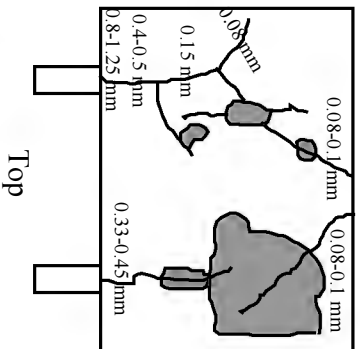
(a) 3A.8 Specimen

Figure A.24 Cracks and stains on macrocell specimens 3A.8 and 3B.1 inspected after 4.5 years of exposure.
