# CONSTRUCTION OF BRIDGE DECKS WITH PRECAST, PRESTRESSED CONCRETE DECK PLANKS

**PHYSICAL RESEARCH REPORT NO. 139  
APRIL 2002**

**Illinois Department of Transportation**

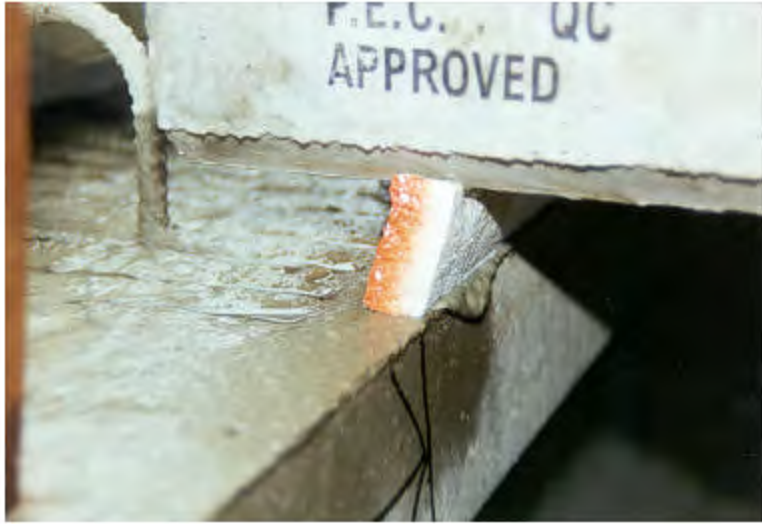
The method of resting the deck planks on the beams also changed. For the 1999 and 2000 construction contracts, leveling jacks were inserted in the plank during fabrication. The leveling screws placed in the jacks allowed the plank to be adjusted to the proper fillet height when planks were seated on the beams. Before planks were seated, polystyrene strips were placed underneath the planks. The polystyrene was to act as a dam for the concrete poured between the planks, which came up underneath the edges of the planks (see Photo 1).

Photo 1. PPC deck plank seated on polystyrene (July 1999 – District 6)

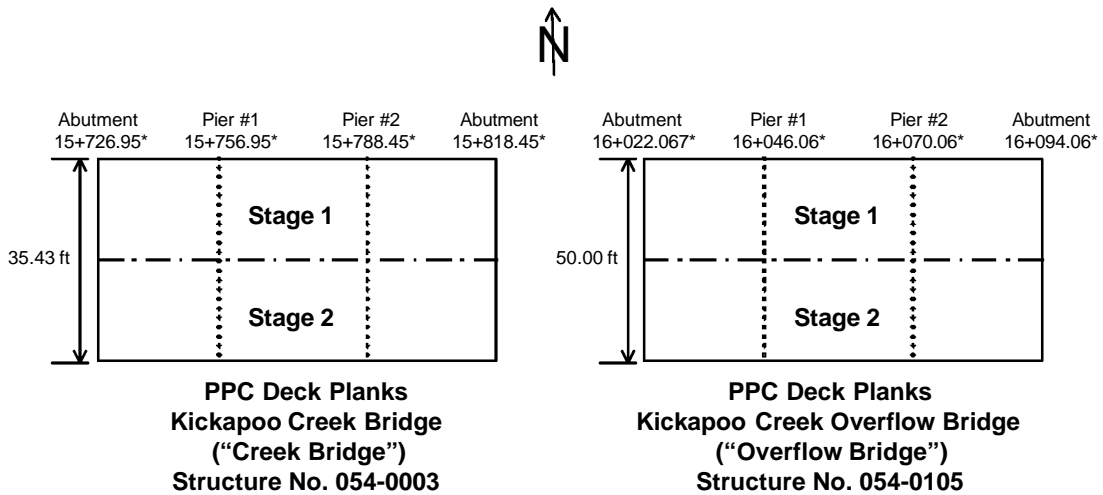
**Figure 2**  
**District 6 PPC Deck Plank Bridges**  
 Logan County  
 (IL 10 & 121 over Kickapoo Creek and Kickapoo Creek Overflow)

A distress survey was performed on the “overflow” bridge on February 24, 2000. Only Stage 1 (westbound lane) was surveyed, since Stage 2 pours on both the “creek” and “overflow” bridges had not yet been completed. Several transverse cracks were found between the west abutment and pier #2 (see Figure 2 for reference). No longitudinal cracks were found. However, just after the deck was uncovered after curing, several people stated that they saw some longitudinal cracks. (See Photo 17). Since the westbound lane (Stage 1) was the only lane open to traffic, the surveyors had to perform the survey from Stage 2, on the other side of the temporary concrete barriers. Surveyors found that the cracks were very difficult to see due to the dryness of the pavement and the grooves saw-cut into the surface. Since Stage 2 of the “creek” bridge did not have forms between the first interior girder and the fascia, the survey was only performed on the “overflow” bridge.

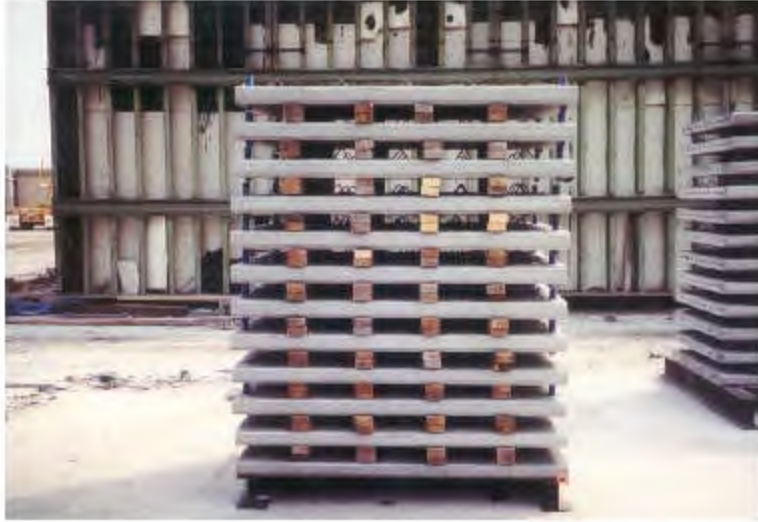
Previously rejected planks were grouped in lots of 10 according to similar cracking patterns. Out of every lot of 10, the IDOT inspector randomly selected one plank as the test plank. All strands on the test plank were cut flush at the ends of the plank. The test planks were set on steel I-beams to ensure flat, straight bearing. Three inches of each edge of the plank rested on the I-beams to simulate the bearing of the structure. The dunnage used on top of the test plank was 2-inch by 4-inch lumber. Two 2-inch by 4-inch pieces were stacked and placed in four locations on top of the test plank. The 2-inch by 4-inch pieces at the ends were placed no less than nine inches from the end of the plank. For the 3-inch thick planks, eleven planks were carefully stacked on top of the test plank with dunnage placed between each of the eleven planks. The eleven planks and dunnage weighed approximately 9900 lb. For the 3.5-inch thick planks, thirteen planks and the dunnage, weighing approximately 11,700 lb., were stacked on the test plank. Photo 5 shows the load test in progress.

Photo 5. Load Test

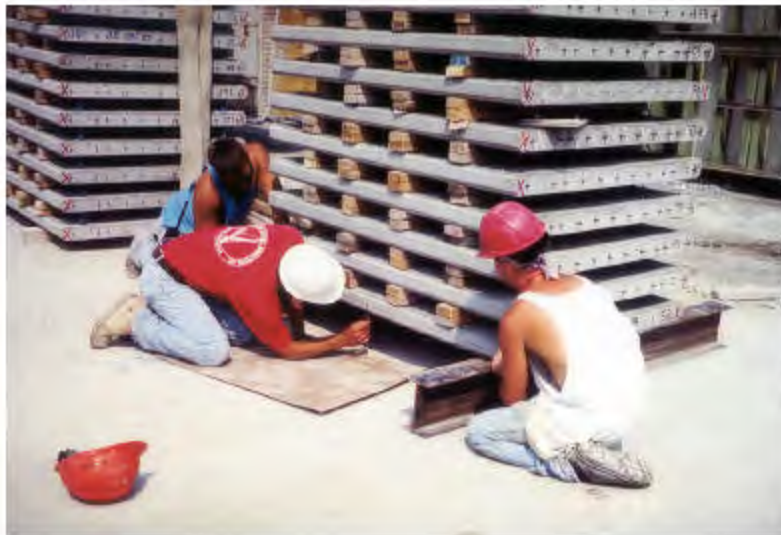
Before loading the test plank, lines were marked on each end of the test plank at mid-depth. The center of the length of the plank was marked with a vertical line. A string line was pulled tight on the mid-depth marks at each end. At the center of the length of the plank, a horizontal line was marked on the vertical line for a straight-line reference. After the test plank was loaded, a string line was held on the end mid-depth lines and pulled tight. The distance from the horizontal line at the center of the plank to the string line was measured and recorded as the deflection, as shown in Photo 6. The load remained in place for 24 hours.

Photo 6. Checking deflection with stringline

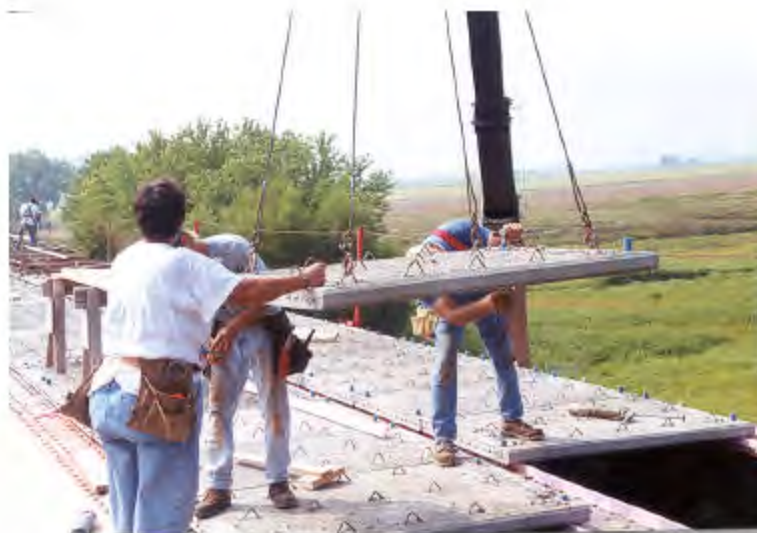
Photo 7. Deck plank seating (District 8 – Stage 2, Sept. 2, 1999)

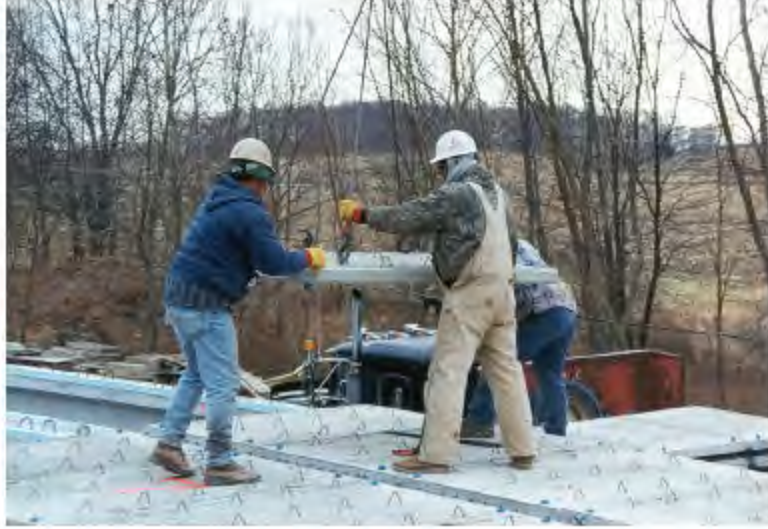
For Stage 2 (overflow bridge), deck plank seating was completed on December 2, 1999, as shown in Photo 9. Due to cold weather, the Stage 2 (overflow bridge) pour was not completed until March 13, 2000. The Stage 2 (creek bridge) deck plank seating was completed on December 14, 2000. The Stage 2 (creek bridge) pour on the creek bridge was on March 22, 2000.

Photo 9. Deck plank seating (District 6 – Stage 2, Dec. 1, 1999)

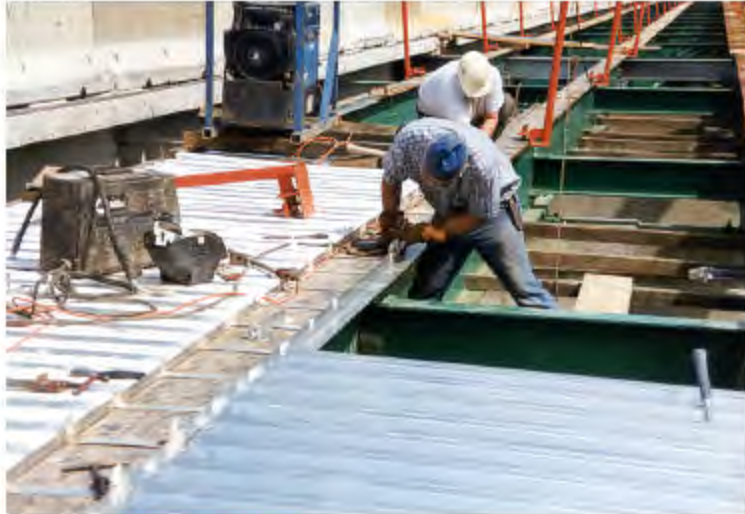
Metal stay-in-place forms were incorporated into two spans of the Jersey-Greene county bridge in District 8. The permanent metal deck forms were placed between the exterior girders in spans 4 & 5 (see page 7 and Photos 20 and 21).

Photo 20. Seating metal stay-in-place forms (District 8 – May 1999)

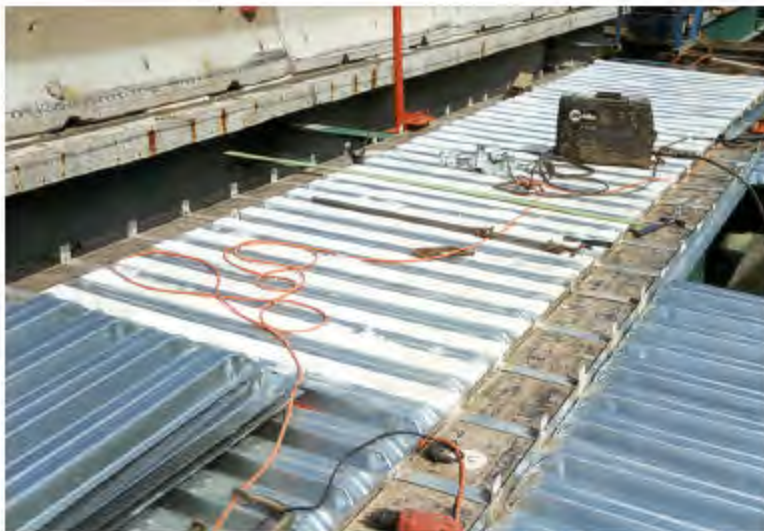
Photo 21. Polystyrene fillers in metal stay-in-place forms (District 8 – May 1999)
