Research  
Paper  
FPL-RP-597

# Field Performance of Timber Bridges

## 21. Humphrey Stress-Laminated T-Beam Bridge

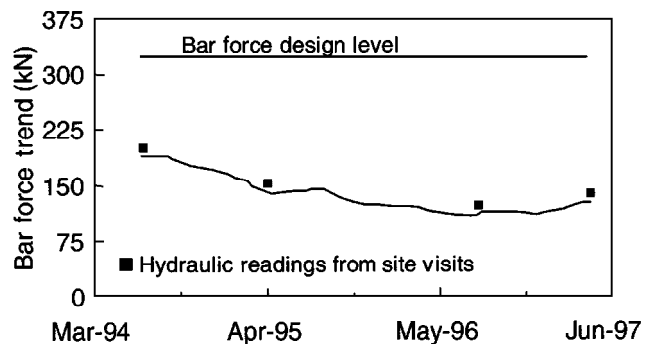
Figure 18—Average bar force trend approximately 8 months after the third bar tensioning.

The average trend for bar force is shown in Figure 18. Bar force data were obtained from the load cells on the bars and verified with hydraulic pump and readings during four site visits. At the start of monitoring (approximately 8 months after bridge installation), tension in all bars was approximately 190 kN (42,700 lb), which corresponds to 1.02 MPa (148 lb/in<sup>2</sup>). Bar force decreased gradually during the monitoring period, to a final value of 150 kN (33,700 lb) or 806 kPa (117 lb/in<sup>2</sup>).

Figure 18 does not reflect losses from the initial bar force of 320 kN (72,000 lb). Bar force losses throughout the monitoring period were probably the result of stress relaxation. Stress relaxation is a time-dependent phenomenon resulting from constant force on the wood laminations. Even with the losses in bar force, interlaminar compression in the Humphrey bridge is still well above the minimum level of 345 kPa (50 lb/in<sup>2</sup>). The large reserve in bar force and interlaminar compression is due to a design bar force that is approximately 2.5 times the recommended value for stress-laminated timber bridge decks (Ritter 1990). The higher design bar force allows a larger amount of bar force to be lost over time while maintaining an acceptable amount of bar force in the bridge. However, additional research is needed to determine the minimum amount of bar force needed in a stress-laminated T-beam bridge to maintain its structural capacity.

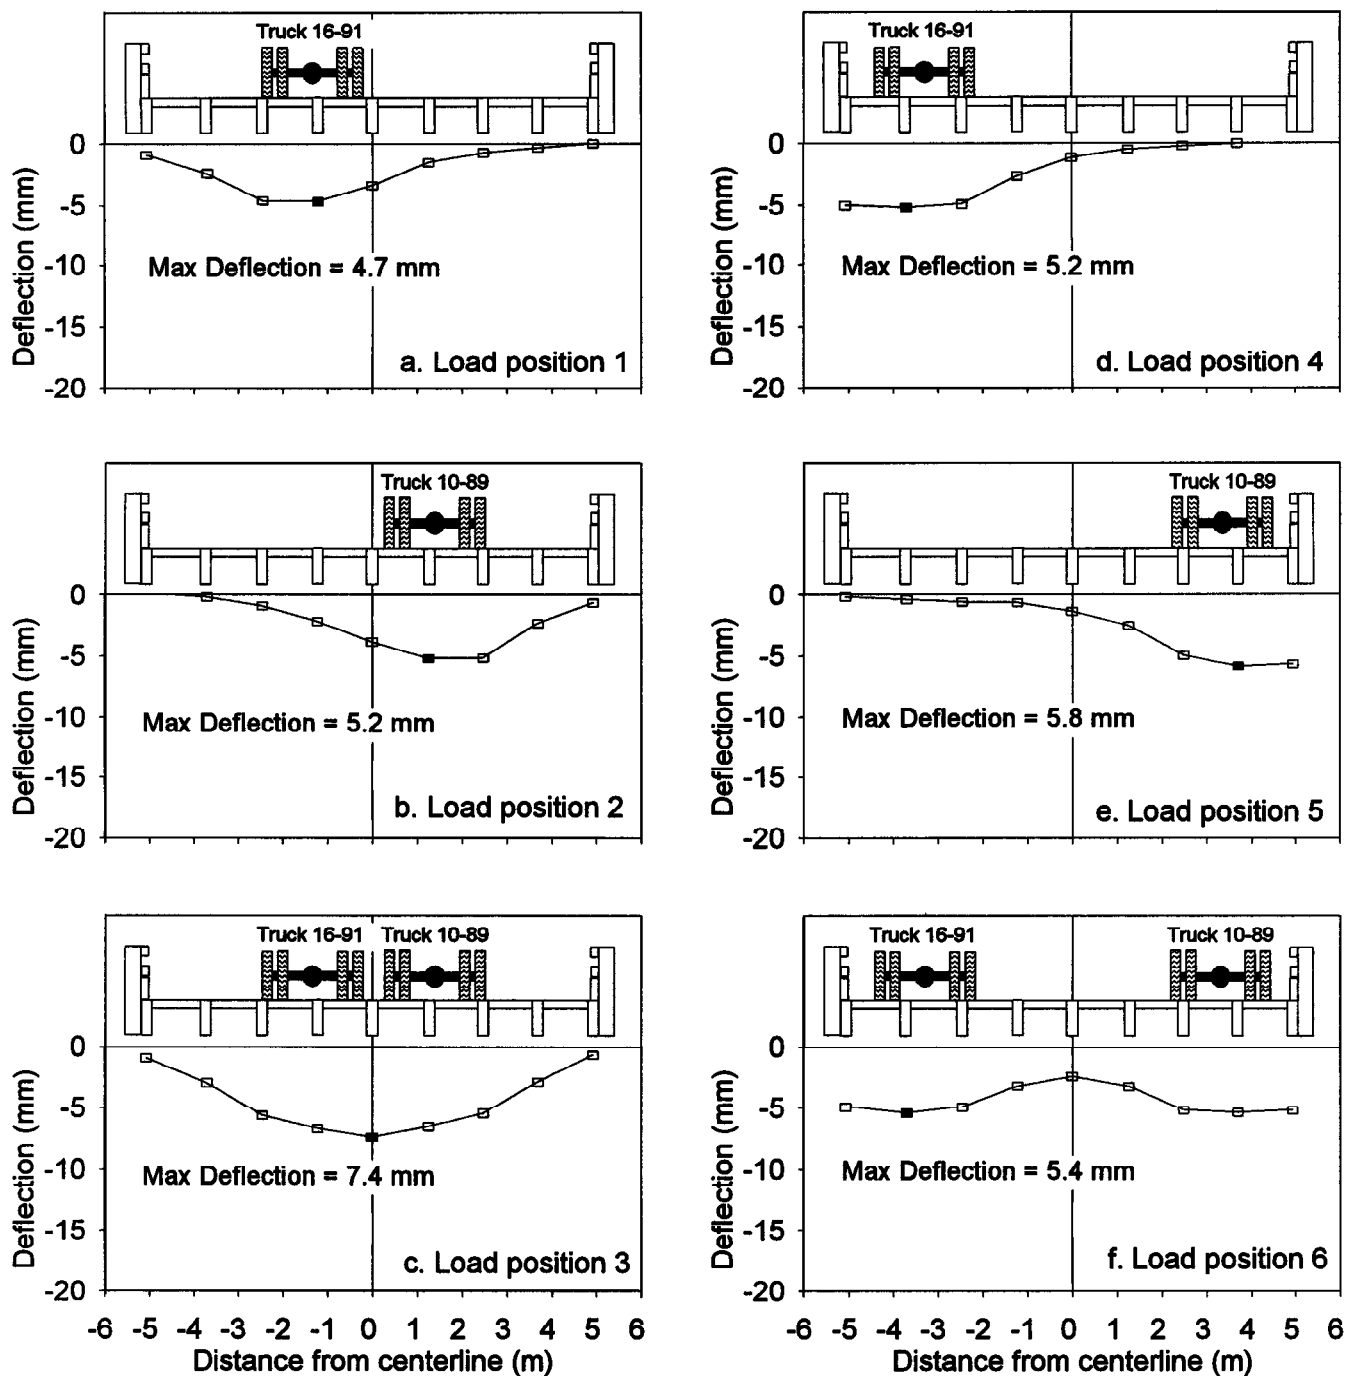
Figure 19—Transverse deflections measured at mid-span (looking east) for load test 1. Bridge cross sections and vehicle positions are presented for the purpose of interpretation only and are not drawn to scale.

The maximum measured transverse deflections for load test are shown in Figure 19. The maximum measured deflections occurred near the wheel lines of the test vehicles.

These deflections were symmetrical between similar load positions such as load positions 1 and 2 and load positions 4 and 5. For the load positions with two vehicles, the deflection from load position 3 was larger than all other measured deflections; the smaller deflection from load position 6 was similar to that of load positions 1, 2, 4, and 5. This was due to the transverse stiffness of the deck created by interlaminar compression stress.

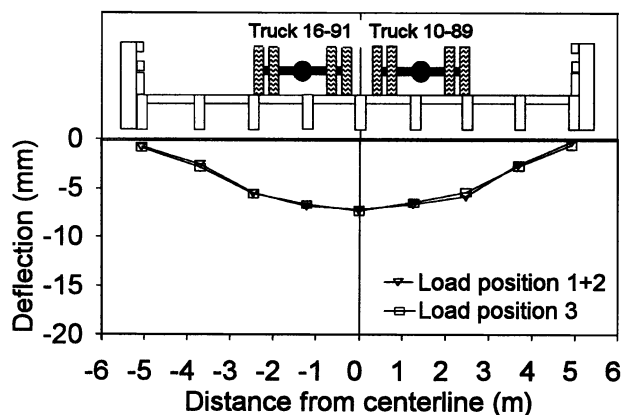
Figure 20—Comparison of measured deflections for load test 1: actual deflection of load position 3 and sum of load positions 1 and 2 (looking east).

Assuming uniform material properties, symmetric loading, and accurate deflection measurements, the bridge deflections for load positions 1 and 2, when summed, should equal the deflections from load position 3. Figure 20 displays the summation of load positions 1 and 2 overlaid on load position 3. As shown, deflections are essentially the same.

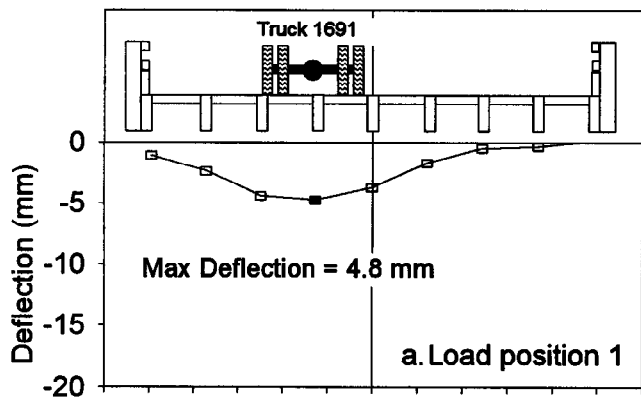
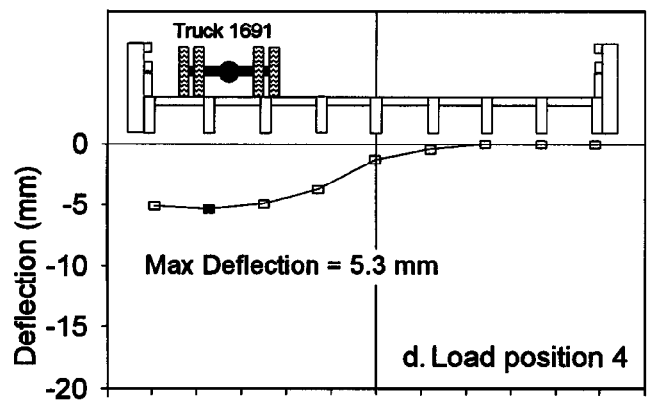
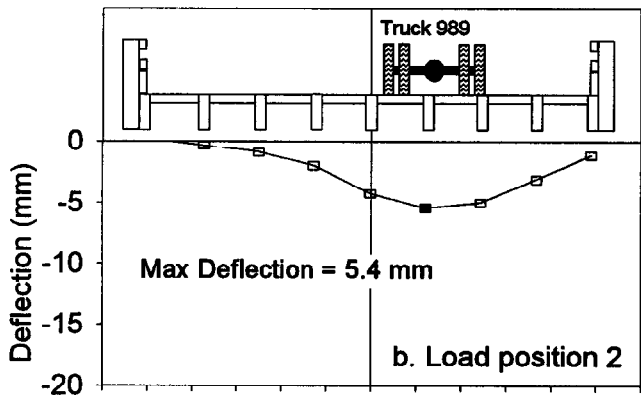
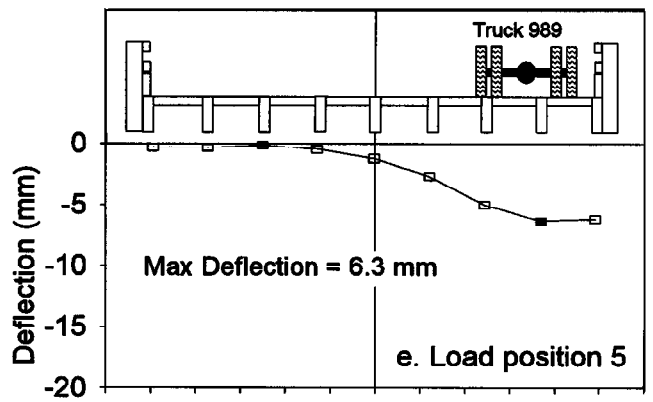
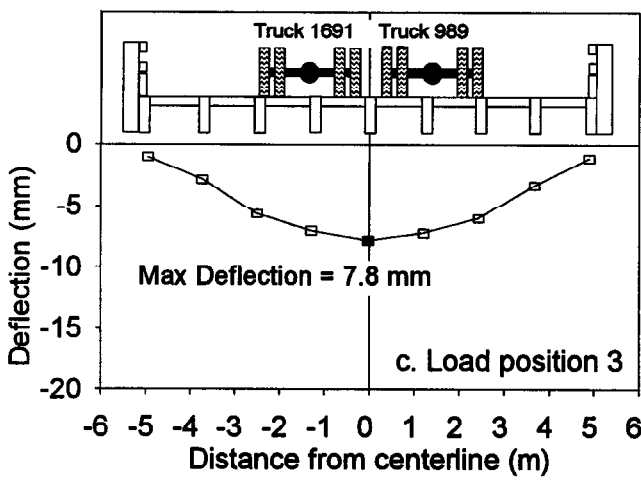
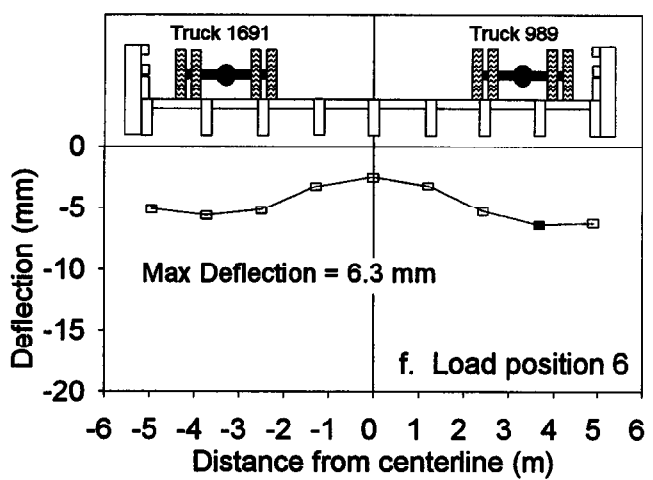
Figure 21—Transverse deflection measured at mid-span (looking east) for load test 2. Bridge cross sections and vehicle positions are presented for the purpose of interpretation only and are not drawn to scale.

The maximum measured transverse deflections for load test 2 (Fig. 21) are shown in Figure 21. Maximum measured deflections, which occurred near the wheel lines of the test vehicles, were symmetrical between similar load positions, such as load positions 1 and 2 and load positions 4 and 5. For the load positions with two vehicles, the deflection from load position 3 was greater than that of all other measured deflections; the smaller deflection from load position 6 was similar to that of load positions 1, 2, 4, and 5. As in load test 1, this was due to the transverse stiffness of the deck created by interlaminar compression stress.

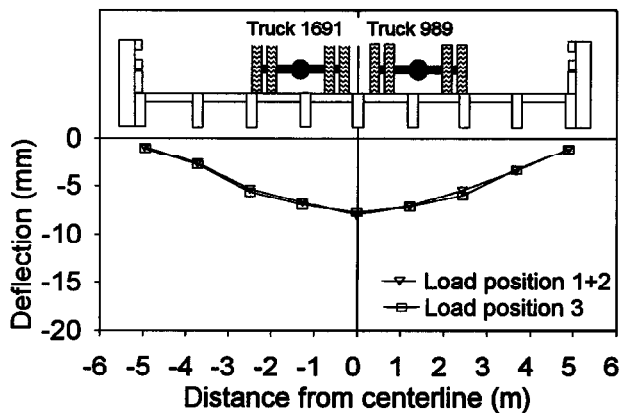
Figure 22—Comparison of measured deflections for load test 2: actual deflection of load position 3 and sum of load positions 1 and 2 (looking east).

Figure 22 displays the summation of load positions 1 and 2 overlaid on load position 3 for load test 2. Aside from slight deflection variations, the deflections are essentially the same.

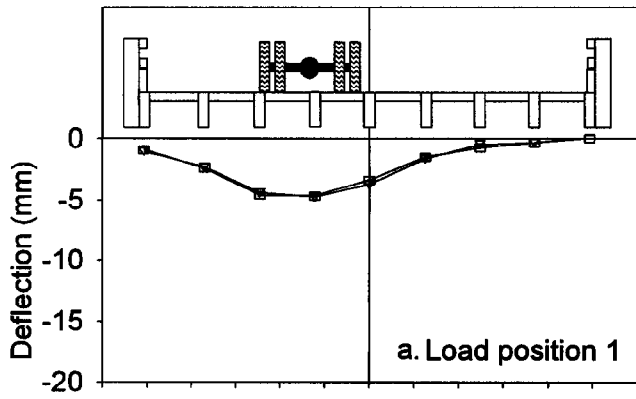
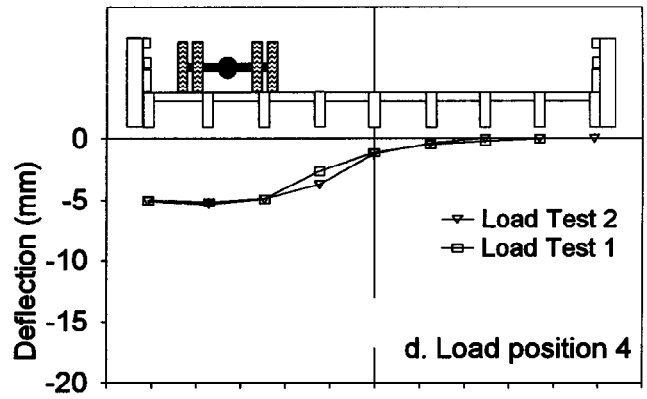
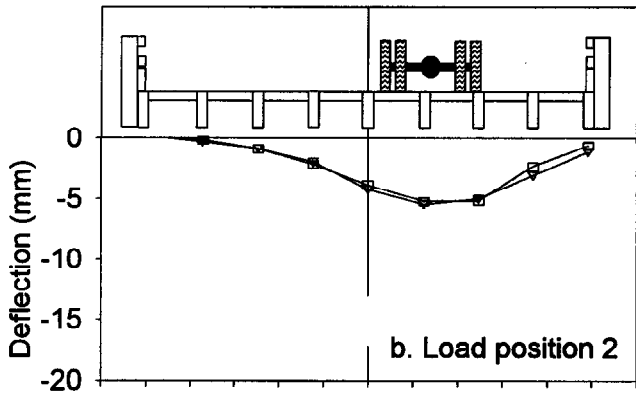
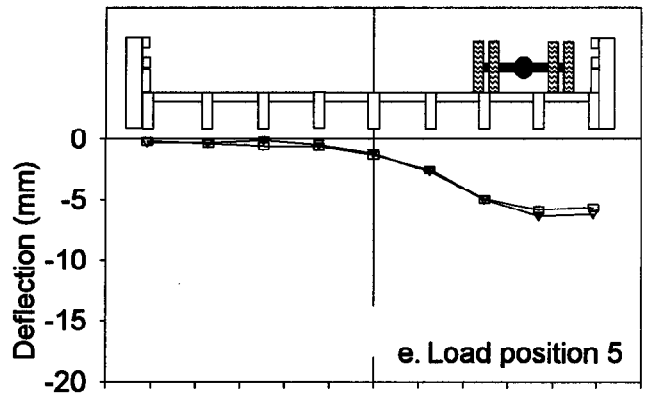
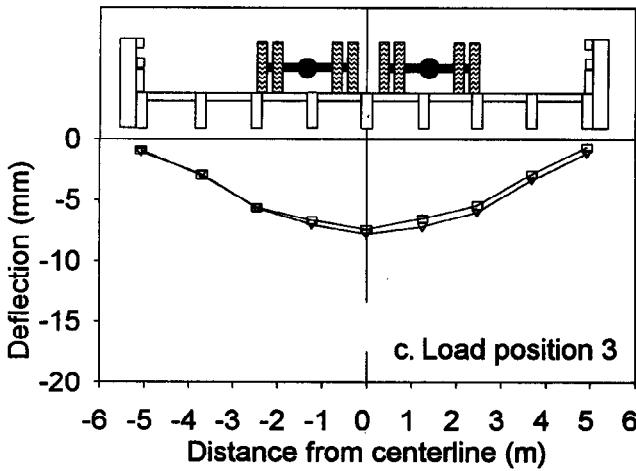
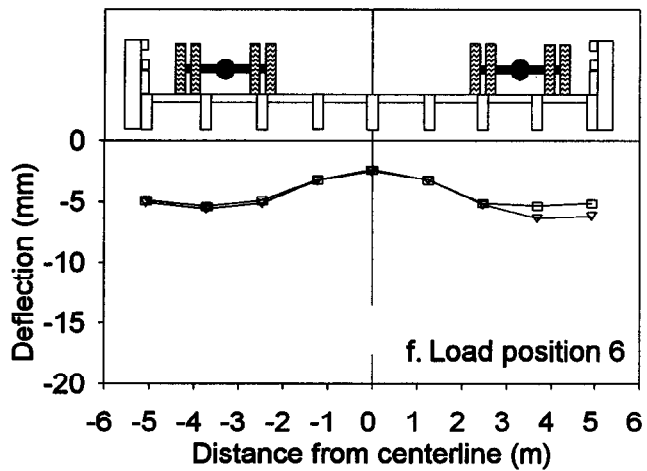
Figure 23—Comparison of load tests 1 and 2 at all load positions.

Comparison of the results from load tests 1 and 2 revealed similar maximum deflections for each load position (Fig. 23). Because a slightly heavier load was used for load test 2, deflections from this load test were slightly greater

than those from load test 1. The effect of load weight was especially evident for load positions 3, 5, and 6 because of the substantially heavier load of the right (upstream) truck (Fig. 23).
