1. Report No.	2. Government Accession No.		3. Recipient's Catalog No.	
FHWA-RD-93-058				
4. Title and Subbide			5. Report Date	
TESTING OF NEW BRIDGE RAIL AN VOLUME I: TECHNICAL REPORT	ND TRANSITION D	DESIGNS	6. Performing Organization Code

10. ADSTACT				
The objectives of this study were to develop safer bridge rail and transition designs and to improve design guidelines. Ten bridge railings and two transitions were designed, tested, and evaluated in accordance with American Association of State Highway and Transportation Officials (AASHTO) requirements. The railings were designed using ultimate strength procedures and collision forces from earlier research. Design procedures, railing designs, and test results are presented. All designs demonstrated acceptable collision performance.			nes. Ten of State th ented. All

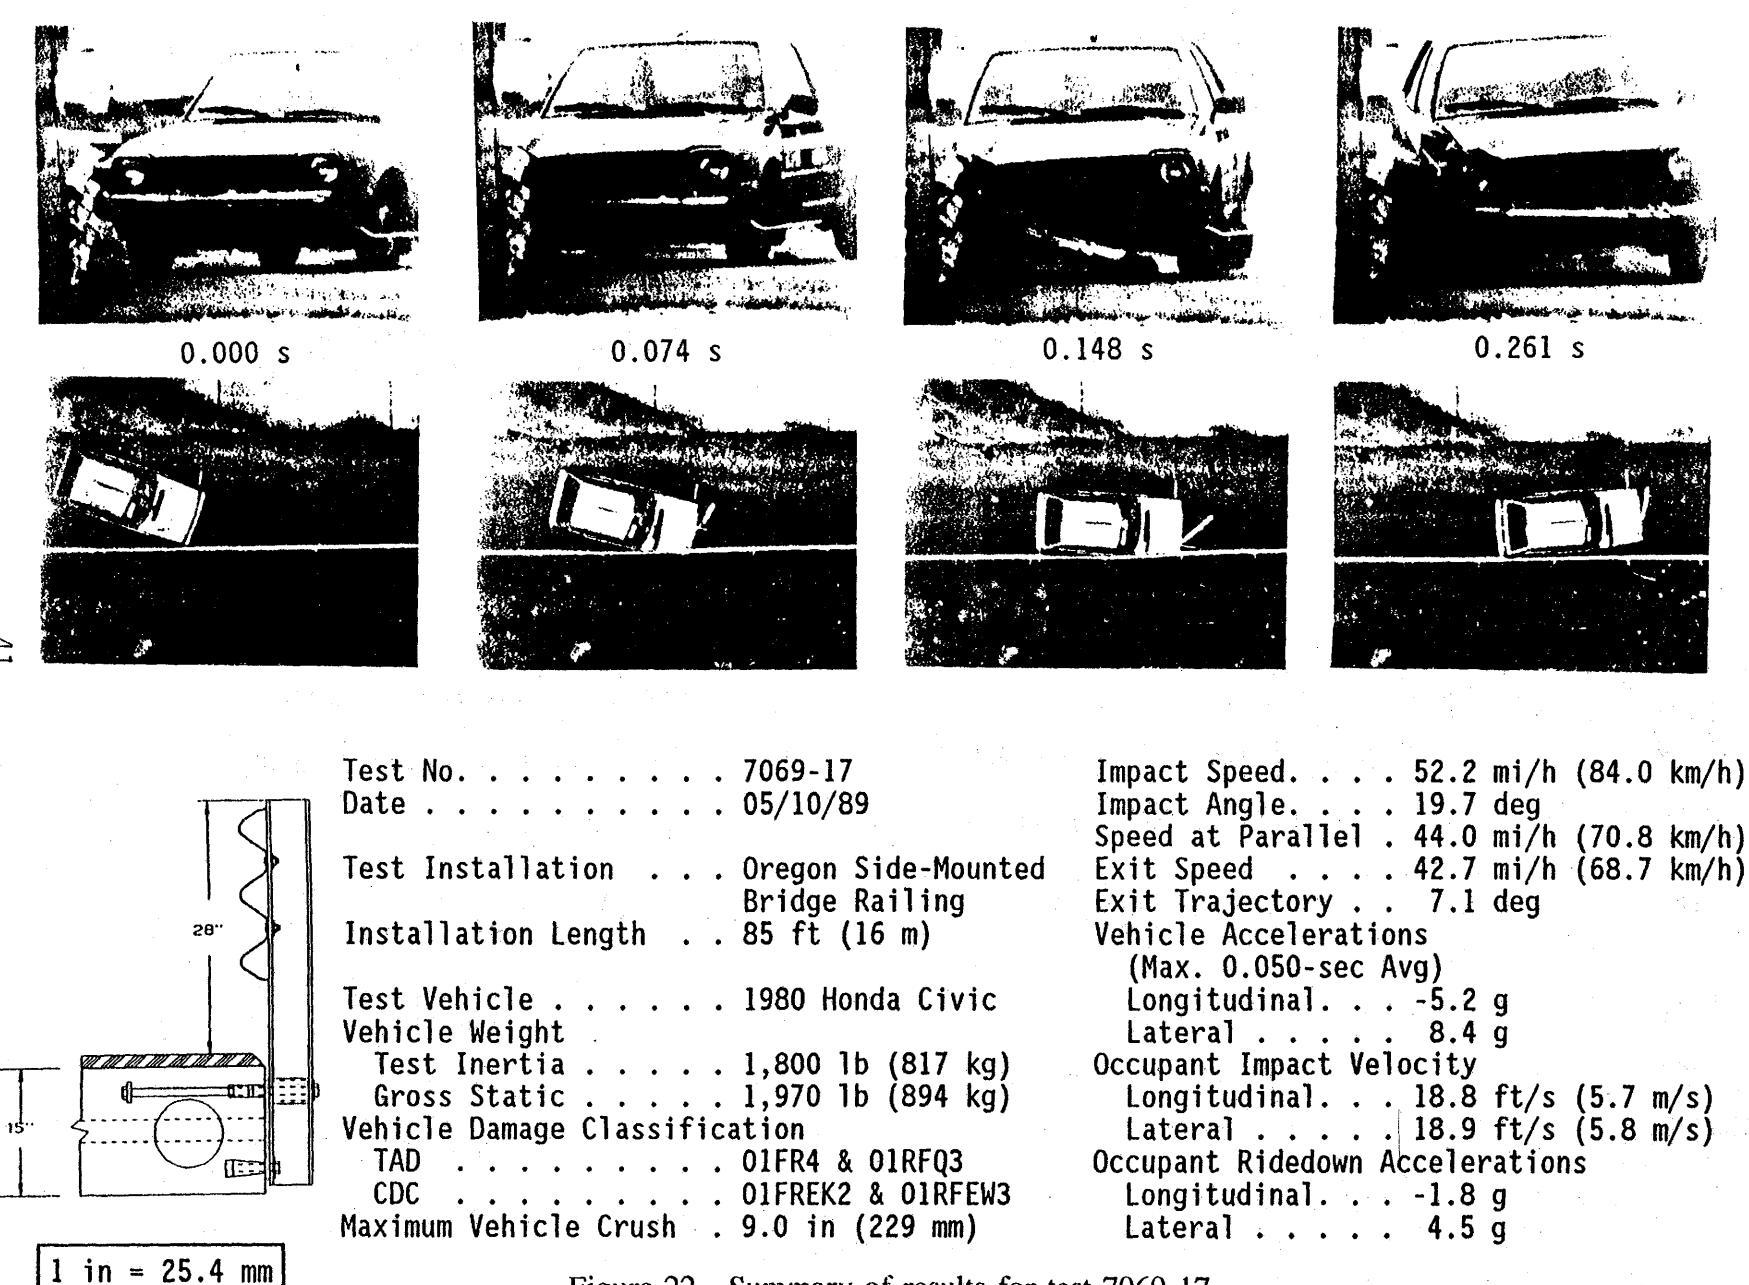
Figure 22. Summary of results for test 7069-17.

considered fair. The occupant risk factors were within the limits recommended in the 1989 AASHTO guide specifications.<sup>(3)</sup> The vehicle trajectory at loss of contact indicates minimum intrusion into adjacent traffic lanes.

Performance of the railing in this test is judged acceptable, as indicated in figure 22 and table 3.

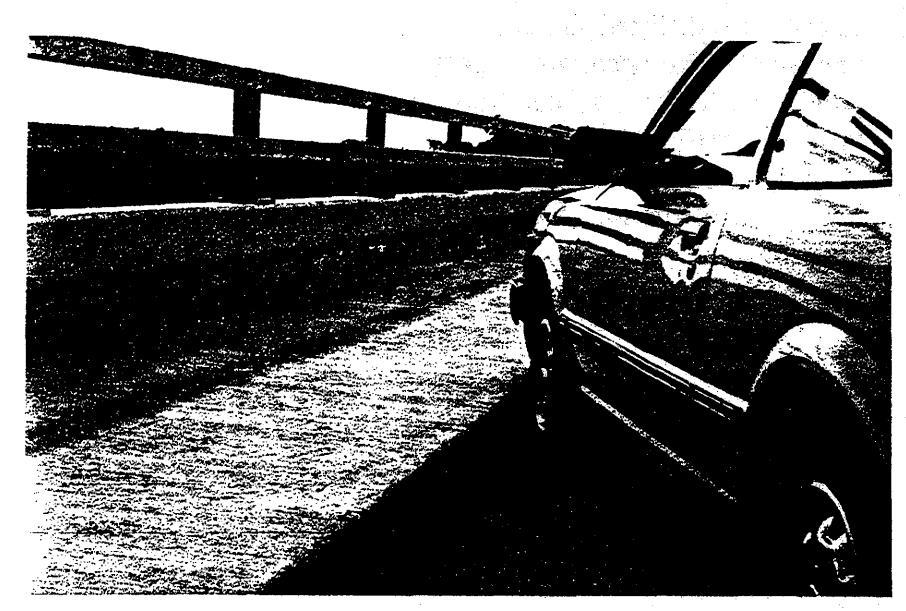
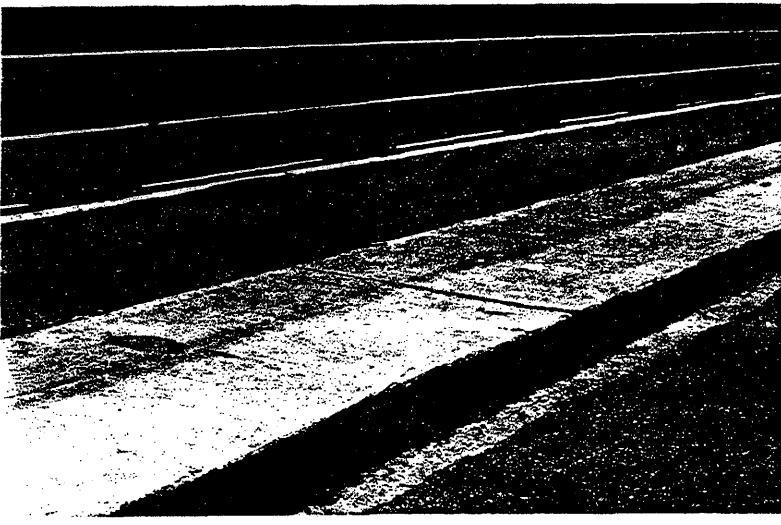
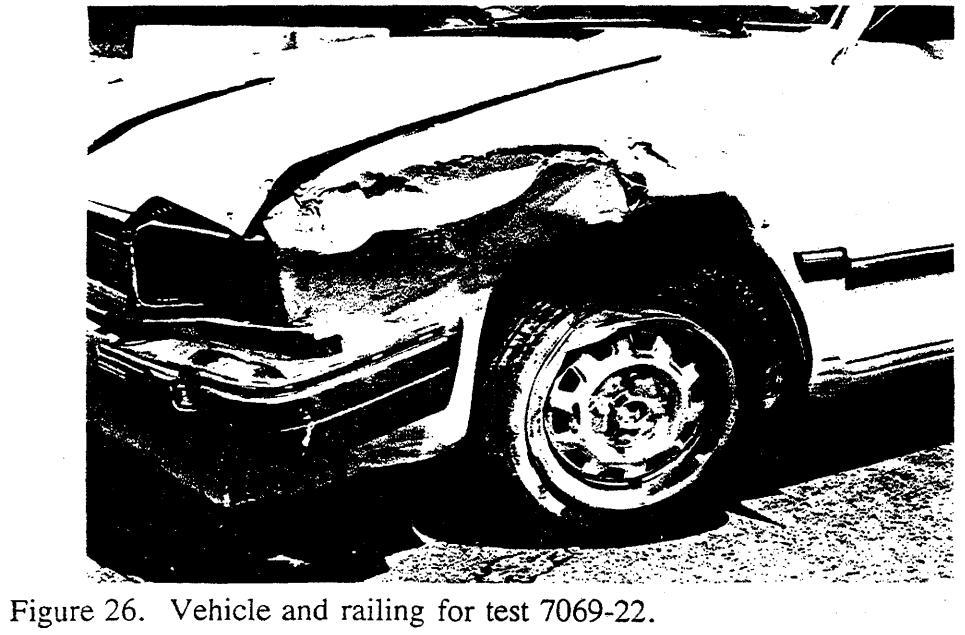
As can be seen in figure 26, the bridge railing system received minimal damage. There was no measurable permanent deformation to the railing elements and only cosmetic damage to the concrete parapet. There were tire marks on the concrete parapet and on the face of the lower metal railing element in the area of impact, and also on the lower part of post 6. The vehicle was in contact with the bridge railing for 11.5 ft (3.5 m). Length of contact with the concrete parapet was 7.0 ft (2.1 m).

The vehicle sustained damage to the left side as shown in figure 26. Maximum crush at the left front corner at bumper height was 6.0 in (152 mm). The left front strut was damaged and the left front wheel was canted inward at the bottom and pushed back reducing the wheelbase on the driver side by 2 in (51 mm). Also, damage was done to the front bumper, hood, left headlight, left front quarter panel, left rear quarter panel, left front and rear tires and rims, and right front tire.

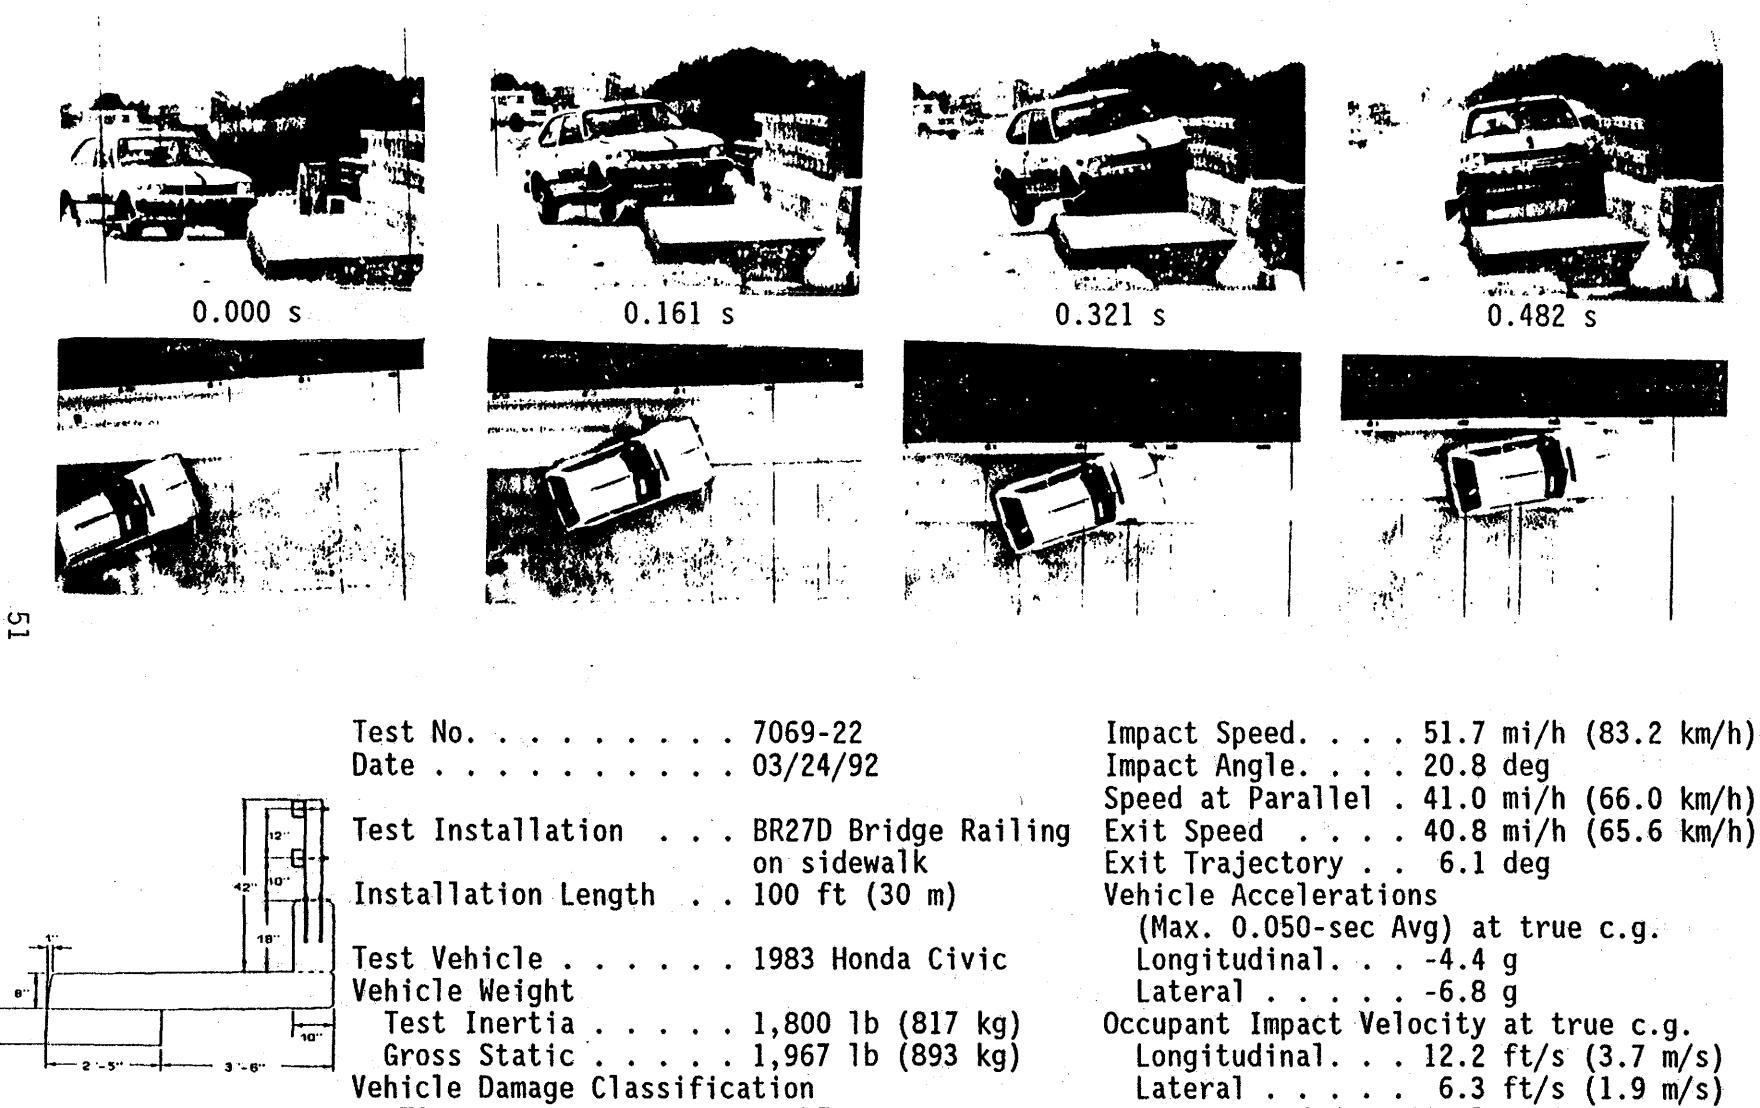
Figure 27. Summary of results for test 7069-22.

smoothly redirected the vehicle. The effective coefficient of friction was considered marginal. The occupant impact velocities and the occupant ridedown accelerations were within the limits. Vehicle trajectory at loss of contact indicated minimum intrusion into adjacent traffic lanes.

Performance of the railing in this test is judged acceptable, as indicated in figure 27 and table 5.

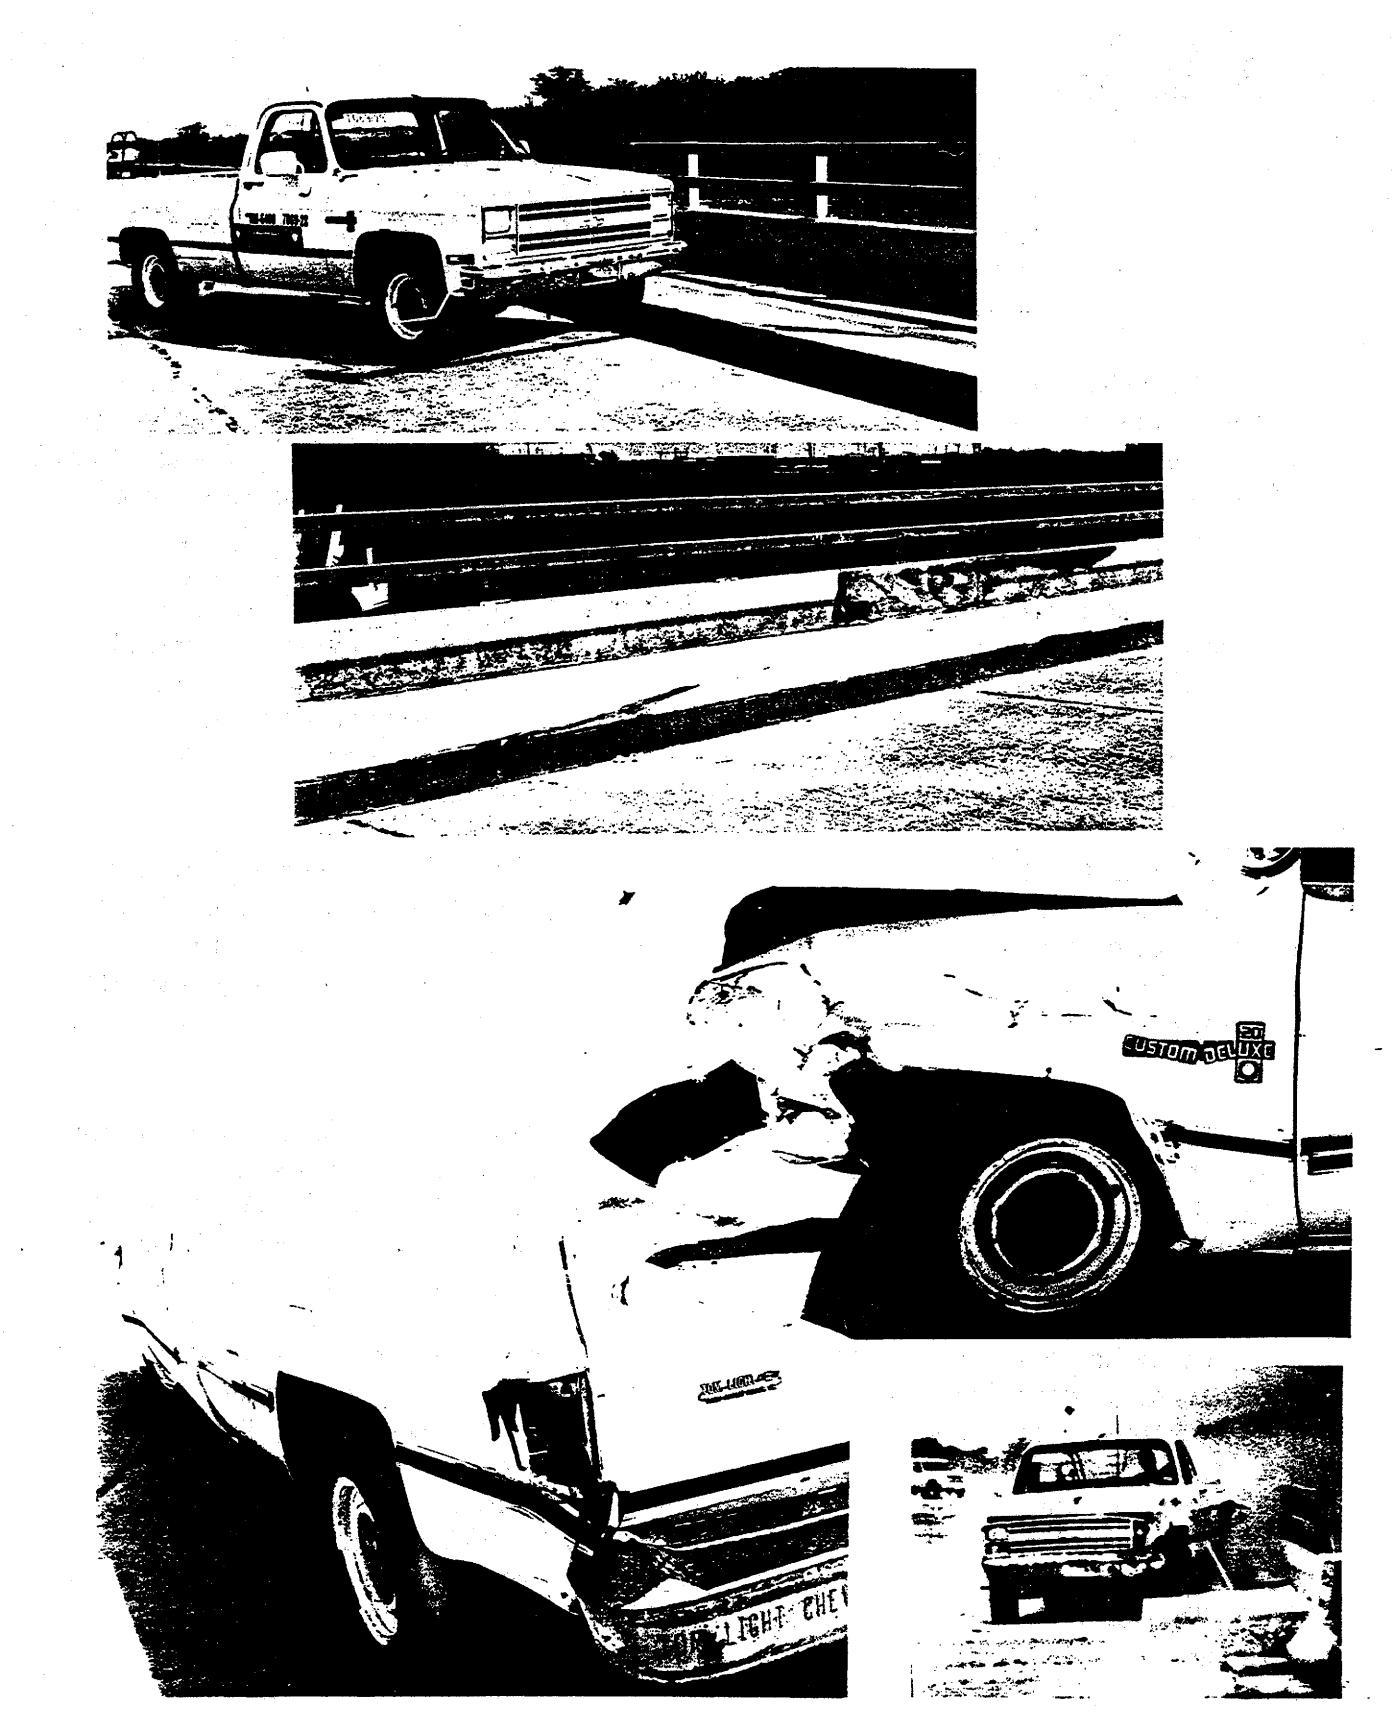
Figure 28. Vehicle and railing for test 7069-23.

The bridge railing received minimal damage (figure 28). The maximum permanent deformation to the railing element was 0.5 in (13 mm) between posts 5 and 6. Posts 5 and 6 were also pushed rearward approximately 3/16 in (05 mm). There was only cosmetic damage to the concrete parapet. There were tire marks on the concrete parapet, on the face of the lower metal railing element in the area of impact, and also on the lower part of posts 5 and 6.

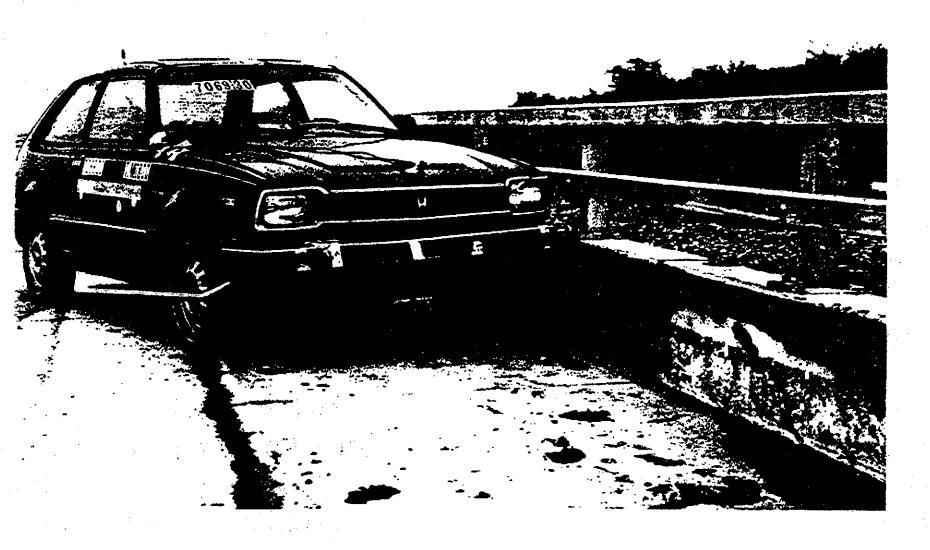
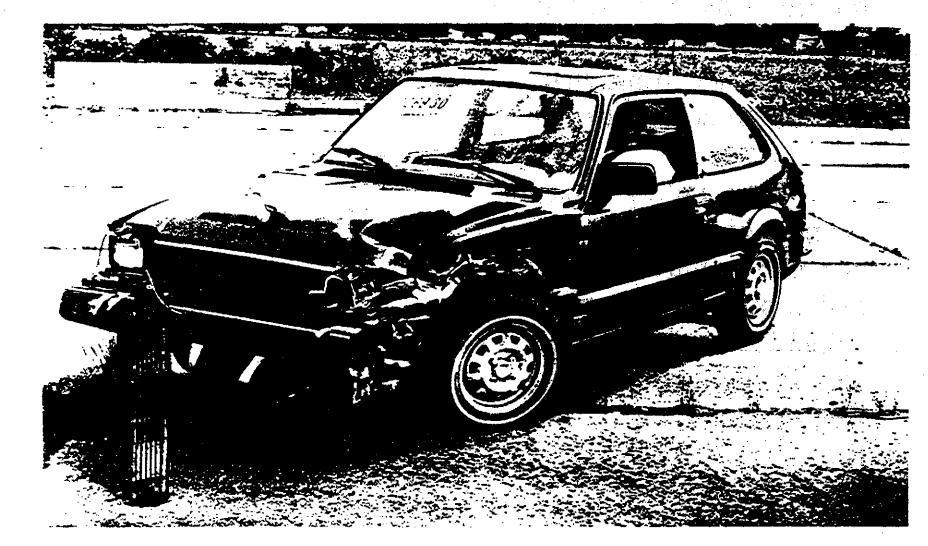
Figure 30. Vehicle and railing for test 7069-30.

The railing contained the vehicle with no lateral movement of the metal railing element of the bridge railing system. There was no intrusion of railing components into the occupant compartment and no debris to present undue hazard to other traffic. The integrity of the occupant compartment was maintained with no intrusion and no deformation. The vehicle remained upright and relatively stable during the collision. The bridge railing smoothly redirected the vehicle. The effective coefficient of friction was considered good. The occupant impact velocities and the occupant ridedown accelerations were within the limits. The vehicle trajectory at loss of contact indicated minimum intrusion into adjacent traffic lanes.

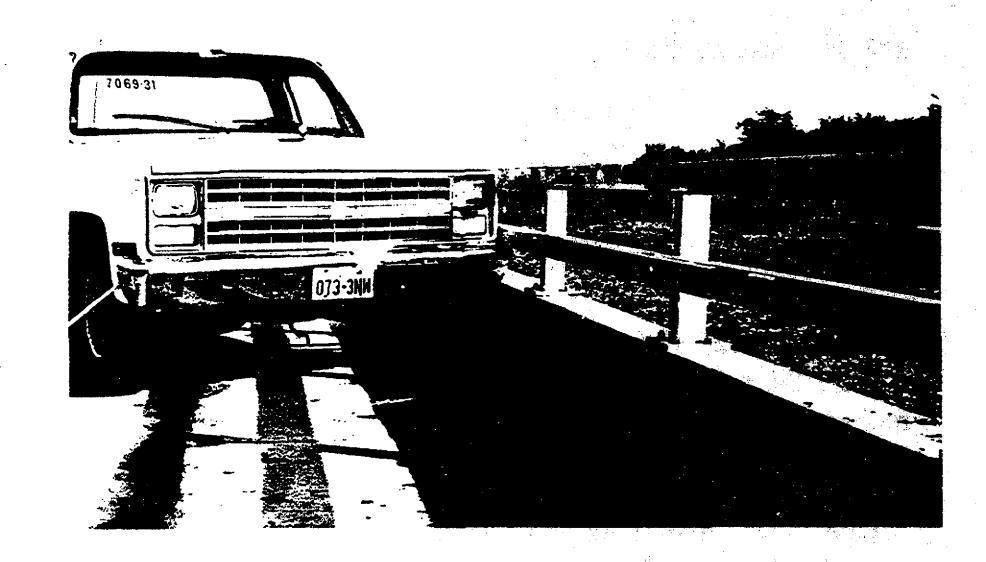
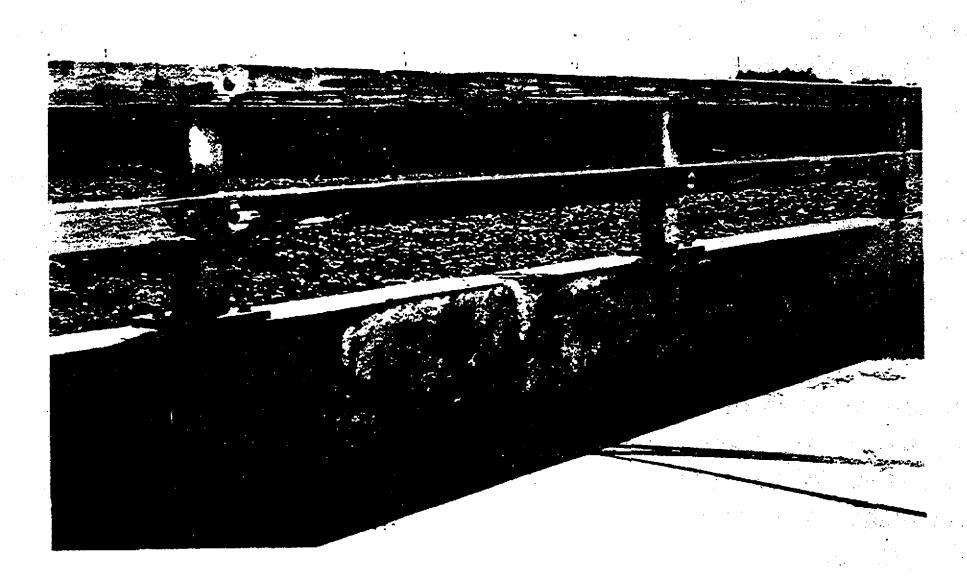
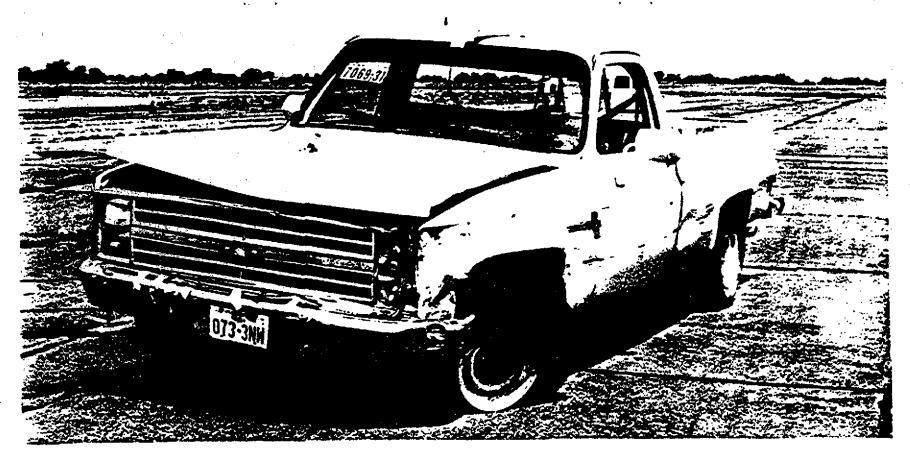
Figure 32. Vehicle and railing for test 7069-31.

The bridge railing received minimal damage (figure 32). The maximum permanent deformation to the railing element was 0.5 in (13 mm) between posts 5 and 6. There was only cosmetic damage to the concrete parapet. There were tire marks on the concrete parapet, on the face of the lower metal railing element in the area of impact, and also on the lower part of post 6.

Maximum crush of the vehicle at the left front corner at bumper height was 6.5 in (165 mm), and the right side was deformed outward 4.0 in (102 mm) (figure 32). Also, damage was done to the front bumper, hood, grill, left front quarter panel, left door, left rear quarter panel, left front and rear tires and rims, rear bumper, and right front quarter panel and right door.

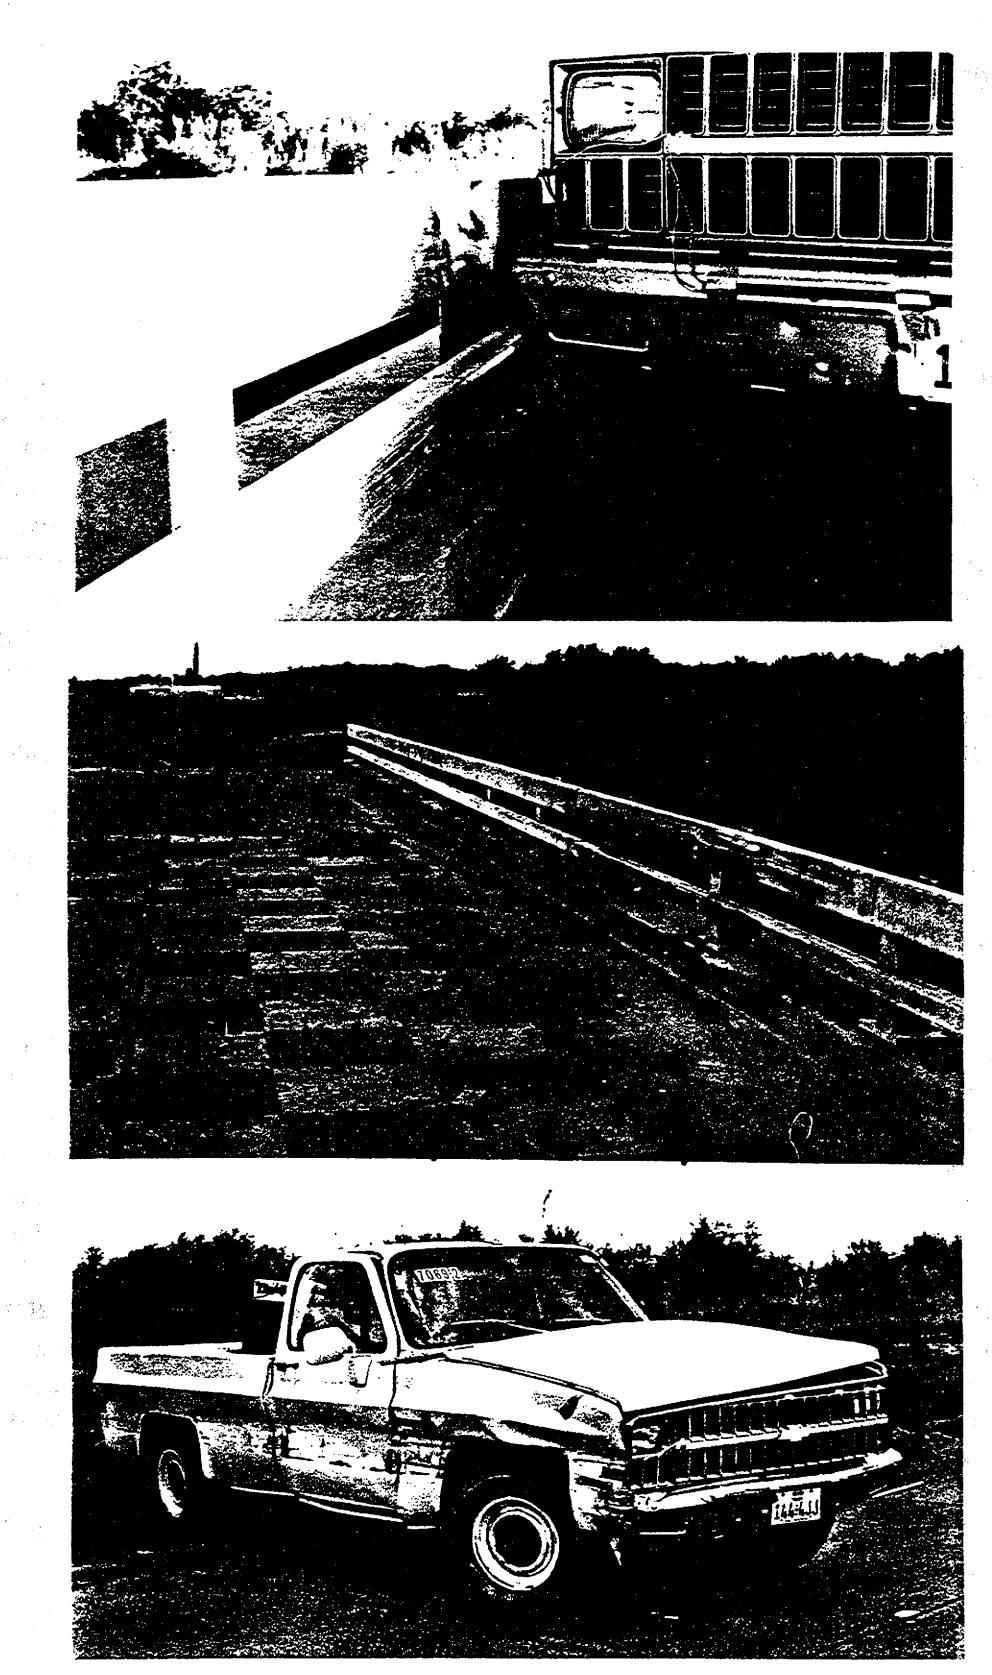
Figure 36. Vehicle and railing for test 7069-2.

The railing received moderate damage (figure 36). There were tire marks on the face of the railings and the curb and minor chips on the edge of the curb. The maximum dynamic deflection of the railing was 2.4 in (61 mm) and maximum permanent deformation was 0.5 in (13 mm). The front of the base plate on post 6 was pulled up slightly and the concrete was chipped around the bolts to the rear of the base plate.

The vehicle sustained extensive damage to the right front corner (figure 36). Maximum crush at the right front corner at bumper height was 5.0 in (127 mm). The right front and right rear wheel rims were bent and the wheel assembly and suspension damaged. The passenger door was bent and jammed and the right rear panel was dented and scraped. The hood was bent and shifted to the left. The windshield frame was bent and the windshield was cracked. The cab of the vehicle was twisted and the frame was bent.

The railing contained and smoothly redirected the vehicle with minimal lateral movement of the railing. There were no debris or detached elements. There was no intrusion into the occupant compartment. The vehicle trajectory at loss of contact indicated minimum intrusion into adjacent traffic lanes. The vehicle remained upright and stable during the entire test period.

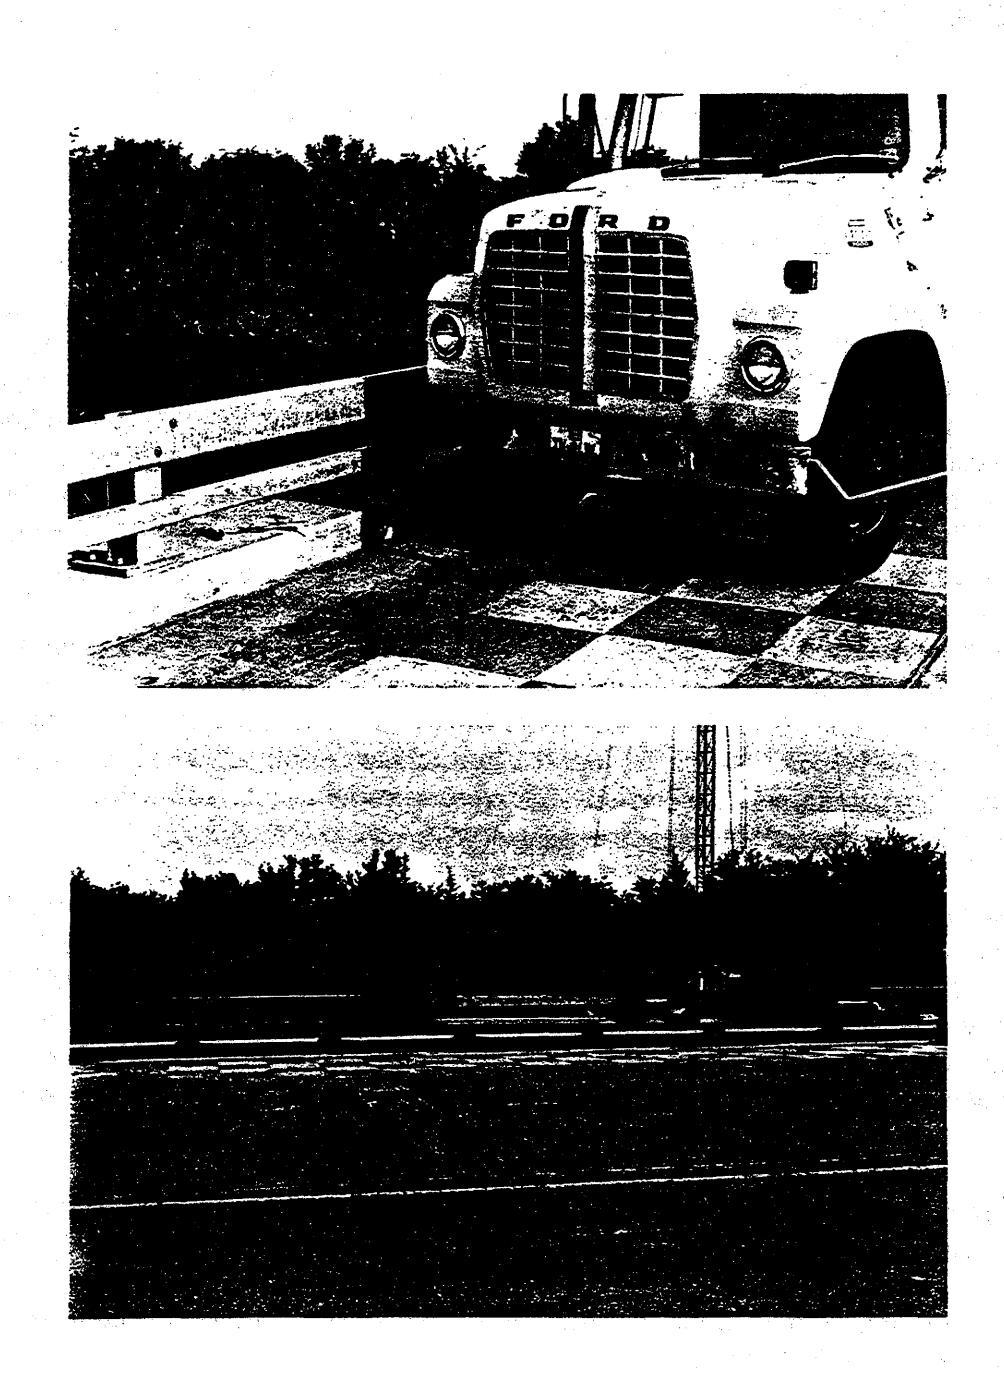
Figure 38. Vehicle and railing for test 7069-15.

Damage to the railing was moderate (figure 38). The bolts connecting the lower railing element to the post were sheared on posts 3 through 7. At post 5 the bolt on the upper railing element was sheared and the face of the element itself was gouged. The flange on post 6 was bent and the concrete curb was cracked at posts 6 through 9. The top of post 8 was bent where it made contact with the box. During the test the lower railing element was pushed down. After the test, the maximum vertical movement was 3 in (76 mm) at post 5.

Damage to the vehicle was extensive. The steering arm rod, u-bolts, spring pins, and front and rear spring mounts were damaged. The frame was bent as well as the rear part of the drive shaft, the rear u-joint, the battery box, and the gas tank. The cargo box was torn during the test and, as the vehicle left the railing and rolled to the right, the load shifted and tore open the right side of the box.

The railing contained and smoothly redirected the vehicle with minimal lateral movement of the railing. There was no intrusion into the occupant compartment and very little deformation of the compartment. The vehicle trajectory at loss of contact indicated minimum intrusion into adjacent traffic lanes, and the vehicle remained relatively stable during the collision.

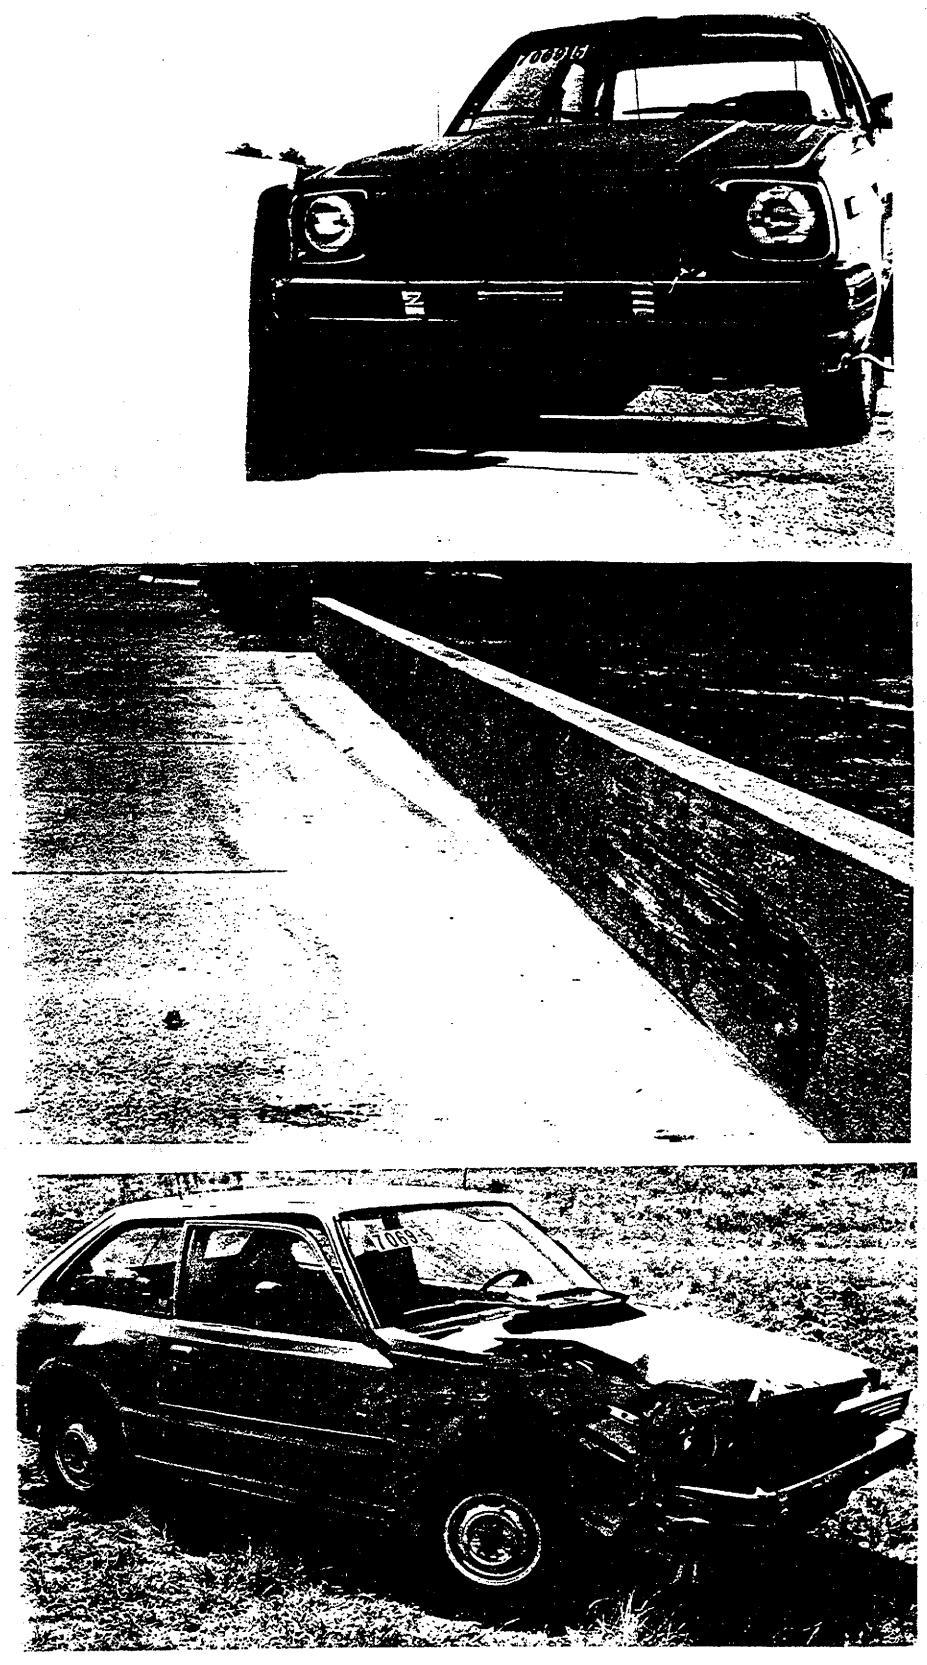
The parapet received cosmetic damage only (figure 40). There were tire marks on the face of the parapet. The vehicle was in contact with the parapet for 10.3 ft (3.1 m).

The vehicle sustained extensive damage to the right front as shown in figure 40. Maximum crush at the right front corner at bumper height was 5.0 in (127 mm). The right front and right rear wheel rims were bent, and the right front strut was bent. The passenger door was bent and jammed, and the right side was dented and scraped. The hood was bent and shifted to the left. The windshield frame was bent, and the windshield was cracked. The roof of the vehicle was buckled and twisted.

The parapet contained and smoothly redirected the vehicle with no lateral movement of the parapet. There were no debris or detached elements. There was no intrusion into the occupant compartment although some deformation of the compartment occurred. The vehicle trajectory at loss of contact indicated minimum intrusion into adjacent traffic lanes. The vehicle remained upright and stable during the entire test period.

The lateral occupant impact velocity of 26.0 ft/s (7.9 m/s) is higher than the maximum acceptable value of 25 ft/s (7.6 m/s). However, the authors conclude that the performance of this parapet in this test is acceptable on the basis of two arguments. The value obtained is marginally close to being acceptable. The acceptable value was selected as a reasonably achievable value for impact angles of 15 degrees, not the more severe condition of 20 degrees used in this test. See figure 41 and table 13.

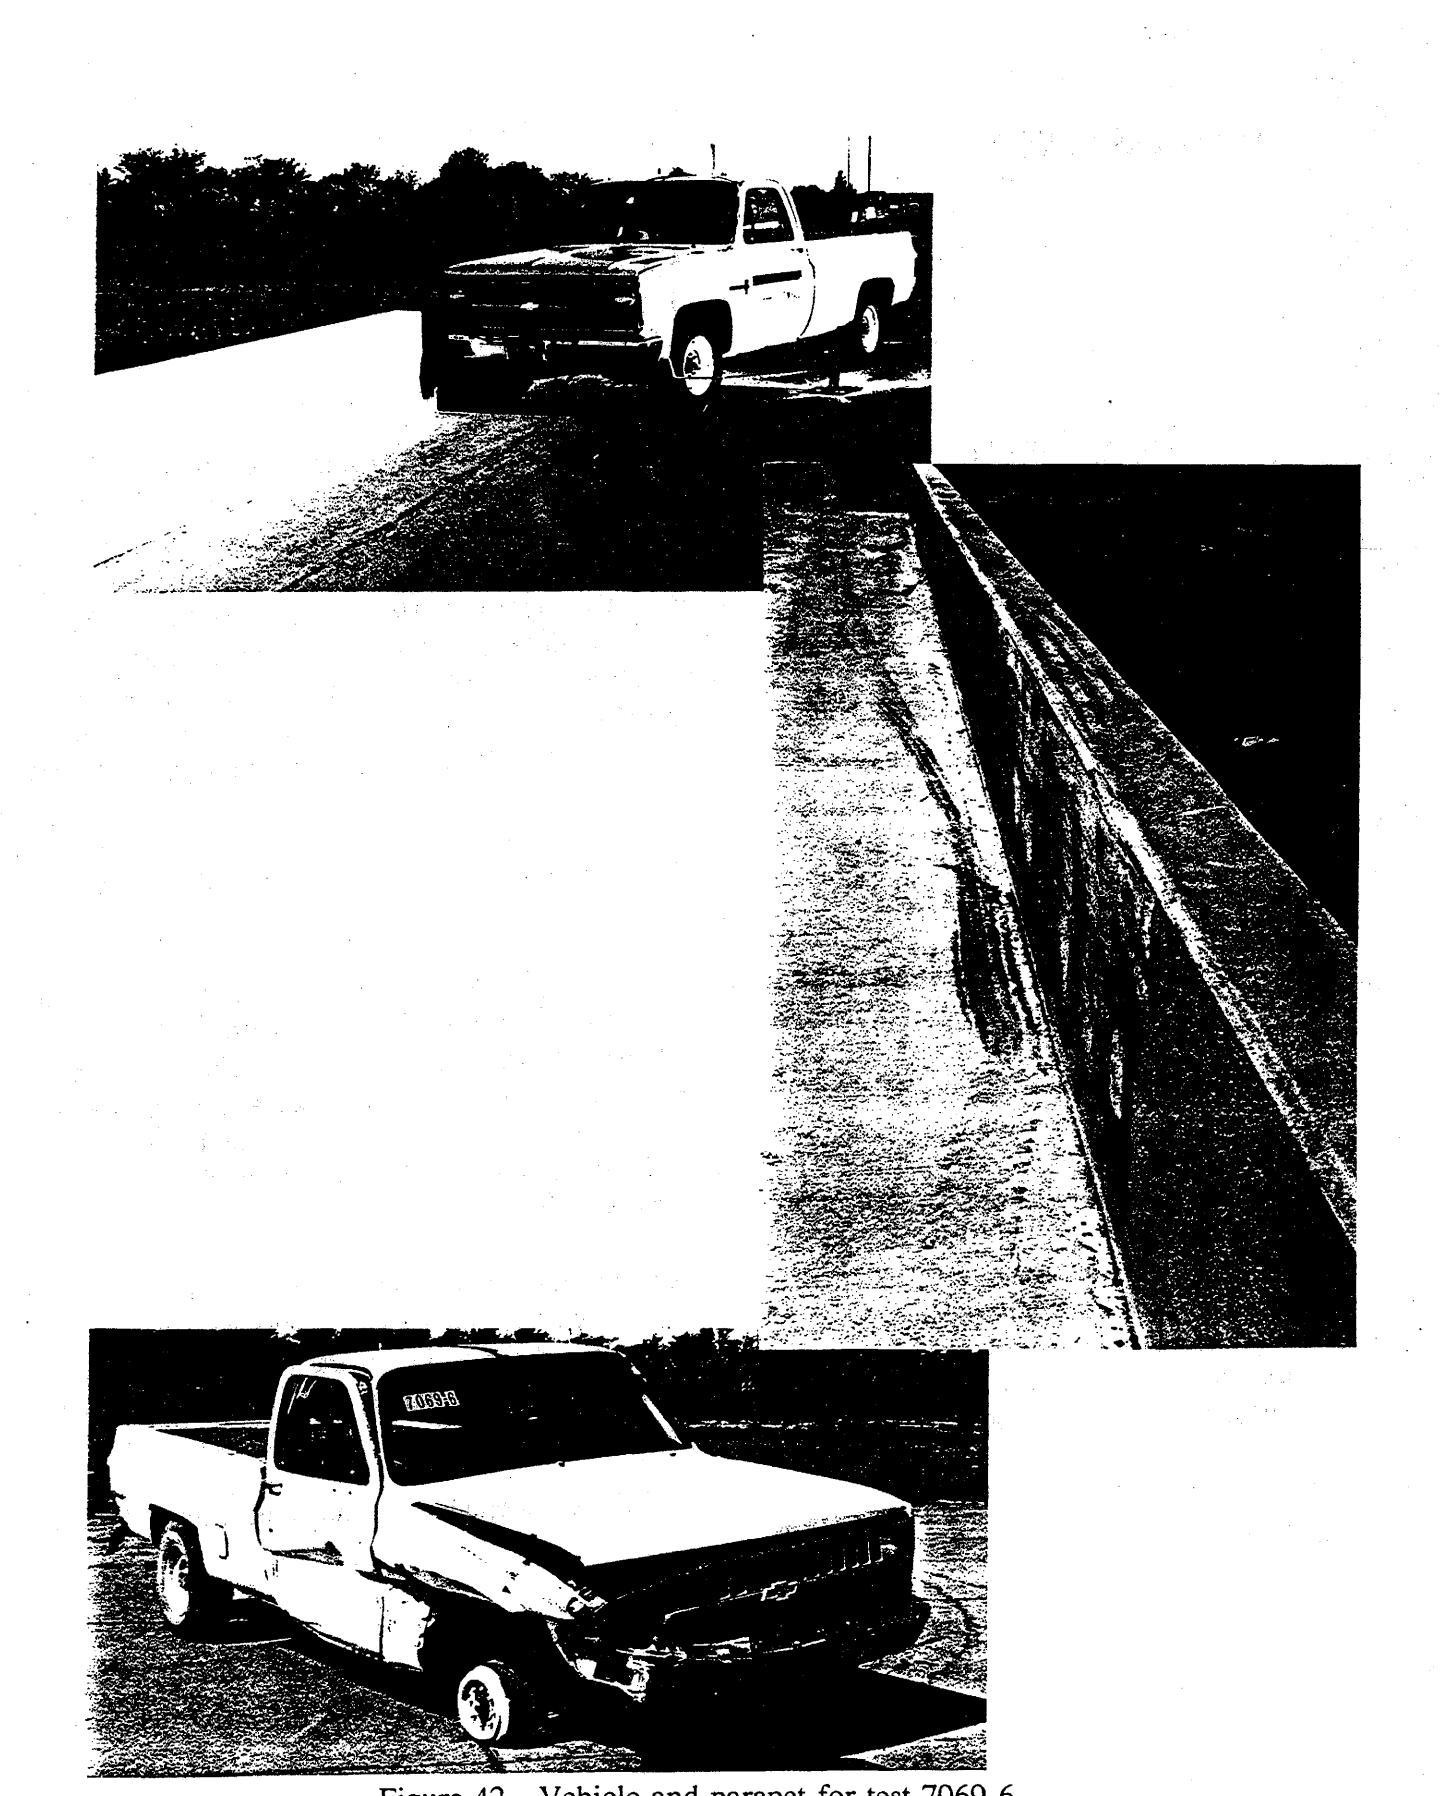
Figure 42. Vehicle and parapet for test 7069-6.

The parapet received only cosmetic damage as shown in figure 42. There were tire marks on the face of the parapet.

The vehicle sustained extensive damage to the right side (figure 42). Maximum crush at the right front corner at bumper height was 9.0 in (229 mm). The right front and right rear wheel rims were bent, and the welds had broken on the right front wheel rim, allowing the outer rim and tire to become completely separated. The wheel assembly and suspension were damaged. The passenger door was bent and jammed, and the window was broken. The right rear panel was dented and scraped. The hood was bent and shifted to the left. The cab of the vehicle was twisted, and the frame was bent.

The parapet contained and smoothly redirected the vehicle with minimal lateral movement of the parapet. There were no debris or detached elements. There was no intrusion into the occupant compartment although some deformation of the right door occurred. The vehicle trajectory at loss of contact indicated minimum intrusion into adjacent traffic lanes. The vehicle remained upright and stable during the entire test period.

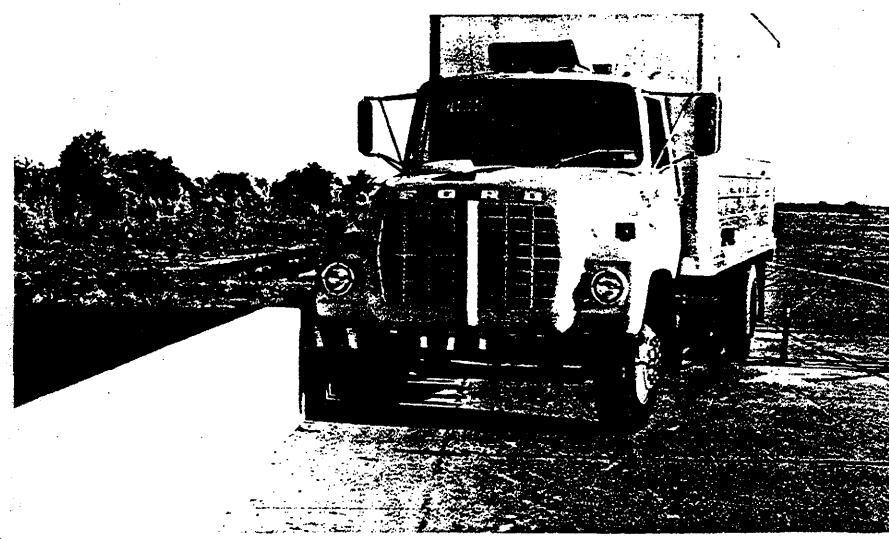
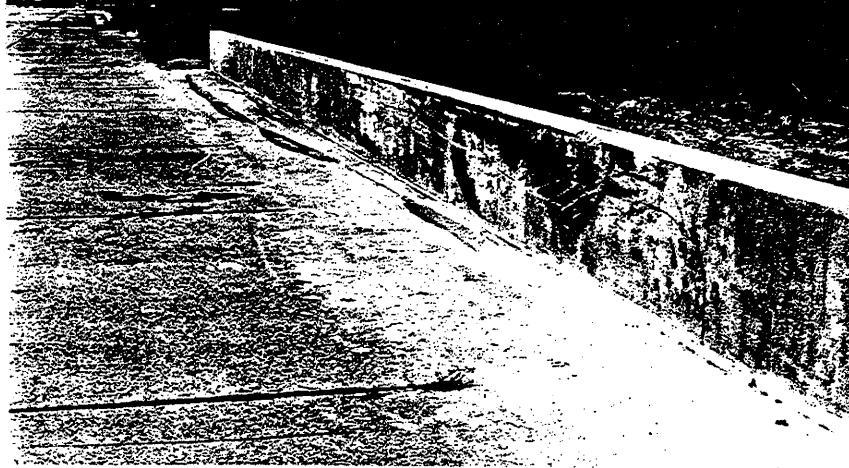
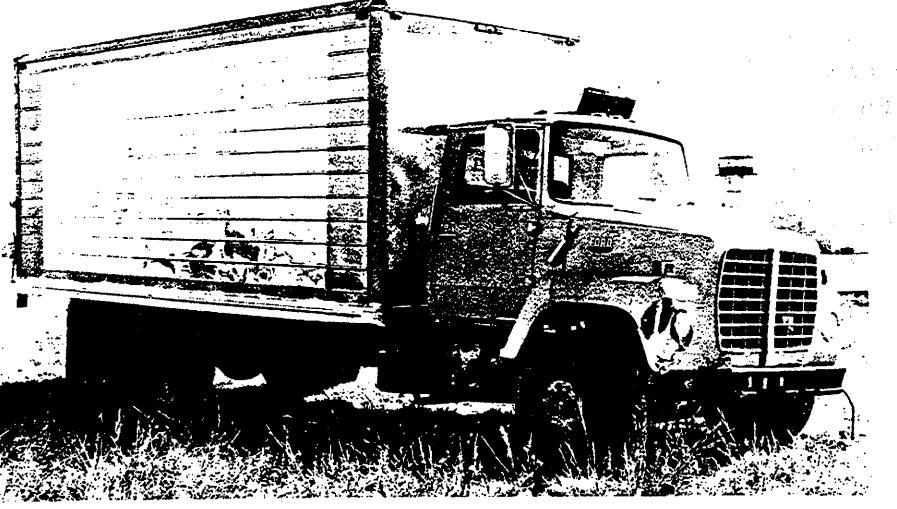
Figure 44. Vehicle and parapet for test 7069-16.

The parapet received only cosmetic damage (figure 44). There were tire marks on the face of the parapet and along the top for about 30 ft (9 m). The bed of the vehicle scraped the top of the parapet for another 15 ft (4.6 m).

The vehicle sustained moderate damage to the right side (figure 44). Maximum crush at the right front corner at bumper height was 10.0 in (254 mm). The front bumper, the hood, and the right front quarter were damaged, and the windshield was cracked. The rear U-bolt on the right front springs was broken, and the springs were dislocated. The fuel tank and straps were also damaged.

The parapet contained and smoothly redirected the vehicle with no lateral movement of the parapet. There was no intrusion into the occupant compartment and very little deformation of the compartment. The vehicle trajectory at loss of contact indicated minimum intrusion into adjacent traffic lanes.
