1. Report No.	2. Government Accession No.		3. Recipient's Catalog No.	
FHWA-RD-93-058				
4. Title and Subbide			5. Report Date	
TESTING OF NEW BRIDGE RAIL AN VOLUME I: TECHNICAL REPORT	ND TRANSITION D	DESIGNS	6. Performing Organization Code

10. ADSTACT				
The objectives of this study were to develop safer bridge rail and transition designs and to improve design guidelines. Ten bridge railings and two transitions were designed, tested, and evaluated in accordance with American Association of State Highway and Transportation Officials (AASHTO) requirements. The railings were designed using ultimate strength procedures and collision forces from earlier research. Design procedures, railing designs, and test results are presented. All designs demonstrated acceptable collision performance.			nes. Ten of State th ented. All

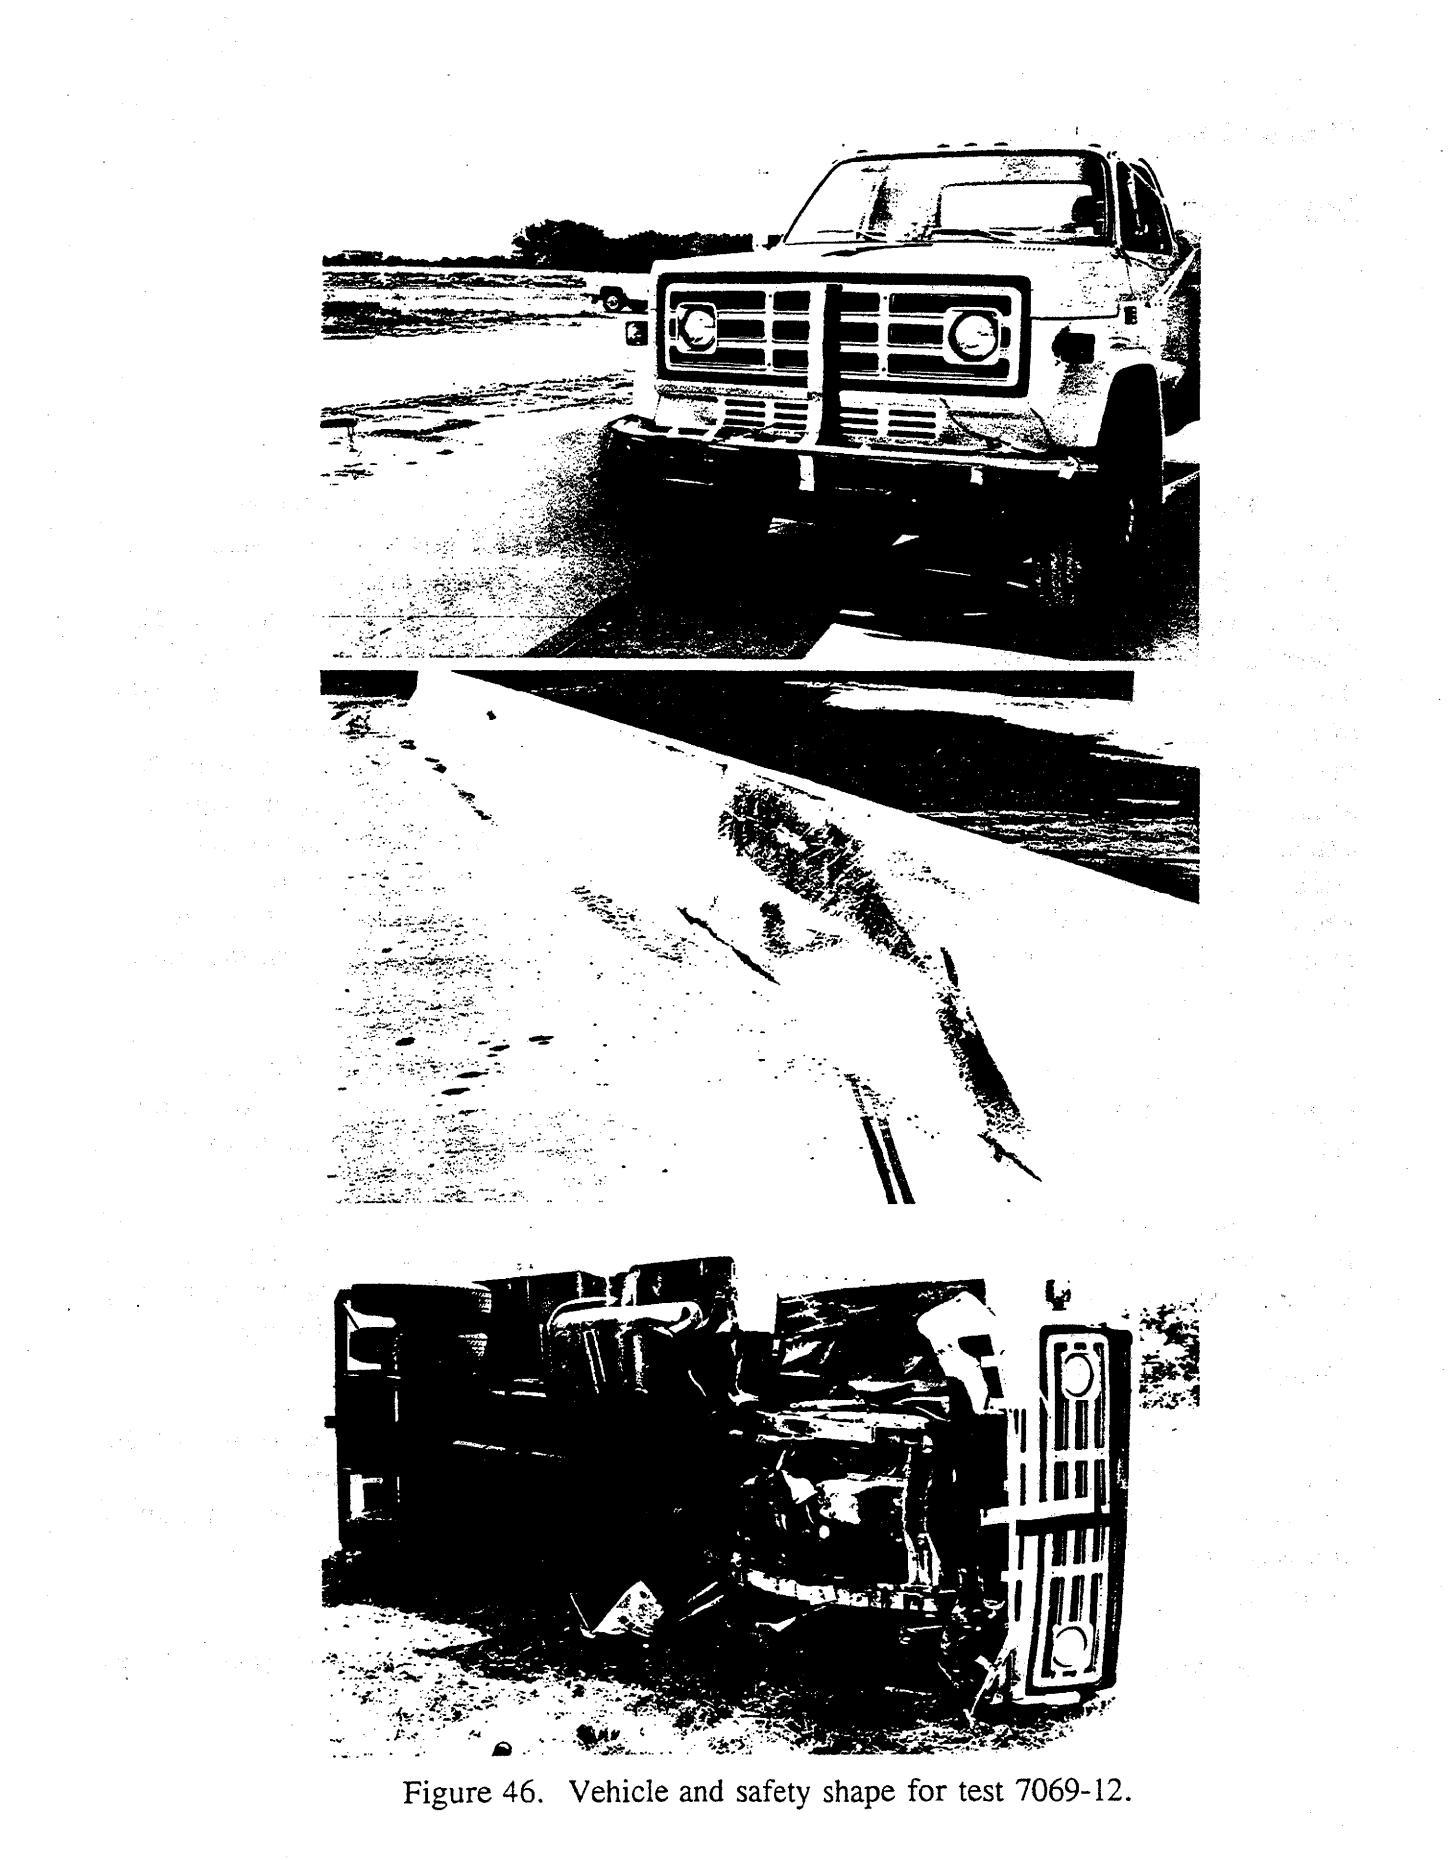
The safety shape received only cosmetic damage and some scraping and gouging (figure 46). There were tire marks on the face and top of the safety shape. The top of the safety shape was scraped along the remaining length by the undercarriage of the truck.

The vehicle sustained extensive damage to the right side. Maximum crush at the right front corner at bumper height was 8.0 in (203 mm). The front axle was torn off the vehicle, and the undercarriage damaged. There was damage to the U-bolts, Pittman arm rod, steering arm, brake lines, and leaf spring bolts. The outer right rear wheel rim and tire were damaged. The fuel tank also sustained damage.

The safety shape contained and redirected the vehicle with no lateral movement of the safety shape. There was no intrusion into the occupant compartment and very little deformation of the compartment. The vehicle trajectory at loss of contact indicated minimum intrusion into adjacent traffic lanes; however, the vehicle did not remain upright after collision.

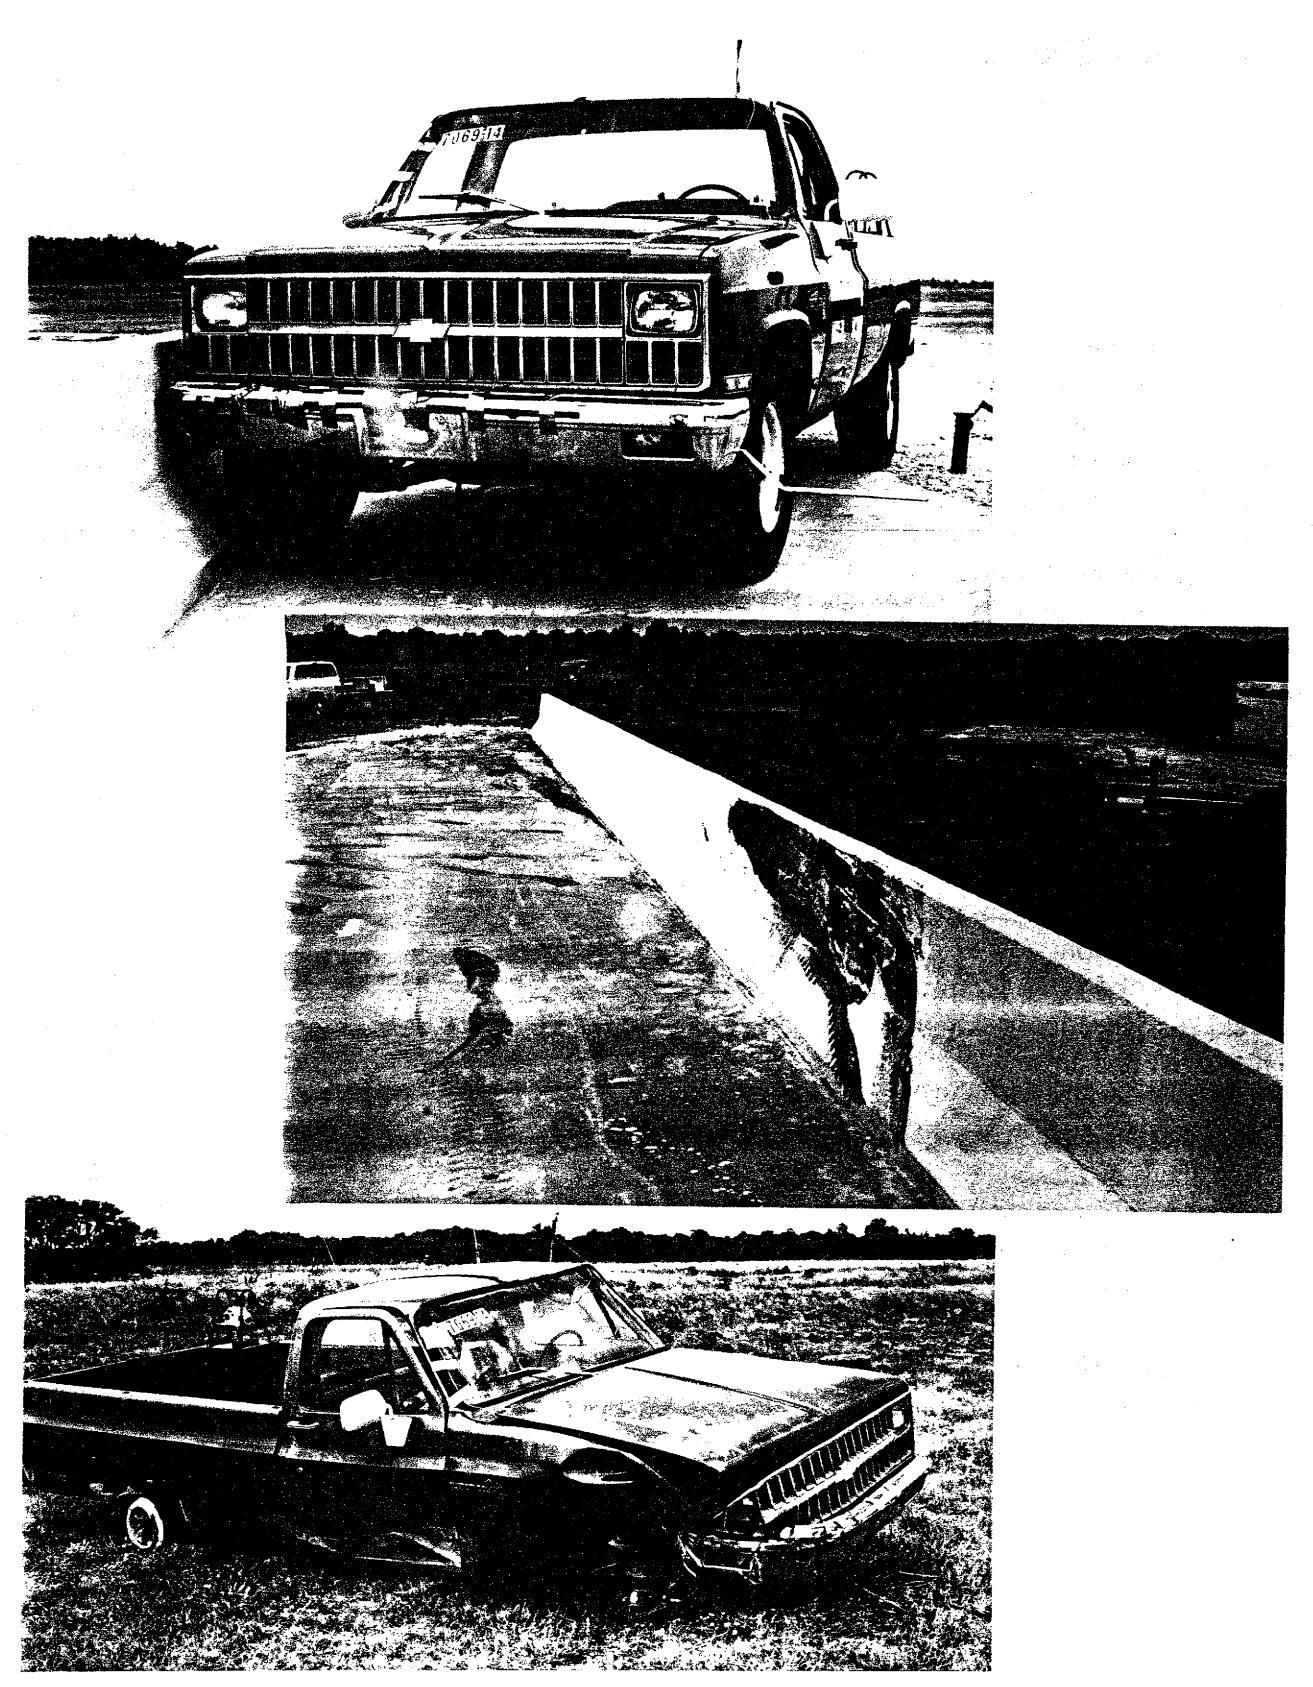
Figure 48. Vehicle and safety shape for test 7069-14.

The safety shape received only cosmetic damage (figure 48). There were tire marks on the face and top of the safety shape.

The safety shape contained and smoothly redirected the vehicle with no lateral movement of the safety shape. There was no intrusion into the occupant compartment and minimal deformation of the compartment. The vehicle trajectory at loss of contact indicated minimum intrusion into adjacent traffic lanes. The vehicle remained upright and relatively stable during the collision.

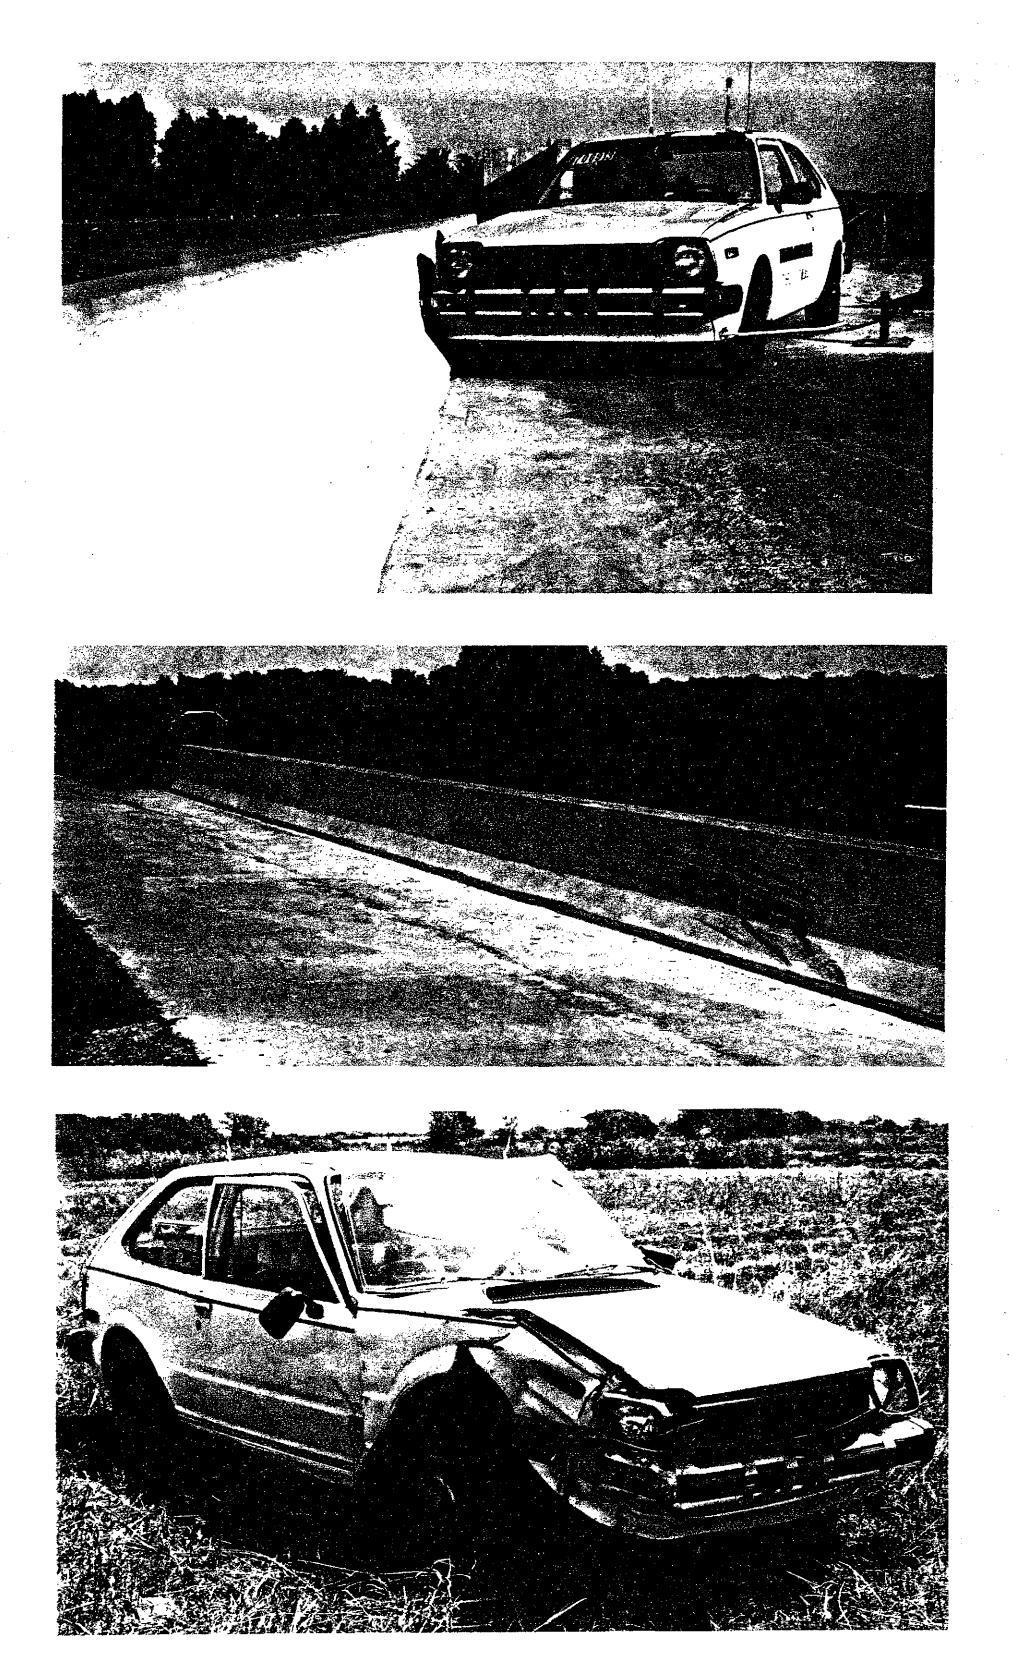
Figure 50. Vehicle and F-shape for test 7069-3.

The railing contained and smoothly redirected the vehicle with no lateral movement of the railing. There were no debris or detached elements. There was no intrusion into the occupant compartment although some deformation of the compartment occurred. The vehicle trajectory at loss of contact indicated minimum intrusion into adjacent traffic lanes. The vehicle remained upright and stable during the entire test period.

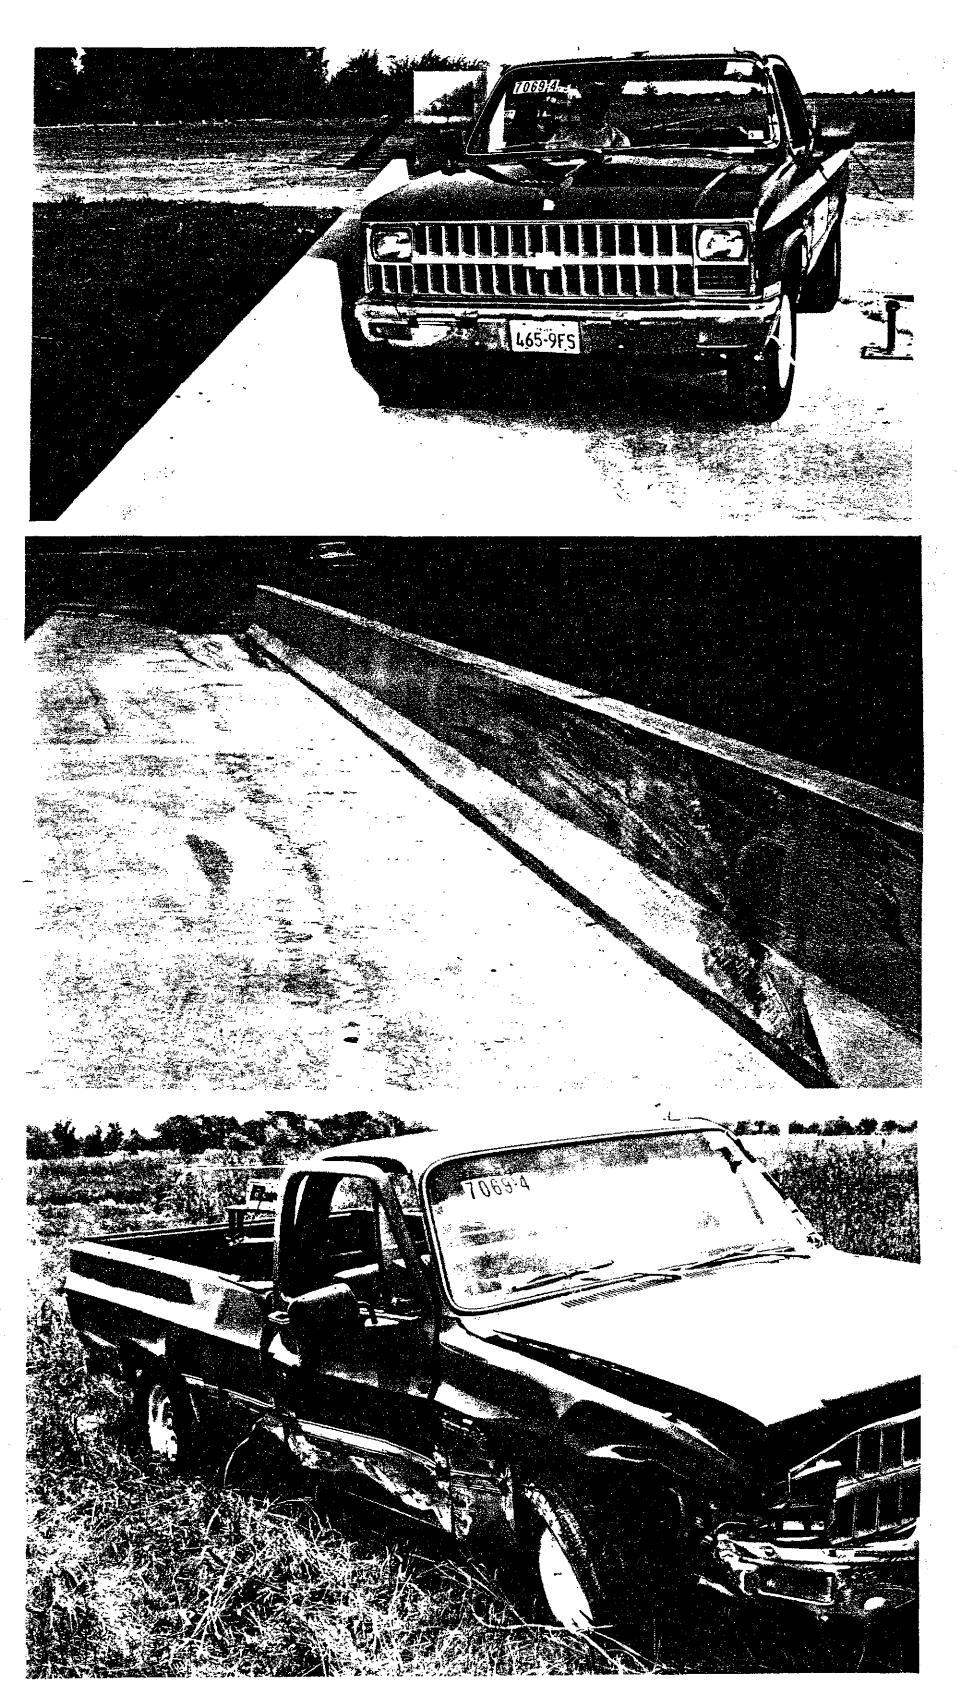
Figure 52. Vehicle and F-shape for test 7069-4.

The railing received only cosmetic damage (figure 52). There were tire marks on the face of the bridge railing which indicated the vehicle rose a maximum height of 24 in (610 mm) above the ground.

The vehicle sustained extensive damage to the right side (figure 52). Maximum crush at the right front corner at bumper height was 5.0 in (127 mm). The right front and right rear wheel rims were bent and the tires were deflated. The wheel assembly and suspension was damaged. The passenger door was bent and jammed and the window broken out. The right rear panel was dented and scraped. The hood was bent and shifted to the left. The cab of the vehicle was twisted.

The railing contained and smoothly redirected the vehicle with minimal lateral movement of the railing. There were no debris or detached elements. There was no intrusion into the occupant compartment although some deformation of the right door occurred. The vehicle trajectory at loss of contact indicated minimum intrusion into adjacent traffic lanes. The vehicle remained upright and stable during the entire test period.

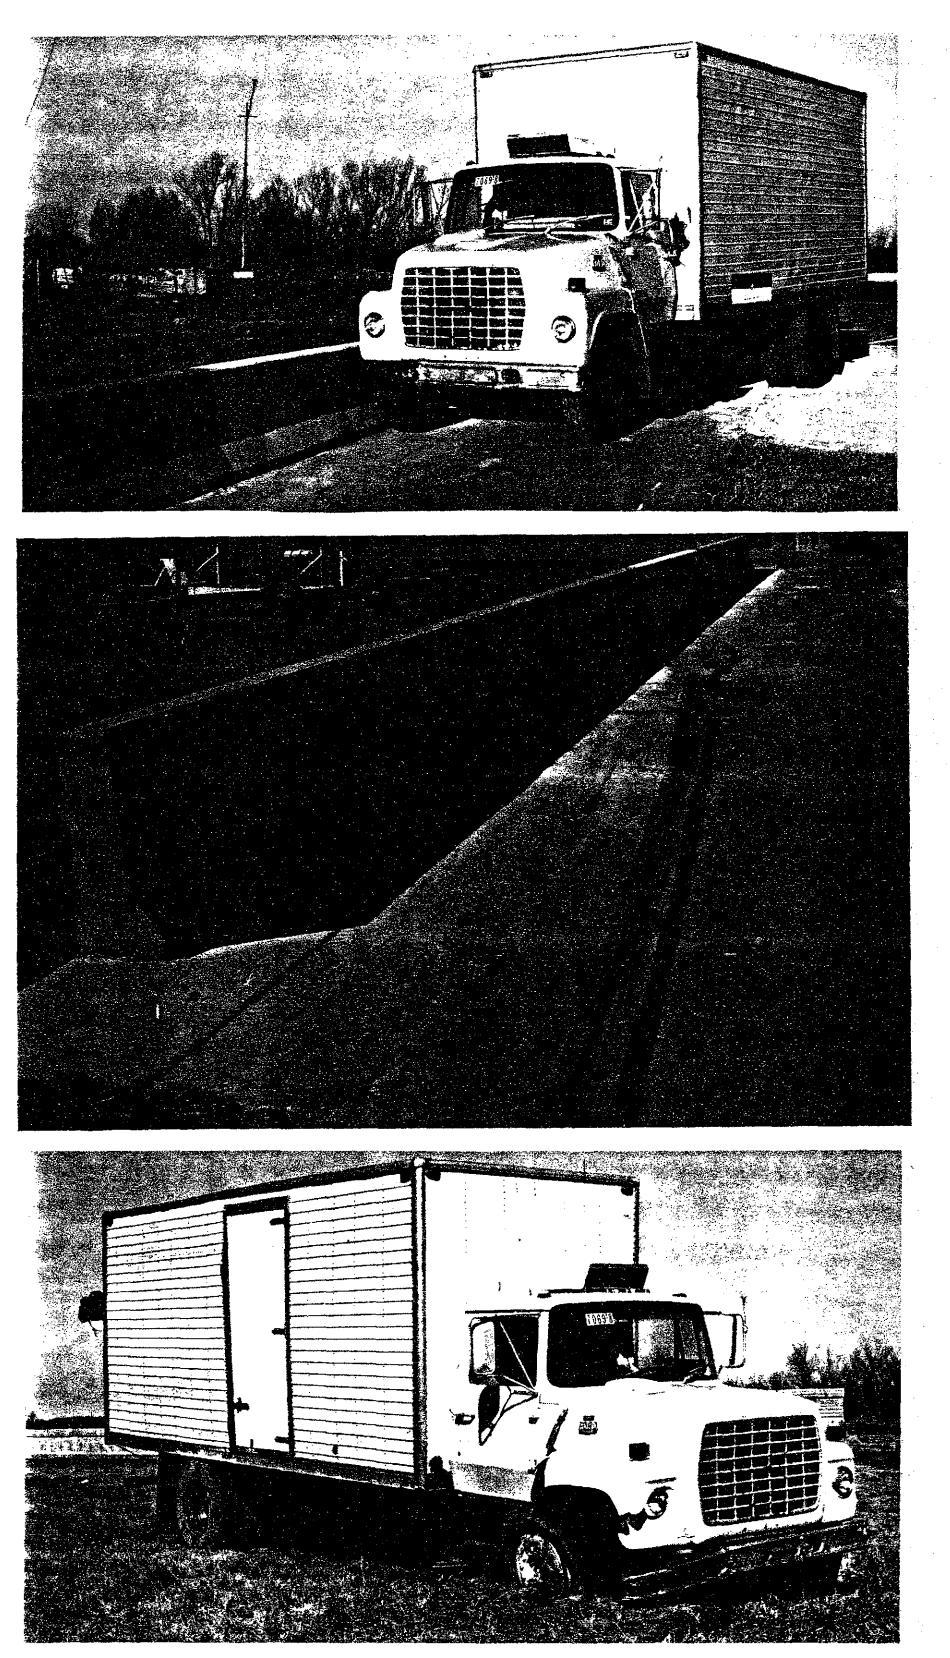
Figure 54. Vehicle and F-shape for test 7069-8.

The railing received only cosmetic damage (figure 54). There were tire marks on the face of the bridge railing and along the top. The top of the bridge railing was scraped along the remaining length from the lower edge of the bed of the truck.

The vehicle sustained extensive damage to the right side (figure 54). Maximum crush at the right front corner at bumper height was 6.0 in (152 mm). The right front wheel rim was bent and the tire damaged. The spring and spring shackle was broken loose from the axle. The steering gear box and steering cylinder was damaged. Also, the fuel tank broke loose from the truck.

The railing contained and smoothly redirected the vehicle with no lateral movement of the railing. There were no debris or detached elements. There was no intrusion into the occupant compartment. The vehicle trajectory at loss of contact indicated minimum intrusion into adjacent traffic lanes. The vehicle remained upright and marginally stable during the entire test period.

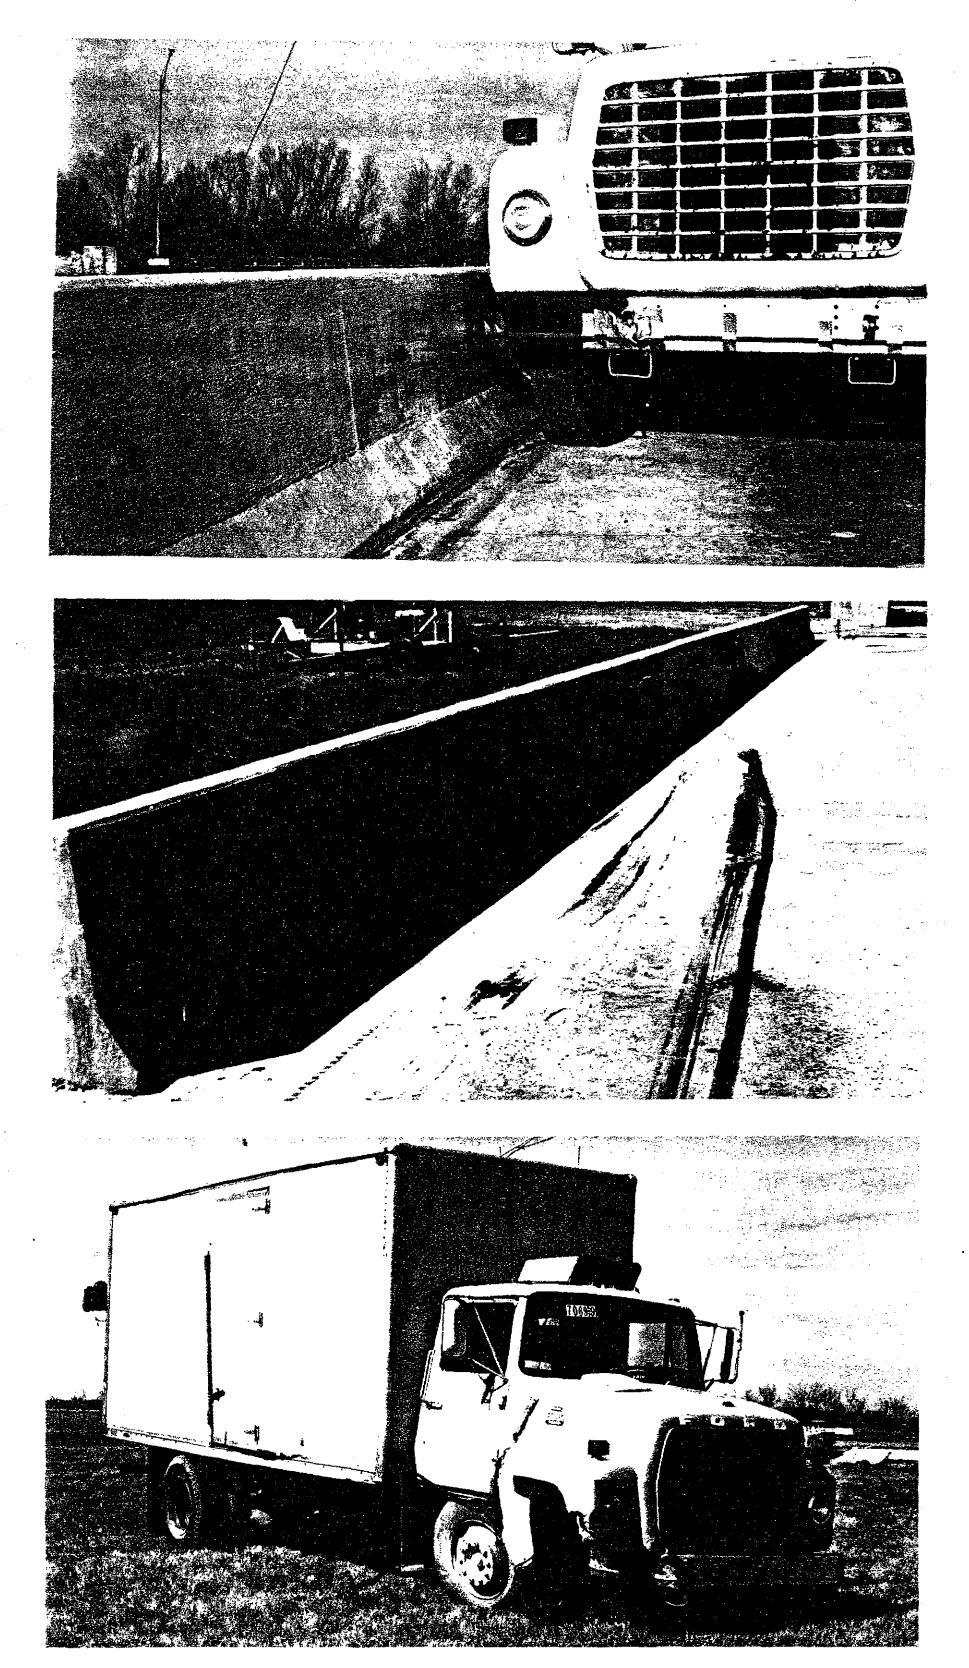
Figure 56. Vehicle and F-shape for test 7069-9.

The railing received only cosmetic damage (figure 56). There were tire marks on the face of the railing and along the top. The top of the bridge railing was scraped along the remaining length from the lower edge of the bed of the truck.

The vehicle sustained extensive damage to the right side (figure 56). Maximum crush at the right front corner at bumper height was 16.0 in (406 mm). The right front wheel rim was bent and the tire damaged. The spring and spring shackle was broken loose from the axle and the axle torn loose on the left side. The steering gear box and steering cylinder was damaged. Also, the fuel tank broke loose from the truck.

The railing contained and smoothly redirected the vehicle with no lateral movement of the railing. There was no debris or detached elements. There was no intrusion into the occupant compartment. The vehicle trajectory at loss of contact indicated minimum intrusion into adjacent traffic lanes. The vehicle remained upright and marginally stable during the entire test period.

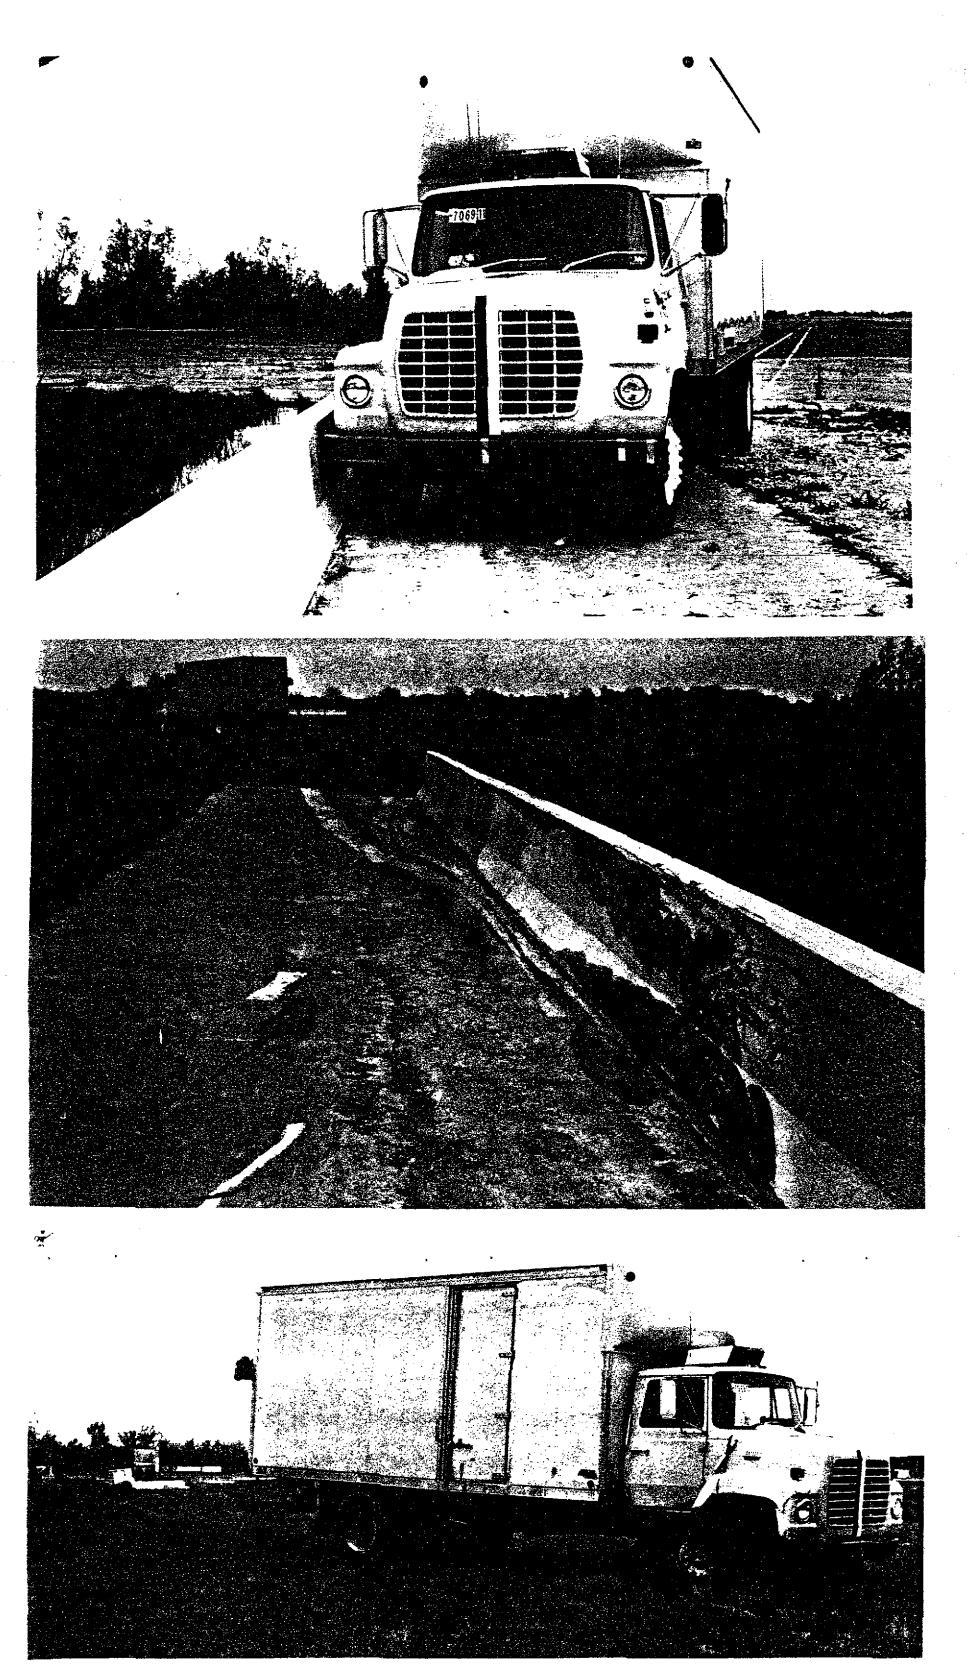
Figure 58. Vehicle and F-shape for test 7069-11.

The railing received only cosmetic damage (figure 58). There were tire marks on the face of the bridge railing and along the top. The top of the bridge railing was scraped along the remaining length from the lower edge of the bed of the truck. The vehicle was in contact with the bridge railing for 39 ft (12 m).

The vehicle sustained extensive damage to the right side as shown in figure 58. Maximum crush at the right front corner at bumper height was 20.0 (508 mm). The front axle was torn loose which caused damage to the springs, shackles, U-bolts, and tie rods. The steering arm and cylinder were damaged and the oil pan was dented. Also, the fuel tank broke loose from the truck.

The railing contained and smoothly redirected the vehicle with no lateral movement of the railing. There was no debris or detached elements. There was no intrusion into the occupant compartment. The vehicle trajectory at loss of contact indicated minimum intrusion into adjacent traffic lanes. The vehicle remained upright and marginally stable during the entire test period.

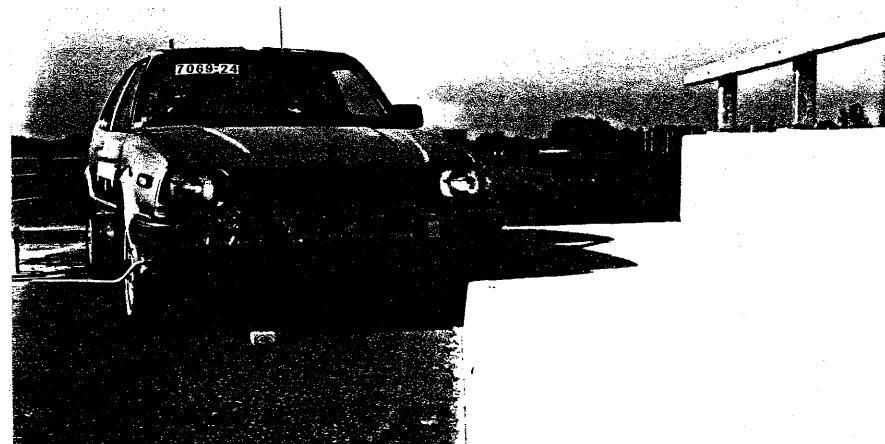
Figure 60. Vehicle and railing for test 7069-24.

The bridge railing system received minimal damage (figure 60). There was no measurable permanent deformation to the metal railing elements; however, the left corner of the bumper had snagged post 6 (leaving plastic trim). Also, posts 5 and 6 were pulled up such that the washers rotated freely under the nuts on the front side of the railing. There was only cosmetic damage to the concrete parapet, i.e., tire marks on the concrete parapet from post 5 on past post 6 and then again between posts 8 and 9 where the vehicle contacted the parapet the second time.

The vehicle sustained damage to the left side (figure 60). Maximum crush at the left front corner at bumper height was 7.5 in (191 mm). The left front strut was bent and the left front wheel was pushed back reducing the wheelbase on the driver side by 3 in (76 mm). Also damage was done to the front bumper, hood, left front quarter panel, left rear quarter panel, rear bumper, left front and rear tires and rims, and right front tire.

The railing contained the vehicle with no lateral movement of the railing. There was no intrusion of railing components into the occupant compartment and no debris to present undue hazard to other traffic. The integrity of the occupant compartment was maintained with no intrusion and no deformation. The vehicle remained upright and relatively stable during the collision. The bridge railing system smoothly redirected the vehicle. Although the lateral ridedown acceleration of 17.2 g's was slightly above the recommended limit, performance was judged acceptable for this category because it was well within the limits of the other three occupant risk factors. The vehicle trajectory at loss of contact indicated minimum intrusion into adjacent traffic lanes.

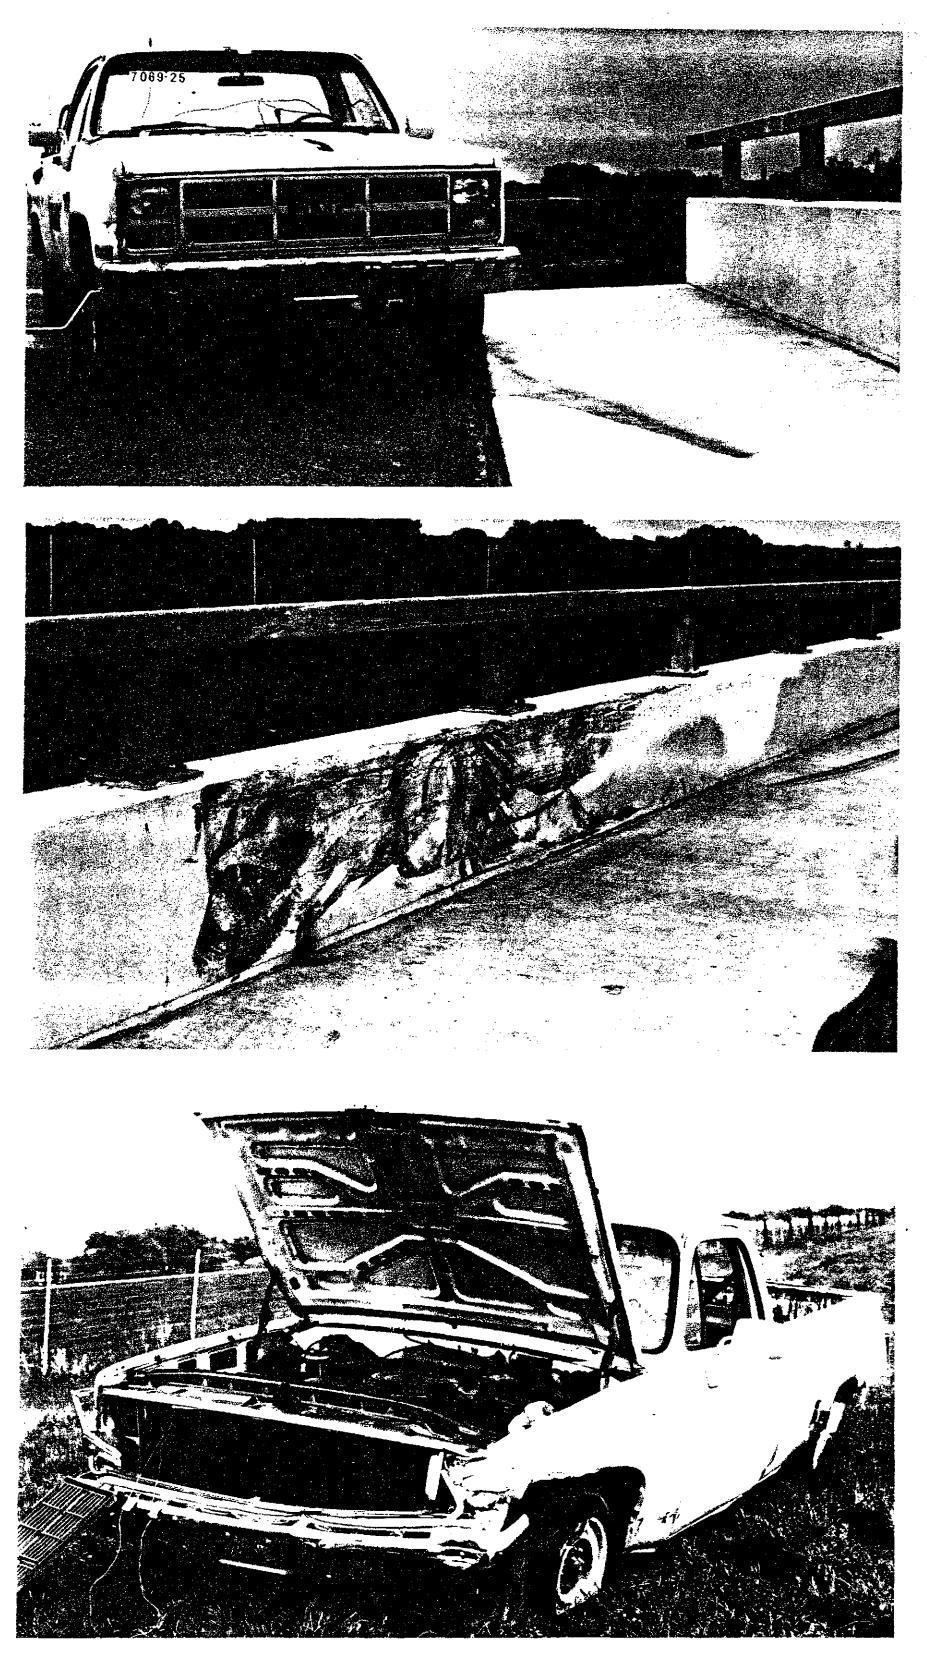
Figure 62. Vehicle and railing for test 7069-25.

The railing system received moderate damage (figure 64). There was no measurable permanent deformation to the metal railing elements in the immediate impact area; however the bolts connecting the railing to the posts from 10 through 14 were sheared as a result of vertical load from the cargo box. There was only cosmetic damage to the concrete parapet, i.e., tire marks on the concrete parapet from post midway of posts 7 and 8 to post 11 and then again from posts 13 to 14.

The vehicle sustained damage to the left side (figure 64). Maximum crush at the left front corner at bumper height was 6.0 in (152 mm). The front axle broke loose and became separated from the vehicle as did the drive shaft. There was damage to the springs and shocks, steering box, front bumper, left front quarter panel, left door, and left front tire and rim. The lower edge of the left side of the cargo box was also damaged.

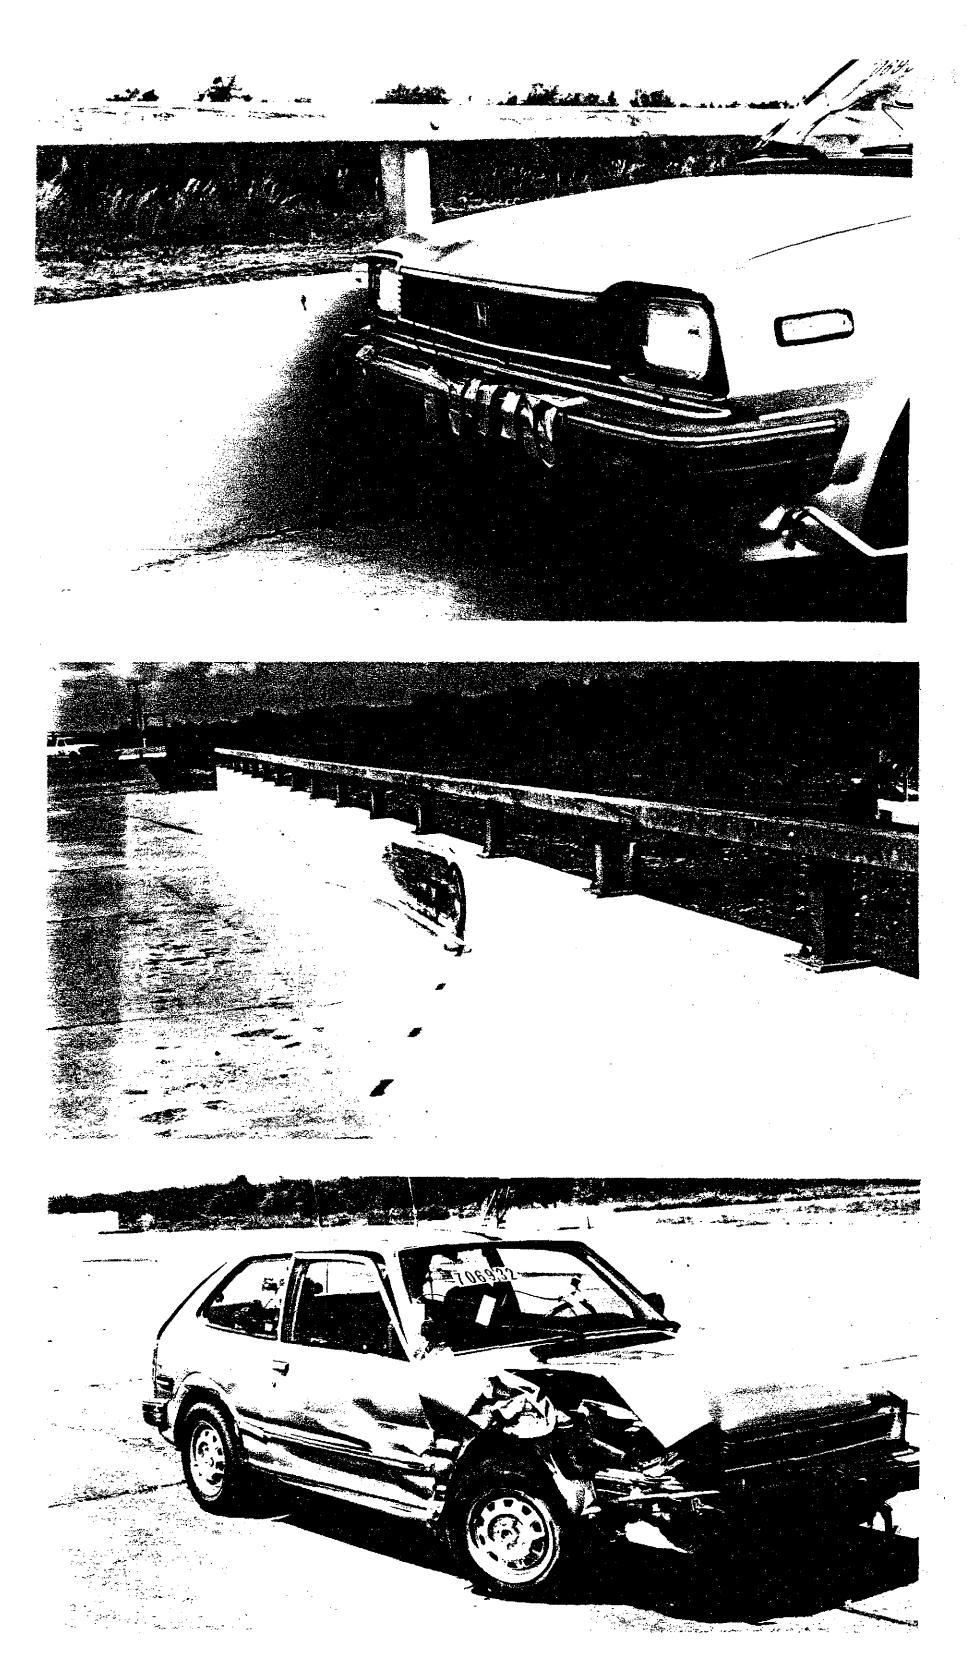
Figure 66. Vehicle and railing for test 7069-32.

The railing received minimal damage (figure 68). There was 0.5 in (13 mm) deformation to the lower metal railing element and there was a hairline crack in the concrete beam 17.5 in (445 mm) down from post 3.

The vehicle sustained damage to the right side (figure 68). Maximum crush at the right front corner at bumper height was 9.0 in (229 mm) and there was a 0.5-in (13-mm) dent into the occupant compartment at the fire wall. The wheelbase on the right side was reduced 2.0 in (51 mm). The sway bars were damaged and the frame was bent. Also, damage was done to the front bumper, hood, grill, radiator, fan, right front quarter panel, right front tire and rim, right door, right rear quarter panel, rear bumper, right rear rim, and left front quarter panel.

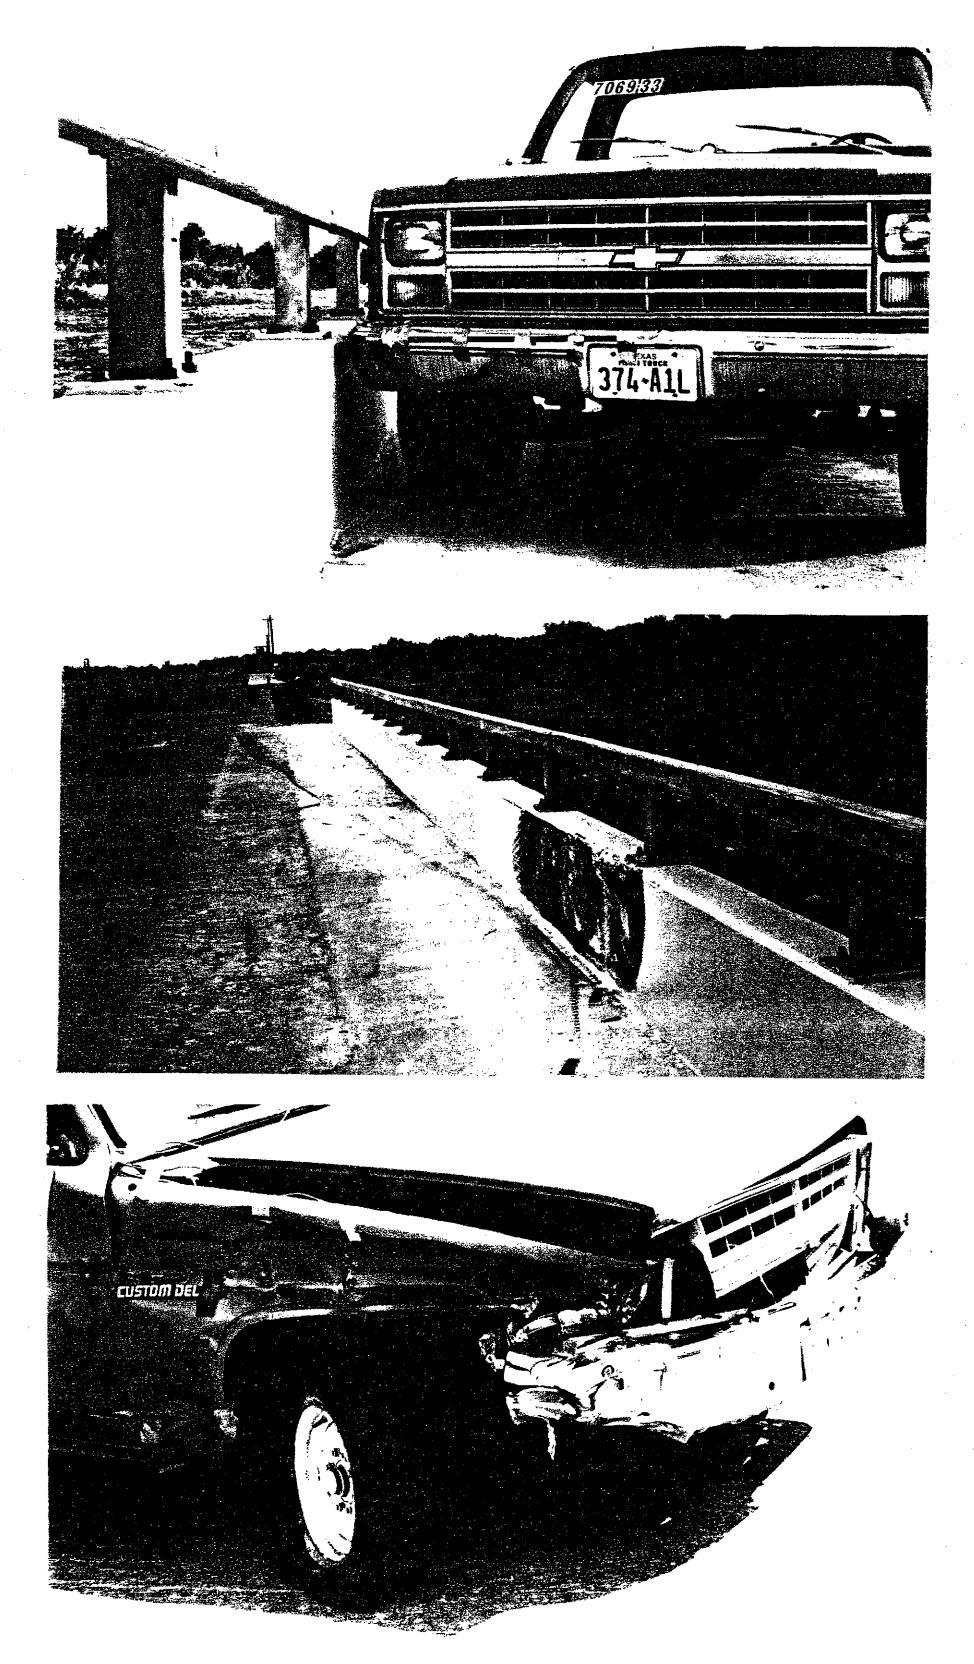
Figure 68. Vehicle and railing for test 7069-33.

The railing received minimal damage with most being contained within the area around posts 4, 5, and 6. Cracking occurred in posts 4 and 5 in the heat affected zone in the posts at the post-to-baseplate connection. The crack occurred at the corners on the traffic side of the tubular steel element (corner of maximum stress) and extended approximately 1 in in both directions. There was a hairline crack in the concrete parapet in line with the rear post bolts at post 4. There was 1.5 in (38 mm) deformation to the metal railing element between posts 4 and 5.

The vehicle sustained damage mostly to the right side (figure 70). Maximum crush at the right front corner at bumper height was 28.0 in (711 mm). The steering arm, front springs and shackles, left front king pin and front axle were damaged and the frame was bent. Also, damage was done to the front bumper, right front quarter panel, right front tire and rim, right door, right rear outside tire and rim, gas tank and box-van.
