1. Report No.	2. Government Accession No.		3. Recipient's Catalog No.	
FHWA-RD-93-058				
4. Title and Subbide			5. Report Date	
TESTING OF NEW BRIDGE RAIL AN VOLUME I: TECHNICAL REPORT	ND TRANSITION D	DESIGNS	6. Performing Organization Code

10. ADSTACT				
The objectives of this study were to develop safer bridge rail and transition designs and to improve design guidelines. Ten bridge railings and two transitions were designed, tested, and evaluated in accordance with American Association of State Highway and Transportation Officials (AASHTO) requirements. The railings were designed using ultimate strength procedures and collision forces from earlier research. Design procedures, railing designs, and test results are presented. All designs demonstrated acceptable collision performance.			nes. Ten of State th ented. All

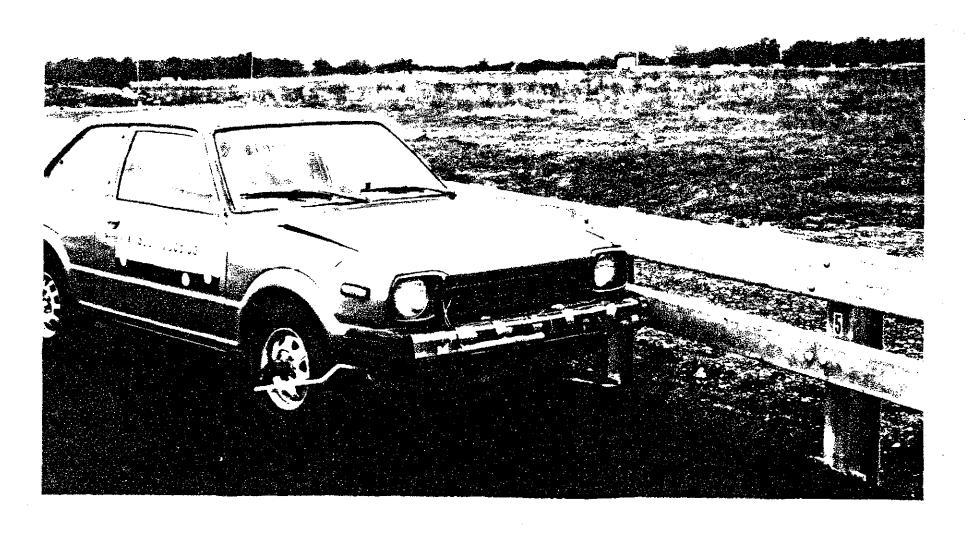
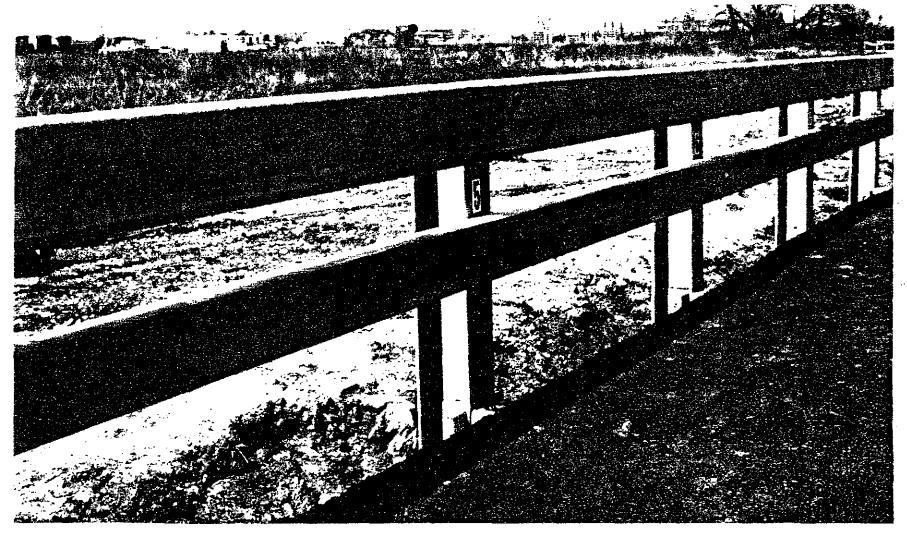
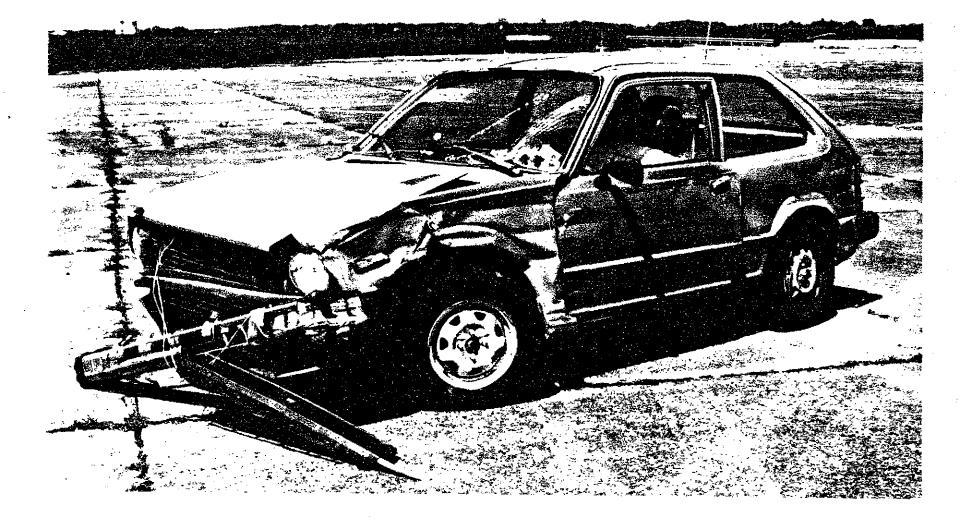
Figure 72. Vehicle and railing for test 7069-35.

The railing received moderate damage (figure 74). There was 1.0 in (25 mm) deformation to the upper rail element and 0.75 in (19 mm) to the lower rail element near post 5. The flanges on posts 4 and 5 were deformed just above the angles (L6x4x1/4x4) and these angles were bent.

The vehicle sustained damage to the left side. Maximum crush at the left front corner at bumper height was 13.0 in (330 mm) and there was a 0.4-in (10-mm) dent into the occupant compartment at the fire wall and center tunnel. The frame was bent and the door on the driver side was deformed outward 3.2 in (81 mm). Also, damage was done to the front bumper, hood, grill, radiator, fan, left front quarter panel, left front tire and rim, left door, left rear quarter panel, rear bumper, and left rear rim. Most of the damage to the right side of the vehicle was sustained when the vehicle impacted the protective barrier.

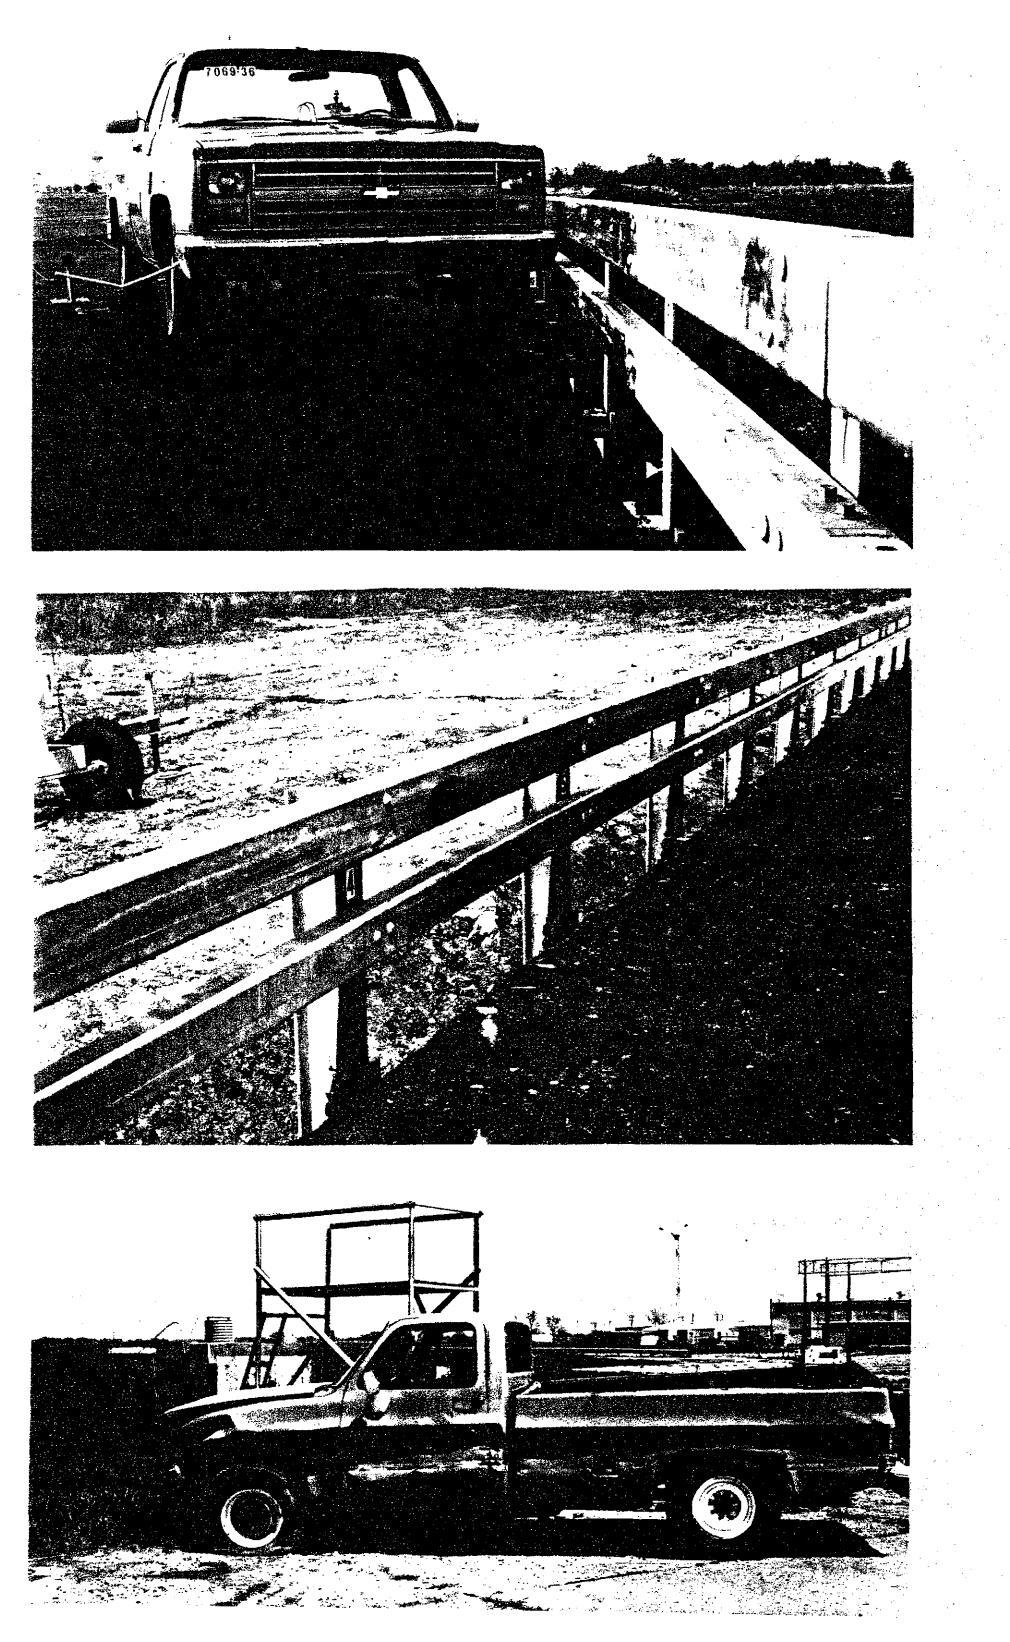
Figure 74. Vehicle and railing for test 7069-36.

The railing received moderate damage with most contained within the area between posts 4 through 7. The upper and lower rails sustained gouges between posts 4 and 5 from the lug nuts of the vehicle's wheel. The head of the lower bolt on the top rail at post 5 was torn off and the bolts on the lower element were loose. The angles at post 4 were slightly bent and those at posts 5 and 6 were deformed. The spacers at posts 4 and 5 were knocked loose and down. There was 2.5 in (64 mm) deformation to the upper rail element at post 5.

The vehicle sustained damage mostly to the left side (figure 76). Maximum crush at the left front corner at bumper height was 8.0 in (203 mm). The front springs, shackles, and U-bolt were damaged and the box-van shifted off the frame approximately 6 in (150 mm). Also, damage was done to the front bumper, left front quarter panel, left front tire and rim, left rear outside tire and rim, and lower edge of the box-van.

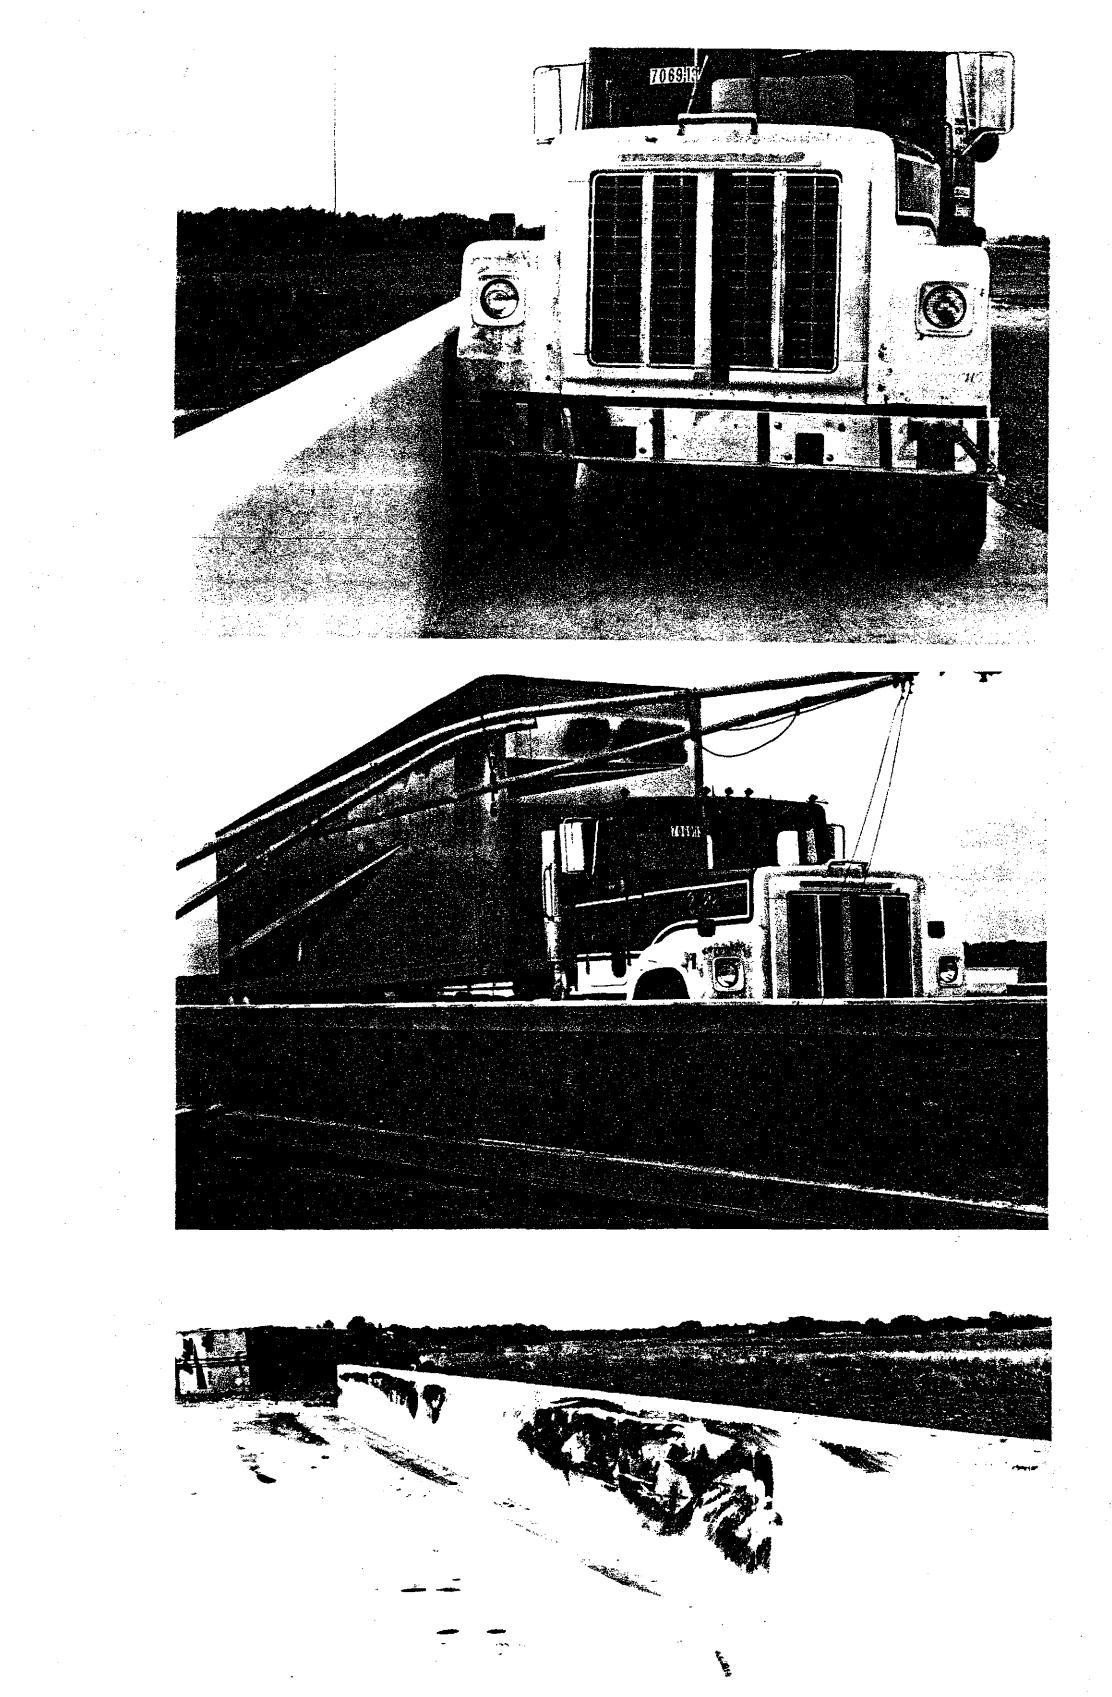
Figure 78. Vehicle and parapet for test 7069-13.

The parapet received only cosmetic damage (figure 78). There were tire marks on the parapet from just before the impact point extending a total of 85 ft (26 m) along the face. There was also a piece of the top of the parapet chipped off.

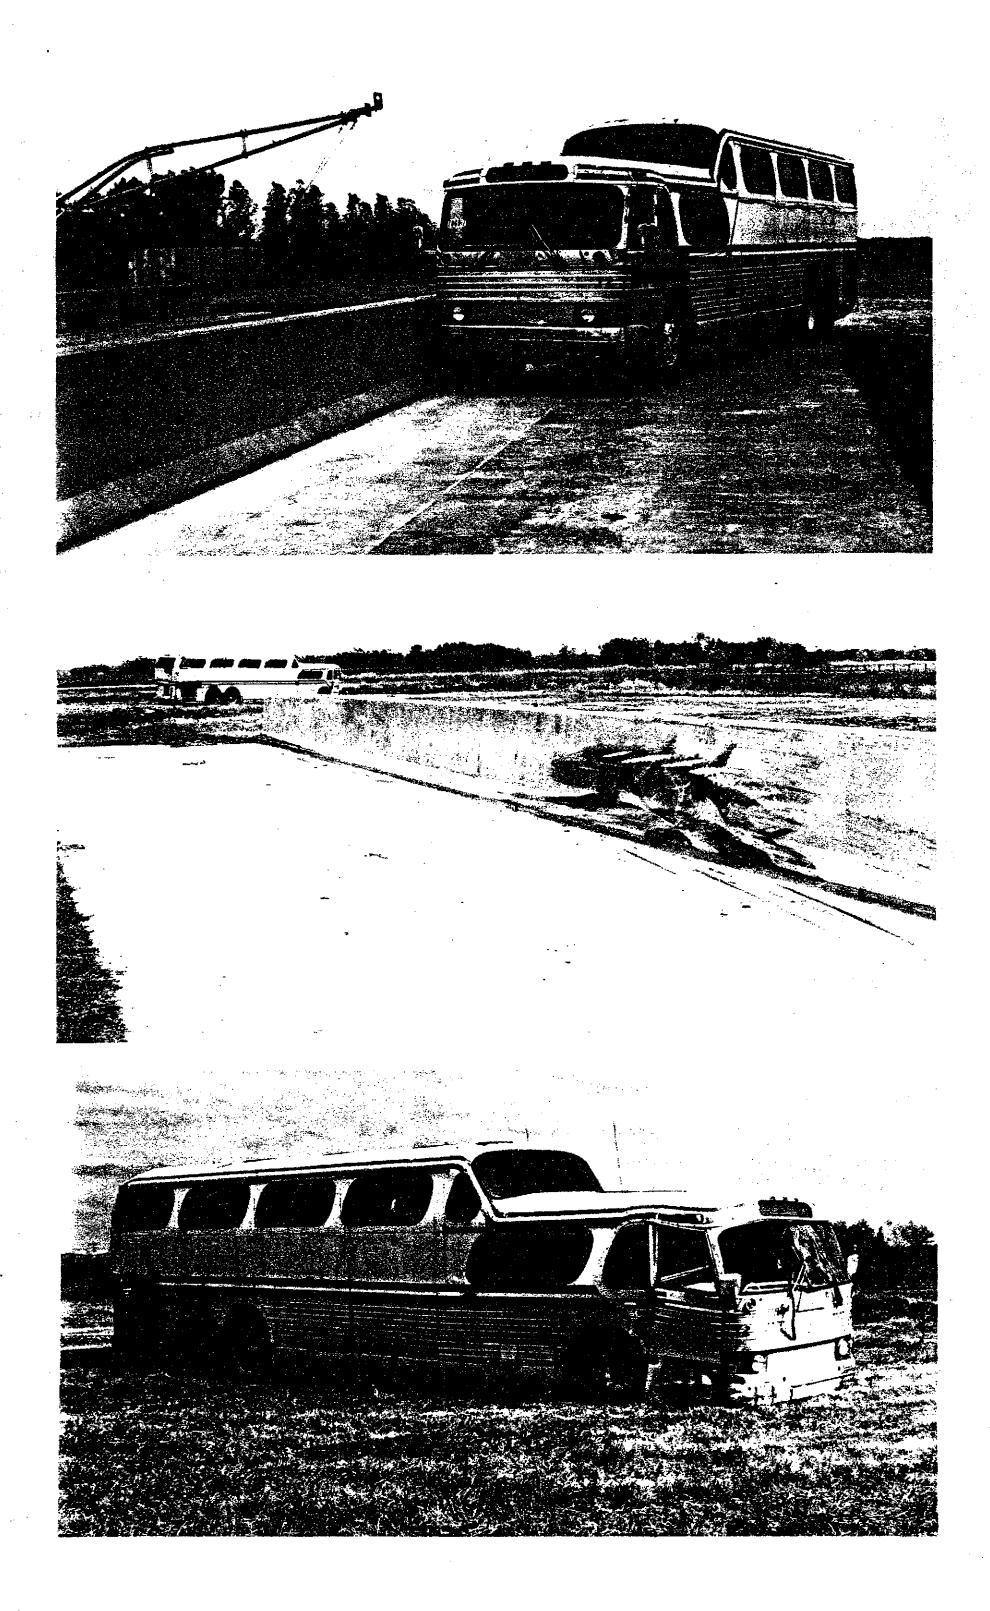
Figure 80. Vehicle and parapet for test 7069-7.

The railing received only cosmetic damage (figure 80). There were tire marks on the bridge railing from just before the impact point extending a total of 25 ft (7.6 m) along the face. The vehicle then lost contact for 26 ft (7.9 m) and contacted the bridge railing for another 21 ft (6.4 m) when the bridge railing ended. There was also a longitudinal hairline crack along the bridge deck starting approximately at the point of impact for about 35 ft (11 m) running parallel to and nominally 2 ft (0.6 m) from the base of the railing.

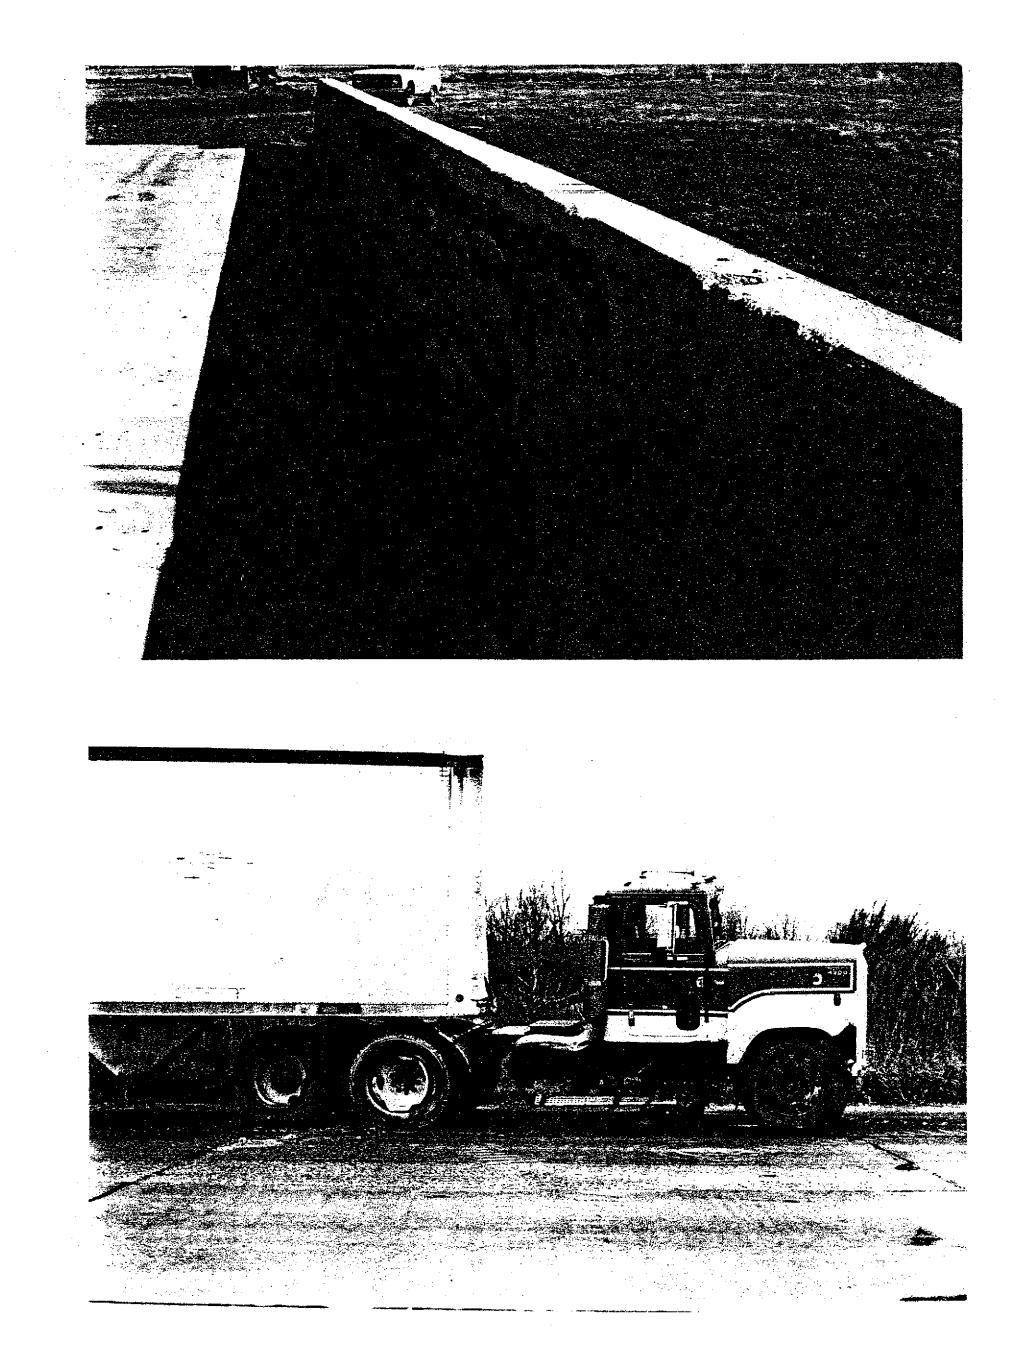
Figure 83. Vehicle and parapet after test 7069-10.

The railing received only cosmetic damage (figure 83). There were tire marks on the bridge railing from just before the impact point extending a total of 72 ft (21.9 m) along the face. There was also a piece of the top of the bridge railing chipped off where the edge of the trailer impacted.

The vehicle sustained extensive damage to the right side (figure 83). Maximum crush at the right front corner at bumper height was 18.0 in (457 mm). Both outside right rear wheel rims of the tractor were bent and the tires were deflated. The front wheel assembly and suspension were damaged. The shock mounts were broken, the tie rods bent, the steering rod was bent, and the springs were loose. The right side door was dented.

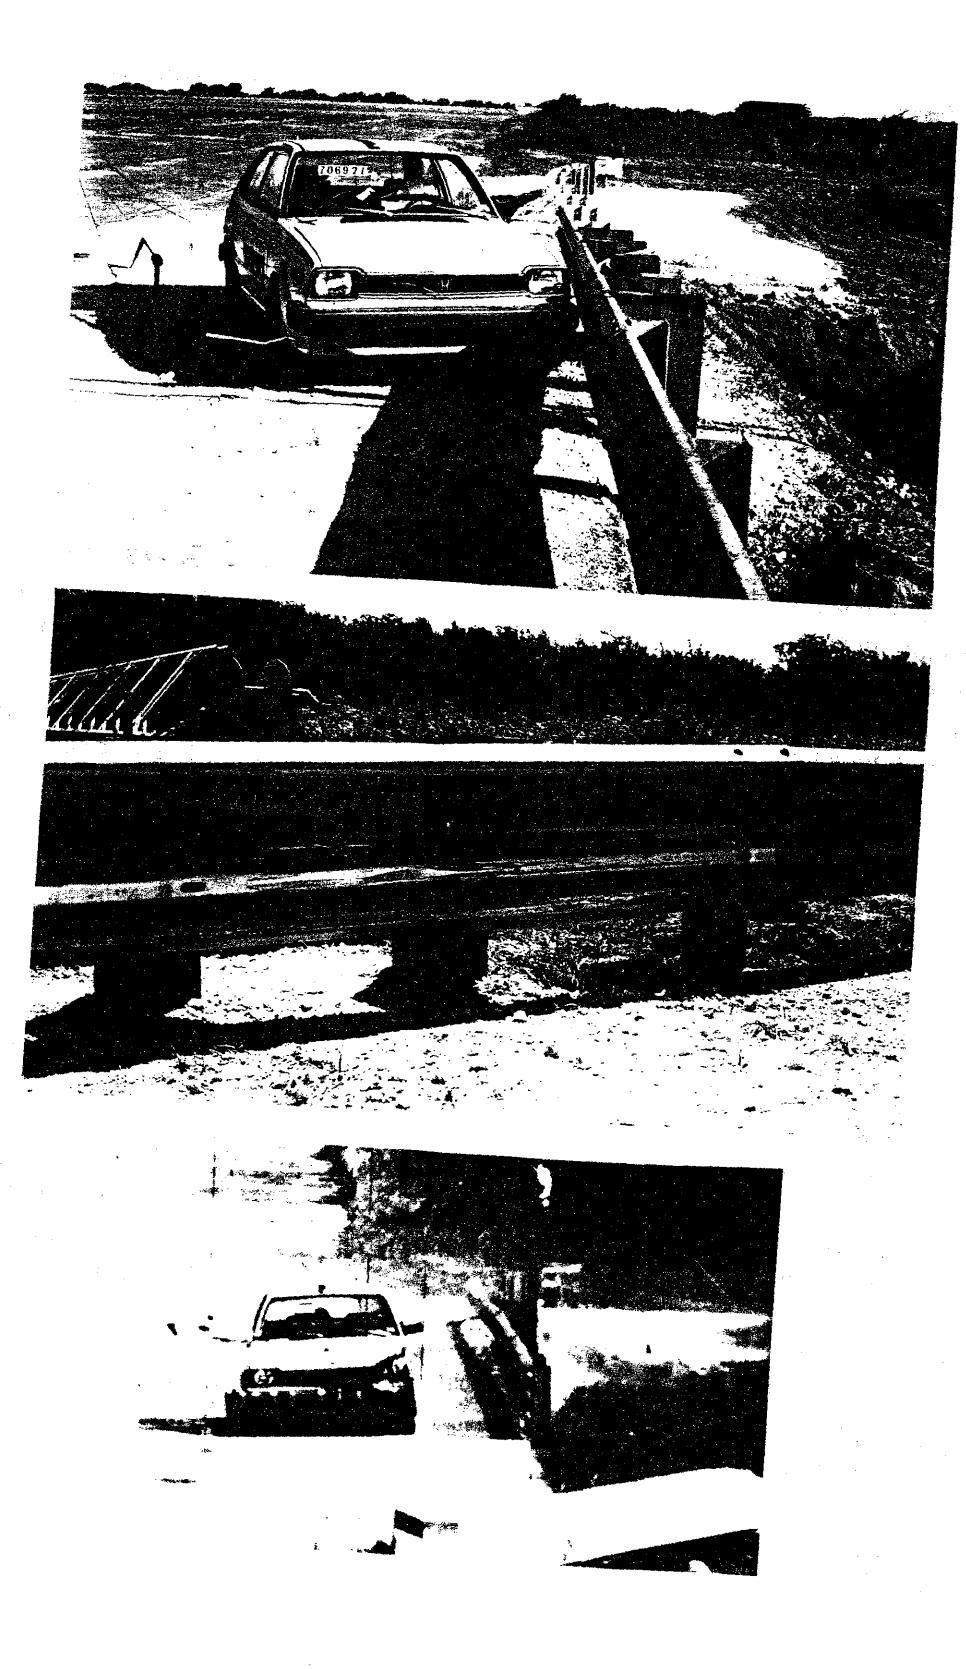
Figure 85. Vehicle and transition for test 7069-27.

The transition received minimal damage (figure 85). Maximum lateral permanent deformation was 0.5 in (13 mm).

The vehicle sustained damage to the left side as shown in figure 8. Maximum crush at the left front corner at bumper height was 8.0 in (203 mm), and the driver door was deformed outward approximately 8.0 in (203 mm). The driver side window was broken out and the door was jammed. Also, damage was done to the front bumper, hood, grill, left front quarter panel, left rear quarter panel, and left front tire and rim.

The transition contained the vehicle with minimal lateral movement of the transition. There was no intrusion of transition components into the occupant compartment. The vehicle remained upright and relatively stable during the collision. The transition redirected the vehicle and the effective coefficient of friction was considered good. Velocity change of the vehicle during the collision was 7.3 mi/h (11.7 km/h). The occupant impact velocities and the occupant ridedown accelerations were within the limits. The vehicle trajectory at loss of contact indicated minimum intrusion into adjacent traffic lanes.

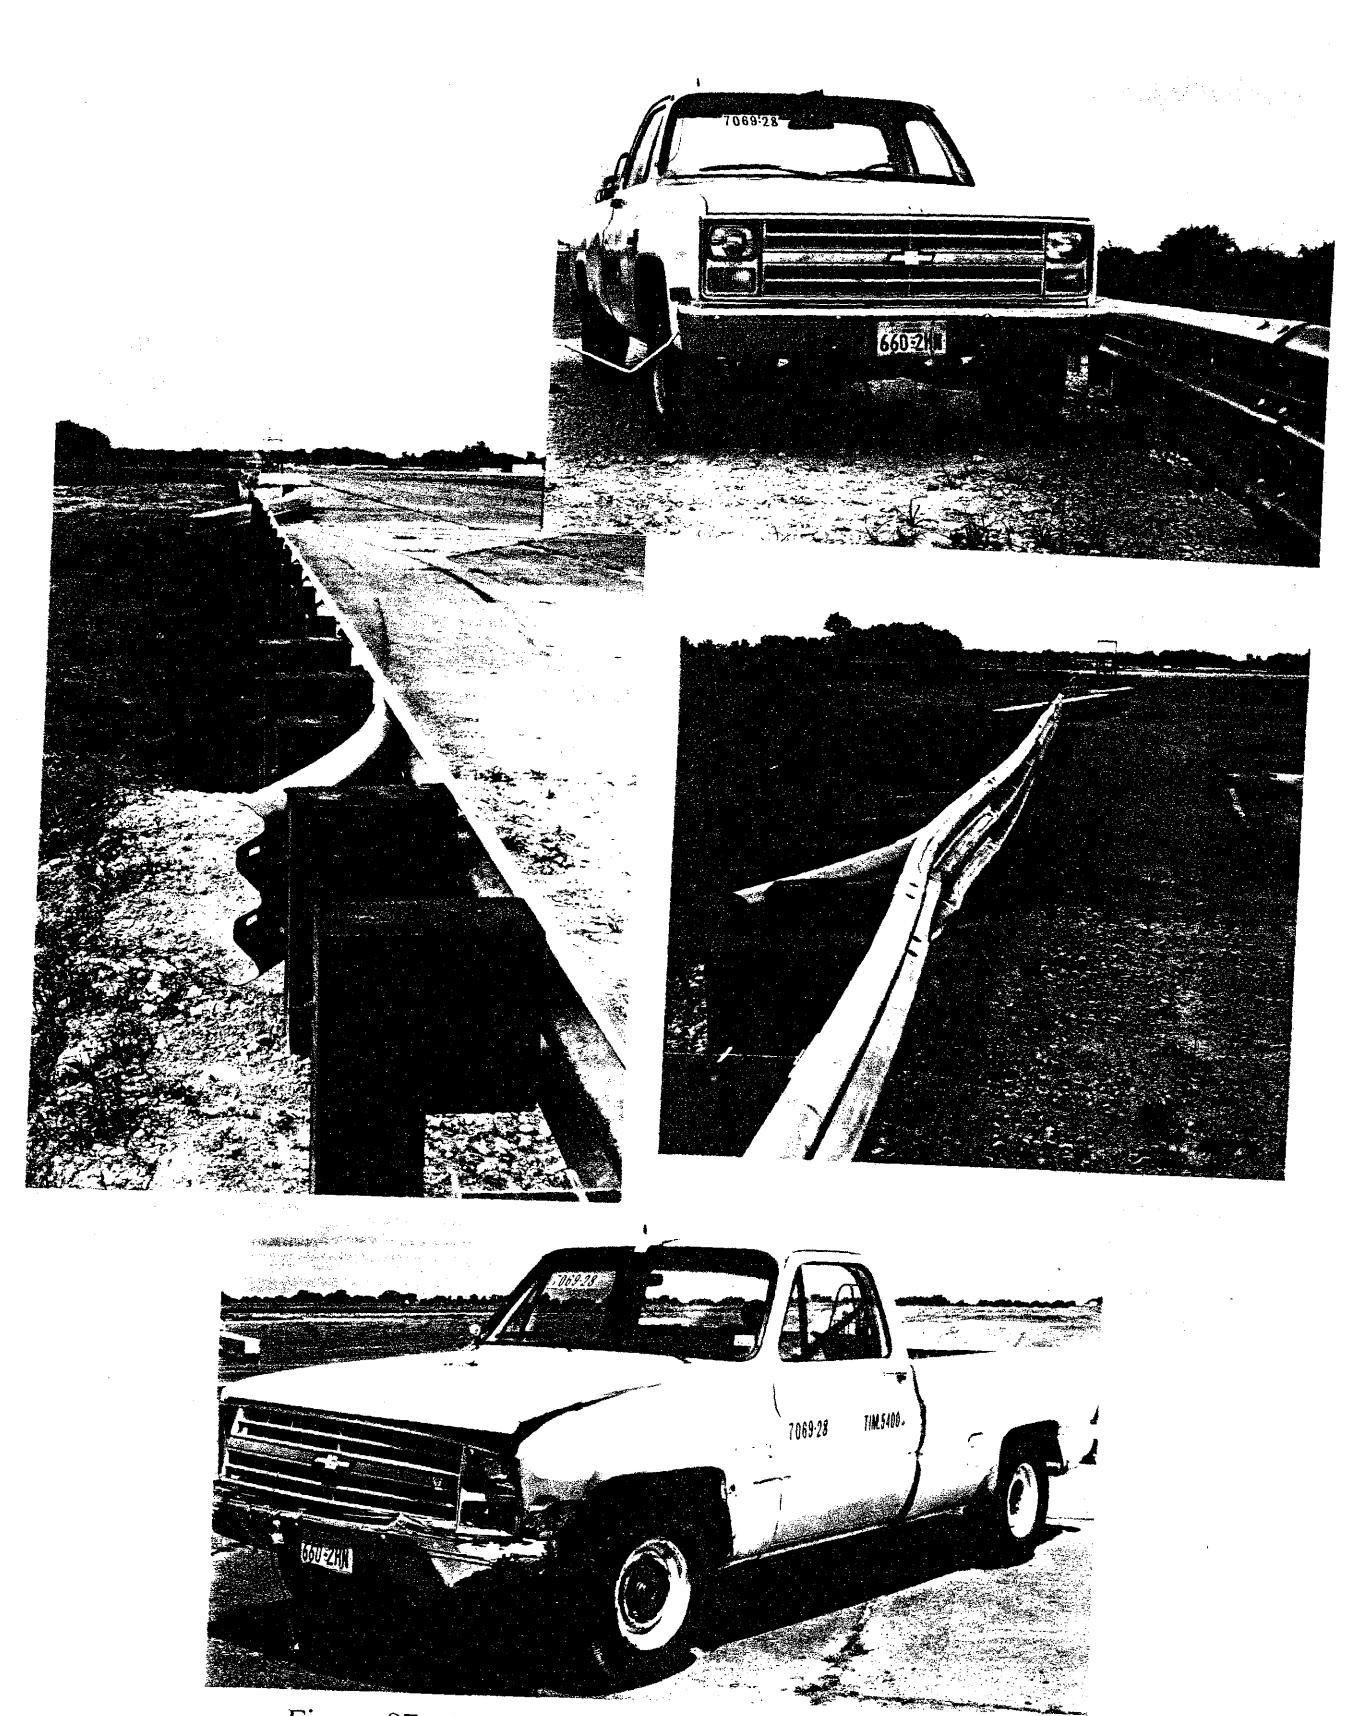
Figure 87. Vehicle and transition for test 7069-28.

The transition received minimal damage (figure 87). Maximum lateral permanent deformation was 3.5 in (89 mm).

The vehicle sustained damage to the left side (figure 87). Maximum crush at the left front corner at bumper height was 8.0 in (203 mm), and the driver door was deformed outward approximately 1.0 in (25 mm). The frame was bent and the cab was deformed. The driver side window was broken out and the door was jammed. Also, damage was done to the front bumper, hood, grill, left front quarter panel, left rear quarter panel, rear bumper, and left front tire and rim.

The transition contained the vehicle with minimal lateral movement of the transition. There was no intrusion of railing components into the occupant compartment. The vehicle remained upright and relatively stable during the collision. The transition redirected the vehicle and the effective coefficient of friction was considered good. Velocity change of the vehicle during the collision was 4.9 mi/h (7.9 km/h). The occupant impact velocities and the occupant ridedown accelerations were within the limits. The vehicle trajectory at loss of contact indicated minimum intrusion into adjacent traffic lanes.

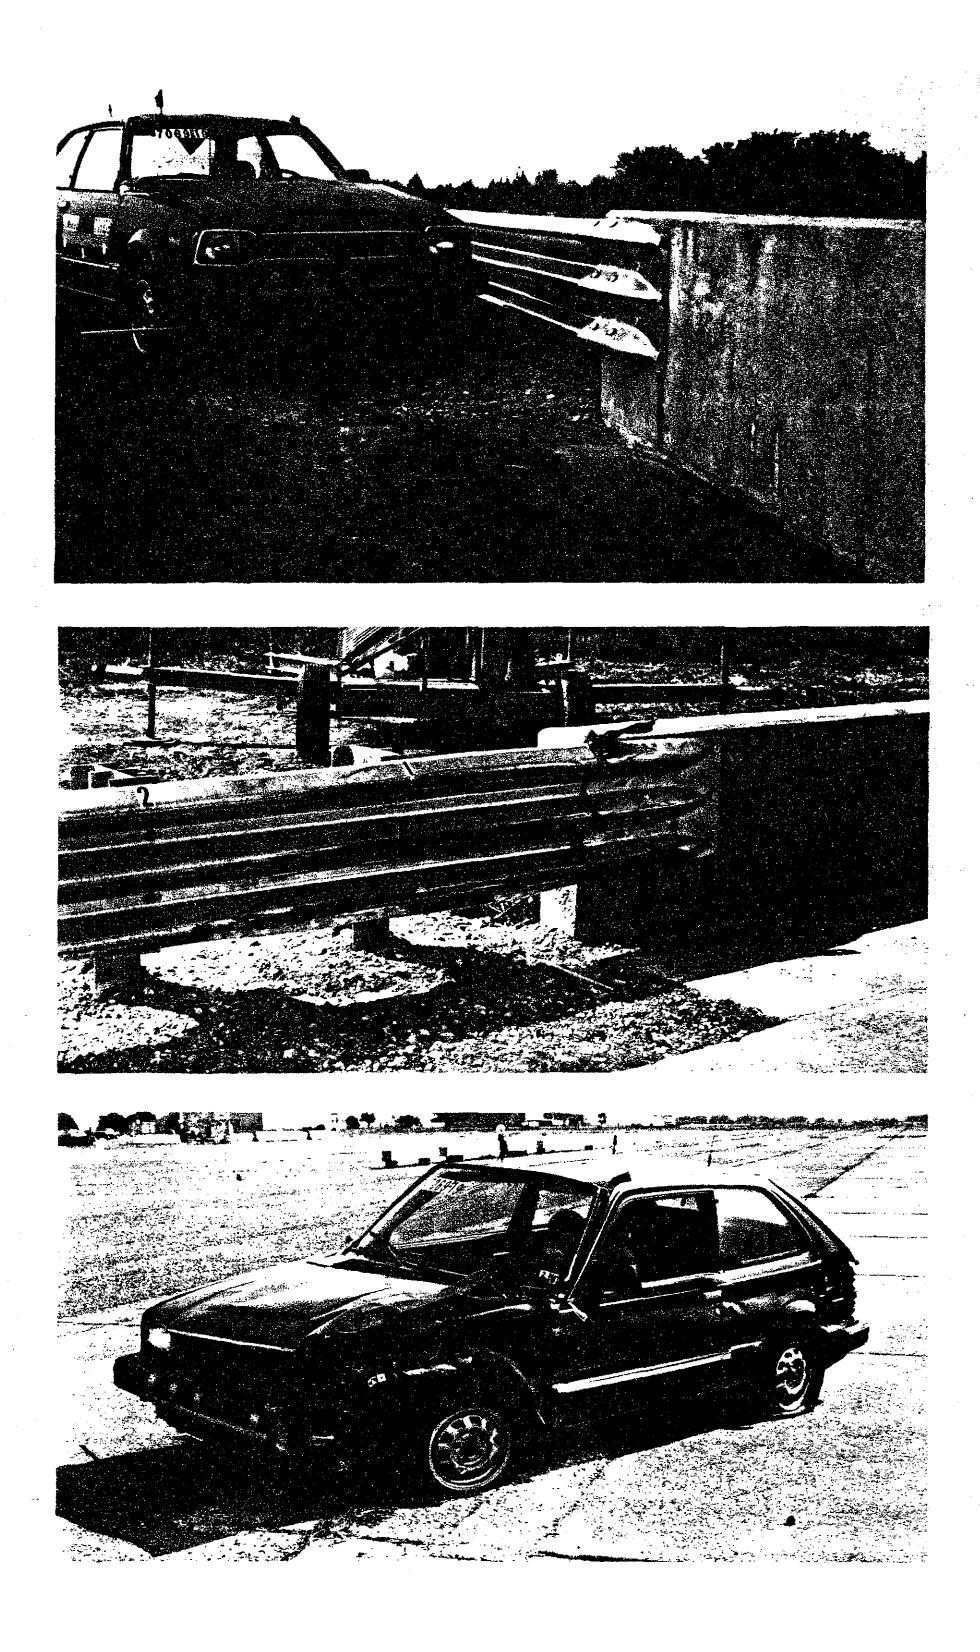
Figure 89. Vehicle and transition for test 7069-19.

The transition received minor damage, most of which was cosmetic in nature (figure 89). Maximum lateral deformation was 0.5 in (13 mm) at the post 2.

The vehicle sustained damage to the left side (figure 89). Maximum crush at the left front corner at bumper height was 11.0 in (279 mm). The strut and constant velocity joint on the left side were damaged and the roof was bent. The left front wheel was canted inward at the bottom and pushed back into the fender well. The left side window was broken out by the dummy's head. Also, damage was done to the front bumper, hood, grill, radiator and fan, left front quarter panel, left door, left rear quarter panel, and left rear tire and rim.

The transition contained the vehicle with minimal lateral movement of the transition. There was no intrusion into the occupant compartment with minimal (but acceptable) deformation of the passenger compartment. The vehicle remained upright and relatively stable during the collision. The transition smoothly redirected the vehicle and the effective coefficient of friction was considered fair. The lateral occupant impact velocity of 25.9 ft/s (7.9 m/s) in this test did not meet with the AASHTO specifications. The longitudinal occupant impact velocity and the occupant ridedown accelerations were within the limits. The vehicle trajectory at loss of contact indicated minimum intrusion into adjacent traffic lanes.

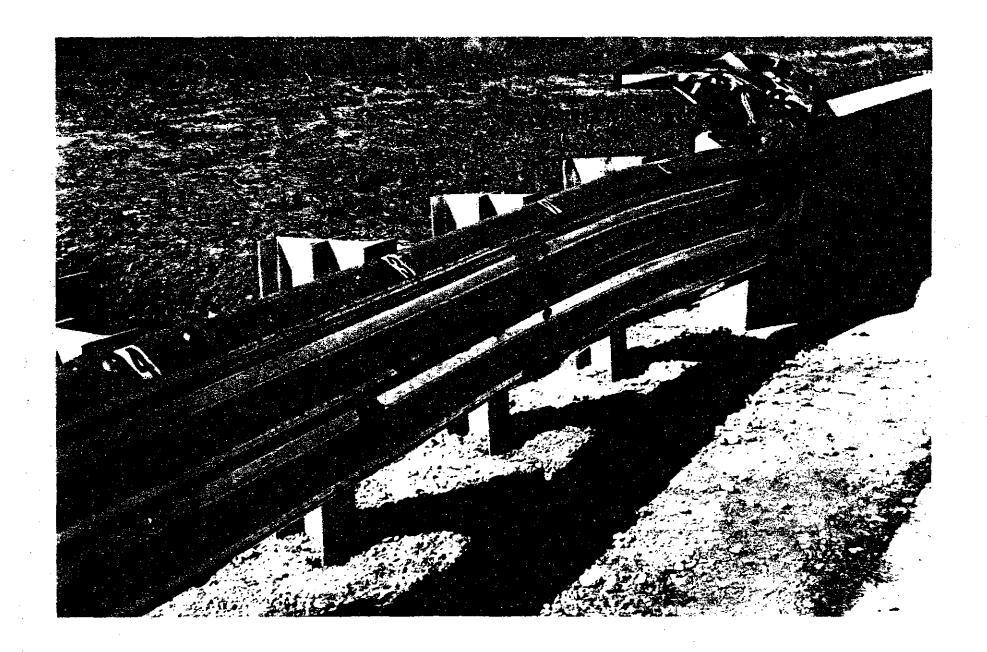
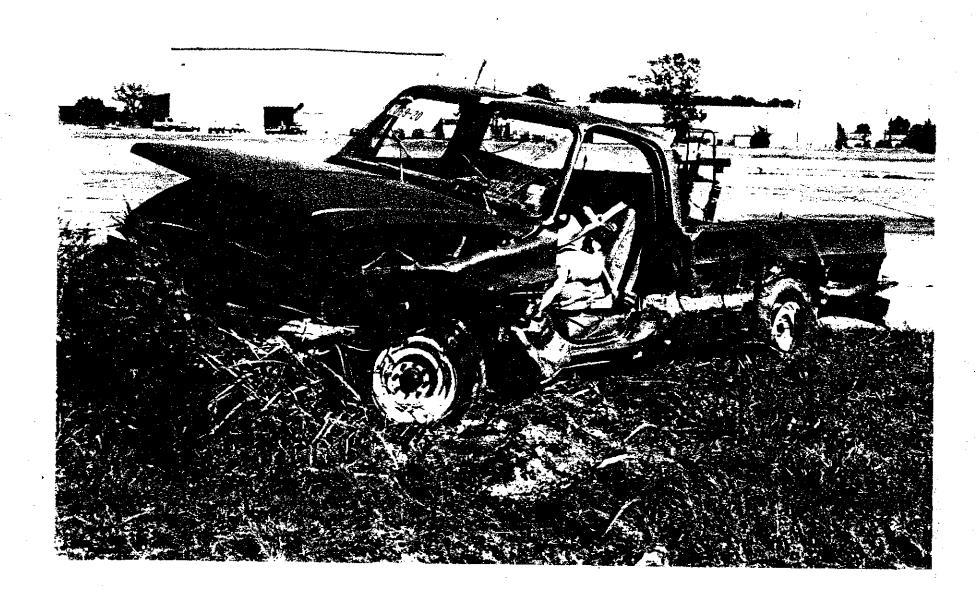
Figure 92. Vehicle and transition after test 7069-20.

The transition received moderate damage (figure 92). Maximum lateral deformation was 6.5 in (165 mm).

The vehicle sustained damage to the left side (figure 92). Maximum crush at the left front corner at bumper height was 22.0 in (559 mm). The sway bar and upper and lower control arm on the left side were damaged and the roof was bent. The left front wheel was canted inward at the bottom and pushed back into the fender well. The left side window was broken out. The door was separated from the vehicle and remained affixed to the transition at the terminal connector. Also, damage was done to the front bumper, hood, grill, radiator and fan, left front quarter panel, left rear quarter panel, and left rear tire and rim.

The transition contained the vehicle with minimal lateral movement of the transition. There was no intrusion of railing components into the occupant compartment; however, the door was detached from the vehicle and remained lodged on the railing. The vehicle remained upright and relatively stable during the collision. The transition redirected the vehicle but the effective coefficient of friction was quite high. Velocity change of the vehicle during the collision was 20.8 mi/h. The occupant impact velocities and the occupant ridedown accelerations were within the limits. The vehicle trajectory at loss of contact indicated minimum intrusion into adjacent traffic lanes.

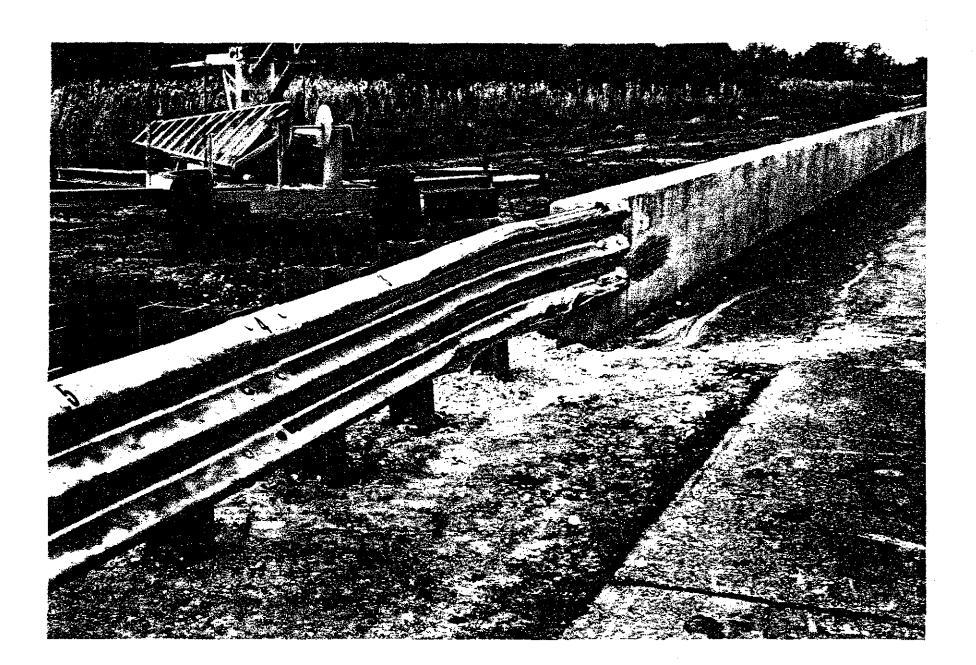
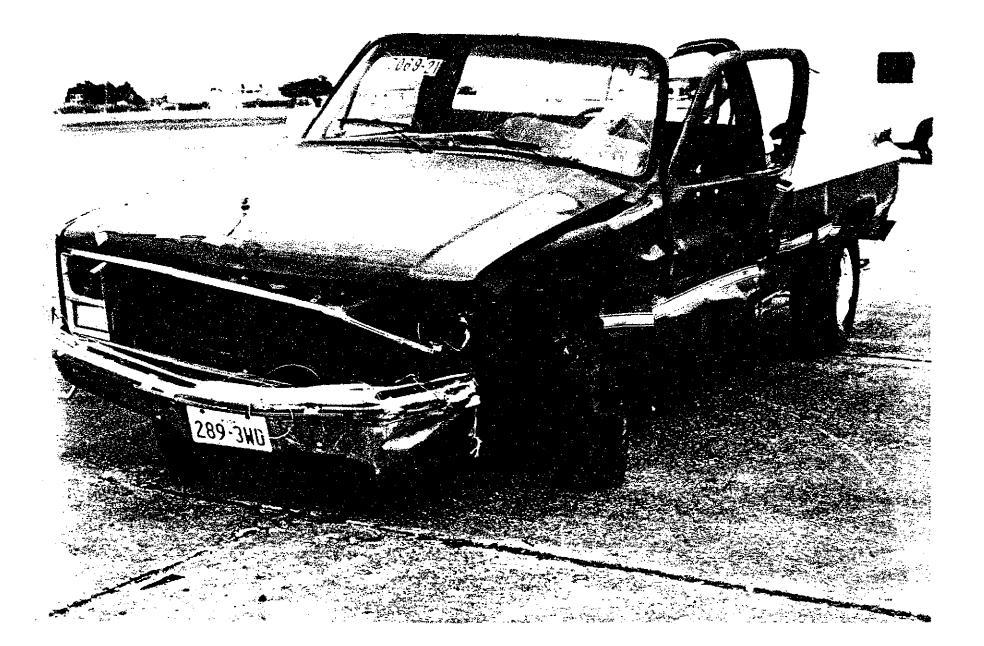
Figure 95. Vehicle and transition after test 7069-21.

The transition received moderate damage (figure 95). Maximum lateral permanent deformation was 5.0 in (127 mm).

The vehicle sustained damage to the left side (figure 95). Maximum crush at the left front corner at bumper height was 15.0 in (381 mm) and the right front corner was deformed outward approximately 4.75 in (121 mm). The sway bar and A-arms on the left side and gas tank were damaged, and the drive shaft, frame, and roof were bent. The floor pan was pushed into the occupant compartment approximately 5 to 7 in (130 to 180 mm) and the dash moved inward approximately 3 in (80 mm). The left front wheel was canted inward at the bottom and pushed back into the fender well reducing the wheelbase on the driver side by 14.0 in (356 mm). The driver side window was broken out and the door was jammed. Also, damage was done to the front bumper, hood, grill, radiator and fan, left front quarter panel, left rear quarter panel, and left rear tire and rim. The tailgate came off the vehicle during the test.

The transition contained the vehicle with minimal lateral movement of the transition. There was no intrusion of railing components into the occupant compartment; however, the floor pan was deformed into the vehicle approximately 5 to 7 in (130 to 180 mm) and the instrument panel was pushed inward approximately 3 - in (80 mm). The vehicle remained

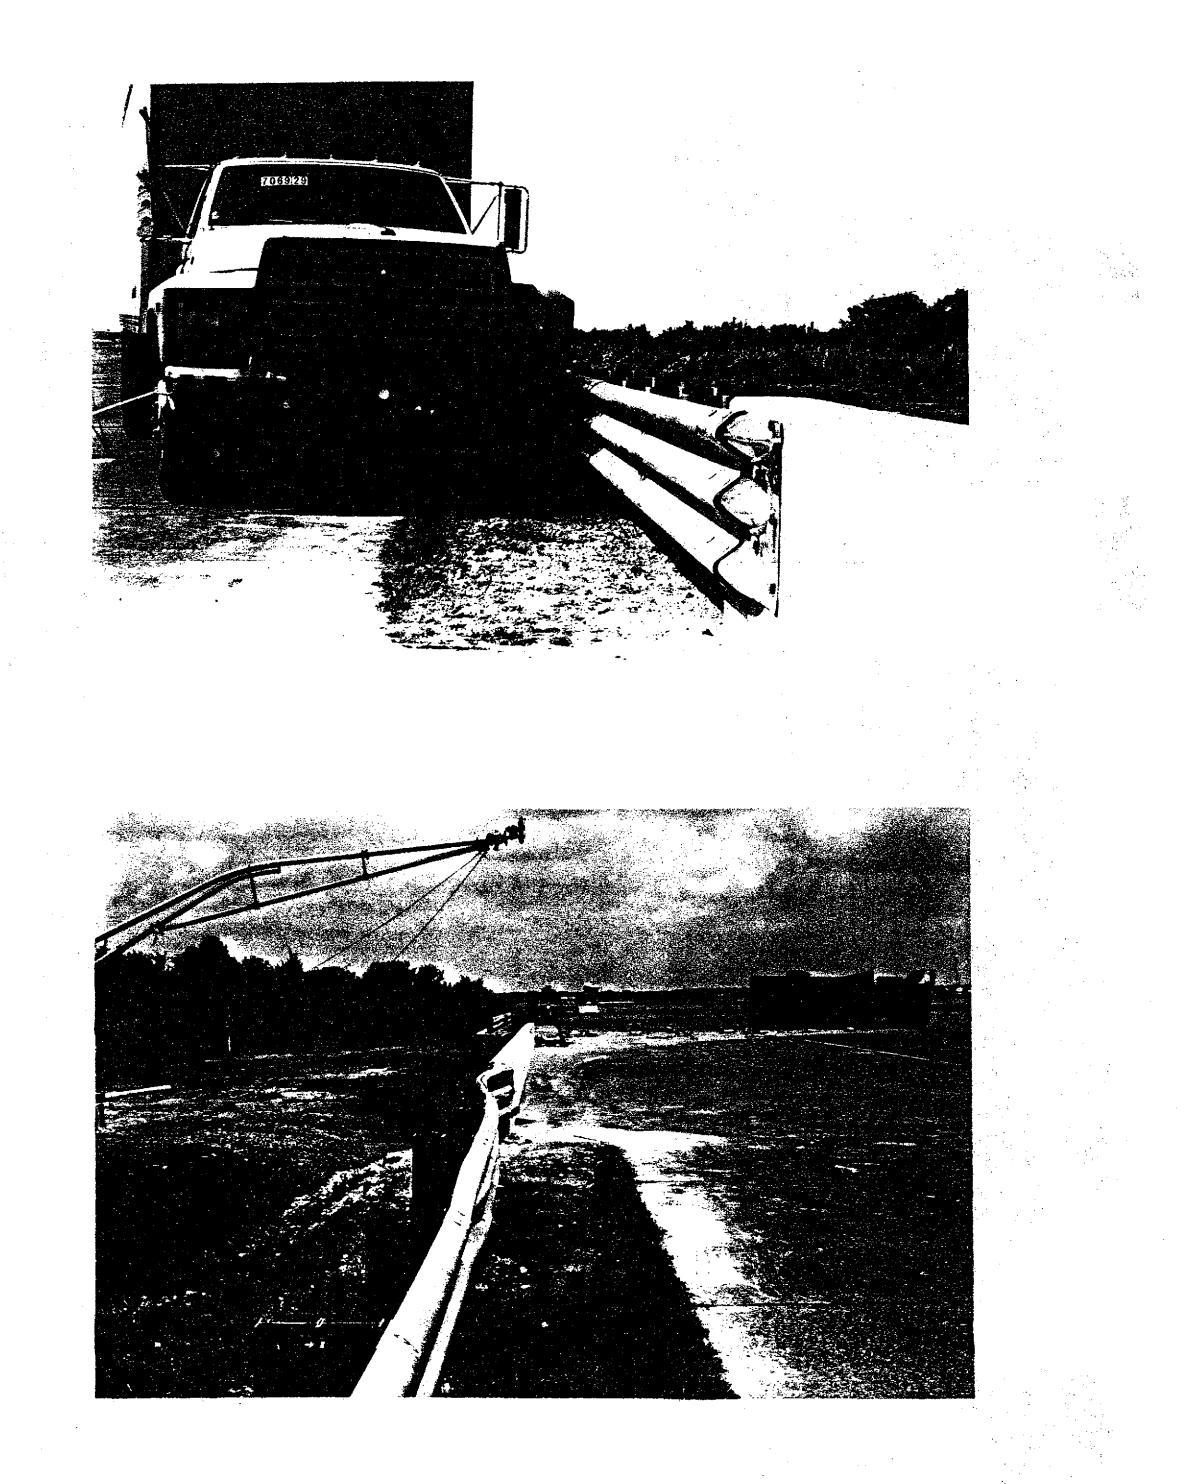
Figure 97. Vehicle and transition for test 7069-29.

The transition received moderate damage (figure 97). Maximum lateral permanent deformation to the transition was 10.0 in (254 mm). The end of the concrete parapet where the terminal connector attached was cracked.

The vehicle sustained damage to the left side. Maximum crush at the left front corner at bumper height was 13.0 in (330 mm). The floor pan was pushed inward and the cab was bent and twisted. The windshield and rear glass were broken. The frame at the rear axle was bent and the van-box was twisted and torn. The driver side window was broken out and the door was jammed. Also, damage was done to the front bumper, hood, left front quarter panel, and outer left rear tire and rim. The right door was also jammed.

The transition contained the vehicle with minimal lateral movement of the transition. There was no intrusion of railing components into the occupant compartment; however, the floor pan was slightly deformed into the vehicle. The vehicle remained upright and relatively stable during the collision; however, after exiting the test installation the vehicle rolled onto its left side 45 ft (14 m) forward of the transition. The transition redirected the vehicle with the effective coefficient of friction rated as good. The vehicle trajectory at loss of contact indicated some intrusion into adjacent traffic lanes.
