The BR27C bridge railing on sidewalk was tested to performance level two requirements.⁽¹⁾ The following nominal test conditions were used:

The BR27C bridge railing on deck was also tested to performance level two requirements.⁽¹⁾ The following nominal test conditions were used:

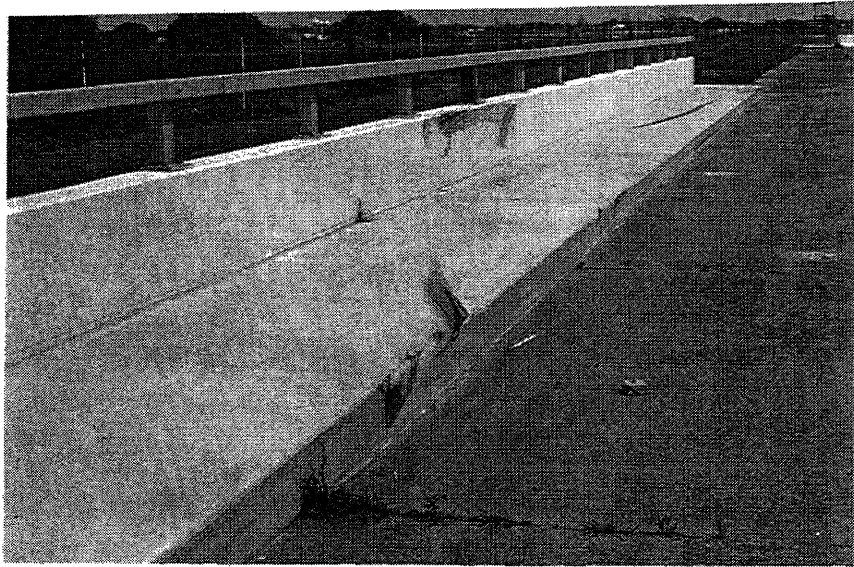
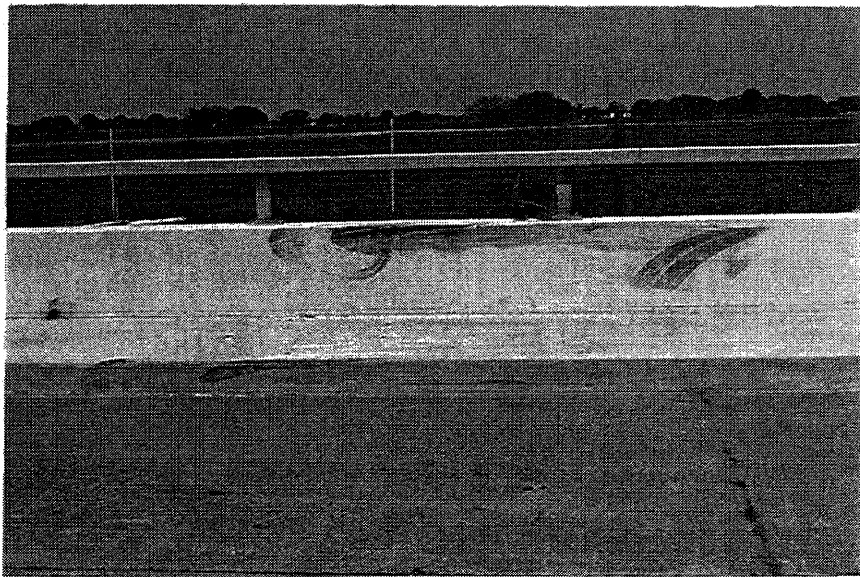
Figure 8. BR27C bridge railing on sidewalk after test 7069-24.

As can be seen in figure 8, the bridge railing system received minimal damage. There was no measurable permanent deformation to the metal railing elements; however, the left corner of the bumper had snagged post 6 (leaving plastic trim). Also, posts 5 and 6 were pulled up such that the washers rotated freely under the nuts on the front side of the railing (see figure 9). There was only cosmetic damage to the concrete parapet, i.e., tire marks on the concrete parapet from post 5 on past post 6 and then again between posts 8 and 9 where the vehicle contacted the parapet the s time. The vehicle was in contact with the bridge railing system for 12.25 ft (3.7 m).

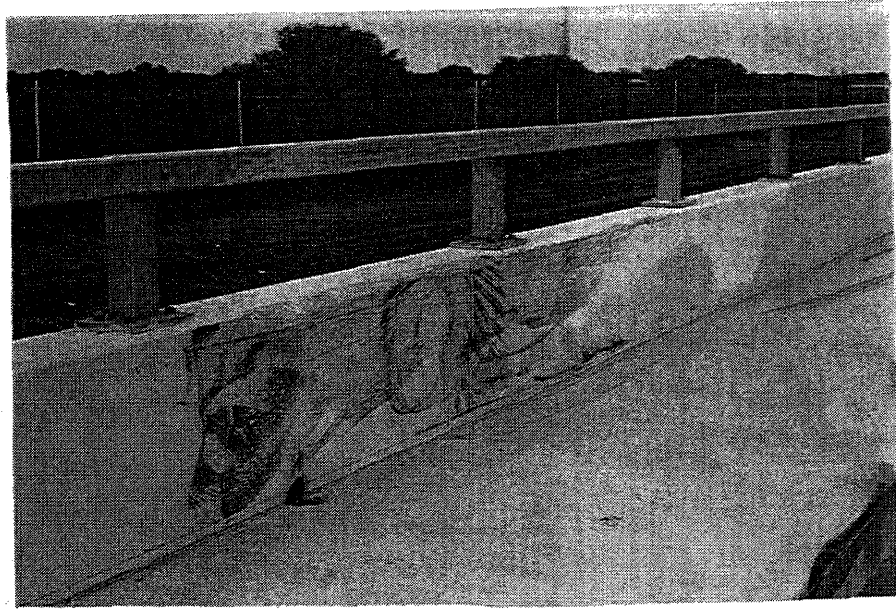
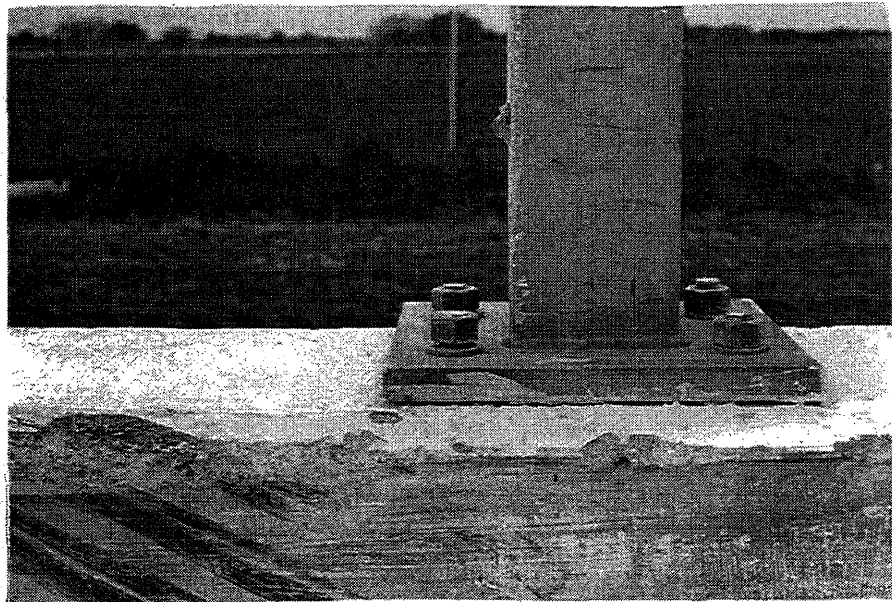
Figure 22. BR27C bridge railing on sidewalk after test 7069-25.

As can be seen in figure 22, the bridge railing system received minimal damage. There was no measurable permanent deformation to the metal railing elements; however, the left corner of the bumper had snagged post 5 and pulled it up such that the washer rotated freely under the nut on the left front side of the railing. There was only cosmetic damage to the concrete parapet, i.e., tire marks on the concrete parapet from post 4 to post 6. The vehicle was in contact with the bridge railing system for a total of 13.0 ft (4.0 m).

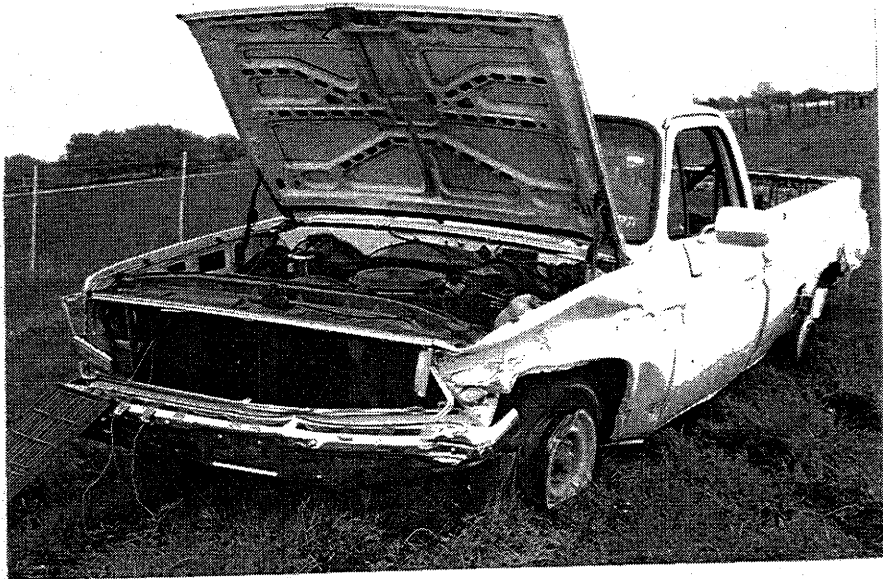
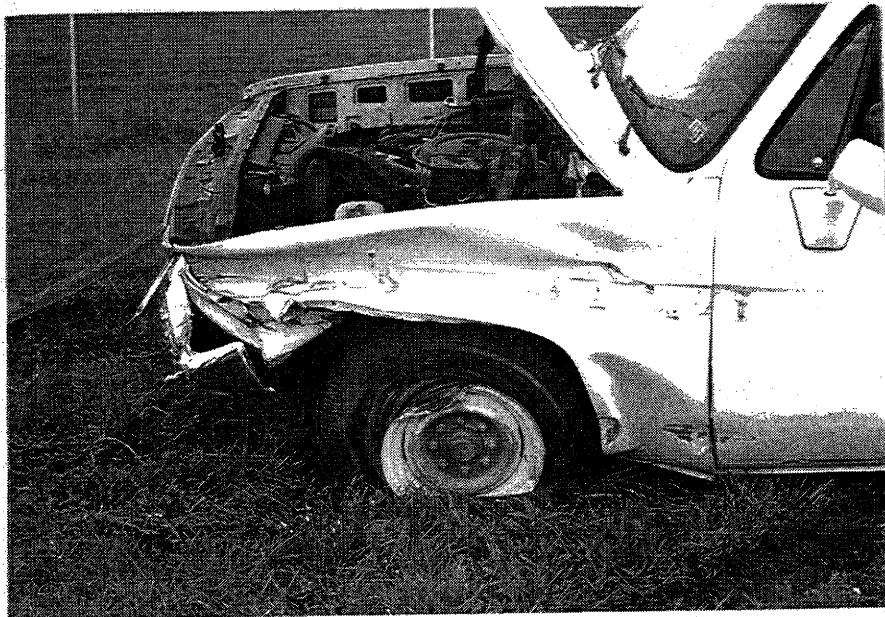
Figure 23. Vehicle after test 7069-25.

The vehicle sustained damage to the left side as shown in figures 23 and 24. Maximum crush at the left front corner at bumper height was 12.0 in (305 mm) and the right front corner was deformed outward 7.0 in (178 mm). The left front wheel was pushed back reducing the wheelbase on the driver side by 2.25 in (57 mm). Also, damage was done to the front bumper, hood, grill, left front quarter panel, left door and glass, left rear quarter panel, rear bumper and tailgate, left front tire and rim, and right front tire. The welds on the left rear rim broke and the tire separated from the rim as shown in figure 24.

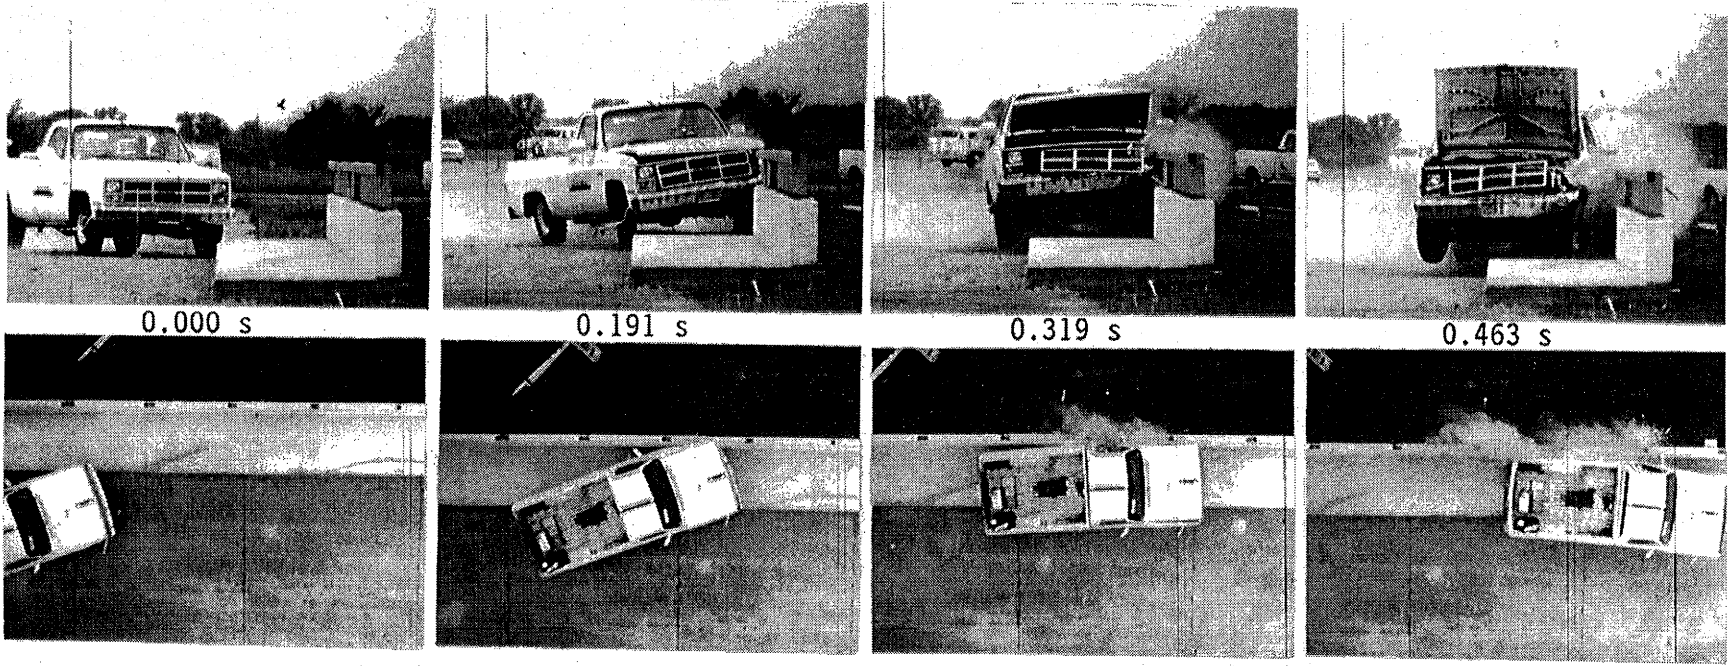
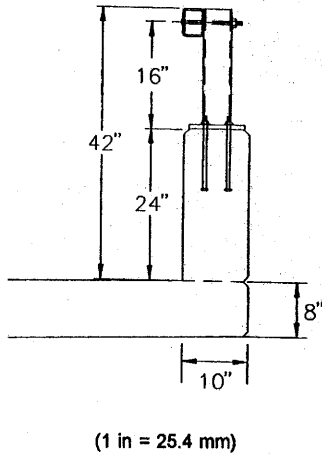
Figure 25. Summary of results for test 7069-25.

The BR27C bridge railing on sidewalk contained the test vehicle with no lateral movement of the bridge railing. There was no intrusion of railing components into the occupant compartment and no debris to present undue hazard to other traffic. The integrity of the occupant compartment was maintained with no intrusion and no deformation. The vehicle remained upright and relatively stable during the collision. The bridge railing system smoothly redirected the vehicle. The effective coefficient of friction was considered good.

The 1989 AASHTO guide specifications sets forth desired (but not required) limits for occupant risk factors for tests with the 5,400-lb (2 452-kg) vehicle.⁽¹⁾ The AASHTO specifications recommend a limit of 30 ft/s (9.1 m/s) for longitudinal occupant impact velocity and 25 ft/s (7.6 m/s) for the lateral occupant impact velocity and a limit of 15 g's for occupant ridedown accelerations in both longitudinal and lateral directions. The occupant risk factors were well within the specified limits. The vehicle trajectory at loss of contact

indicated minimum intrusion into adjacent traffic lanes. See figure 25 and table 3 for more details.

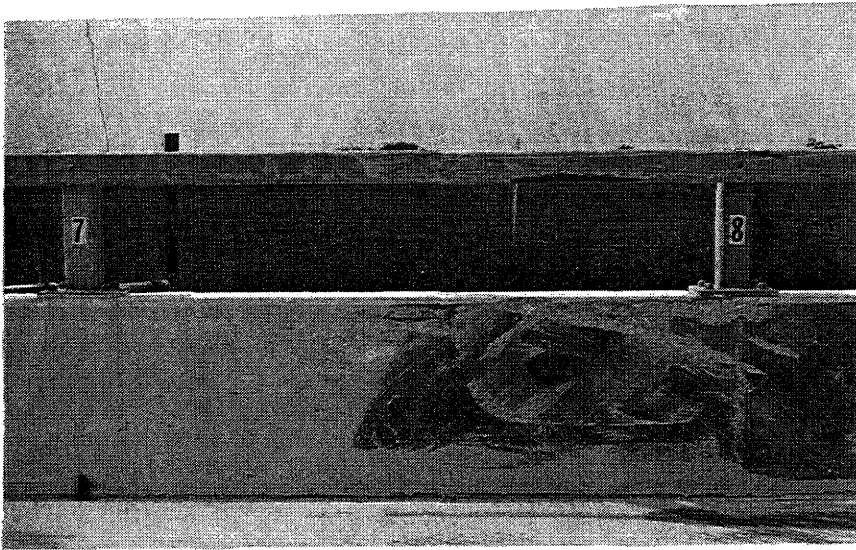
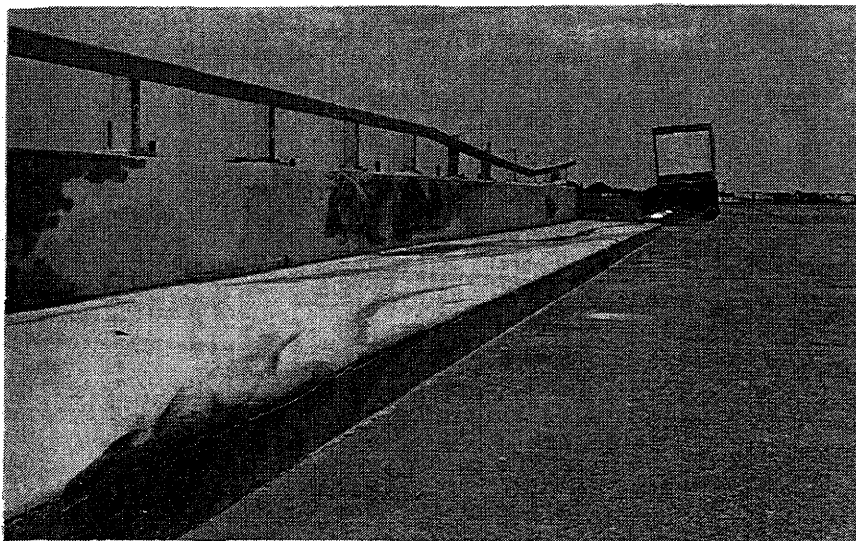
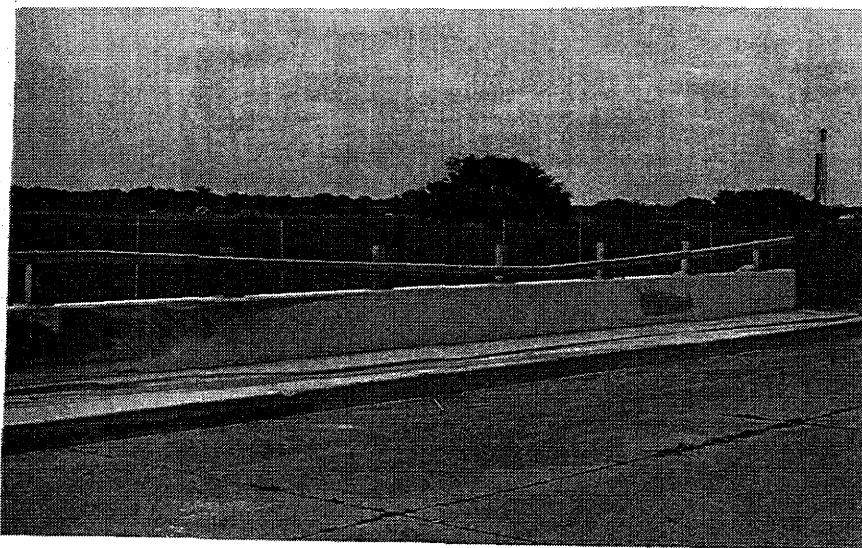
Figure 41. BR27C bridge railing on sidewalk after test 7069-26.

As can be seen in figure 41, the bridge railing system received moderate damage. There was no measurable permanent deformation to the metal railing elements in the immediate impact area; however the bolts connecting the railing to the posts from 10 through 14 were sheared as a result of vertical load from the cargo box. There was only cosmetic damage to the concrete parapet, i.e., tire marks on the concrete parapet from post midway of posts 7 & 8 to post 11 and from posts 13 to 14. The vehicle was in contact with the bridge railing system for a total of 63 ft (19 m).

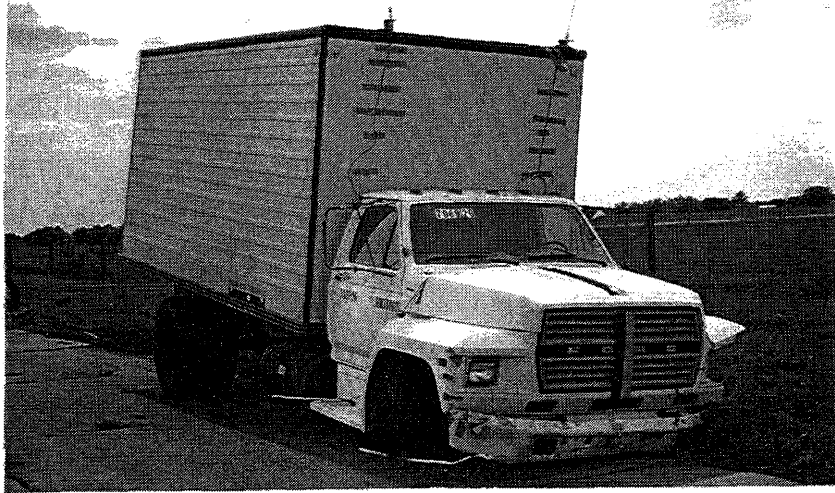
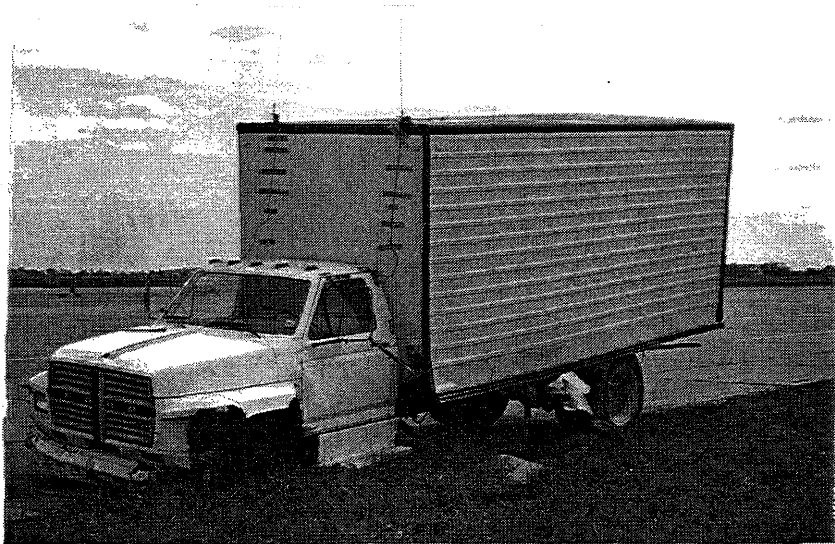
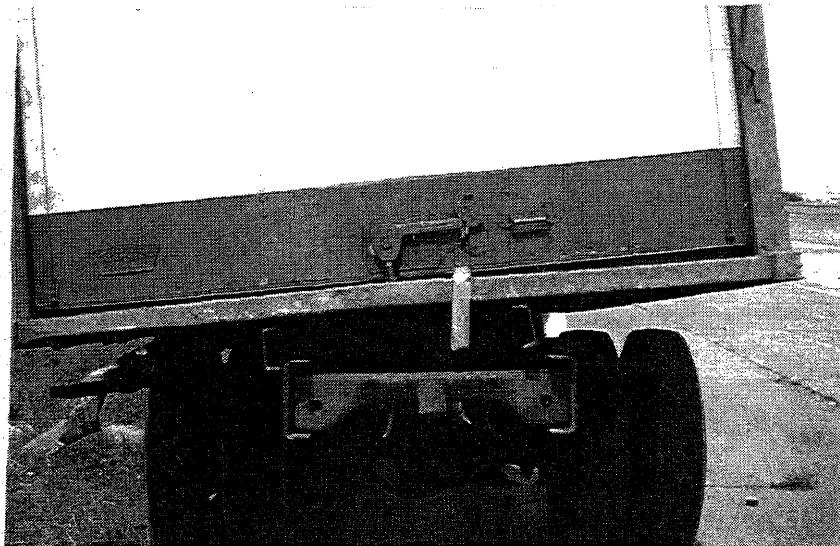
Figure 42. Vehicle after test 7069-26.

The vehicle sustained damage to the left side as shown in figure 42. Maximum crush at the left front corner at bumper height was 6.0 in (152 mm). The front axle broke loose and became separated from the vehicle as did the driveshaft (see figure 43). There was damage to the springs and shocks, steering box, front bumper, left front quarter panel, left door, and left front tire and rim. The lower edge of the left side of the cargo box was also damaged.

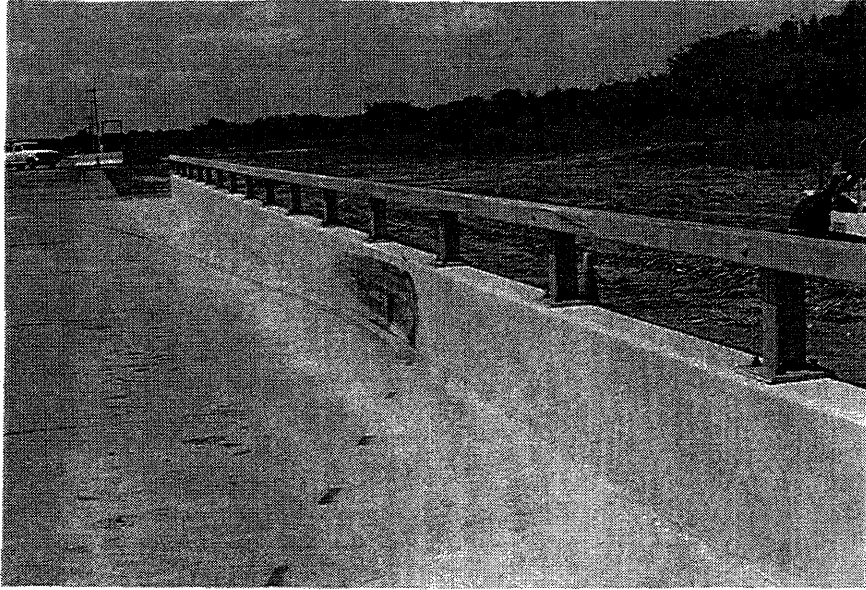
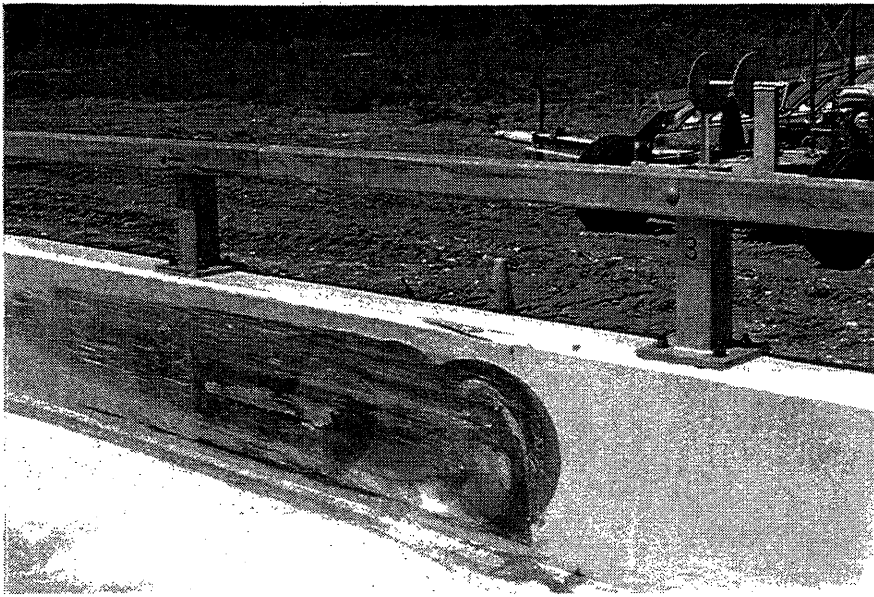
Figure 59. BR27C bridge railing on deck after test 7069-32.

As can be seen in figure 59, the bridge railing received minimal damage. There was no deformation to the metal railing element. The vehicle was in contact with the bridge railing for 9.9 ft (3.0 m).

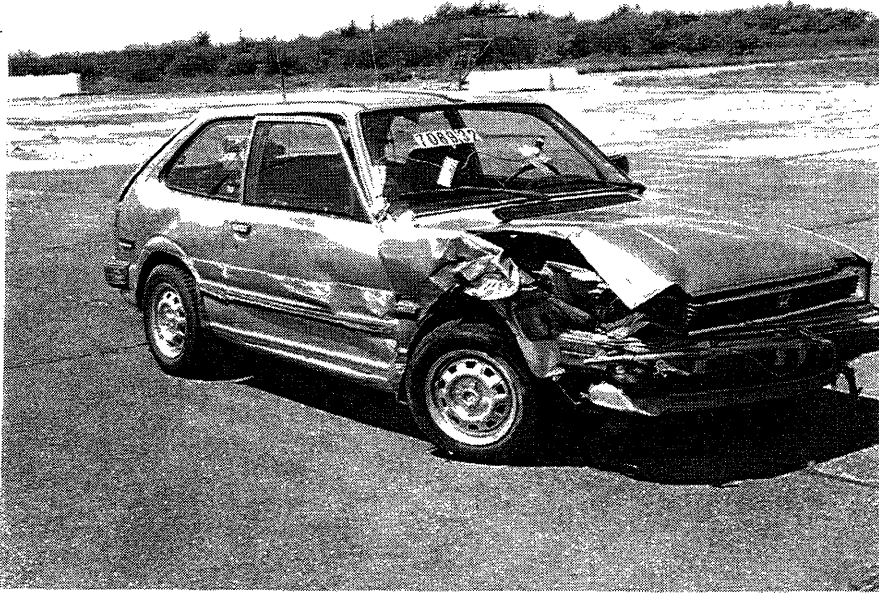
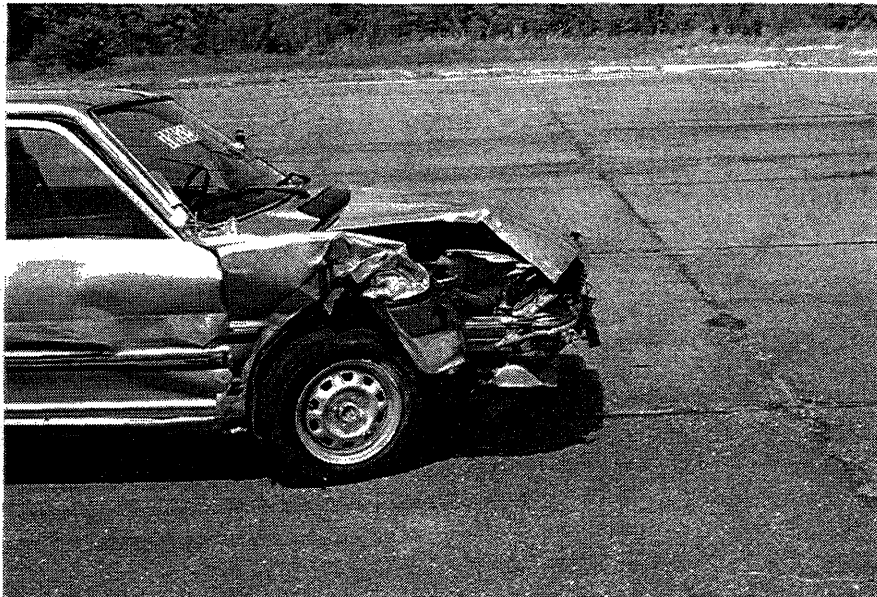
Figure 60. Vehicle after test 7069-32.

The vehicle sustained damage to the right side as shown in figure 60. Maximum crush at the right front corner at bumper height was 6.5 in (165 mm) and there was a 1.0-in (25-mm) dent into the occupant compartment at the firewall. The passenger door was deformed outward approximately 1.3 in (33 mm) and the wheelbase on the right side was reduced 3.0 in (76 mm). There was an 8-in by 14-in by 7/16-in (203-mm by 356-mm by 11-mm) deep dent in the roof just over the right rear passenger location. The right front strut and sway bar were damaged and the instrument panel was bent. Also, damage was done to the front bumper, hood, grill, radiator, fan, right front quarter panel, right front rim, right door, right rear quarter panel, and right rear rim.

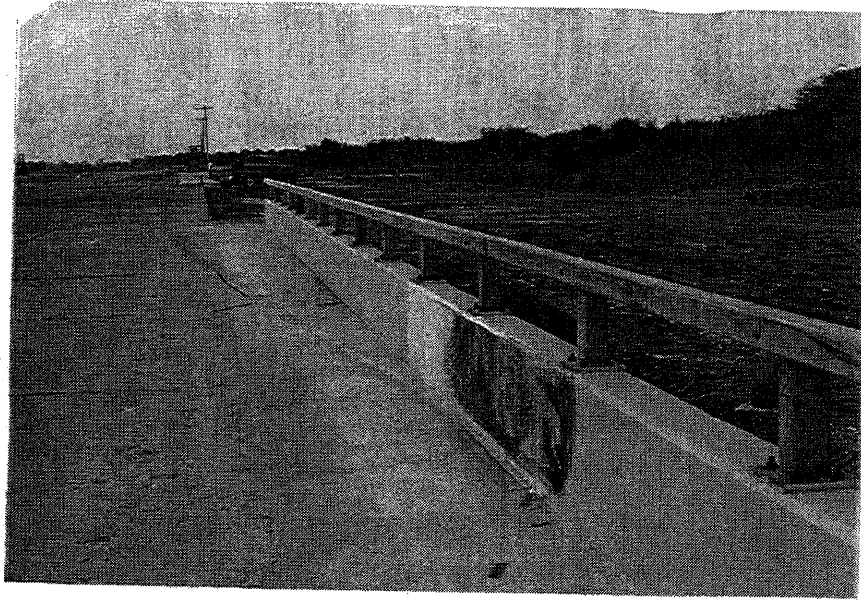
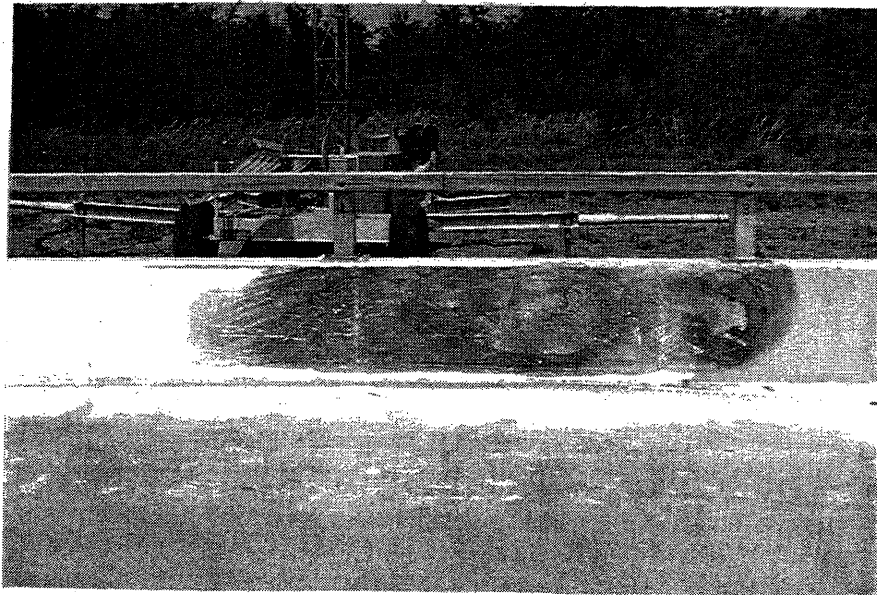
Figure 72. BR27C bridge railing on deck after test 7069-33.

As can be seen in figure 72, the bridge railing received minimal damage. There was 0.5-in (13-mm) deformation to the lower metal railing element and there was a hairline crack in the concrete beam 17.5 in (445 mm) down from post 3. The vehicle was in contact with the bridge railing for 11.0 ft (3.4 m).

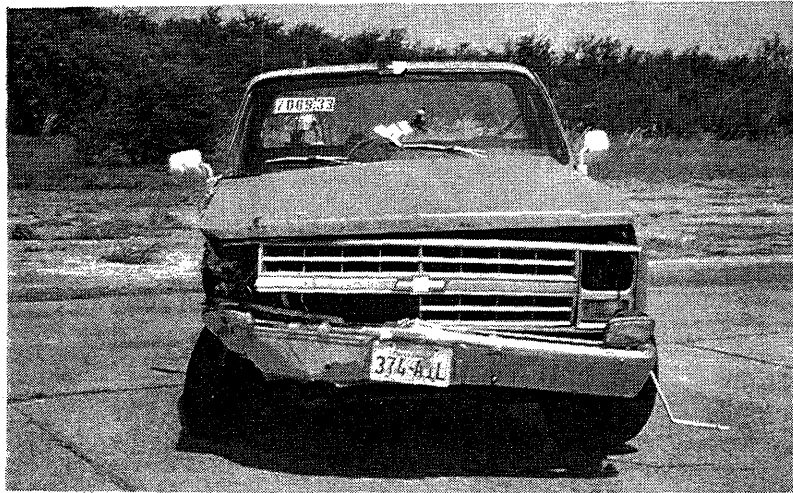
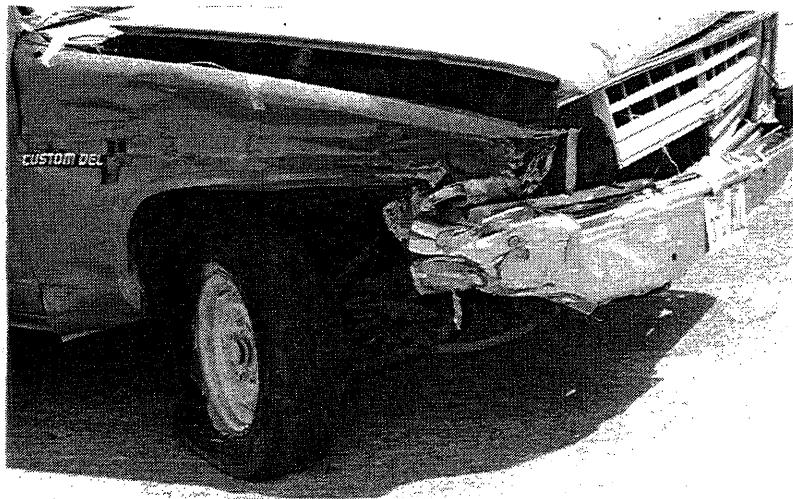
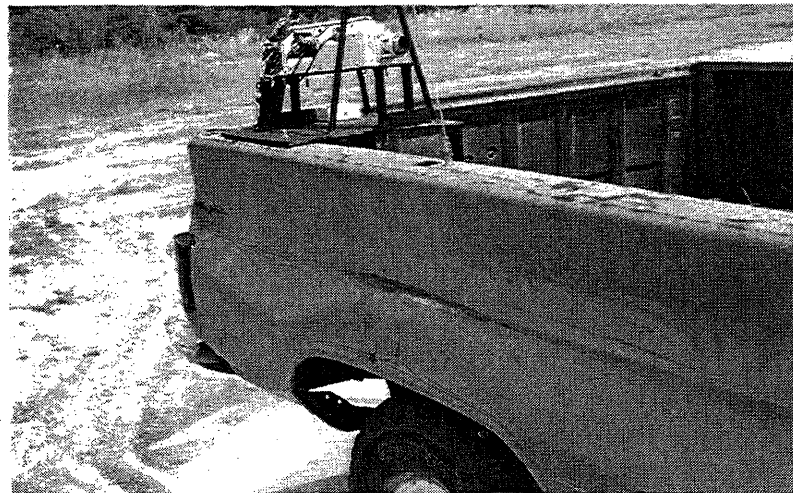
Figure 73. Vehicle after test 7069-33.

The vehicle sustained damage to the right side as shown in figure 73. Maximum crush at the right front corner at bumper height was 9.0 in (229 mm) and there was a 0.5-in (1.3-cm) dent into the occupant compartment at the firewall. The wheelbase on the right side was reduced 2.0 in (51 mm). The sway bar was damaged and the frame was bent. Also, damage was done to the front bumper, hood, grill, radiator, fan, right front quarter panel, right front tire and rim, right door, right rear quarter panel, rear bumper, right rear rim, and left front quarter panel.

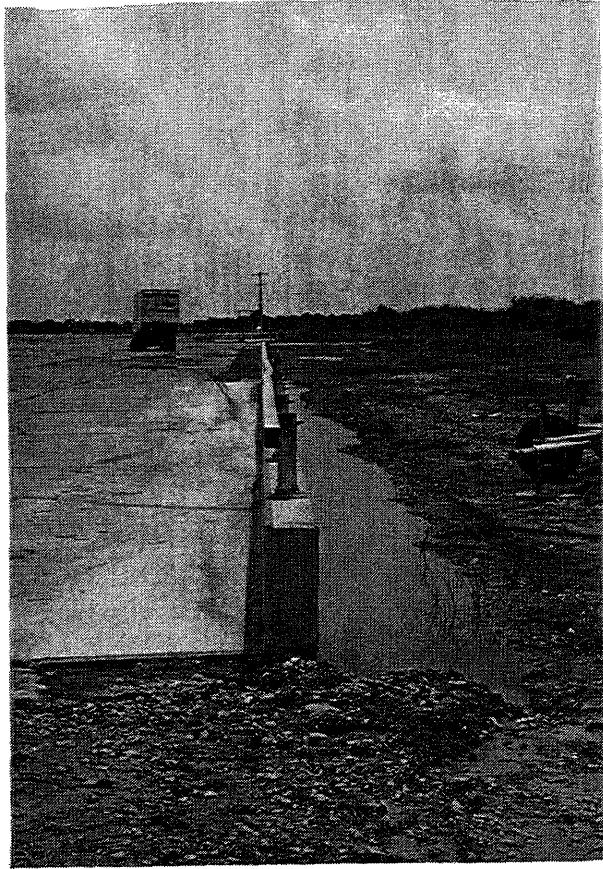
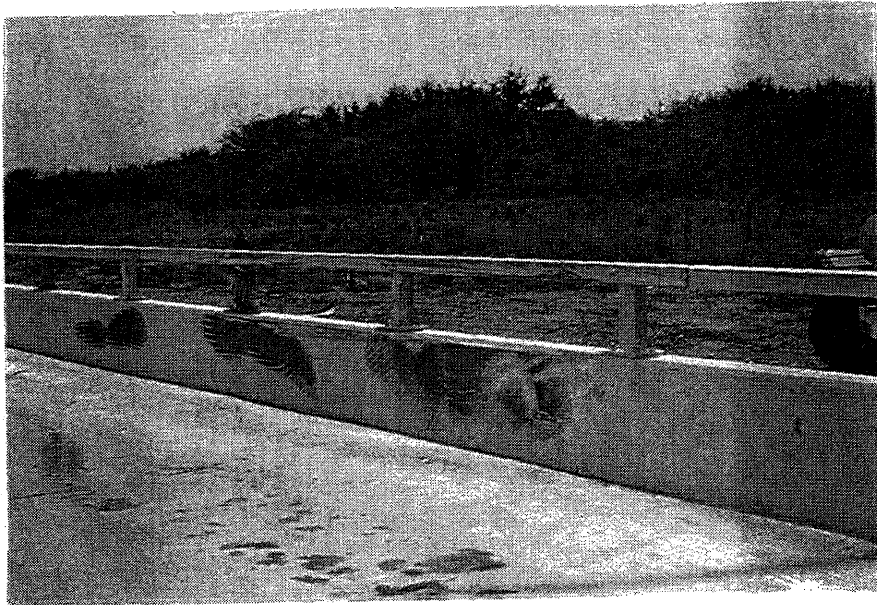
Figure 89. Test site after test 7069-34.

As can be seen in figures 89 and 90, the bridge railing received minimal damage with most being contained within the area around posts 4, 5, and 6. Cracking occurred in posts 4 and 5 in the heat affected zone in the posts at the post-to-baseplate connection. The crack occurred at the corners on the traffic side of the tubular steel element (corner of maximum stress) and extended approximately 1 in in both directions. There was a hairline crack in the concrete parapet in line with the rear bolts at post 4. There was 1.5-in (38-mm) deformation to the metal railing element between posts 4 and 5. The vehicle was in contact with the bridge railing for 41.0 ft (12.5 m).

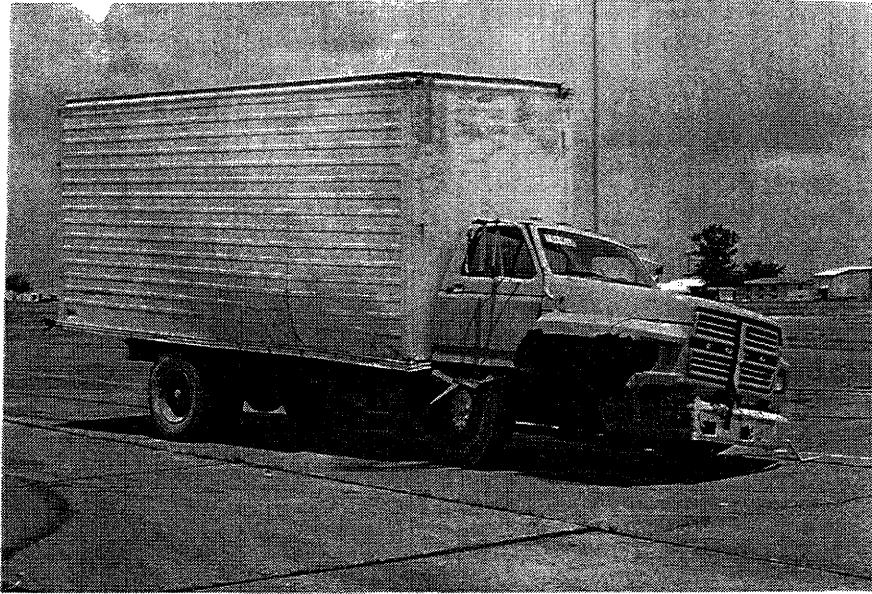
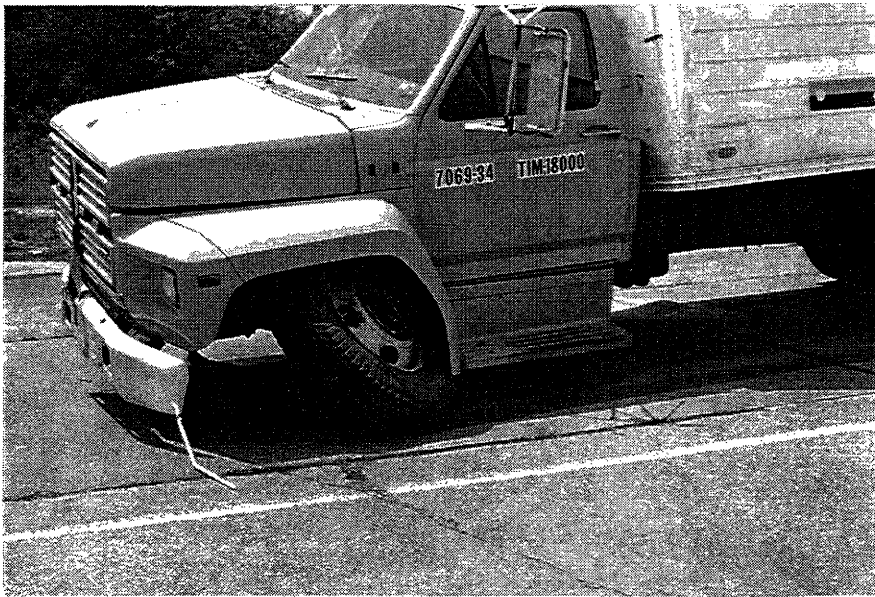
Figure 91. Vehicle after test 7069-34.

The vehicle sustained damage mostly to the right side as shown in figure 91 and 92. Maximum crush at the right front corner at bumper height was 28.0 in (711 mm). The steering arm, front springs and shackles, left front king pin, and front axle were damaged and the frame was bent. Also, damage was done to the front bumper, right front quarter panel, right front tire and rim, right door, right rear outside tire and rim, gas tank, and box-van.

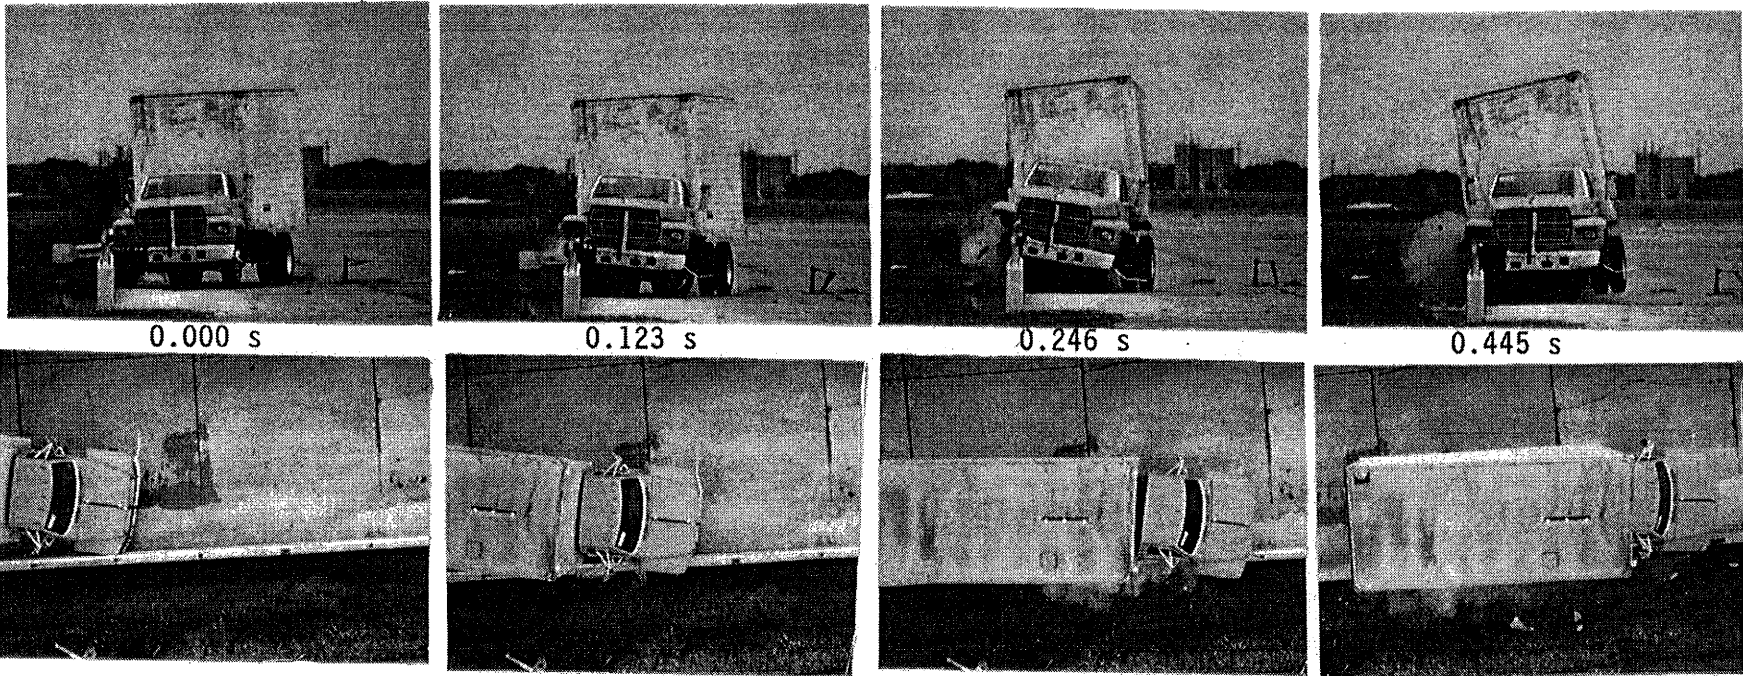
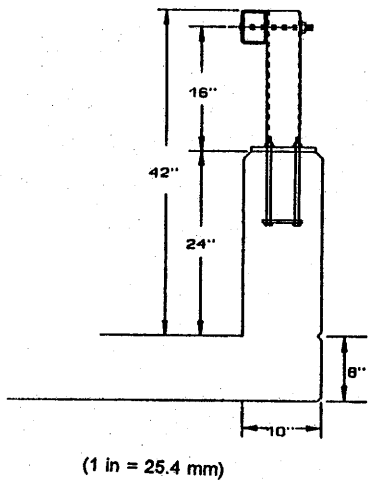
Test No.	7069-34	Impact Speed. . . .	52.5 mi/h (84.5 km/h)
Date	08/12/92	Impact Angle. . . .	12.8 deg
Test Installation . . .	BR27C Bridge Railing on deck	Speed at Parallel . . .	46.8 mi/h (75.3 km/h)
Installation Length . .	100 ft (30 m)	Exit Speed	44.6 mi/h (71.8 km/h)
Test Vehicle	1981 Ford Single-Unit Truck	Exit Trajectory . . .	3.5
Vehicle Weight		Vehicle Accelerations	
Empty Weight	10,490 lb (4,762 kg)	(Max. 0.050-sec Avg) at c.g.	
Test Inertia	18,000 lb (8,172 kg)	Longitudinal. . . .	-1.9 g
Maximum Vehicle Crush .	28.0 in (711 mm)	Lateral	4.3 g
Max. Perm. Deform. . . .	1.5 in (38 mm)	Occupant Impact Velocity at true c.g.	
		Longitudinal. . . .	8.2 ft/s (2.5 m/s)
		Lateral	13.1 ft/s (4.0 m/s)
		Occupant Ridedown Accelerations	
		Longitudinal. . . .	-1.1 g
		Lateral	5.2 g

Figure 93. Summary of results for test 7069-34.

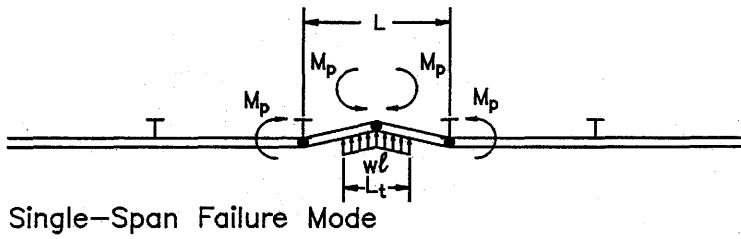
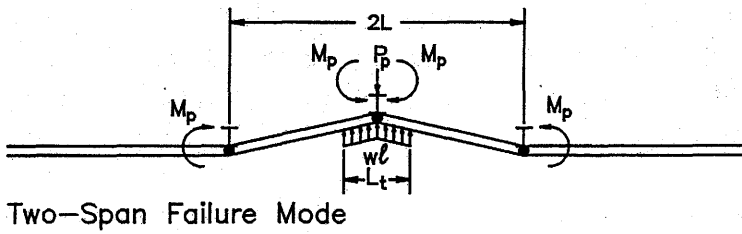
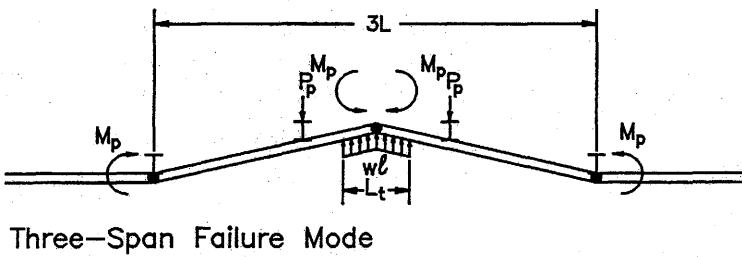
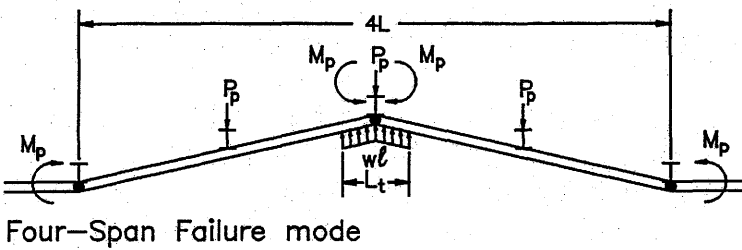
Figure 104. Plan view illustrating some possible failure mechanisms.

The railing consists of a metal beam-and-post portion mounted on top of a concrete parapet. Strength of the metal portion is first analyzed assuming that the concrete parapet has adequate strength to support the metal railing. Equations given in figure 104 are used to compute strength of the metal railing.² The metal rail element is a TS 4 by 3 by 1/4-in (102 by 76 by 6-mm) ASTM A500 grade B with a plastic section modulus of 3.3 in^3 ($54\,077 \text{ mm}^3$) and a plastic moment capacity of 12.7 ft-kips (17.2 m-kN).

If the force were located at the metal rail element, it would be 16 in (406 mm) above the base of the post and the strength of the post would be 8.5 kips (37.8 kN). Under this loading situation, the strength of the metal portion of the railing, computed in accordance with figure 104, would be 20.6 kips (91.7 kN) for a one-span mechanism, 18.6 kips (82.8 kN) for a two-span mechanism, 18.0 kips (80.1 kN) for a three-span mechanism, and 22.3 kips (99.2 kN) for a four-span mechanism. The three-span mechanism controls and computed capacity of the railing is 18.0 kips (80.1 kN). The force would be located at 40 in (1.02 m) above the top of the sidewalk.

If it is assumed that load is applied to the metal rail element and to the parapet such that maximum resistance of the railing system is obtained, a three-span failure mechanism would be involved in the metal portion of the railing and a yieldline failure pattern in the parapet would be located at midlength of the failure mechanism in the metal railing. Total strength of the railing system would be approximately 18.0 kips (80.1 kN) plus 73 kips (324.9 kN) equals 91 kips (405 kN) located 27 in (686 mm) above the sidewalk.

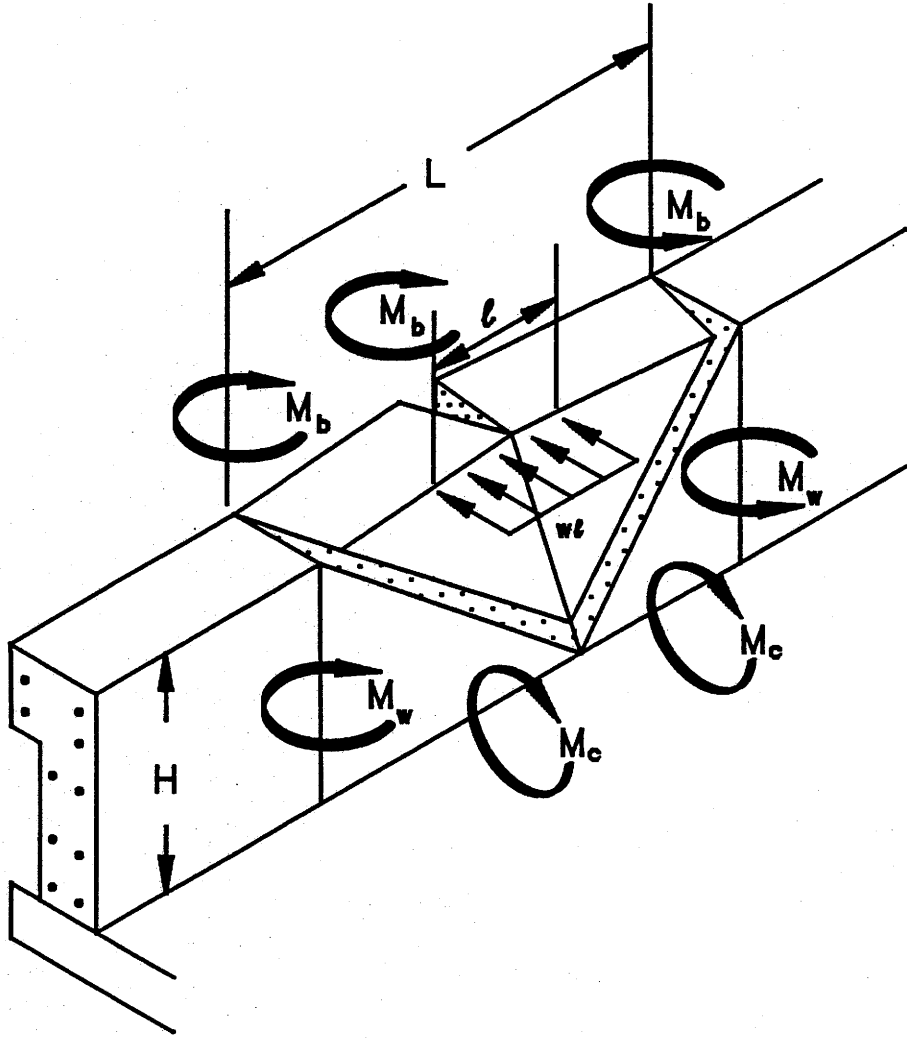
Figure 105. Yieldline failure pattern for concrete parapet.

The strength of the concrete parapet may be analyzed using the equations for the yieldline mechanism shown in figure 105. Computed cantilever moment capacity of the parapet, M_c , is 10.8 ft-k/ft (48.1 m-kN/m). Moment capacity of the parapet about a vertical axis, M_w , is 19.6 ft-k/ft (87.2 m-kN/m). No additional beam stiffening exists along the top of the parapet; therefore, M_b is zero. These values result in a length of failure mechanism, L , of 9.6 ft (2.9 m) and computed strength of the parapet is 73.3 kips (326.2 kN).
