**EVALUATION OF THE CRASHWORTHINESS OF THIN-WALLED
ALUMINUM AND STEEL U-CHANNEL SIGN SUPPORTS**

New Hampshire Department of Transportation
Bureau of Traffic
220 Sheep Davis Road (NH 106)
Concord, New Hampshire 03302-0483

TTI Project No. 405231-1F
Final Report

June 1995

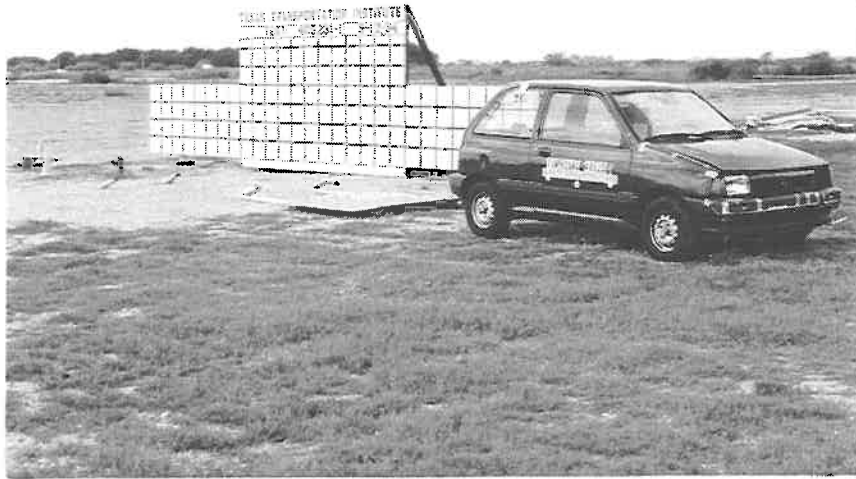
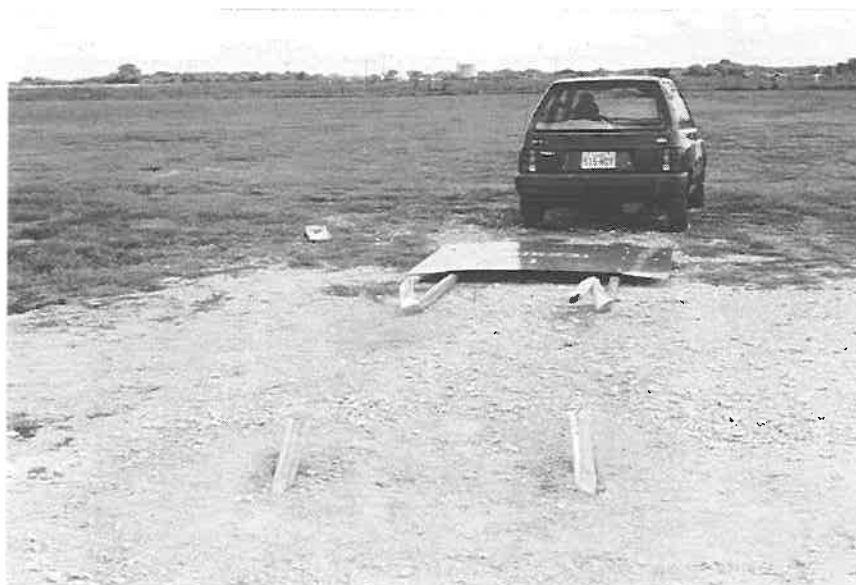
Figure 11 . Final rest position of the sign installation and vehicle (test 405231-1).

As the vehicle impacted the sign installation, the supports began to bend at ground level and deform around the bumper. As the vehicle continued traveling forward, the supports yielded allowing the vehicle to continue moving. The supports pocketed around the front bumper, thus leading to the tensile failure of the left and right supports at 0.131 and 0.180 seconds, respectively. As the supports failed, the vehicle passed over the ground stubs with the upper portion of the sign installation remaining in contact with the front of the vehicle. The remaining intact portion of the sign installation rotated toward the ground allowing the vehicle to travel over the installation upon exiting the impact site. The sign panel began to contact the ground at approximately 0.853 seconds. At 1.051 seconds the front tires struck the panel, the vehicle traveled over the installation and exited the view of the high-speed camera. The vehicle came to rest upright 9.1 m (30.0 ft) downstream and 1.4 m (4.5 ft) right of the point of impact. Final rest positions of the vehicle and sign installation are shown in Figure 11. Sequential photographs of the crash test are shown in Appendix B.

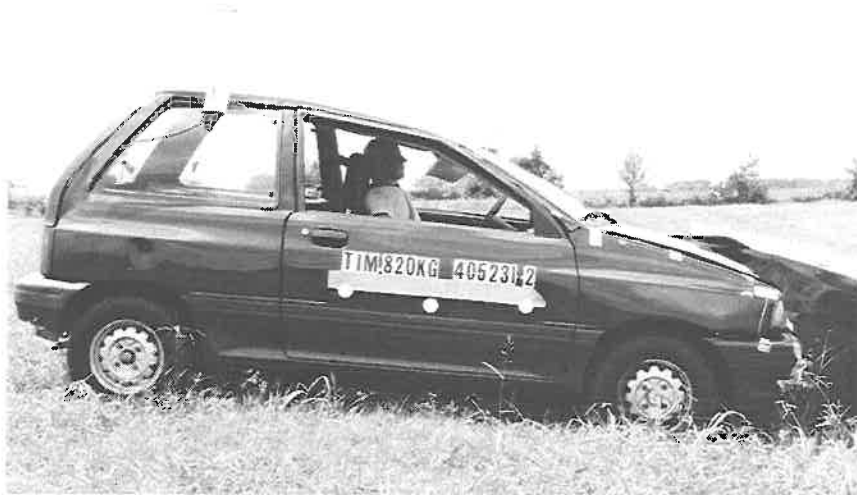
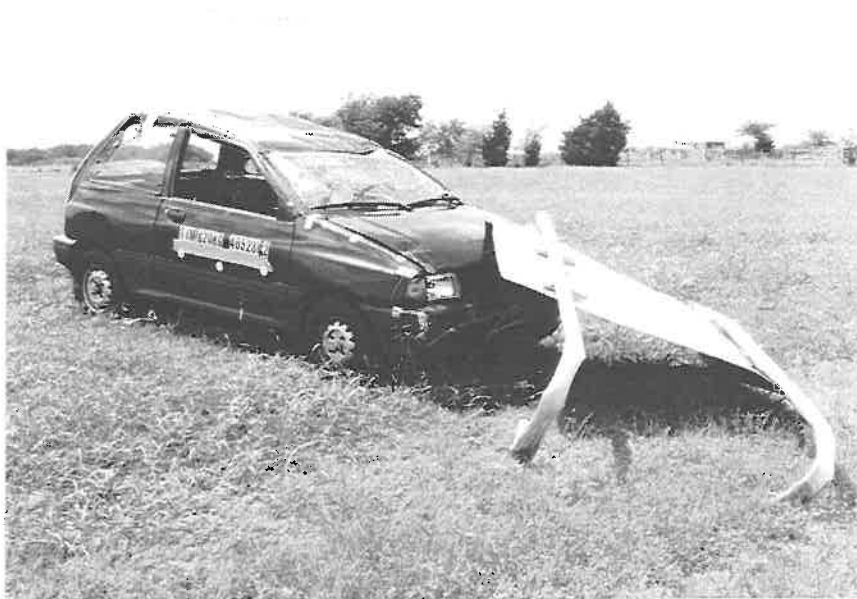
Figure 18 . Final rest position of the sign installation and vehicle (test 405231-2).

As the vehicle impacted the sign installation, the supports began to bend at ground level and deform around the bumper. As the vehicle continued traveling forward, the supports yielded allowing the vehicle to continue moving. The supports pocketed around the front bumper, thus leading to the tensile failure of both sign supports at approximately 0.040 seconds. As the supports failed, the vehicle passed over the ground stubs as the upper portion of the sign installation continued to rotate over the front of the vehicle. The sign panel struck the roof of the vehicle at 0.087 seconds. The sign panel struck the roof with a force sufficient enough to deform the roof and A-pillars and cause the left passenger window to shatter. The brakes were applied and the vehicle exited traveling 83.7 km/h (52.0 mi/h) with the sign panel and supports still in contact with the front of the vehicle. The vehicle came to final rest upright 107.6 m (353.0 ft) downstream and 3.0 m (10.0 ft) right of the point of impact. Final rest positions of the vehicle and sign installation are shown in Figure 18. Sequential photographs of the crash test are shown in Appendix B.

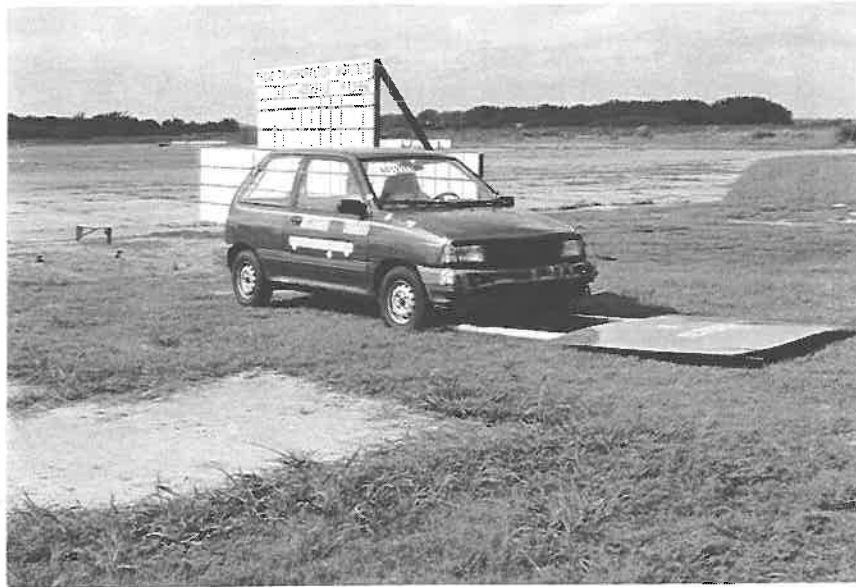
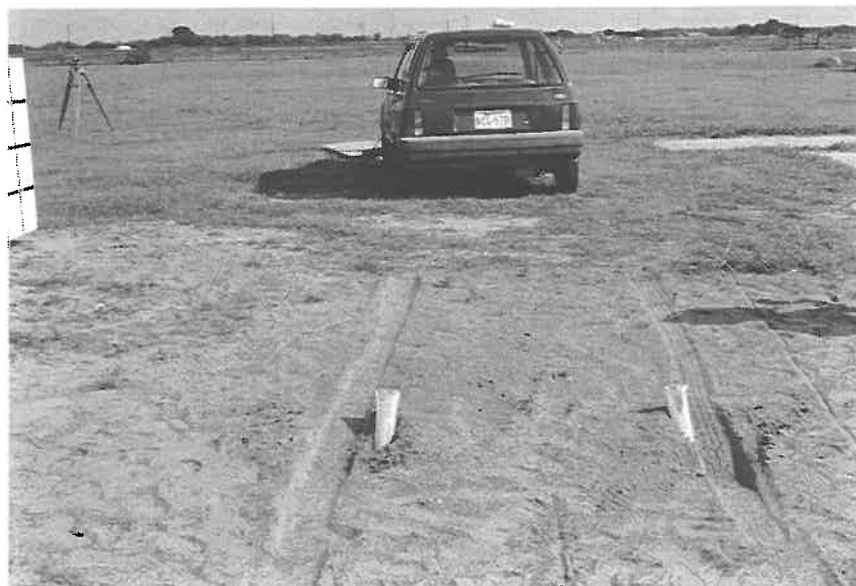
Figure 25 . Final rest position of the sign installation and vehicle (test 405231-3).

As the vehicle impacted the sign installation, the supports began to bend at ground level and deform around the bumper. As the vehicle continued traveling forward, the supports yielded allowing the vehicle to continue moving. The supports pocketed around the front bumper, thus leading to the tensile failure of the left and right supports at 0.111 seconds. As the supports failed, the vehicle passed over the ground stubs with the upper portion of the sign installation remaining in contact with the front of the vehicle. The remaining intact portion of the sign installation was projected ahead of the vehicle. The vehicle again struck the supports at approximately 0.854 seconds. Shortly thereafter, the supports rotated away from the vehicle and toward the ground, allowing the vehicle to travel partially over the installation. The vehicle came to rest upright, over the sign installation, 8.6 m (28.1 ft) downstream and 0.3 m (1.0 ft) left of the point of impact. Final rest positions of the vehicle and sign installation are shown in Figure 25. Sequential photographs of the crash test are shown in Appendix B.

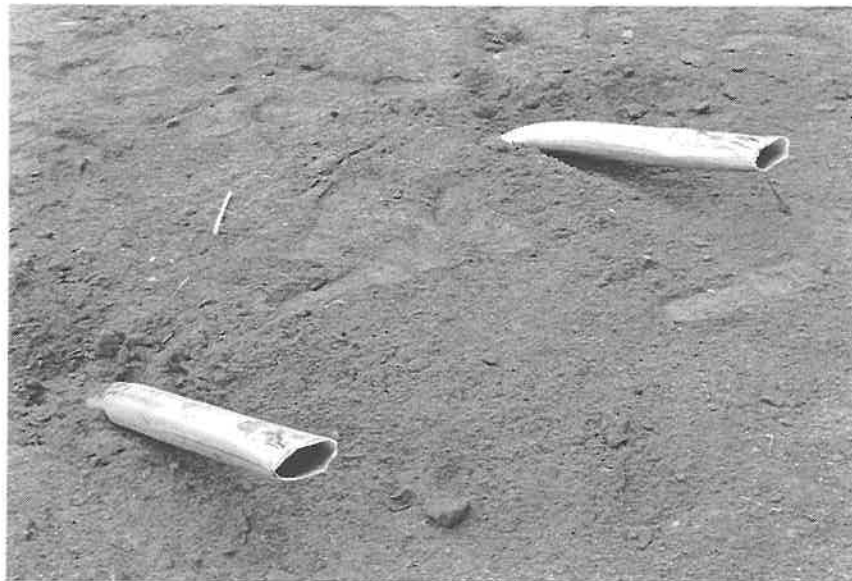
Figure 32 . Dual 3 in. aluminum sign support installation anchored in weak soil after test 405231-4.

As shown in Figure 32, the supports were bent and fractured. The left support failed 610 mm (24.0 in) from ground level and the right support 584 mm (23.0 in) from ground level. The mounting and anchoring hardware received minimal damage and could be reused in field renovation of this installation. However, the sign panel required replacement. Damage sustained by the vehicle during this test is shown in Figure 33. The vehicle sustained moderate roof, hood and top of doors damage. In addition, minor damage to the front bumper, grill, windshield and left front fender were sustained. Maximum vertical crush to the roof was 90 mm (3.5 in).

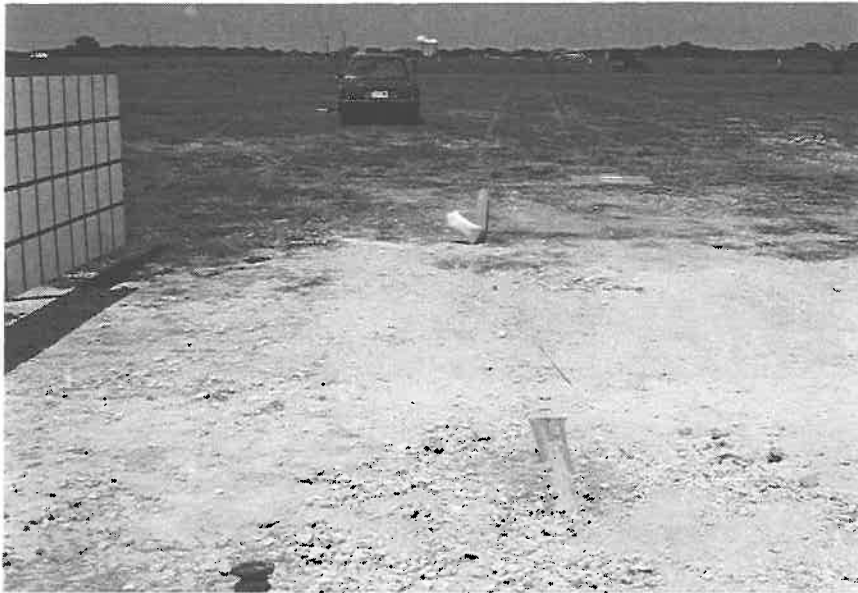
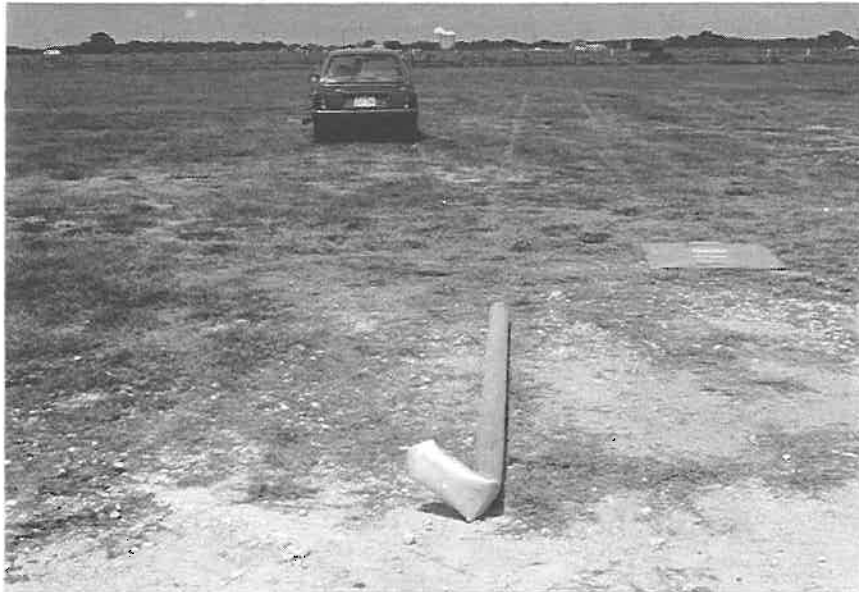
Figure 44 . Final rest position of the sign installation and vehicle (test 405231-6).

As the vehicle impacted the sign installation, the support began to bend at ground level and deform around the bumper. As the vehicle continued traveling forward, the support yielded allowing the vehicle to continue moving. The support pocketed around the front bumper, thus leading to the tensile failure of the support at 0.092 seconds. As the support failed, the vehicle passed over the ground stub with the upper portion of the sign installation remaining in contact with the front of the vehicle. The remaining intact portion of the sign installation was projected ahead of the vehicle. Shortly thereafter, the support rotated away from the vehicle and toward the ground, allowing the vehicle to travel over the installation. As the vehicle passed over the installation, the sign panel was pulled from the support by snagging on the vehicle. The vehicle came to rest upright 24.2 m (79.5 ft) downstream and 2.3 m (7.5 ft) left of the point of impact. Final rest positions of the vehicle and sign installation are shown in Figure 44. Sequential photographs of the crash test are shown in Appendix B.

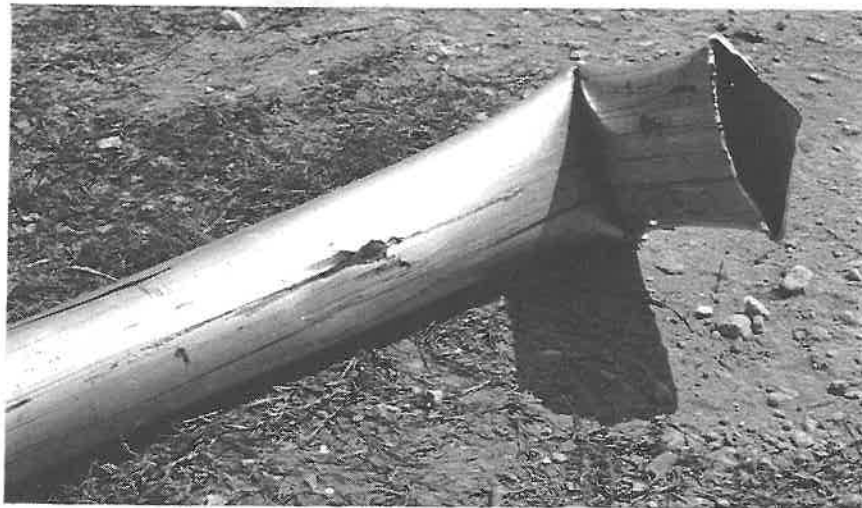
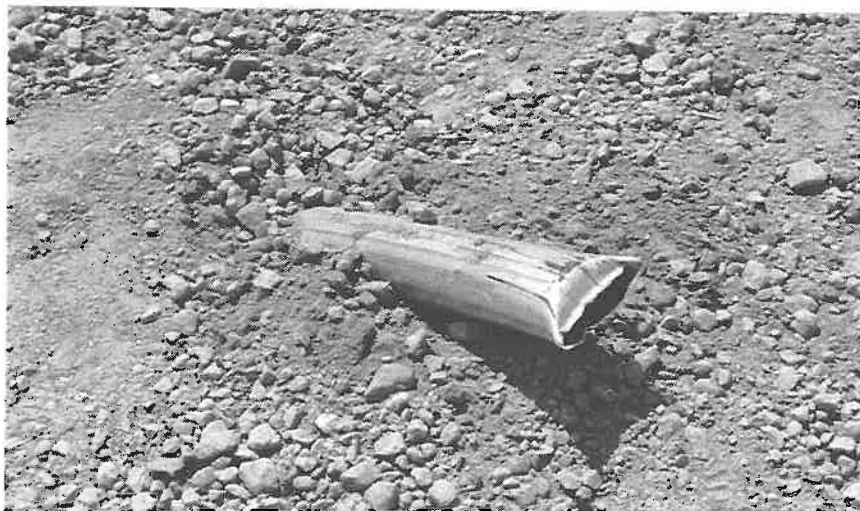
As shown in Figure 45, the support was bent and fractured. The support failed 521 mm (20.5 in) from ground level. The sign panel and all mounting and anchoring hardware received minimal damage and could be reused in field renovation of this installation. Damage sustained by the vehicle during this test is shown in Figure 46. The vehicle sustained primarily cosmetic damage to the bumper and left front fender. There was no deformation to the vehicle occupant compartment.

Figure 45 . Single 4 in. aluminum sign support installation anchored in strong soil after test 405231-6.

B.	The test article should readily activate in a predictable manner by breaking away, fracturing, or yielding.	The sign support yielded by bending the aluminum tube at ground level and fracturing in tension near bumper level.		Pass	
<u>Occupant Risk</u>

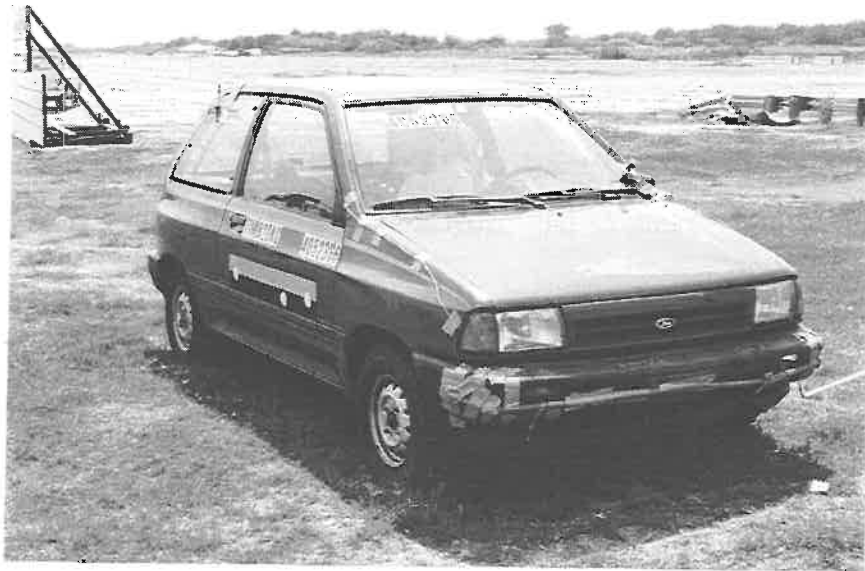
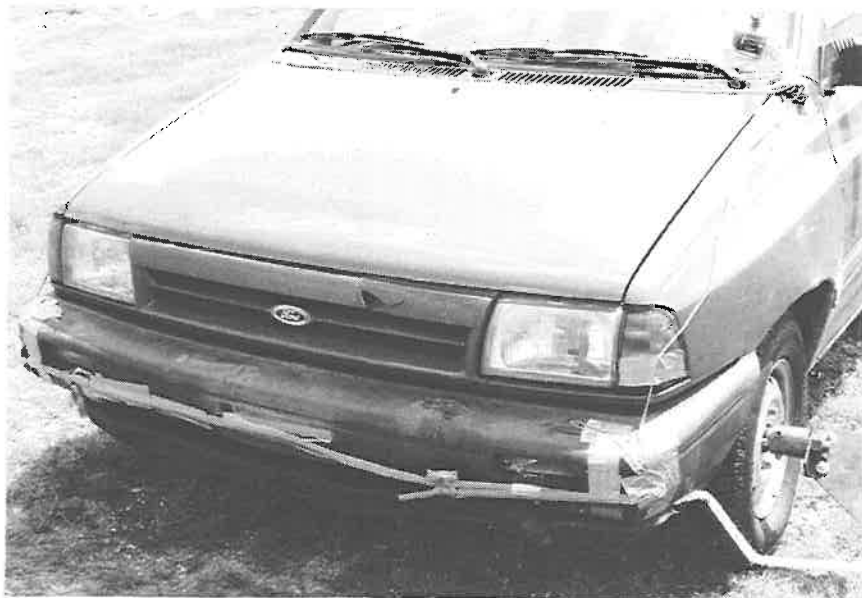
Figure 46 . Vehicle after test 405231-6.

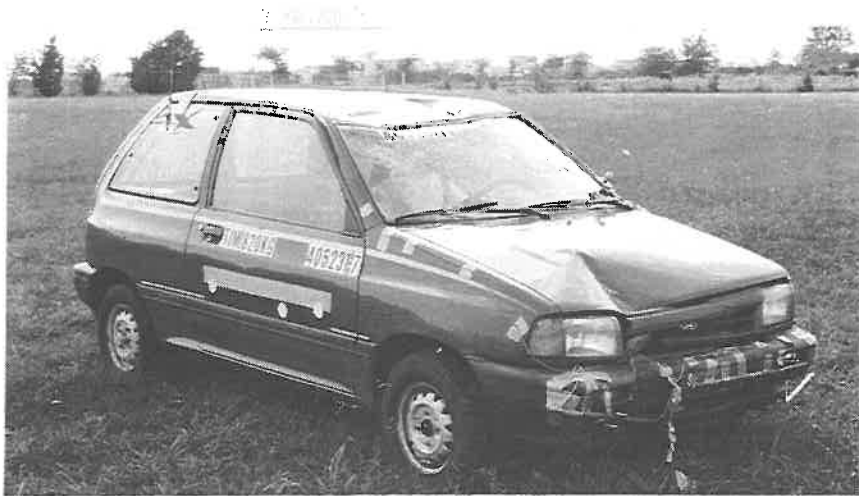
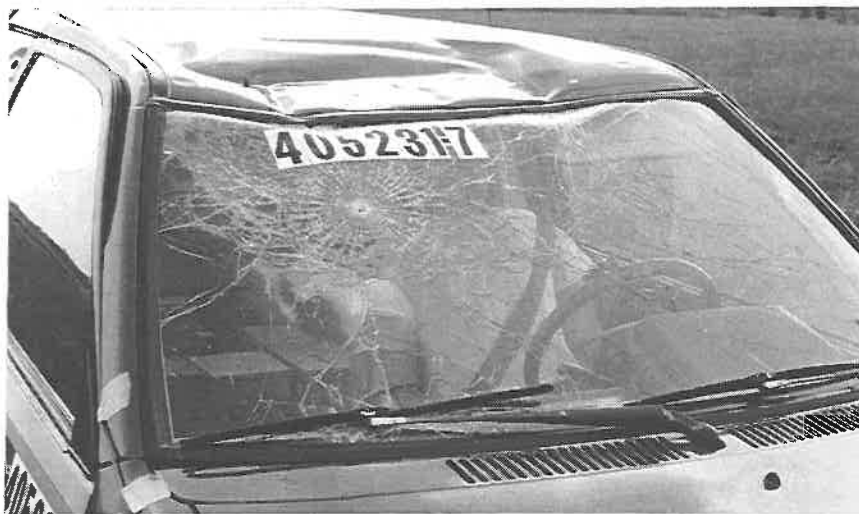
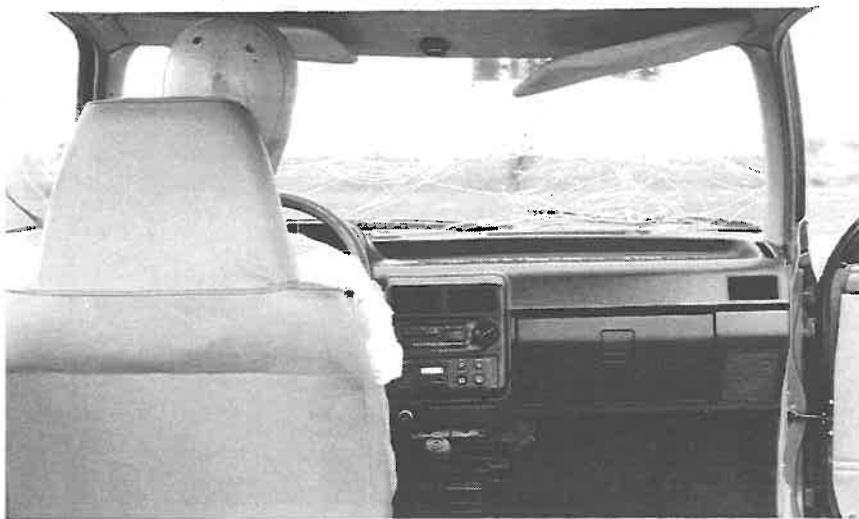
Figure 52 . Vehicle after test 405231-7.

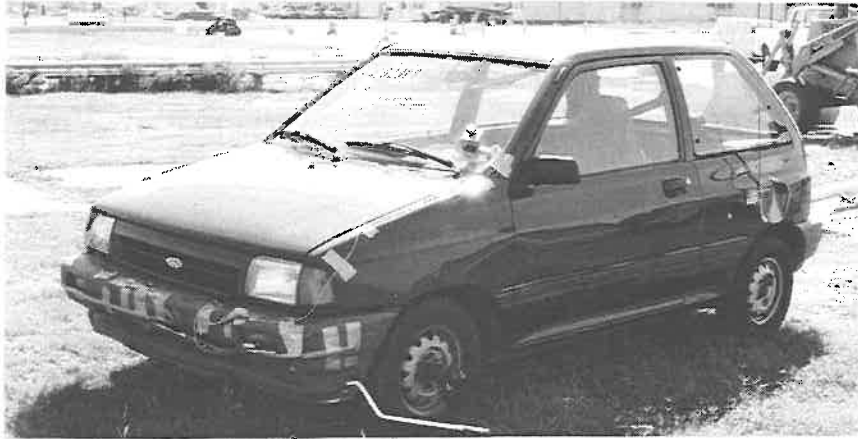
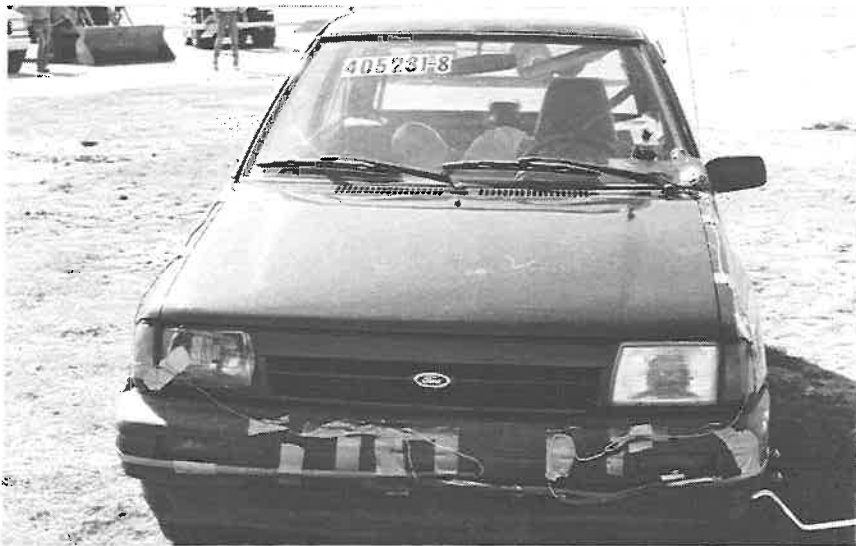
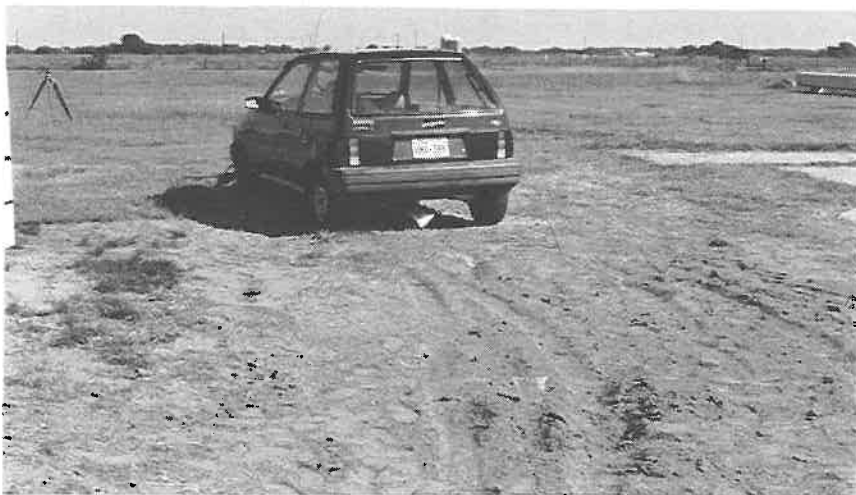
Figure 58 . Vehicle after test 405231-8.

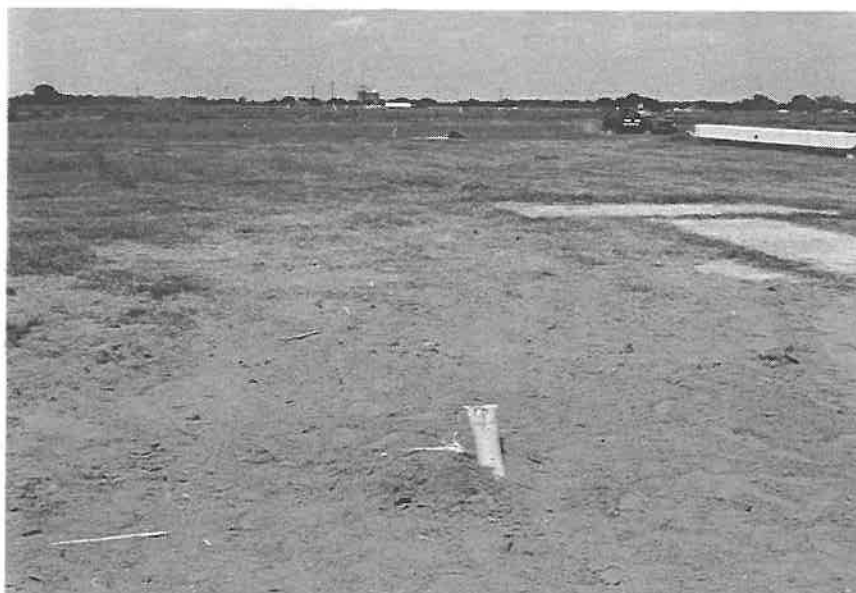
As the vehicle impacted the sign installation, the support began to bend at ground level and collapse in and around the bumper. As the vehicle continued traveling forward it began to yaw clockwise, the support yielded allowing the vehicle to continue moving. The support pocketed around the front bumper, thus leading to the tensile failure of the sign support at approximately 0.045 seconds. As the support failed, the vehicle passed over the ground stub as the upper portion of the sign installation continued to rotate over the front of the vehicle. The sign panel struck the roof of the vehicle at 0.074 seconds. The sign panel struck the roof with a force sufficient enough to deform the roof and right A-pillar and cause the right passenger window to shatter. The sign installation then rotated up and away from the vehicle, exiting to the right. The vehicle exited traveling 88.4 km/h (54.9 mi/h), the brakes were applied and the vehicle came to rest out of view of the high-speed. The vehicle came to final rest upright 50.0 m (164.0 ft) downstream and 12.2 m (40.0 ft) right of the point of impact. The sign support and sign panel came to rest 44.5 m (146.0 ft) down and 2.1 m (7.0 ft) to the right of impact sight. Final rest positions of the vehicle and sign installation are shown in Figure 63. Sequential photographs of the crash test are shown in Appendix B.

Figure 63 . Final rest position of the sign installation and vehicle (test 405231-9).

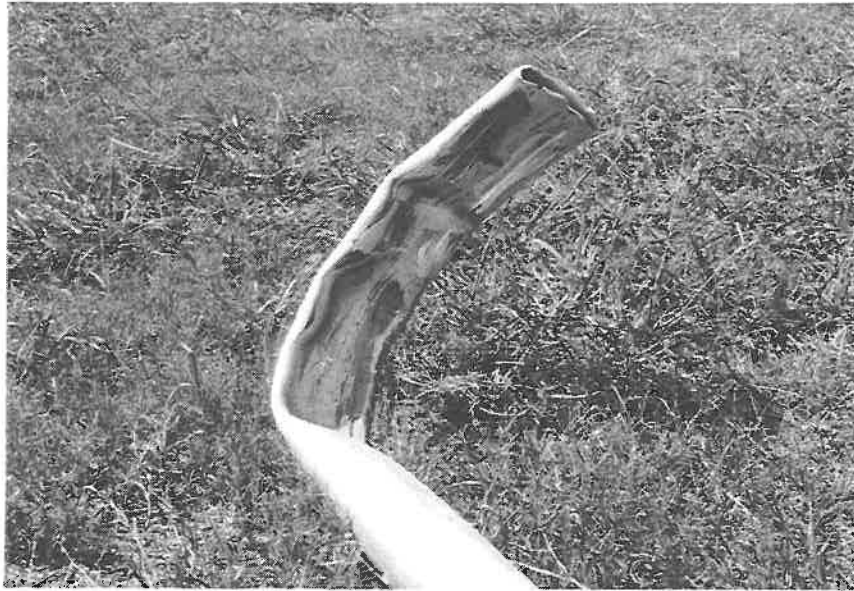
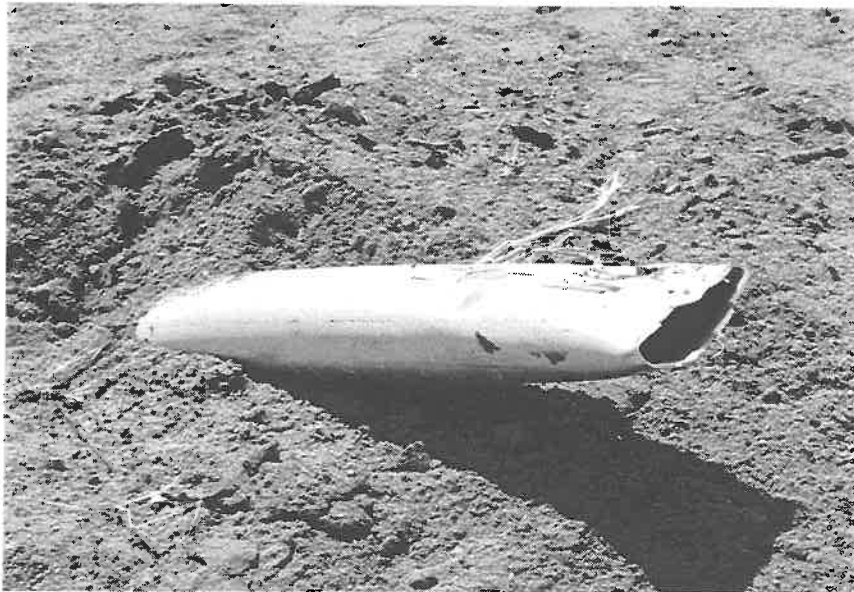
Figure 64 . Single 4 in. aluminum sign support installation anchored in weak soil after test 405231-9.

As shown in Figure 64, the support was bent and fractured. The support failed 609.6 mm (24.0 in) from ground level. The mounting and anchoring hardware received minimal damage and could be reused in field renovation of this installation. However, the sign panel required replacement. Damage sustained by the vehicle during this test is shown in Figure 65. The vehicle sustained moderate roof, hood, windshield, top of right door and bumper damage. Maximum vertical crush to the roof was 110 mm (4.3 in). Maximum deformation to the front of the vehicle at the impact point was 40 mm (1.6 in). There were deformation and minor intrusion into the

B.	The test article should readily activate in a predictable manner by breaking away, fracturing, or yielding.	The sign support yielded by bending the aluminum tube at ground level and fracturing in tension near bumper level.		Pass	
Occupant Risk

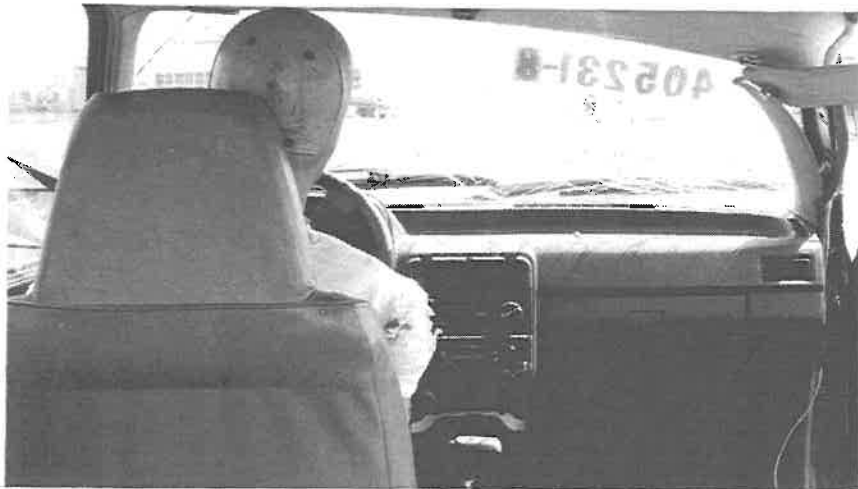
Figure 65 . Vehicle after test 405231-9.
100

vehicle occupant compartment. The occupant compartment was punctured by one of the bolts anchoring the sign panel to the support.

D.	Detached elements should not penetrate the occupant compartment, or present an undue hazard to other traffic, pedestrians, or personnel in a work zone. Deformations of the occupant compartment that could cause serious injuries should not be permitted.	The sign support fractured but did not present a hazard to other travel lanes. There was deformation of the front portion of the occupant compartment, but no actual intrusion into the compartment.		Pass

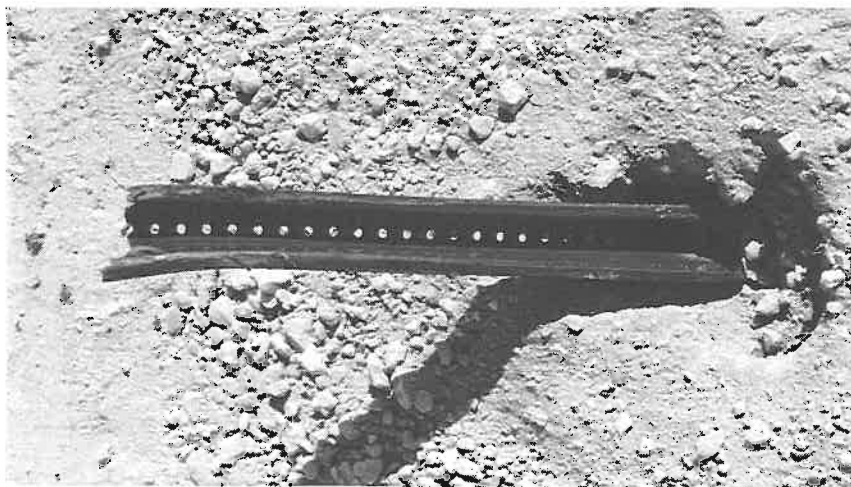
Figure 71. dual 2-1/2 lb steel U-channel support installation anchored in strong soil after test 405231-10.

As shown in Figure 71, the supports were bent and fractured. The left support failed 533 mm (21.0 in) from ground level and the right support remained intact. Damage sustained by the vehicle during this test is shown in Figure 72. The vehicle sustained only cosmetic damage to the bumper. The vehicle occupant compartment was not deformed.

B.	The test article should readily activate in a predictable manner by breaking away, fracturing, or yielding.	The left sign support yielded by bending the steel U-channel at ground level and fracturing near bumper level. The right support was bent at ground level, but did not fracture.		Pass	
<u>Occupant Risk</u>

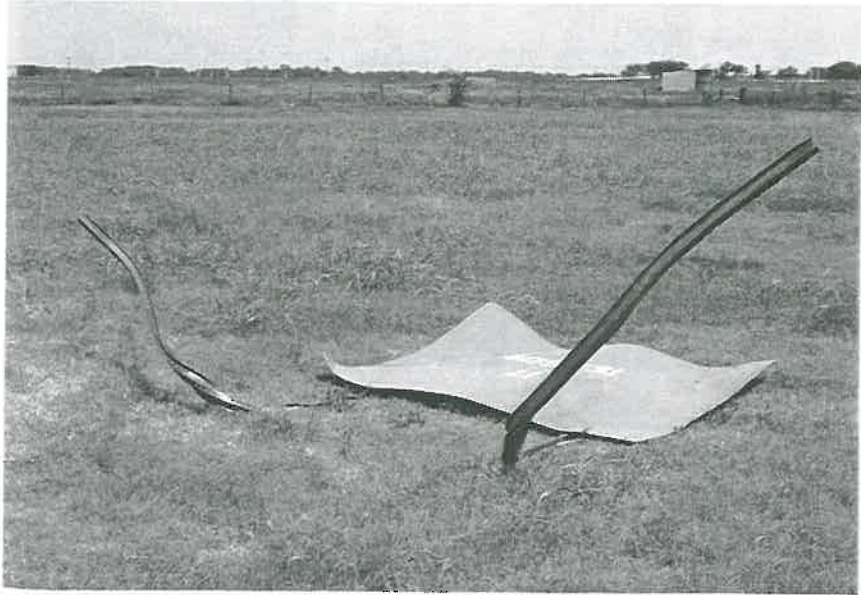
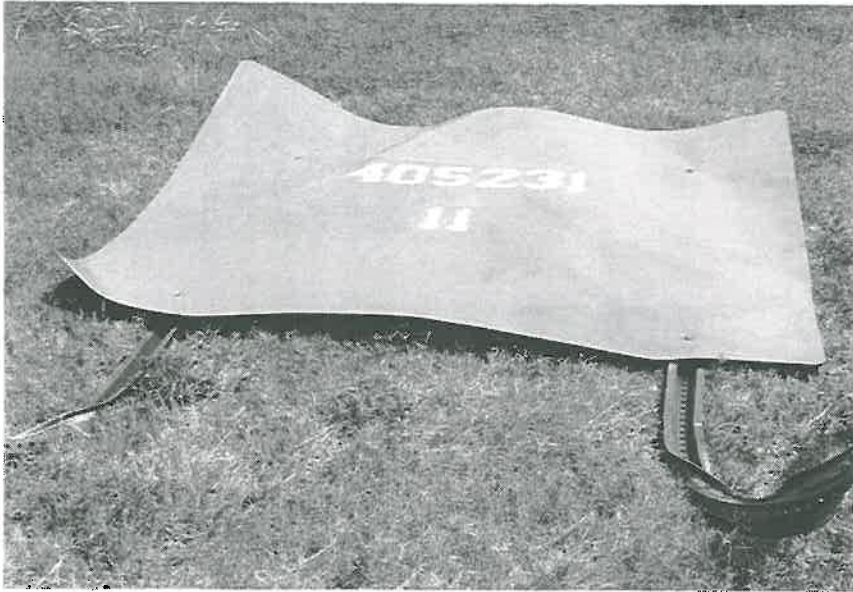
Figure 78. Dual 2-1/2 lb steel U-channel support installation anchored in strong soil after test 405231-11.

As shown in Figure 78, the supports were bent and twisted. The supports pulled completely from the ground without fracturing. The sign support and sign panel came to rest just ahead of the vehicle. Damage sustained by the vehicle during this test is shown in Figure 79. The vehicle sustained moderate roof, hood, windshield and bumper damage. Maximum vertical crush to the roof was 180 mm (7.1 in). Maximum deformation to the front of the vehicle at the impact point was 105 mm (4.1 in). There was deformation, but no intrusion into the vehicle occupant compartment.

B.	The test article should readily activate in a predictable manner by breaking away, fracturing, or yielding.	The sign supports yielded by bending the steel U-channel at ground level and fracturing near the bumper level.		Pass	
<u>Occupant Risk</u>

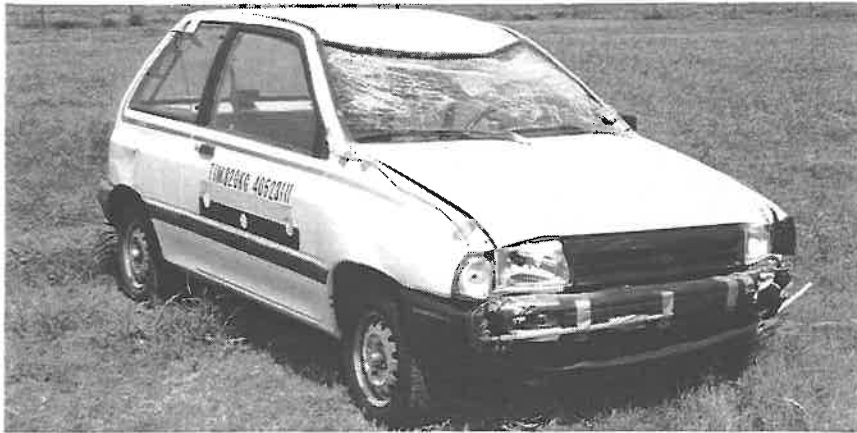
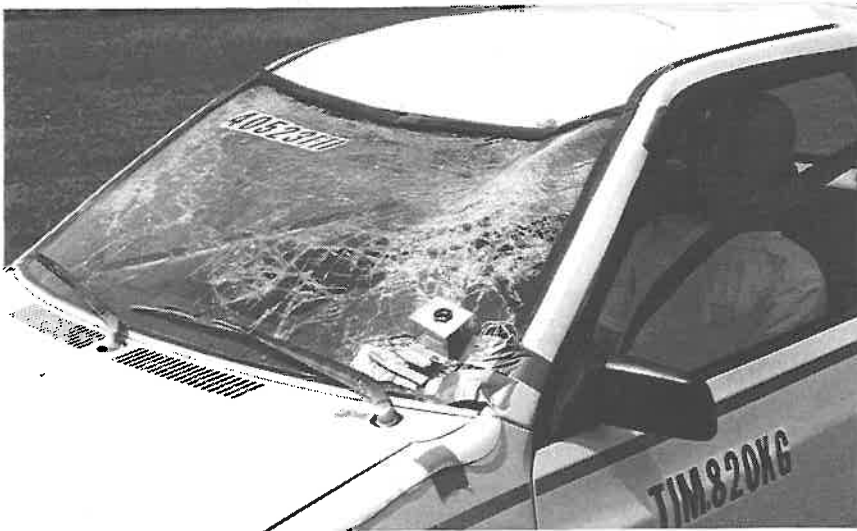
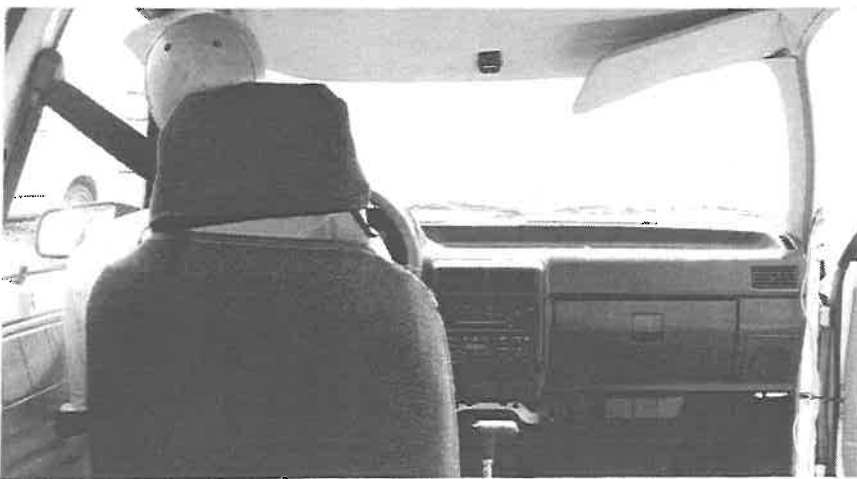
Figure 79 . Vehicle after test 405231-11.

As the vehicle impacted the sign installation, the supports began to bend at ground level and pocket around the front of the vehicle. The sign panel struck the roof of the vehicle at 0.072 seconds. The sign panel struck the roof with a force sufficient to deform the roof and A-pillars and break the windshield. At some indeterminable time, the supports were completely pulled from the ground. The sign installation remained wrapped around the front of the vehicle as it exited. The brakes were applied and the vehicle came to rest out of view of the high-speed camera. The vehicle came to final rest upright 61.3 m (201.0 ft) downstream and 16.6 m (54.5 ft) right of the point of impact. Final rest positions of the vehicle and sign installation are shown in Figure 77. Sequential photographs of the crash test are shown in Appendix B.

D.	Detached elements should not penetrate the occupant compartment, or present an undue hazard to other traffic, pedestrians, or personnel in a work zone. Deformations of the occupant compartment that could cause serious injuries should not be permitted.	The sign supports fractured but did not present a hazard to other travel lanes. There was deformation of the front portion of the occupant compartment, but no actual intrusion into the compartment		Pass

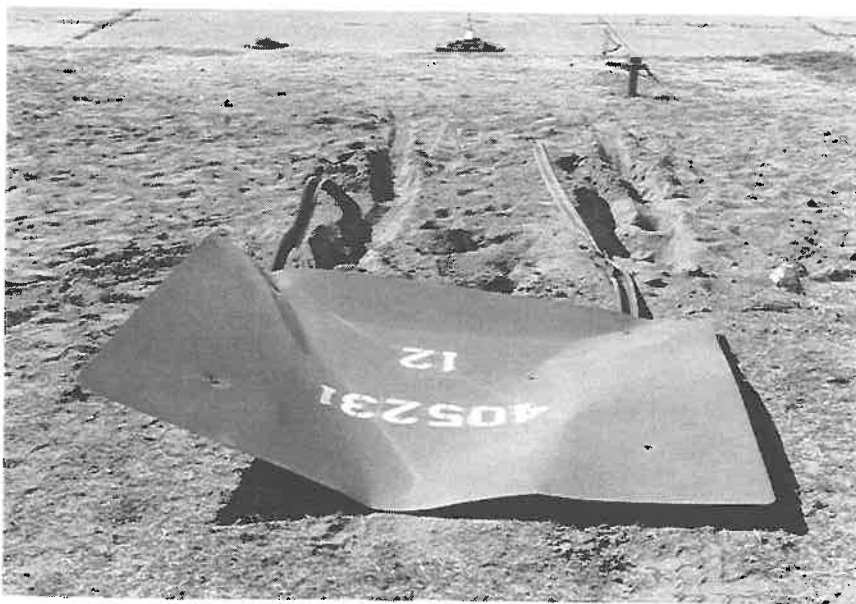
As the vehicle impacted the sign installation, the right support began to deflect outward, losing contact with the bumper. Thereafter, the right support scraped along the right front fender. The left support deformed and was pulled downward until the sign panel came into contact with the hood of the vehicle. As the left support was pulled down, the right support was pulled firmly into the right fender. The lower edge of the sign panel struck the hood at approximately 0.276 seconds. As the vehicle became snared under the sign panel at approximately 0.330 seconds, the right and left support began pulling from the ground. The vehicle, while still in contact with the supports, lost contact with the sign panel at 0.608 seconds. Contact with the supports was lost very shortly thereafter and the vehicle came to rest atop the installation near the point of impact. Final rest positions of the vehicle and sign installation are shown in Figure 84. Sequential photographs of the crash test are shown in Appendix B.

Figure 84 . Final rest position of the sign installation and vehicle (test 405231-12).

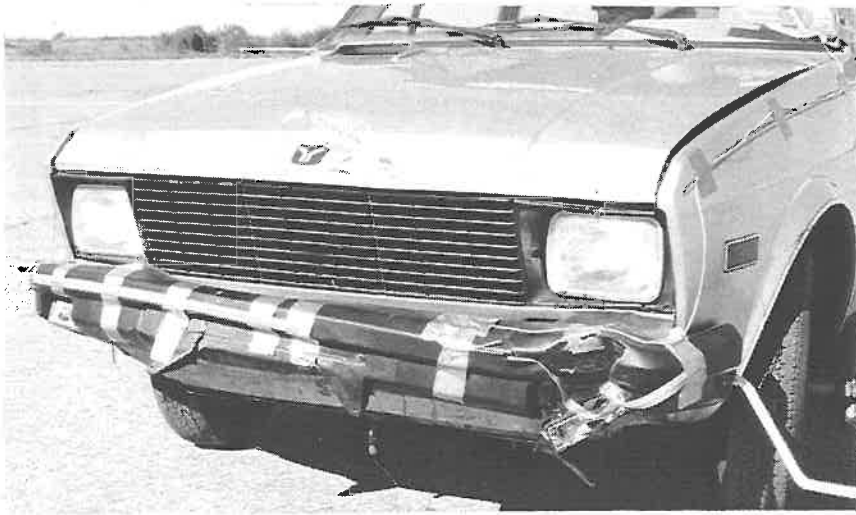
As shown in Figure 85, the supports were bent and pulled up from the ground. The left support was completely pulled from the ground while 18 mm (0.7 in) of the right support remained in the ground. Damage sustained by the vehicle during this test is shown in Figure 86. The vehicle sustained 100.0 mm (3.9 in) of crush to the bumper. In addition, the right front fender and hood were dented and scraped. There was no deformation to the vehicle occupant compartment.

Figure 85. Dual 2-1/2 lb steel U-channel support installation anchored in weak soil after test 405231-12.

B.	The test article should readily activate in a predictable manner by breaking away, fracturing, or yielding.	The sign supports yielded by bending the steel U-channel at ground level.		Pass	
Occupant Risk

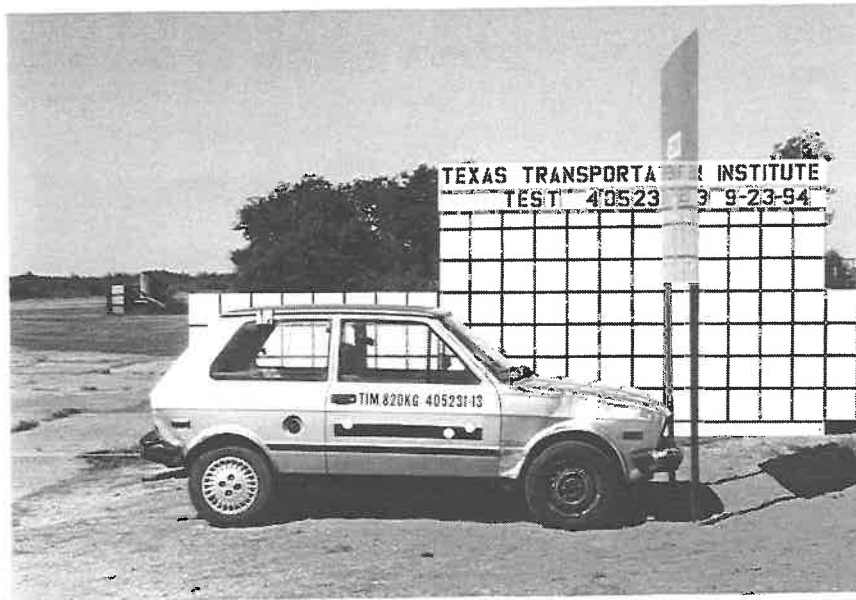
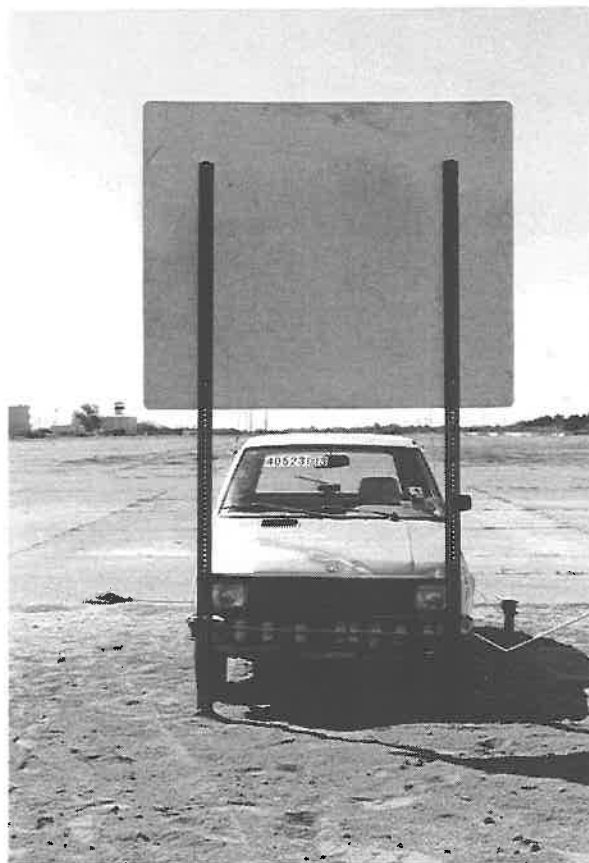
Figure 88 . Vehicle/sign geometrics for test 405231-13.

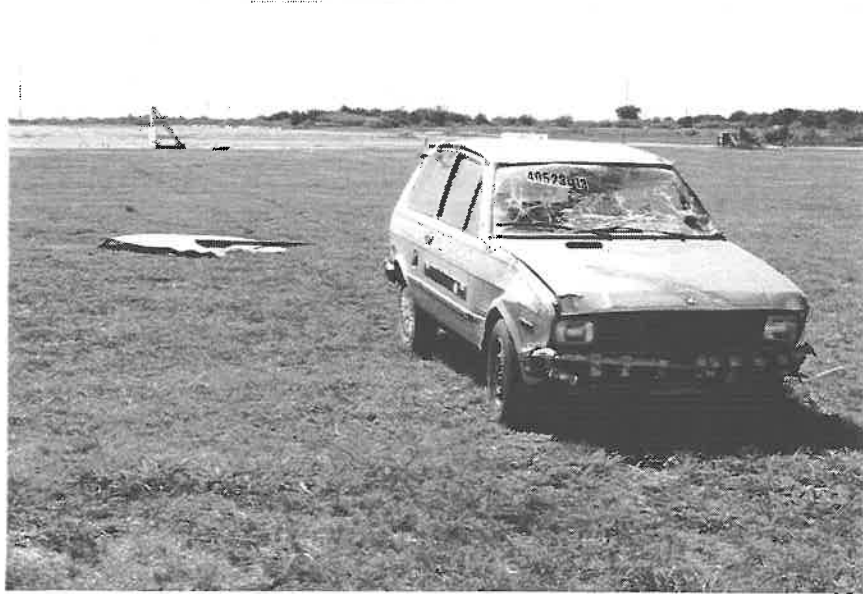
As the vehicle impacted the sign installation, the supports began to bend at ground level and at the vehicle's hood. The right support fractured at 0.029 seconds and the left support at 0.034 seconds. The sign panel rotated over the hood striking the roof of the vehicle at 0.076 seconds. The sign panel and attached support fragments remained atop the roof/windshield area of the vehicle as the vehicle cleared the ground stubs at 0.143 seconds. The vehicle was traveling 91.1 km/h (56.6 mi/h) after the supports fractured. The vehicle exited, the brakes were applied and the vehicle came to rest out of view of the high-speed camera. The vehicle came to final rest upright 80.8 m (265.0 ft) downstream and 1.5 m (5.0 ft) right of the point of impact. Final rest positions of the vehicle and sign installation are shown in Figure 91. Sequential photographs of the crash test are shown in Appendix B.

Figure 91 . Final rest position of the sign installation and vehicle (test 405231-13).

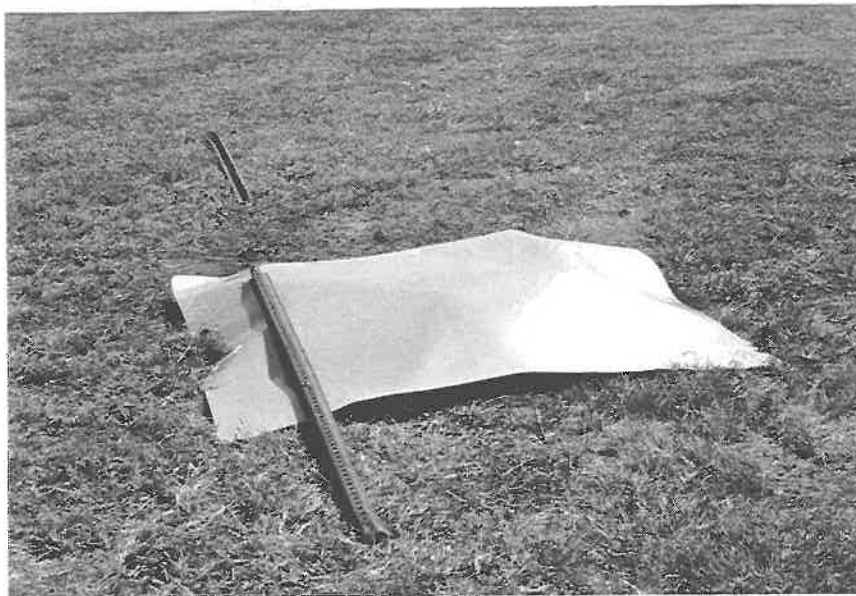
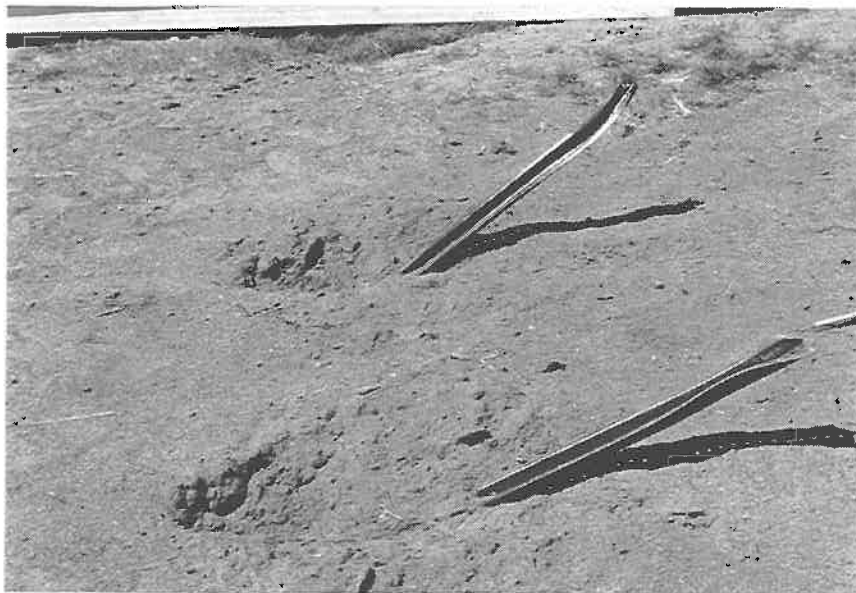
As shown in Figure 92, the supports were fractured and bent. The right support fractured 977 mm (38.5 in) from ground level and the left support 840 mm (33.1 in) from ground level. The right sign support and the sign panel came to rest 75.6 m (248.0 ft) down and 2.7 m (9.0 ft) to the right of the point of impact. The upper portion of the left support, detached from the sign panel, came to rest 72.6 m (238.0 ft) from the point of impact and inline with the sign panel. Damage sustained by the vehicle during this test is shown in Figure 93. The vehicle sustained minor damage to the roof and hood. The windshield was broken and the bumper required replacement. Maximum vertical crush to the roof was 20 mm (0.8 in). Maximum deformation to the front of the vehicle at the impact point was 90 mm (3.5 in). There was deformation, but no intrusion into the vehicle occupant compartment.

Figure 92. Dual 2-1/2 lb steel U-channel support installation anchored in weak soil after test 405231-13.

B.	The test article should readily activate in a predictable manner by breaking away, fracturing, or yielding.	The sign supports yielded by bending the steel U-channel at ground level and fracturing near the bumper level.		Pass	
<u>Occupant Risk</u>
