**EVALUATION OF THE CRASHWORTHINESS OF THIN-WALLED
ALUMINUM AND STEEL U-CHANNEL SIGN SUPPORTS**

New Hampshire Department of Transportation
Bureau of Traffic
220 Sheep Davis Road (NH 106)
Concord, New Hampshire 03302-0483

TTI Project No. 405231-1F
Final Report

June 1995

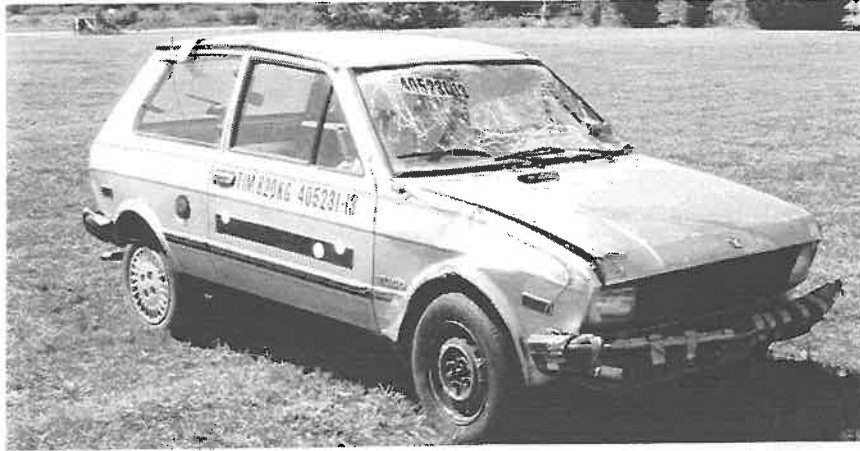
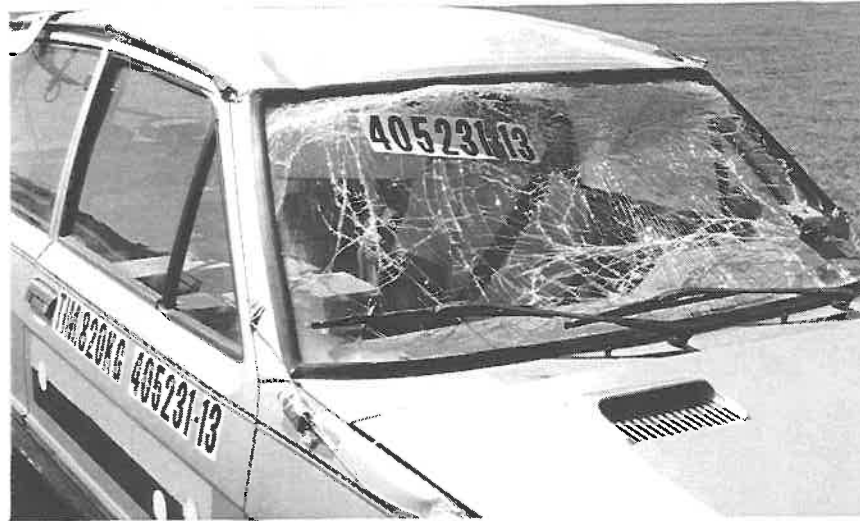
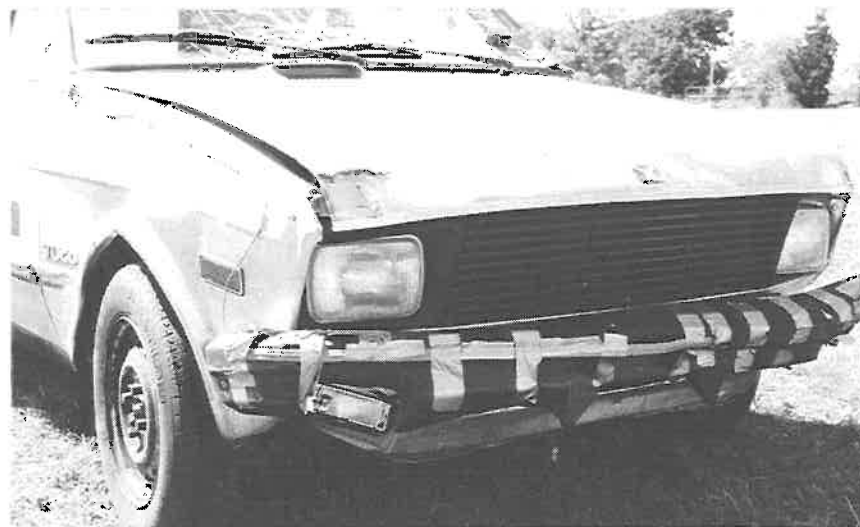
As shown in Figure 92, the supports were fractured and bent. The right support fractured 977 mm (38.5 in) from ground level and the left support 840 mm (33.1 in) from ground level. The right sign support and the sign panel came to rest 75.6 m (248.0 ft) down and 2.7 m (9.0 ft) to the right of the point of impact. The upper portion of the left support, detached from the sign panel, came to rest 72.6 m (238.0 ft) from the point of impact and inline with the sign panel. Damage sustained by the vehicle during this test is shown in Figure 93. The vehicle sustained minor damage to the roof and hood. The windshield was broken and the bumper required replacement. Maximum vertical crush to the roof was 20 mm (0.8 in). Maximum deformation to the front of the vehicle at the impact point was 90 mm (3.5 in). There was deformation, but no intrusion into the vehicle occupant compartment.

Figure 93 . Vehicle after test 405231-13.

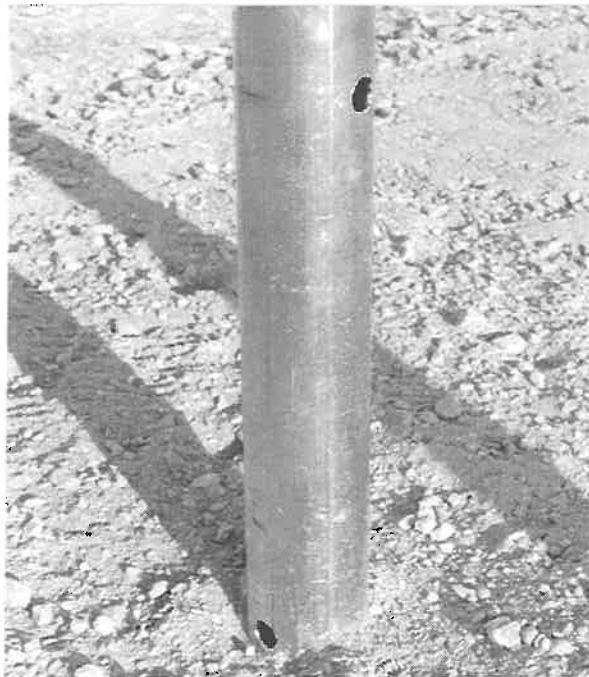
Both the 25 mm (1.0 in) and 32 mm (1.25 in) diameter holes, test 405231-14 and 15 respectively, proved unsuccessful in full-scale crash testing. The results of these two tests are given in Table 26 and warrant no further discussion. However, a successful retrofit was found utilizing a 38 mm (1.5 in) diameter hole. This test is discussed in the section that follows.

Figure 95 . Dual 4 in. aluminum sign support installation modified with four - 1.0 in. holes and anchored in strong soil (test 405231-14).

Following the failure of the 35 km/h (21.8 mi/h) test involving the dual 102 mm (4.0 in) diameter dual aluminum sign support installation anchored in strong soil (test no. 405231-5), the Department acknowledged the need for a suitable retrofit for supports of this type already installed in the field. Two developmental tests (405231-14 & 15) were performed to evaluate the impact performance of the 102 mm (4.0 in) diameter supports when modified by reducing the cross-sectional area by placing four (4) holes through the supports. These modifications are illustrated in Figures 95 and 96.

The dual 102 mm (4.0 in) diameter aluminum supports with 3.2 mm (0.125 in) wall thicknesses were modified as shown in Figure 95. The sign supports were modified by drilling two 38 mm (1.5 in) holes in the support cross-section at two different elevations along each support (4 holes total). The two elevations of four holes each were drilled at ground level and 457 mm (18.0 in) up from ground level. The holes drilled at ground level were oriented 90 degrees to the plane of the sign panel or parallel to the direction of impact. The holes drilled 457 mm (18.0 in) above ground level were oriented parallel to the plane of the sign panel or transverse to the direction of impact. The 102 mm (4.0 in) diameter aluminum support sign installation, when modified as described above, performed satisfactorily in both the low-speed and high-speed crash tests (16 and 17) conducted in strong soil. A low-speed test (22) performed in weak soil produced unsatisfactory results.

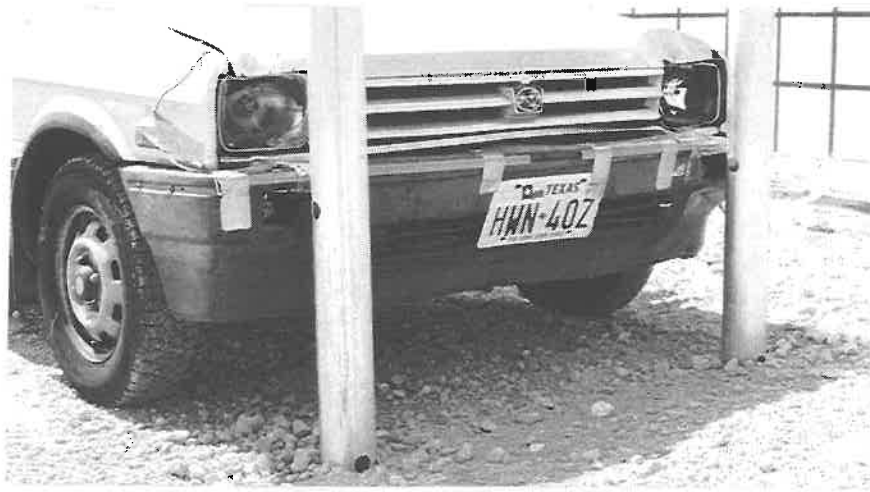
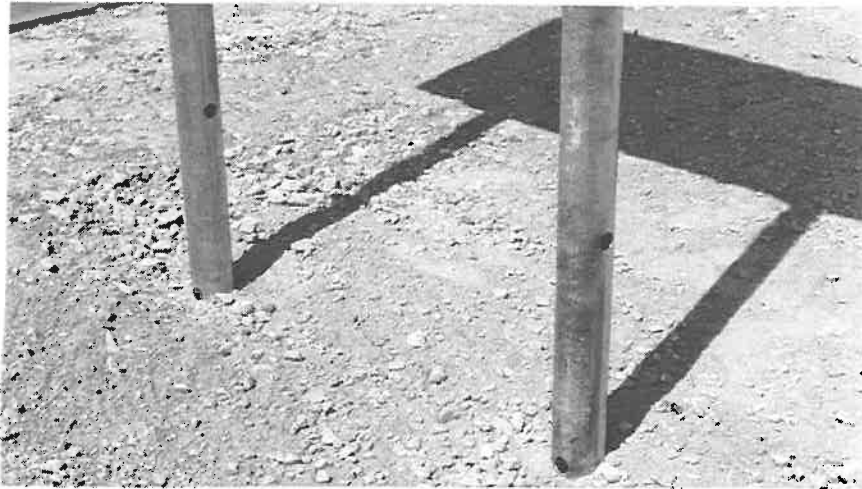
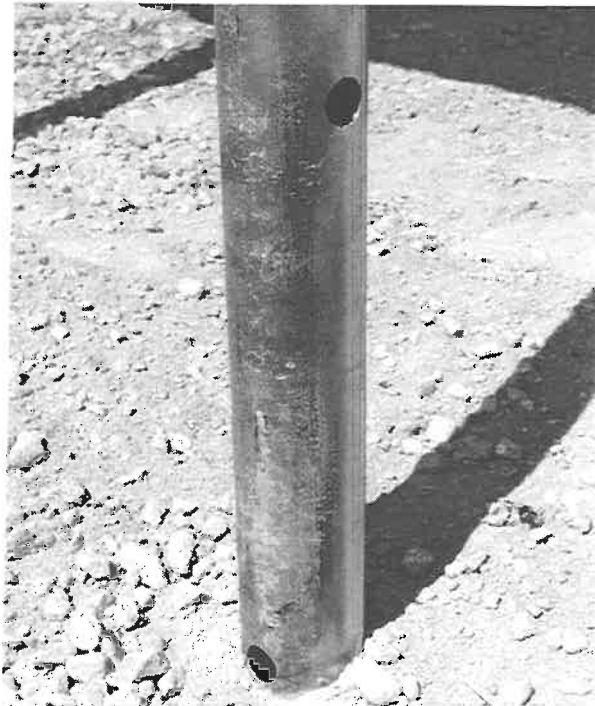
Figure 96 . Dual 4 in. aluminum sign support installation modified with four - 1.25 in. holes and anchored in strong soil (test 405231-15).

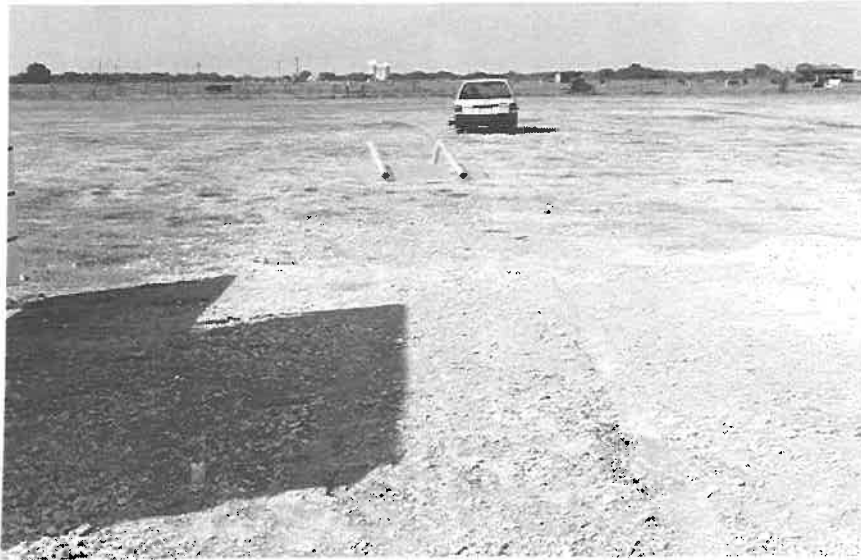
seconds. As the vehicle continued traveling forward, the supports fractured at ground level at 0.060 second. The vehicle exited the impact site by 0.409 seconds traveling 30.4 km/h (18.9 mi/h). The sign panel and attached supports continued to rotate over the vehicle. The sign panel struck the front portion of the roof of the vehicle at 0.925 seconds. The sign installation was displaced away from the vehicle upon exit. The vehicle came to rest upright 33.5 m (110.0 ft) downstream and 1.8 m (6.0 ft) right of the point of impact. Final rest positions of the vehicle and sign installation are shown in Figure 100. Sequential photographs of the crash test are shown in Appendix B.

Figure 100 . Final rest position of the sign installation and vehicle (test 405231-16).

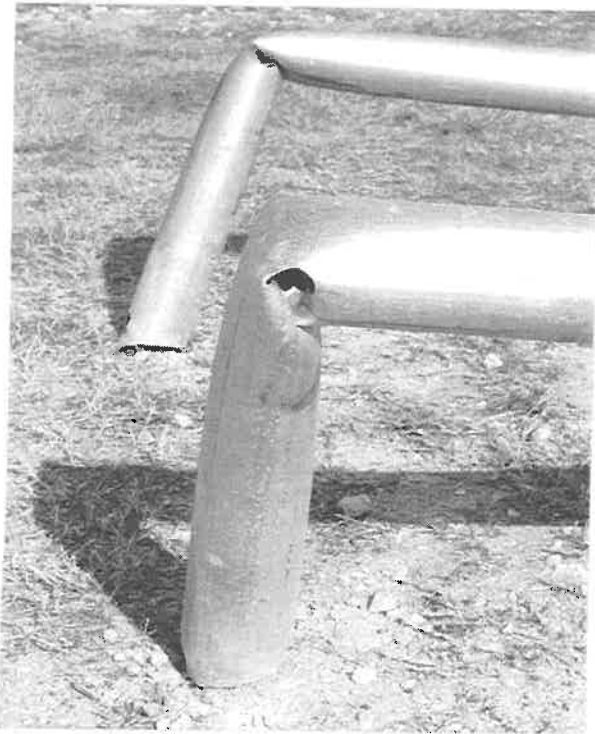
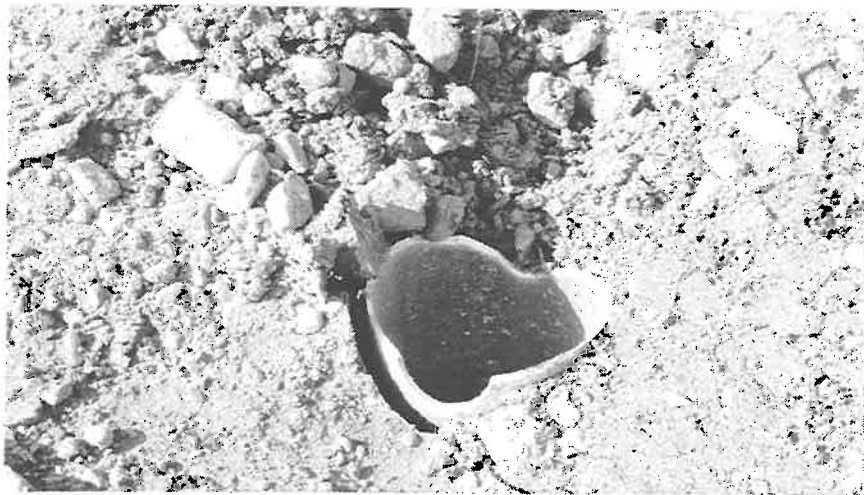
As shown in Figure 101, the supports were bent and fractured. The left and right supports failed their entire cross-sections at the holes located at ground level. In addition, both supports were collapsed at the holes located near bumper height. The sign panel and all mounting and anchoring hardware received minimal damage and could be reused in field renovation of this installation. Damage sustained by the vehicle during this test is shown in Figure 102. The vehicle sustained minor damage to the bumper, hood and windshield. Maximum deformation to the vehicle was 60 mm (2.4 in), located at the leading edge of the hood directly above the headlights. There was no deformation to the vehicle occupant compartment.

Figure 101. Dual 4 in. aluminum sign support installation modified with four - 1.5 in. holes and anchored in strong soil after test 405231-16.

B.	The test article should readily activate in a predictable manner by breaking away, fracturing, or yielding.	Both the right and left sign supports yielded by fracturing the aluminum tubes at the holes located at ground level and also by bending at the holes located near bumper level.		Pass	
<u>Occupant Risk</u>

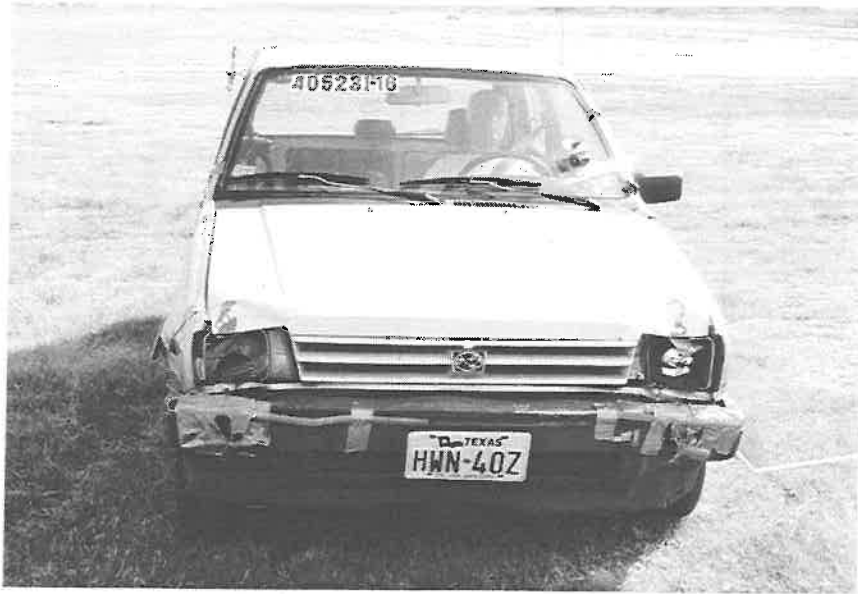
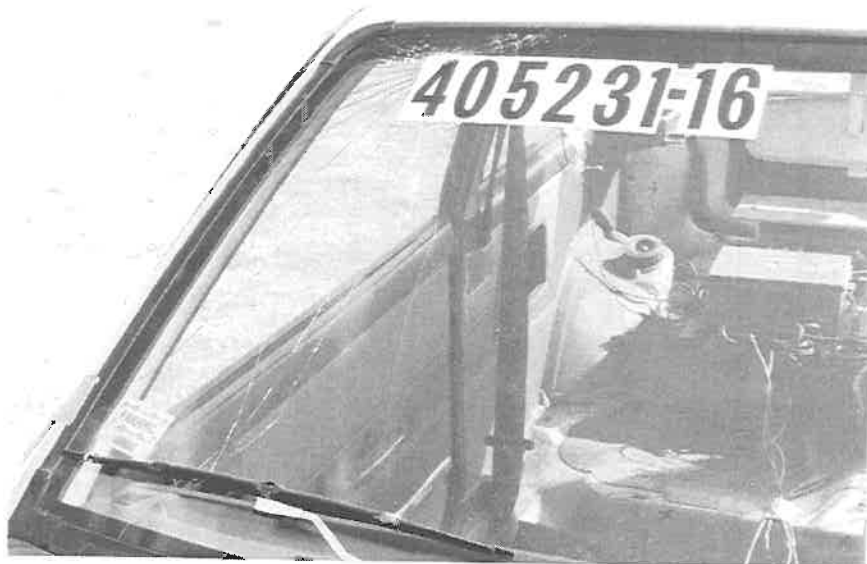
Figure 102. Vehicle after test 405231-16.

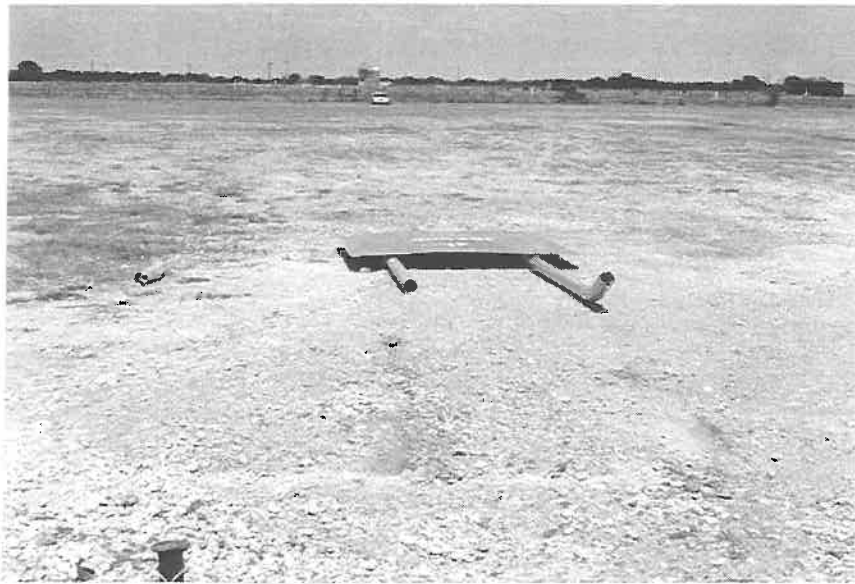
Figure 107. Final rest position of the sign installation and vehicle (test 405231-17).

As the vehicle impacted the sign installation, the supports began to bend at ground level and deform at bumper height. As the vehicle continued traveling forward, the right support fractured at ground level at 0.015 seconds and the left support fractured at 0.017 seconds. The vehicle lost contact with the supports at 0.064 seconds as the sign installation rotated up and over the vehicle. As the sign supports struck the ground at approximately 0.493 seconds, the splice weld made to construct the left support failed. The vehicle exited the impact site traveling 93.8 km/h (58.3 mi/h), the brakes were applied and the vehicle came to final rest upright 117.4 m (385.0 ft) downstream and 5.5 m (18.0 ft) left of the point of impact. Final rest positions of the vehicle and sign installation are shown in Figure 107. Sequential photographs of the crash test are shown in Appendix B.

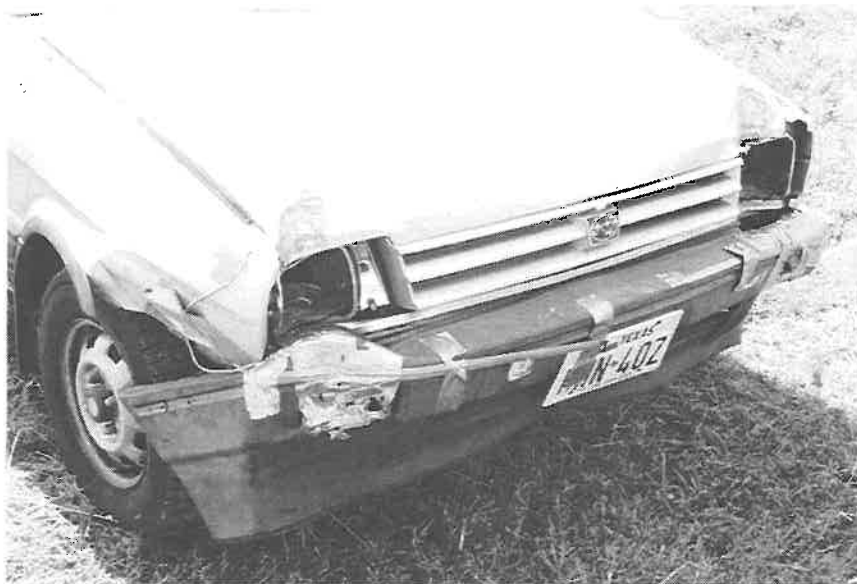
Figure 109. Vehicle after test 405231-17.
163

minor damage to the bumper and hood. Maximum deformation to the vehicle was 90 mm (3.5 in), located at the leading edge of the hood directly above the headlights. There was no deformation to the vehicle occupant compartment.

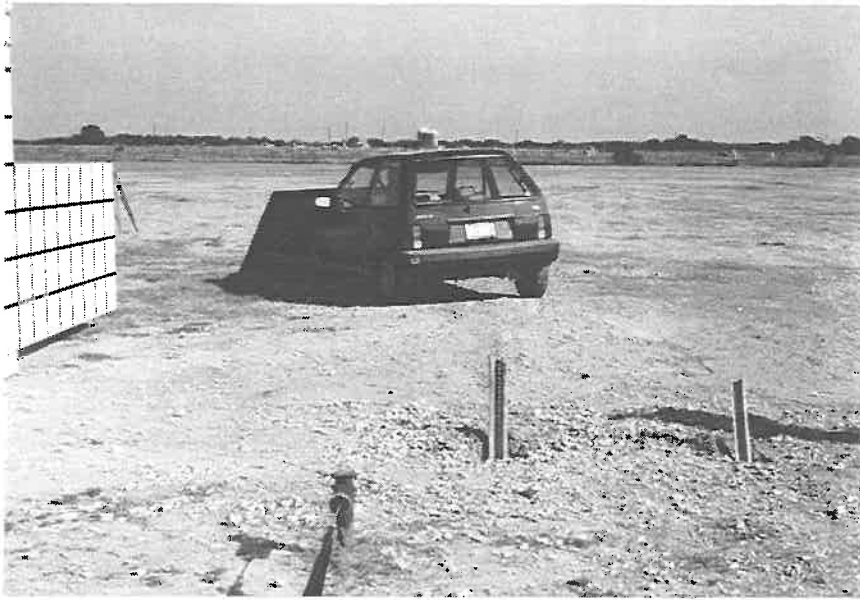
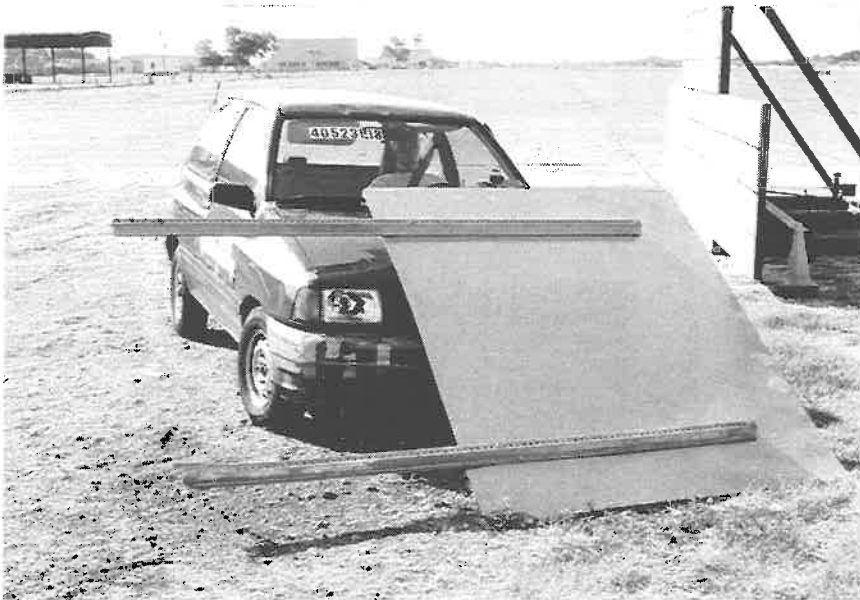
Figure 114. Final rest position of the sign installation and vehicle (test 405231-18).

As the vehicle impacted the sign installation, the supports began to deflect rearward, then subsequently fracture at bumper level. The right support fractured at 0.010 seconds and the left support at 0.034 seconds. As the vehicle continued traveling forward, the vehicle momentarily lost contact with the upper portion of the supports that were still attached to the sign panel and now rotating over the front of the vehicle. The front of the vehicle at this point was beginning to climb the ground stubs and the front wheels of the vehicle lost contact with the ground at 0.136 seconds. The detached portion of the sign support struck the roof of the vehicle at 0.286 seconds. As the vehicle traveled up and over the ground stubs, the rear axle struck the stubs next causing the rear wheels to lose contact with the ground. As the rear of the vehicle went airborne at 0.504 seconds, the front of the vehicle came back down with the front wheels contacting the ground at 0.607 seconds. The rear of the vehicle was back in contact with the ground at 1.128 seconds. The sign panel bounced off the roof of the vehicle, recontacted the hood and front of the vehicle several times, then eventually slid off the front of the vehicle. The vehicle traveled clear of the support stubs at 16.1 km/h (10.0 mi/h), the brakes were applied and the vehicle came to rest 7.6 m (25.0 ft) downstream and 1.2 m (4.0 ft) from the point of impact. Final rest positions of the vehicle and sign installation are shown in Figure 114. Sequential photographs of the crash test are shown in Appendix B.

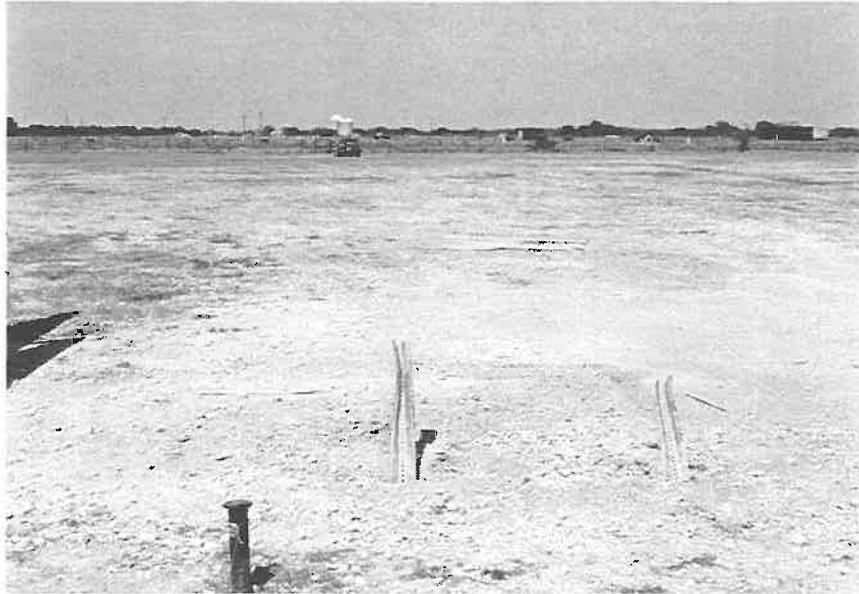
Figure 121 . Final rest position of the sign installation and vehicle (test 405231-19).

As the vehicle impacted the sign installation, the supports began to deflect rearward, then subsequently fractured at bumper level. The left support fractured at 0.010 seconds and the right support at 0.017 seconds. As the vehicle continued traveling forward, the vehicle momentarily lost contact (at 0.035 seconds) with the upper portion of the supports that were still attached to the sign panel and were rotating over the front of the vehicle. The sign panel struck the top, rear portion of the roof of the vehicle at 0.104 seconds. The vehicle passed beneath and the sign panel lost contact at 0.161 seconds. The vehicle traveled clear of the support stubs at 89.8 km/h (55.8 mi/h), the brakes were applied and the vehicle came to rest 96.0 m (315.0 ft) downstream and 4.6 m (15.0 ft) from the point of impact. Final rest positions of the vehicle and sign installation are shown in Figure 121. Sequential photographs of the crash test are shown in Appendix B.

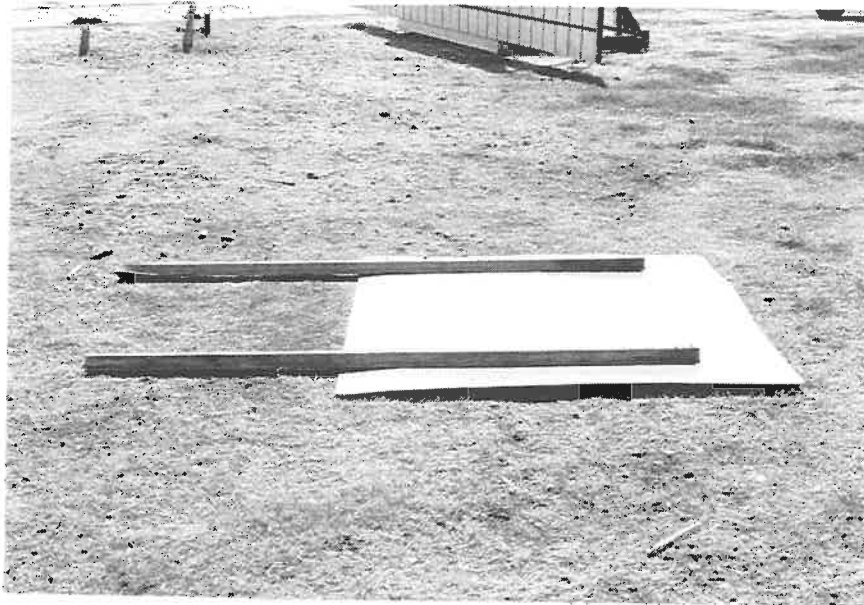
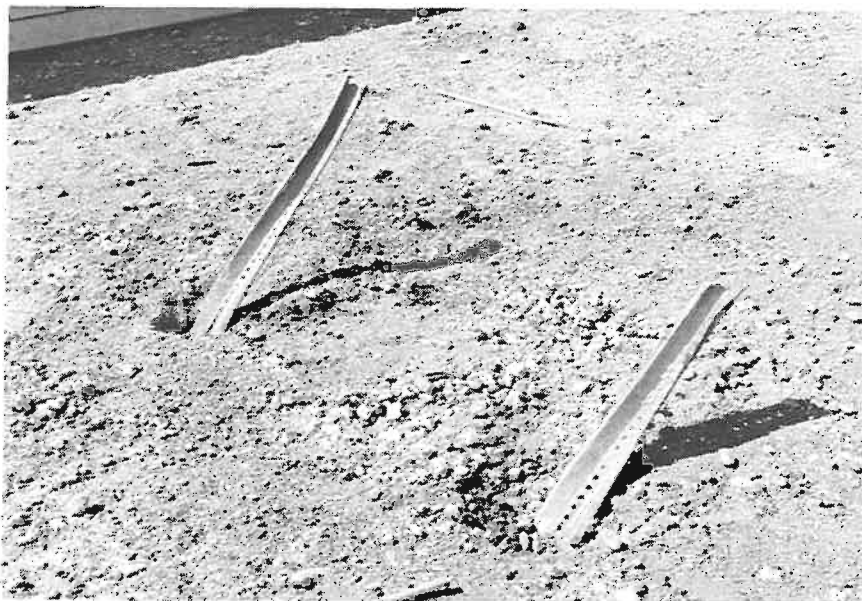
Figure 122. Dual 3-lb sign support installation anchored in strong soil after test 405231-19.

As shown in Figure 122, the supports were bent and fractured. The right support failed 584 mm (23.0 in) from ground level and the left support 737 mm (29.0 in). Damage to the vehicle during this test is shown in Figure 123. The vehicle sustained minor damage to the bumper, hood, roof and left front fender. Maximum crush to the bumper was 100 mm (3.9 in). There was no deformation to the vehicle occupant compartment.

B.	The test article should readily activate in a predictable manner by breaking away, fracturing, or yielding.	The sign supports fractured 584 mm (23 in) and 737 mm (29 in) from ground level (right and left support, respectively).		Pass	
<u>Occupant Risk</u>

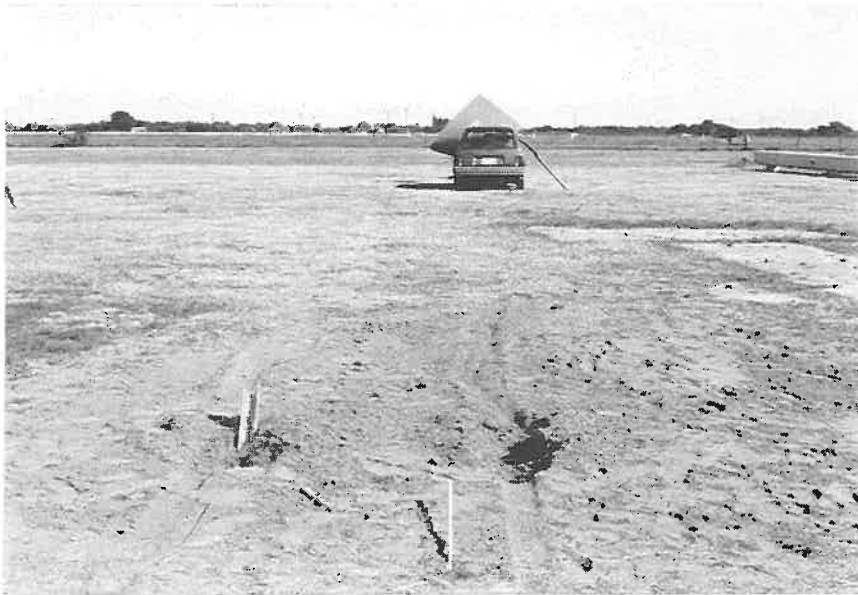
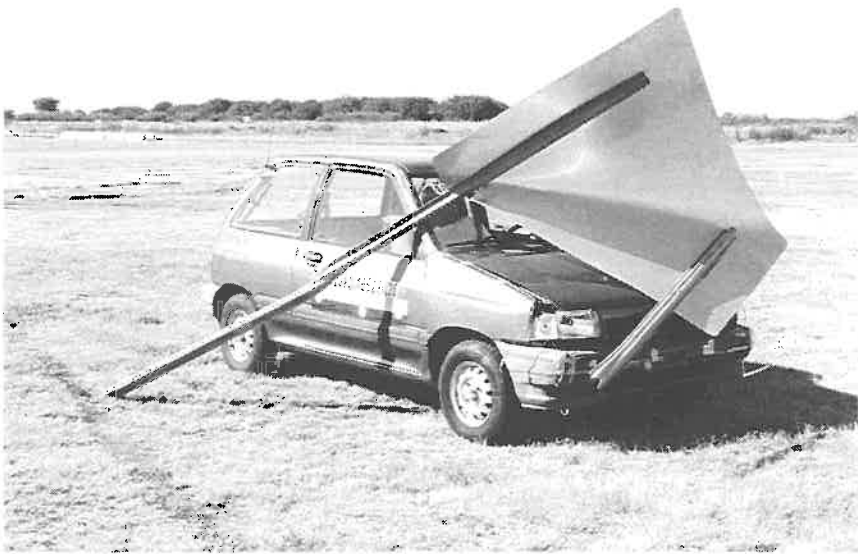
Figure 128. Final rest position of the sign installation and vehicle (test 405231-20).

As the vehicle impacted the sign installation, the right support began to deflect and twist outward. The left support fractured at bumper level at 0.034 seconds. Shortly thereafter, at 0.074 seconds, the right support slipped off the end of the bumper. The right support scraped along the right front fender and the sign panel and left support rotated clockwise into the front upper corner of the fender and over the vehicle. The sign panel struck the right side of the windshield at 0.419 seconds. Shortly thereafter, the vehicle snared the bottom of the sign panel on the right A-pillar and acted as a momentum arm, pulling the right support out the ground. The right support was pulled from the ground between 0.480 and 0.687 seconds. The vehicle exited traveling 19.3 km/h (12.0 mi/h) while still in contact with the sign installation and came to rest 27.4 m (90.0 ft) down and 1.5 m (5.0 ft) to the right of the point of impact. Final rest positions of the vehicle and sign installation are shown in Figure 128. Sequential photographs of the crash test are shown in Appendix B.

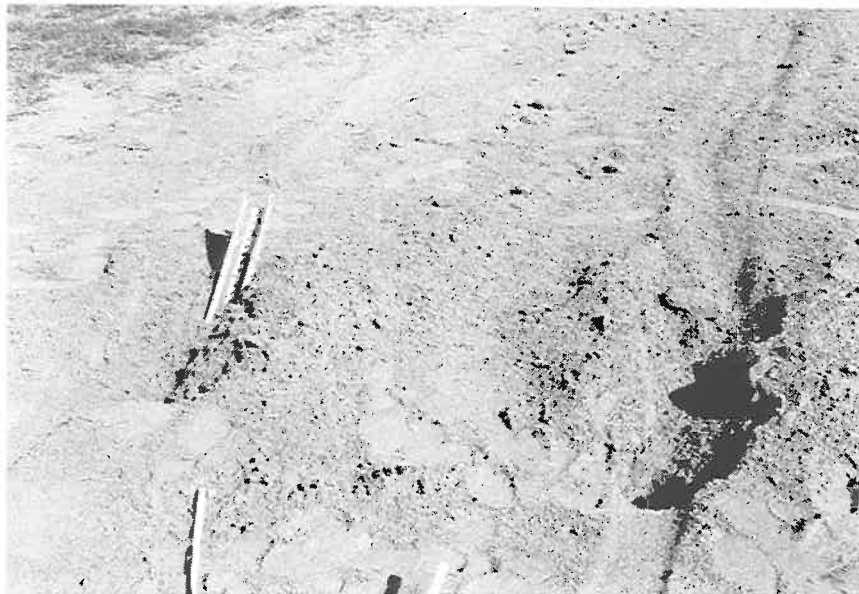
Figure 129. Dual 3-lb sign support installation anchored in weak soil after test 405231-20.

As shown in Figure 129, the left support fractured and the right support was pulled up from the ground. The left support was pushed rearward 648 mm (25.5 in) and fractured 406 mm (16.0 in) from ground level. The sign installation stayed on the front of the vehicle during the crash. Damage sustained by the vehicle during this test is shown in Figure 130. The vehicle sustained a 100 mm (3.9 in) cut in the right front fender. Damage sustained by the vehicle was primarily cosmetic, with the notable exception of a dent in the right A-pillar. There was no deformation to the vehicle occupant compartment.

B.	The test article should readily activate in a predictable manner by breaking away, fracturing, or yielding.	The left sign support fractured 406 mm (16 in) from ground level and the right support was pulled from the soil.		Pass	
<u>Occupant Risk</u>

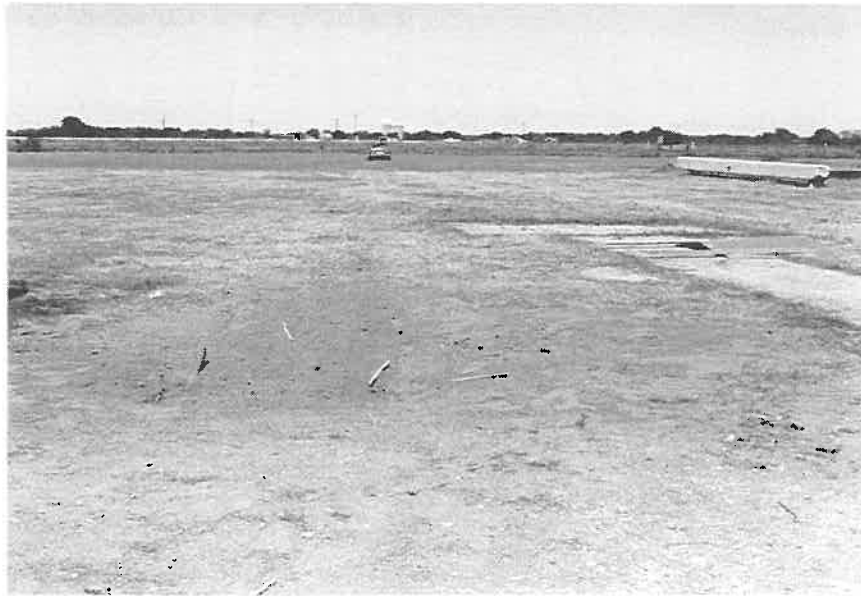
Figure 135. Final rest position of the sign installation and vehicle (test 405231-21).

As the vehicle impacted the sign installation, the supports began to bend at ground and bumper. The right support fractured at bumper level at 0.010 seconds and the left support at 0.015 seconds. The sign panel, rotating up and over the vehicle, lost contact temporarily at 0.047 seconds. The sign panel struck the roof of the vehicle at 0.091 seconds. The vehicle lost contact with the sign panel traveling 93.5 km/h (58.1 mi/h), the brakes were applied and the vehicle came to rest out of view of the high-speed camera. The vehicle came to final rest upright 95.9 m (314.5 ft) downstream from the point of impact. Final rest positions of the vehicle and sign installation are shown in Figure 135. Sequential photographs of the crash test are shown in Appendix B.

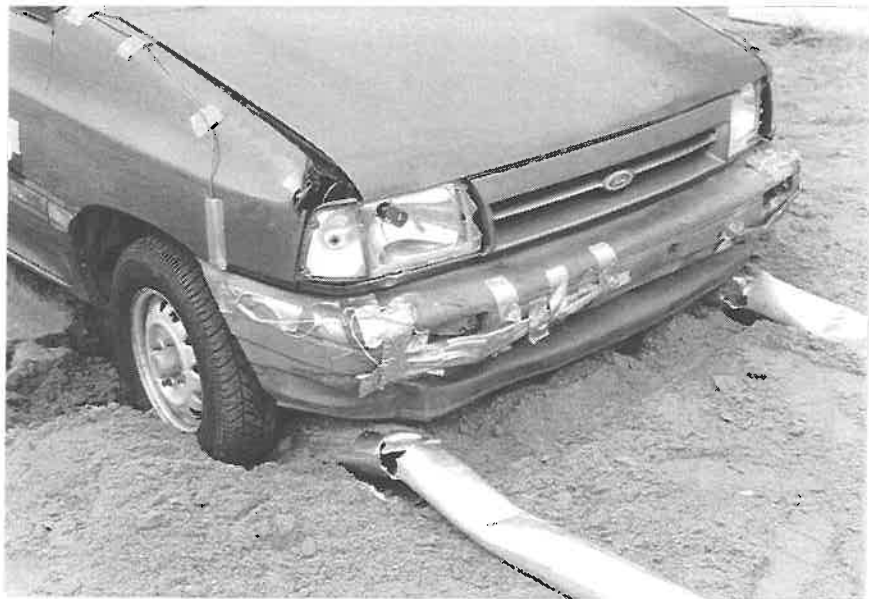
Figure142. Final rest position of the sign installation and vehicle (test 405231-22).
211

As the vehicle impacted the sign installation, the supports began to deform at bumper height and ground level. The vehicle pocketed in the supports at bumper level and forward travel terminated as the supports were bent over. As forward motion terminated, the rear wheels lost contact with the ground at 0.187 seconds. The rear of the vehicle rotated upward and the sign supports yielded losing contact with the vehicle at 0.320 seconds. As the rear of the vehicle was airborne, the sign panel, still attached to the supports, contacted the ground at 0.506 seconds. Shortly thereafter, the rear wheels of the vehicle came back into contact with the ground at 0.669 seconds and the vehicle came to final rest over the sign supports and 1.2 m (4.0 ft) from the point of impact as shown in Figure 142. Sequential photographs of the crash test are shown in Appendix B.

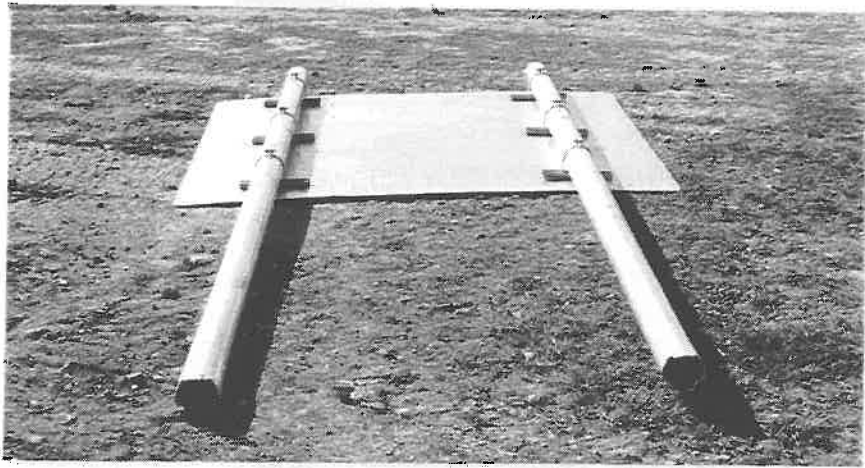
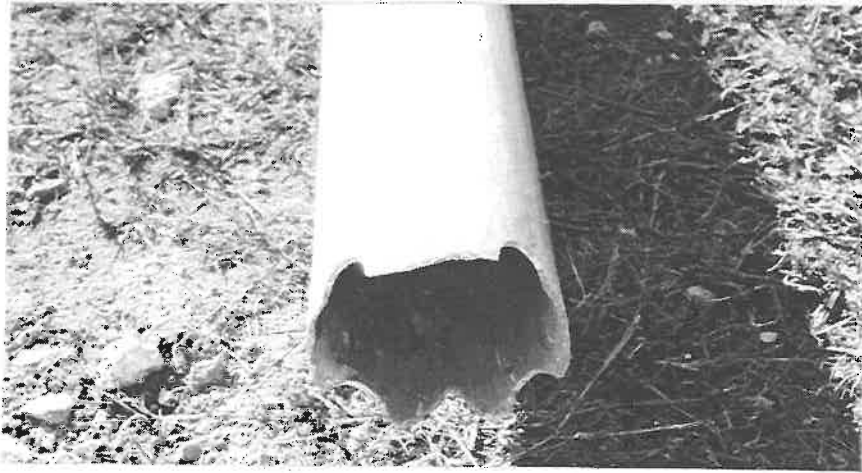
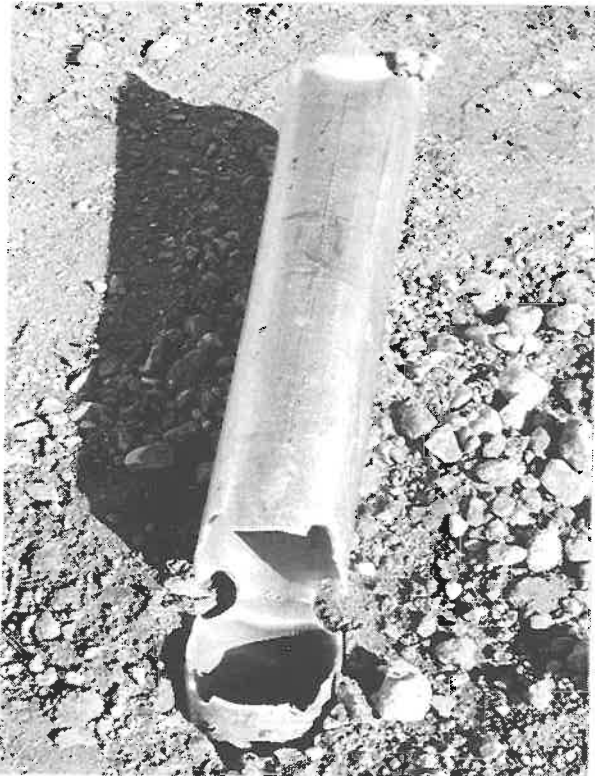
Figure 150 . Dual 4-in with 1-in holes aluminum sign support installation anchored in strong soil after test 405231-23.

As shown in Figure 150, the supports were bent and fractured. The left and right supports failed in tension across their entire cross-section at the holes located near bumper height. In addition, both supports failed in tension across all but the most rearward part of their cross\sections at the holes located at ground level. The sign panel and all mounting and anchoring

hardware received minimal damage and could be reused in field renovation of this installation. Damage sustained by the vehicle during this test is shown in Figure 151. The vehicle sustained minor damage to the bumper and roof. No measurable deformation to the vehicle was recorded. There was no deformation to the vehicle occupant compartment and no intrusion into the compartment.

B.	The test article should readily activate in a predictable manner by breaking away, fracturing, or yielding.	The sign supports yielded by fracturing the aluminum tubes at bumper level and partially fracturing and bending at ground level.		Pass	
<u>Occupant Risk</u>

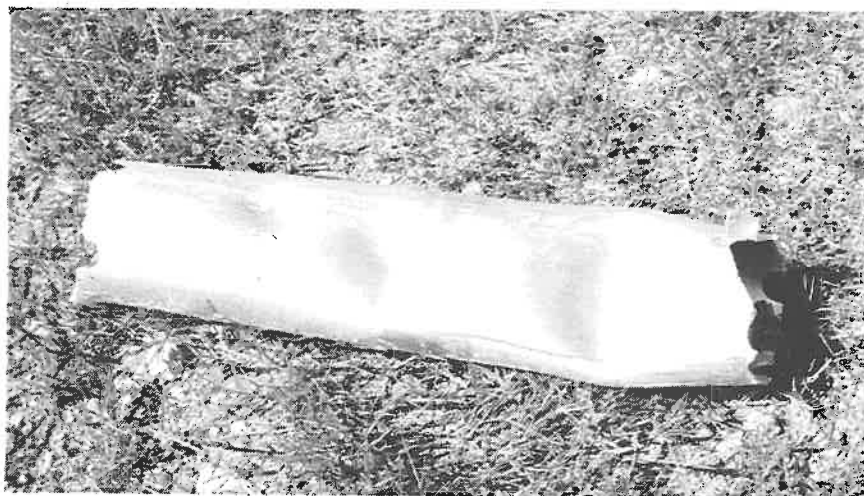
Figure 157. Dual 4-in with 1-in holes aluminum sign support installation anchored in strong soil after test 405231-24.

As shown in Figure 157, the supports were bent and fractured. The left and right supports failed in tension across their entire cross-sections at the holes located near bumper height. In addition, the right support failed in tension across all but the most rearward part of its cross-section at the holes located at ground level. The left support failed the entire cross-section at the holes located at ground level. The sign panel and all mounting and anchoring hardware received minimal damage and could be reused in field renovation of this installation. Damage sustained to the vehicle during this test is shown in Figure 158. The vehicle sustained minor damage to the

B.	The test article should readily activate in a predictable manner by breaking away, fracturing, or yielding.	The sign supports yielded by fracturing the aluminum tubes at bumper level. The left support was fractured and the right support only partially fractured at ground level.		Pass	
<u>Occupant Risk</u>

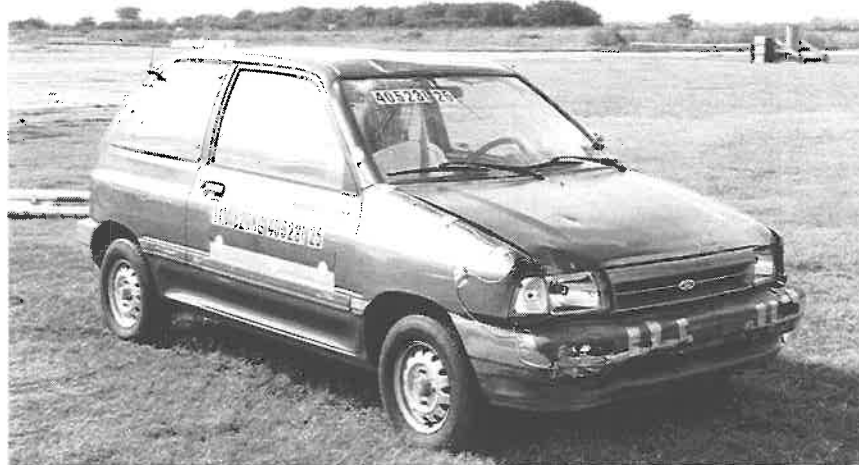
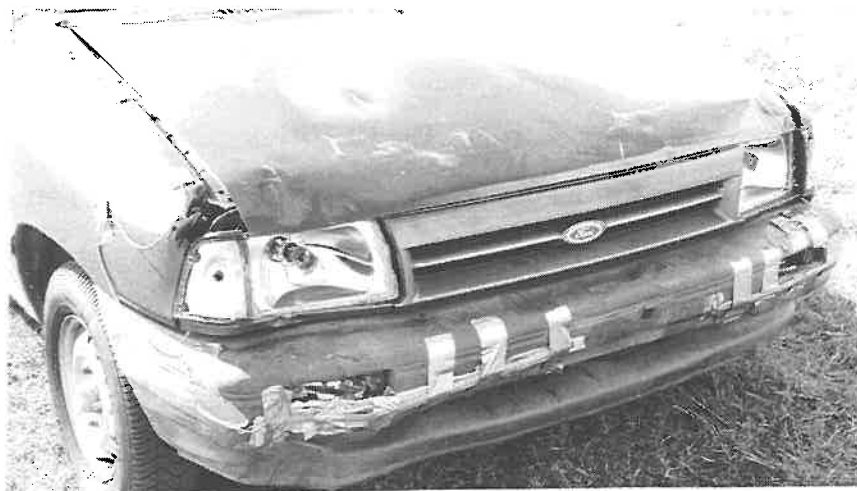
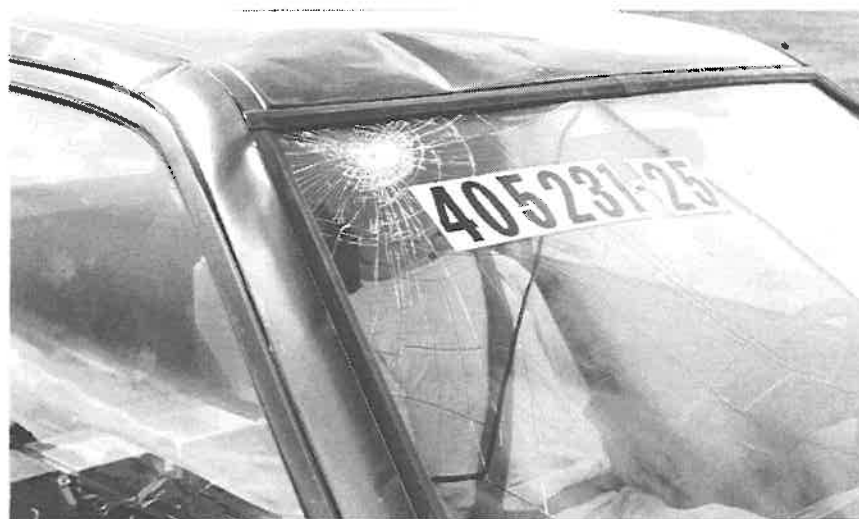
Figure 165 . Vehicle after test 405231-25.
243

minor damage to the bumper, hood and roof. The upper right side of the windshield was struck and broken. The roof was deformed 7 mm (0.3 in). There was no deformation to, or intrusion into, the vehicle occupant compartment.

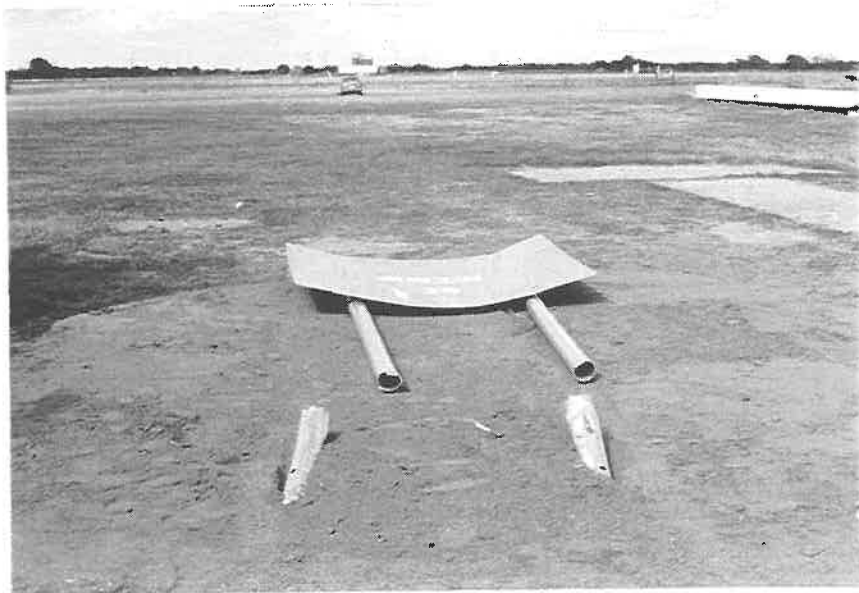
Figure 170 . Final rest position of sign installation and vehicle (test 405231-26).
251

Upon impact the supports began to deflect at the ground and bumper height. As the vehicle continued traveling forward, the right support began to fracture near the upper holes at 0.005 seconds ; the left support began to fracture near the upper holes at 0.010 seconds. As the vehicle traveled over the stubs, the vehicle pushed the supports and attached sign panel upward and over the hood and roof of the vehicle. The vehicle lost contact with the supports at 0.039 seconds. The sign installation rotated 270 degrees over the vehicle and came to rest 3.3 m (10.7 ft) from the point of impact. The vehicle lost contact with the installation traveling 98.6 km/h (61.3 mi/h). The brakes were applied, and the vehicle came to rest upright 102.3 m (335.5 ft) downstream from the point of impact. Final rest positions of the vehicle and sign installation are shown in Figure 170. Sequential photographs of the crash test are shown in Appendix B.

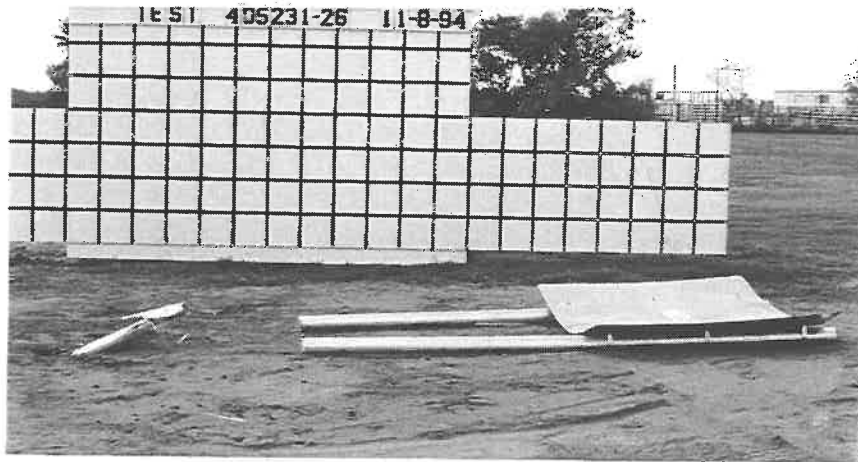
Figure 171. Dual 4-in with 1-in holes aluminum sign support anchored in weak soil after test 405231-26.

As shown in Figure 171, the supports were bent and fractured. The left and right supports failed in tension across their entire cross-section at the upper holes. The sign panel and all mounting and anchoring hardware received minimal damage and could be reused in field renovation of this installation. Damage sustained by the vehicle during this test is shown in Figure 172. The vehicle sustained minor damage to the bumper and hood. No measurable deformation to the vehicle was recorded. There was no deformation to, or intrusion into, the vehicle occupant compartment.

B.	The test article should readily activate in a predictable manner by breaking away, fracturing, or yielding.	The sign supports yielded by fracturing the aluminum tubes at bumper level. In addition, the supports were bent and pushed rearward at ground level.		Pass	
<u>Occupant Risk</u>
