# Guardrail Testing Program II

## Final Report

Transportation Research Report TRP-03-52-95

FHWA Contract No. DTFH71-90-C-00035

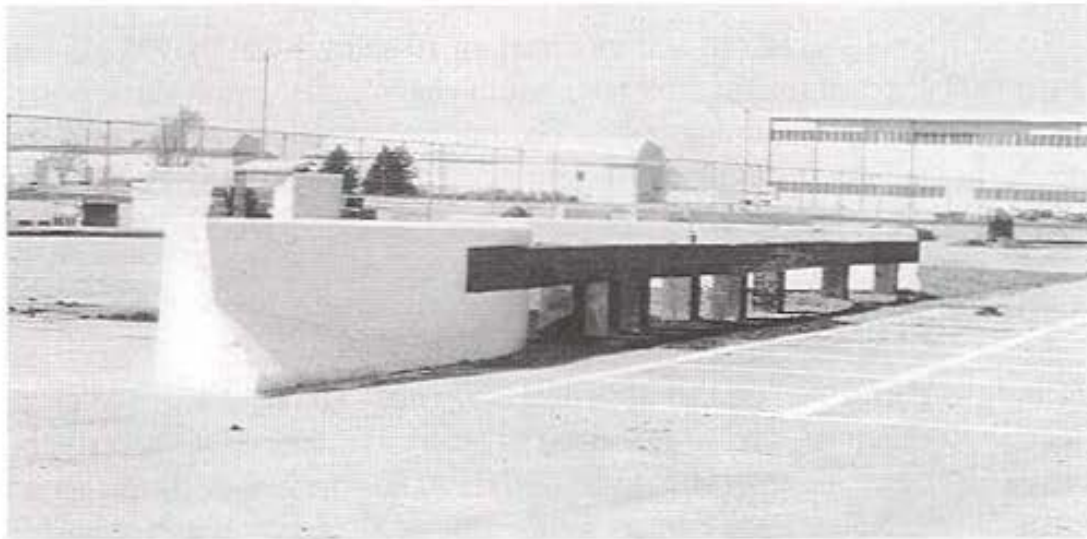
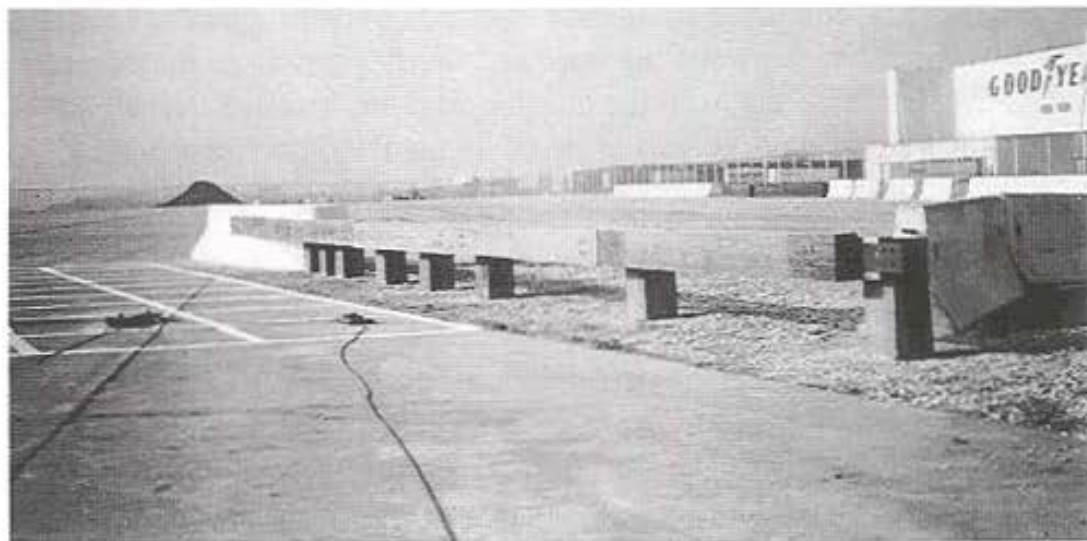
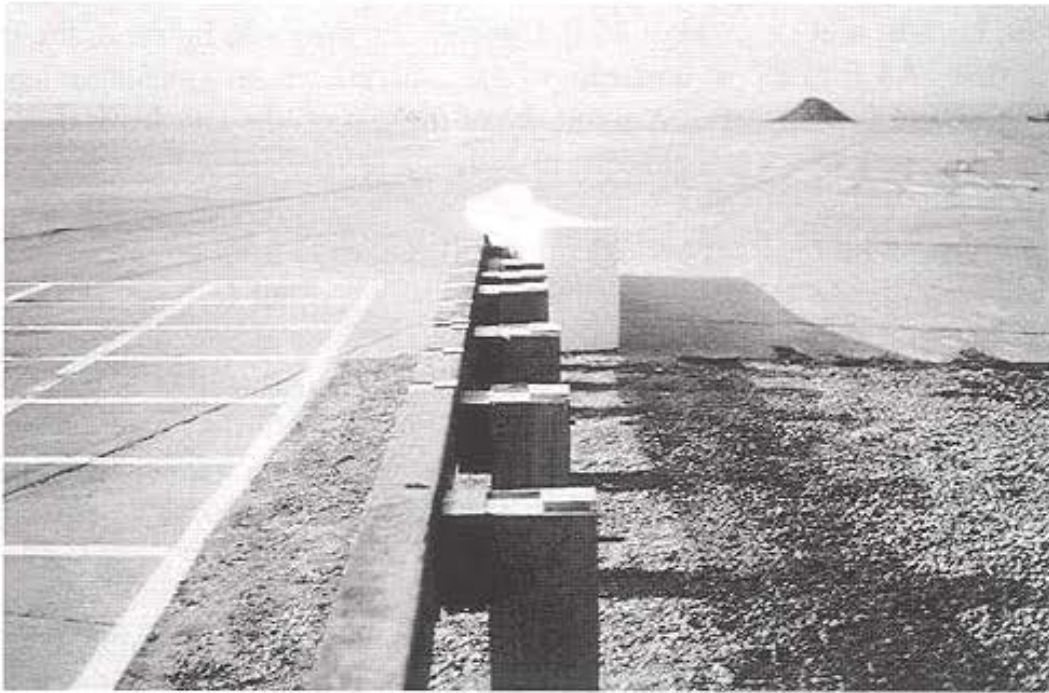
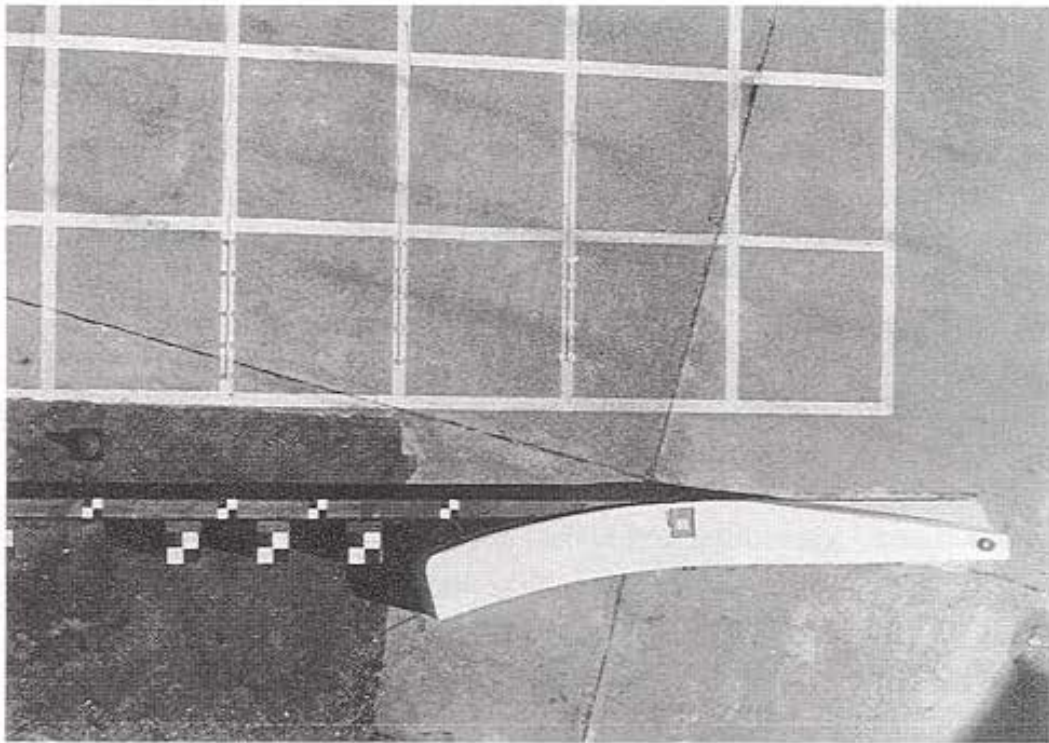
Figure 1. The Steel-Backed Wood Rail to Bridge Rail Transition.

Photographs of the Steel-Backed Wood Rail to Bridge Rail Transition are shown in figure 1. Plan drawings of the original system, as well as the subsequently modified systems, are presented in appendix A. The approach rail consists of 6-in by 10-in by 9-ft 11-in (152 mm by 254 mm by 3.04 m) timber, backed with  $\frac{3}{8}$ -in (10-mm) ASTM A588 steel plate. This plate is attached to the back of the timber rail with  $\frac{3}{8}$ -in by 4-in (16-mm by 102-mm) ASTM A588 lag screws. The splice details vary as shown in the plan drawings. One of the major design changes throughout the evolution of this system was the stiffening of the first splice location. This splice originally consisted of one  $\frac{3}{8}$ -in (10-mm) plate fastening the rails together and was eventually modified to include a 6-in by 4-in by  $\frac{1}{2}$ -in (152-mm by 102-mm by 13-mm) structural tube.

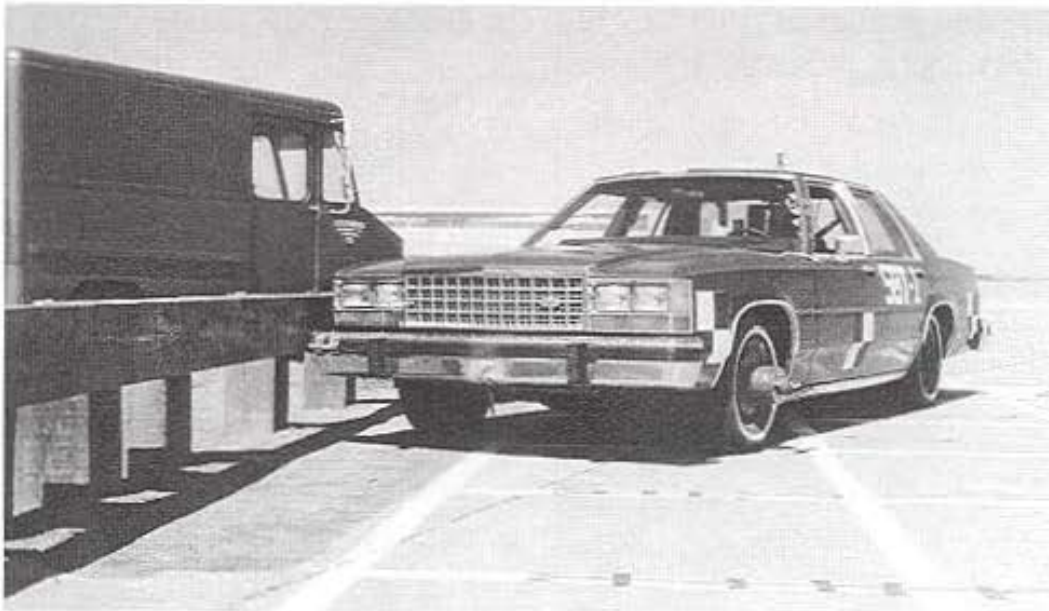
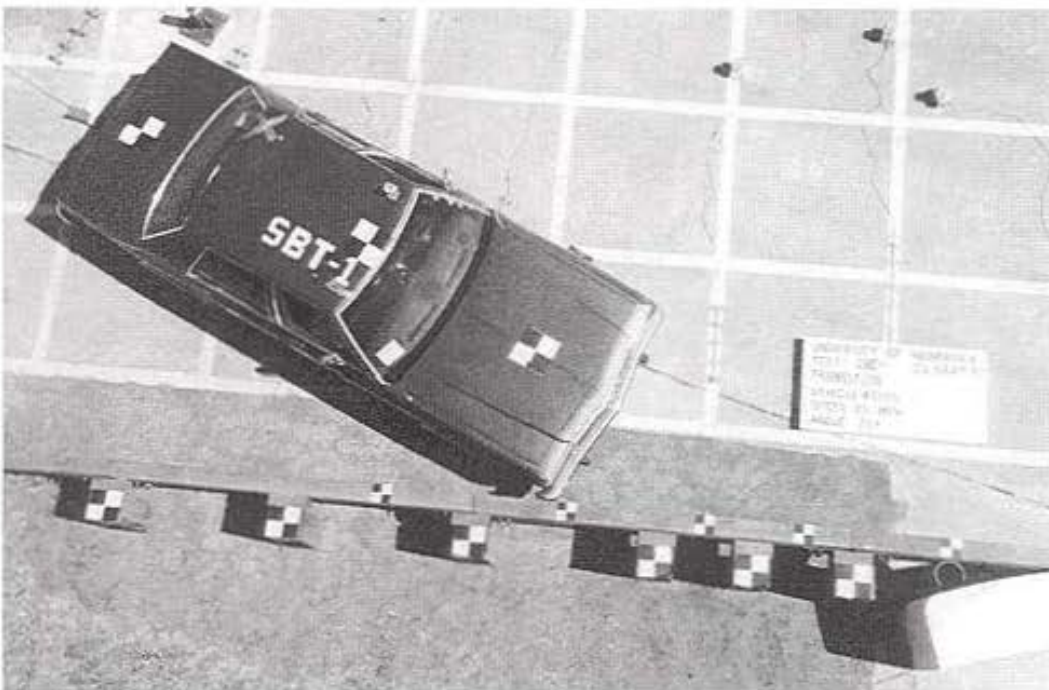
Figure 2. Impact Location, Test SBT-1.

The 1985 Ford LTD impacted the Steel-Backed Wood Rail to Bridge Rail Transition at 61.7 mi/h (99.3 km/h) and an angle of 25.0 degrees. As shown in figure 2, the target impact point was located 17.5 ft (5.33 m) upstream of the concrete barrier attachment and midway between the third and fourth posts. A summary of the test results and sequential photographs are shown in figure 3, and additional sequential photos are presented in figure 4.

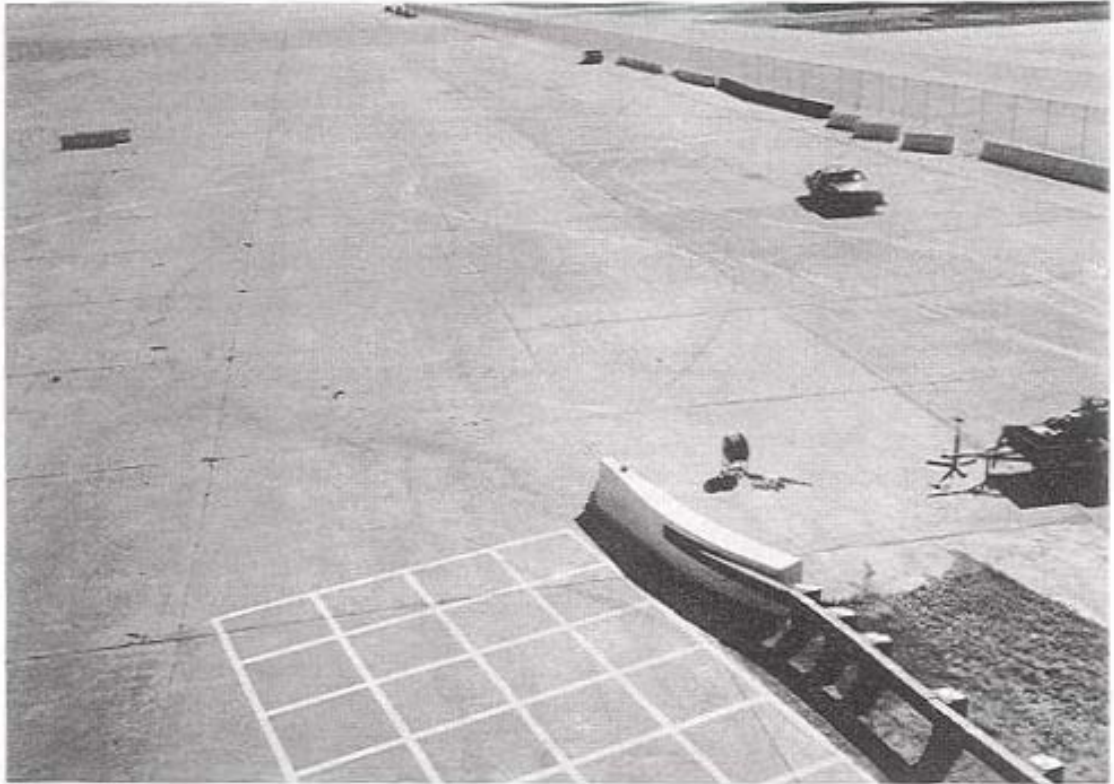
Figure 5. Vehicle Trajectory, Test SBT-1.

Upon impact with the steel-backed wood rail, the right-front corner of the vehicle began to crush inward. As the collision continued, the wood rail deflected considerably, with the maximum dynamic deflection of 13 in (130 mm) occurring at post no. 1 at 130 ms. At 133 ms, the vehicle impacted the end of the concrete abutment resulting in major damage to the vehicle. Approximately 167 ms after impact, the buckling of the vehicle roof became very evident. At 204 ms after impact, the vehicle became parallel to the system, and at 439 ms it exited the barrier at an angle of 17.5 degrees. The vehicle came to rest downstream and behind the rail as shown in figure 5.

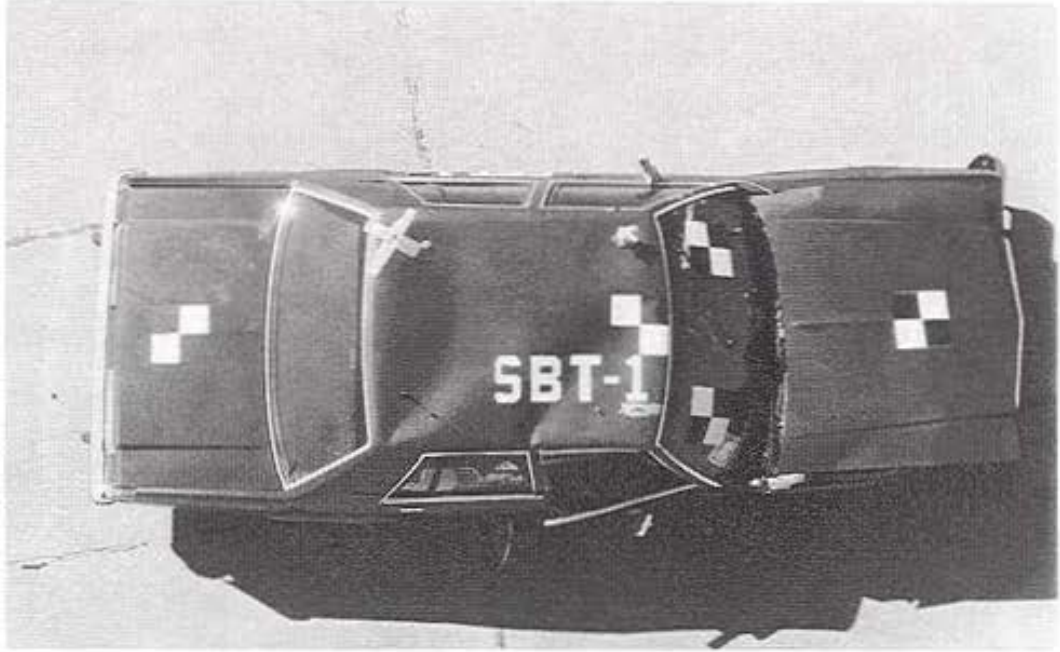
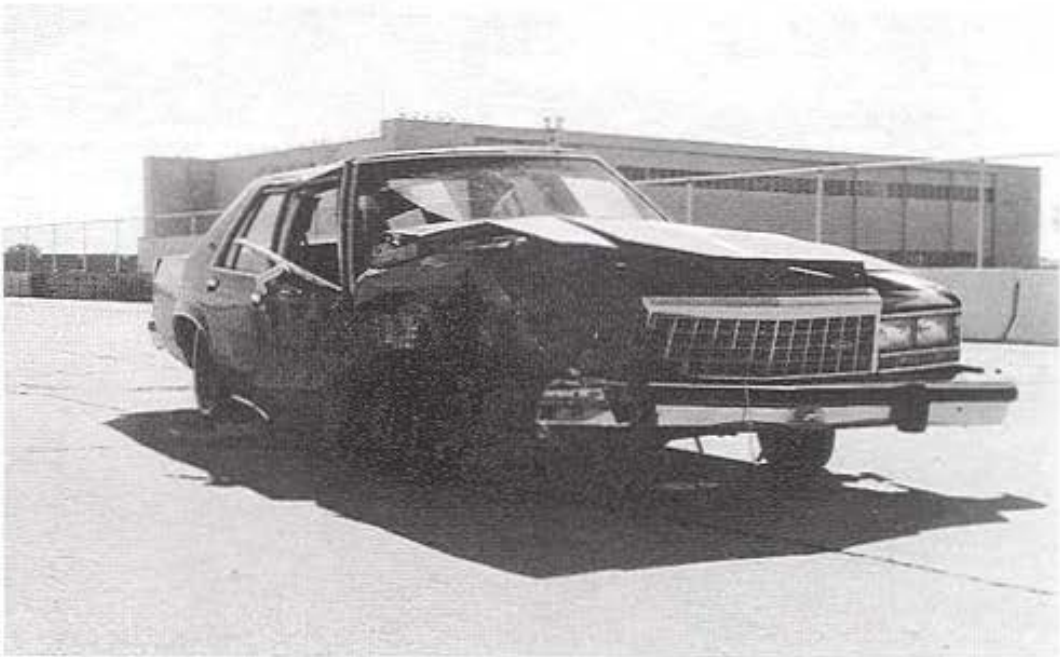
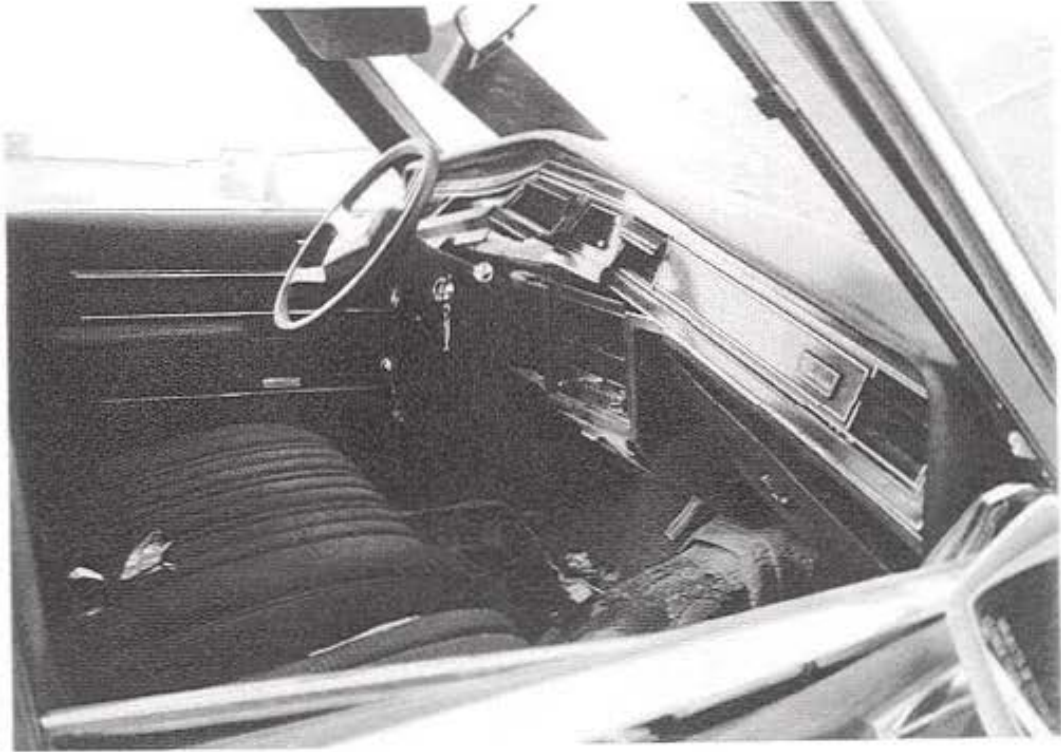
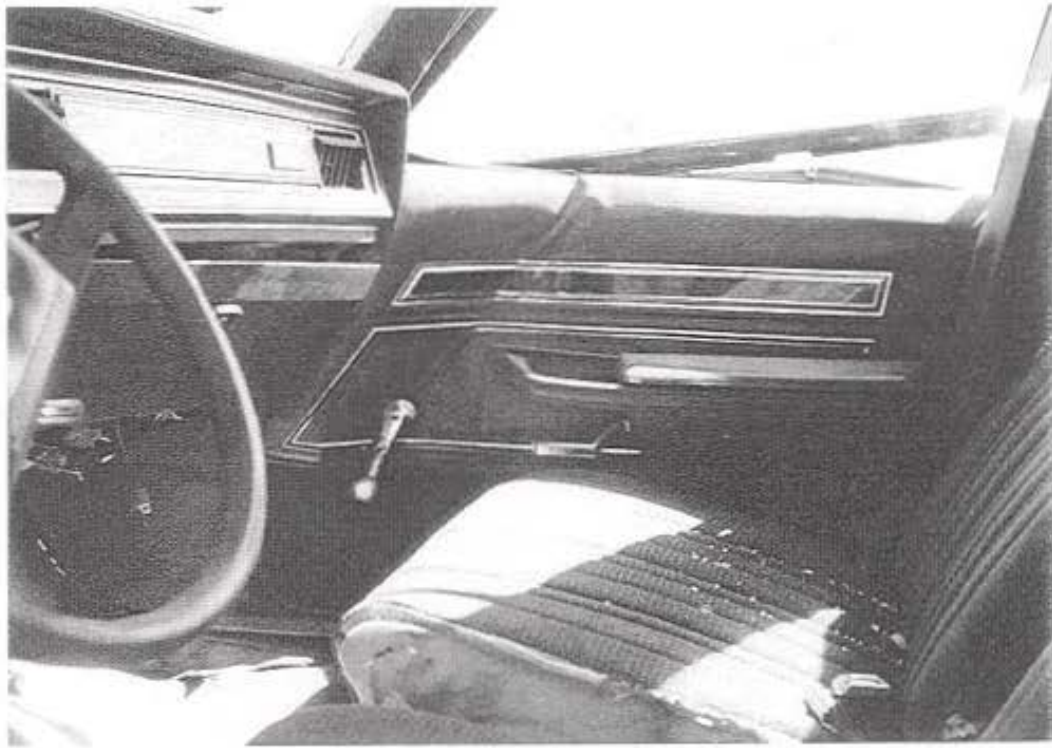
Figure 6. Vehicle Damage, Test SBT-1.

Damage to the vehicle, which can be seen in figure 6, included major crushing and deformation of the right front corner of the vehicle, as well as buckling of the vehicle roof. The entire front half of the vehicle was bent slightly toward the driver's side. Interior occupant compartment damage included buckling of the floorboard on the passenger's side, as well as buckling of the dash. The maximum crush deformation of 17 in (492 mm) is shown in figure 7.

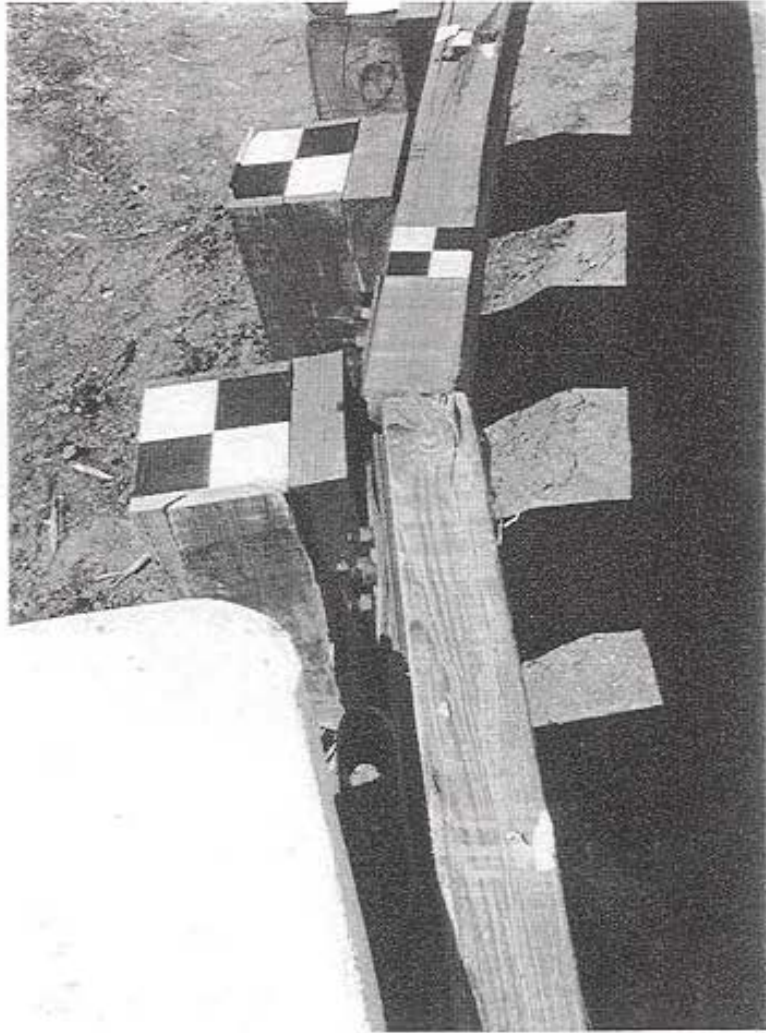
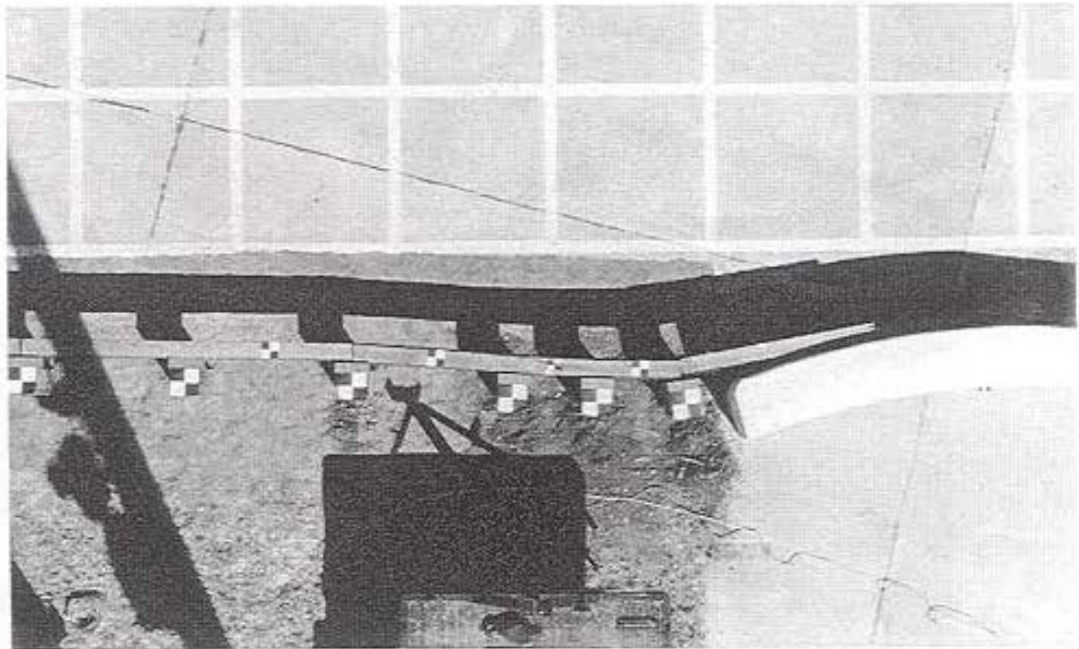
Figure 8. System Damage, Test SBT-1.

The damage to the system, shown in figures 8 and 9 consisted of a maximum permanent set deformation of 11.25 in (286 mm) at post no. 1. A flexural failure occurred in the first timber rail section, approximately 4.5 ft (1.37 m) from the downstream end of the rail. The 8-in (203-mm) inside diameter (I.D.) pipe located between the first rail and the concrete abutment was completely flattened. There was evidence of vehicle snagging at the splice between rail nos. 1 and 2, as sheet metal from the vehicle was embedded in the end of rail no. 1. There were continuous scrape marks along the face of the rail from the point of impact to exit, as well as impact markings on the concrete abutment.

The impact with the end of the concrete abutment caused excessive occupant compartment deformation, which resulted in the failure of this test. It was determined that the stiffness of the steel-backed wood rail was inadequate as it deflected considerably, allowing the

vehicle to impact the end of the concrete abutment. The system was redesigned by Eastern Federal Lands Highway Division engineers for the next test by increasing the length of posts nos. 1, 2, and 3 from 7 ft (2.13 m) to 8 ft (2.44 m). The 8-in (203-mm) I.D. pipe spacer between the rail and concrete abutment was replaced with an angled block of wood to restrict the deflection of the first rail. The splice between the first and second rails was stiffened by adding a second  $\frac{3}{8}$ -in (10-mm) backup plate. The bolts at this splice were moved closer to the post and increased in number from 8 to 12. The details of these design changes are presented in the plan drawings in appendix A.

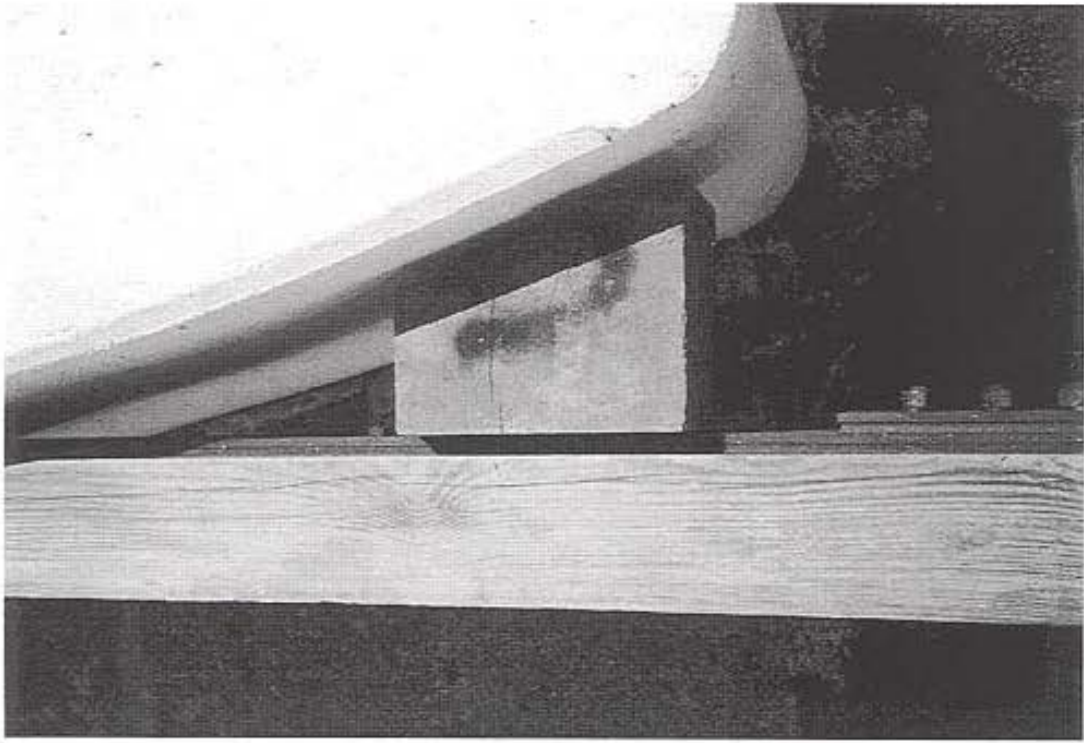
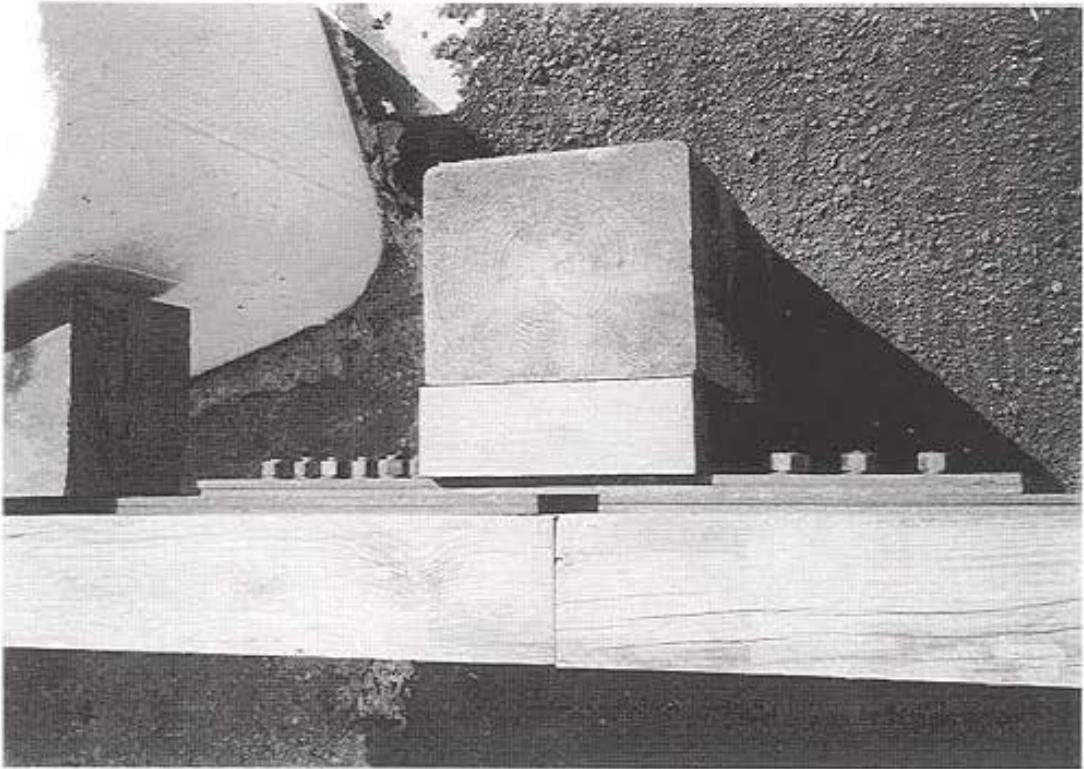
**Figure 10.** Design Modifications, Test SBT-2.

For this test, the system was modified as described in the previous section. These modifications are shown in figure 10, and details can be found in the plan drawings in appendix A. The 1984 Buick LeSabre impacted the system at 61.1 mi/h (98.3 km/h) and 26.5 degrees. The impact point was located midway between the third and fourth posts from the concrete bridge abutment, as shown in figure 11. A summary of the test results and sequential photographs are shown in figure 12. Additional sequential photos are presented in figure 13.

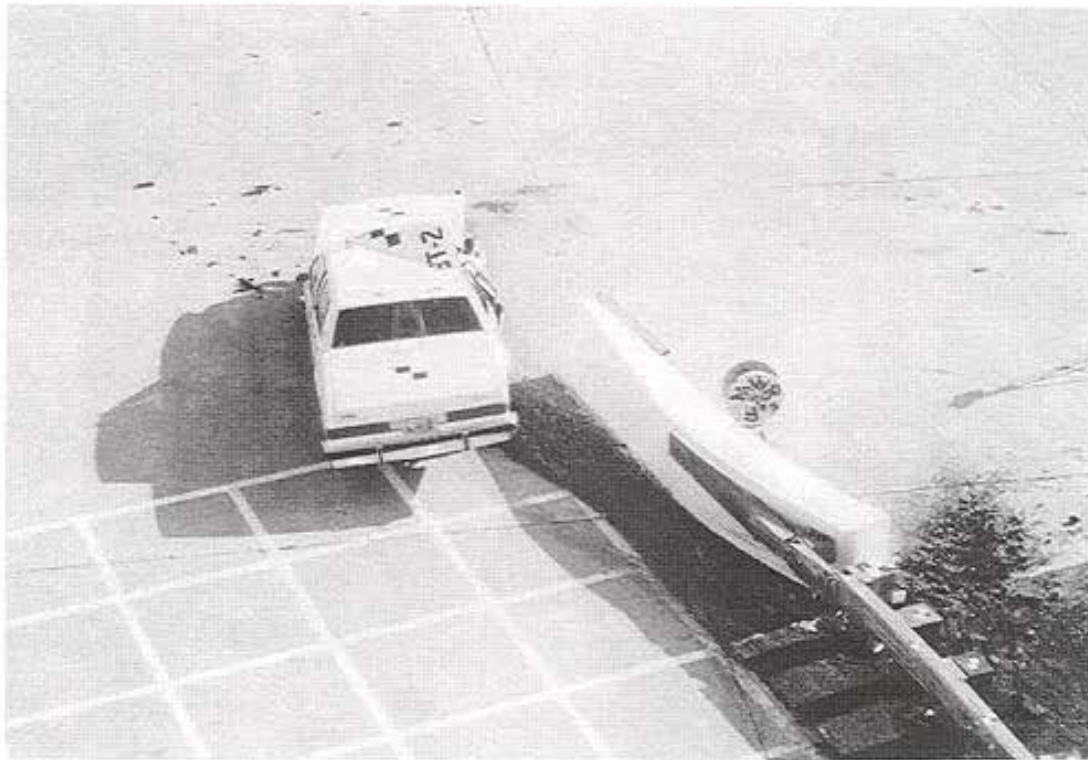
Figure 14. Vehicle Trajectory, Test SBT-2.

Upon impact with the wood rail, the right front corner of the test vehicle began to crush inward. Rail no. 2 began to deflect shortly after impact, but the wood spacer block between the concrete and rail prevented rail no. 1 from deflecting. As a result of this significant difference in stiffness, the splice between these two rails yielded, and 110 ms after impact the first rail speared into the vehicle. The vehicle never became parallel to the rail, and it exited at 450 ms as its center of mass was traveling at an angle of 17.3 degrees to the barrier. The snagging at the first splice resulted in major vehicle and occupant compartment deformation, and the sedan was brought to a complete stop shortly after it exited the rail, as can be seen by its final resting position shown in figure 14.

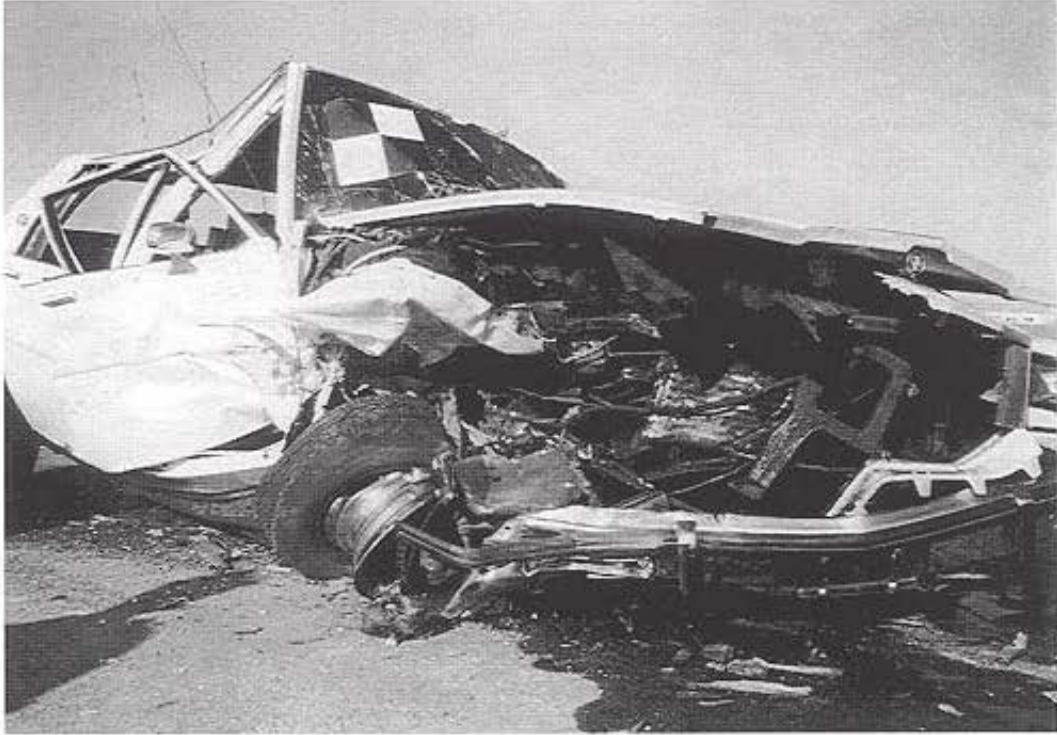
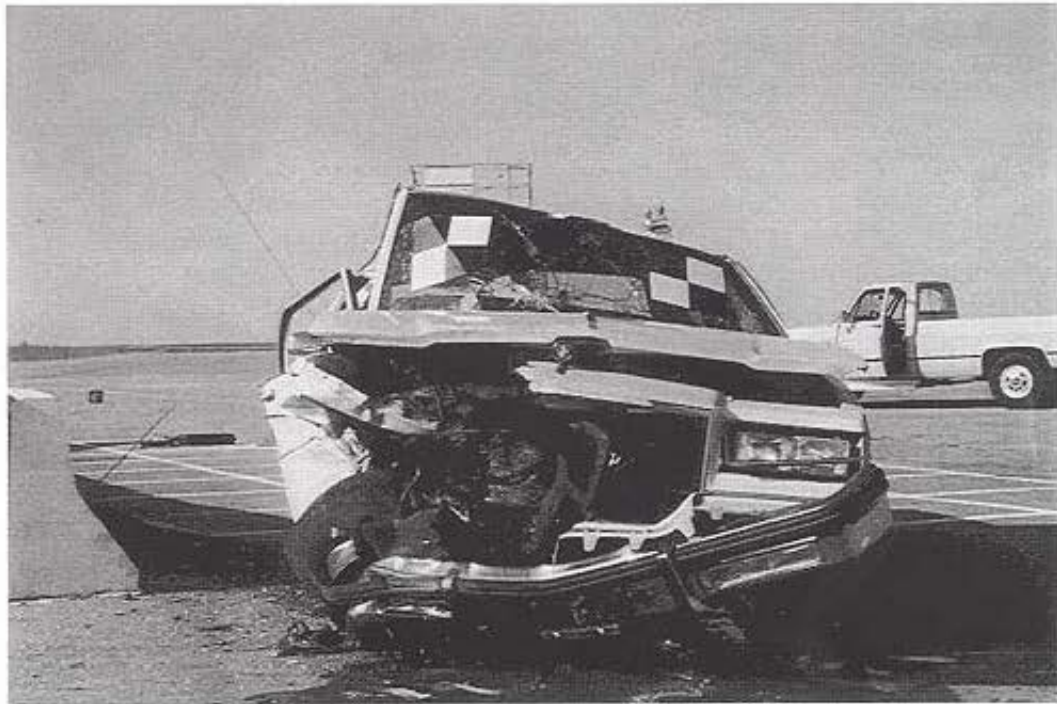
Figure 15. Vehicle Damage, Test SBT-2.

The damage to the vehicle was substantial as shown in figure 15. The entire front-right portion of the vehicle was crushed and pushed back toward the occupant compartment. The firewall and floorboard were pushed backwards and up on the passenger's side, and a section of the wood rail penetrated the firewall on the extreme right hand side. The windshield was broken and the roof of the vehicle was buckled considerably. The maximum vehicle crush of 31.5 in (800 mm) is shown schematically in figure 16.

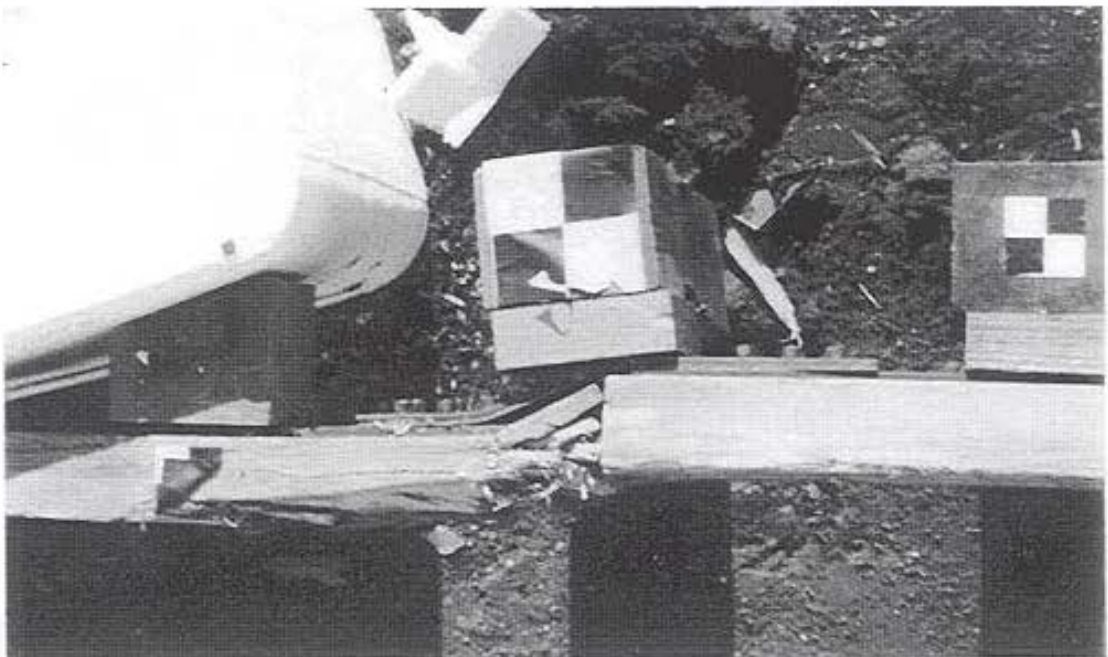
Figure 17. System Damage, Test SBT-2.

Damage to the steel-backed wood rail was considerable as can be seen in figure 17. The upstream end of rail no. 1 was damaged as the vehicle snagged on it, and the splice plates between rails no. 1 and no. 2 were bent significantly. There were marks along the face of the rail and concrete abutment throughout the length of contact.

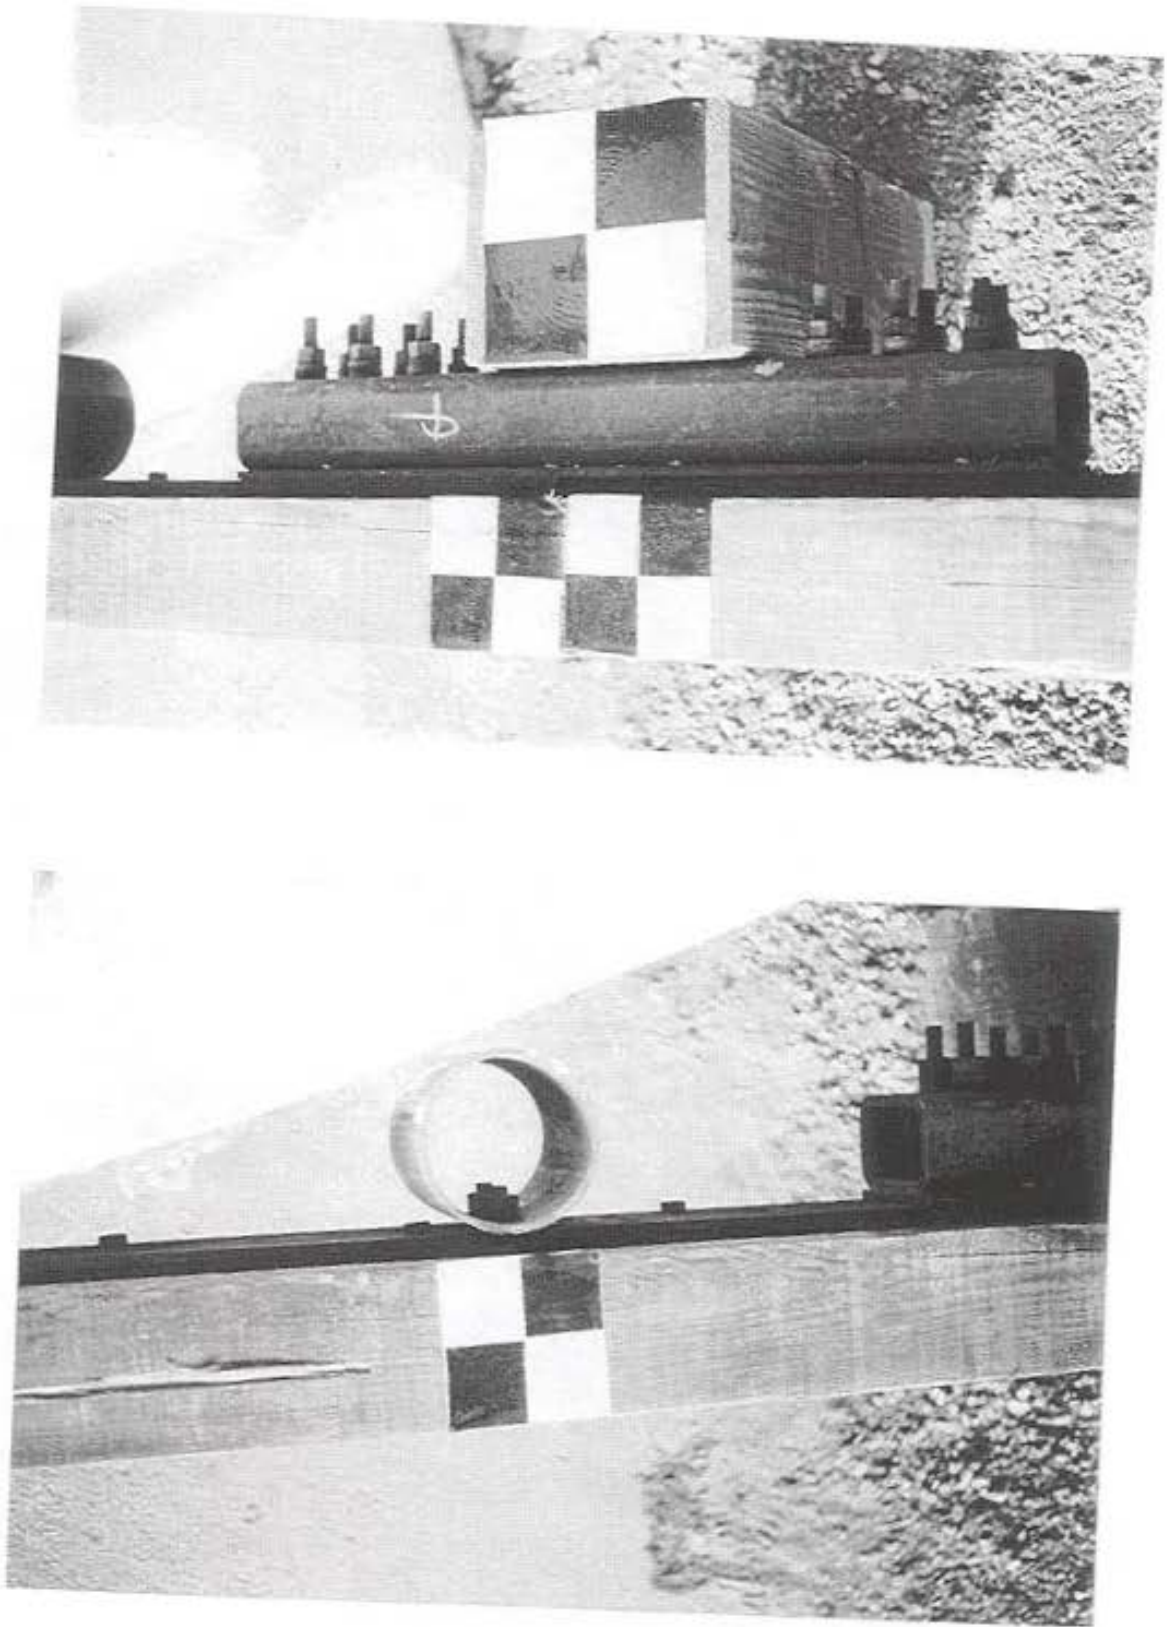
Figure 18. Design Modifications, Test SBT-3.

The change in the splice detail appears to have improved the performance of the system considerably, as the rail deflection was greatly reduced. This resolved the problem of impacting the end of the concrete abutment, but produced a new problem where the front wheel was now forced under the rail and snagged on post nos. 1 and 2. Tire marks on the posts indicated that a maximum snag of 5.5 in (140 mm) occurred at post no. 2. To remedy this problem, a 4-in (102 mm) deep blockout was added to post no. 1 and the 4-in (102 mm) blockout at post nos. 2 and 3 were increased to a depth of 8 in (203 mm). The details of these design changes can be seen in appendix A.

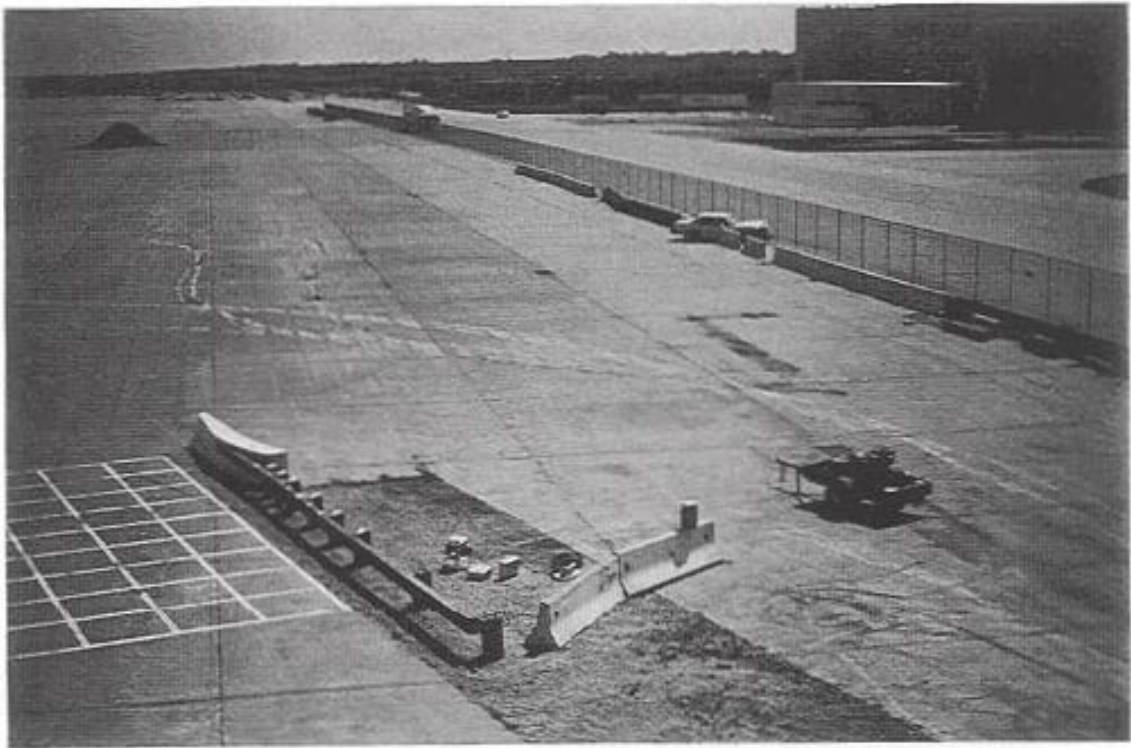
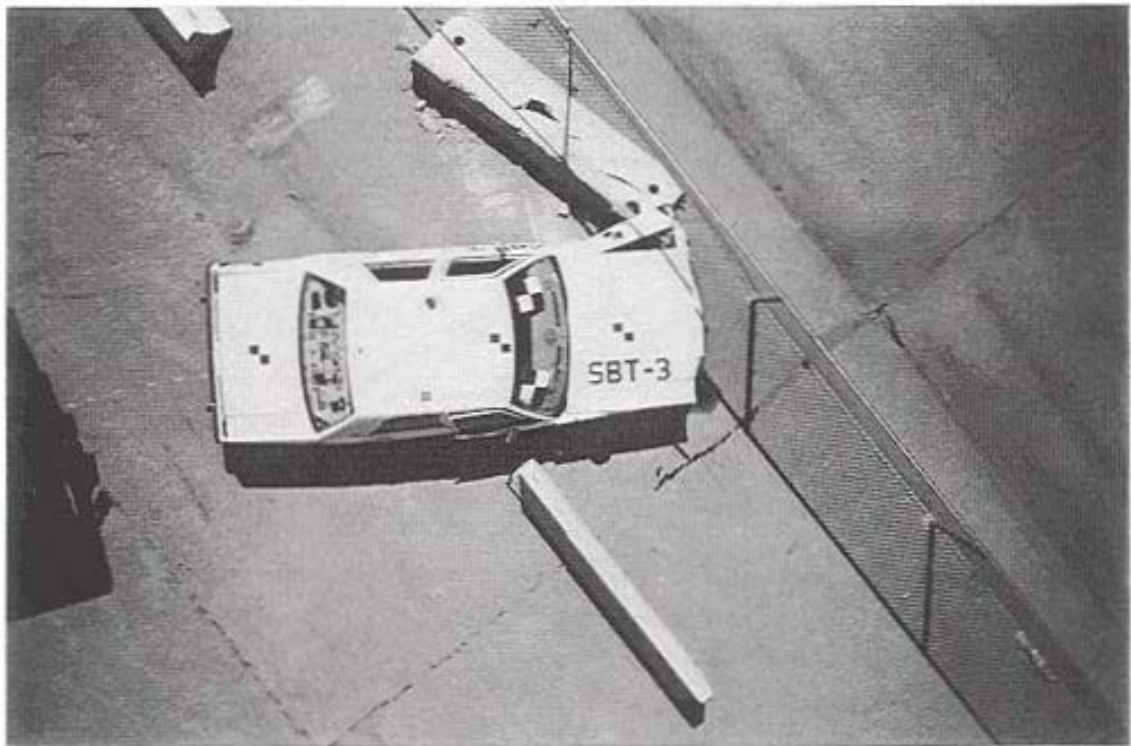
Figure 22. Vehicle Trajectory, Test SBT-3.

Upon impact with the wood rail, the right-front corner of the test vehicle was crushed inward and the wheel was forced under the rail and back toward the post. This resulted in considerable tire snagging on posts nos. 1 and 2, which pushed the wheel back against the firewall and resulted in significant deformation of the occupant compartment. The vehicle became parallel to the system at 212 ms, and exited at 343 ms and 5.8 degrees. The maximum dynamic deflection of this system was limited to 6.4 in (163 mm) at post no. 3, and there was no problem with the vehicle impacting the end of the concrete abutment. The final resting position of the vehicle was downstream and behind the rail, as seen in figure 22.

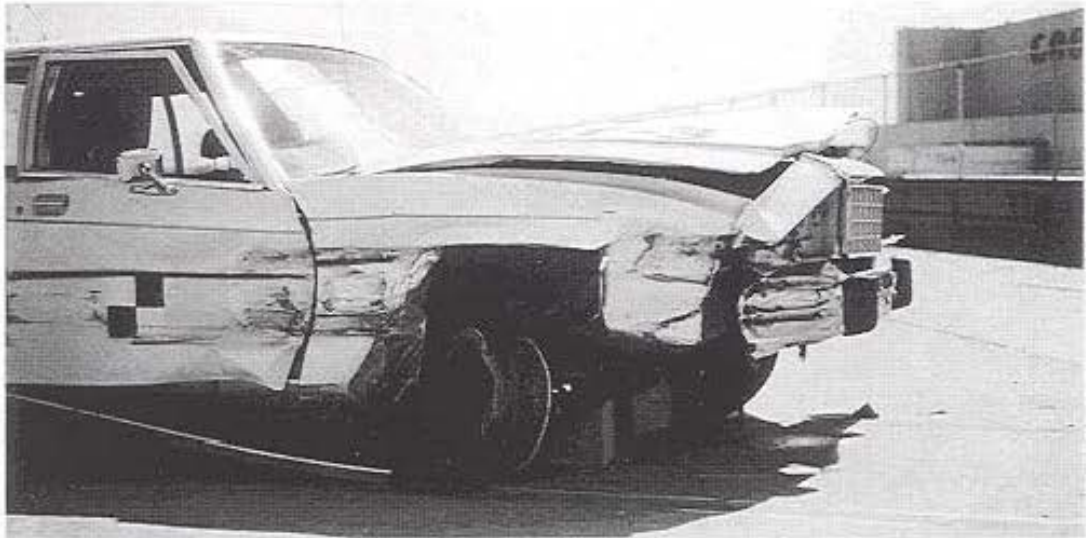
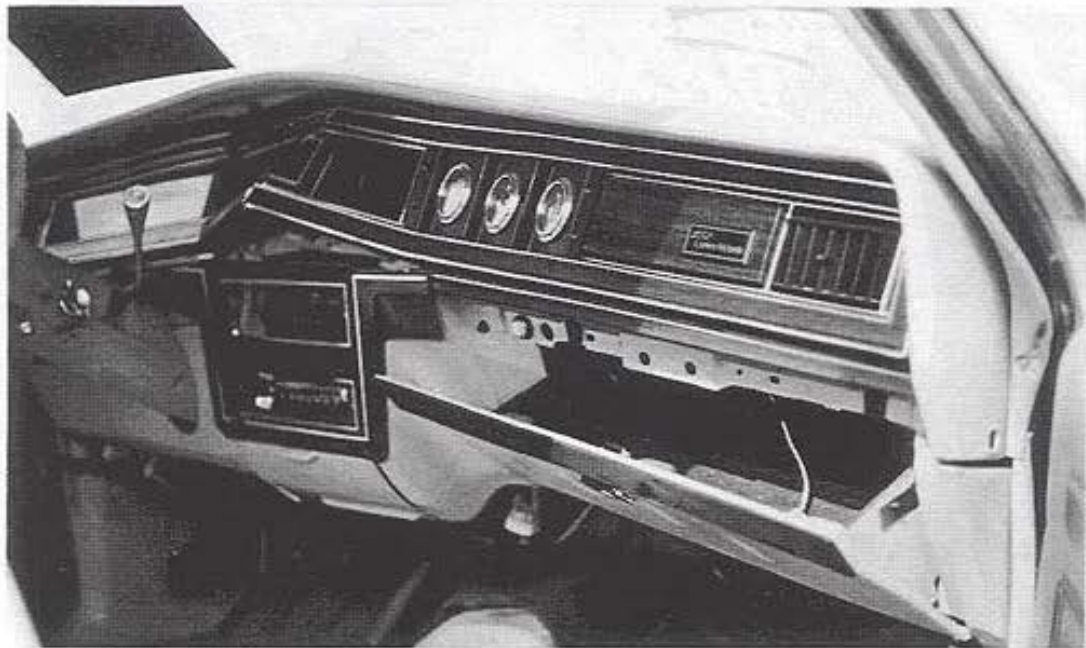
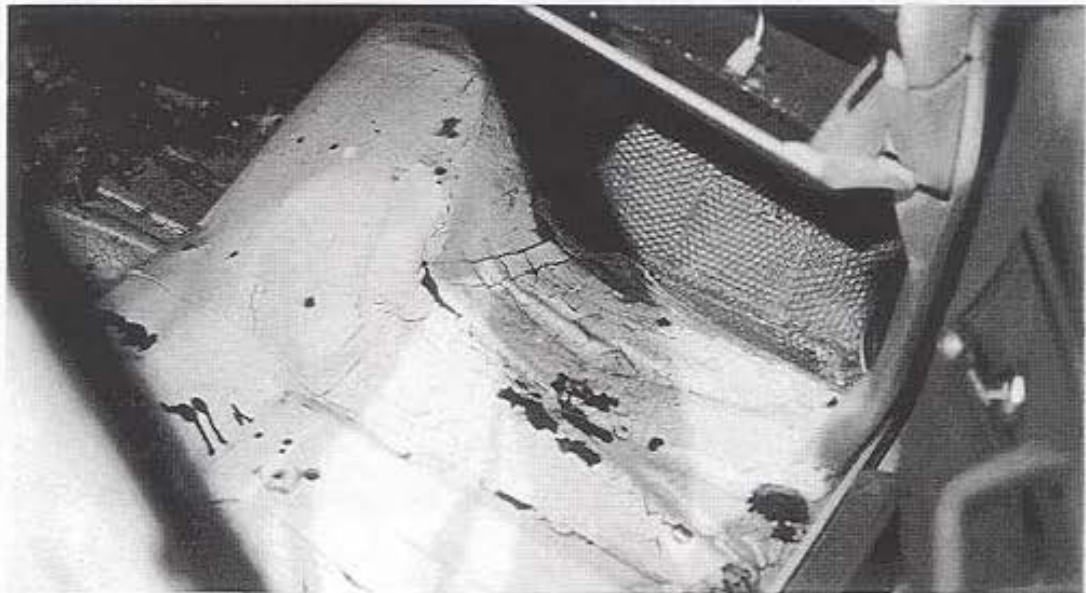
Figure 23. Vehicle Damage, Test SBT-3.

The vehicle damage, shown in figure 23, consisted of the crushing of the front-right corner of the vehicle, as well as scrapes and dents continuing down the side to the rear wheel assembly. The tire was torn off the front-right wheel, and the rim was bent. Occupant compartment damage included buckling of the floor on the passenger's side of the vehicle, as well as buckling of the dashboard. The maximum crush deformation of 13.75 in (349 mm) is shown schematically in figure 24.
