# Guardrail Testing Program II

## Final Report

Transportation Research Report TRP-03-52-95

FHWA Contract No. DTFH71-90-C-00035

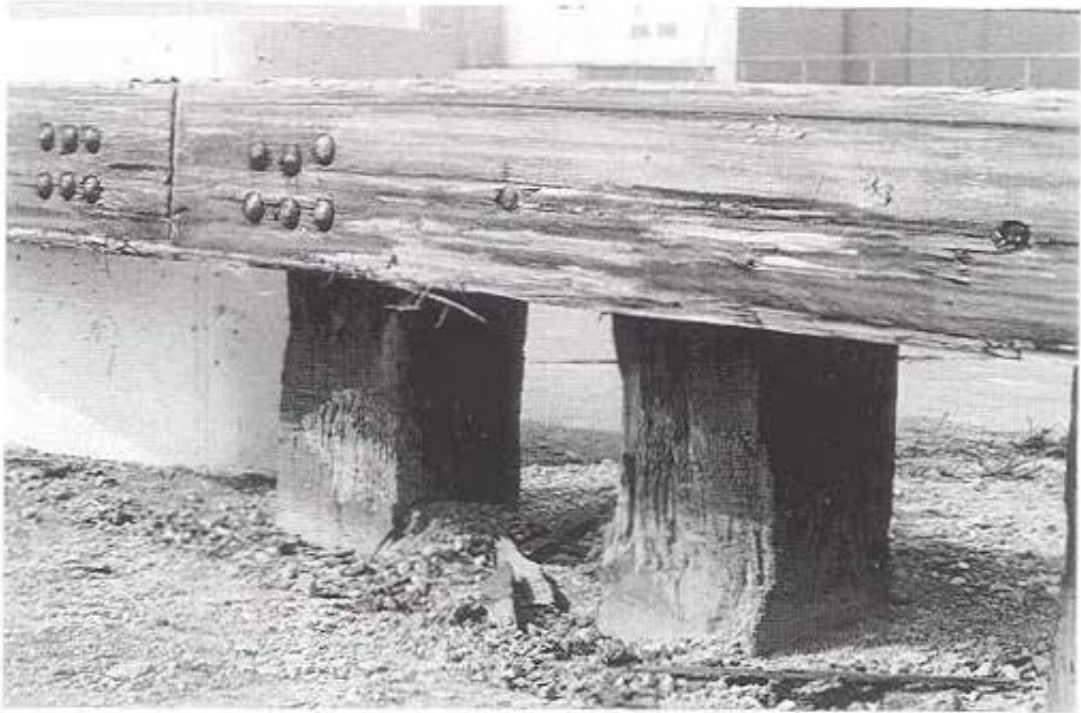
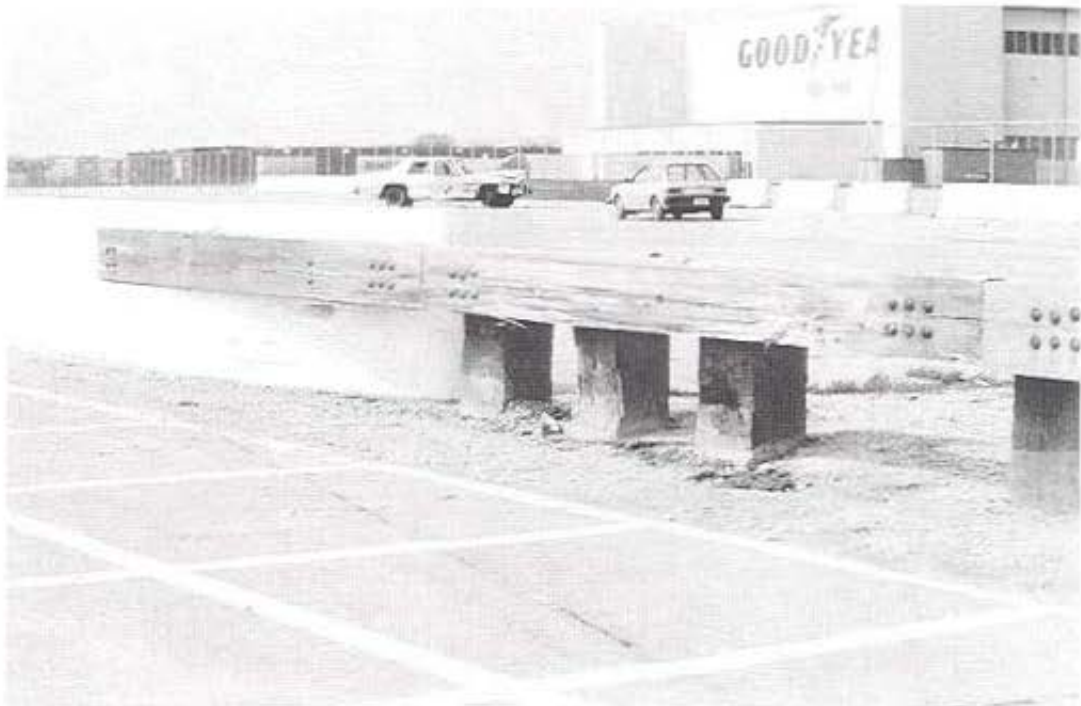
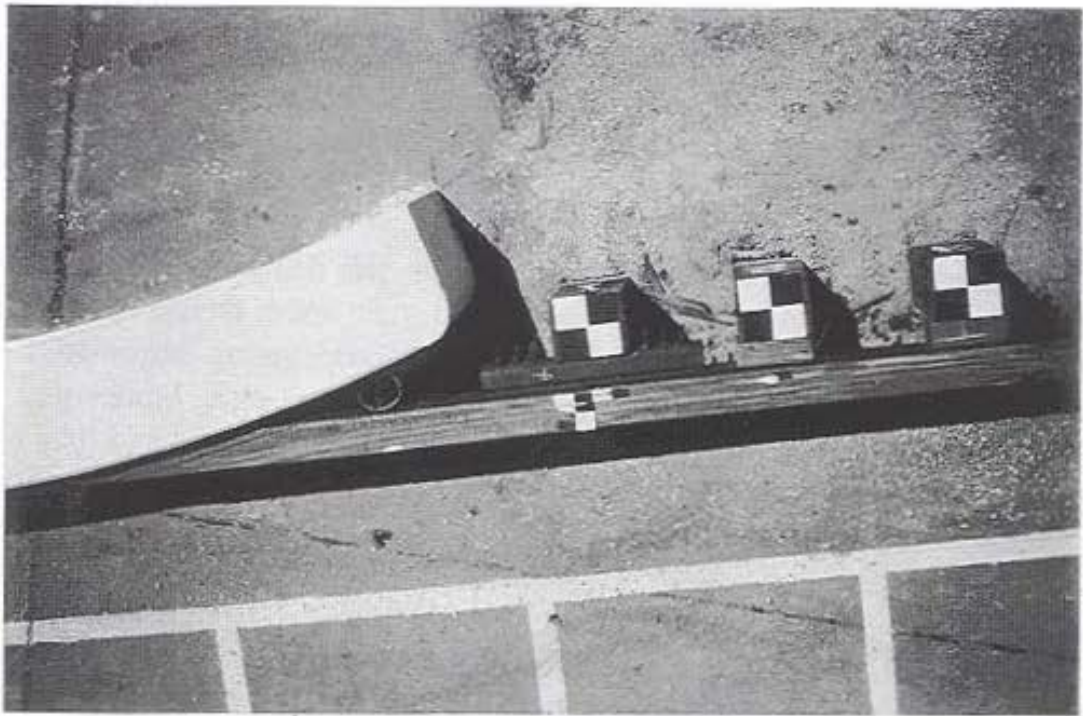
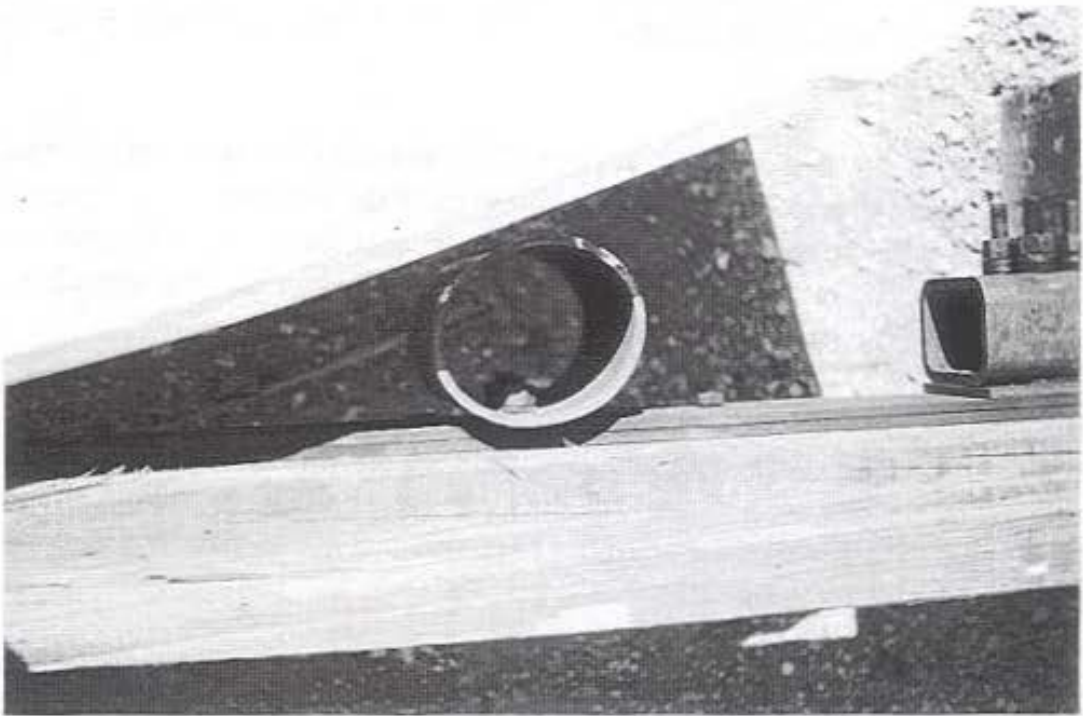
Figure 25. System Damage, Test SBT-3.

Damage to the system, shown in figure 25, consisted of minor scrapes along the face of the rail, and significant gouges in post nos. 1 and 2. There were only minor tire marks evident on the concrete abutment. The maximum permanent set deflection of the rail was 2.5 in (64 mm), which occurred at post no. 2.

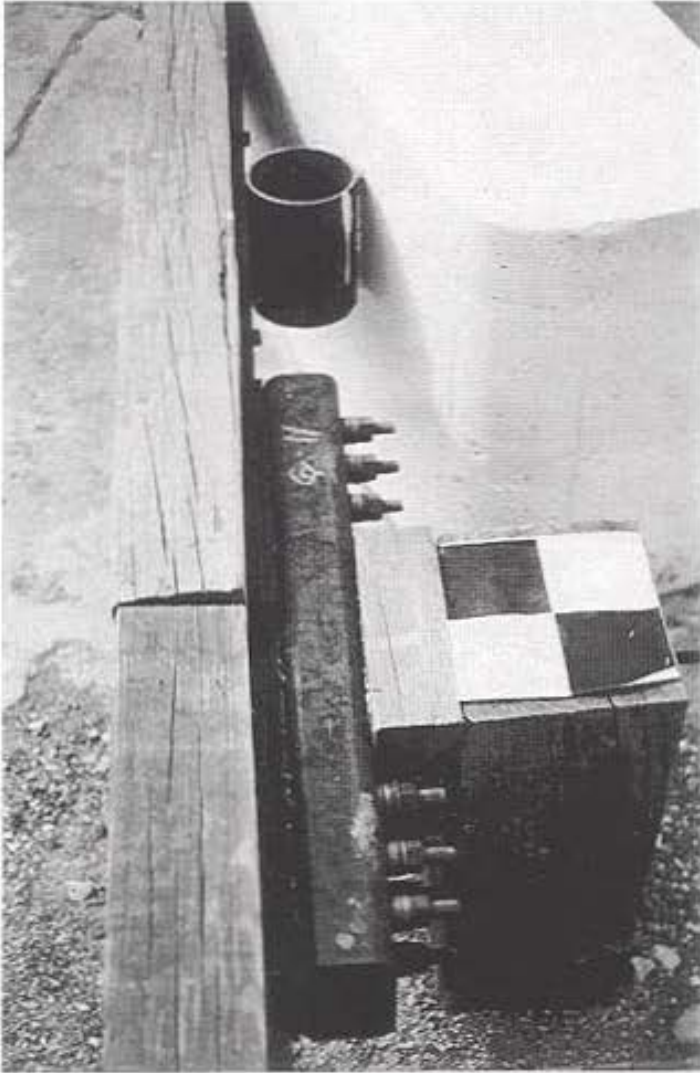
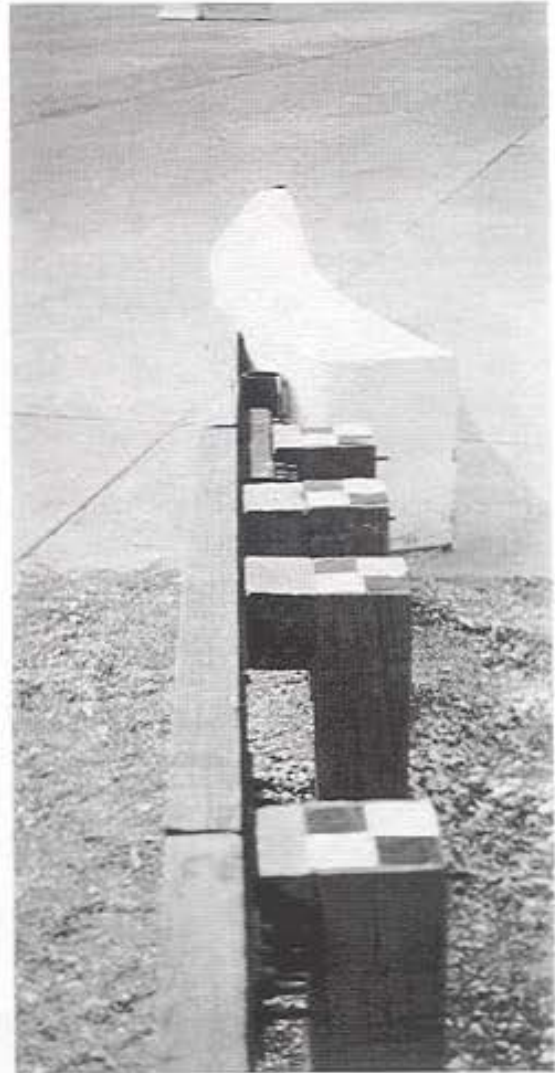
Figure 26. Design Modifications, Test SBT-4.

The design changes discussed in the previous section were incorporated into the system for this test. These changes can be seen in figure 26, and the design details are presented in appendix A. A 1984 Mercury Grand Marquis impacted the system at 60.0 mi/h (96.5 km/h) and 26.2 degrees. The impact point was located midway between the third and fourth posts from the concrete bridge abutment as shown in figure 27. A summary of the test results and sequential photographs are shown in figure 28. Additional sequential photos are shown in figure 29.

It was obvious from the results of this test that the additional 4 in (102 mm) of blockout was not sufficient to eliminate the snagging or reduce it to a tolerable amount. It was deemed impractical to extend the blockout beyond 8 in (203 mm), so it was decided to add a rub rail to the system to reduce the snag potential. A 4-in by 6 in by 11-ft 6 in (102-mm by 152-mm by

3.55-m) wood rub rail was attached to post nos. 1, 2, and 3 for the next test. The details of this design change can be found in appendix A.

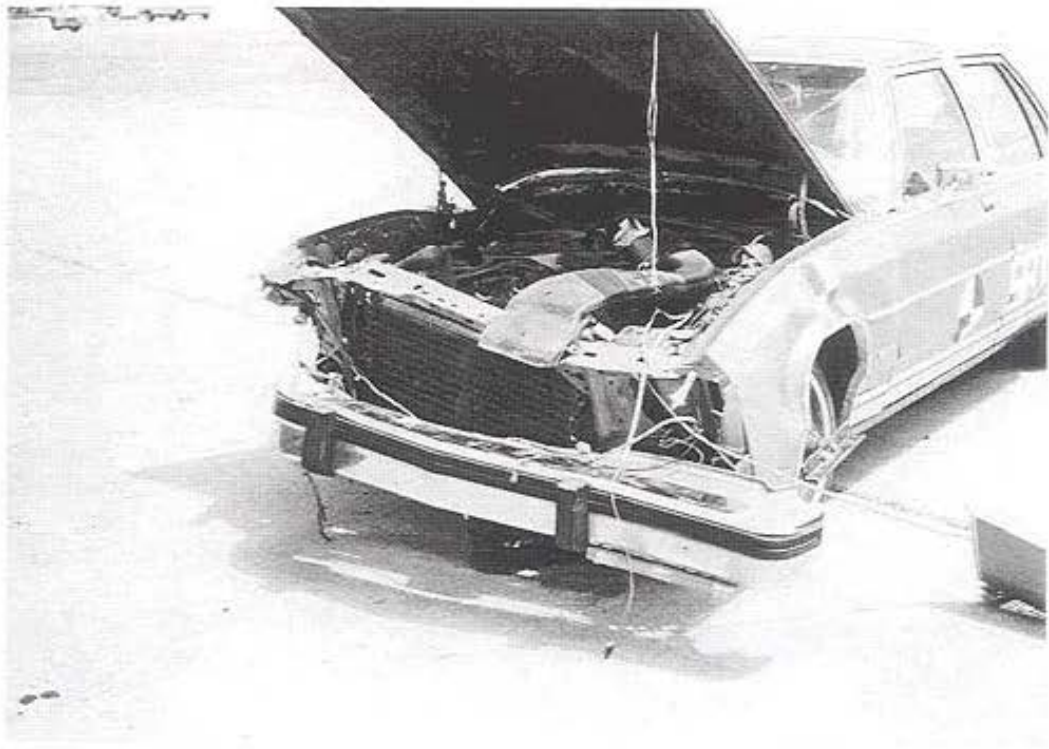
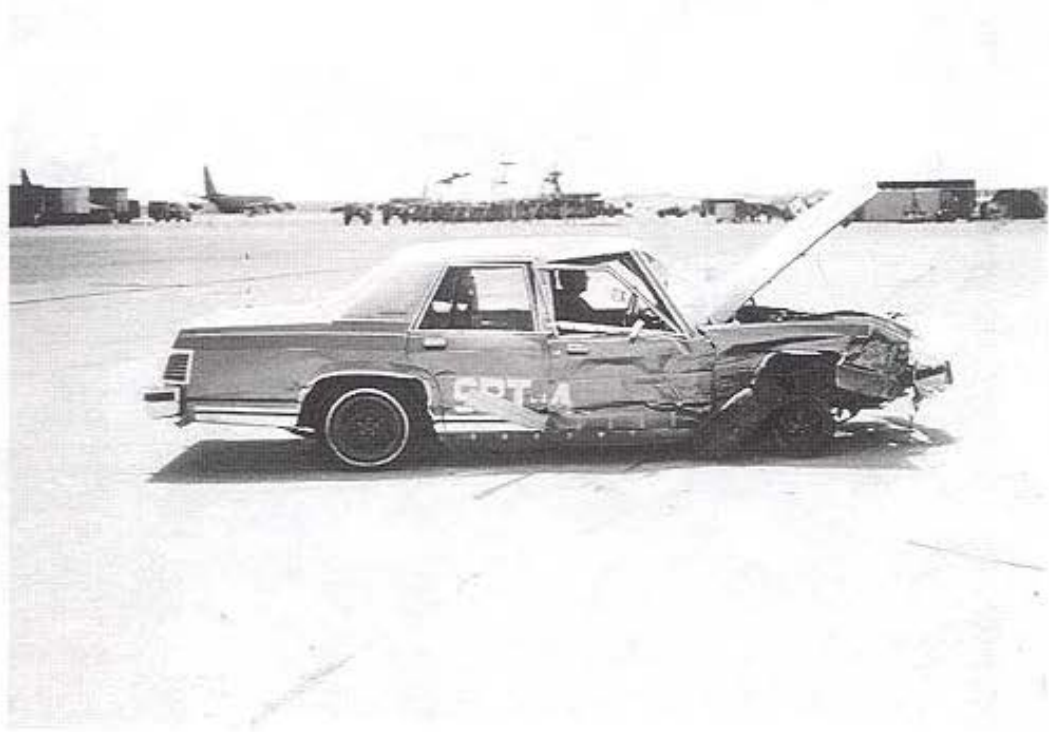
Figure 31. Vehicle Damage, Test SBT-4.

The damage to the vehicle, shown in figure 31, consisted of deformation of the front-right corner of the vehicle, which continued down the passenger side of the vehicle as scrapes and dents. The front-left tire was removed from the rim, and the front bumper was pushed toward the left away from the longitudinal centerline of the vehicle. The entire front end of the vehicle was pushed toward the left side, and the roof was buckled. Interior occupant compartment damage consisted of buckling of the floorboard on the passenger side and the front dashboard. The maximum crush deformation of 13.75 in (349 mm) is shown schematically in figure 32.

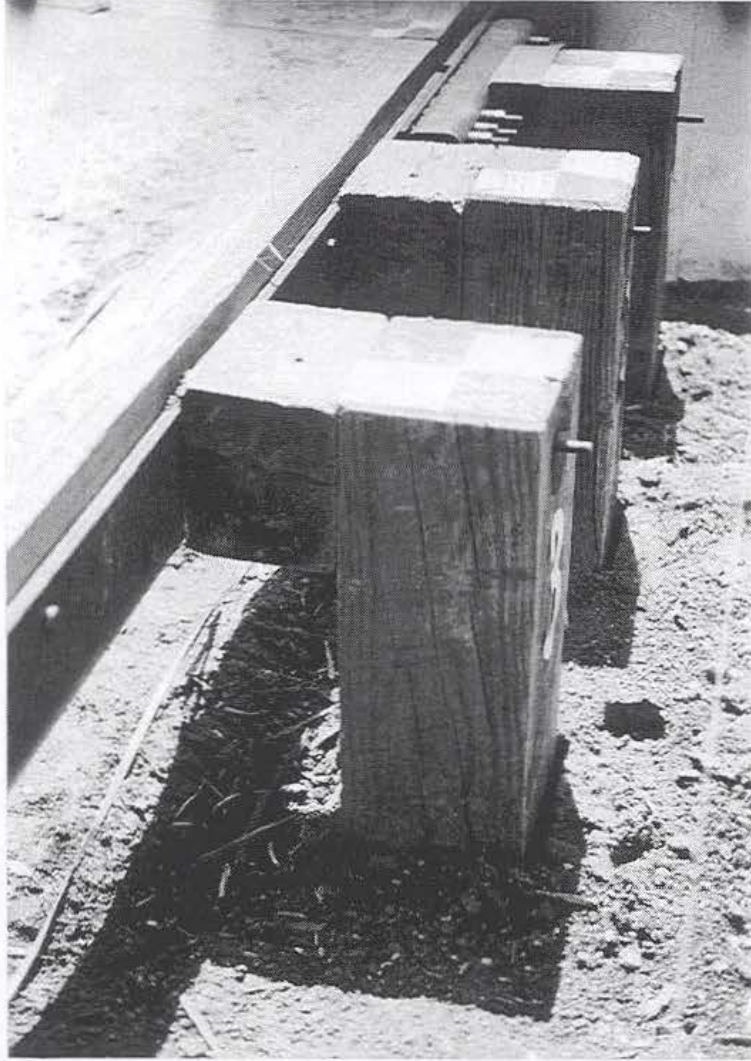
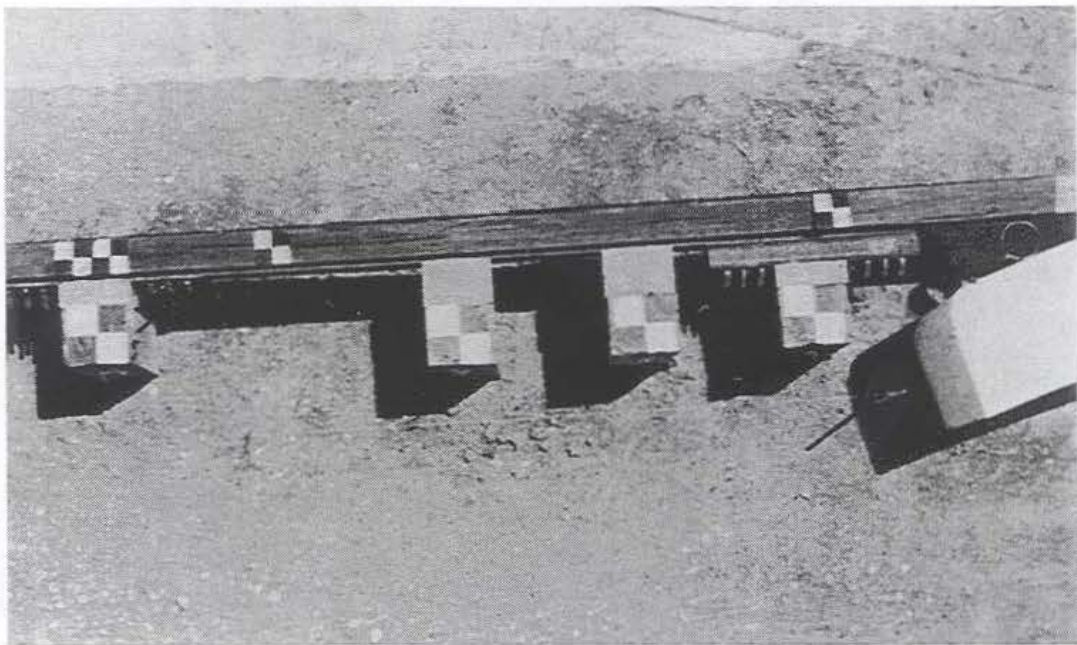
**Figure 33.** System Damage, Test SBT-4.

Damage to the system, shown in figure 33 consisted of scrapes and gouges along the face of the rail from the impact point to the midspan of the first rail. The spacer pipe between the rail and concrete abutment was deformed slightly, and the soil was gouged considerably in front of post nos. 1, 2, and 3. Markings on the posts indicated that the vehicle snagged approximately 1 in on posts no. 1 and 3 in on post no. 2.

To eliminate the wheel snagging observed in the previous test, a rub rail was added to the system, as shown in figure 34 and appendix A. The 1984 Ford LTD impacted the system at 58.6 mi/h (94.3 km/h) and 24.8 degrees. The impact point was located midway between the third and fourth posts from the concrete bridge abutment as shown in figure 35. A summary of the test results and sequential photographs are shown in figure 36. Additional sequential photographs are shown in figure 37.

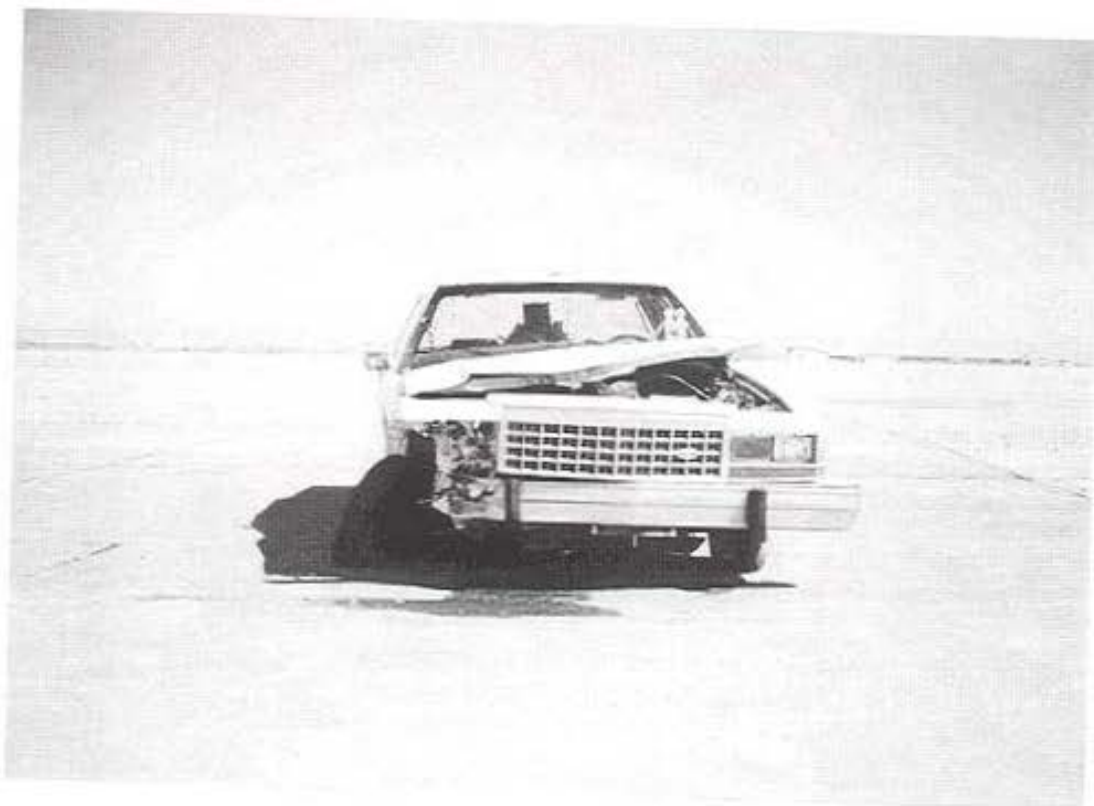
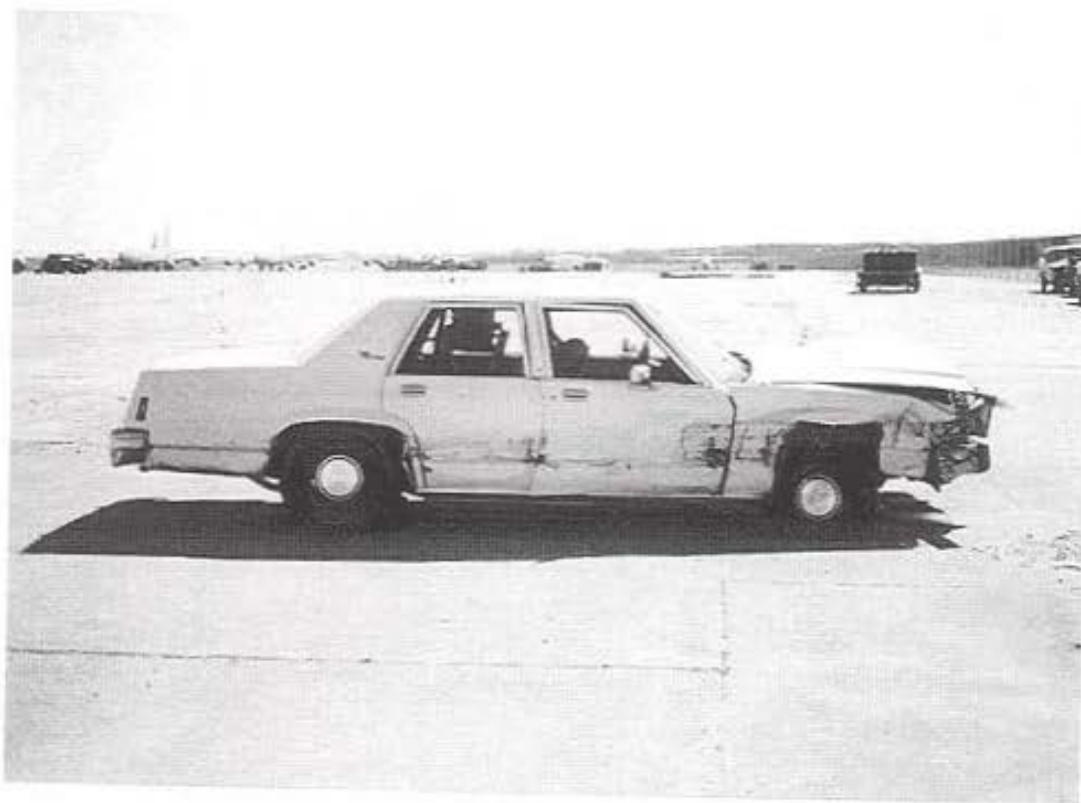
Figure 39. Vehicle Damage, Test SBT-5.

Damage to the vehicle, shown in figure 39, included deformation of the front-right corner, continuing along the length of the vehicle to the rear wheel assembly. There was no evidence of snagging, and the occupant compartment remained intact with the exception of minor deformation of the floorboard on the passenger's side. The maximum crush deformation of 19.4 in (492 mm) is shown schematically in figure 40.

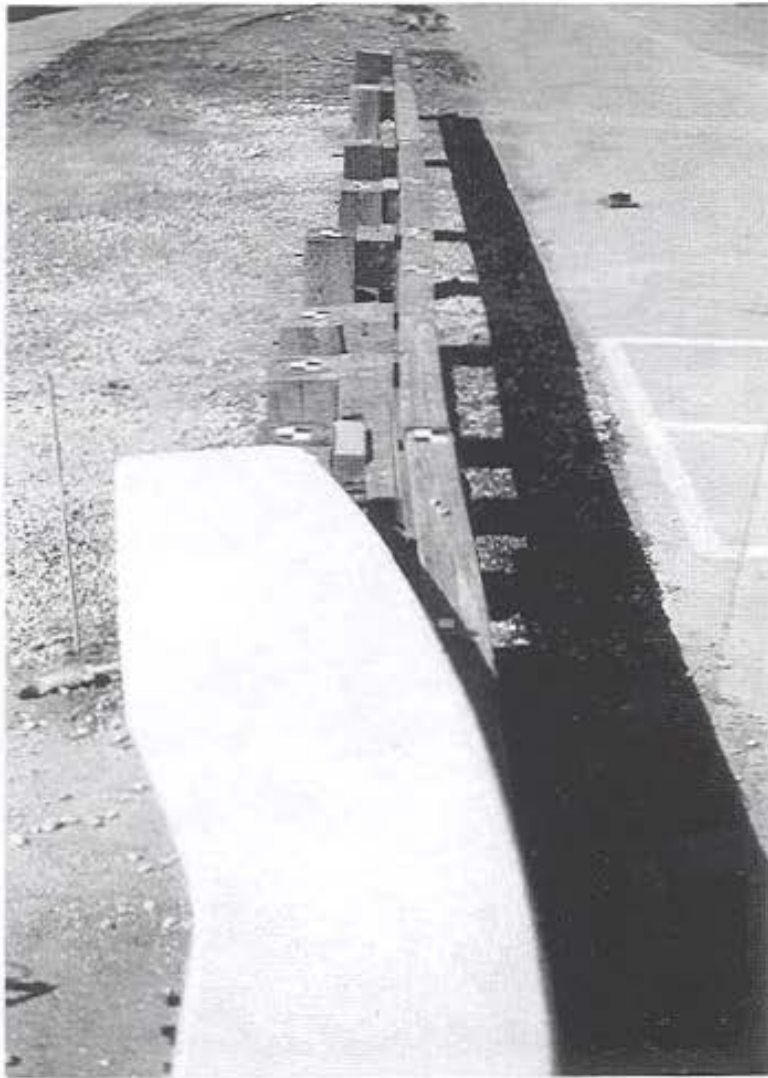
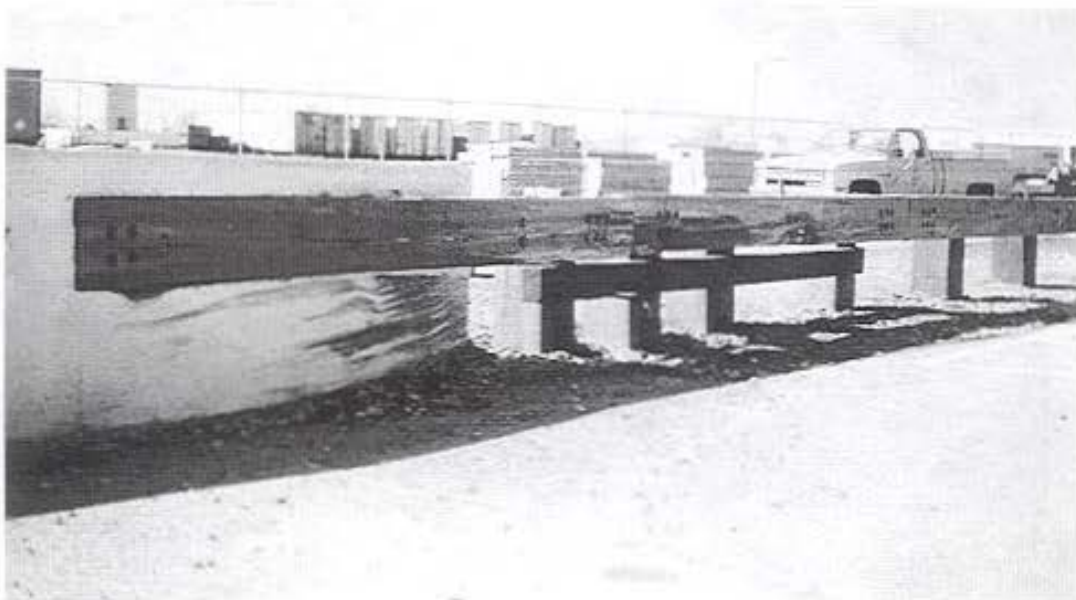
Figure 41. System Damage, Test SBT-5.

As can be seen in figure 41, the wood rail sustained minor scraping and gouging along its face. The rub rail showed signs of tire contact starting 10.5 in (267 mm) downstream of post no. 3 and continuing to the end of the rail. A 4-in (102-mm) deep trench was dug by the vehicle starting at post no. 3 and continuing to post no. 1. Full tire contact was evident on the concrete abutment starting at its upstream end and continuing until 3 in (76 mm) before the end of the first rail. The spacer pipe between the wood rail and the concrete abutment was slightly deformed.

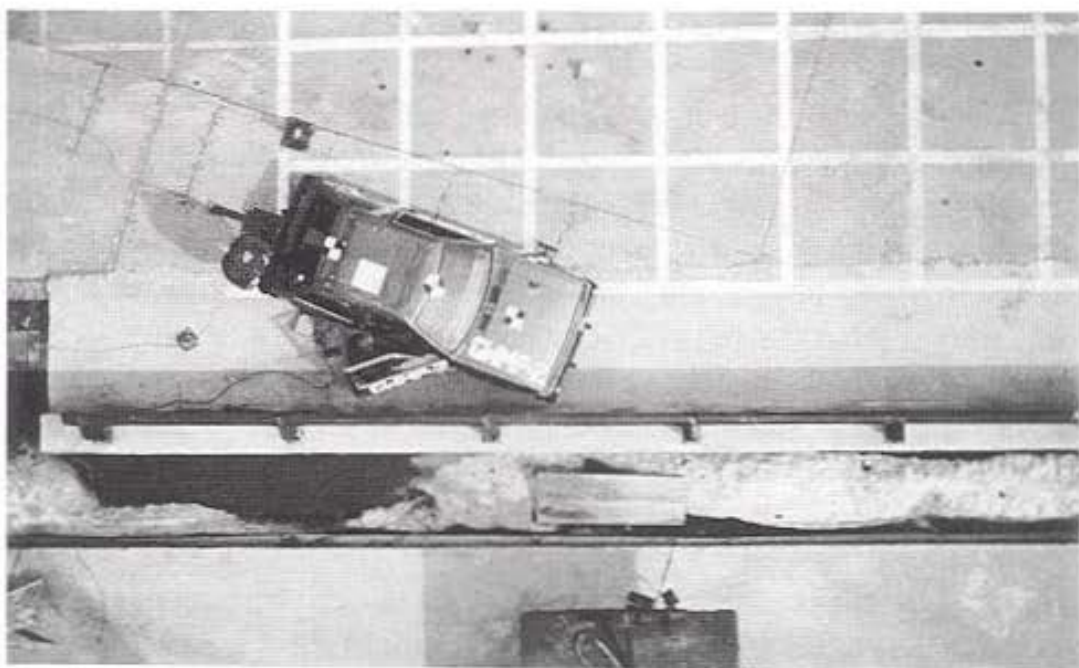
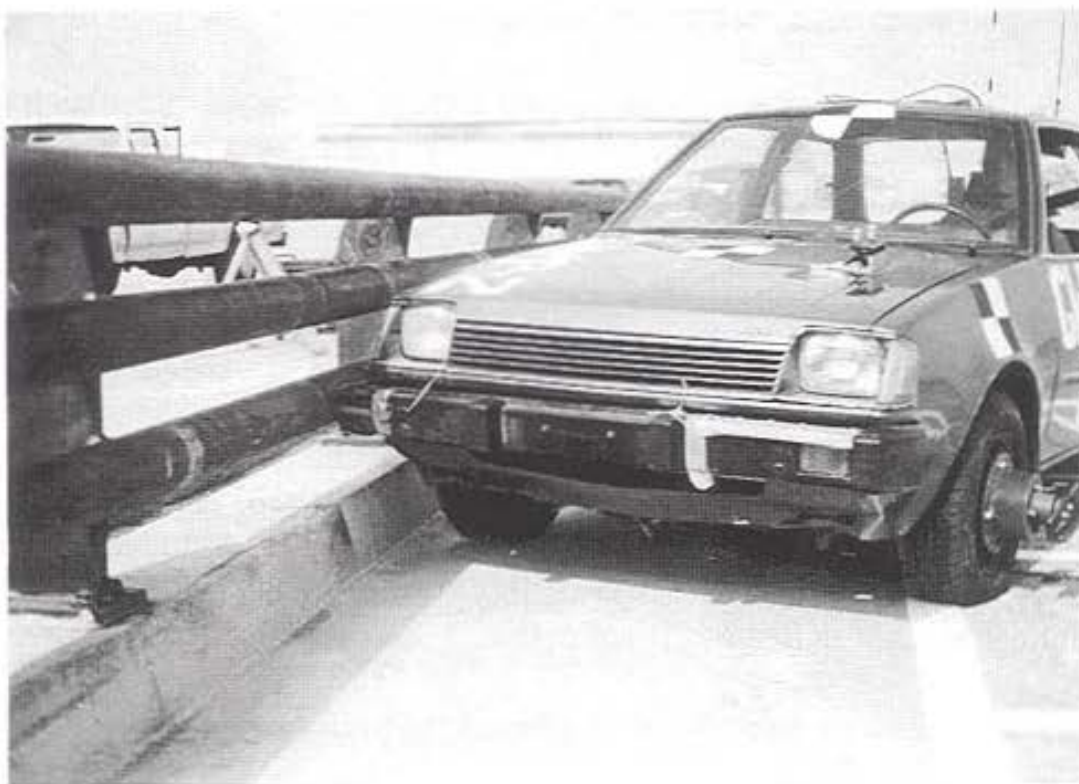
Figure 51. Impact Location, Test GWMP-2.

The 1984 Dodge Colt impacted the George Washington Memorial Parkway Bridge Rail at 52.6 mi/h (84.65 km/h) and 22.6 degrees. The impact point was located midway between the third and fourth posts from the upstream end of the installation as shown in figure 51. A summary of the test results and sequential photographs are shown in figure 52.

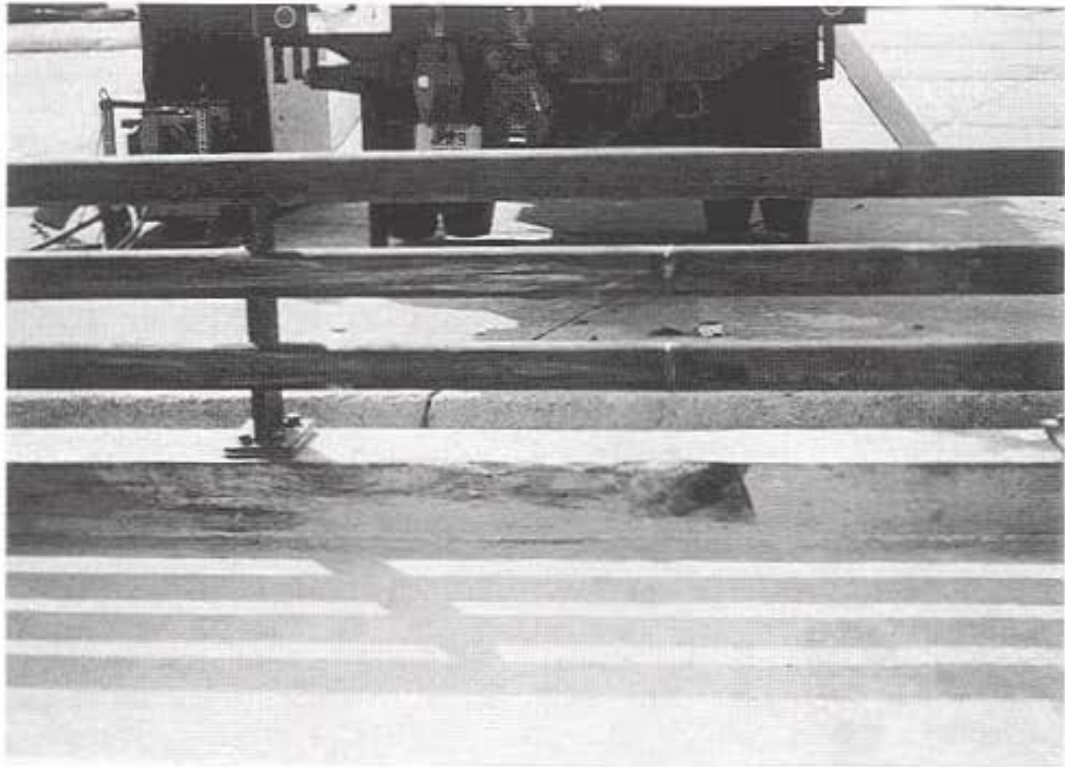
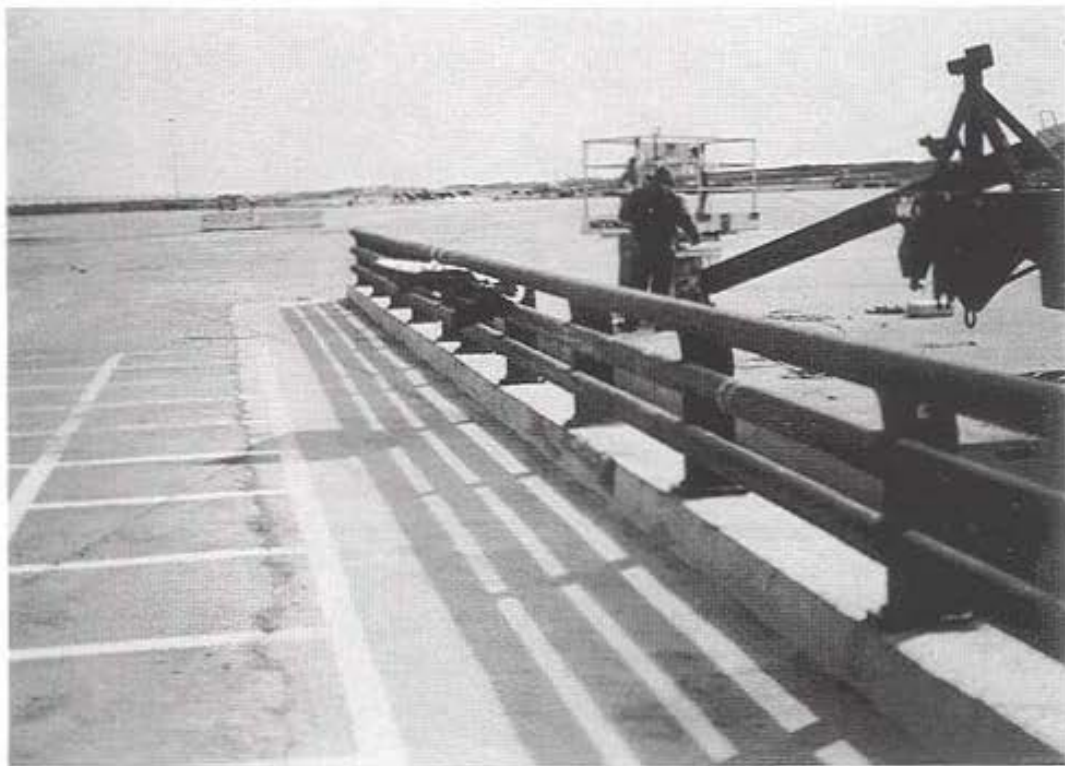
Figure 56. Bridge Rail Damage, Test GWMP-2.

As shown in figure 56, the bridge rail and curb sustained minor scrapes in the area where the impact occurred. Contact with the middle and lower rail began at the midspan between posts nos. 4 and 5, and continued to the midspan between posts nos. 3 and 4.

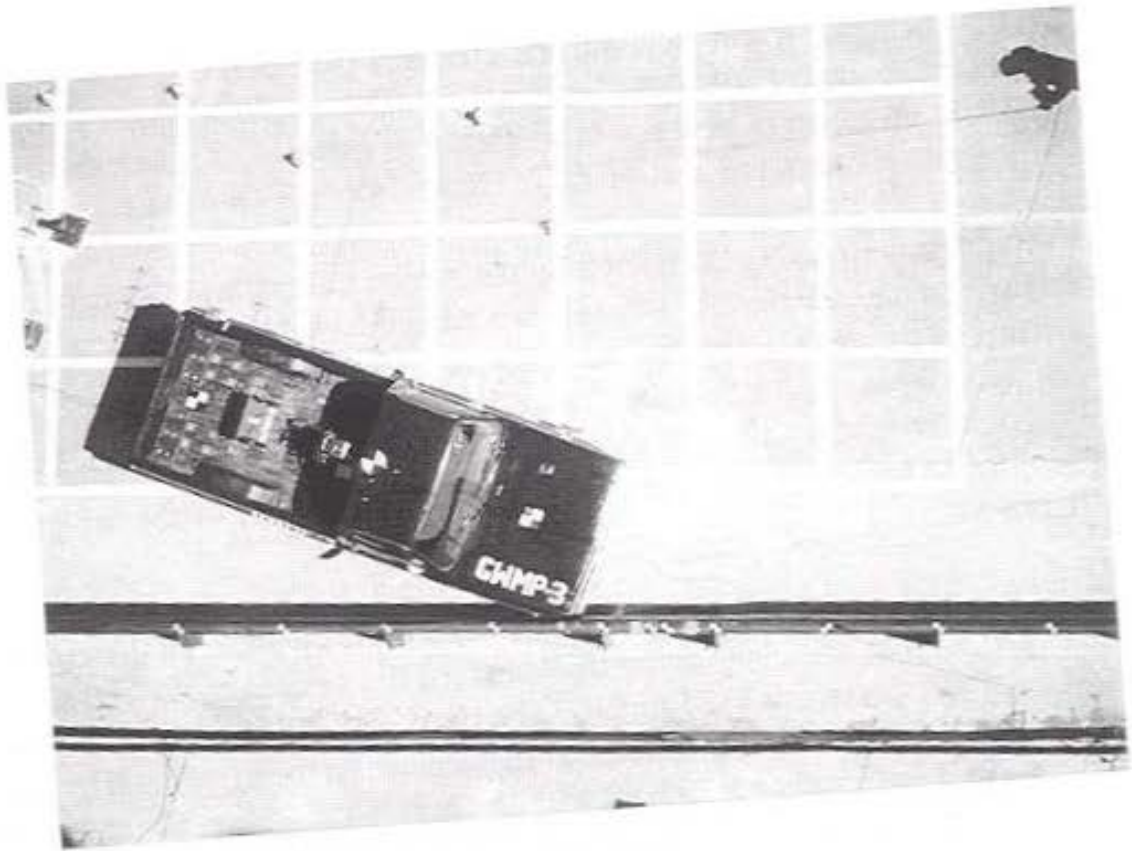
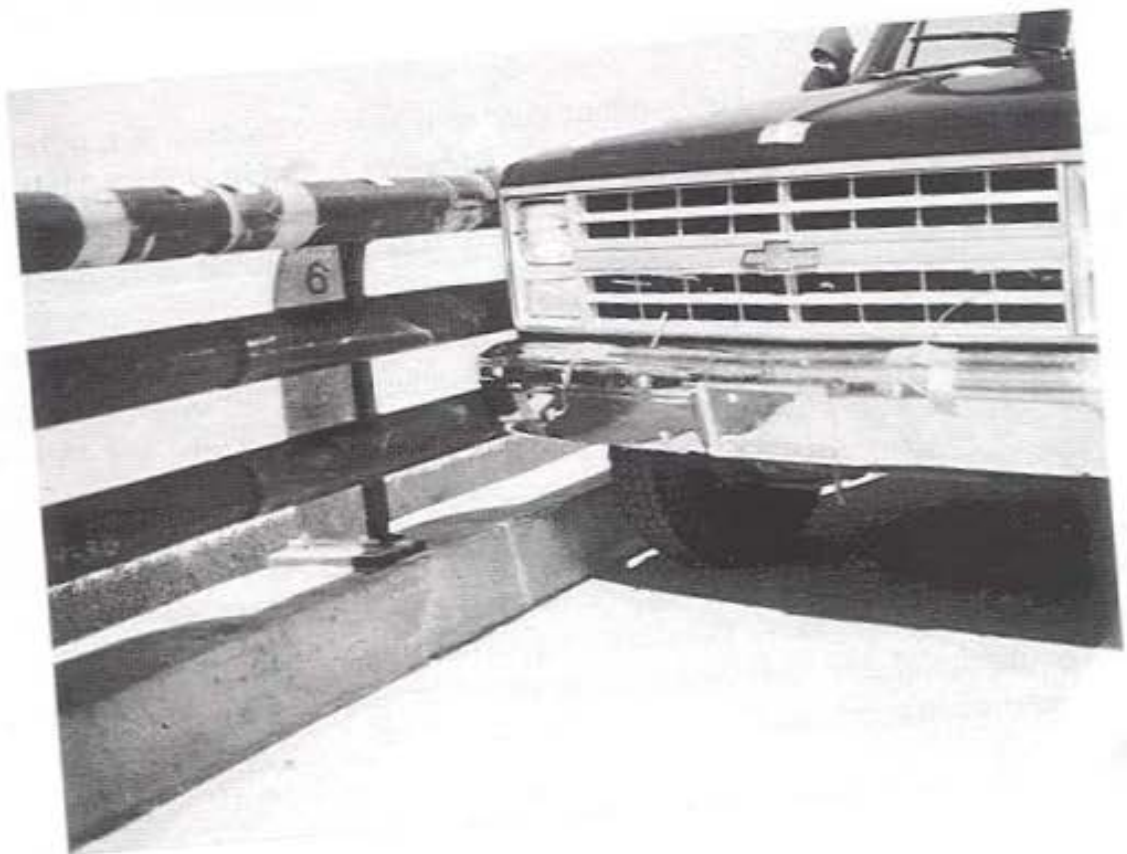
Figure 57. Impact Location, Test GWMP-3.

The 1985 Chevrolet  $\frac{3}{4}$ -ton pickup truck impacted the system at 46.6 mi/h (75.0 km/h) and 22.7 degrees. The impact point was located 3 ft 3.5 in (1.0 m) upstream of the expansion joint, or 1 ft 3.5 in upstream of post no. 6, as shown in figure 57. A summary of the test results and sequential photographs are shown in figure 58.

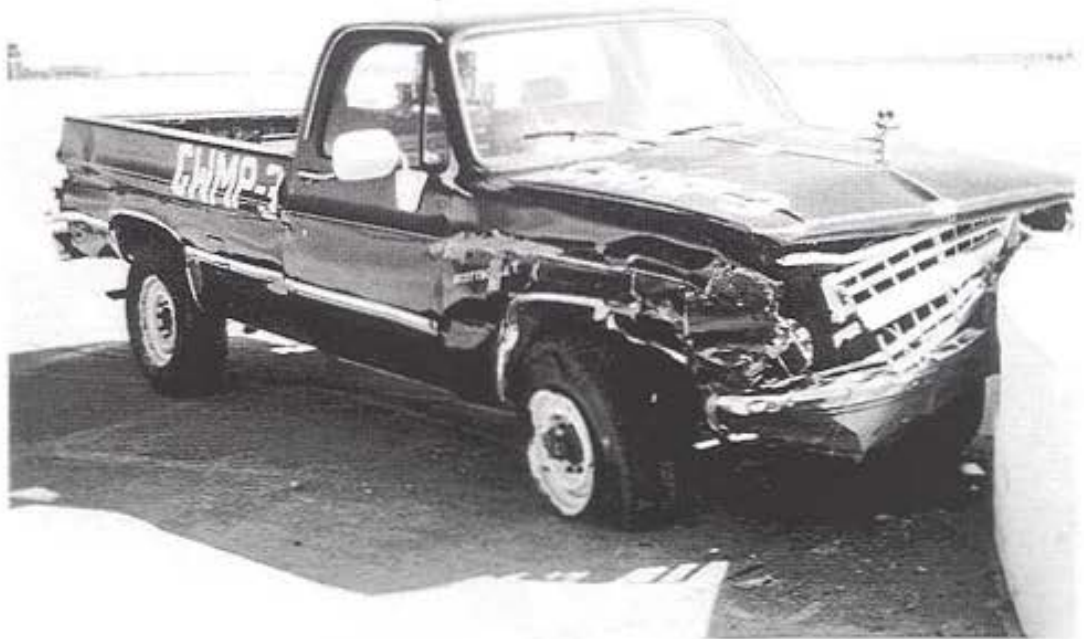
Figure 60. Vehicle Damage, Test GWMP-3.

The vehicle damage, shown in figure 60, included the crushing of the right-front corner of the vehicle, and scrapes and dents along the length of the passenger side. The right-front tire was blown out and the rim was deformed. The maximum crush deformation of 9.75 in (24.8 cm) is shown in figure 61. All damage to the vehicle on the driver's side of the longitudinal centerline occurred after impact with the bridge rail. Near the end of the vehicle's trajectory, the vehicle struck an obstacle on the testing grounds, resulting in damage to the left-front corner of the vehicle.

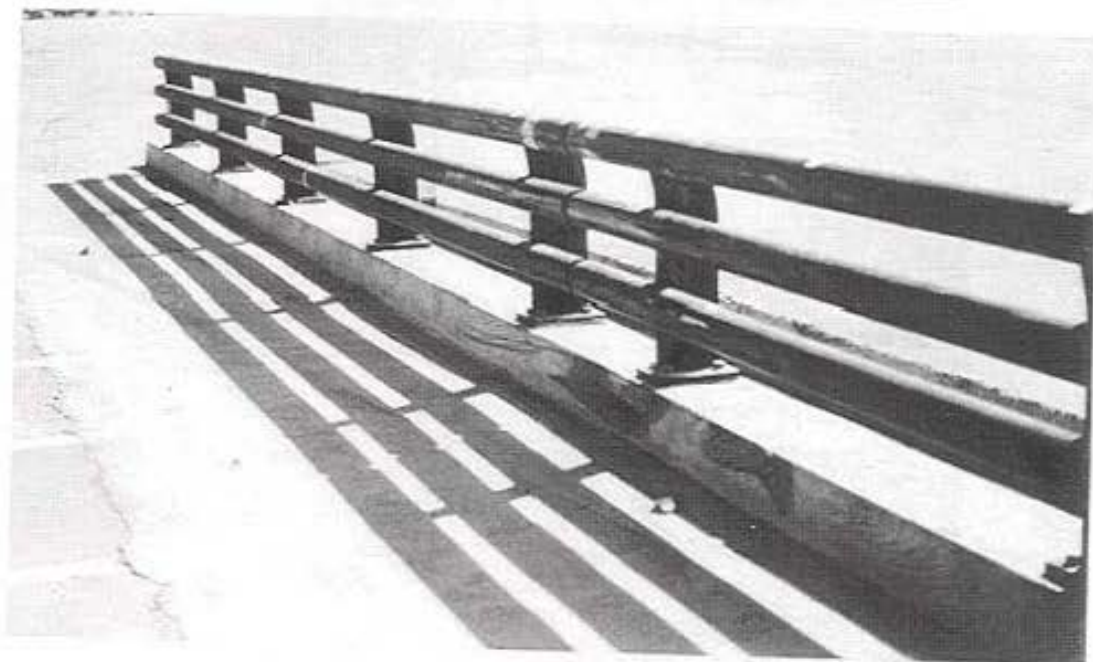
Figure 62. Bridge Rail Damage, Test GWMP-3.

The bridge rail sustained only minor cosmetic damage on each of the three rails as shown in figure 62. Contact with each of the rails began 3 ft 5 in (1.04 m) upstream of the expansion joint. The vehicle remained in contact with the rail for 8 ft (2.44 m) on the bottom rail, 8 ft 6 in (2.59 m) on the middle rail, and 8 ft 2 in (2.49 m) on the top rail.

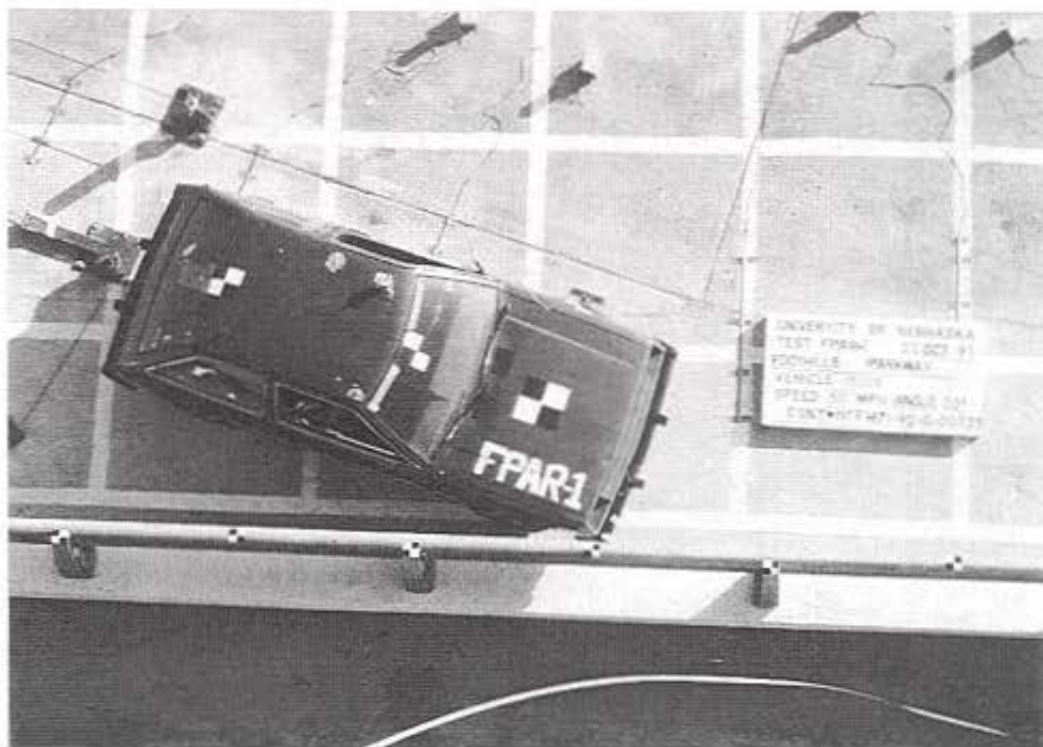
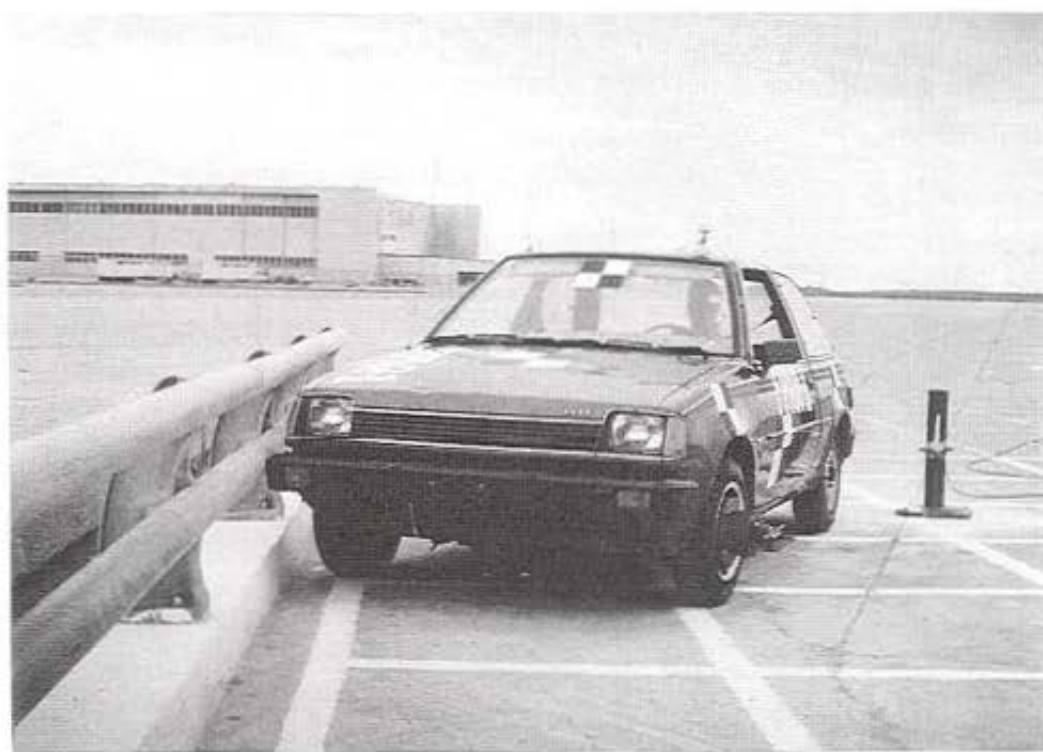
Figure 68. Impact Location, Test FPAR-1.

The 1984 Dodge Colt impacted the Foothills Parkway Bridge Rail at 52.0 mi/h (83.7 km/h) and 22.0 degrees. As shown in figure 68, the impact point was located midspan between the third and fourth posts from the upstream end of the installation (3 ft 11 in (1.2 m) downstream of post no. 3). A summary of the test results and sequential photographs are shown in figure 69. Additional sequential photographs are shown in figure 70.

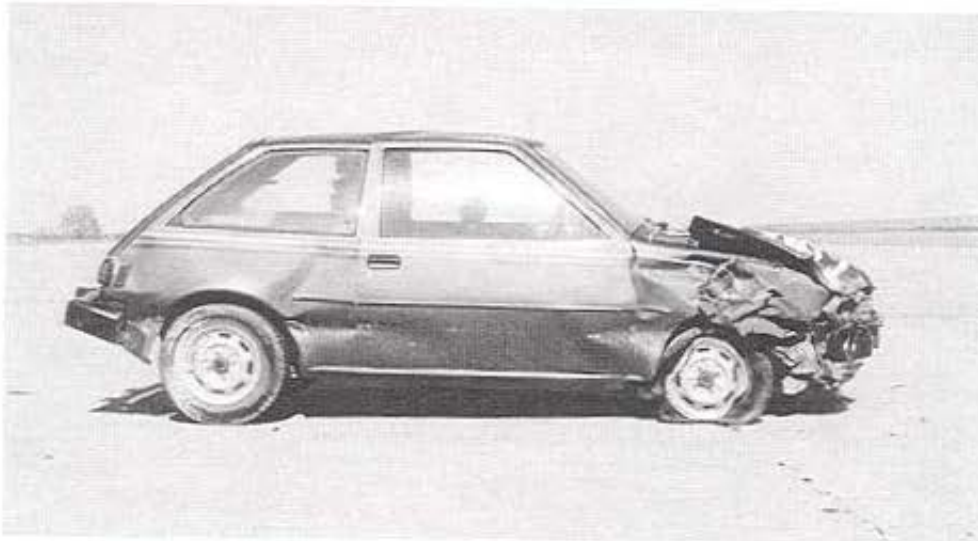
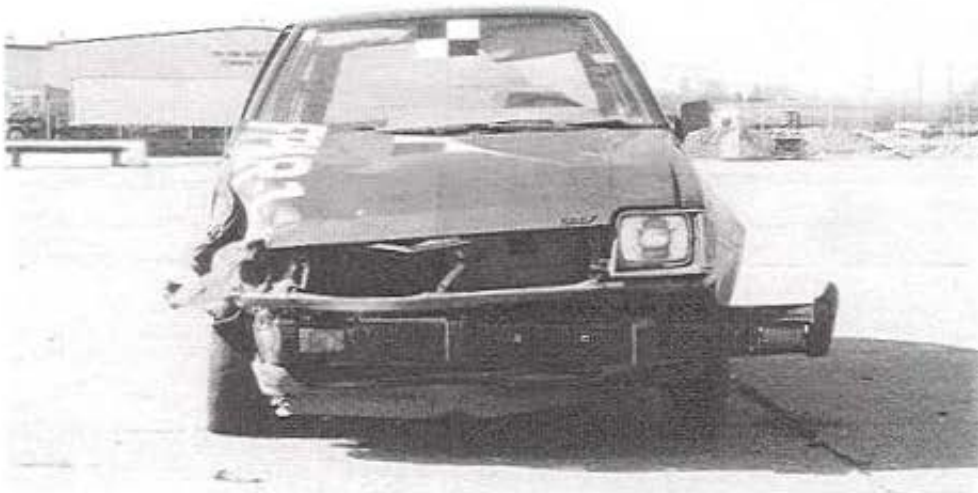
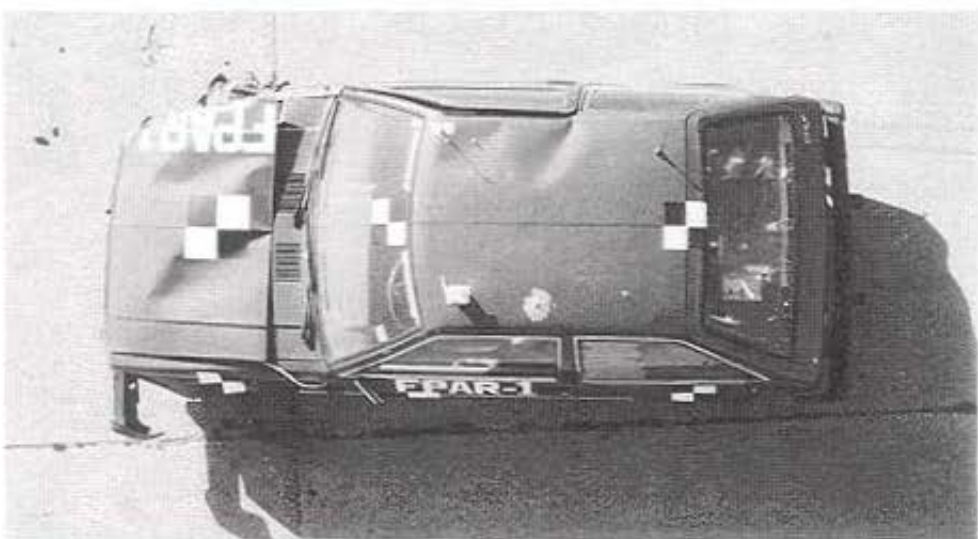
Figure 72. Vehicle Damage, Test FPAR-1.

The vehicle damage, shown in figure 72, included the crushing of the right-front corner of the vehicle, and minor scrapes and dents along the length of the passenger side. The right-front tire was blown out, and the rim was bent. The maximum crush deformation of 11.25 in (28.6 cm) is shown in figure 73.
