# Guardrail Testing Program II

## Final Report

Transportation Research Report TRP-03-52-95

FHWA Contract No. DTFH71-90-C-00035

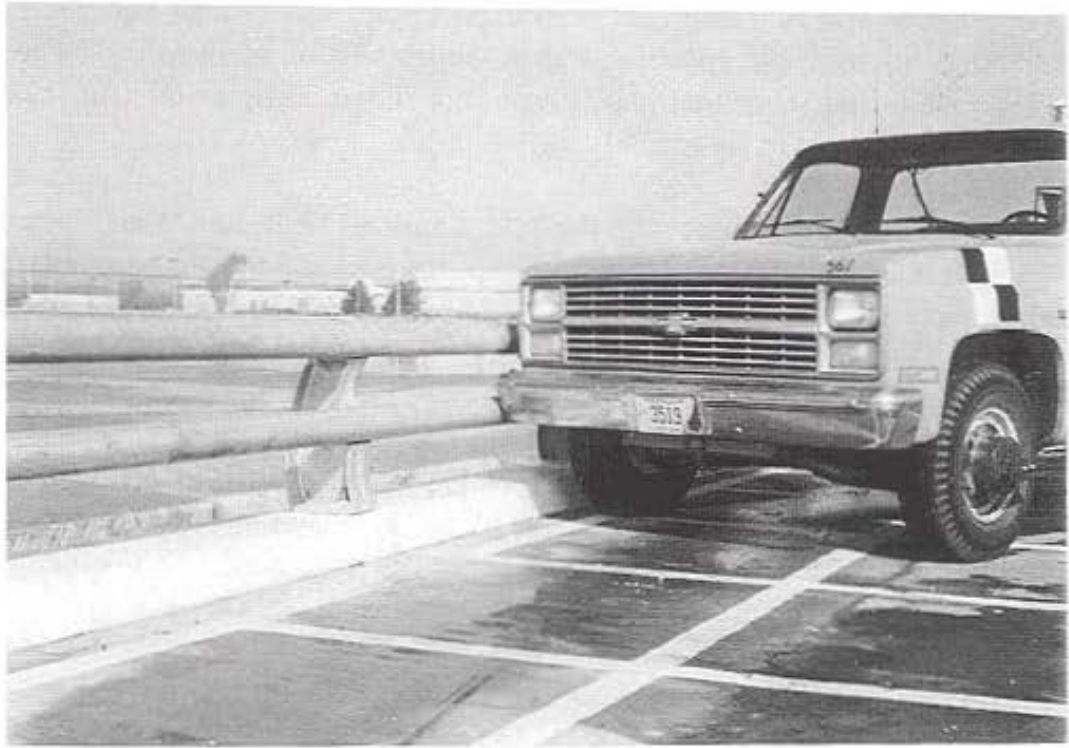
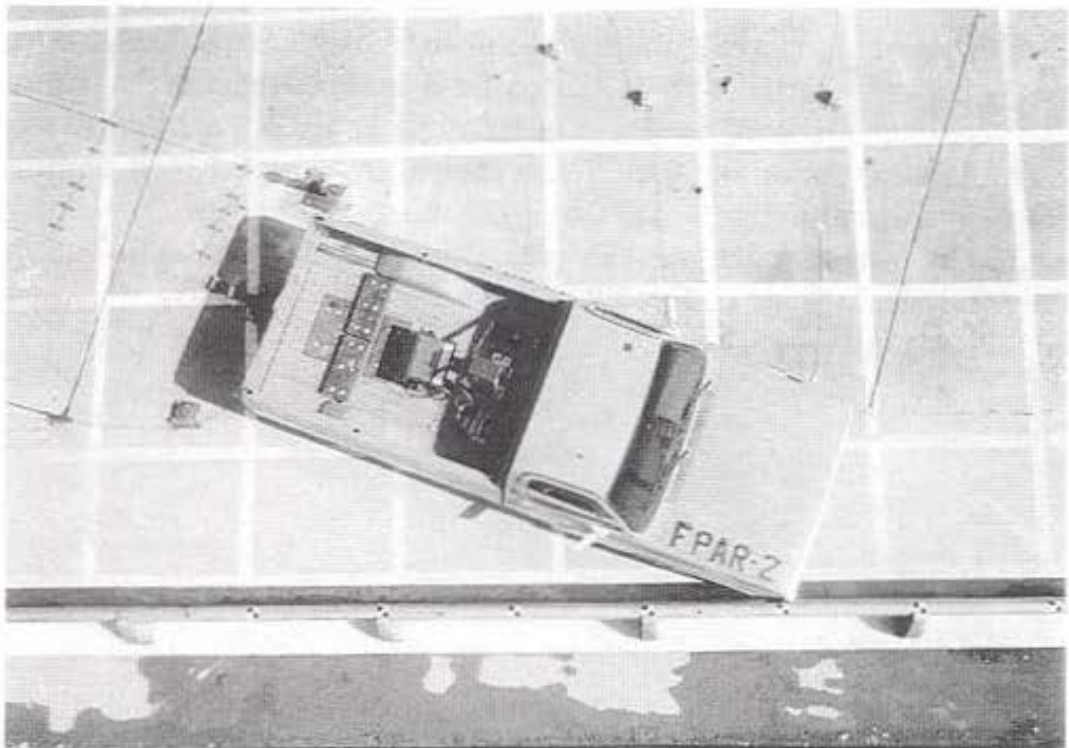
Figure 76. Impact Location, Test FPAR-2.

The 1984 Chevy  $\frac{3}{4}$  ton pickup impacted the Foothills Parkway Bridge Rail at 46.6 mi/h (75.0 km/h) and 20.7 degrees. The impact point was located midspan between the sixth and seventh posts from the upstream end of the installation as shown in figure 76. A summary of the test results and sequential photographs are shown in figure 77. Additional sequential photographs are shown in figure 78.

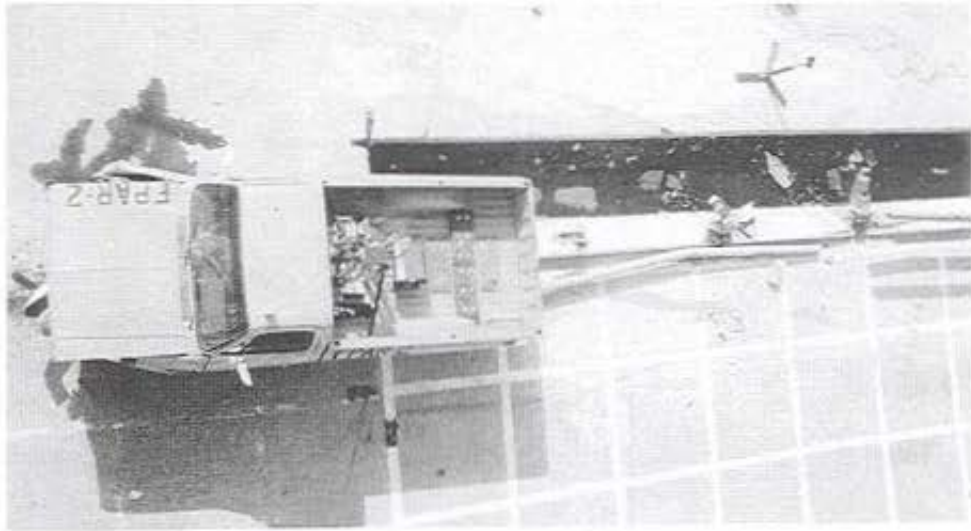
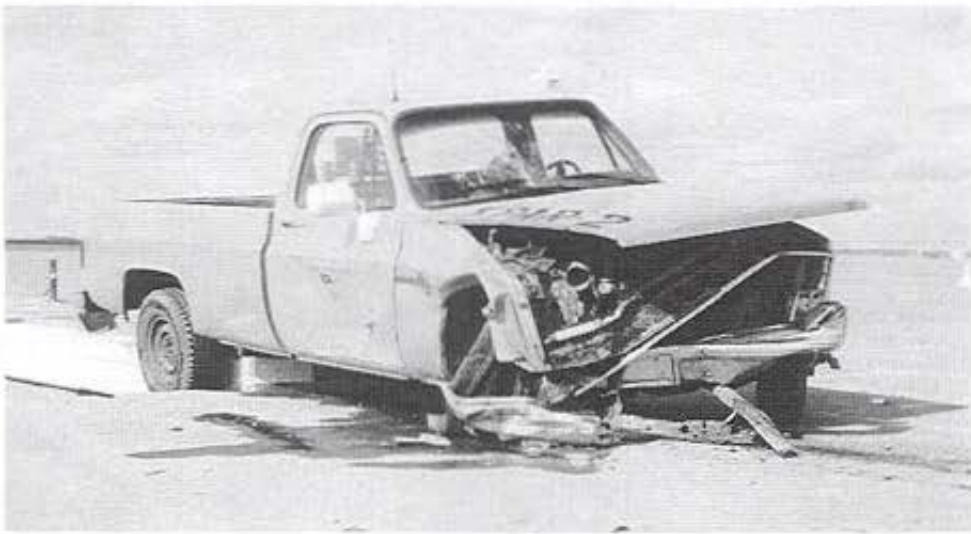
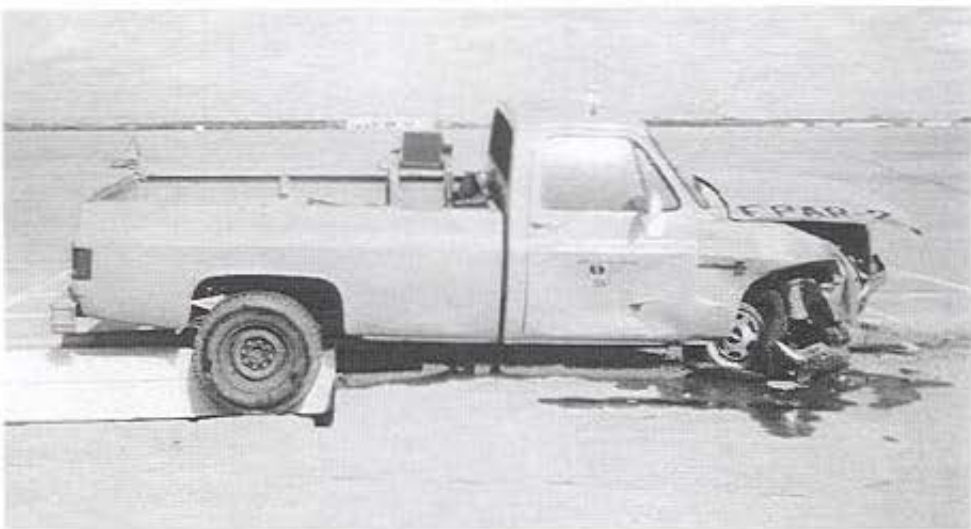
Figure 79. Vehicle Damage, Test FPAR-2.

The vehicle damage, shown in figure 79, included the crushing of the right-front corner of the vehicle and minor scrapes and dents along the length of the passenger side. The right-front tire was blown out, and the rim was bent. The maximum crush deformation of 26.5 in (67.3 cm) is shown in figure 80.

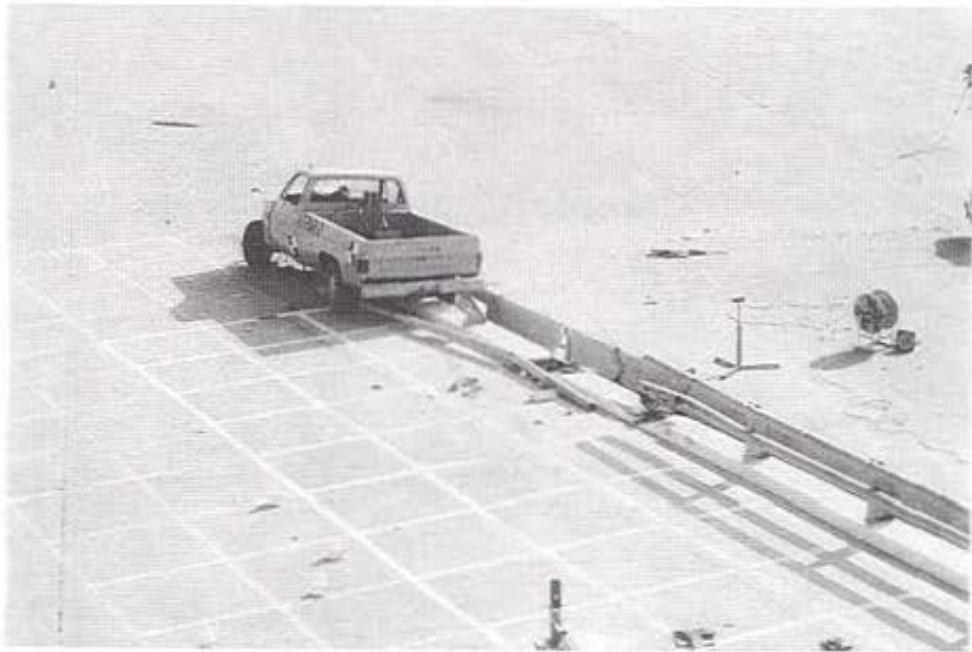
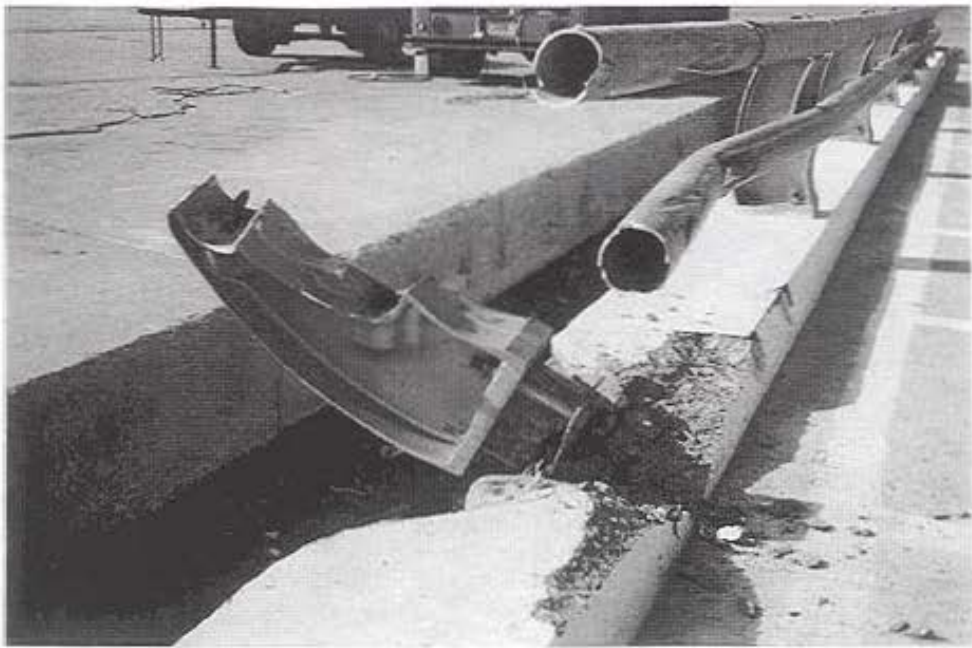
Figure 81. Bridge Rail Damage, Test FPAR-2 (continued).

Shortly after the impact with the bridge railing, both the top and bottom rail fractured completely through at post no. 7. In addition, the post and anchor assembly was uprooted from the concrete curb. After the vehicle had penetrated the bridge rail, it continued down the length of the system, knocking posts over until it came to a stop when the rear axle snagged on the last post.

As shown in figure 81, the bridge rail and curb were totally destroyed in the area where the impact occurred. It was evident from this test that both the post-to-deck connection and the aluminum rail itself needed to be redesigned. FHWA engineers remedied the first of these problems, as shown in figure 67, by extending the anchor bolts through the entire deck instead of simply casting them into the 6 (152 mm) in curb. The aluminum rail was then redesigned by increasing the wall thickness from 7/32 in (5.6 mm) to 7/16 in (11.1mm). This new design was evaluated in Test FPAR-3.

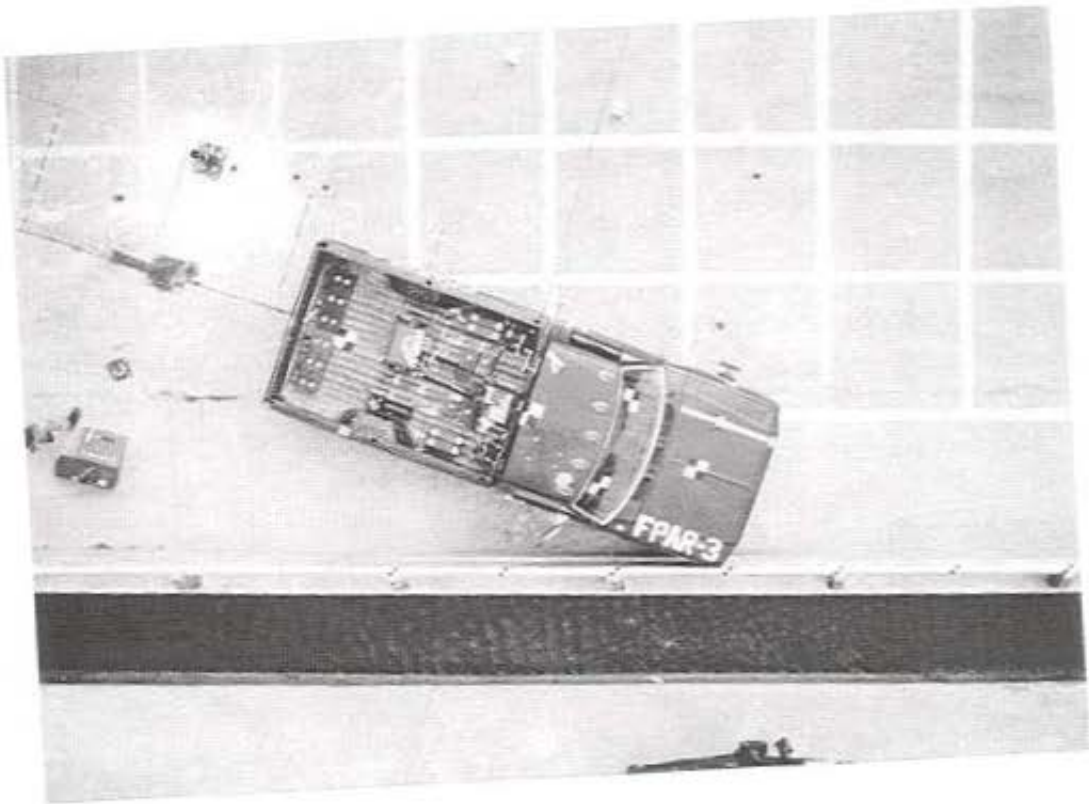
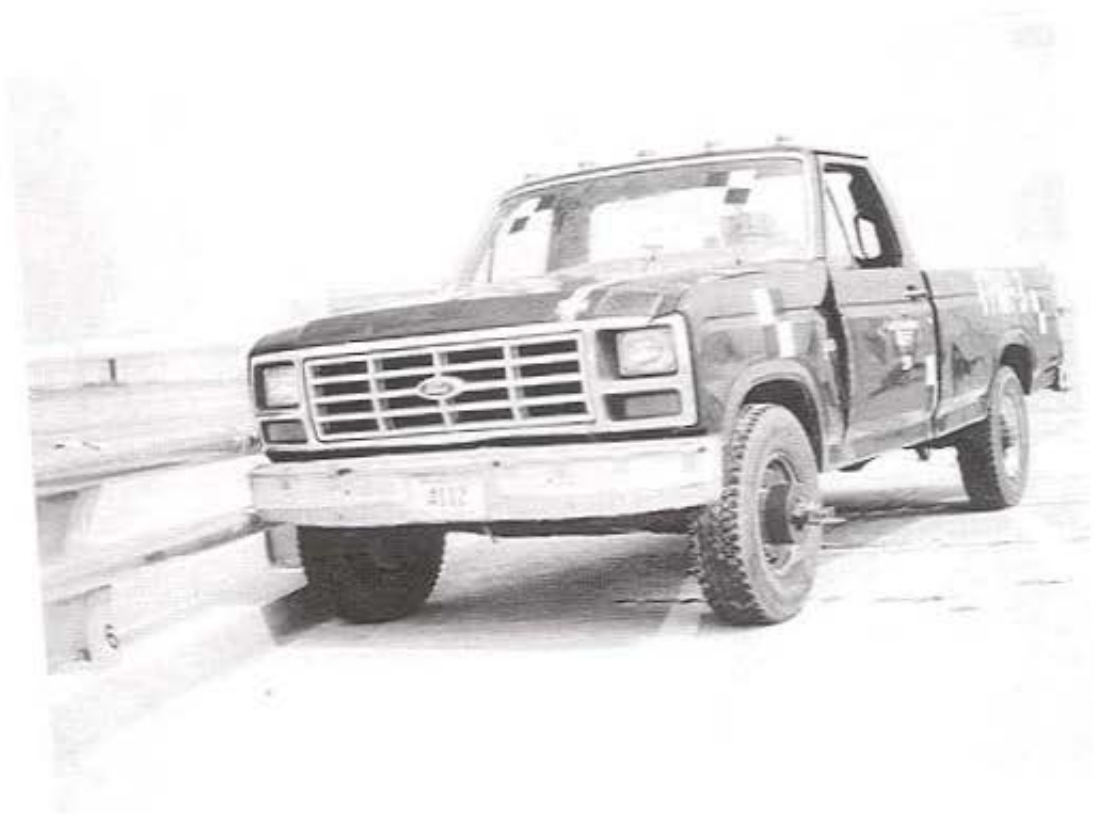
Figure 82. Impact Location, Test FPAR-3.

The 1985 Ford  $\frac{3}{4}$  ton pickup impacted the Foothills Parkway Bridge Rail at 45.7 mi/h (73.5 km/h) and 22.7 degrees. The impact point was located midspan between the fifth and sixth posts from the upstream end of the installation as shown in figure 82. A summary of the test results and sequential photographs are shown in figure 83. Additional sequential photographs are shown in figure 84.

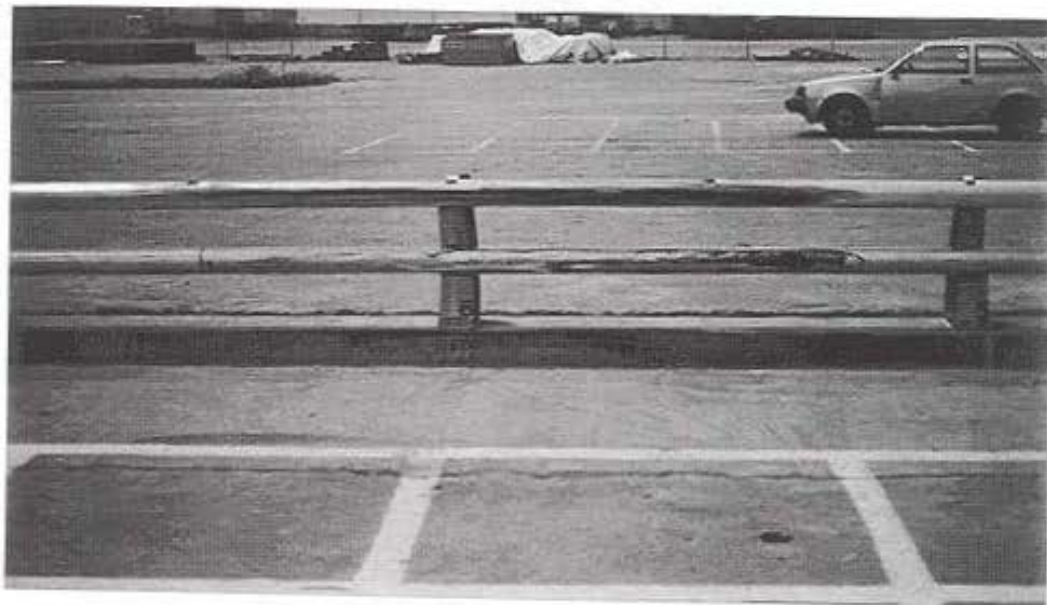
Figure 85. Bridge Rail Damage, Test FPAR-3.

The vehicle was smoothly redirected by the bridge railing, with a relatively small amount of damage to the rail and vehicle. There was no snagging of the vehicle or any evidence of cracking in the deck or curb. The maximum permanent set deflection of 1.9 in (4.8 cm) occurred midspan of posts nos. 5 and 6. The damage to the bridge rail is shown in figure 85, and the vehicle trajectory is shown in figure 86.

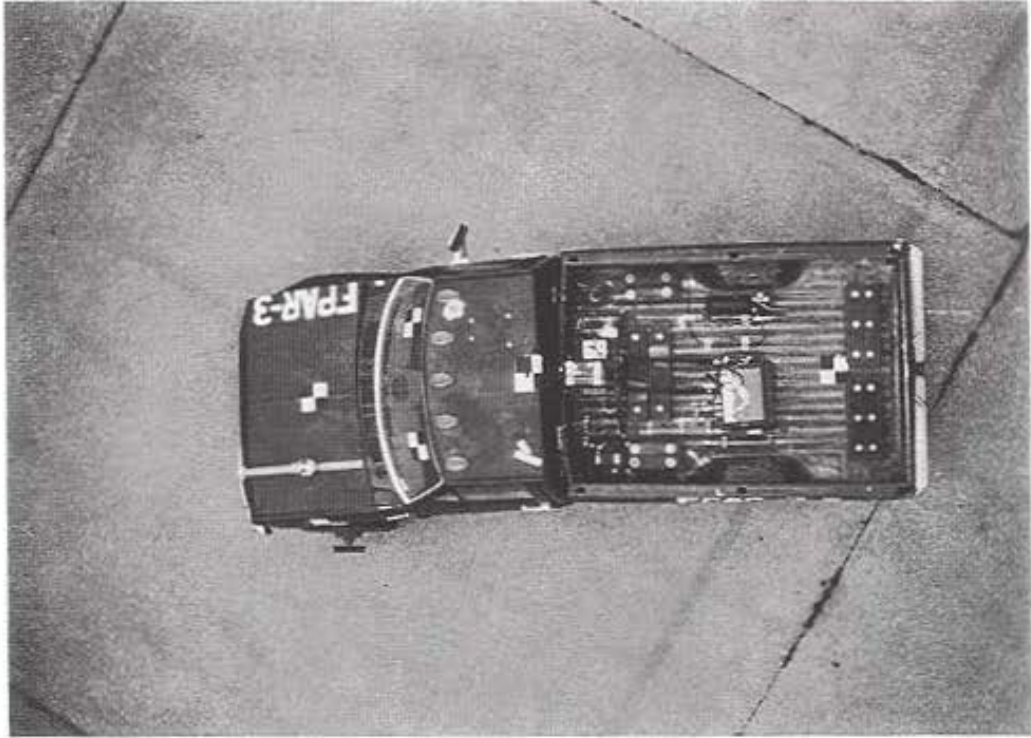
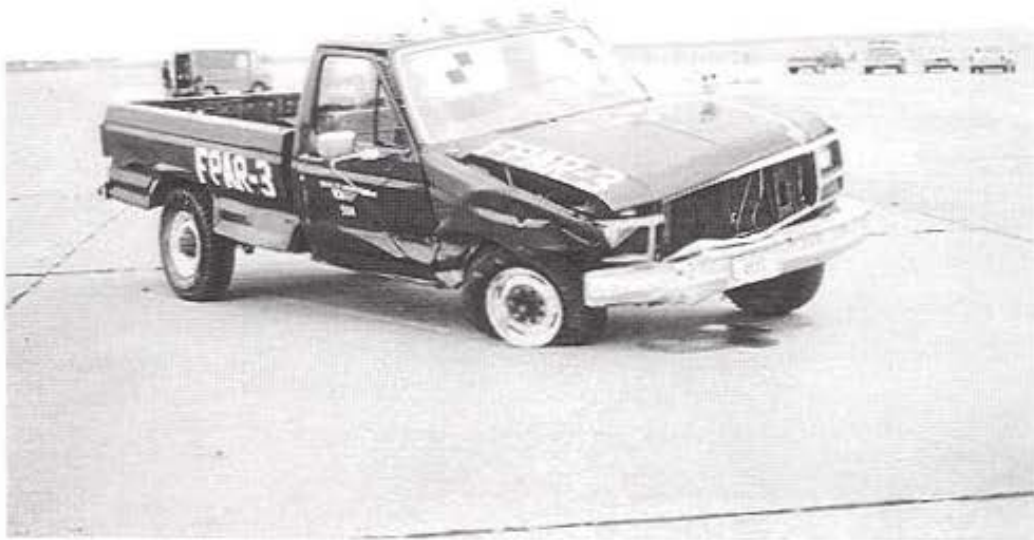
Figure 87. Vehicle Damage, Test FPAR-3.

The vehicle damage, shown in figure 87, included the crushing of the right-front corner of the vehicle and scrapes and dents along the length of the passenger side. The right-front tire was blown out, and the rim was bent. The maximum crush deformation of 10.75 in (27.3 cm) is shown in figure 88.

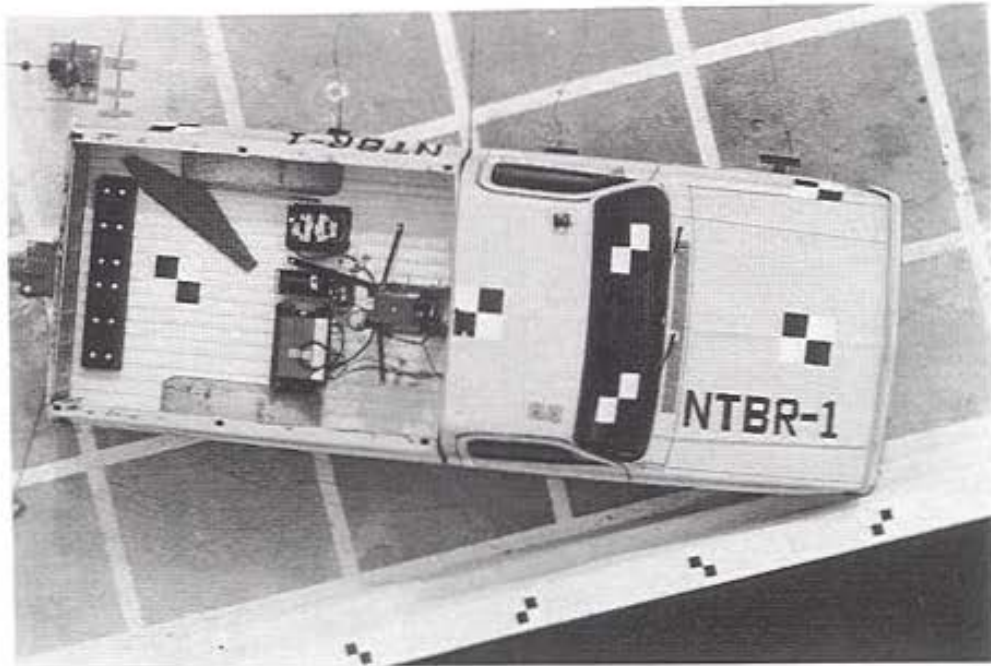
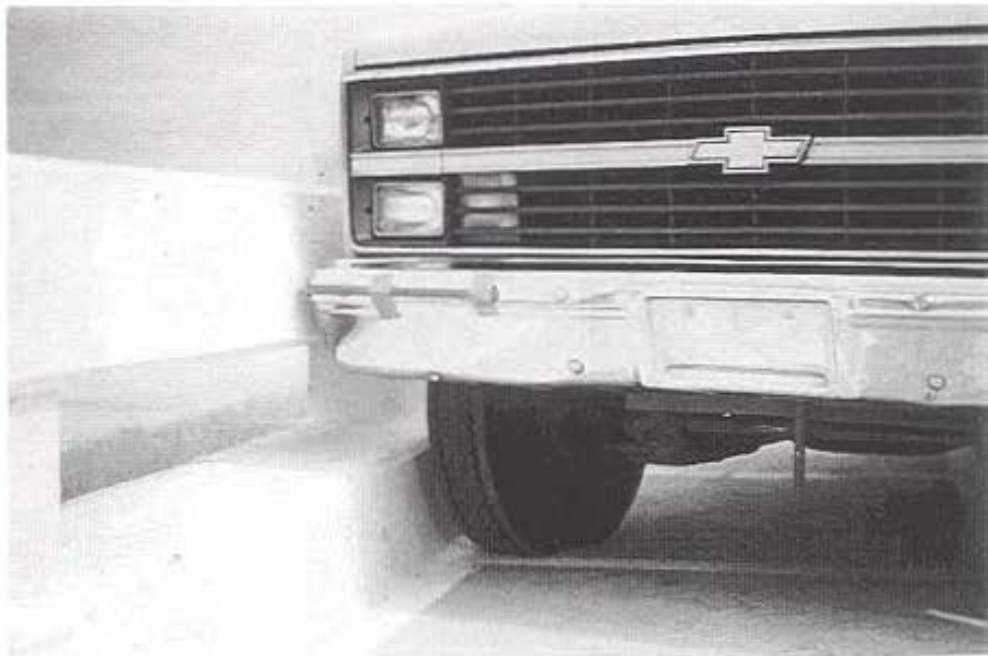
Figure 91. Vehicle Impact Location, Test NTBR-1.

The 1984 Chevrolet Custom Deluxe 20 pickup impacted the bridge rail at 45.2 mi/h (72.7 km/h) and 22.4 degrees. The impact point, shown in figure 91, was located at midspan between post nos. 5 and 6, or 4-ft 6 5/8-in (1.39 m) upstream from the center of the bridge rail expansion joint. A summary of the test results and sequential photographs are shown in figure 92. Additional sequential photographs are shown in figure 93.

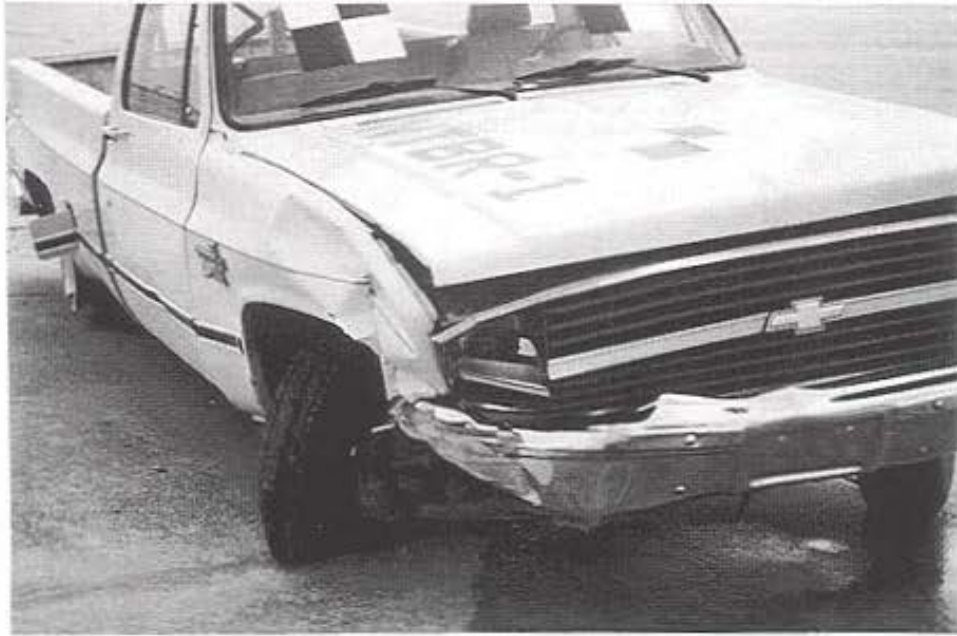
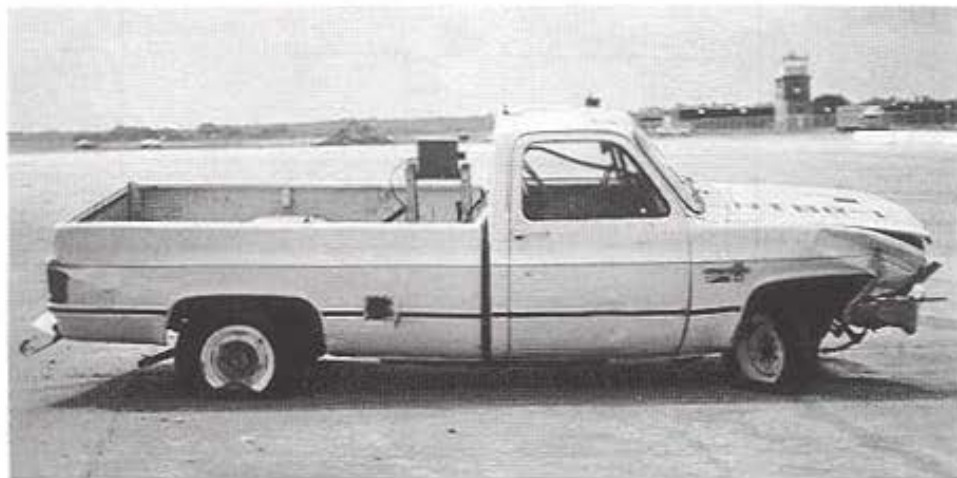
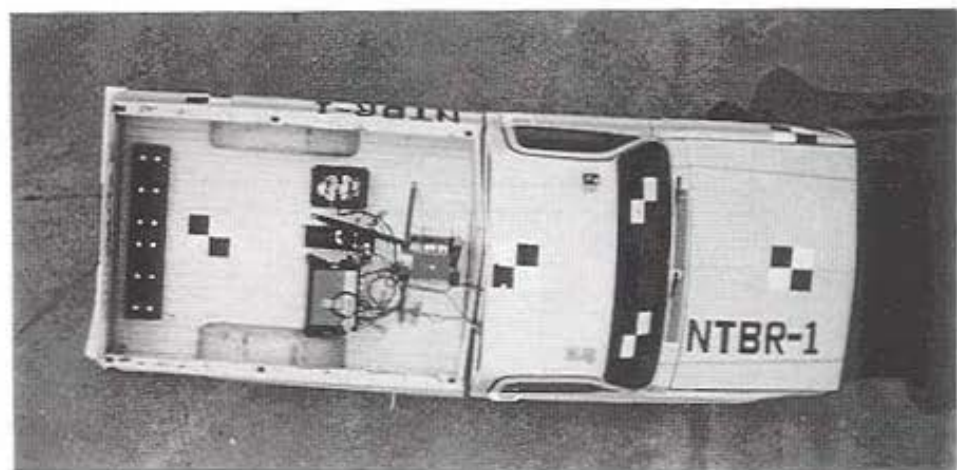
Figure 95. Vehicle Damage, Test NTBR-1.

Test vehicle damage was relatively minor and was largely limited to the right-front quarter panel and front bumper, as shown in figure 95. Both right-side tires were blown out, and the rims were damaged during the impact. The right-rear bumper also received minor

damage. There was no intrusion or deformation of the occupant compartment. Vehicle crush measurements are shown in figure 96. The bridge rail received superficial damage, as shown in figure 97. Heavy tire marks and deep scrapes on the rail indicating large contact forces were found over a 13-ft 11-in (4.2 m) length of the bridge rail. Lighter tire marks and small scrapes were observed over a 13 ft (4 m) length of the rail. Evidence of impact with the curb was limited to 4-ft 8-in (1.4 m) of tire marks.

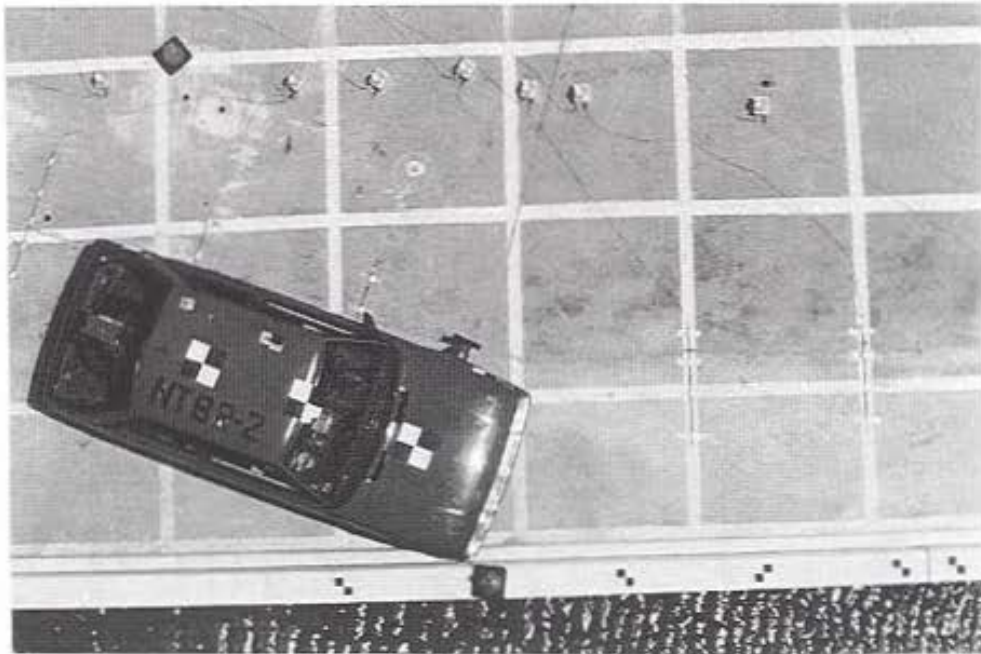
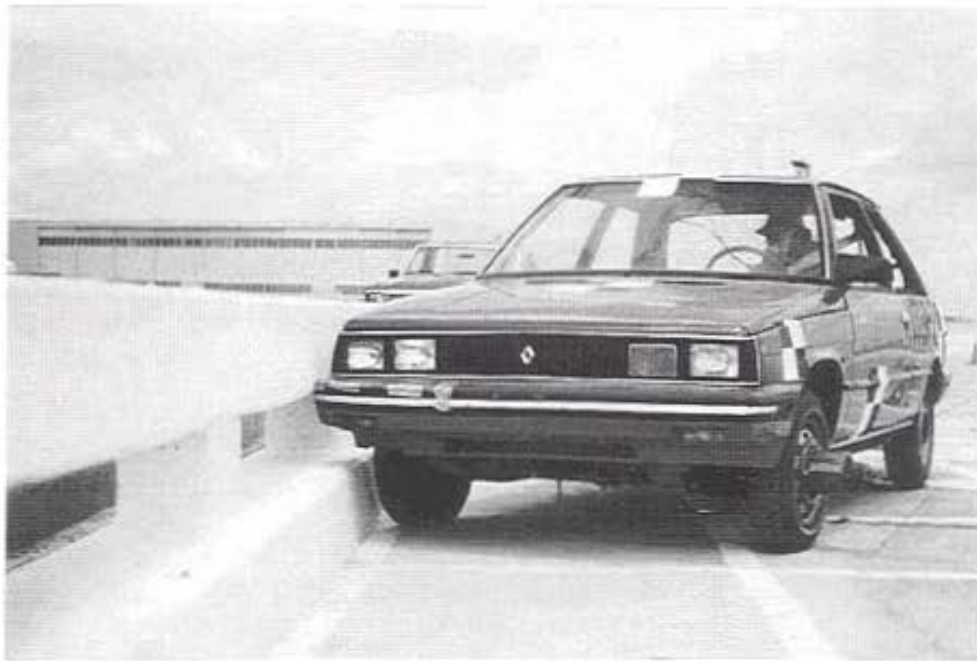
Figure 98. Vehicle Impact Location, Test NTBR-2.

The 1984 Renault Encore impacted the bridge rail at 51.5 mi/h (82.9 km/h) and 19.5 degrees. The impact point, shown in figure 98, was located at midspan between post nos. 4 and 5. A summary of the test results and sequential photographs are shown in figure 99. Additional sequential photographs are shown in figure 100.

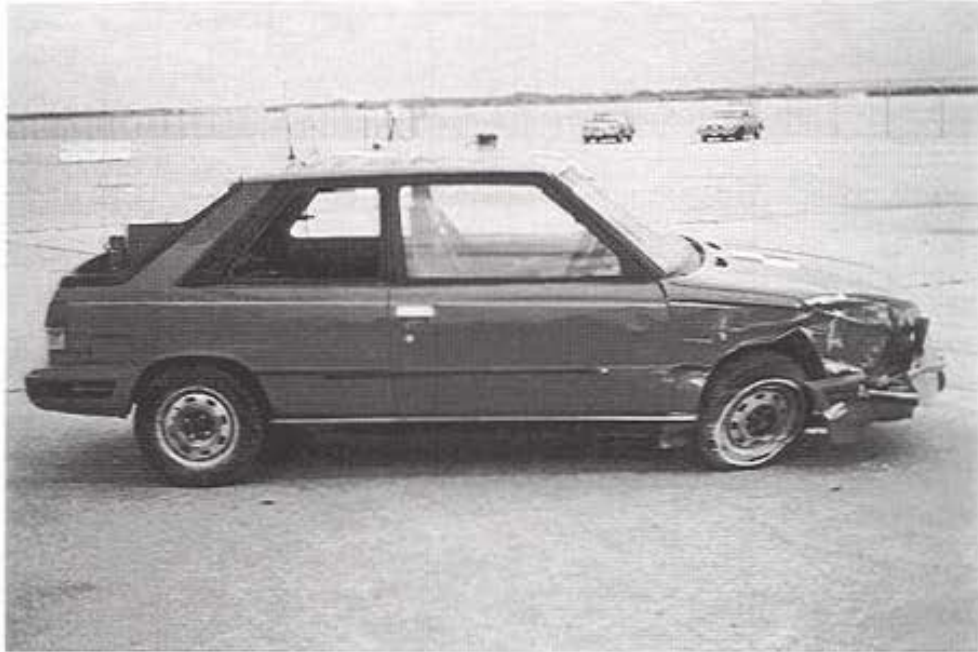
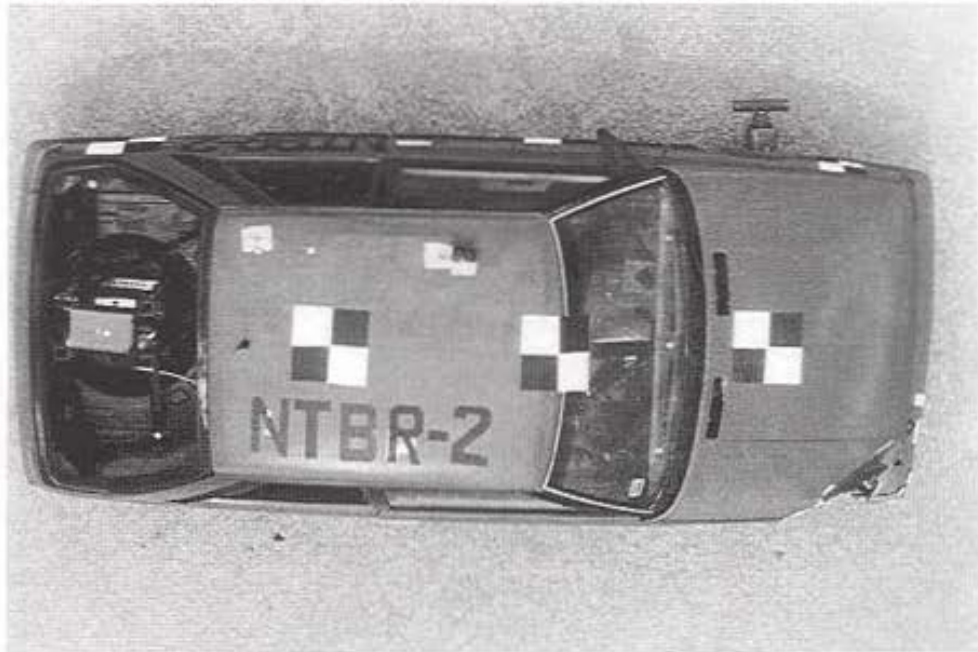
Figure 102. Vehicle Damage, Test NTBR-2.

Test vehicle damage was relatively minor and was largely limited to the right-front quarter panel and wheel, and front bumper, as shown in figure 102. There was slight buckling of the right-front floorboard and roof. The vehicle remained upright both during and after the test, and there was no intrusion of the occupant compartment. Vehicle crush measurements are shown in figure 103.

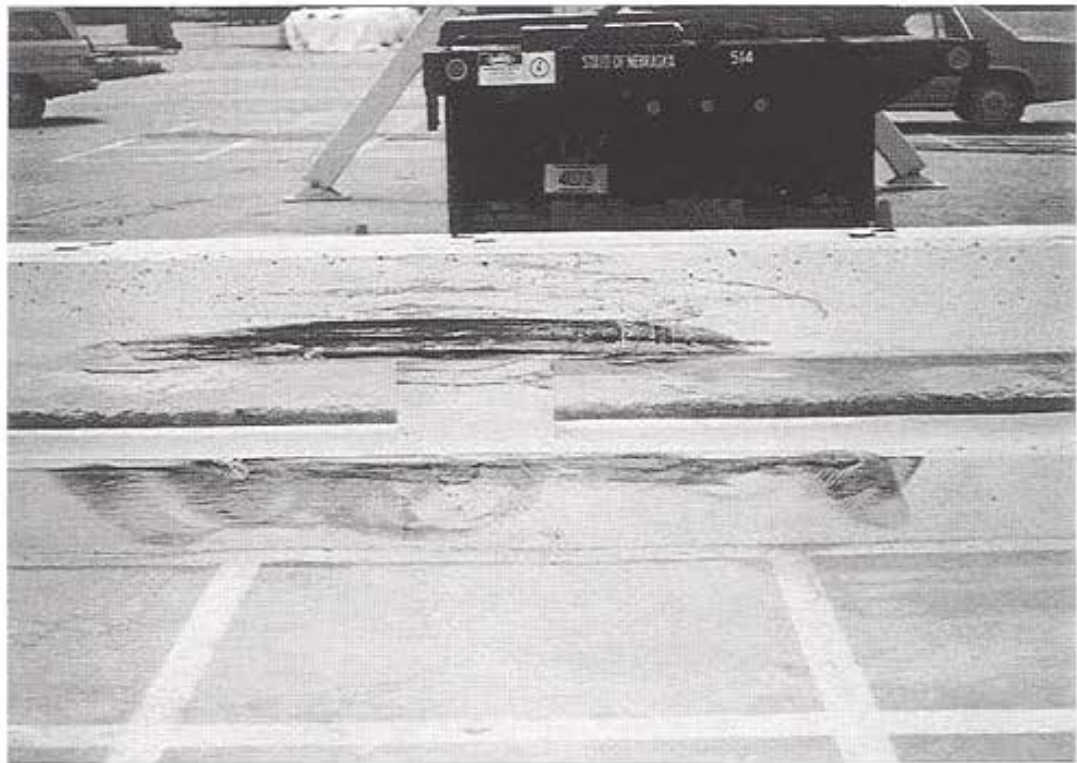
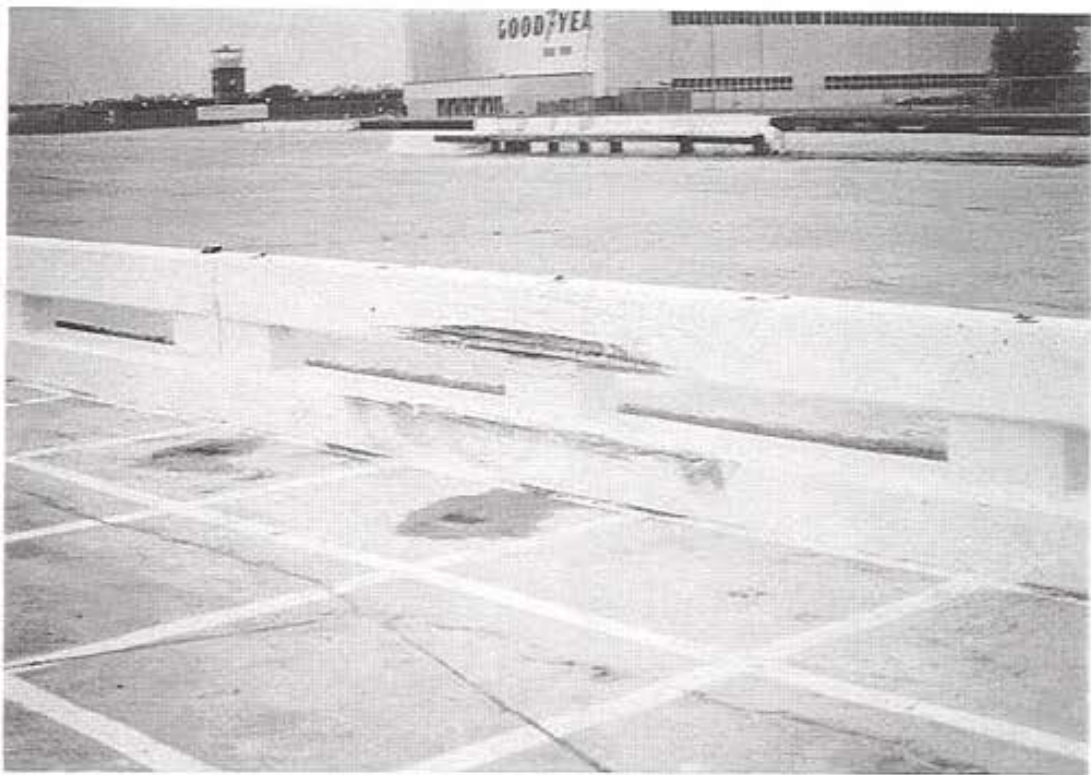
Figure 104. Bridge Rail Damage, Test NTBR-2.

Bridge rail damage is shown in figure 104. Tire marks and minor concrete spalling accounted for the majority of the damage. The length of the markings on the rail were approximately 7.5 ft (2.3 m), caused by the scraping of the bumper and the fender. The length of the markings on the curb were 8.5 ft (2.6 m), caused by the rubbing of the right-front tire which blew out at impact.

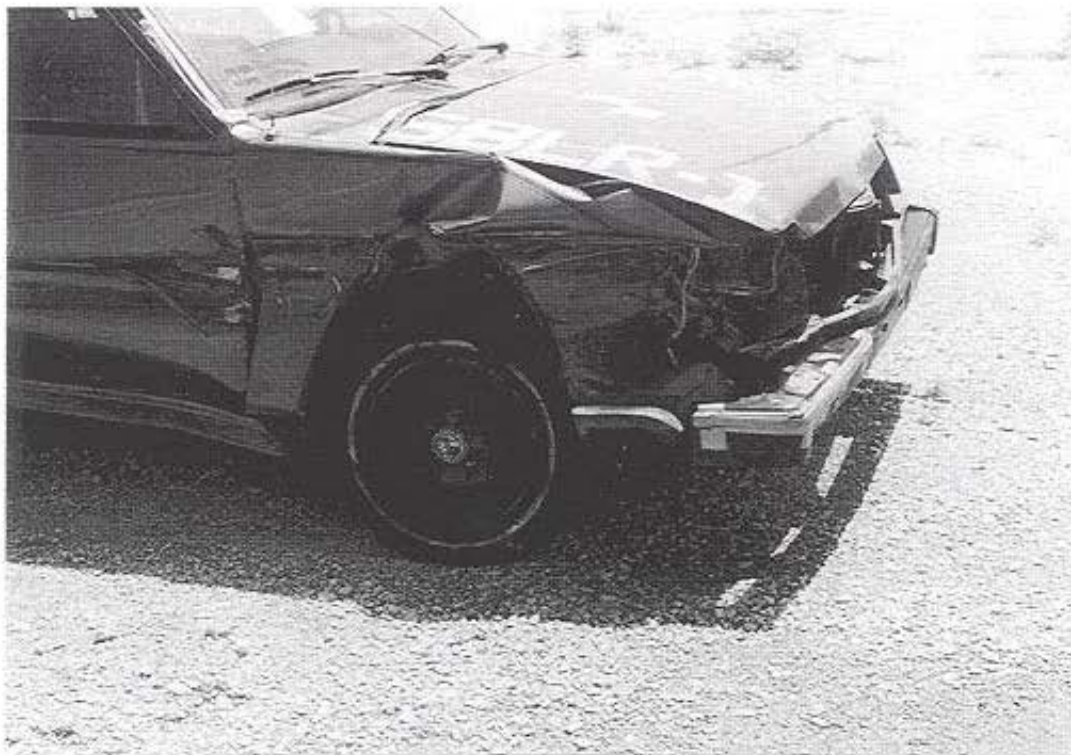
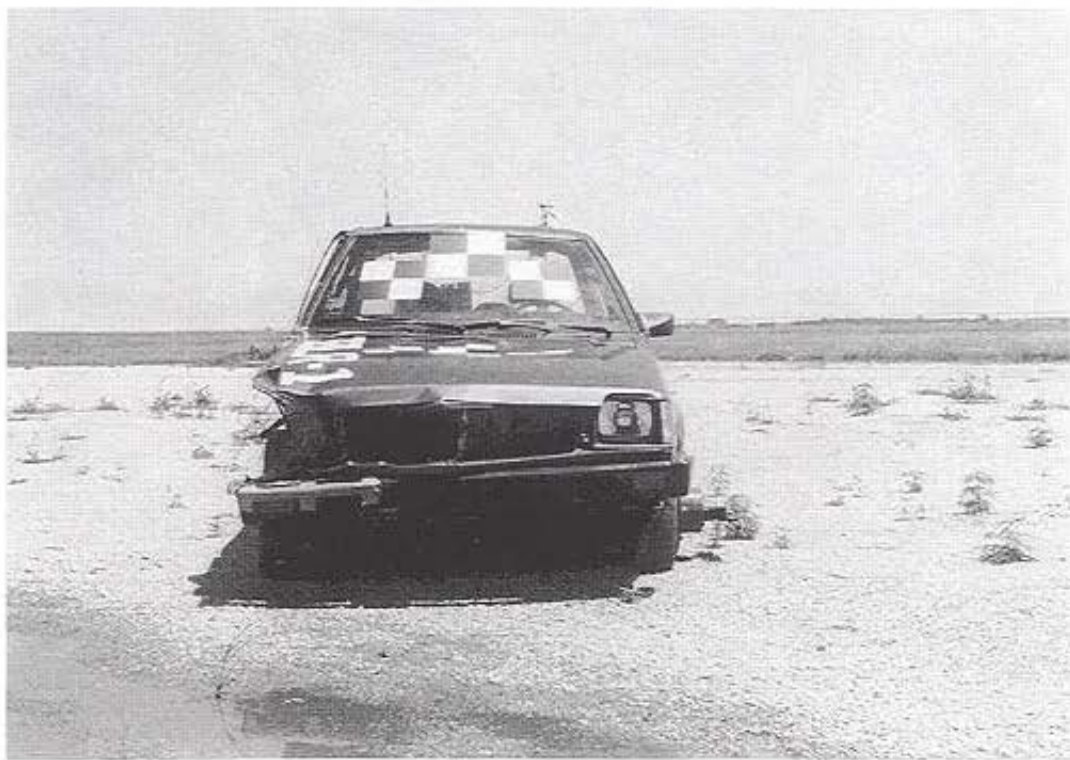
**Figure 110.** Vehicle Damage, Test SBLR-1.

Test vehicle damage was relatively minor and was largely limited to the right-front quarter panel and passenger door, as shown in figure 110. There was no intrusion or deformation of the occupant compartment. Vehicle crush measurements are shown in figure 111.

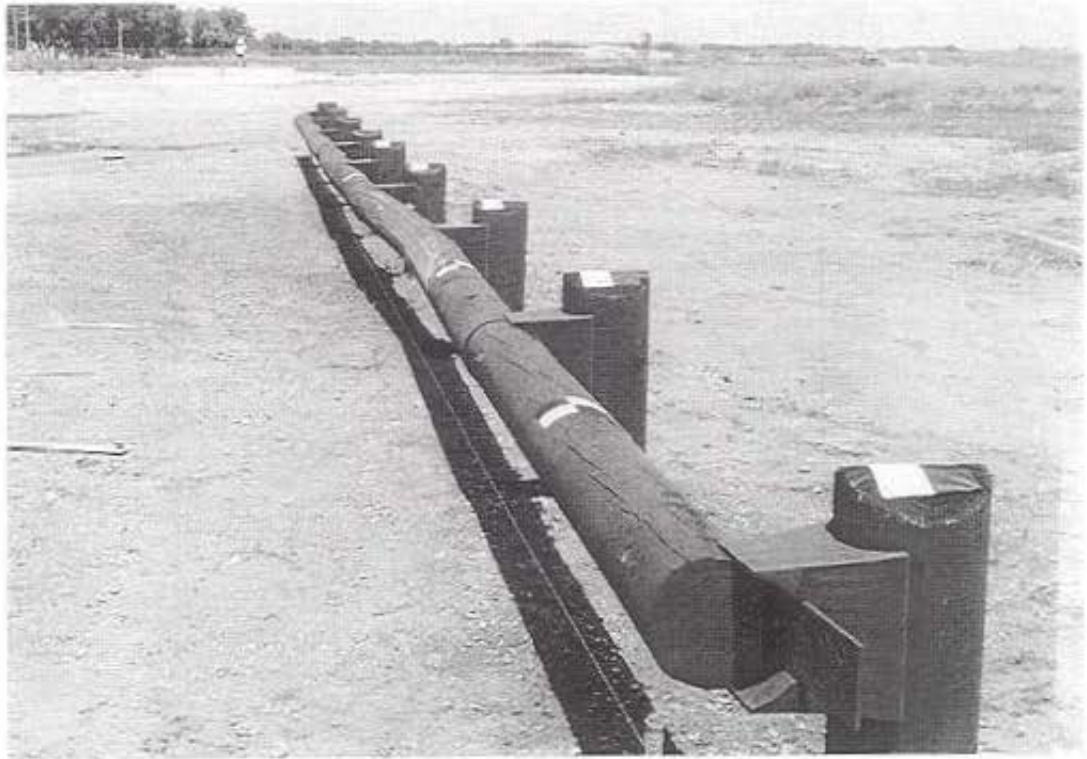
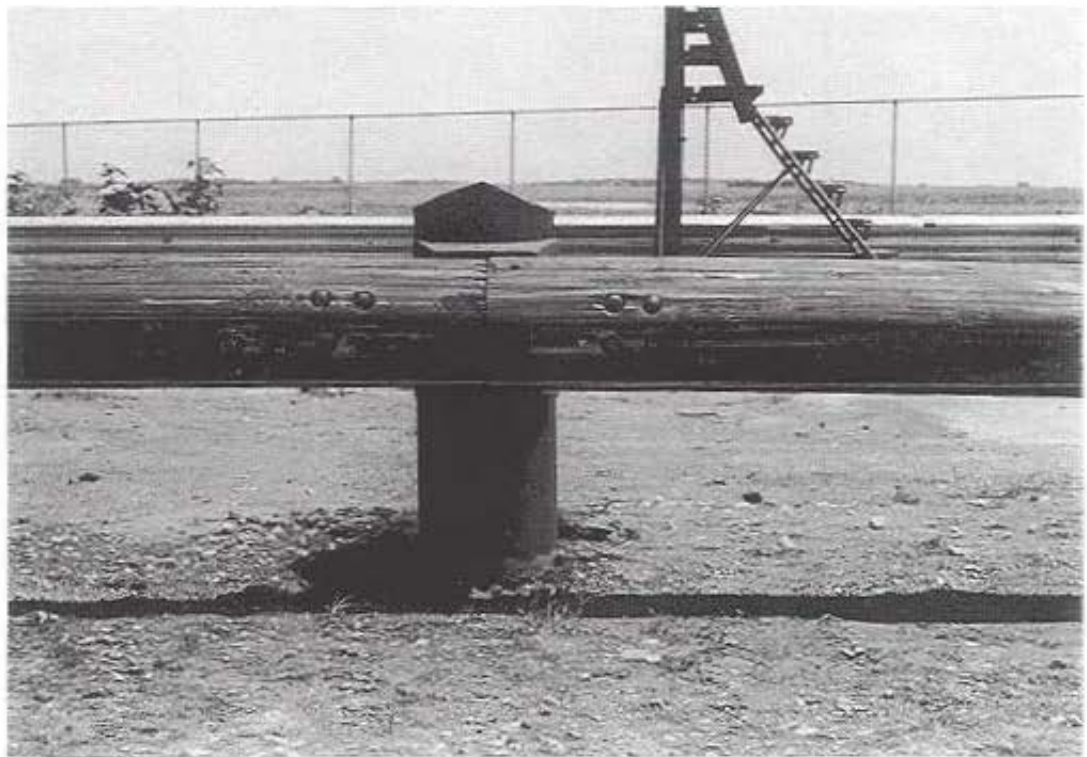
**Figure 112.** Log Rail Damage, Test SBLR-1.

Damage to the log rail consisted of minor scrapes on the surface of the rail and a maximum permanent deflection of 2 15/16 in (75 mm) at the first post after impact. This damage can be seen in figure 112. The effective coefficient of friction was found to be 1.18 and would be classified as marginal according to the *AASHTO Guide Specifications for Bridge Railings*.<sup>(8)</sup>

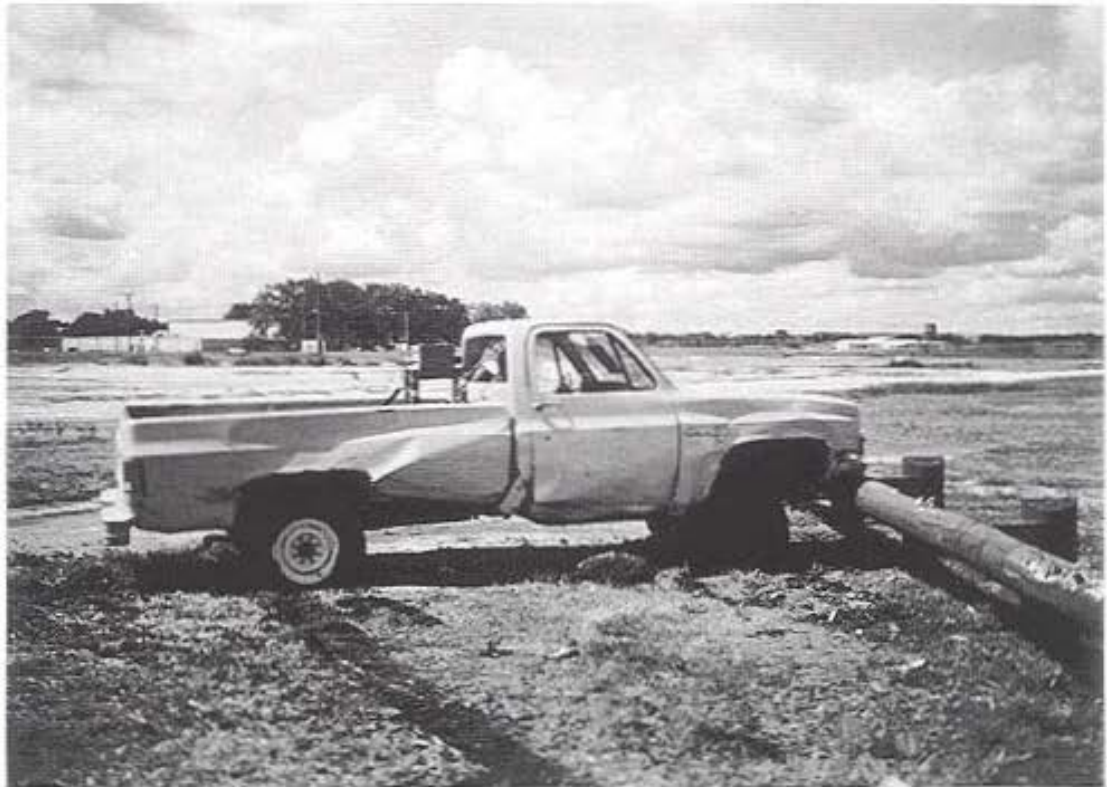
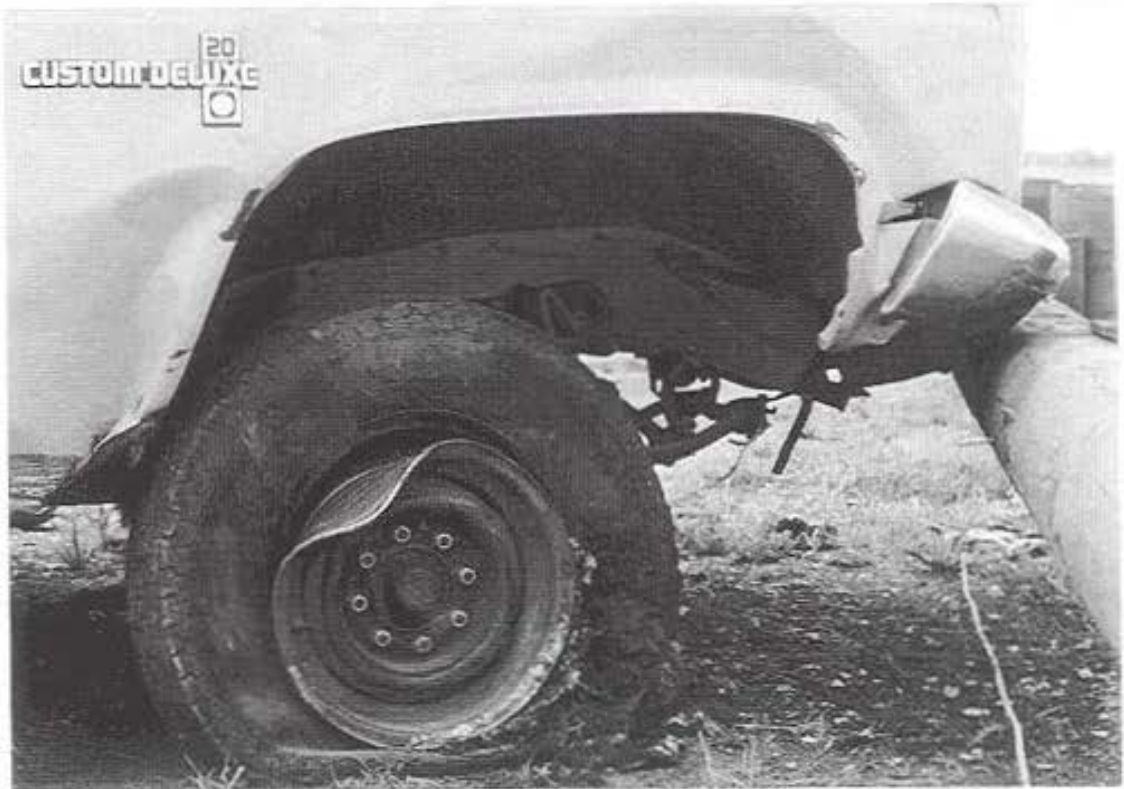
Figure 117. Vehicle Damage, Test SBLR-2.

Test vehicle damage, shown in figure 117, was limited to the undercarriage on the right front corner and along the right side. Vehicle crush measurements are shown in figure 118. The vehicle remained upright both during and after the test, and there was no intrusion of the occupant compartment.
