1. Report No. FHWA-RD-96-199		2. Government Accession No.		3. Recipient's Catalog No.	
4. Title and Subtitle NCHRP REPORT 350 COMPLIANCE TEST 5-12 OF THE 1.07-m VERTICAL WALL BRIDGE RAILING				5. Report Date

6. Performing Organization Code	
7. Author(s) Dean C. Alberson, Richard A. Zimmer, and Wanda L. Menges				8. Performing Organization Report No. Project 405511-2

9. Performing Organization Name and Address Texas Transportation Institute The Texas A&M University System College Station, Texas 77843-3135				10. Work Unit No. 3A5B

11. Contract or Grant No. DTFH61-95-C-00136	
12. Sponsoring Agency Name and Address Office of Safety and Traffic Operations R&D Federal Highway Administration 6300 Georgetown Pike McLean, Virginia 22101-2296				13. Type of Report and Period Covered Final Report September 1995 - May 1996

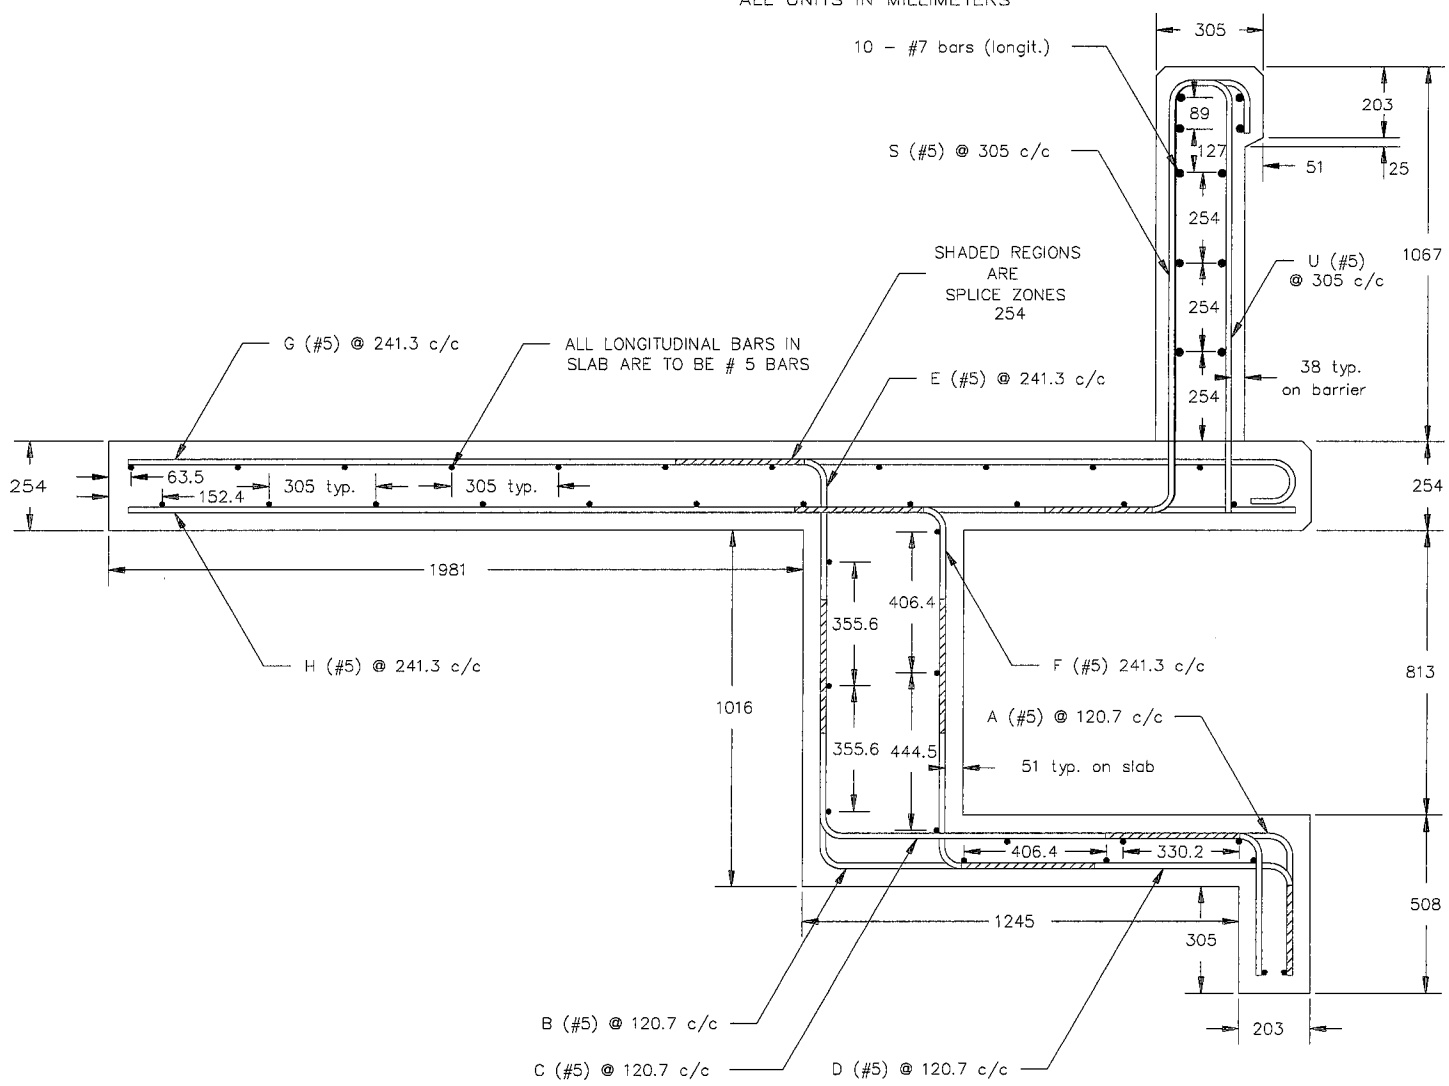
Figure 1. Details of the 1.07-m vertical wall bridge railing installation.

The 1.07-m vertical wall bridge railing used for this crash test was constructed under a previous study. The total length of the original installation was 30.5 m and was extended to 39.6 m. A cross section of the test installation is shown in figure 1 and photographs of the completed installation are shown in figure 2.

The 1.07-m vertical wall bridge railing is 254 mm thick, with a thickened section of 305 mm at the top. This “beam” along the top edge serves to enhance the longitudinal distribution of forces within the wall and the deck. Two types of vertical reinforcing bars are alternated to provide #5 bars spaced at 152 mm in the traffic face. The collision force used in the design was 685 kN uniformly distributed over a longitudinal distance of 1.07-m at 864 mm above the deck surface.

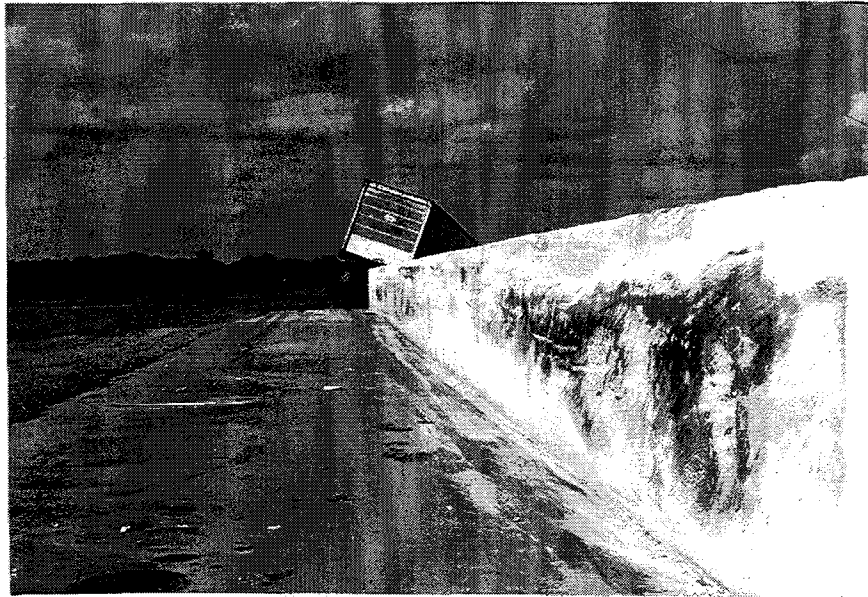
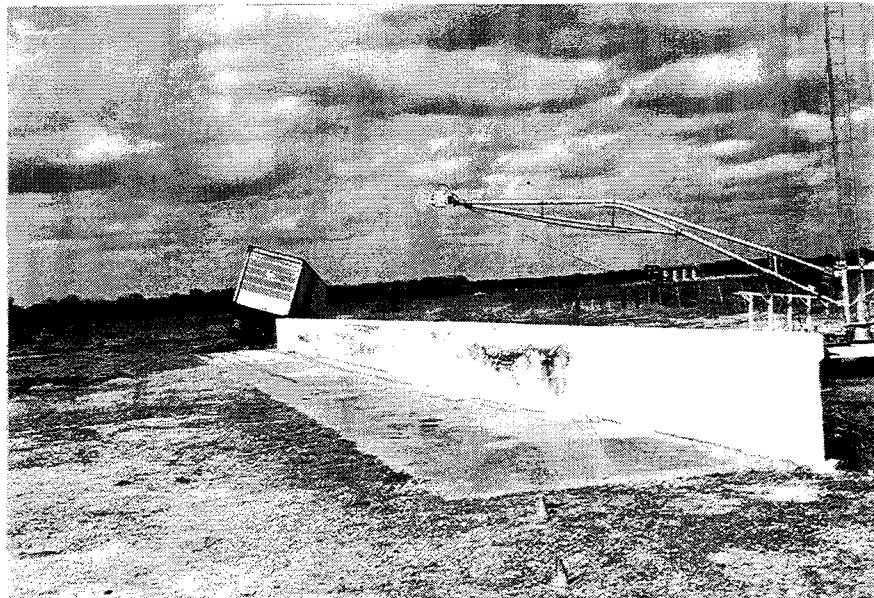
Figure 8. After-impact trajectory for test 405511-2.

Damage to the vertical wall bridge railing was mostly cosmetic, as shown in figures 8 and 9. There were tire marks and gouging all along the face of the bridge railing. Some spalling of concrete along the top of the bridge railing was caused as the van trailer rode along the top. The total length of contact of the vehicle with the bridge railing was 34.6 m. There was no structural damage to the connection with the bridge deck.
