1. Report No. FHWA-RD-96-032	2. Government Accession No.	3. Recipient's Catalog No.	
4. Title and Subtitle CRASH TESTING AND EVALUATION OF RETROFIT BRIDGE RAILINGS AND TRANSITION		5. Report Date	6. Performing Organization Code

7. Author(s) C. Eugene Buth and Wanda L. Menges		8. Performing Organization Report No. Research Foundation 72070	
9. Performing Organization Name and Address Texas Transportation Institute The Texas A&M University System College Station, Texas 77843-3135		10. Work Unit No. NCP No.	11. Contract or Grant No. DTFH61-92-C-00025

12. Sponsoring Agency Name and Address Office of Safety & Traffic Operations R&D Federal Highway Administration 6300 Georgetown Pike McLean, Virginia 22101-2296		13. Type of Report and Period Covered Final Report May 1992 - August 1995

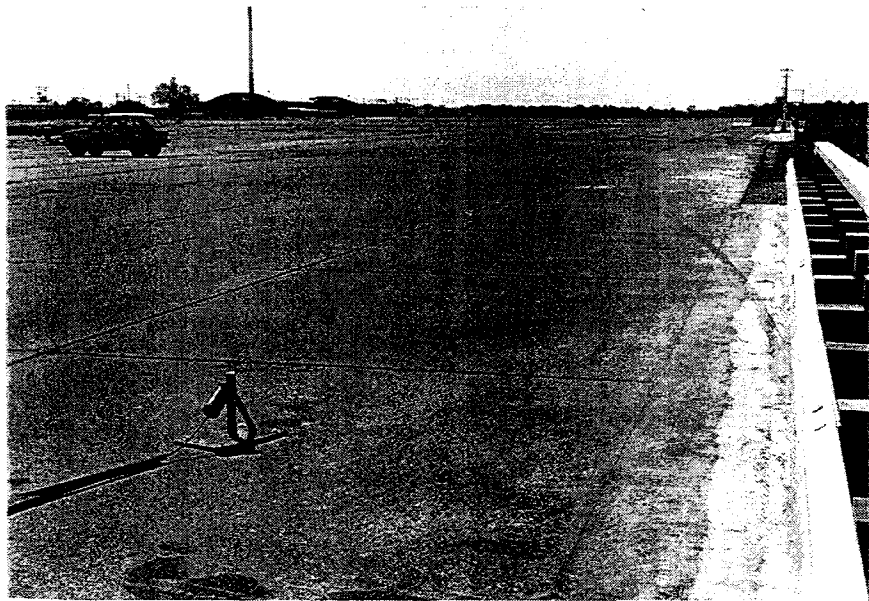
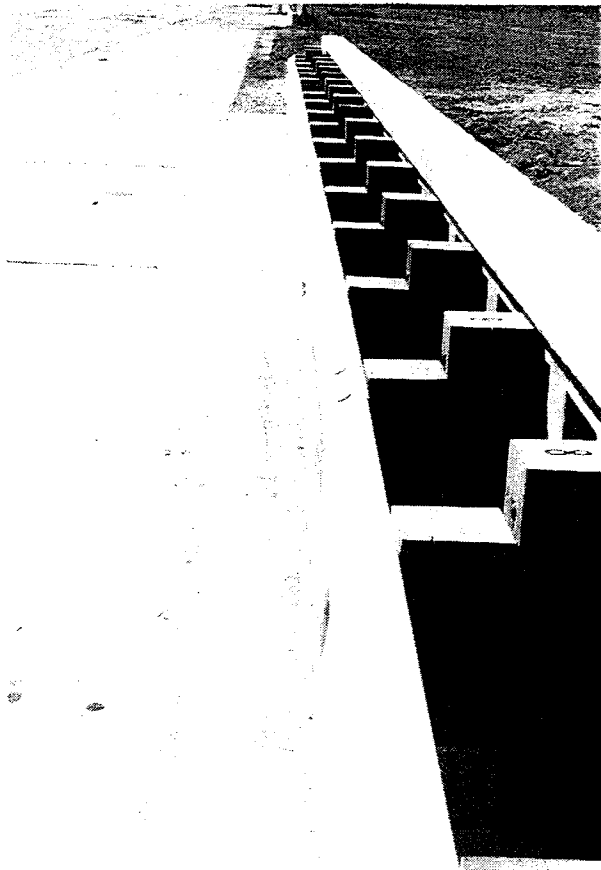
Figure 7. Site after test 472070-1.

As can be seen in figures 7 and 8, the installation received minimal damage. The curb received cosmetic damages only. There was no evidence of lateral movement of the timber blockouts. The W-beam was marred by tire marks and there was no measurable permanent deformation of the W-beam. The vehicle was in contact with the installation for 2.5 m (8.3 ft).

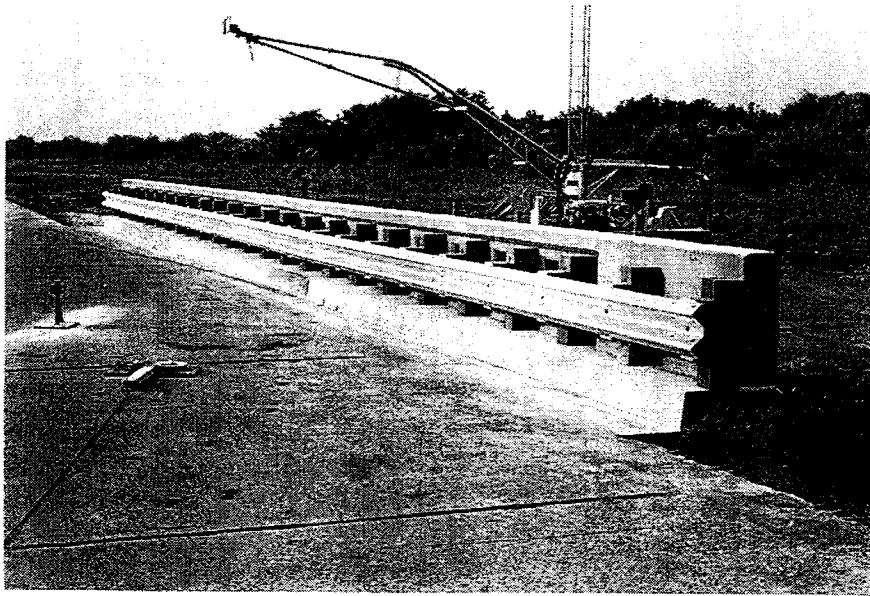
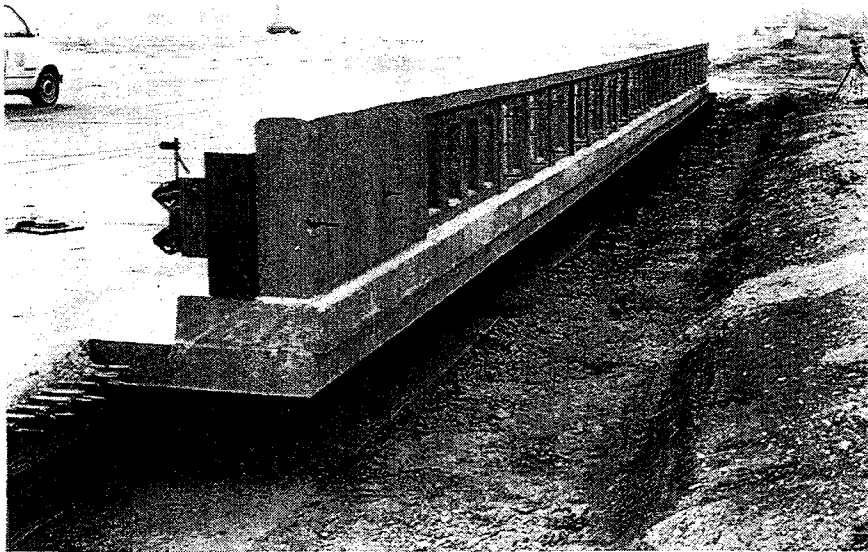
The W-beam retrofit sustained cosmetic damage only during the first test, therefore the retrofit was cleaned and repaired for use in the second test (as shown in figures 11 and 12). A 1986 Ford F250 pickup, shown in figures 13 and 14, was used for the second crash test. Test inertia weight of the vehicle was 2452 kg (5400 lb) and its gross static weight was 2528 kg (5569 lb). The height to the lower edge of the vehicle bumper was 419 mm (16.5 in) and it was 705 mm (27.8 in) to the upper edge of the bumper. Additional dimensions and

Figure 11. W-beam retrofit for baluster bridge railing before test 472070-2.

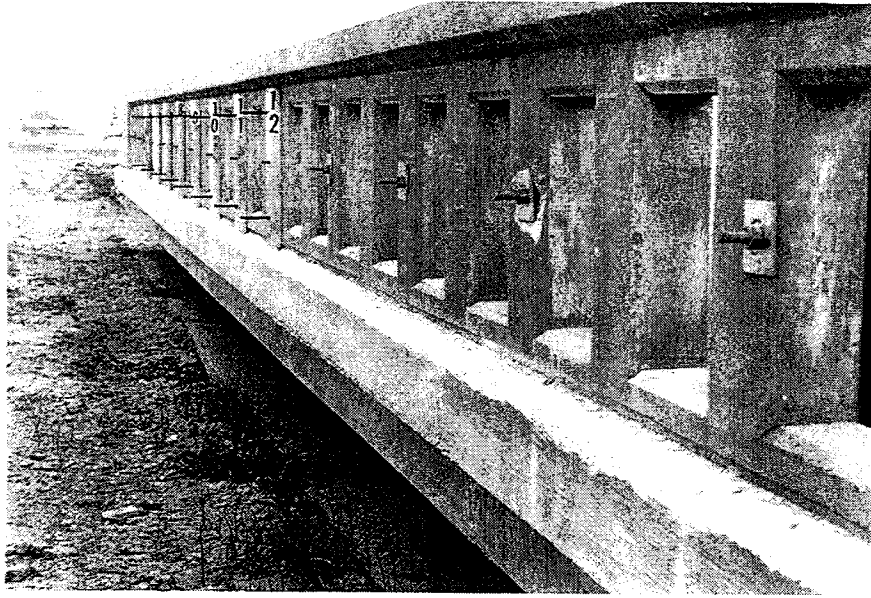
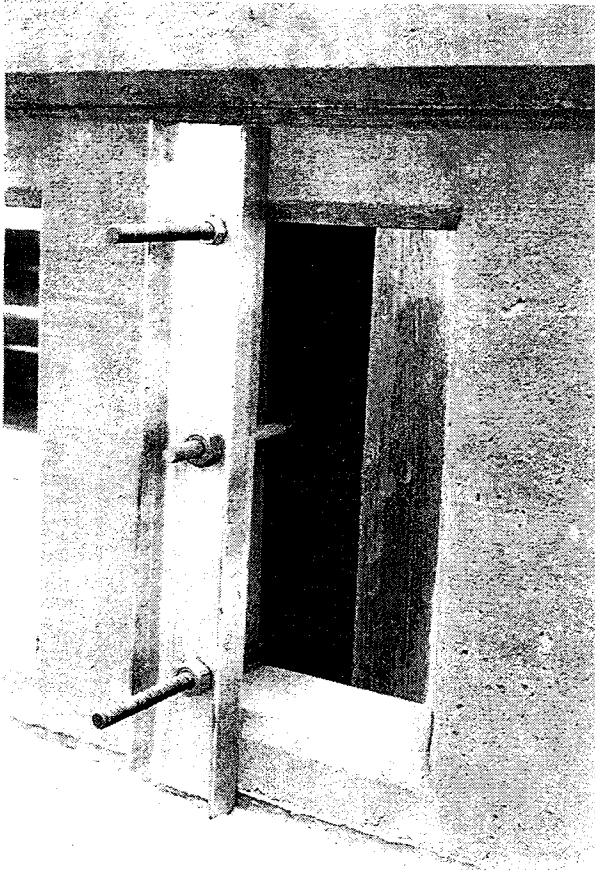
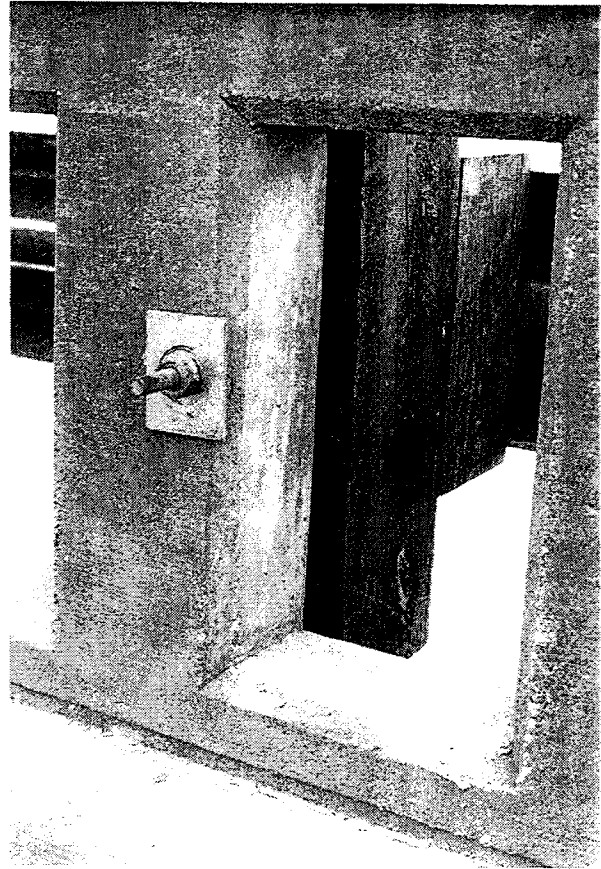
Figure 12. W-beam retrofit for baluster bridge railing (field side view).

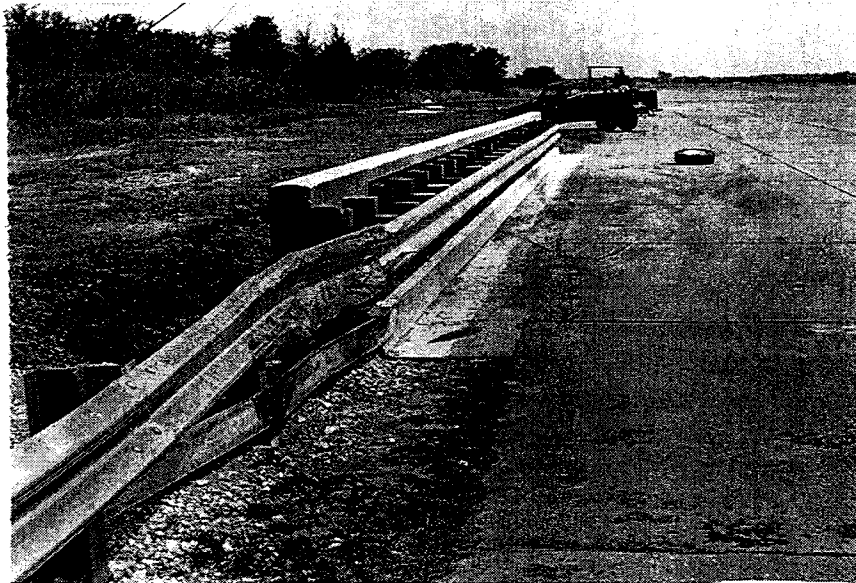
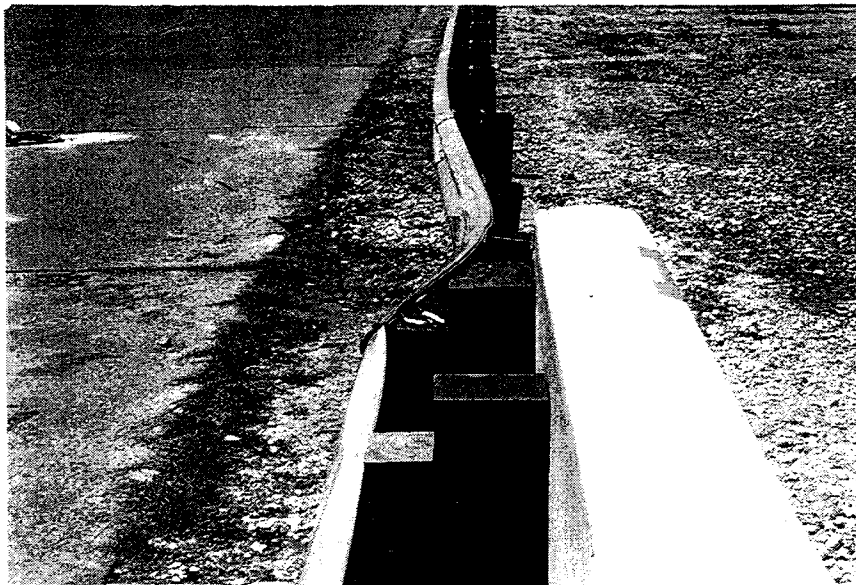
Figure 23. Site after test 472070-3.

As can be seen in figures 23 and 24, the installation received moderate damage. The first seven posts from the end of the bridge railing were displaced laterally toward the bridge rail. Maximum permanent deformation was 140 mm (5.5 in) at post 2. The first wood post and blockout on the bridge railing were damaged and the end of the concrete parapet was chipped. The vehicle was in contact with the installation for 3.8 m (12.4 ft).

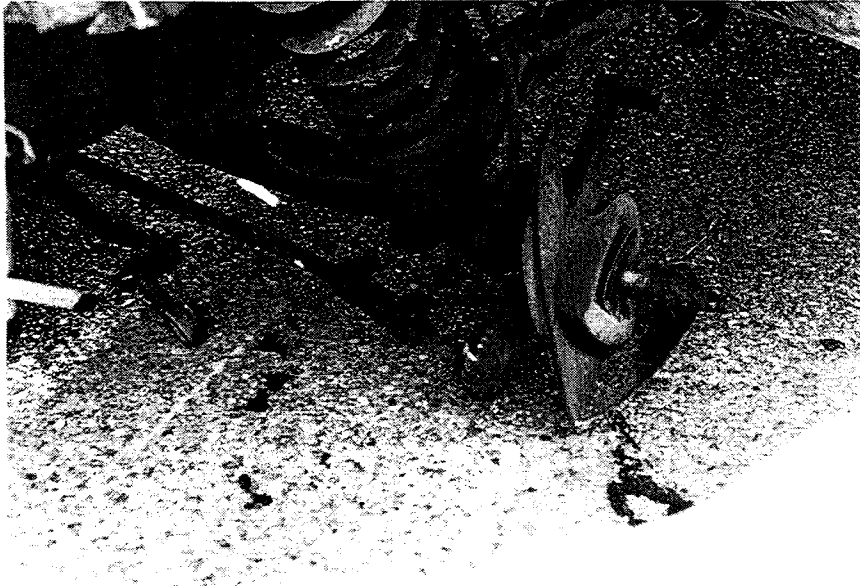
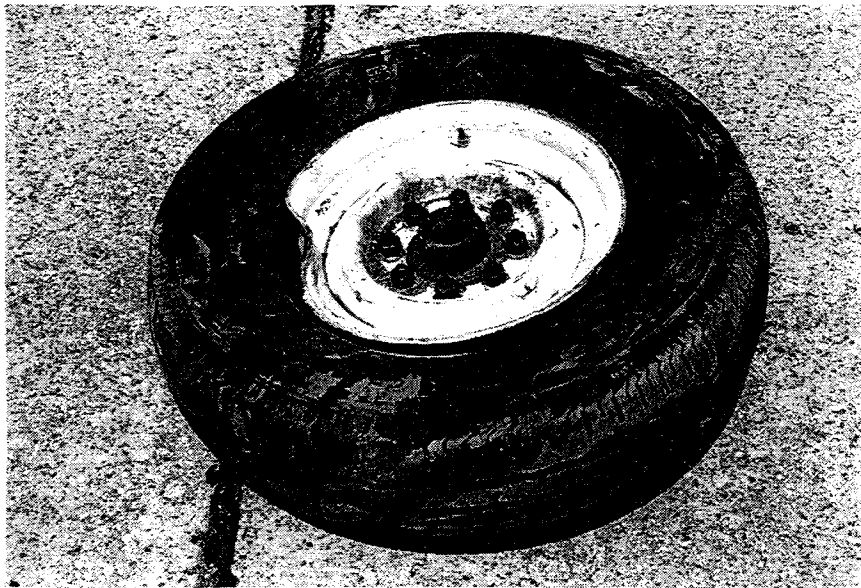
The vehicle sustained moderate damage to the front and left side as shown in figure 25. Maximum exterior crush at the right front corner at bumper height of the vehicle was 380 mm (15.0 in), and there was 24 mm (0.9 in) deformation into the occupant compartment at the center of the floorpan area. The left front wheel, caliper, and rotor were pulled off the vehicle as shown in figure 26. The left front frame, tie rod, shock, radius arm, and I-beam were bent. The steering shaft broke at the box to the pitman arm. There was also damage to the front bumper, hood, grill, radiator, left front quarter-panel, door, left rear quarter-panel and left rear wheel rim.

Figure 26. Damage to left wheel of vehicle after test 472070-3.

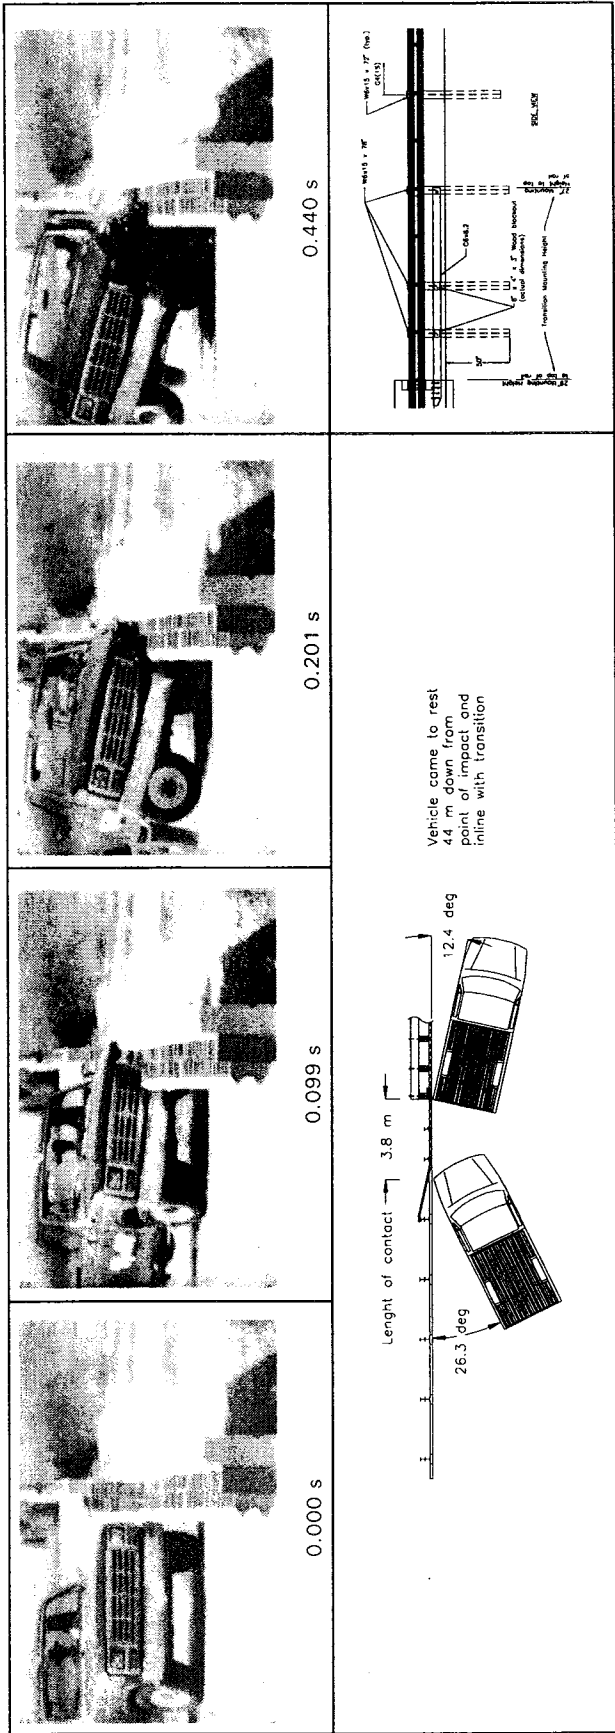
Figure 27. Summary of results for test 472020-3.

General Information		Impact Conditions		Test Article Deflections (m)	
Test Agency	Texas Transportation Institute	Speed (km/h)	73.1 (45.4 mi/h)	Dynamic	N/A
Test No.	472070-3	Angle (deg)	26.3	Permanent	0.14 (0.5 ft)
Date	07/08/94	Exit Conditions		Vehicle Damage	
Test Article		Speed (km/h)	45.0 (28.0 mi/h)	Exterior	
Type	Transition	Angle (deg)	12.4	VDS	11LFGQ5
Name	W-beam Retrofit	Occupant Risk Values		CDC	11FLEK3 & 11LDEW3
Installation Length (m)	19 m (62.5 ft)	Impact Velocity (m/s)		Interior	
Size and/or dimension and material of key elements	Nested W-beam on steel posts	x-direction	7.6 (24.8 ft/s)	OCDI	FS0000000
Soil Type and Condition	Strong soil, dry	y-direction	6.7 (22.0 ft/s)	Maximum Exterior Vehicle Crush (mm)	380 (15.0 in)
Test Vehicle		THIV (optional)		Max. Occ. Compart. Deformation (mm)	24 (0.9 in)
Type	Production Model	Ridedown Accelerations (g's)		Post-Impact Behavior	
Designation	2000P	x-direction	-10.0	Max. Roll Angle (deg)	33

Model	1986 Ford F250	y-direction	11.6	Max. Pitch Angle (deg)	-9
Mass (kg) Curb	1960 (4317 lb)	z-direction	3.5	Max. Yaw Angle (deg)	-16
Test Inertial	2000 (4405 lb)				
Dummy	75 (165 lb)				
Gross Static	2076 (4573 lb)

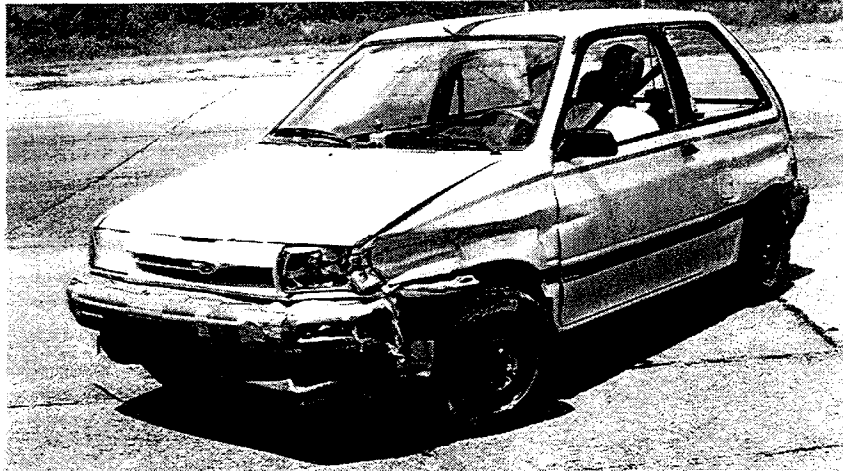
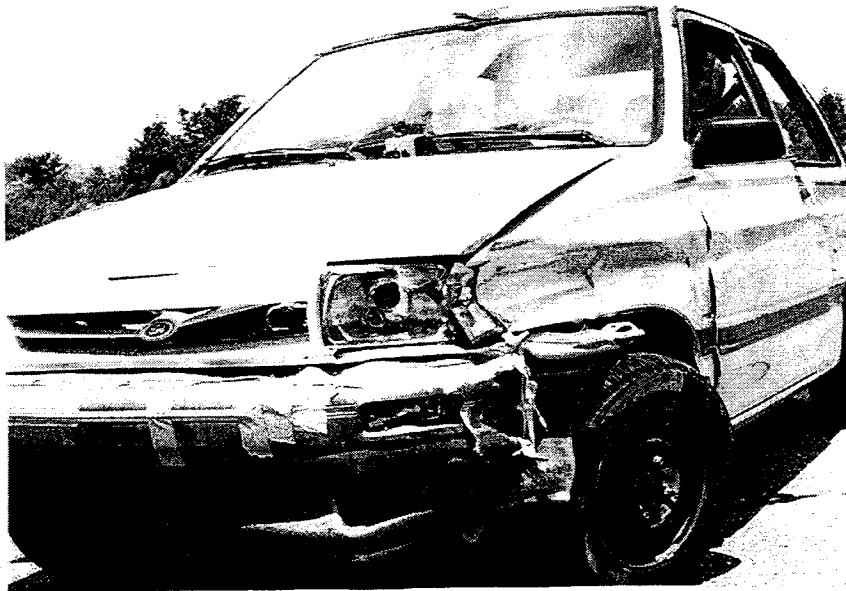
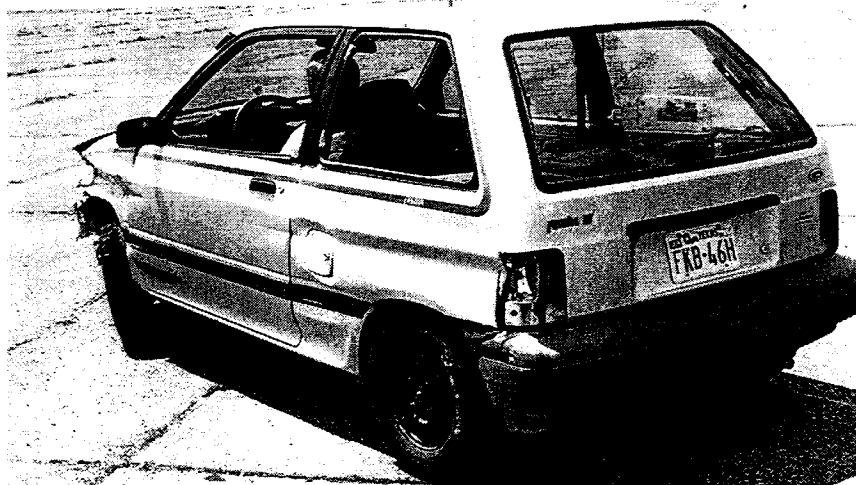
Figure 31. Vehicle after test 472070-4.

The vehicle sustained moderate damage to the left front quarter with minor damage to the left side as shown in figure 31. Maximum exterior crush at the left front corner at bumper height of the vehicle was 190 mm (7.5 in), and there was no deformation into the occupant compartment. Damage was sustained to the left front strut, front bumper, grill, hood, left front wheel rim, and rear hatch. The entire left side was dented and scraped.

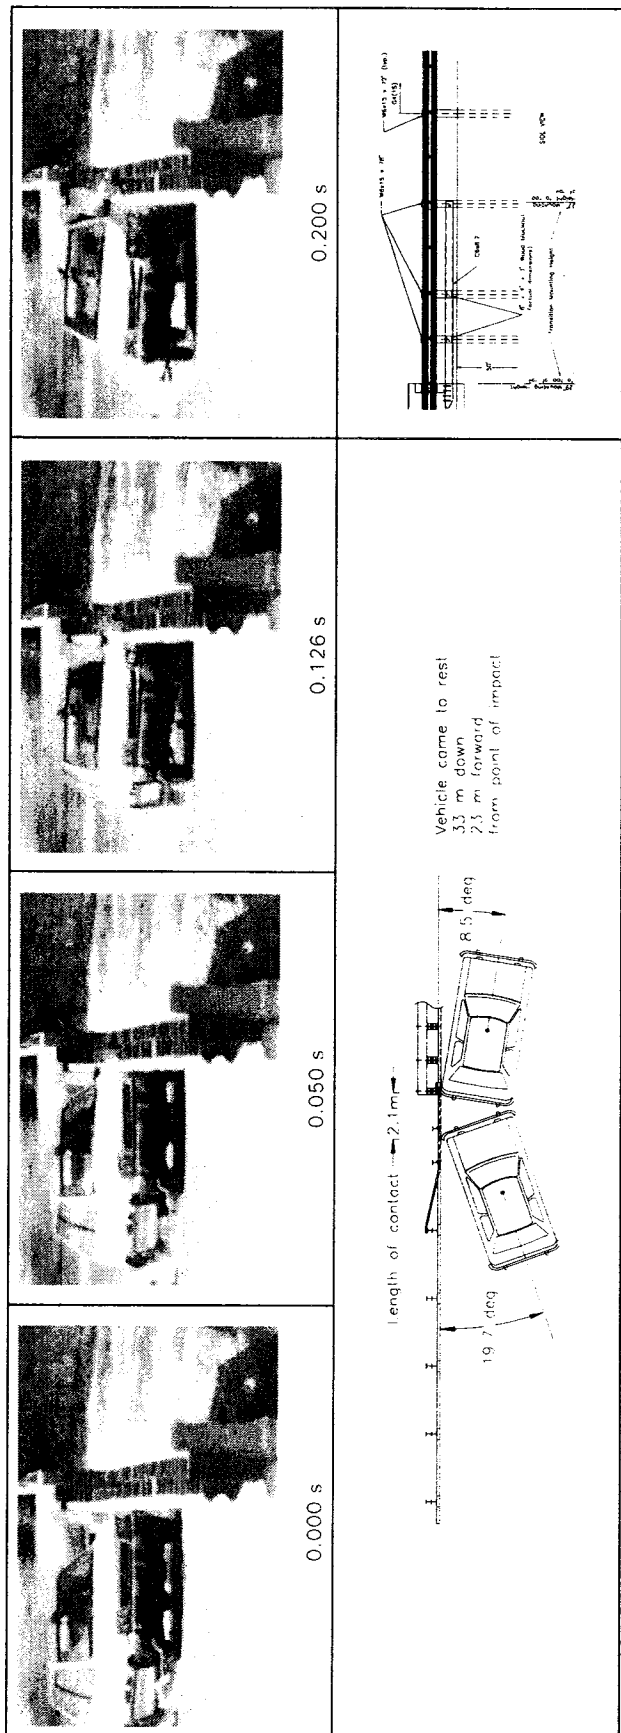
General Information		Impact Conditions		Test Article Deflections (m)	
Test Agency	Texas Transportation Institute	Speed (km/h)	70.4 (43.8 mi/h)	Dynamic	0.06 (0.21 ft)
Test No.	472070-4	Angle (deg)	19.7	Permanent	0.01 (0.02 ft)
Date	08/02/94	Exit Conditions		Vehicle Damage	
Test Article		Speed (km/h)	60.0 (37.3 mi/h)	Exterior	
Type	Transition	Angle (deg)	8.5	VDS	11LFQ5
Name	W-beam Retrofit	Occupant Risk Values		CDC	11FLEK3 & 11LDEW3
Installation Length (m)	19 (62.5 ft)	Impact Velocity (m/s)		Interior	
Size and/or dimension and material of key elements	Nested W-beam on steel posts	x-direction	3.9 (12.8 ft/s)	OCDI	FS0000000
Soil Type and Condition	Strong soil, dry	y-direction	5.7 (18.8 ft/s)	Maximum Exterior	
Test Vehicle		THIV (optional)		Vehicle Crush (mm)	190 (7.5 in)
Type	Production Model	Ridedown Accelerations (g's)		Max. Occ. Compart.	
Designation	820C	x-direction	-2.1	Deformation (mm)	0 (0 in)
Model	1988 Ford Festiva L	y-direction	7.2	Post-Impact Behavior

Mass (kg) Curb	804 (1771 lb)	PHD (optional)		Max. Roll Angle (deg)	
Test Inertial Dummy	820 (1806 lb)	ASI (optional)		Max. Pitch Angle (deg)	
Gross Static	75 (165 lb)	Max. 0.050-s Average (g's)		Max. Yaw Angle (deg)	
	897 (1976 lb)	x-direction	-4.7		
		y-direction	8.3		
		z-direction	-1.1

The W-beam retrofit functioned as intended during the small automobile test by containing and redirecting the vehicle with minimal deflection of the W-beam guardrail. There were no detached elements or debris to exhibit undue hazard to occupants of the vehicle or others in the area. The vehicle received moderate damage with no deformation into the occupant compartment. The vehicle remained upright and relatively stable during the collision period. The occupant impact velocities and ridedown accelerations were well within the NCHRP Report 350 limits and the exit trajectory was satisfactory.

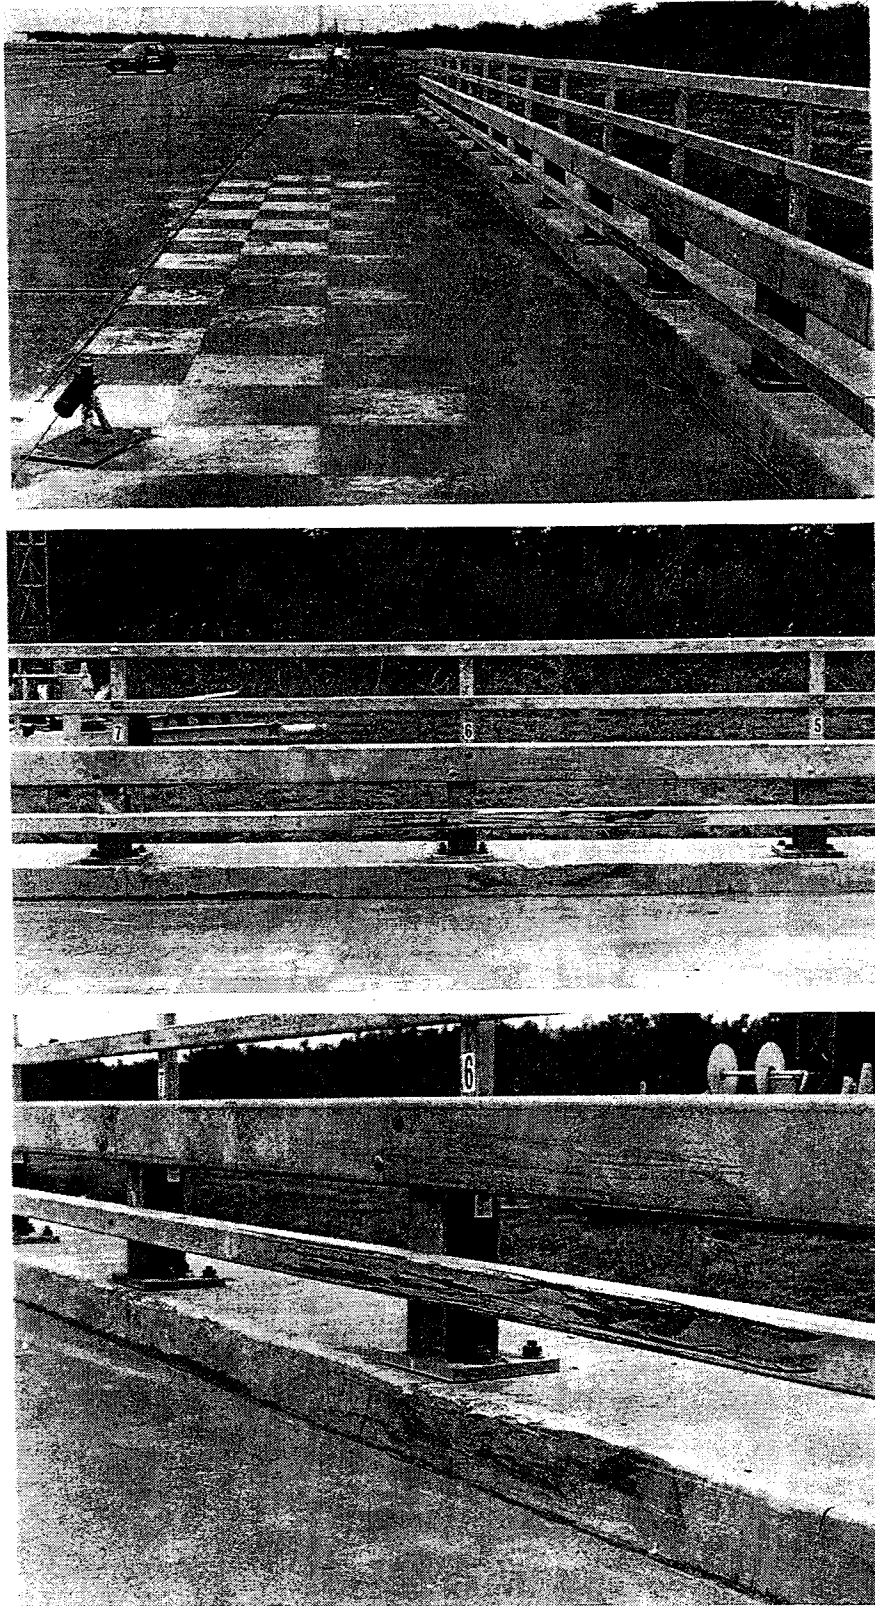
Figure 37. Pedestrian/bicycle railing on Illinois 2399-1 after test 472070-5.

As seen in figure 37, the installation minimal damage. There were tire marks on the face of the curb and both metal rail elements of the Illinois 2399-1 traffic railing. The curb was chipped slightly at the point of impact. Length of initial contact with the traffic railing was 3.0 m (10 ft). The vehicle contacted the traffic railing again near the end leaving only tire marks on the face of the curb and lower element. There was no contact with the pedestrian/bicycle railing.

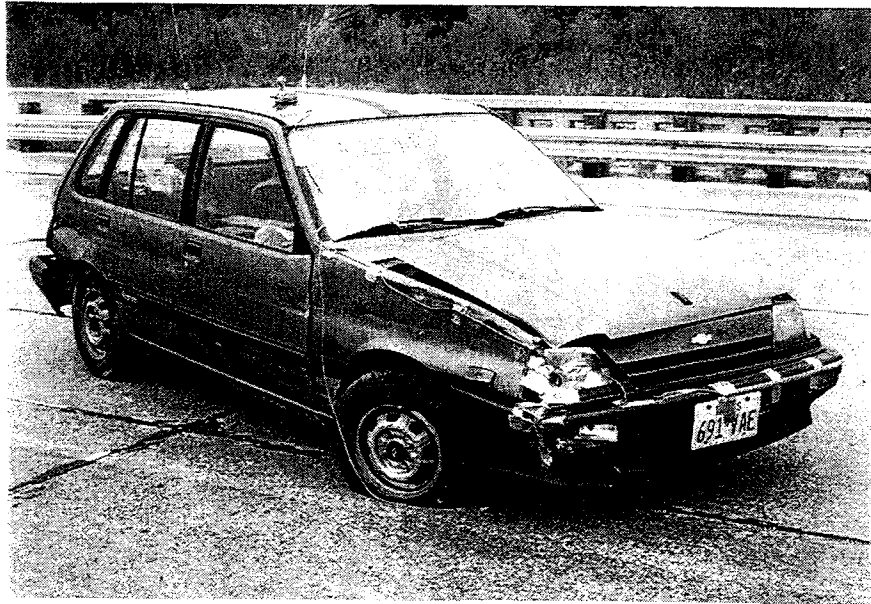
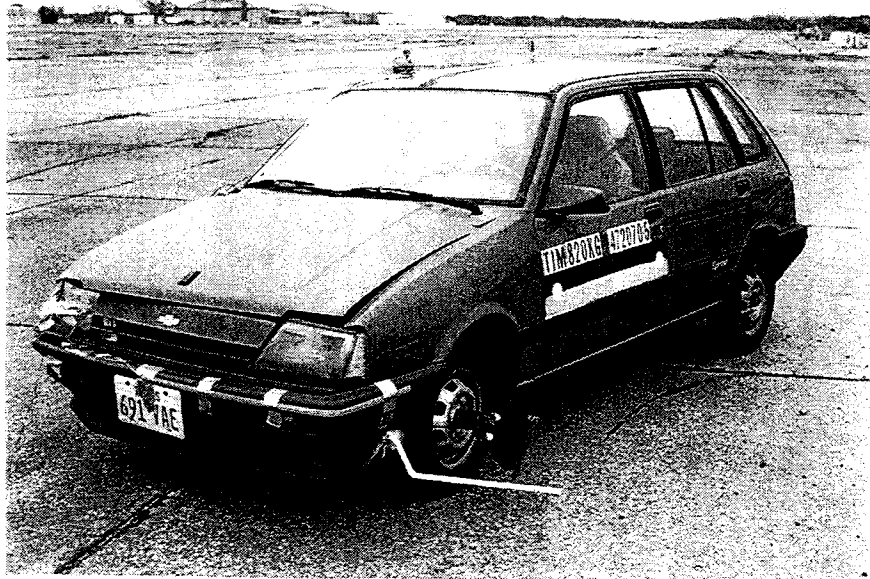
Figure 38. Vehicle after test 472070-5.

The vehicle sustained minimal damage as shown in figure 38. The strut and front axle on the right side were damaged. The front bumper, right front quarter panel, both doors, and rear quarter panel were scraped. Maximum exterior crush at the right front corner of the vehicle was 140 mm (5.5 in) and there was no deformation into the occupant compartment.

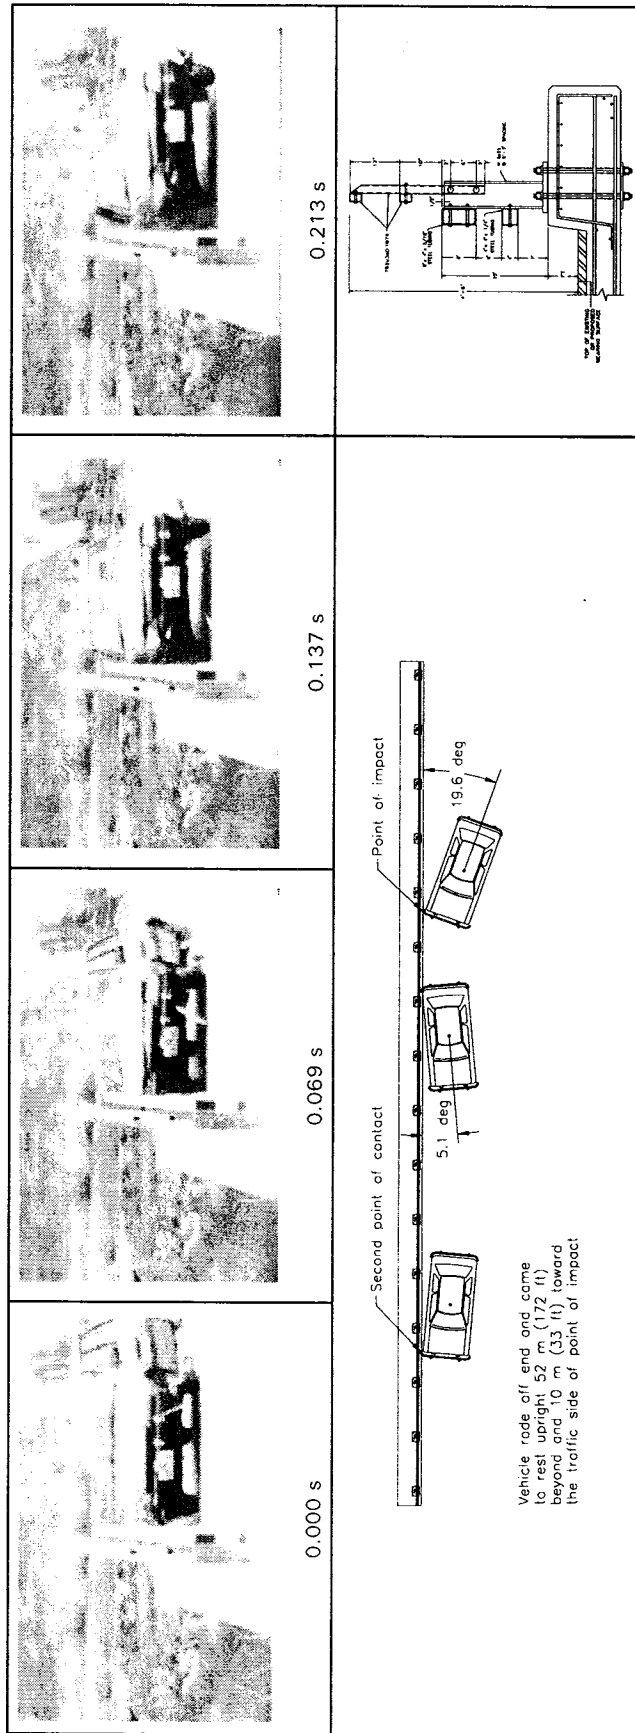
**General Information**  
 Test Agency . . . . . Texas Transportation Institute  
 Test No. . . . . 472070-5  
 Date . . . . . 01/25/95  
 Test Article . . . . . Pedestrian/Bicycle Railing  
 Name . . . . . Double Tube Ped/Bicycle railing  
 on Illinois 2399-1 traffic railing  
 Installation Length (m) . . . . . 30 m (100 ft)  
 Key elements . . . . . TS2x3x0.1875 railings on  
 Illinois 2399-1 traffic railing  
 Soil Type and Condition . . . . . N/A  
 Test Vehicle  
 Type . . . . . Production  
 Designation . . . . . 820C  
 Model . . . . . 1988 Chevrolet Sprint  
 Mass (kg) Curb . . . . . 713 (1570 lb)  
 Test Inertial . . . . . 820 (1806 lb)  
 Dummy . . . . . 76 (167 lb)  
 Gross Static . . . . . 896 (1974 lb)

**Impact Conditions**  
 Speed (km/h) . . . . . 82.7 (51.4 mi/h)  
 Angle (deg) . . . . . 19.6  
 Exit Conditions  
 Speed (km/h) . . . . . 74.5 (46.3 mi/h)  
 Angle (deg) . . . . . 5.1  
 Occupant Risk Values  
 Impact Velocity (m/s)  
 x-direction . . . . . 3.3 (10.8 ft/s)  
 y-direction . . . . . 5.7 (18.6 ft/s)  
 THIV (optional) . . . . .  
 Ridedown Accelerations (g's)  
 x-direction . . . . . -3.4  
 y-direction . . . . . -13.1  
 PHD (optional) . . . . .  
 ASI (optional) . . . . .  
 Max. 0.050-s Average (g's)  
 x-direction . . . . . -4.3  
 y-direction . . . . . -10.0  
 z-direction . . . . . -1.3

**Test Article Deflections (m)**  
 Dynamic . . . . . nil  
 Permanent . . . . . nil  
 Vehicle Damage  
 Exterior  
 VDS . . . . . 01RD2  
 CDC . . . . . 01RDES2  
 Interior  
 OCDI . . . . . AS0000000  
 Maximum Exterior  
 Vehicle Crush (mm) . . . . . 140 (5.5 in)  
 Max. Occ. Compart.  
 Deformation (mm) . . . . . 0  
 Post-Impact Behavior  
 Max. Roll Angle (deg) . . . . . -8.9  
 Max. Pitch Angle (deg) . . . . . 4.6  
 Max. Yaw Angle (deg) . . . . . -21.7

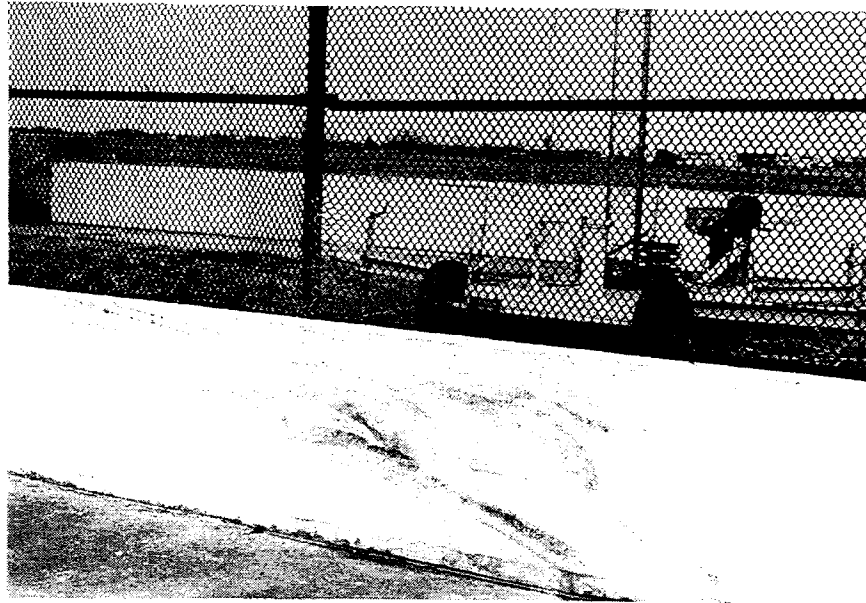
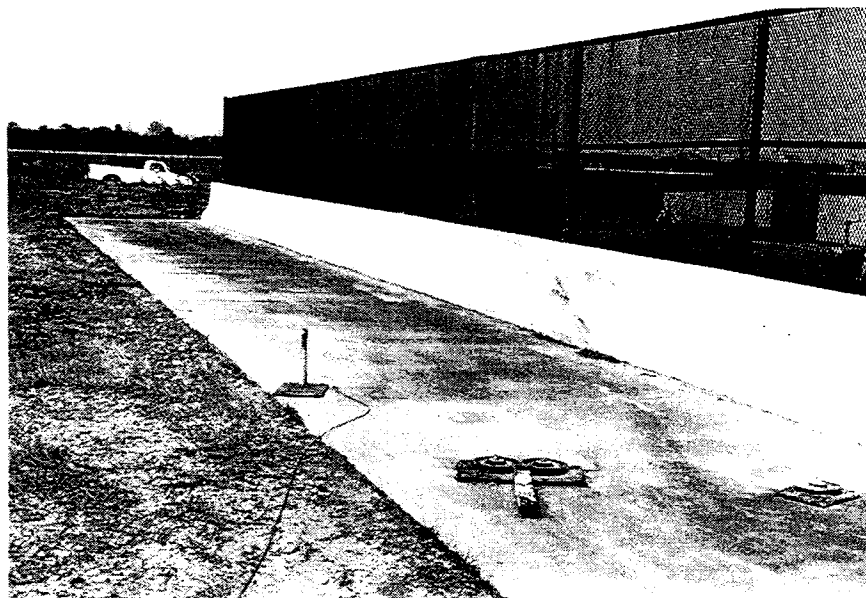
Figure 45. Vandal protection fence on New Jersey safety shape after test 472070-6.

As seen in figure 45, the installation received minimal damage. There were tire marks on the face of the safety shape and the lower edge of the wire fabric was pushed behind the lower horizontal line rail between post 5 and 6. The middle horizontal line rail was disconnected on the upstream side at the post 5 location and the post 5 anchor was pushed back 13 mm (0.5 in) as shown in figure 46. Maximum dynamic deflection of the fence was 142 mm (5.6 in) (measured at the top of the rail) and maximum residual deformation was 76 mm (3.0 in). Total length of contact with the installation was 5.2 m (17.0 ft).

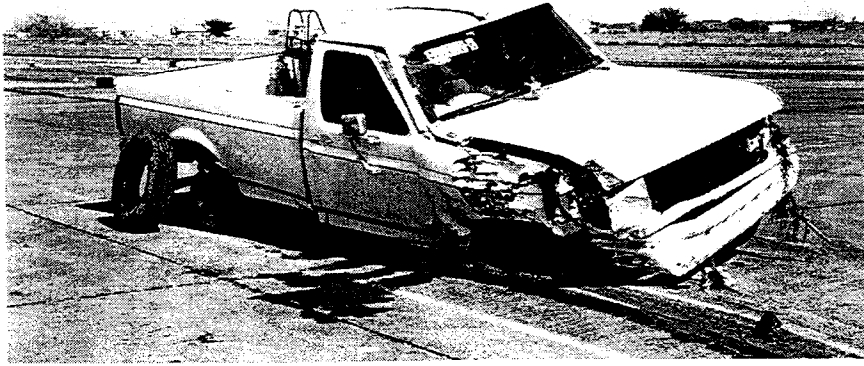
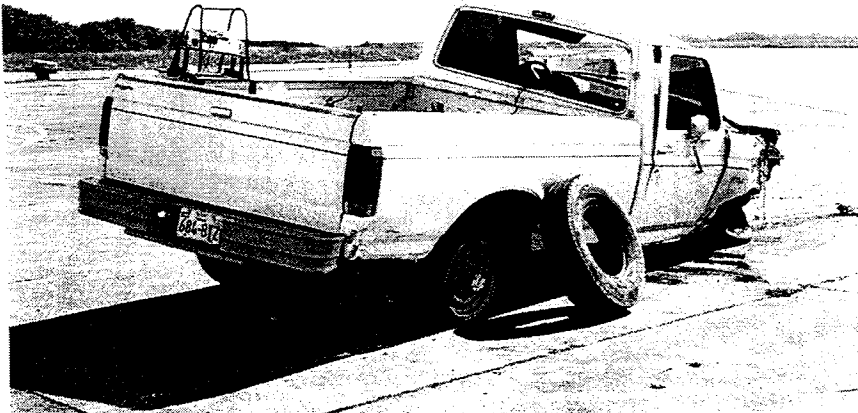
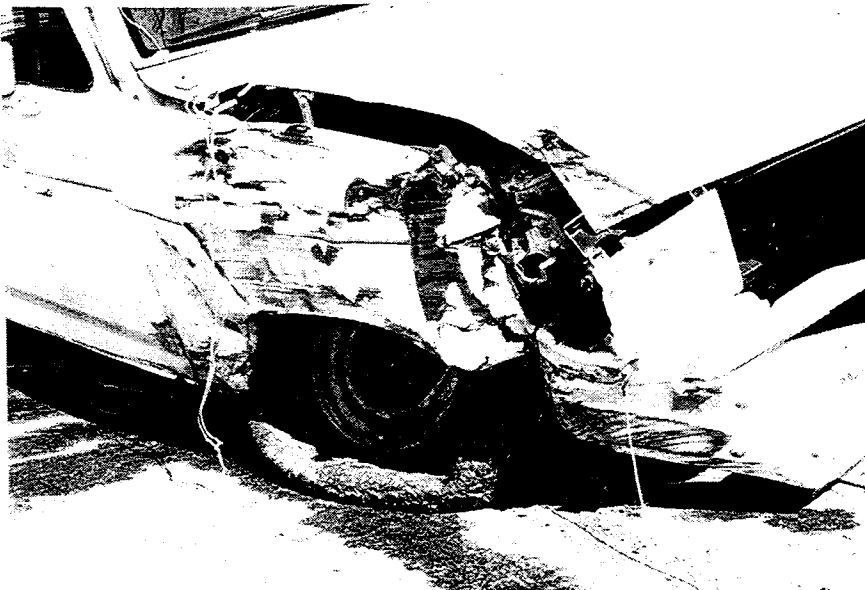
Figure 47. Vehicle after test 472070-6.

The vehicle sustained moderate damage as shown in figure 47. The stabilizer bar, floorpan, frame and front axle on the right side were bent and the windshield was cracked. The front bumper, hood, grill, right front quarter panel, both doors, and rear quarter panel were damaged. There was a small fold running diagonally in the floorpan of the occupant compartment. Maximum exterior crush at the right front corner of the vehicle was 170 mm (6.7 in). There was 70 mm (2.8 in) deformation into the occupant compartment of the firewall on the passenger side of the vehicle.

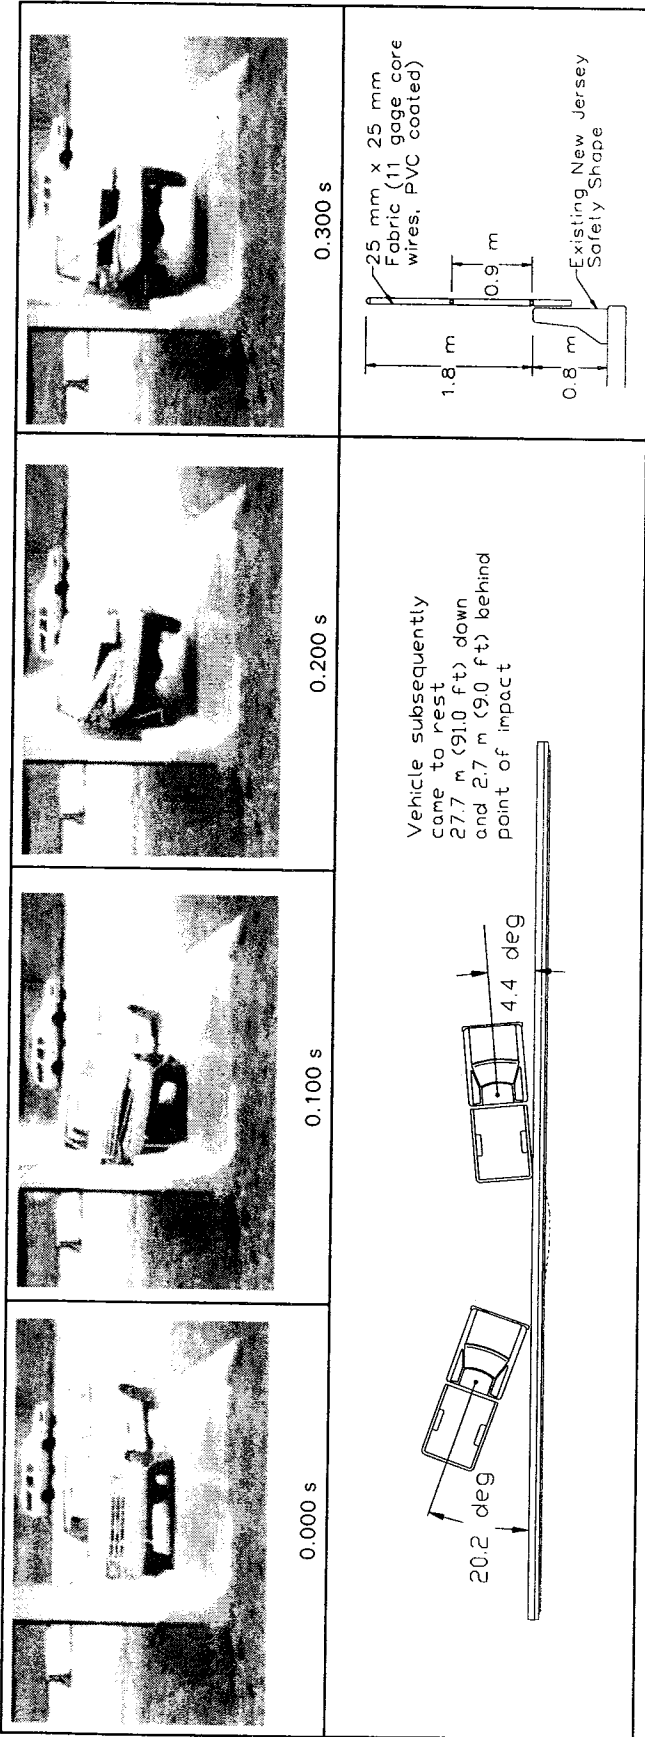
General Information		Impact Conditions		Test Article Deflections (m)	
Test Agency	Texas Transportation Institute	Speed (km/h)	101.1 (62.8 mi/h)	Dynamic	0.14 (0.47 ft)
Test No.	472070-6	Angle (deg)	20.2	Permanent	0.08 (0.25 ft)
Date	03/10/95	Exit Conditions		Vehicle Damage	
Test Article		Speed (km/h)	79.6 (49.5 mi/h)	Exterior	
Type	Retrofit Bridge Rail	Angle (deg)	4.4	VDS	01RFQ5
Name	Vandal Protection Fence on NJSS	Occupant Risk Values		CDC	01FREK2 & 01RDES3
Installation Length (m)	30 m (100 ft)	Impact Velocity (m/s)		Interior	
Size and/or dimension and material of key elements	1.8 m (6.0 ft) tall (1 in x 1 in) Fabric (11 gage core wires, PVC coated)	x-direction	5.0 (16.5 ft/s)	OCDI	RS0000000
Soil Type and Condition	on bridge deck, dry	y-direction	2.8 (9.1 ft/s)	Maximum Exterior	
Test Vehicle		THIV (optional)		Vehicle Crush (mm)	170 (6.7 in)
Type	Production	Ridedown Accelerations (g's)		Max. Occ. Compart.

Designation	Pickup	x-direction	-5.6	Deformation (mm)	70 (2.8 in)
Model	1991 Ford F250	y-direction	-7.6		
Mass (kg)	2208 (4863 lb)	PHD (optional)			
Test Inertial Dummy	2450 (5397 lb) 75 (165 lb)	ASI (optional)			
Gross Static	2525 (5562 lb)	Max. 0.050-s Average (g's)			
		x-direction	-8.4		
		y-direction	-5.4		
		z-direction	-8.0		
				Post-impact Behavior	
				Max. Roll Angle (deg)	30
				Max. Pitch Angle (deg)	9
				Max. Yaw Angle (deg)	-19

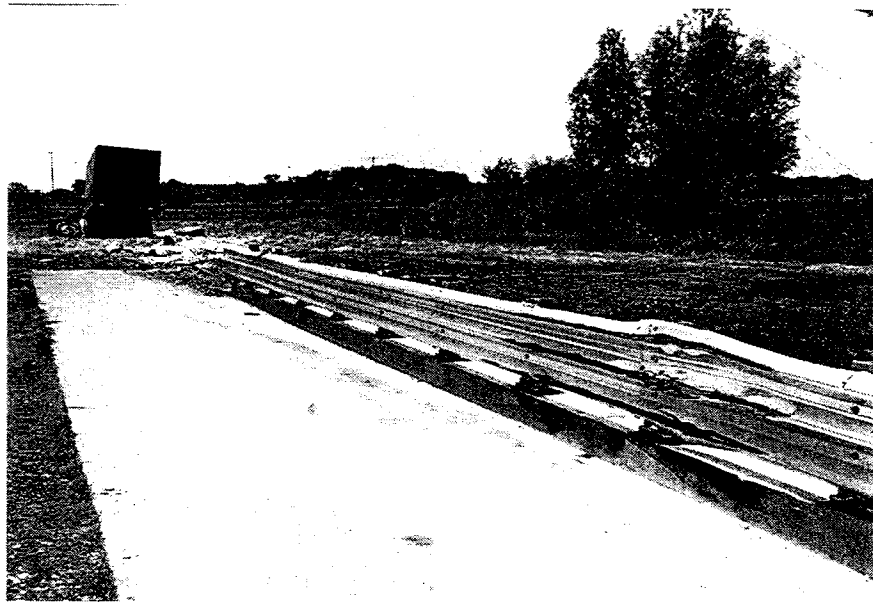
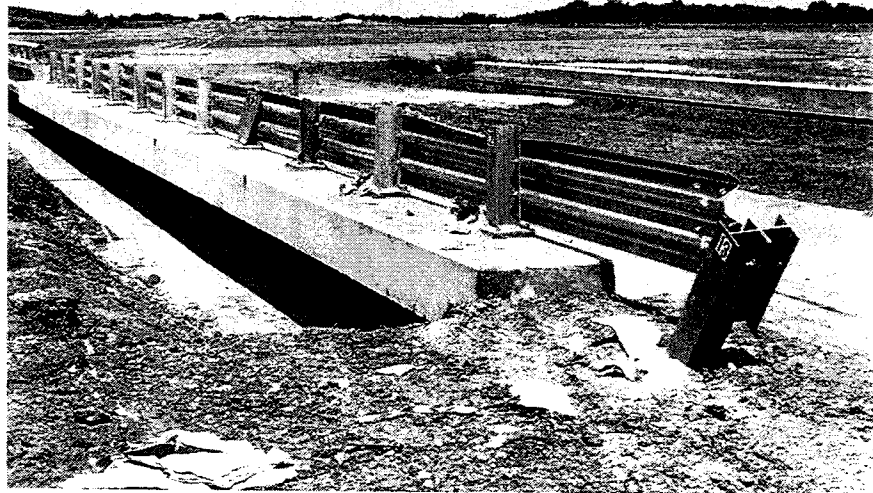
Figure 54. Delaware retrofit bridge railing after test 472070-7.

As seen in figures 54 through 56, the installation received moderate damage. There were tire marks on the face of the curb from the point of impact for 4.1 m (13.3 ft). Initial length of contact with the thrie beam rail element was 5.1 m (16.8 ft). Maximum residual deformation was 114 mm (4.5 in) near post 5. The grout around post 4 and 5 was disturbed, but there were no cracks in the curb. The box-van made contact with the tops of post 5 through 13. Post 8 through 10 were twisted about their vertical axis and post 11 was bent slightly. The thrie beam element was pulled away from post 13 and the post was bent laterally. Total length of contact with the installation was 18.6 m (61.0 ft).

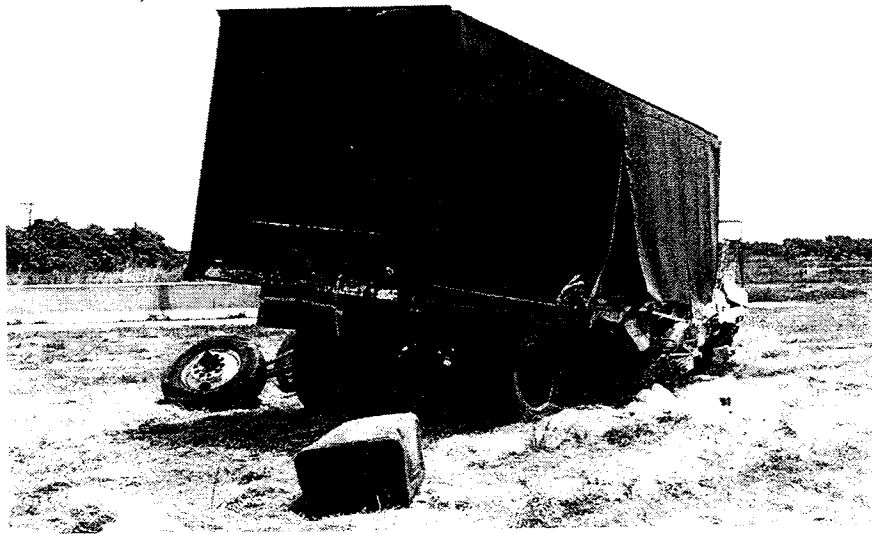
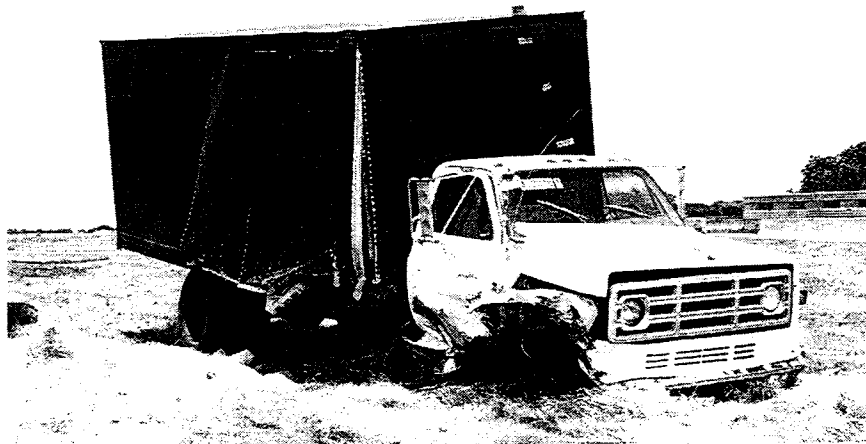
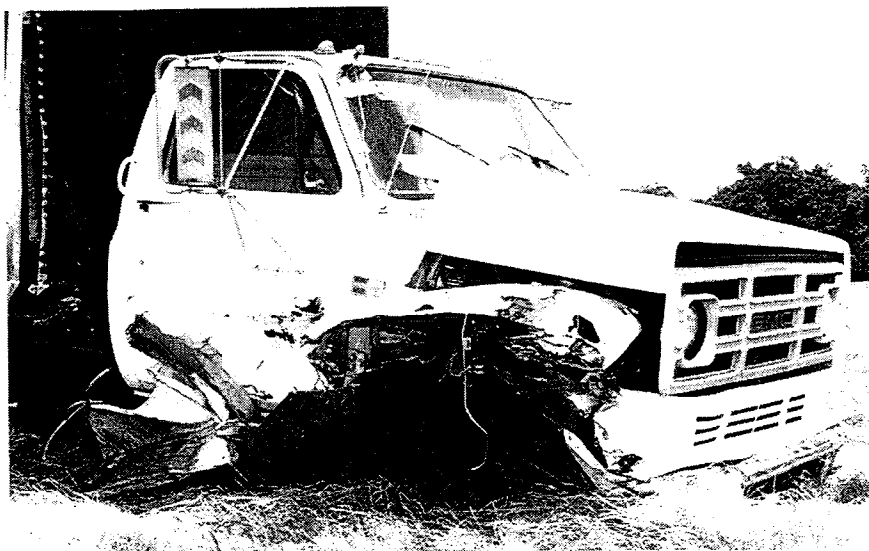
Figure 57. Vehicle after test 472070-7.

The vehicle sustained moderate damage as shown in figure 57. The front axle was separated from the vehicle. There was damage to the front suspension, springs, U-bolts, and steering arm. Damage was also done to the bumper, hood, grill, right front quarter-panel, right door, fuel tank, and right rear outside rim and tire. The right side and floor of the box-van was torn open. Maximum exterior crush at the right front corner of the vehicle was 320 mm (12.6 in).
