1. Report No. FHWA-RD-96-032	2. Government Accession No.	3. Recipient's Catalog No.	
4. Title and Subtitle CRASH TESTING AND EVALUATION OF RETROFIT BRIDGE RAILINGS AND TRANSITION		5. Report Date	6. Performing Organization Code

7. Author(s) C. Eugene Buth and Wanda L. Menges		8. Performing Organization Report No. Research Foundation 72070	
9. Performing Organization Name and Address Texas Transportation Institute The Texas A&M University System College Station, Texas 77843-3135		10. Work Unit No. NCP No.	11. Contract or Grant No. DTFH61-92-C-00025

12. Sponsoring Agency Name and Address Office of Safety & Traffic Operations R&D Federal Highway Administration 6300 Georgetown Pike McLean, Virginia 22101-2296		13. Type of Report and Period Covered Final Report May 1992 - August 1995

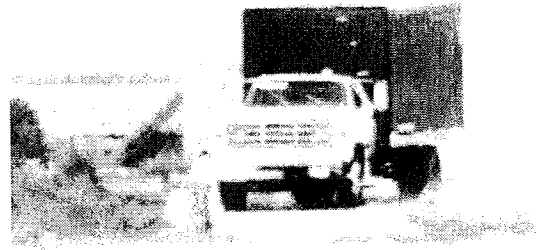
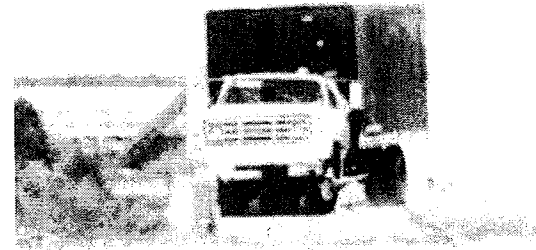
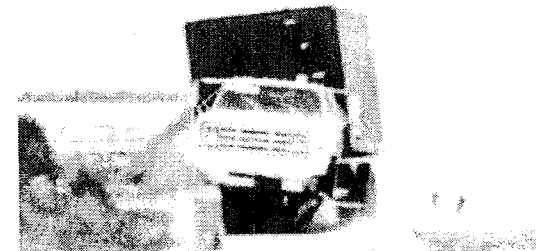
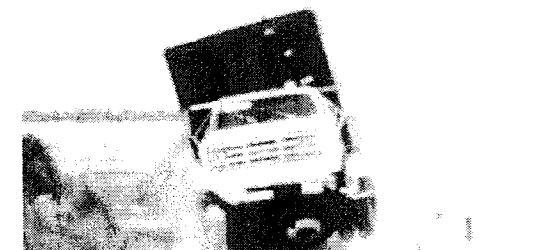
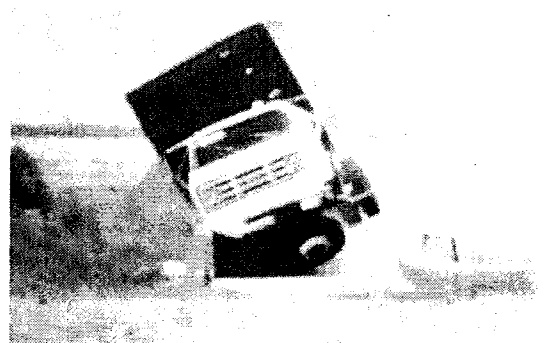
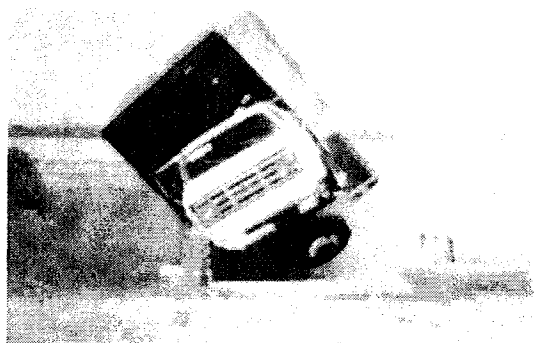
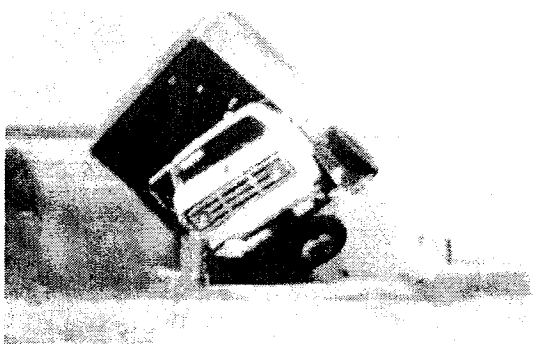
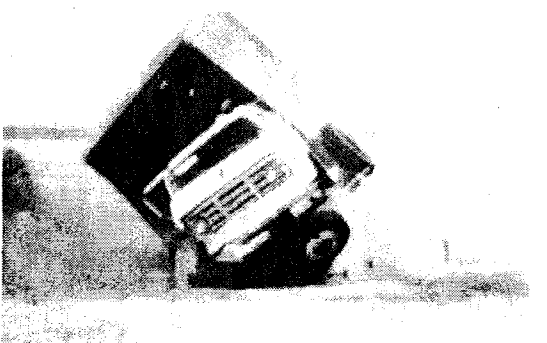
Figure 78. Sequential photographs for test 472070-7 (overhead and frontal views).

The vehicle bumper contacted the length-of-need section of the Delaware retrofit bridge railing 0.5 m (1.6 ft) downstream of post 4. The vehicle was traveling at a speed of 83.1 km/h (51.7 mi/h) and at an angle of 14.2 degrees at time of impact. Redirection of the vehicle began at 0.119 second. The rear of the vehicle made contact with the bridge railing at 0.297 second. At 0.343 second the vehicle became parallel with the installation, traveling at 77.1 km/h (47.9 mi/h). The vehicle continued to roll clockwise onto the bridge railing with the box-van riding on top of the thrie beam element. The vehicle reached a maximum roll angle of 44 degrees at 1.097 second before it rode off the end of the bridge railing and righted itself. As the vehicle exited the installation, it was traveling at a speed of 63.5 km/h (39.5 mi/h) and exit angle of approximately 0 degrees. Brakes were applied as the vehicle exited the test area, and the vehicle subsequently came to rest 53.7 m (176.5 ft) beyond the point of impact and aligned with the traffic face of the bridge railing. Sequential photographs are shown in appendix C, figures 78 and 79.

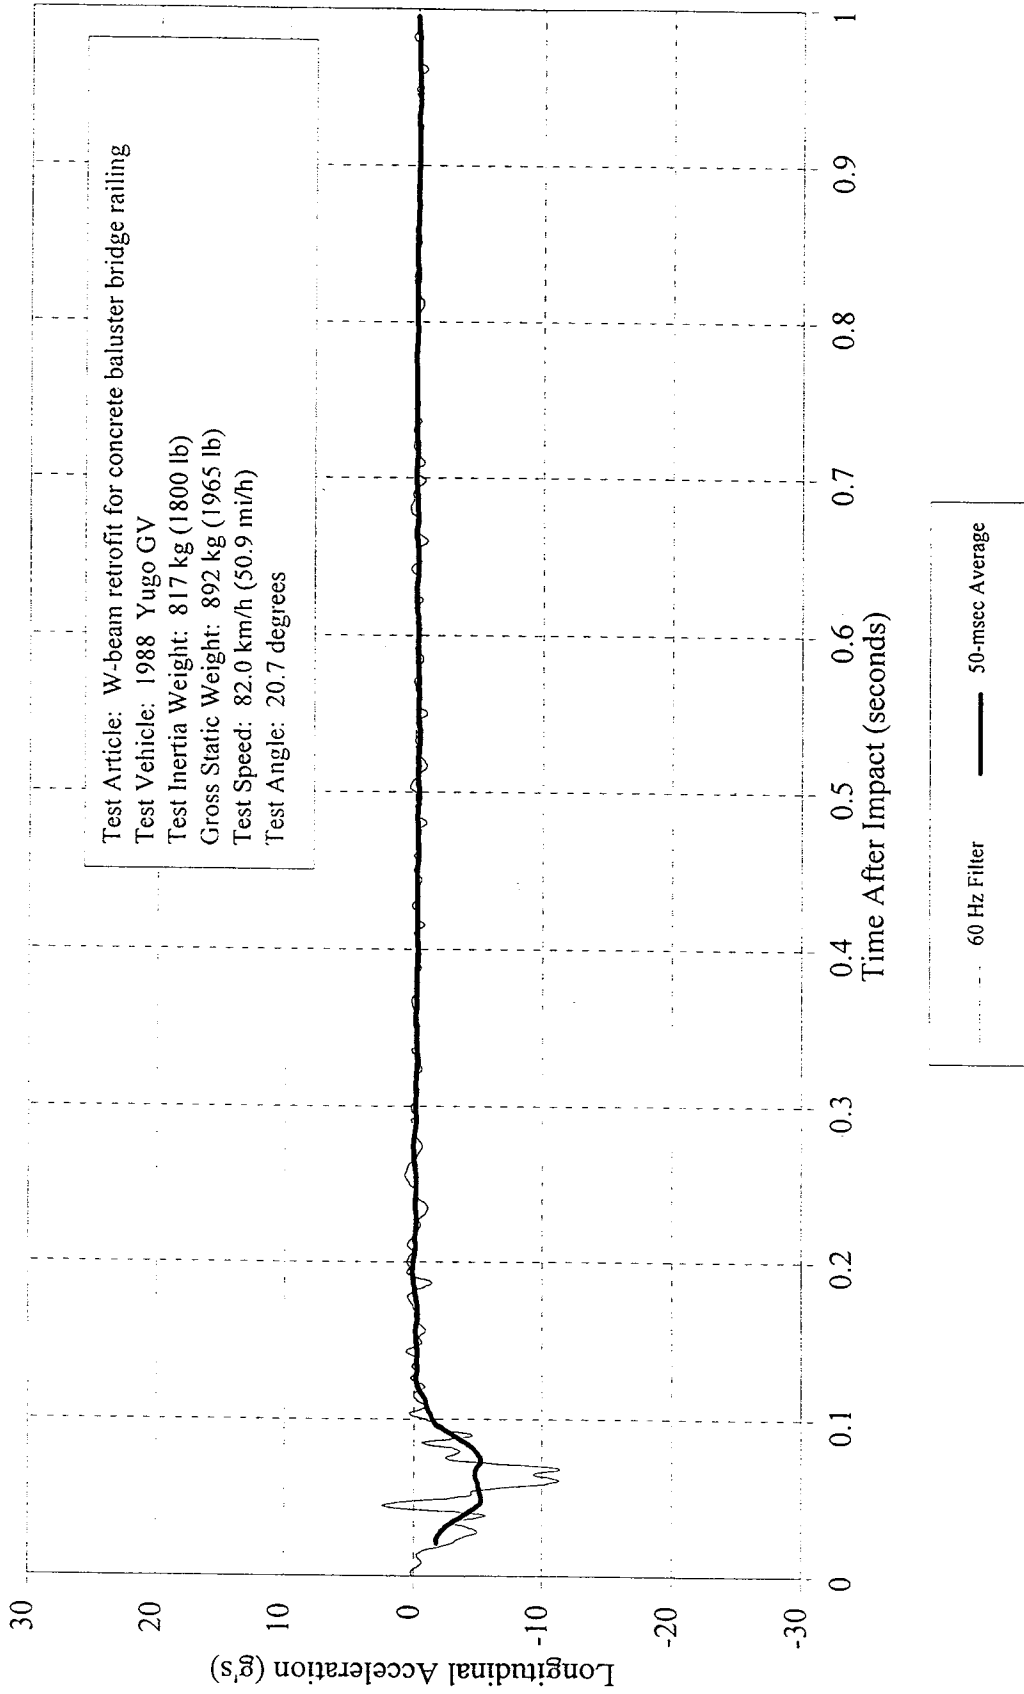
Figure 86. Vehicle longitudinal accelerometer trace for test 472070-1.

Data from the accelerometer located at the center-of-gravity were digitized for evaluation of occupant risk and were computed as follows. In the longitudinal direction, occupant impact velocity was 4.1 m/s (13.5 ft/s) at 0.214 second, the highest 0.010-second average ridedown acceleration was -1.2 g between 0.229 and 0.239 second, and the maximum 0.050-second average acceleration was -5.5 g between 0.049 and 0.099 second. Lateral occupant impact velocity was 6.9 m/s (22.7 ft/s) at 0.101 second, the highest 0.010-second occupant ridedown acceleration was -4.4 g between 0.198 and 0.208 second and the maximum 0.050-second average acceleration was -10.8 g between 0.042 and 0.092 second. These data and other pertinent information from the test are summarized in figure 10. Vehicular angular displacements are displayed in appendix D, figure 80. Vehicular accelerations versus time traces filtered digitally at 60 Hz are presented in appendix E, figures 86 through 88.

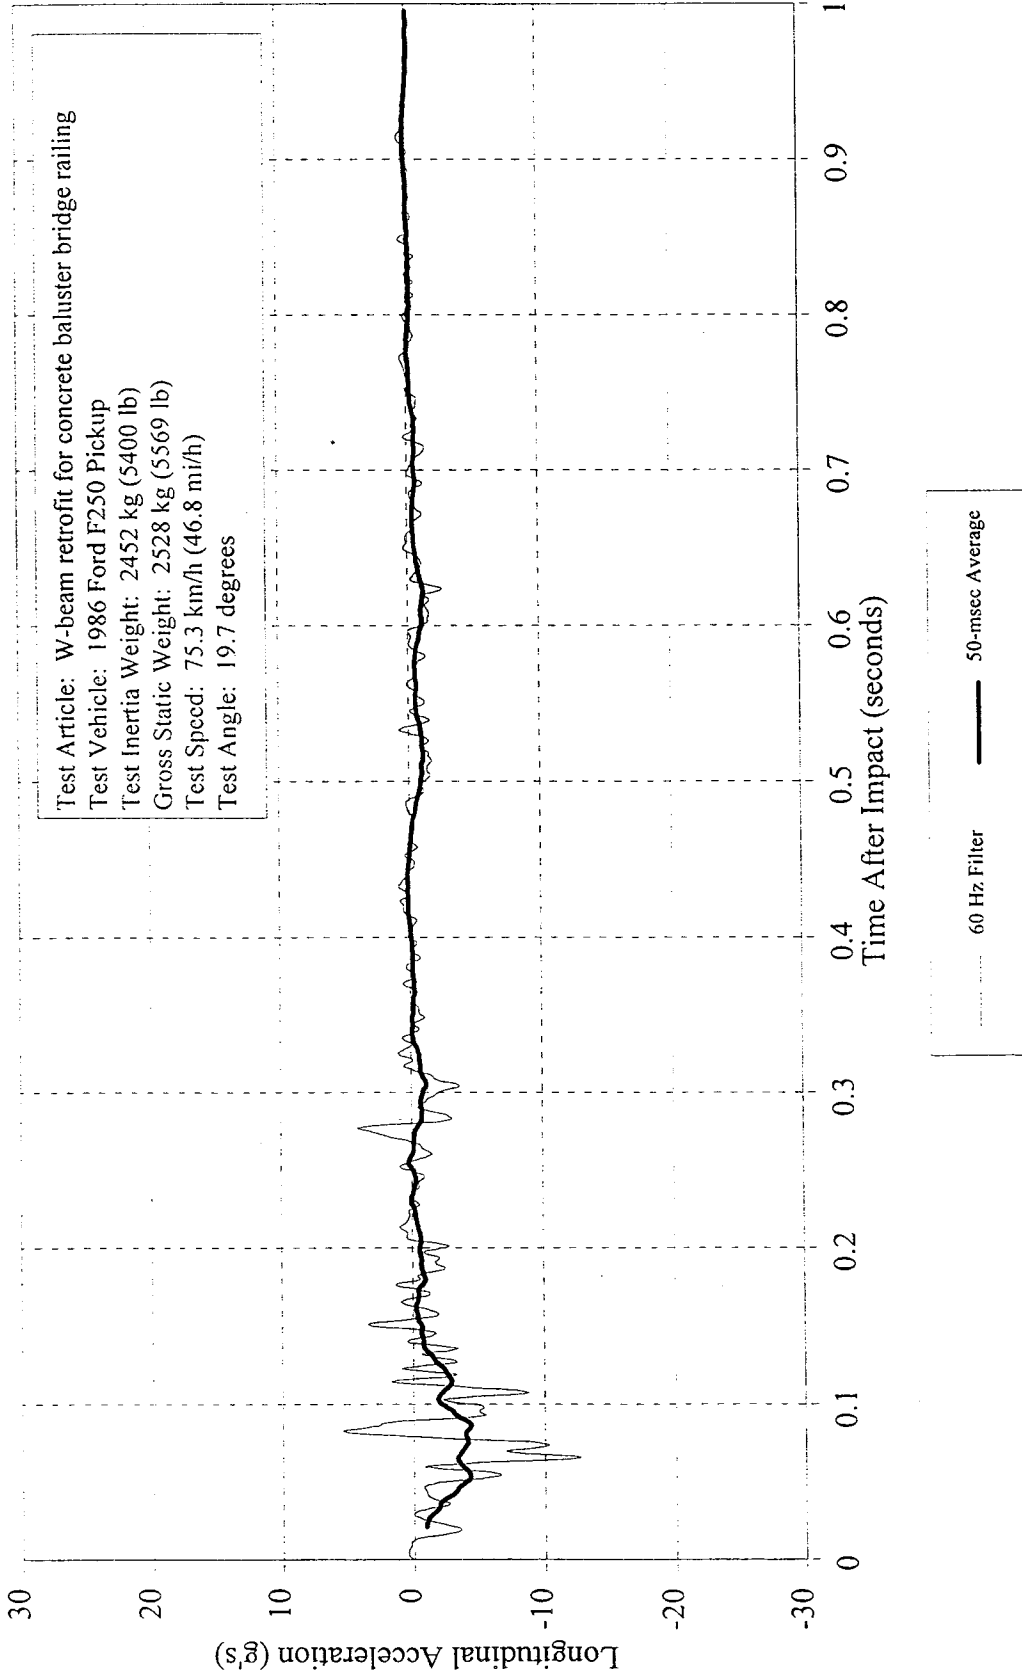
Figure 89. Vehicle longitudinal accelerometer trace for test 472070-2.

Data from the accelerometer located at the center-of-gravity were digitized for evaluation of occupant risk and were computed as follows. In the longitudinal direction, occupant impact velocity was 3.9 m/s (12.7 ft/s) at 0.247 second, the highest 0.010-second average ridedown acceleration was 3.0 g between 0.270 and 0.280 second, and the maximum 0.050-second average acceleration was -4.5 g between 0.061 and 0.110 second. Lateral occupant impact velocity was 4.7 m/s (15.5 ft/s) at 0.153 second, the highest 0.010-s occupant ridedown acceleration was -9.1 g between 0.294 and 0.304 second and the maximum 0.050-second average acceleration was -8.2 g between 0.066 and 0.116 second. These data and other pertinent information from the test are summarized in figure 17. Vehicular angular displacements are displayed in appendix D, figure 81. Vehicular accelerations versus time traces filtered digitally at 60 Hz are presented in appendix E, figures 89 through 91.

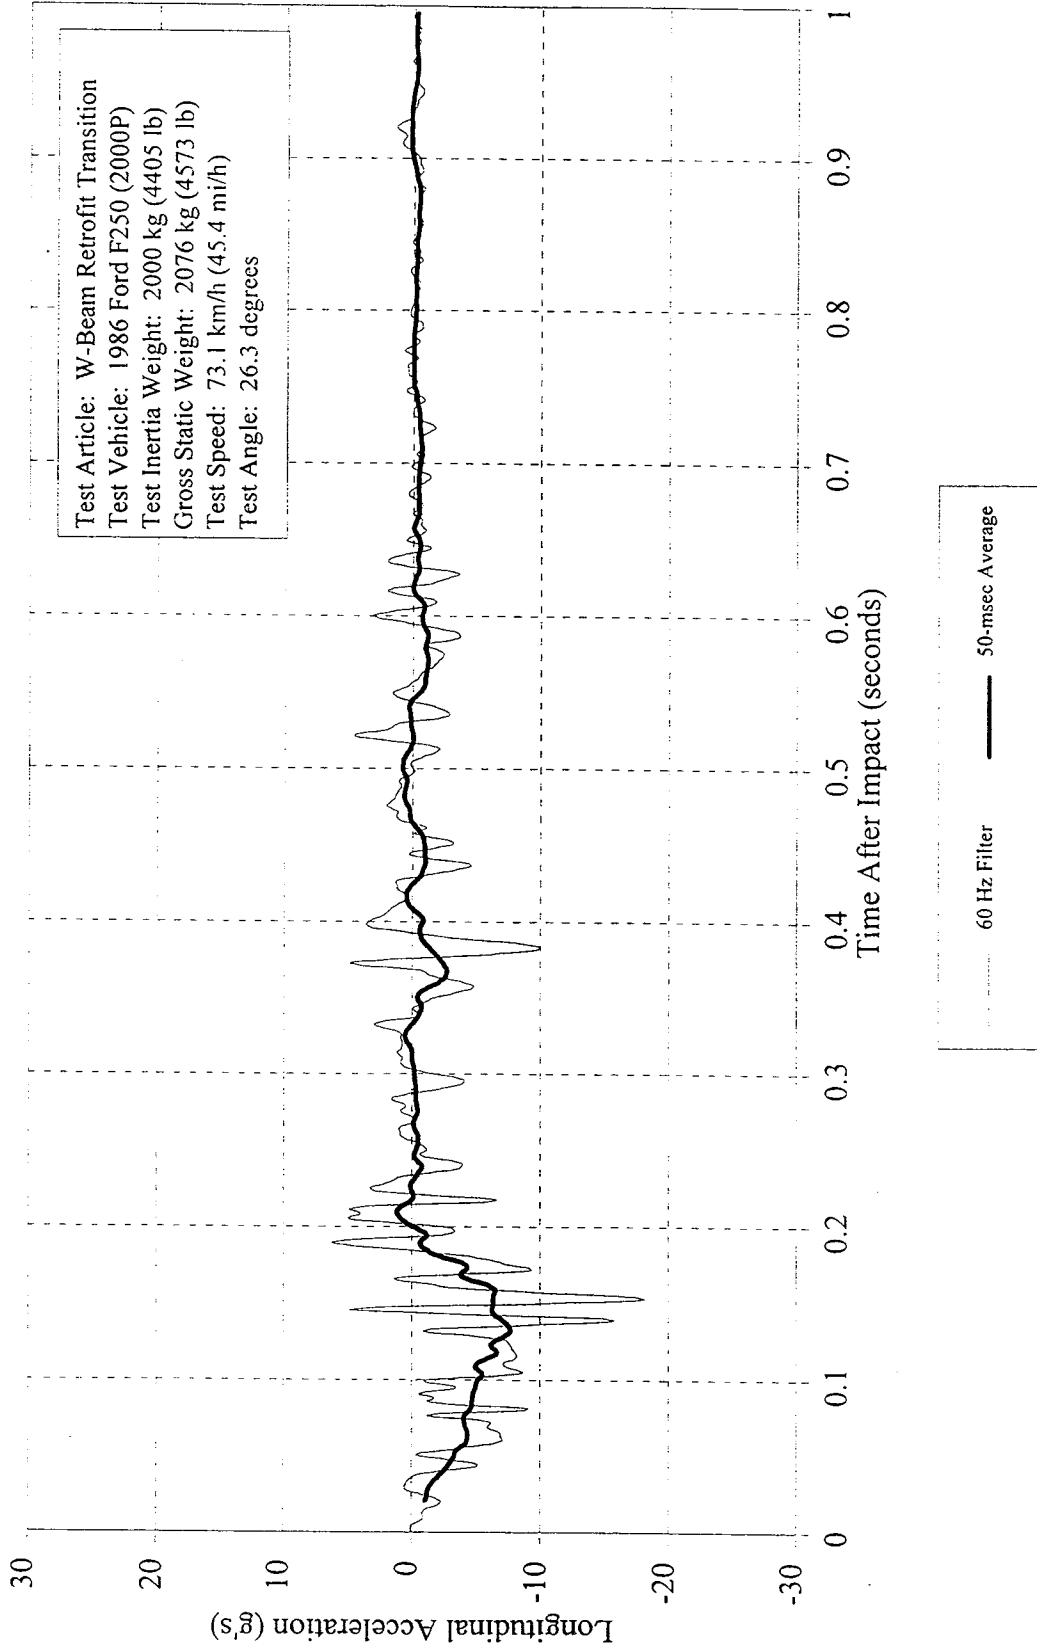
Figure 92. Vehicle longitudinal accelerometer trace for test 472070-3.

maximum 0.050-second average acceleration was -7.7 g between 0.109 and 0.159 second. Lateral occupant impact velocity was 6.7 m/s (22.0 ft/s) at 0.153 second, the highest 0.010-second occupant ridedown acceleration was 11.6 g between 0.383 and 0.393 second and the maximum 0.050-second average acceleration was 8.4 g between 0.106 and 0.156 second. These data and other pertinent information from the test are summarized in figure 27. Vehicular angular displacements are displayed in appendix D, figure 82. Vehicular accelerations versus time traces filtered digitally at 60 Hz are presented in appendix E, figures 92 through 94.

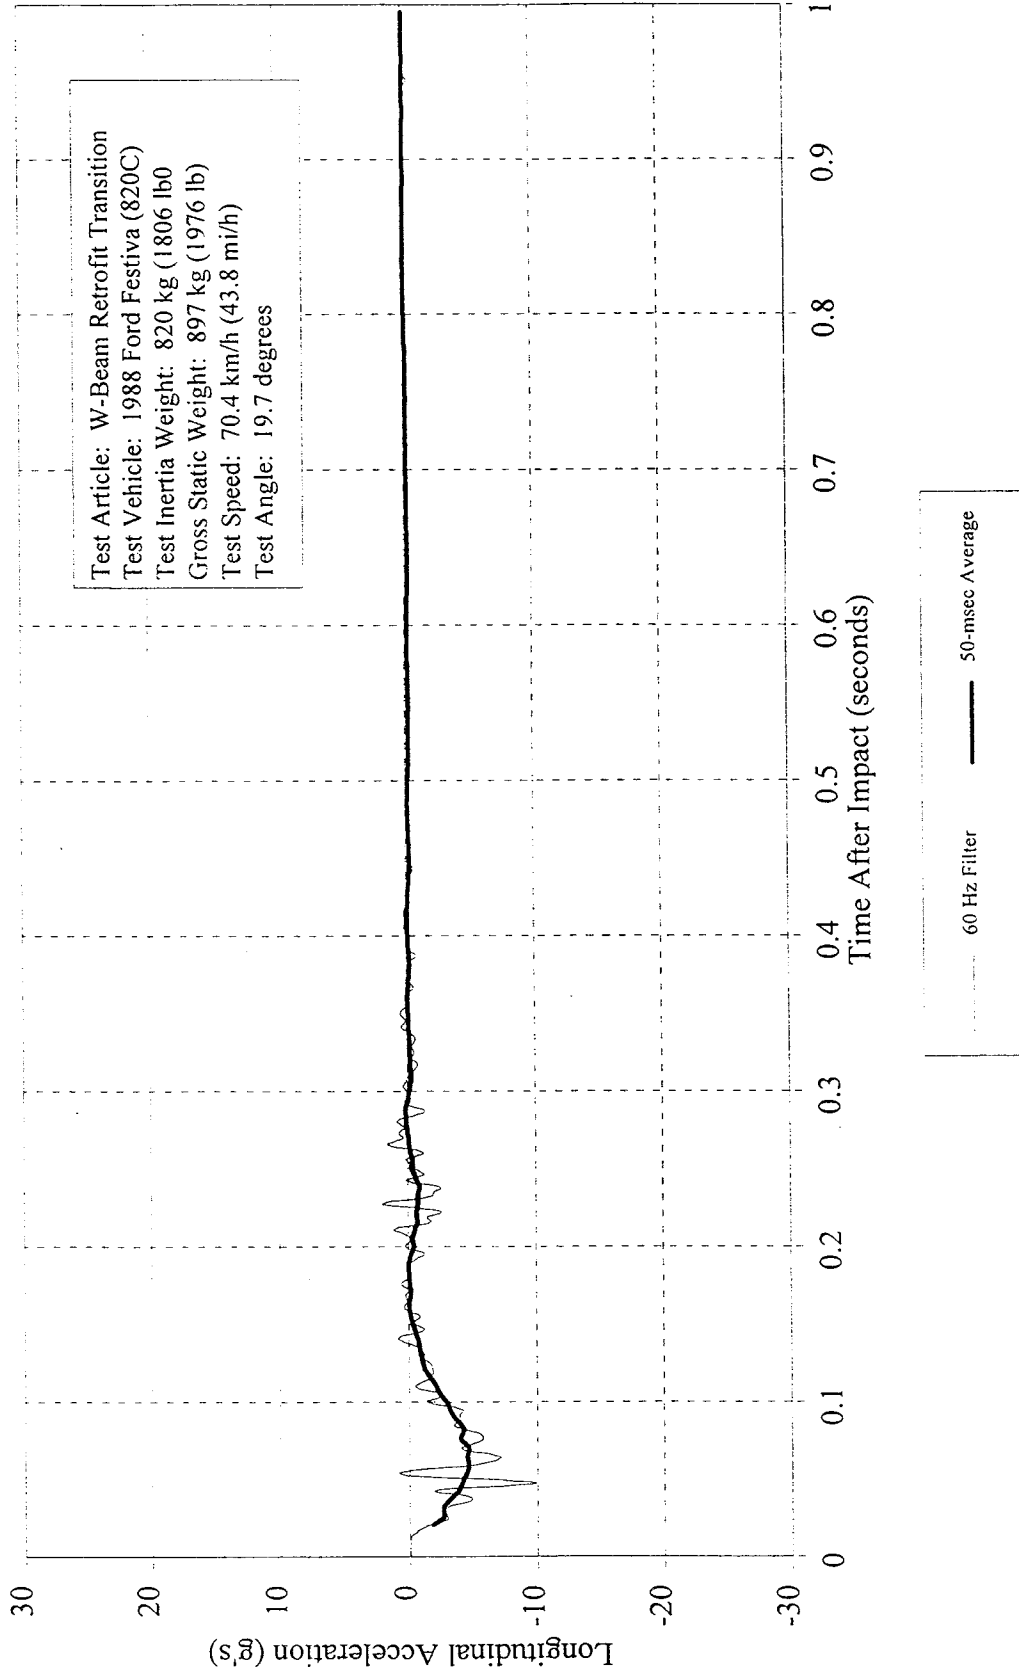
Figure 95. Vehicle longitudinal accelerometer trace for test 472070-4.

Data from the accelerometer located at the center-of-gravity were digitized for evaluation of occupant risk and were computed as follows. In the longitudinal direction, occupant impact velocity was 3.9 m/s (12.8 ft/s) at 0.232 second, the highest 0.010-second average ridedown acceleration was -2.1 g between 0.214 and 0.224 second, and the maximum 0.050-second average acceleration was -4.7 g between 0.045 and 0.095 second. Lateral occupant impact velocity was -5.7 m/s (-18.8 ft/s) at 0.119 second, the highest 0.010-second occupant ridedown acceleration was 7.2 g between 0.209 and 0.219 second and the maximum 0.050-second average acceleration was 8.3 g between 0.045 and 0.095 second. These data and other pertinent information from the test are summarized in figure 32. Vehicular angular displacements were not available for this test due to instrumentation failure. Vehicular accelerations versus time traces filtered digitally at 60 Hz are presented in appendix E, figures 95 through 97.
