Publication No. FHWA-RD-99-027

**FULL-SCALE CRASH EVALUATION OF THE NETC 4-BAR
SIDEWALK-MOUNTED STEEL BRIDGE RAILING**

7. Author(s) Kimball, C.E., Mayer, J.B.		6. Performing Organization Code	
9. Performing Organization Name and Address Southwest Research Institute 6220 Culebra Road San Antonio, Texas 78238-5166		8. Performing Organization Report No. 18-8518

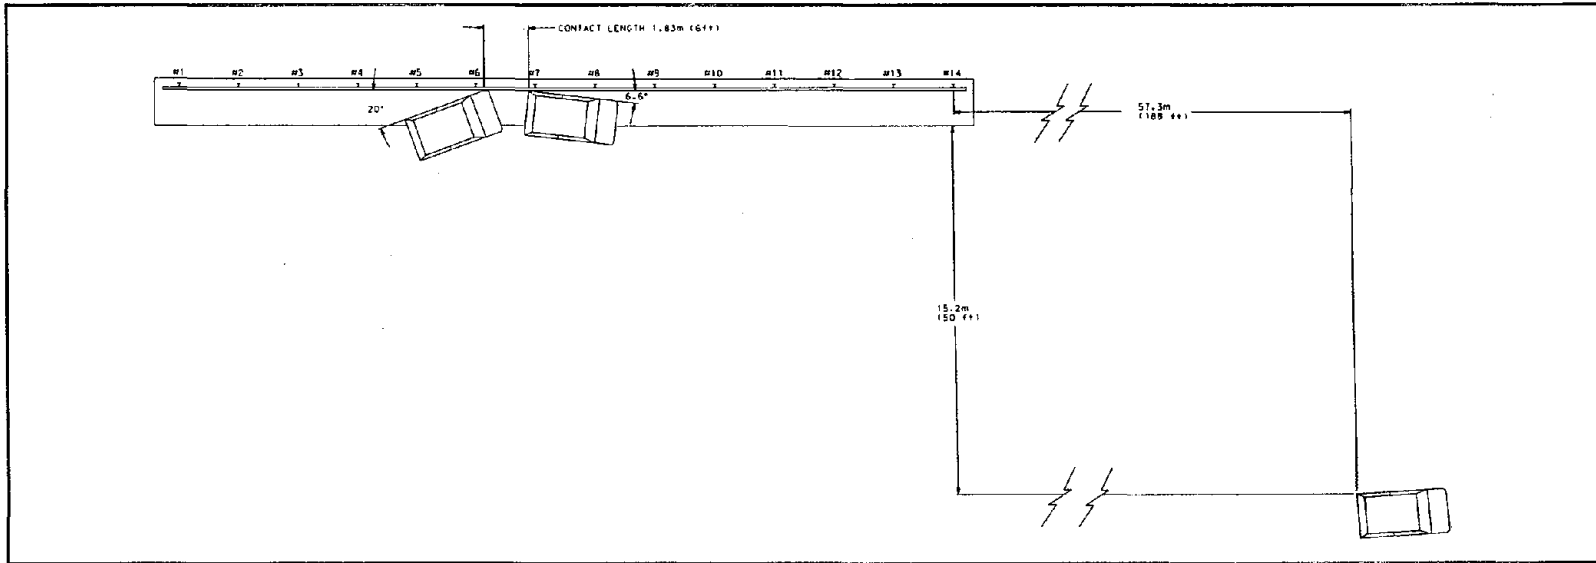
Figure 8. Impact sequence and summary of test conditions and results - Test NETC-1.

This was the first test of the series and utilized a small car as the test vehicle. As shown in the test summary diagram of figure 8, the vehicle traversed the sidewalk and impacted the barrier 610 mm downstream of post 6, maintaining contact with the longitudinal rails for 1.83 m as it was redirected, exiting the installation at a 6.6° angle (calculated from measured tire marks). Figures 9 and 10 show the redirection sequence of the vehicle from overhead as well as behind the barrier viewpoints. The post-impact trajectory of the vehicle was such that it traveled in a relatively straight line after loss of contact, coming to a stop 77 m downstream of initial

4. General Information		7. Test Vehicle (Continued)		10. Ridedown Acceleration (g's)	
Test Agency	Southwest Research Institute	Mass (kg) Dummy(s)	75	y-direction	*
Test Number	NETC-1	Mass (kg) Gross Static	902	11. Test Article Deflection (m)	
Test Date	11/18/97	8. Impact Conditions		Dynamic	0

5. Test Article		Speed (km/h)	100.0	Permanent	0
Type	Bridge Rail	Angle (deg)	20.0	12. Vehicle Damage	
Installation Length (m)	32.9	9. Exit Conditions		Exterior	
Barrier	4 Steel Rails	Speed (km/h)	18.3	VDS	11-FL-2

*No occupant risk data - lateral accelerometer malfunctioned during test.

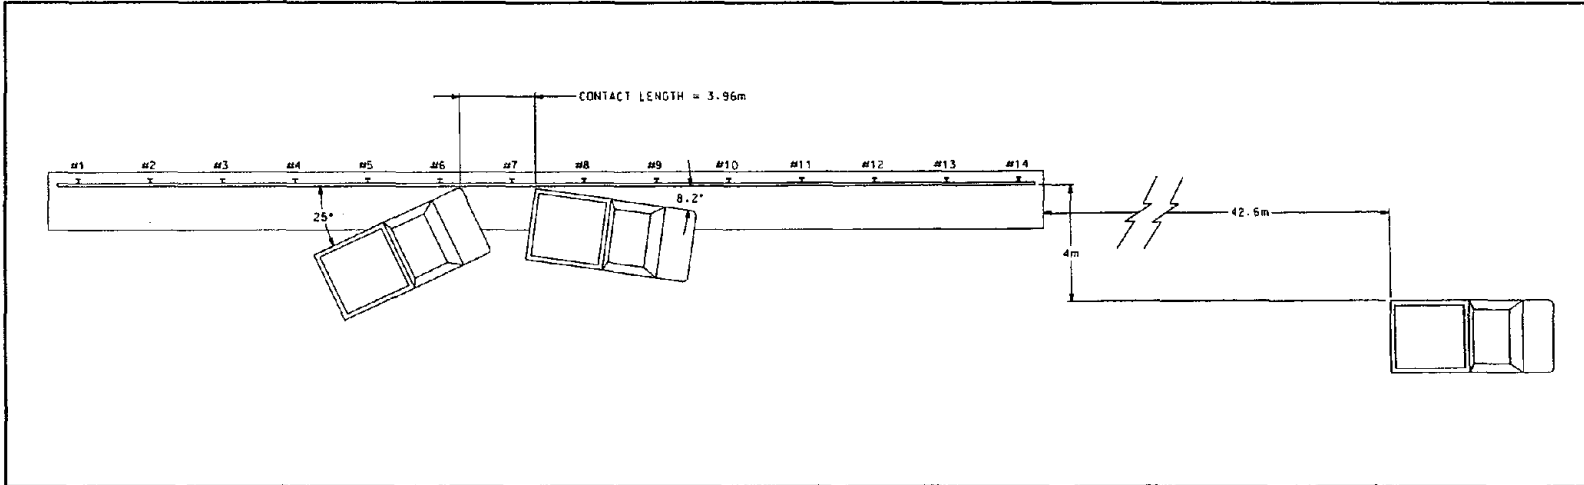
Figure 11. Impact sequence and summary of test conditions and results - Test NETC-2.

Test NETC-2. In this pickup truck test, as shown in figure 11, the vehicle traversed the sidewalk and impacted the barrier 610 mm downstream of post 6, maintaining contact with the longitudinal rails for 3.96 m as it was redirected, exiting the installation at an 8.2 degree angle (calculated from measured tire marks). Figures 12 and 13 show the redirection sequence of the vehicle from overhead as well as behind the barrier viewpoints. The post-impact trajectory of the vehicle was such that it traveled in a relatively straight line after loss of contact, coming to a stop 62 m downstream of the initial impact point (brakes had been applied immediately after loss of contact with the barrier). Three of the vehicle accelerometers, the lateral accelerometer at the c.g. and the longitudinal accelerometers mounted on the instrument panel and bottom of the engine, malfunctioned at impact, resulting in no data on those channels. The net effect of the data loss from the lateral accelerometer was that the 50 msec average vehicle acceleration and occupant risk values in the lateral direction could not be calculated. However, the more important (for this test) longitudinal factors could be calculated and were as follows:

4. General Information		7. Test Vehicle (Continued)		10. Ridedown Acceleration (g's)	
Test Agency	Southwest Research Institute	Mass (kg) Dummy(s)	75	y-direction	*
Test Number	NETC-2	Mass (kg) Gross Static	2,109	11. Test Article Deflection (mm)	
Test Date	11/20/97	8. Impact Conditions		Dynamic	25 (est.)

5. Test Article		Speed (km/h)	100.0	Permanent	13
Type	Bridge Rail	Angle (deg)	25.0	12. Vehicle Damage	
Installation Length (m)	34.1	9. Exit Conditions		Exterior	
Barrier	4 Bar, Sidewalk-Mounted	Speed (km/h)	17	VDS	11-FL-3

*No data - vehicle lateral accelerometer malfunctioned during test.

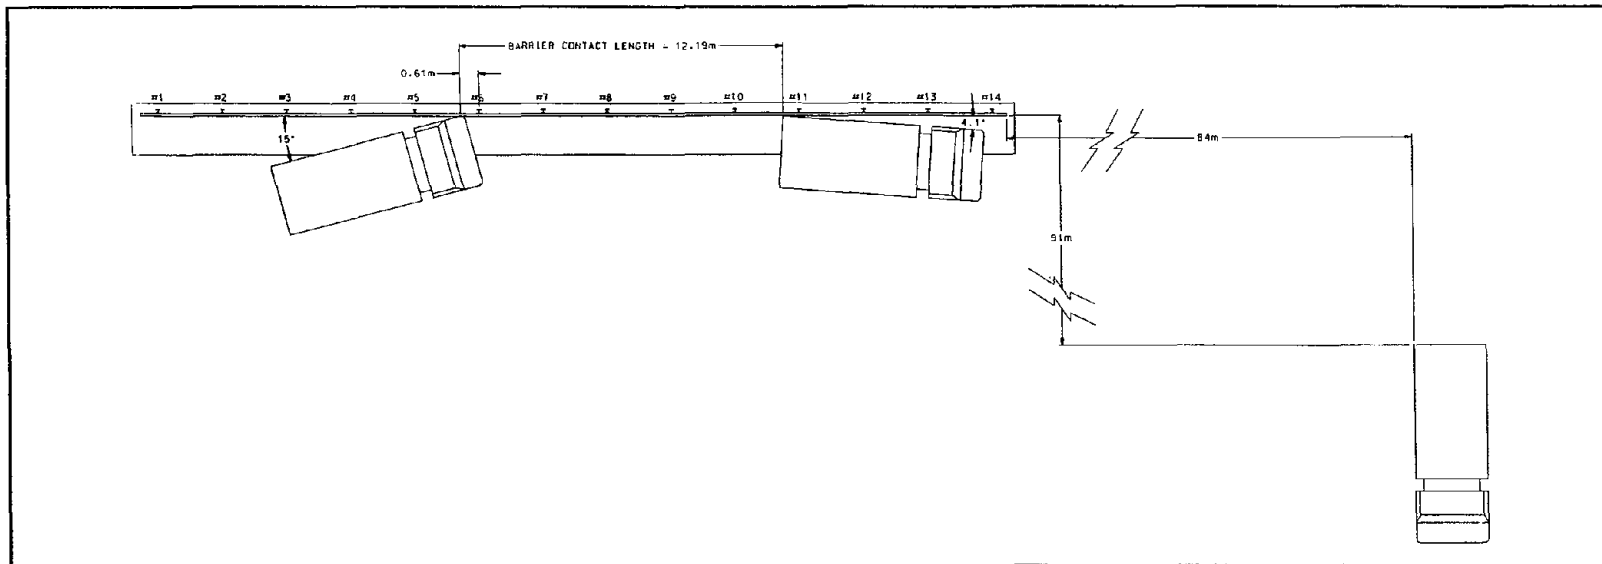
Figure 14. Impact sequence and summary of test conditions and results - Test NETC-3.

Test NETC-3. As shown in the test summary diagram of figure 14, the single-unit van truck traversed the sidewalk and impacted the barrier 610 mm upstream of post 6, deflecting the two top rails approximately 25 mm at the splice between posts 6 and 7 while maintaining contact with the longitudinal rails for 12.19 m as it was redirected. The vehicle then exited the barrier at a 4.1 degree angle (calculated from measured tire marks). Figures 15 and 16 show the redirection sequence of the vehicle from overhead as well as behind the barrier viewpoints. Since the front axle was dislodged during the impact, the vehicle veered hard to the right after exiting and stopped 84 m downstream and 91 m normal to the test installation. Although some of the vehicle accelerometers had interruptions in their data due to the impact, only one, the longitudinal accelerometer mounted on the bottom of the engine, suffered complete data loss. Maximum 50 msec average accelerations in the longitudinal and lateral directions were -2.72 g's and -5.79 g's , respectively. Occupant risk values were as follows: (1) the occupant impact velocities were 1.65 m/sec in the longitudinal direction and -2.89 m/sec in the lateral direction, and (2) the maximum occupant ridedown accelerations were -8.95 g's in the longitudinal direction and 14.30 g's in the lateral direction.

4. General Information		7. Test Vehicle (Continued)		10. Ridedown Acceleration (g's)	
Test Agency	Southwest Research Institute	Mass (kg) Dummy(s)	N/A	y-direction	14.30
Test Number	NETC-3	Mass (kg) Gross Static	8,108	11. Test Article Deflection (mm)	
Test Date	12/18/97	8. Impact Conditions		Dynamic	25

5. Test Article		Speed (km/h)	80	Permanent	13
Type	Bridge Rail	Angle (deg)	15.0	12. Vehicle Damage	
Installation Length (m)	34.1	9. Exit Conditions		Exterior	
Barrier	4 Rails, Sidewalk-Mounted	Speed (km/h)	57.6	VDS	N/A

6. Soil Type and Condition	N/A	Angle (deg)	4.1	CDC	N/A
7. Test Vehicle		10. Occupant Risk Values		Interior	
Type	Production	Impact Velocity (m/s)		OCDI	N/A
Designation	8000S	x-direction	1.65	13. Post-Impact Vehicular Behavior	
Model	1993 International 4600 LP	y-direction	-2.89	Maximum Roll Angle (deg)	20 Approximate
Mass (kg) Curb	8,108	Ridedown Acceleration (g's)		Maximum Pitch Angle (deg)	5 Approximate
Mass (kg) Test Inertial	8,108	X-direction	-8.95	Maximum Yaw Angle (deg)	N/A
