FINAL REPORT ~ FHWA-OK-17-03

OVERTURNING FORCES AT BRIDGE ABUTMENTS AND THE INTERACTION OF HORIZONTAL FORCES FROM ADJACENT ROADWAYS

January 2018

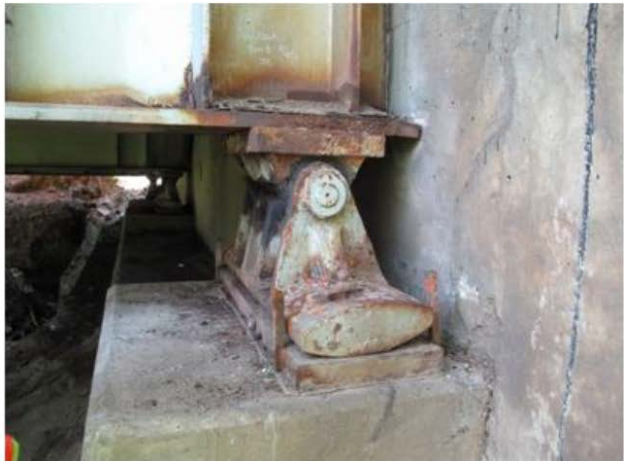
The US 64 Westbound over Shell Creek (NBI No. 18141) is located in Tulsa County, Oklahoma. This bridge is experiencing number of problems related to the interactions between bridge abutments and adjacent roadways. These problems include, expansion joints closing (Figure 13), roller support bearings tilting (Figure 14), and beams pushing against abutment backwalls (Figures 14 and 15).

Figure 14. Northern most rocker bearing (before and after straightening) and girder on the west abutment of the Shell Creek Bridge

The Shell Creek Bridge is experiencing number of problems related to the interactions between bridge abutments and adjacent roadways, including expansion joints closing, roller support bearings tilting, and beams pushing against abutment backwalls. It is likely that these problems are related to both pavement pressure and lateral displacements of the approach embankments. The tilting of the bearings (Figure 14) indicate that the major contributing factor for the distresses observed is the pavement pressure.

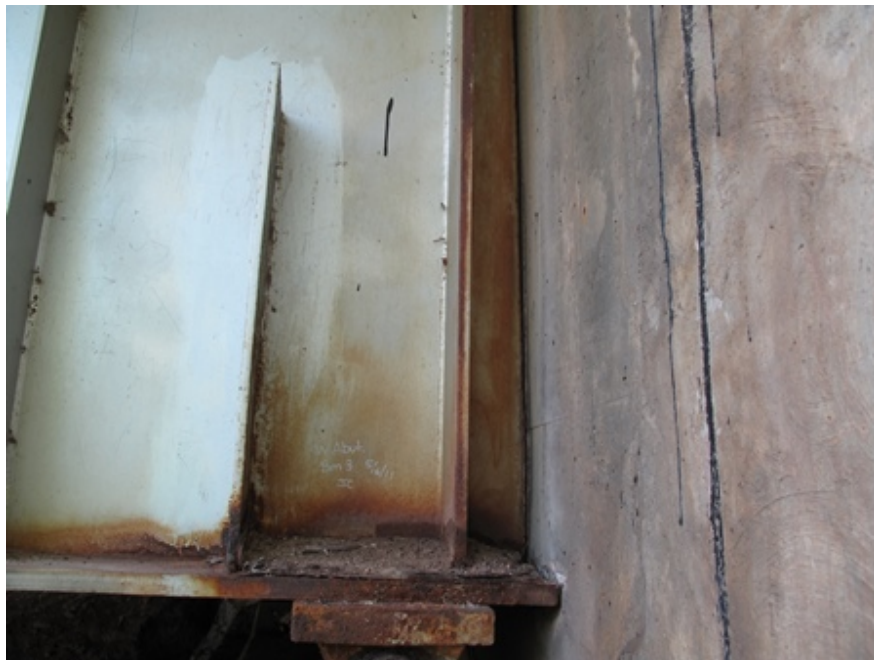
Figure 15. A beam pushing against an abutment backwall on the Shell Creek Bridge

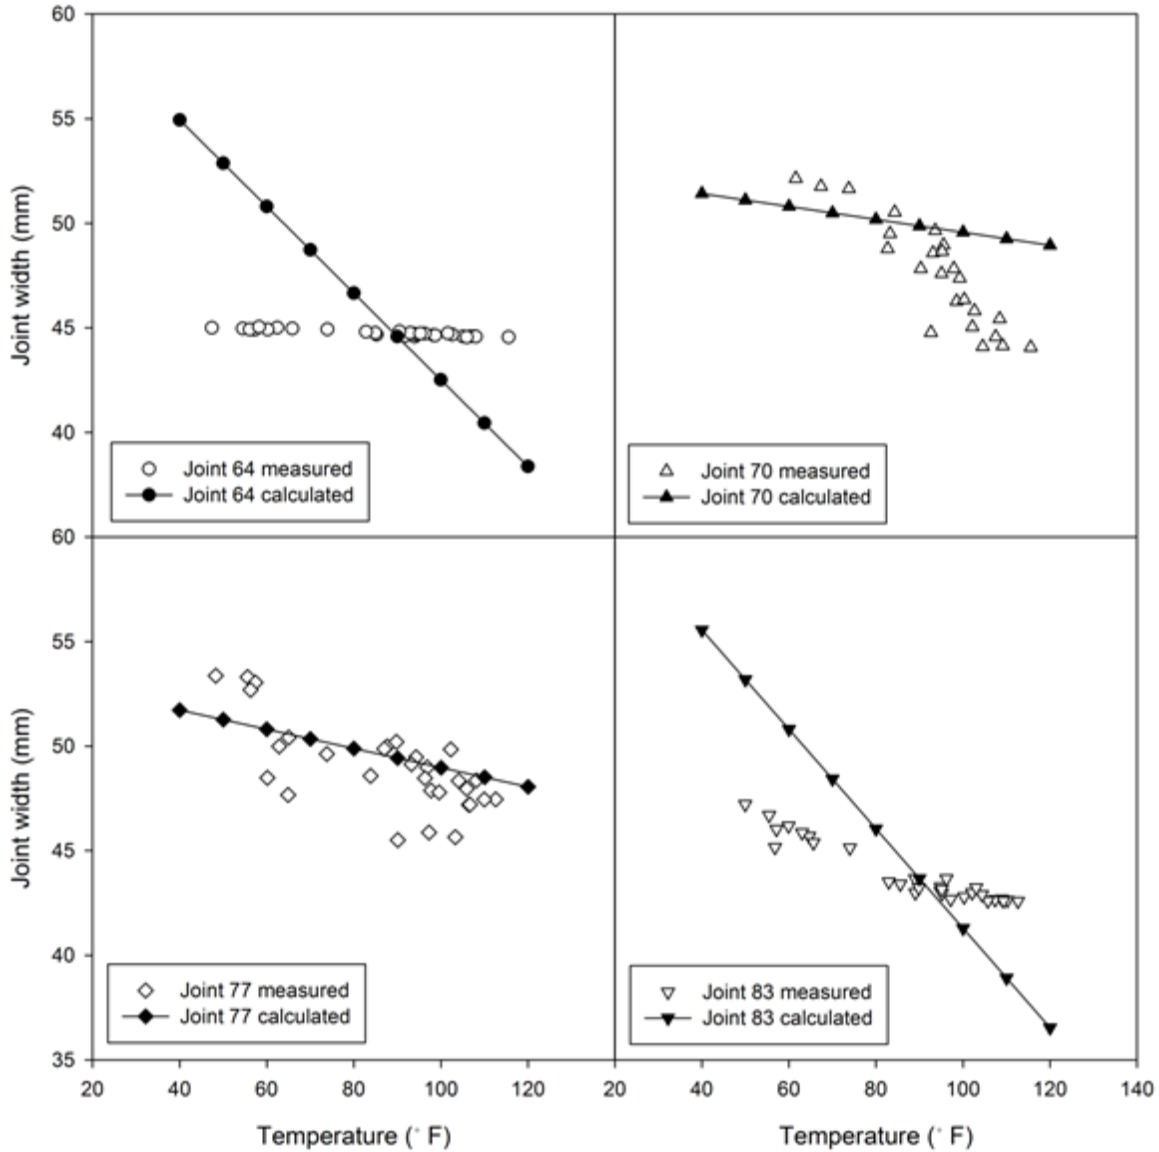
The variations of joint widths with temperature for I-244 bridges are shown in Figures 28-31. Except for Joint 70 (Figure 31), for all other interior joints, the measured variations

Figure 31. Joint Widths of Expansion Joints for I-244 West over N. Detroit Ave. (NBI No. 18028)

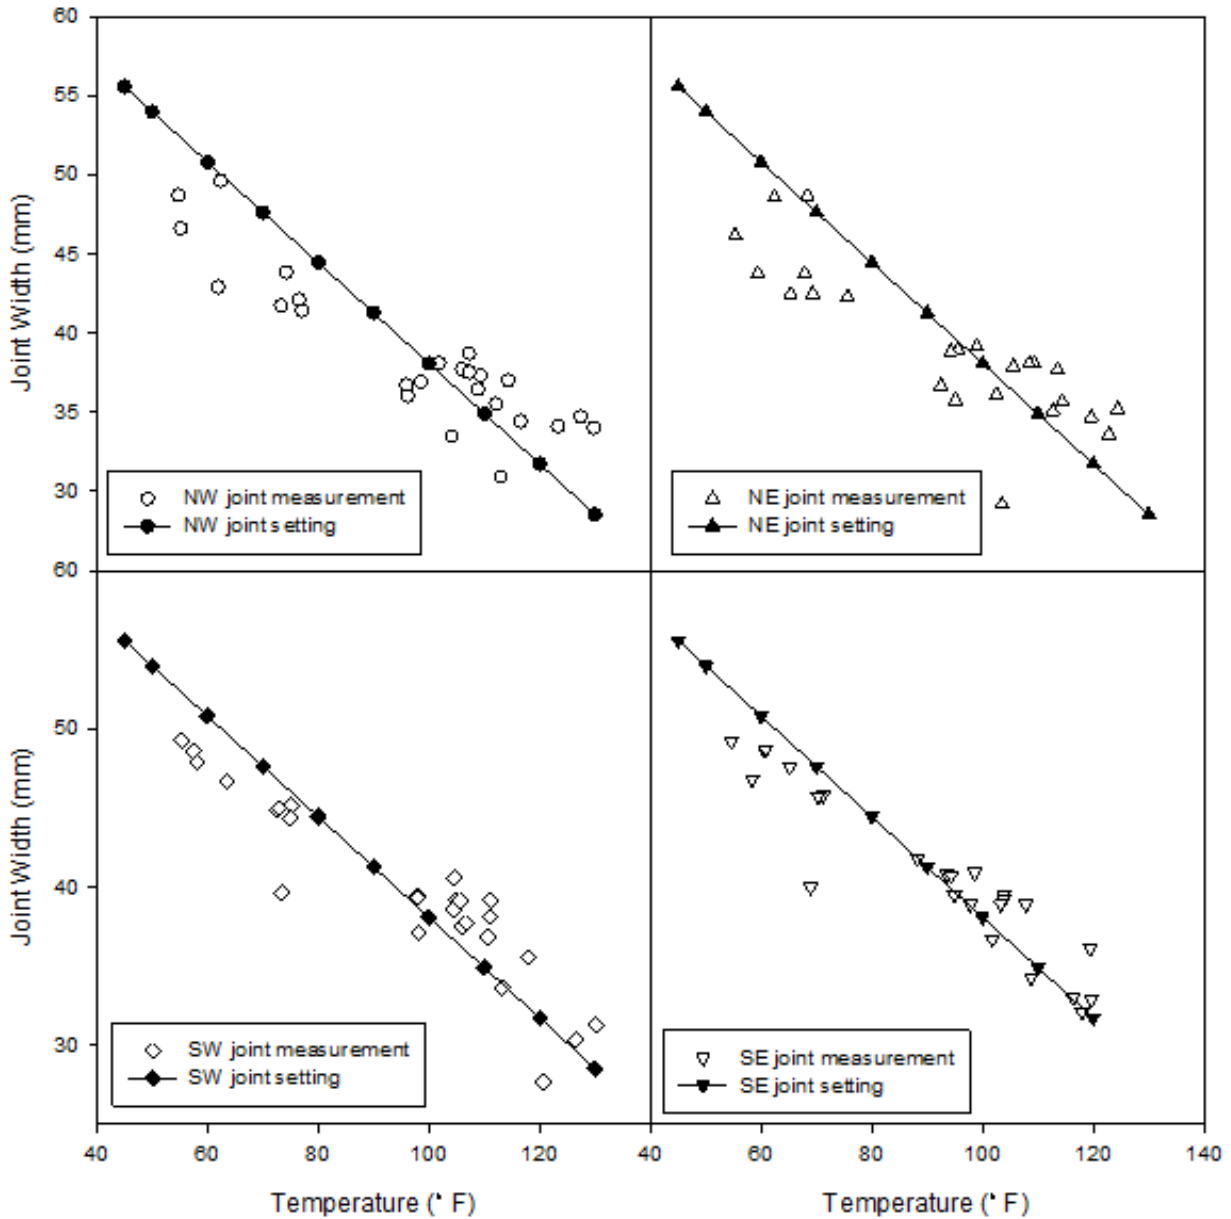
The expansion joints where measurements were taken for this bridge are shown in Figure 32. Measurements were taken on both east and west sides of the joints. The joint widths were measured and calculated in the same manner as for the I-244 Bridges. The measured joint widths are compared to the calculated widths in Figure 33. Based on this comparison, these joints also appeared to be functioning properly at this time.

Figure 33. Joint widths of expansion joints on SH 76 over Rush Creek

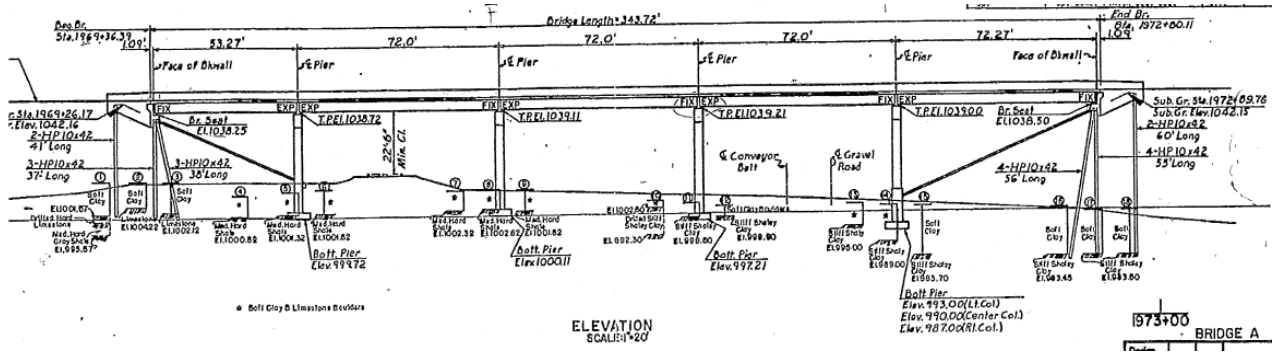
backwalls (Figures 36 and 37). These problems were noticed as early as in 1983. It is believed these problems were related to the lateral deformation of the embankments on top of the soft clay layer (see Figure 35) early in the life of the bridges. Rotation of the top of the anchor bolts towards the abutment backwall (Figure 36) and buckling/cracking of the slope wall (Figure 37) are strong evidence for lateral deformations of the approach embankments.

Figure 35. Elevation of the SH-3 north bridge over BNSF railroad

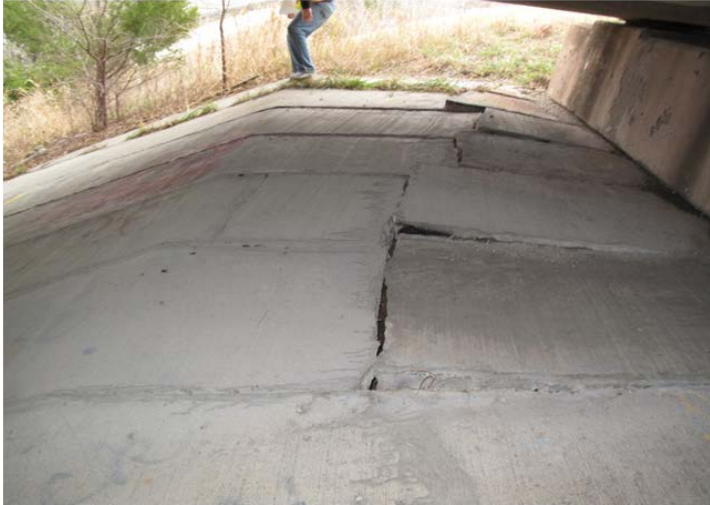
Figure 37. Cracks in the slope-wall

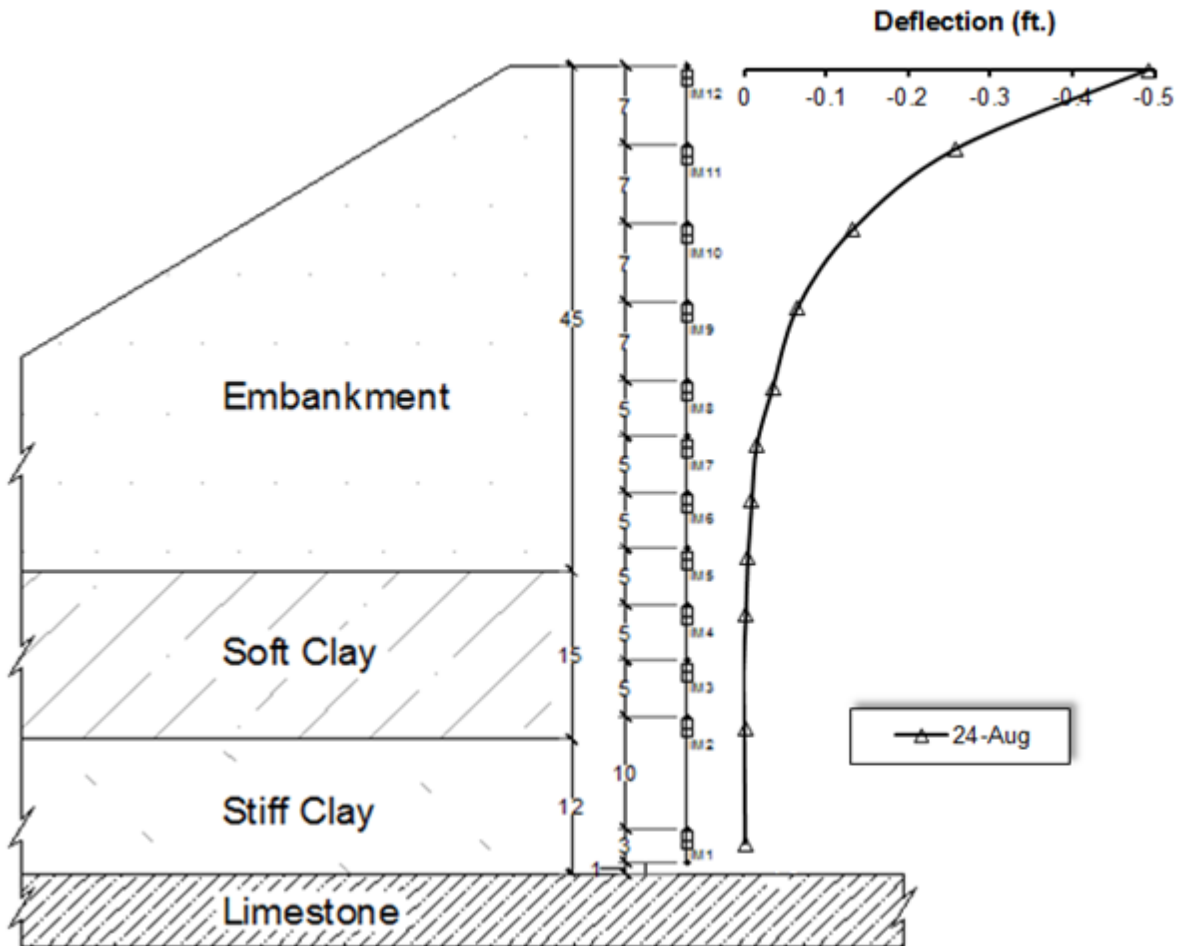
Selected inclinometer data are presented in Figures 53 and 54 (see Figure 39 for the locations). The deflection profile of the embankment on August 24, 2013 is shown in Figure 55. The data from the instruments indicate that the expansion joints are essentially closed and as the bridge heats the deck is pushing against the approach slab which in turn is transmitting these forces into the abutment and the approach embankment. As the bridge cools, the deck, abutment, and the embankment are all relaxing. While the trend in the measured inclinometer data is consistent with the above described behavior, the deflection magnitudes need further analyses and verification.

Figure 55. SH-3 bridges over BNSF railroad – eastern embankment deflection profile on August 24, 2013

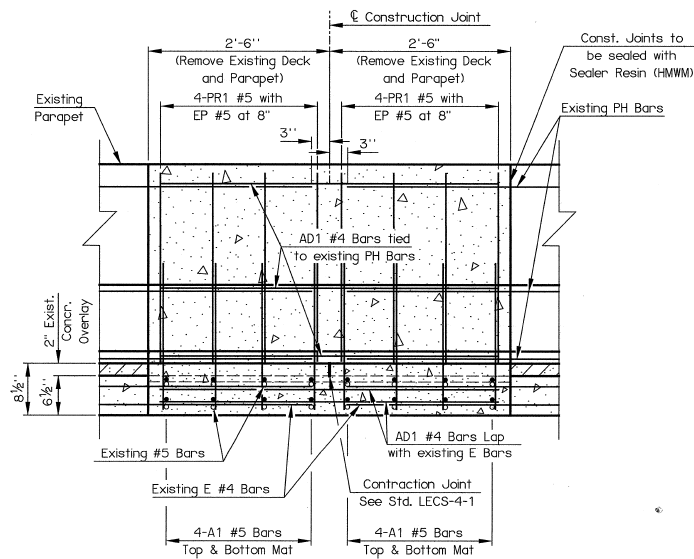
Figure 70. Details of new construction joints at Pier No. 2 and Pier No. 3 for SH-3 north bridge over BNSF railroad

The repairs to SH-3 north bridge, as shown in Figure 68, were done from August 2015 to January 2016. Two new sealed expansion joints were constructed at Piers No.1 and No.4. The design details of these expansion joints are given in Figure 69. The existing expansion joints at Piers No. 2 and No. 3 were eliminated and construction joints were created at these locations. The design details of these construction joints are given in Figure 70. The construction joints at the abutments were also rehabilitated. The design details of the rehabilitated construction joints at the abutments are given in Figure 71. In addition, several bearing assemblies and beam pedestals were repaired.

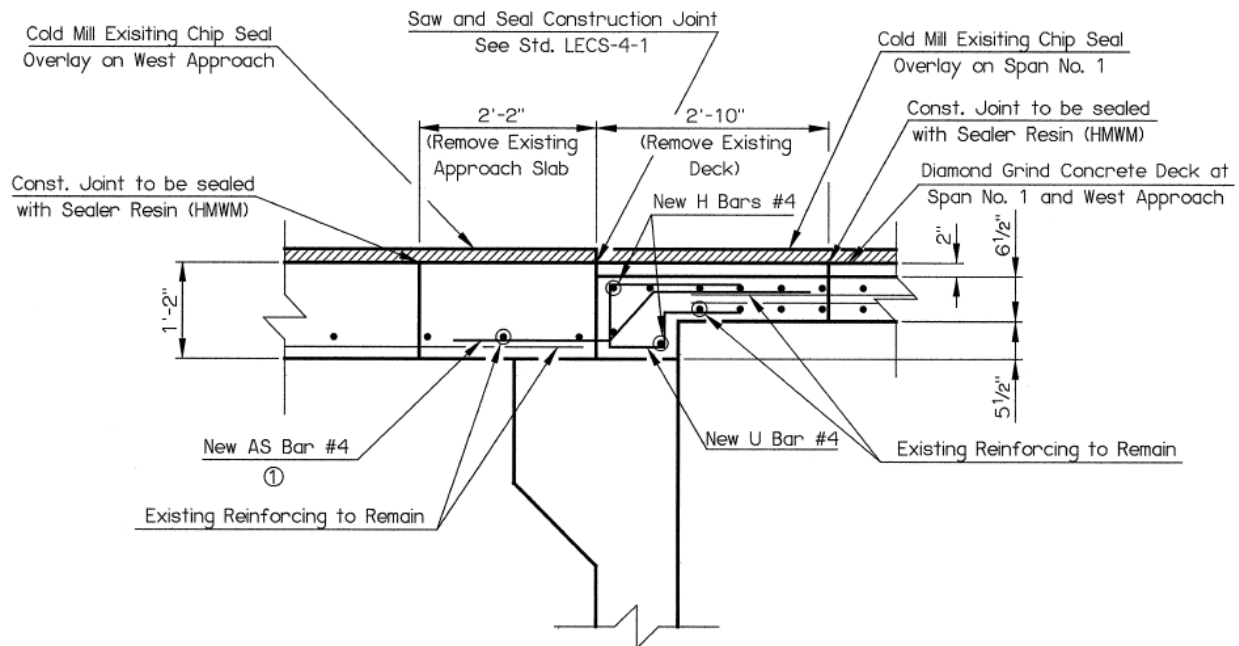
Figure 71. Details of rehabilitated construction joints at abutments for SH-3 north bridge over BNSF railroad

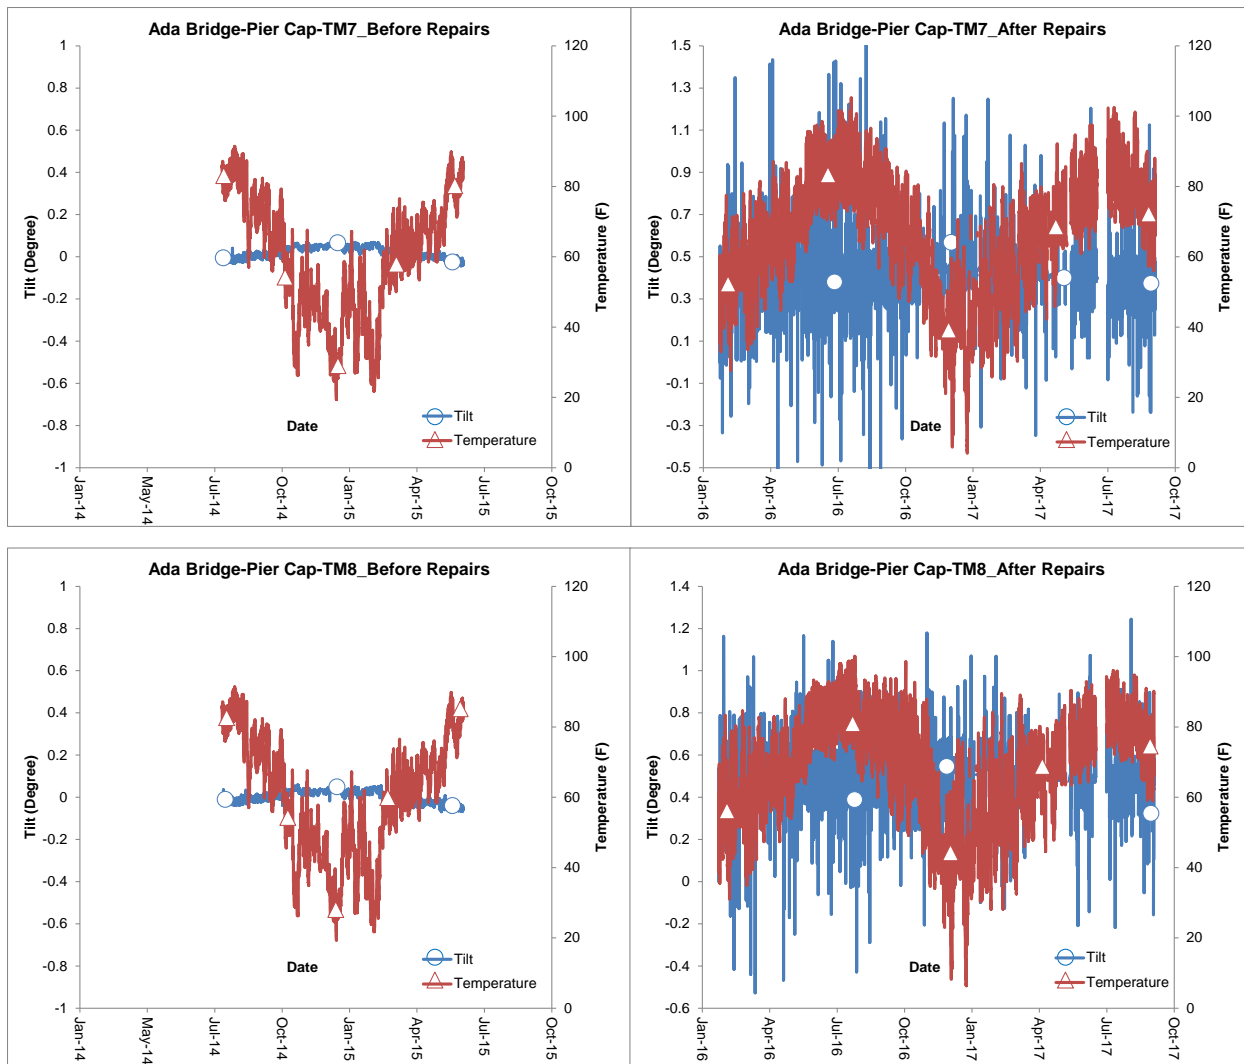
All tiltmeter data and corresponding temperature data for tiltmeters installed on pier caps of the north bridge are presented in Figures 80 – 83. Some of the tiltmeter data is too noisy and may indicate malfunctioning tiltmeters. There is generally an opposite trend between tilt and temperature variations for TM1-4 and TM7-8. Substantially more daily variations in tilt can be seen after the repairs. Same trend between tilt and temperature variations is observed for TM5. When the temperature increases, the Pier No.3 is tilting away from Abutment No. 2 (eastern abutment). These observations seem to indicate that the repairs to SH-3 North Bridge are working as intended.

Figure 80. SH-3 north bridge over BNSF railroad – pier cap tiltmeter TM1 and TM2 data after repairs

Figure 81. SH-3 north bridge over BNSF railroad – pier cap tiltmeter TM3 and TM4 data after repairs

Figure 82. SH-3 north bridge over BNSF railroad – pier cap tiltmeter TM5 data after repairs

Figure 83. SH-3 north bridge over BNSF railroad – pier cap tiltmeter TM7 and TM8 data after repairs

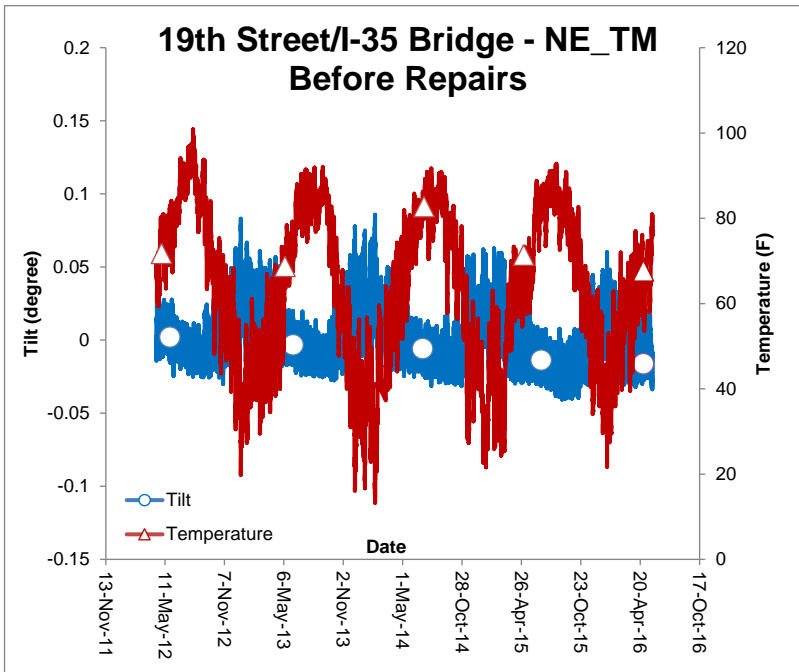
Figure 97. Eastside of the 19th Street/I-35 Bridge – northeast tiltmeter (NE_TM) data before repairs

Figure 97 shows the data collected by the northeast tiltmeter. It can be seen that as the temperature increases the tilt decreases and vice versa. This indicates as the temperature rises from winter to summer the abutment tilts toward the approach pavement. Same behavior can also be observed in the southeast tiltmeter (Figure 98) as well as the tiltmeters located on the western abutment (see for example, Figure 99 and 100). The maximum measured tilts are, however, larger for the southeast and southwest tiltmeters than for their northern counterparts.

As seen from the eastern tiltmeter data (Figures 97 and 98), the south section of the eastern abutment backwall tilts more than the north section. This is likely because on the south side of the eastern pavement, there is additional space between the approach slab and approach pavement along the construction joint for the bridge deck/approach slab to thermally expand and contract during temperature cycles. An observation that supports this interpretation is that there is far more spalling of concrete/U-shaped cracks on the southern side of the east abutment backwall than the northern side. As the overstressed abutment backwall tilts back and forth, it leads to U-shaped cracks and eventual spalling of concrete. Therefore, more tilting on the south side leads to more cracking and spalling on this side. As mentioned earlier, prior to

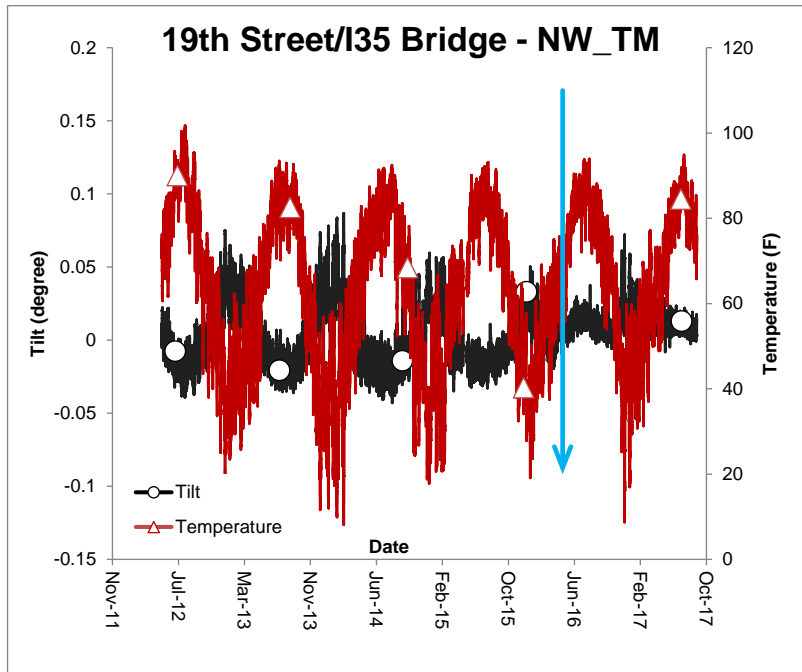
Figure 99. Westside of the 19th Street/I-35 Bridge – northwest tiltmeter (NW_TM) data

It appears from the data presented that thermal expansion of the bridge deck is controlling the behavior of the abutment backwall. It can be assumed that at this point the bridge deck

cannot thermally expand toward the center because of the closed center expansion joint. As a result, as the temperature rises, the bridge deck expands outward and pushes on the both eastern and western approach slabs. The opposite is true when the temperature decreases. As the approach slabs moves toward the approach pavements the friction from the approach slabs and bridge deck “drags” the abutment back walls with the approach slabs. Figure 101 shows a cross-section through the bridge deck, abutment back wall, and approach slab. As seen from this figure, the bridge deck and the approach slab are tied together with reinforcing steel. This means that for all practical purposes the bridge deck and approach slab are acting together as a single structural element.

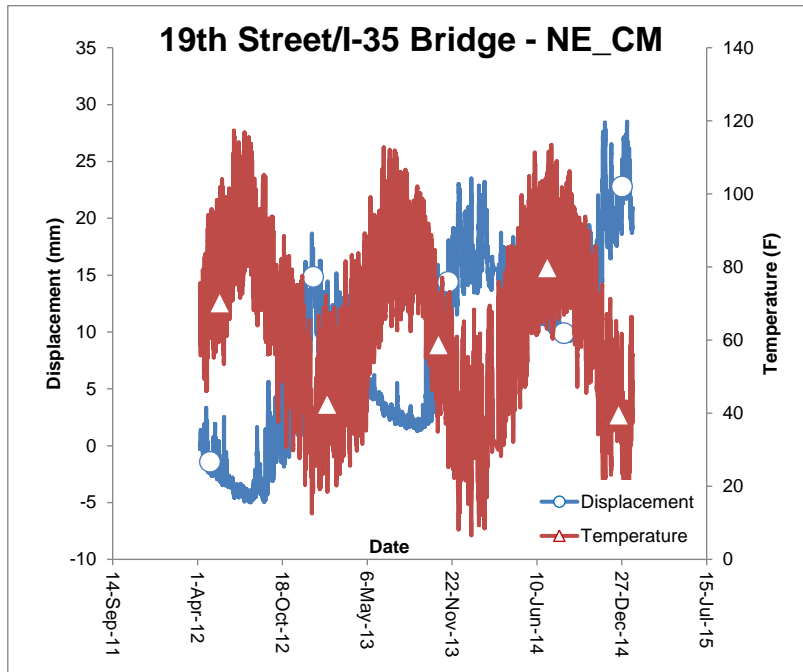
Figure 103. Eastern side of the 19th Street/I-35 Bridge – northeast crackmeter NE_CM data before repairs

If Figure 103 is compared with Figure 104, larger amplitudes can be seen in the southeast crackmeter when compared to the northeast crackmeter. This comparison is similar to that made between the northeast and southeast tiltmeters. This likely means that there is additional room at the construction joint between the east approach slab and the east approach pavement at the south side for expansion and contraction of the approach pavement to occur. The amplitude of expansion or contraction is larger on eastern side than the western one. The reason for this may be that the approach slab and the approach pavement are locked together more on the western side.

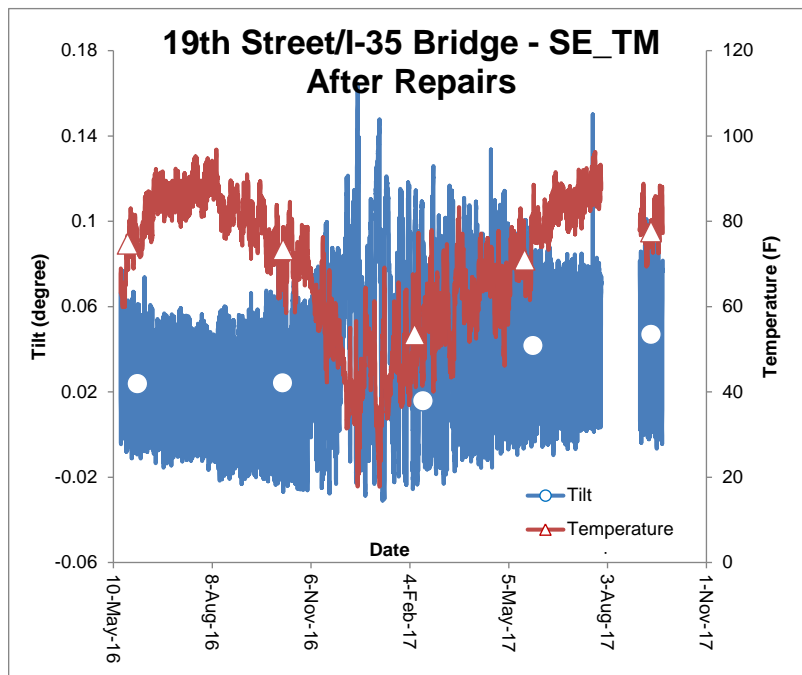
Figure 122. Eastern side of the 19th Street/I-35 Bridge – comparison of southeast tiltmeter SE_TM data before and after repairs

Figures 122 and 123 show the data trends for tiltmeters located on each corner of the eastern abutment backwall before and after repairs. The same time period from 2014 and 2016 is used to compare data from before and after repairs. Same trend in tilt can be observed before and after repairs, i.e., as the temperature increases the tilt decreases and vice versa. Substantially more daily variations in tilt can, however, be seen after the repairs. This is likely because the deck/approach slab has now more space to expand/contract into the pressure relief joint.

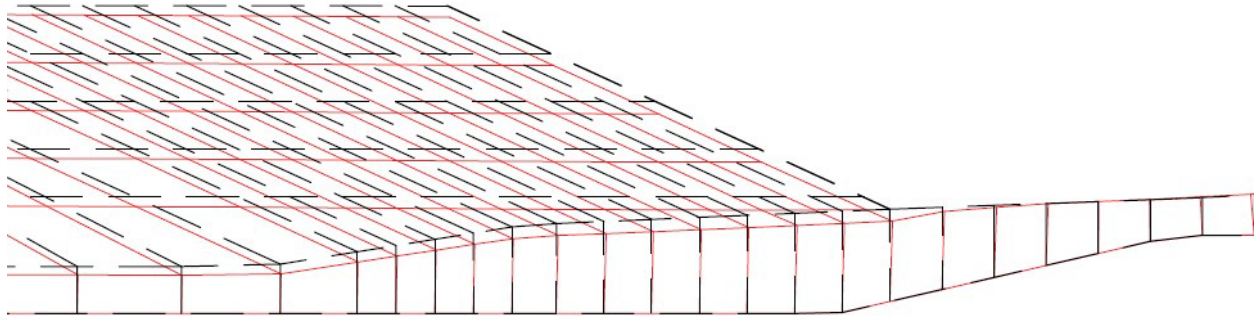
Figure 132. Saturated finite element analysis deformed mesh

The results of the saturated analysis showed a horizontal displacement at the crest of the embankment of 0.512 feet or 6 inches. The vertical displacement for the saturated analysis was calculated at 2.25 feet. As mentioned previously it is not believed the embankment settled this

entire amount. This vertical and horizontal displacement of the embankment near the crest can be seen in Figure 132 below. In the figure the original mesh is shown by dash lines and is slightly taller than the deformed mesh which is shown by solid lines.
